# IndianOil

## JOURNEY RISK MANAGEMENT (JRM) STUDY

### Salem Terminal TO VADIVELAN AGENCIES

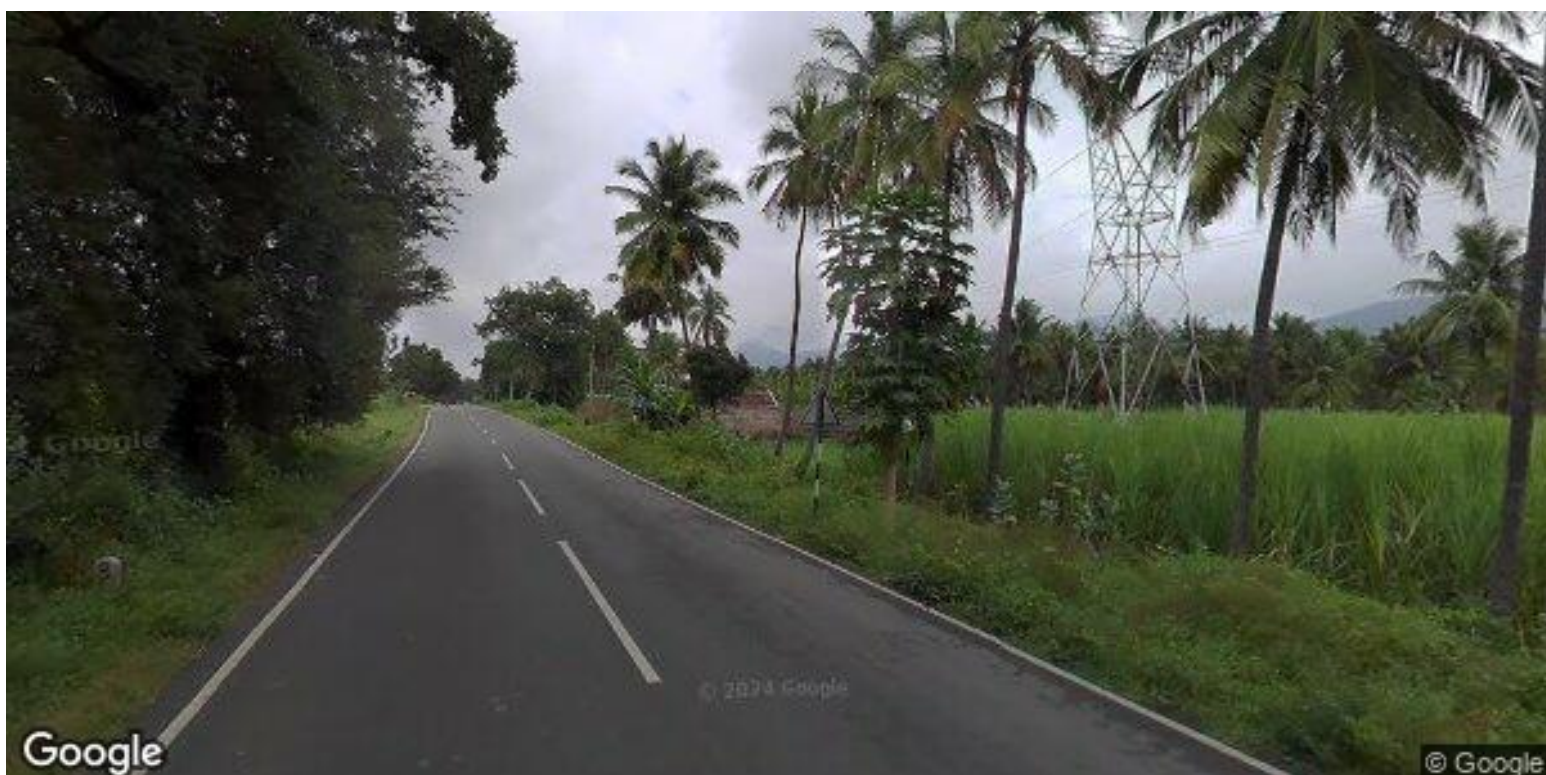
**Coordinates:** 11.84832, 78.36115

**Risk Type:** Turn

**Risk Level:** Medium

**Speed Limit:** 30 KM/Hr

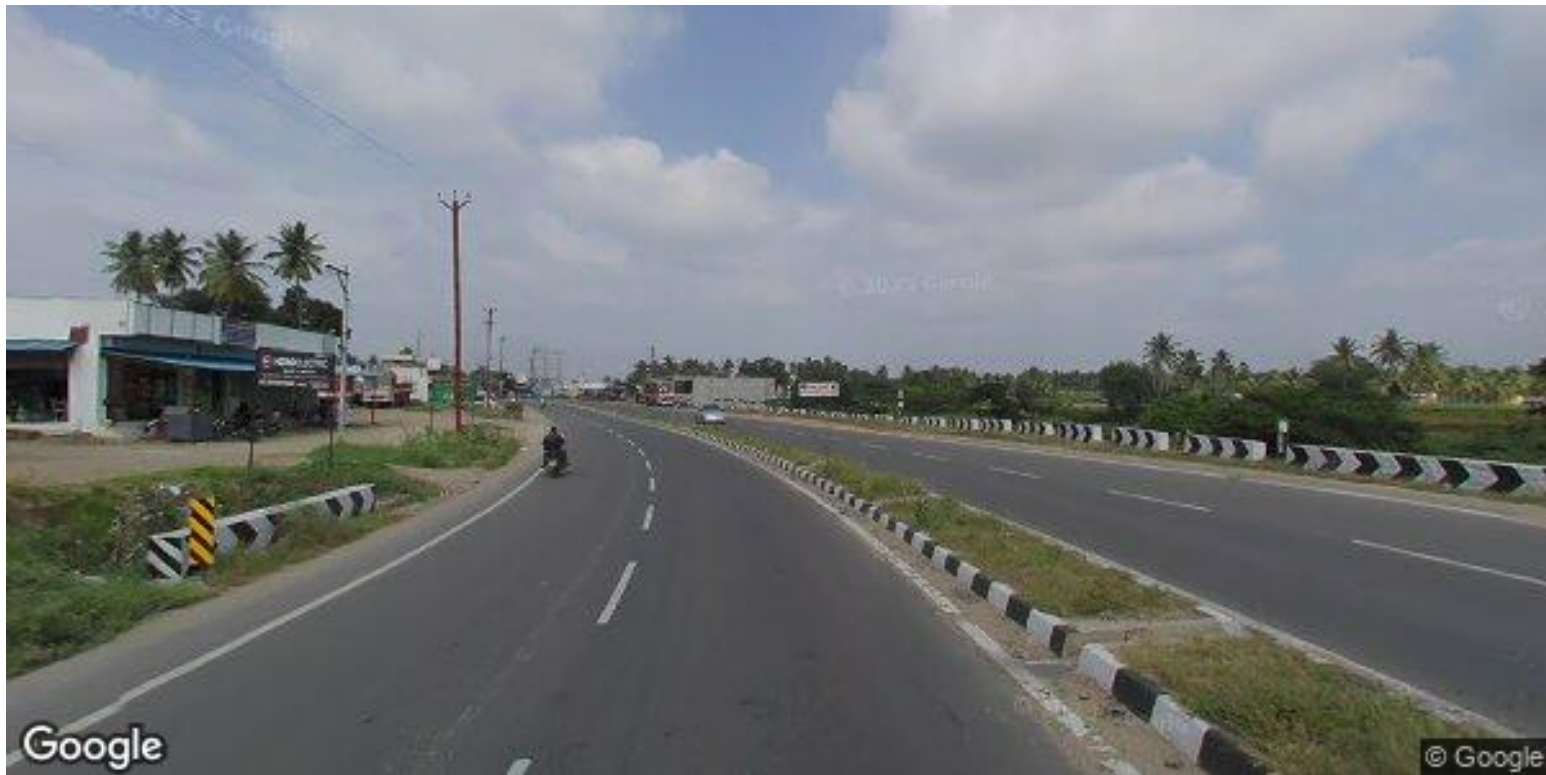
**Coordinates:** 12.04286, 78.48352

**Risk Type:** Turn

**Risk Level:** Medium

**Speed Limit:** 30 KM/Hr

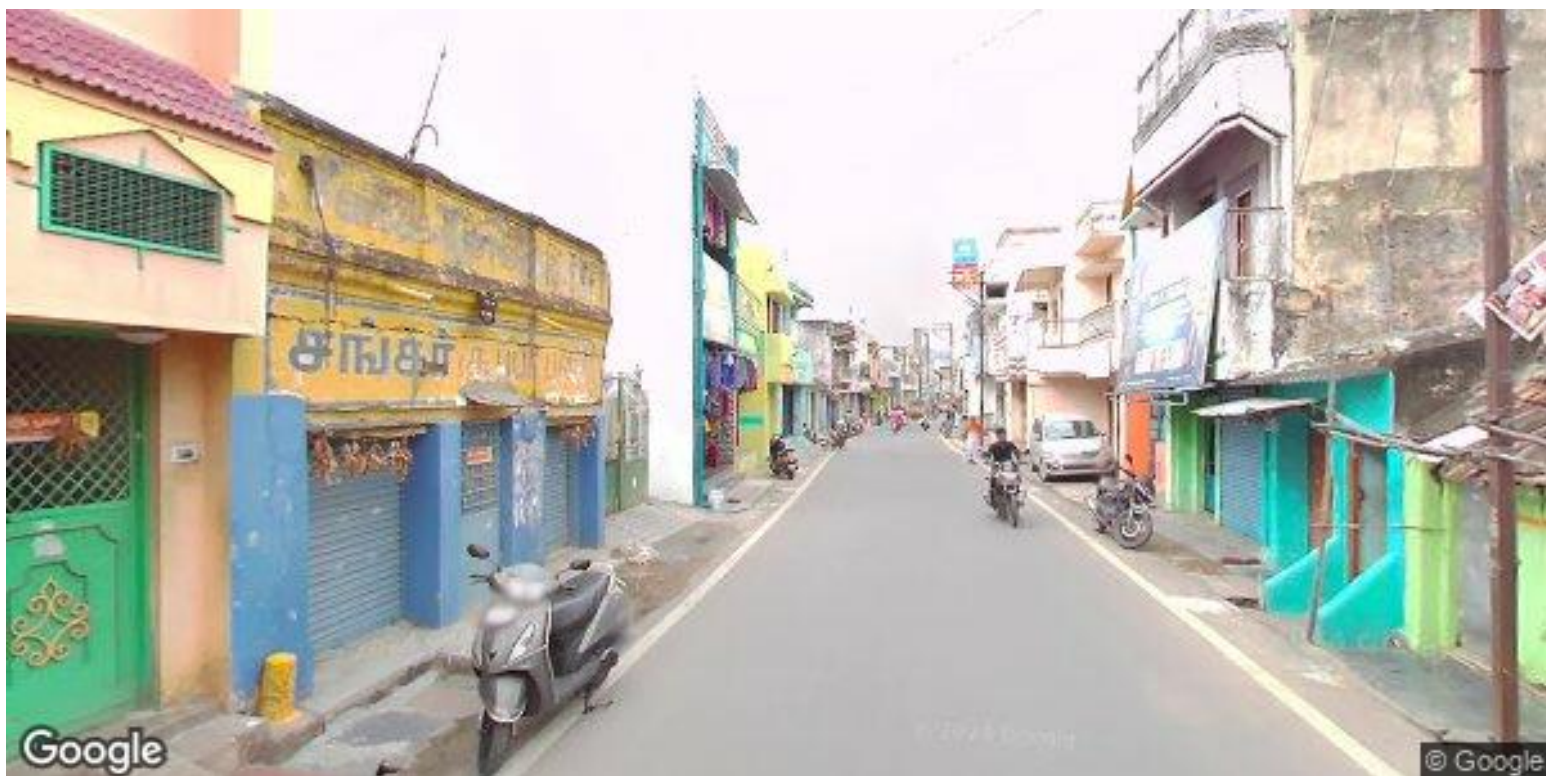
**Coordinates:** 12.05026, 78.48298

**Risk Type:** Turn

**Risk Level:** Medium

**Speed Limit:** 30 KM/Hr

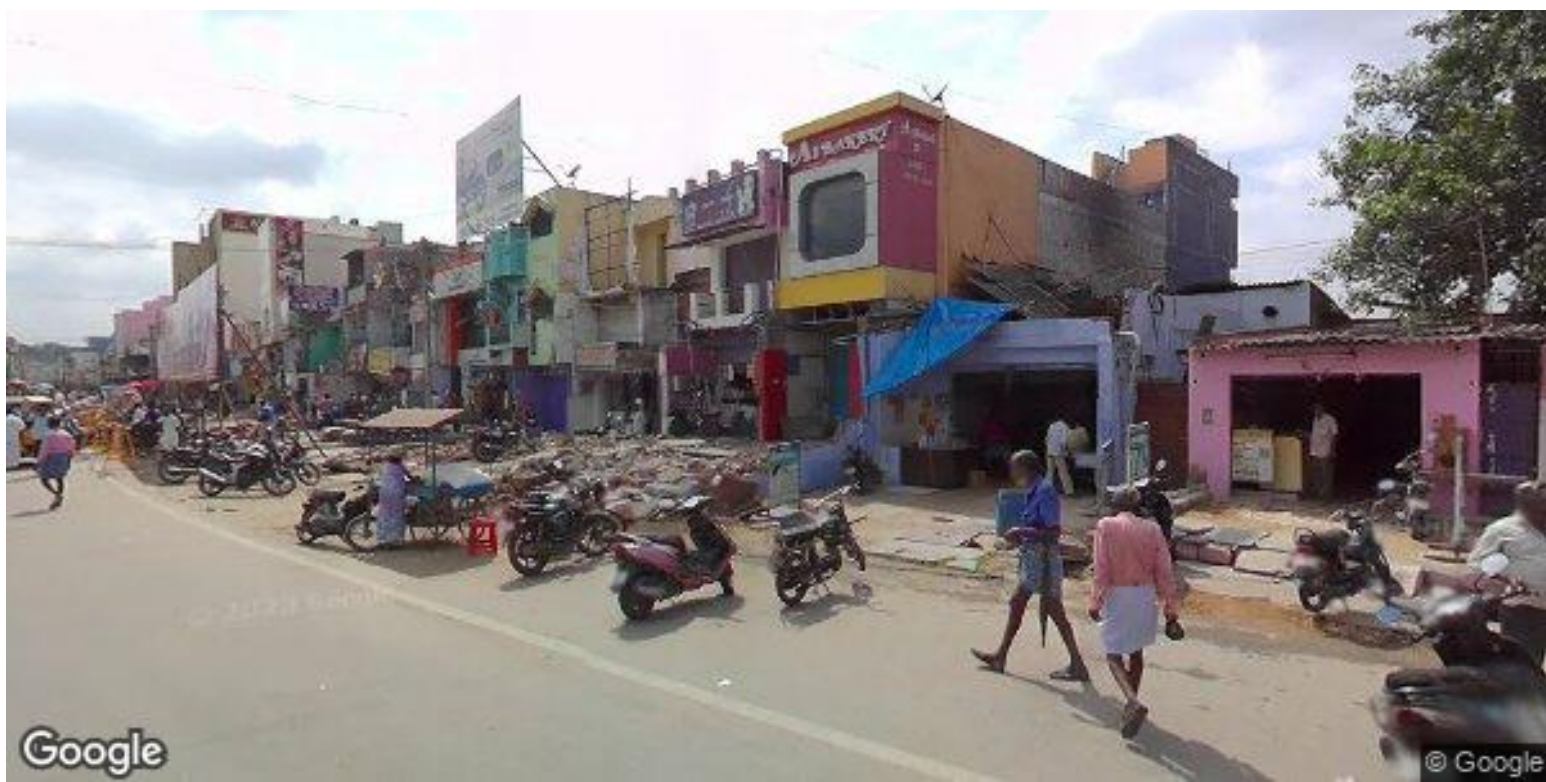
**Coordinates:** 12.05407, 78.48313

**Risk Type:** Turn

**Risk Level:** Medium

**Speed Limit:** 30 KM/Hr

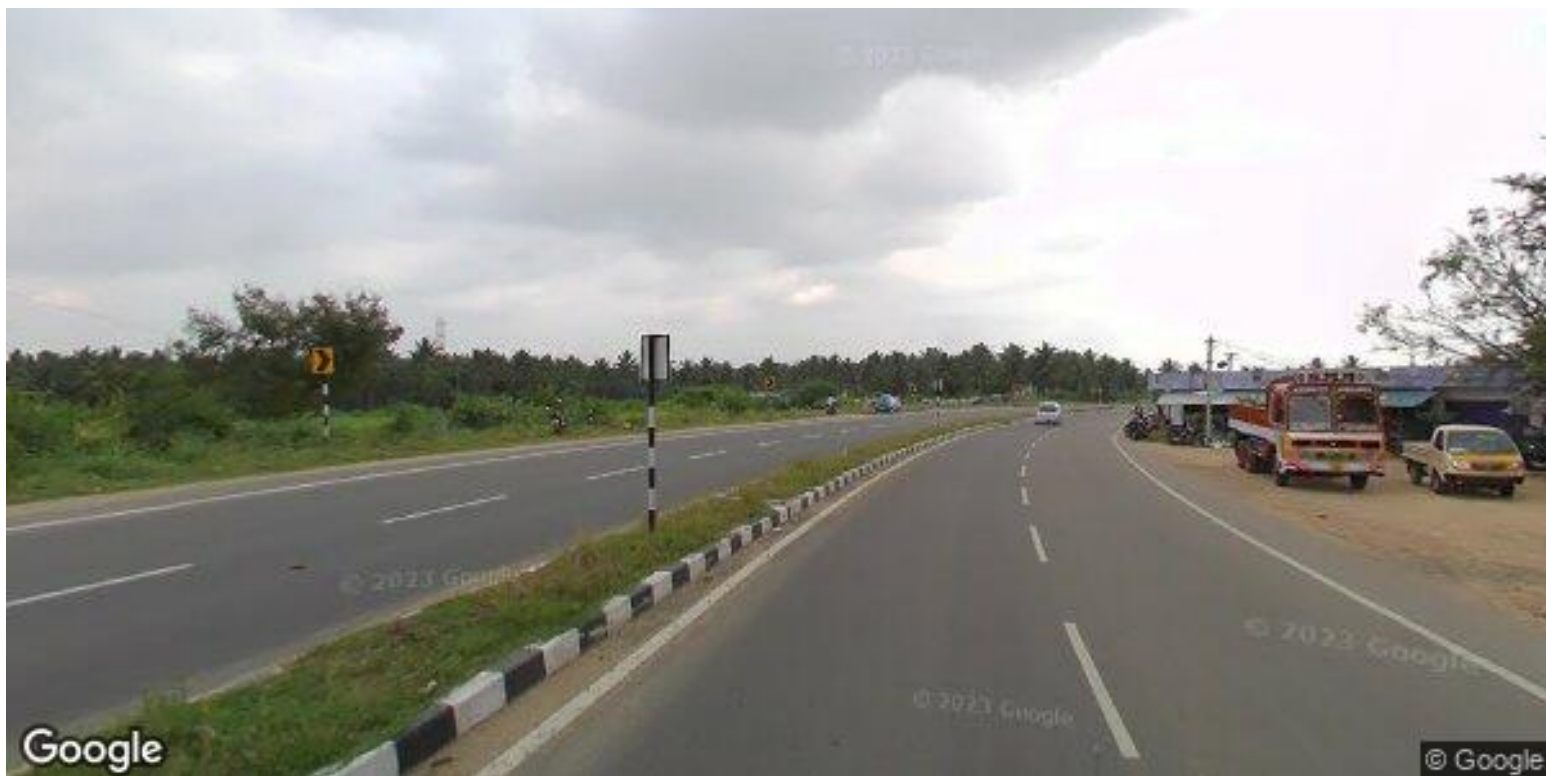
**Coordinates:** 12.07232, 78.47720

**Risk Type:** Turn

**Risk Level:** Medium

**Speed Limit:** 30 KM/Hr

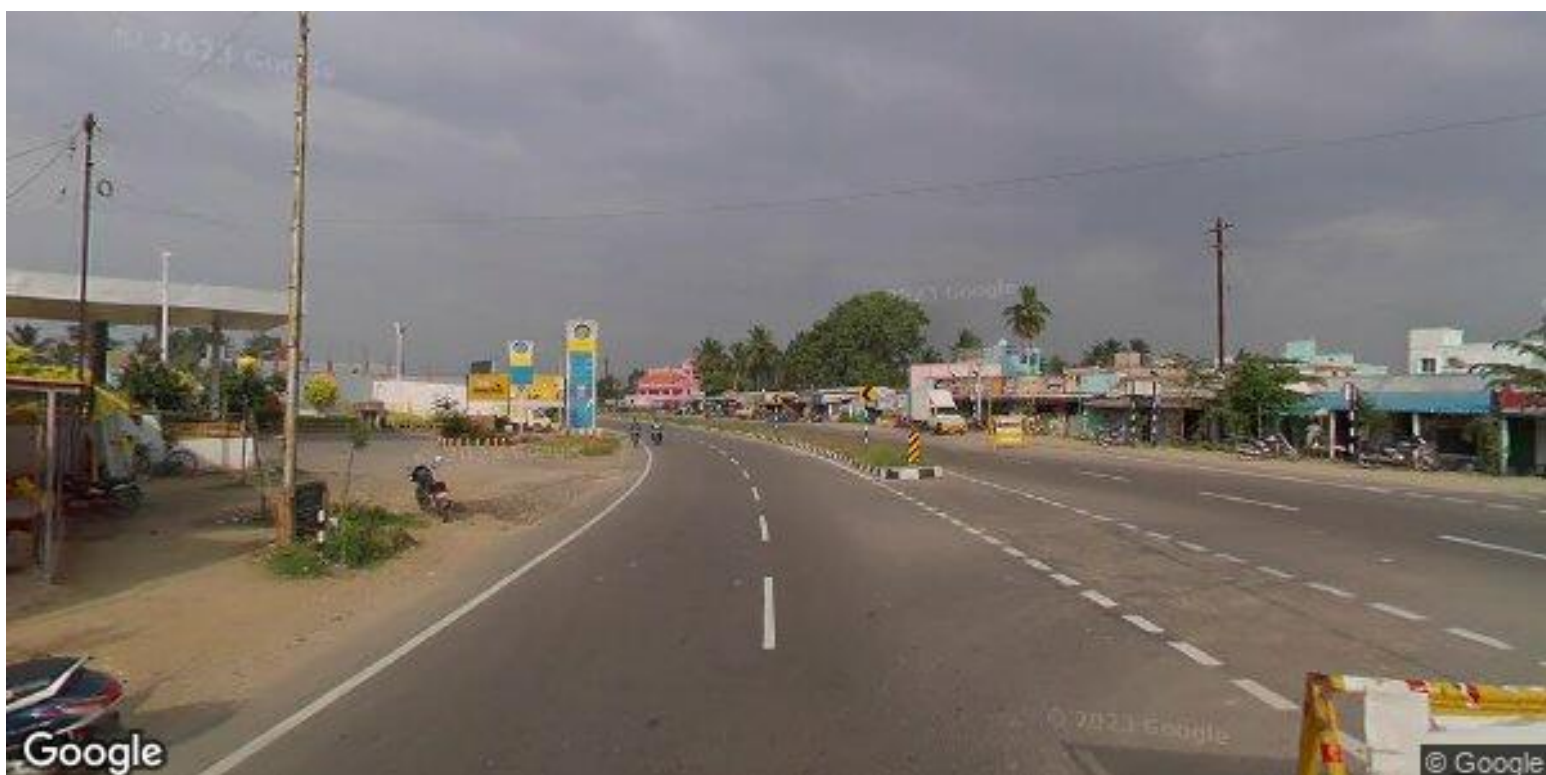
**Risk Type:** Turn  
**Risk Level:** Medium  
**Speed Limit:** 30 KM/Hr  
**Coordinates:** 12.17751, 78.54783

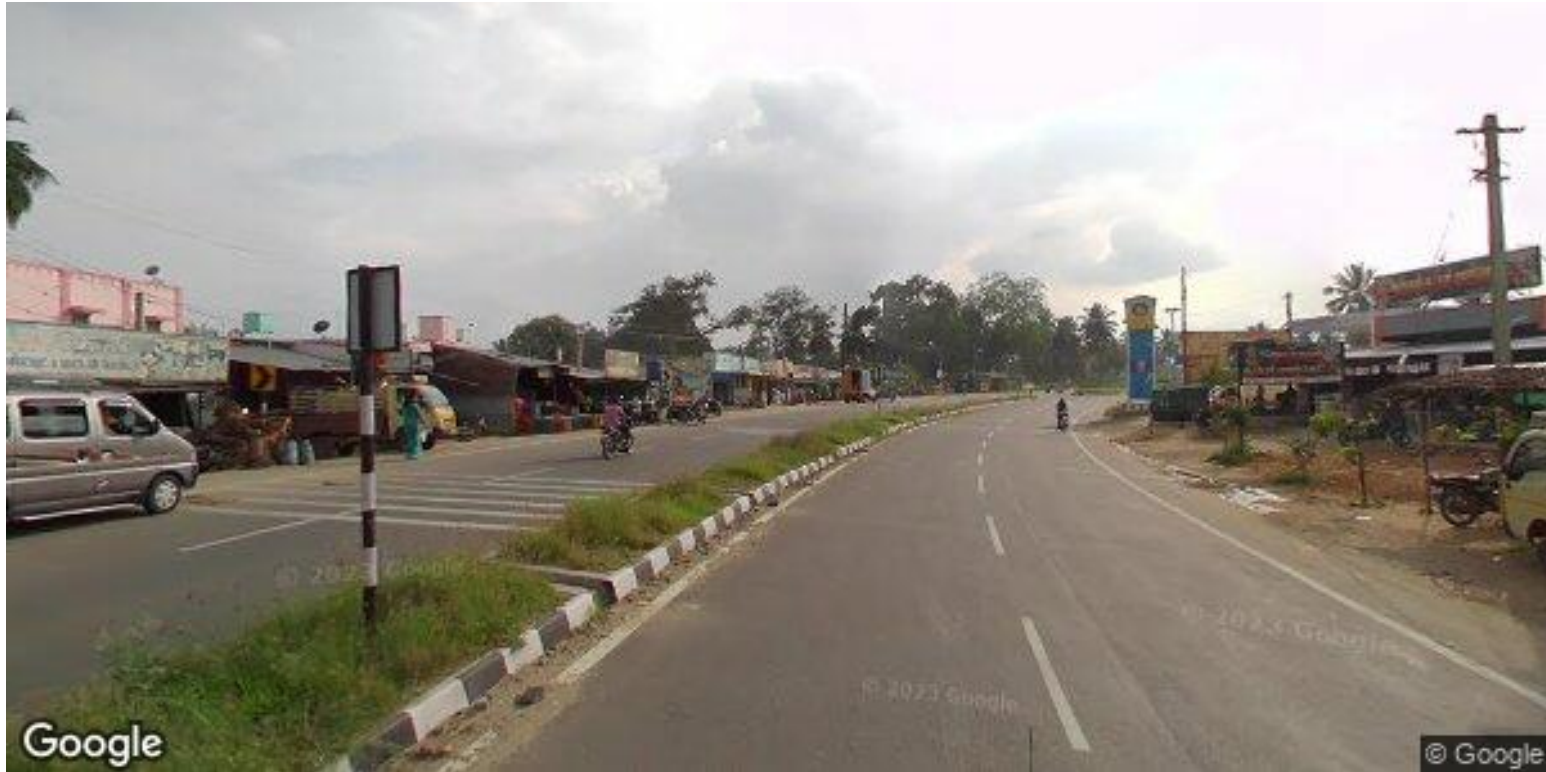
**Risk Type:** Turn  
**Risk Level:** Medium  
**Speed Limit:** 30 KM/Hr  
**Coordinates:** 12.17821, 78.54845

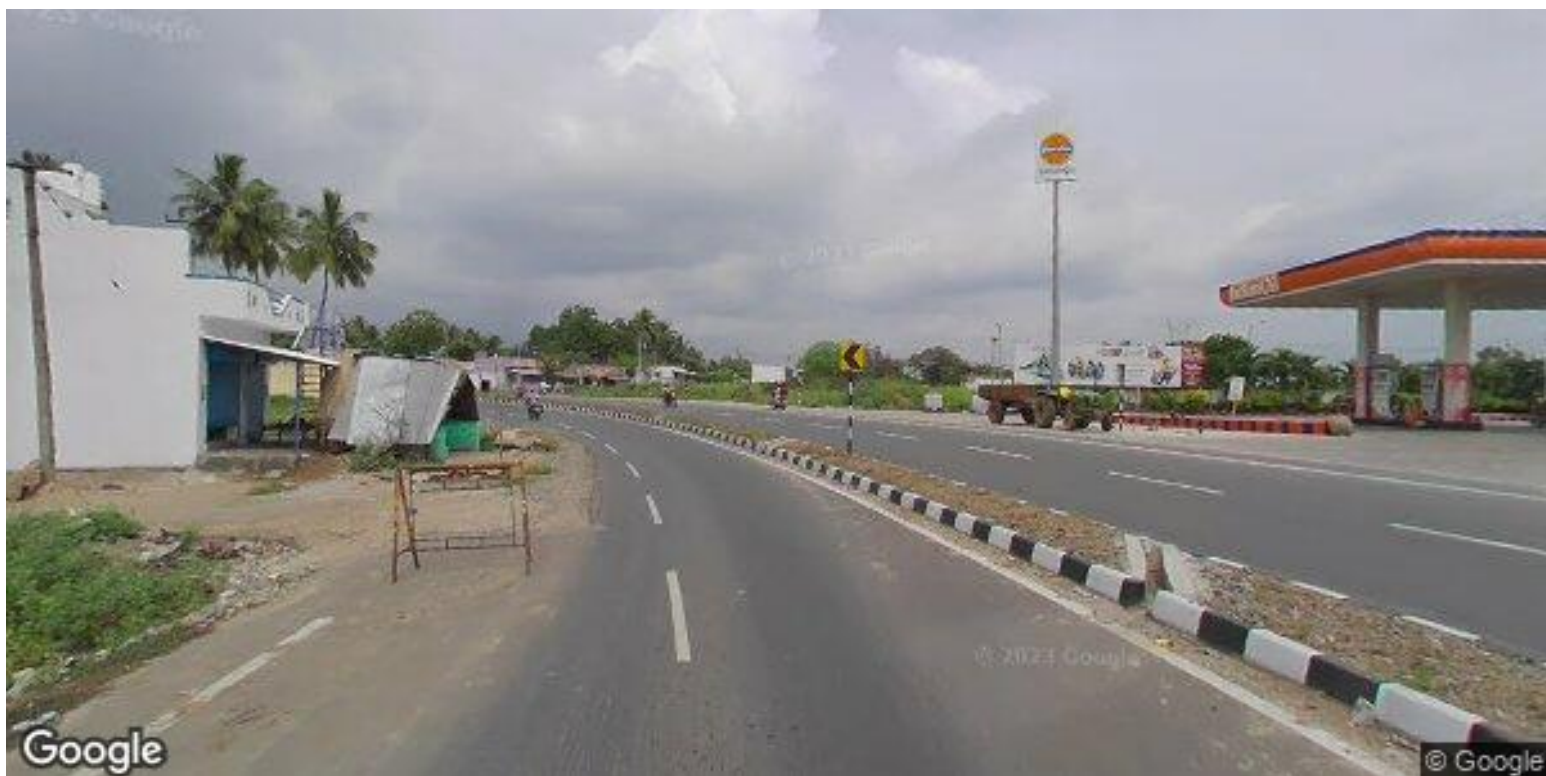
**Risk Type:** Turn  
**Risk Level:** High  
**Speed Limit:** 15 KM/Hr  
**Coordinates:** 12.18592, 78.54966

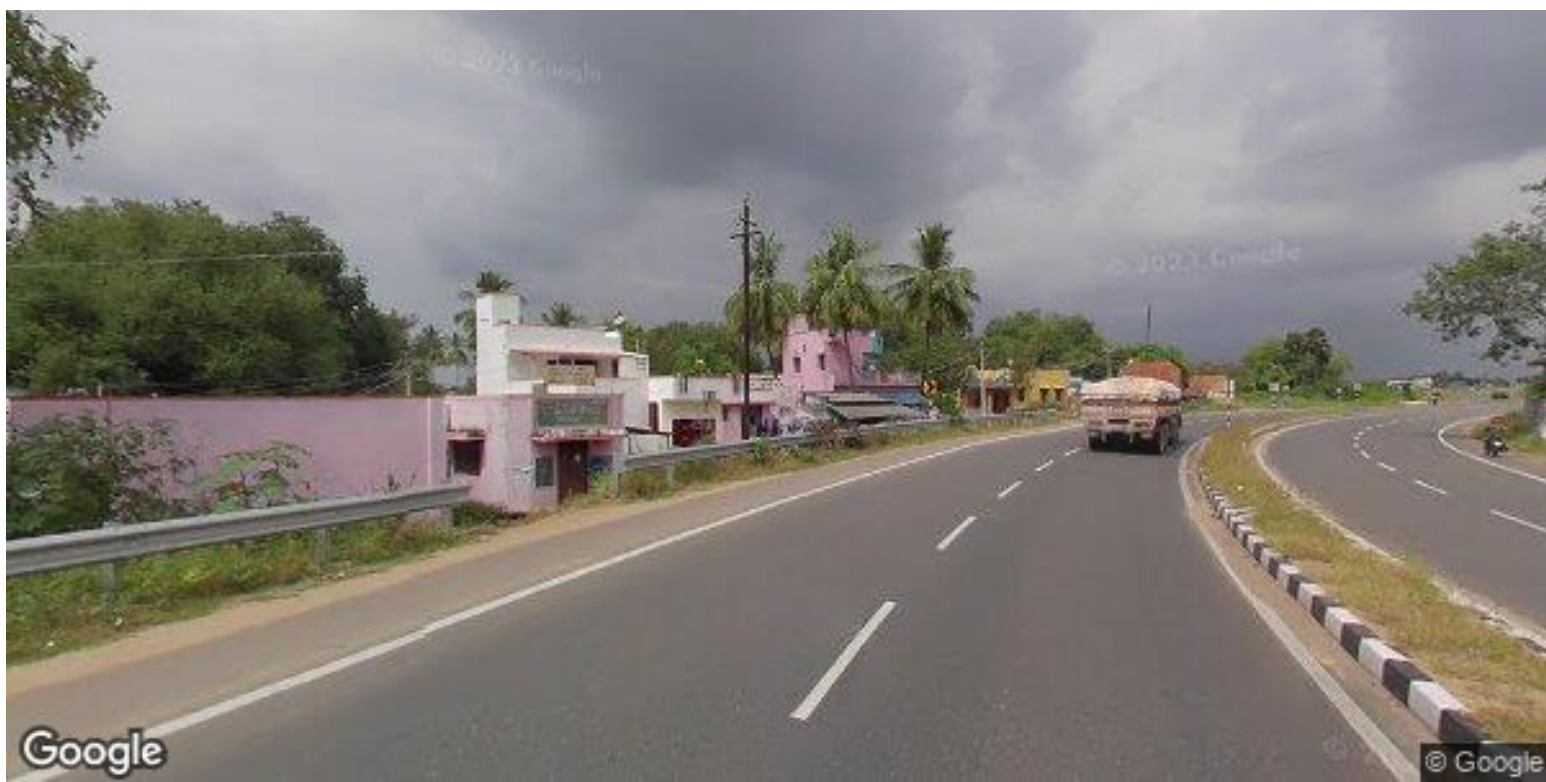
**Coordinates:** 12.20108, 78.54385

**Risk Type:** Turn

**Risk Level:** Medium

**Speed Limit:** 30 KM/Hr

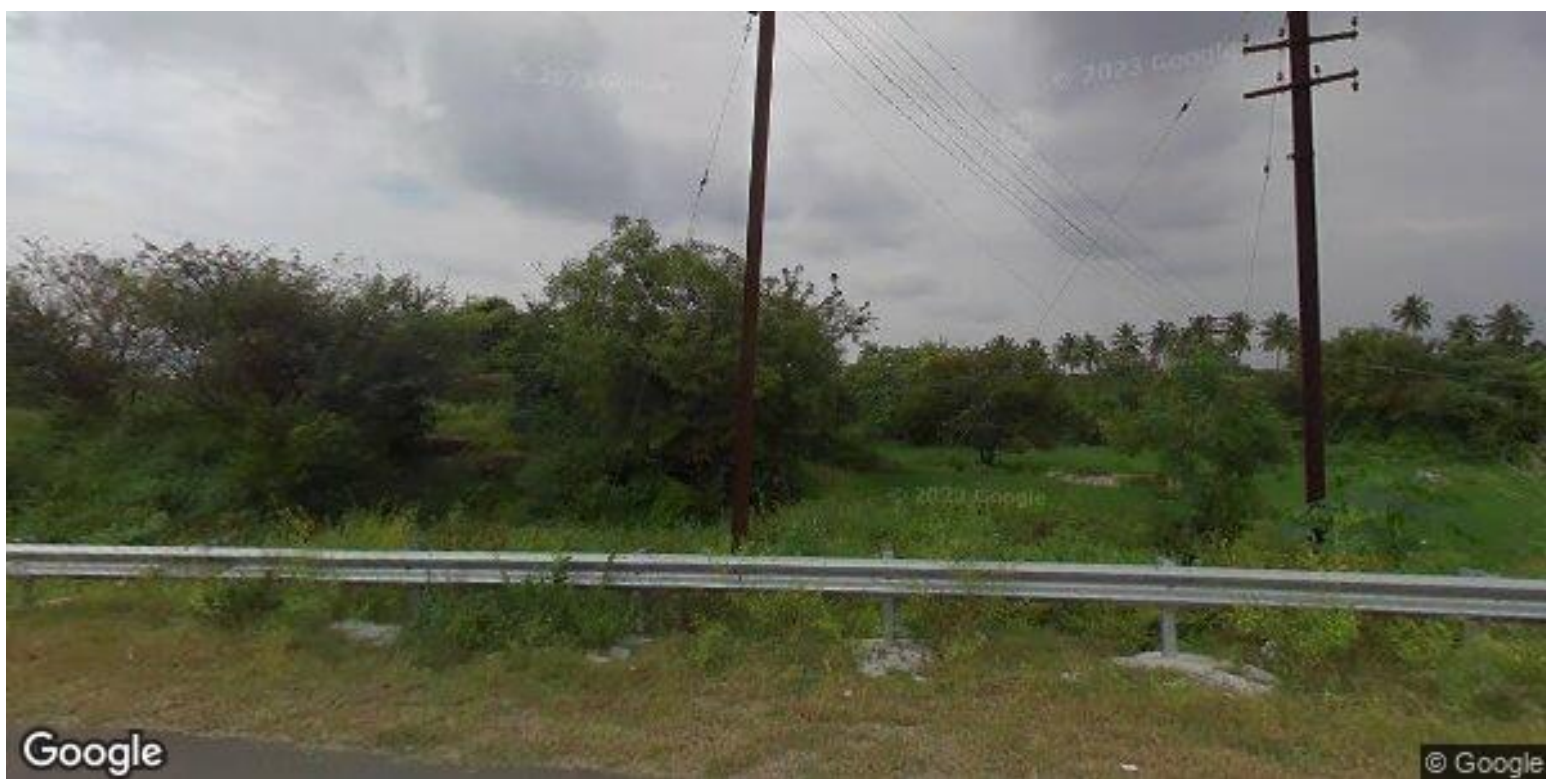
**Coordinates:** 12.20933, 78.54354

**Risk Type:** Turn

**Risk Level:** Medium

**Speed Limit:** 30 KM/Hr

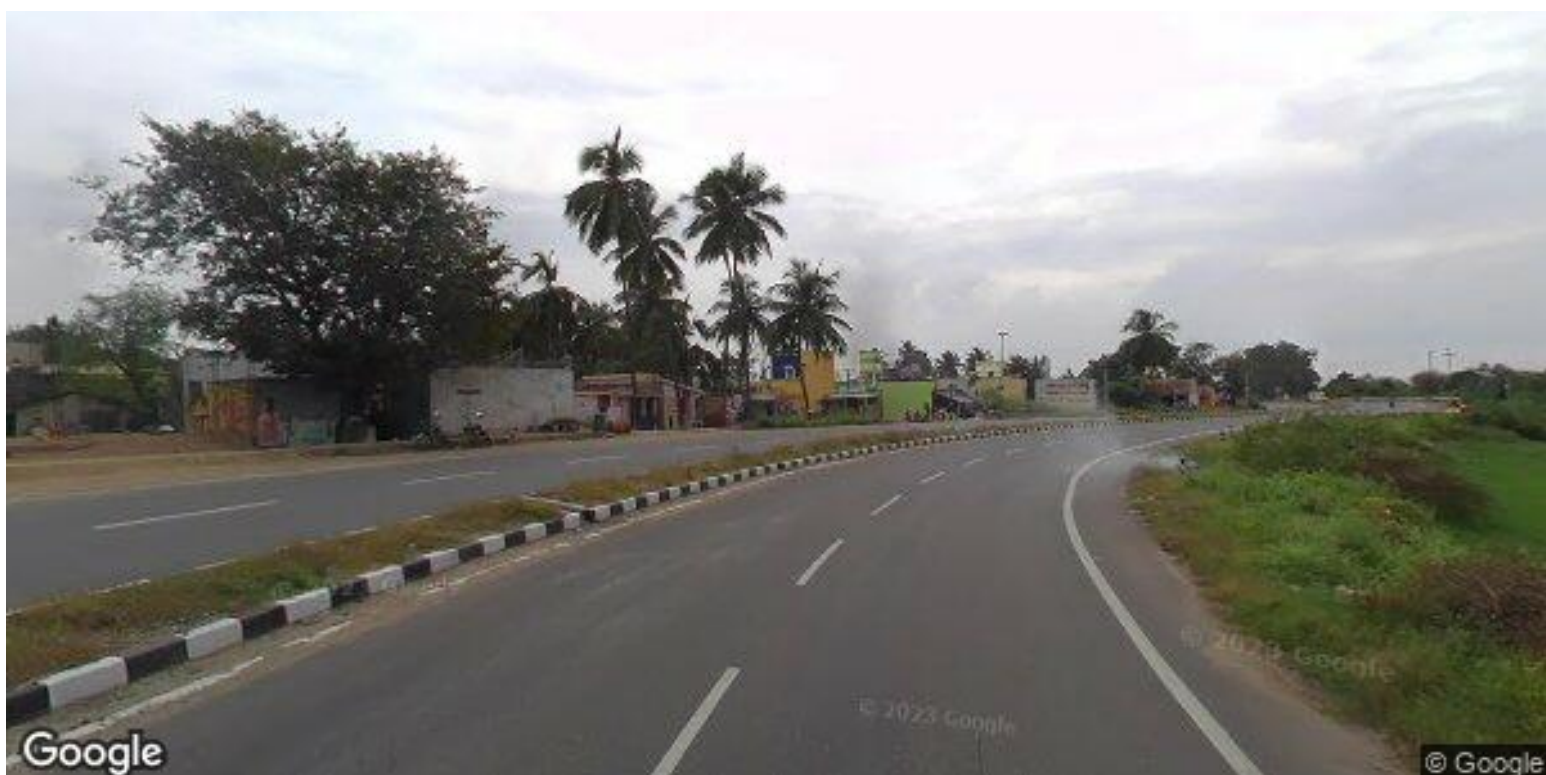
**Risk Type:** Turn  
**Risk Level:** Medium  
**Speed Limit:** 30 KM/Hr  
**Coordinates:** 12.21071, 78.54412

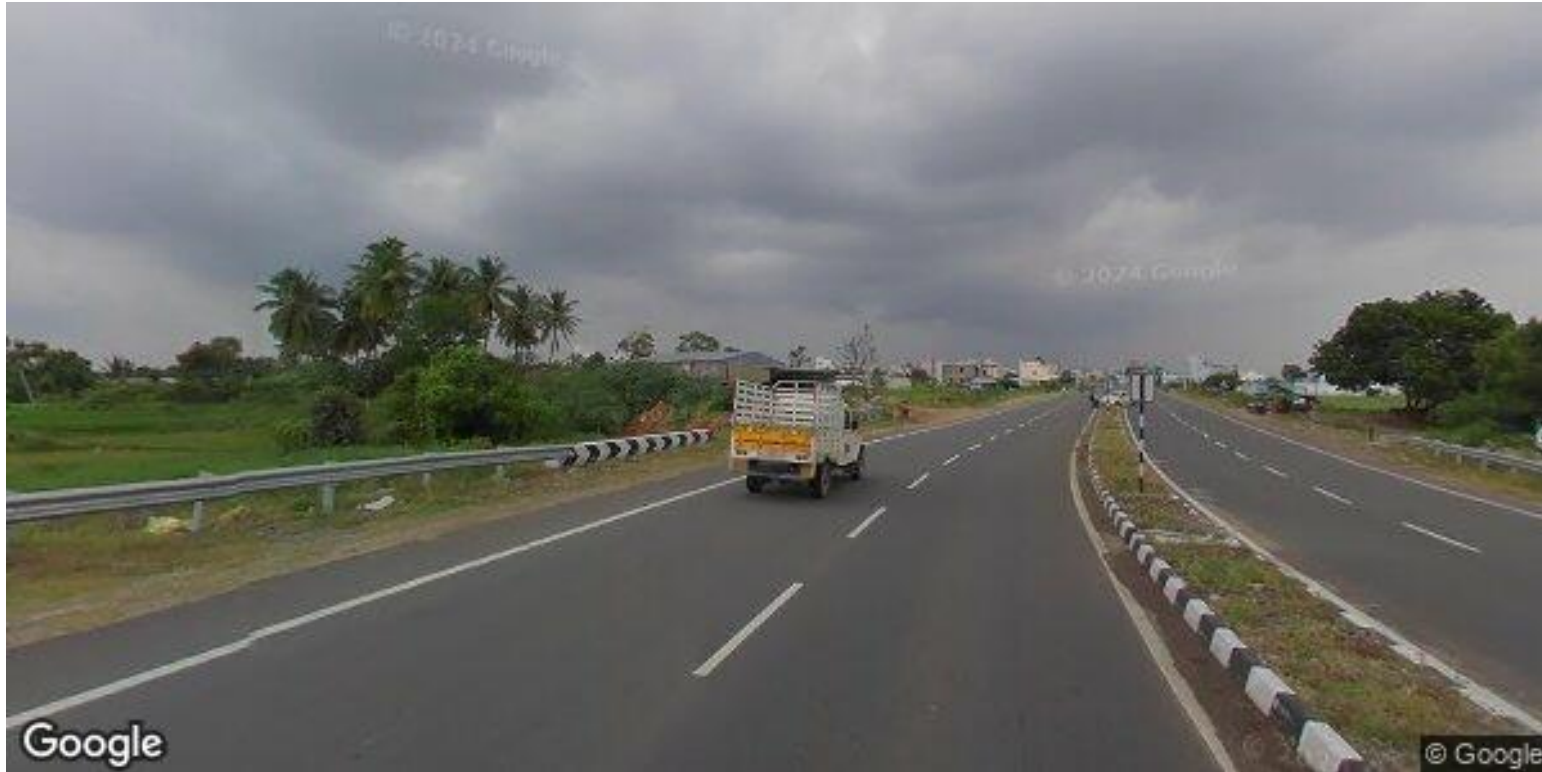
**Risk Type:** Turn  
**Risk Level:** Medium  
**Speed Limit:** 30 KM/Hr  
**Coordinates:** 12.24997, 78.53501

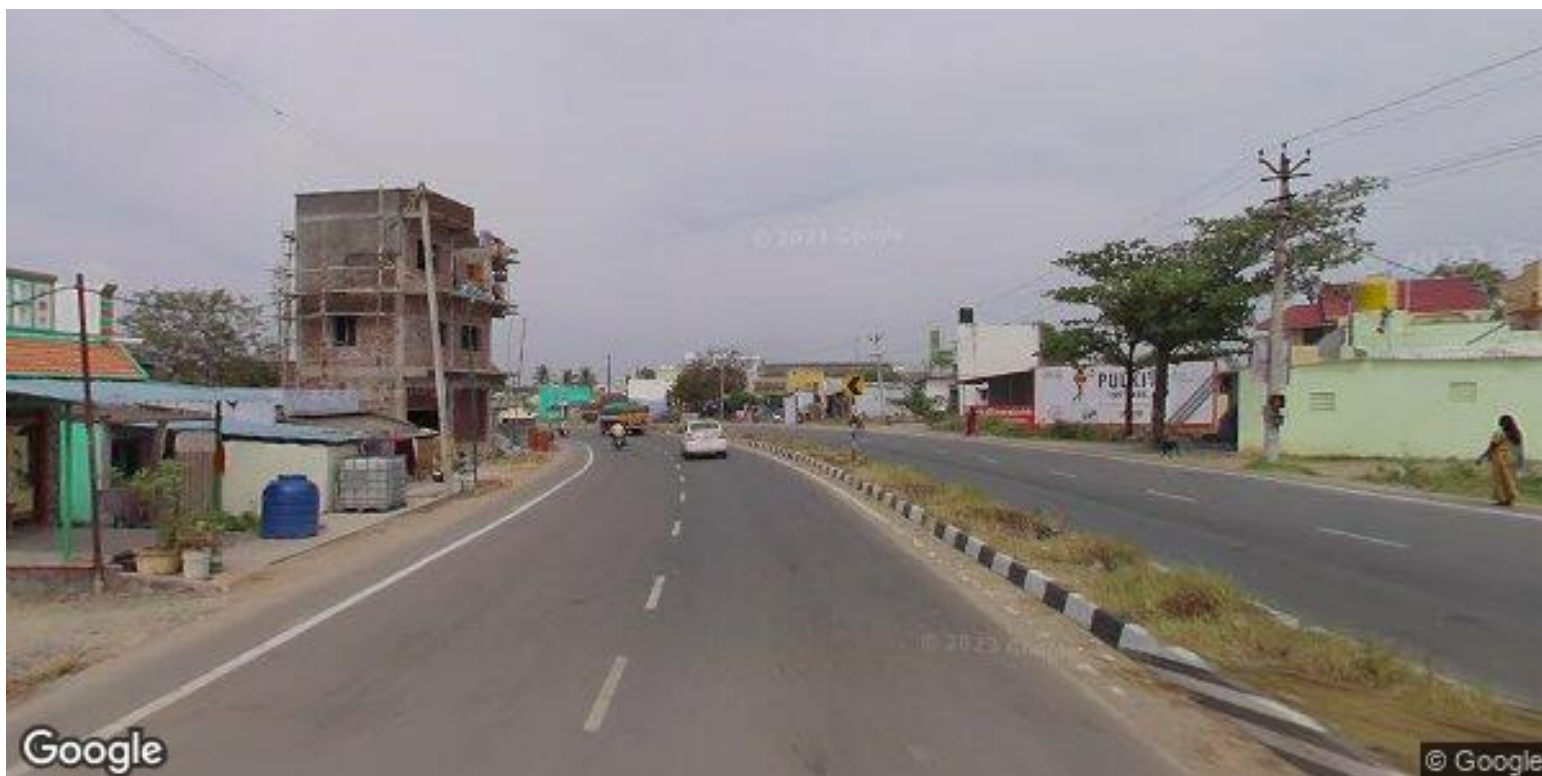
**Risk Type:** Turn  
**Risk Level:** Medium  
**Speed Limit:** 30 KM/Hr  
**Coordinates:** 12.25781, 78.53395

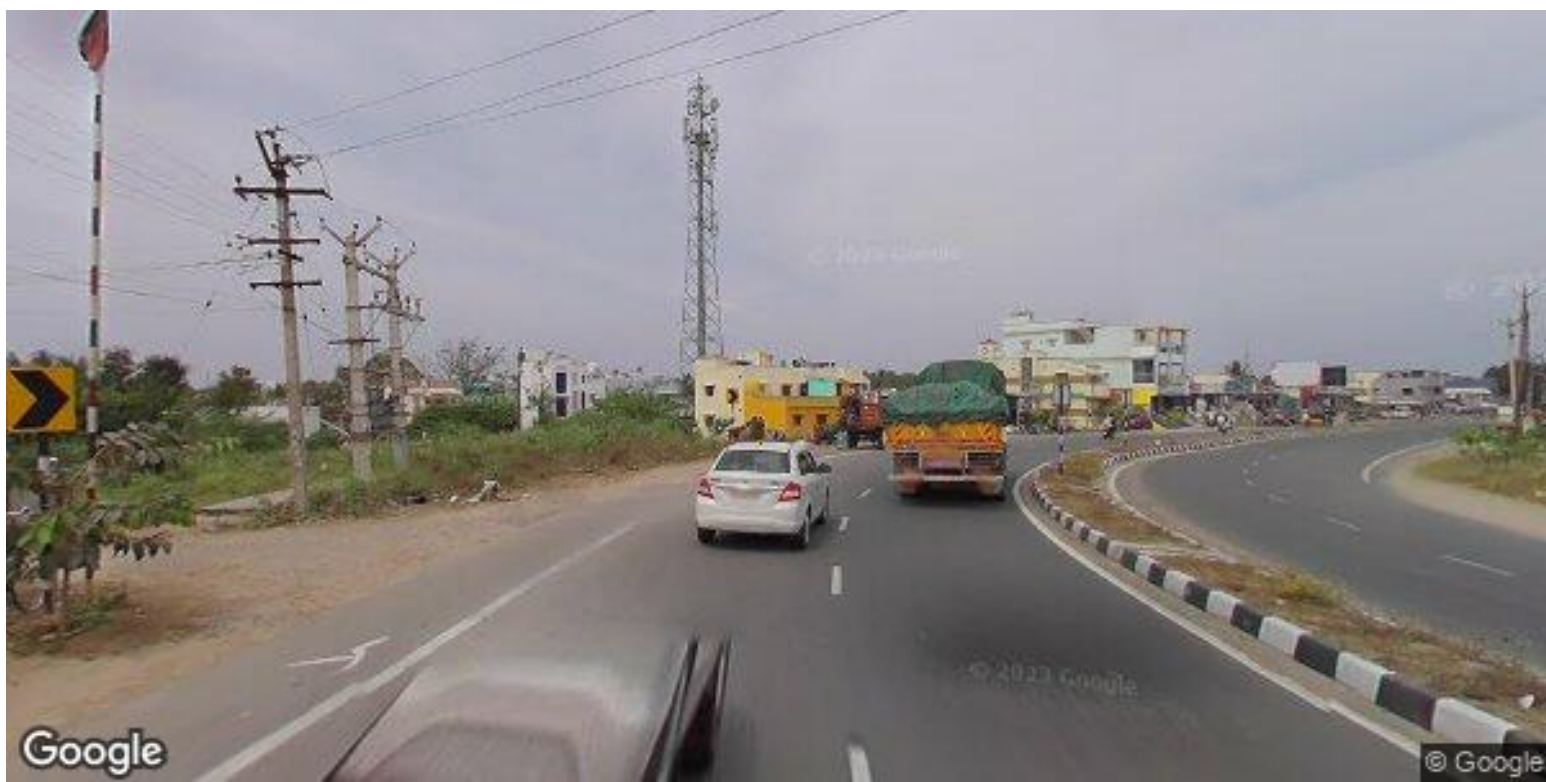
**Coordinates:** 12.25897, 78.53314

**Risk Type:** Turn

**Risk Level:** Medium

**Speed Limit:** 30 KM/Hr

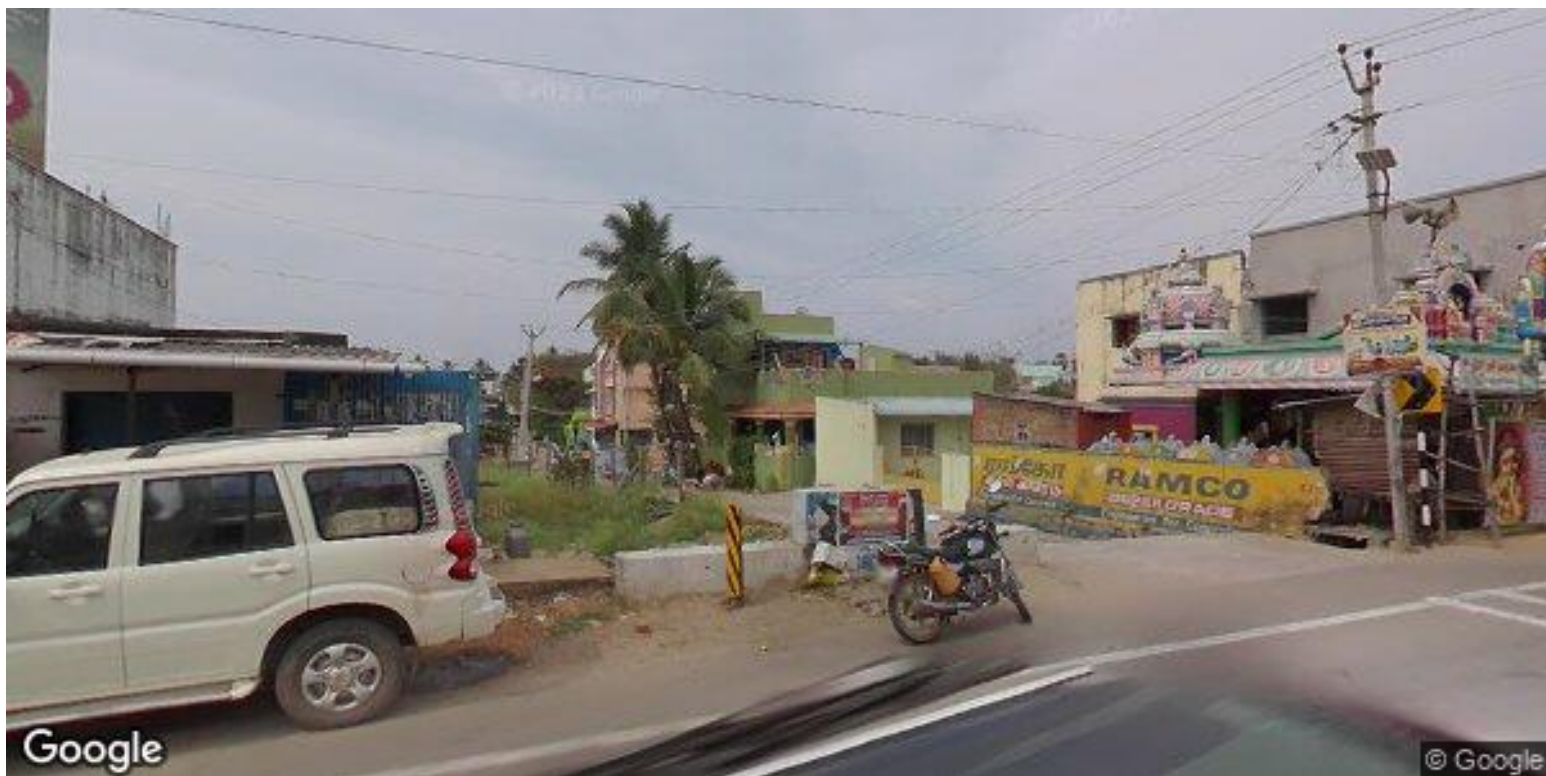
**Coordinates:** 12.26049, 78.53306

**Risk Type:** Turn

**Risk Level:** Medium

**Speed Limit:** 30 KM/Hr

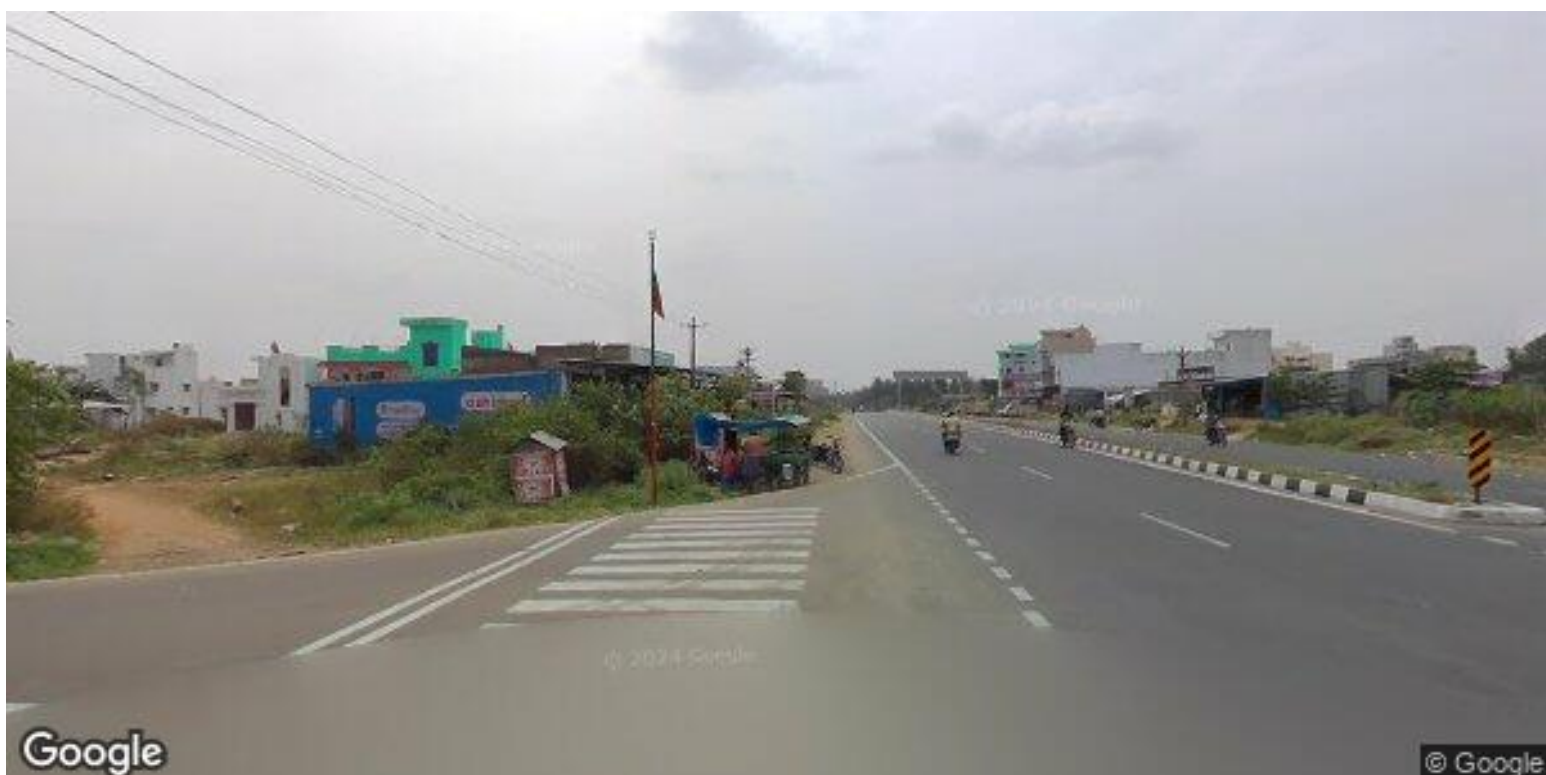
**Coordinates:** 12.27845, 78.53587

**Risk Type:** Blind Spot

**Risk Level:** Blind Spot

**Speed Limit:** 10 KM/Hr
