# IndianOil

## JOURNEY RISK MANAGEMENT (JRM) STUDY

### Salem Terminal TO AMMAN AGENCIES

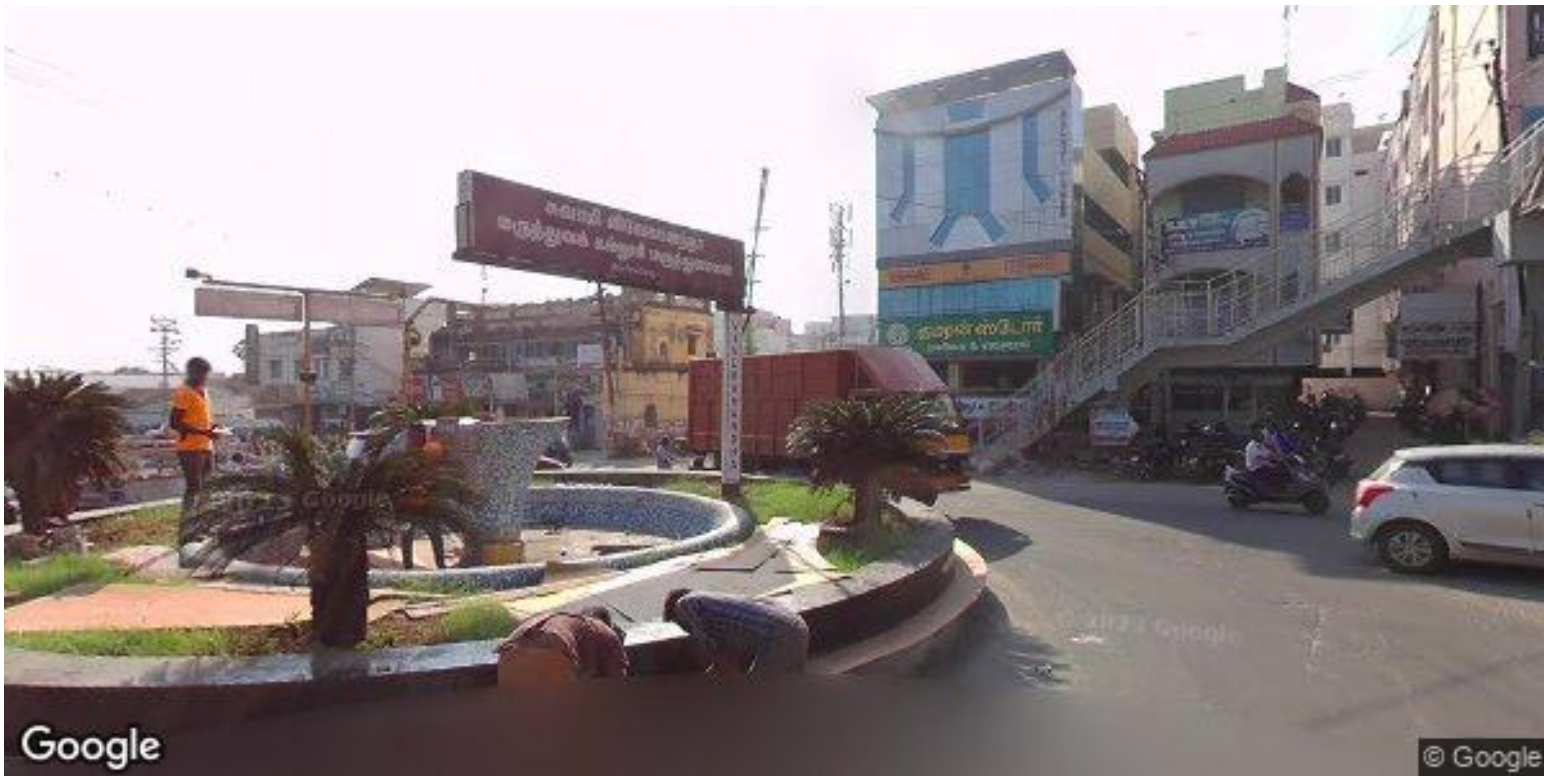
**Coordinates:** 11.38395, 77.89480

**Risk Type:** Roundabout

**Risk Level:** High

**Speed Limit:** 15 KM/Hr

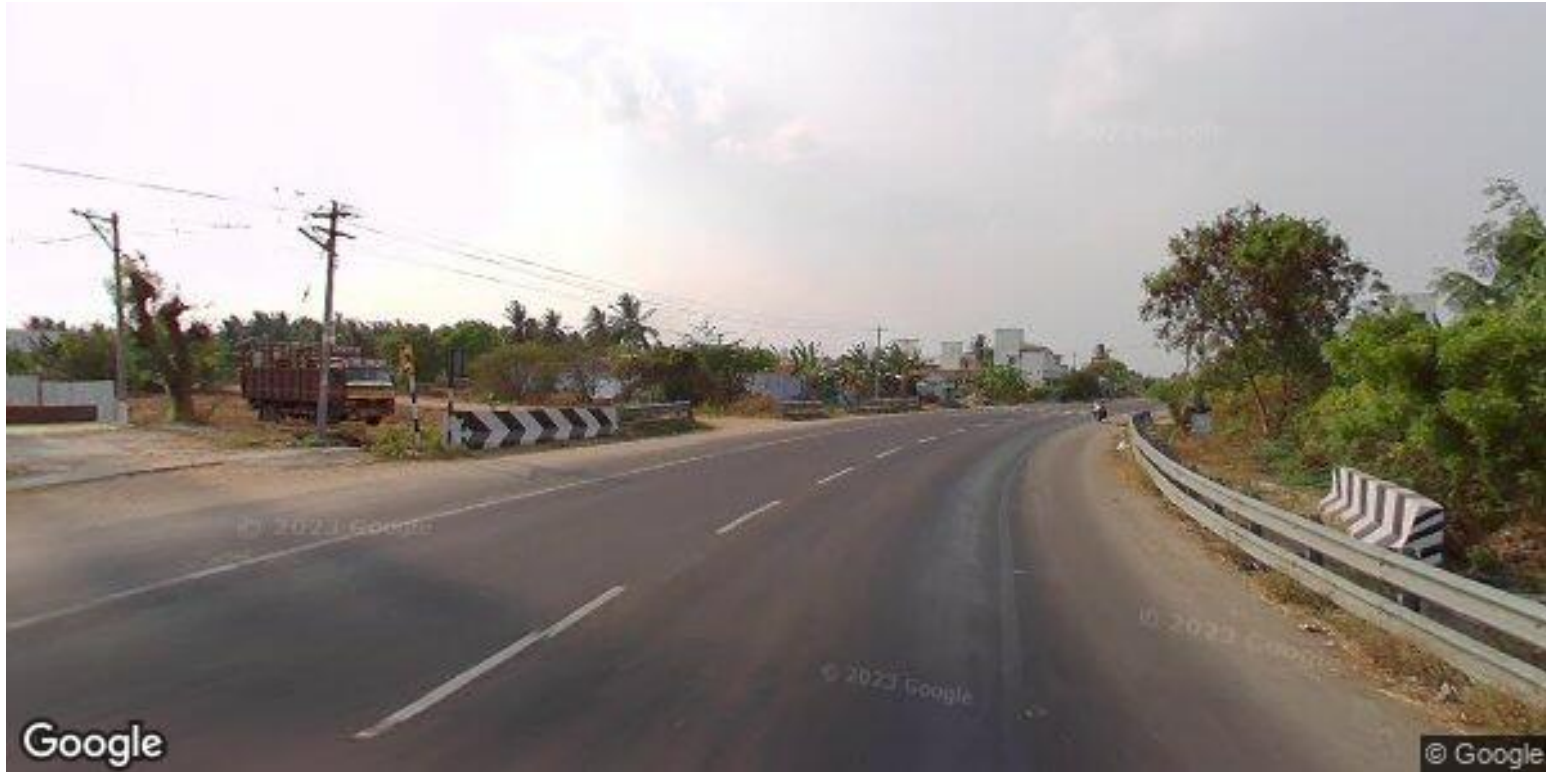
**Risk Type:** Turn  
**Risk Level:** Medium  
**Speed Limit:** 30 KM/Hr  
**Coordinates:** 11.16749, 78.01572

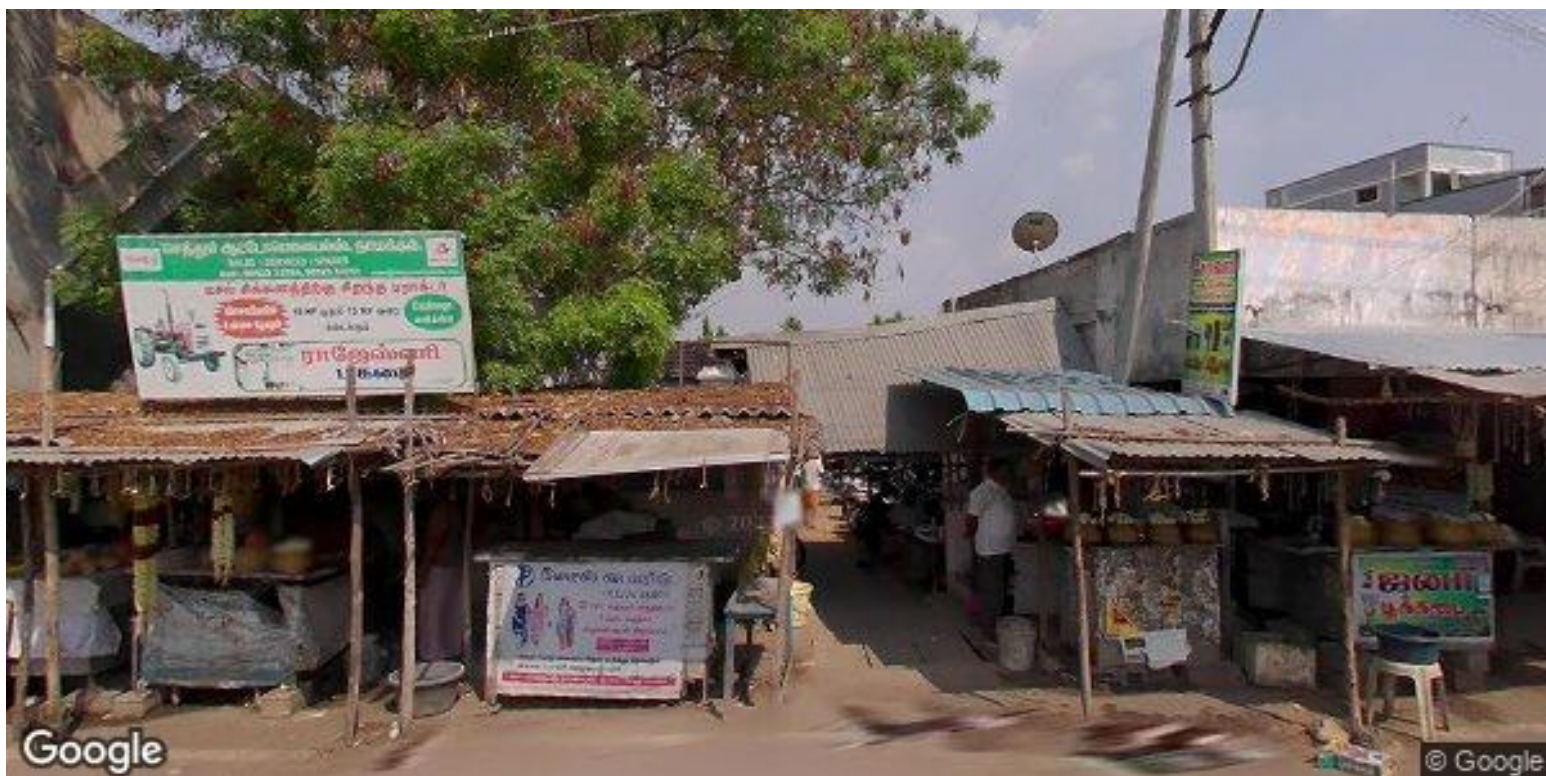
**Risk Type:** Turn  
**Risk Level:** Medium  
**Speed Limit:** 30 KM/Hr  
**Coordinates:** 11.15573, 78.02176

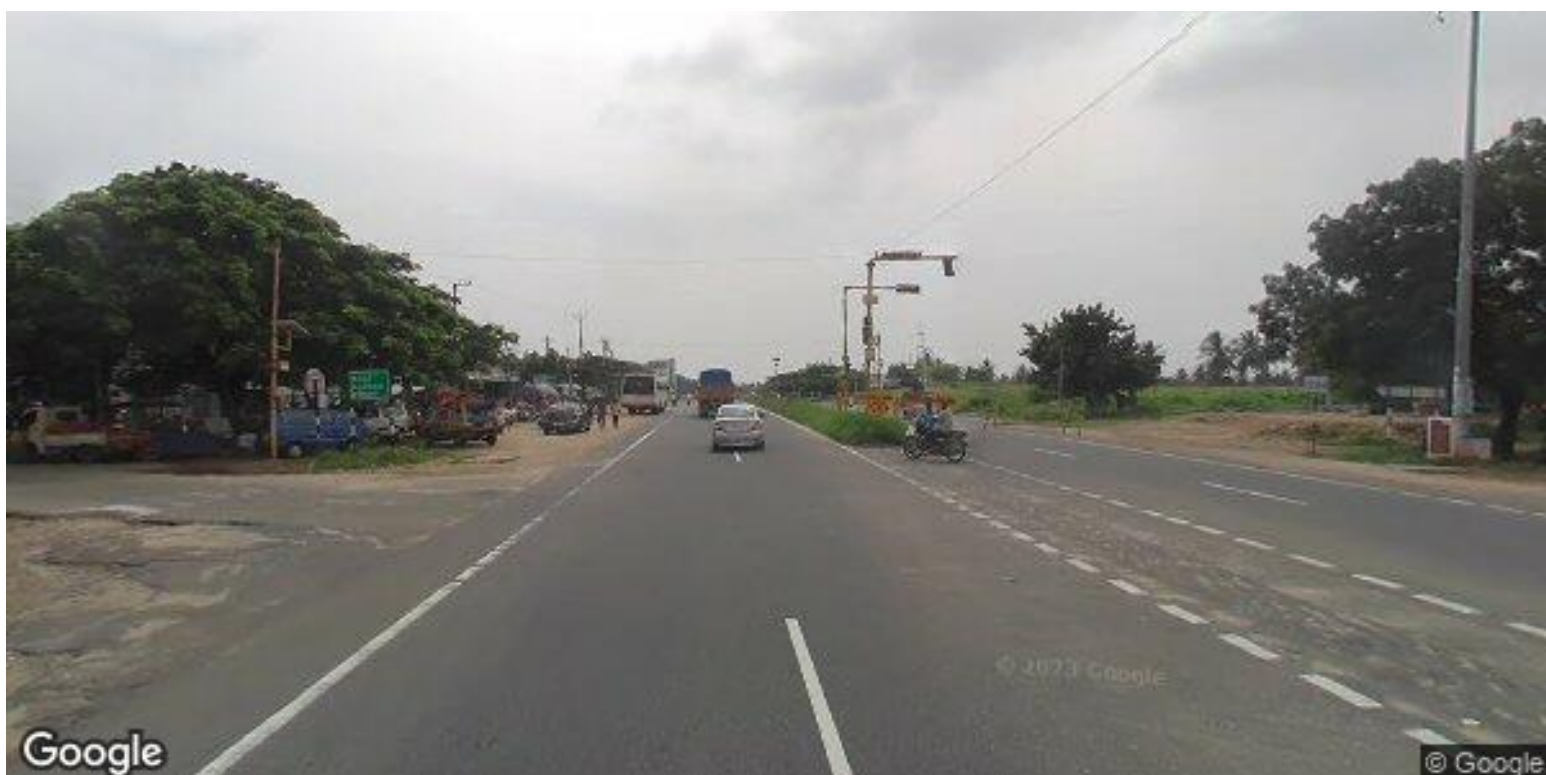
**Risk Type:** Turn  
**Risk Level:** High  
**Speed Limit:** 15 KM/Hr  
**Coordinates:** 11.02679, 78.06555

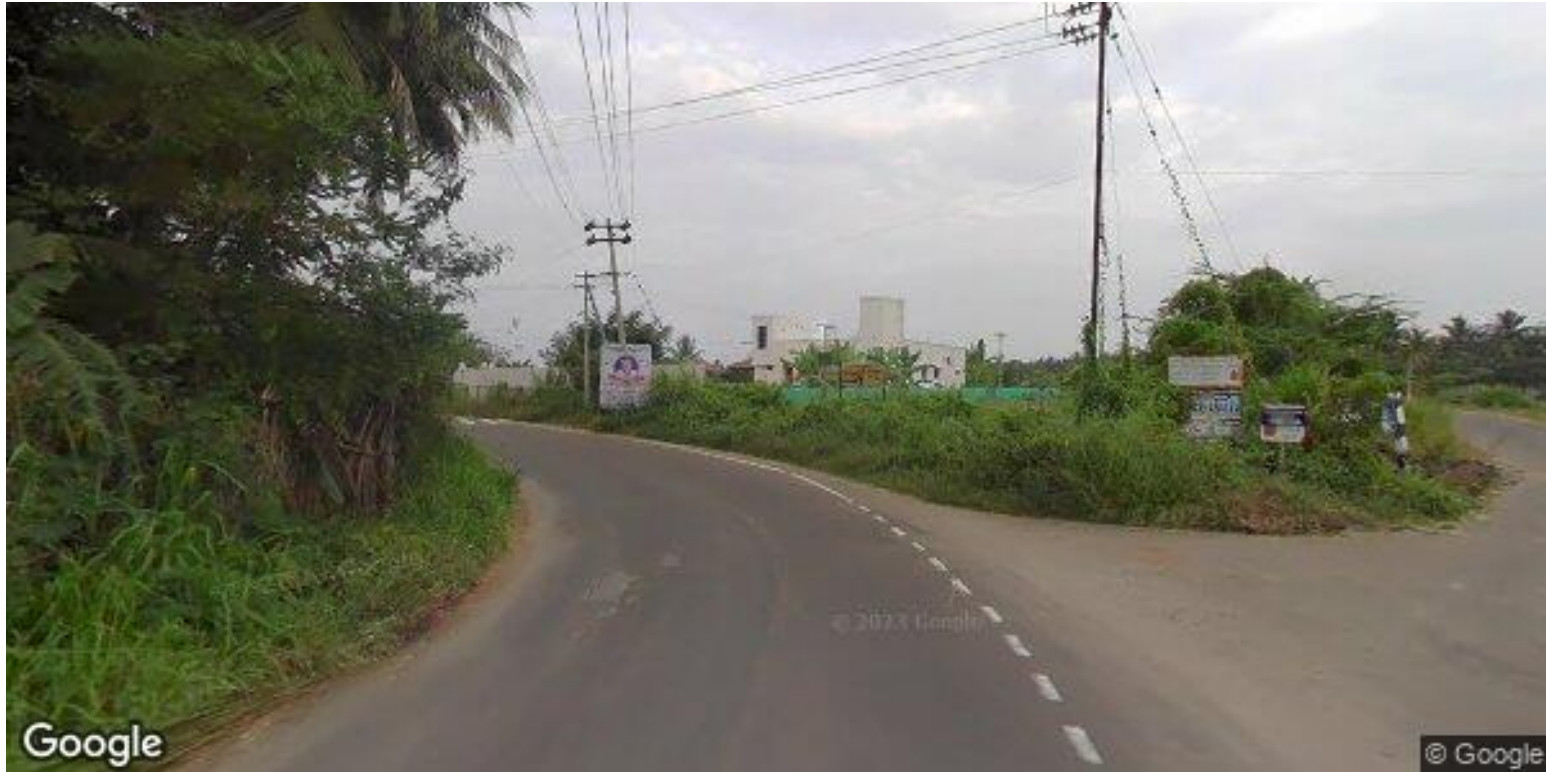
**Risk Type:** Turn  
**Risk Level:** Medium  
**Speed Limit:** 30 KM/Hr  
**Coordinates:** 11.02740, 78.07688

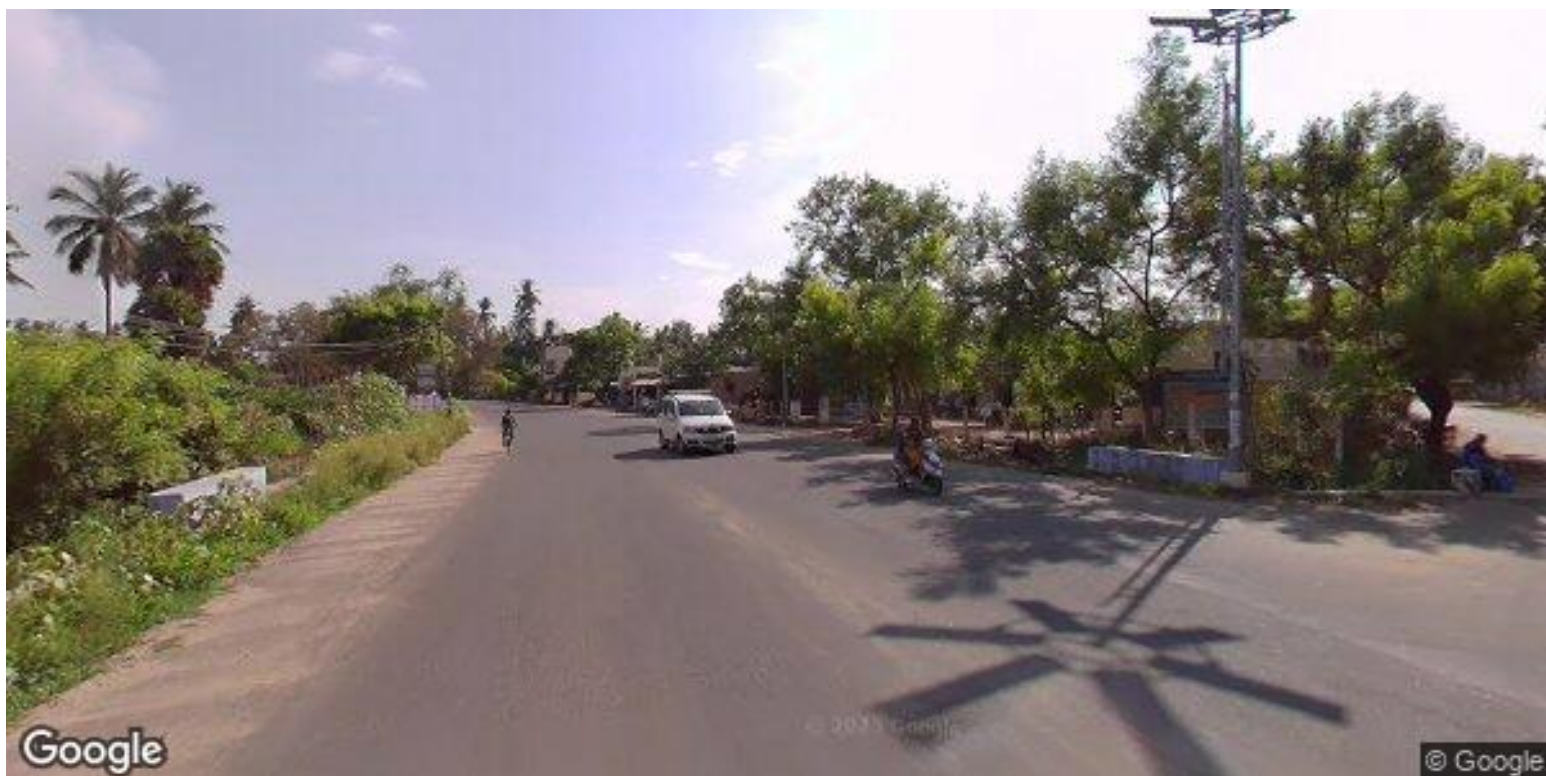
**Risk Type:** Blind Spot  
**Risk Level:** Blind Spot  
**Speed Limit:** 10 KM/Hr  
**Coordinates:** 11.03771, 78.11595

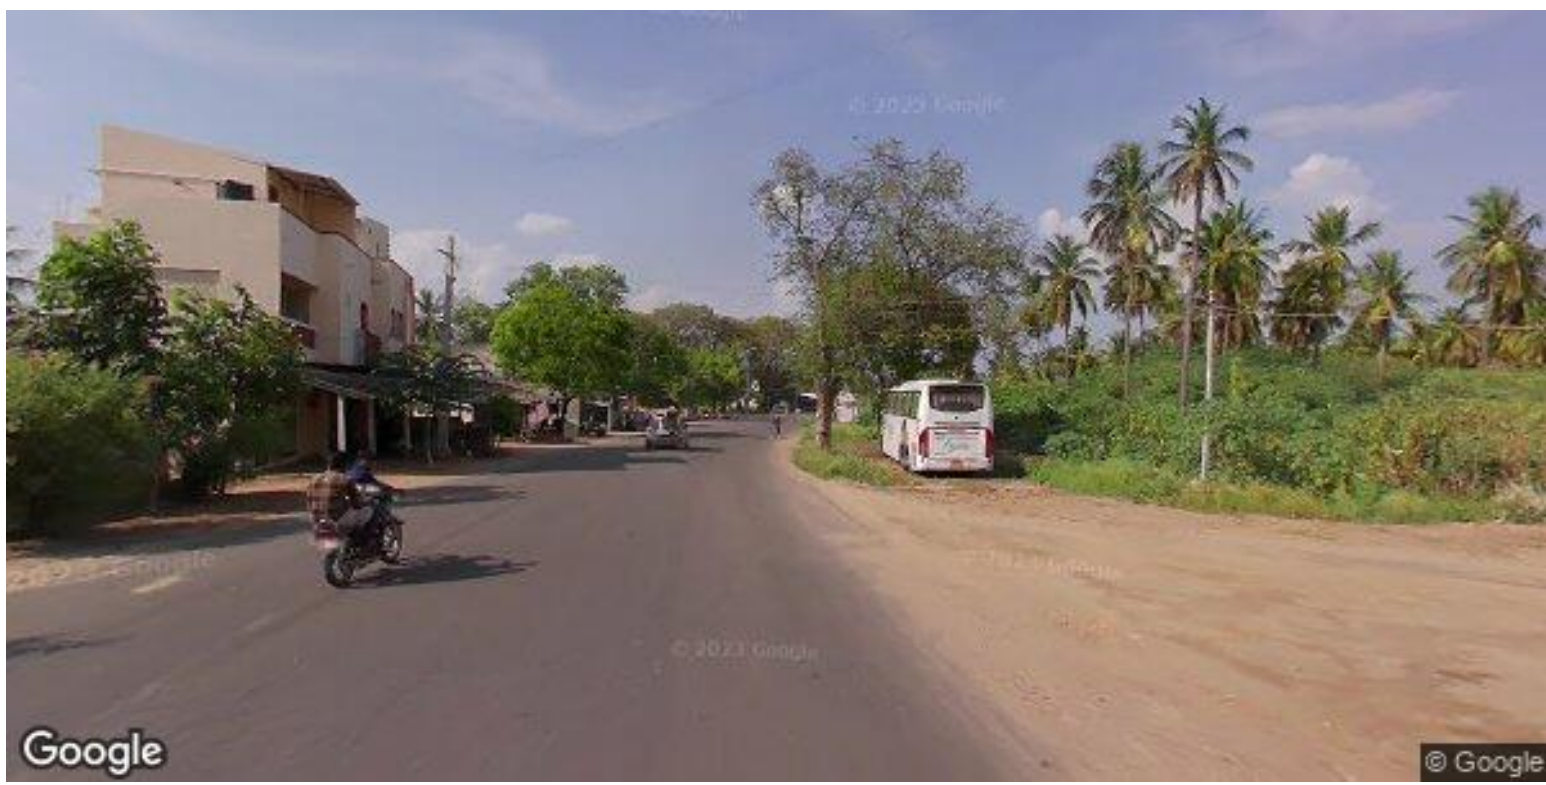
**Coordinates:** 11.03684, 78.11528

**Risk Type:** Turn

**Risk Level:** High

**Speed Limit:** 15 KM/Hr
