# IndianOil

## JOURNEY RISK MANAGEMENT (JRM) STUDY

### Salem Terminal TO SAKTHI FUELS

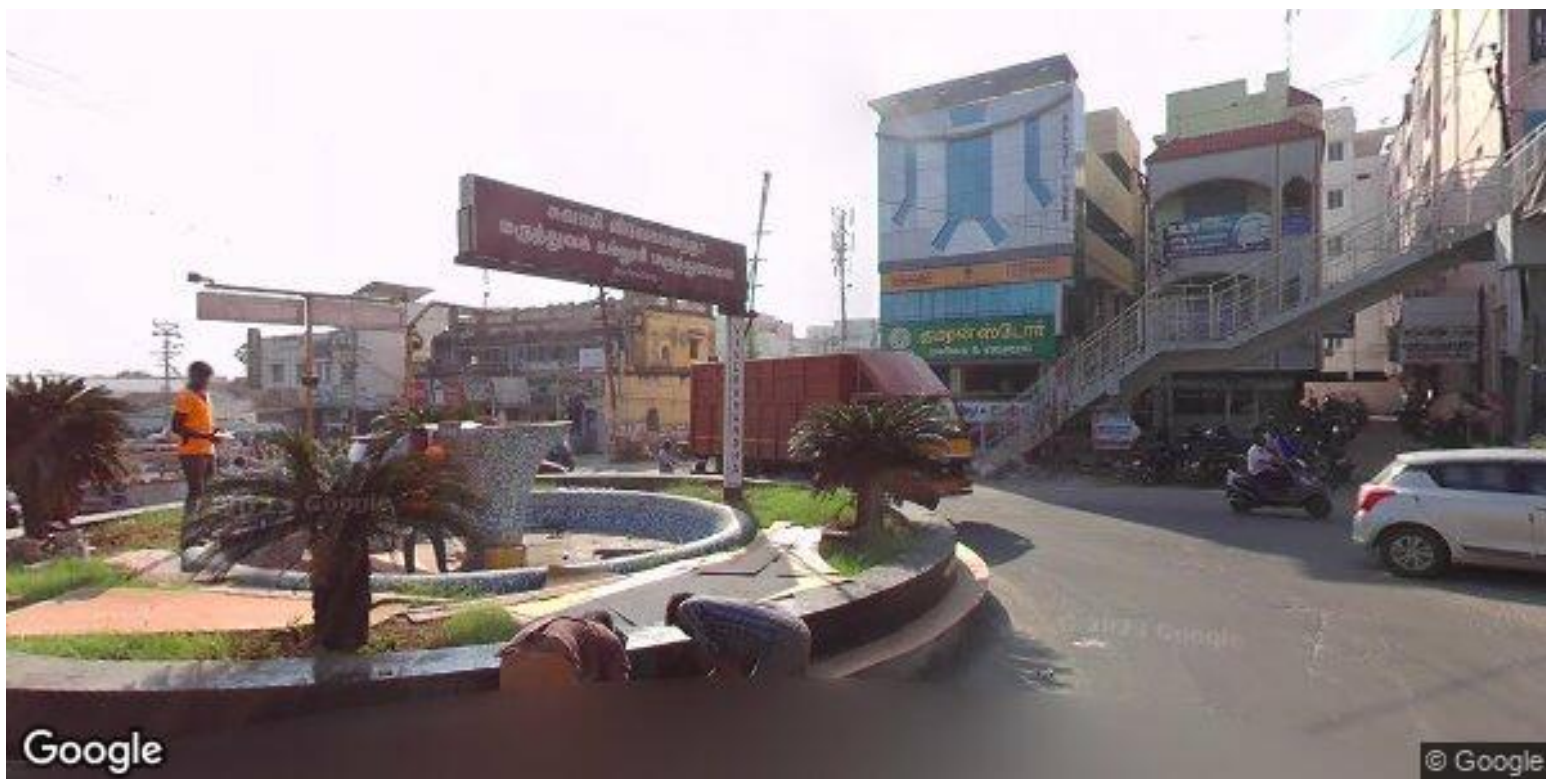
**Coordinates:** 11.38395, 77.89480

**Risk Type:** Roundabout

**Risk Level:** High

**Speed Limit:** 15 KM/Hr

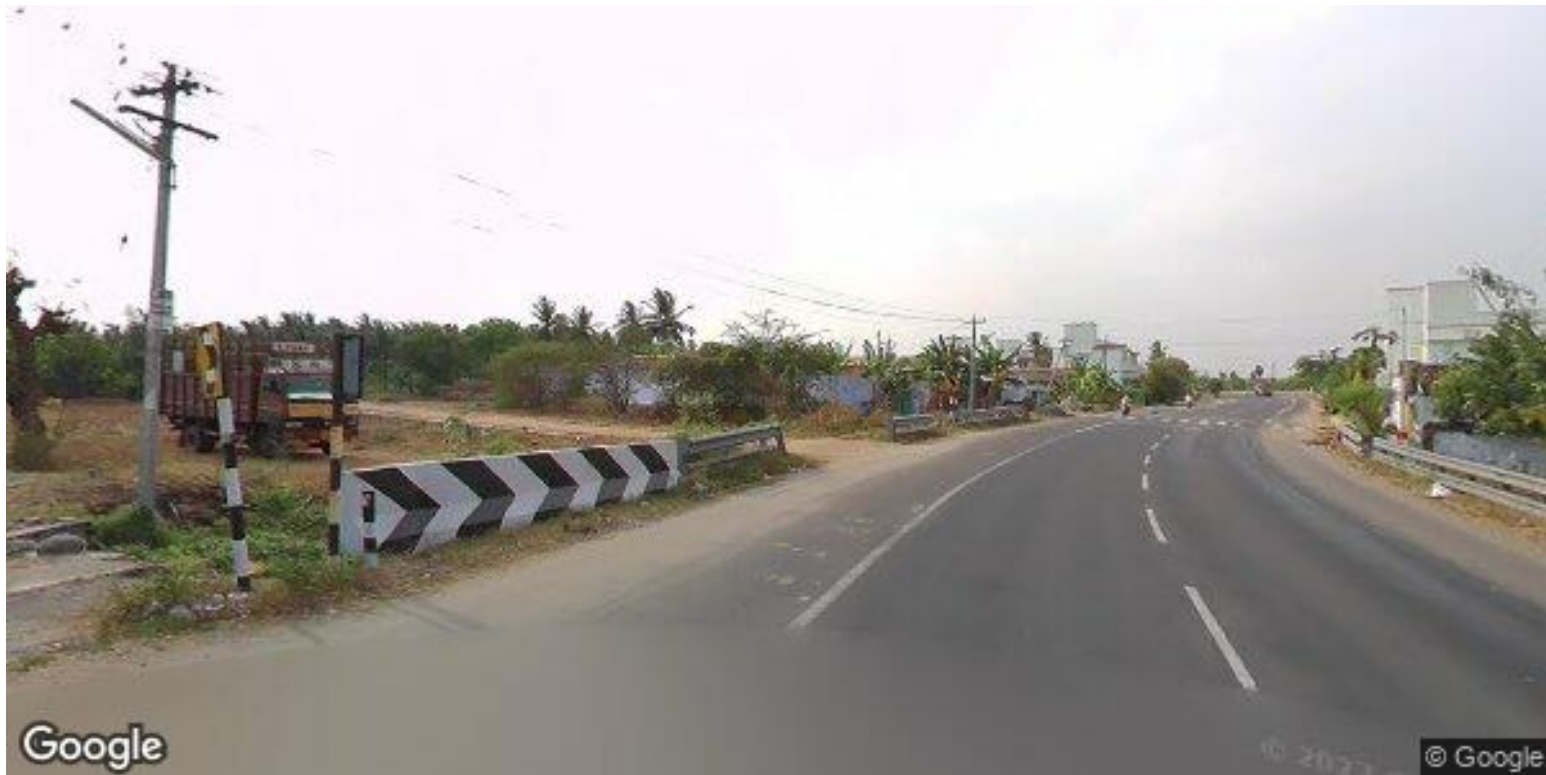
**Coordinates:** 11.16755, 78.01568

**Risk Type:** Turn

**Risk Level:** Medium

**Speed Limit:** 30 KM/Hr

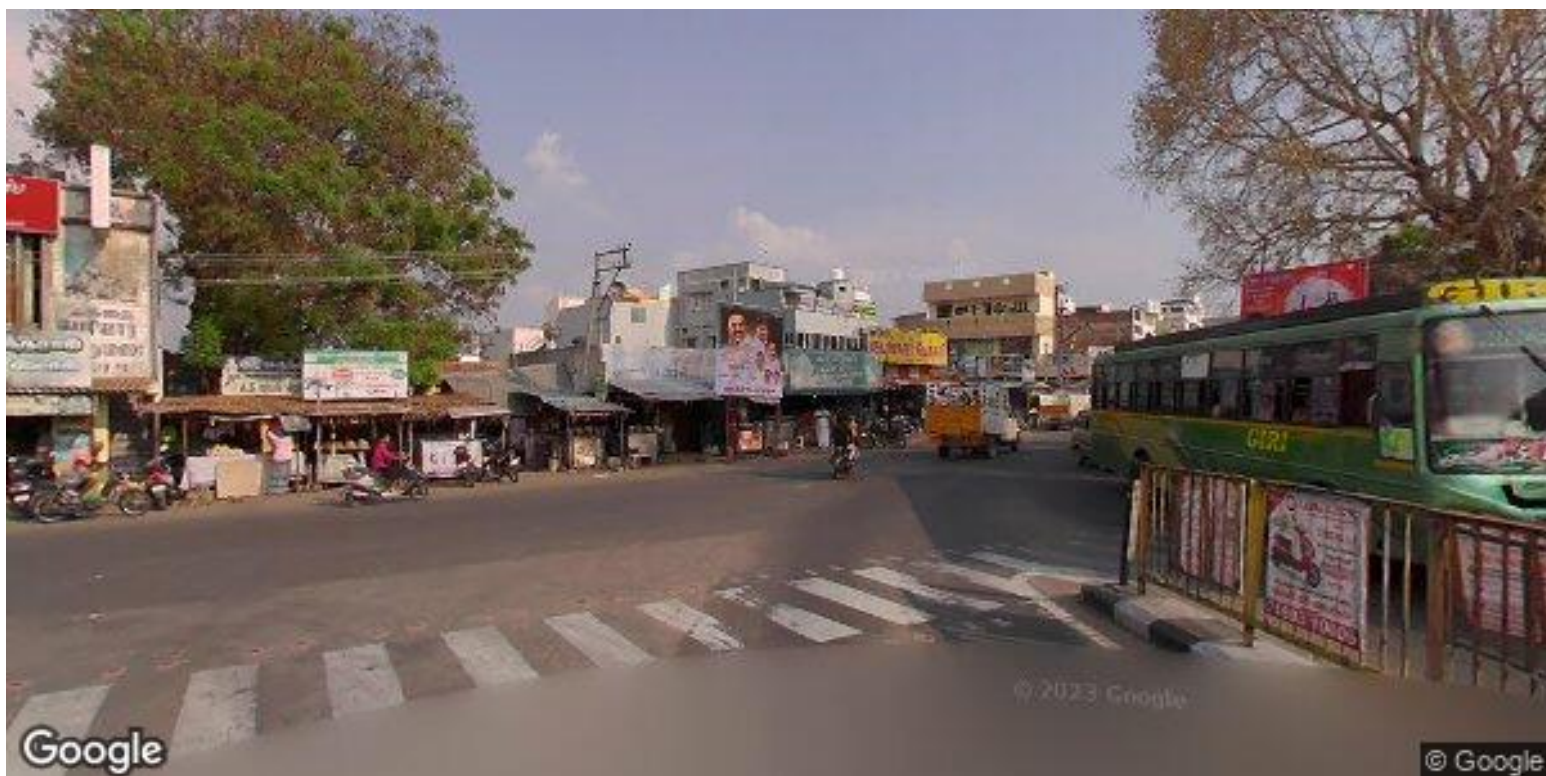
**Coordinates:** 11.15579, 78.02169

**Risk Type:** Turn

**Risk Level:** Medium

**Speed Limit:** 30 KM/Hr

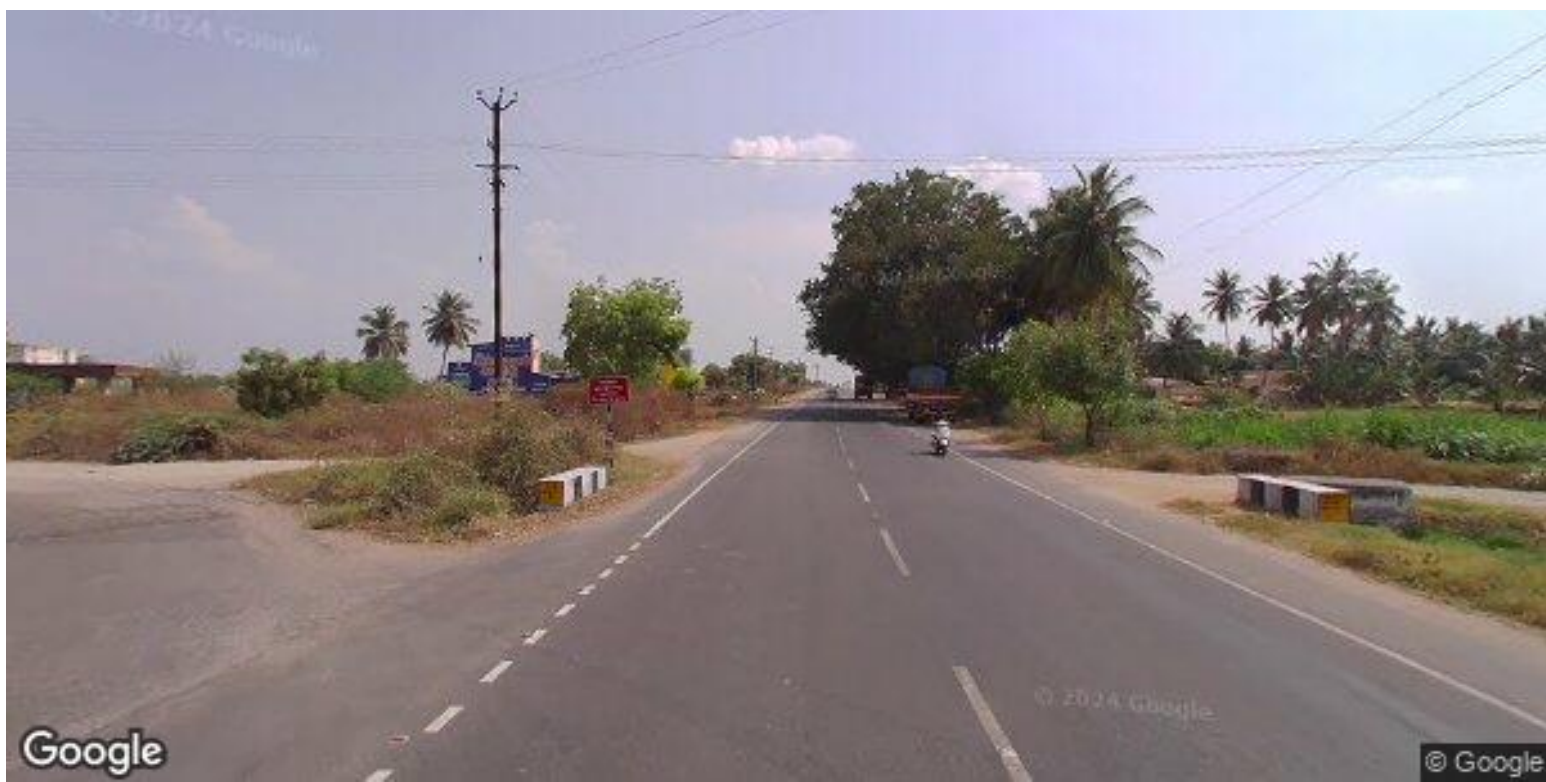
**Coordinates:** 11.14545, 78.02208

**Risk Type:** Turn

**Risk Level:** High

**Speed Limit:** 15 KM/Hr

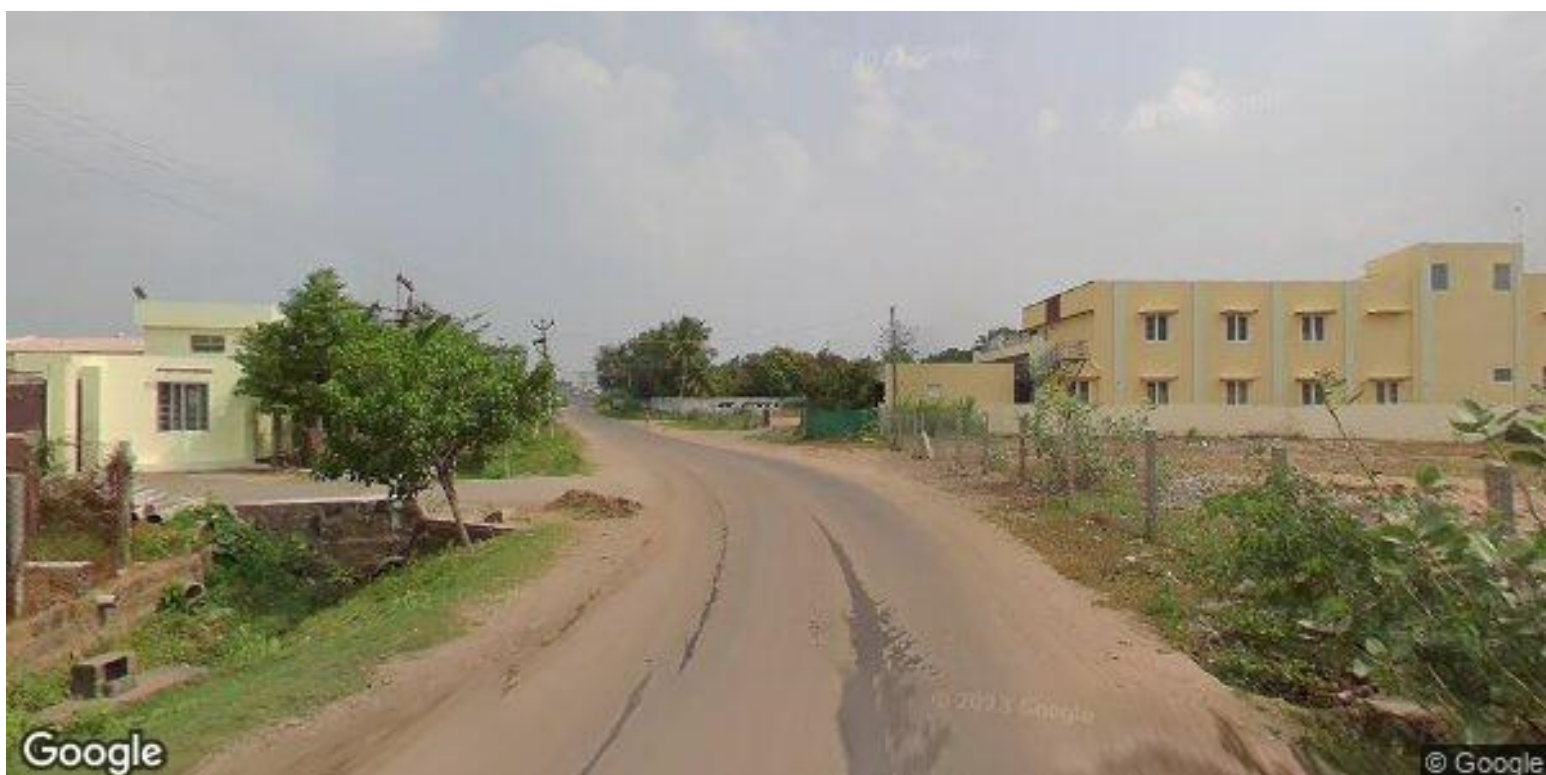
**Coordinates:** 10.95026, 78.04855

**Risk Type:** Turn

**Risk Level:** Medium

**Speed Limit:** 30 KM/Hr

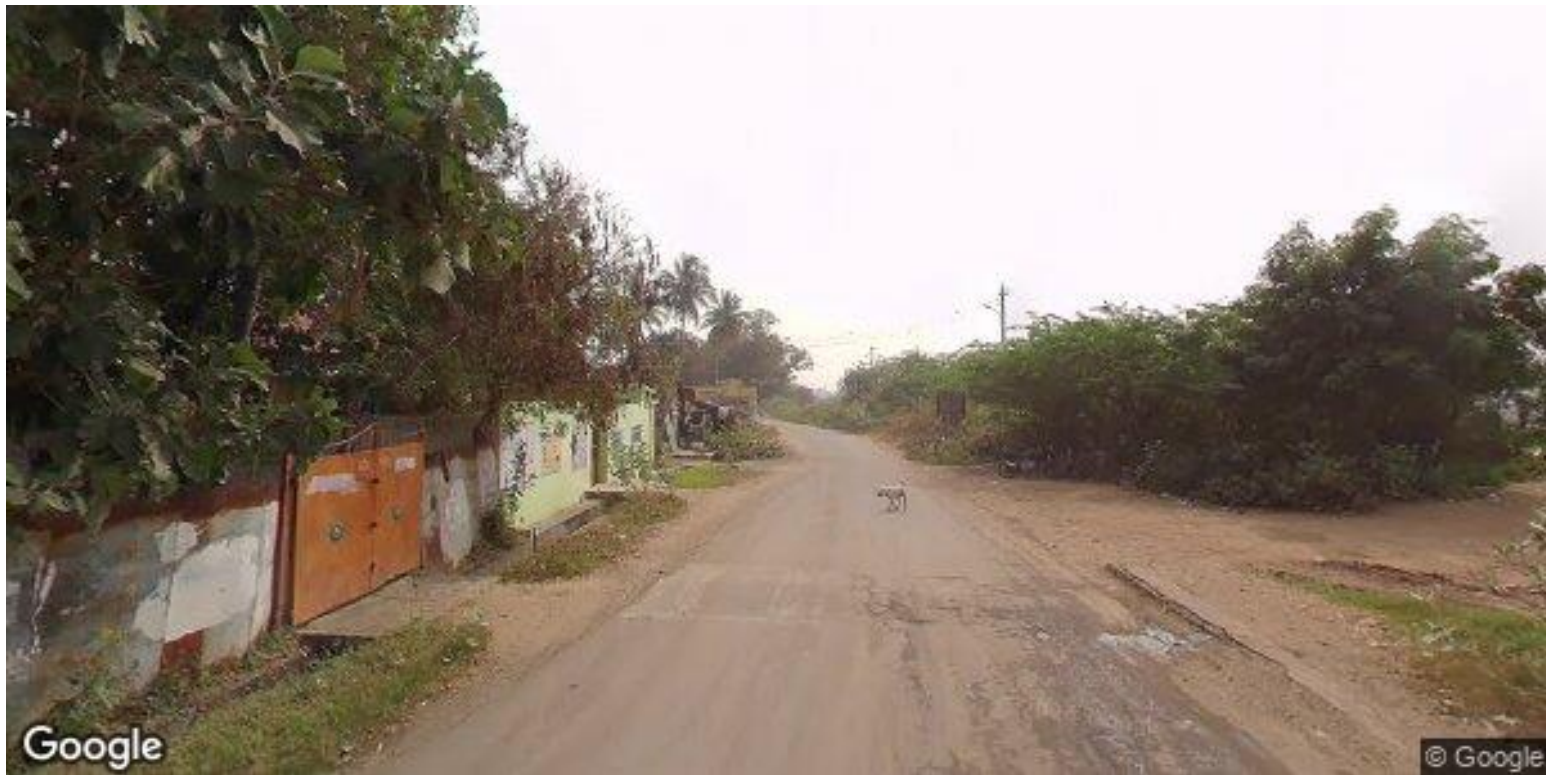
**Coordinates:** 10.95212, 78.03978

**Risk Type:** Turn

**Risk Level:** High

**Speed Limit:** 15 KM/Hr

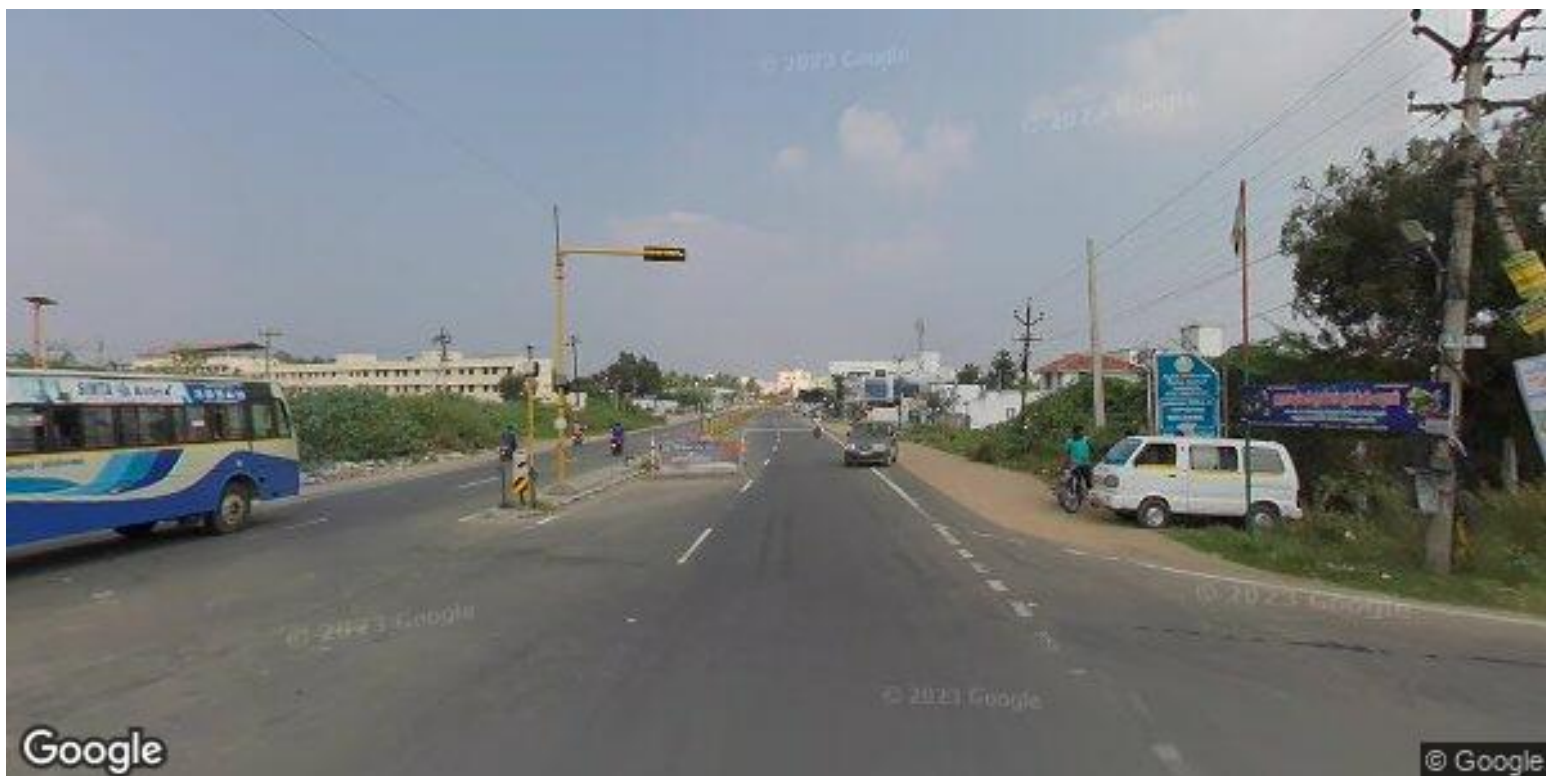
**Coordinates:** 10.96305, 78.04058

**Risk Type:** Blind Spot

**Risk Level:** Blind Spot

**Speed Limit:** 10 KM/Hr
