# IndianOil

## JOURNEY RISK MANAGEMENT (JRM) STUDY

### Salem Terminal to P.N.ANNA PETROL BUNK

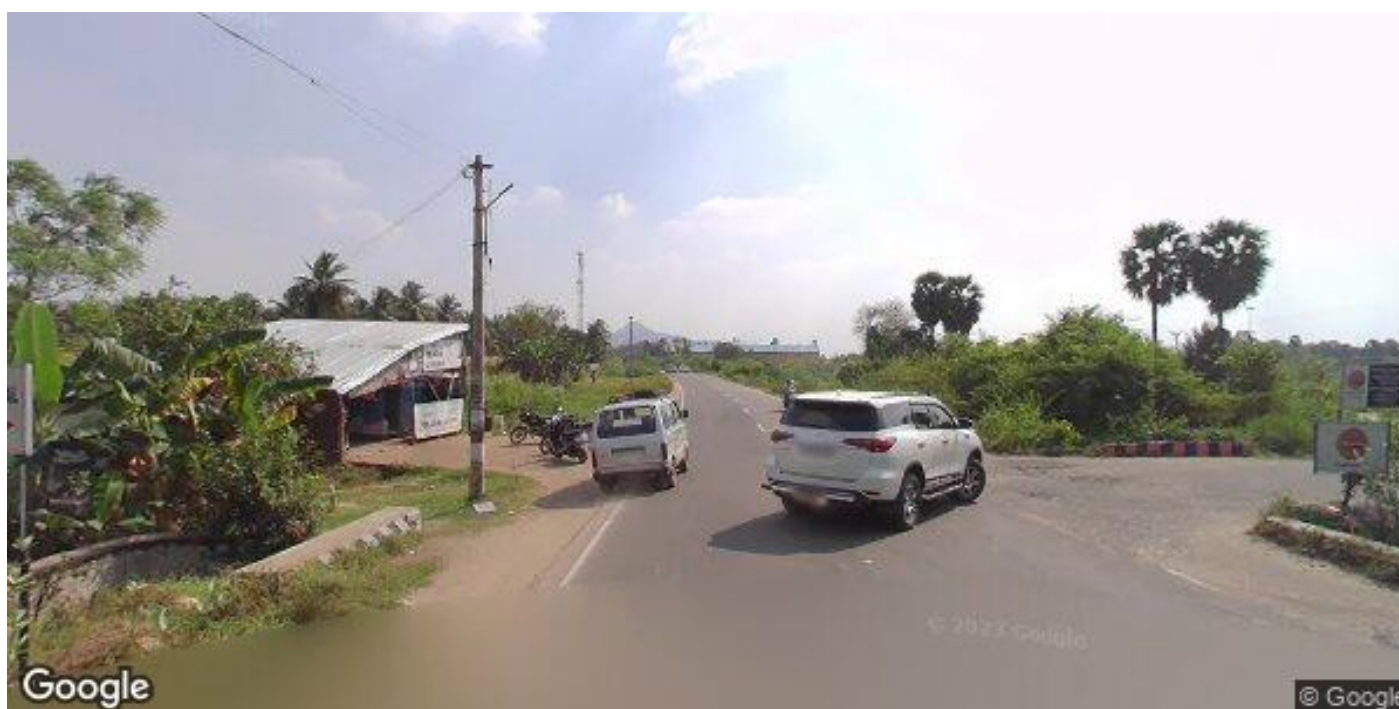
| | Risk Type | Risk Level | Coordinates | Speed Limit |
|---|---|---|---|---|
| 3 | Turn | High | 11.44029, 77.87544 | 15 KM/Hr |

**Risk Type:** Turn  
**Risk Level:** High  
**Speed Limit:** 15 KM/Hr  
**Coordinates:** 11.44029, 77.87544

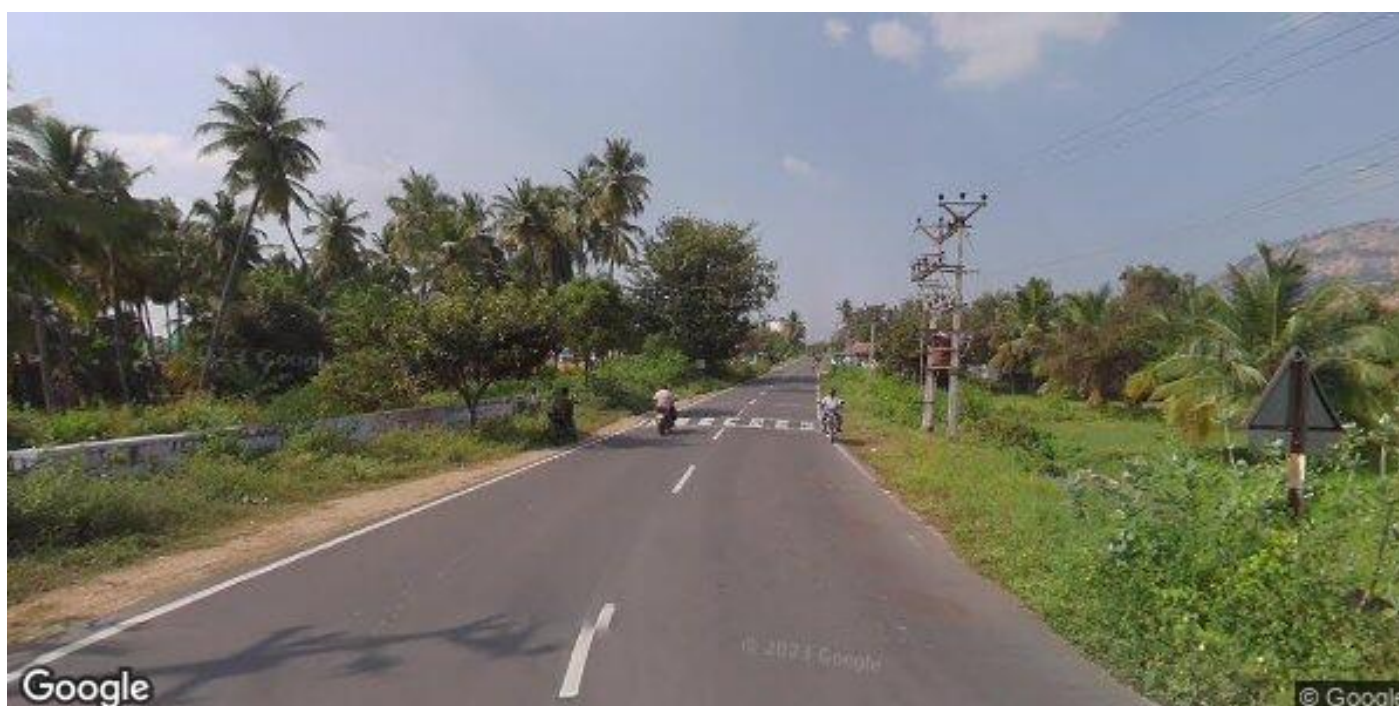
| | Risk Type | Risk Level | Coordinates | Speed Limit |
|---|---|---|---|---|
| 4 | Turn | Medium | 11.45353, 77.85697 | 30 KM/Hr |

**Risk Type:** Turn  
**Risk Level:** Medium  
**Speed Limit:** 30 KM/Hr  
**Coordinates:** 11.45353, 77.85697

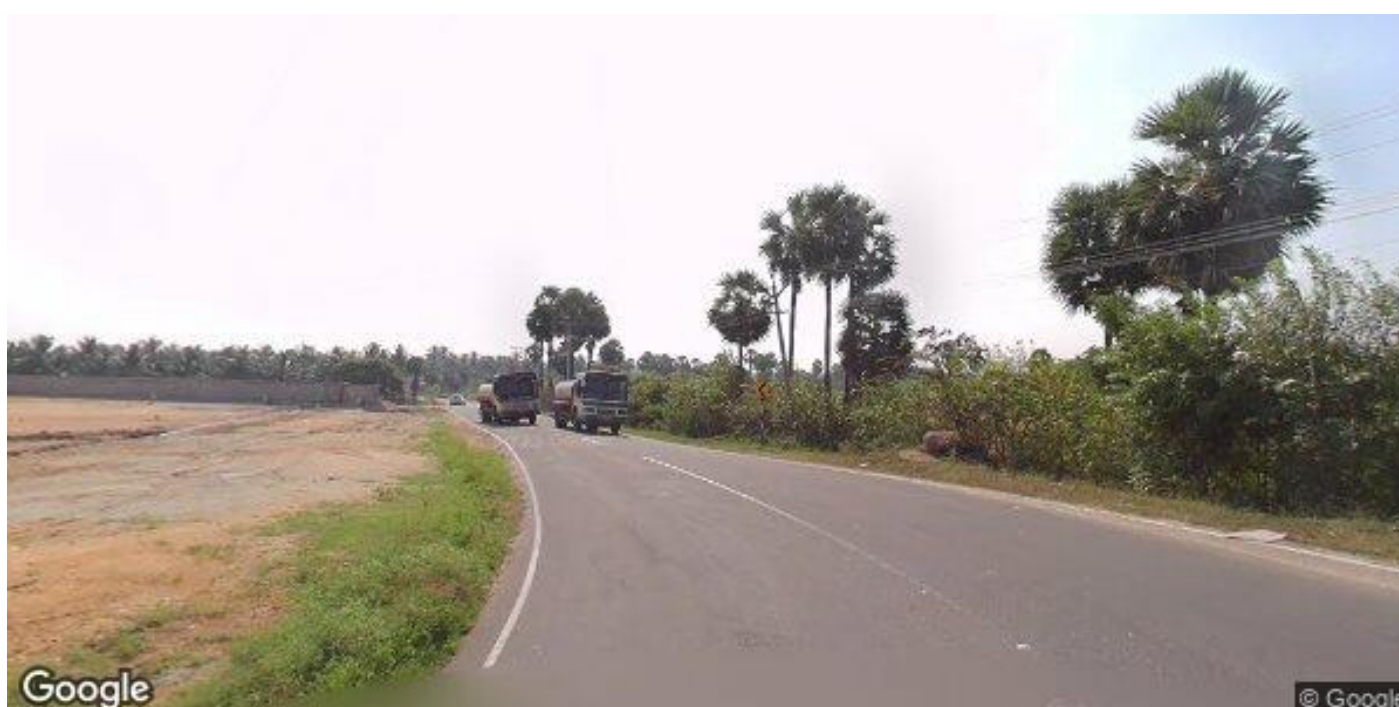
| | Risk Type | Risk Level | Coordinates | Speed Limit |
|---|---|---|---|---|
| 5 | Turn | Medium | 11.45839, 77.85143 | 30 KM/Hr |

**Risk Type:** Turn  
**Risk Level:** Medium

**Speed Limit: 30 KM/Hr**  
**Coordinates: 11.45839, 77.85143**

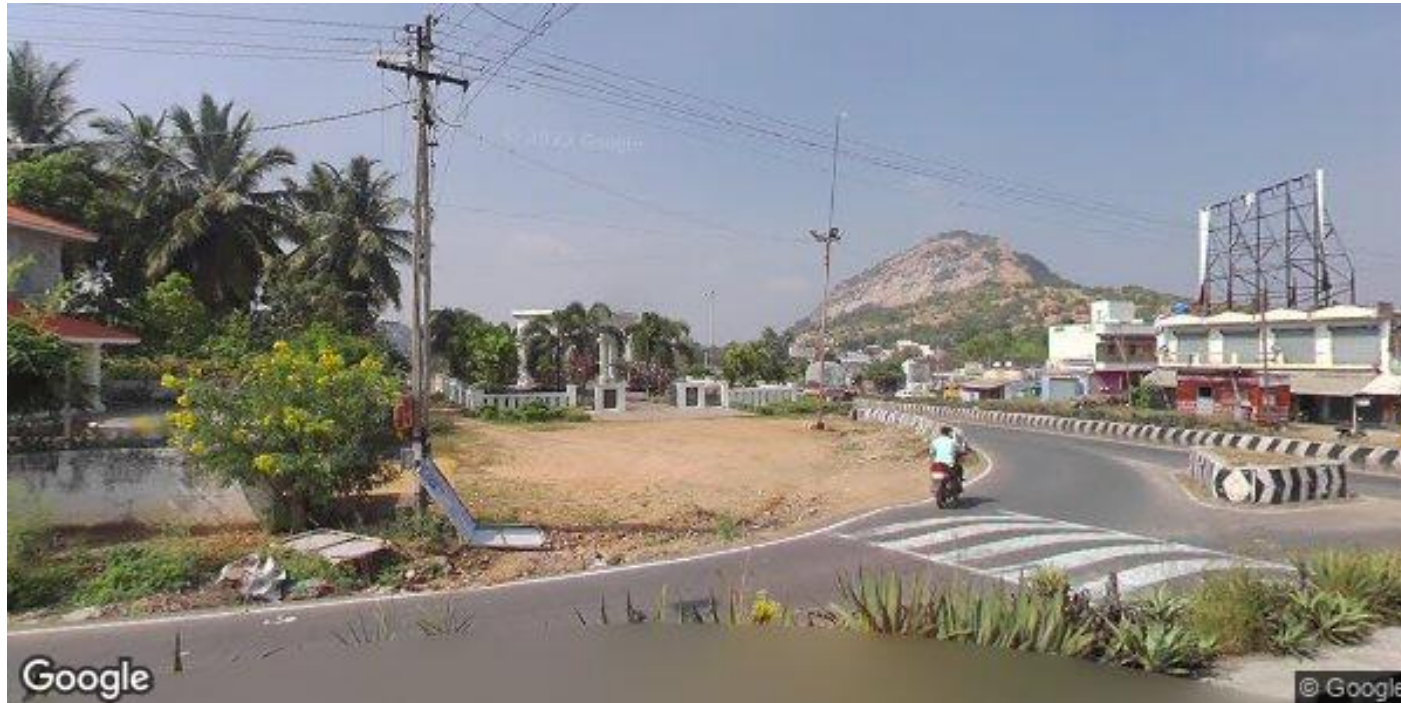
| | Risk Type | Risk Level | Coordinates | Speed Limit |
|---|---|---|---|---|
| 6 | Turn | Medium | 11.46307, 77.84941 | 30 KM/Hr |

**Risk Type: Turn**  
**Risk Level: Medium**  
**Speed Limit: 30 KM/Hr**  
**Coordinates: 11.46307, 77.84941**

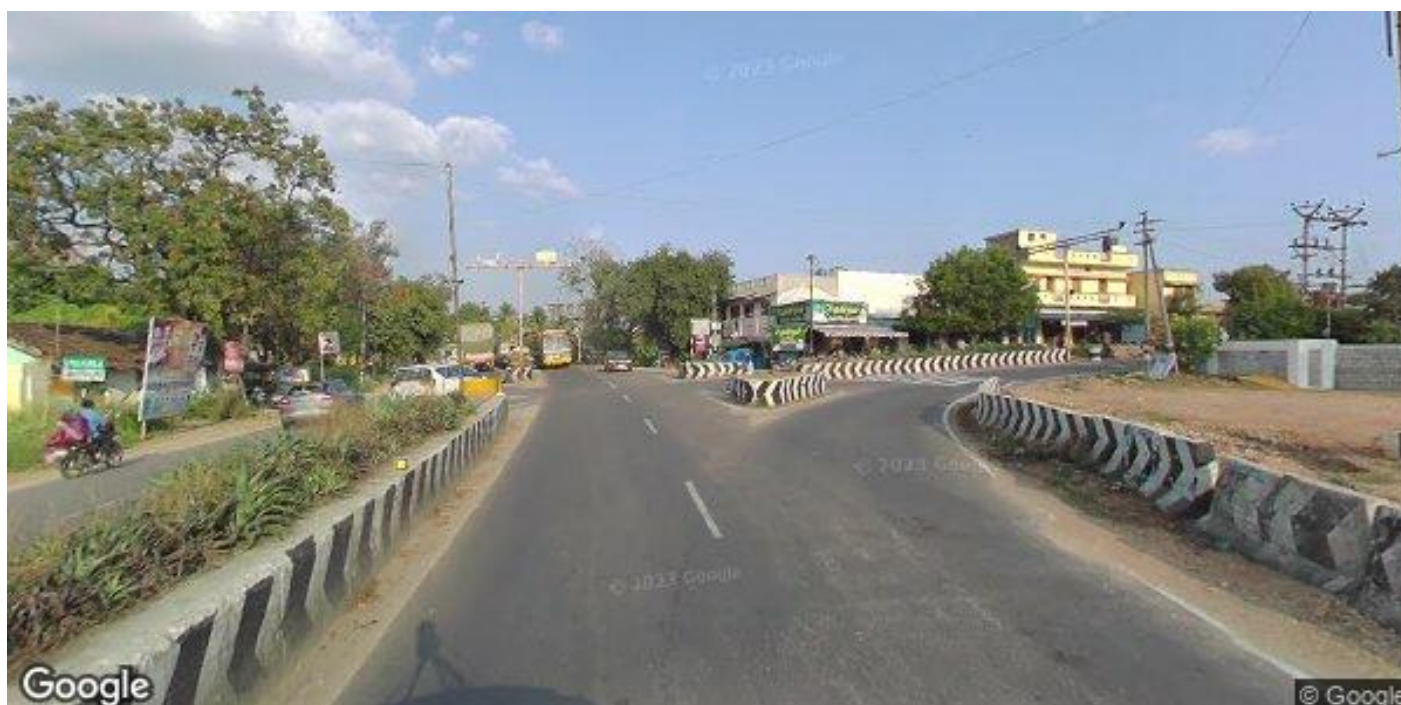
| | Risk Type | Risk Level | Coordinates | Speed Limit |
|---|---|---|---|---|
| 7 | Turn | Medium | 11.46318, 77.84913 | 30 KM/Hr |

**Risk Type: Turn**  
**Risk Level: Medium**  
**Speed Limit: 30 KM/Hr**  
**Coordinates: 11.46318, 77.84913**

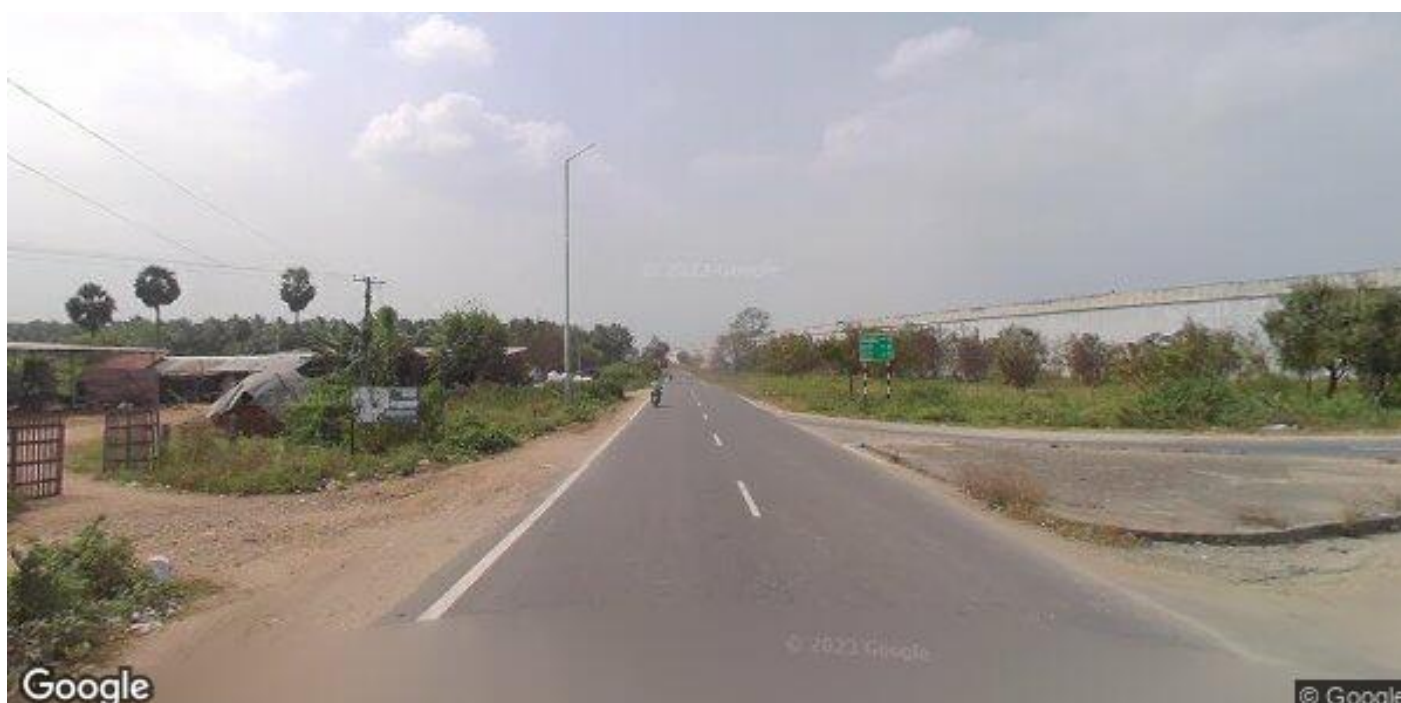
| | Risk Type | Risk Level | Coordinates | Speed Limit |
|---|---|---|---|---|
| 8 | Turn | High | 11.45542, 77.81725 | 15 KM/Hr |

**Risk Type:** Turn  
**Risk Level:** High  
**Speed Limit:** 15 KM/Hr  
**Coordinates:** 11.45542, 77.81725
