# IndianOil

## JOURNEY RISK MANAGEMENT (JRM) STUDY

### Salem Terminal to PALANIMALAI TRADERS

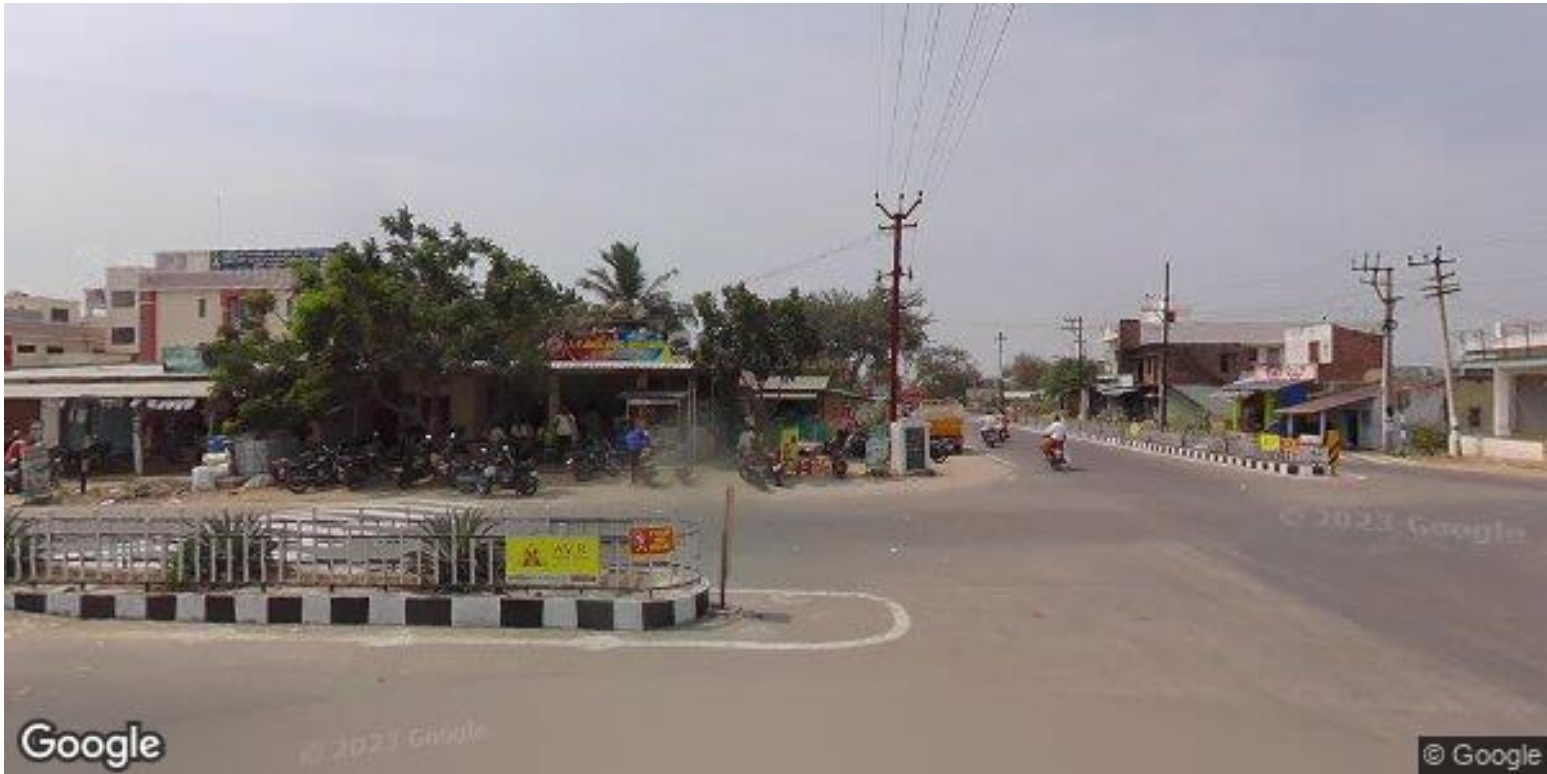
**Risk Type:** Roundabout  
**Risk Level:** High  
**Speed Limit:** 15 KM/Hr  
**Coordinates:** 11.58300, 77.85813

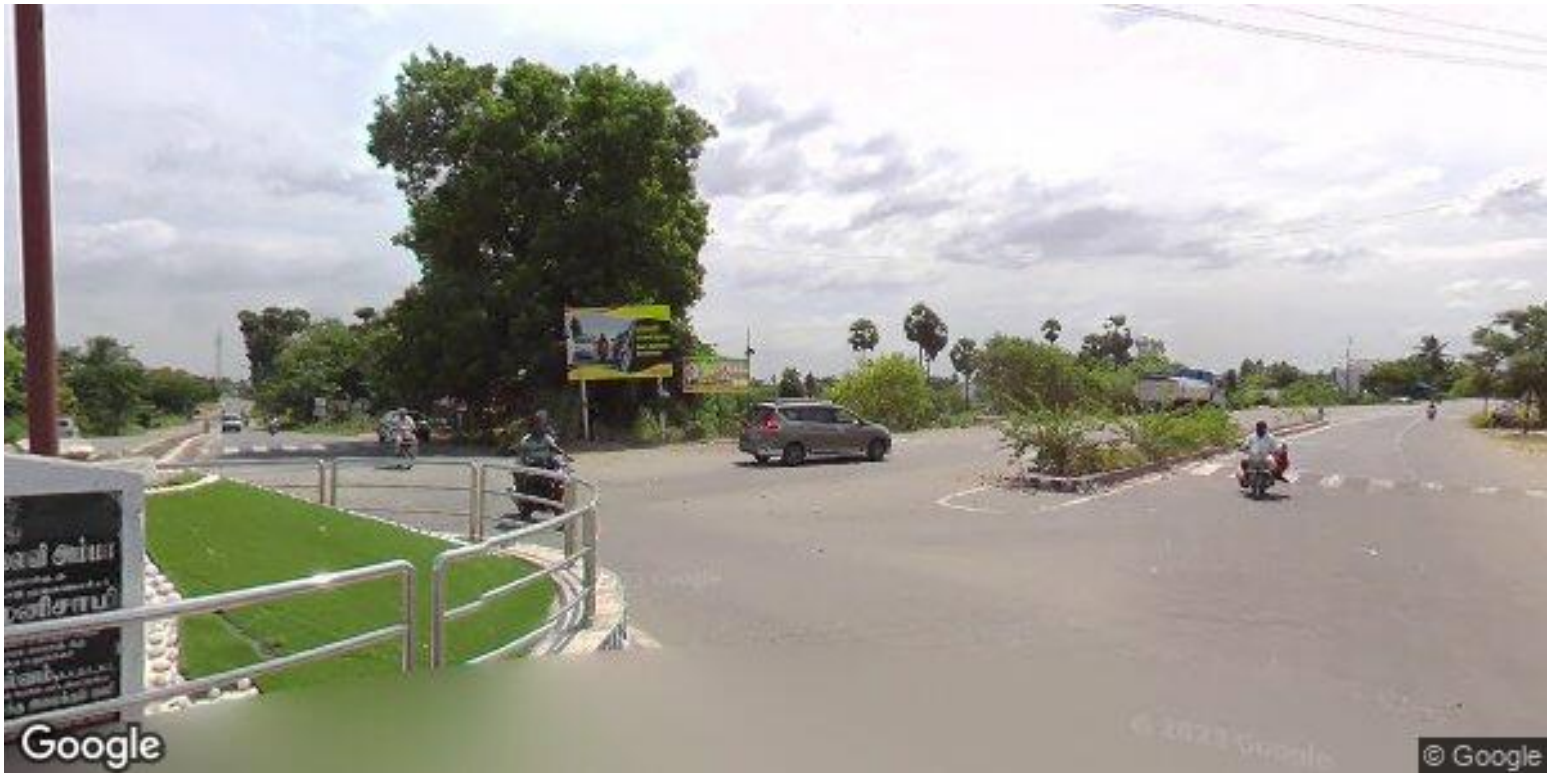
**Risk Type:** Roundabout  
**Risk Level:** High  
**Speed Limit:** 15 KM/Hr  
**Coordinates:** 11.60348, 77.83967

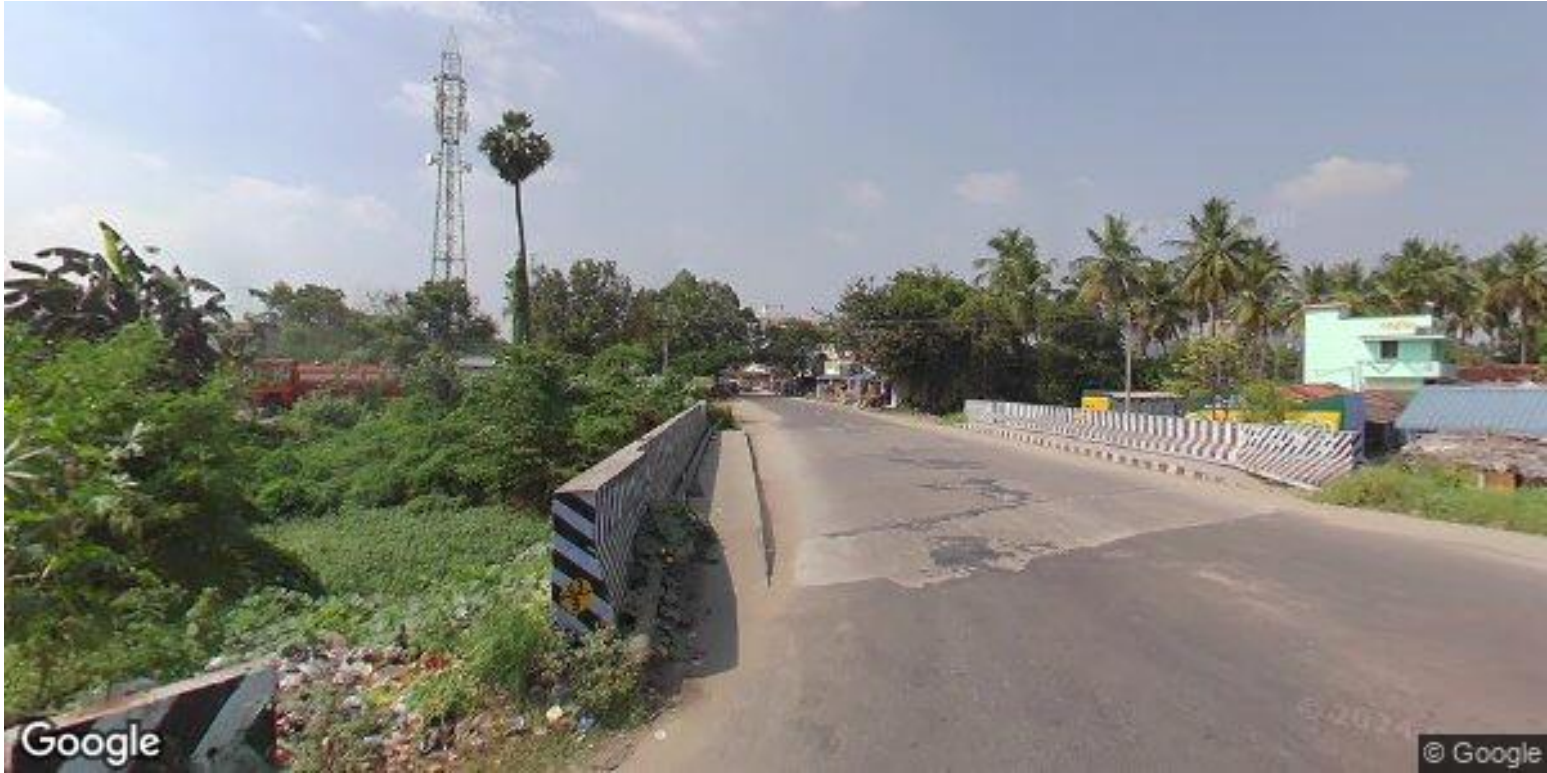
**Risk Type:** Turn  
**Risk Level:** Medium  
**Speed Limit:** 30 KM/Hr  
**Coordinates:** 11.44900, 77.87406

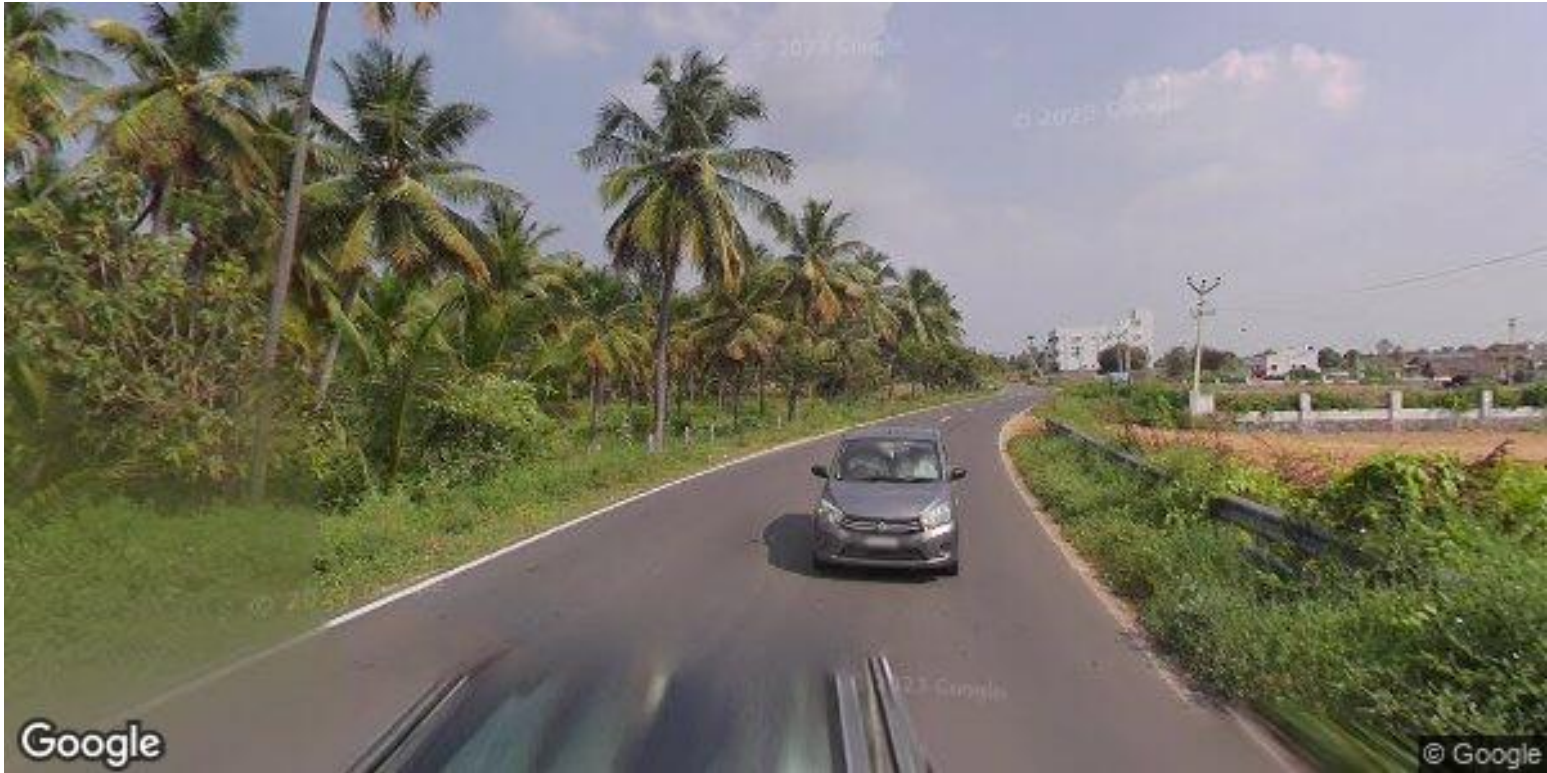
**Risk Type:** Turn  
**Risk Level:** Medium  
**Speed Limit:** 30 KM/Hr  
**Coordinates:** 11.45357, 77.85789

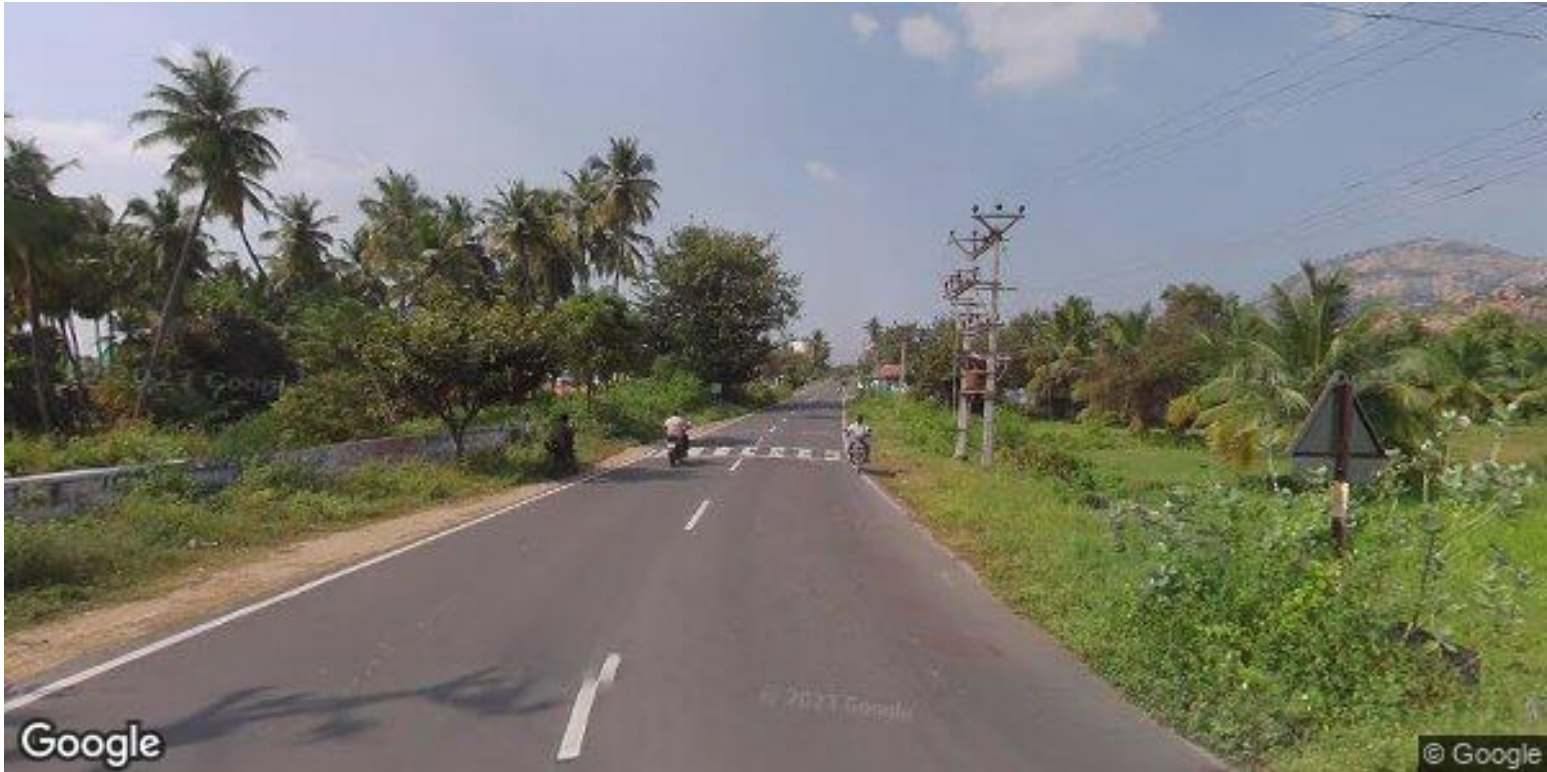
**Risk Type:** Turn  
**Risk Level:** Medium  
**Speed Limit:** 30 KM/Hr  
**Coordinates:** 11.45352, 77.85698

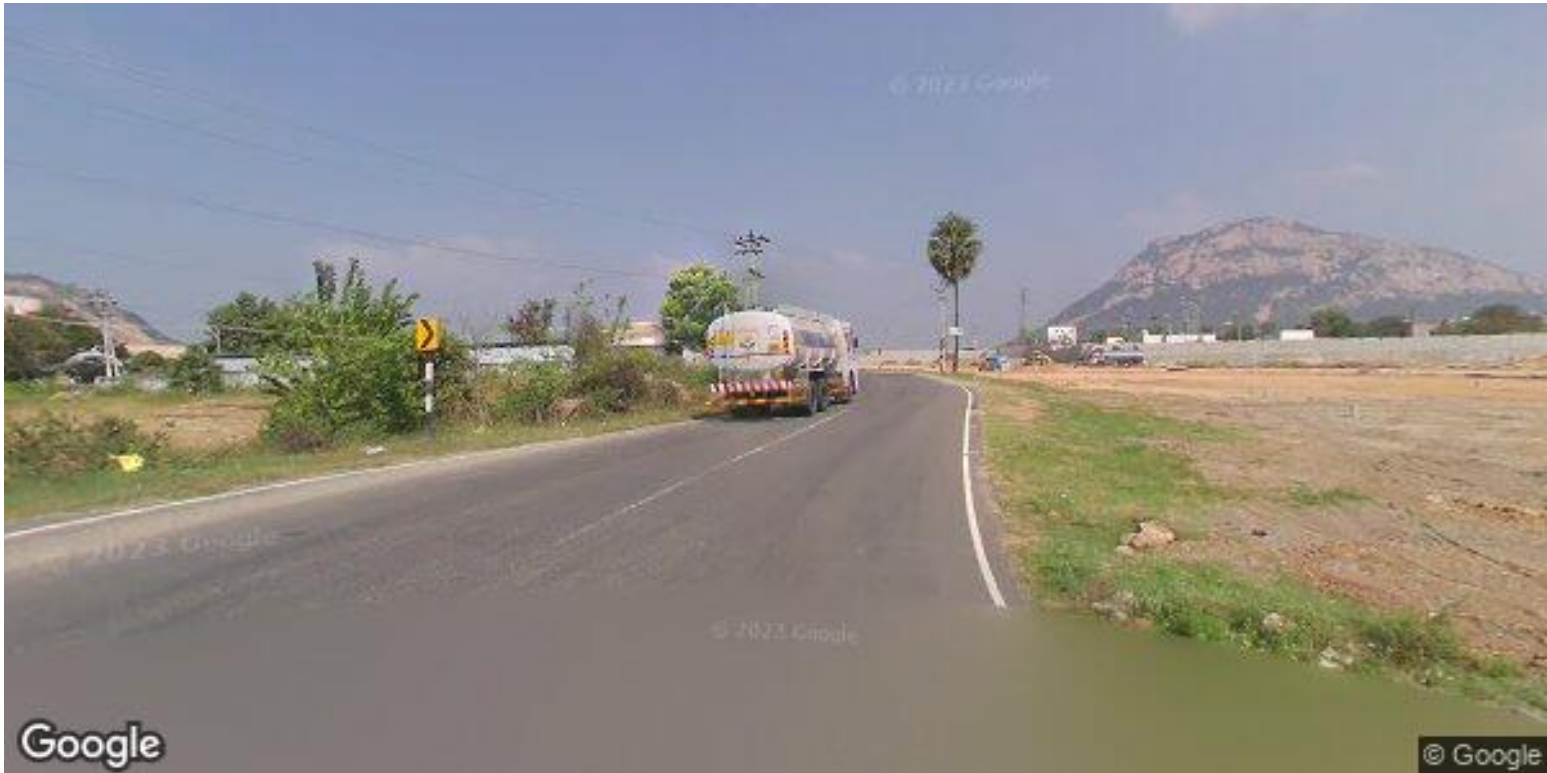
**Risk Type:** Turn  
**Risk Level:** Medium  
**Speed Limit:** 30 KM/Hr  
**Coordinates:** 11.45847, 77.85140

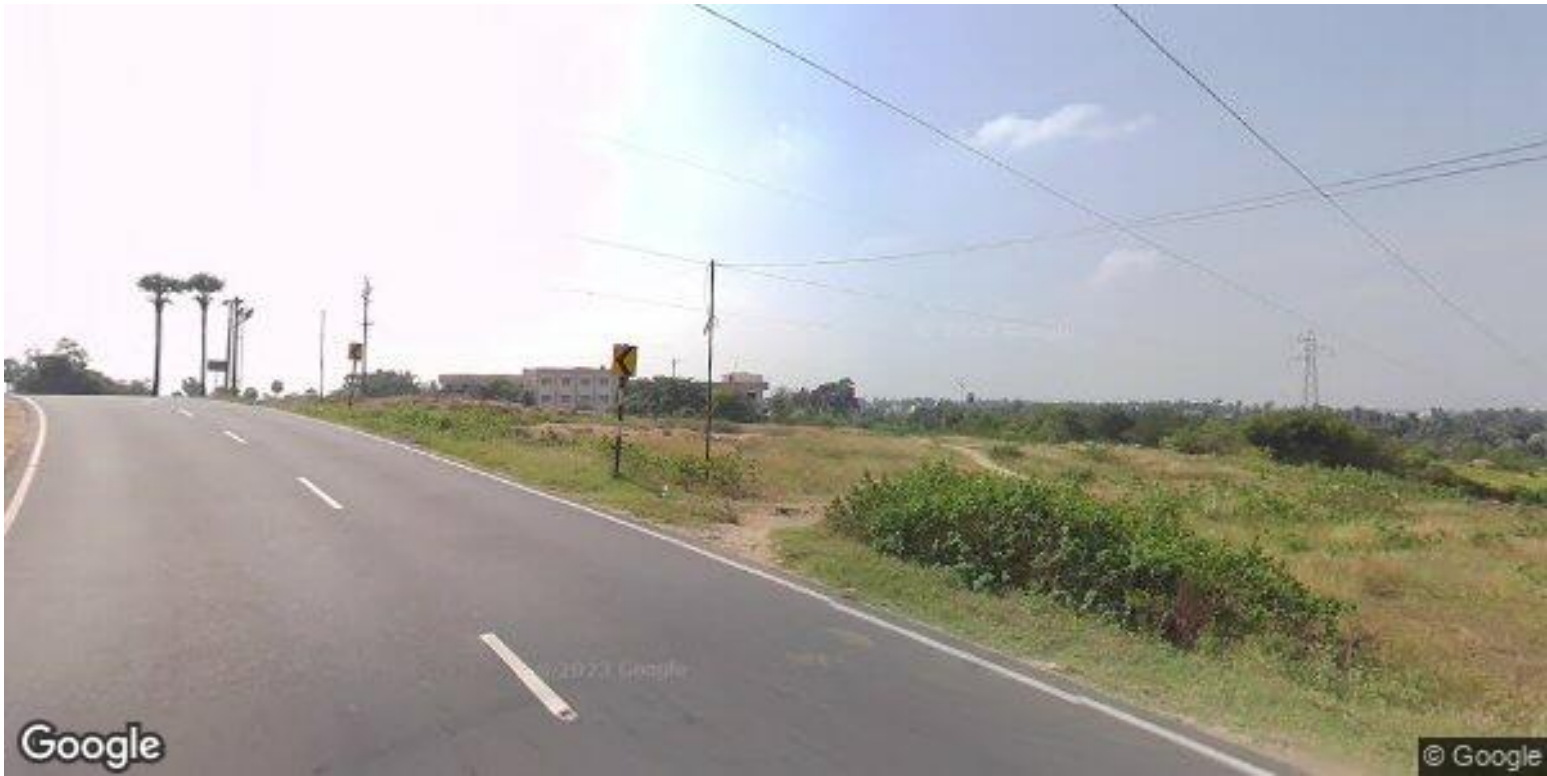
**Risk Type:** Turn  
**Risk Level:** Medium  
**Speed Limit:** 30 KM/Hr  
**Coordinates:** 11.46048, 77.85036

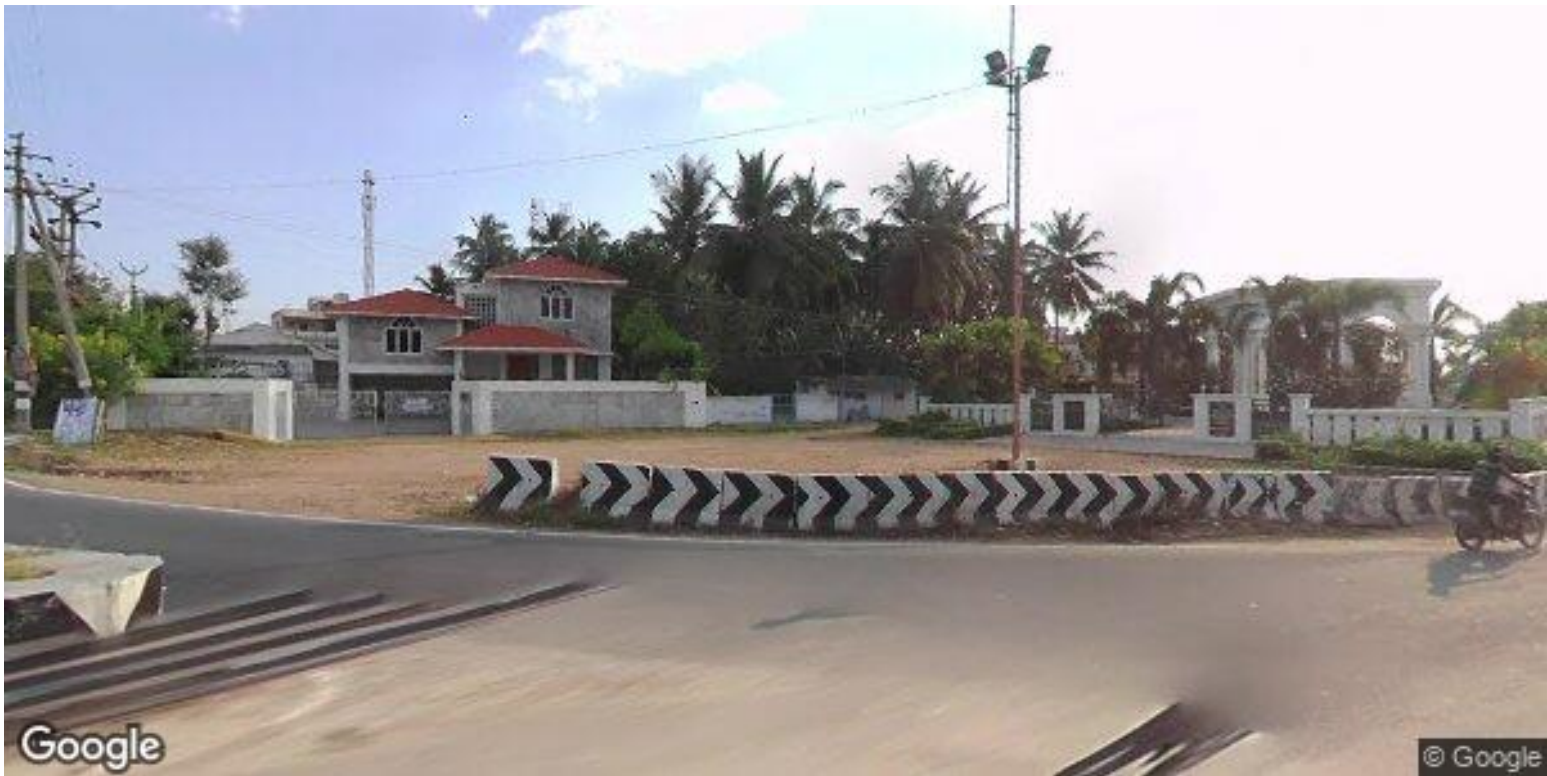
**Risk Type:** Turn  
**Risk Level:** Medium  
**Speed Limit:** 30 KM/Hr  
**Coordinates:** 11.46314, 77.84928

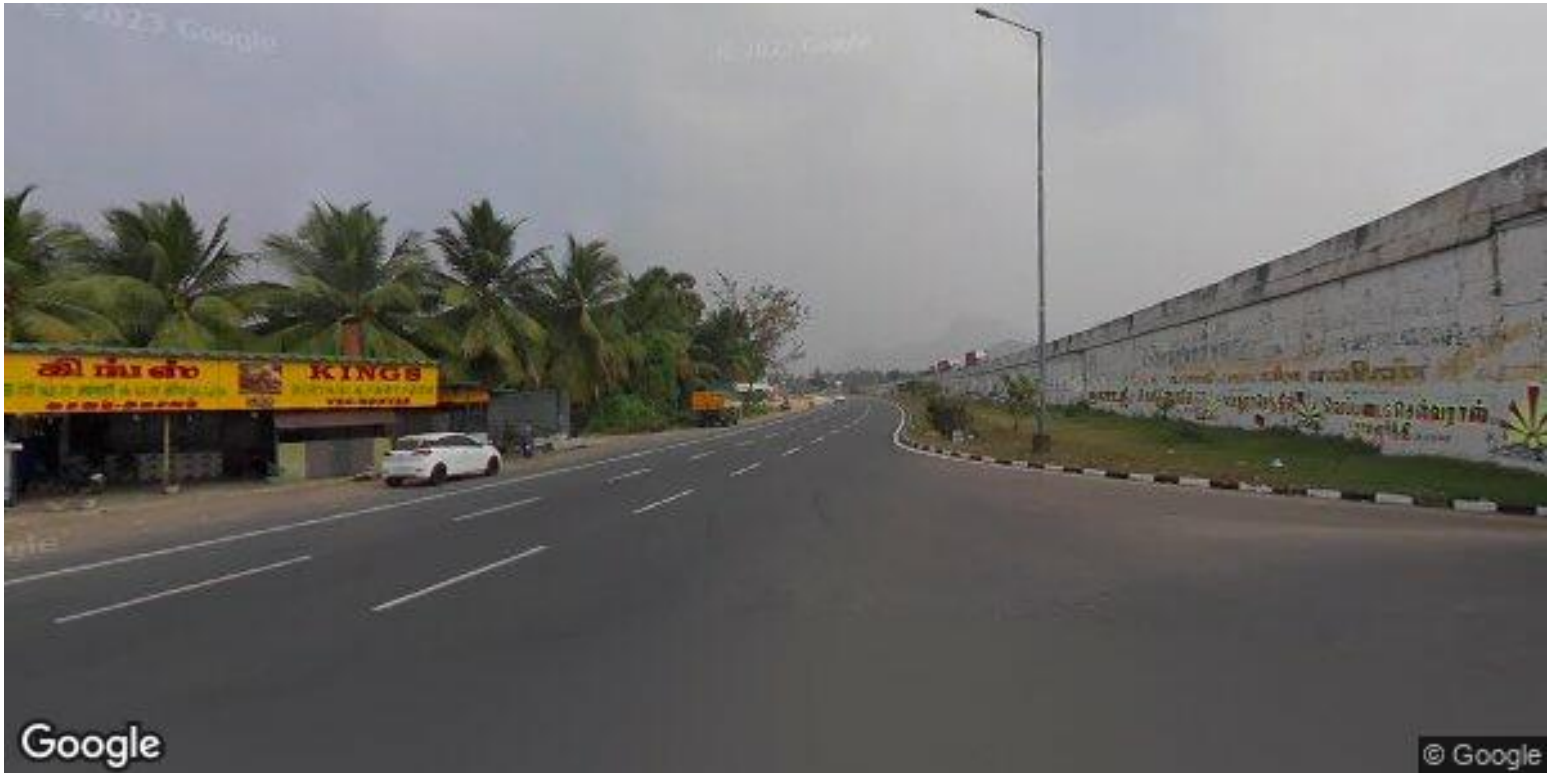
**Risk Type:** Turn  
**Risk Level:** High  
**Speed Limit:** 15 KM/Hr  
**Coordinates:** 11.45634, 77.81673

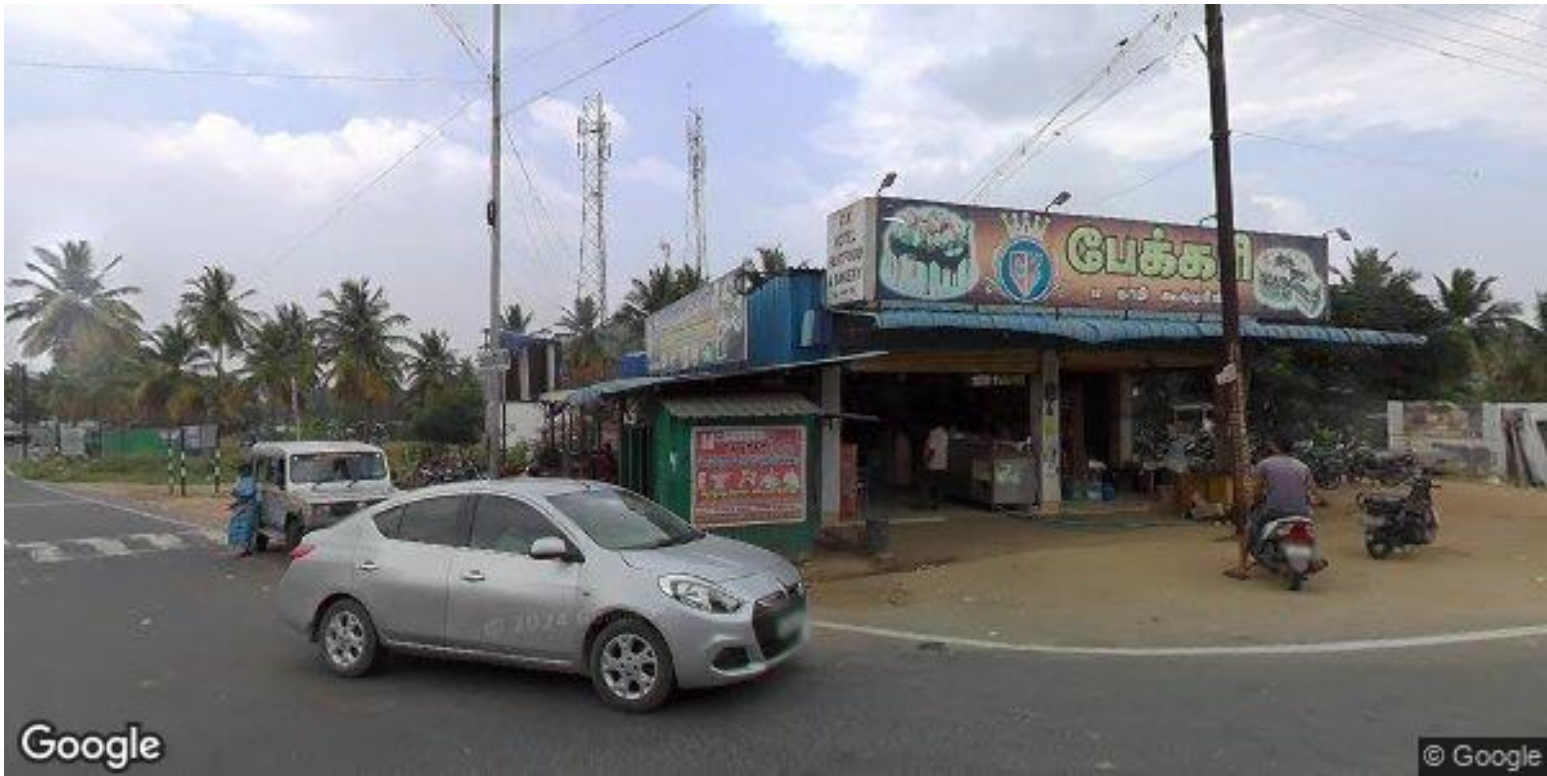
**Risk Type:** Blind Spot  
**Risk Level:** Blind Spot  
**Speed Limit:** 10 KM/Hr  
**Coordinates:** 11.49390, 77.86748

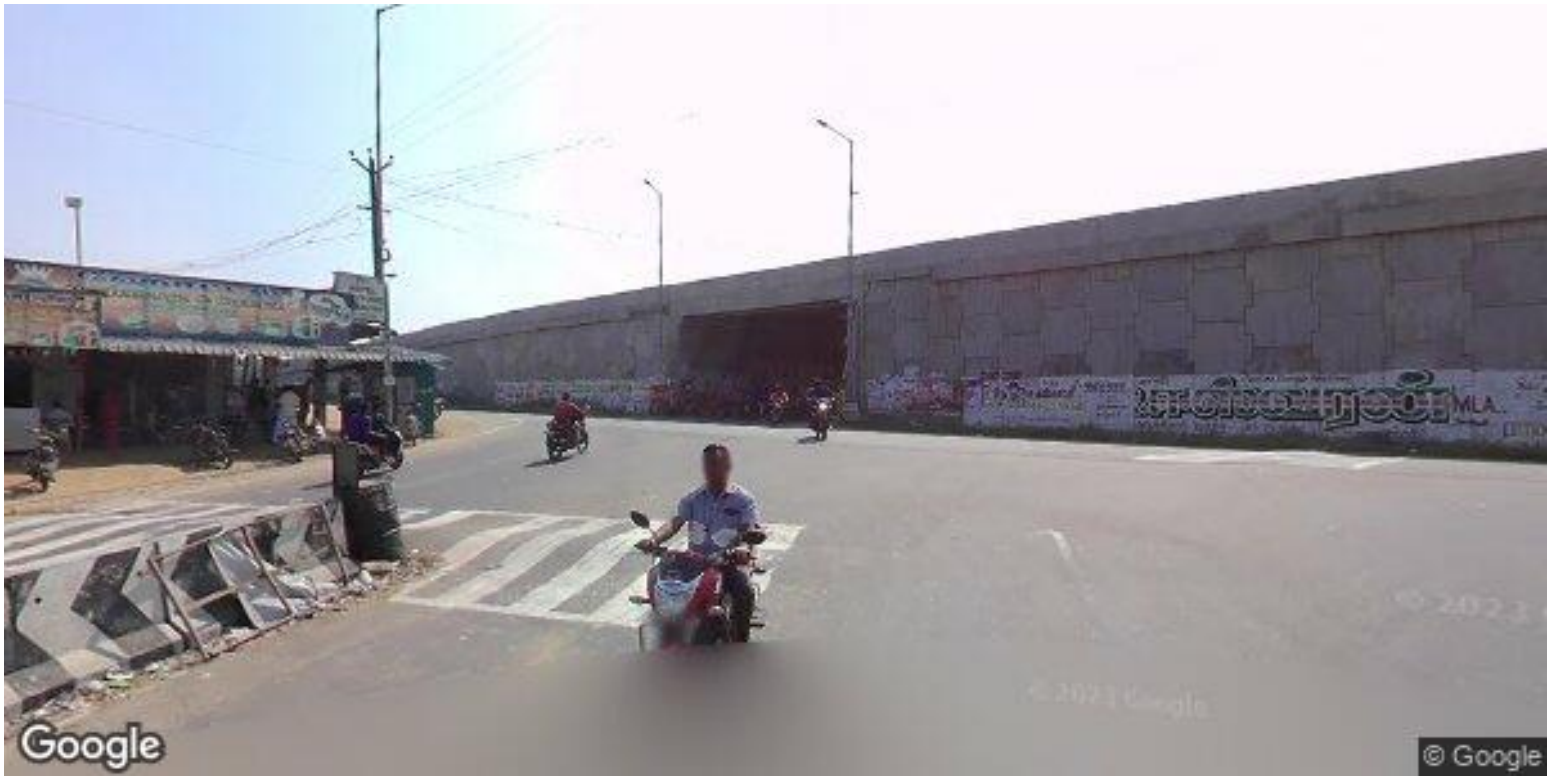
**Risk Type:** Turn  
**Risk Level:** Medium  
**Speed Limit:** 30 KM/Hr  
**Coordinates:** 11.49404, 77.86724

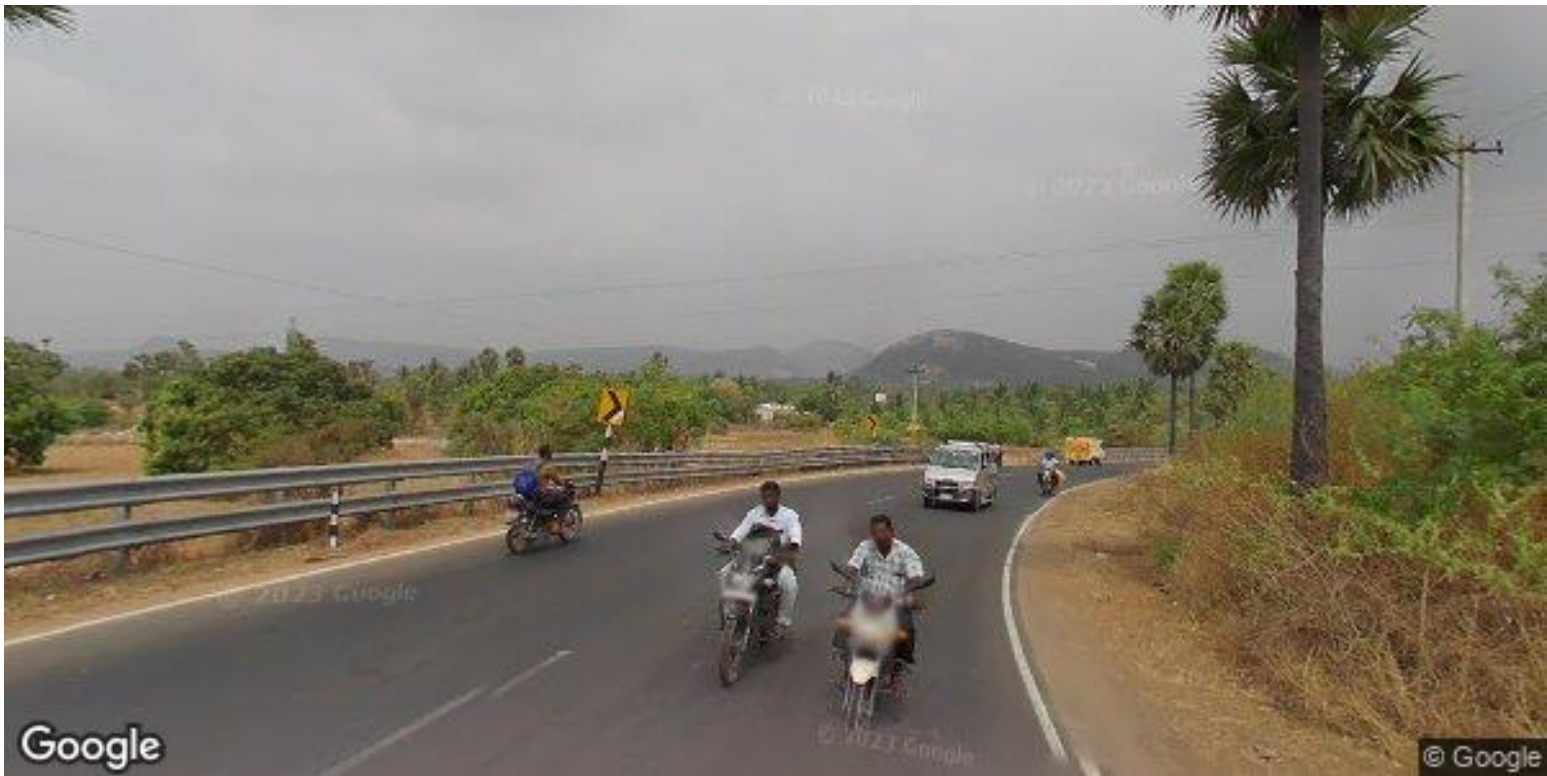
**Risk Type:** Turn  
**Risk Level:** Medium  
**Speed Limit:** 30 KM/Hr  
**Coordinates:** 11.50866, 77.86053

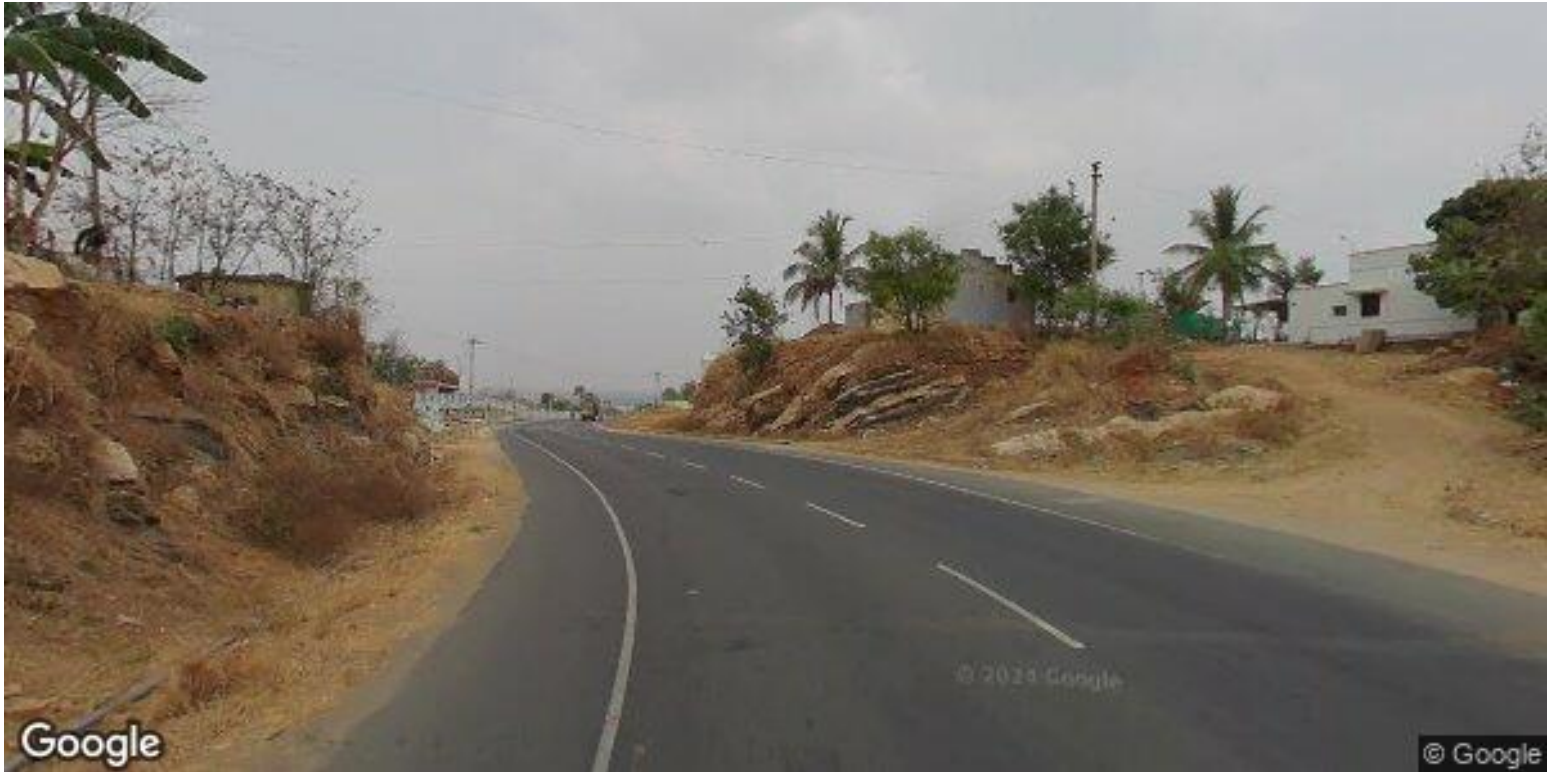
**Risk Type:** Turn  
**Risk Level:** Medium  
**Speed Limit:** 30 KM/Hr  
**Coordinates:** 11.55039, 77.85511

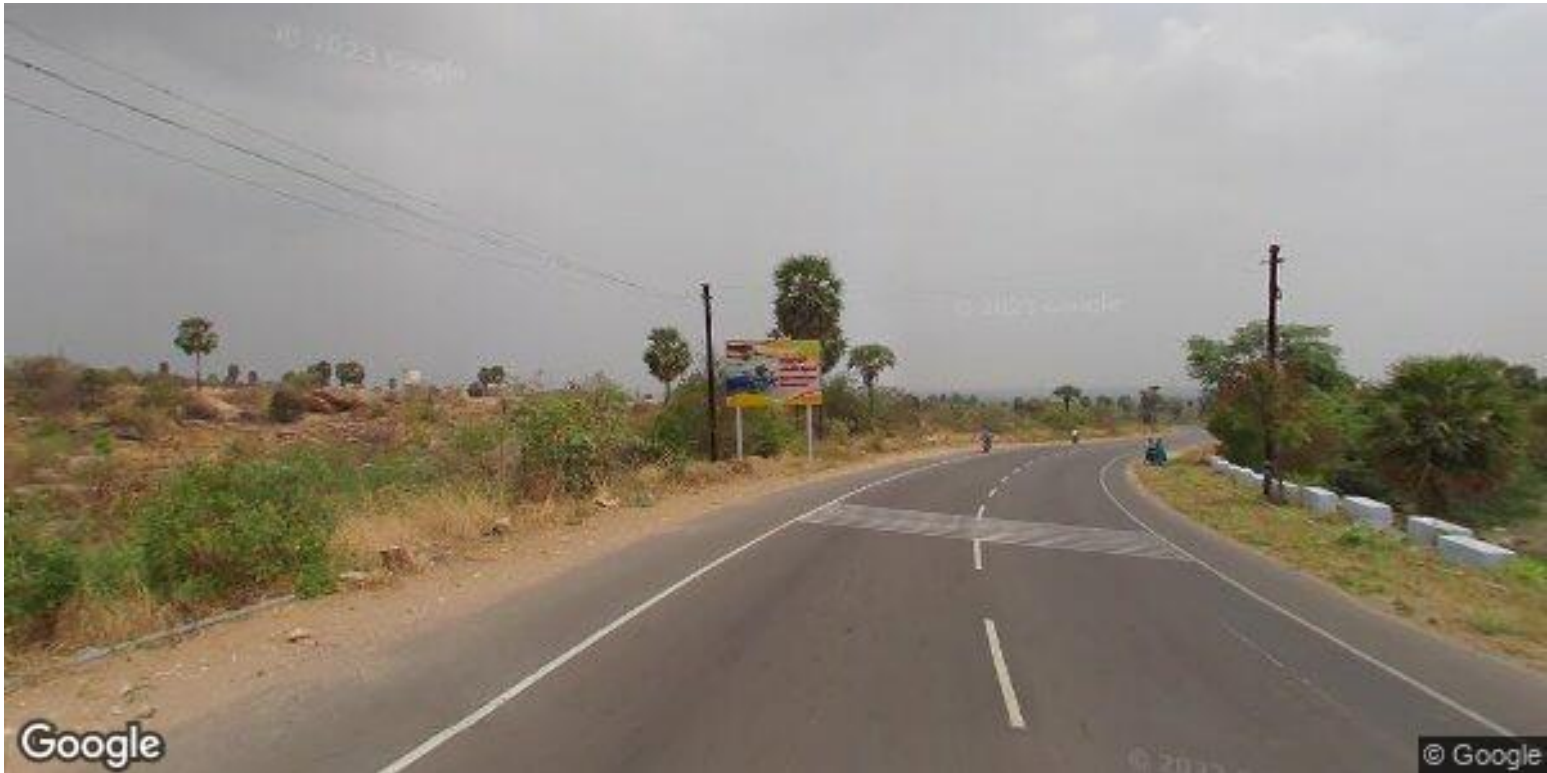
**Risk Type:** Turn  
**Risk Level:** Medium  
**Speed Limit:** 30 KM/Hr  
**Coordinates:** 11.55460, 77.85624

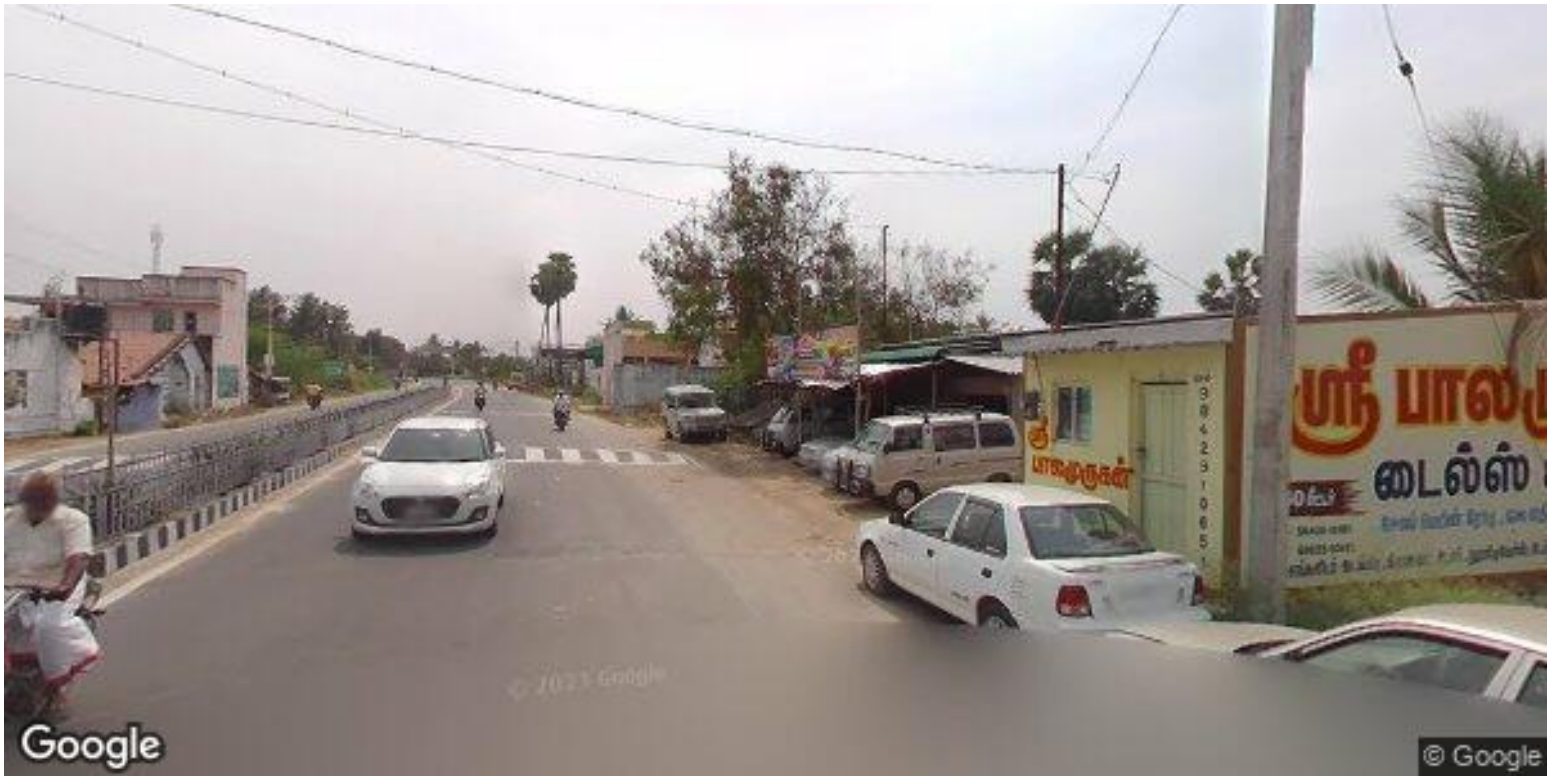
**Risk Type:** Turn  
**Risk Level:** High  
**Speed Limit:** 15 KM/Hr  
**Coordinates:** 11.57893, 77.85430

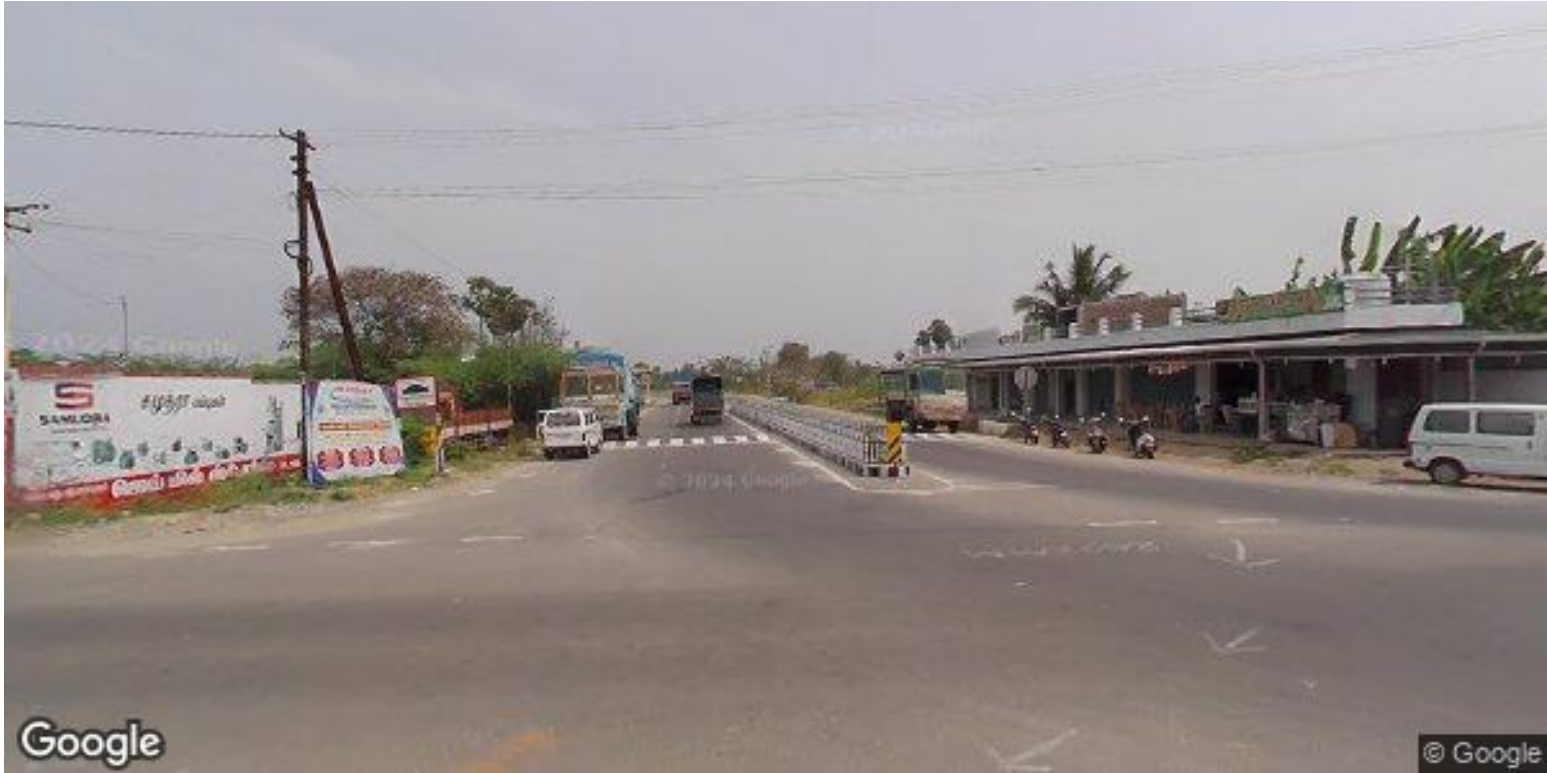
**Risk Type:** Turn  
**Risk Level:** Medium  
**Speed Limit:** 30 KM/Hr  
**Coordinates:** 11.57903, 77.85441

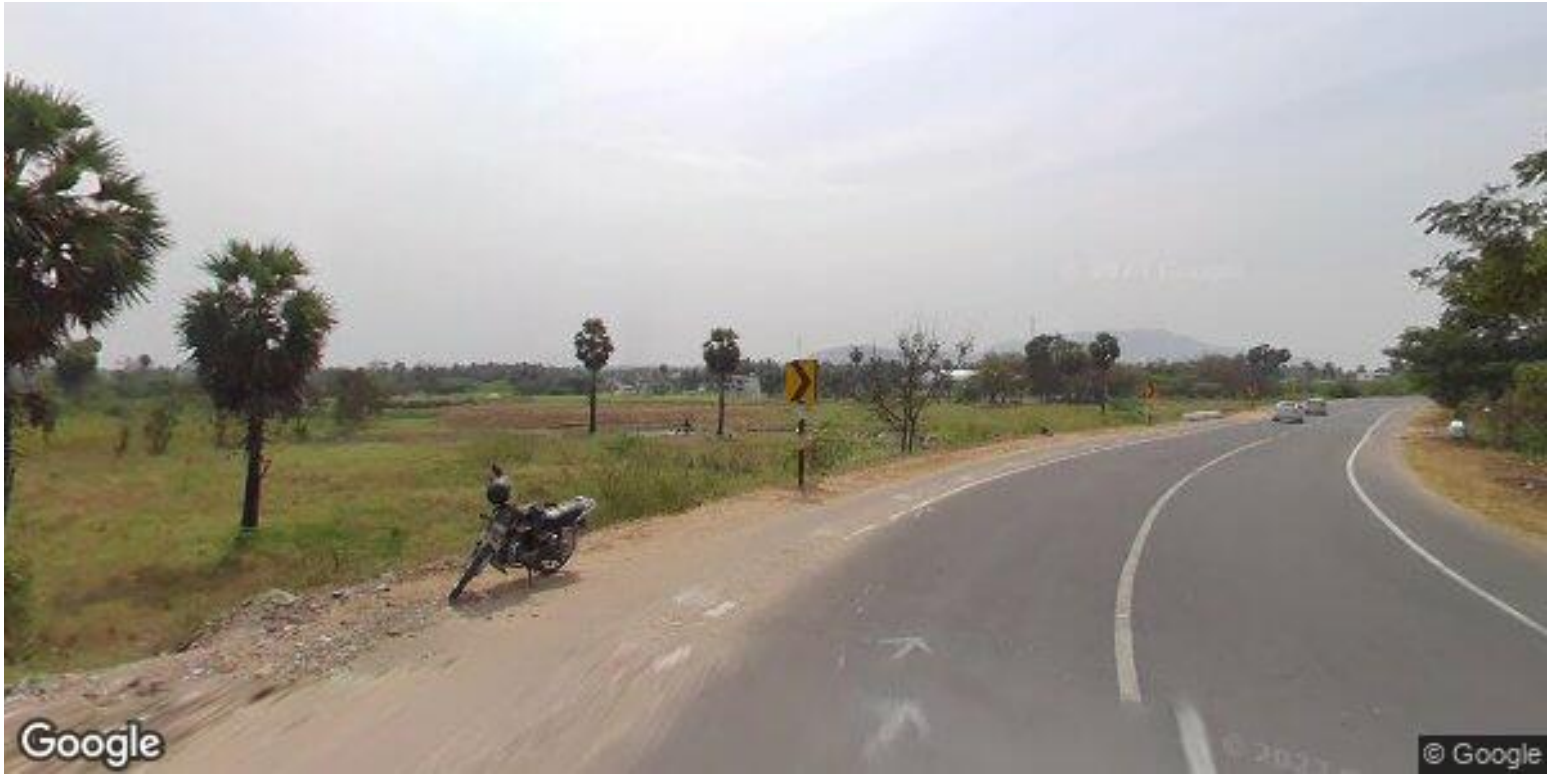
**Risk Type:** Turn  
**Risk Level:** Medium  
**Speed Limit:** 30 KM/Hr  
**Coordinates:** 11.58022, 77.85744

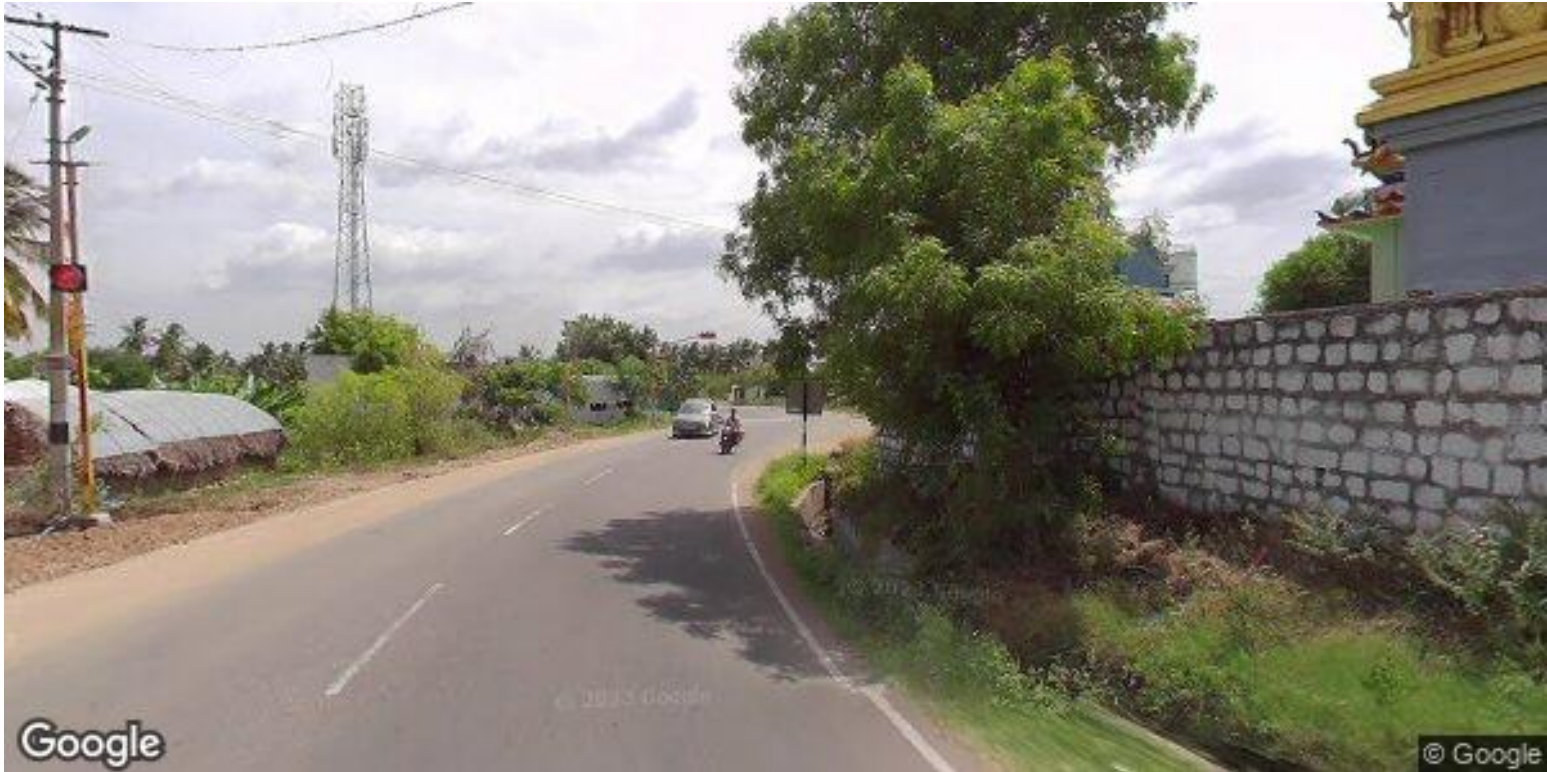
**Risk Type:** Turn  
**Risk Level:** Medium  
**Speed Limit:** 30 KM/Hr  
**Coordinates:** 11.60727, 77.84032

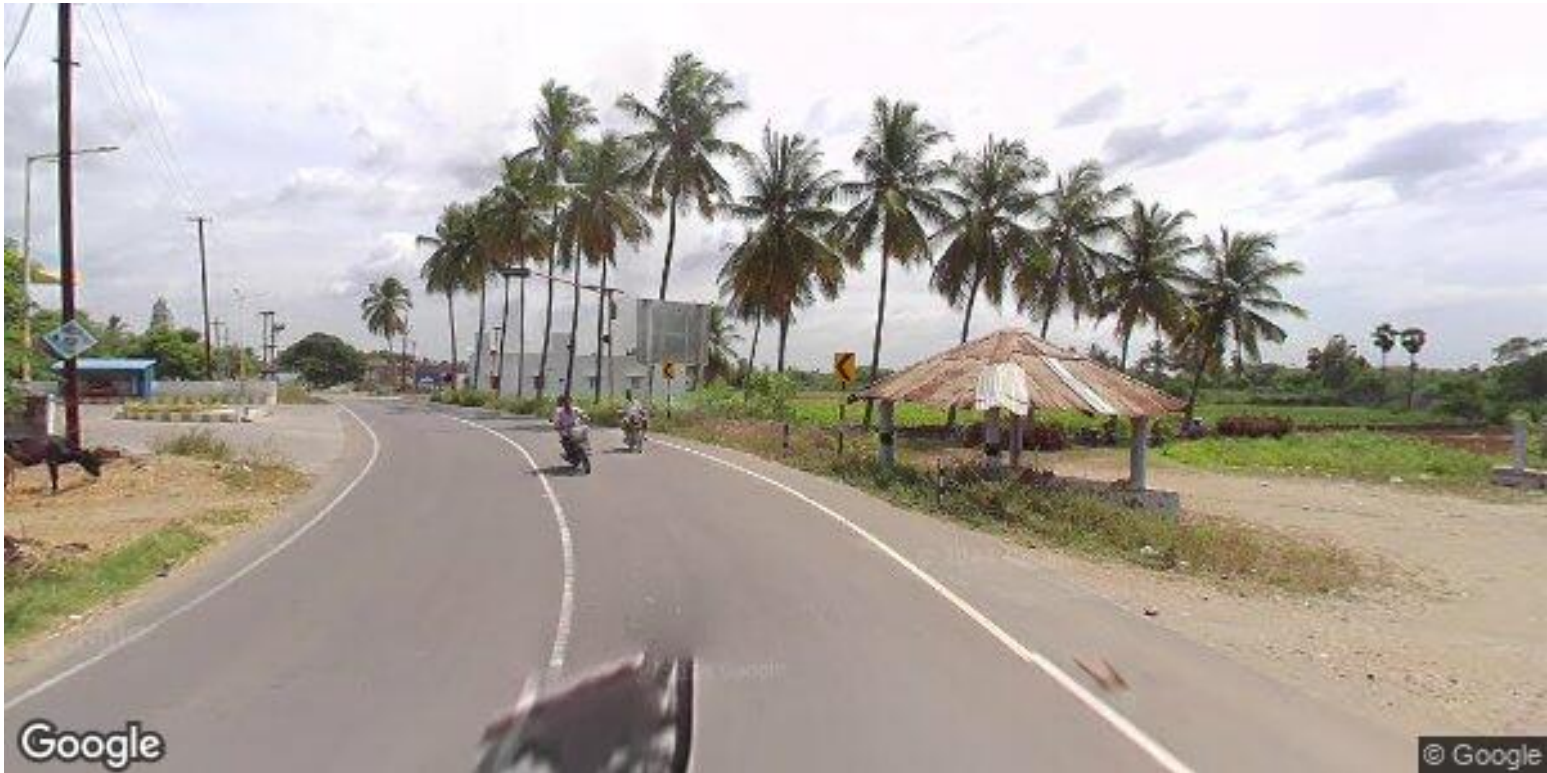
**Risk Type:** Turn  
**Risk Level:** Medium  
**Speed Limit:** 30 KM/Hr  
**Coordinates:** 11.60972, 77.84164
