# IndianOil

## JOURNEY RISK MANAGEMENT (JRM) STUDY

### Salem Terminal to PALANIMALAI TRADERS

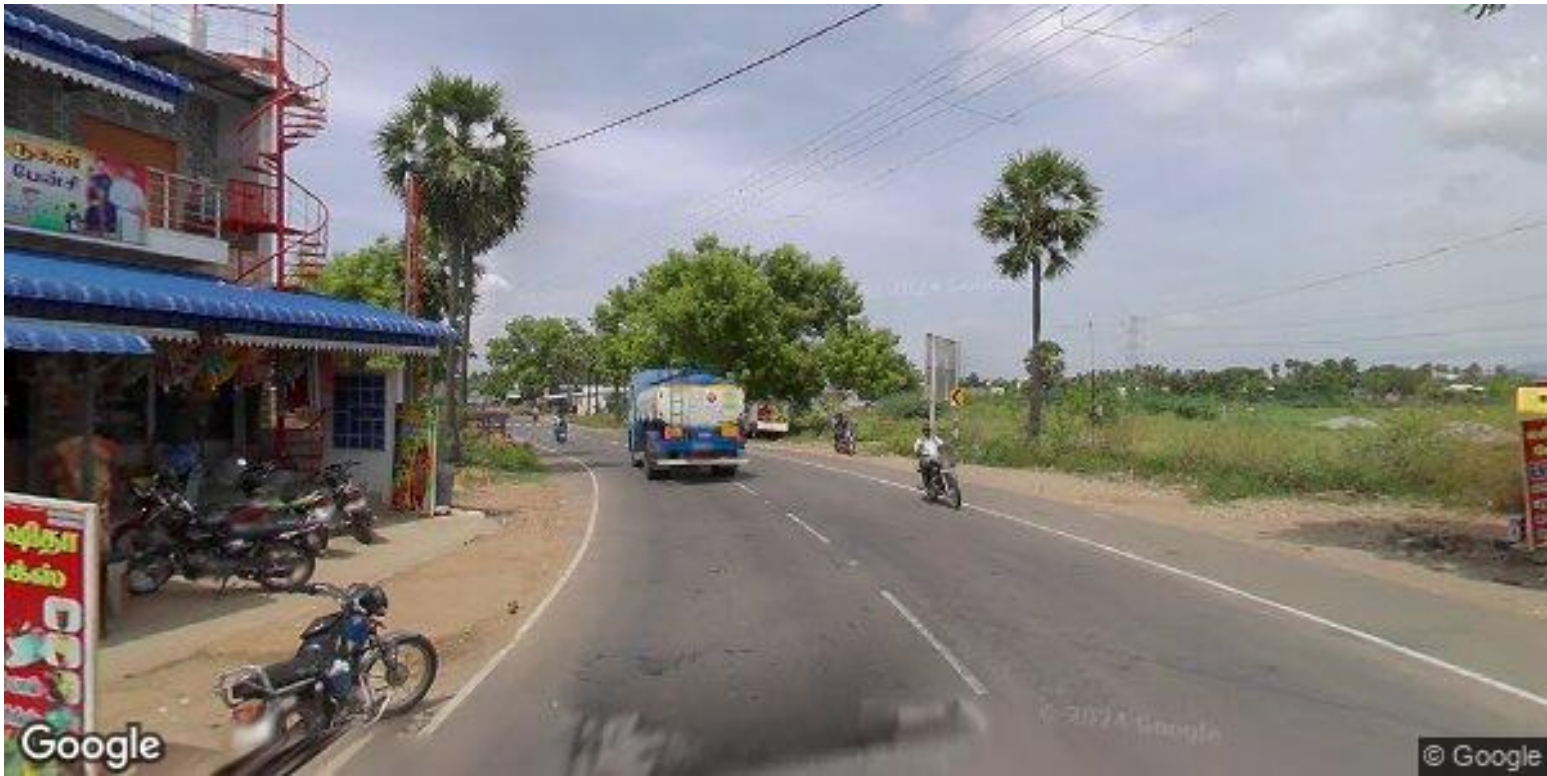
**Risk Type:** Turn  
**Risk Level:** Medium  
**Speed Limit:** 30 KM/Hr  
**Coordinates:** 11.64064, 77.84611

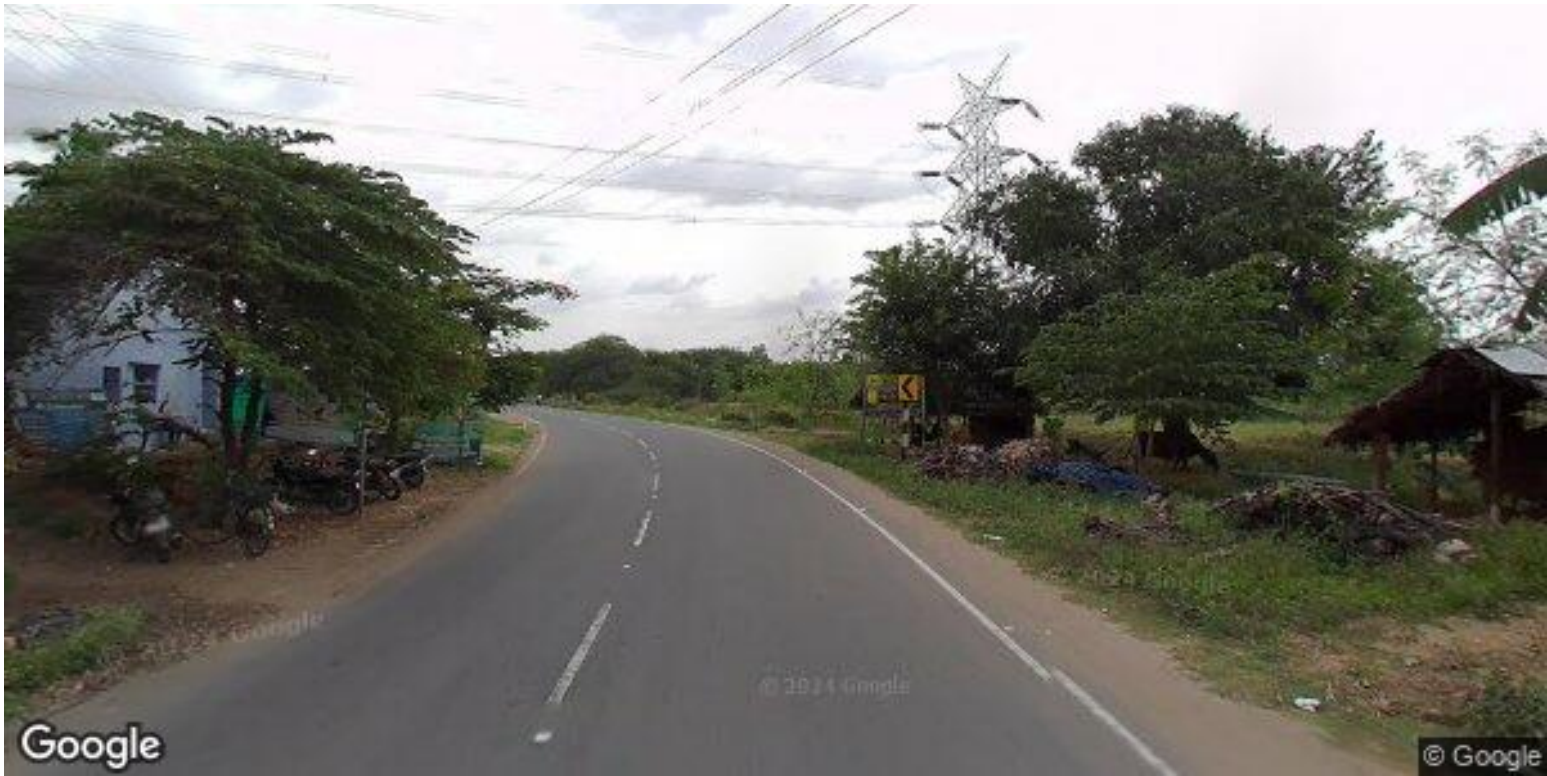
**Risk Type:** Turn  
**Risk Level:** Medium  
**Speed Limit:** 30 KM/Hr  
**Coordinates:** 11.64535, 77.85122

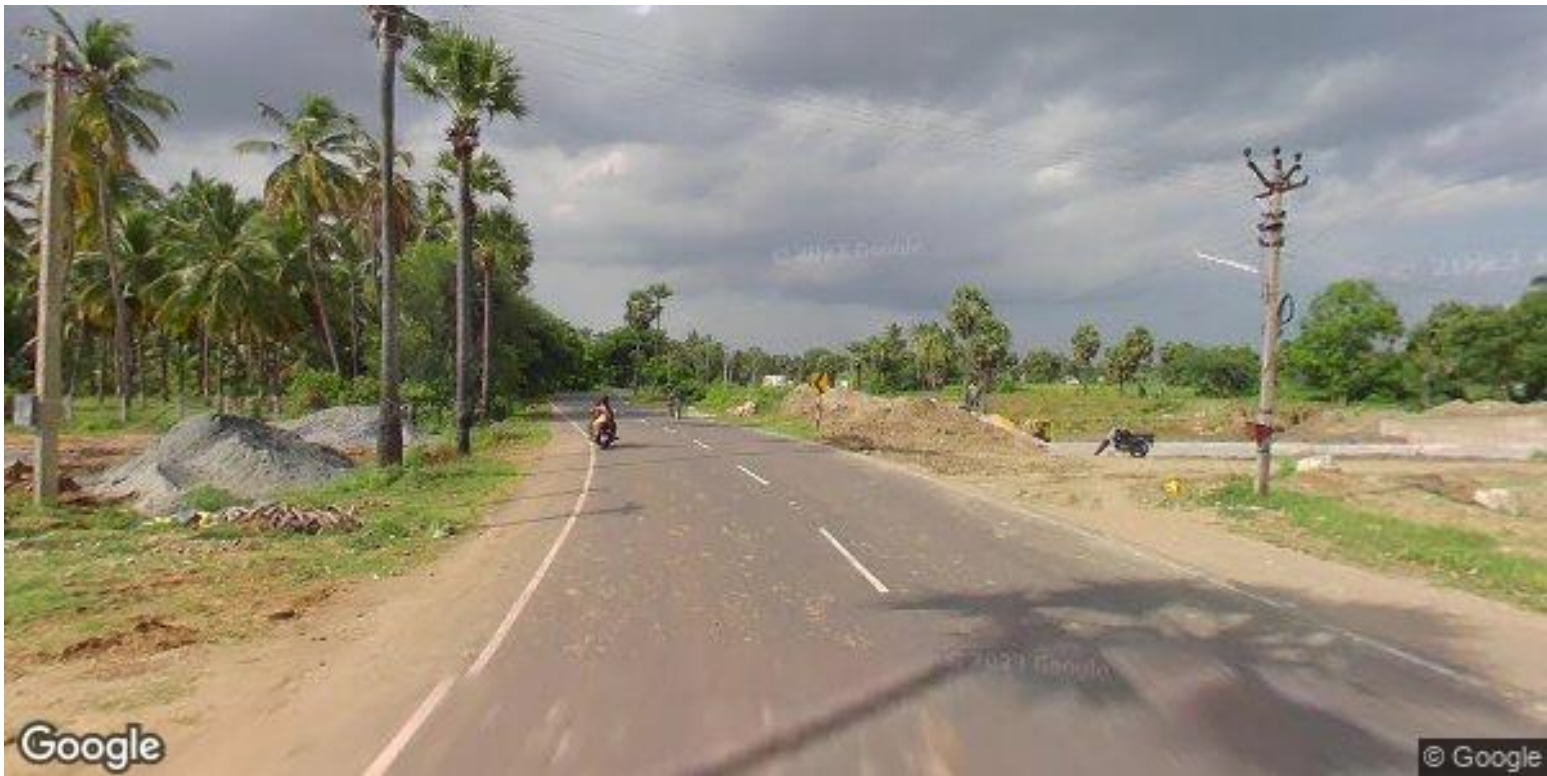
**Risk Type:** Turn  
**Risk Level:** Medium  
**Speed Limit:** 30 KM/Hr  
**Coordinates:** 11.66467, 77.85599

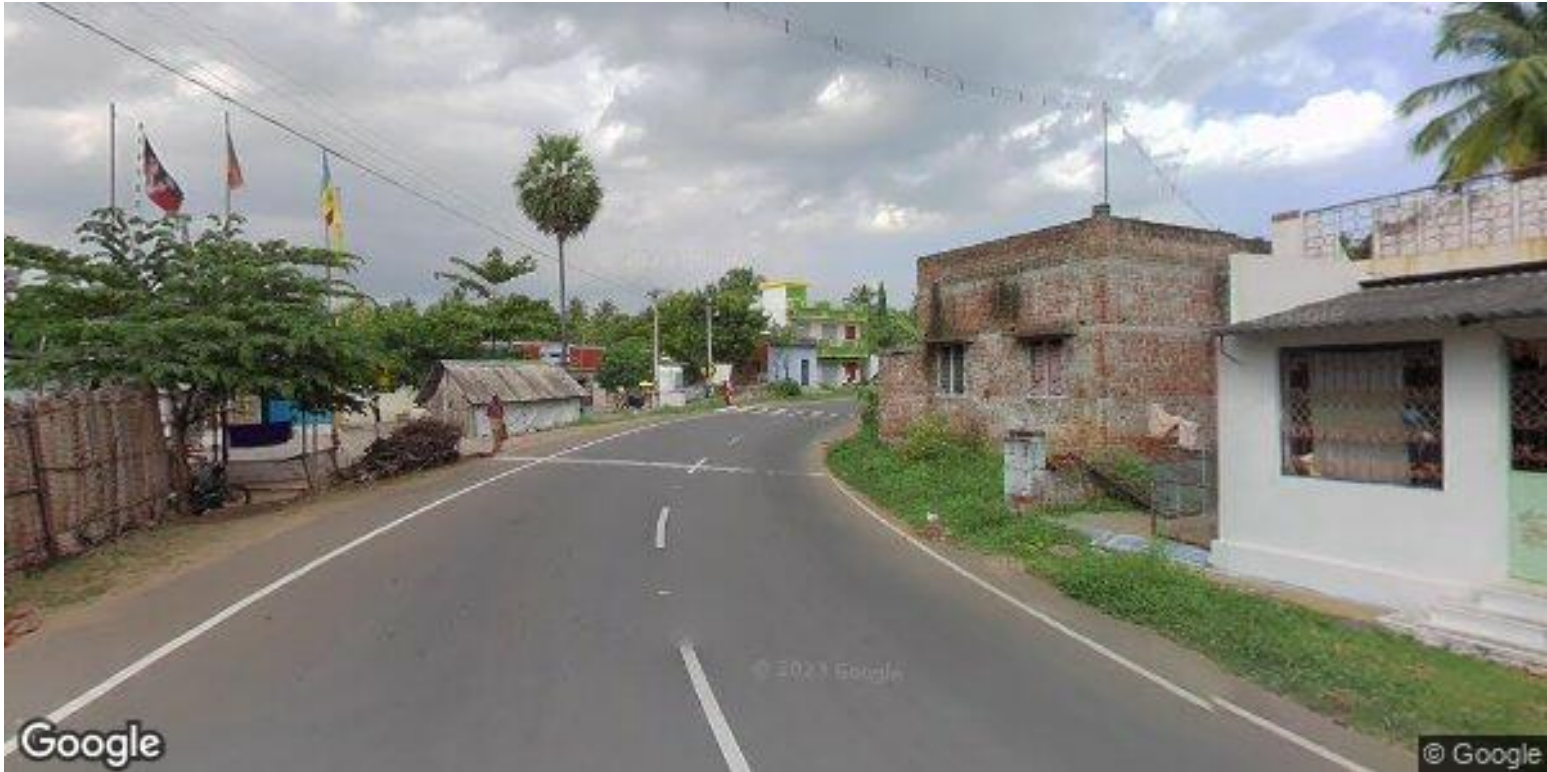
**Risk Type:** Turn  
**Risk Level:** Medium  
**Speed Limit:** 30 KM/Hr  
**Coordinates:** 11.67301, 77.86024

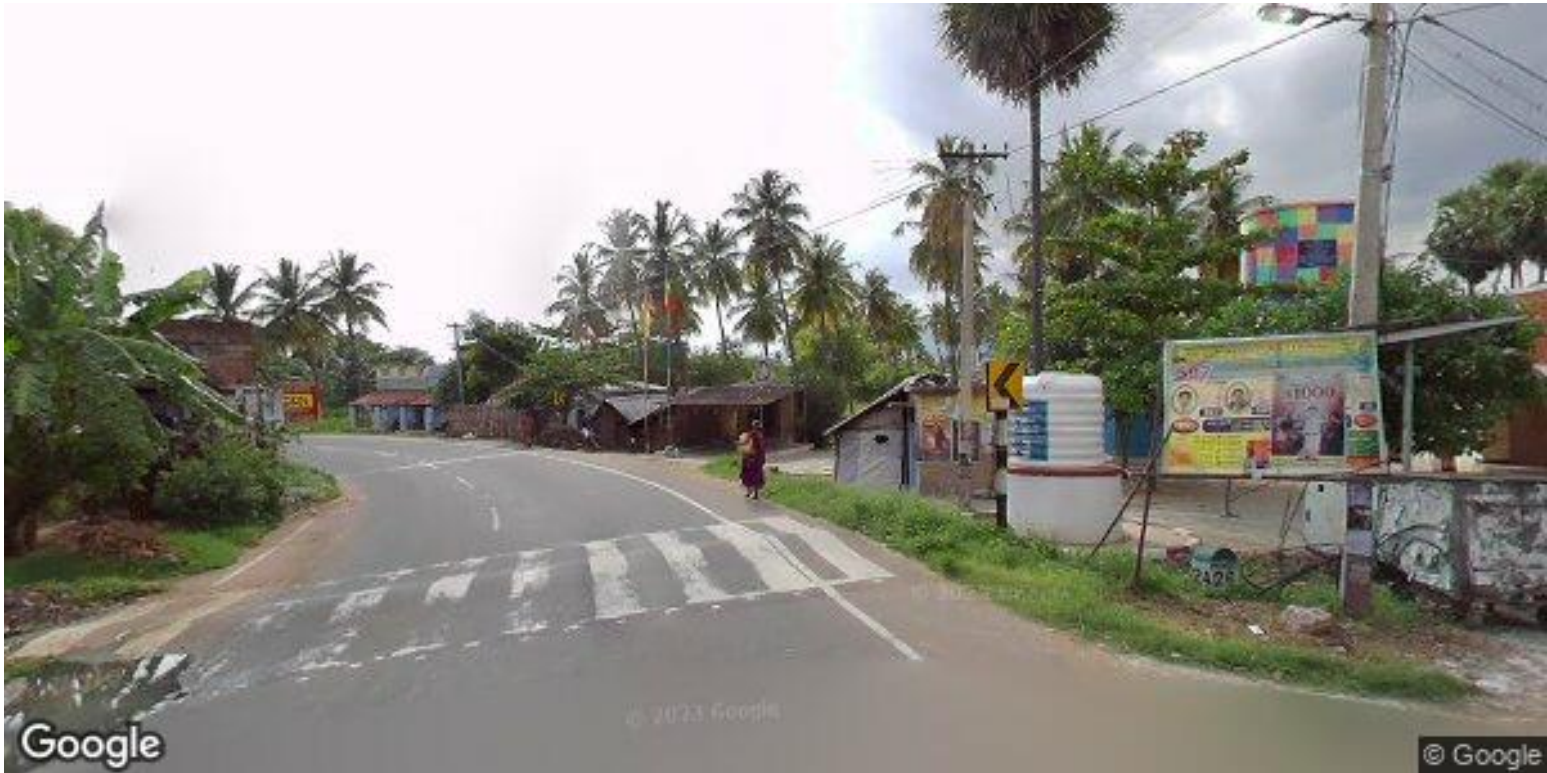
**Risk Type:** Turn  
**Risk Level:** Medium  
**Speed Limit:** 30 KM/Hr  
**Coordinates:** 11.67326, 77.86058

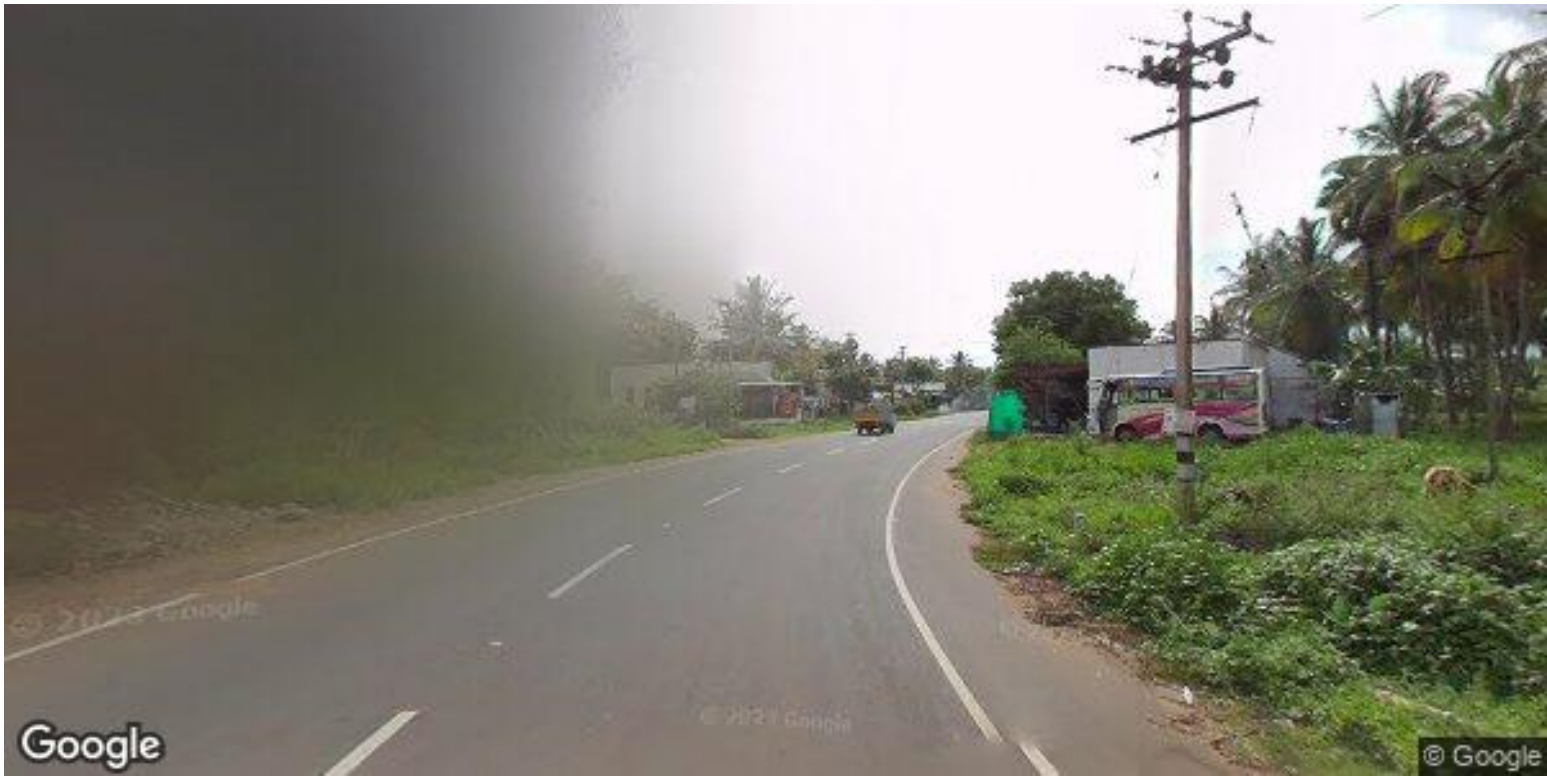
**Risk Type:** Turn  
**Risk Level:** Medium  
**Speed Limit:** 30 KM/Hr  
**Coordinates:** 11.67373, 77.86230

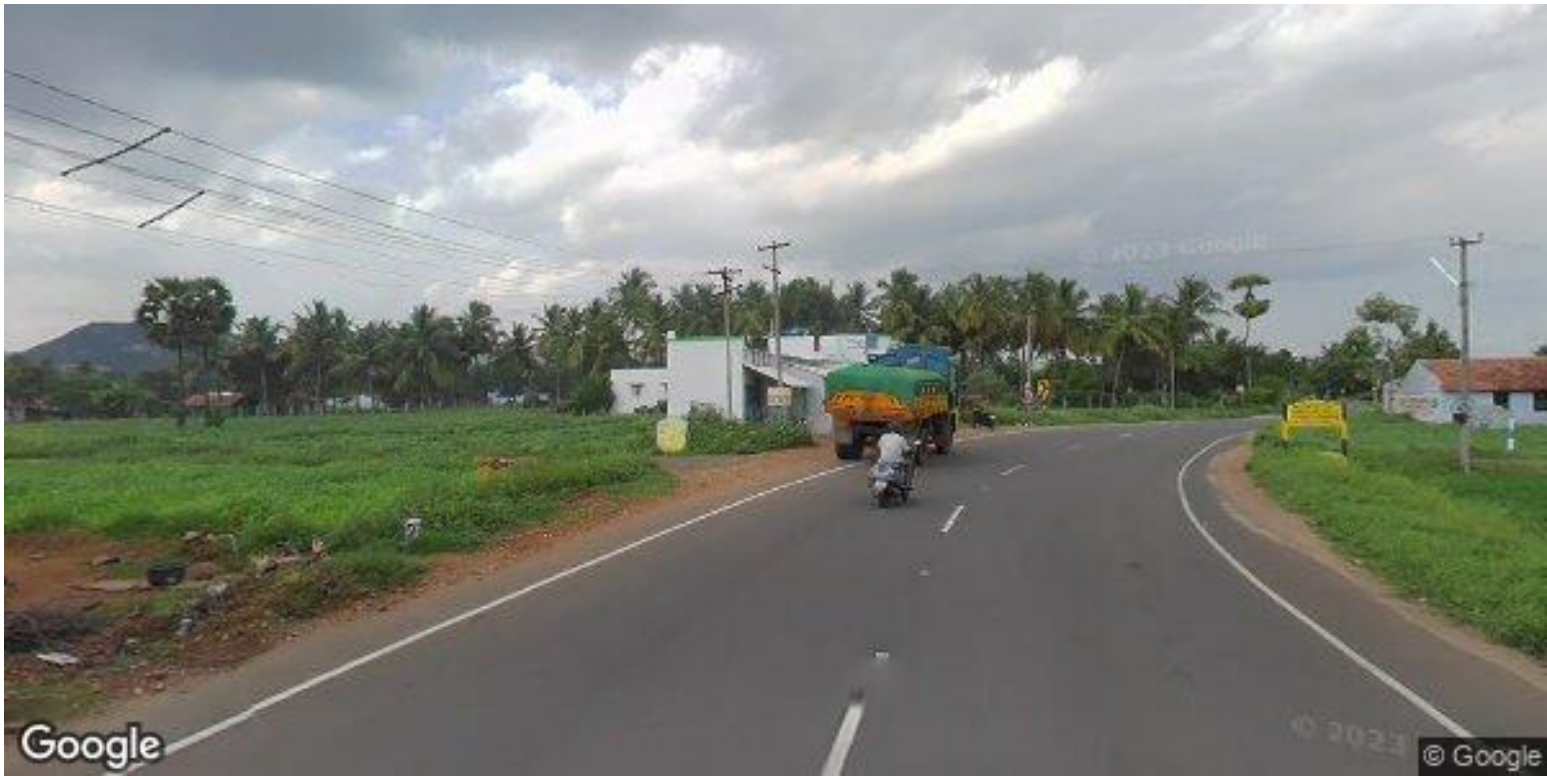
**Risk Type:** Turn  
**Risk Level:** Medium  
**Speed Limit:** 30 KM/Hr  
**Coordinates:** 11.68171, 77.86676

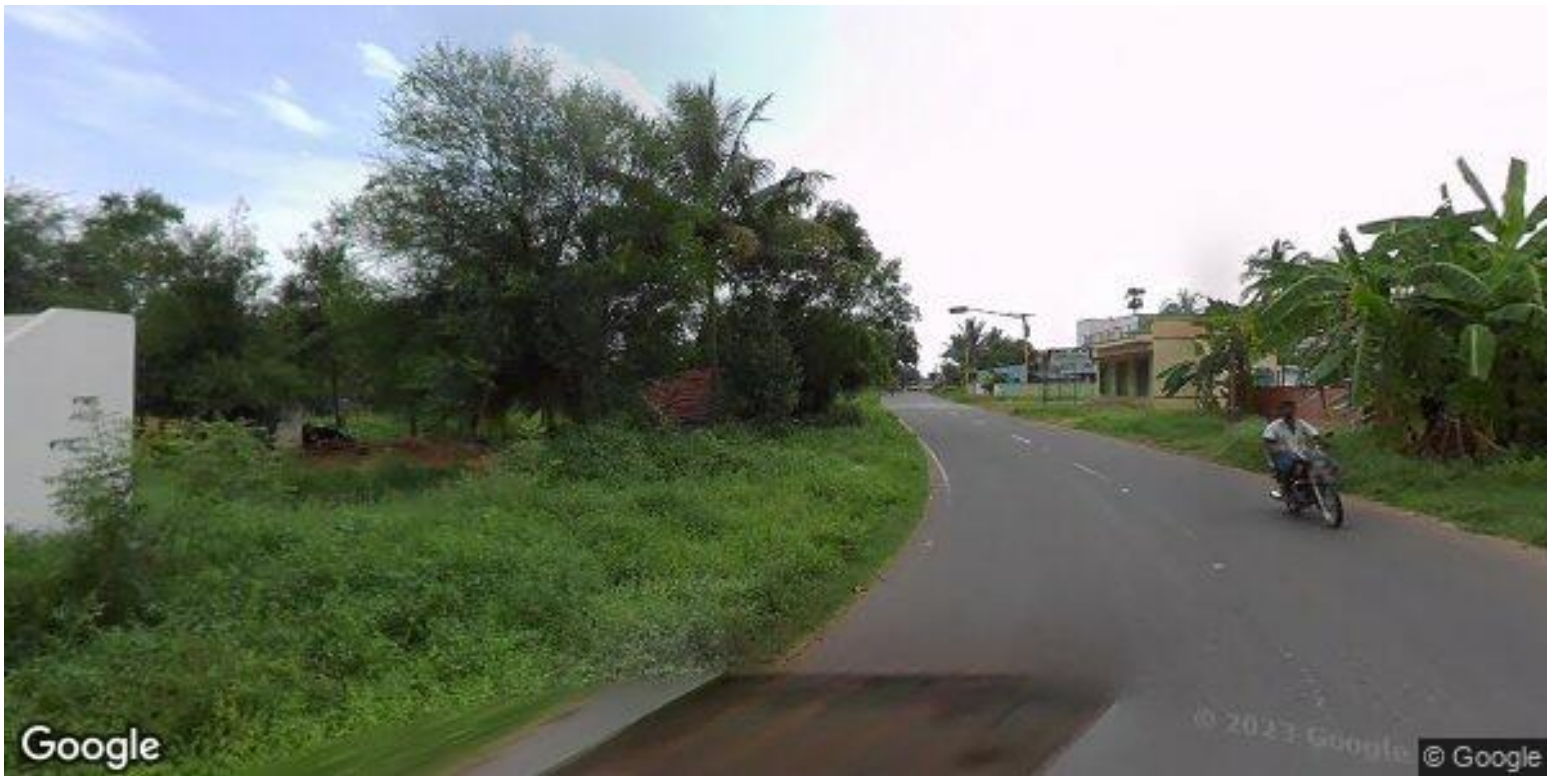
**Risk Type:** Turn  
**Risk Level:** High  
**Speed Limit:** 15 KM/Hr  
**Coordinates:** 11.68490, 77.86893

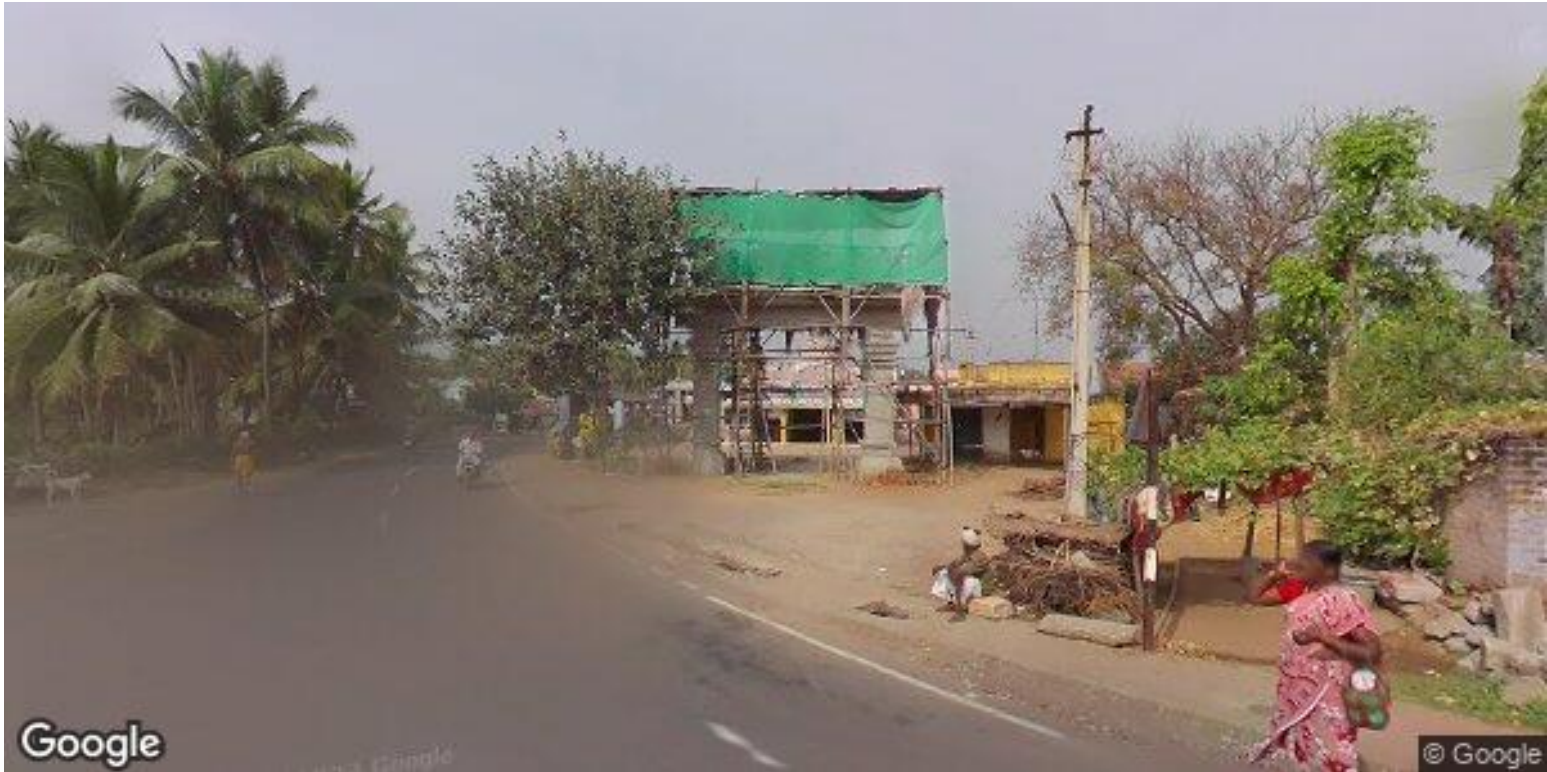
**Risk Type:** Turn  
**Risk Level:** High  
**Speed Limit:** 15 KM/Hr  
**Coordinates:** 11.68472, 77.87281

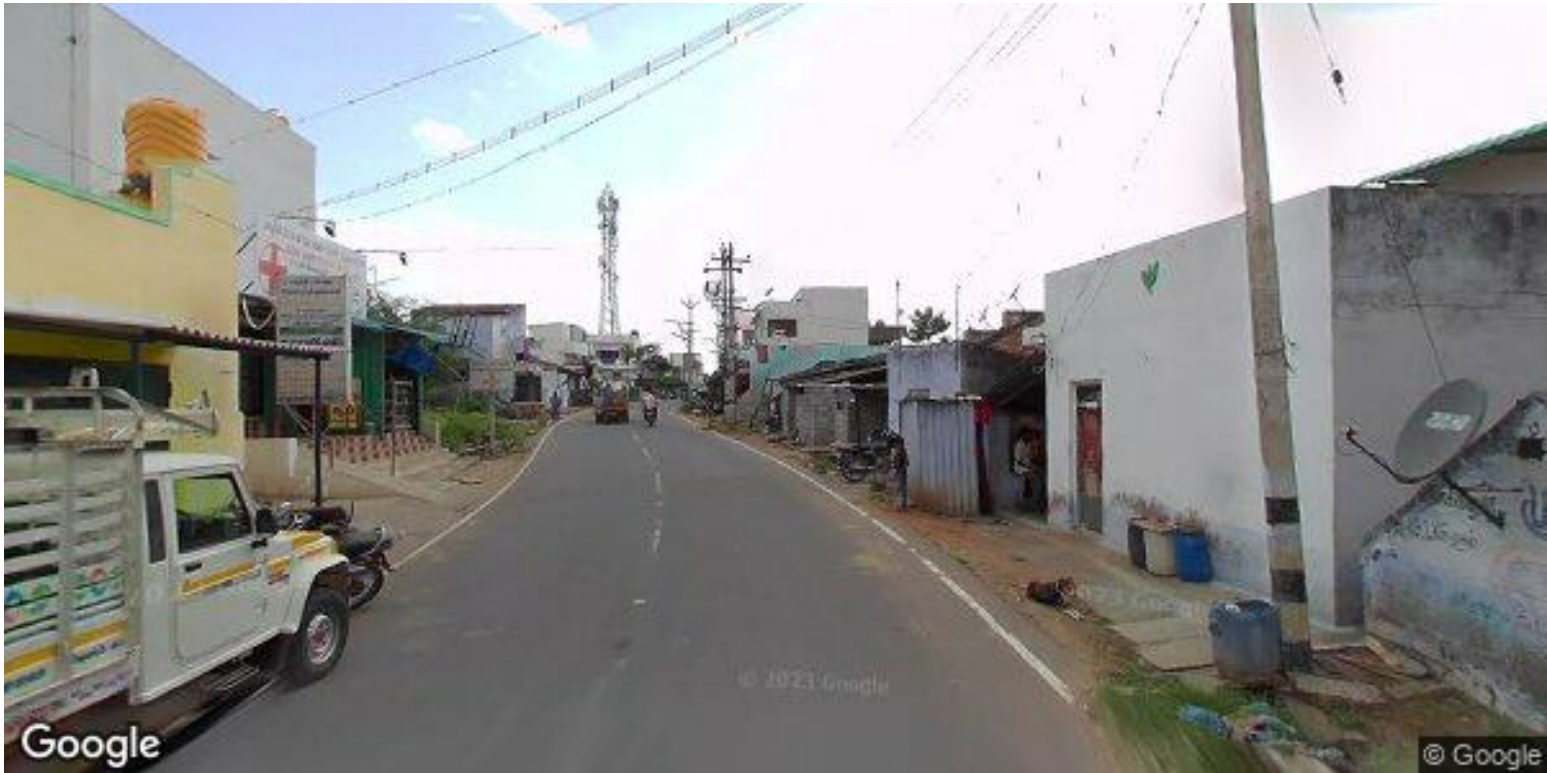
**Risk Type:** Turn  
**Risk Level:** Medium  
**Speed Limit:** 30 KM/Hr  
**Coordinates:** 11.69280, 77.87439

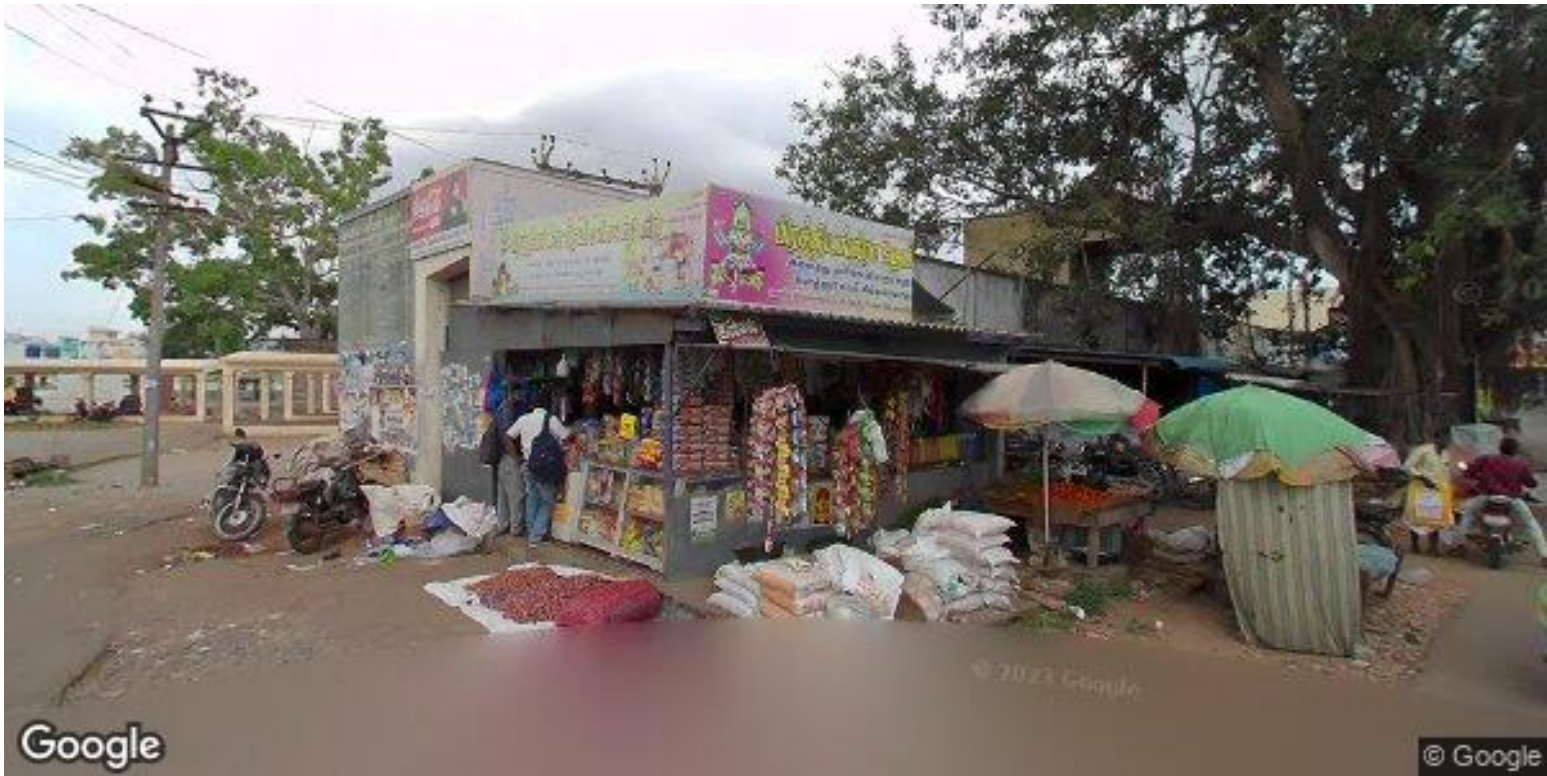
**Risk Type:** Turn  
**Risk Level:** Medium  
**Speed Limit:** 30 KM/Hr  
**Coordinates:** 11.69458, 77.87589

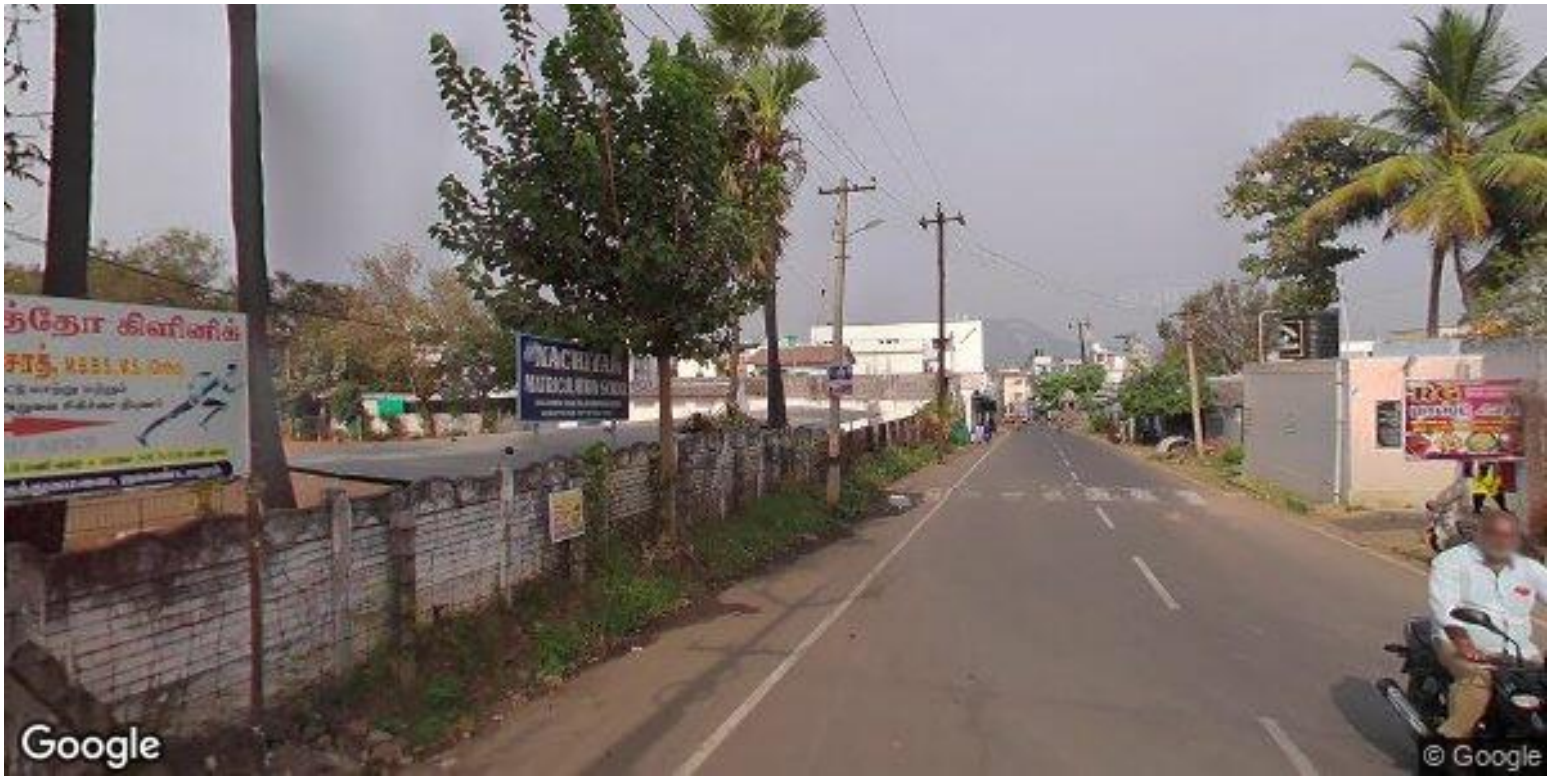
**Risk Type:** Blind Spot  
**Risk Level:** Blind Spot  
**Speed Limit:** 10 KM/Hr  
**Coordinates:** 11.69360, 77.87831

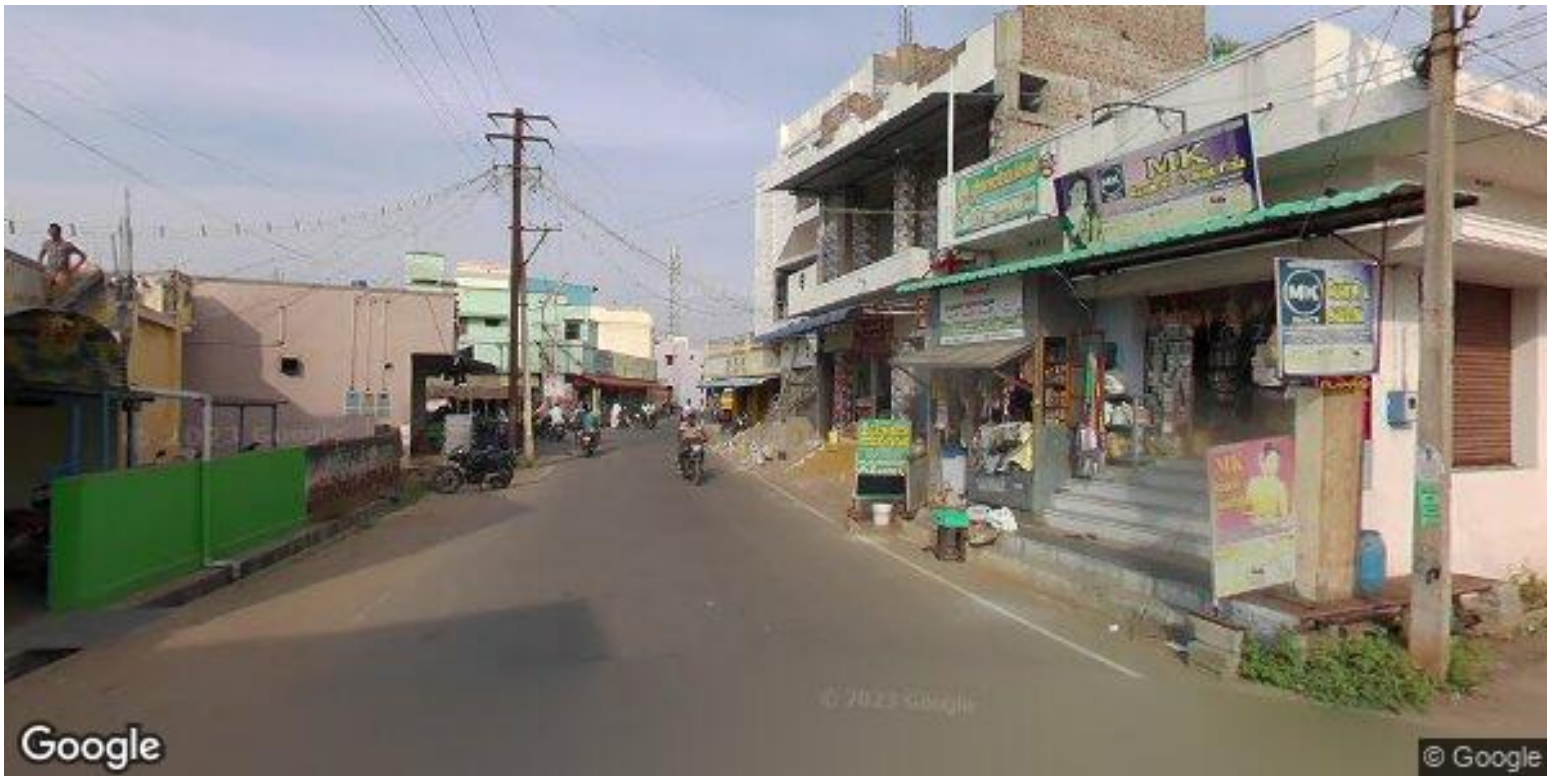
Risk Type: Turn

Risk Level: Medium

Speed Limit: 30 KM/Hr

Coordinates: 11.69523, 77.87892

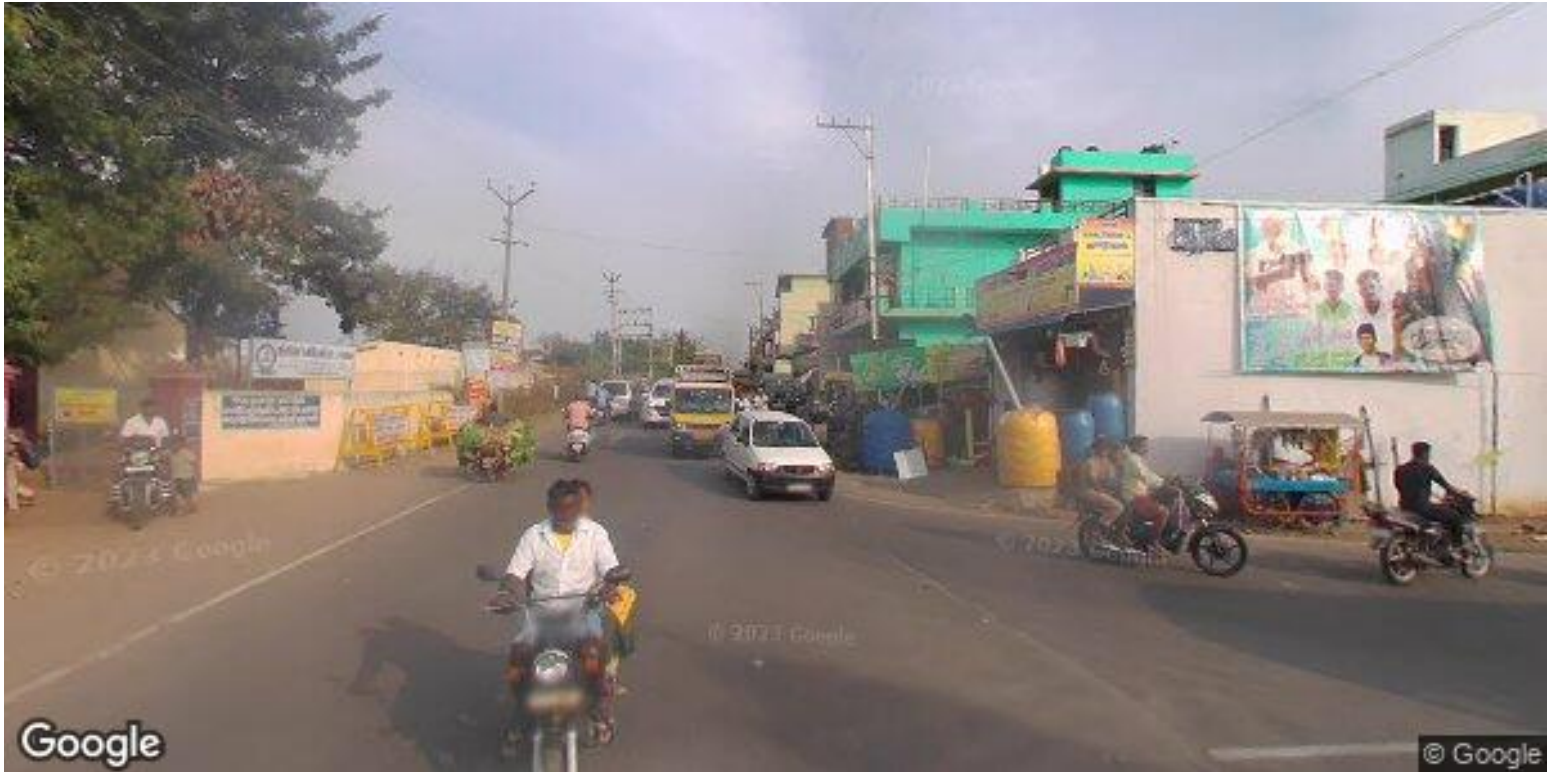
Risk Type: Turn

Risk Level: High

Speed Limit: 15 KM/Hr

Coordinates: 11.69918, 77.88105
