# IndianOil

## JOURNEY RISK MANAGEMENT (JRM) STUDY

### Salem Terminal TO SRI V.M.S AGENCY

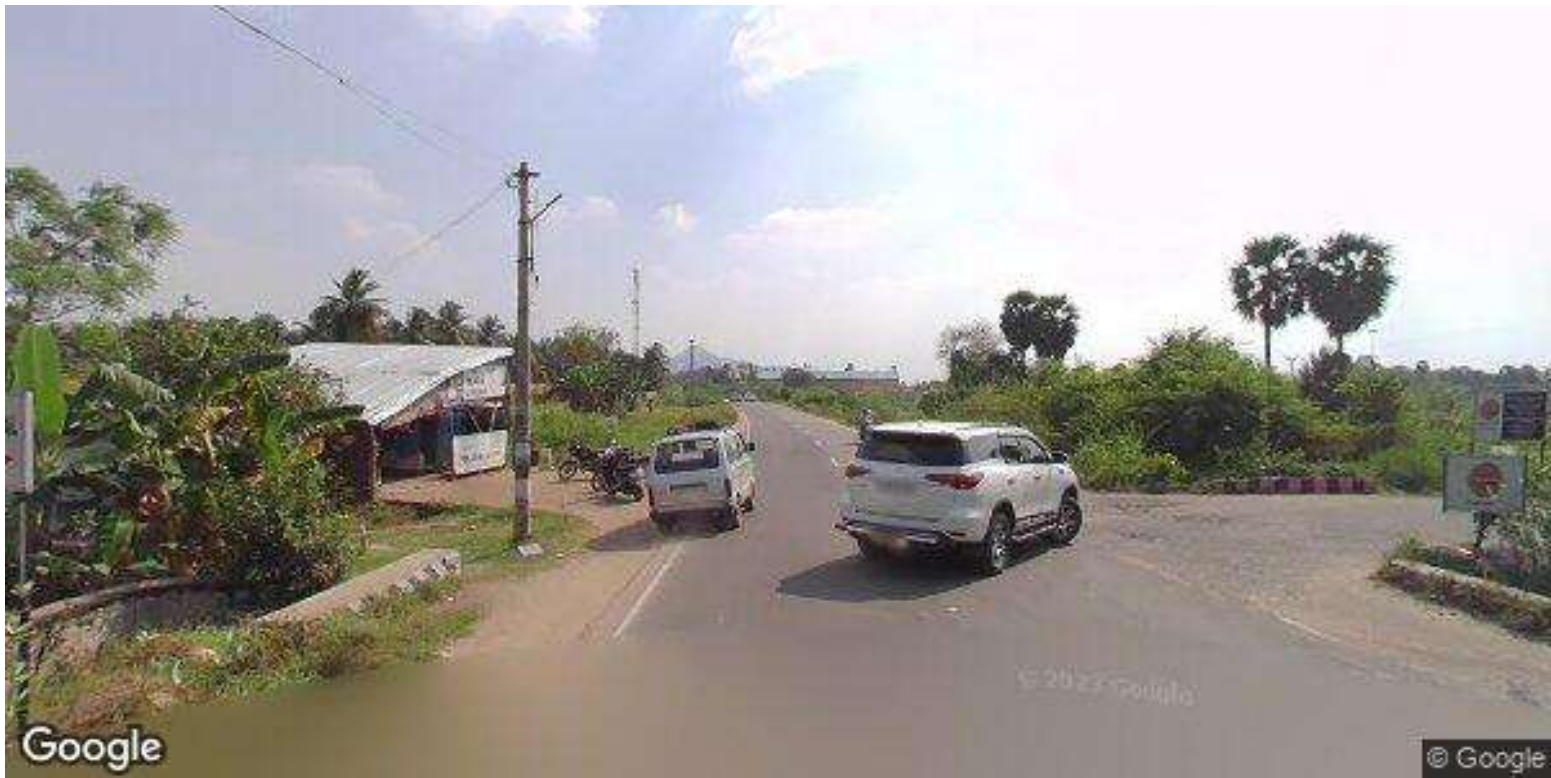
Coordinates: 11.44029, 77.87544

Risk Type: Turn

Risk Level: High

Speed Limit: 15 KM/Hr

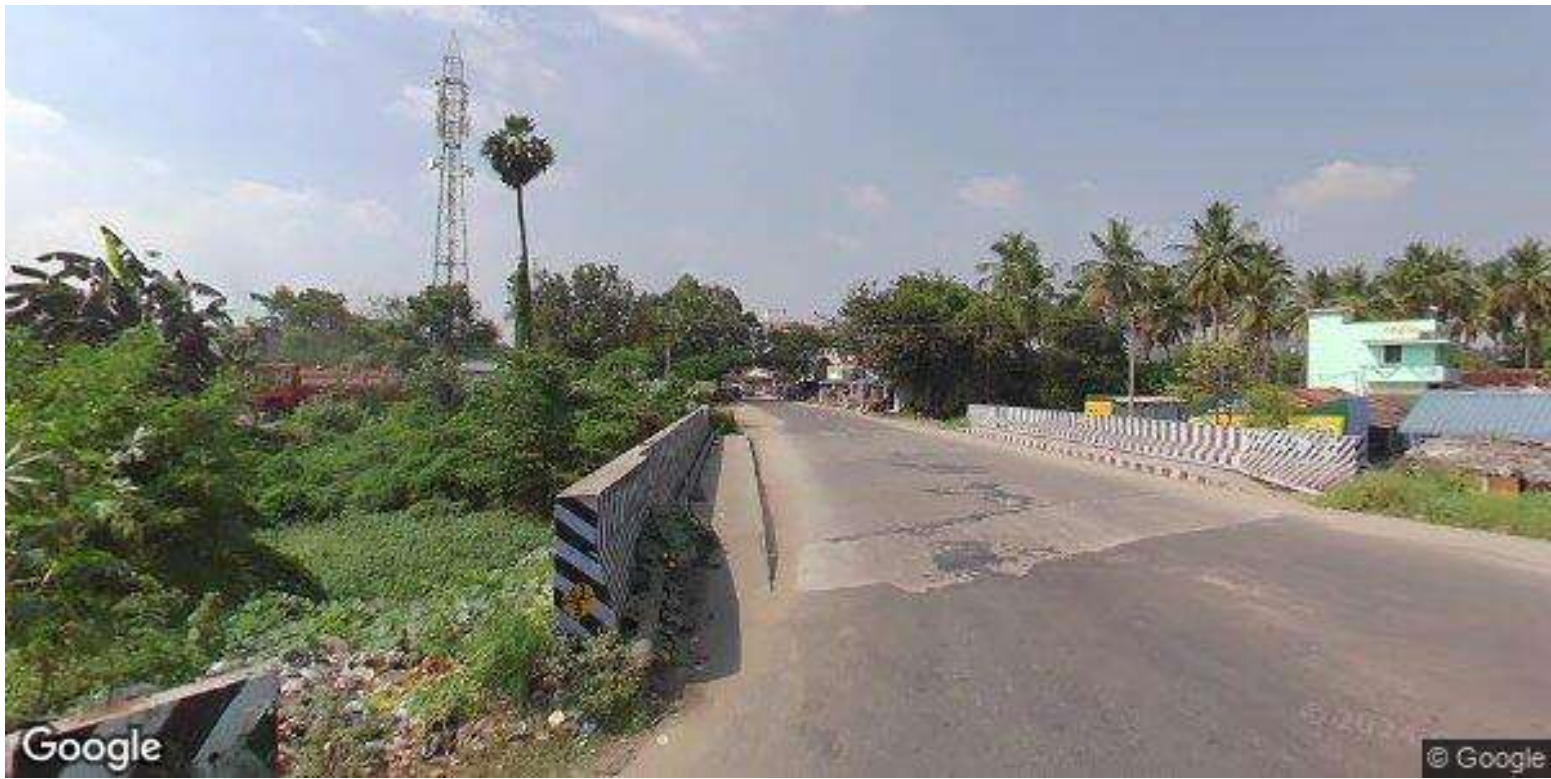
Risk Type: Turn

Risk Level: High

Speed Limit: 15 KM/Hr  
Coordinates: 11.44900, 77.87406

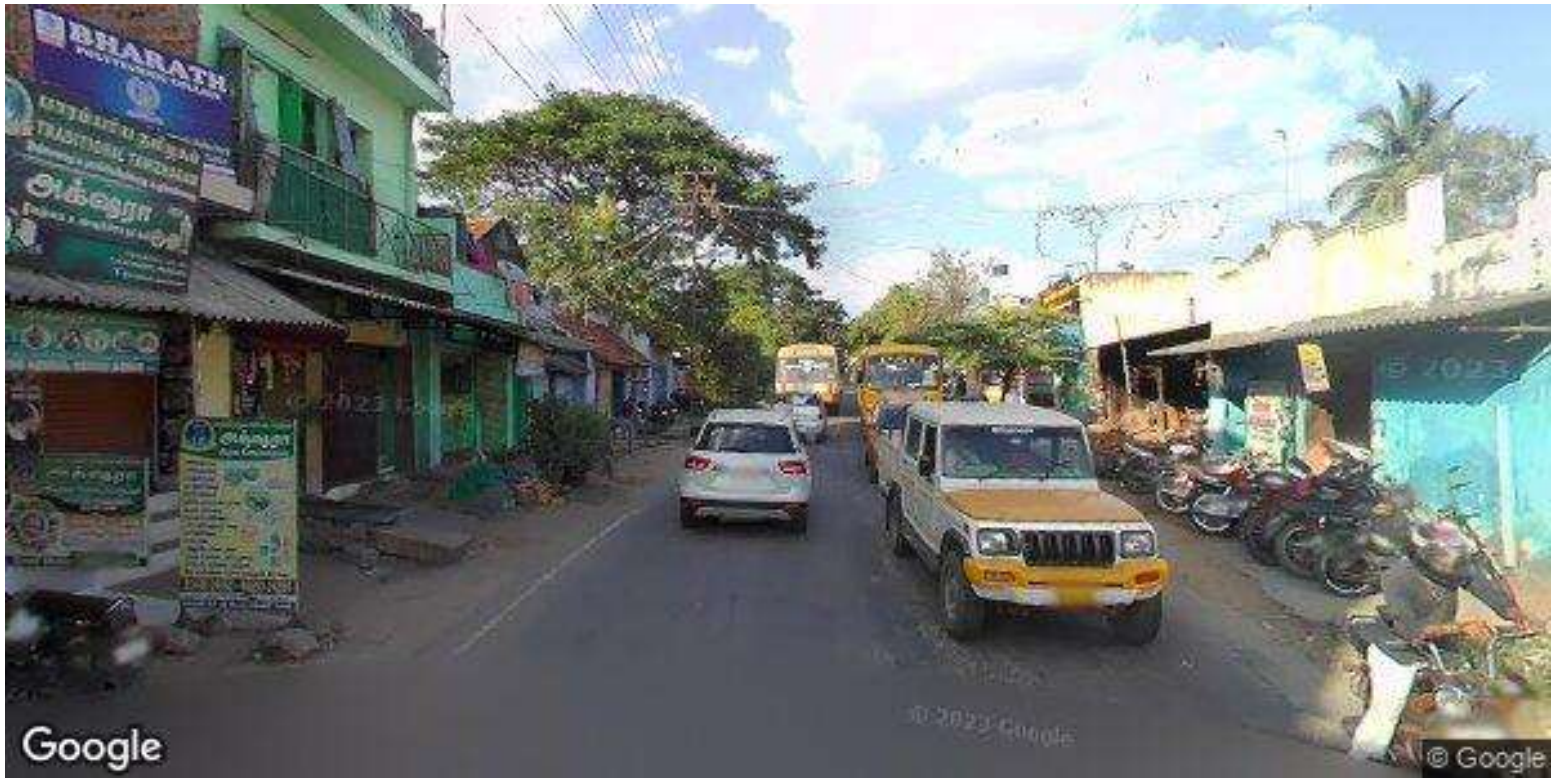
Risk Type: Turn  
Risk Level: High  
Speed Limit: 15 KM/Hr  
Coordinates: 11.45028, 77.87202

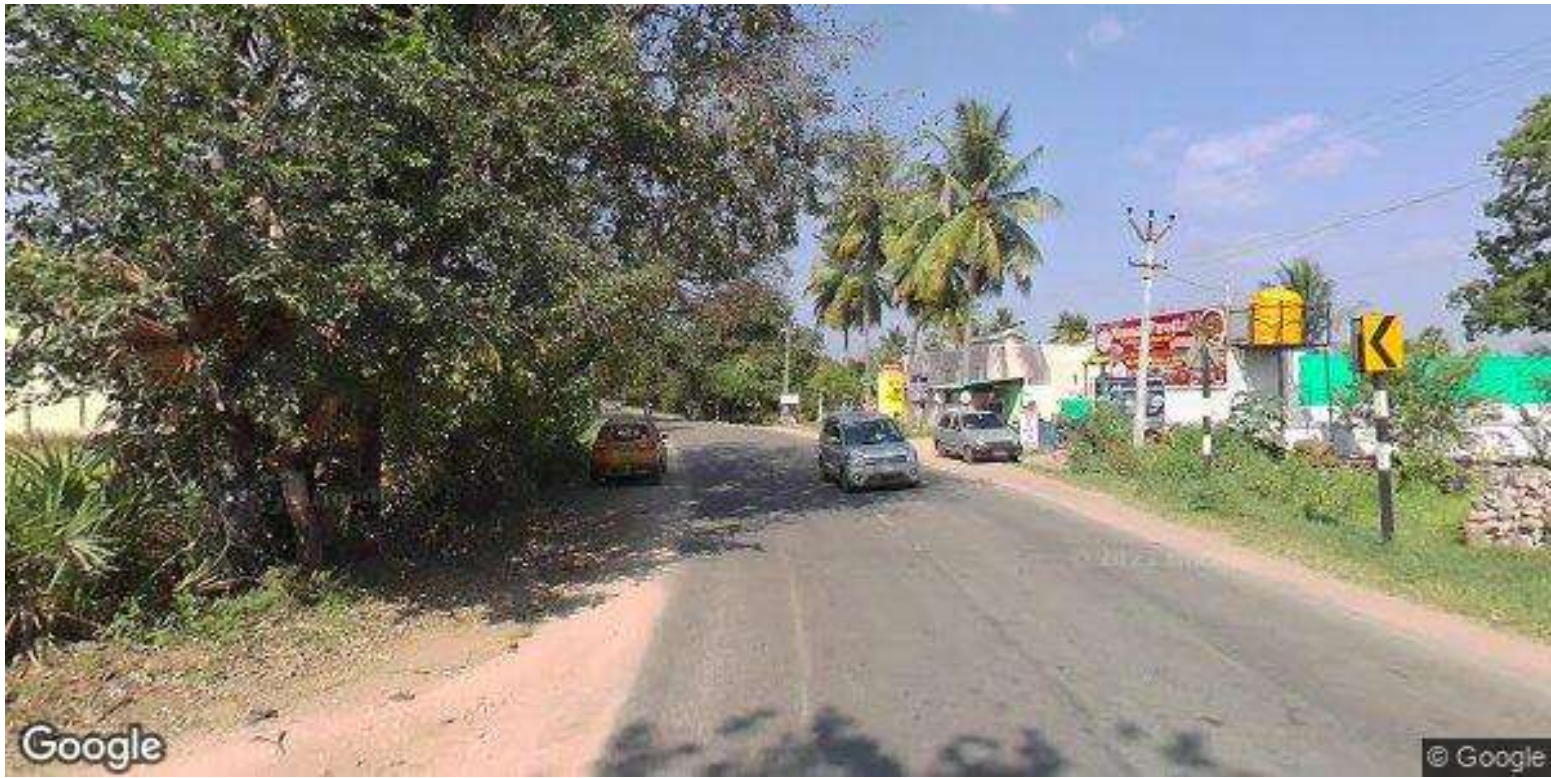
Risk Type: Turn  
Risk Level: Medium  
Speed Limit: 30 KM/Hr  
Coordinates: 11.45309, 77.87325

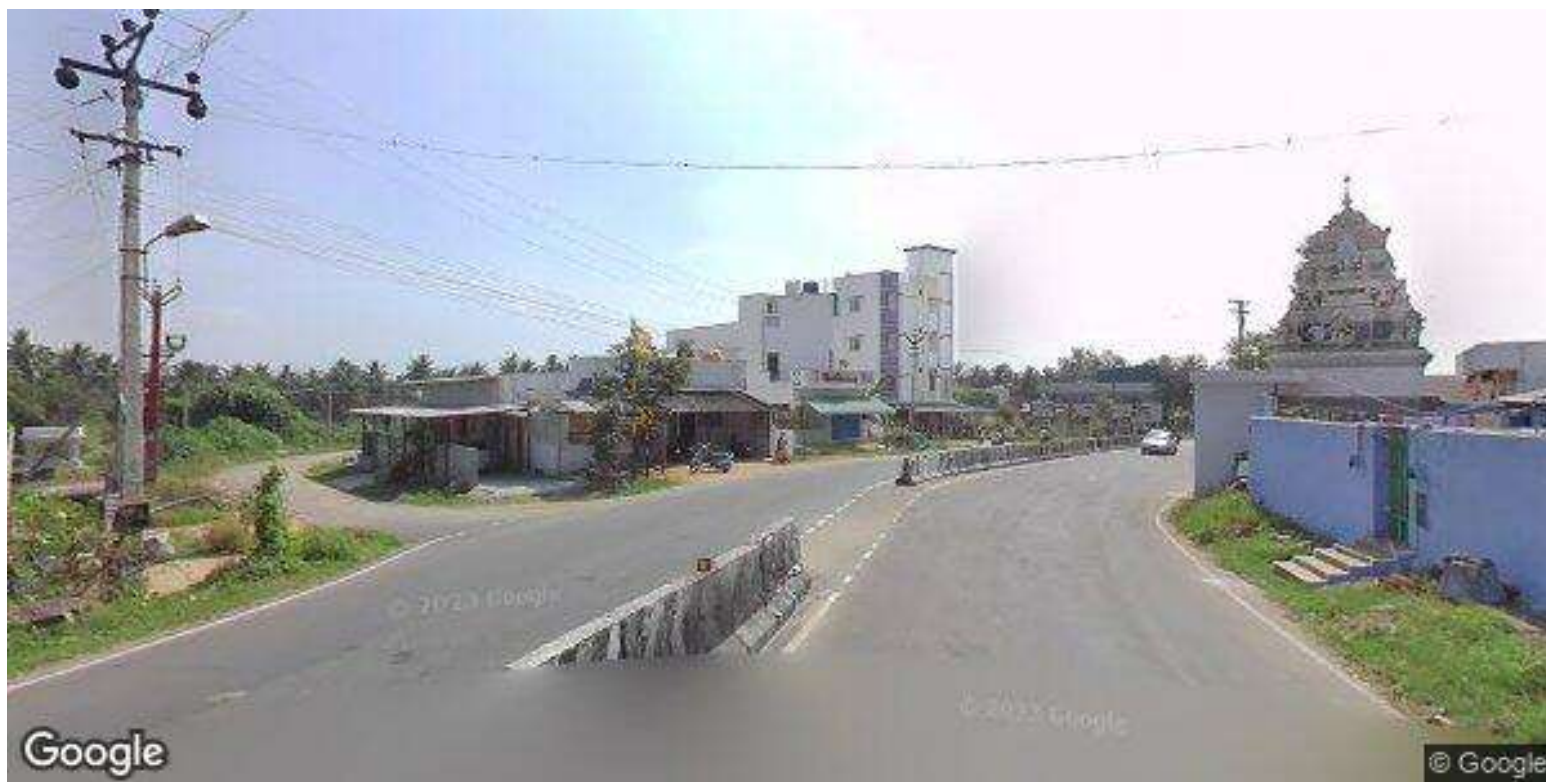
**Coordinates:** 11.46400, 77.87323

**Risk Type:** Turn

**Risk Level:** Medium

**Speed Limit:** 30 KM/Hr

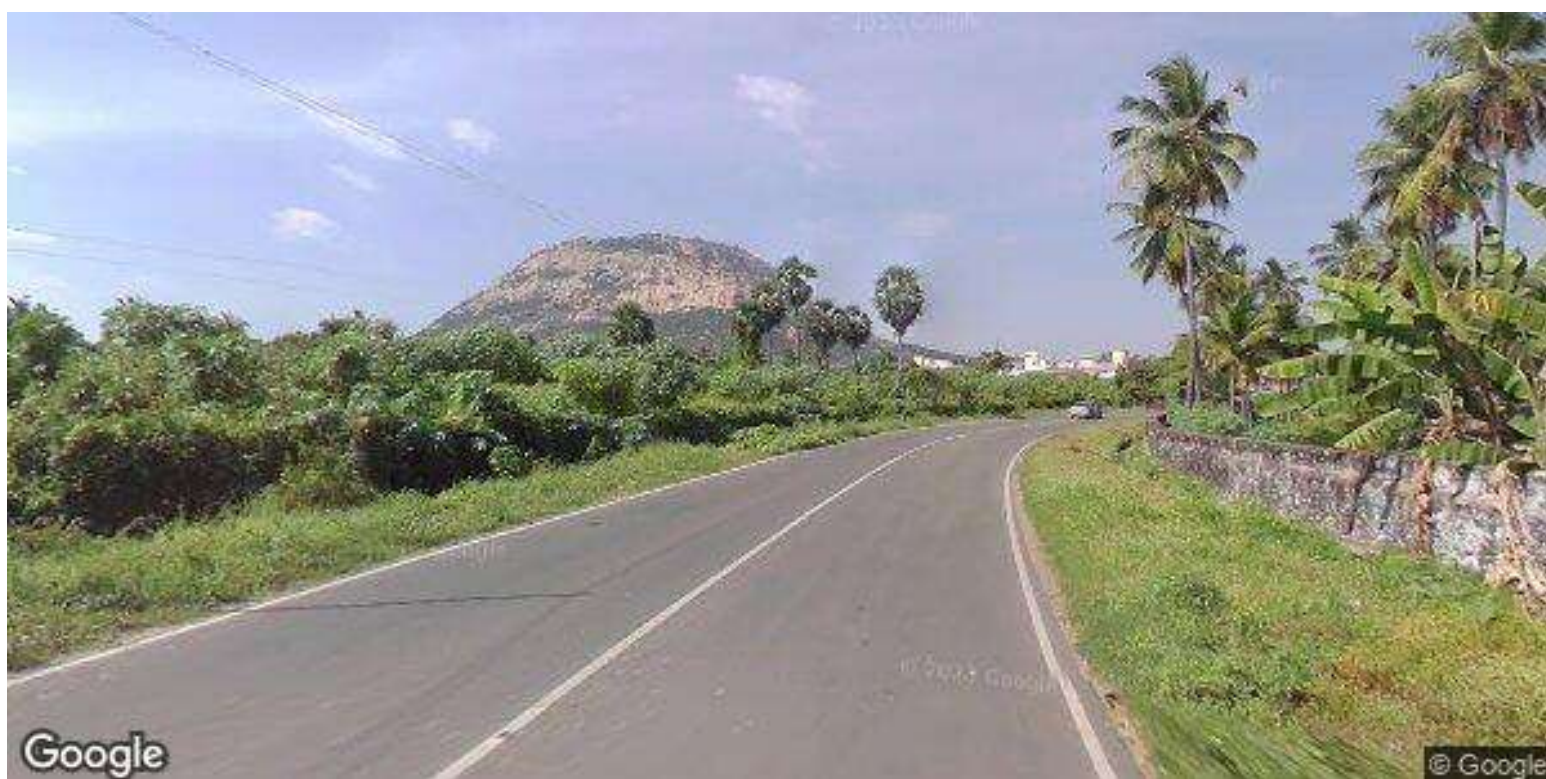
**Coordinates:** 11.46765, 77.87037

**Risk Type:** Turn

**Risk Level:** Medium

**Speed Limit:** 30 KM/Hr

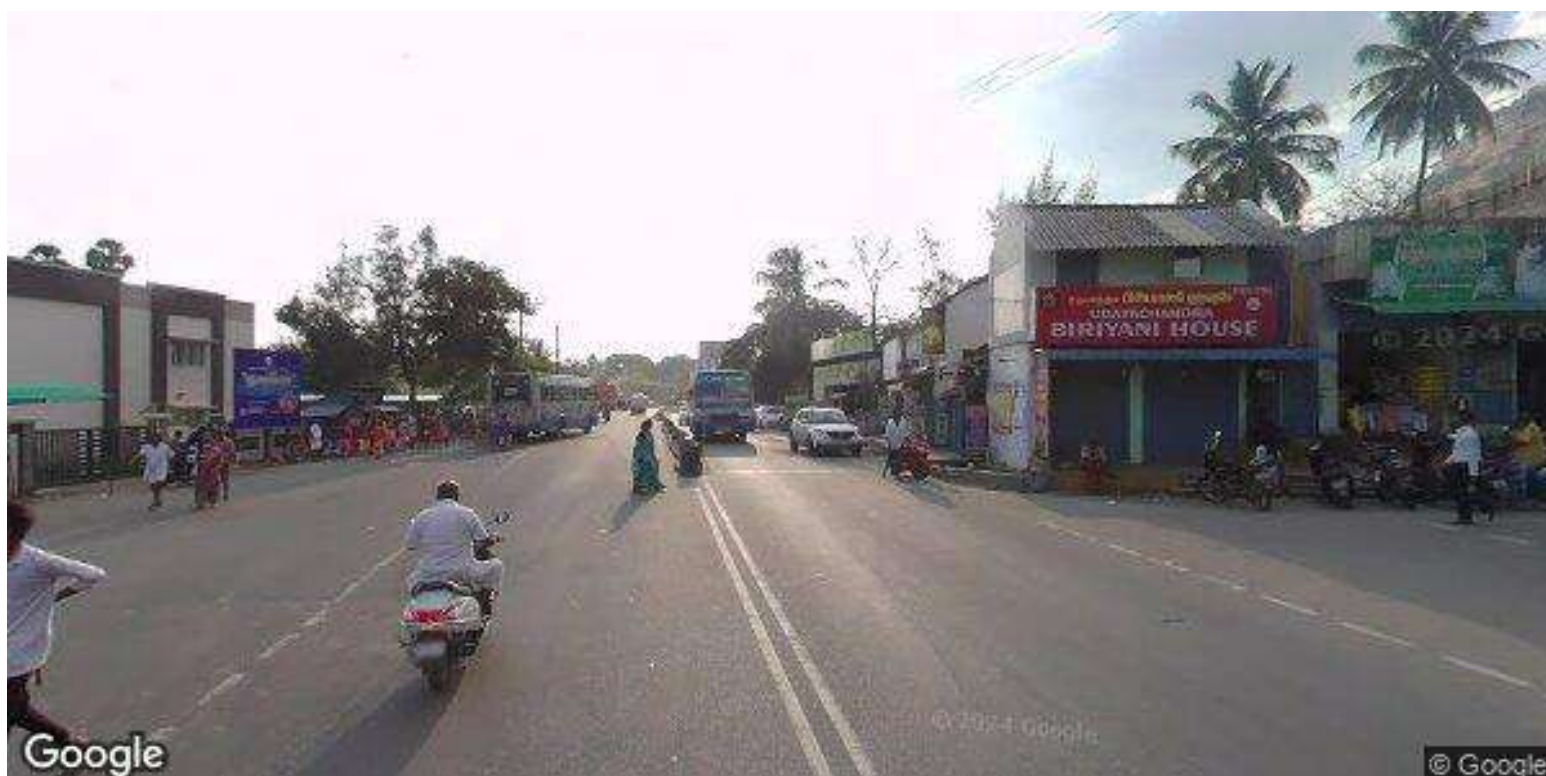
**Risk Type:** Turn  
**Risk Level:** High  
**Speed Limit:** 15 KM/Hr  
**Coordinates:** 11.47403, 77.86841

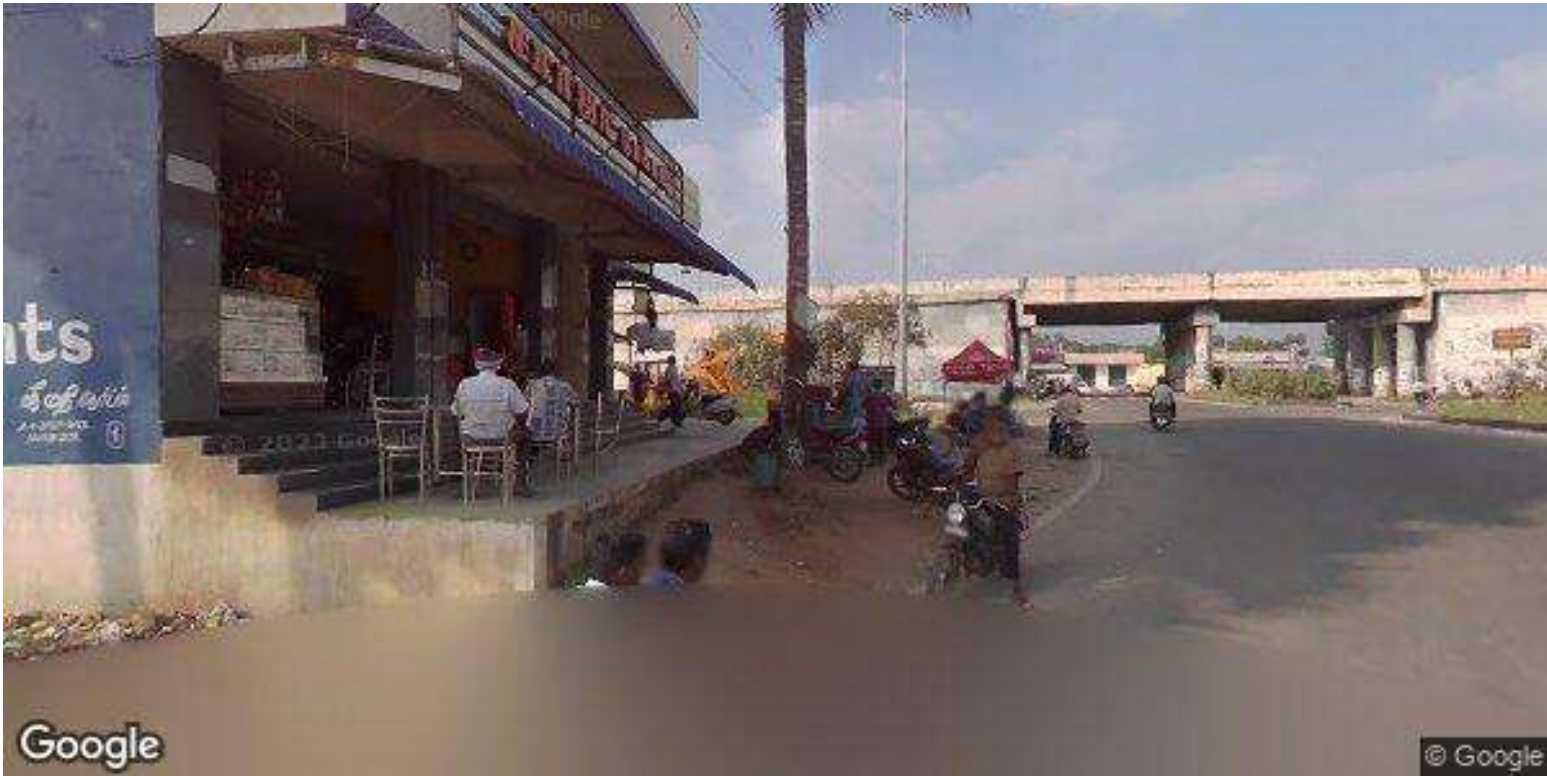
**Risk Type:** Turn  
**Risk Level:** High  
**Speed Limit:** 15 KM/Hr  
**Coordinates:** 11.49149, 77.89601

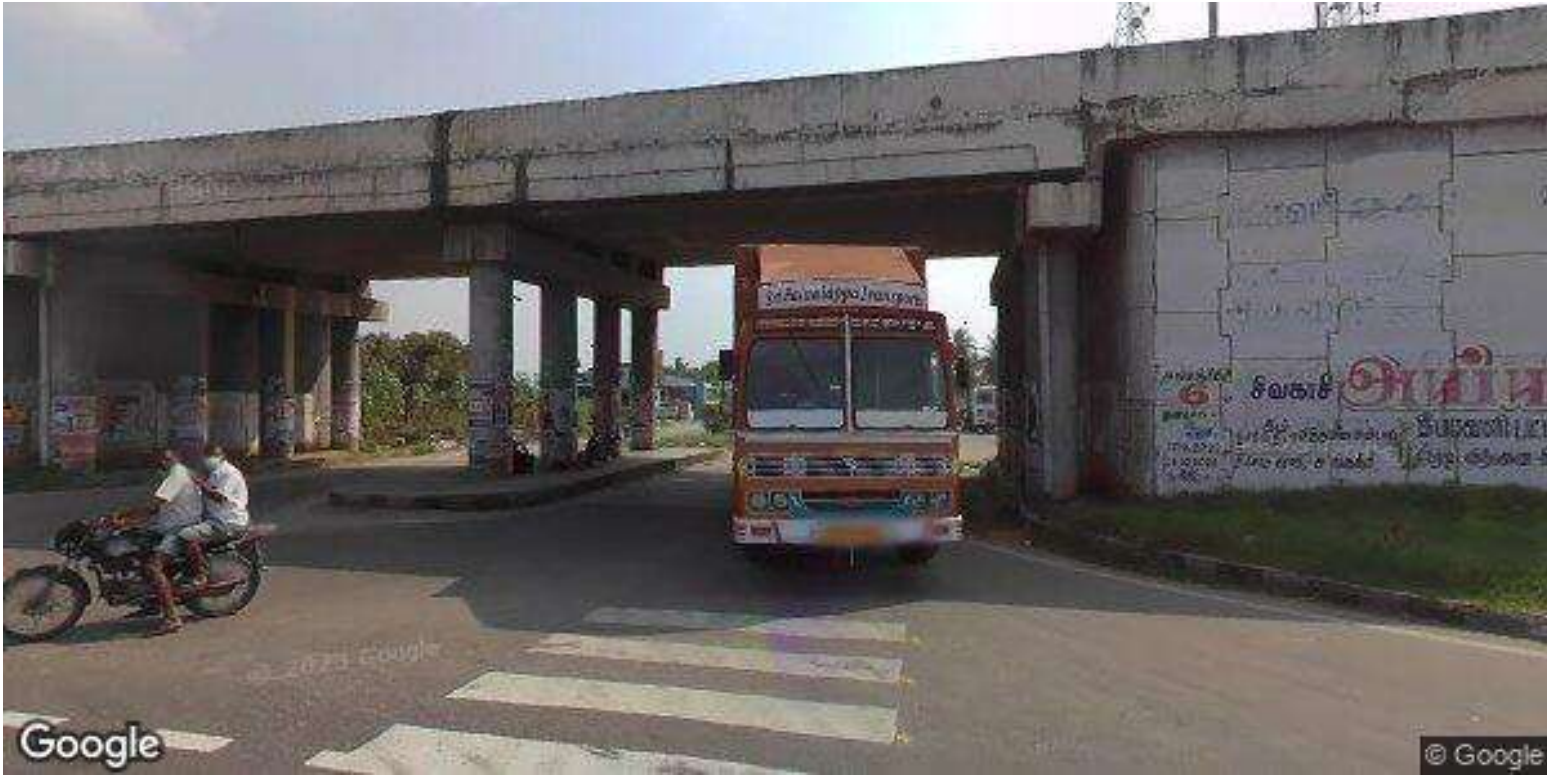
**Risk Type:** Turn  
**Risk Level:** High  
**Speed Limit:** 15 KM/Hr  
**Coordinates:** 11.49224, 77.89601

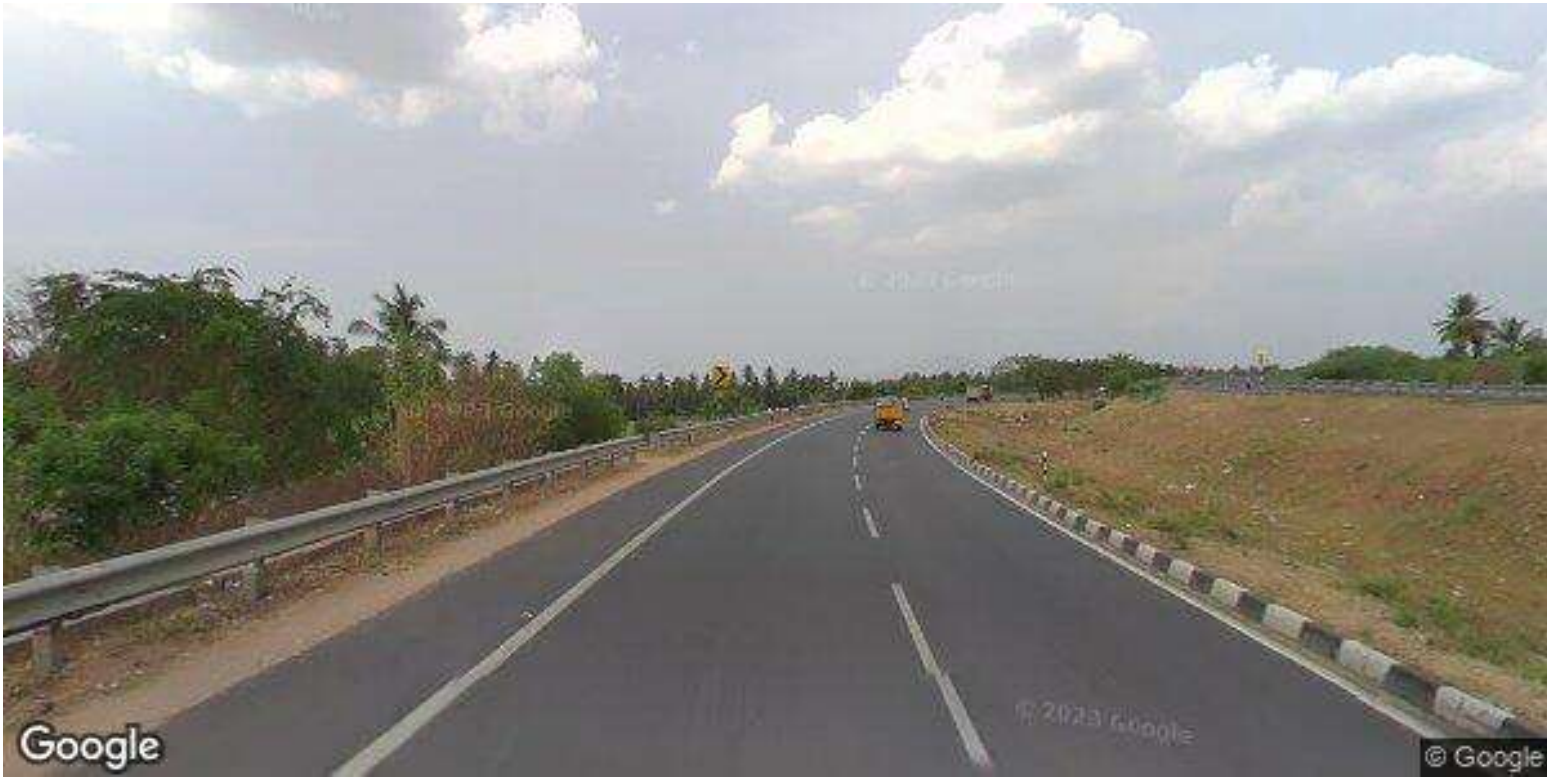
**Risk Type:** Turn  
**Risk Level:** Medium  
**Speed Limit:** 30 KM/Hr  
**Coordinates:** 11.53501, 77.95707

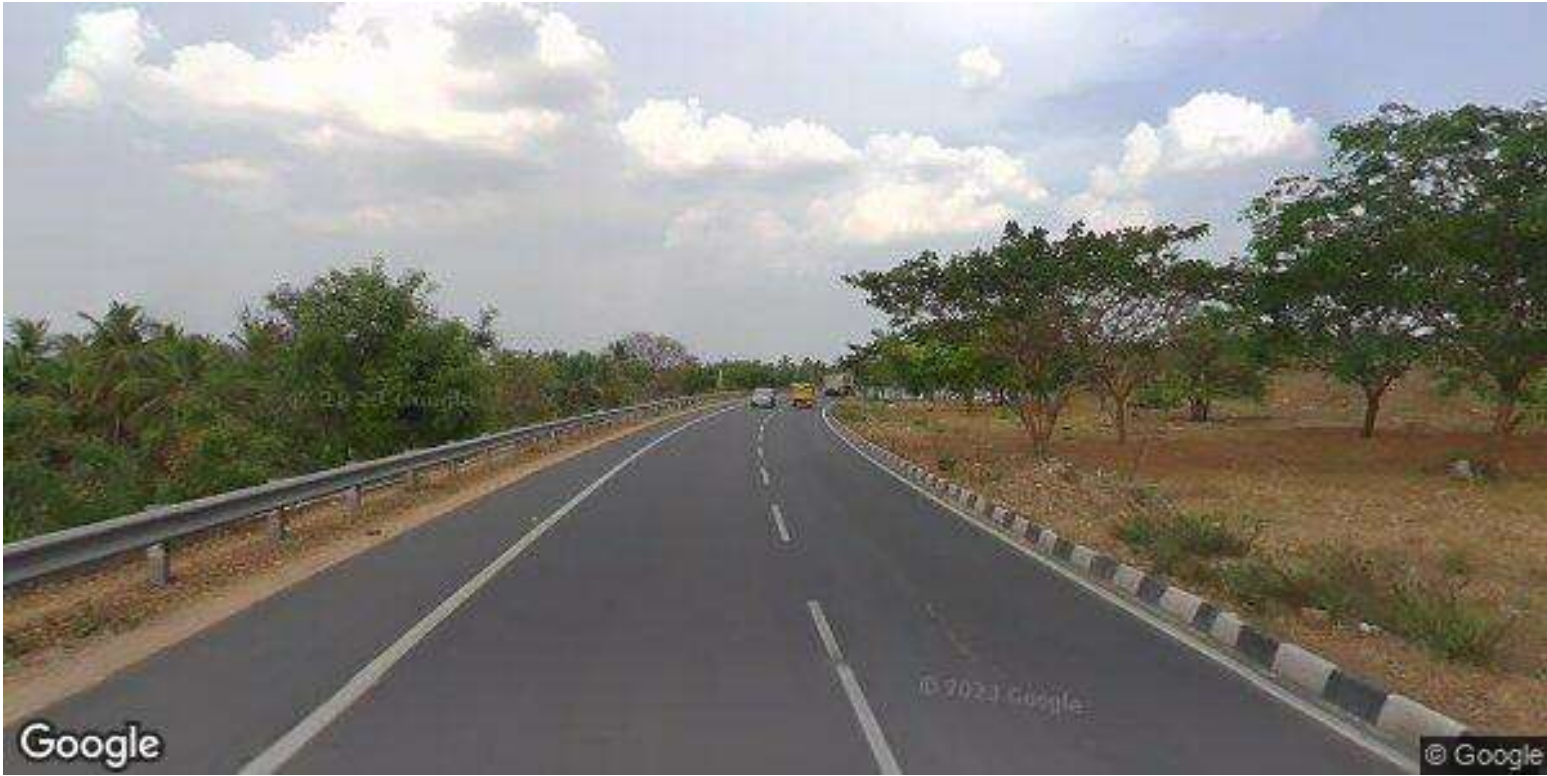
**Risk Type:** Turn  
**Risk Level:** Medium  
**Speed Limit:** 30 KM/Hr  
**Coordinates:** 11.53601, 77.95856

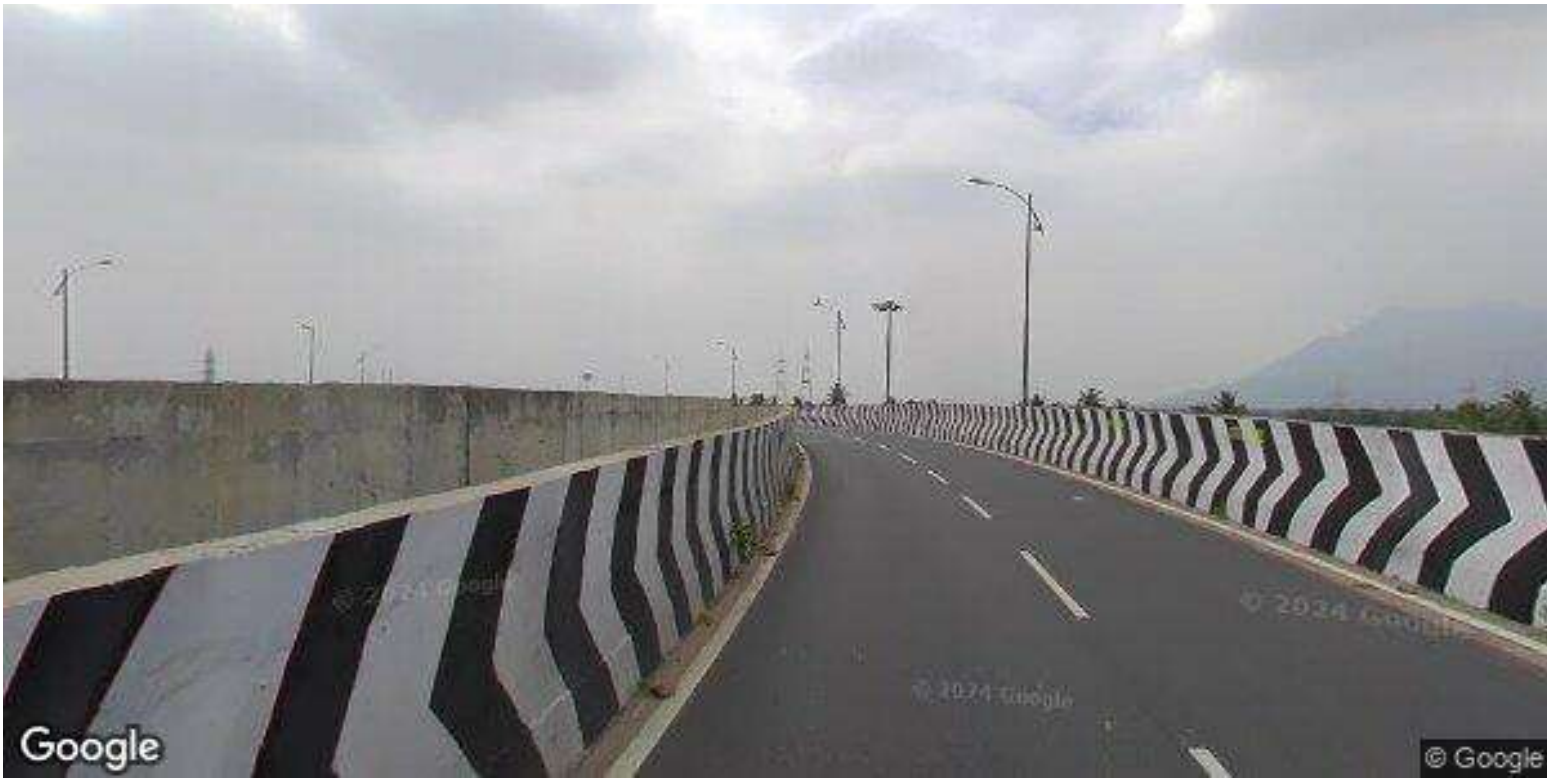
**Risk Type:** Turn  
**Risk Level:** Medium  
**Speed Limit:** 30 KM/Hr  
**Coordinates:** 11.64180, 78.11808

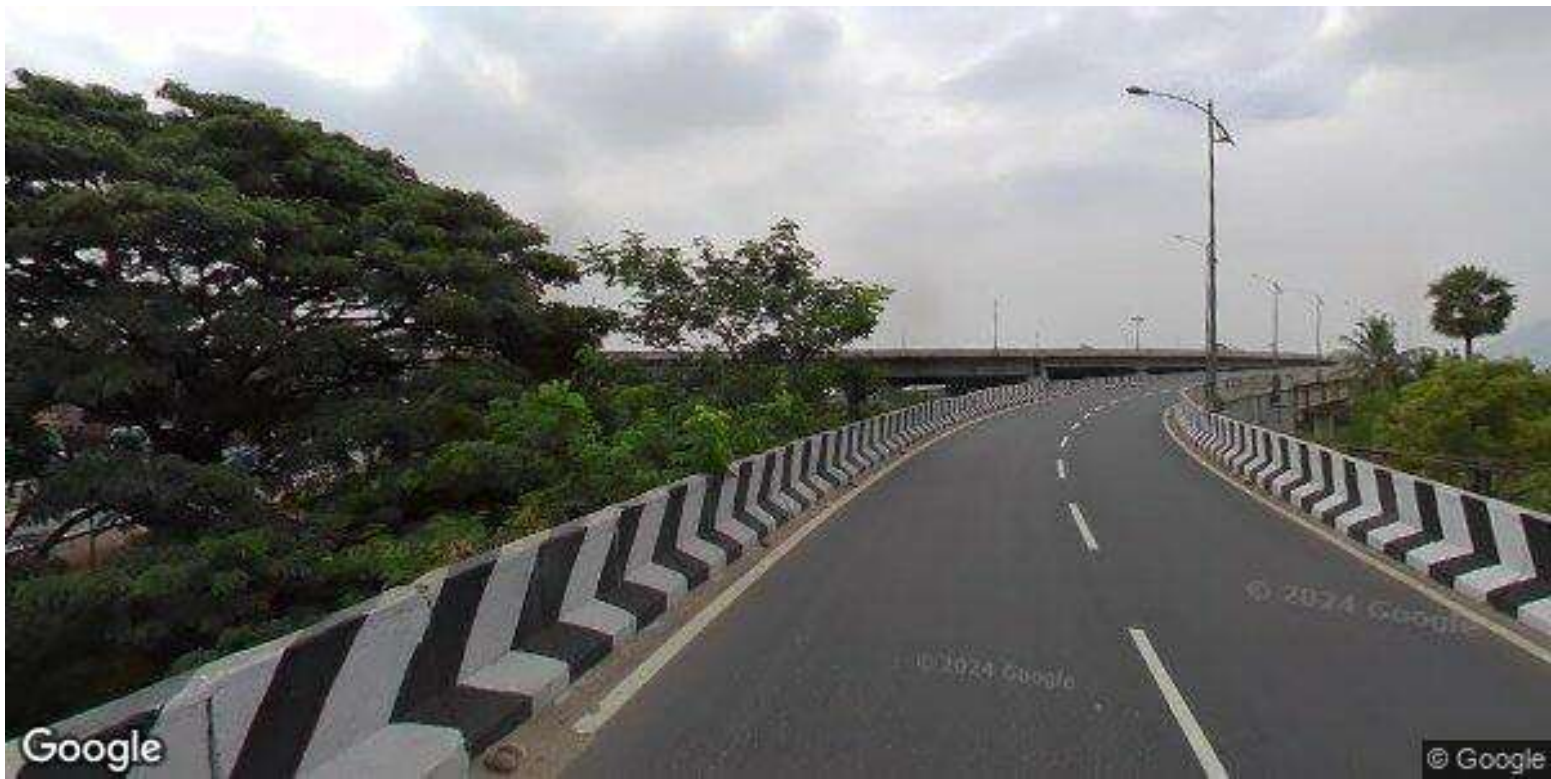
**Risk Type:** Turn  
**Risk Level:** Medium  
**Speed Limit:** 30 KM/Hr  
**Coordinates:** 11.64325, 78.11993

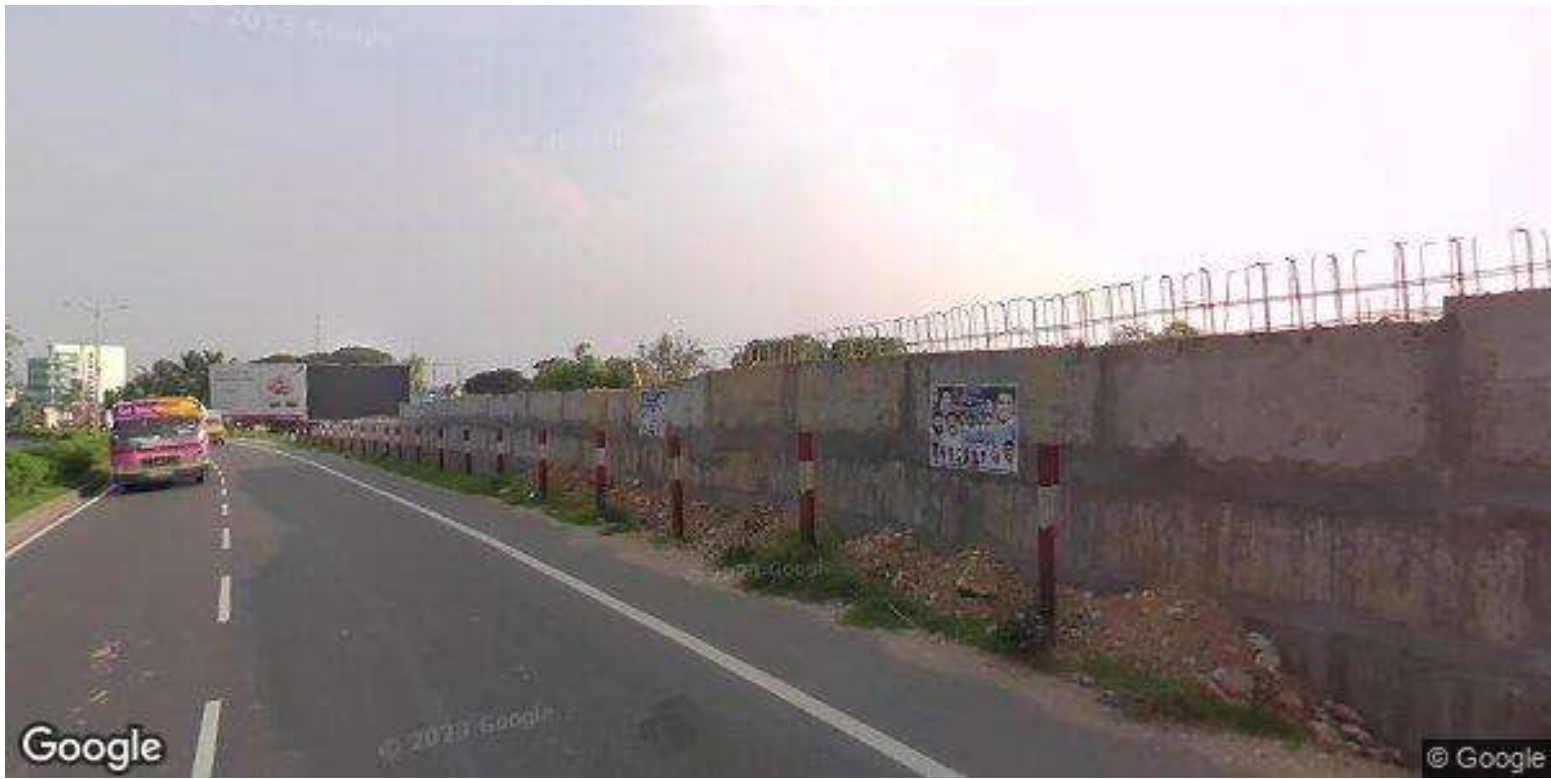
**Risk Type:** Turn  
**Risk Level:** Medium  
**Speed Limit:** 30 KM/Hr  
**Coordinates:** 11.69519, 78.10775

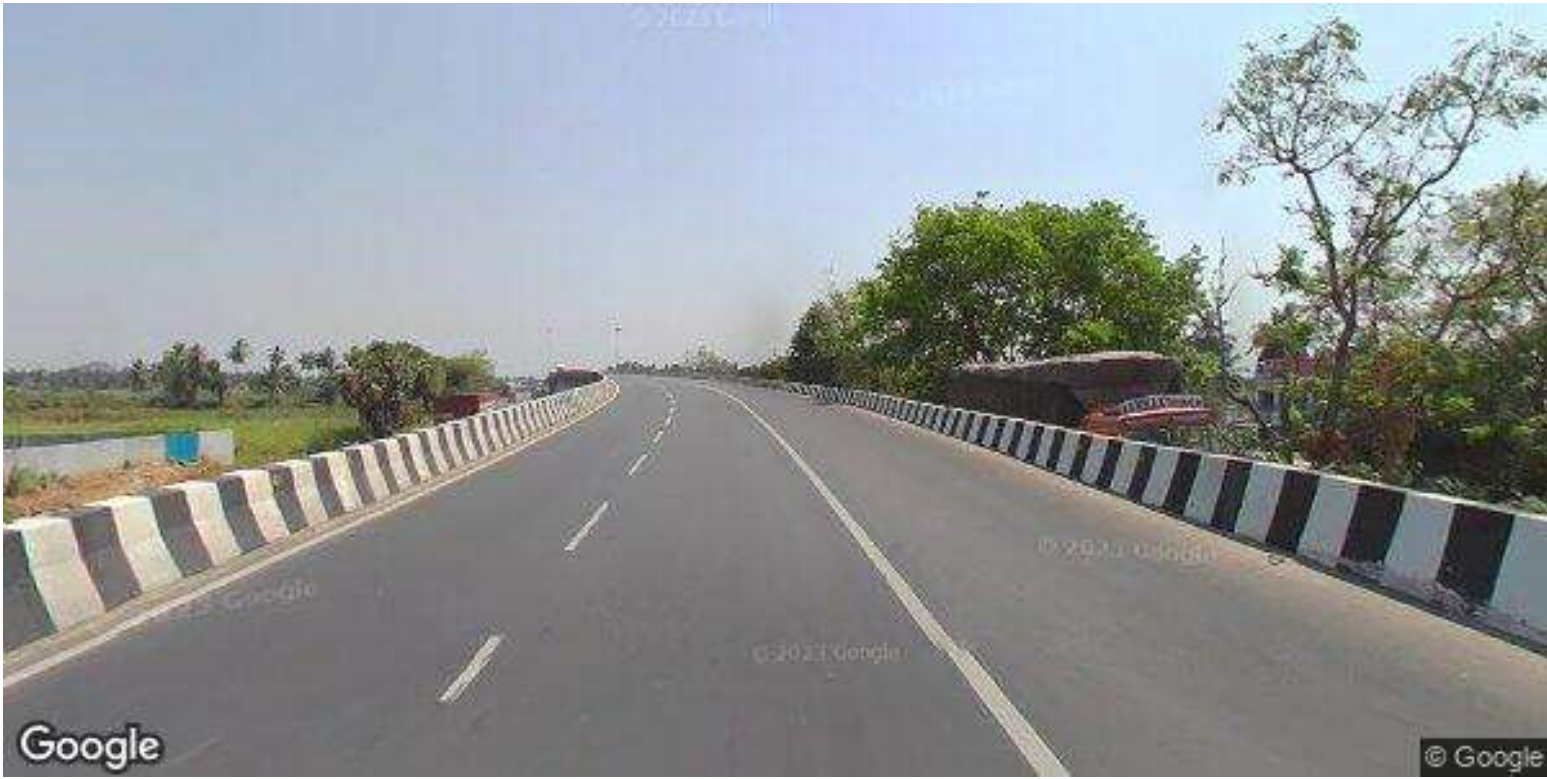
**Risk Type:** Turn  
**Risk Level:** Medium  
**Speed Limit:** 30 KM/Hr  
**Coordinates:** 11.73958, 78.05105

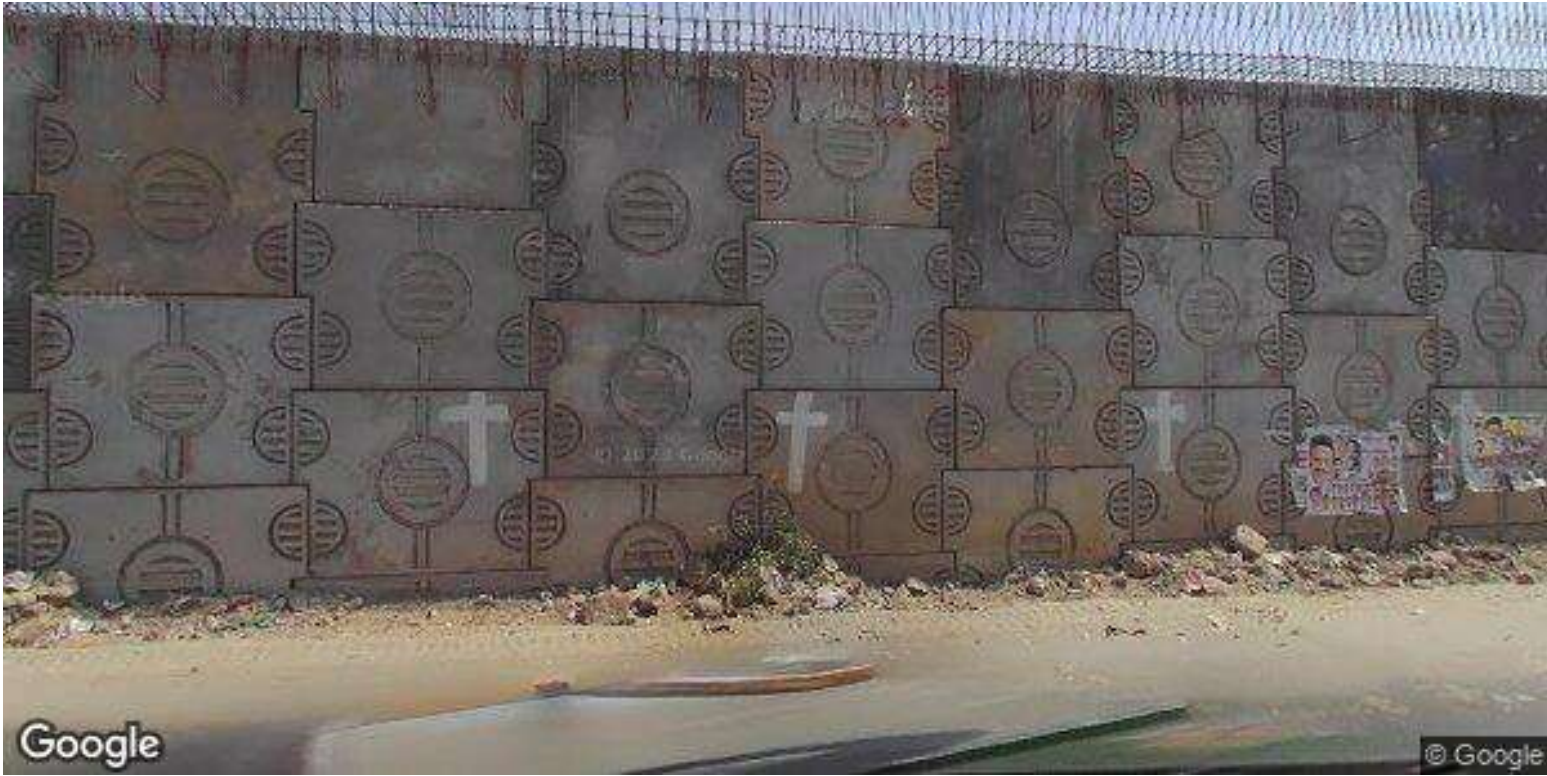
**Risk Type:** Turn  
**Risk Level:** Medium  
**Speed Limit:** 30 KM/Hr  
**Coordinates:** 11.75835, 78.05016

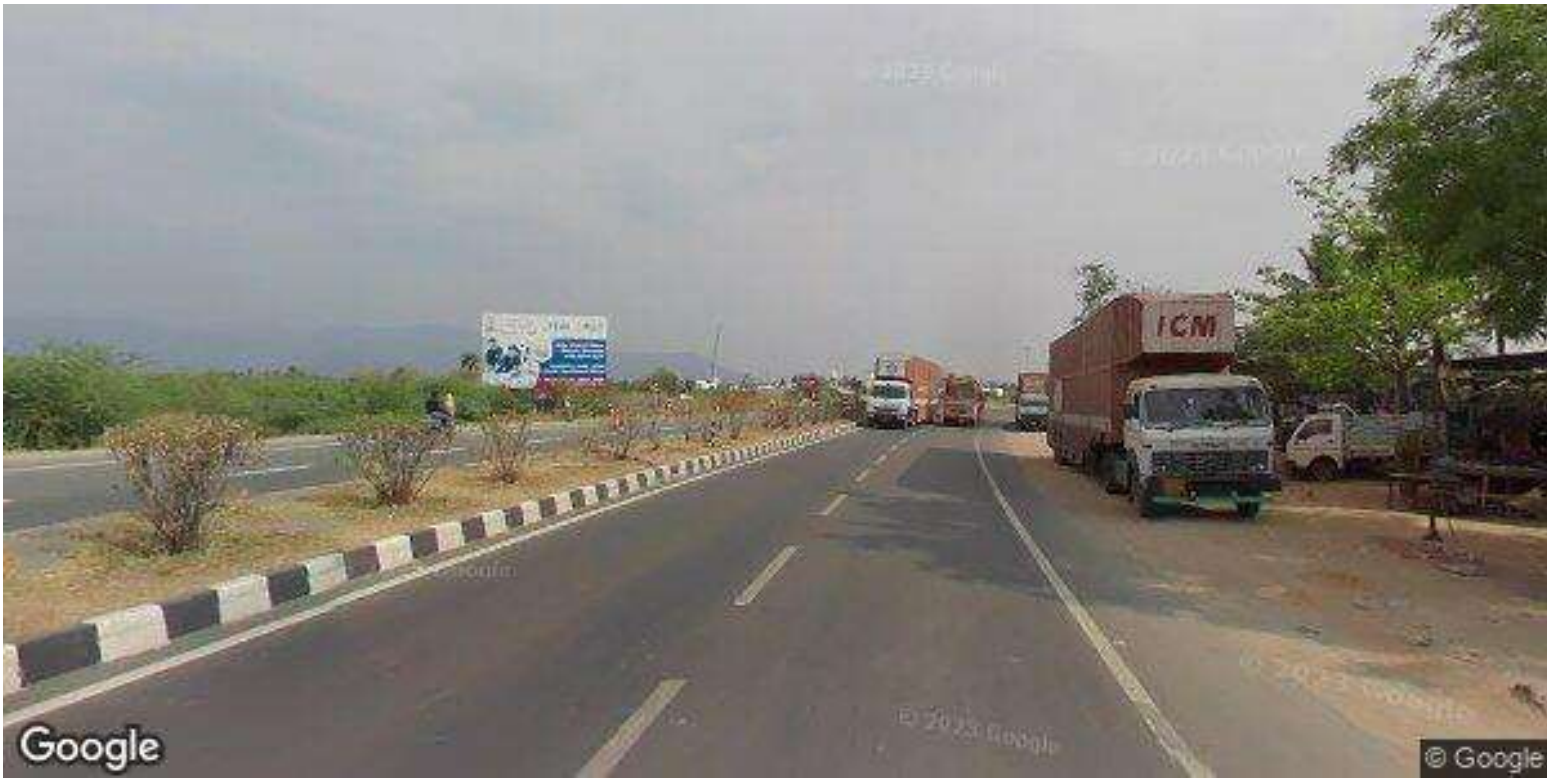
**Risk Type:** Turn  
**Risk Level:** Medium  
**Speed Limit:** 30 KM/Hr  
**Coordinates:** 11.87942, 78.08197

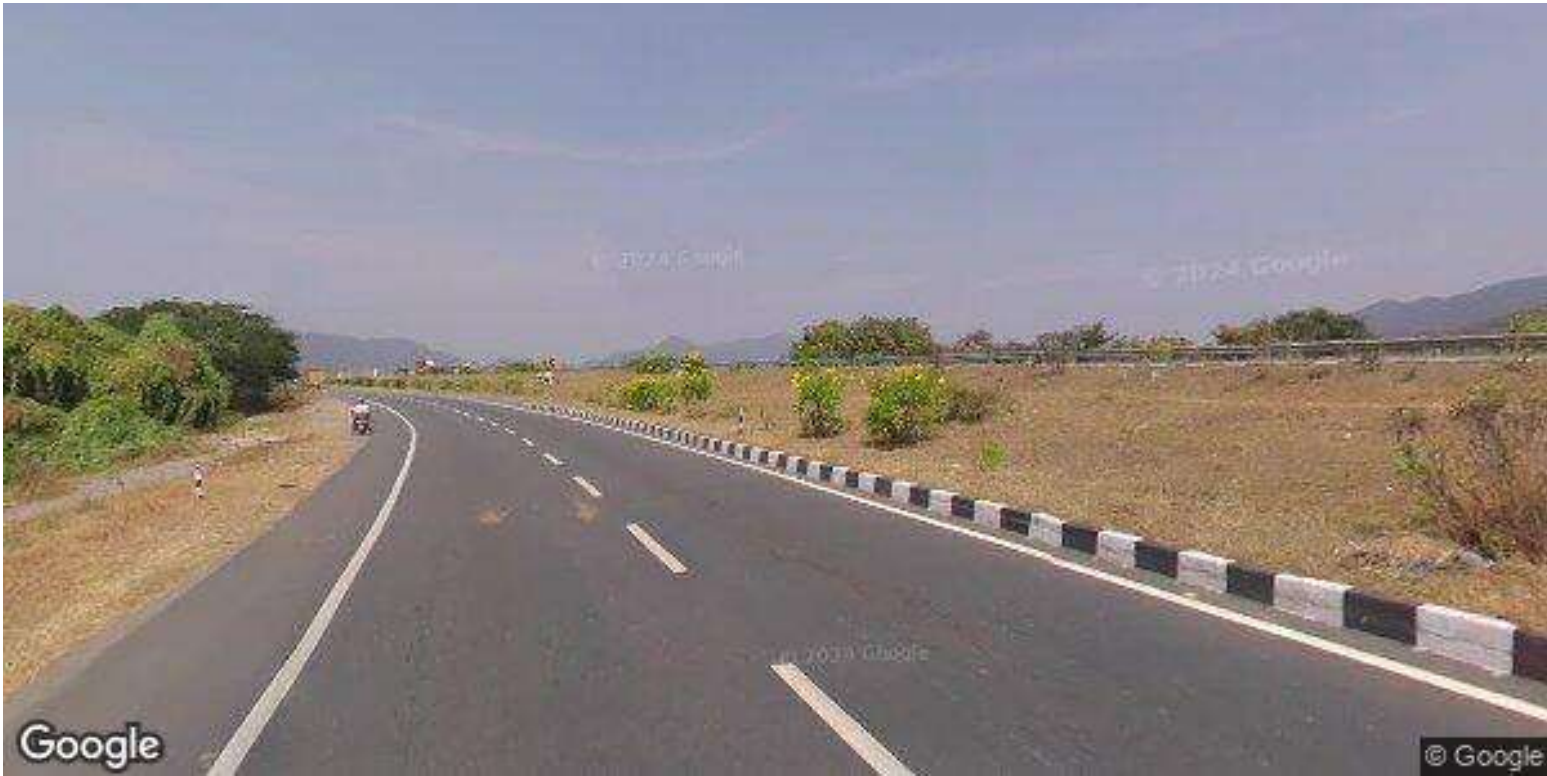
**Risk Type:** Turn  
**Risk Level:** Medium  
**Speed Limit:** 30 KM/Hr  
**Coordinates:** 11.92585, 78.06507
