# IndianOil

## JOURNEY RISK MANAGEMENT (JRM) STUDY

### Salem Terminal TO SRI V.M.S AGENCY

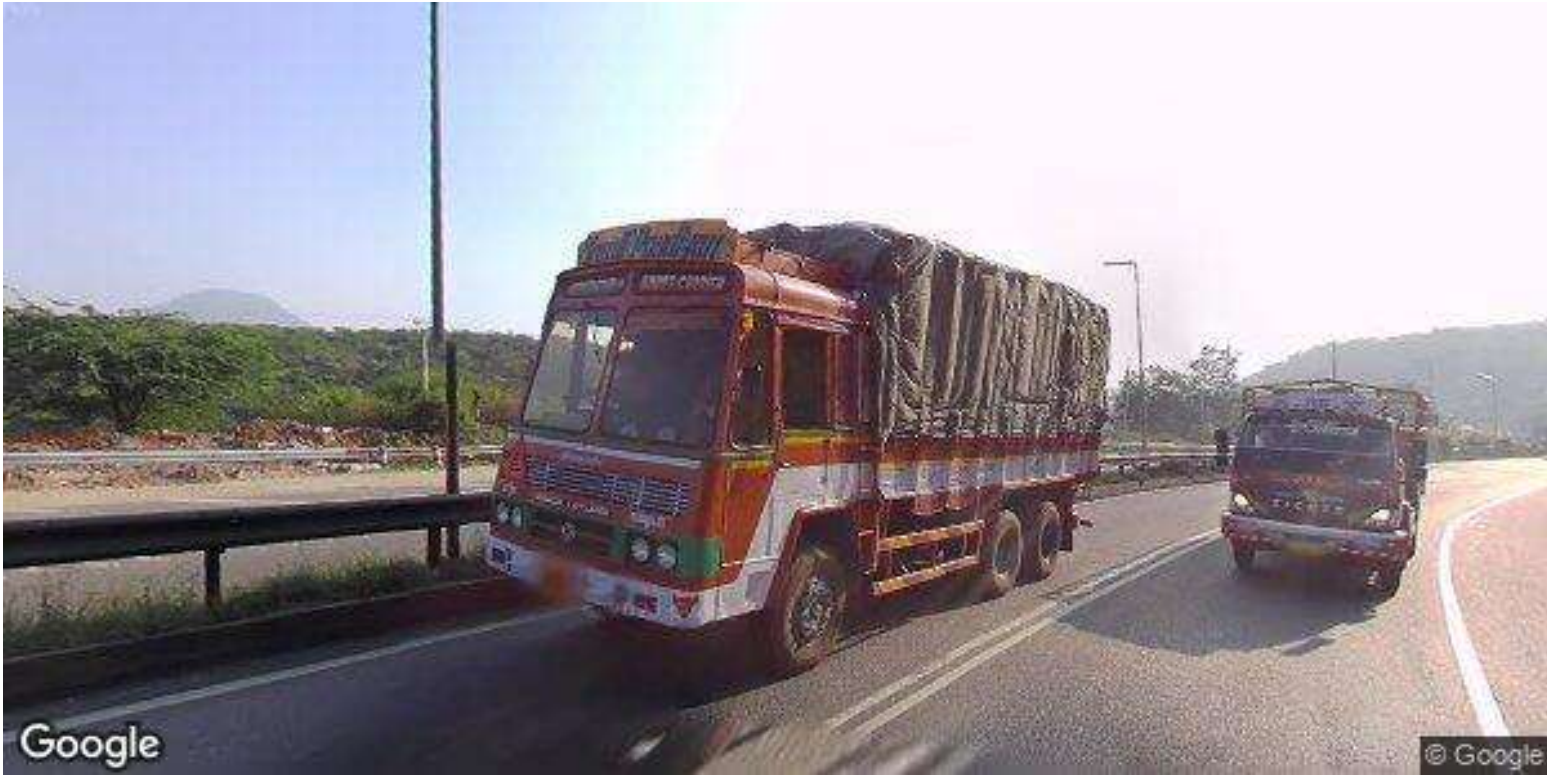
**Risk Type:** Turn  
**Risk Level:** Medium  
**Speed Limit:** 30 KM/Hr  
**Coordinates:** 11.95818, 78.04978

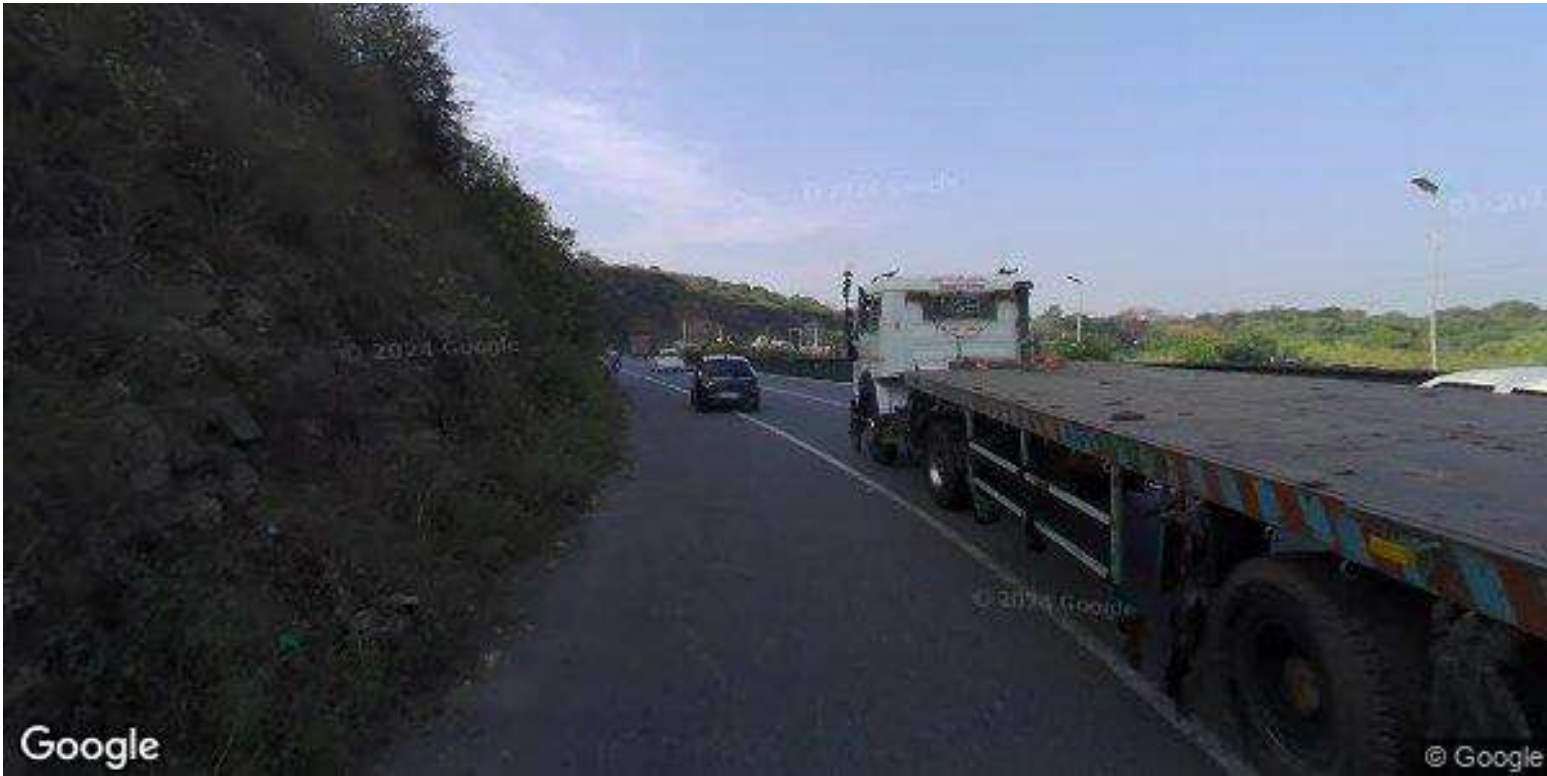
**Risk Type:** Turn  
**Risk Level:** Medium  
**Speed Limit:** 30 KM/Hr  
**Coordinates:** 11.95876, 78.04990

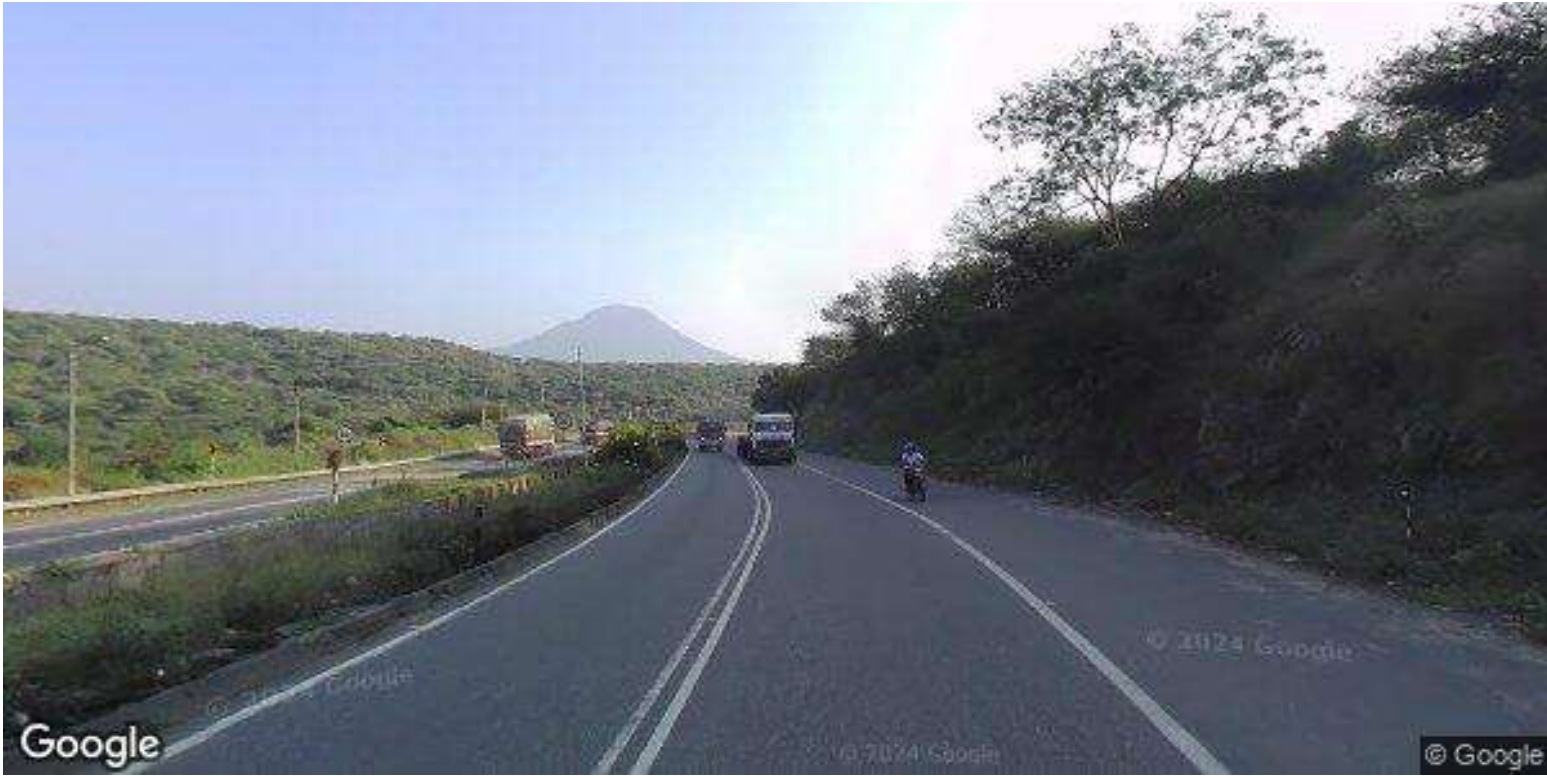
**Risk Type:** Turn  
**Risk Level:** Medium  
**Speed Limit:** 30 KM/Hr  
**Coordinates:** 11.95988, 78.04948

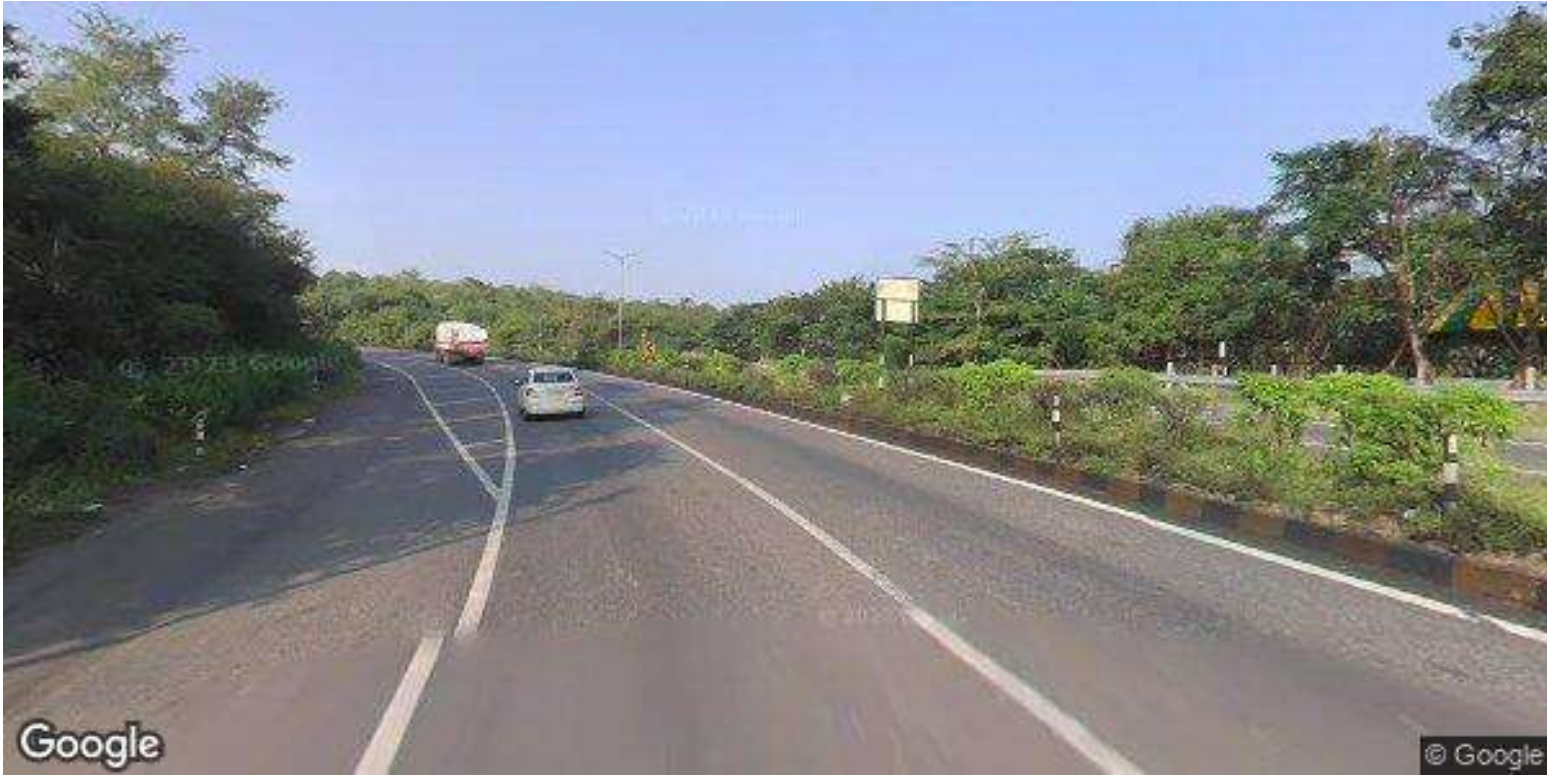
**Risk Type:** Turn  
**Risk Level:** Medium  
**Speed Limit:** 30 KM/Hr  
**Coordinates:** 11.96304, 78.05136

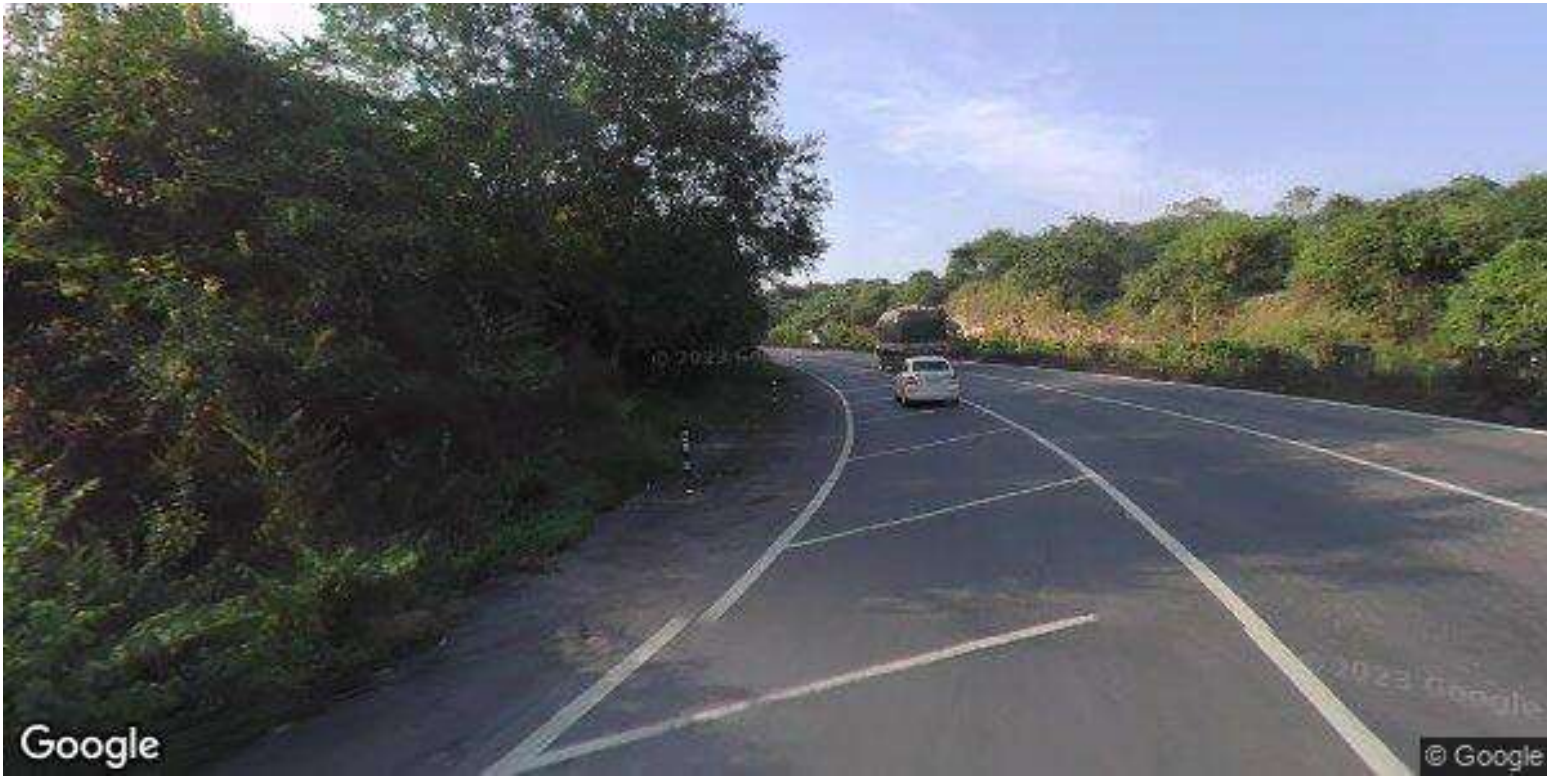
**Risk Type:** Turn  
**Risk Level:** Medium  
**Speed Limit:** 30 KM/Hr  
**Coordinates:** 11.96399, 78.05135

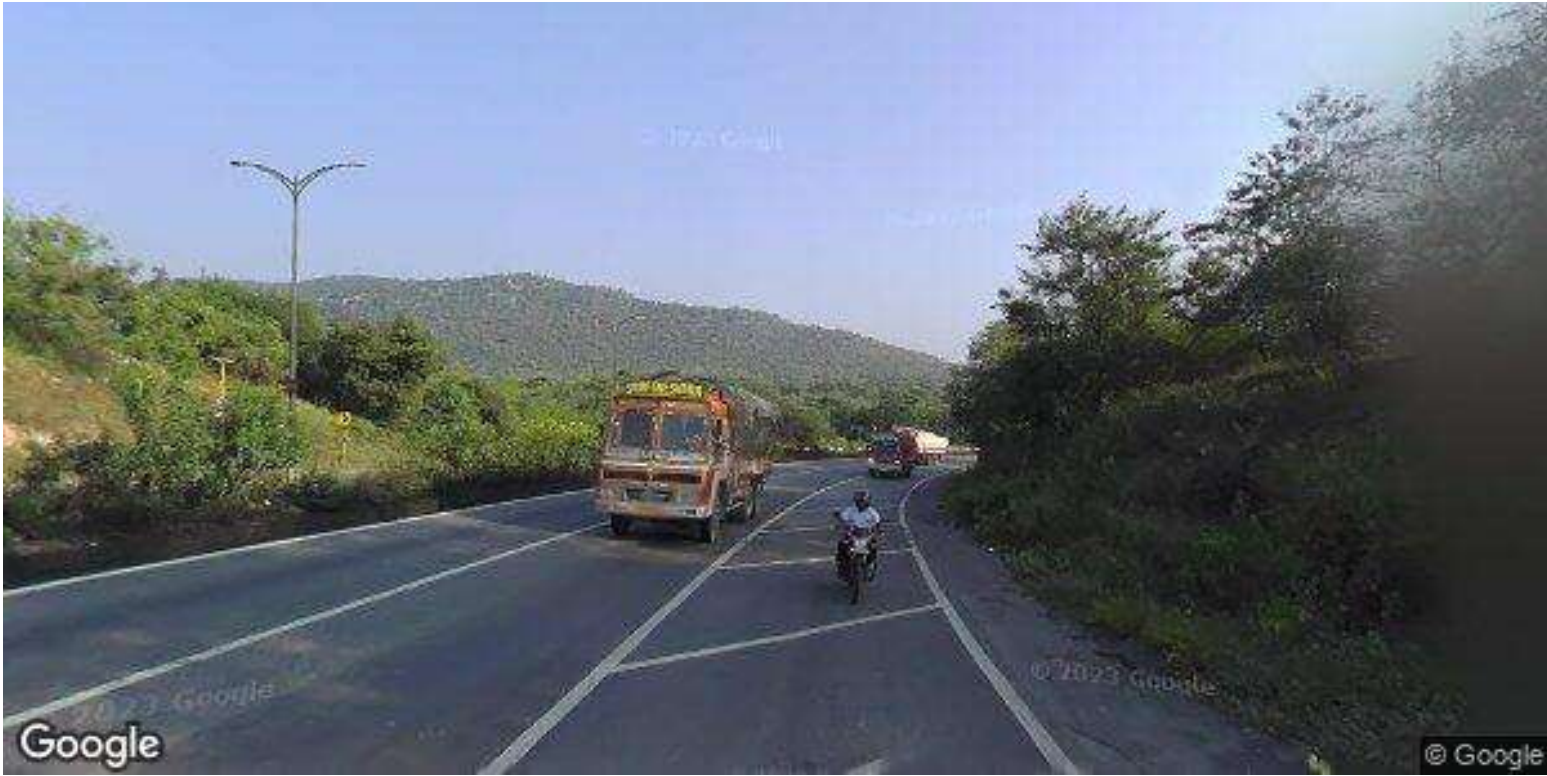
**Risk Type:** Turn  
**Risk Level:** Medium  
**Speed Limit:** 30 KM/Hr  
**Coordinates:** 11.96458, 78.05084

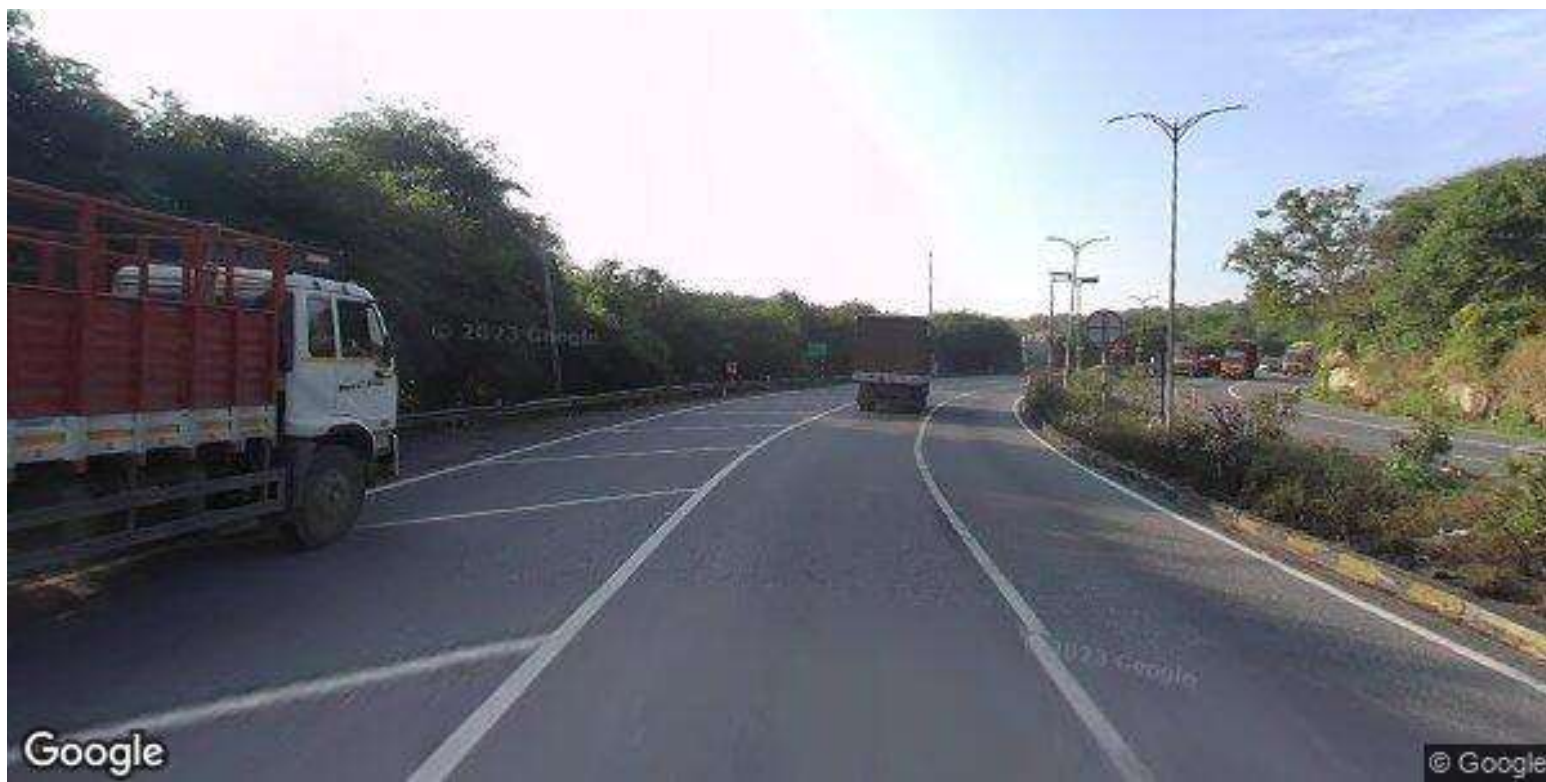
**Coordinates:** 11.96496, 78.04988

**Risk Type:** Turn

**Risk Level:** Medium

**Speed Limit:** 30 KM/Hr

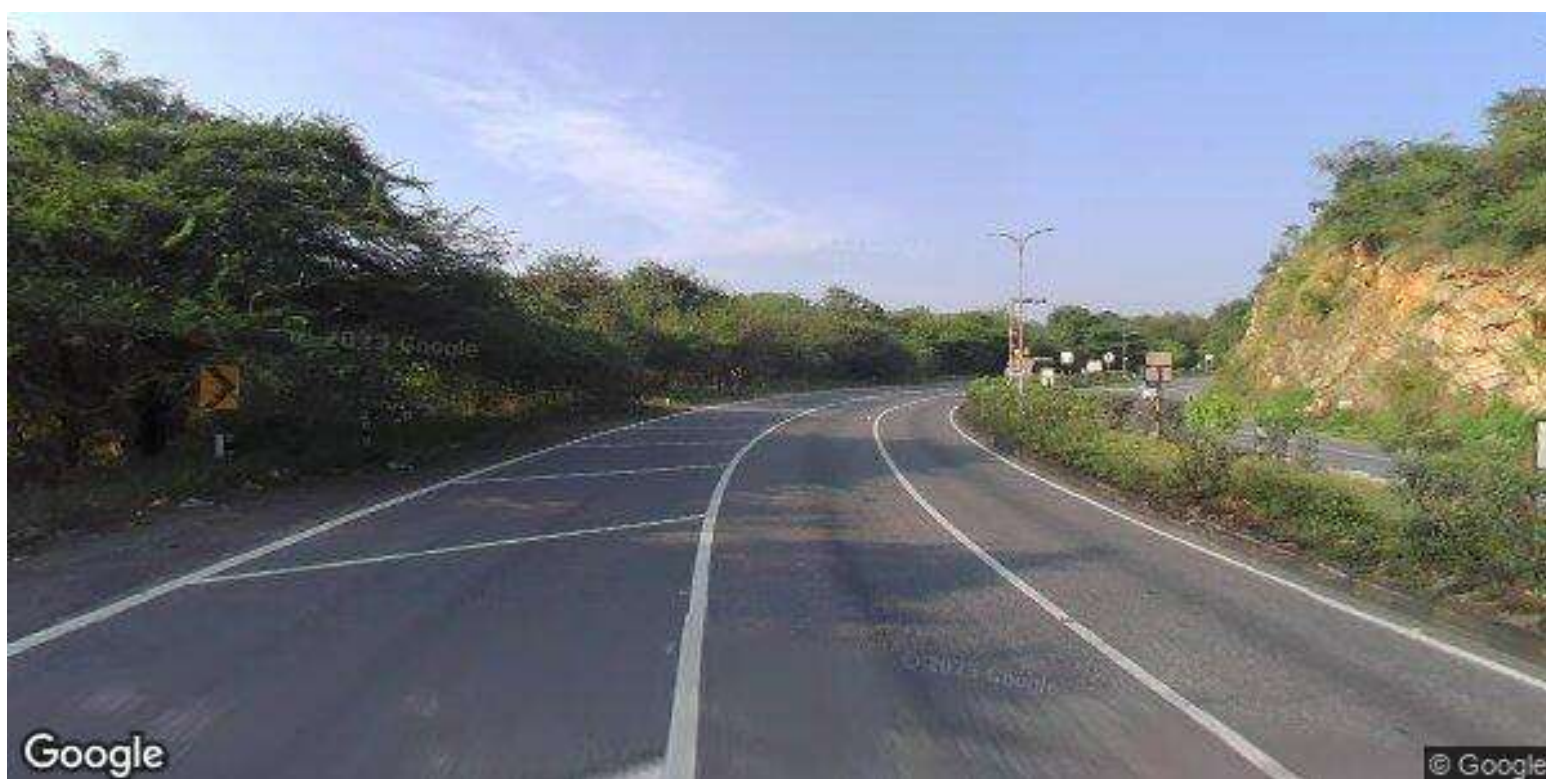
**Coordinates:** 11.96580, 78.04923

**Risk Type:** Turn

**Risk Level:** High

**Speed Limit:** 15 KM/Hr

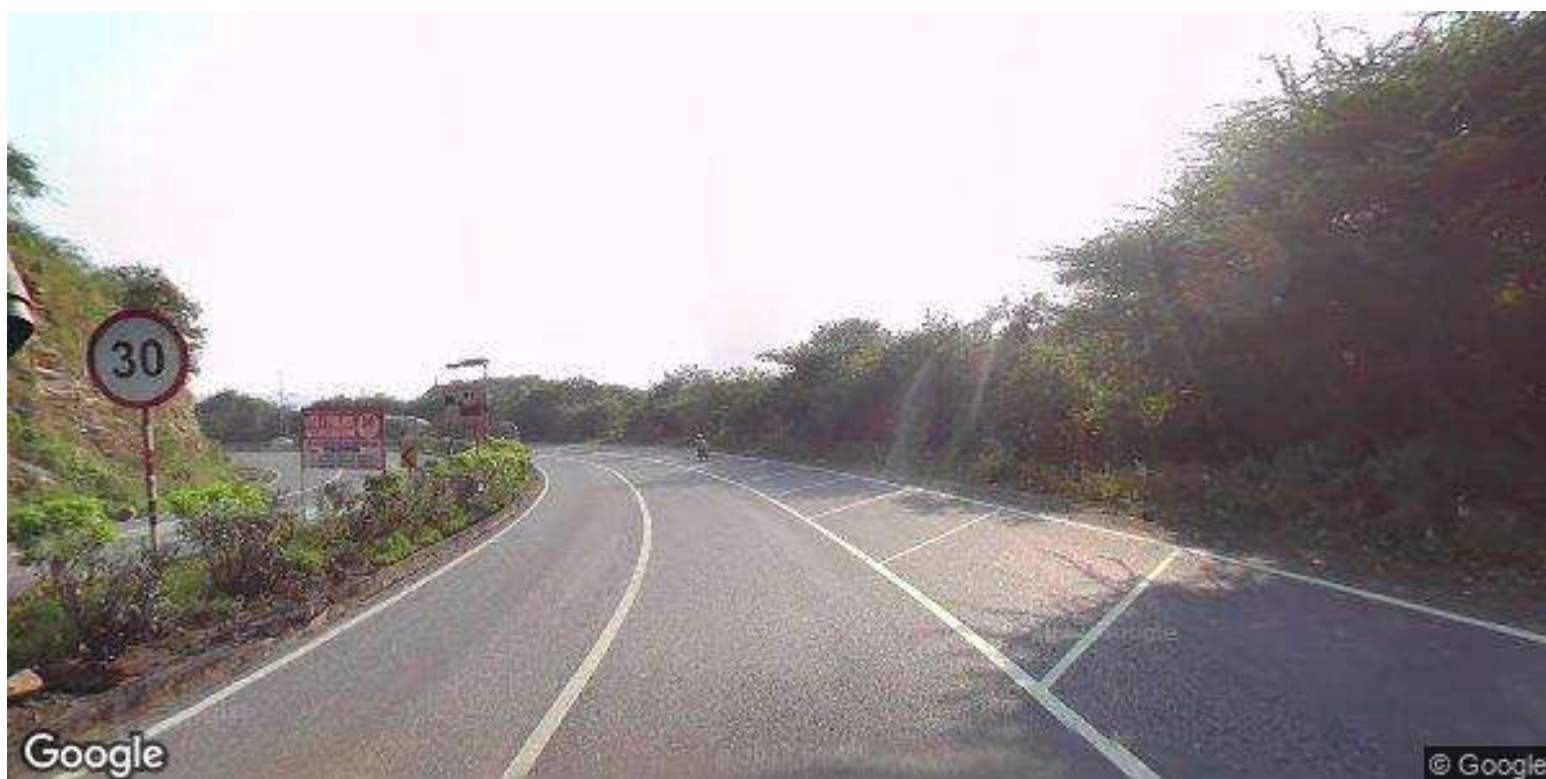
**Risk Type:** Turn  
**Risk Level:** Medium  
**Speed Limit:** 30 KM/Hr  
**Coordinates:** 11.96675, 78.04939

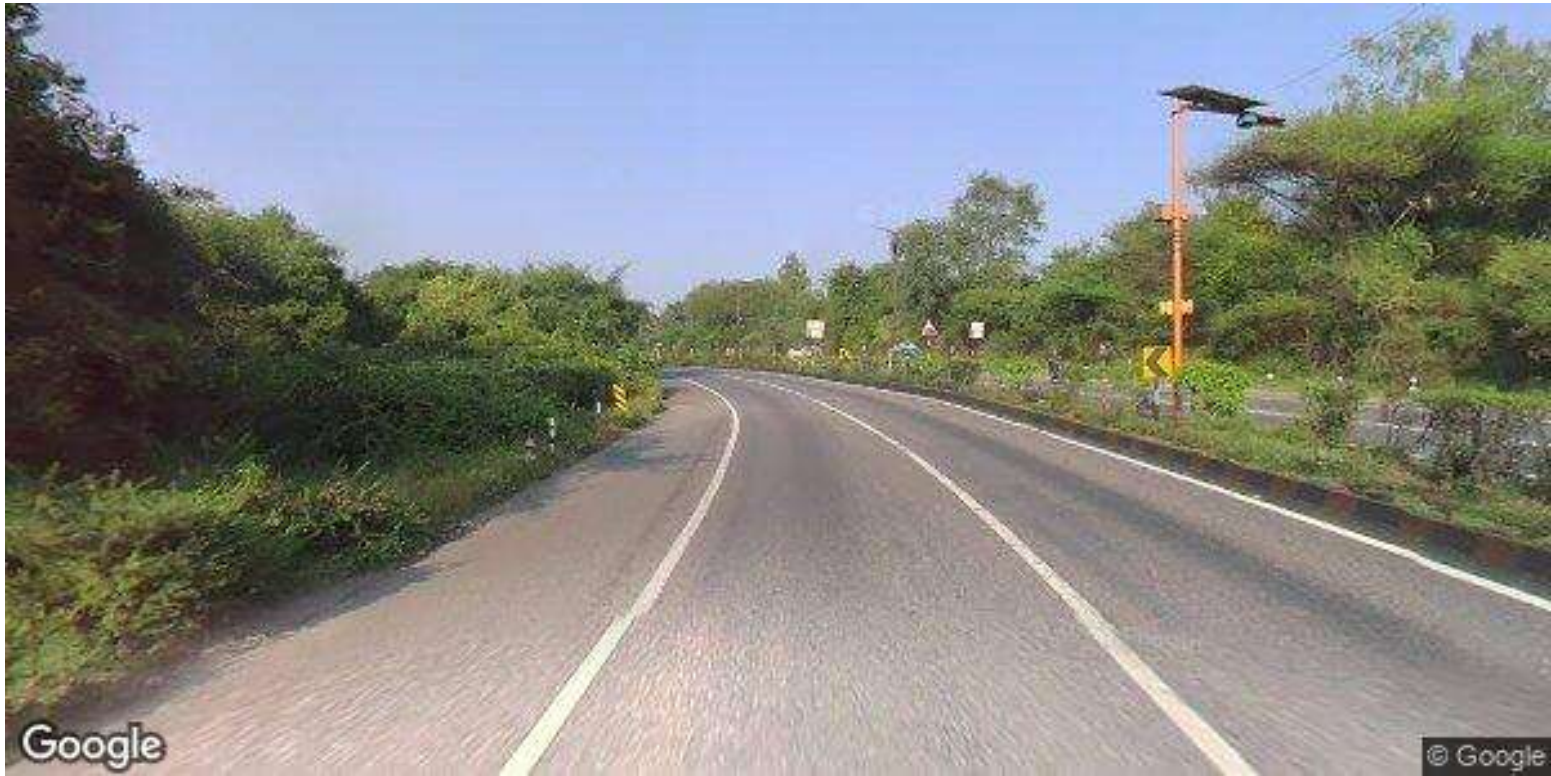
**Risk Type:** Turn  
**Risk Level:** Medium  
**Speed Limit:** 30 KM/Hr  
**Coordinates:** 11.96791, 78.05070

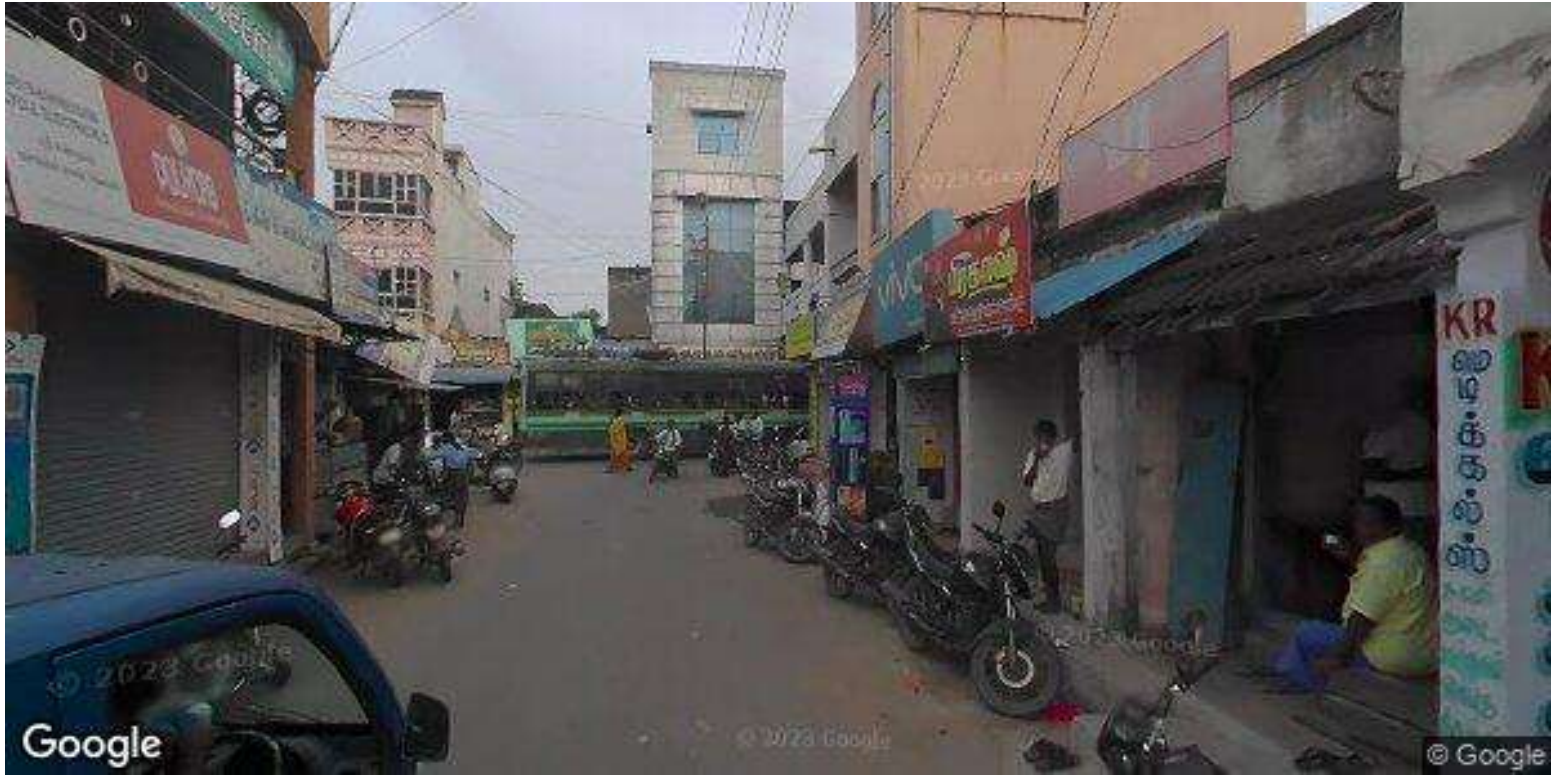
**Risk Type:** Turn  
**Risk Level:** High  
**Speed Limit:** 15 KM/Hr  
**Coordinates:** 12.30929, 78.20303

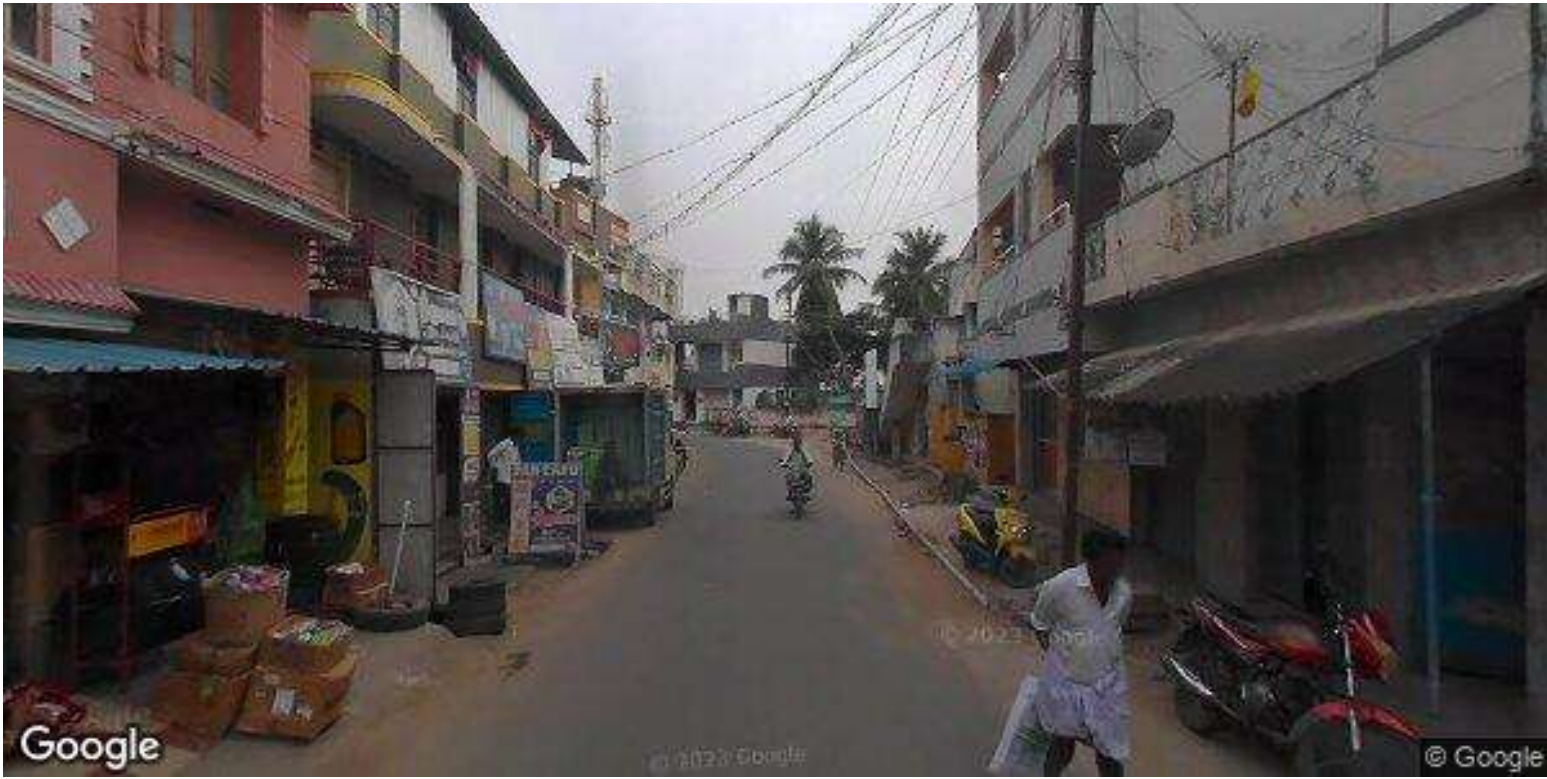
**Risk Type:** Turn  
**Risk Level:** Medium  
**Speed Limit:** 30 KM/Hr  
**Coordinates:** 12.31000, 78.20220

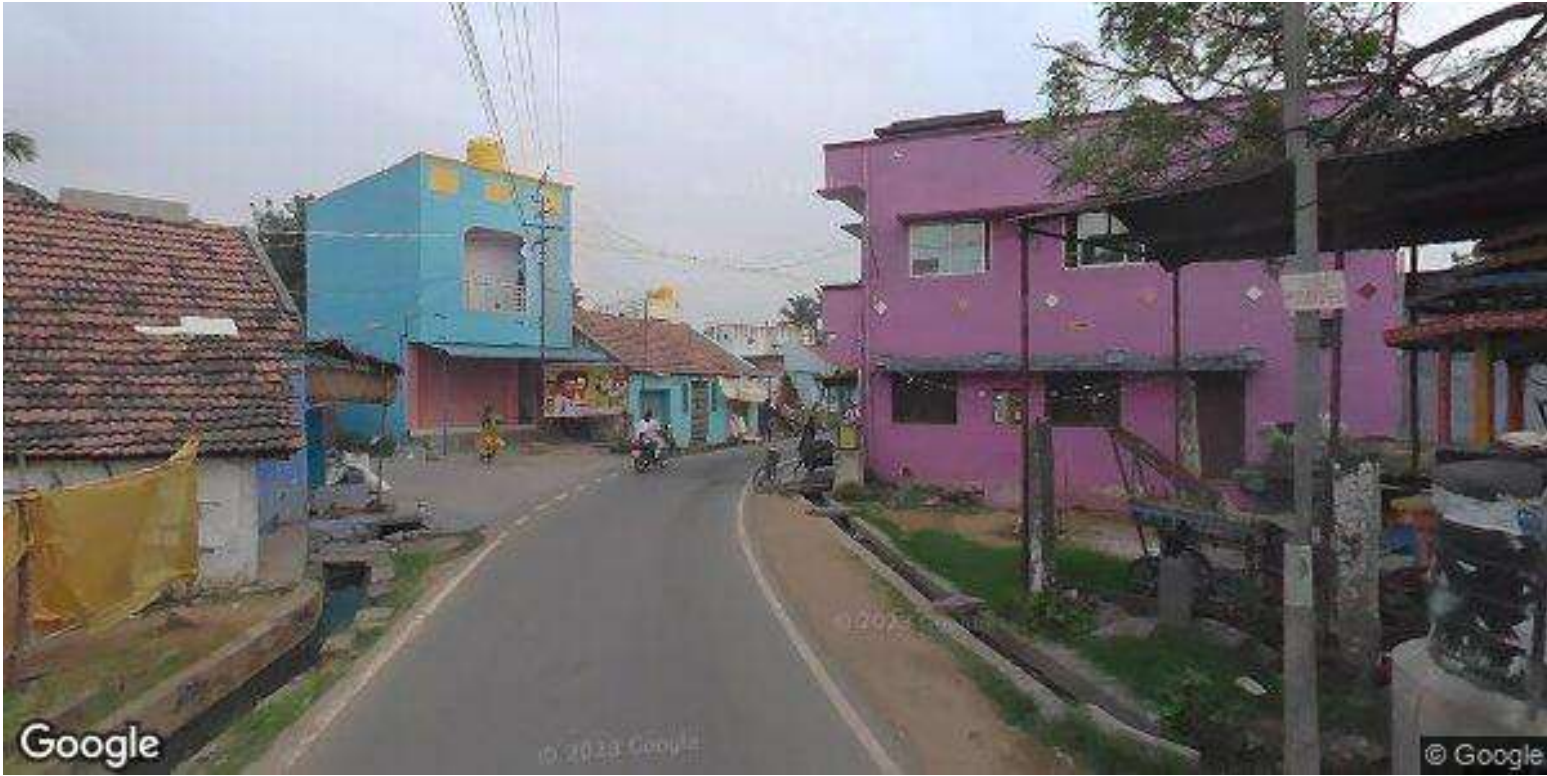
**Risk Type:** Turn  
**Risk Level:** High  
**Speed Limit:** 15 KM/Hr  
**Coordinates:** 12.31077, 78.20193

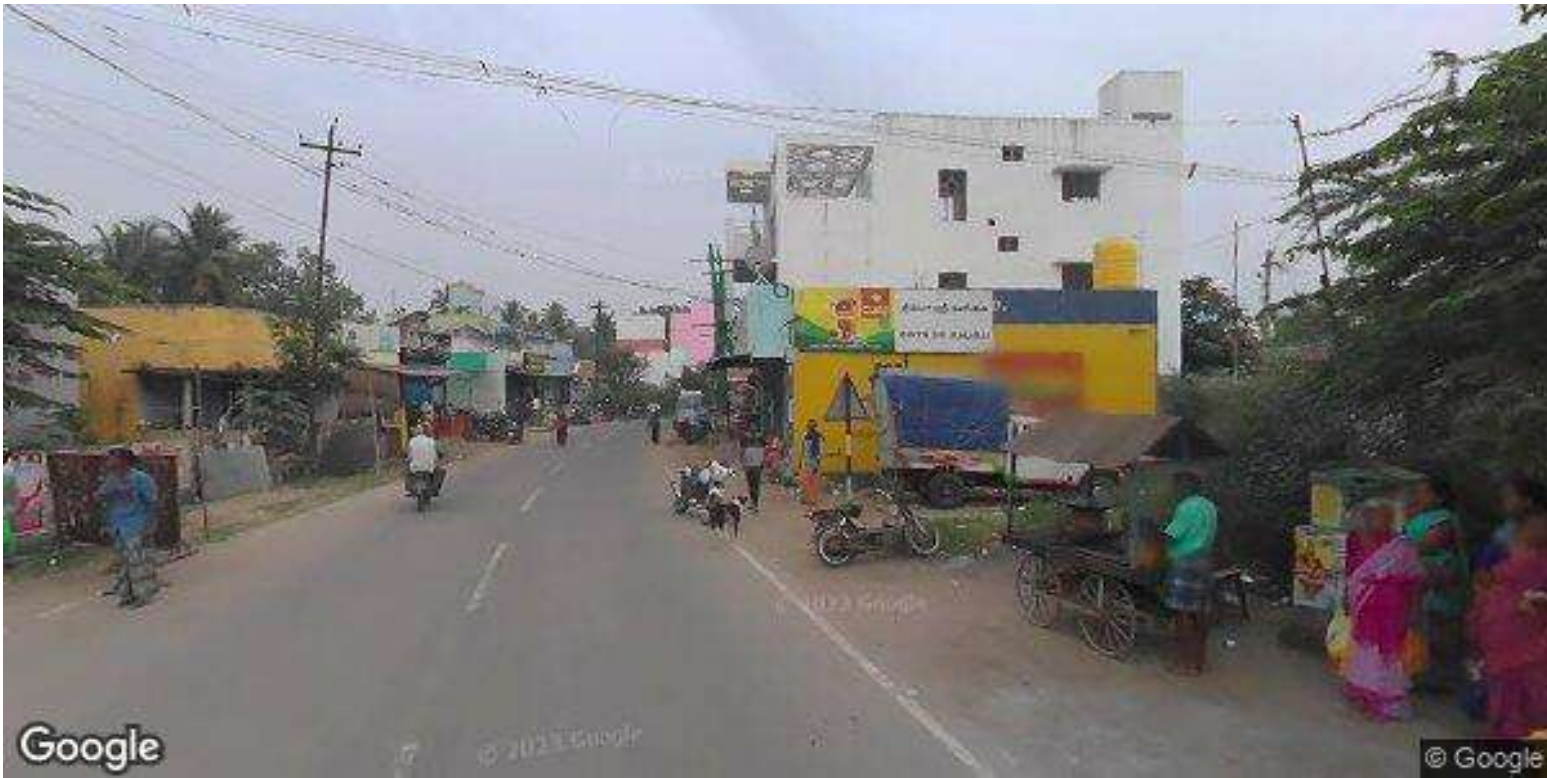
**Coordinates:** 12.31088, 78.20138

**Risk Type:** Turn

**Risk Level:** High

**Speed Limit:** 15 KM/Hr
