# IndianOil

## JOURNEY RISK MANAGEMENT (JRM) STUDY

### Salem Terminal to SASTHA FUELS

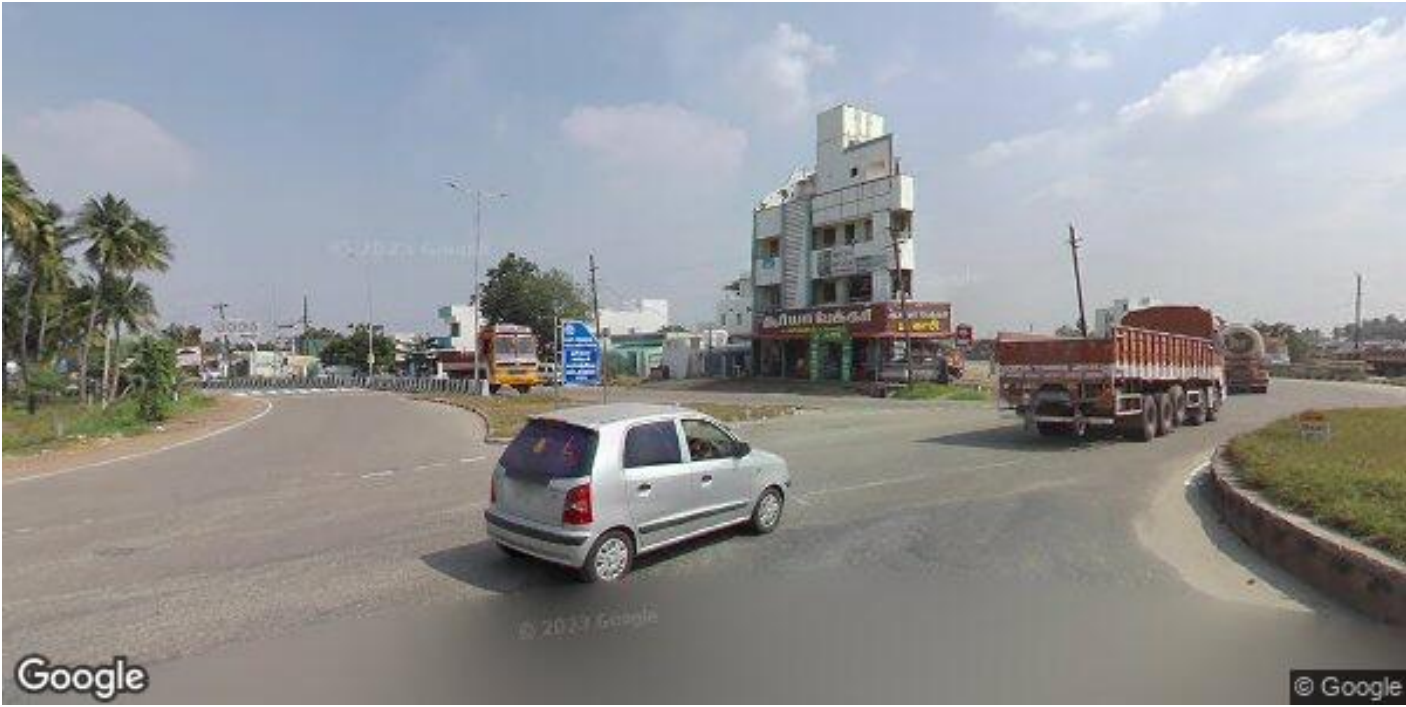
**Risk Type:** Roundabout  
**Risk Level:** High  
**Speed Limit:** 15 KM/Hr  
**Coordinates:** 10.92958, 78.05452

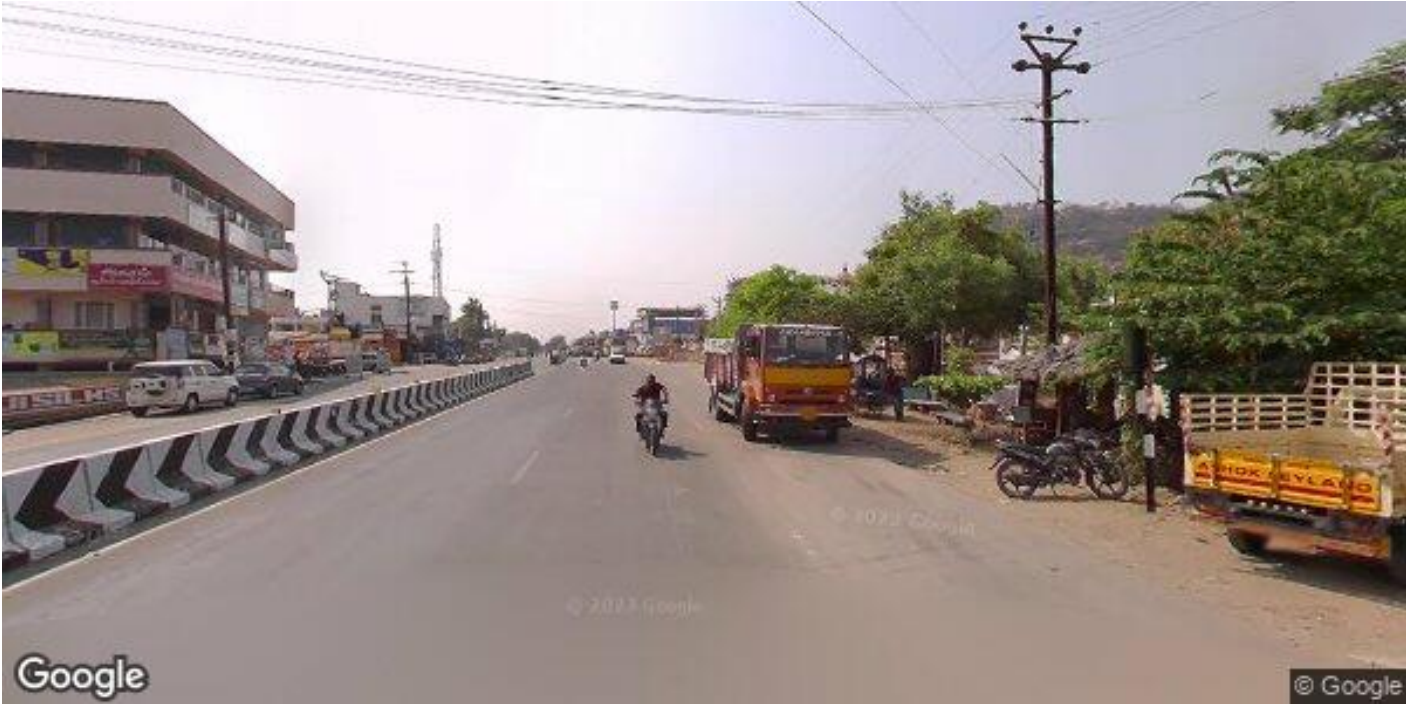
**Risk Type:** Turn  
**Risk Level:** Medium  
**Speed Limit:** 30 KM/Hr  
**Coordinates:** 11.39685, 77.88861

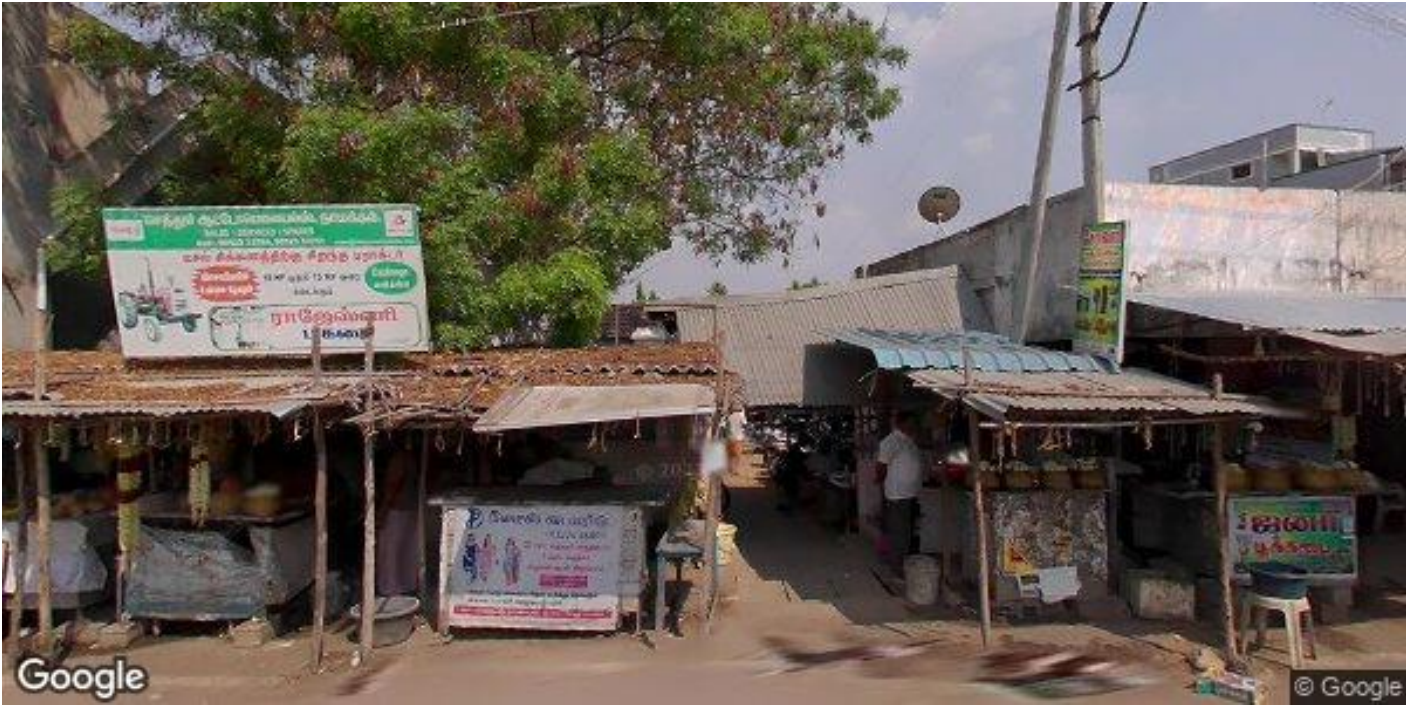
**Risk Type:** Turn  
**Risk Level:** High  
**Speed Limit:** 15 KM/Hr  
**Coordinates:** 11.15573, 78.02176

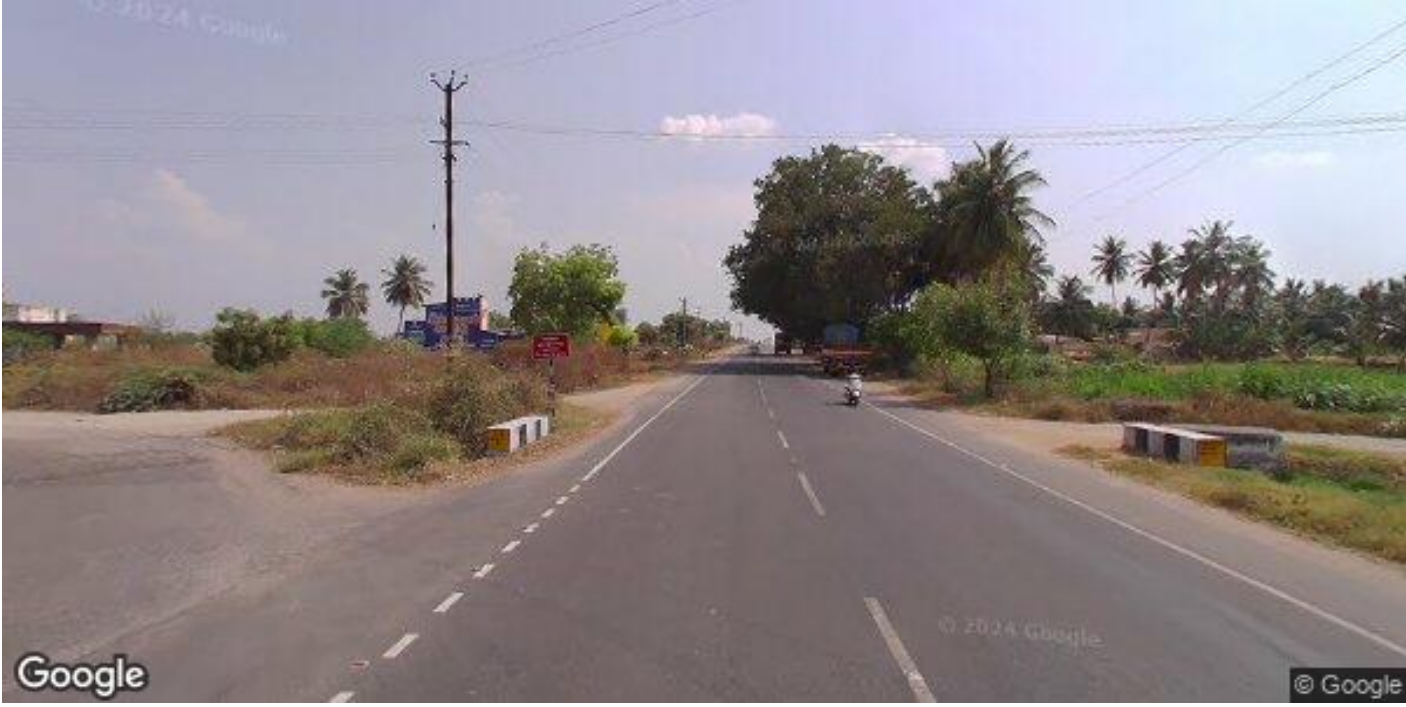
**Risk Type:** Turn  
**Risk Level:** High  
**Speed Limit:** 15 KM/Hr  
**Coordinates:** 11.14545, 78.02208

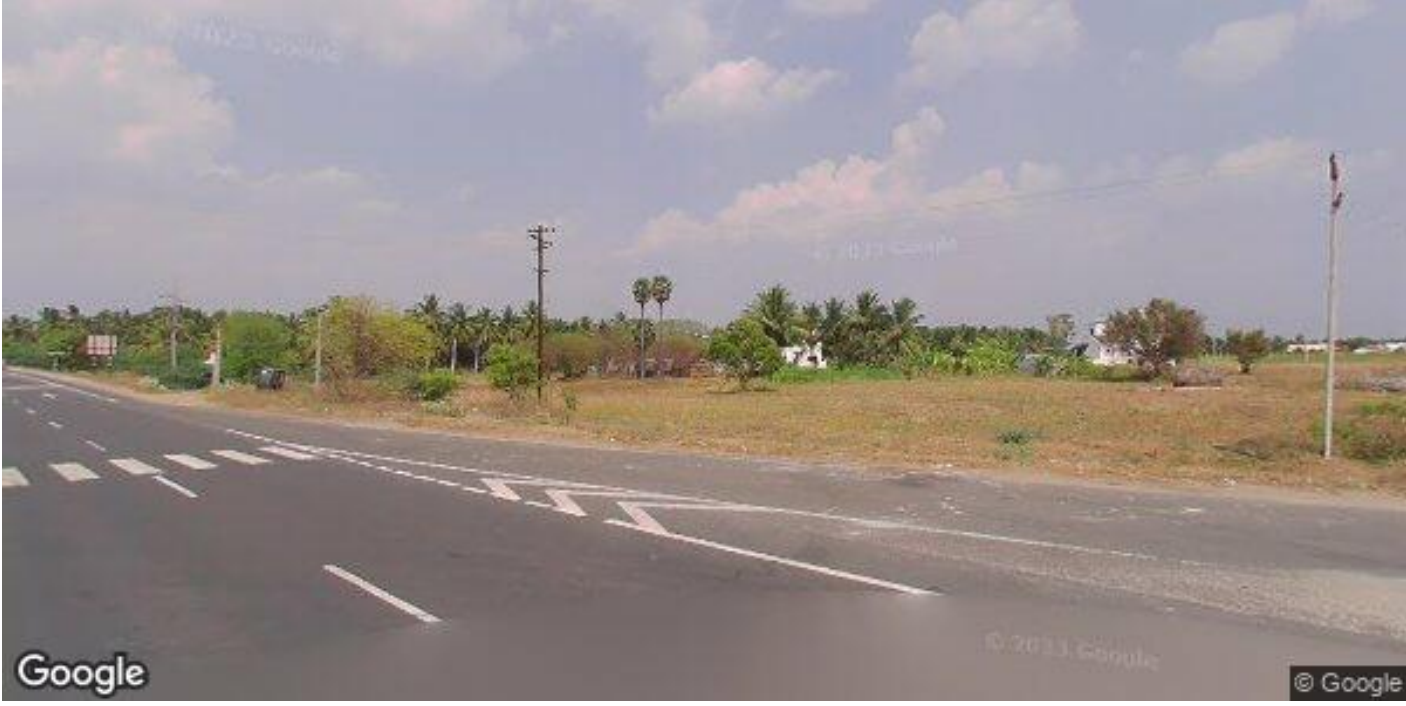
**Risk Type:** Turn  
**Risk Level:** High  
**Speed Limit:** 15 KM/Hr  
**Coordinates:** 11.14480, 78.02291

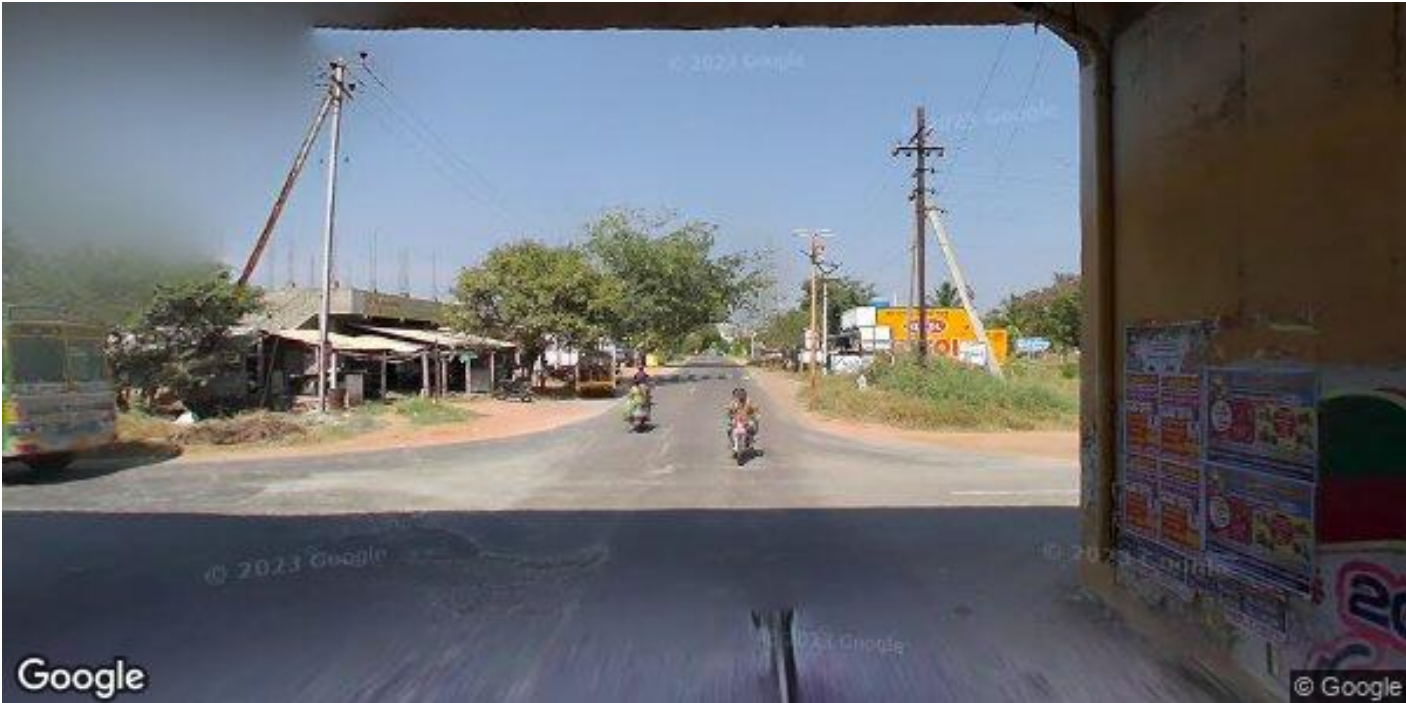
**Risk Type:** Turn  
**Risk Level:** High  
**Speed Limit:** 15 KM/Hr  
**Coordinates:** 10.92509, 78.15310

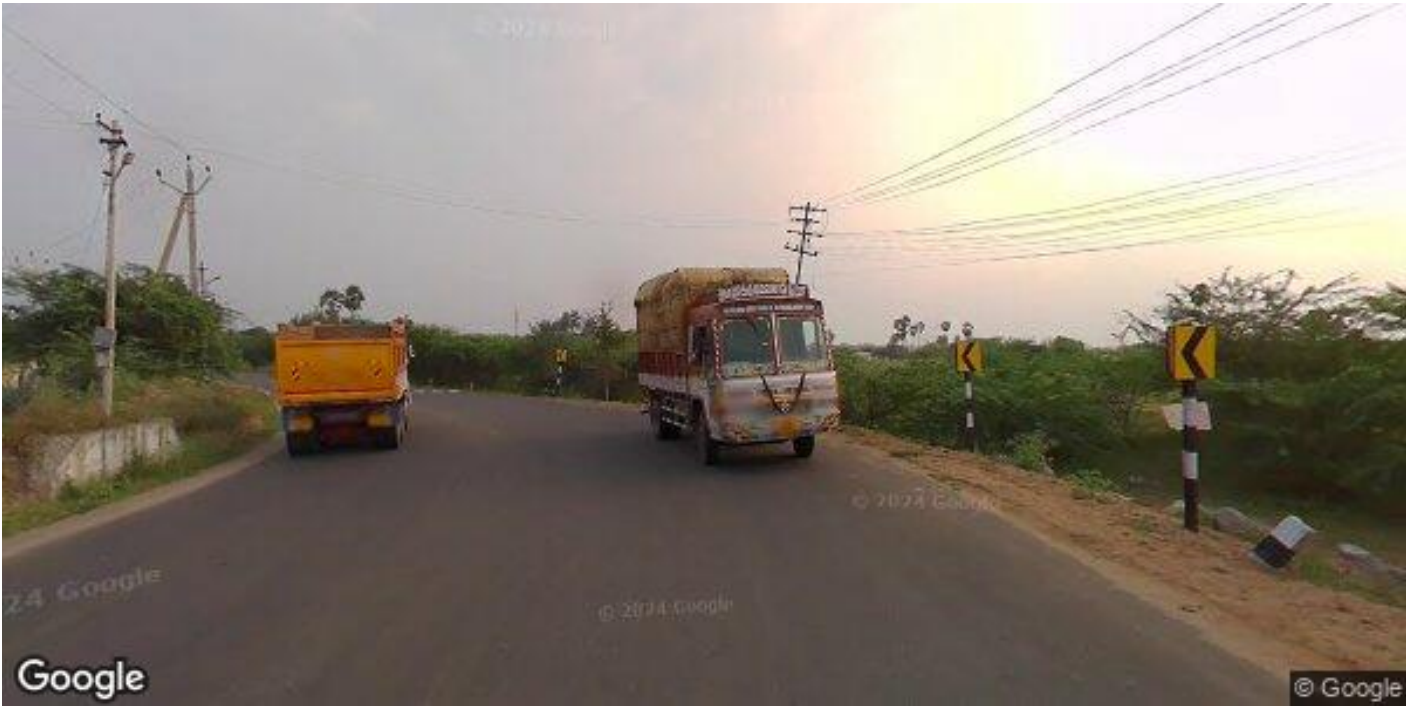
**Risk Type:** Turn  
**Risk Level:** Medium  
**Speed Limit:** 30 KM/Hr  
**Coordinates:** 10.90842, 78.15408

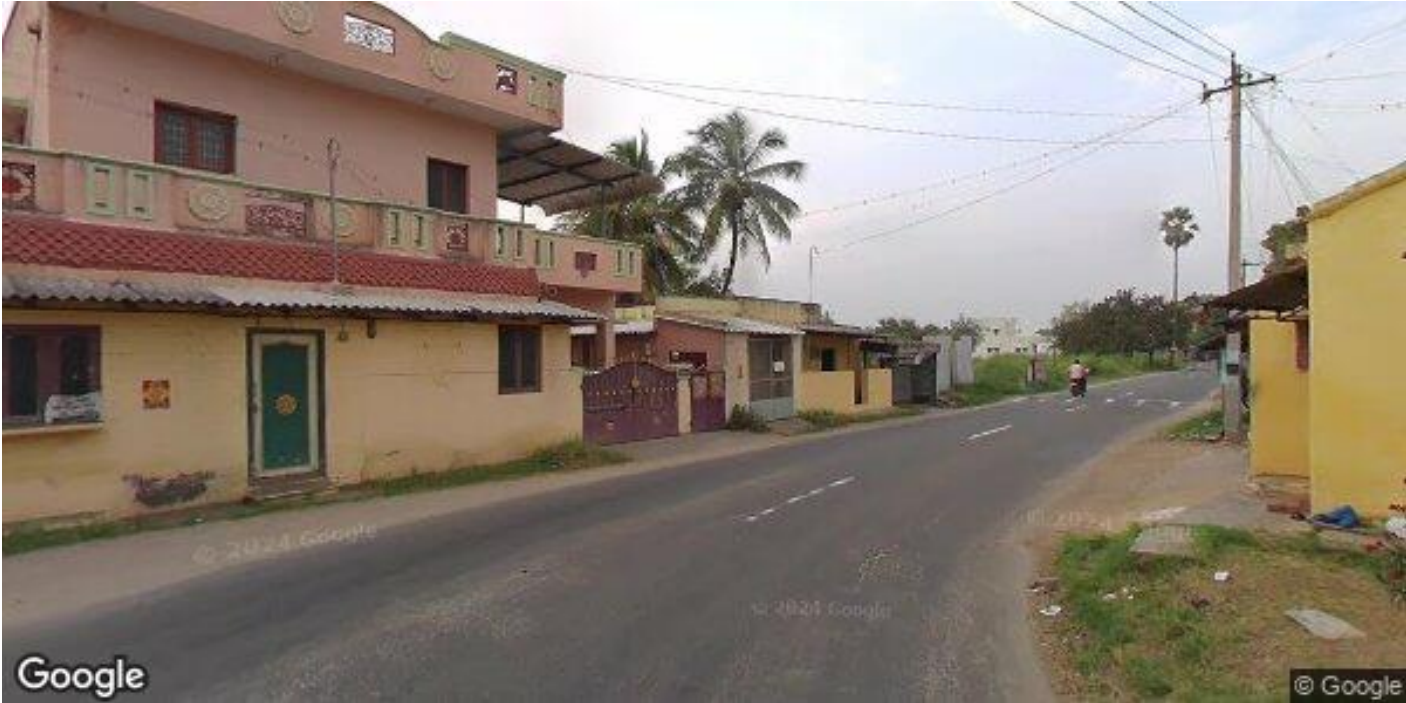
**Risk Type:** Turn  
**Risk Level:** High  
**Speed Limit:** 15 KM/Hr  
**Coordinates:** 10.90229, 78.15716

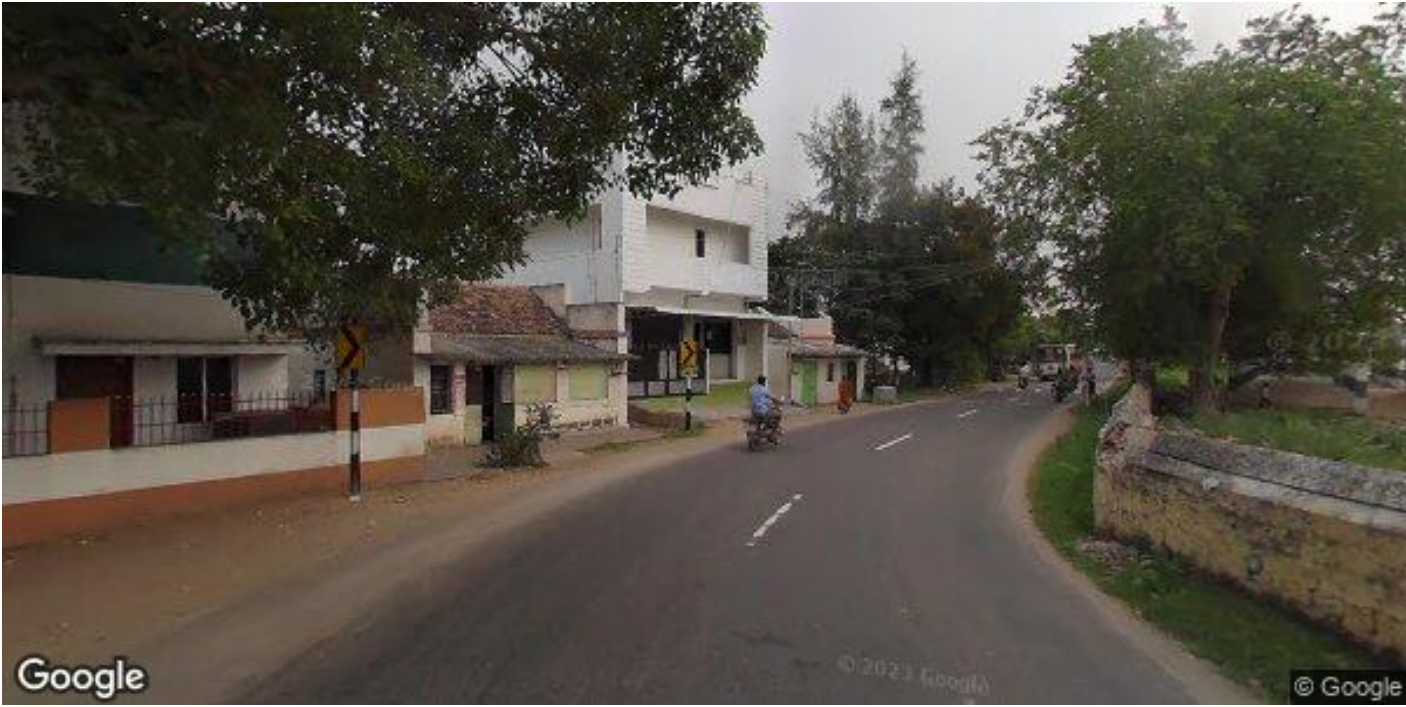
**Risk Type:** Turn  
**Risk Level:** High  
**Speed Limit:** 15 KM/Hr  
**Coordinates:** 10.90225, 78.15799

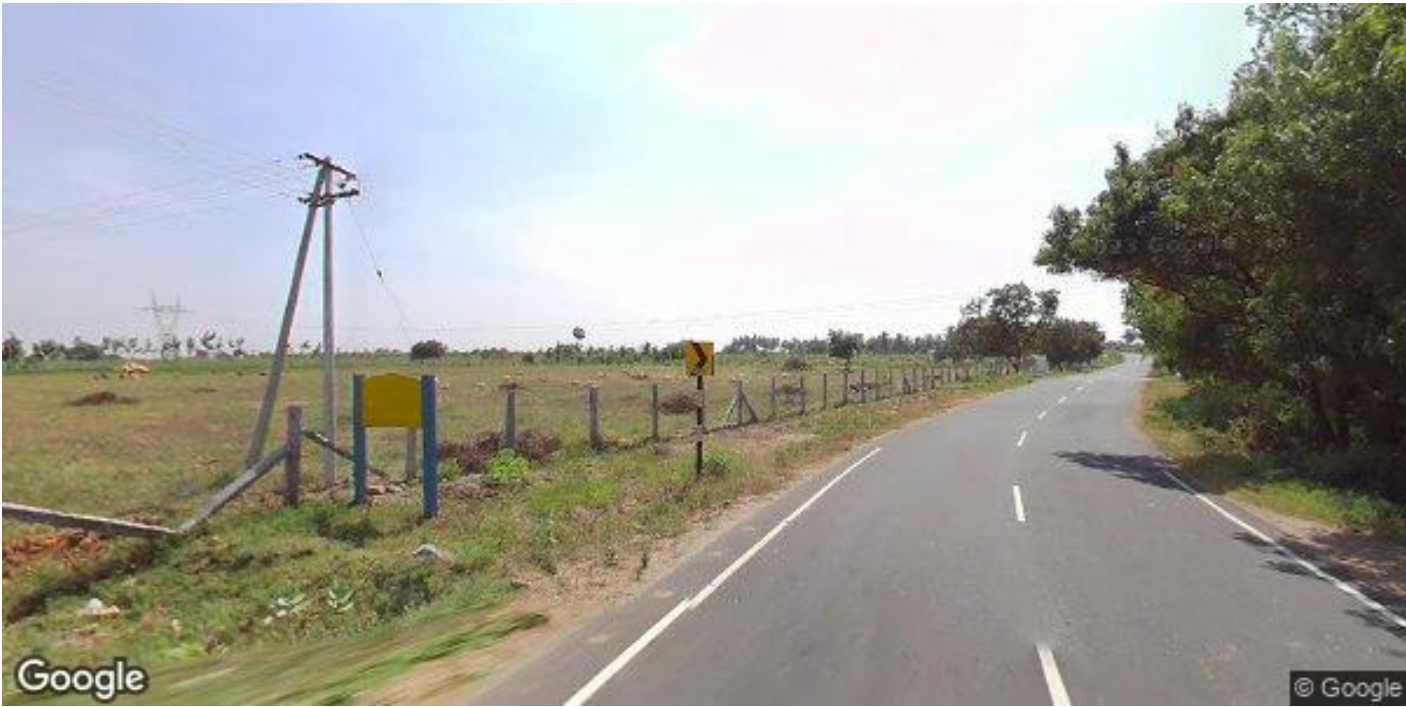
**Risk Type:** Turn  
**Risk Level:** Medium  
**Speed Limit:** 30 KM/Hr  
**Coordinates:** 10.88119, 78.16362

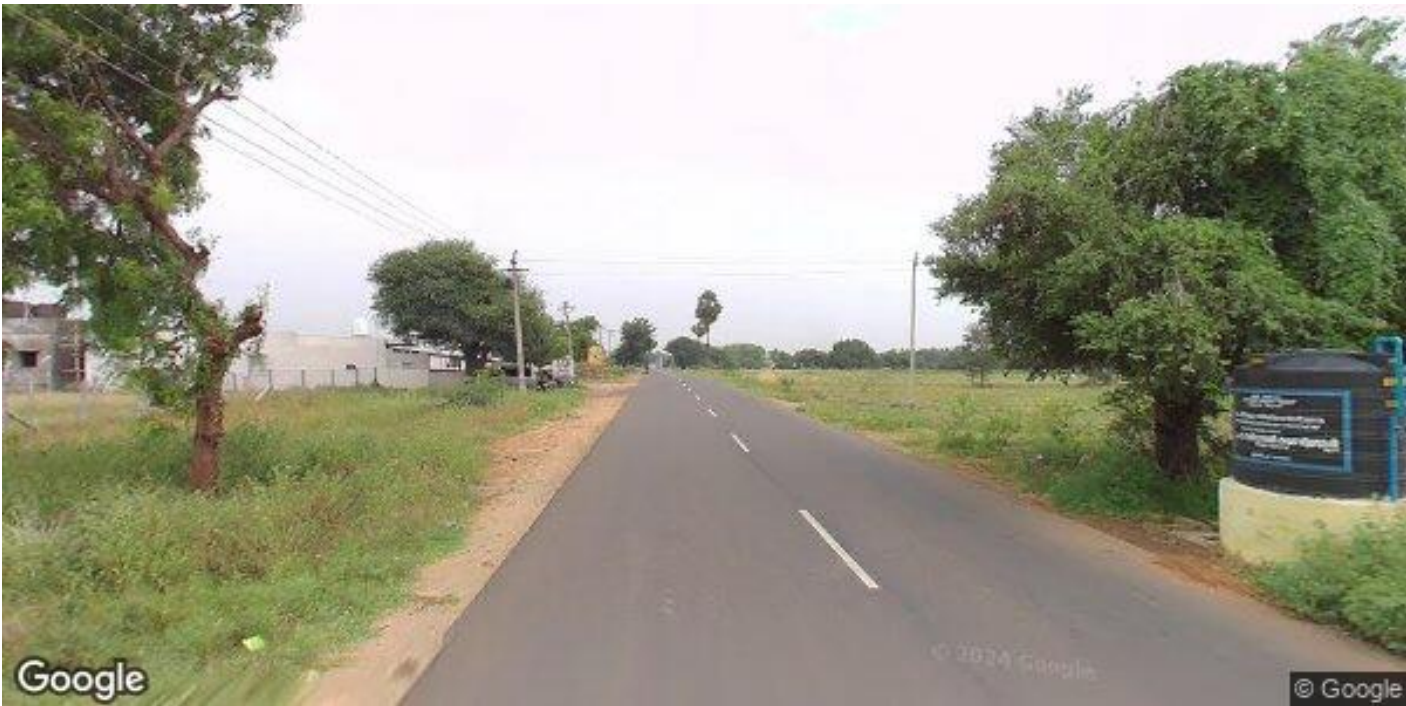
**Risk Type:** Blind Spot  
**Risk Level:** Blind Spot  
**Speed Limit:** 10 KM/Hr  
**Coordinates:** 10.85366, 78.16142
