# IndianOil

## JOURNEY RISK MANAGEMENT (JRM) STUDY

### Salem Terminal to SAMAYAVALLI ARUMUGAM PET.BUNK

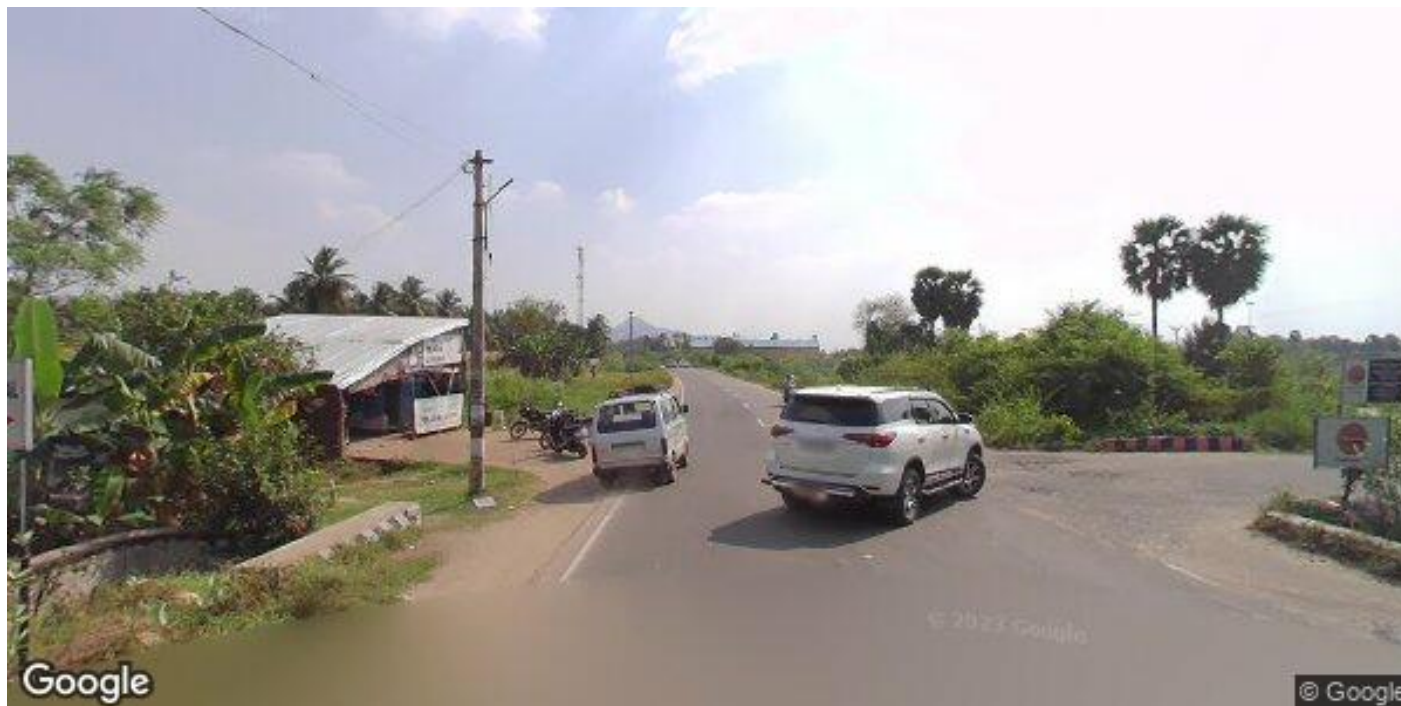
**Risk Type:** Turn  
**Risk Level:** High  
**Speed Limit:** 15 KM/Hr  
**Coordinates:** 11.44029, 77.87544

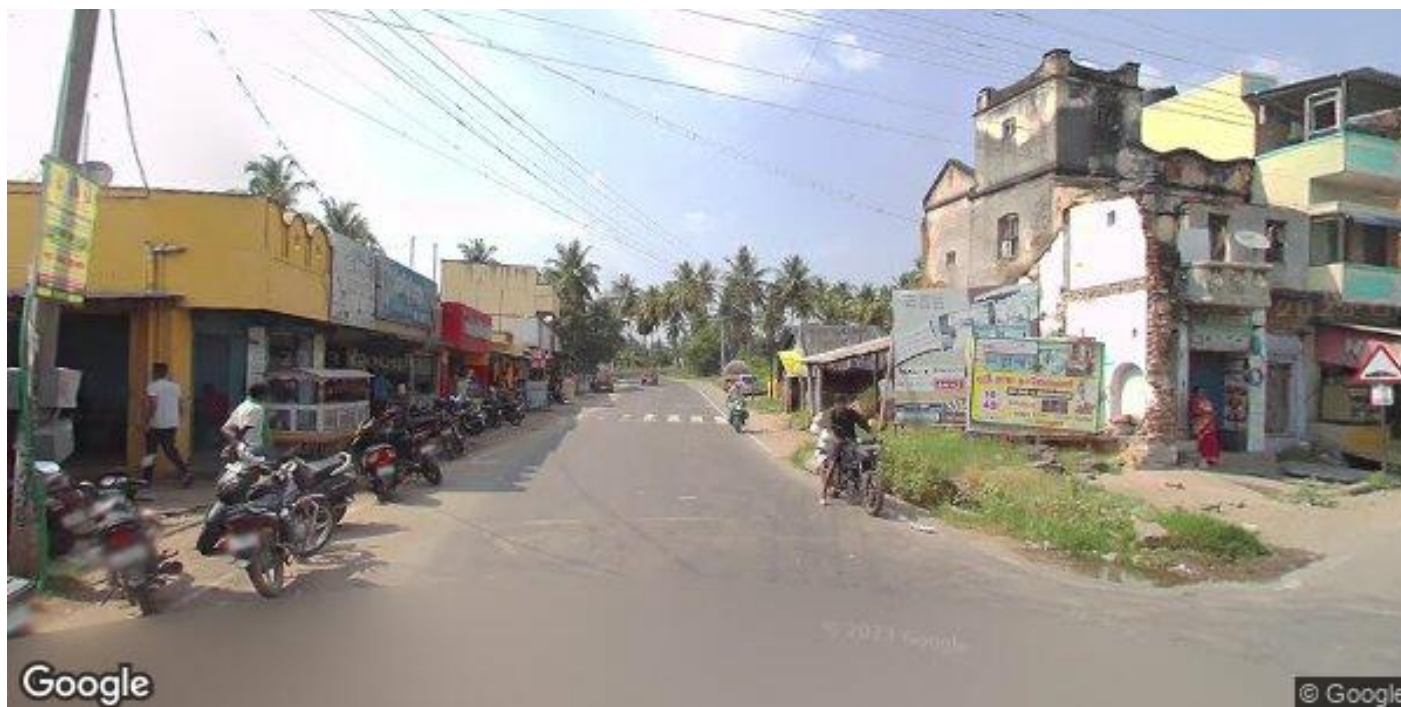
**Risk Type:** Turn  
**Risk Level:** High  
**Speed Limit:** 15 KM/Hr  
**Coordinates:** 11.45007, 77.87201

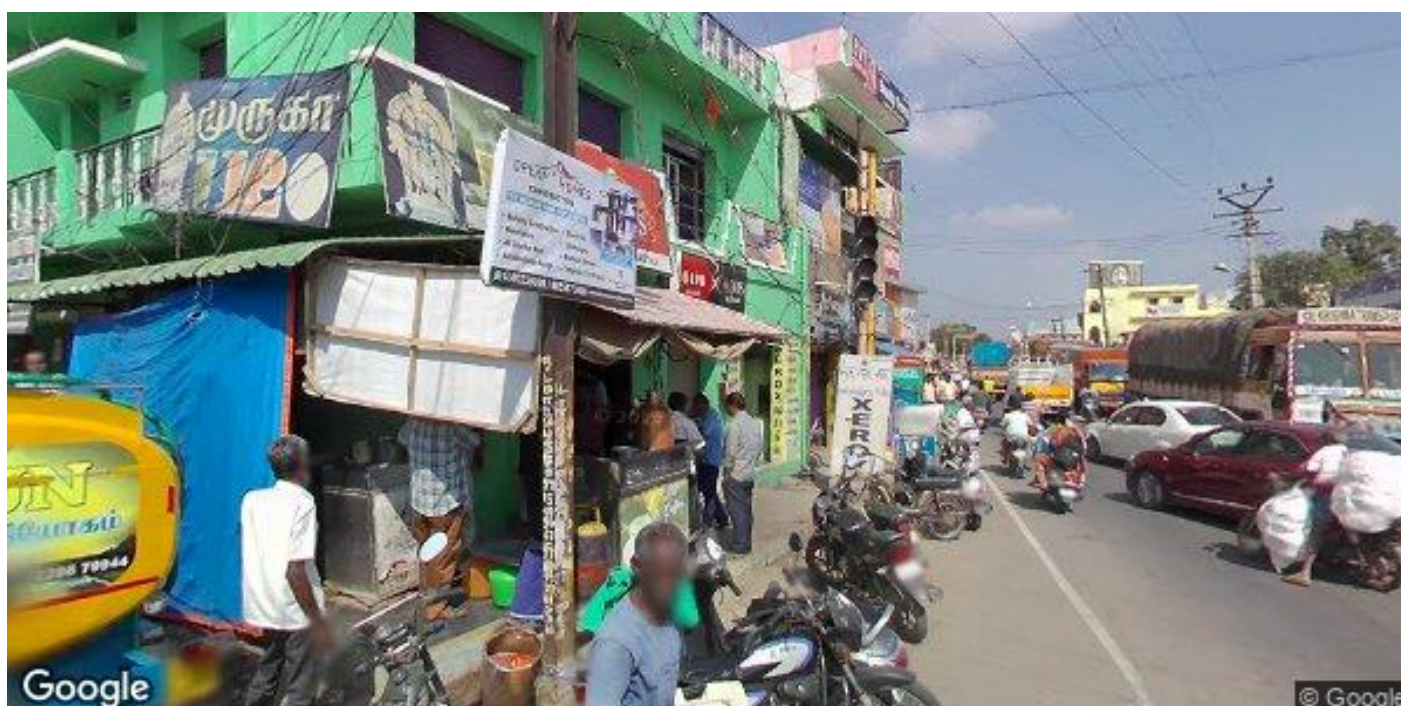
**Risk Type:** Turn  
**Risk Level:** High

**Speed Limit: 15 KM/Hr**  
**Coordinates: 11.47407, 77.86839**

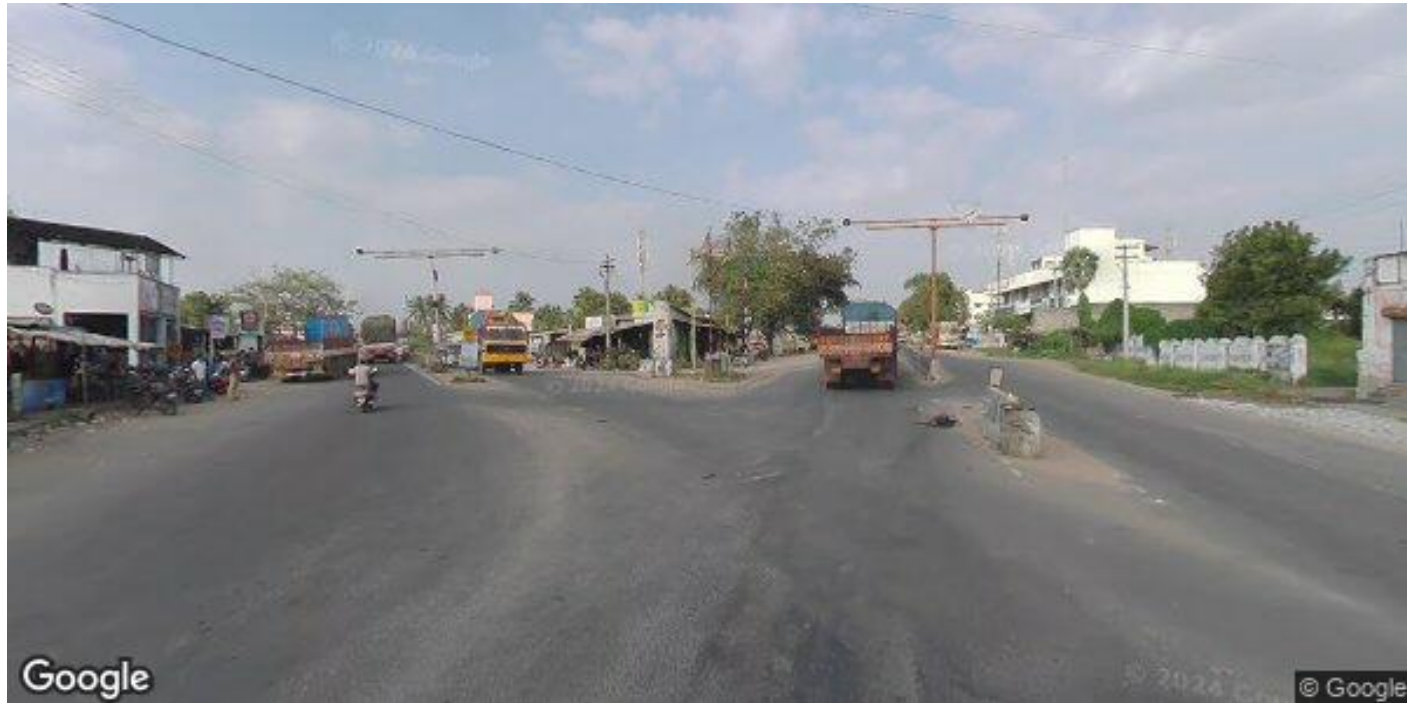
**Risk Type: Turn**  
**Risk Level: Medium**  
**Speed Limit: 30 KM/Hr**  
**Coordinates: 11.48366, 77.88781**

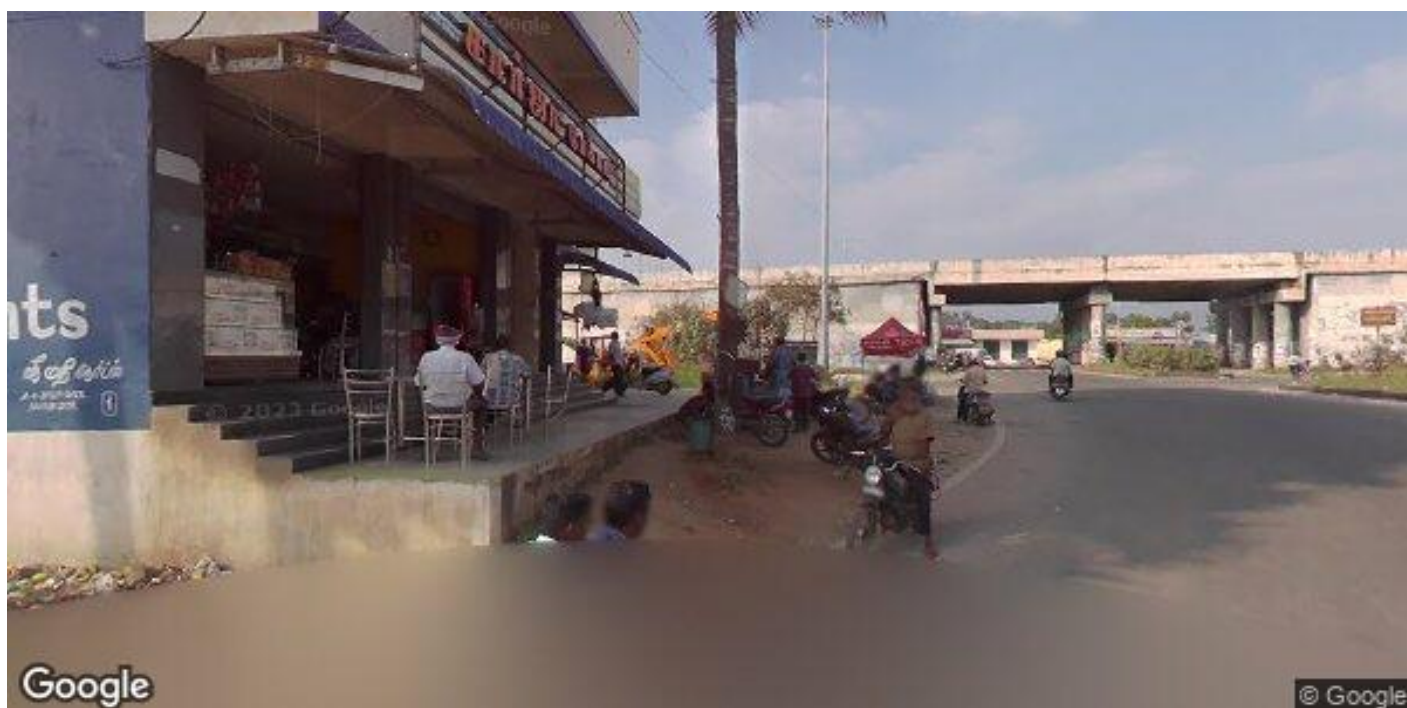
**Risk Type: Turn**  
**Risk Level: High**  
**Speed Limit: 15 KM/Hr**  
**Coordinates: 11.49149, 77.89601**

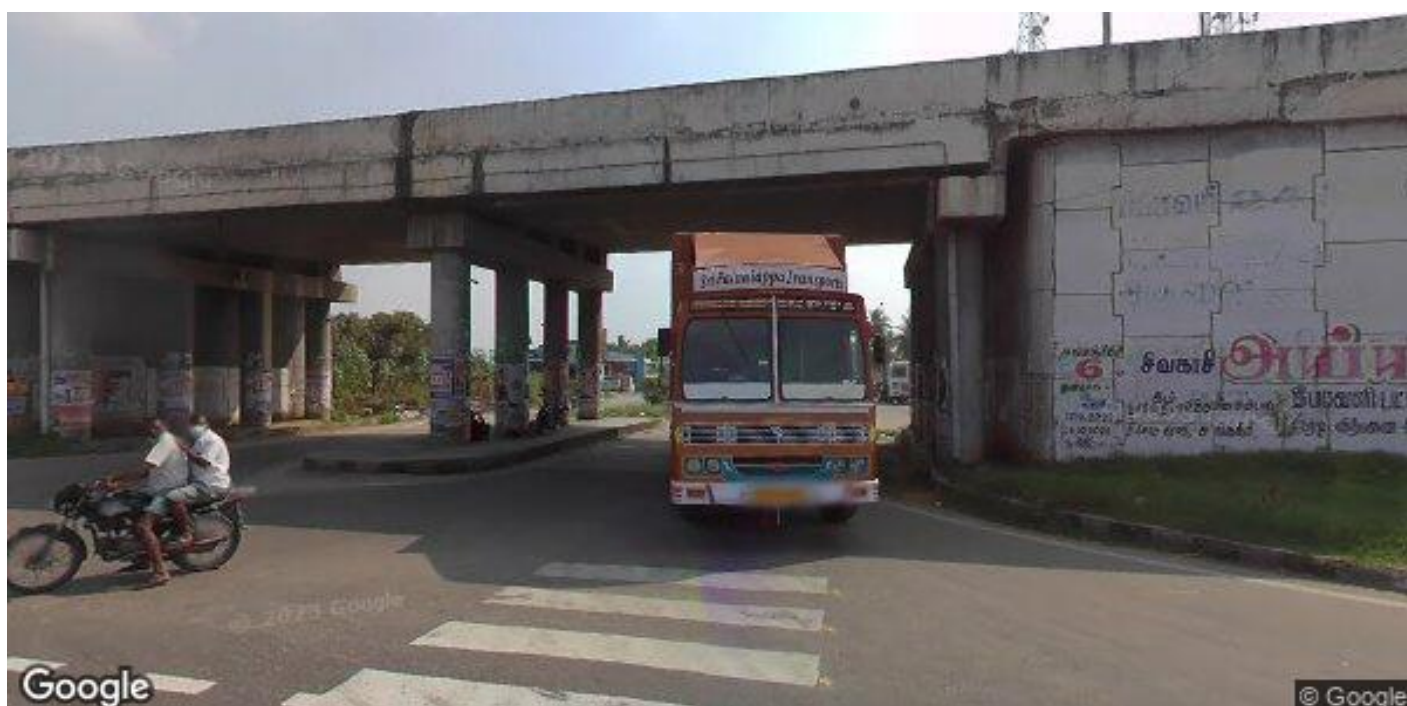
**Risk Type:** Turn  
**Risk Level:** High  
**Speed Limit:** 15 KM/Hr  
**Coordinates:** 11.49224, 77.89601

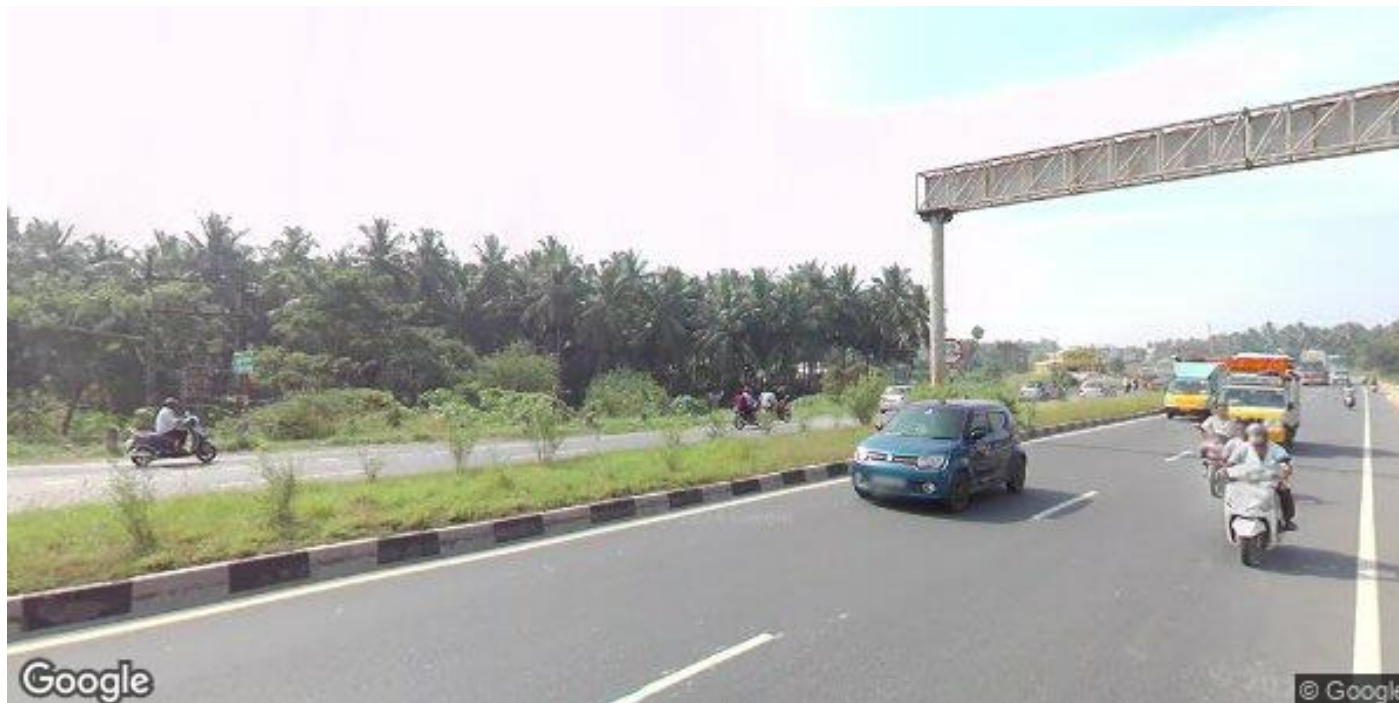
**Risk Type:** Turn  
**Risk Level:** Medium  
**Speed Limit:** 30 KM/Hr  
**Coordinates:** 11.60942, 78.10056

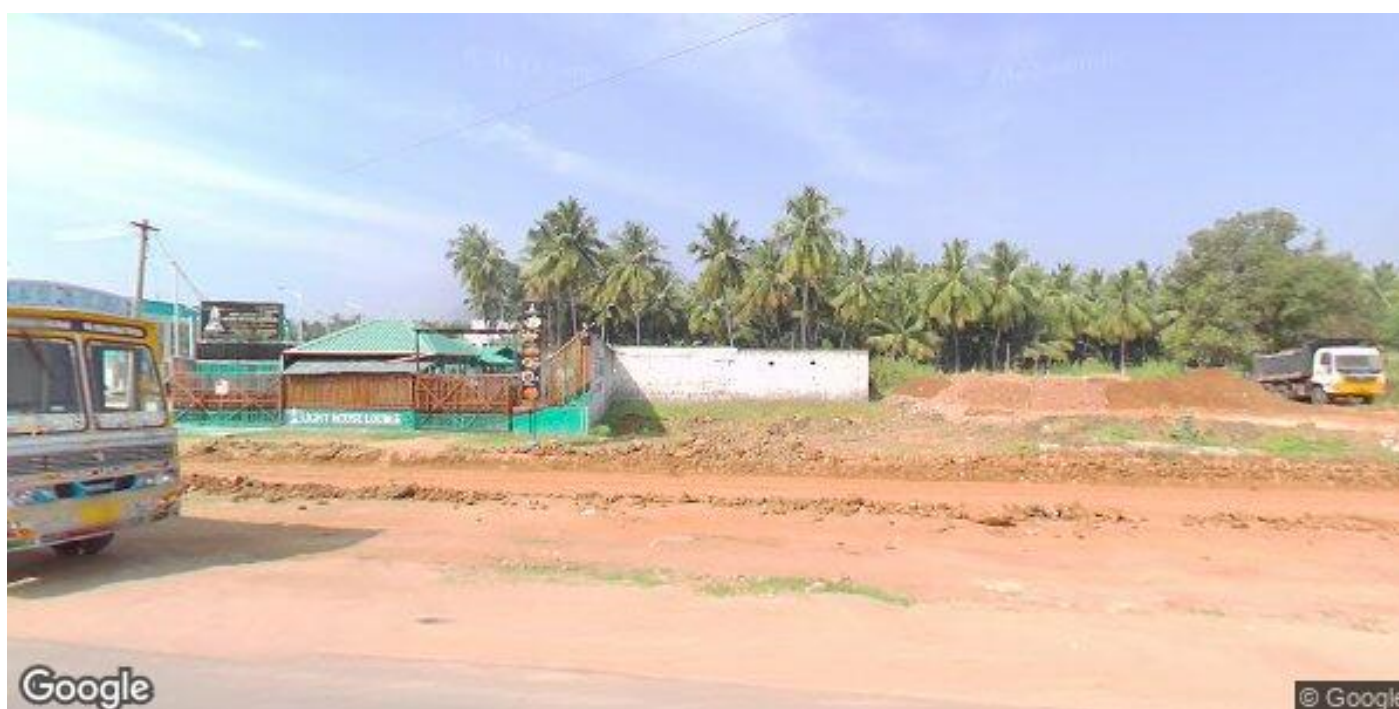
**Risk Type:** Turn  
**Risk Level:** Medium  
**Speed Limit:** 30 KM/Hr  
**Coordinates:** 11.61736, 78.10588

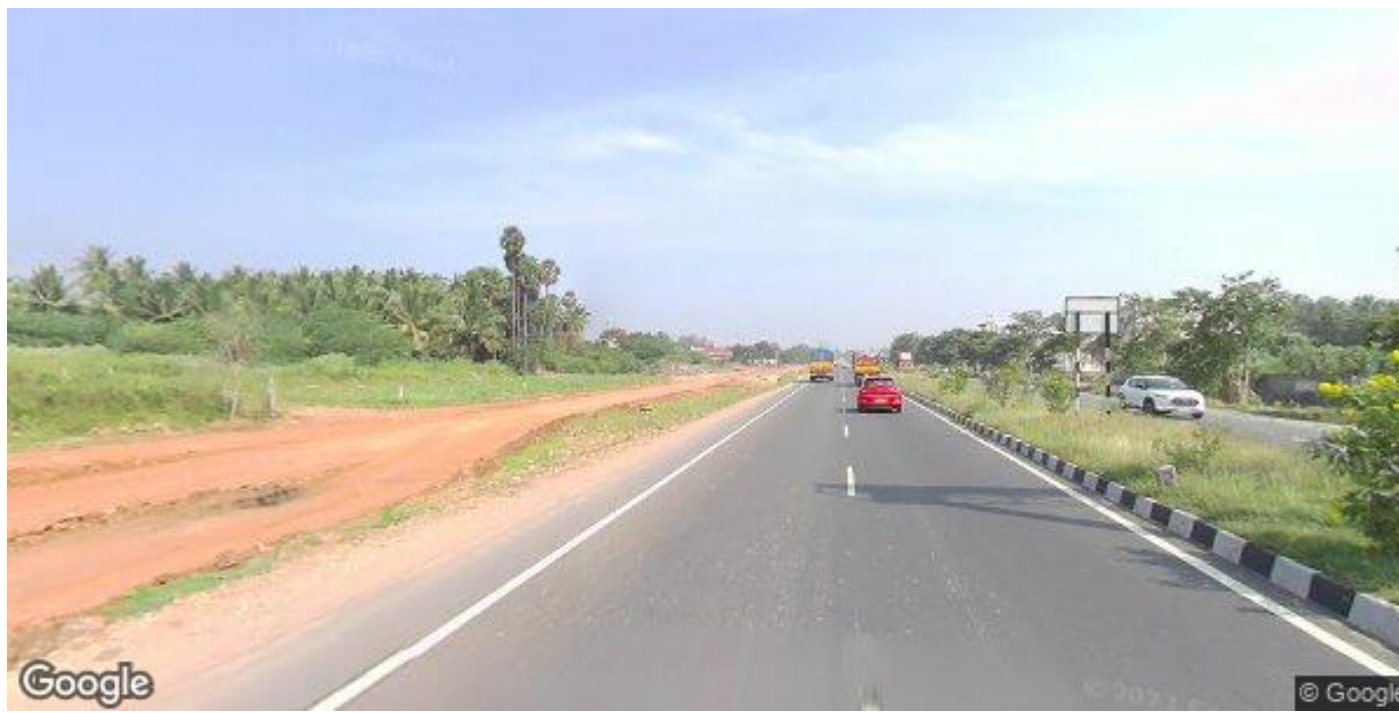
**Risk Type:** Turn  
**Risk Level:** Medium  
**Speed Limit:** 30 KM/Hr  
**Coordinates:** 11.61753, 78.10608

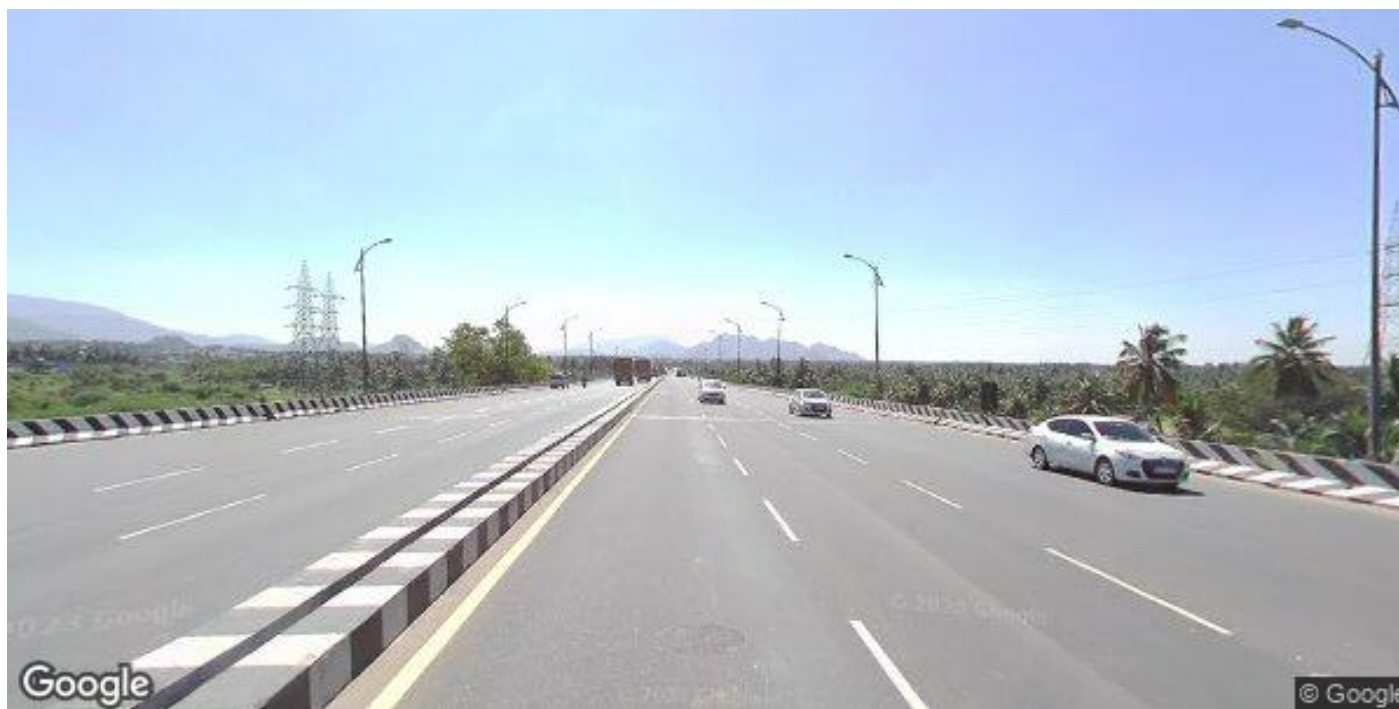
**Risk Type:** Turn  
**Risk Level:** Medium  
**Speed Limit:** 30 KM/Hr  
**Coordinates:** 11.64007, 78.11794

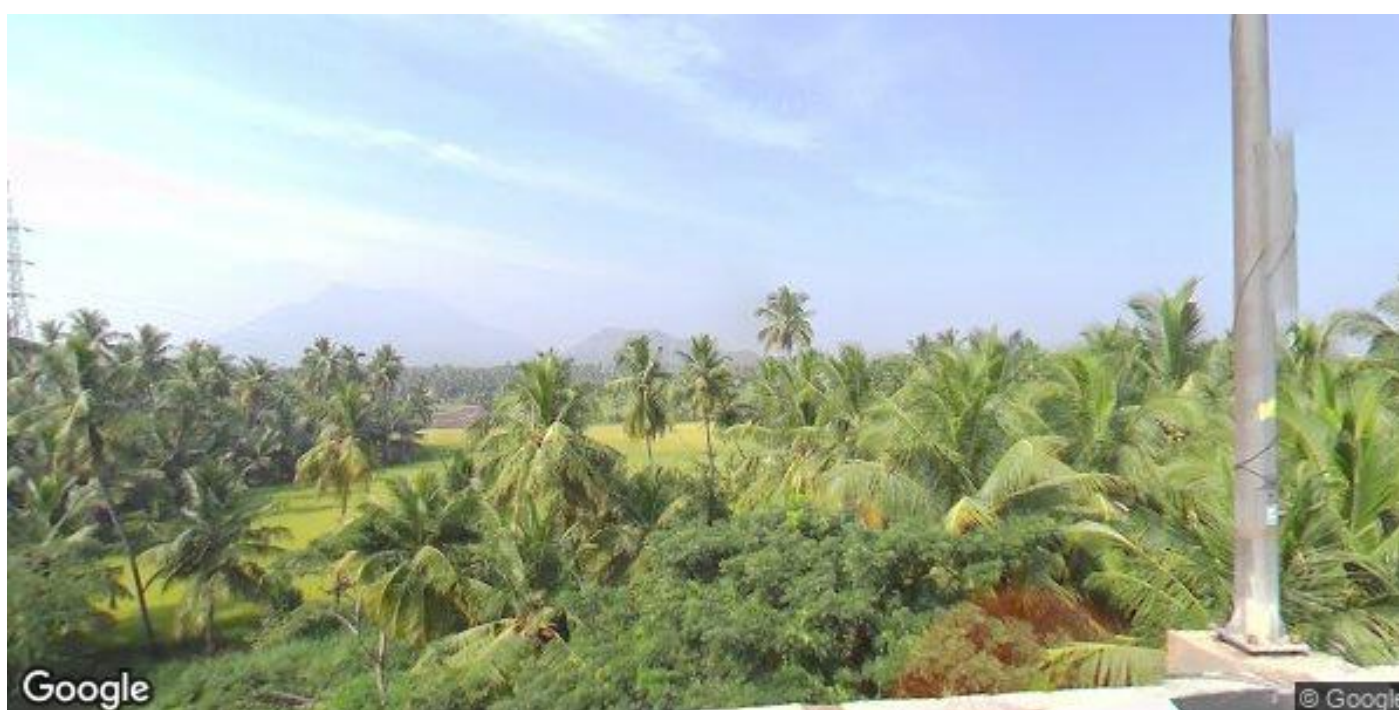
**Risk Type:** Turn  
**Risk Level:** Medium  
**Speed Limit:** 30 KM/Hr  
**Coordinates:** 11.64020, 78.11786

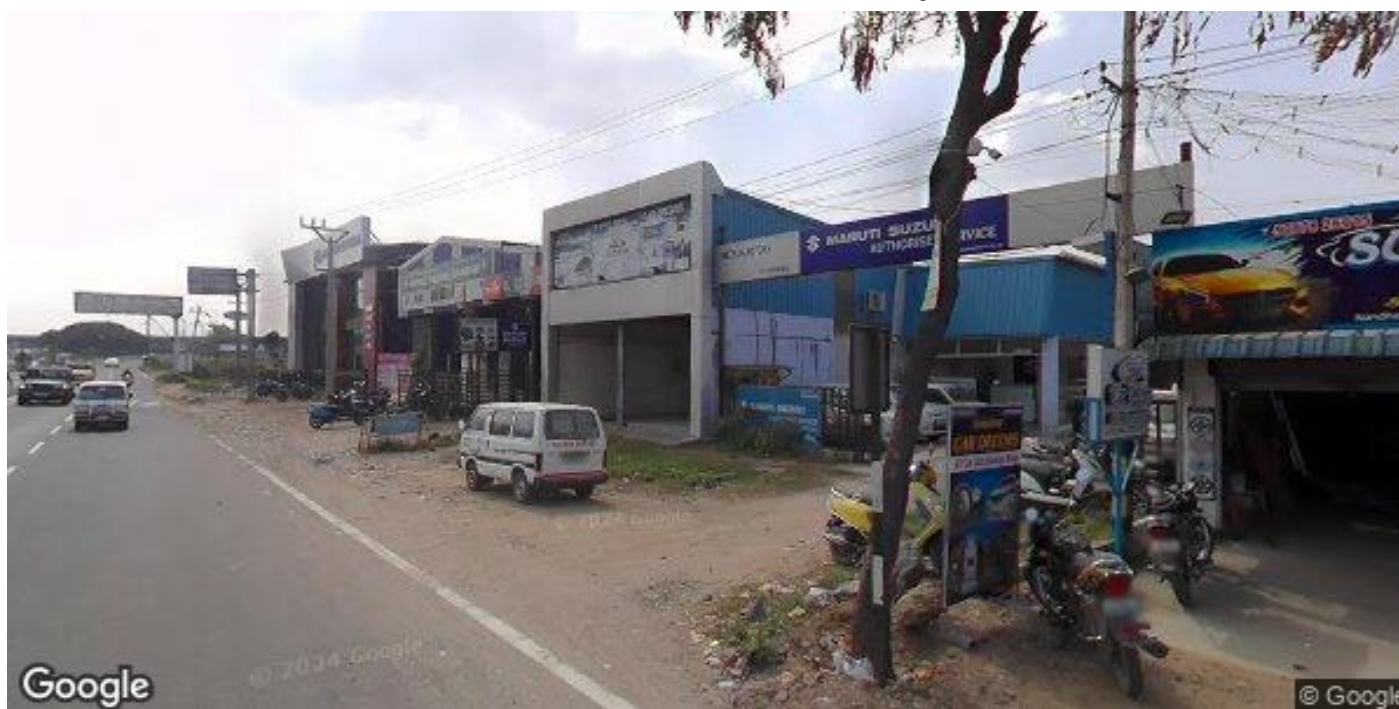
**Risk Type:** Turn  
**Risk Level:** Medium  
**Speed Limit:** 30 KM/Hr  
**Coordinates:** 11.64497, 78.12028

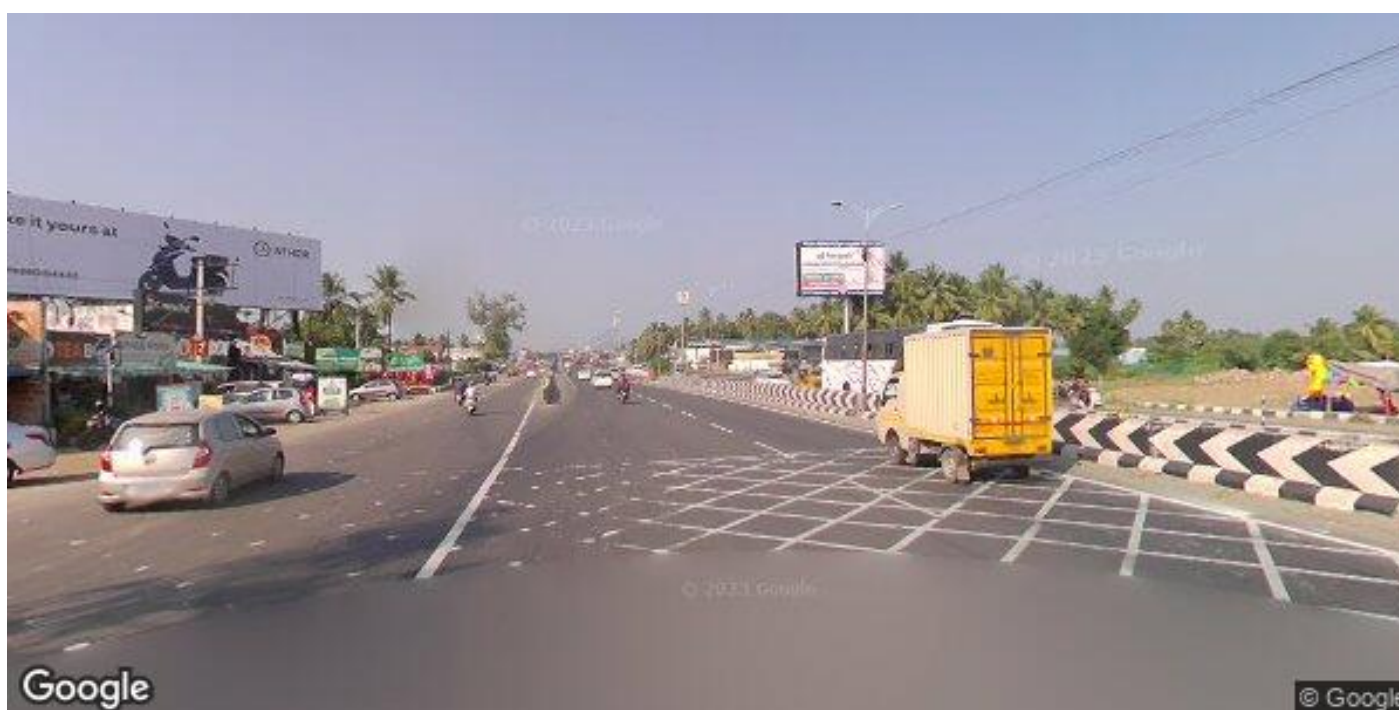
**Risk Type:** Turn  
**Risk Level:** High  
**Speed Limit:** 15 KM/Hr  
**Coordinates:** 11.64503, 78.12034

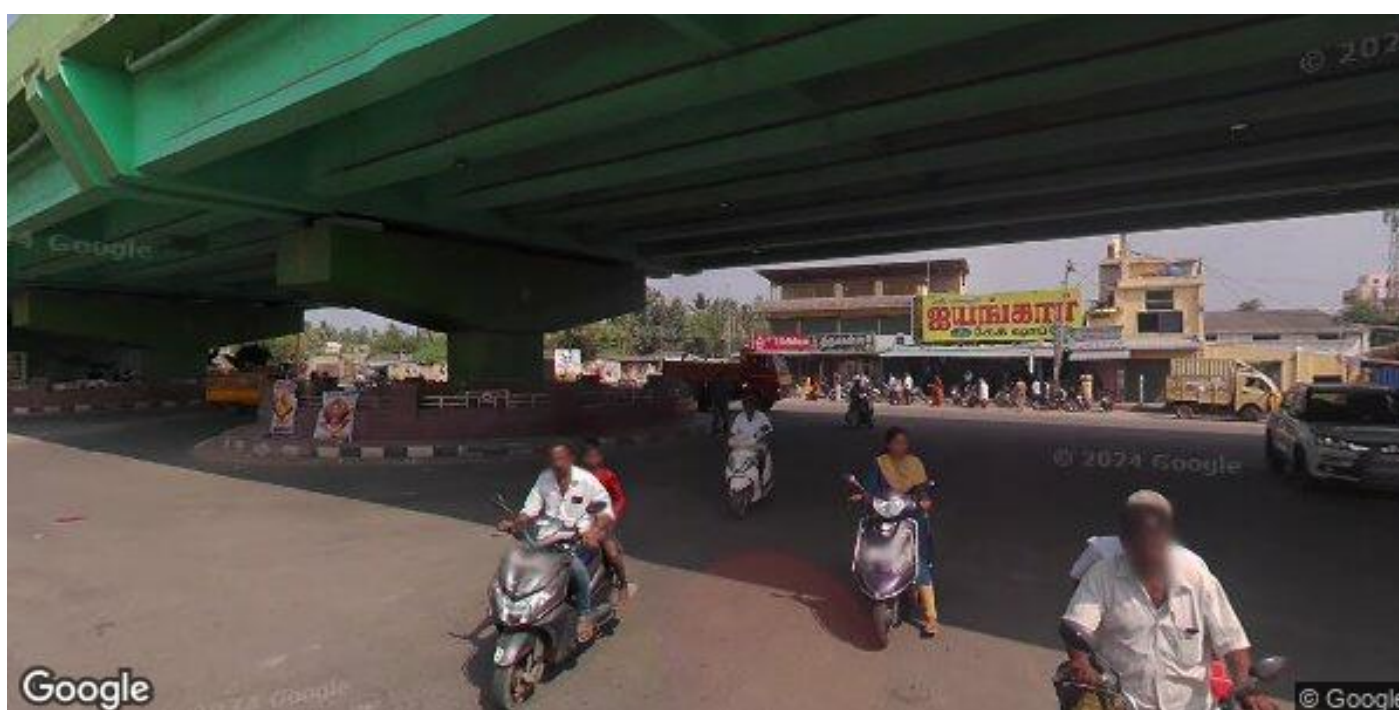
**Risk Type:** Blind Spot  
**Risk Level:** Blind Spot  
**Speed Limit:** 10 KM/Hr  
**Coordinates:** 11.64952, 78.12062
