# IndianOil

## JOURNEY RISK MANAGEMENT (JRM) STUDY

### Salem Terminal to SRI ANDAVAR FUELS

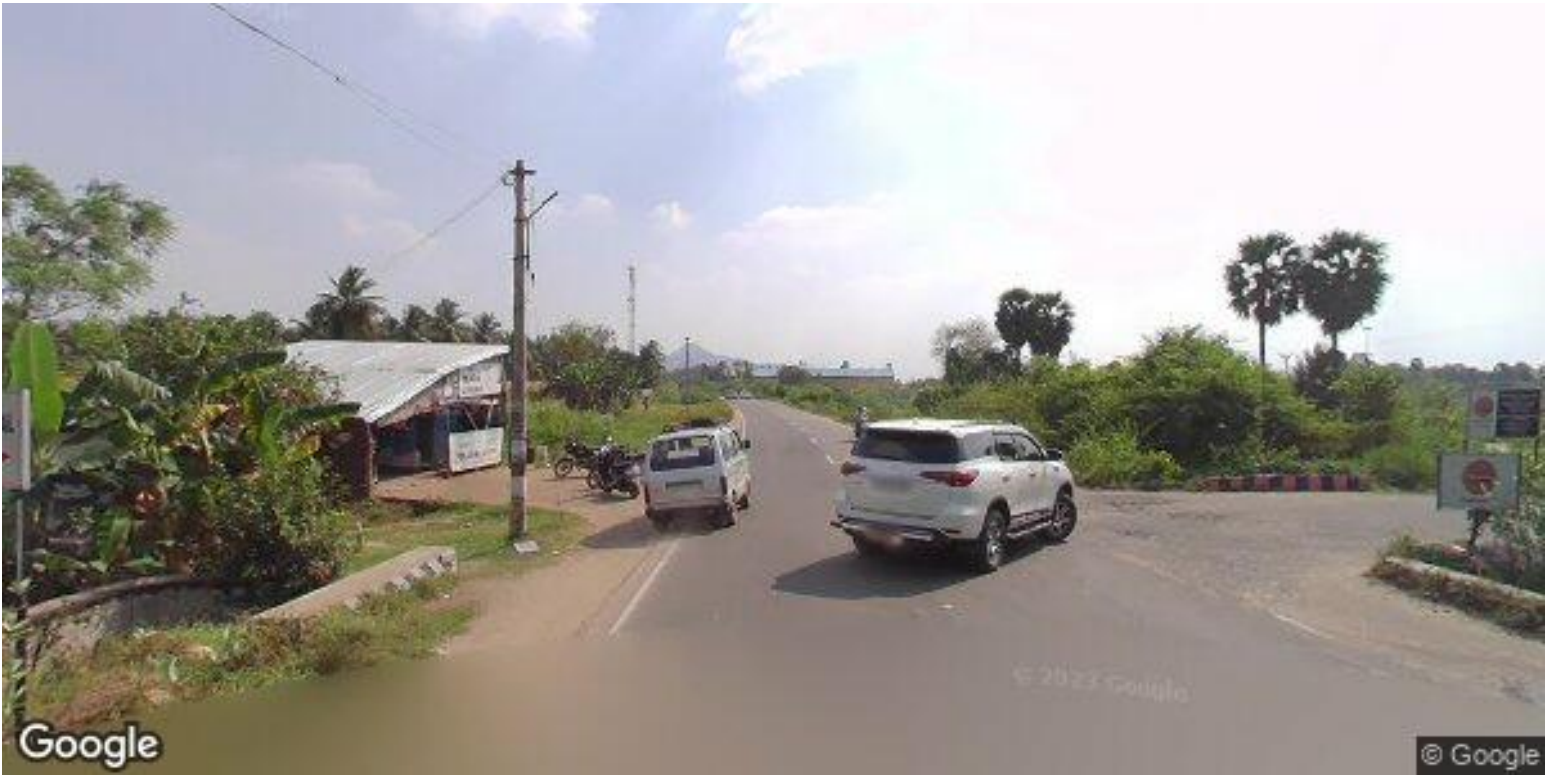
Coordinates: 11.44029, 77.87544

Risk Type: Turn

Risk Level: High

Speed Limit: 15 KM/Hr

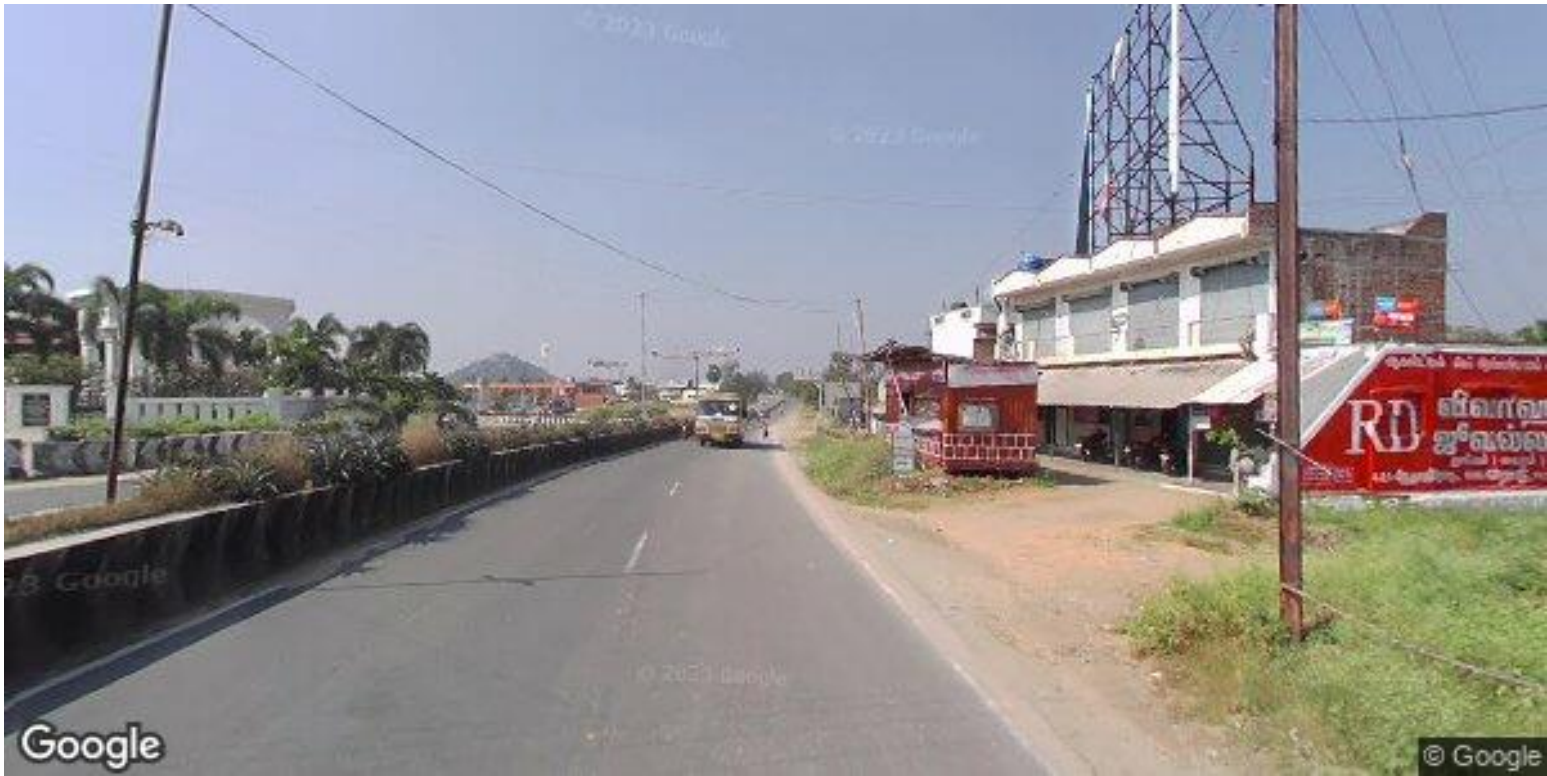
**Risk Type:** Blind Spot  
**Risk Level:** Blind Spot  
**Speed Limit:** 10 KM/Hr  
**Coordinates:** 11.46330, 77.84929

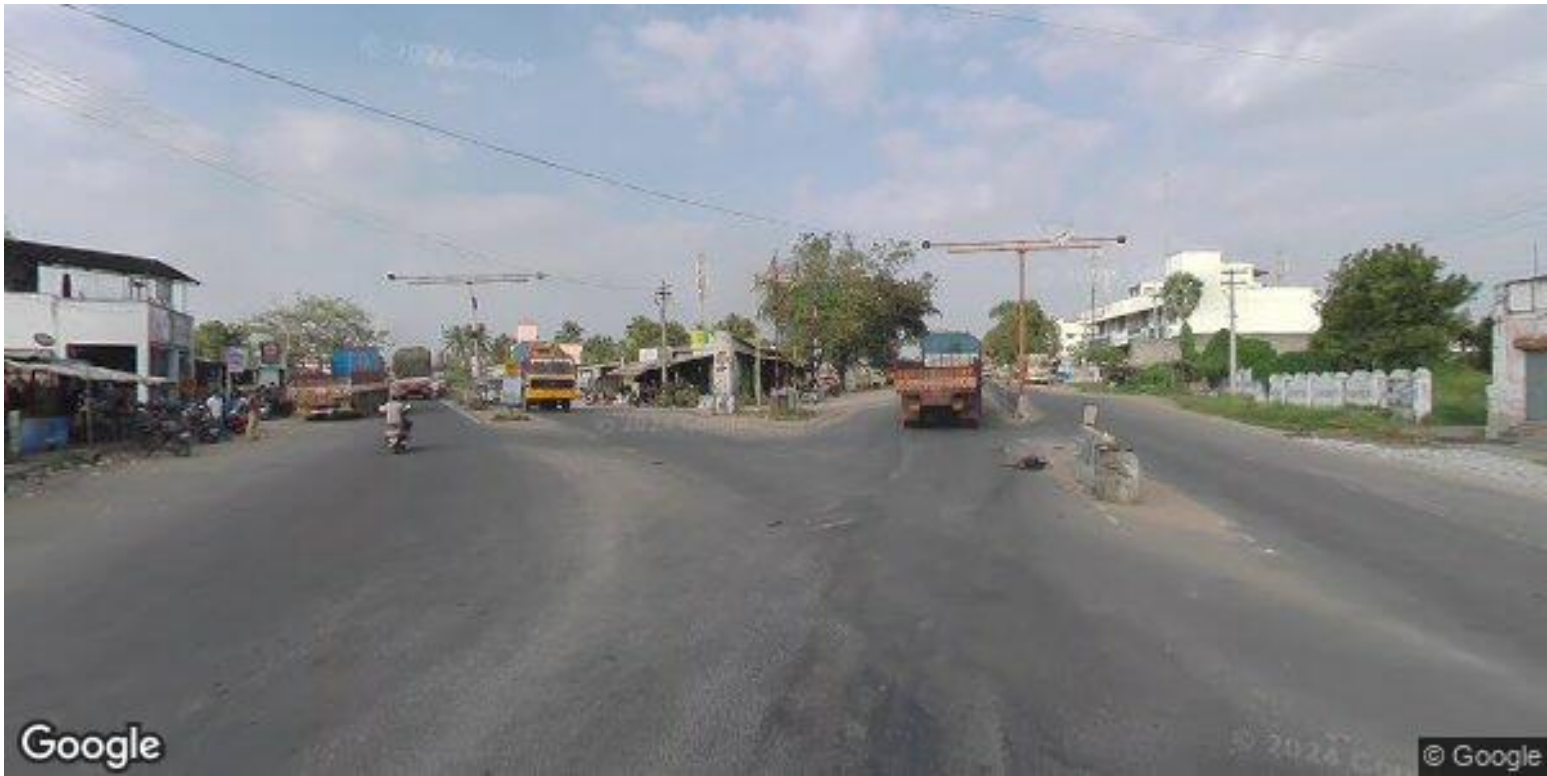
**Risk Type:** Turn  
**Risk Level:** Medium  
**Speed Limit:** 30 KM/Hr  
**Coordinates:** 11.48366, 77.88781

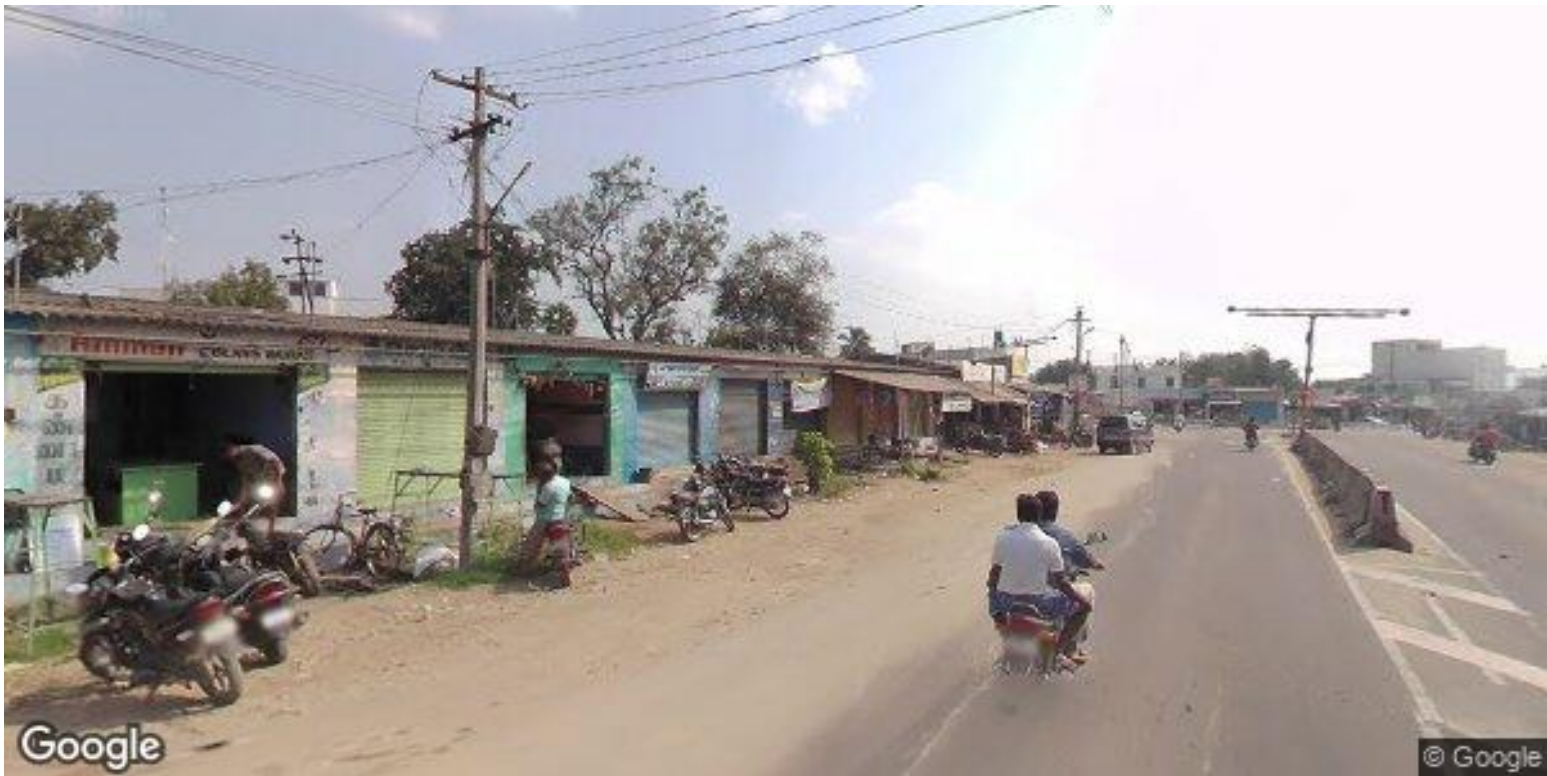
**Coordinates:** 11.48446, 77.88787

**Risk Type:** Turn

**Risk Level:** Medium

**Speed Limit:** 30 KM/Hr
