## **JOURNEY RISK MANAGEMENT (JRM) STUDY**

### **Salem Terminal To SRI ALMP AGENCIES**

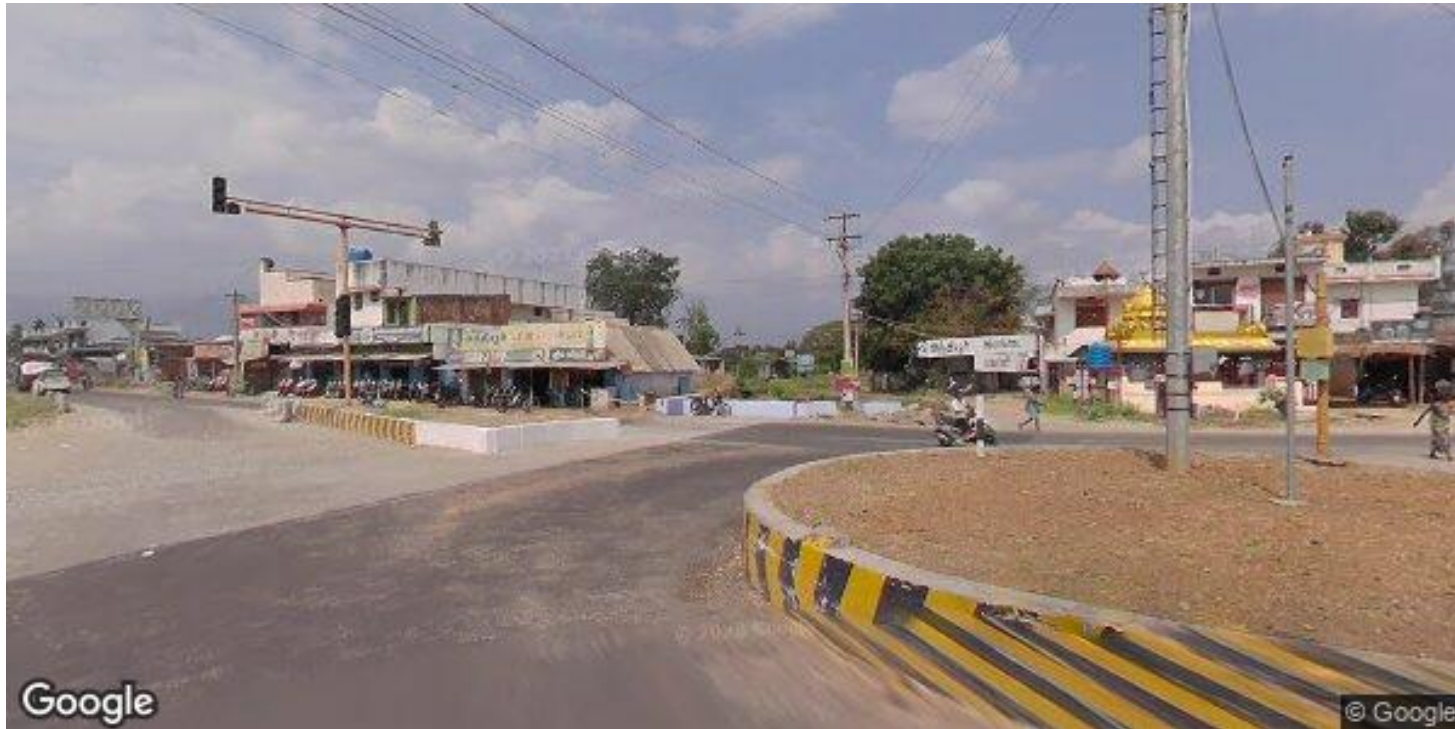
**Coordinates:** 11.56355, 77.59597

**Risk Type:** Roundabout

**Risk Level:** High

**Speed Limit:** 15 KM/Hr

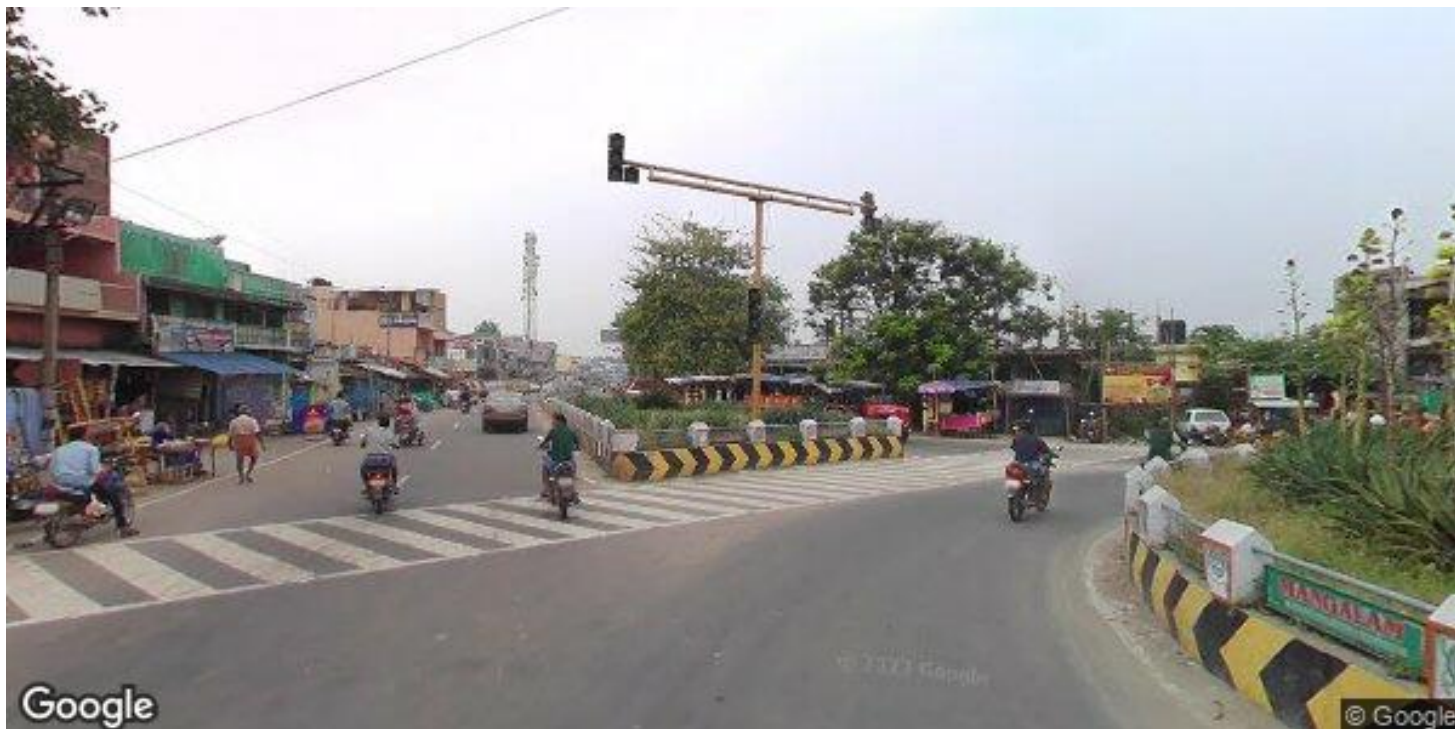
**Coordinates:** 11.57607, 77.58841

**Risk Type:** Roundabout

**Risk Level:** High

**Speed Limit:** 15 KM/Hr

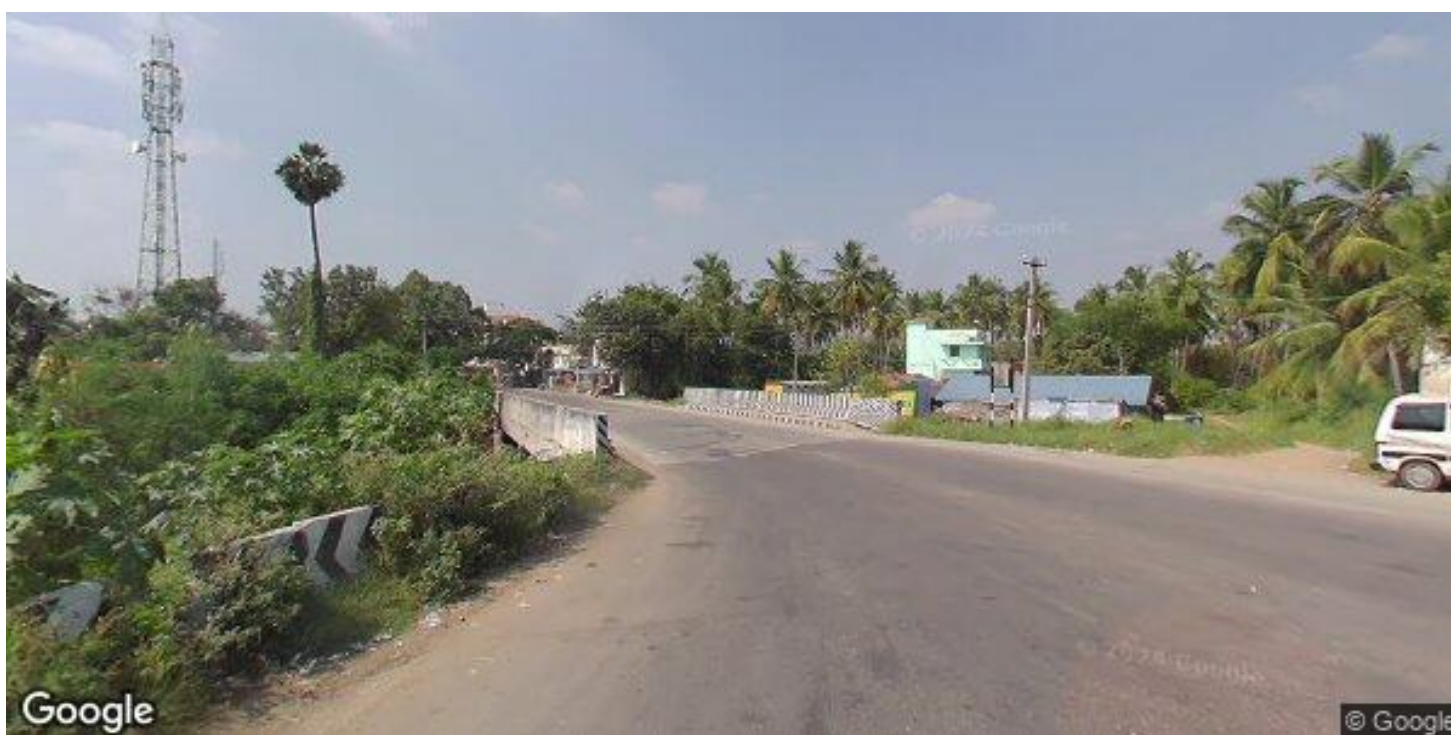
**Risk Type:** Turn  
**Risk Level:** Medium  
**Speed Limit:** 30 KM/Hr  
**Coordinates:** 11.44893, 77.87413

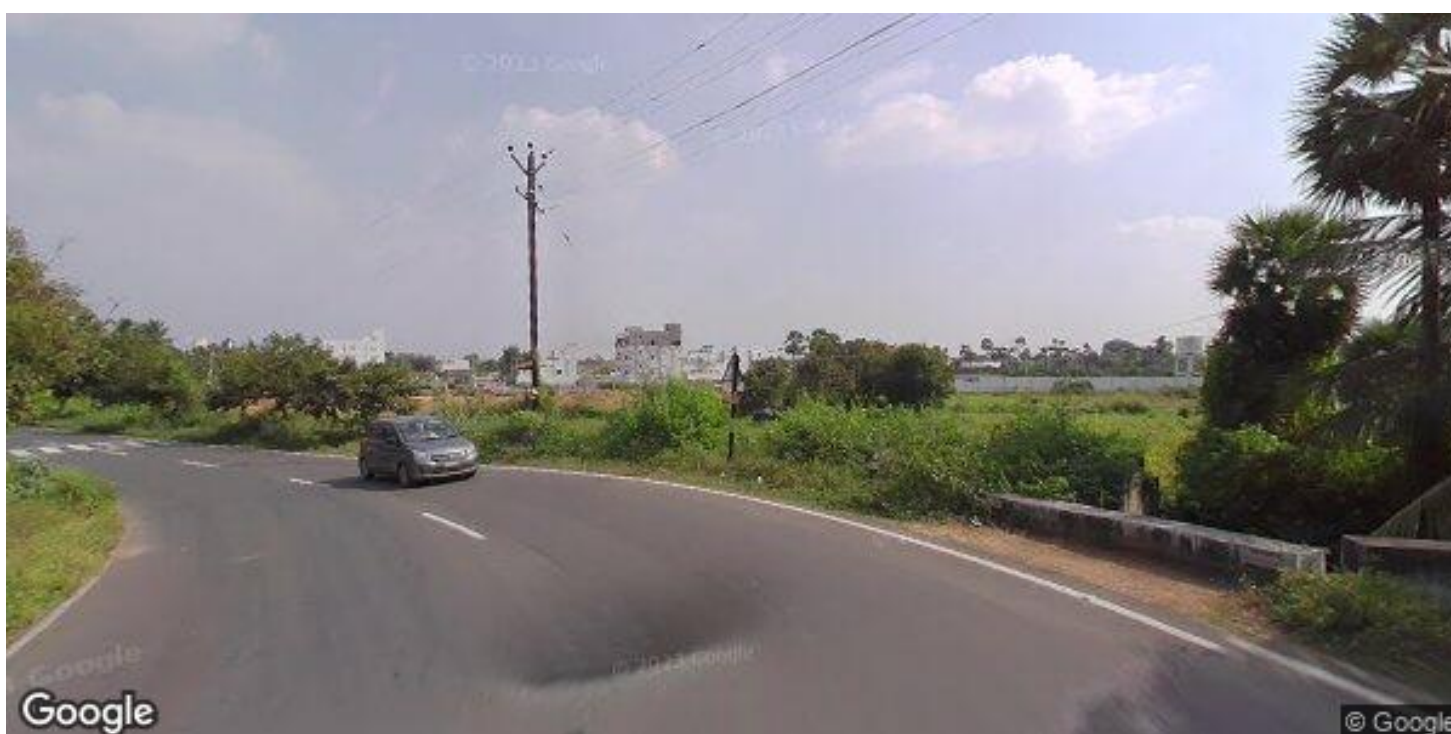
**Coordinates: 11.45350, 77.85700**

**Risk Type:** Turn  
**Risk Level:** High

**Speed Limit: 15 KM/Hr**

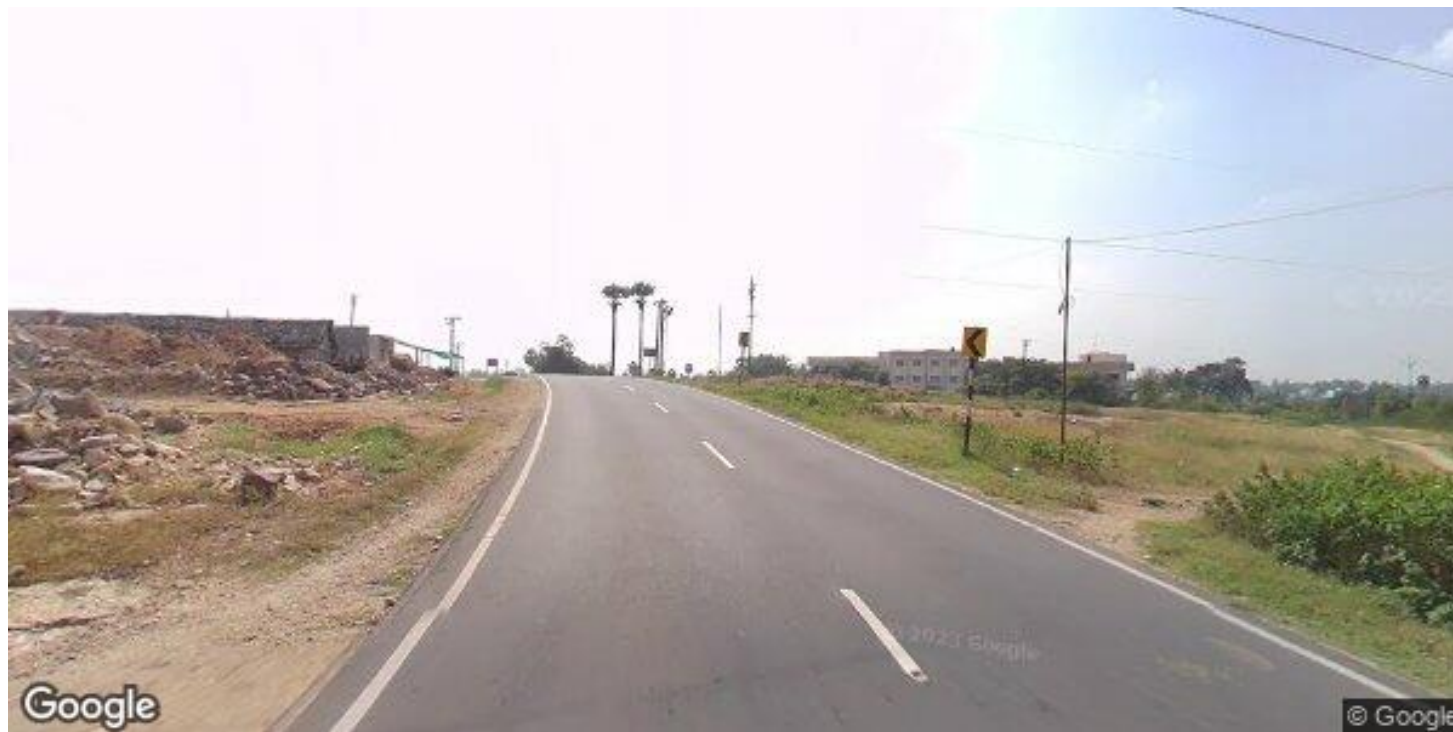
**Coordinates: 11.46046, 77.85037**

**Risk Type: Turn**

**Risk Level: Medium**

**Speed Limit: 30 KM/Hr**

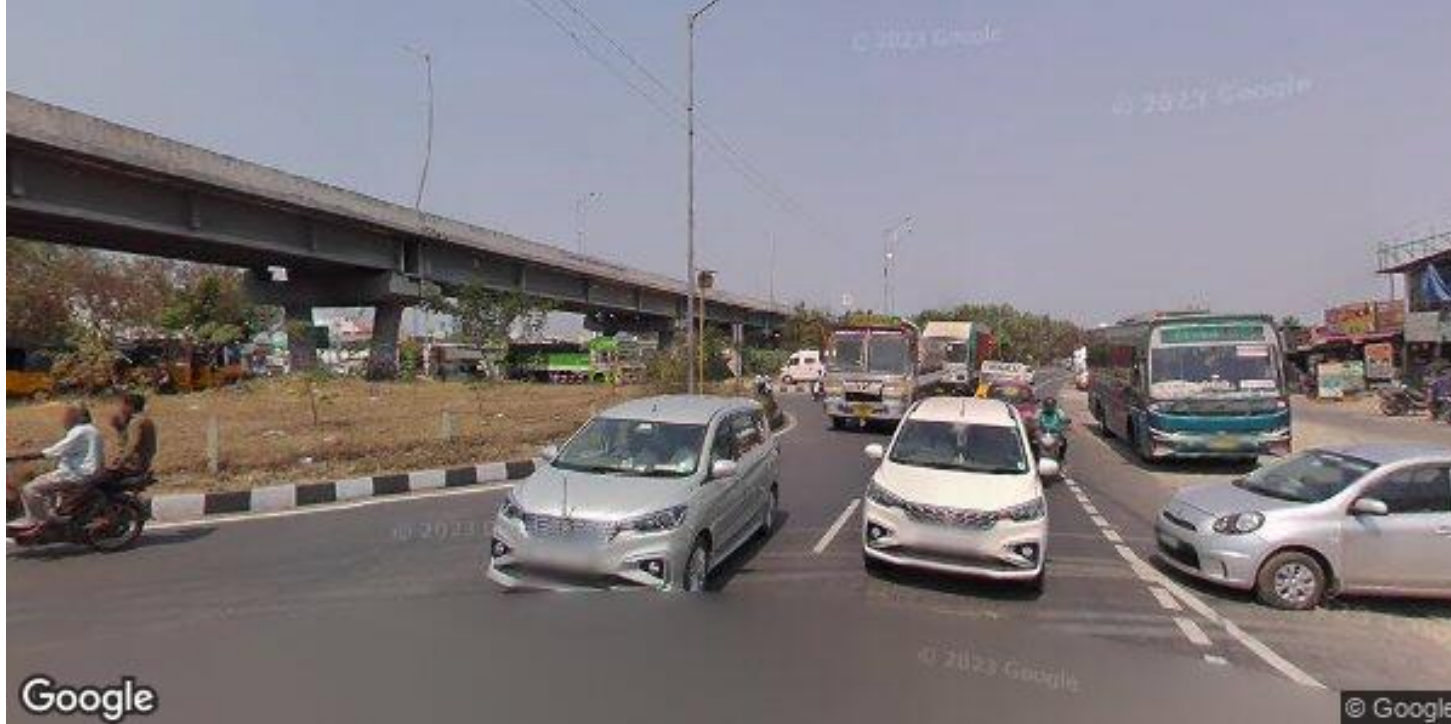
**Coordinates:** 11.43001, 77.67575

**Risk Type:** Turn

**Risk Level:** High

**Speed Limit:** 15 KM/Hr

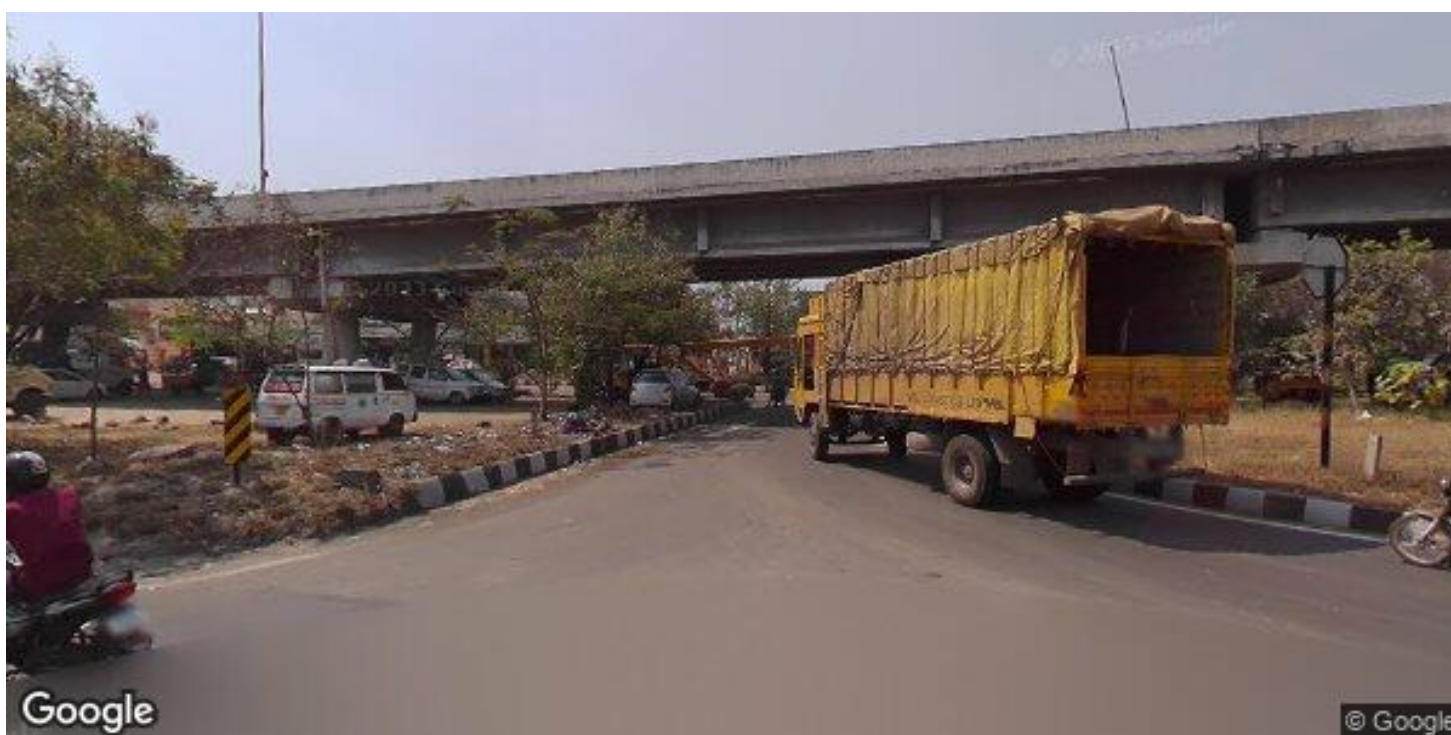
**Coordinates:** 11.43000, 77.67564

**Risk Type:** Turn

**Risk Level:** Medium

**Speed Limit:** 30 KM/Hr

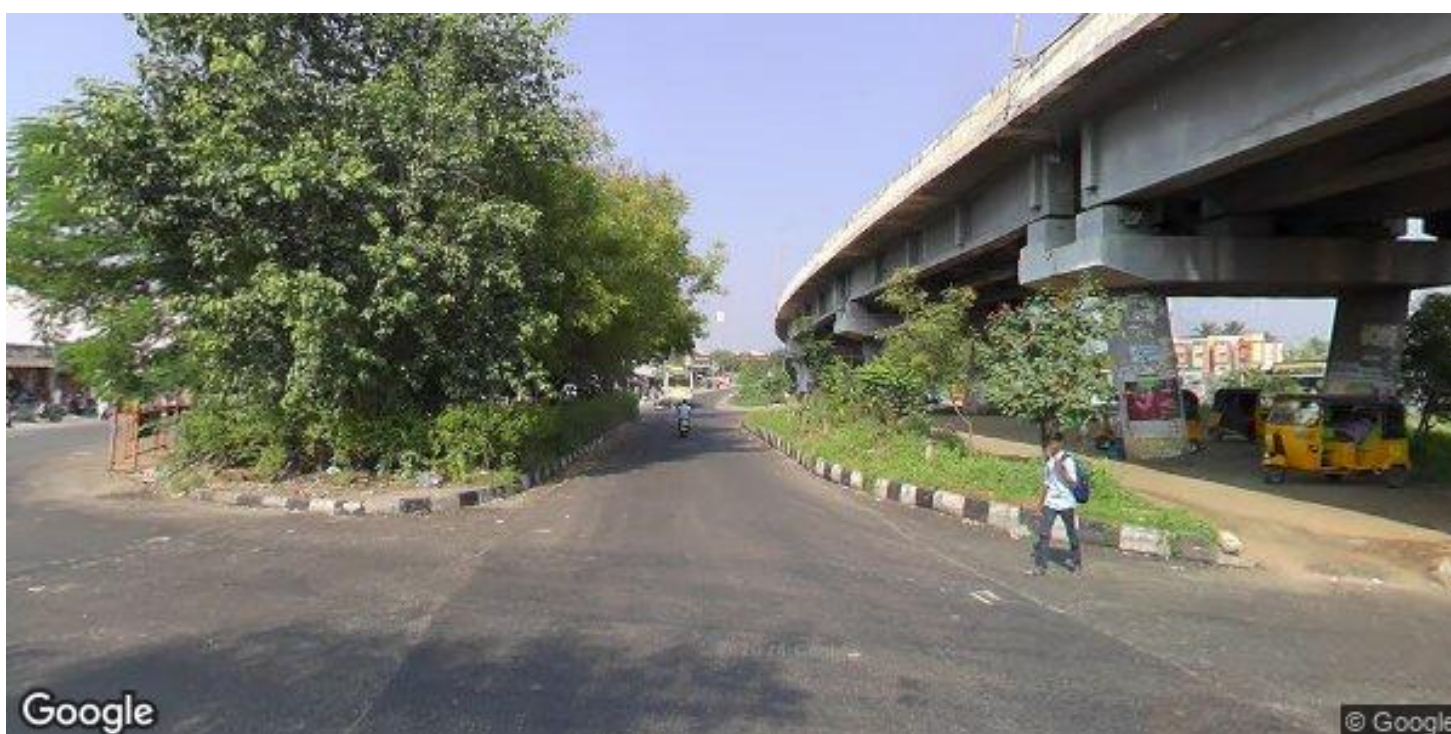
**Coordinates: 11.43009, 77.67540**

**Risk Type:** Turn

**Risk Level:** Medium

**Speed Limit: 30 KM/Hr**

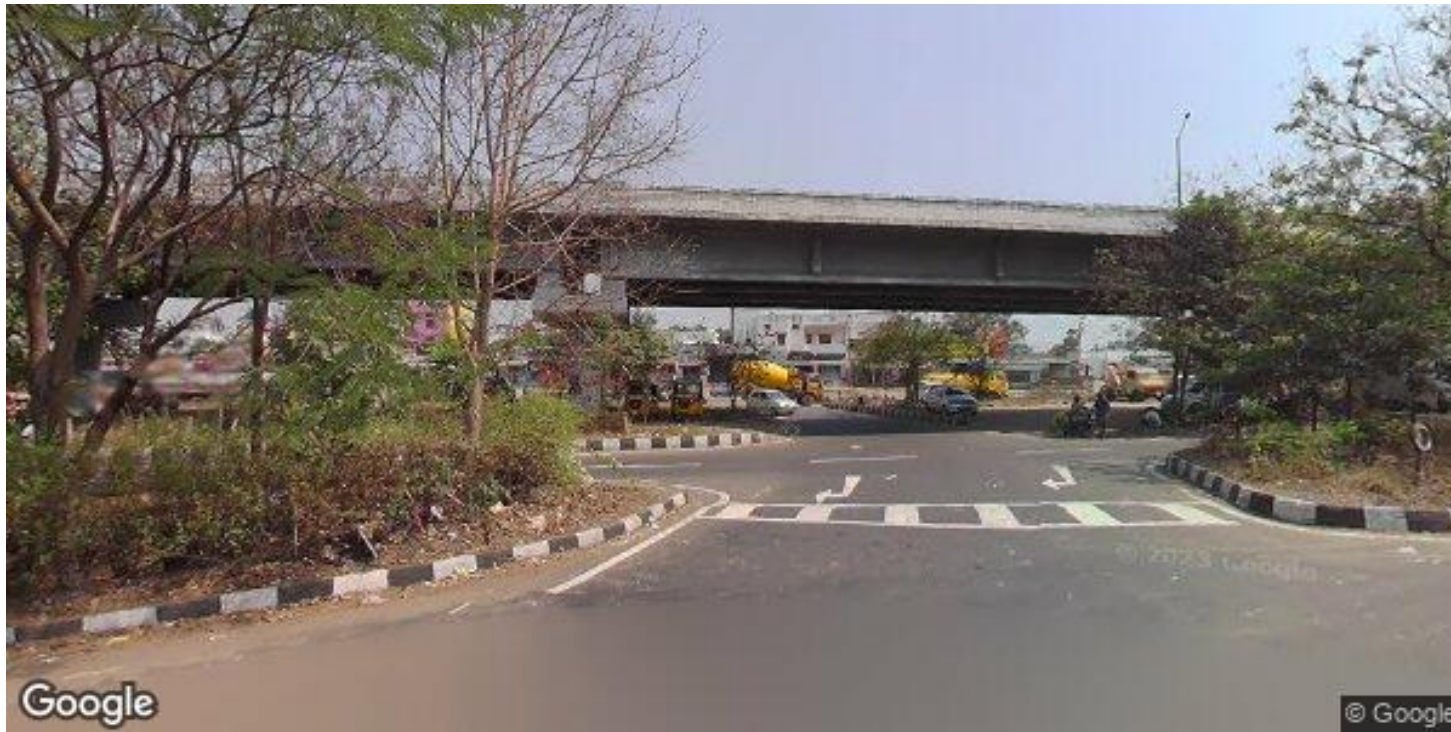
**Coordinates: 11.43026, 77.67525**

**Risk Type: Turn**

**Risk Level: High**

**Speed Limit: 15 KM/Hr**

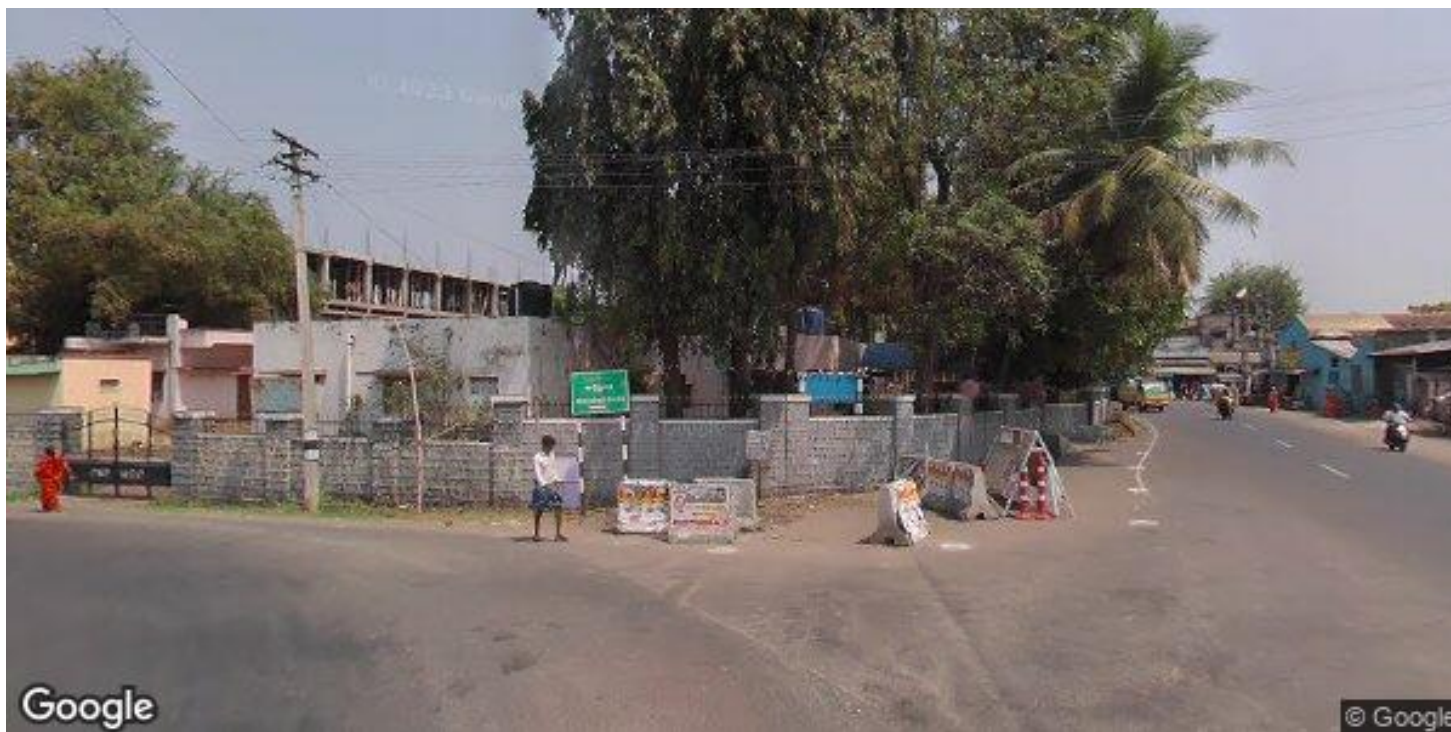
**Coordinates: 11.43864, 77.68225**

**Risk Type: Turn**

**Risk Level: High**

**Speed Limit: 15 KM/Hr**

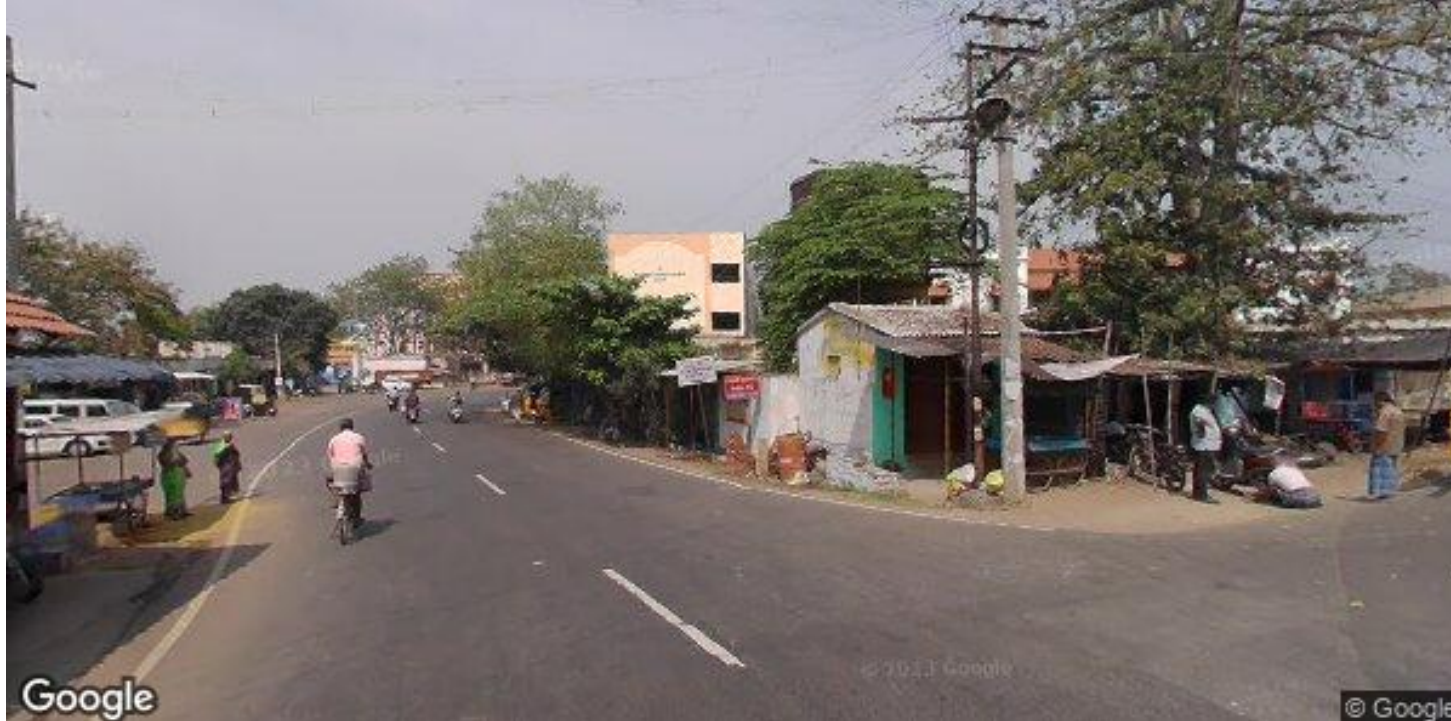
**Coordinates:** 11.43965, 77.68224

**Risk Type:** Turn

**Risk Level:** Medium

**Speed Limit:** 30 KM/Hr

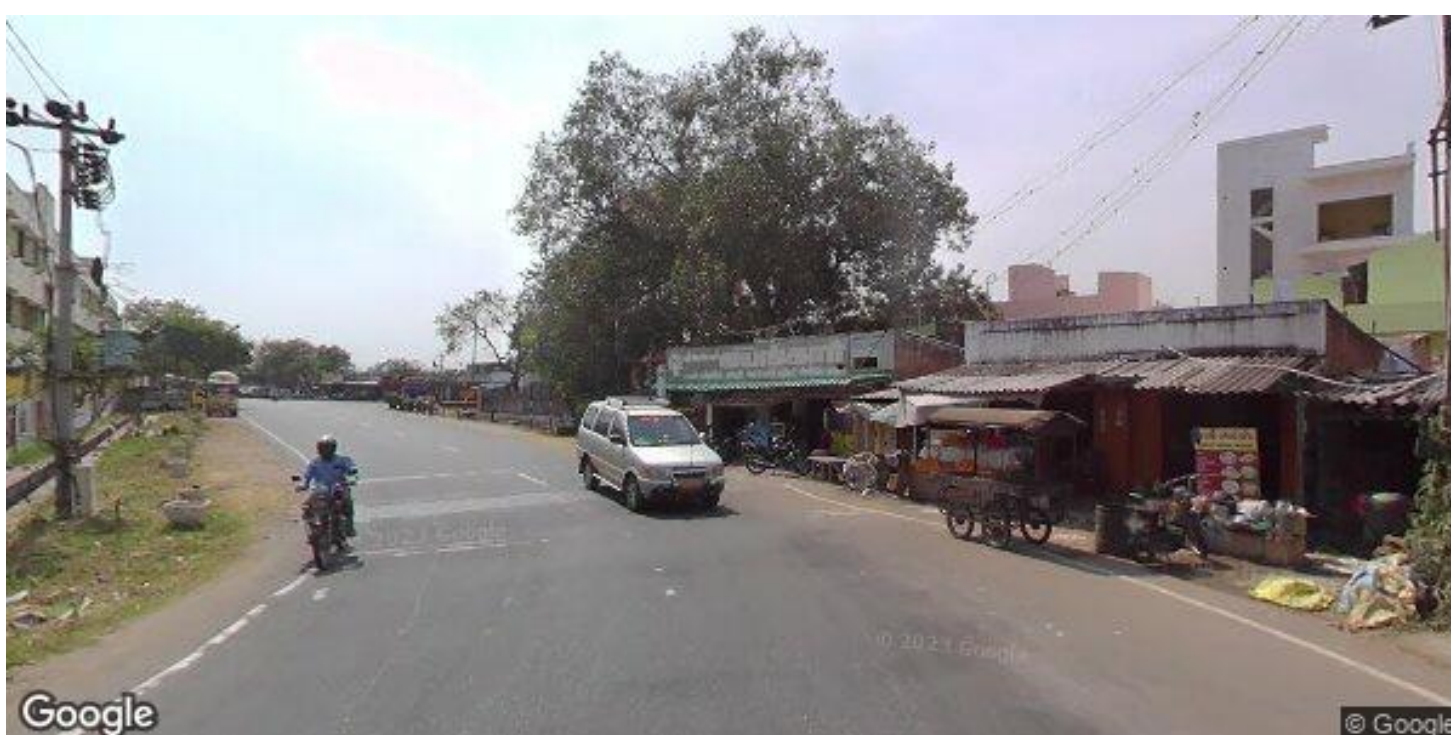
**Coordinates:** 11.44105, 77.68188

**Risk Type:** Turn

**Risk Level:** High

**Speed Limit:** 15 KM/Hr

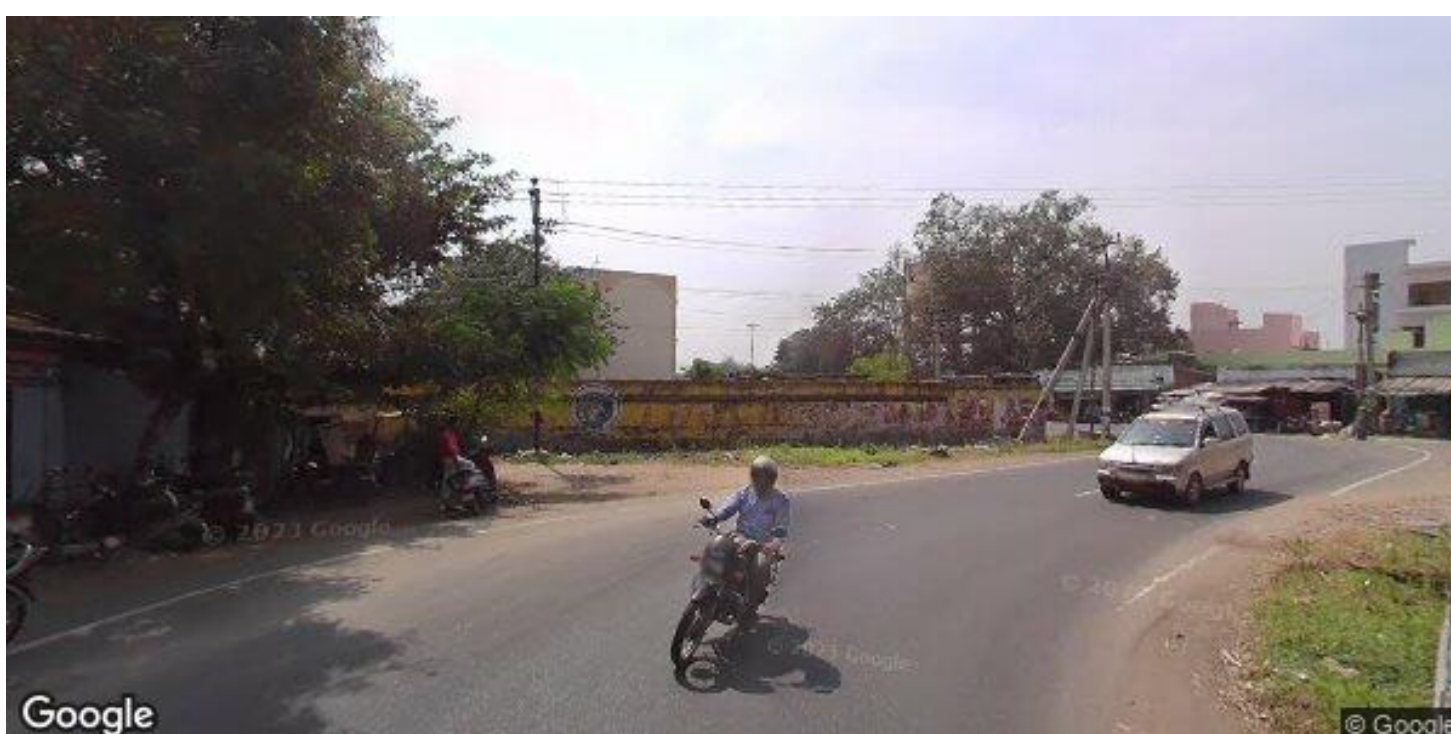
Coordinates: 11.44120, 77.68218

**Risk Type:** Turn

**Risk Level:** High

Speed Limit: 15 KM/Hr

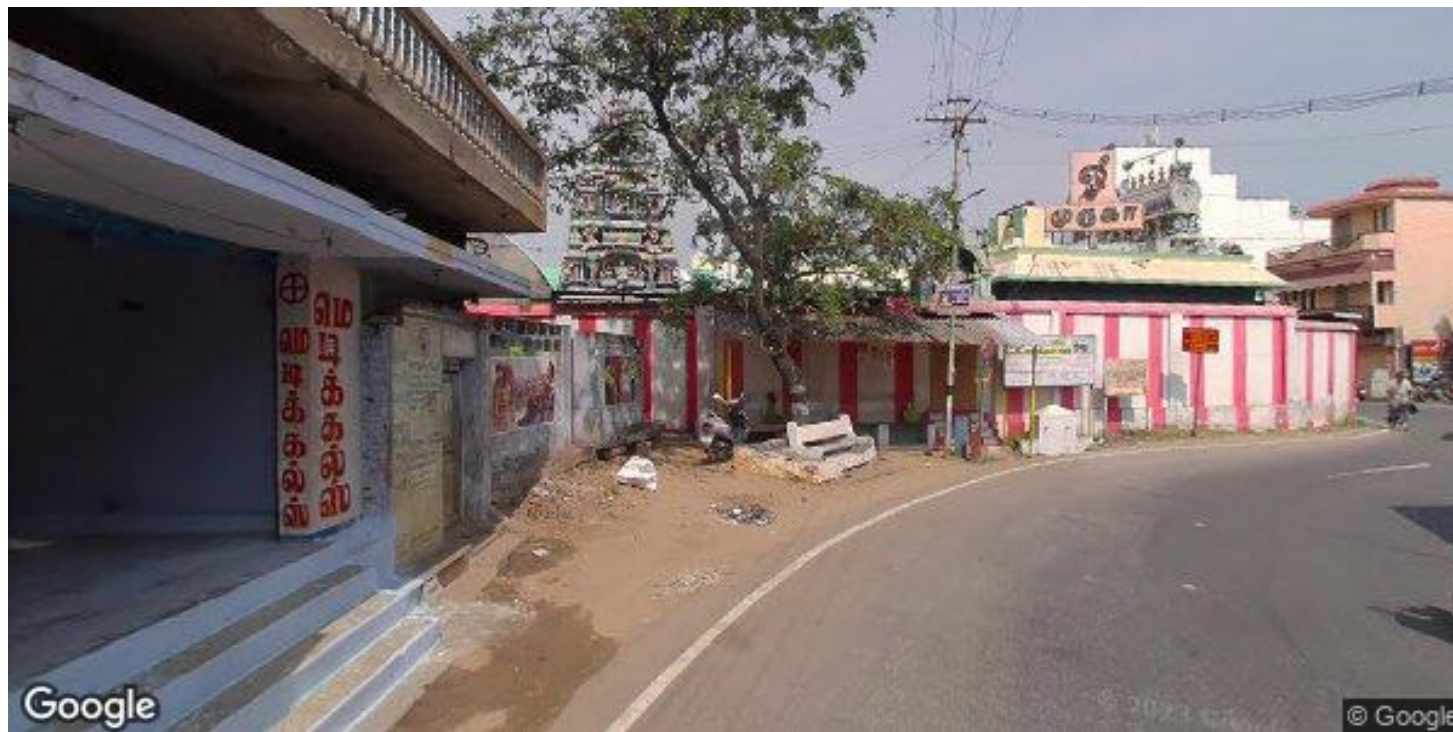
Coordinates: 11.44288, 77.68254

Risk Type: Turn

Risk Level: High

Speed Limit: 15 KM/Hr

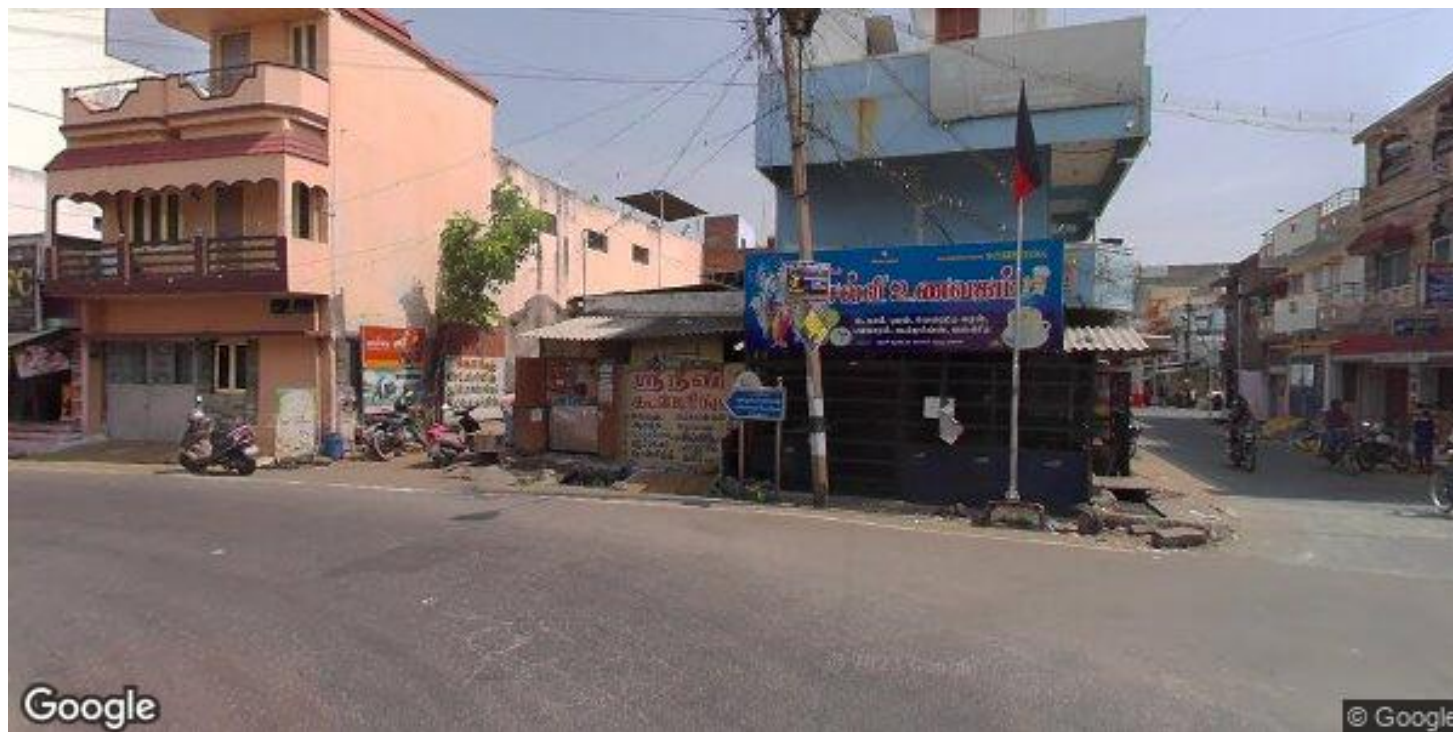
Coordinates: 11.44298, 77.68273

Risk Type: Turn

Risk Level: High

Speed Limit: 15 KM/Hr

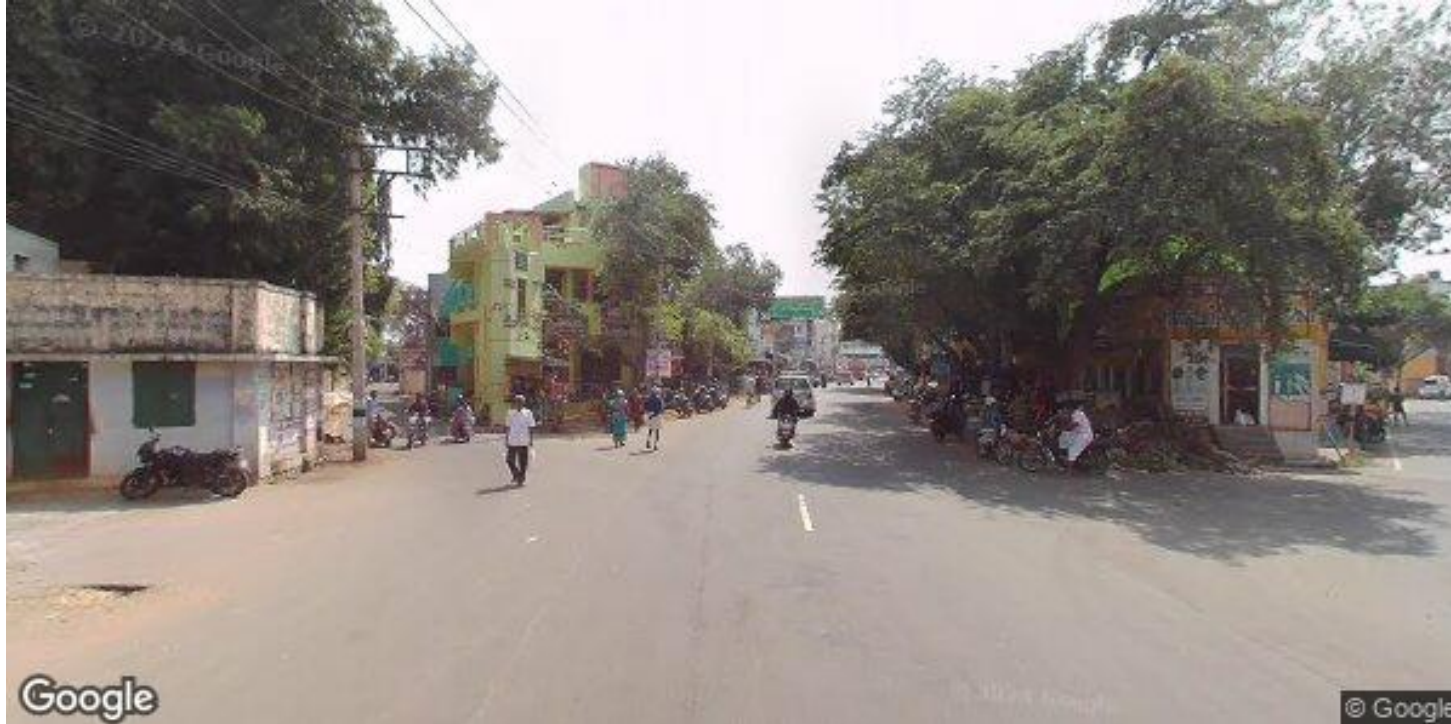
**Risk Type:** Turn  
**Risk Level:** High  
**Speed Limit:** 15 KM/Hr  
**Coordinates:** 11.44858, 77.68333

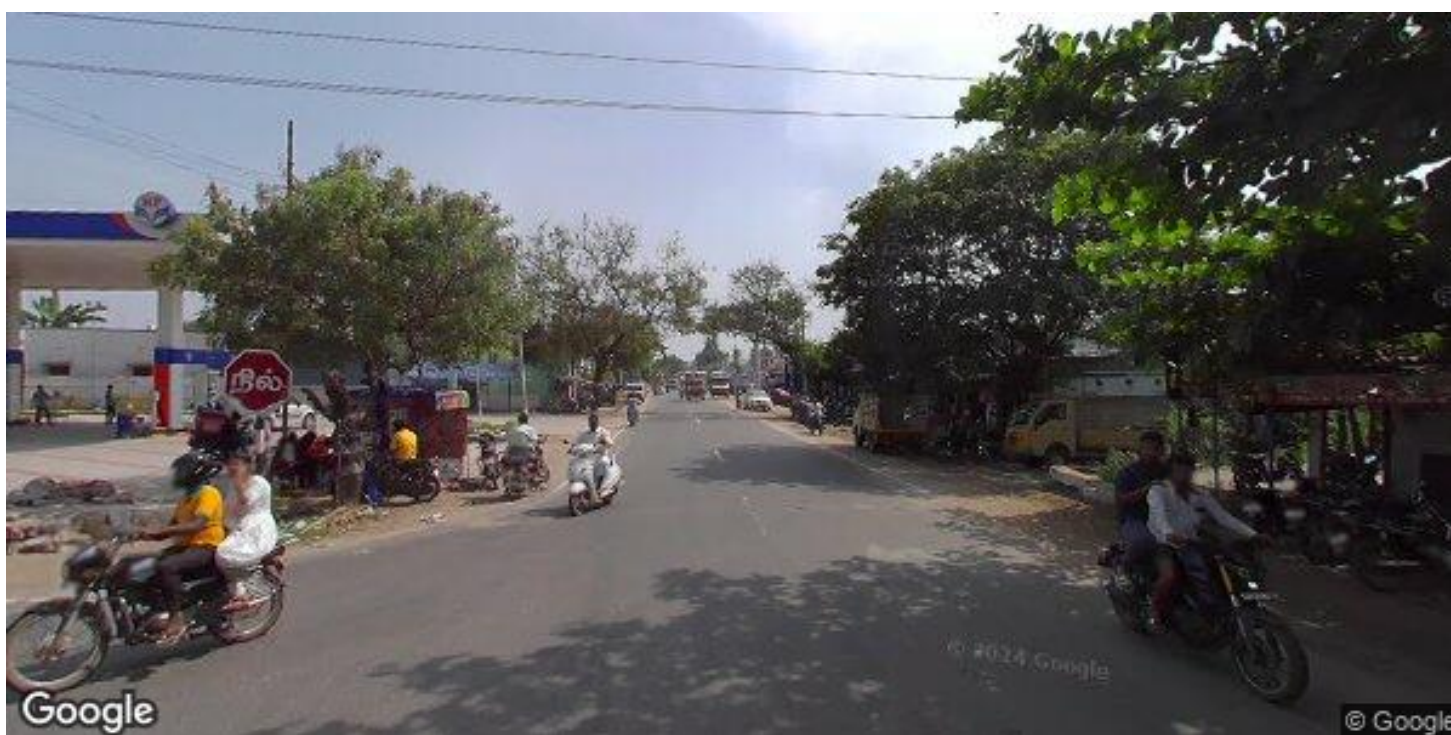
**Risk Type:** Turn  
**Risk Level:** High  
**Speed Limit:** 15 KM/Hr  
**Coordinates:** 11.45649, 77.67621

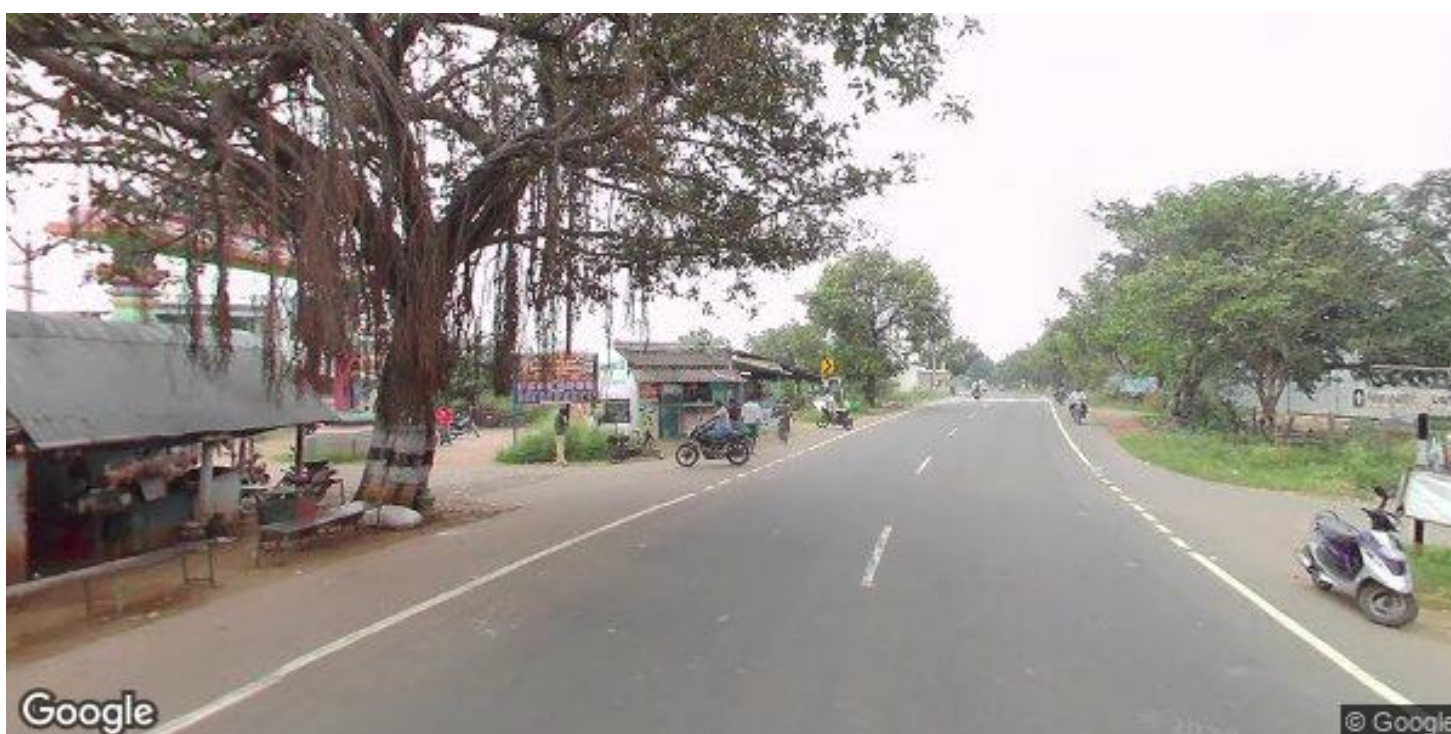
**Coordinates: 11.54439, 77.61209**

**Risk Type:** Turn  
**Risk Level:** Medium

**Speed Limit: 30 KM/Hr**

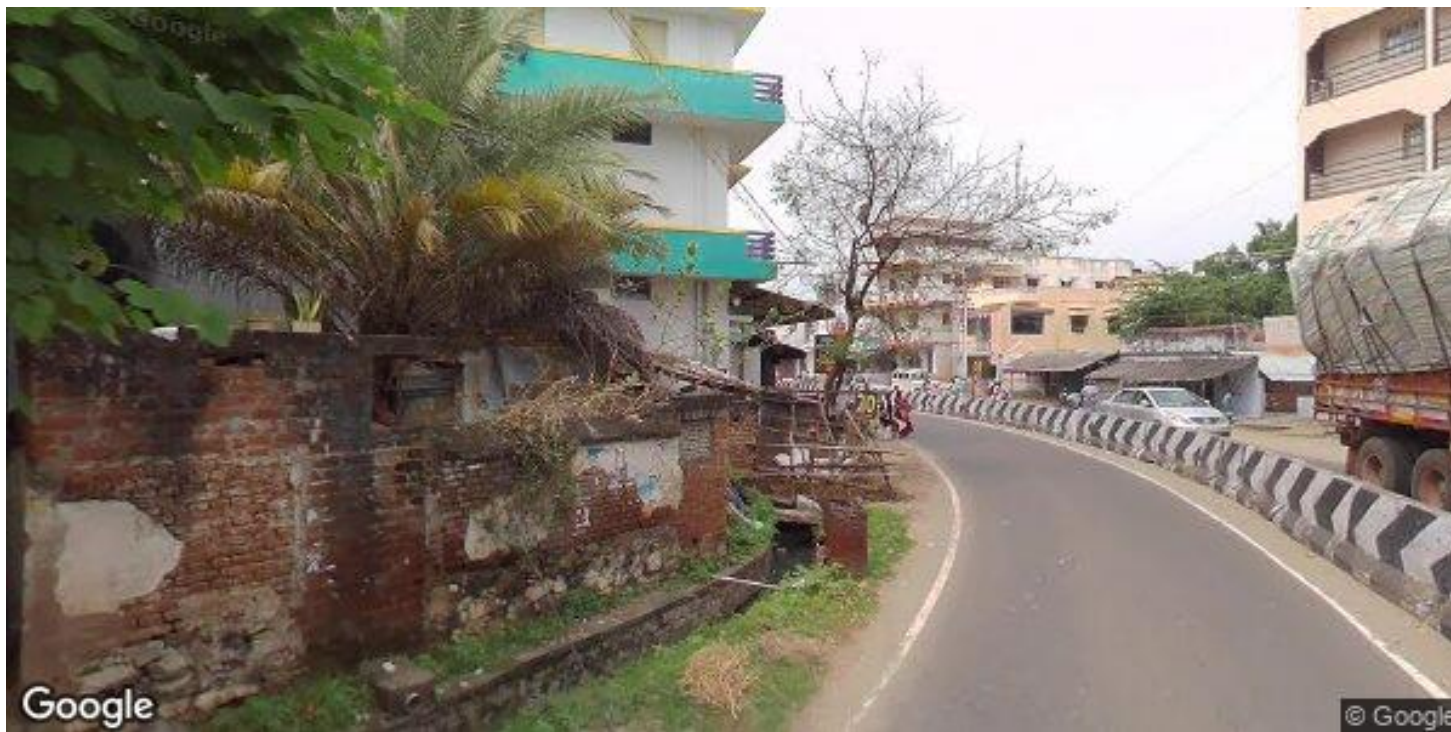
**Coordinates: 11.58067, 77.58800**

**Risk Type: Turn**

**Risk Level: Medium**

**Speed Limit: 30 KM/Hr**

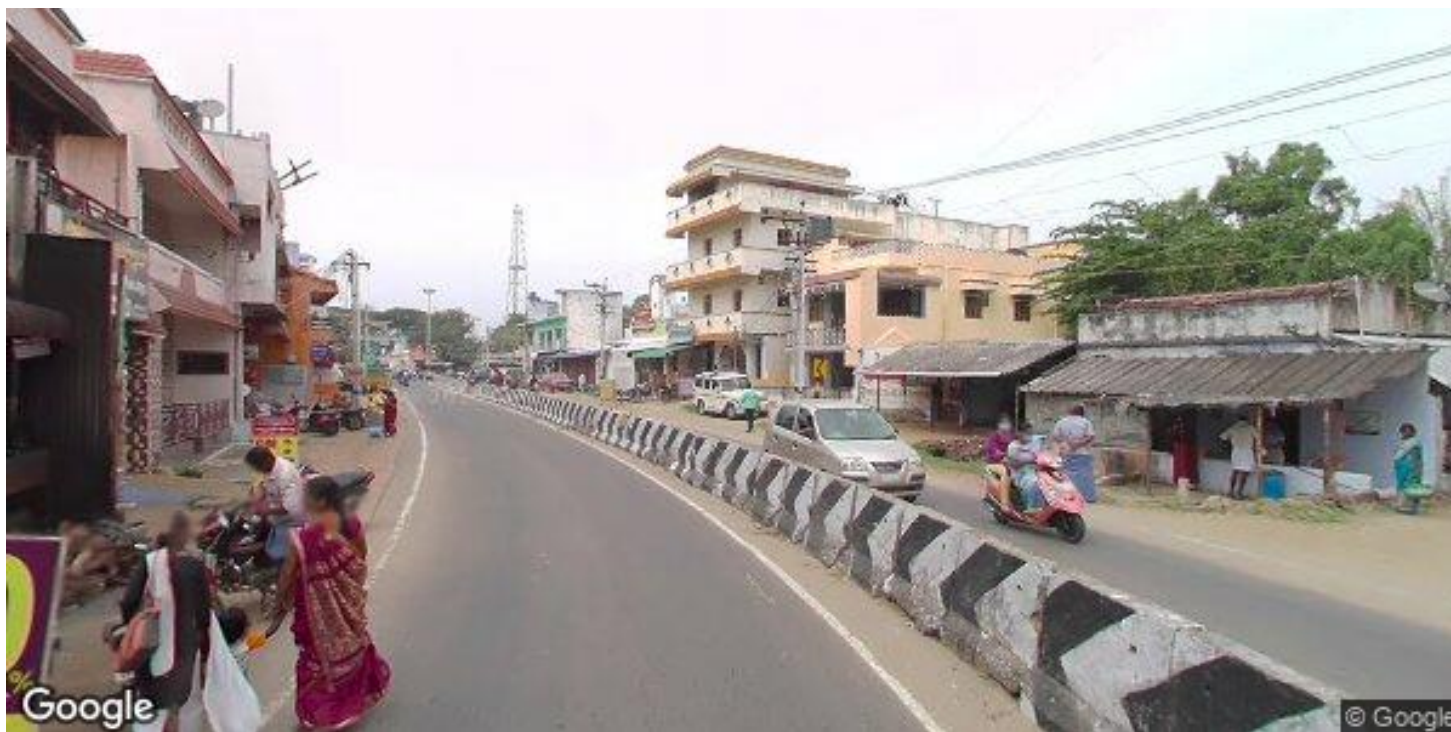
**Coordinates: 11.58080, 77.58786**

**Risk Type: Turn**

**Risk Level: Medium**

**Speed Limit: 30 KM/Hr**
