## JOURNEY RISK MANAGEMENT (JRM) STUDY

### Salem Terminal to CHENNAMMAL AGENCIES

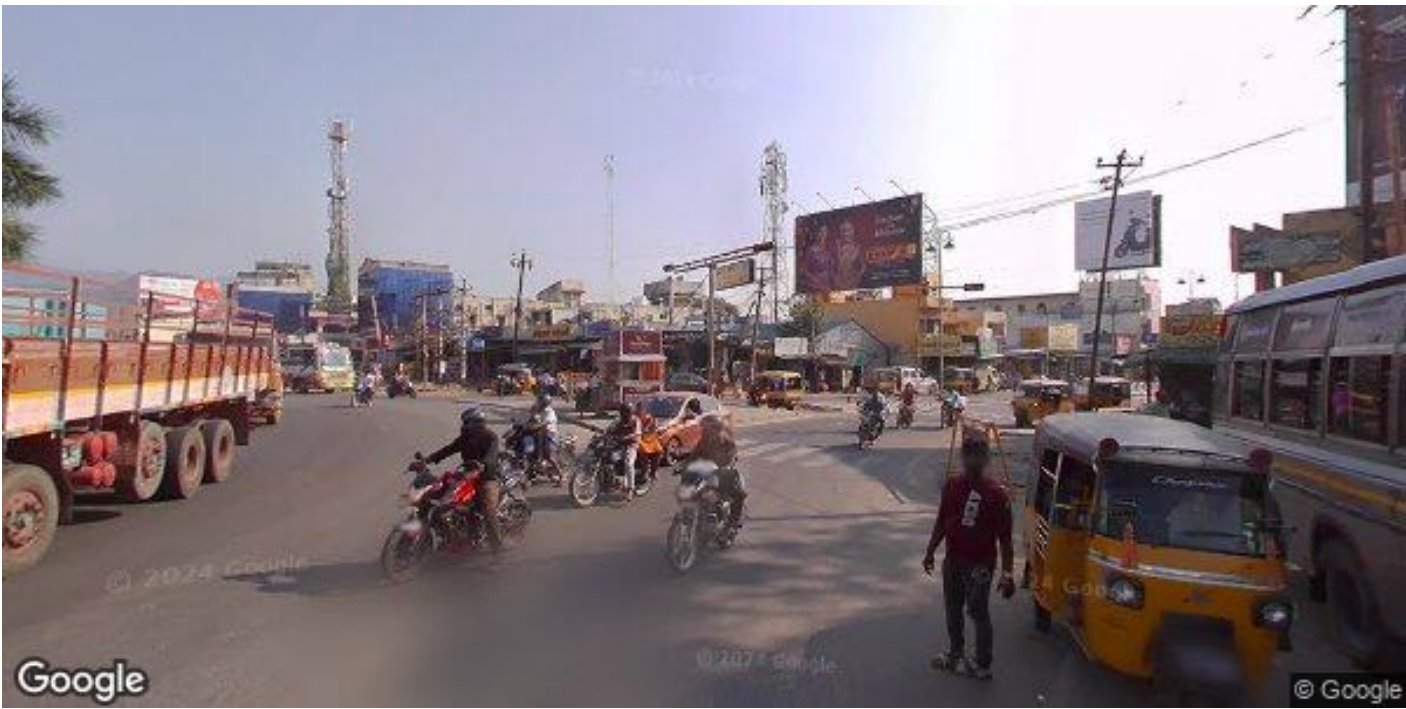
Risk Type: Roundabout  
Risk Level: High

**Speed Limit: 15 KM/Hr**  
**Coordinates: 11.63266, 78.12699**

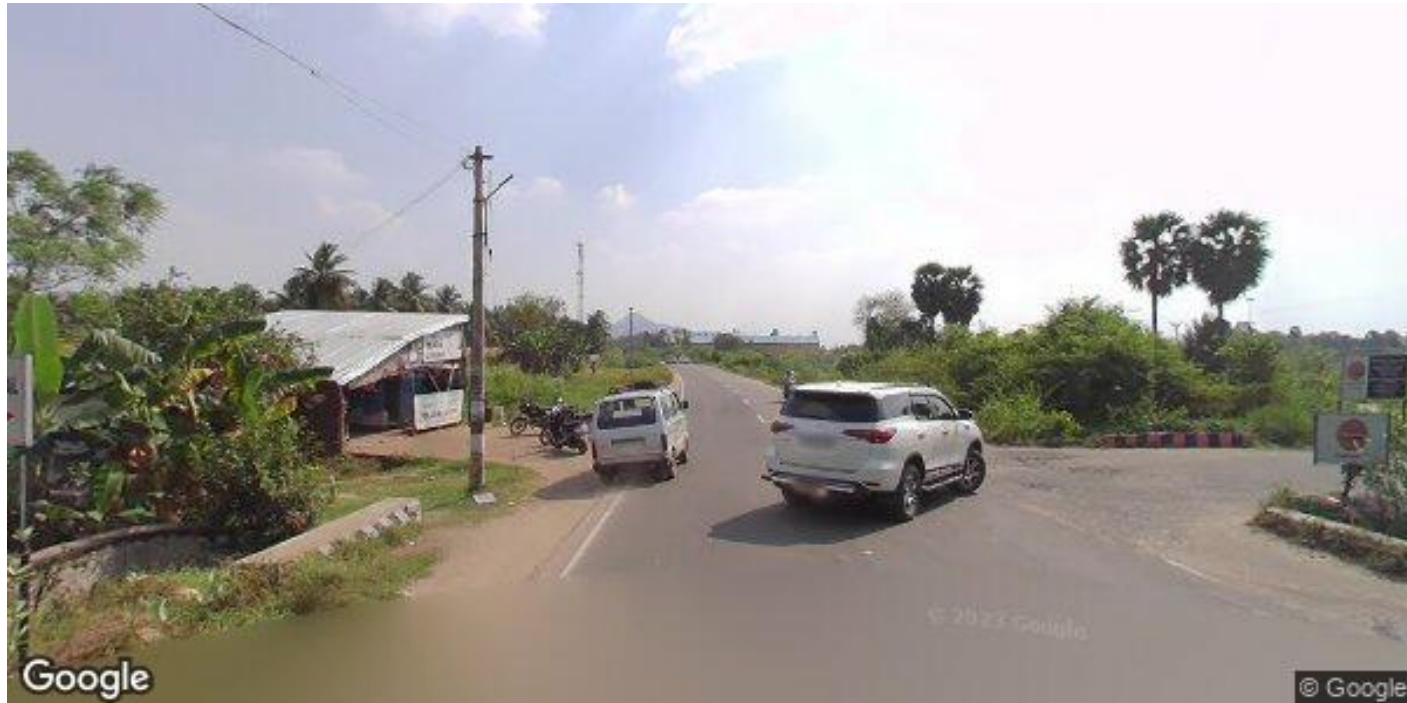
**Risk Type: Turn**  
**Risk Level: High**  
**Speed Limit: 15 KM/Hr**  
**Coordinates: 11.44029, 77.87544**

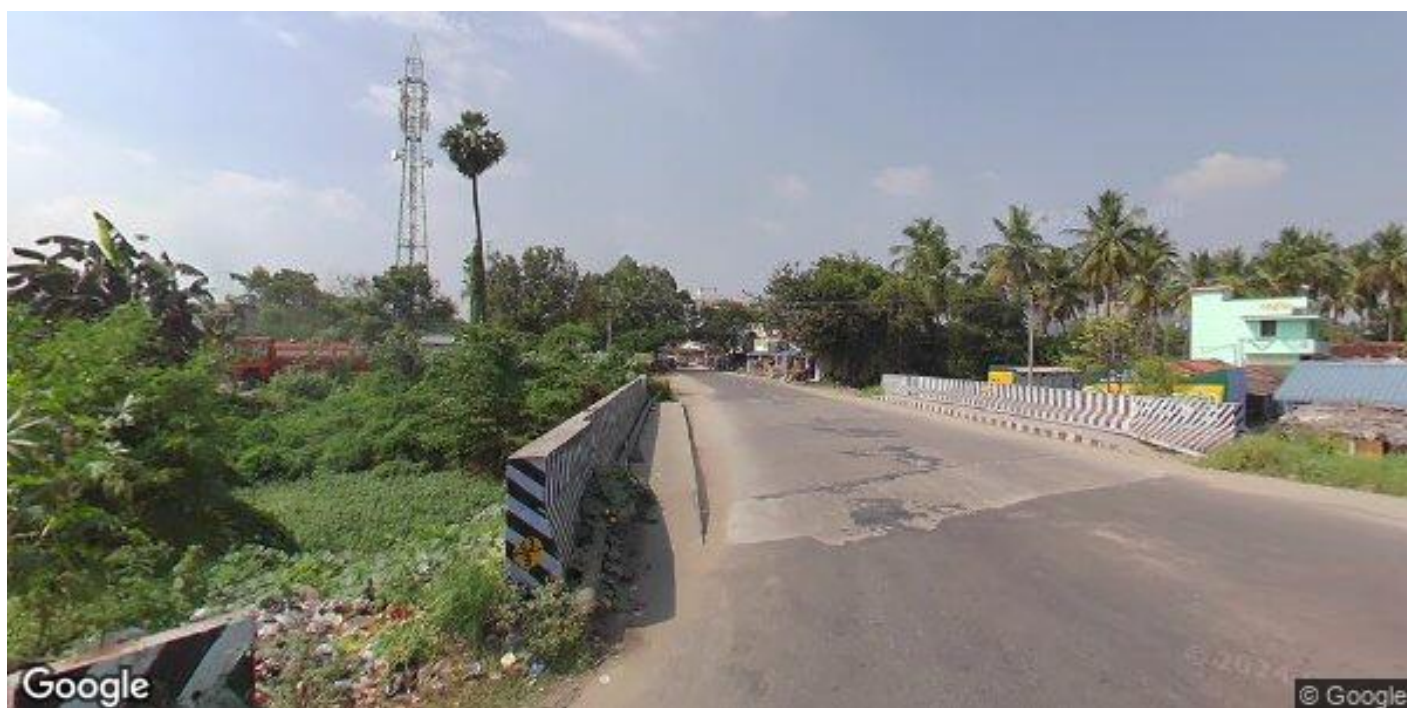
**Risk Type: Turn**  
**Risk Level: High**  
**Speed Limit: 15 KM/Hr**  
**Coordinates: 11.44900, 77.87406**

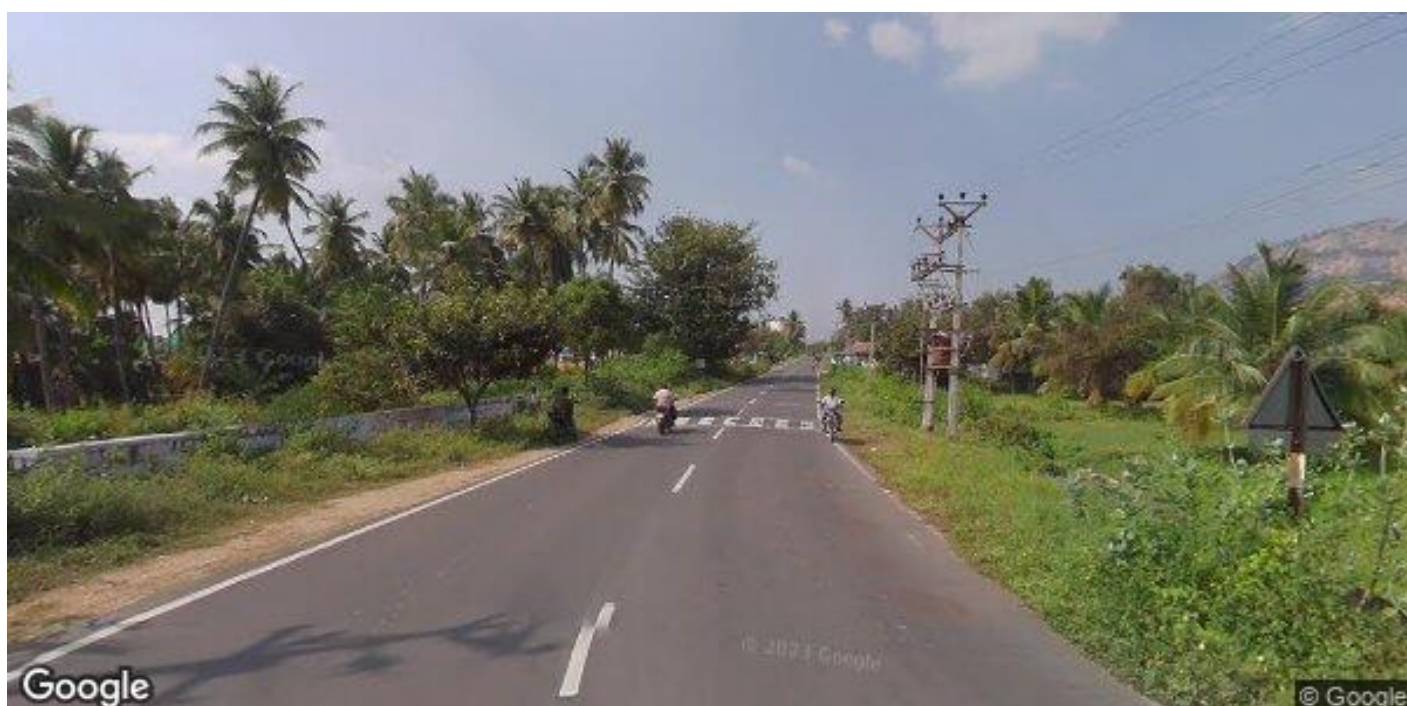
**Risk Type:** Turn  
**Risk Level:** High  
**Speed Limit:** 15 KM/Hr  
**Coordinates:** 11.45353, 77.85697

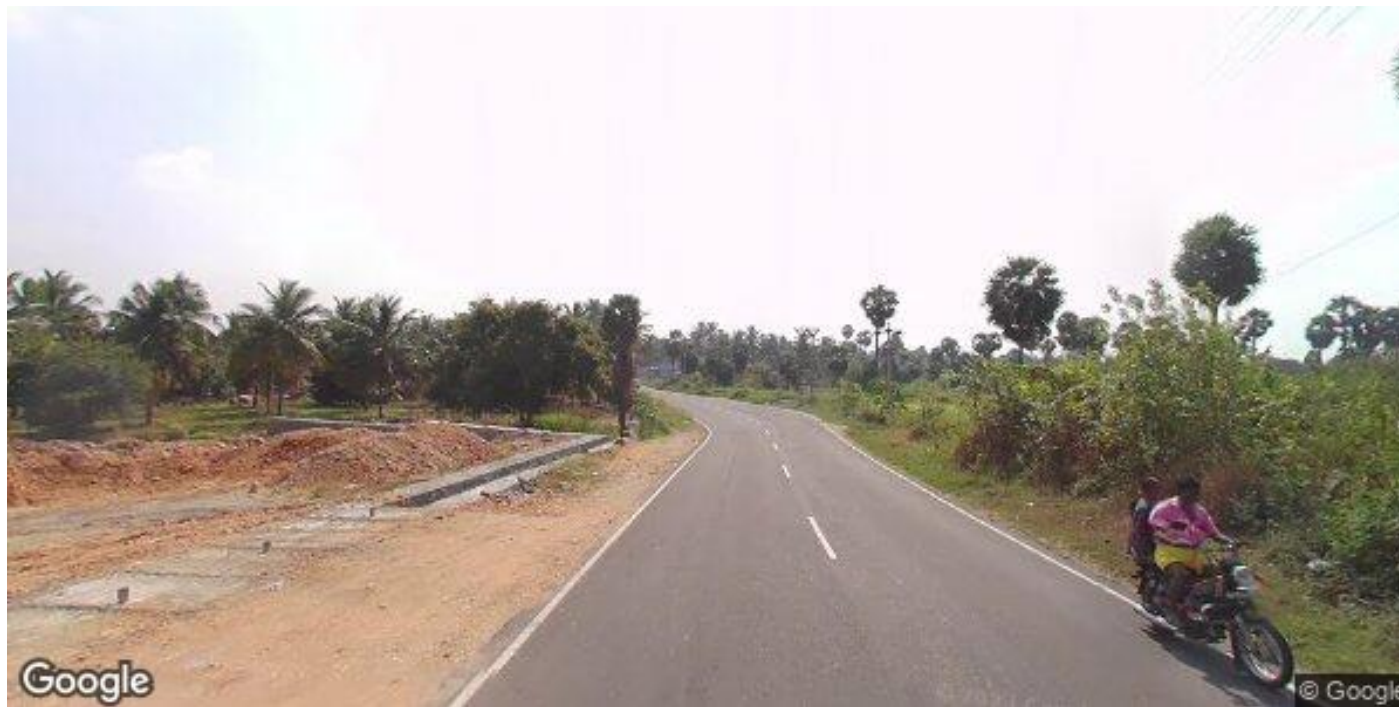
**Risk Type:** Turn  
**Risk Level:** Medium  
**Speed Limit:** 30 KM/Hr  
**Coordinates:** 11.45781, 77.85203

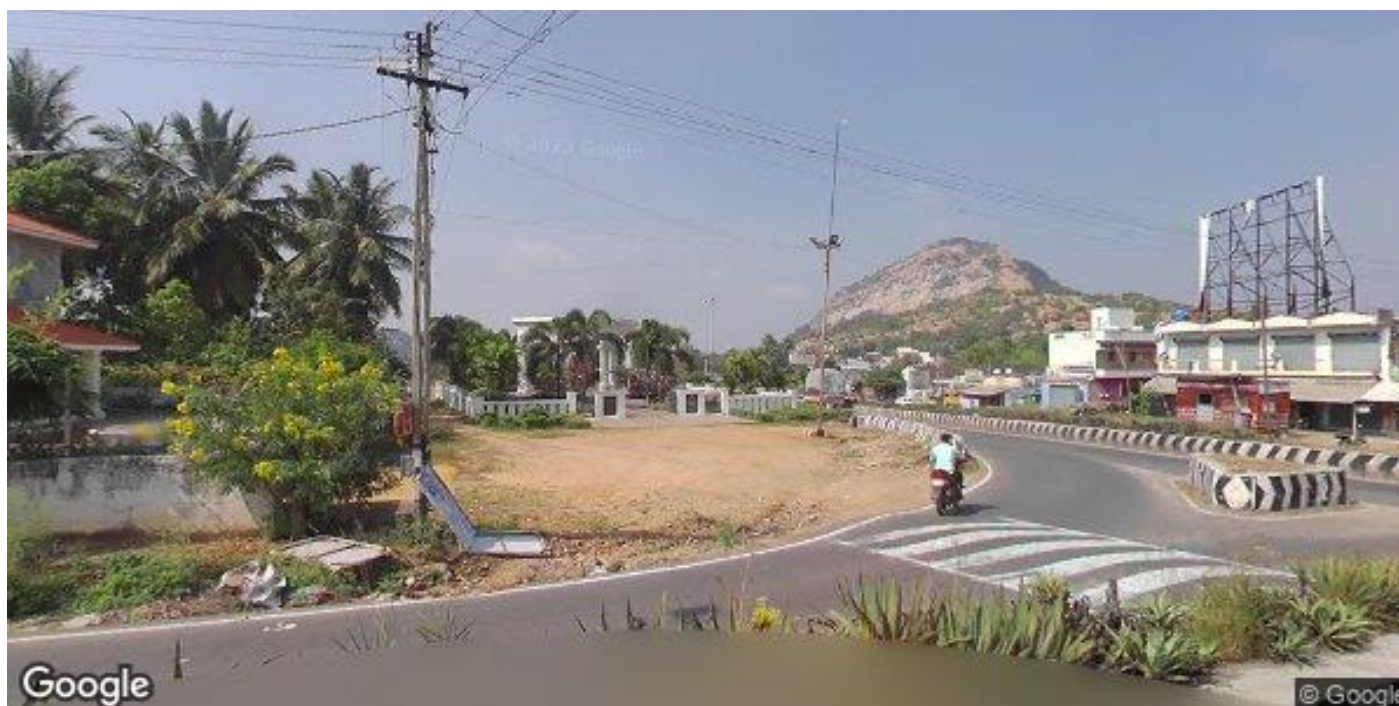
**Risk Type:** Turn  
**Risk Level:** High  
**Speed Limit:** 15 KM/Hr  
**Coordinates:** 11.46307, 77.84941

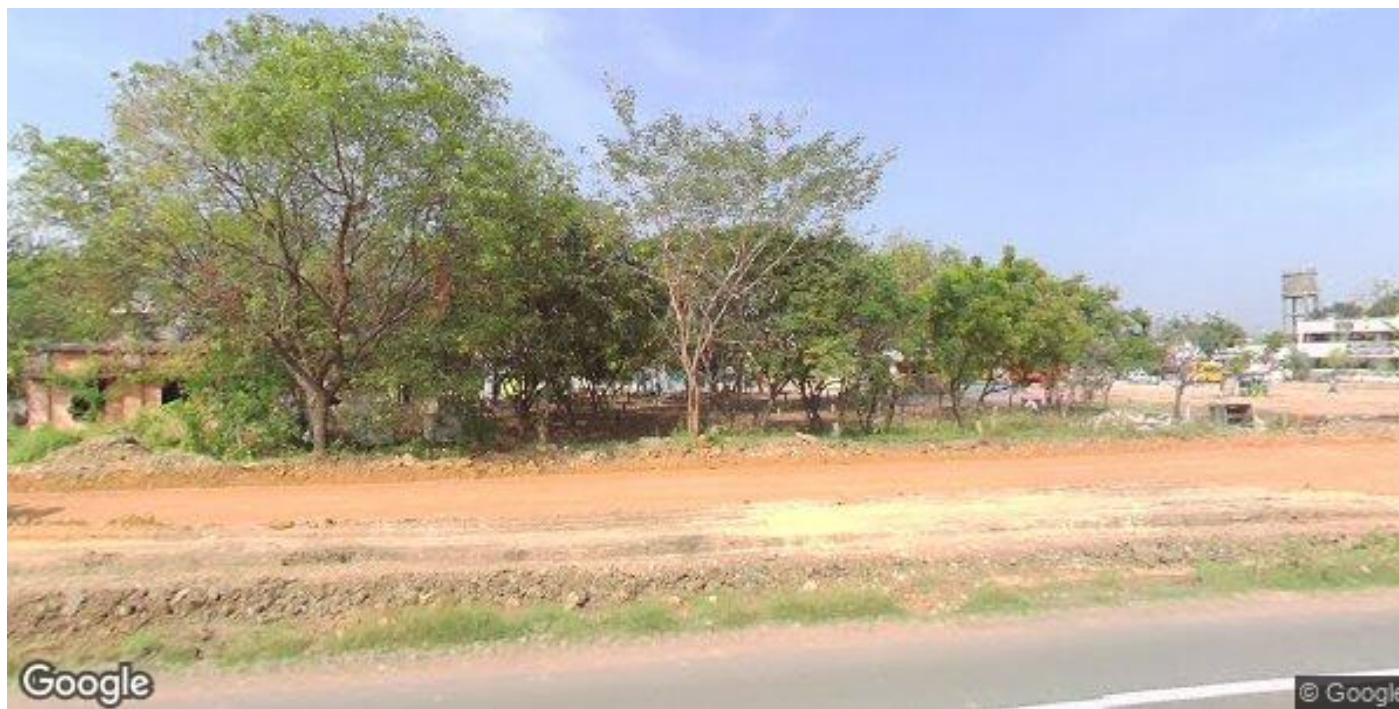
**Risk Type:** Turn  
**Risk Level:** Medium  
**Speed Limit:** 30 KM/Hr  
**Coordinates:** 11.62100, 78.10723

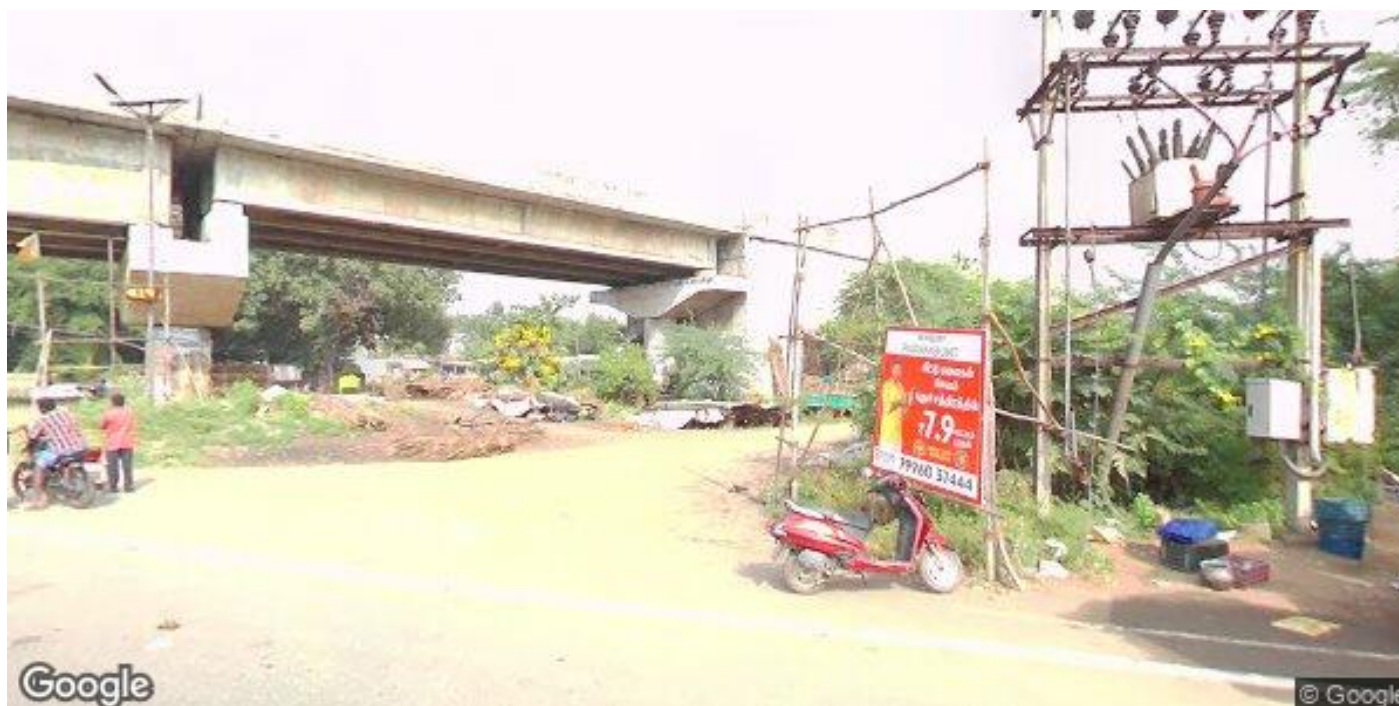
**Risk Type:** Blind Spot  
**Risk Level:** Blind Spot  
**Speed Limit:** 10 KM/Hr  
**Coordinates:** 11.61235, 78.10438

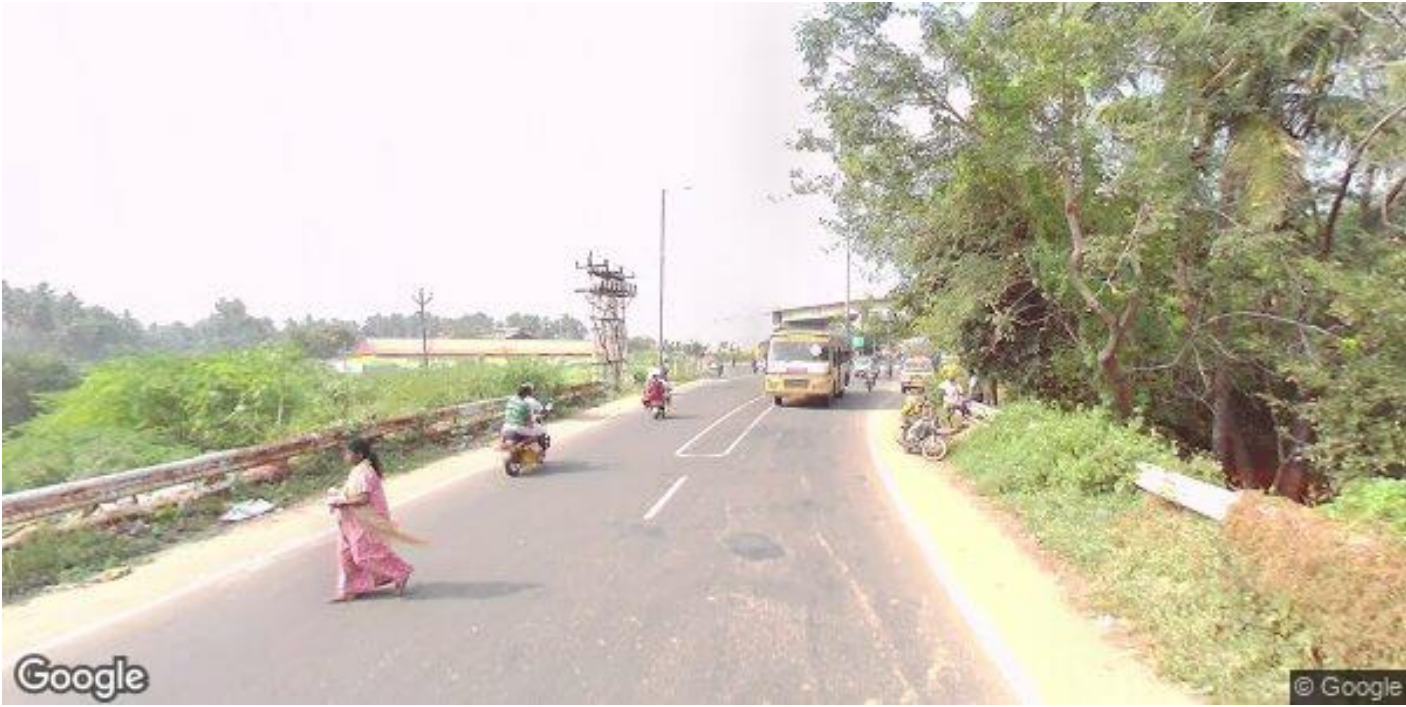
**Risk Type:** Turn  
**Risk Level:** Medium  
**Speed Limit:** 30 KM/Hr  
**Coordinates:** 11.61235, 78.10495

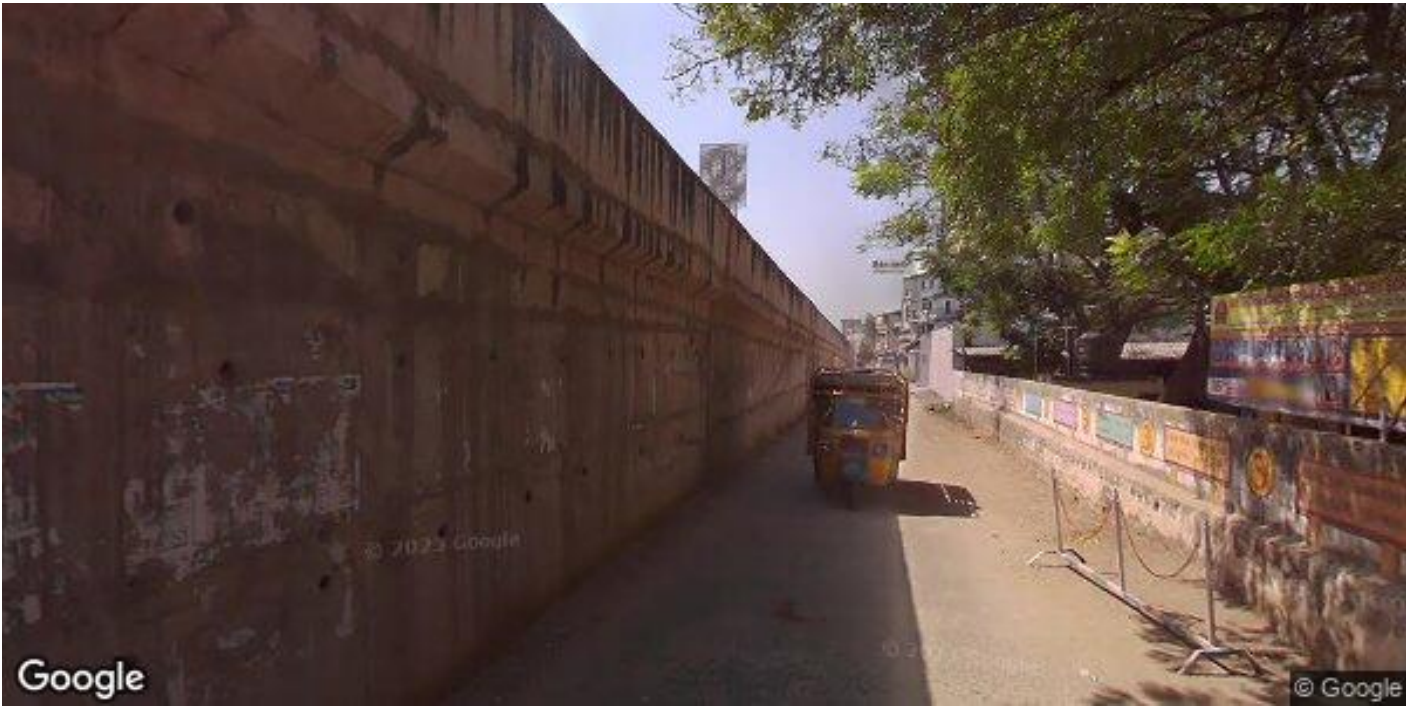
**Risk Type:** Blind Spot  
**Risk Level:** Blind Spot  
**Speed Limit:** 10 KM/Hr  
**Coordinates:** 11.62871, 78.12299

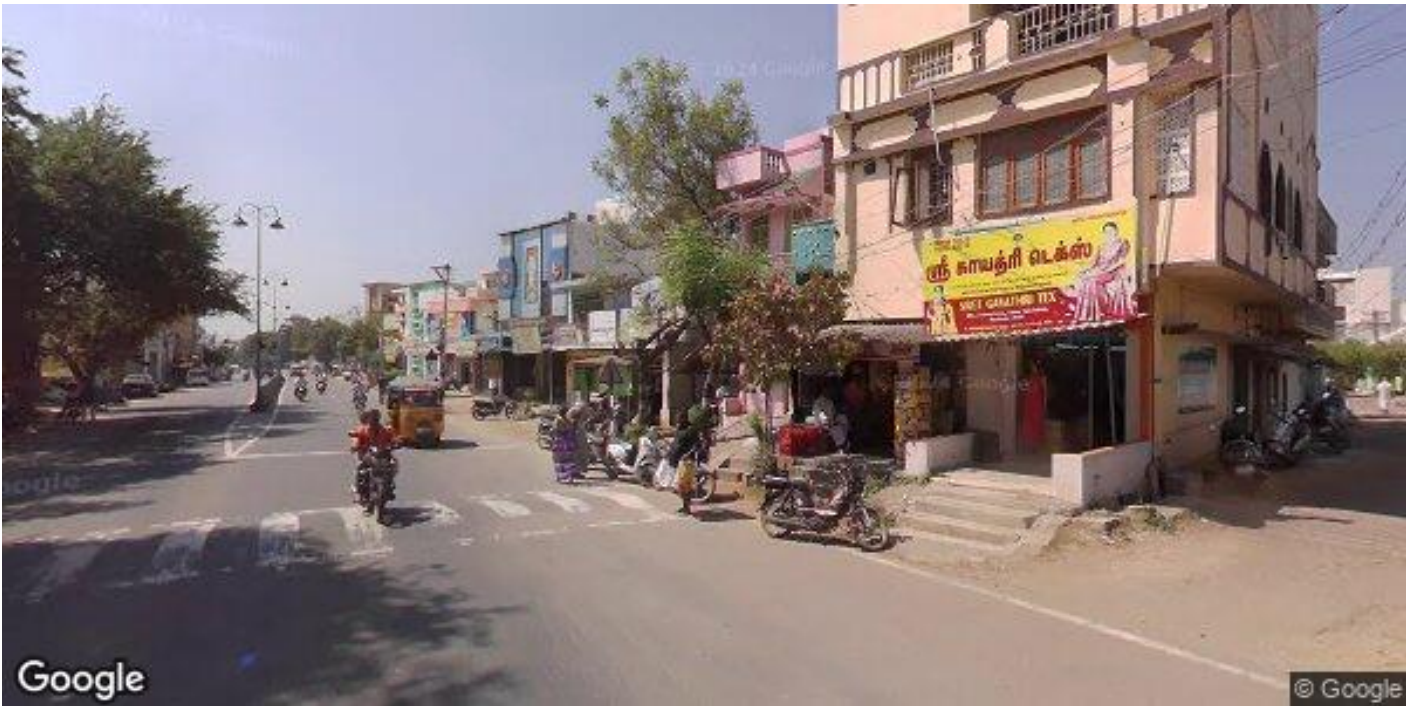
**Risk Type:** Blind Spot  
**Risk Level:** Blind Spot  
**Speed Limit:** 10 KM/Hr  
**Coordinates:** 11.62788, 78.12219

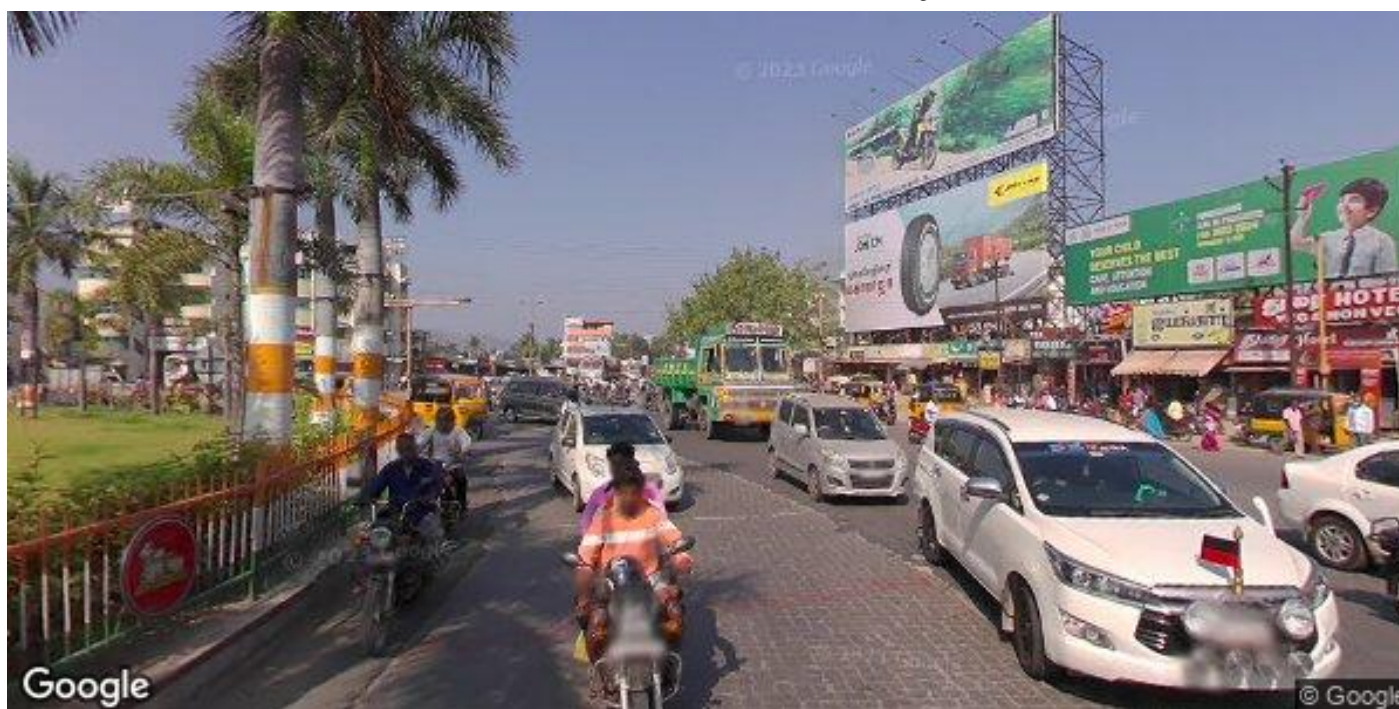
**Risk Type:** Turn  
**Risk Level:** High  
**Speed Limit:** 15 KM/Hr  
**Coordinates:** 11.63302, 78.12742

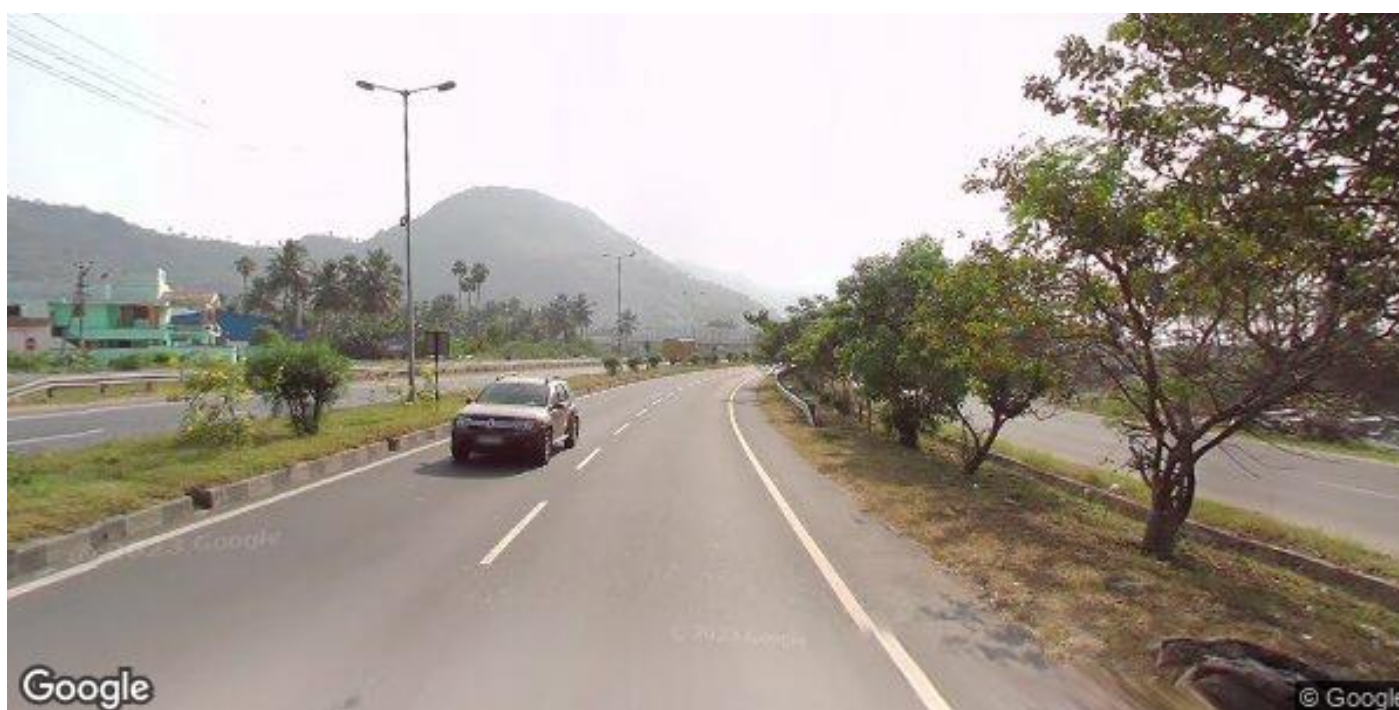
**Risk Type:** Turn  
**Risk Level:** Medium  
**Speed Limit:** 30 KM/Hr  
**Coordinates:** 11.62938, 78.16601

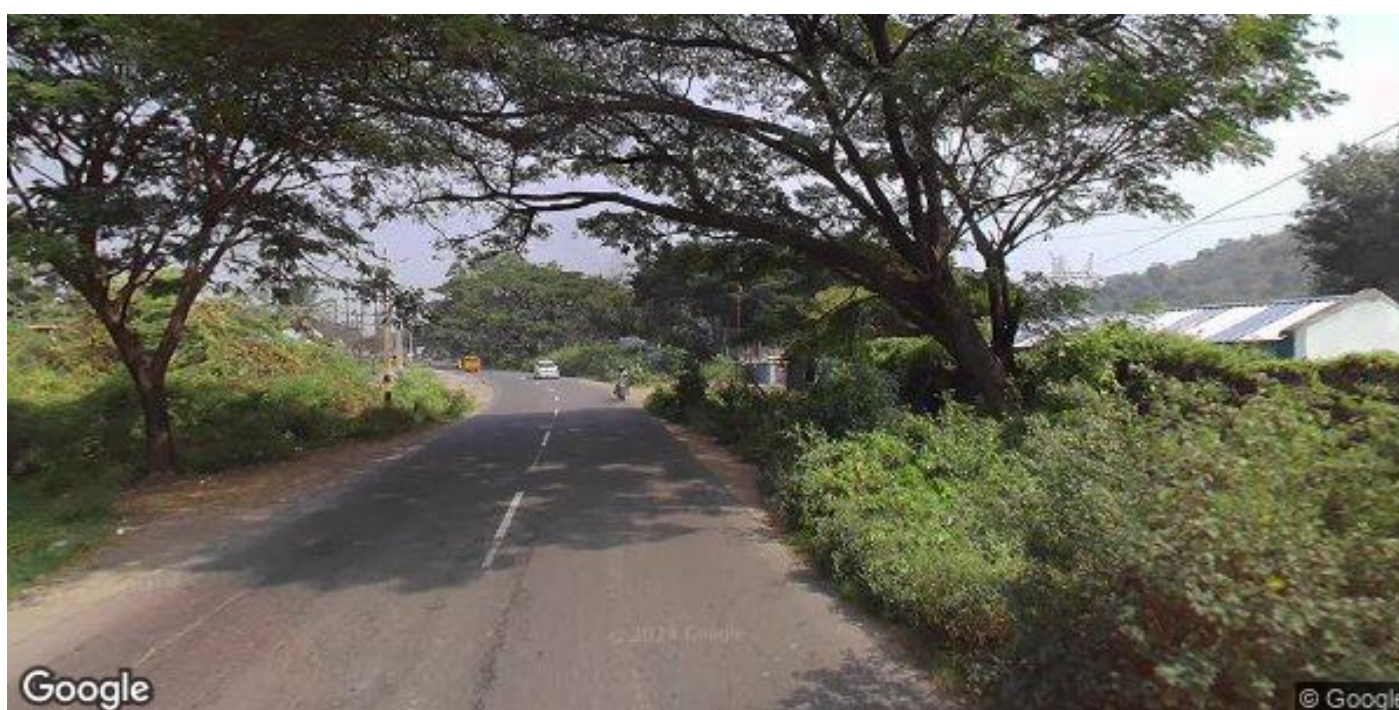
**Risk Type:** Turn  
**Risk Level:** Medium  
**Speed Limit:** 30 KM/Hr  
**Coordinates:** 11.65825, 78.20469

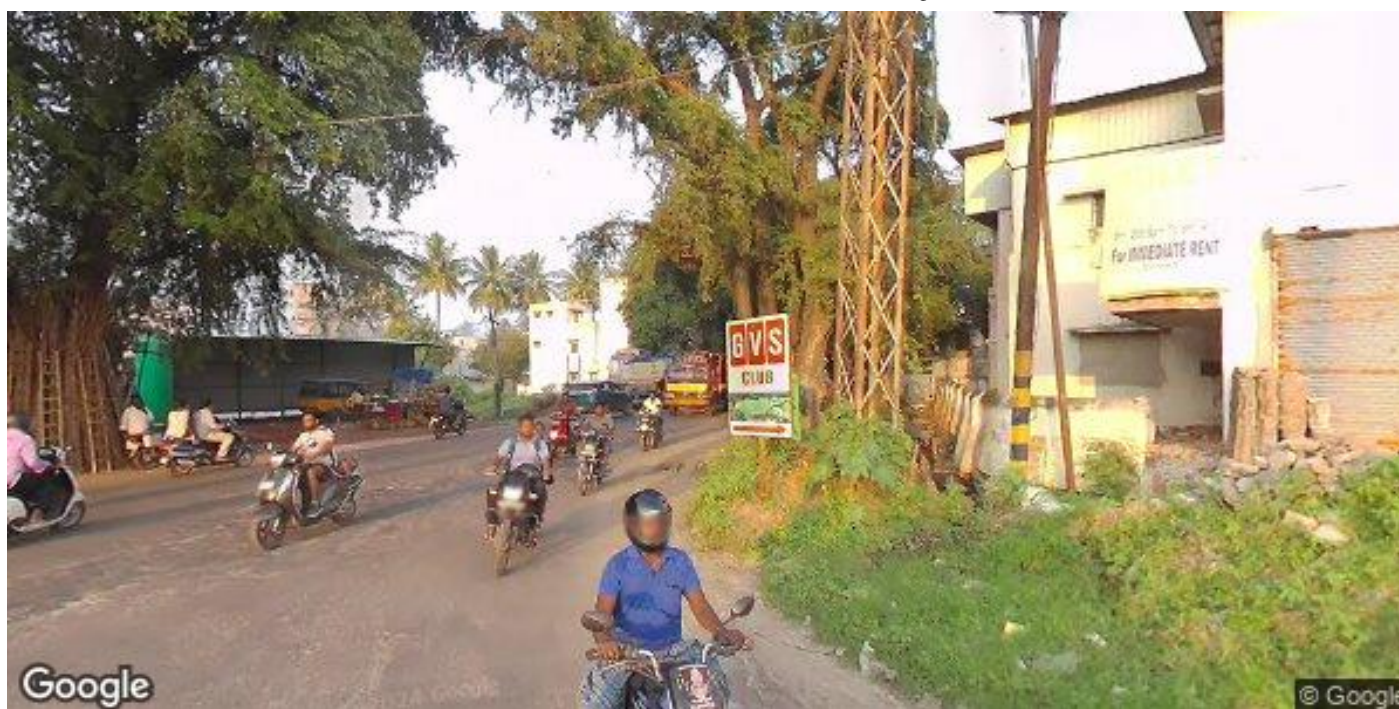
**Risk Type:** Turn  
**Risk Level:** Medium  
**Speed Limit:** 30 KM/Hr  
**Coordinates:** 11.66366, 78.20649

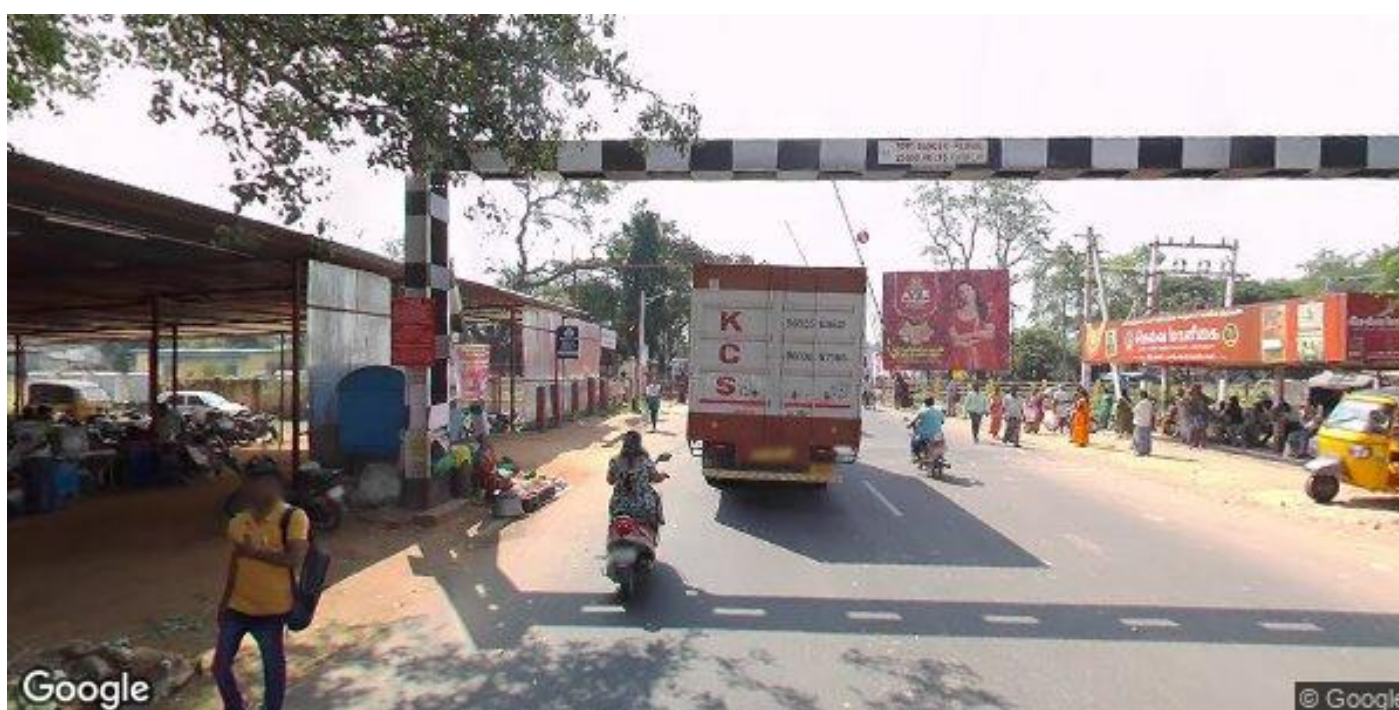
**Risk Type:** Turn  
**Risk Level:** Medium  
**Speed Limit:** 30 KM/Hr  
**Coordinates:** 11.67182, 78.23141

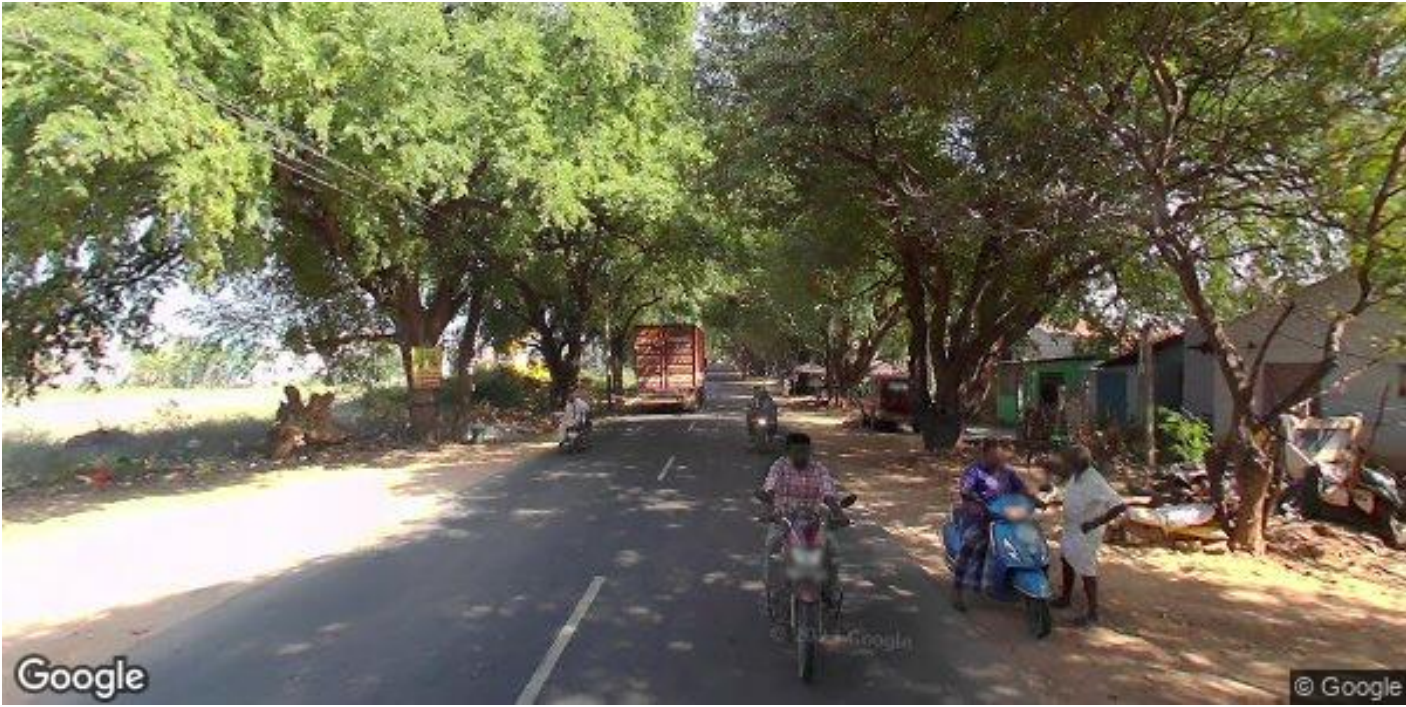
**Risk Type:** Turn  
**Risk Level:** Medium  
**Speed Limit:** 30 KM/Hr  
**Coordinates:** 11.67500, 78.23962

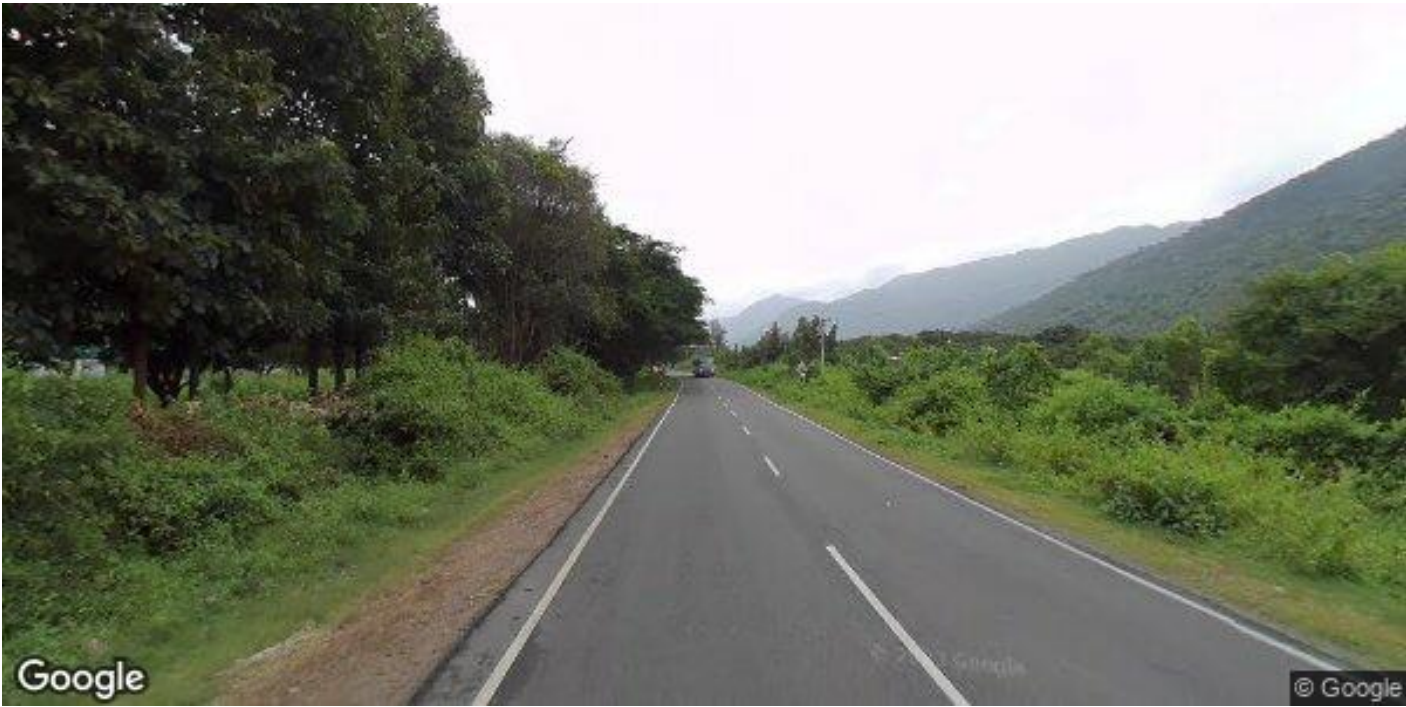
**Risk Type:** Turn  
**Risk Level:** Medium  
**Speed Limit:** 30 KM/Hr  
**Coordinates:** 11.80474, 78.33353

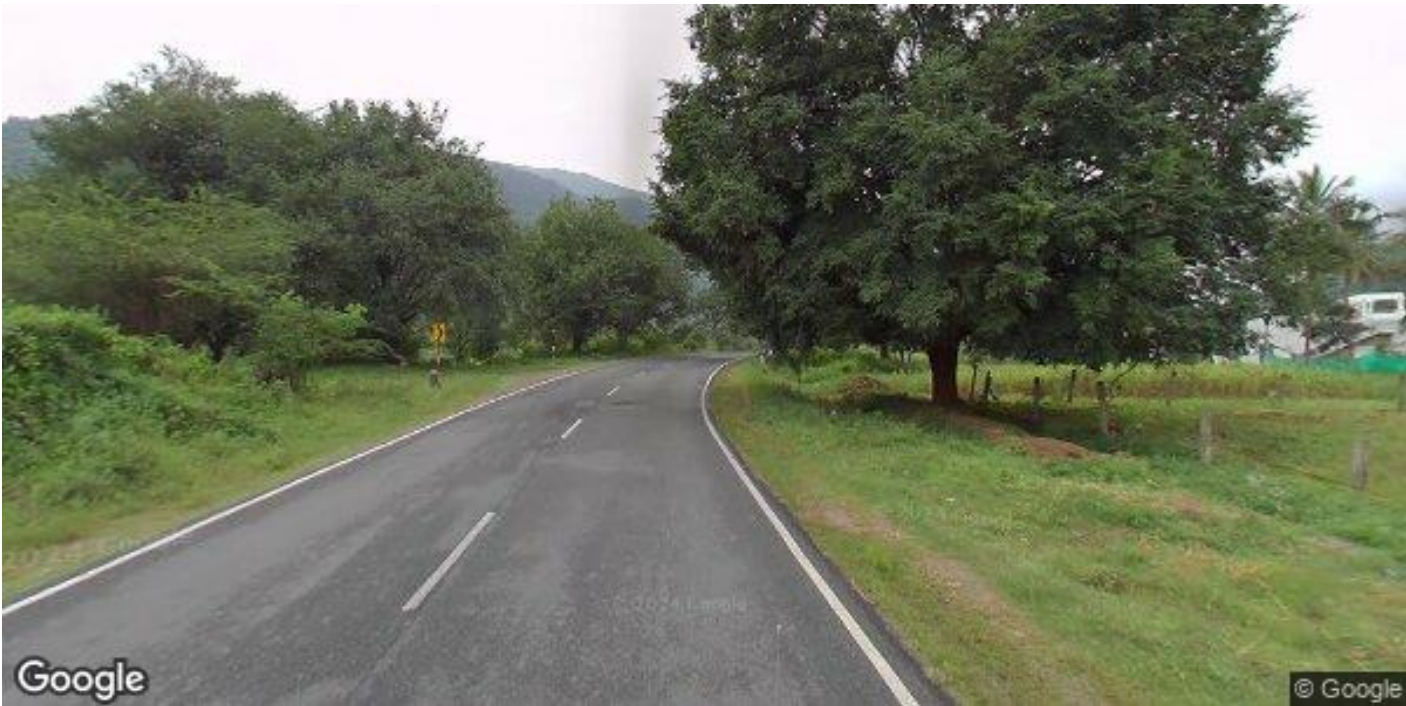
**Risk Type:** Turn  
**Risk Level:** Medium  
**Speed Limit:** 30 KM/Hr  
**Coordinates:** 11.81272, 78.34092

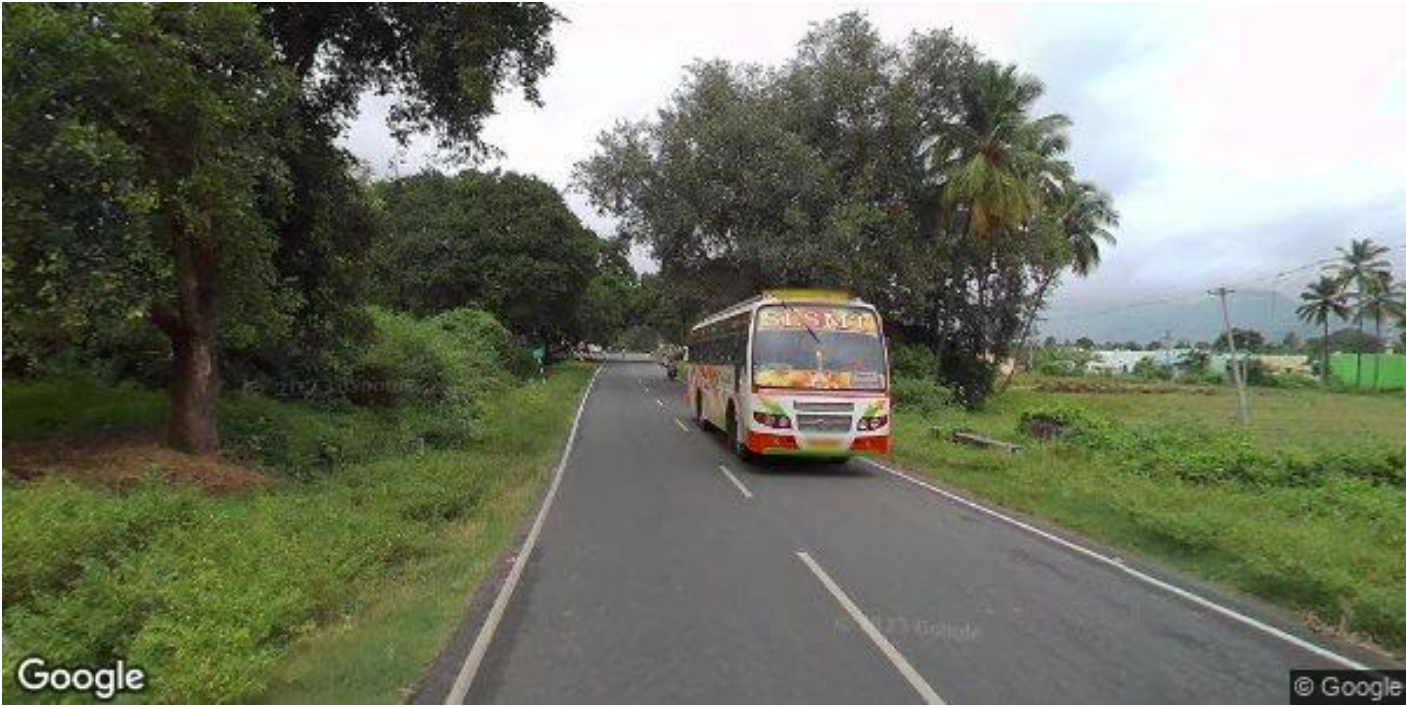
**Risk Type:** Turn  
**Risk Level:** Medium  
**Speed Limit:** 30 KM/Hr  
**Coordinates:** 11.83514, 78.35305

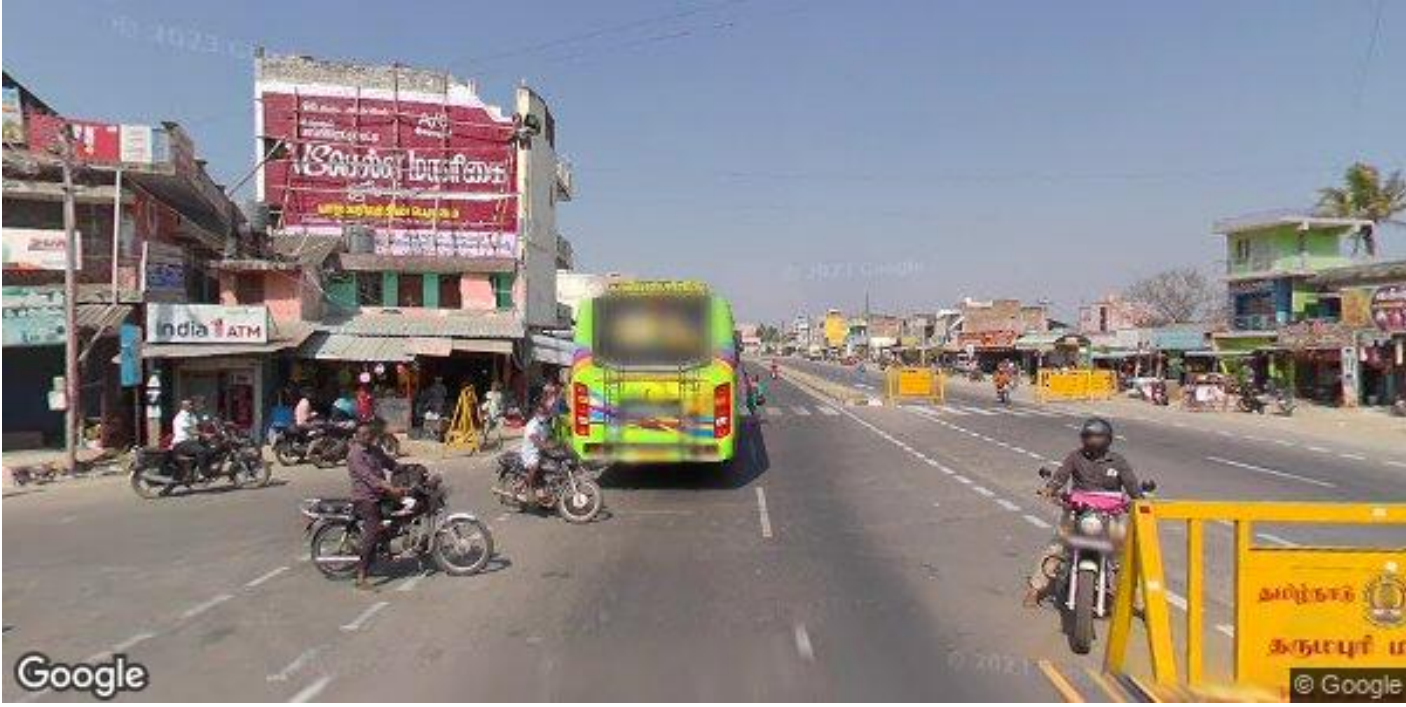
**Risk Type:** Turn  
**Risk Level:** Medium  
**Speed Limit:** 30 KM/Hr  
**Coordinates:** 11.99608, 78.44589

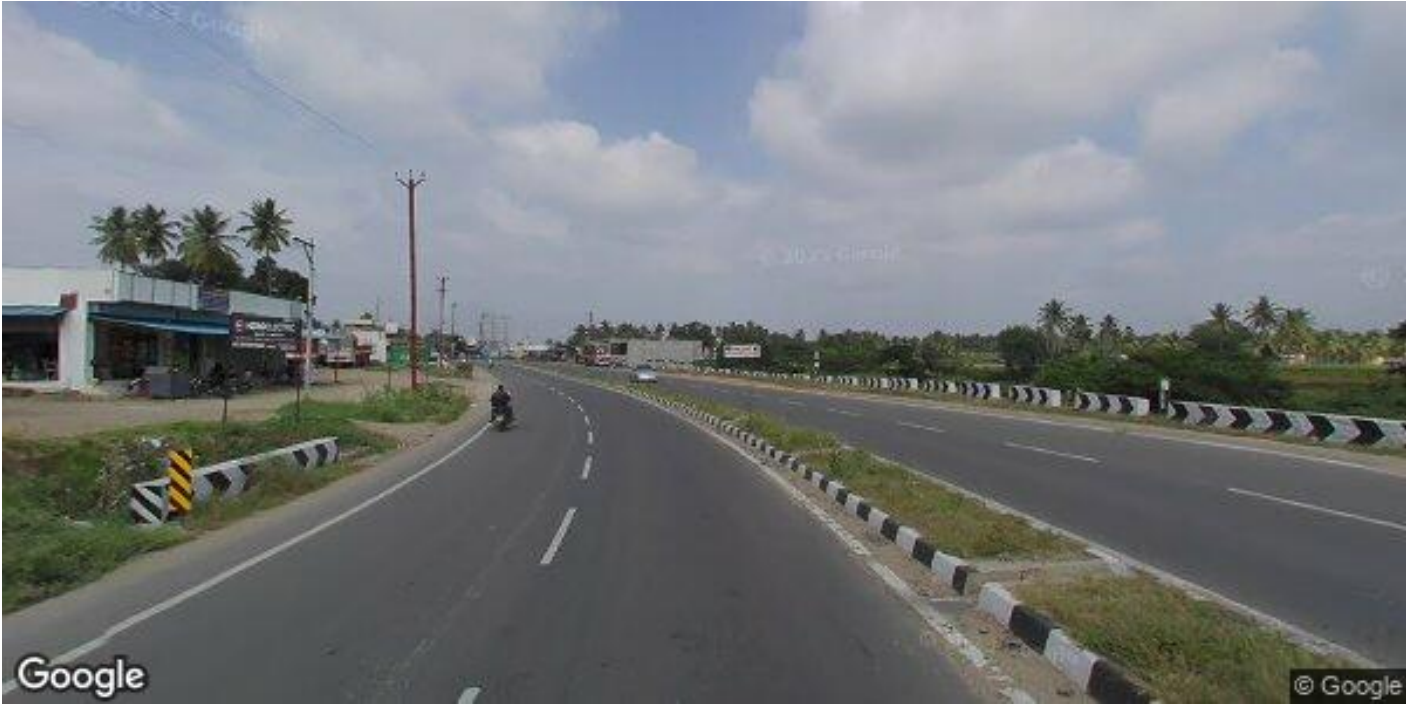
**Risk Type:** Turn  
**Risk Level:** Medium  
**Speed Limit:** 30 KM/Hr  
**Coordinates:** 12.04286, 78.48352
