## JOURNEY RISK MANAGEMENT (JRM) STUDY

### Salem Terminal to CHENNAMMAL AGENCIES

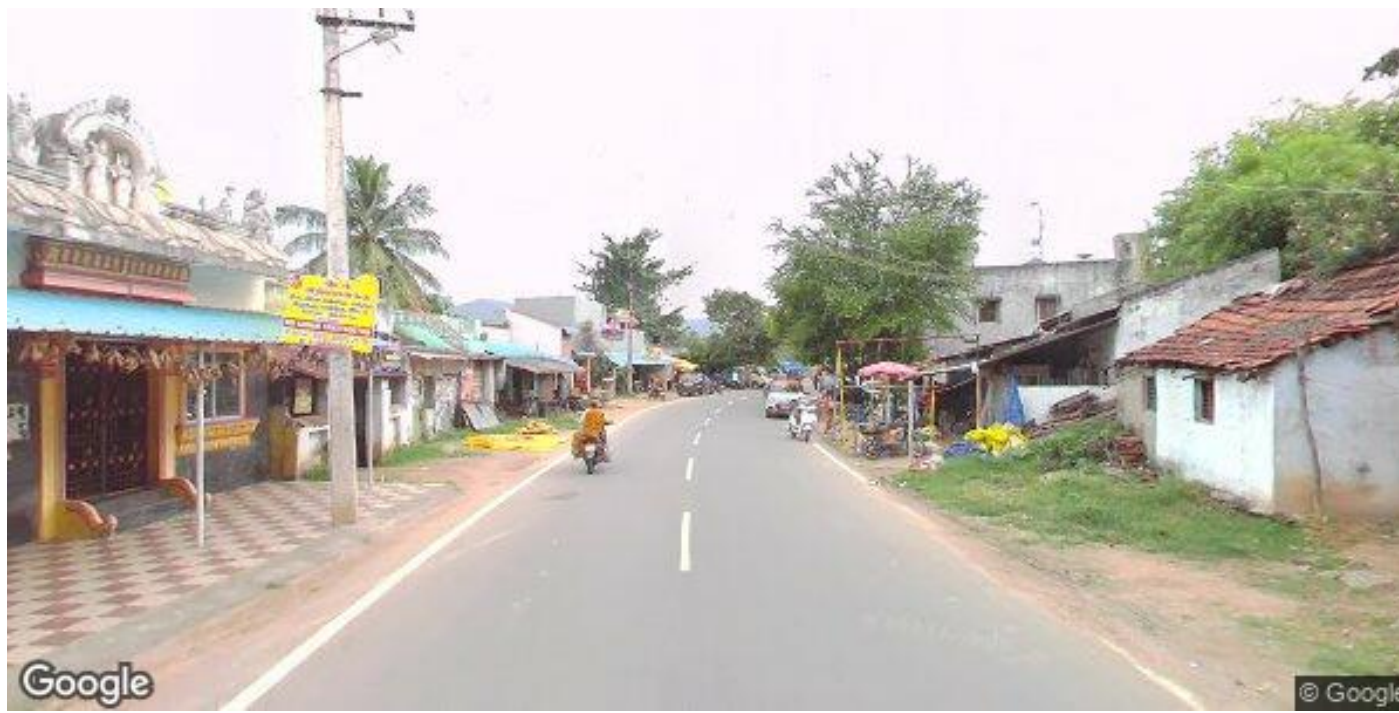
**Risk Type:** Turn  
**Risk Level:** Medium  
**Speed Limit:** 30 KM/Hr  
**Coordinates:** 12.04845, 78.48385

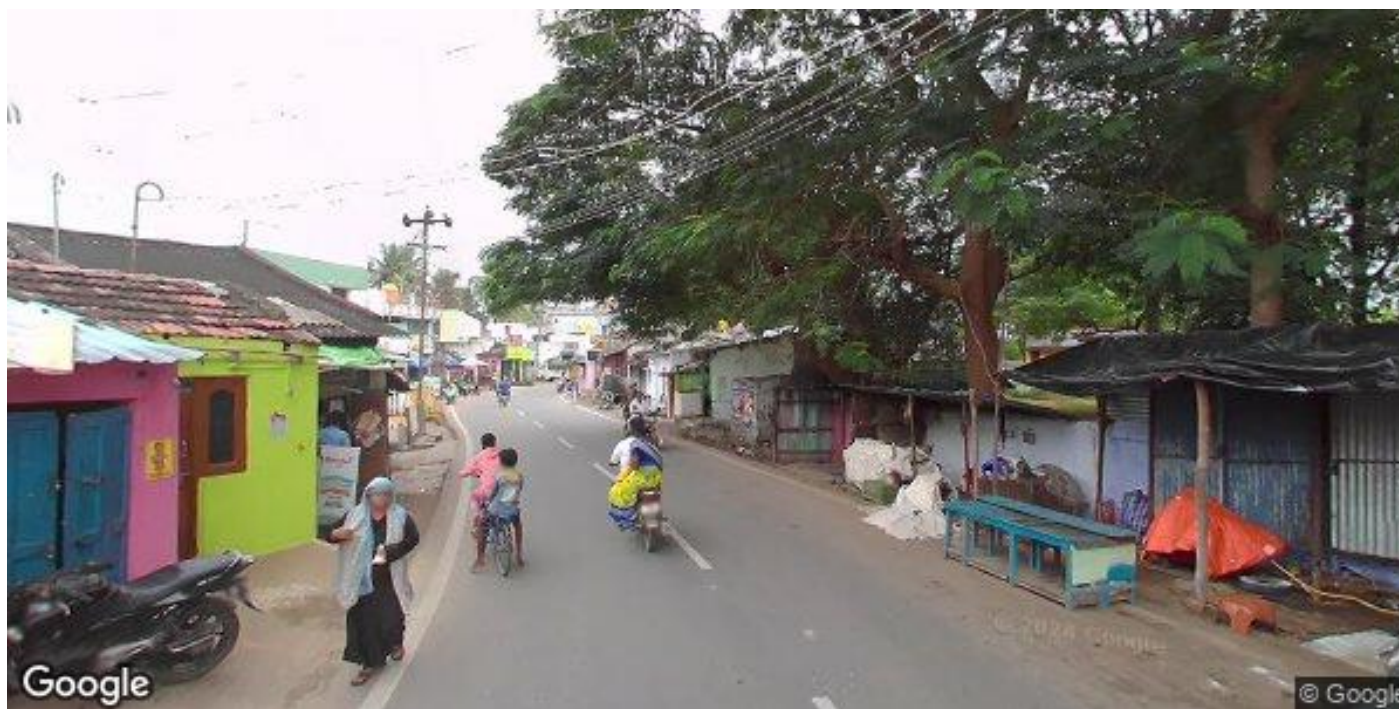
**Risk Type:** Turn  
**Risk Level:** Medium  
**Speed Limit:** 30 KM/Hr  
**Coordinates:** 12.04958, 78.48314

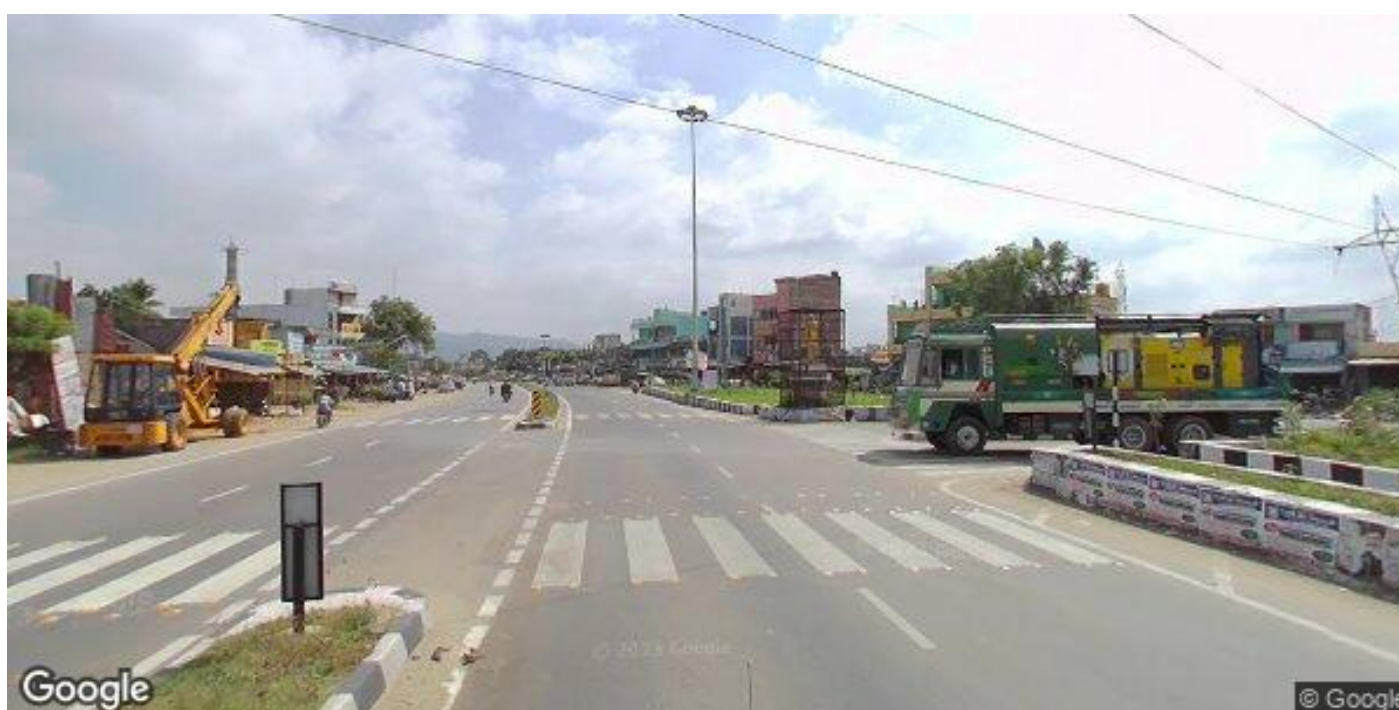
**Risk Type:** Turn  
**Risk Level:** Medium  
**Speed Limit:** 30 KM/Hr  
**Coordinates:** 12.06149, 78.47722

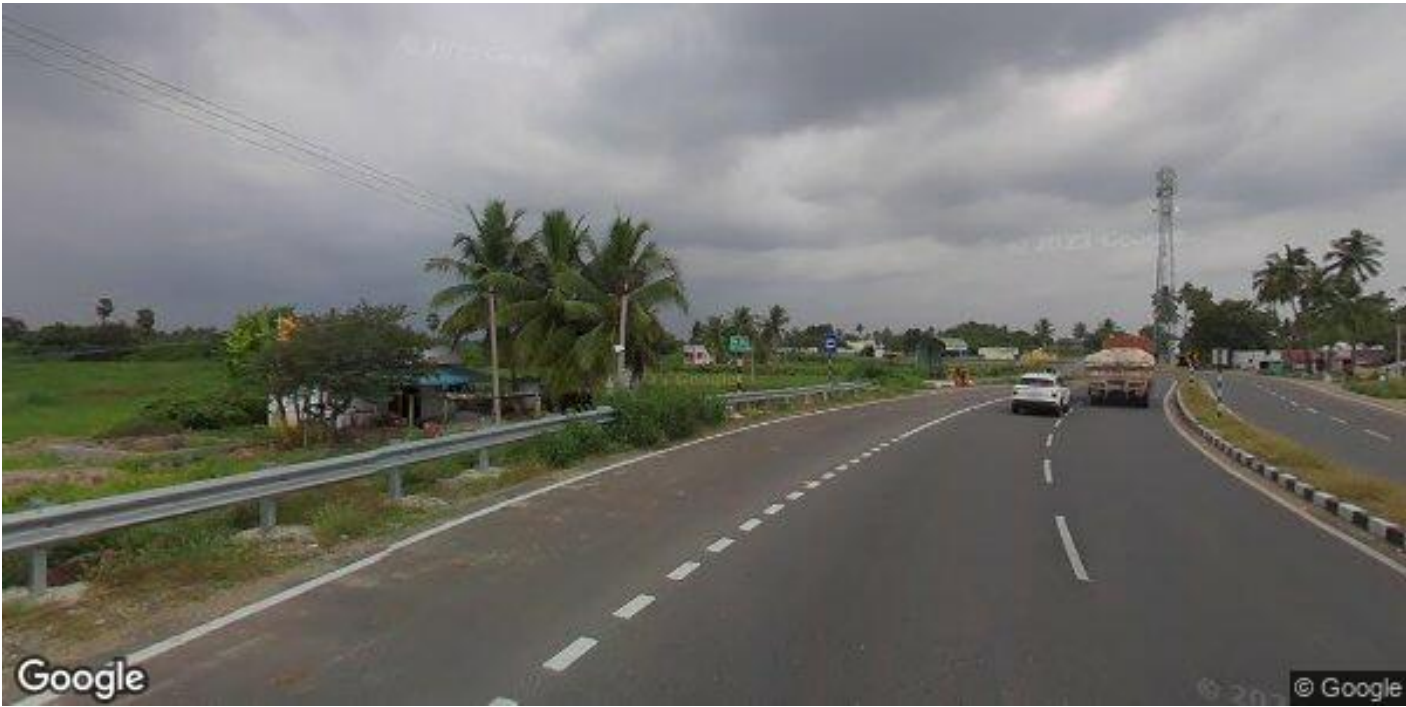
**Risk Type:** Turn  
**Risk Level:** Medium  
**Speed Limit:** 30 KM/Hr  
**Coordinates:** 12.20953, 78.54358

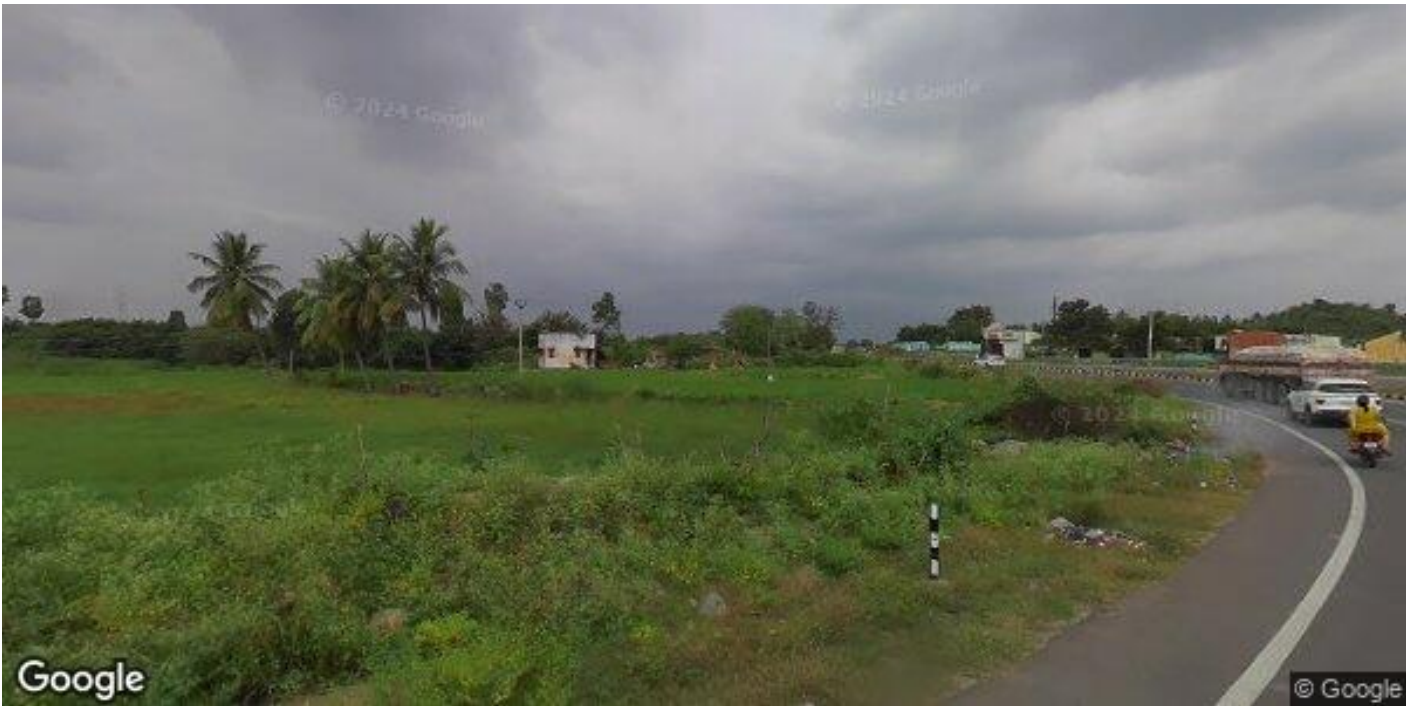
**Risk Type:** Turn  
**Risk Level:** High  
**Speed Limit:** 15 KM/Hr  
**Coordinates:** 12.21030, 78.54402

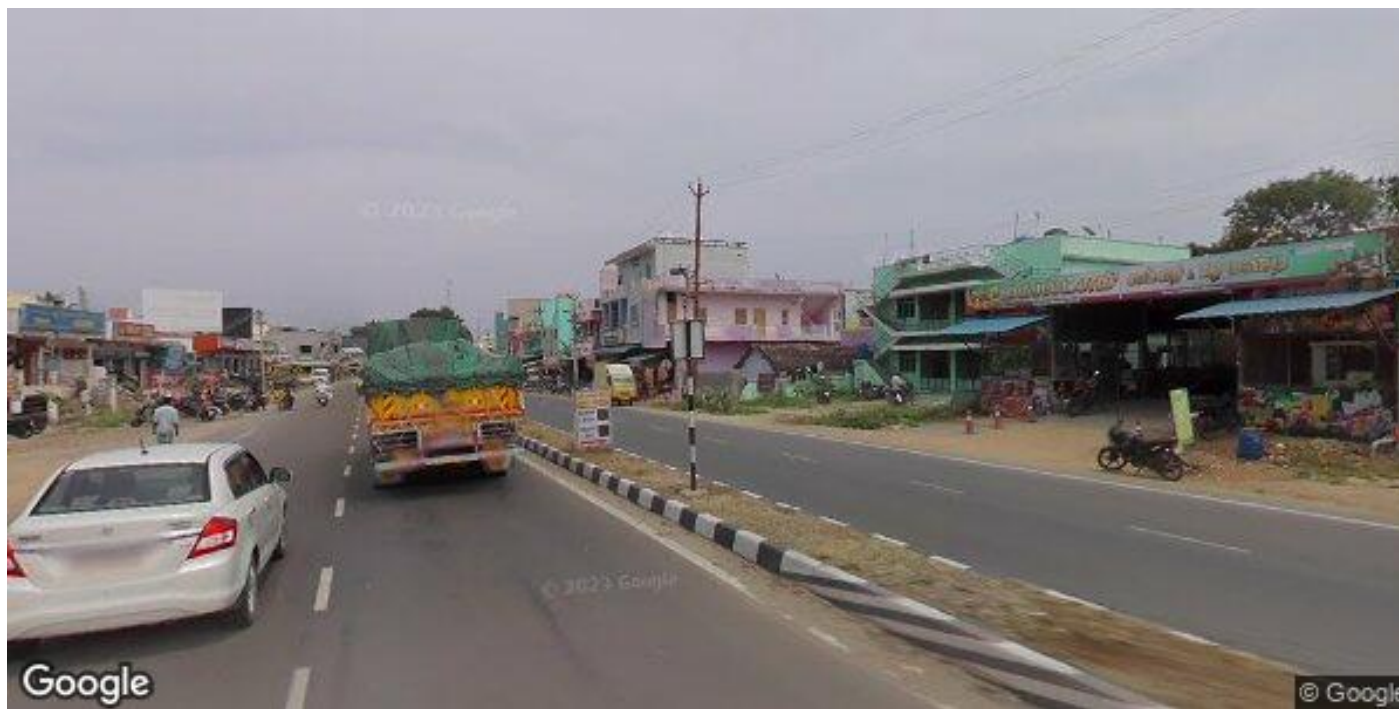
**Risk Type:** Turn  
**Risk Level:** Medium  
**Speed Limit:** 30 KM/Hr  
**Coordinates:** 12.25956, 78.53301

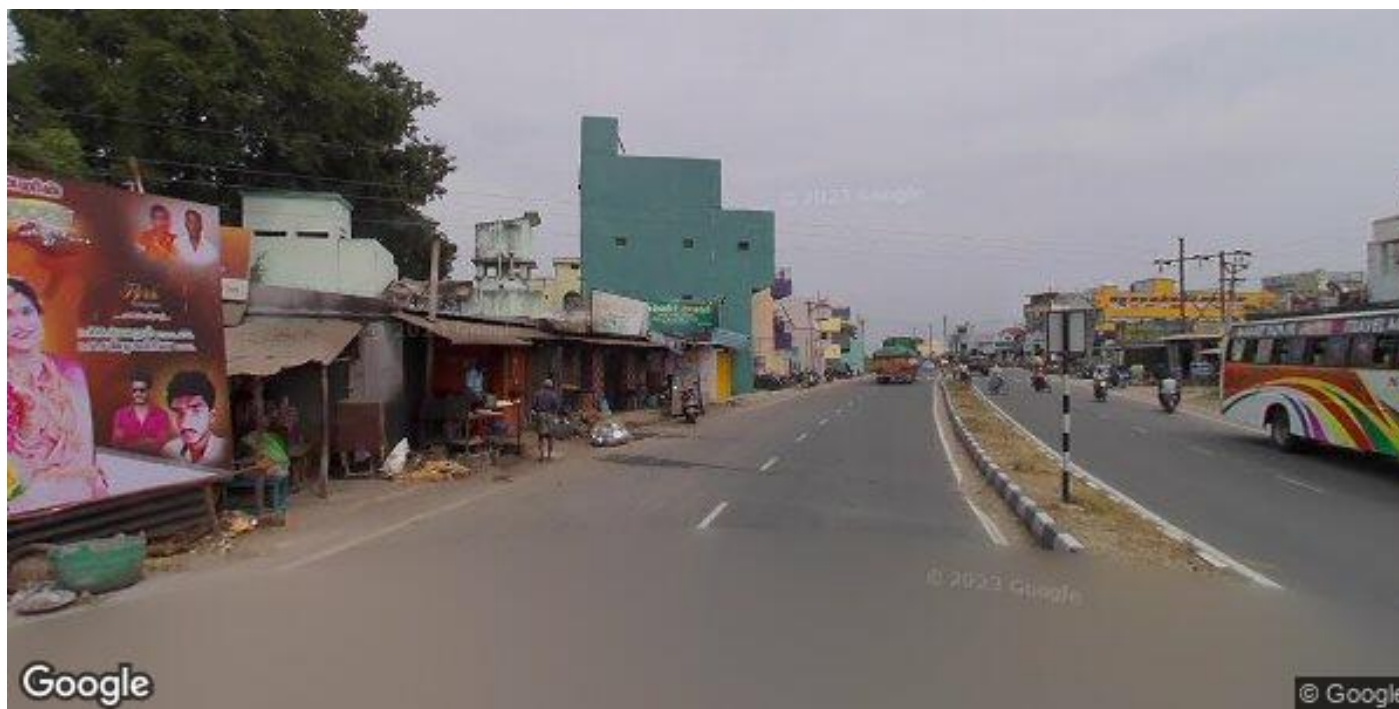
**Risk Type:** Turn  
**Risk Level:** Medium  
**Speed Limit:** 30 KM/Hr  
**Coordinates:** 12.26092, 78.53324

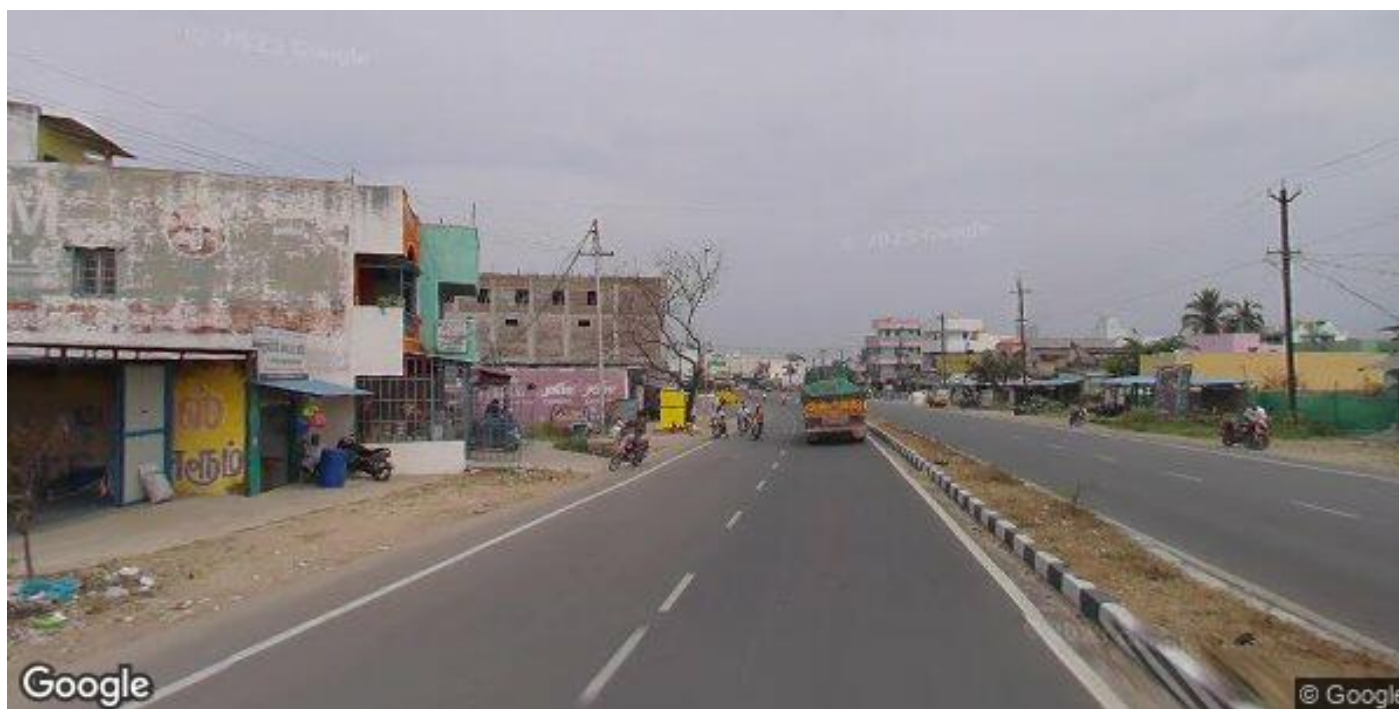
**Risk Type:** Turn  
**Risk Level:** Medium  
**Speed Limit:** 30 KM/Hr  
**Coordinates:** 12.26207, 78.53436

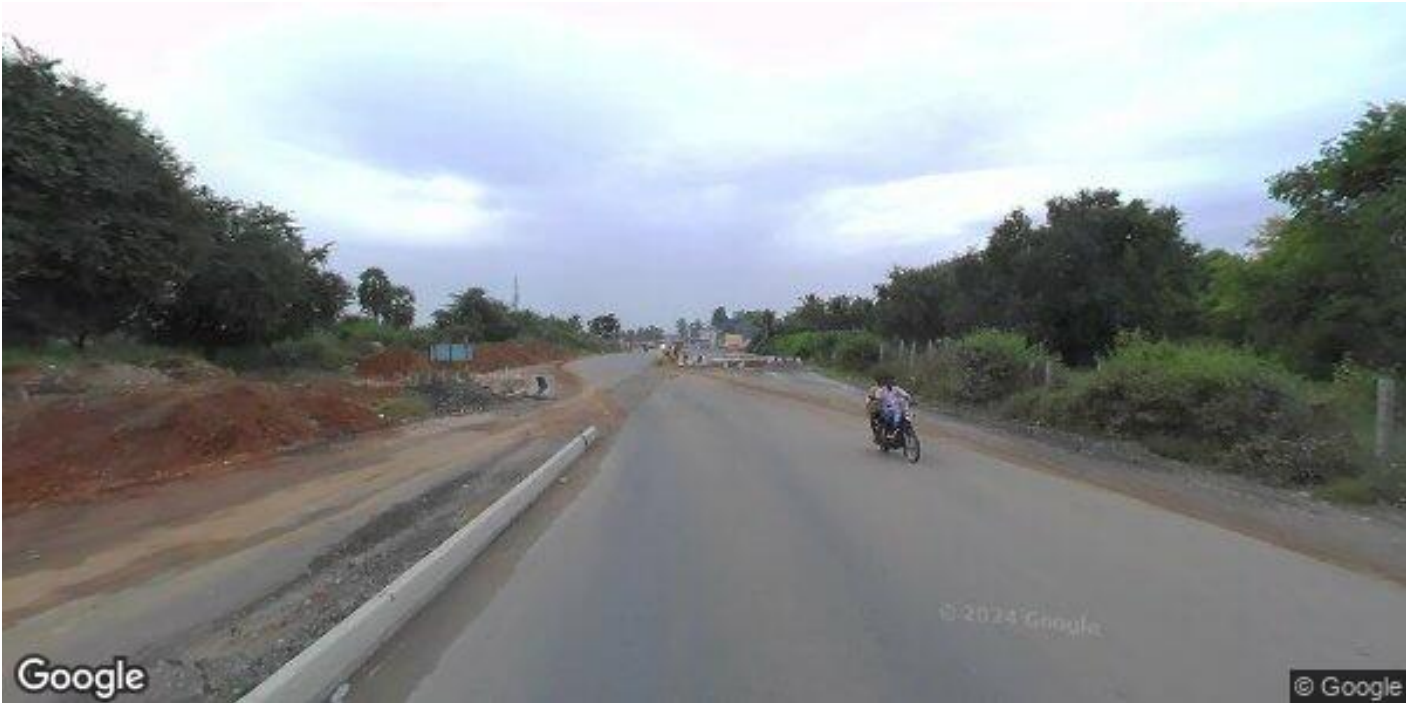
**Risk Type:** Turn  
**Risk Level:** Medium  
**Speed Limit:** 30 KM/Hr  
**Coordinates:** 12.31095, 78.53818

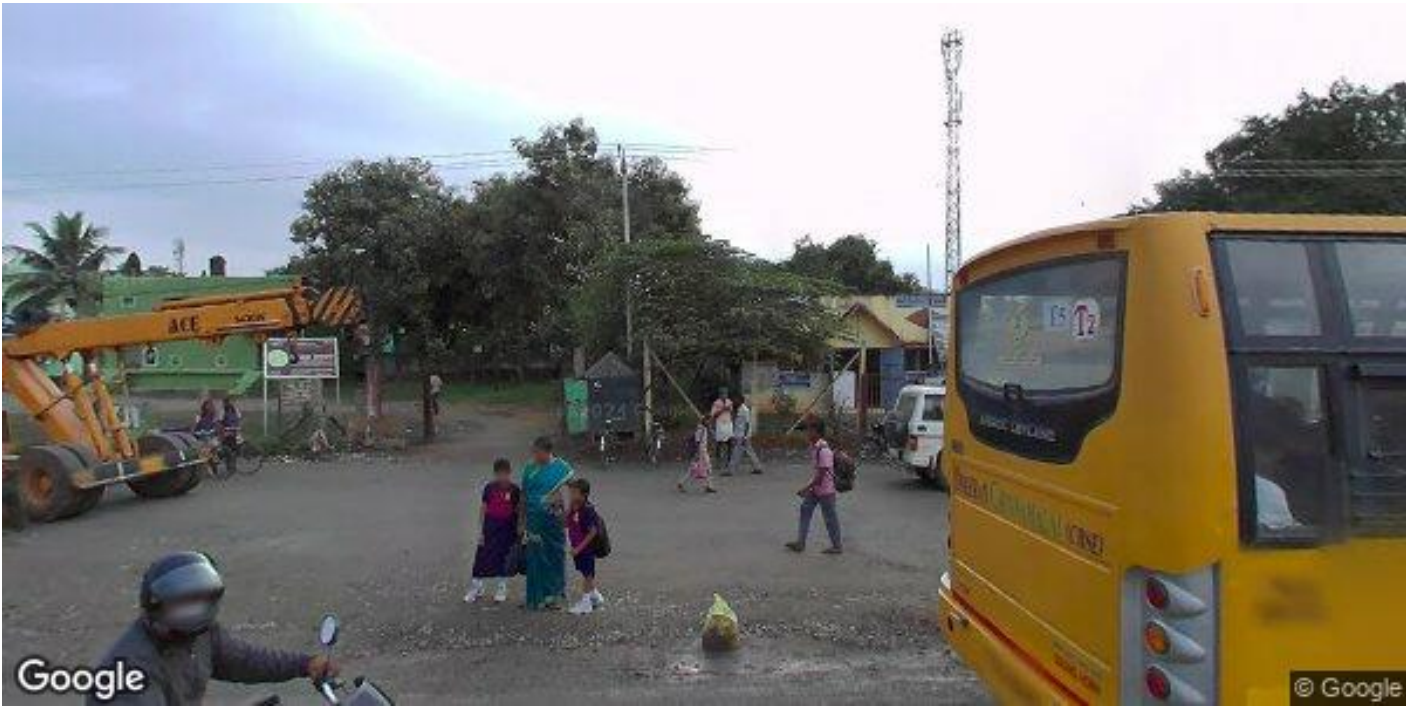
**Risk Type:** Turn  
**Risk Level:** High  
**Speed Limit:** 15 KM/Hr  
**Coordinates:** 12.36356, 78.54371
