# IndianOil

## JOURNEY RISK MANAGEMENT (JRM) STUDY

### Salem Terminal TO SRI DHANALAKSHMI AGENCIES

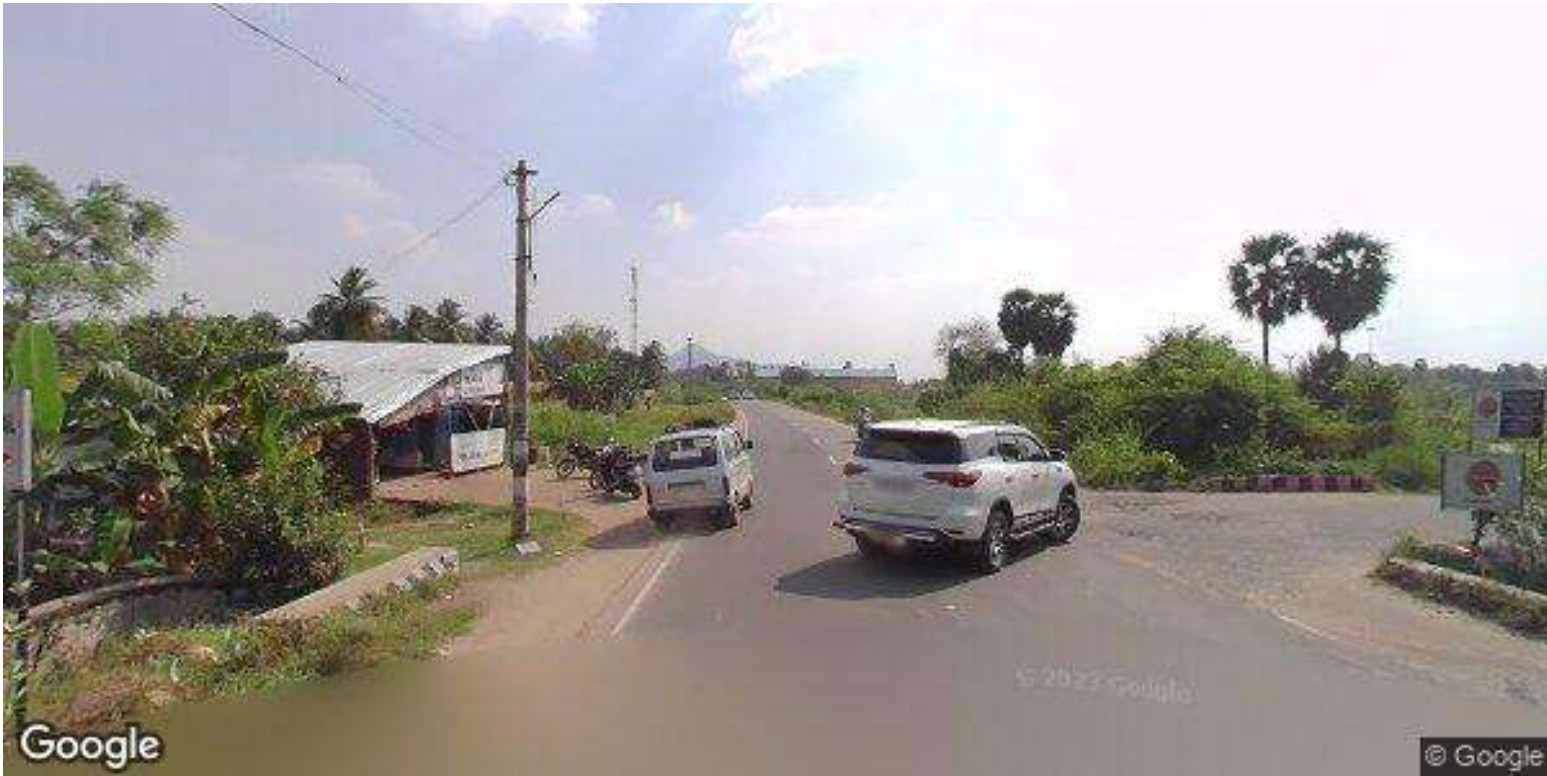
Coordinates: 11.44029, 77.87544

Risk Type: Turn

Risk Level: High

Speed Limit: 15 KM/Hr

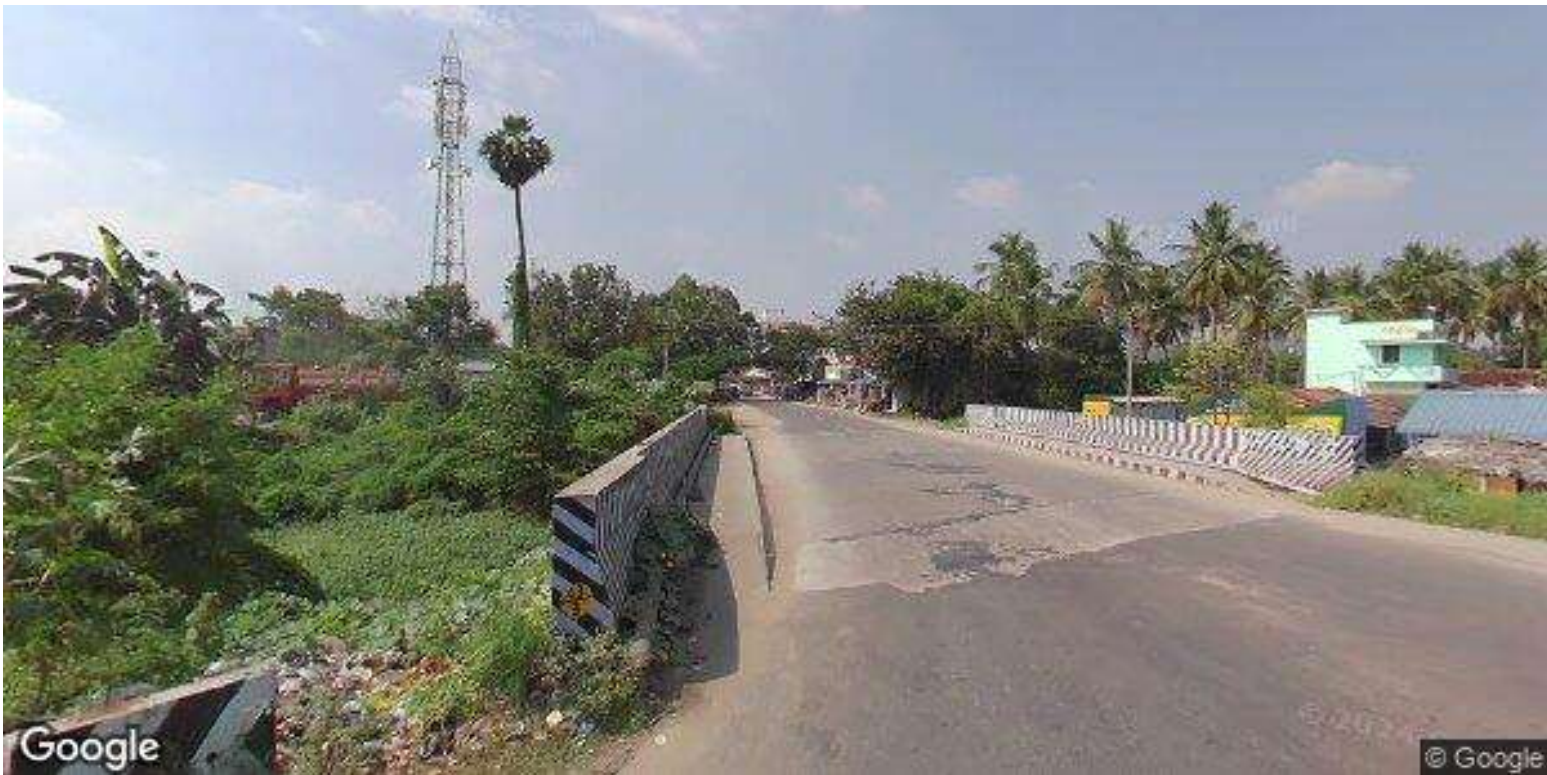
Coordinates: 11.44900, 77.87406

Risk Type: Turn

Risk Level: Medium

Speed Limit: 30 KM/Hr

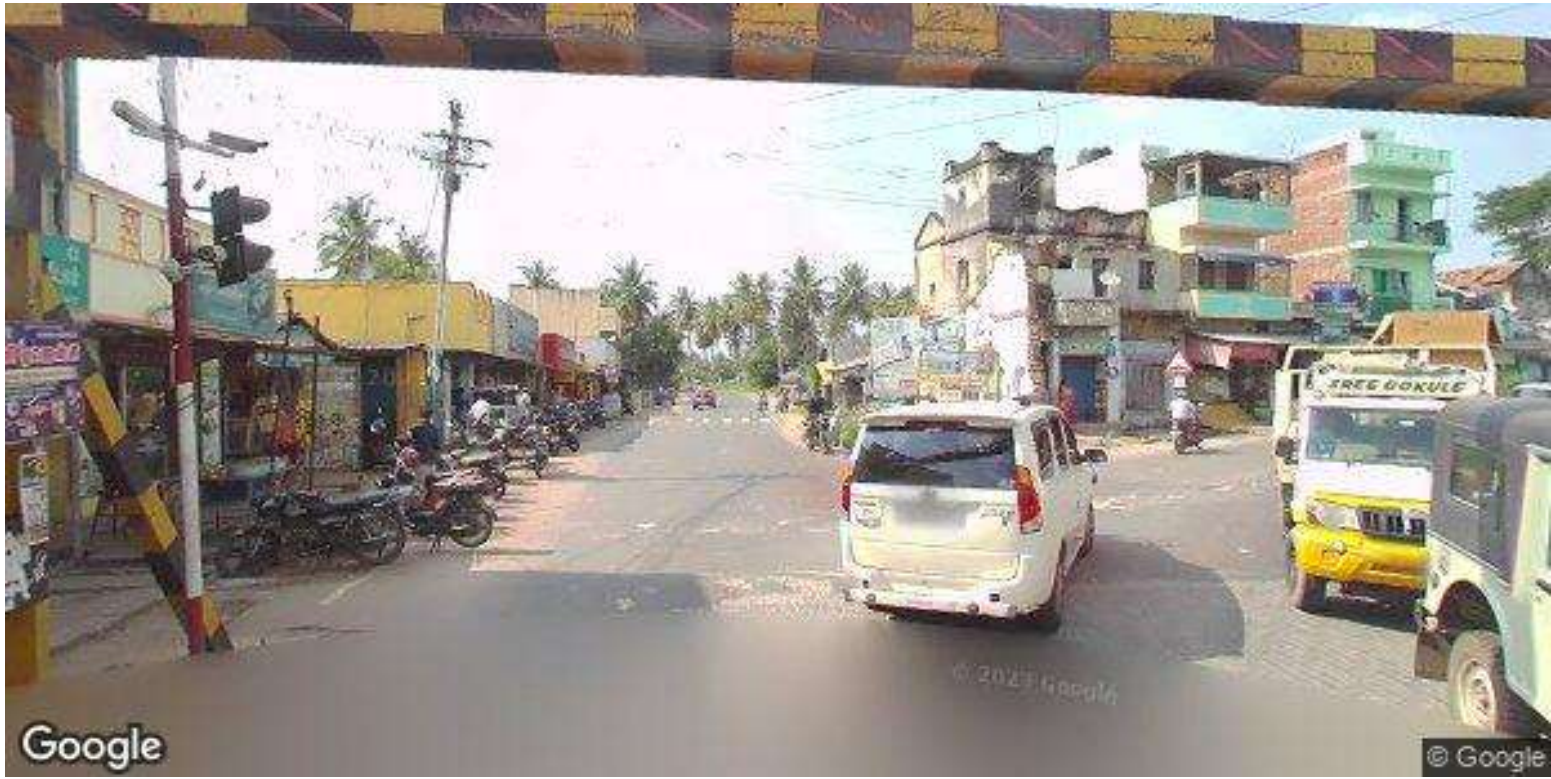
Risk Type: Turn  
Risk Level: High  
Speed Limit: 15 KM/Hr  
Coordinates: 11.45004, 77.87206

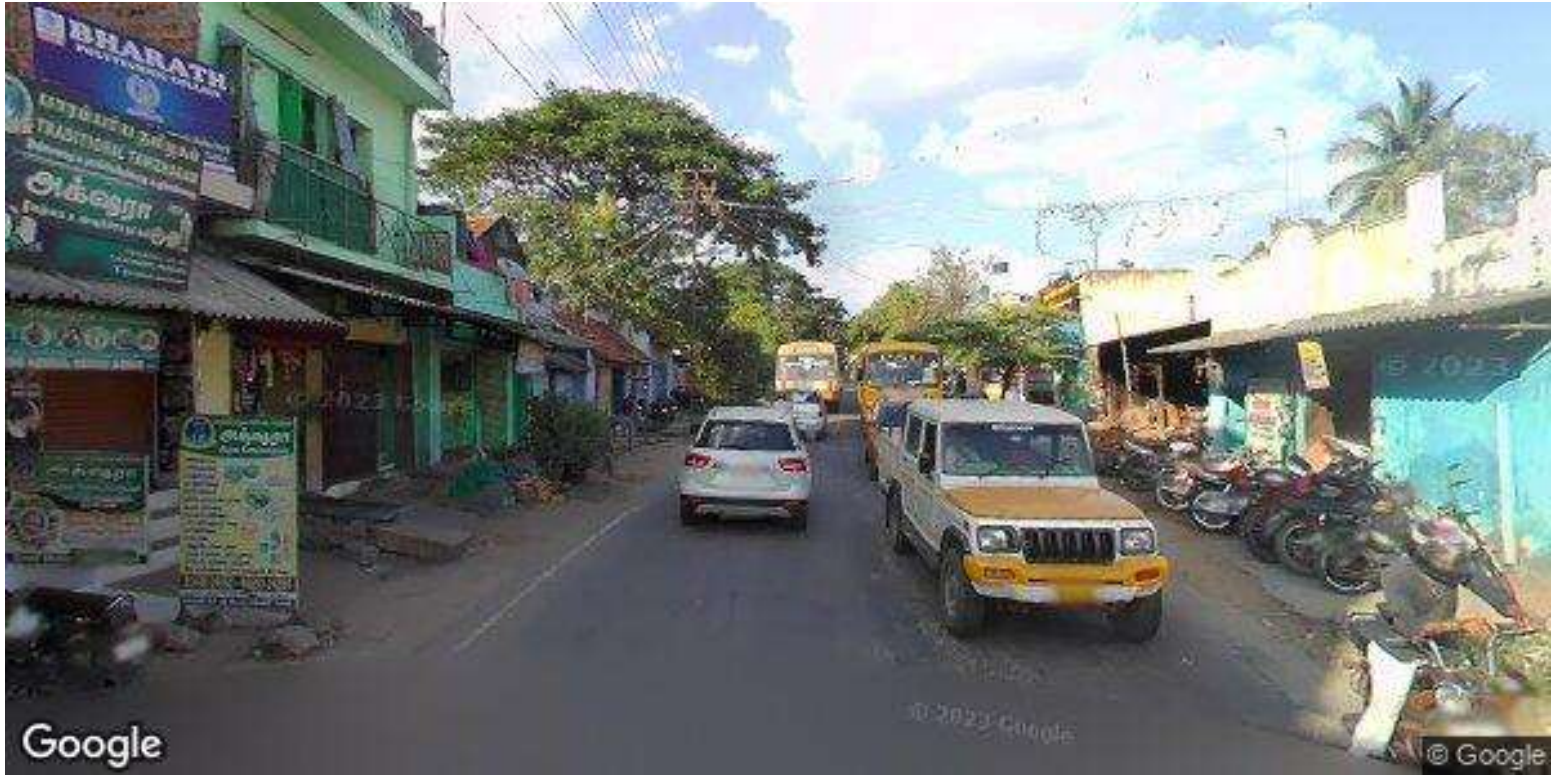
Risk Type: Turn  
Risk Level: Medium  
Speed Limit: 30 KM/Hr  
Coordinates: 11.45028, 77.87202

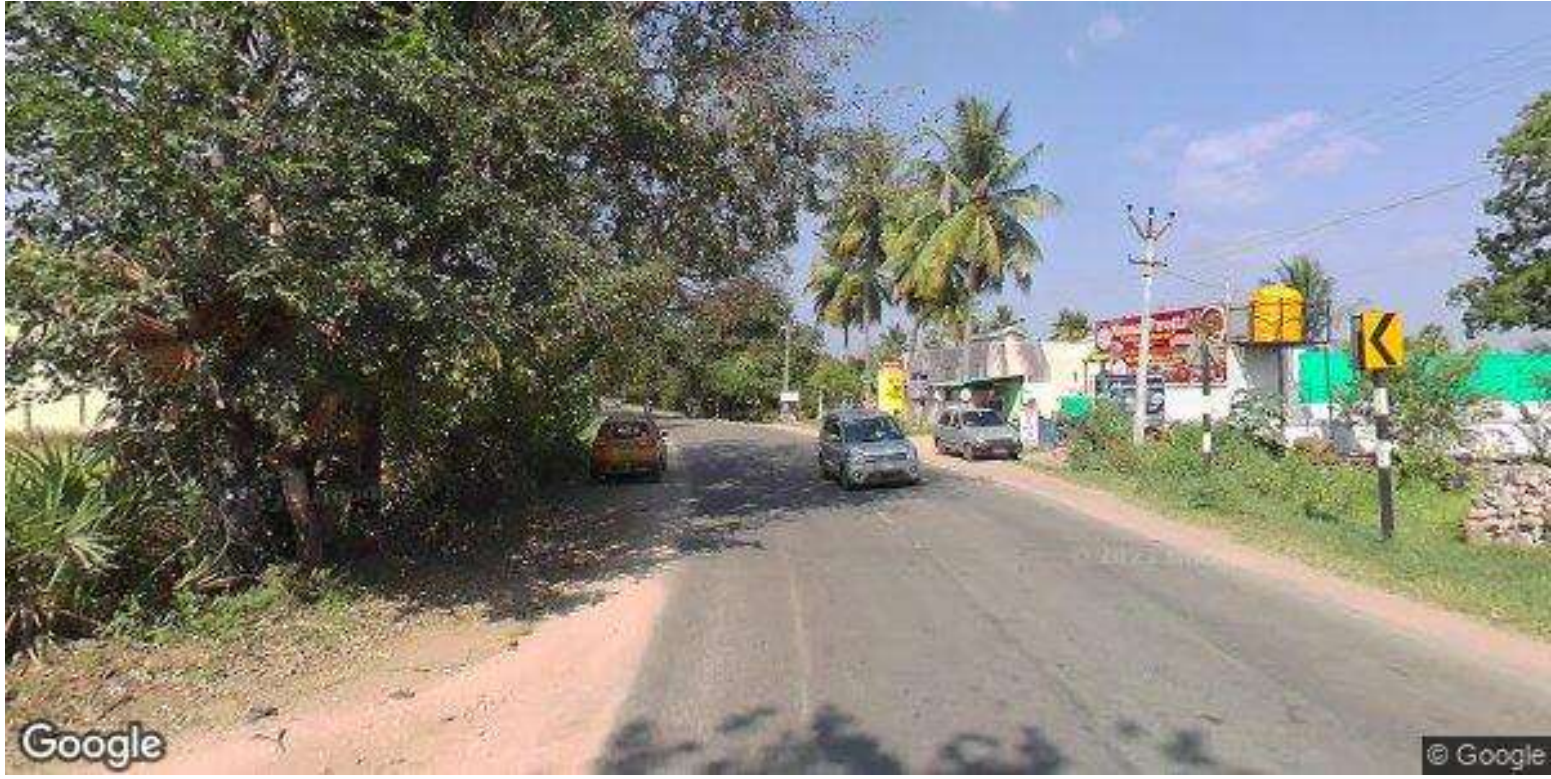
**Risk Type:** Turn  
**Risk Level:** Medium  
**Speed Limit:** 30 KM/Hr  
**Coordinates:** 11.45309, 77.87325

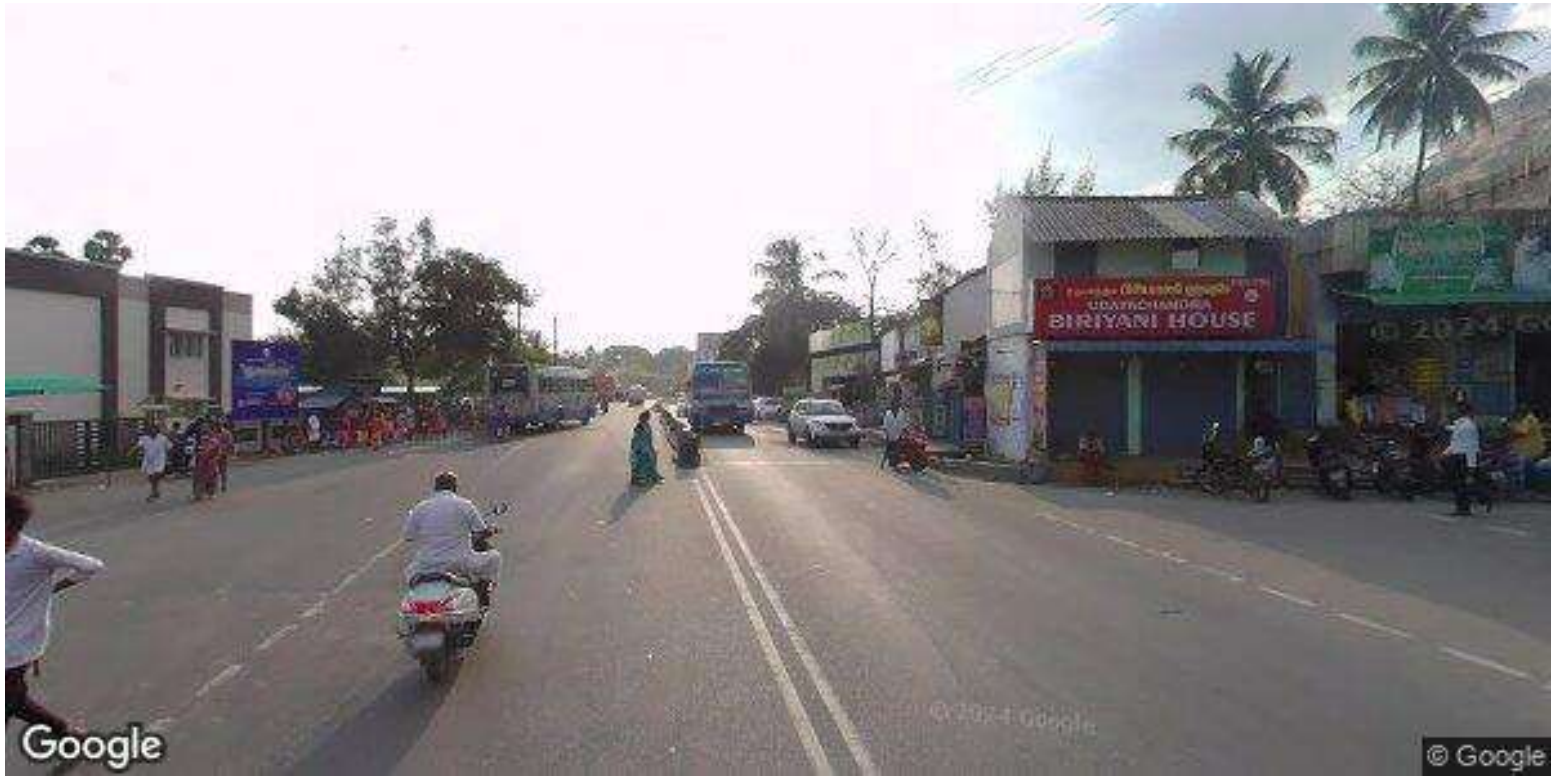
**Risk Type:** Turn  
**Risk Level:** High  
**Speed Limit:** 15 KM/Hr  
**Coordinates:** 11.47403, 77.86841

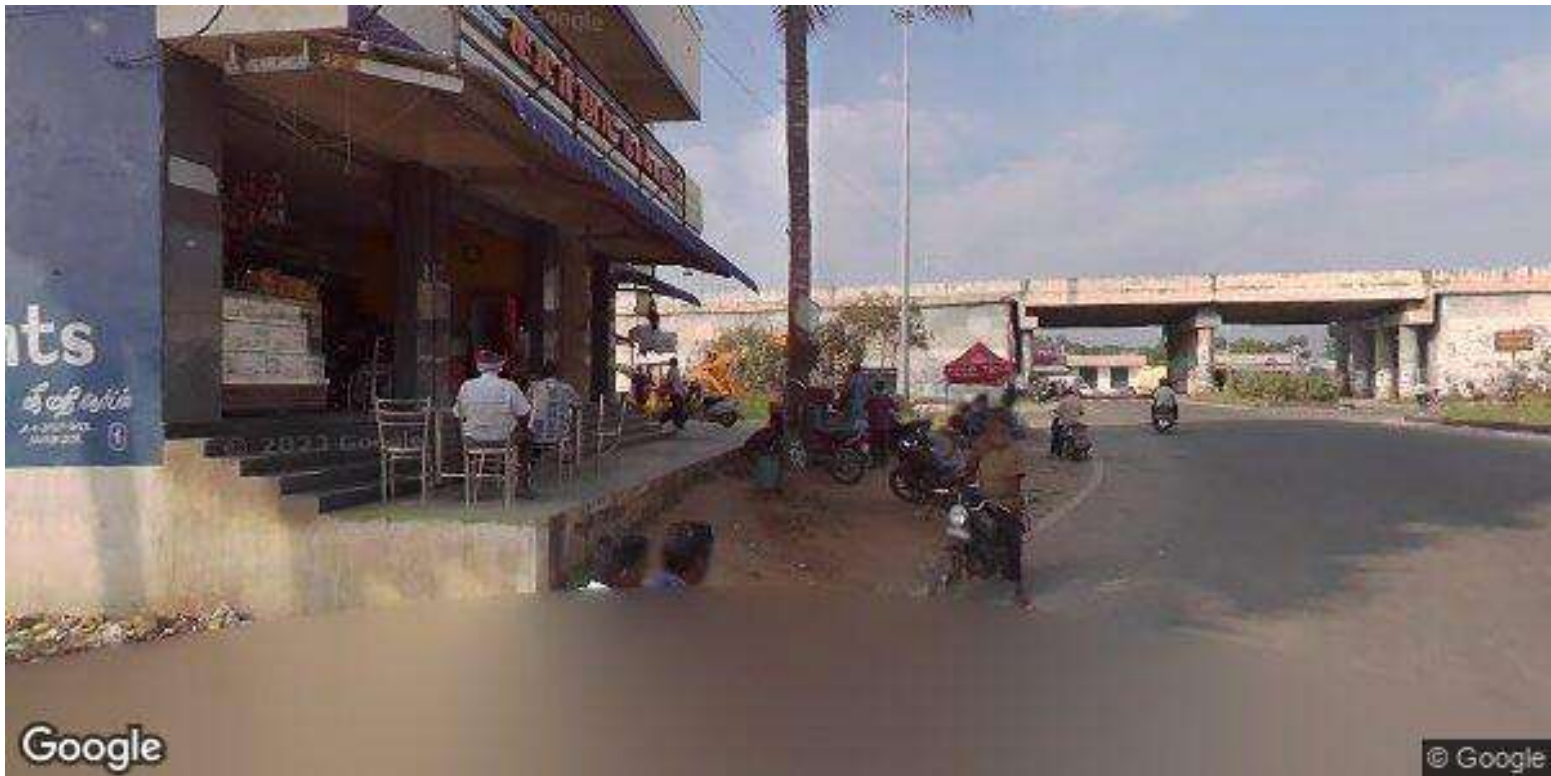
**Risk Type:** Turn  
**Risk Level:** High  
**Speed Limit:** 15 KM/Hr  
**Coordinates:** 11.49149, 77.89601

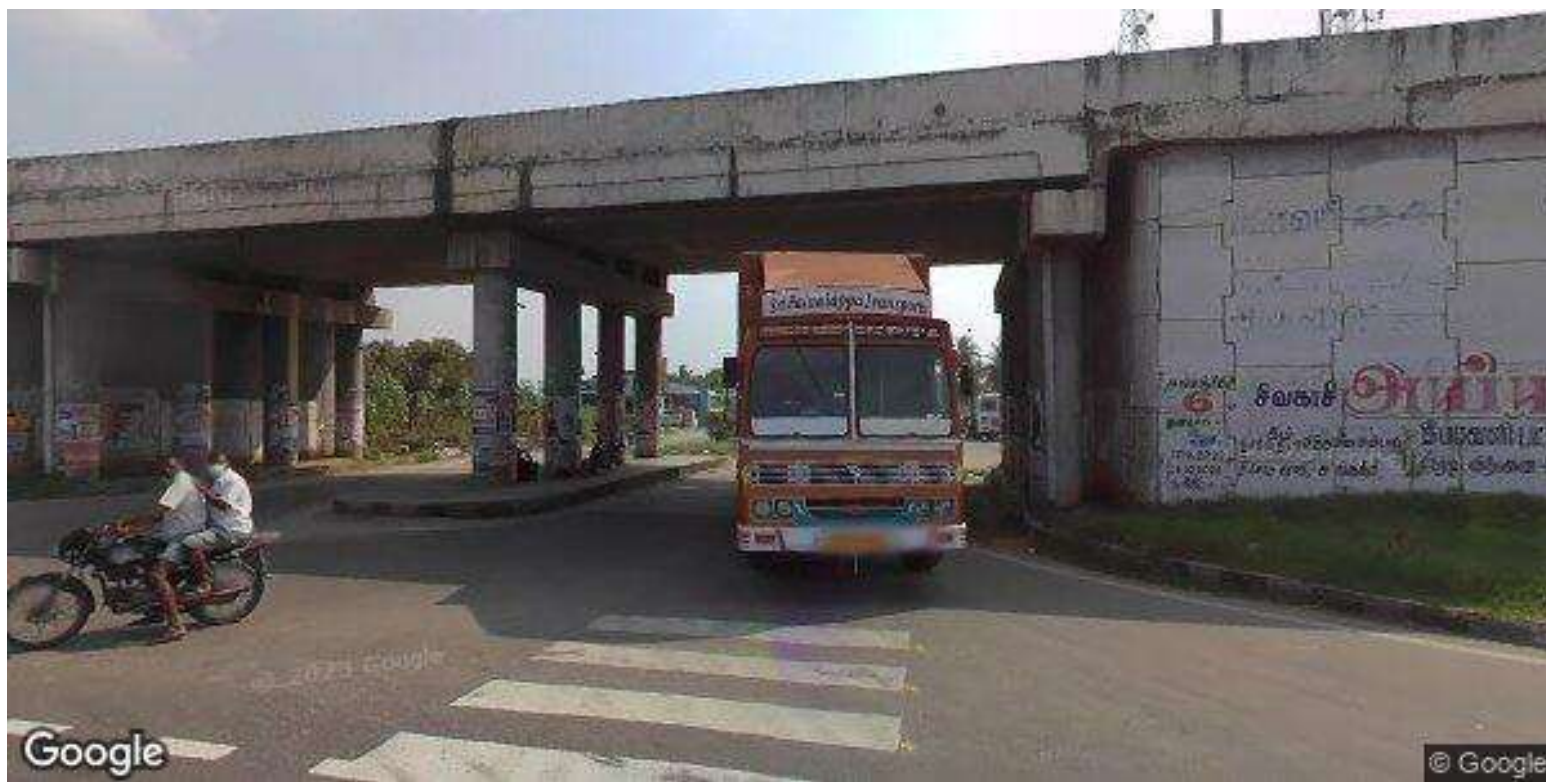
**Coordinates:** 11.49224, 77.89601

**Risk Type:** Turn

**Risk Level:** High

**Speed Limit:** 15 KM/Hr

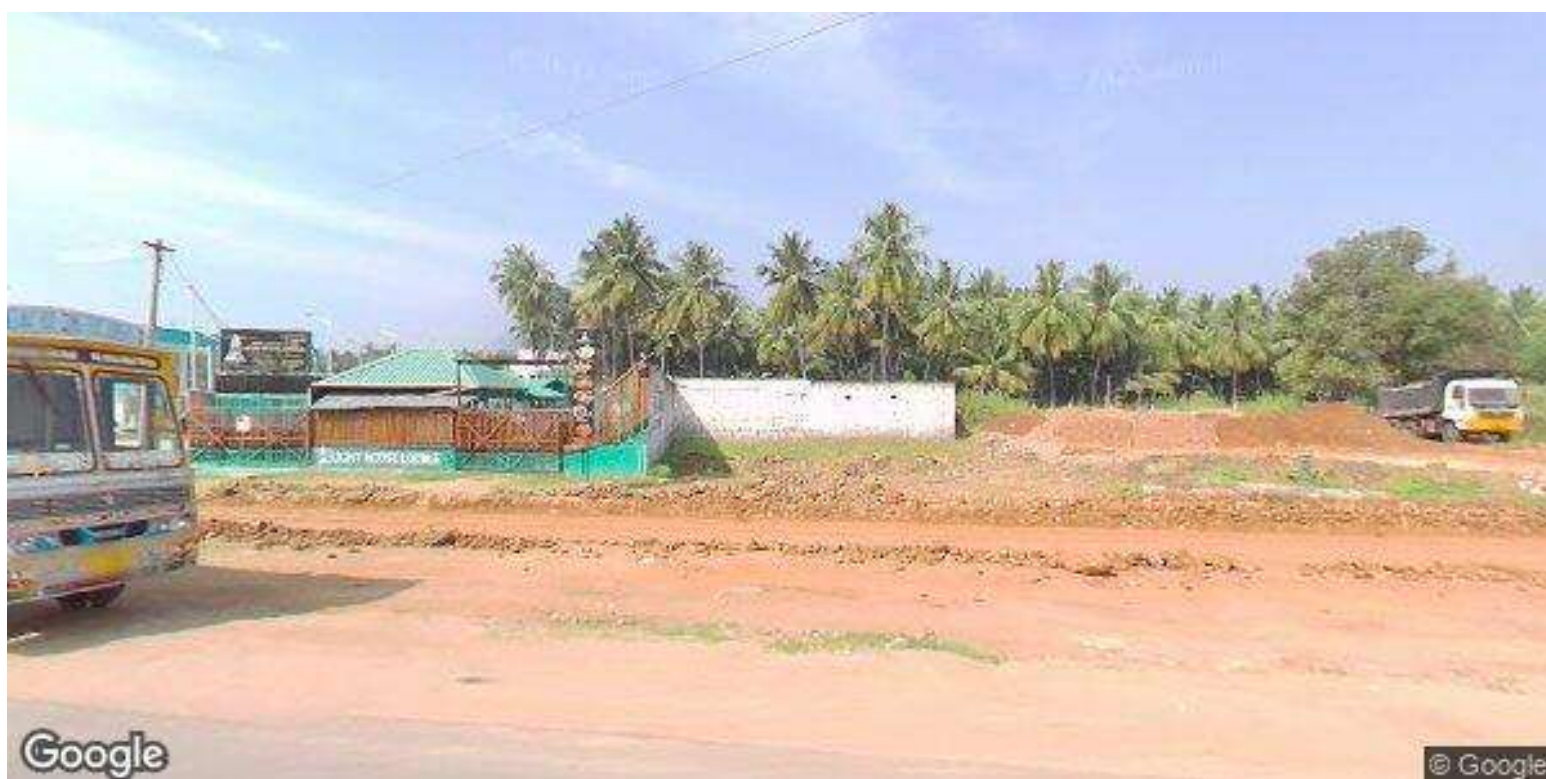
**Coordinates:** 11.61736, 78.10588

**Risk Type:** Turn

**Risk Level:** Medium

**Speed Limit:** 30 KM/Hr

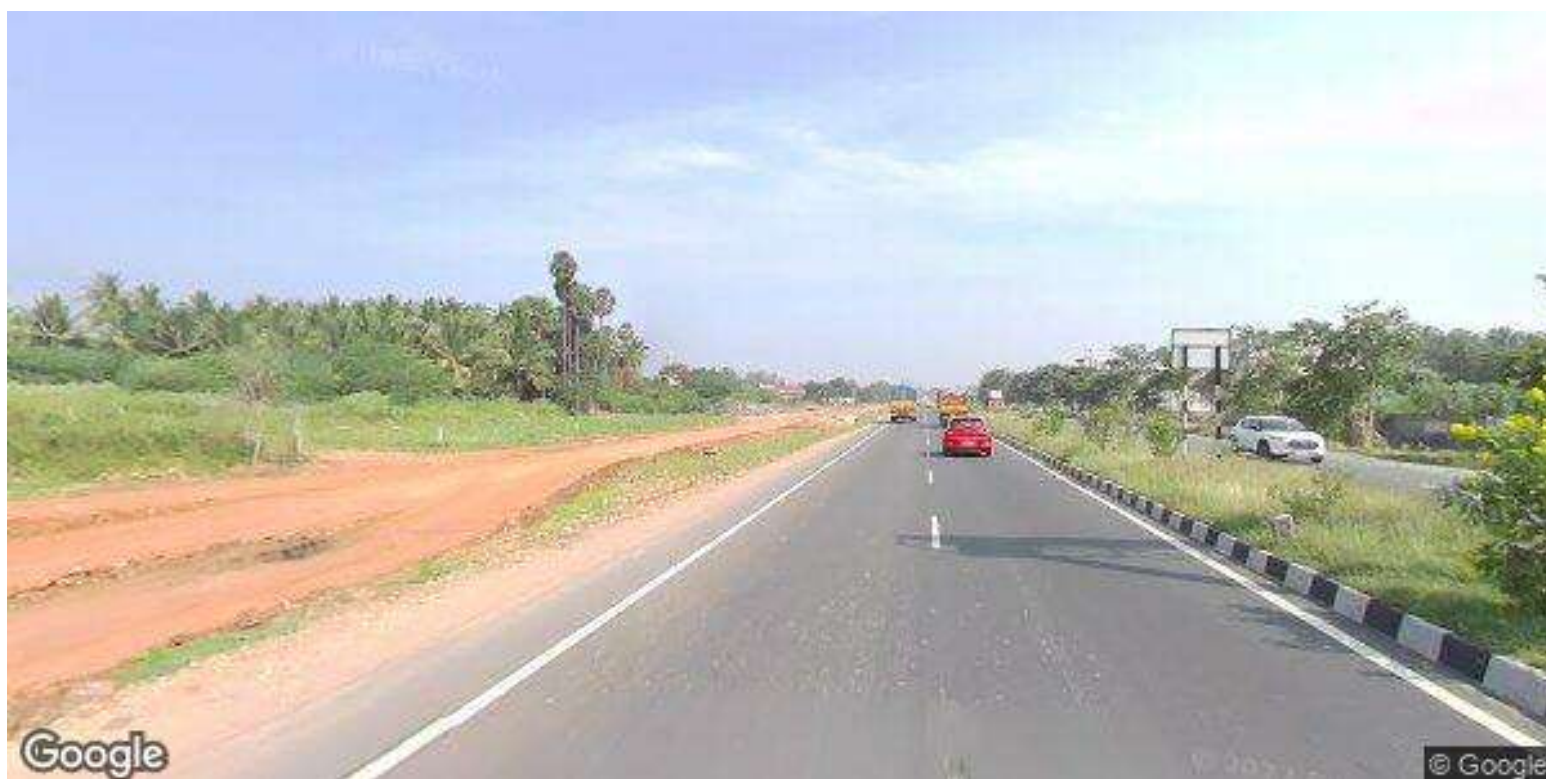
**Coordinates: 11.61753, 78.10608**

**Risk Type: Turn**

**Risk Level: Medium**

**Speed Limit: 30 KM/Hr**

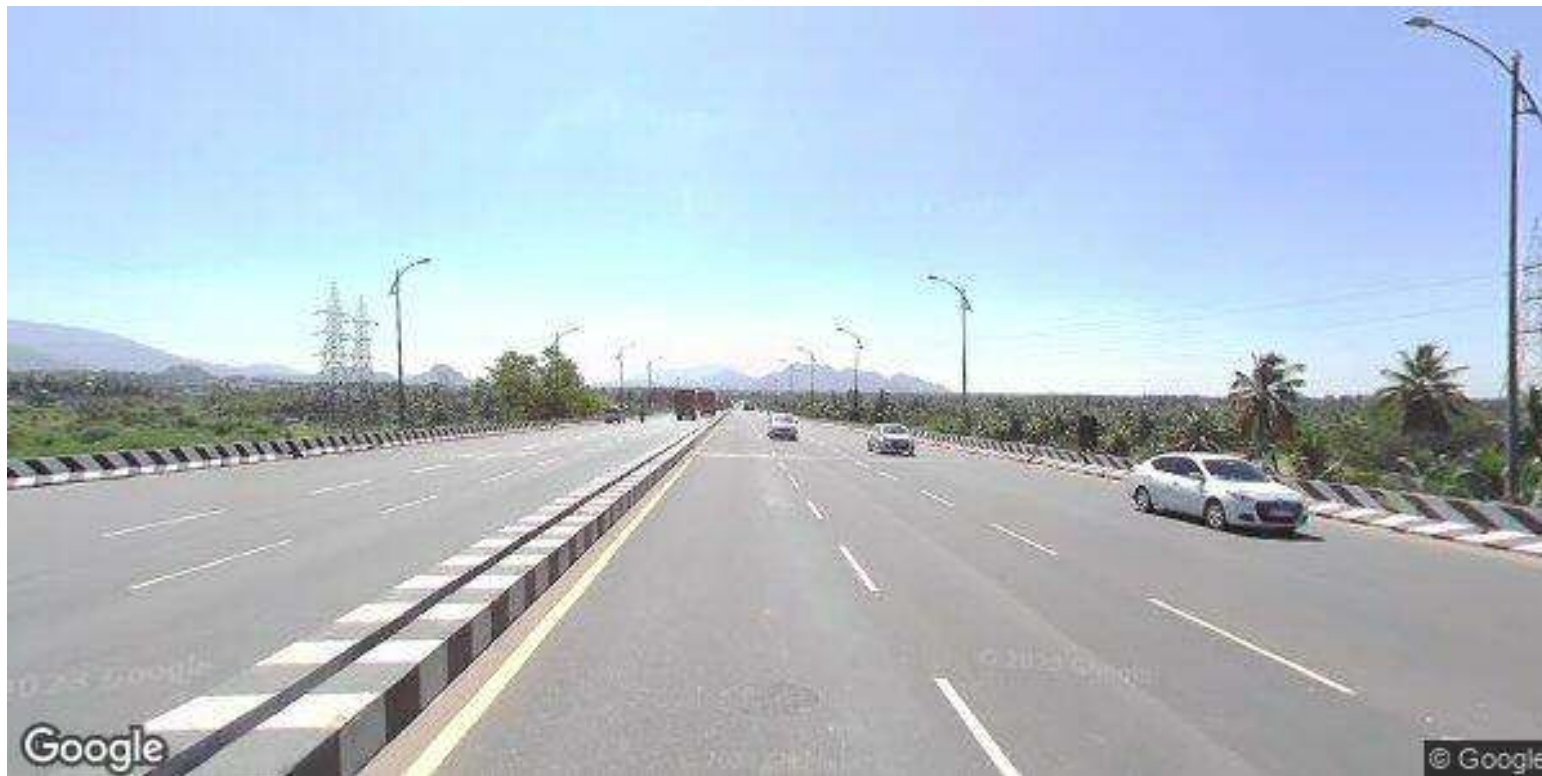
**Coordinates: 11.64007, 78.11794**

**Risk Type: Turn**

**Risk Level: Medium**

**Speed Limit: 30 KM/Hr**

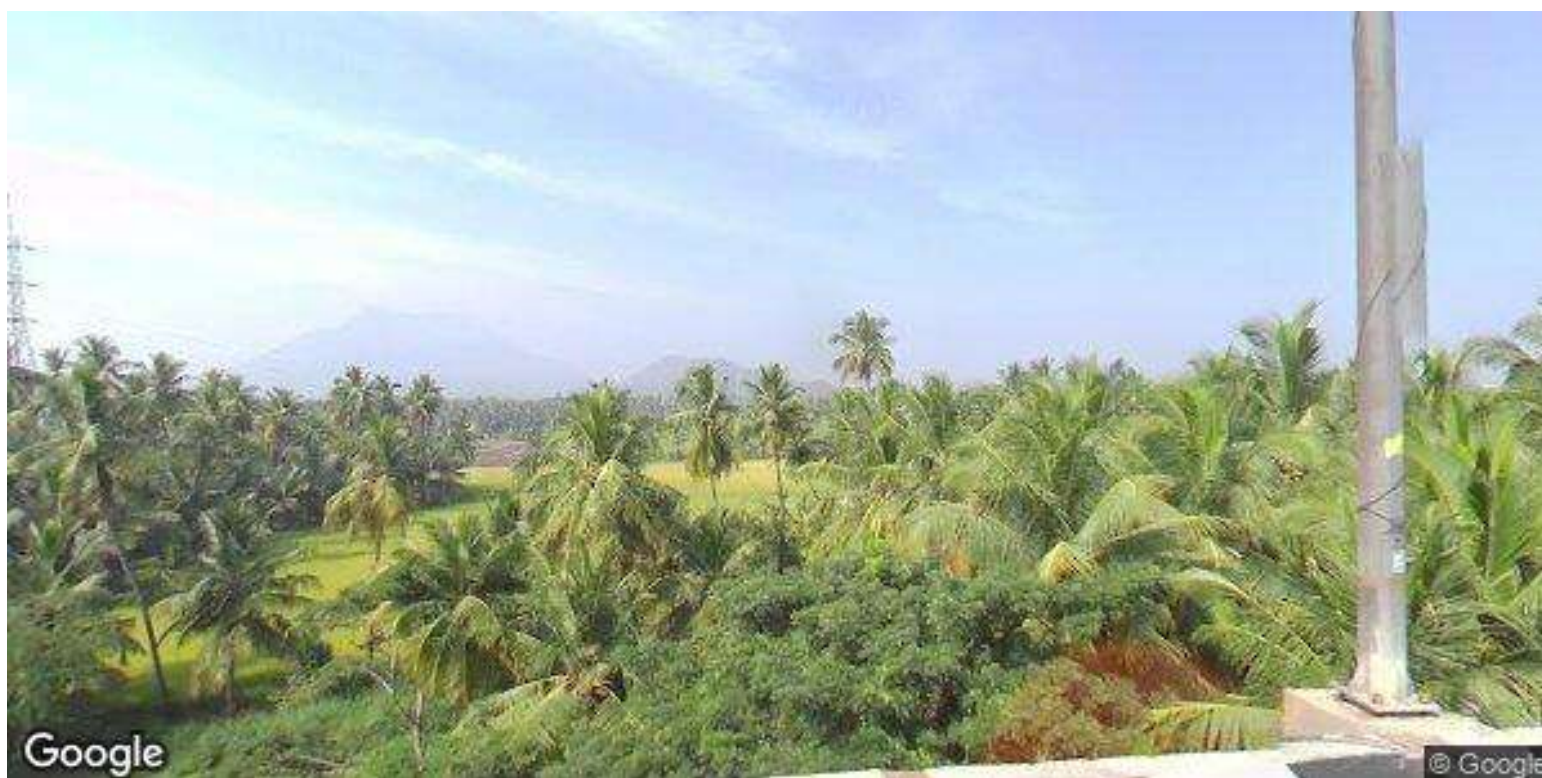
**Coordinates: 11.64020, 78.11786**

**Risk Type: Turn**

**Risk Level: Medium**

**Speed Limit: 30 KM/Hr**

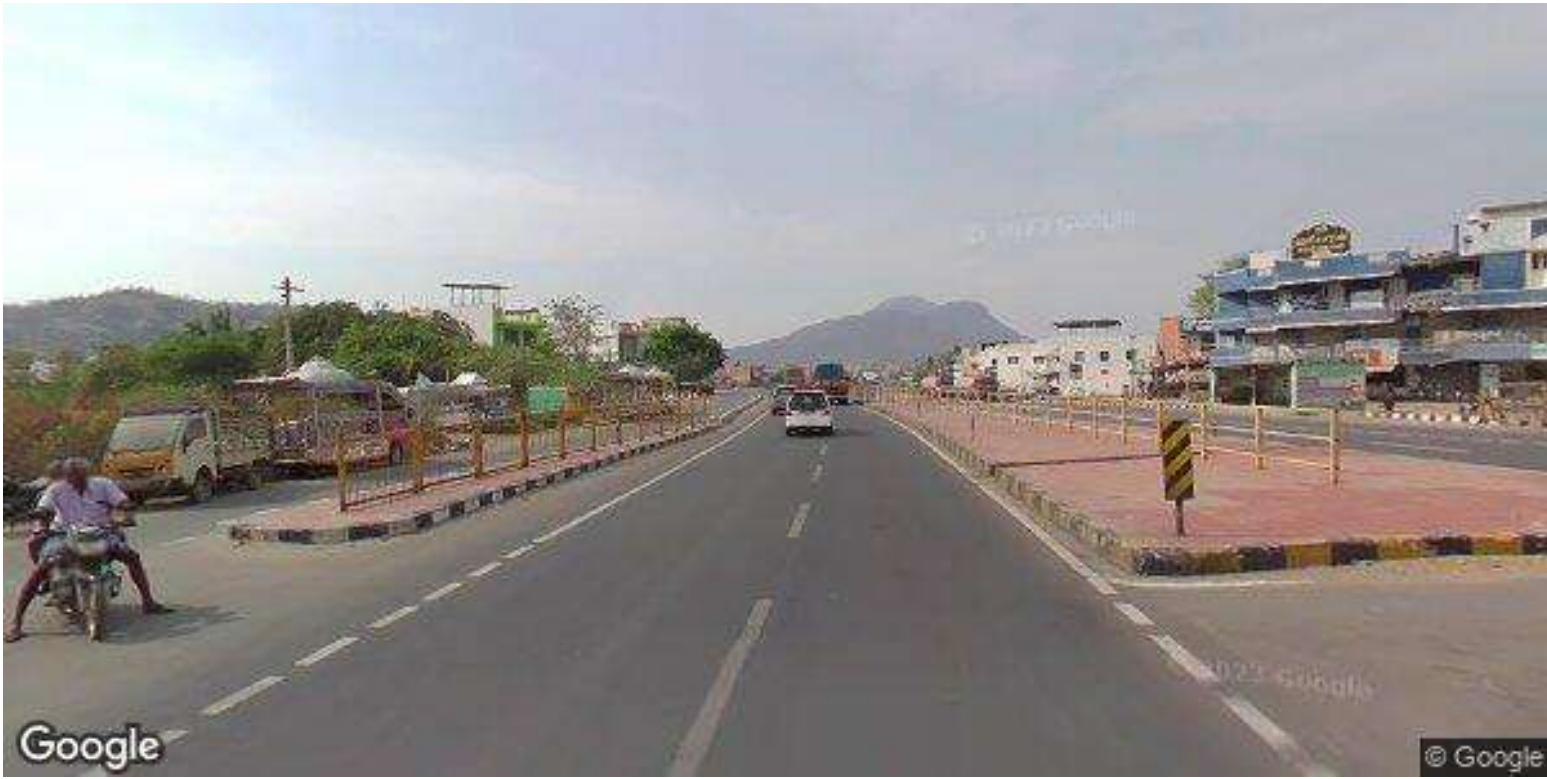
**Risk Type:** Blind Spot  
**Risk Level:** Blind Spot  
**Speed Limit:** 10 KM/Hr  
**Coordinates:** 11.87104, 78.08356

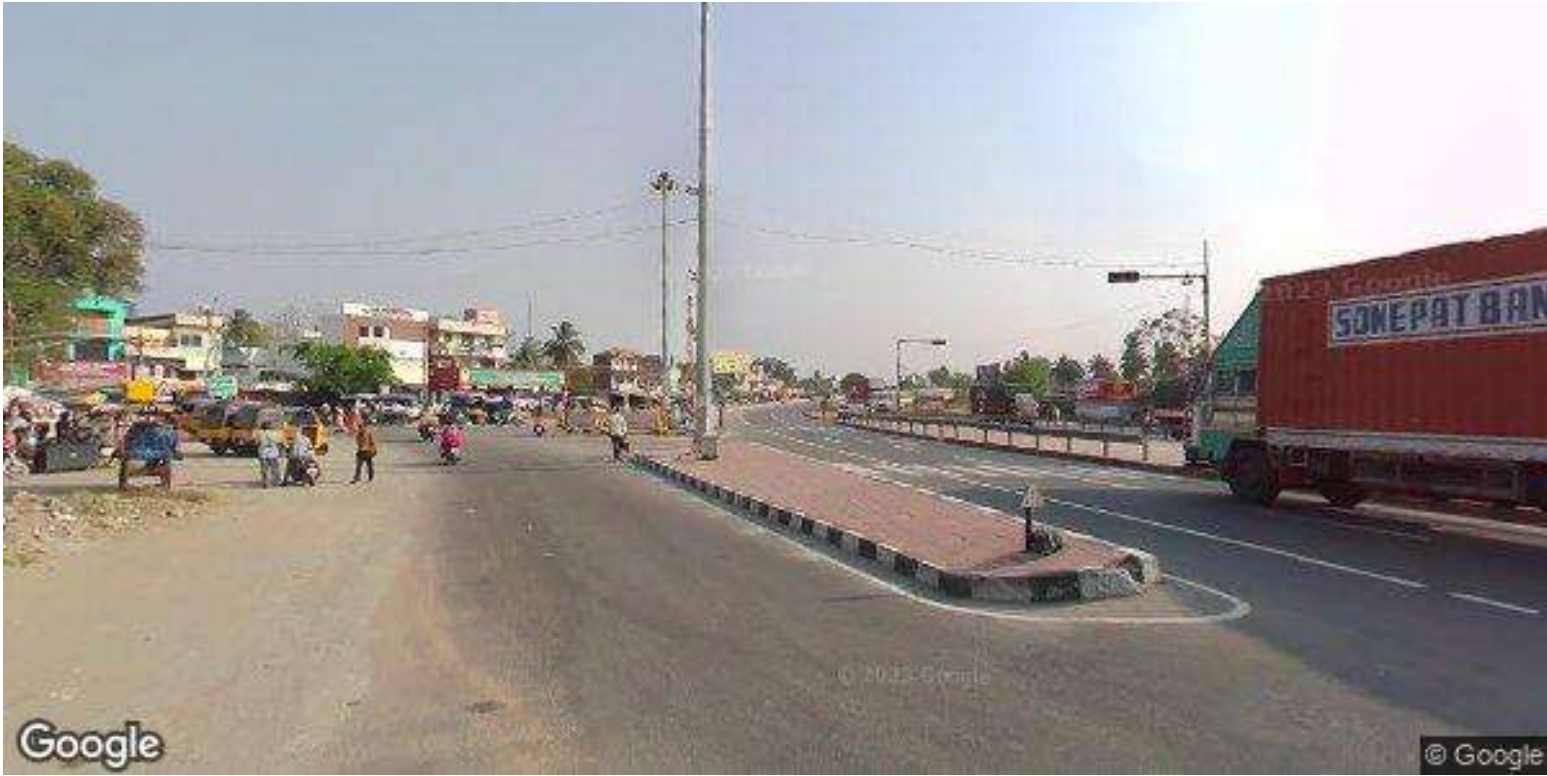
**Risk Type:** Turn  
**Risk Level:** High  
**Speed Limit:** 15 KM/Hr  
**Coordinates:** 11.87111, 78.08382

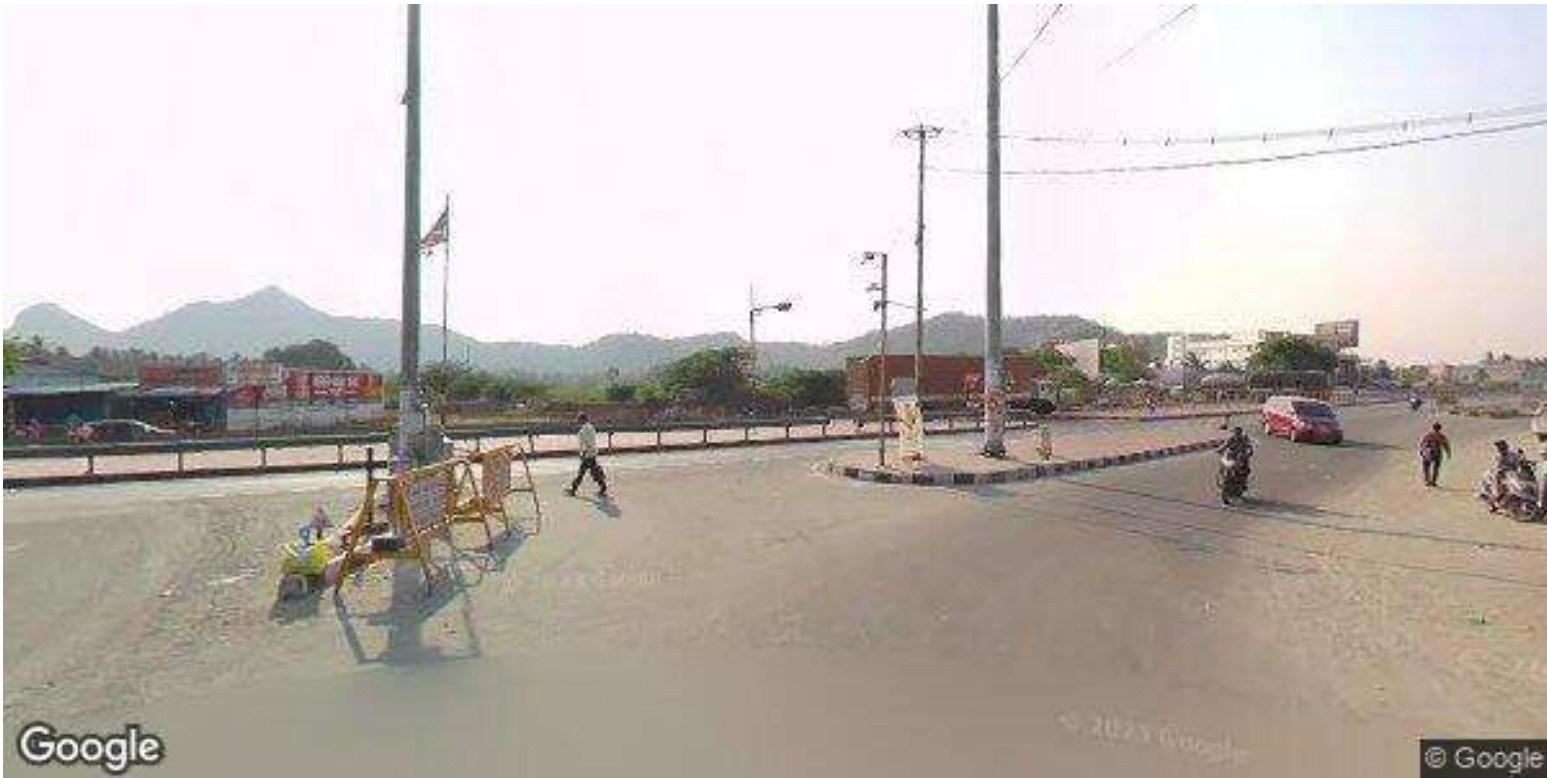
Coordinates: 11.87077, 78.08404

Risk Type: Turn

Risk Level: High

Speed Limit: 15 KM/Hr

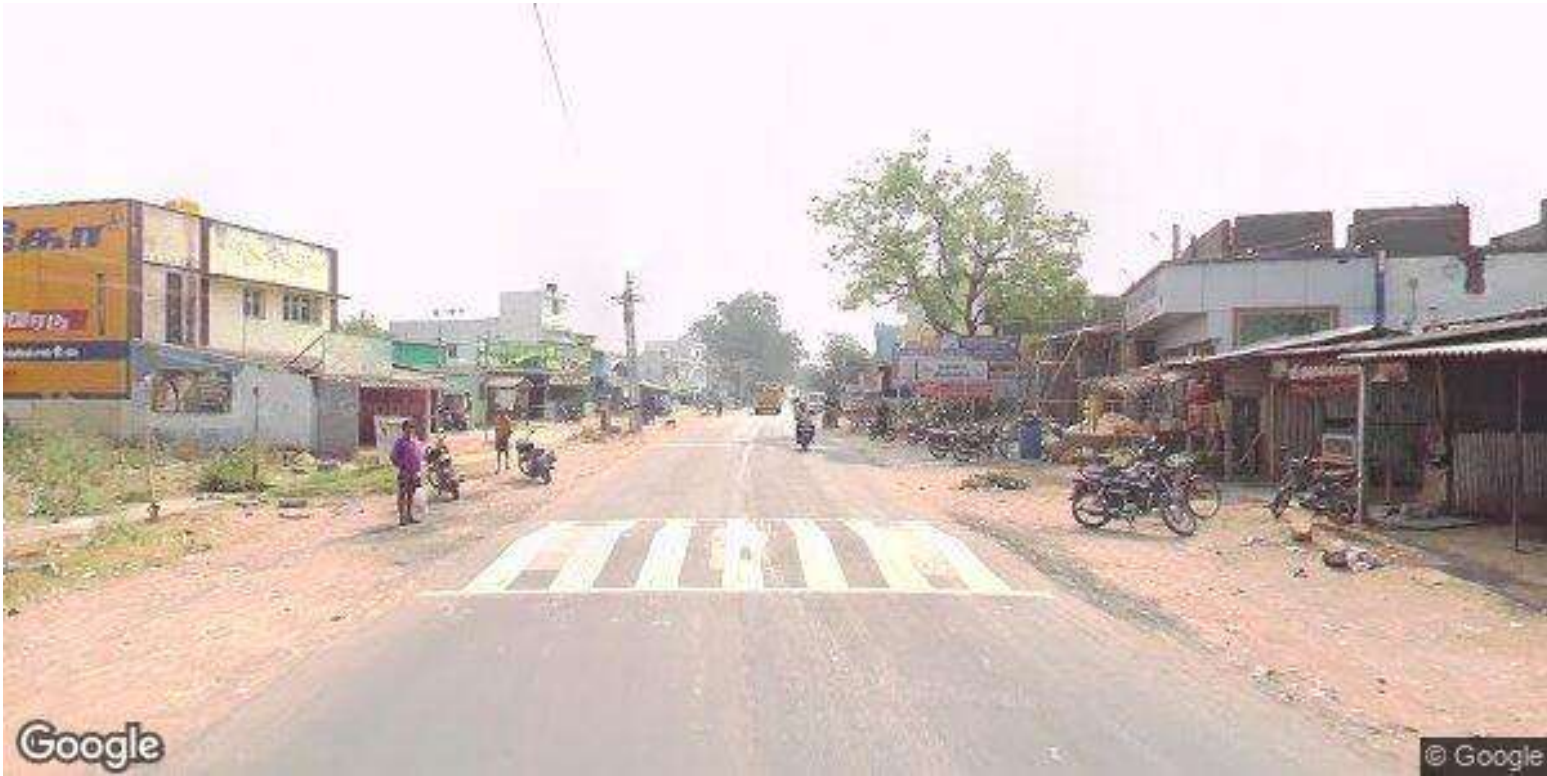
Coordinates: 11.87255, 78.08723

Risk Type: Turn

Risk Level: Medium

Speed Limit: 30 KM/Hr
