# IndianOil

## JOURNEY RISK MANAGEMENT (JRM) STUDY

### Salem Terminal to ARUN FUEL

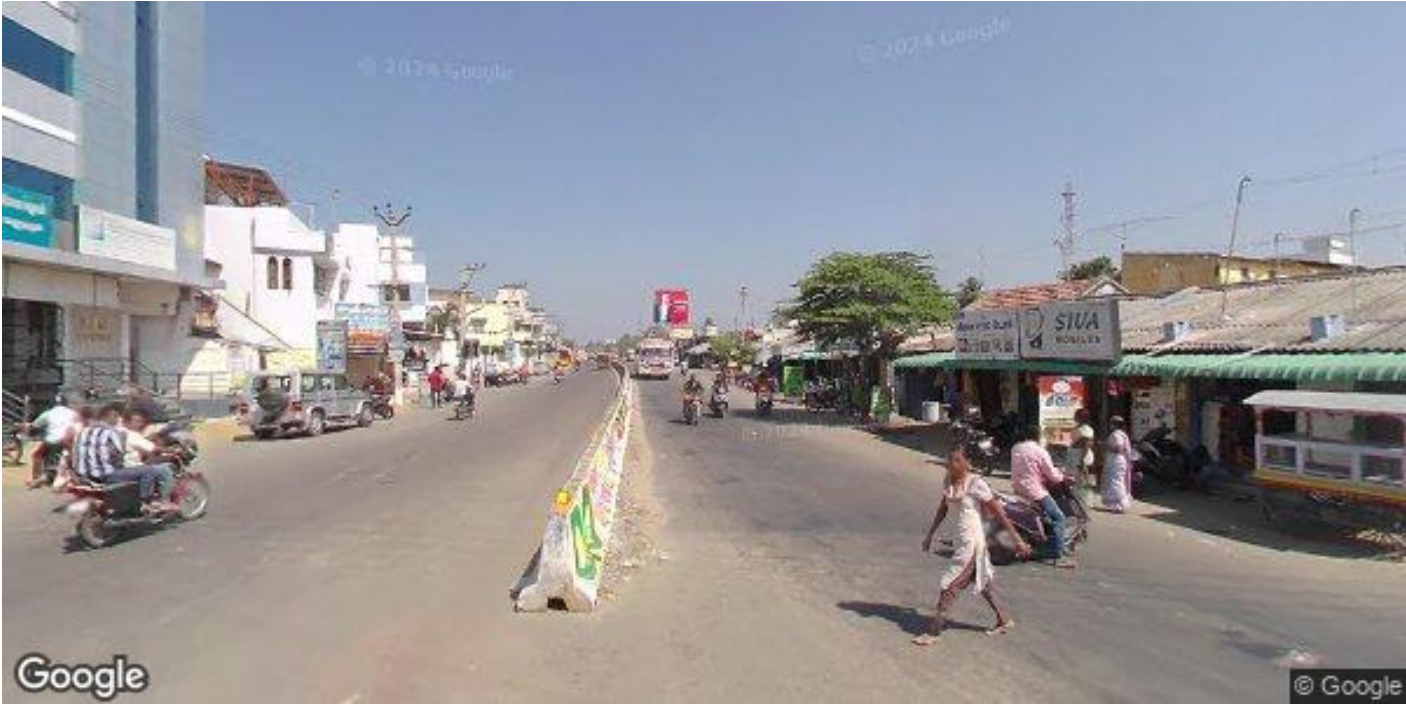
Coordinates: 11.37086, 77.74828

Risk Type: Roundabout

Risk Level: High

Speed Limit: 15 KM/Hr

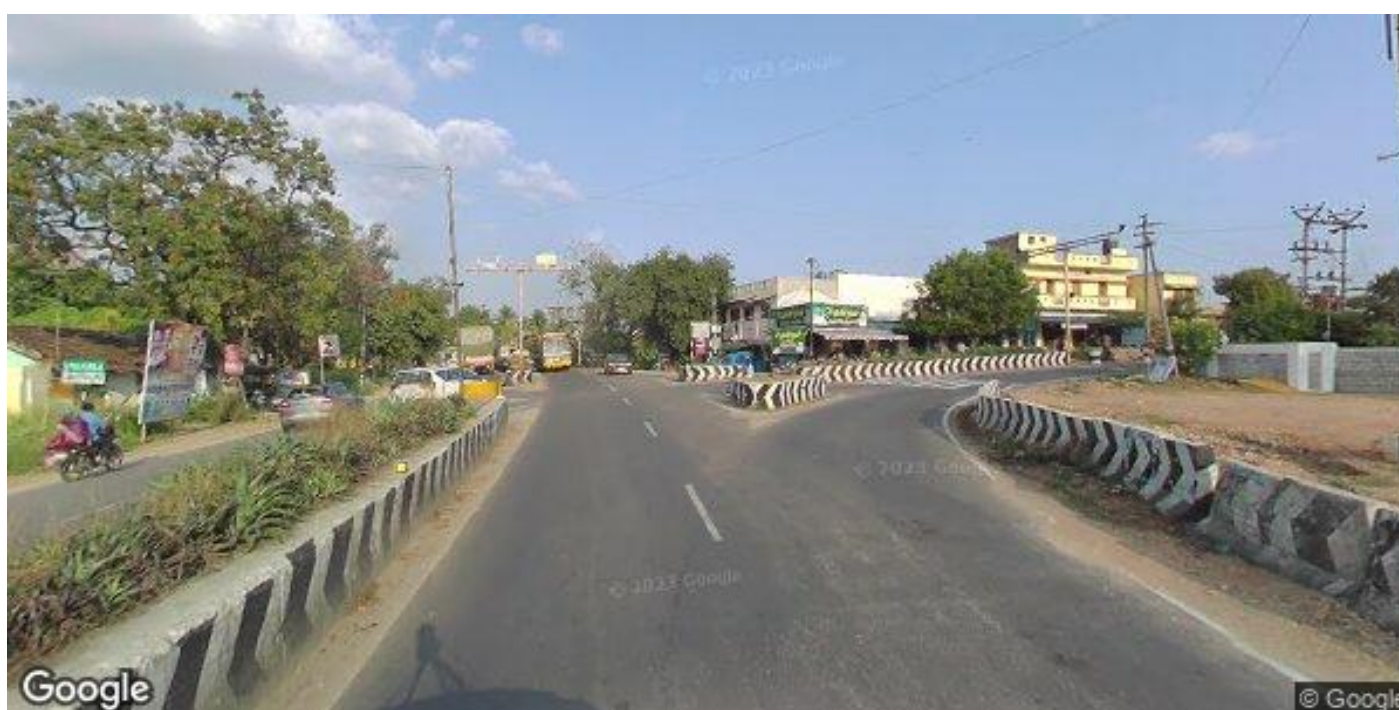
**Risk Type:** Turn  
**Risk Level:** Medium  
**Speed Limit:** 30 KM/Hr  
**Coordinates:** 11.46318, 77.84913

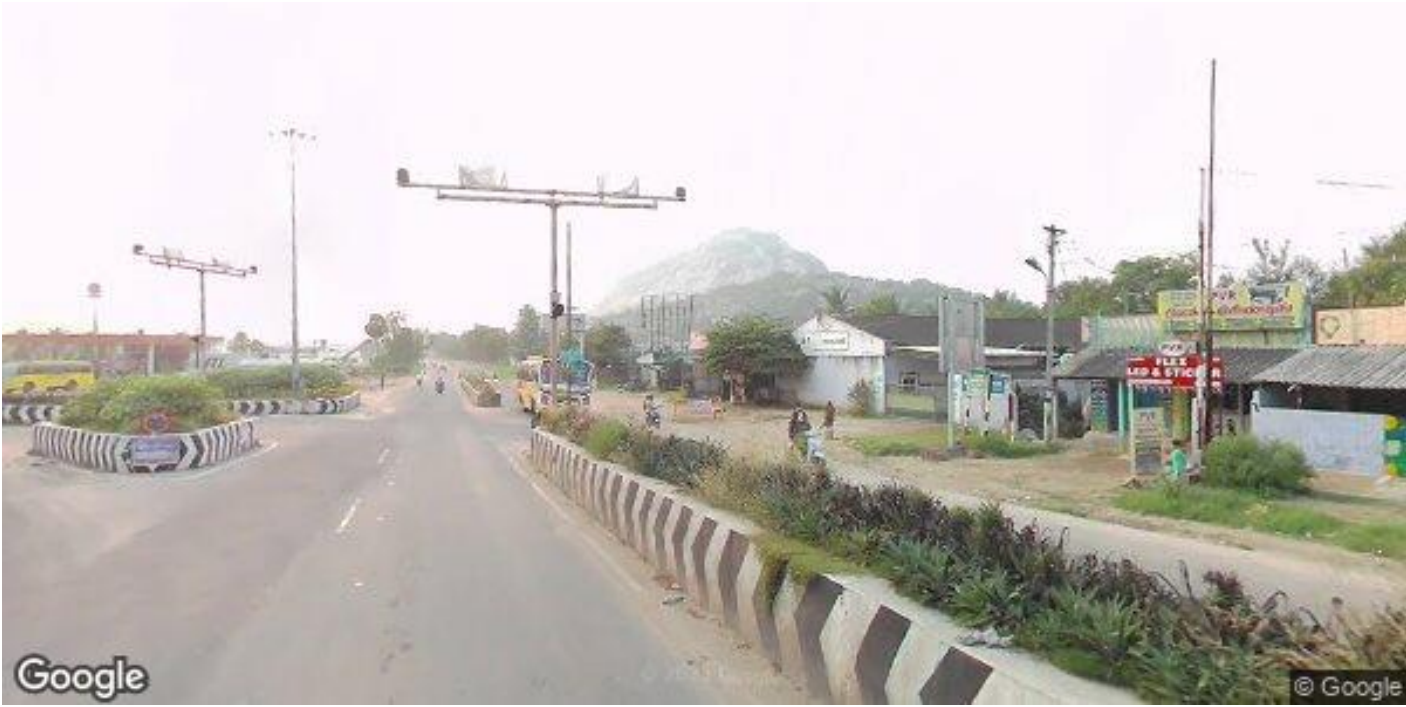
**Risk Type:** Turn  
**Risk Level:** Medium  
**Speed Limit:** 30 KM/Hr  
**Coordinates:** 11.46312, 77.84886

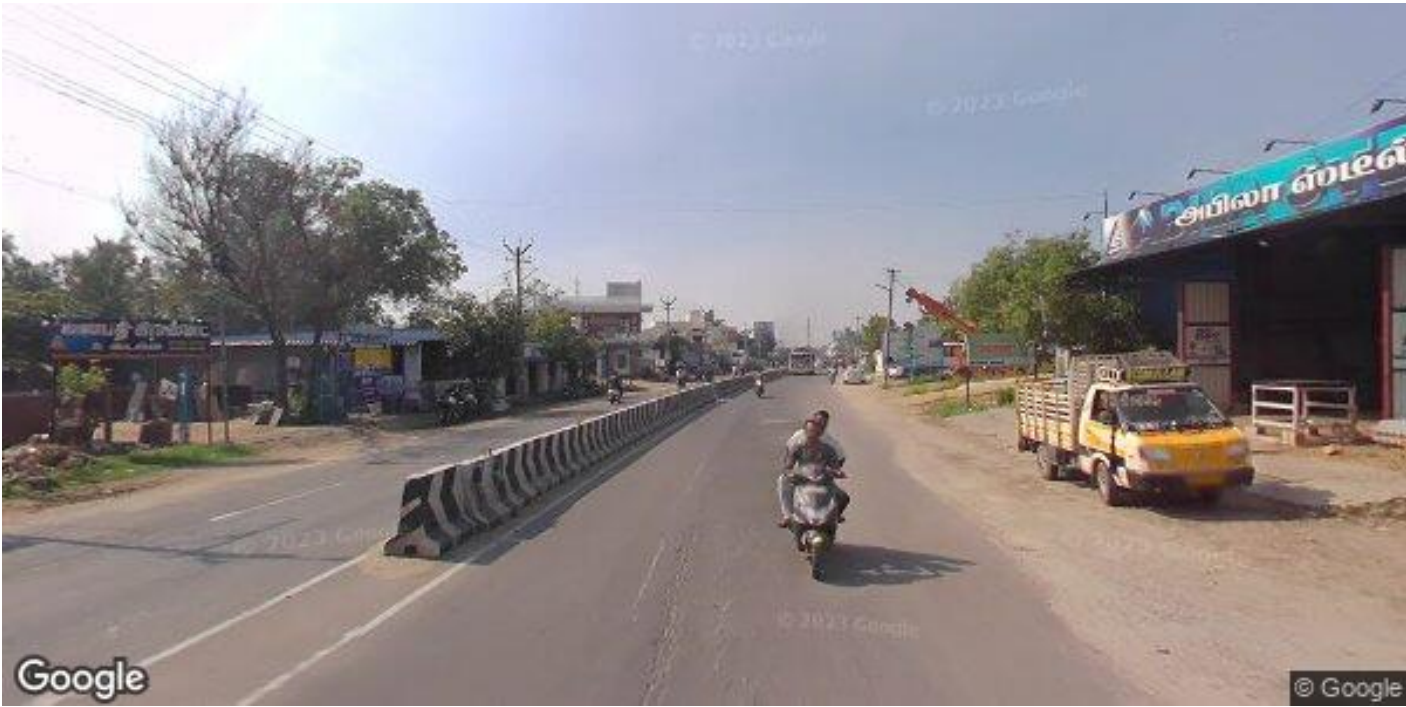
**Risk Type:** Turn  
**Risk Level:** High  
**Speed Limit:** 15 KM/Hr  
**Coordinates:** 11.37391, 77.75093
