# IndianOil

## **JOURNEY RISK MANAGEMENT (JRM) STUDY**

### **Salem Terminal TO UVANCHITRA AGENCIES**

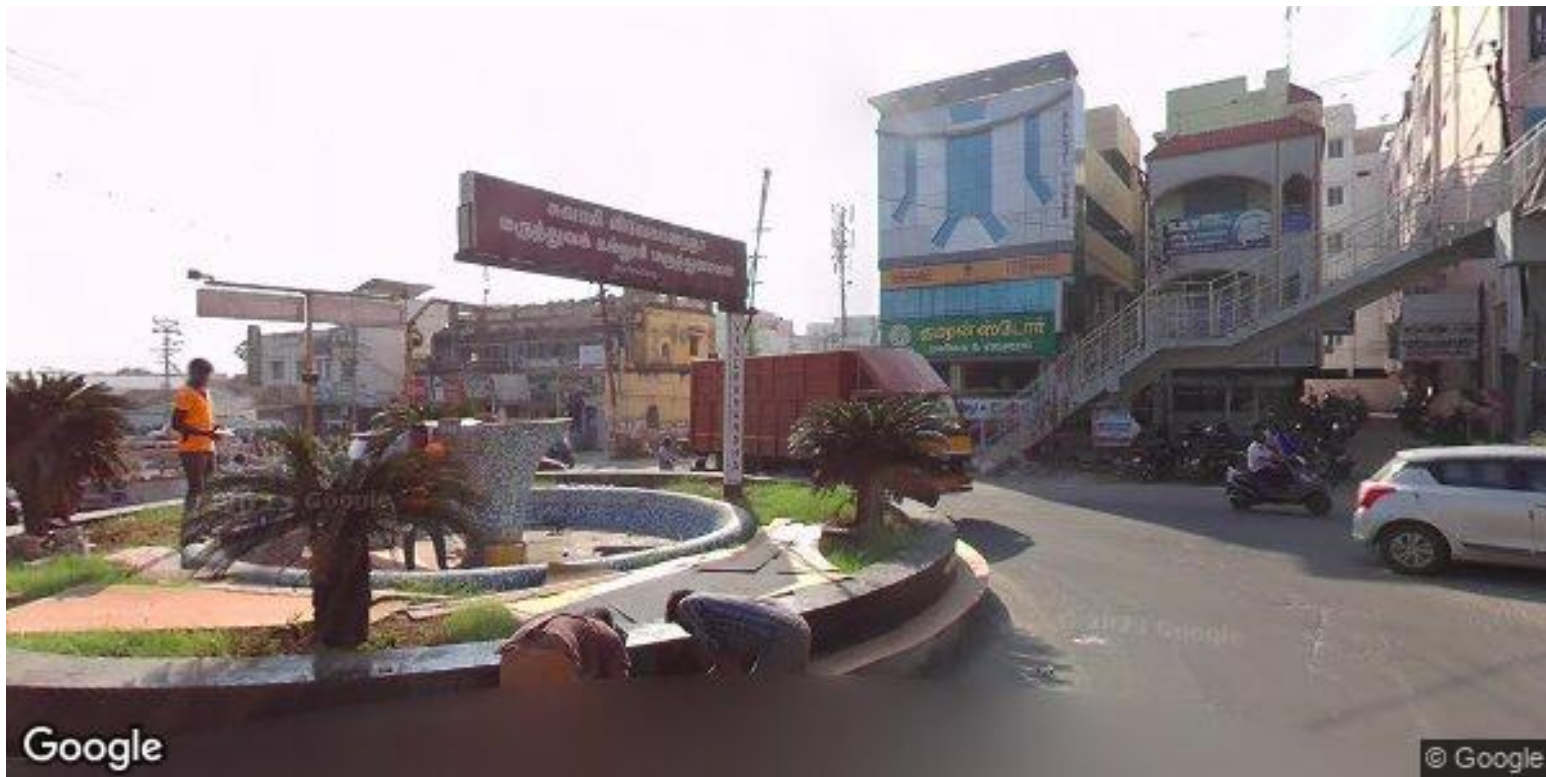
**Coordinates:** 11.38395, 77.89480

**Risk Type:** Roundabout

**Risk Level:** High

**Speed Limit:** 15 KM/Hr

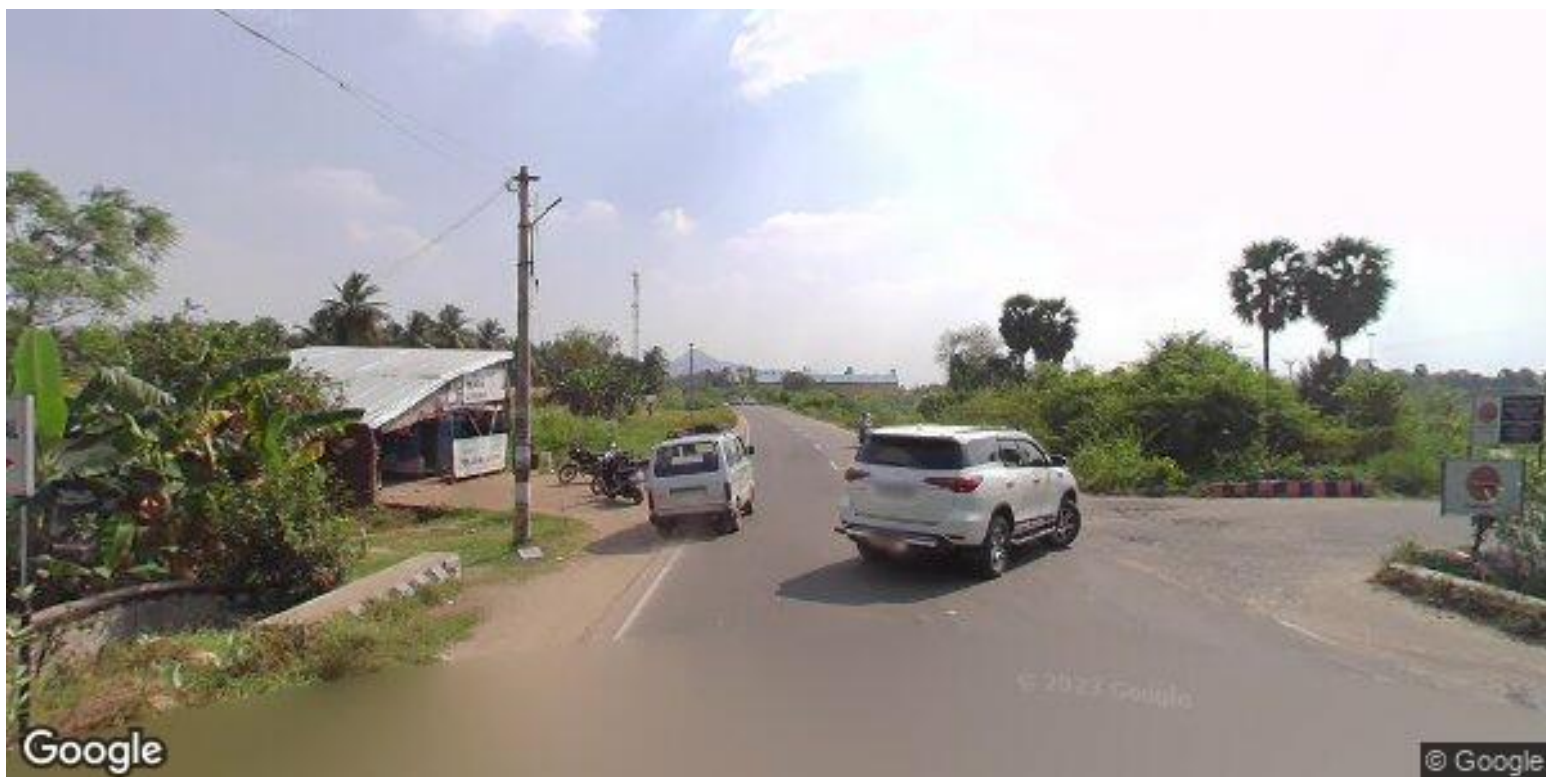
**Coordinates:** 11.44029, 77.87544

**Risk Type:** Blind Spot

**Risk Level:** Blind Spot

**Speed Limit:** 10 KM/Hr

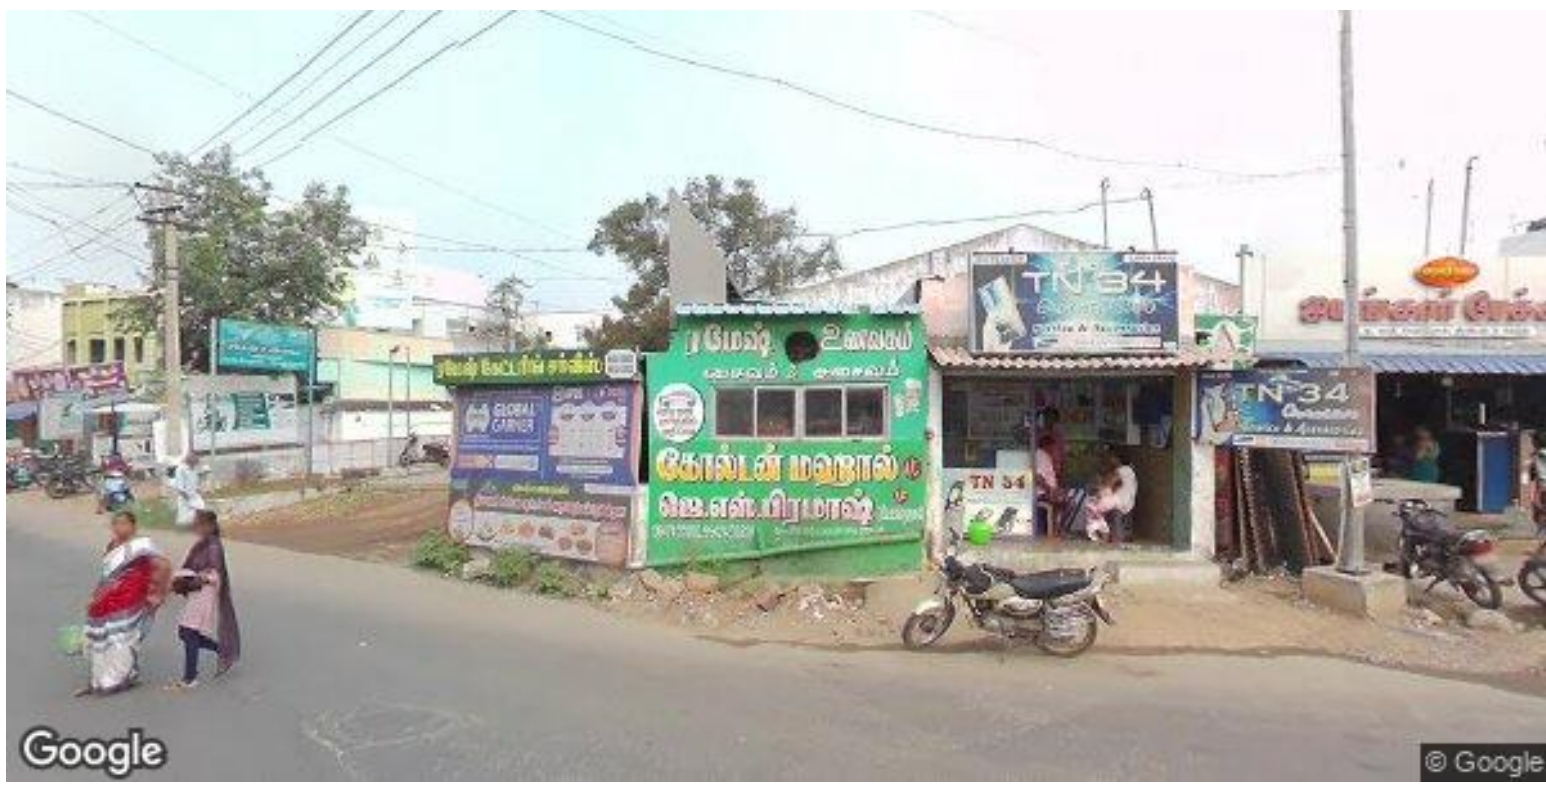
**Coordinates:** 11.38346, 77.89975

**Risk Type:** Turn

**Risk Level:** High

**Speed Limit:** 15 KM/Hr

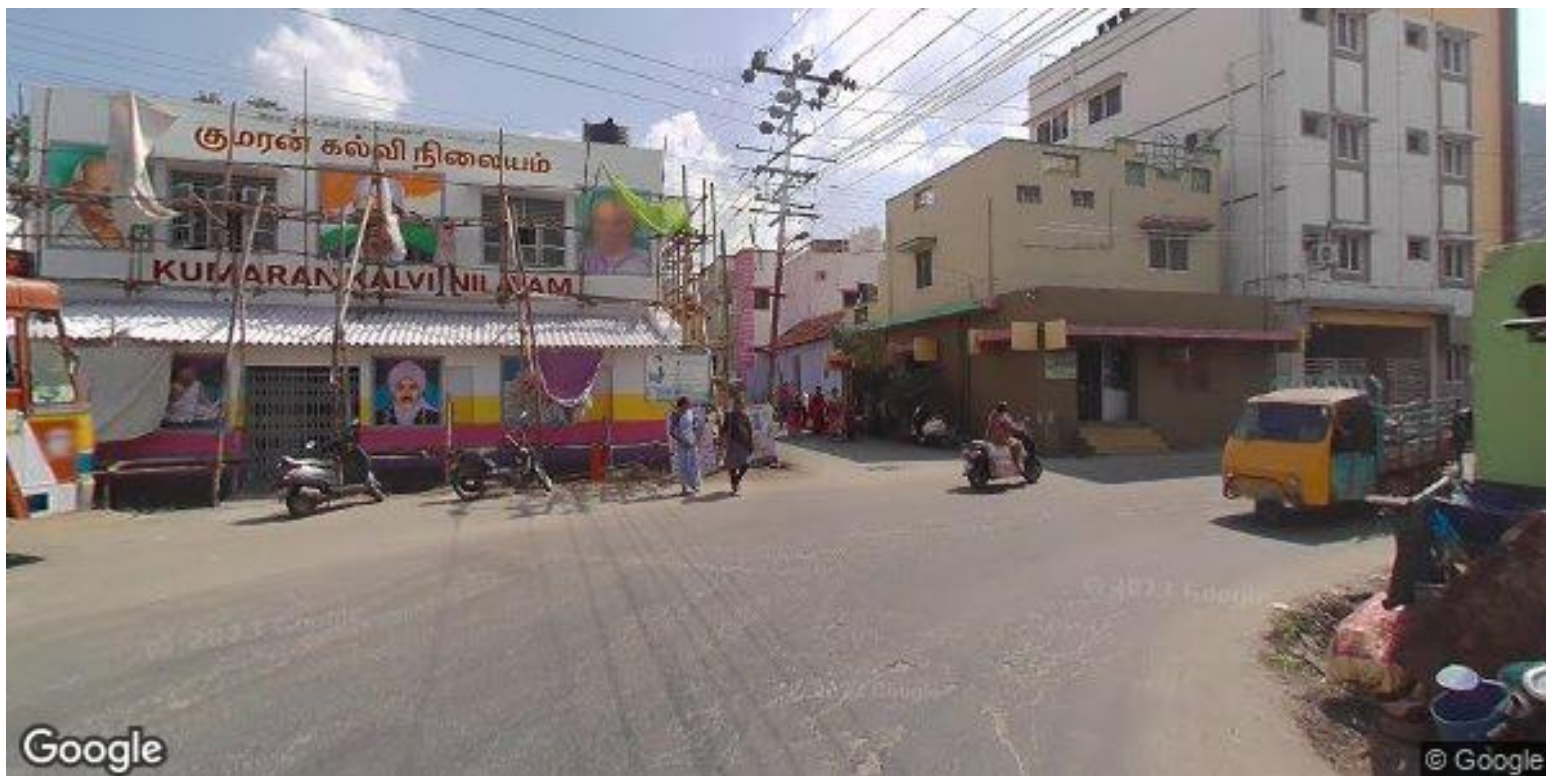
**Coordinates:** 11.38188, 77.90257

**Risk Type:** Turn

**Risk Level:** Medium

**Speed Limit:** 30 KM/Hr
