# IndianOil

## JOURNEY RISK MANAGEMENT (JRM) STUDY

### Salem Terminal to USHA FUELS

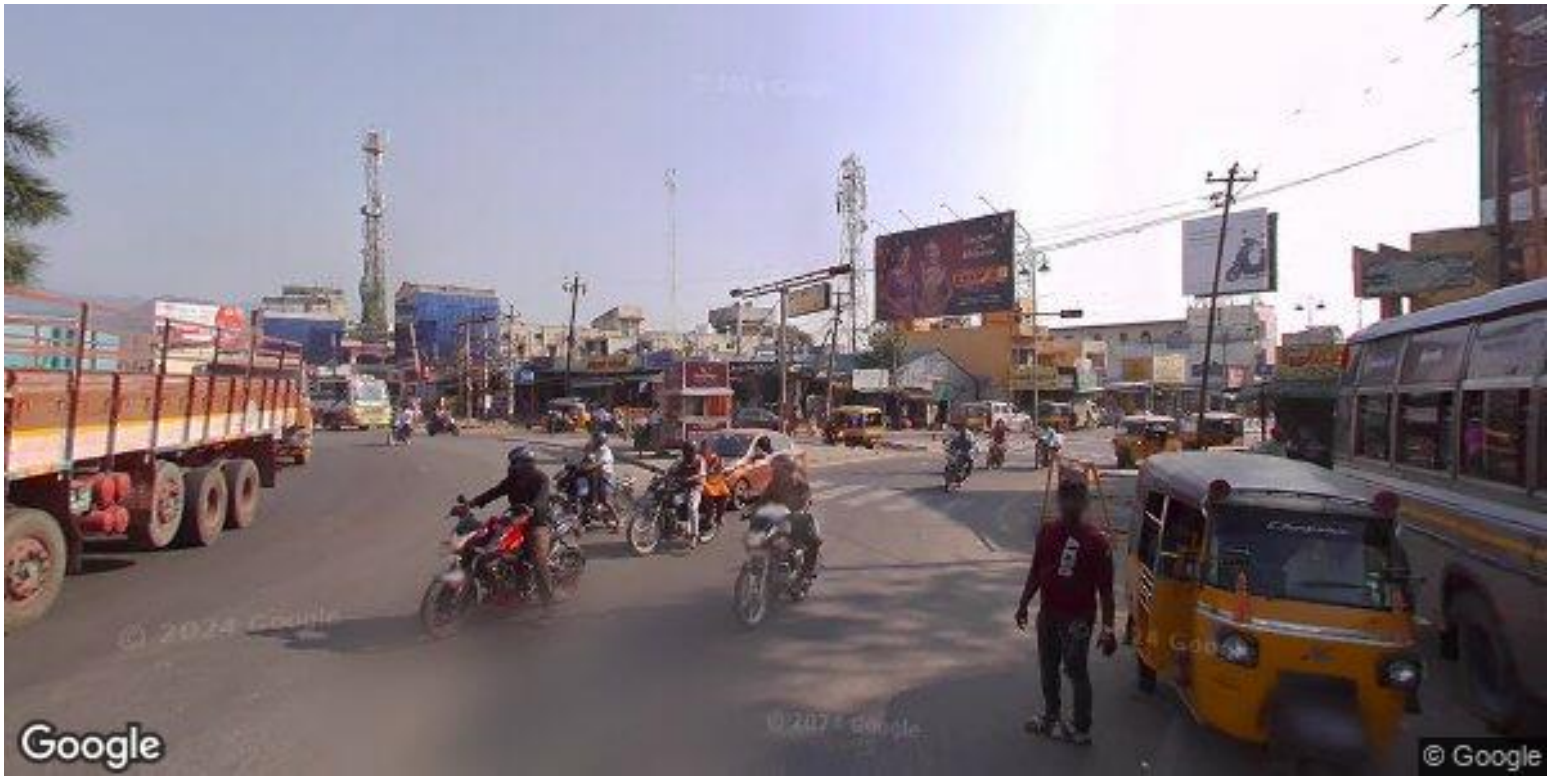
**Risk Type:** Roundabout  
**Risk Level:** High  
**Speed Limit:** 15 KM/Hr  
**Coordinates:** 11.63266, 78.12699

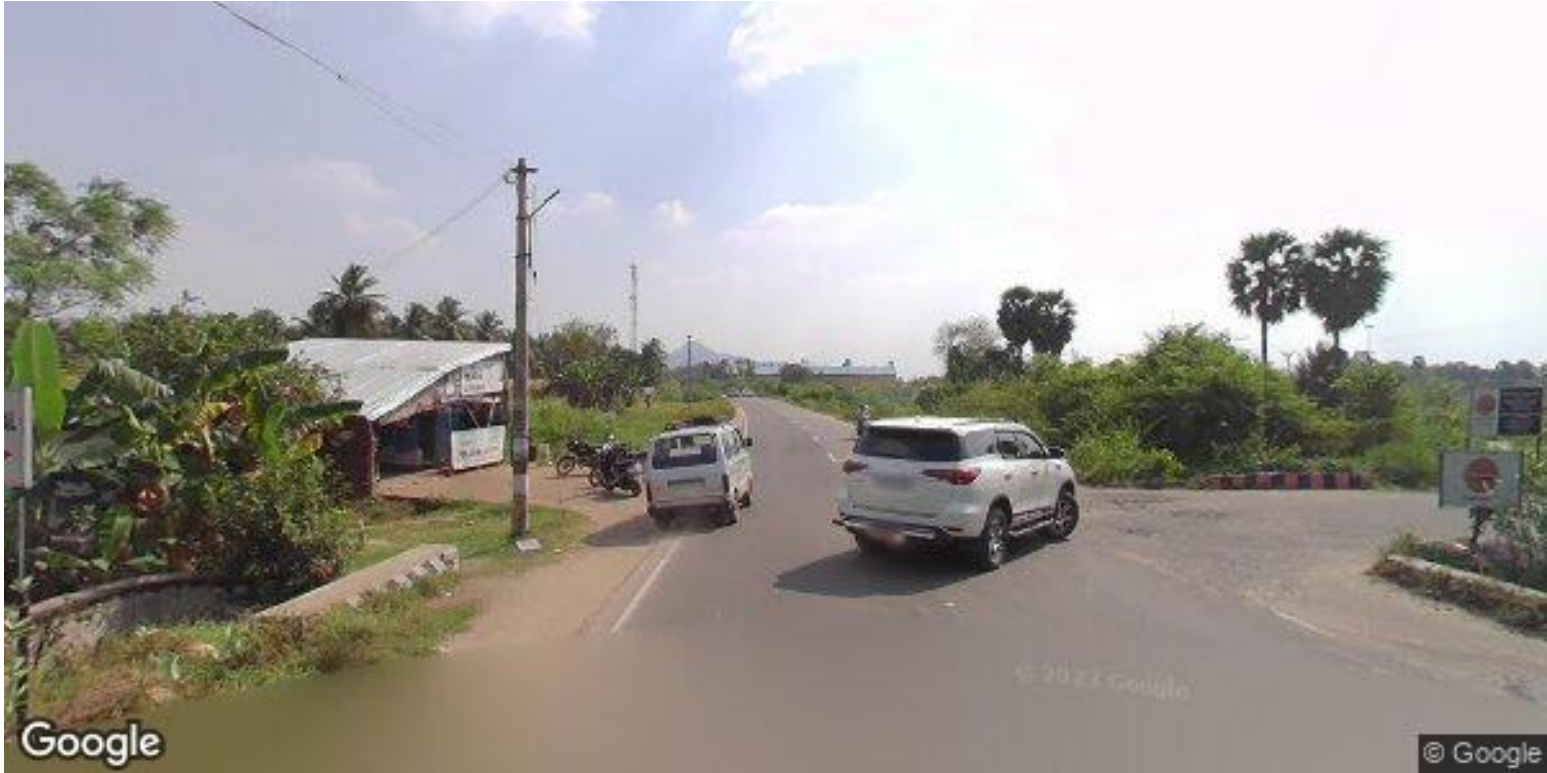
**Risk Type:** Turn  
**Risk Level:** High  
**Speed Limit:** 15 KM/Hr  
**Coordinates:** 11.44029, 77.87544

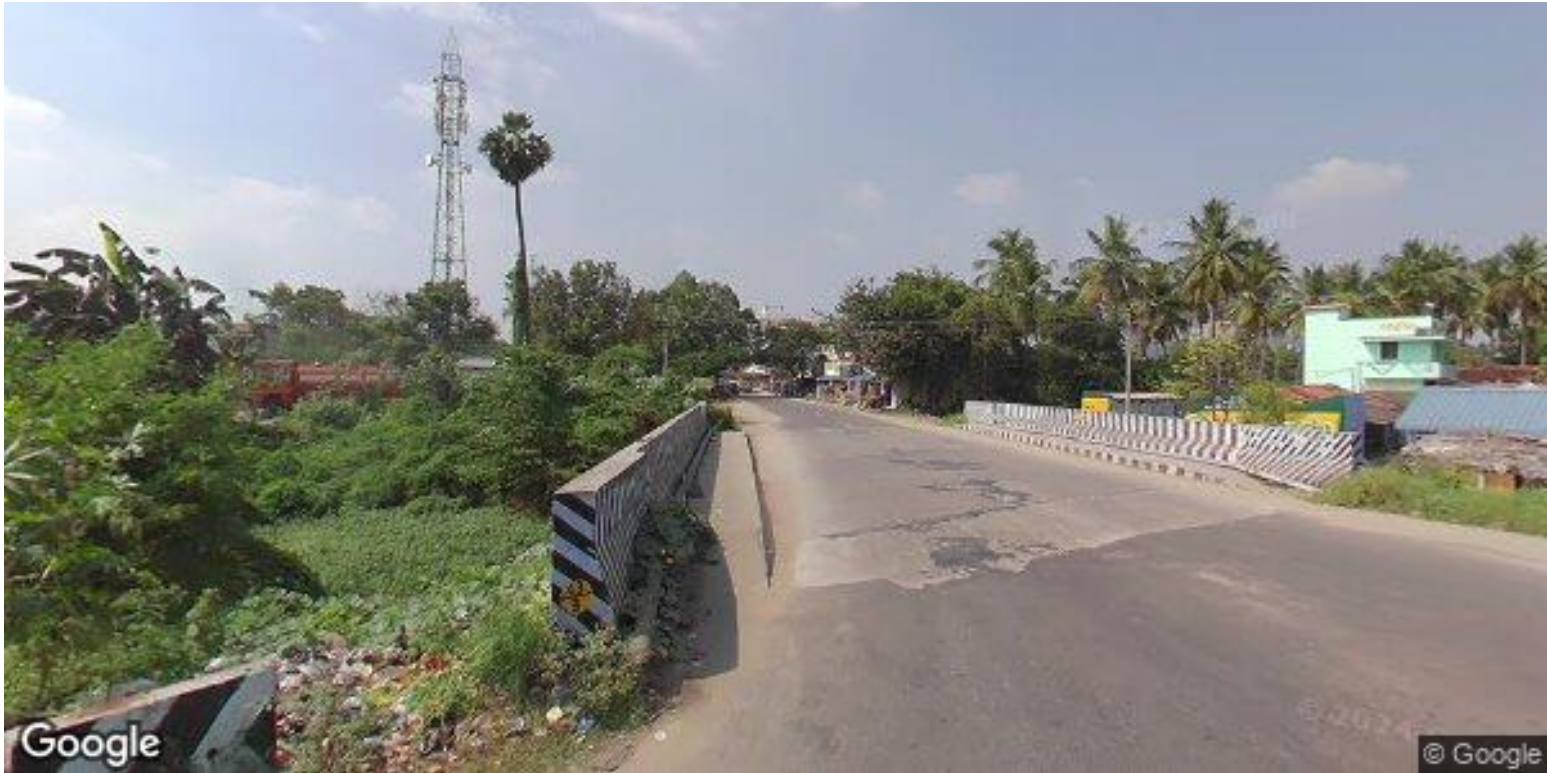
**Risk Type:** Turn  
**Risk Level:** High  
**Speed Limit:** 15 KM/Hr  
**Coordinates:** 11.44900, 77.87406

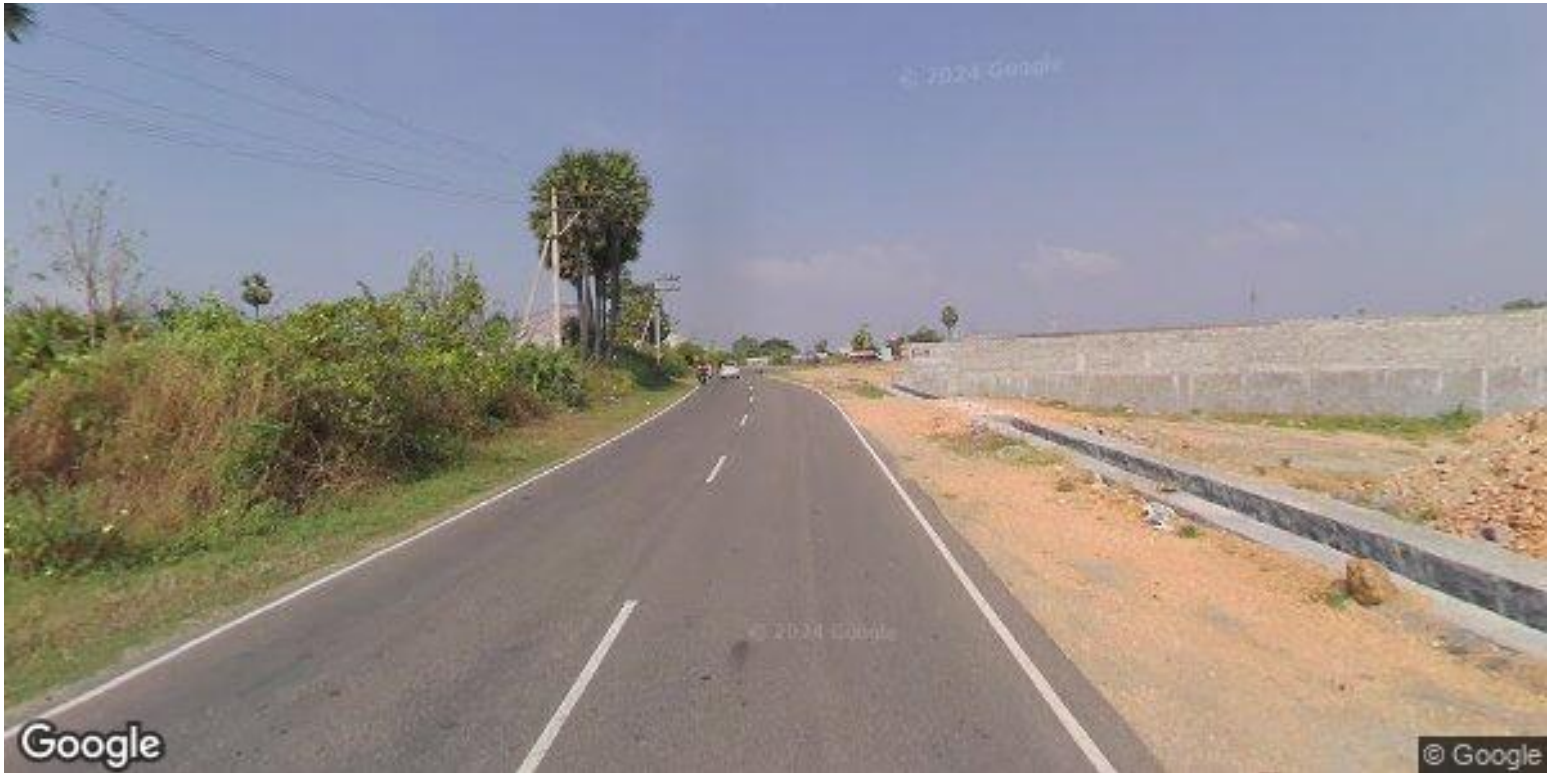
**Risk Type:** Turn  
**Risk Level:** Medium  
**Speed Limit:** 30 KM/Hr  
**Coordinates:** 11.45764, 77.85219

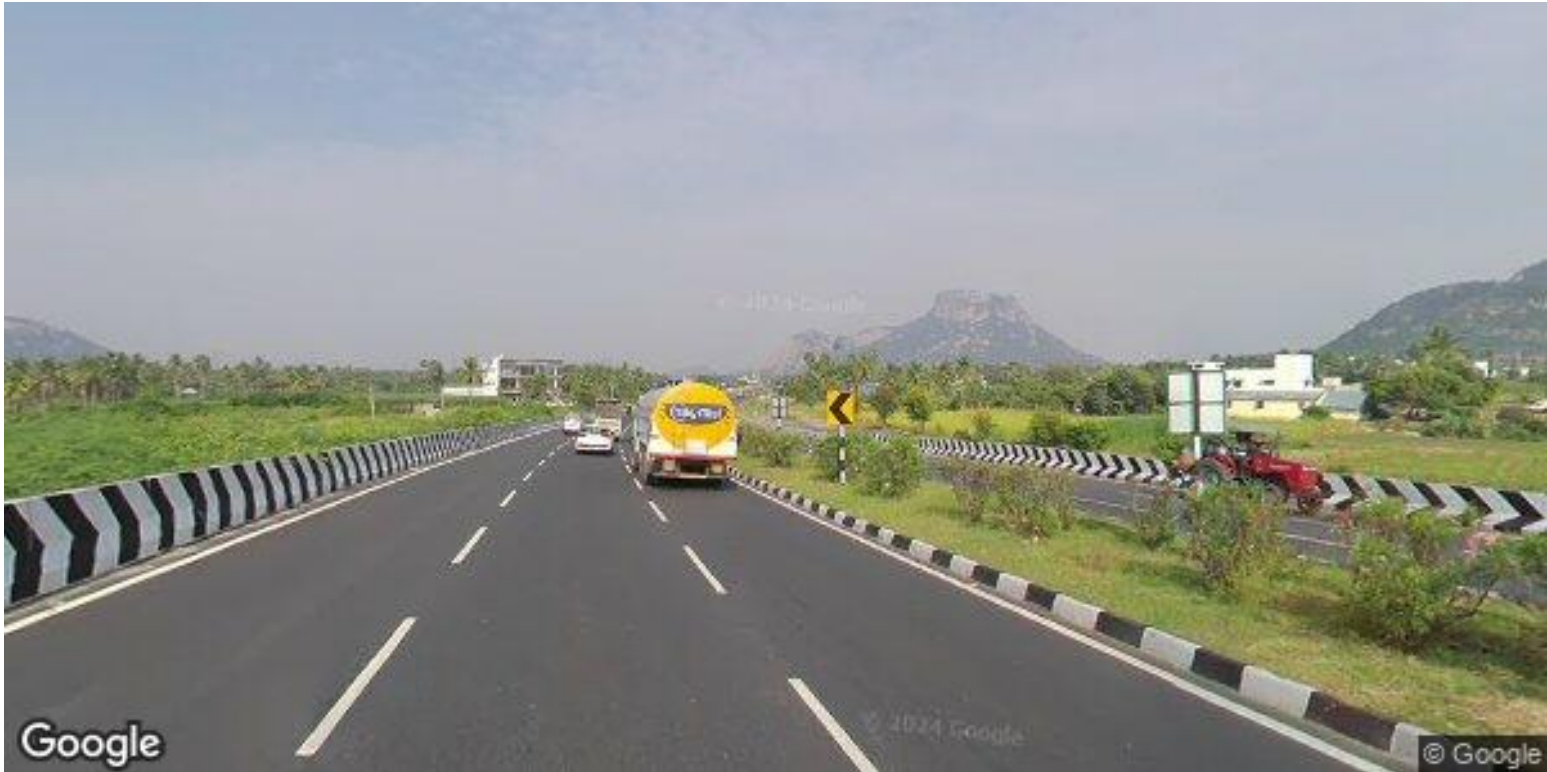
**Risk Type:** Turn  
**Risk Level:** Medium  
**Speed Limit:** 30 KM/Hr  
**Coordinates:** 11.46916, 77.82431

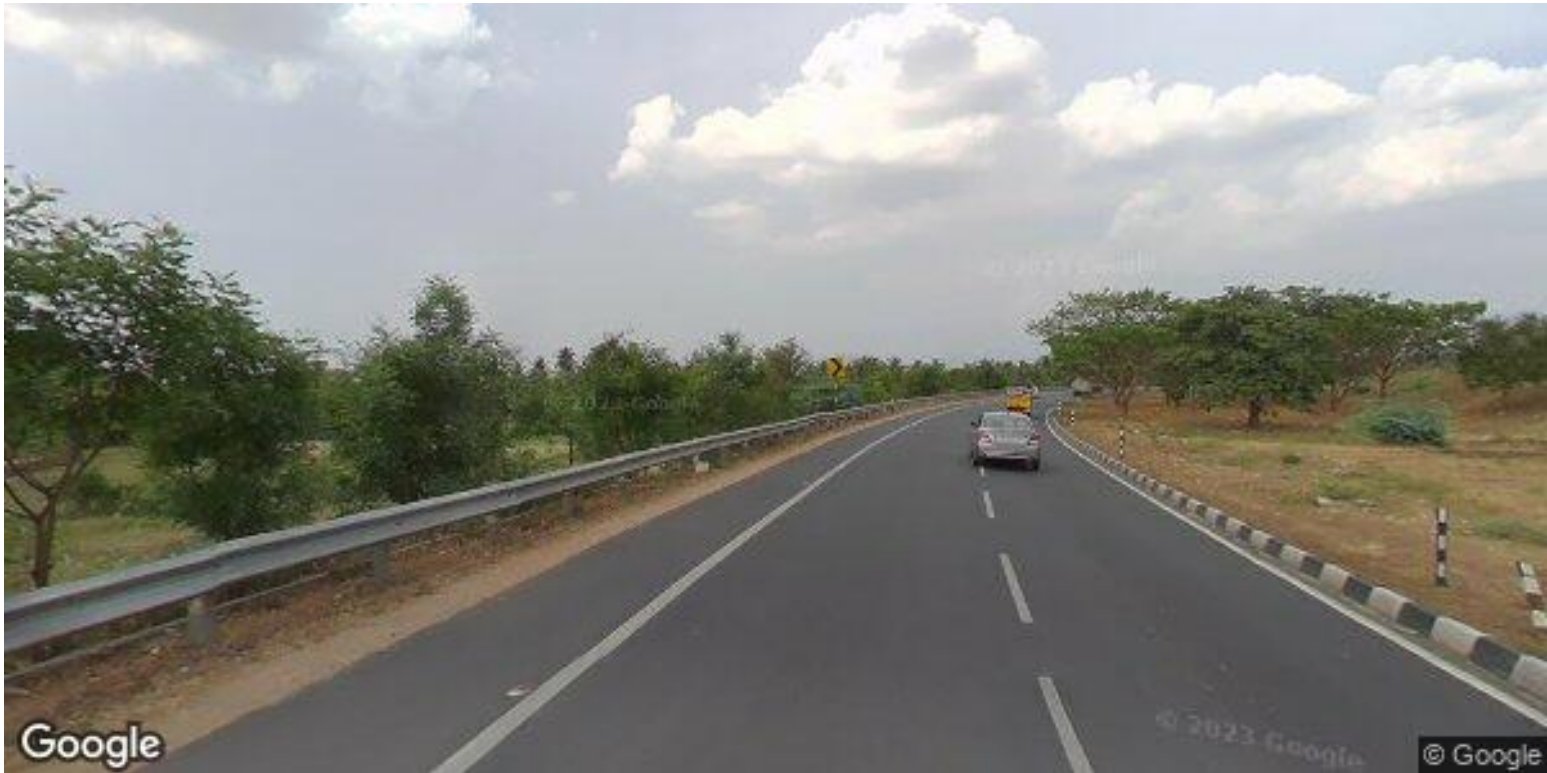
**Risk Type:** Turn  
**Risk Level:** Medium  
**Speed Limit:** 30 KM/Hr  
**Coordinates:** 11.53560, 77.95773

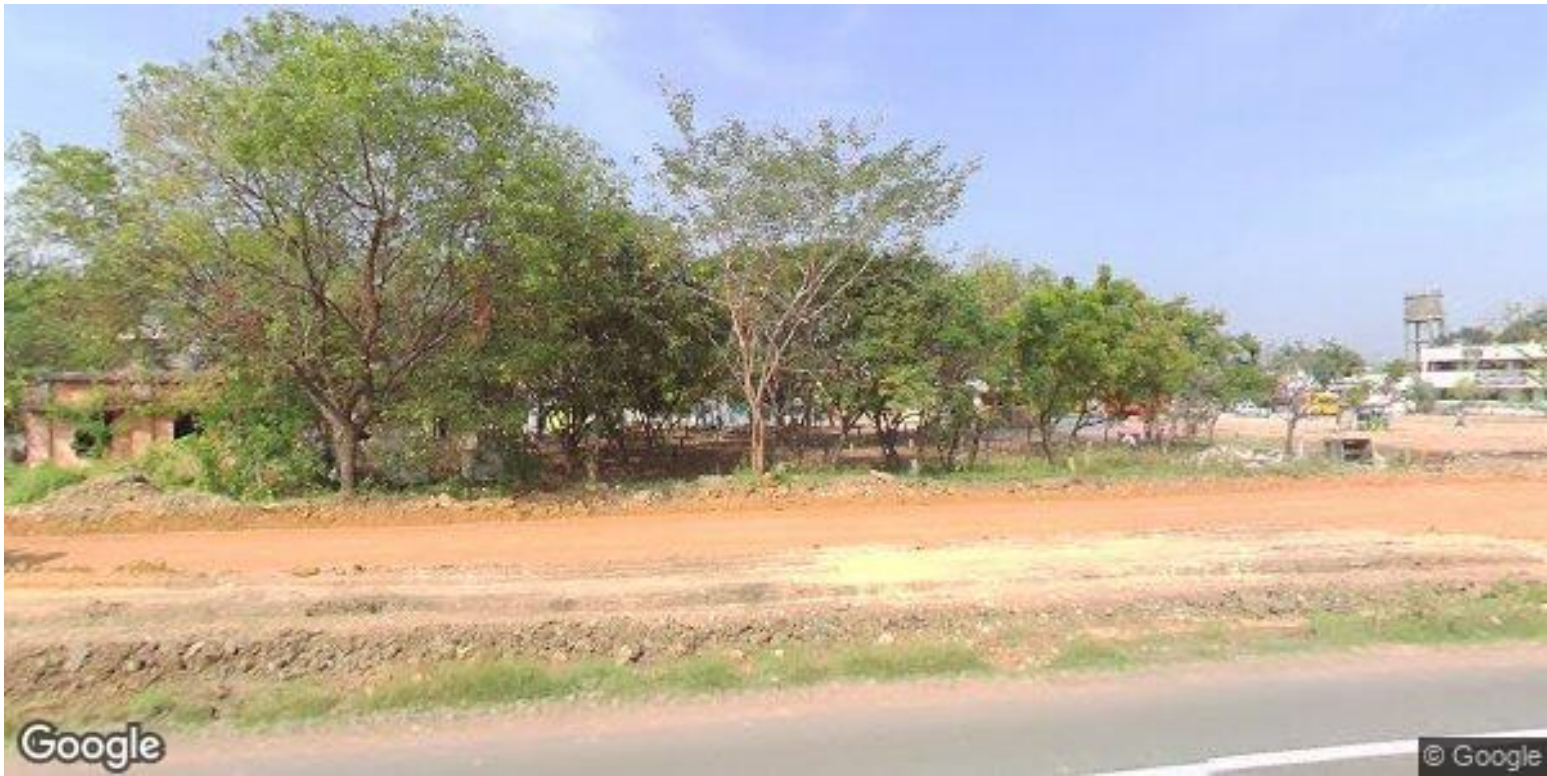
**Risk Type:** Turn  
**Risk Level:** Medium  
**Speed Limit:** 30 KM/Hr  
**Coordinates:** 11.62100, 78.10723

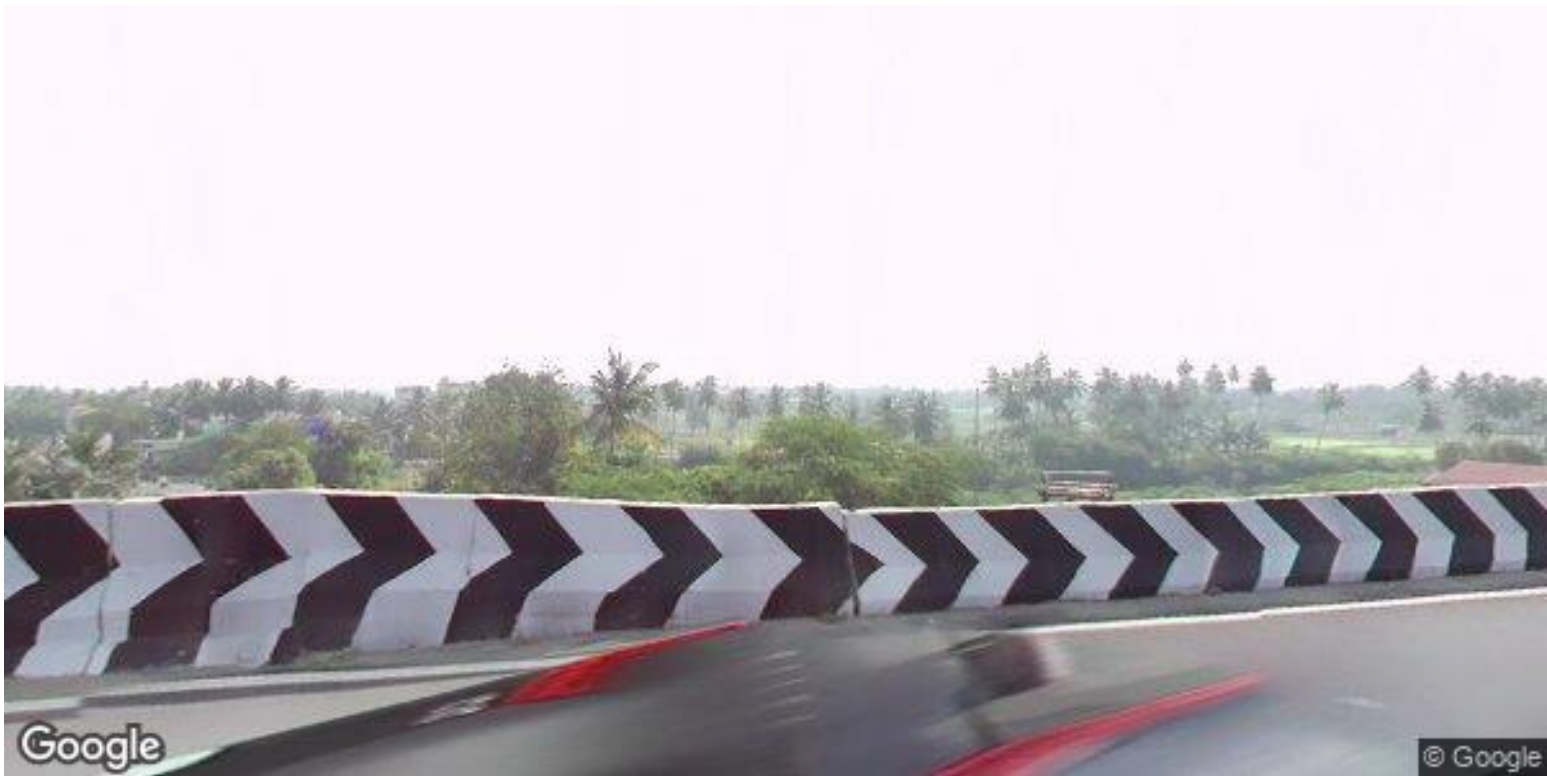
**Risk Type:** Turn  
**Risk Level:** High  
**Speed Limit:** 15 KM/Hr  
**Coordinates:** 11.61249, 78.10443

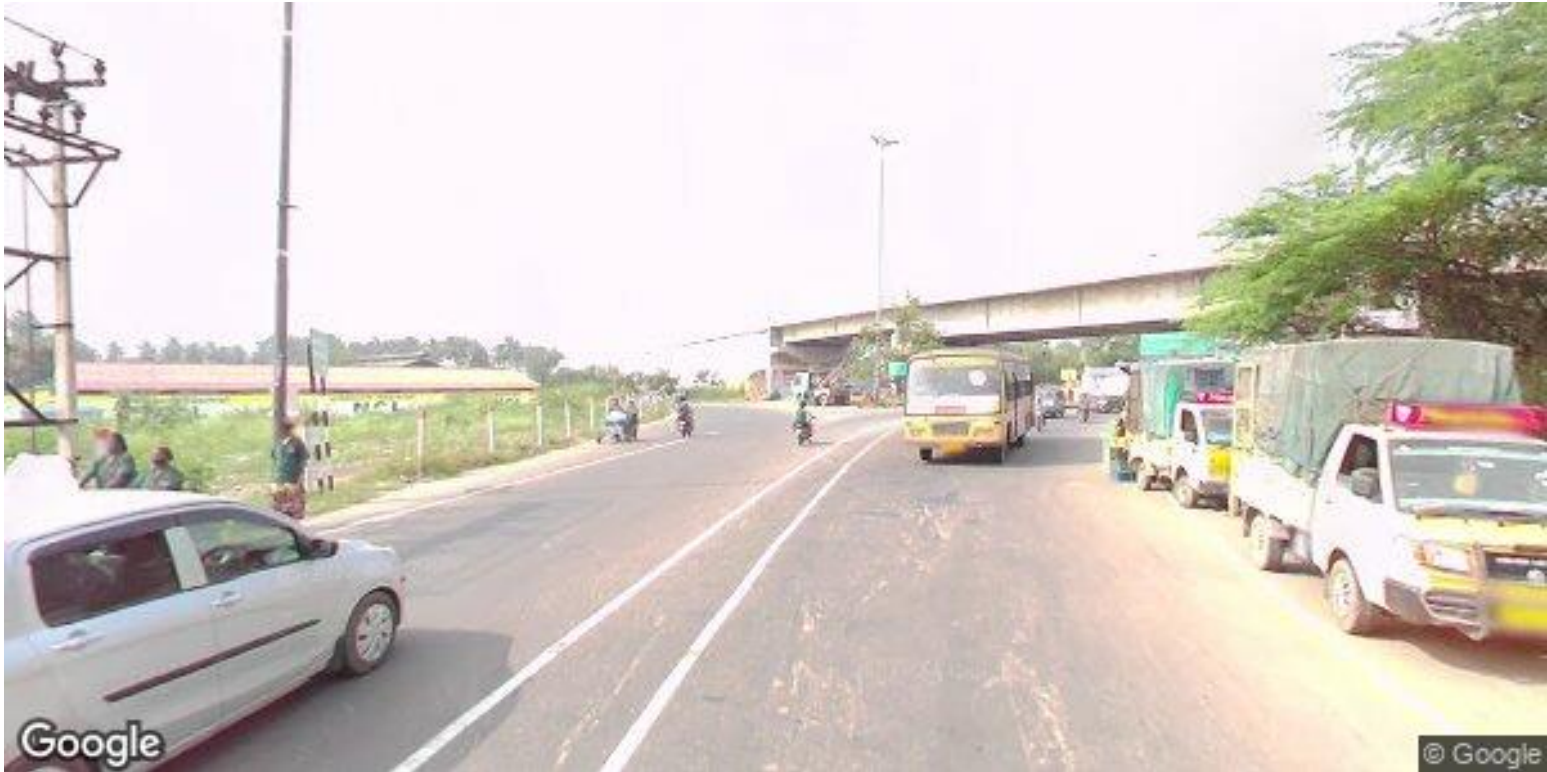
**Risk Type:** Turn  
**Risk Level:** High  
**Speed Limit:** 15 KM/Hr  
**Coordinates:** 11.61224, 78.10469

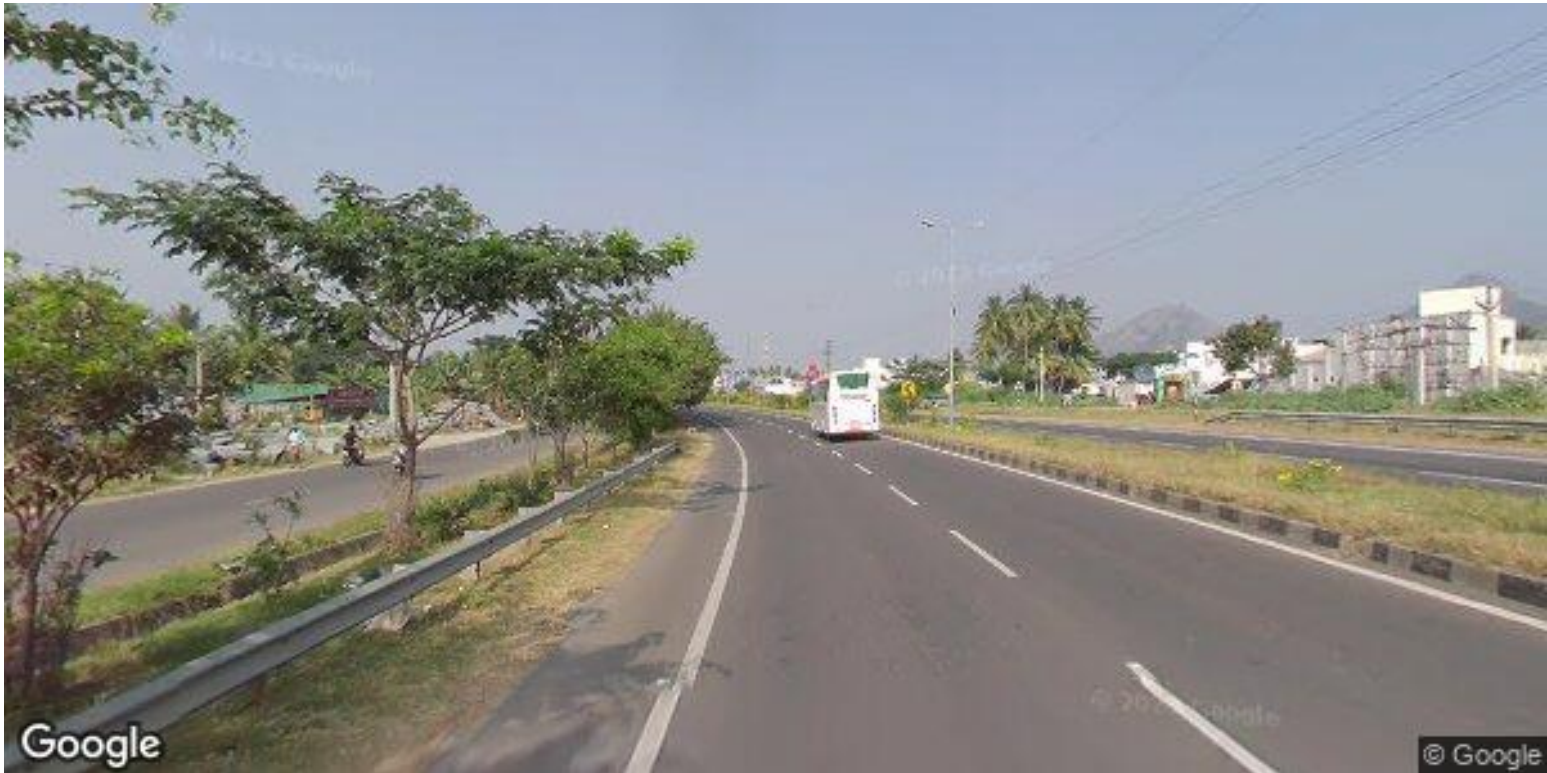
**Risk Type:** Turn  
**Risk Level:** Medium  
**Speed Limit:** 30 KM/Hr  
**Coordinates:** 11.62901, 78.16571

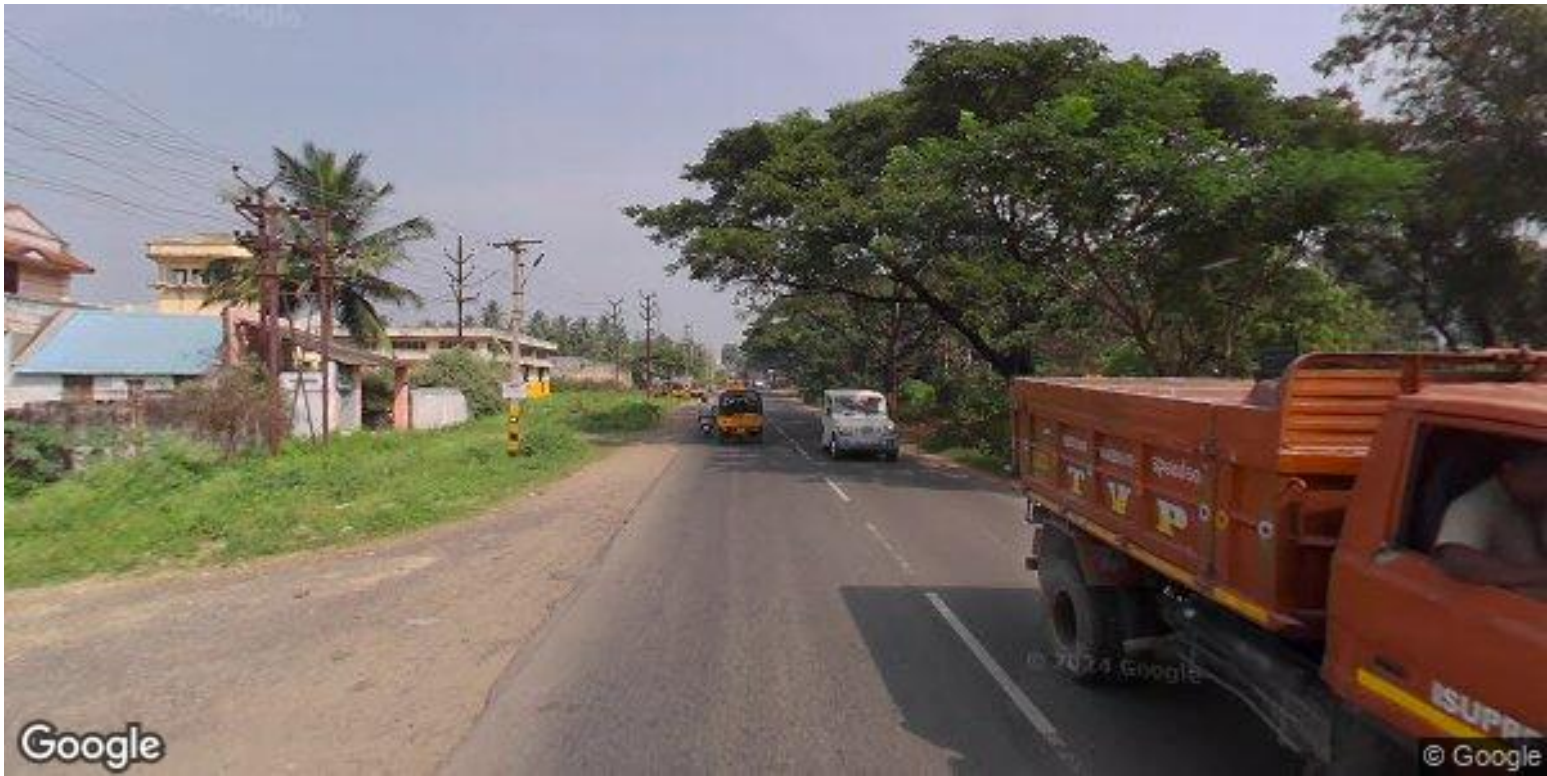
**Risk Type:** Turn  
**Risk Level:** Medium  
**Speed Limit:** 30 KM/Hr  
**Coordinates:** 11.65889, 78.20502

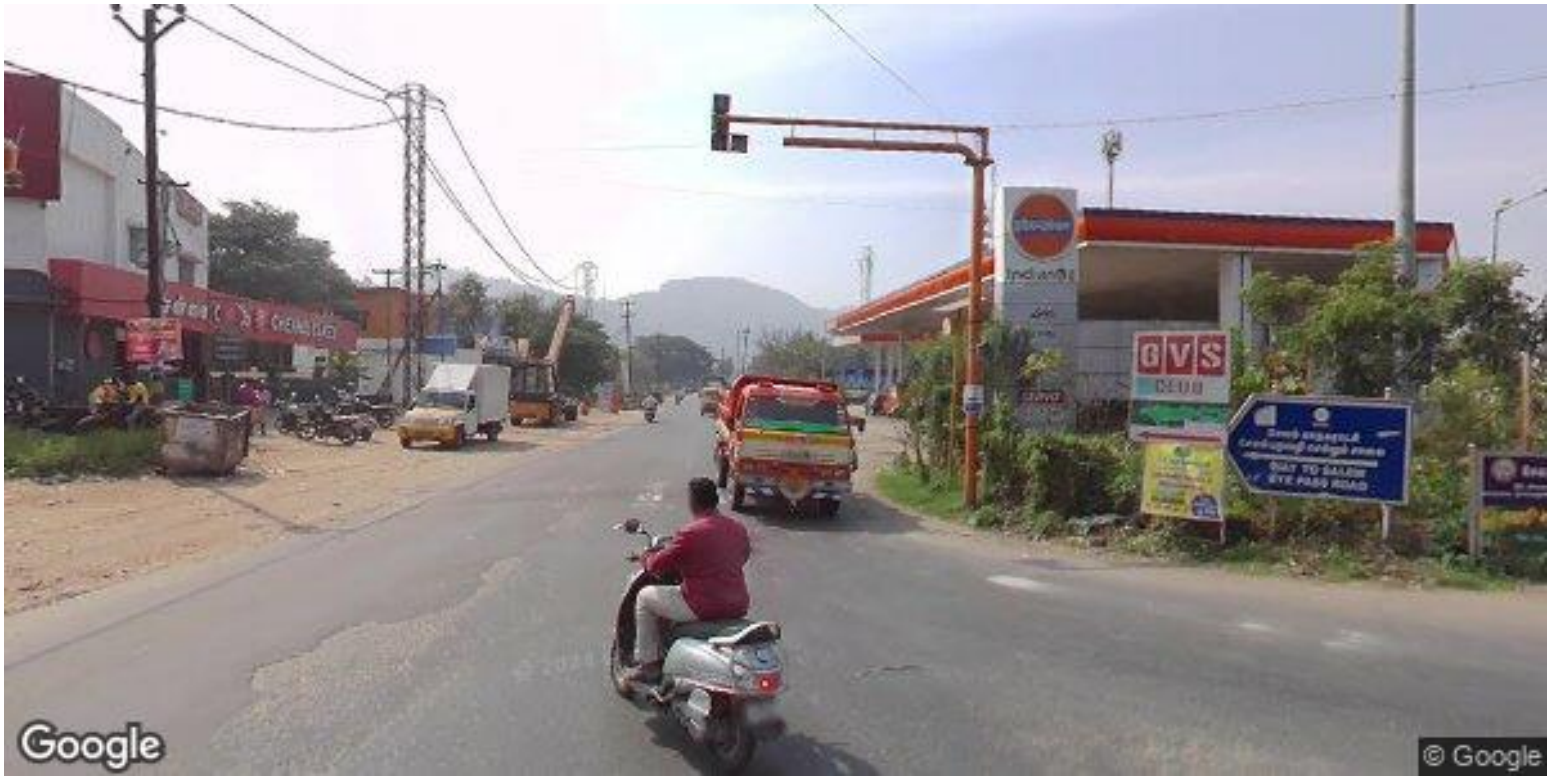
**Risk Type:** Turn  
**Risk Level:** Medium  
**Speed Limit:** 30 KM/Hr  
**Coordinates:** 11.66354, 78.20645

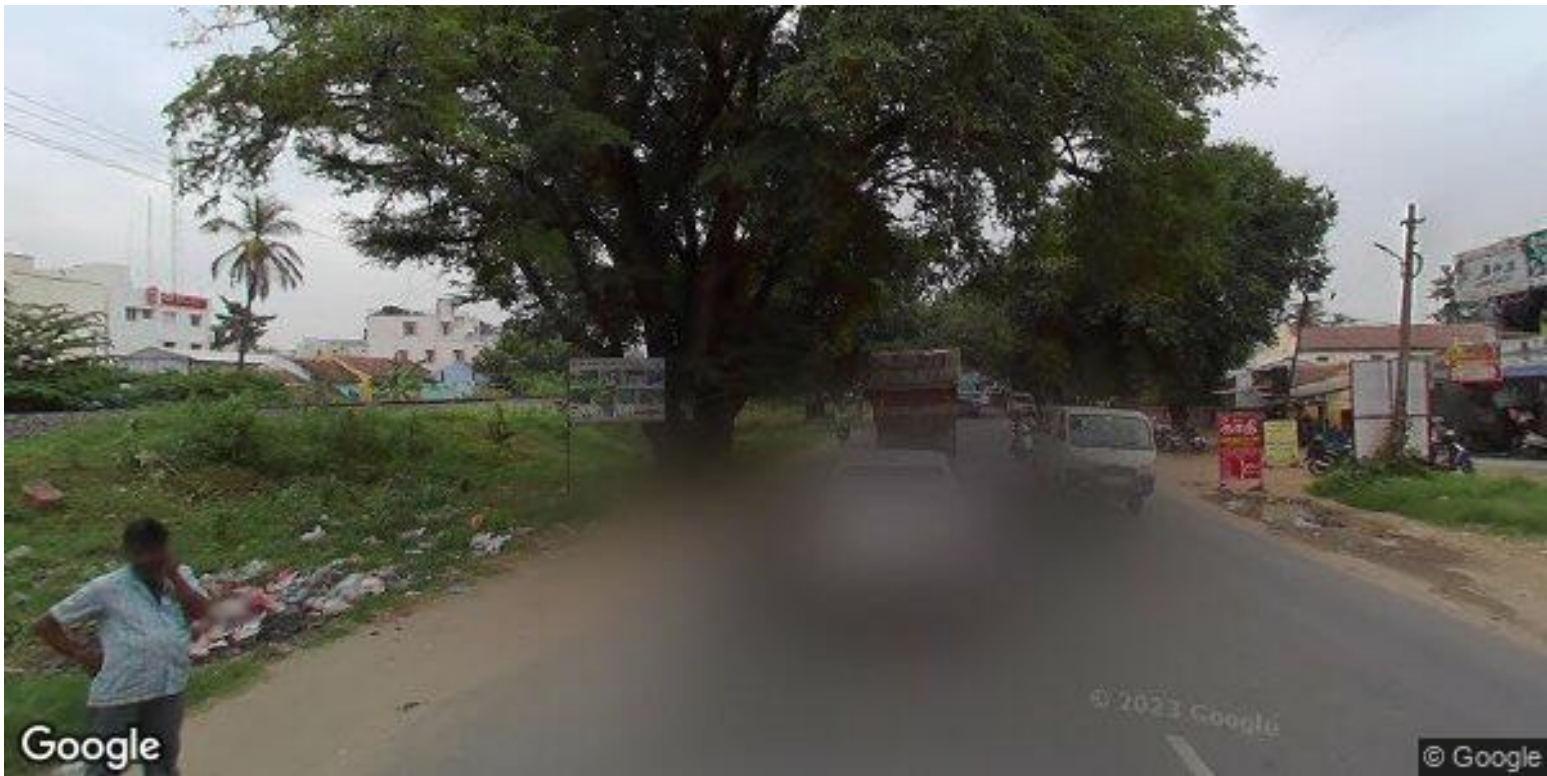
Coordinates: 11.67130, 78.23006

Risk Type: Turn

Risk Level: Medium

Speed Limit: 30 KM/Hr

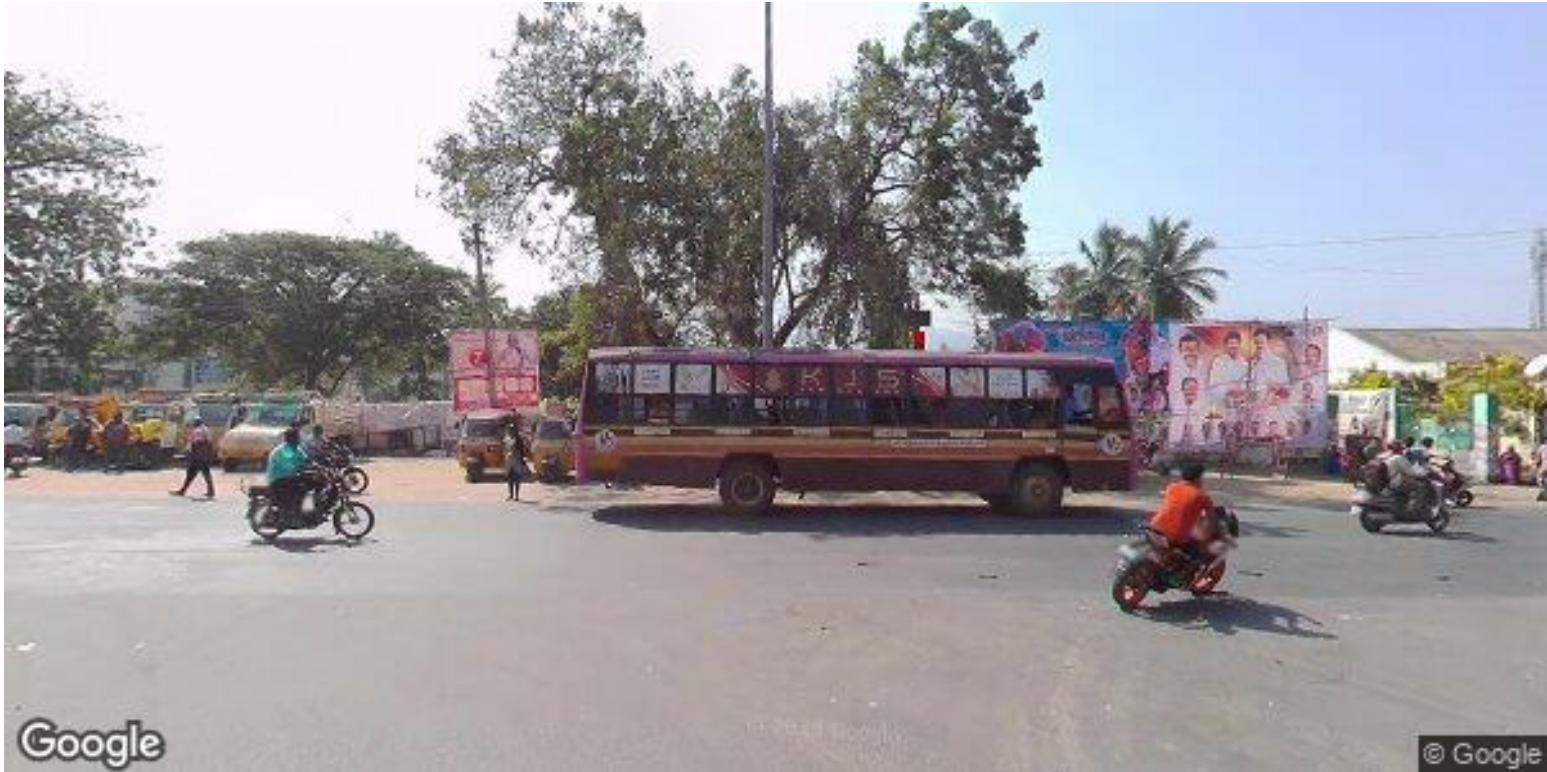
Coordinates: 11.67120, 78.23136

Risk Type: Blind Spot

Risk Level: Blind Spot

Speed Limit: 10 KM/Hr

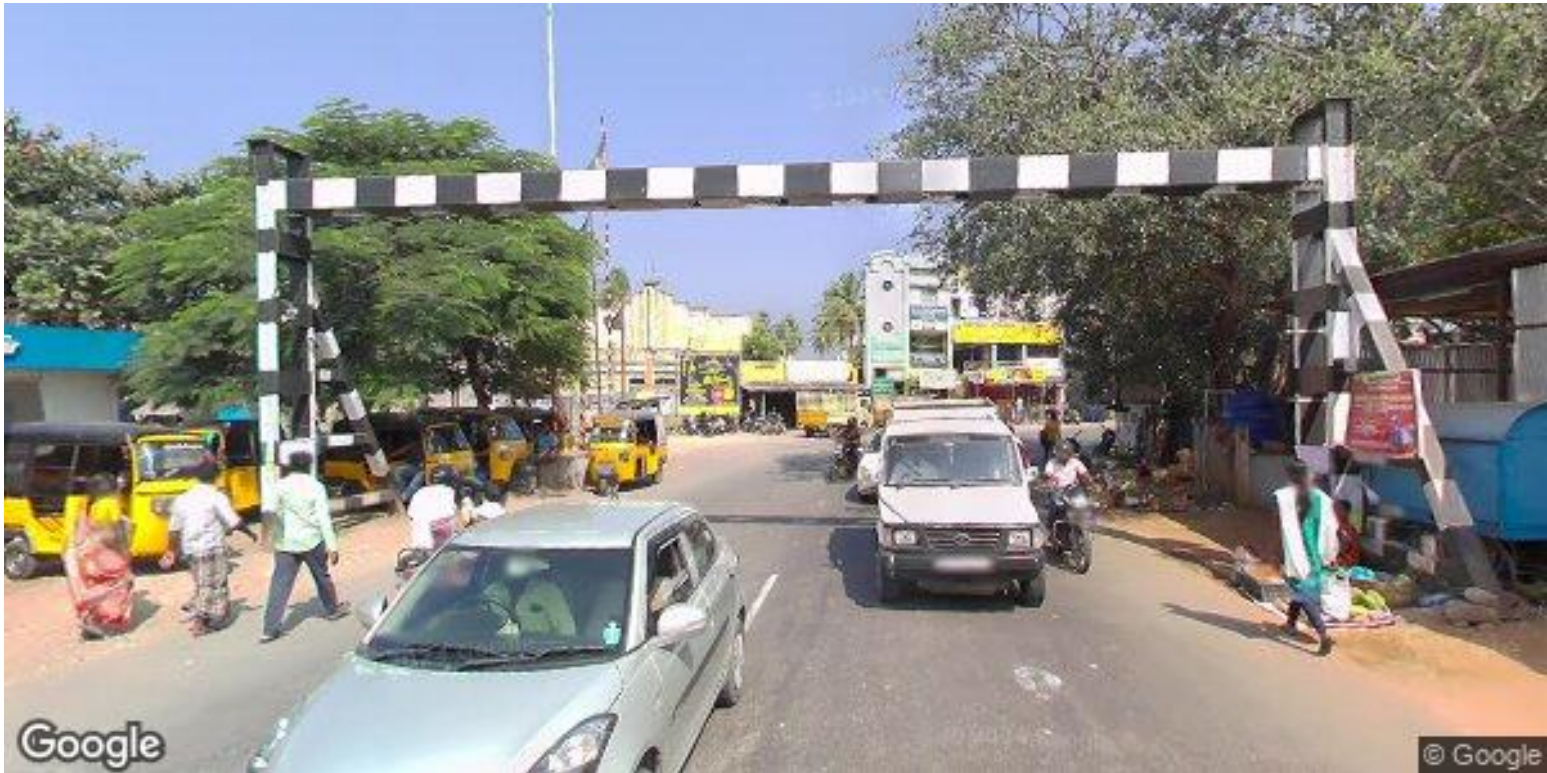
Coordinates: 11.67171, 78.23139

Risk Type: Turn

Risk Level: High

Speed Limit: 15 KM/Hr

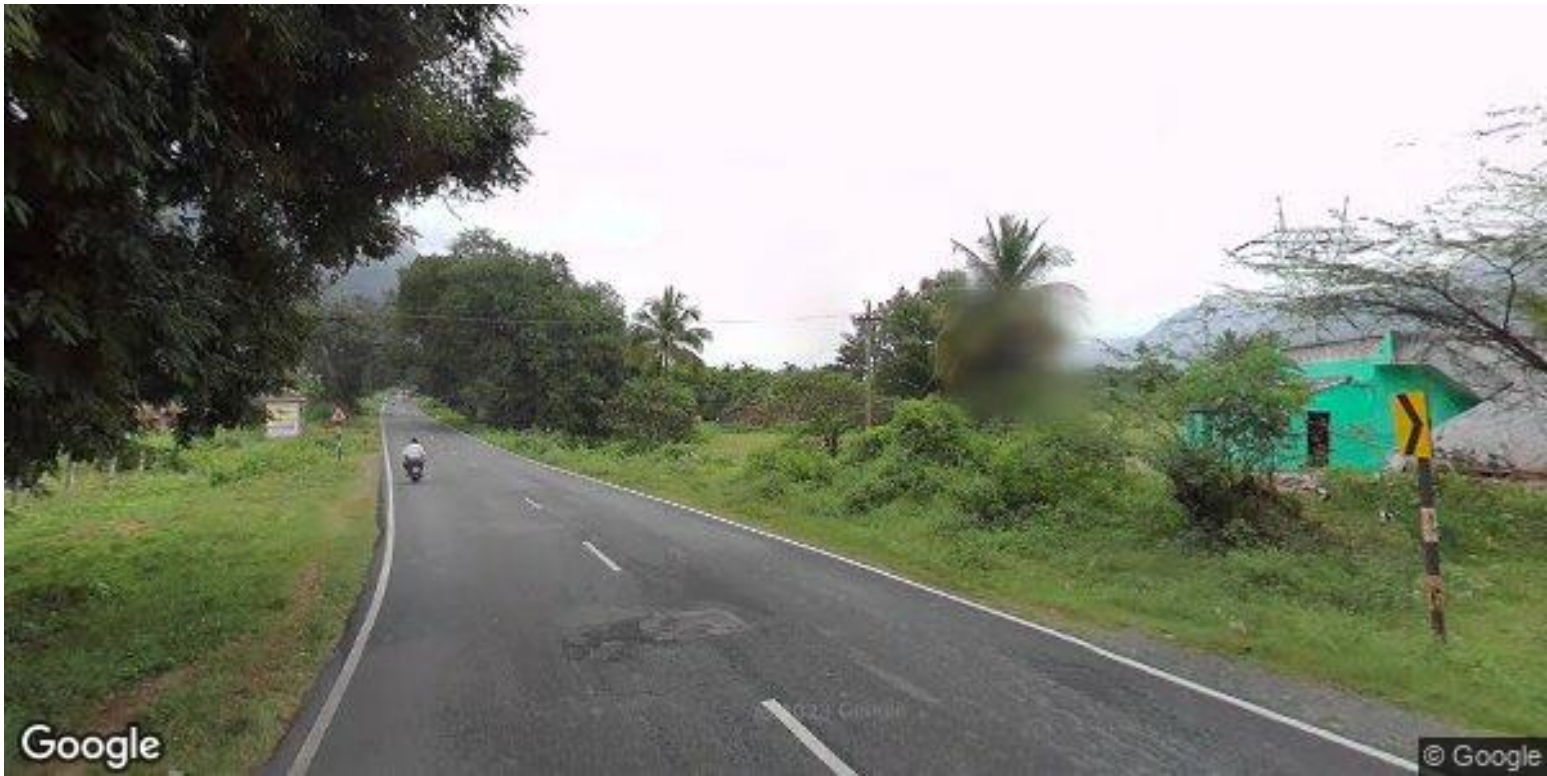
**Risk Type:** Turn  
**Risk Level:** Medium  
**Speed Limit:** 30 KM/Hr  
**Coordinates:** 11.81249, 78.34088

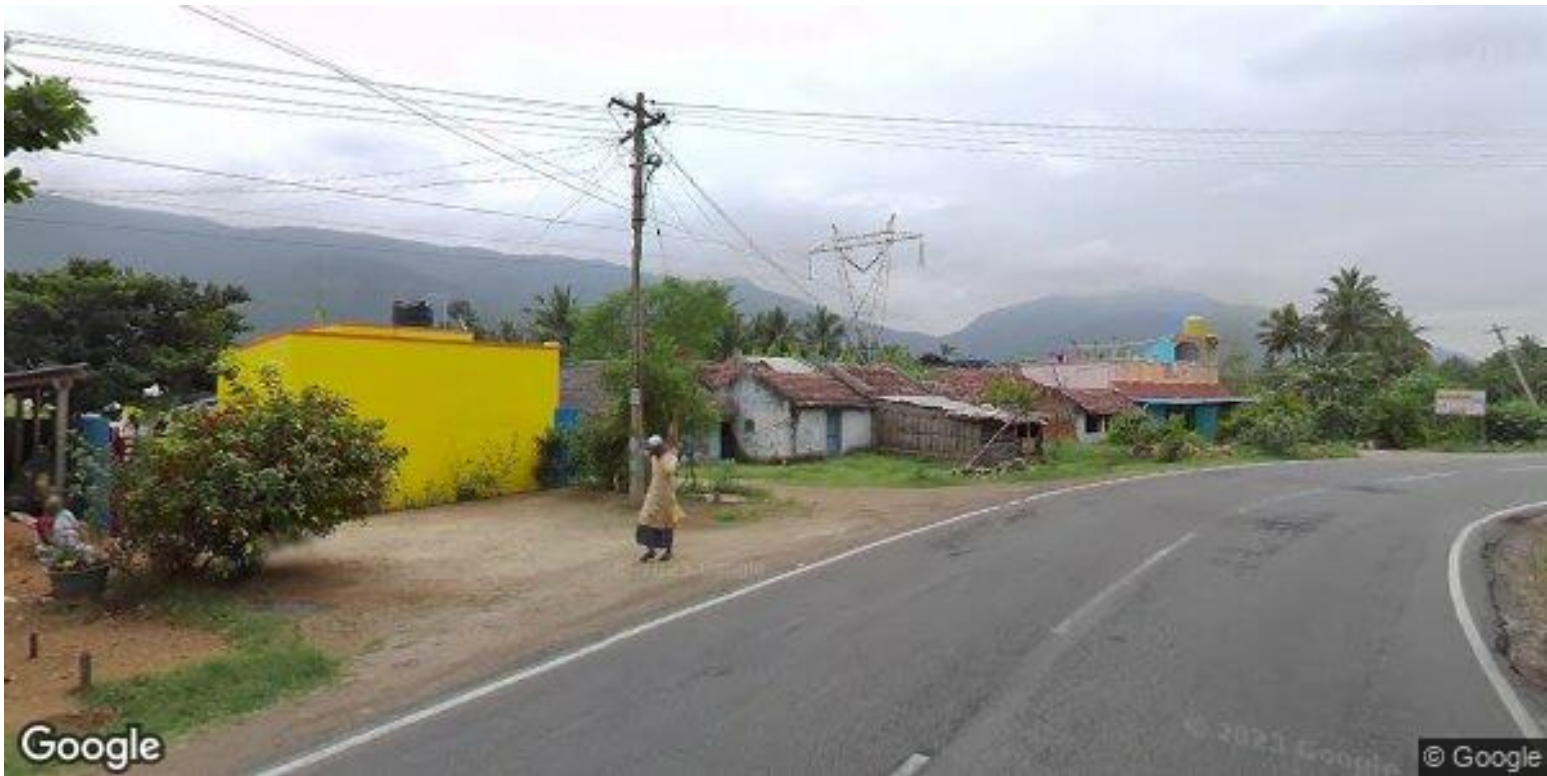
**Risk Type:** Turn  
**Risk Level:** Medium  
**Speed Limit:** 30 KM/Hr  
**Coordinates:** 11.83492, 78.35299

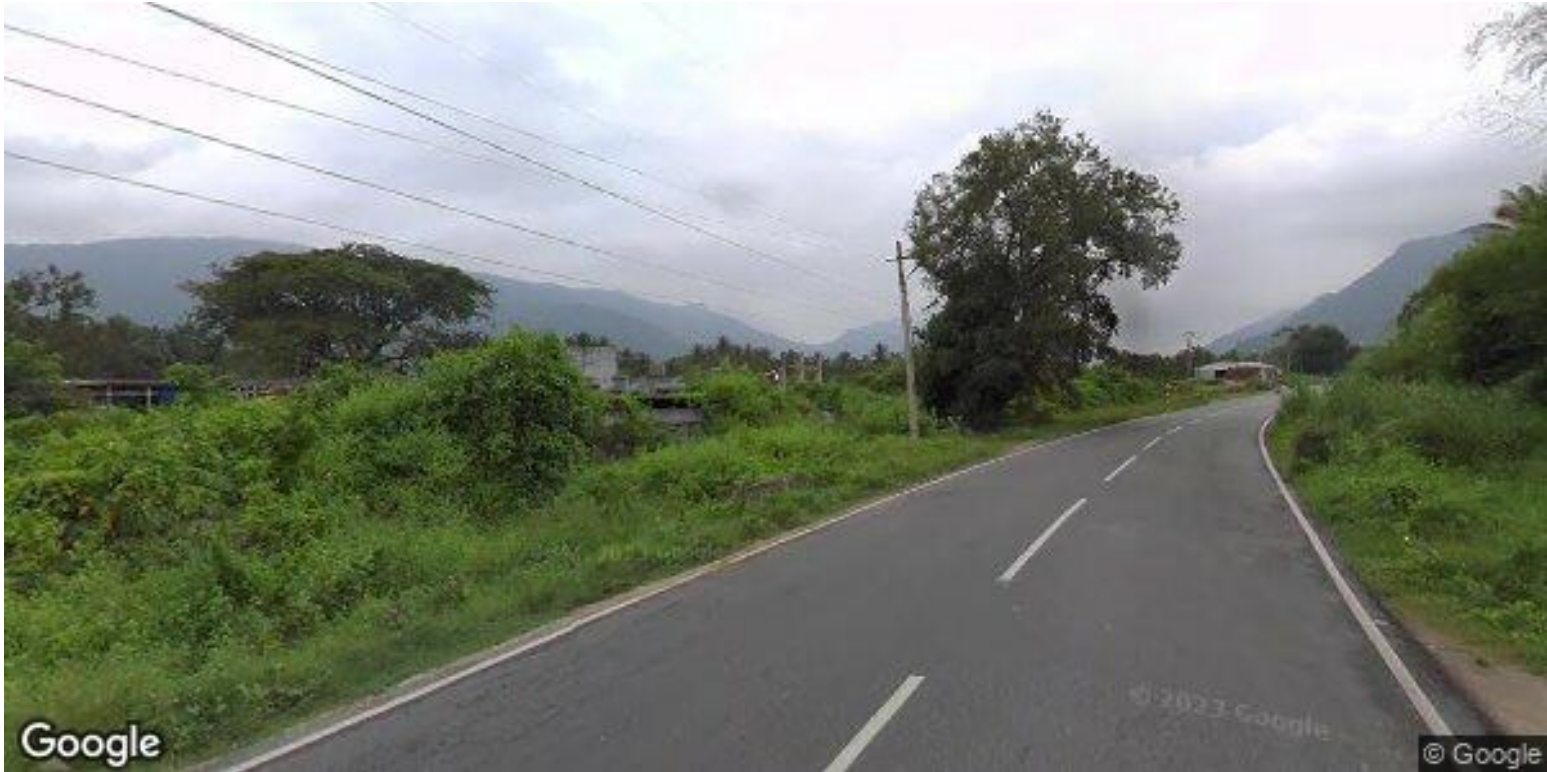
**Risk Type:** Turn  
**Risk Level:** Medium  
**Speed Limit:** 30 KM/Hr  
**Coordinates:** 11.84761, 78.36080

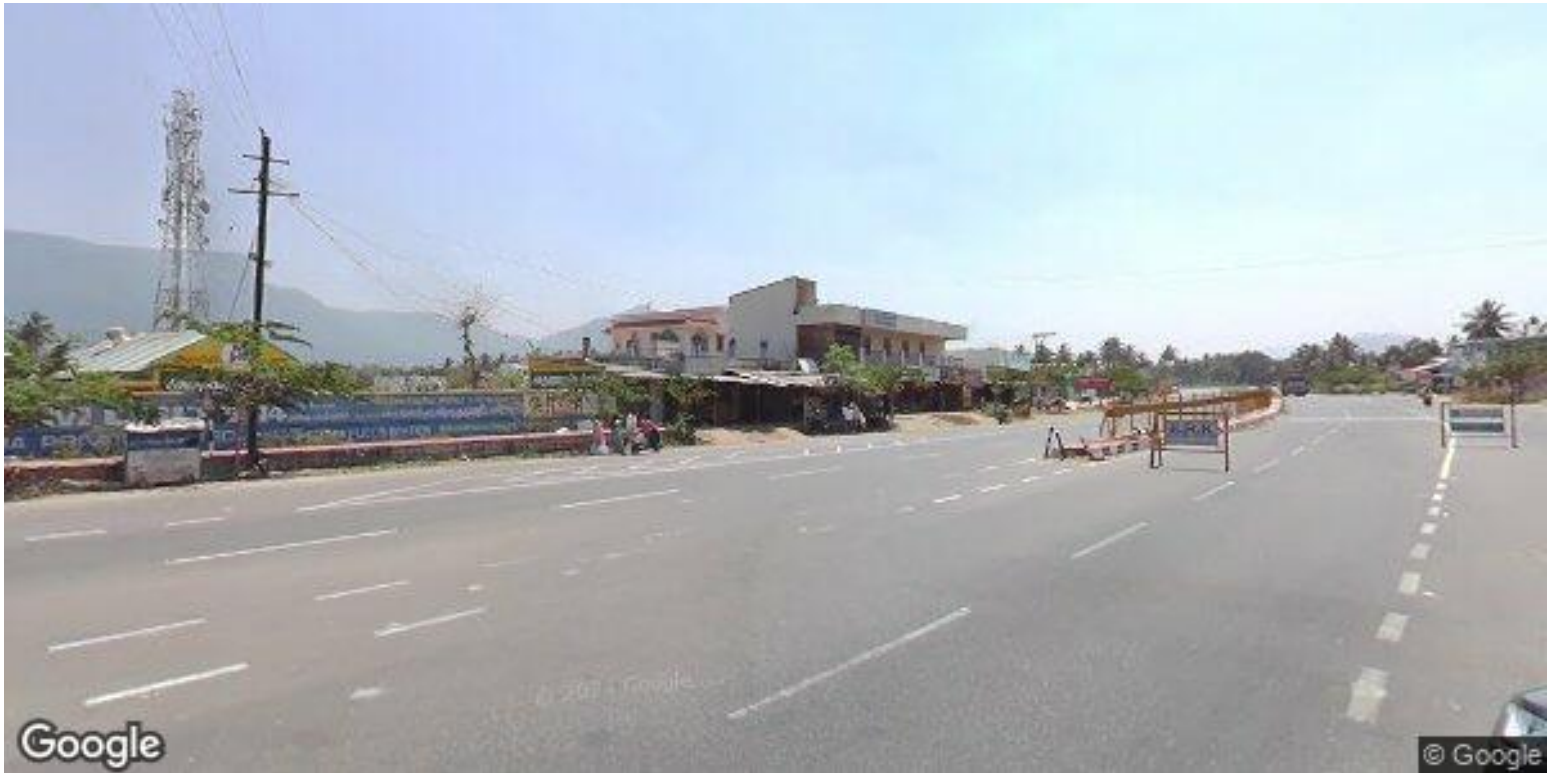
**Risk Type:** Turn  
**Risk Level:** High  
**Speed Limit:** 15 KM/Hr  
**Coordinates:** 11.93919, 78.40422
