# IndianOil

## JOURNEY RISK MANAGEMENT (JRM) STUDY

### Salem Terminal to USHA FUELS

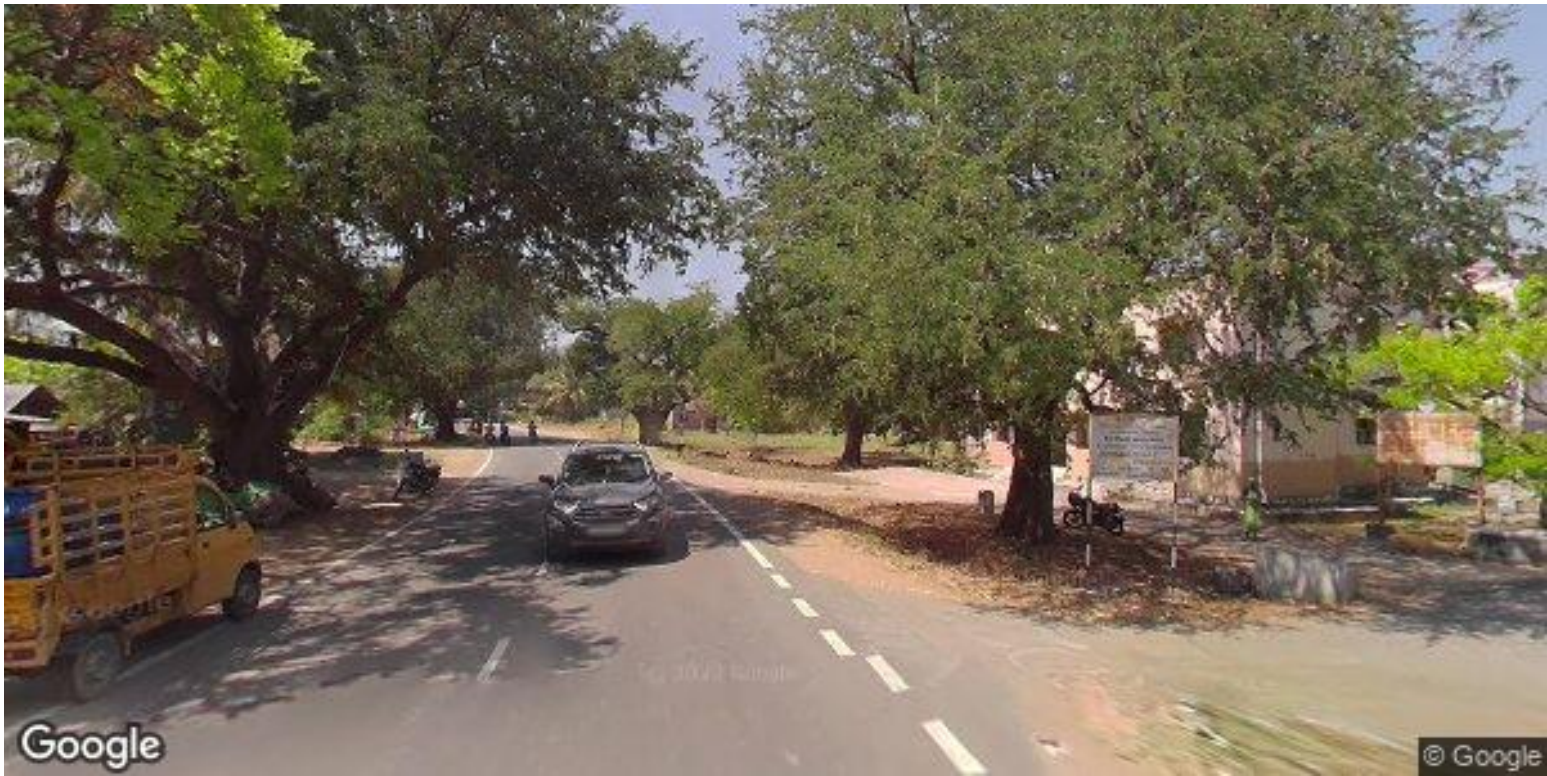
**Risk Type:** Turn  
**Risk Level:** Medium  
**Speed Limit:** 30 KM/Hr  
**Coordinates:** 11.93992, 78.40355

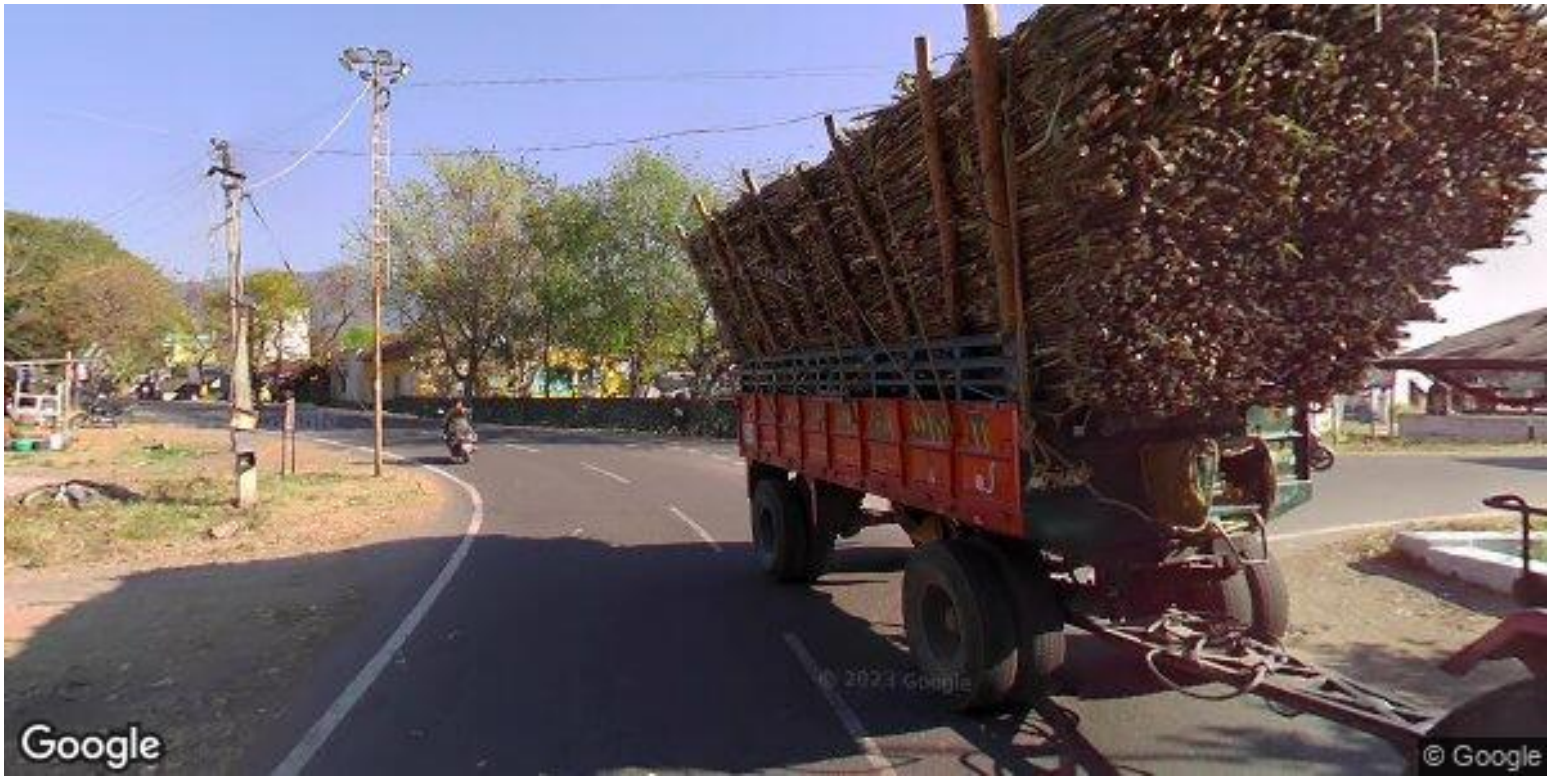
**Risk Type:** Turn  
**Risk Level:** High  
**Speed Limit:** 15 KM/Hr  
**Coordinates:** 11.94056, 78.40185

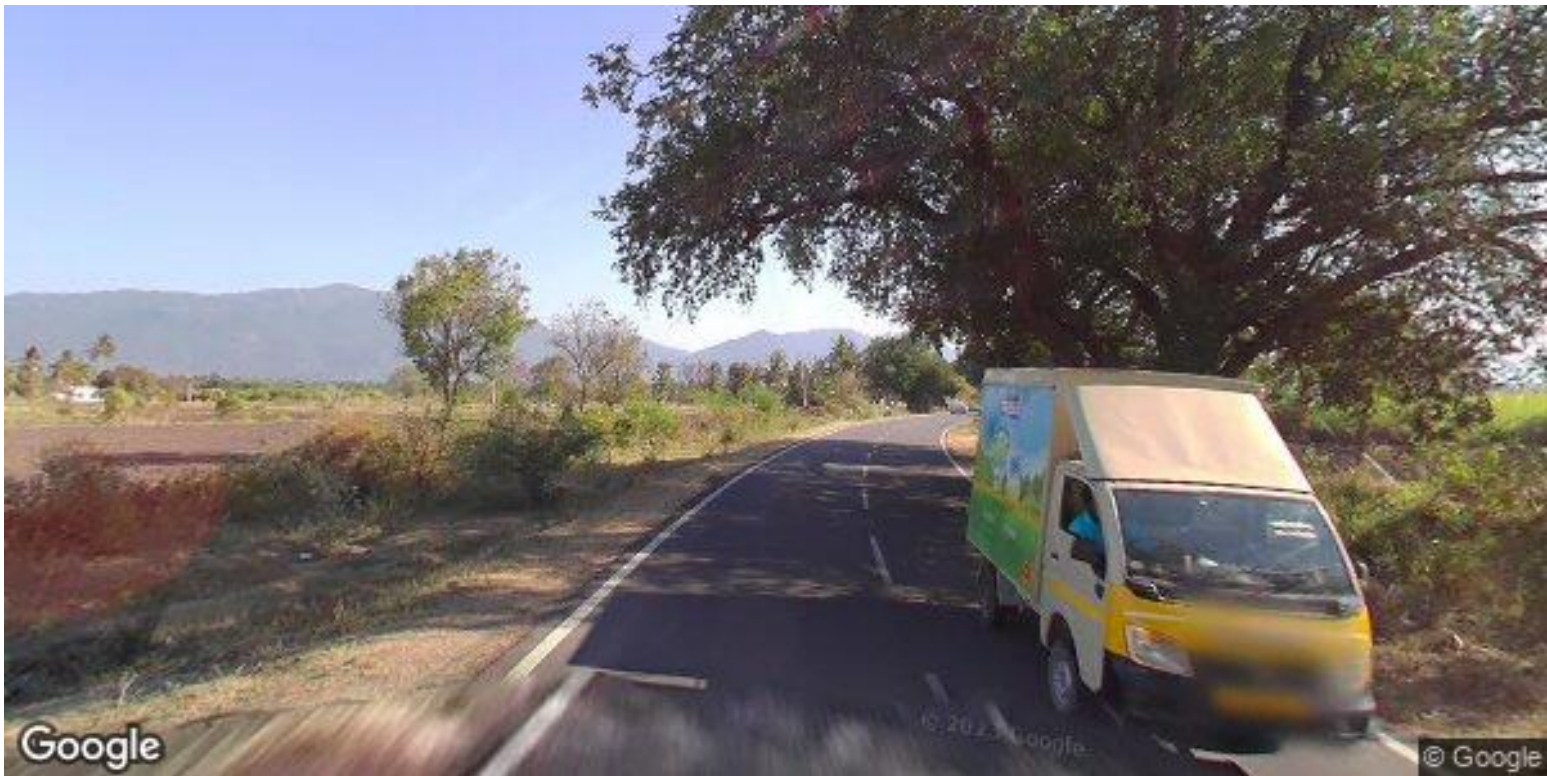
**Risk Type:** Turn  
**Risk Level:** Medium  
**Speed Limit:** 30 KM/Hr  
**Coordinates:** 11.95589, 78.39972

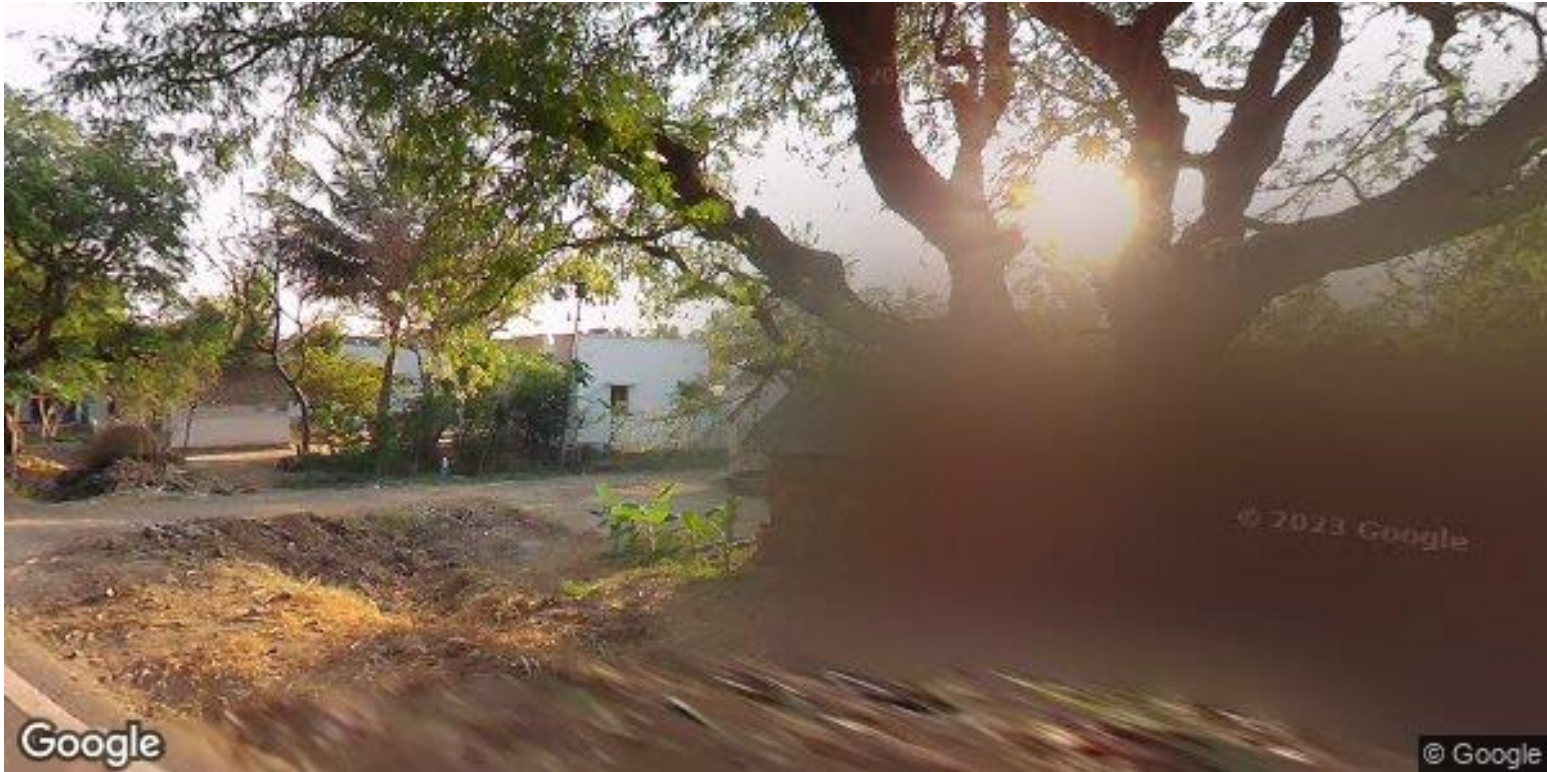
**Risk Type:** Turn  
**Risk Level:** Medium  
**Speed Limit:** 30 KM/Hr  
**Coordinates:** 11.96475, 78.39648

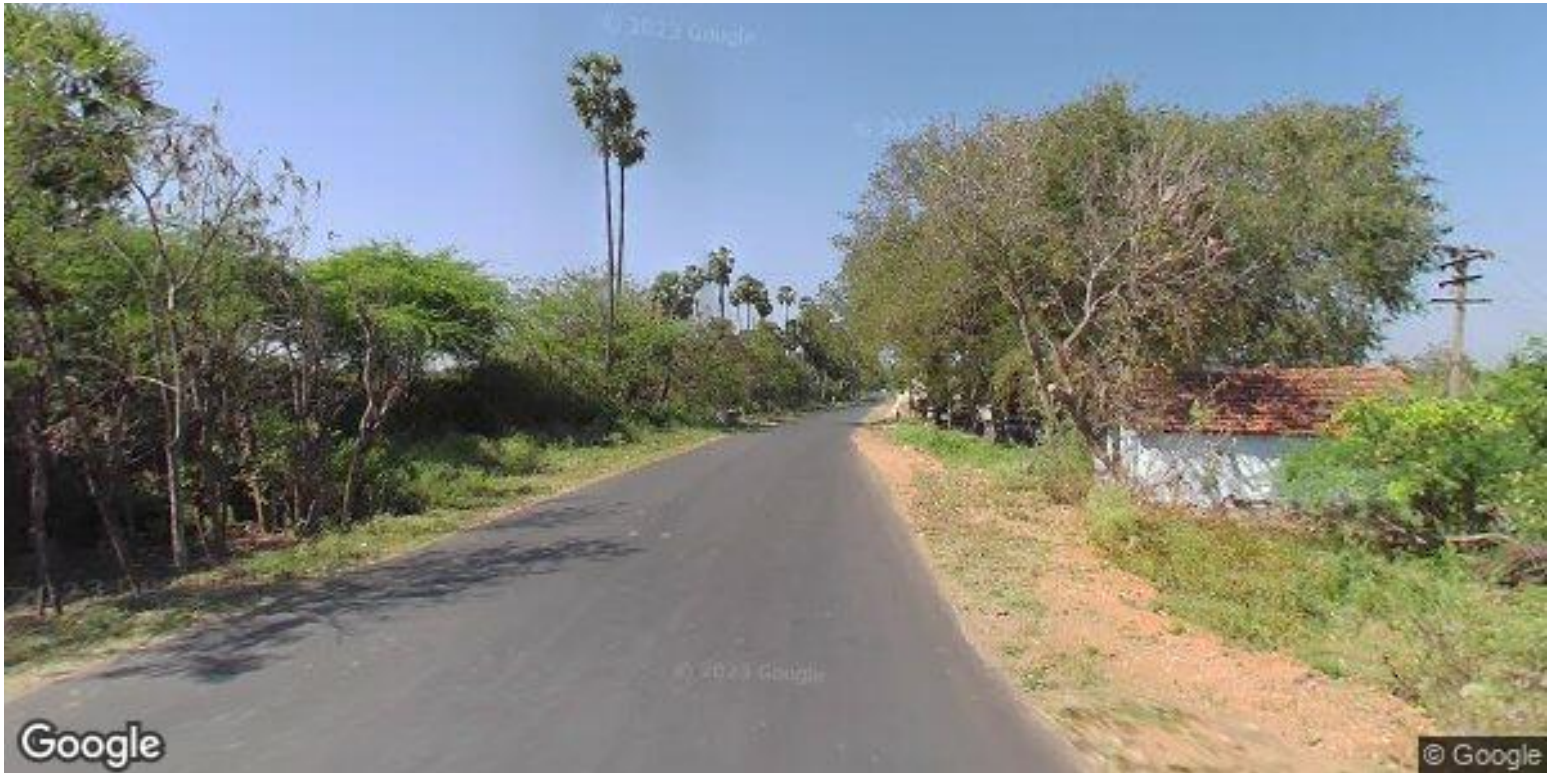
**Risk Type:** Turn  
**Risk Level:** Medium  
**Speed Limit:** 30 KM/Hr  
**Coordinates:** 12.00574, 78.39736

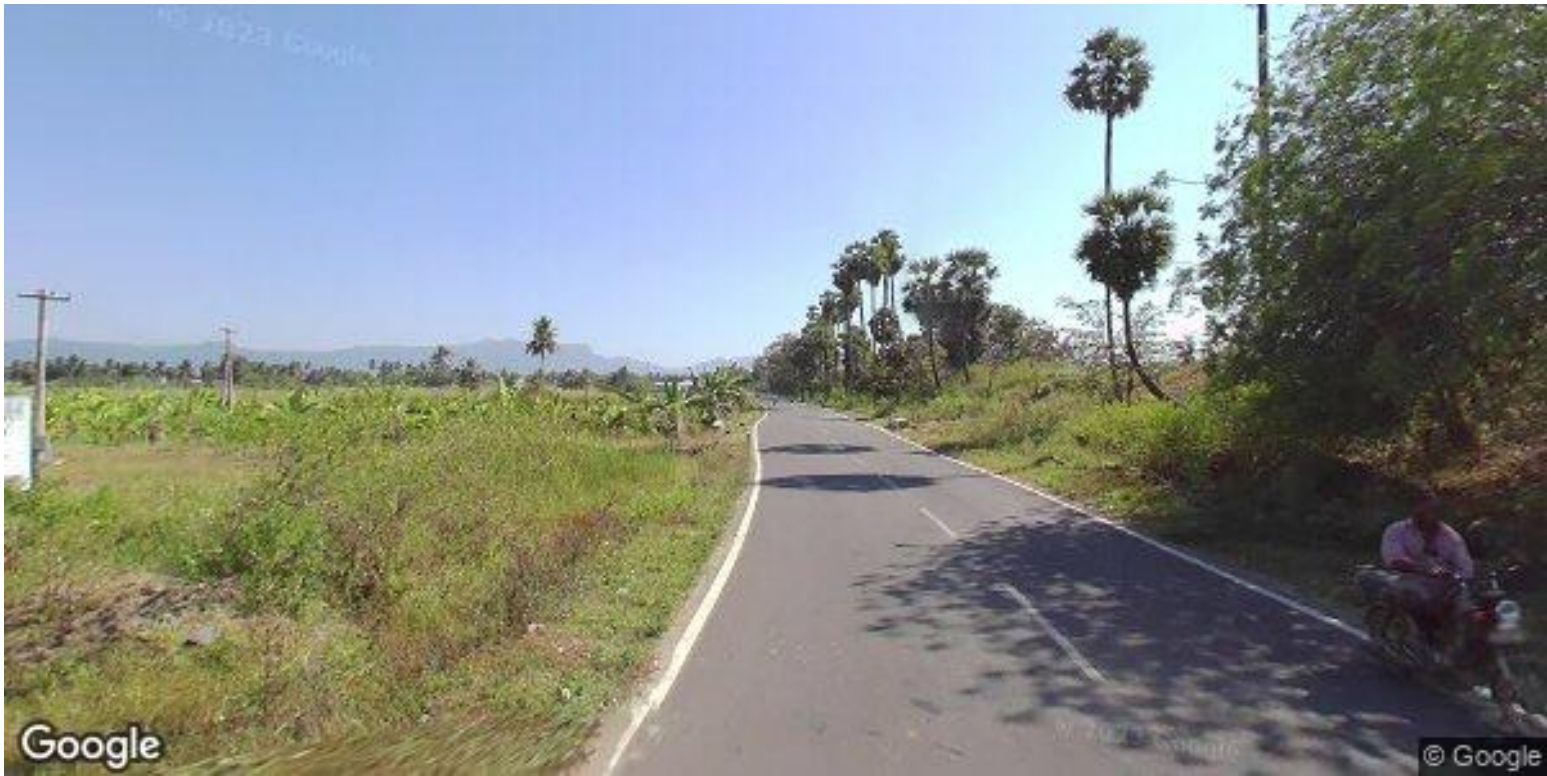
**Risk Type:** Turn  
**Risk Level:** Medium  
**Speed Limit:** 30 KM/Hr  
**Coordinates:** 12.00993, 78.39696

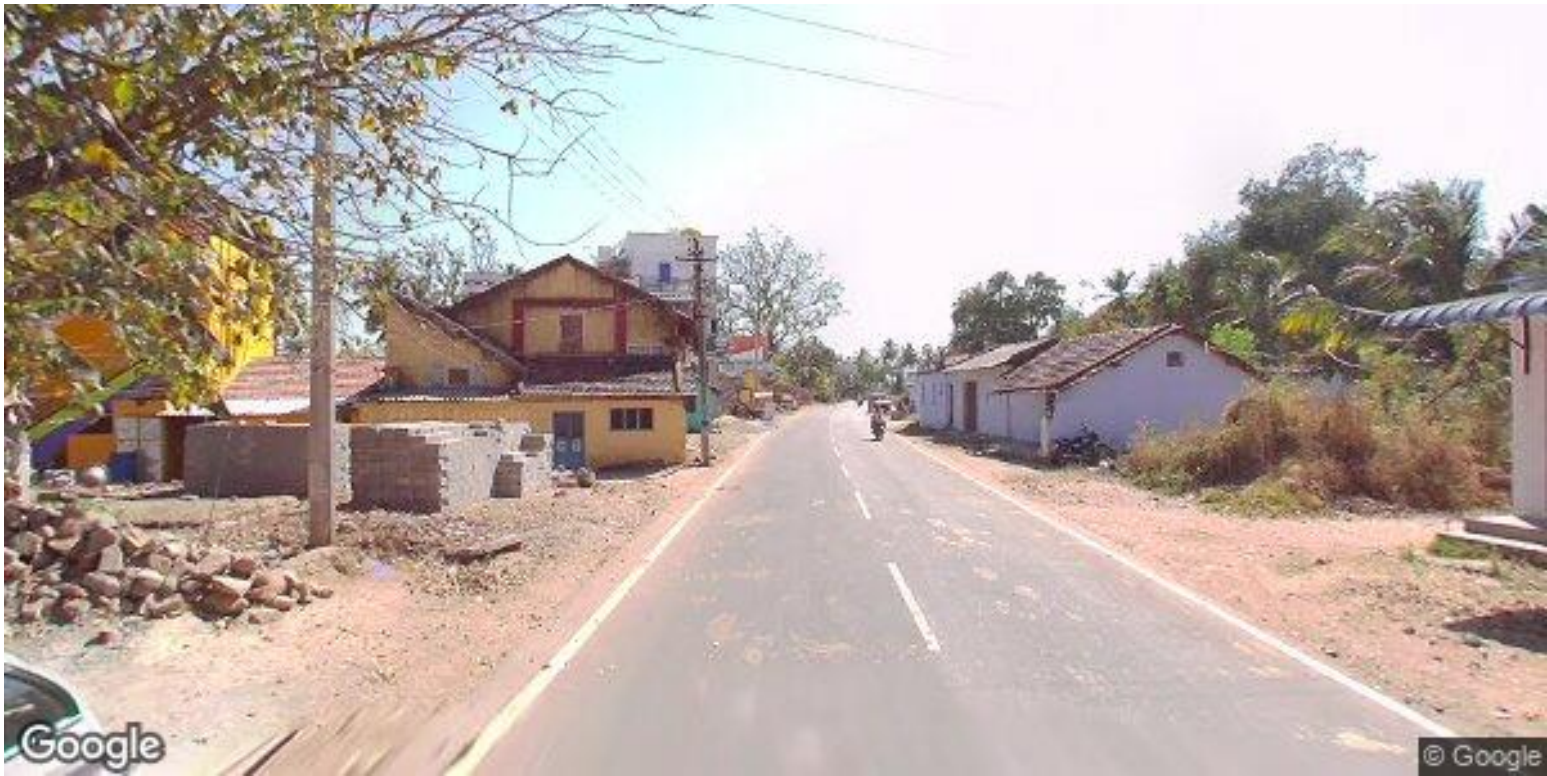
**Risk Type:** Turn  
**Risk Level:** Medium  
**Speed Limit:** 30 KM/Hr  
**Coordinates:** 12.01166, 78.39848

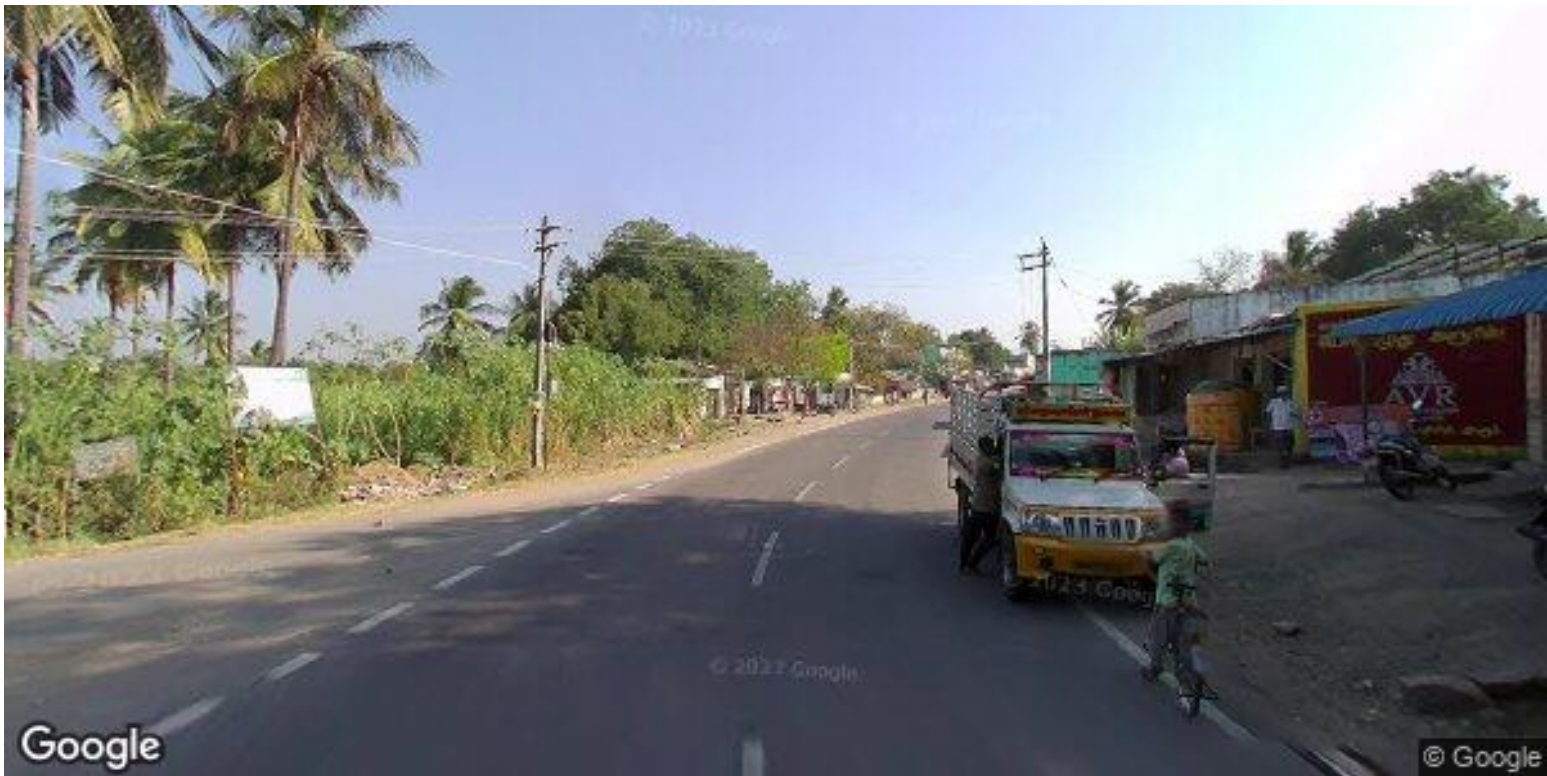
**Risk Type:** Turn  
**Risk Level:** Medium  
**Speed Limit:** 30 KM/Hr  
**Coordinates:** 12.01396, 78.39882

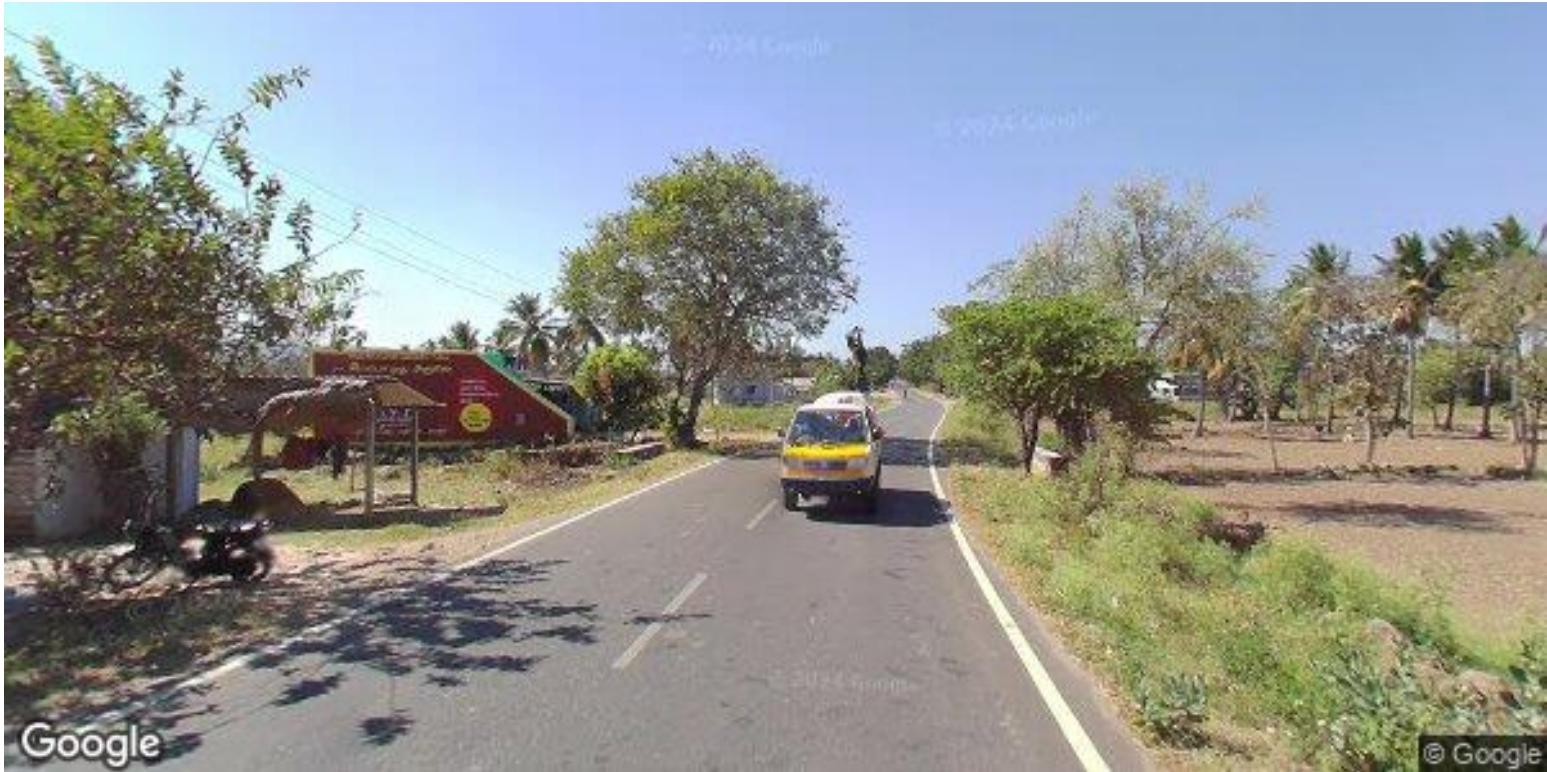
**Risk Type:** Turn  
**Risk Level:** Medium  
**Speed Limit:** 30 KM/Hr  
**Coordinates:** 12.01559, 78.39604

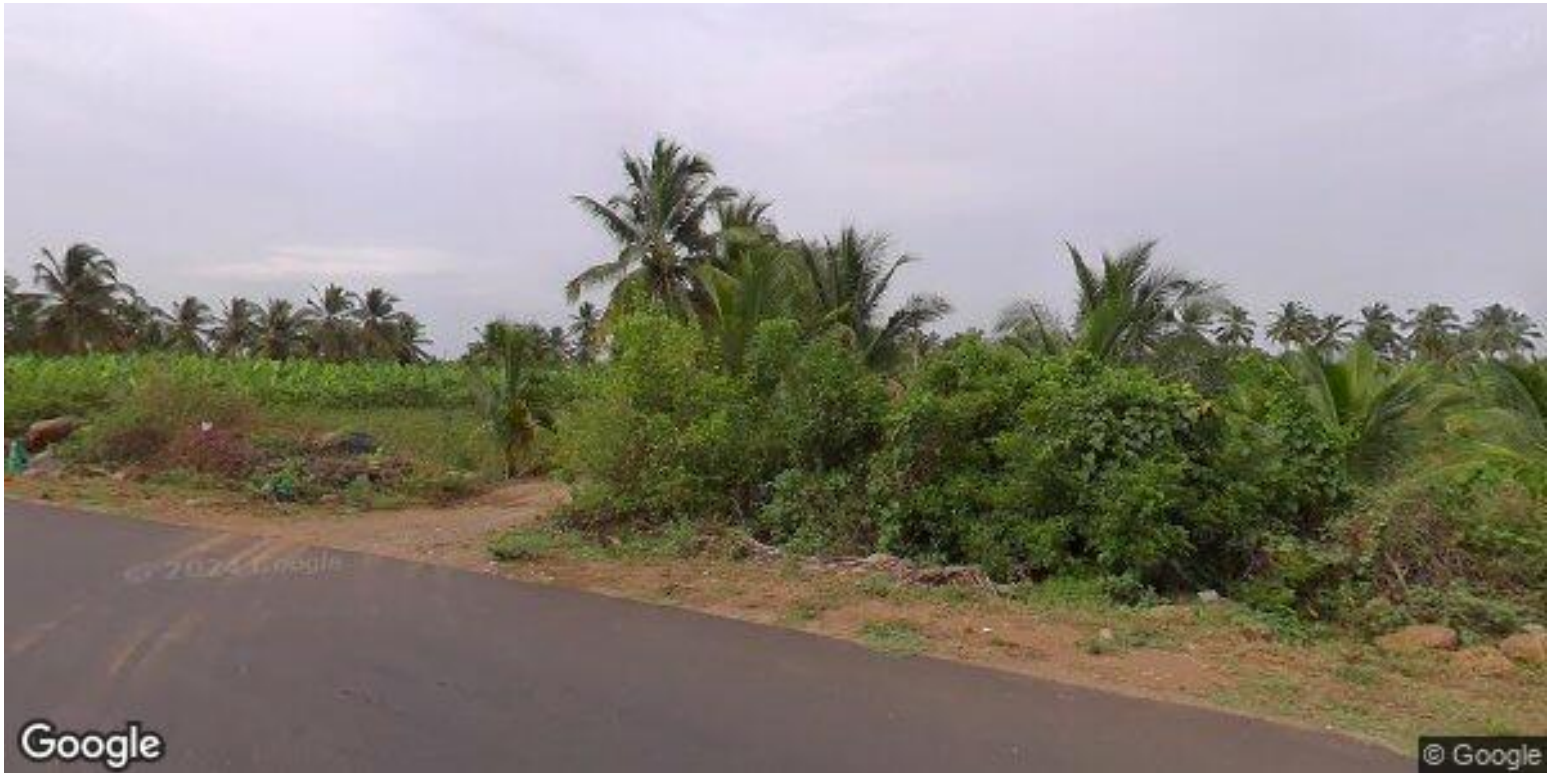
**Risk Type:** Turn  
**Risk Level:** Medium  
**Speed Limit:** 30 KM/Hr  
**Coordinates:** 12.06704, 78.36322

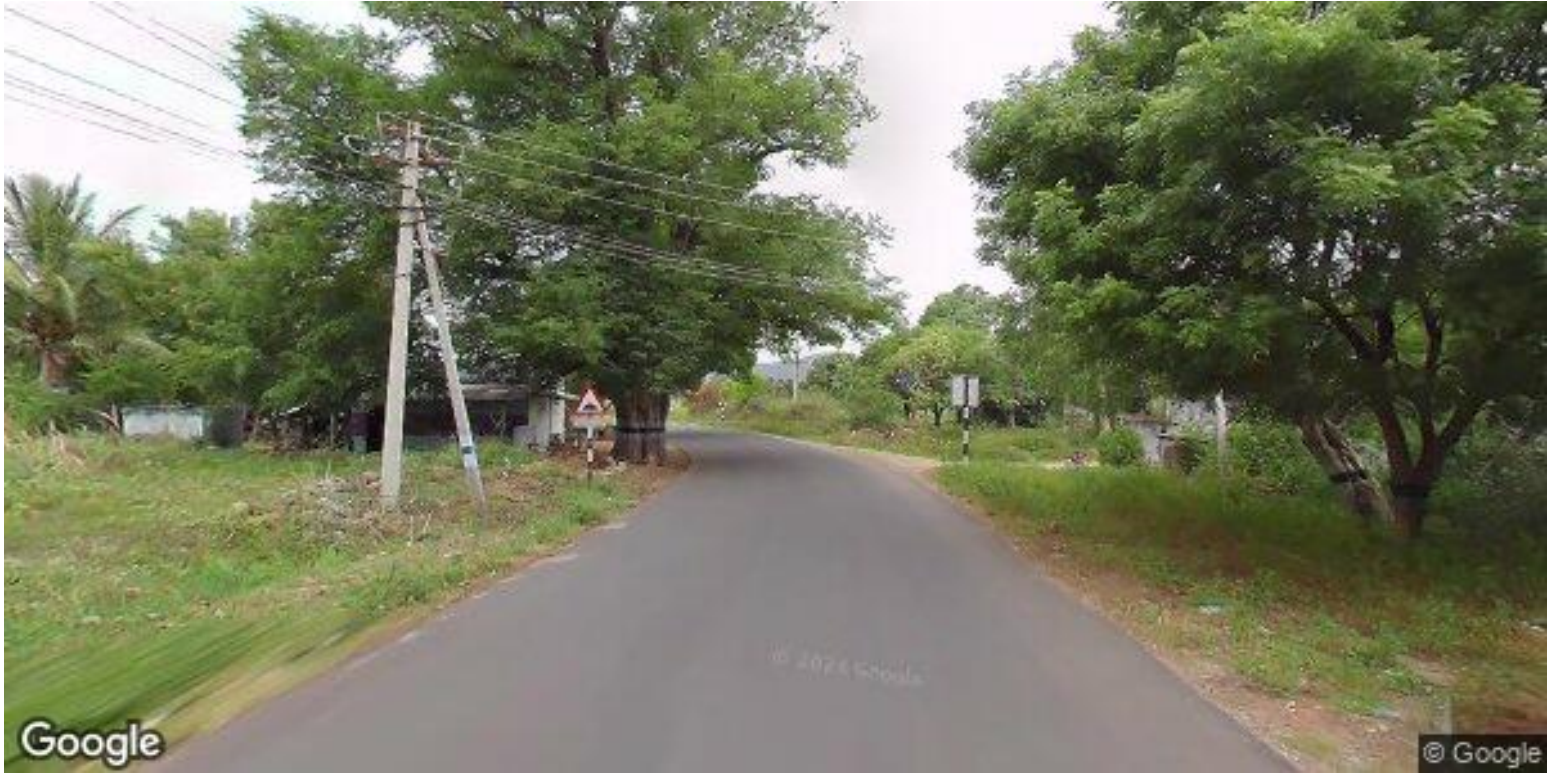
**Risk Type:** Turn  
**Risk Level:** Medium  
**Speed Limit:** 30 KM/Hr  
**Coordinates:** 12.07739, 78.35549

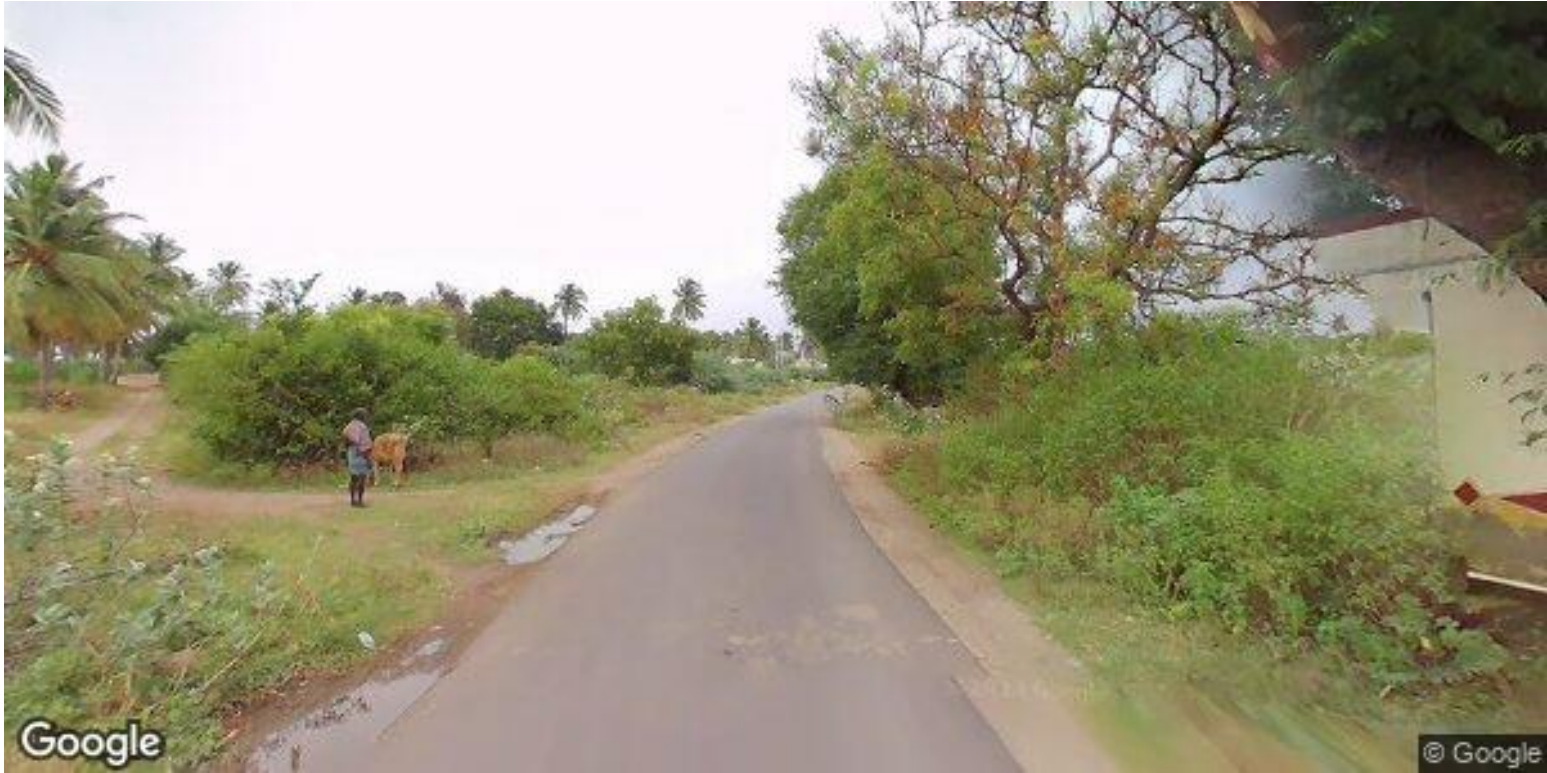
**Risk Type:** Turn  
**Risk Level:** High  
**Speed Limit:** 15 KM/Hr  
**Coordinates:** 12.07974, 78.35572

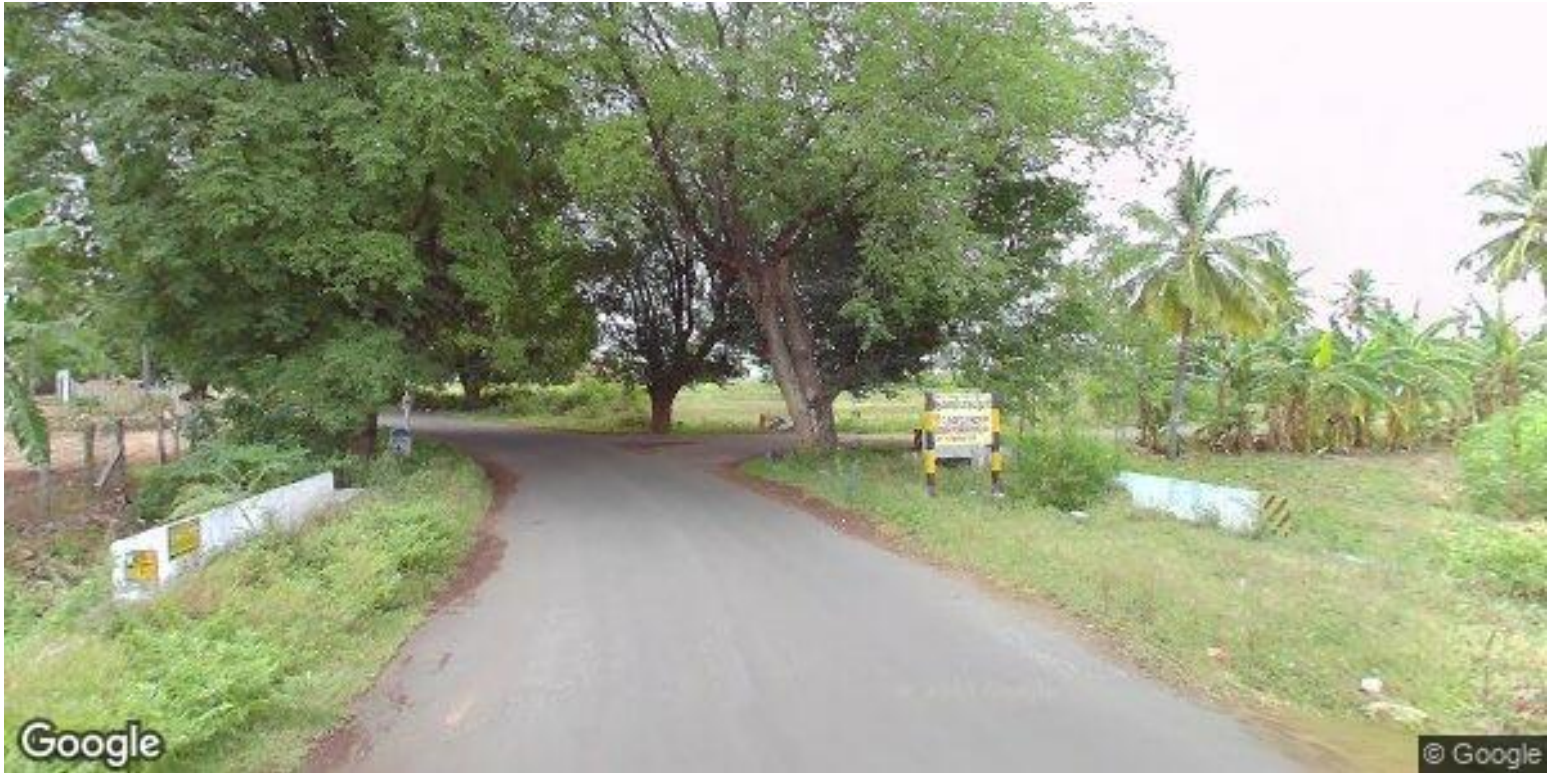
**Risk Type:** Turn  
**Risk Level:** High  
**Speed Limit:** 15 KM/Hr  
**Coordinates:** 12.09483, 78.37653

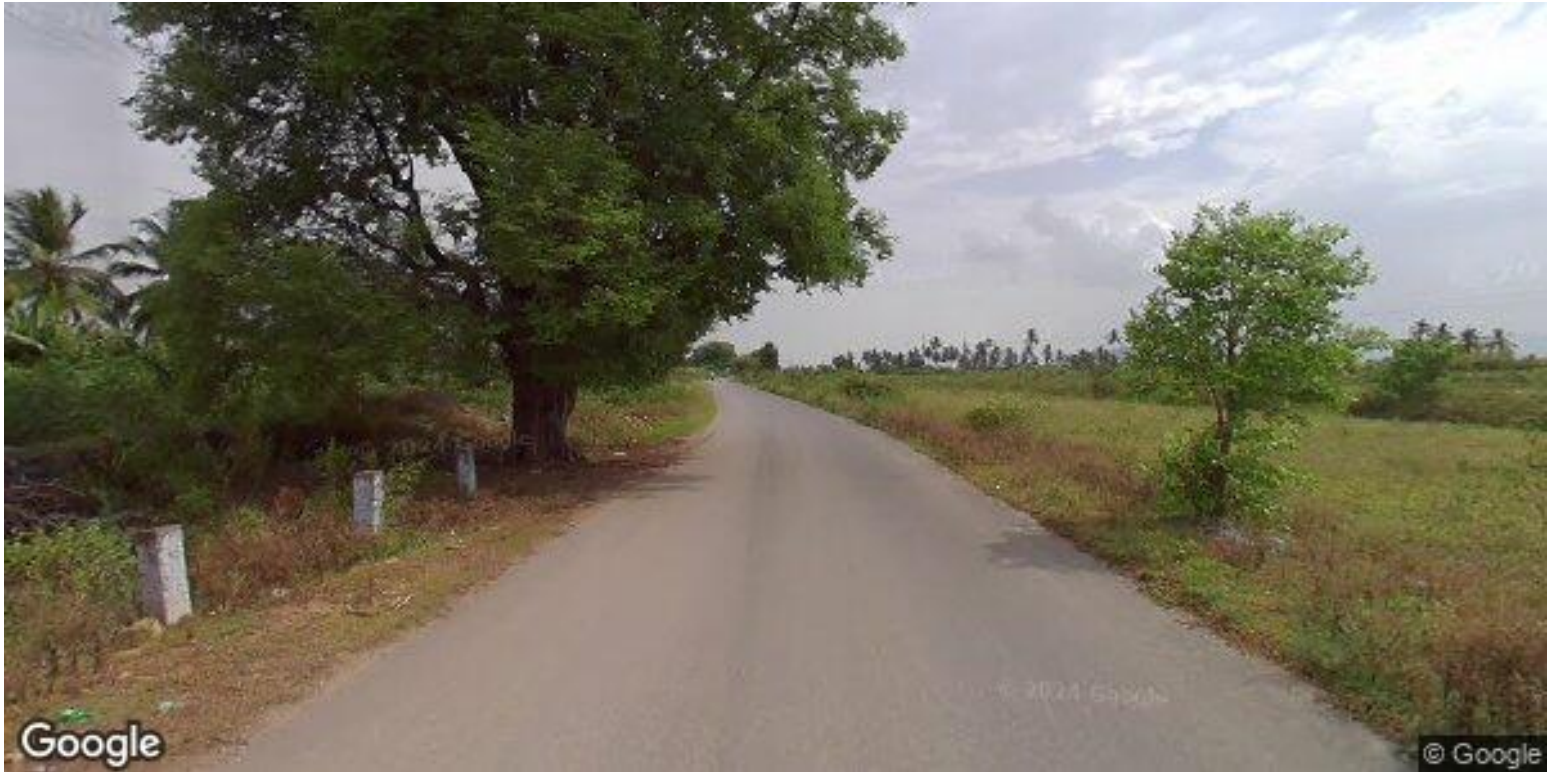
**Risk Type:** Turn  
**Risk Level:** Medium  
**Speed Limit:** 30 KM/Hr  
**Coordinates:** 12.10614, 78.38344

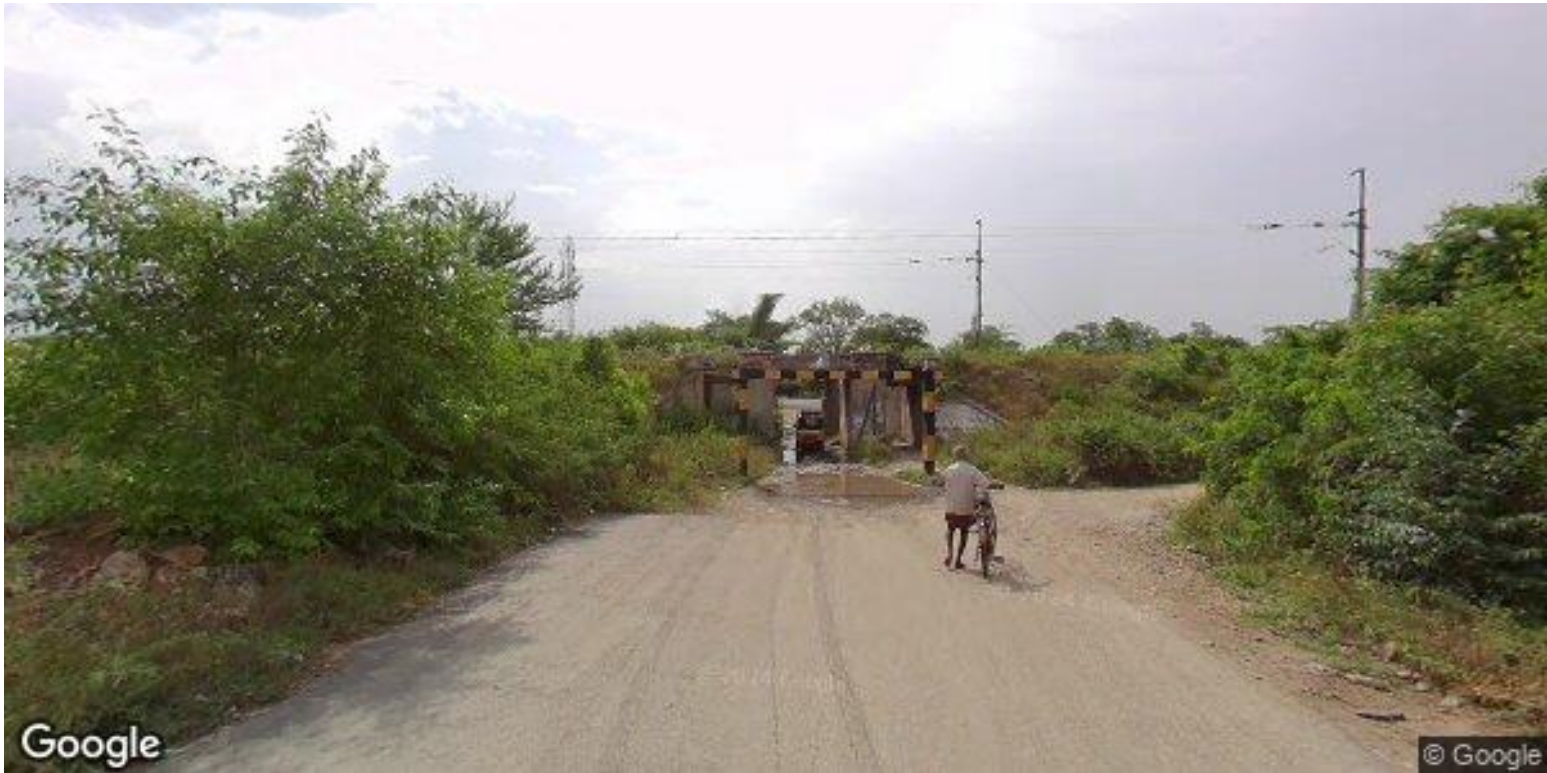
**Risk Type:** Turn  
**Risk Level:** High  
**Speed Limit:** 15 KM/Hr  
**Coordinates:** 12.10659, 78.38344

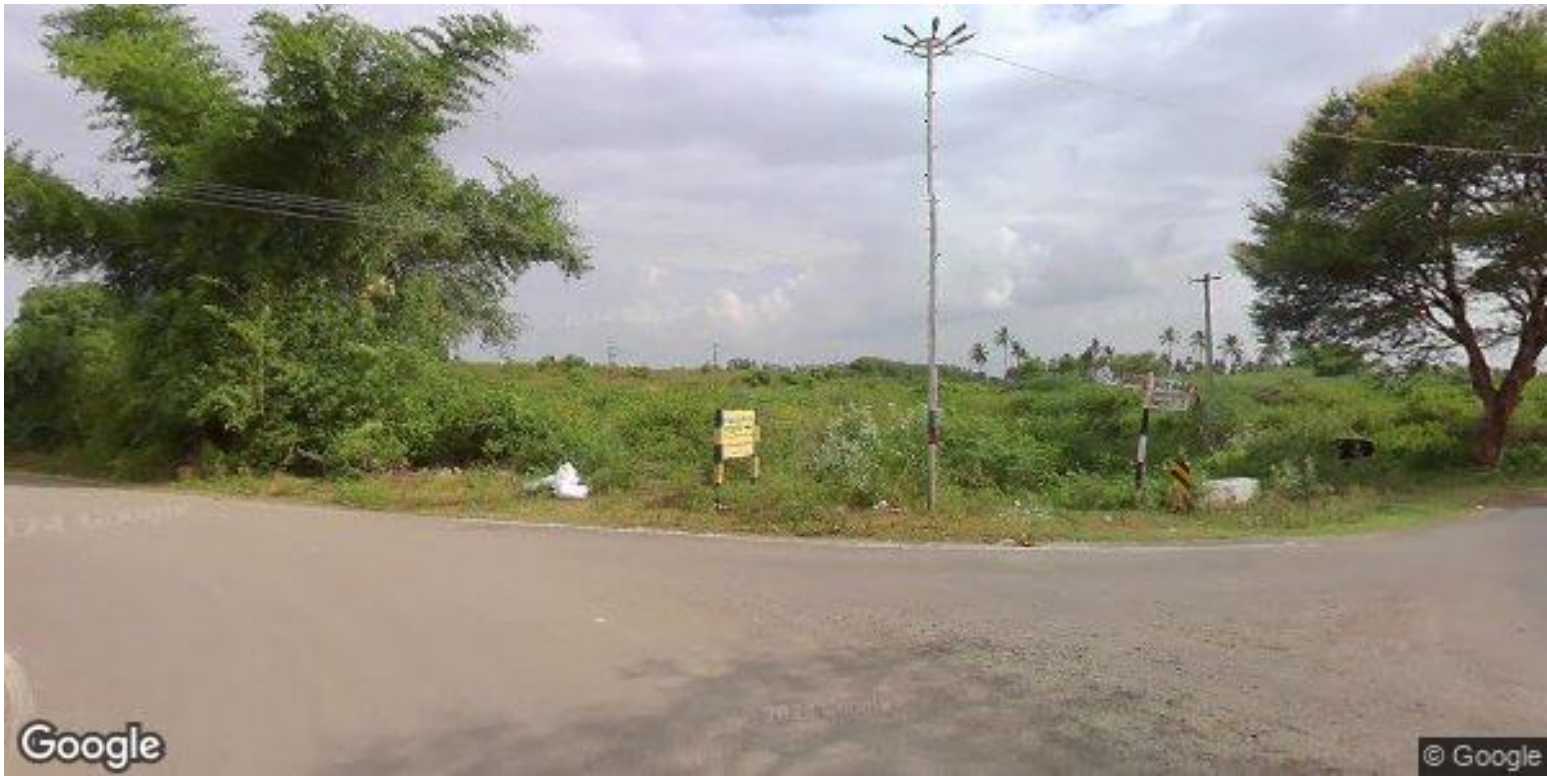
**Risk Type:** Turn  
**Risk Level:** High  
**Speed Limit:** 15 KM/Hr  
**Coordinates:** 12.10716, 78.38254

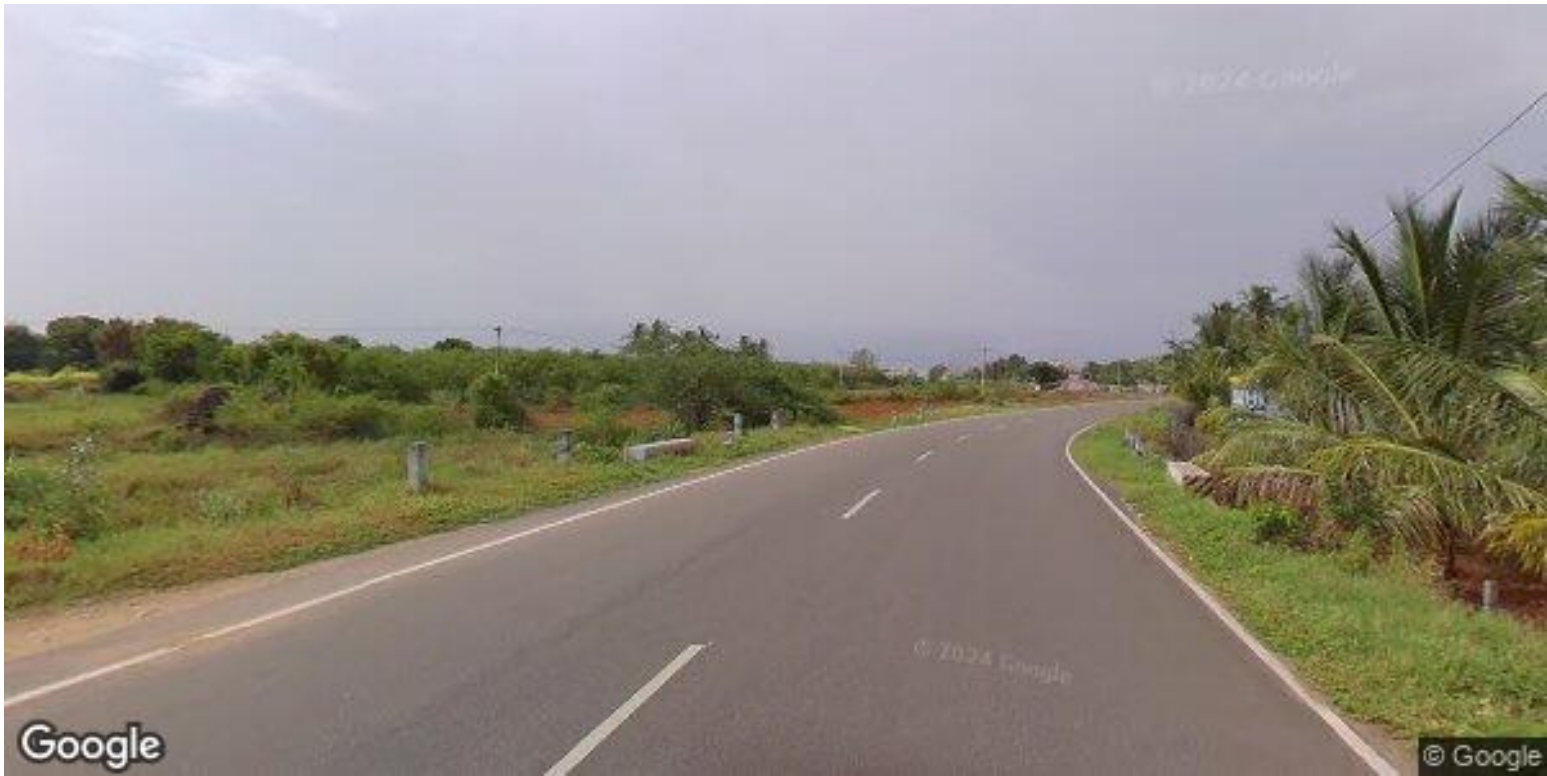
**Risk Type:** Turn  
**Risk Level:** Medium  
**Speed Limit:** 30 KM/Hr  
**Coordinates:** 12.12102, 78.39077

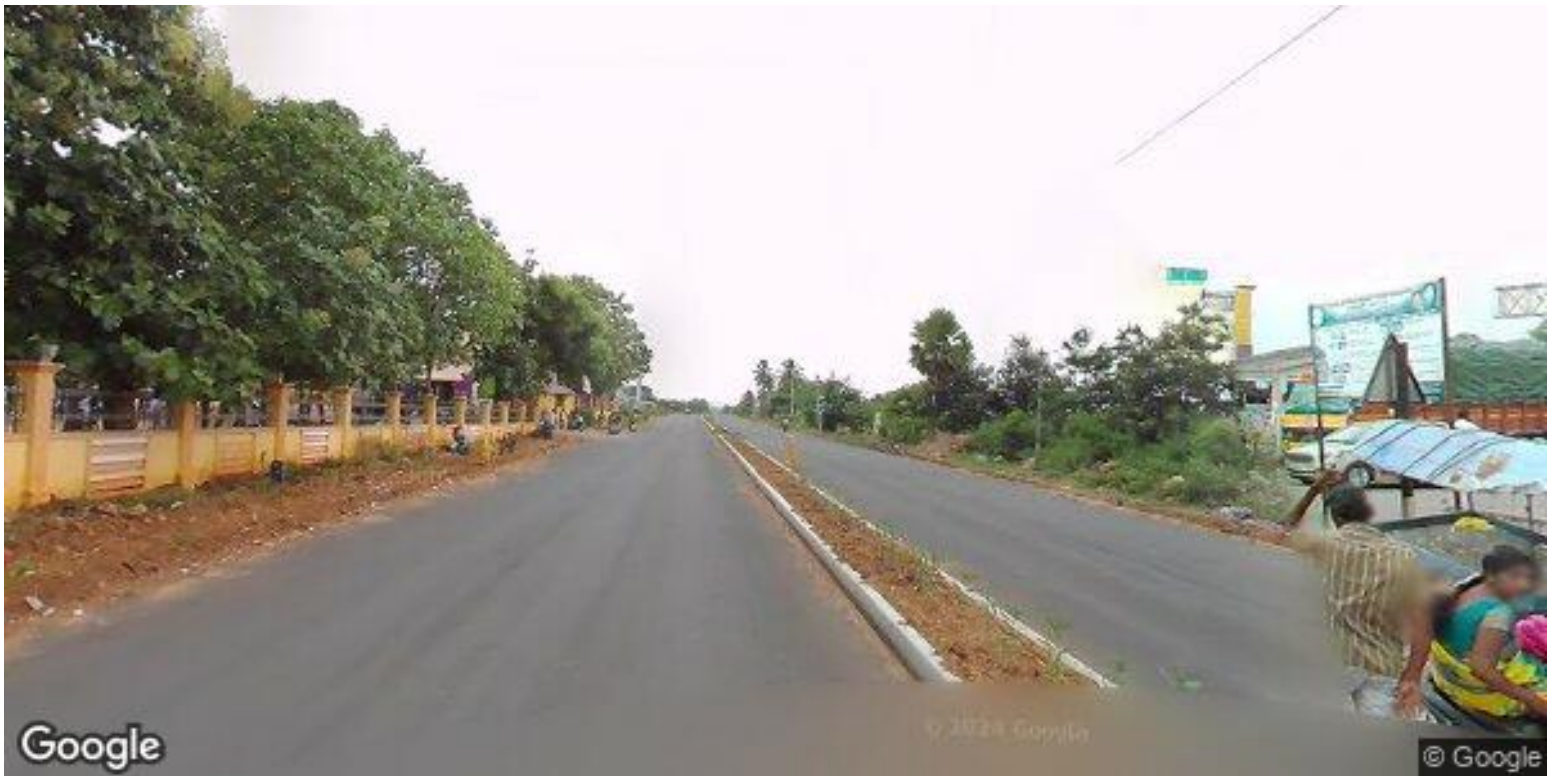
Coordinates: 12.12617, 78.39336

Risk Type: Turn

Risk Level: Medium

Speed Limit: 30 KM/Hr

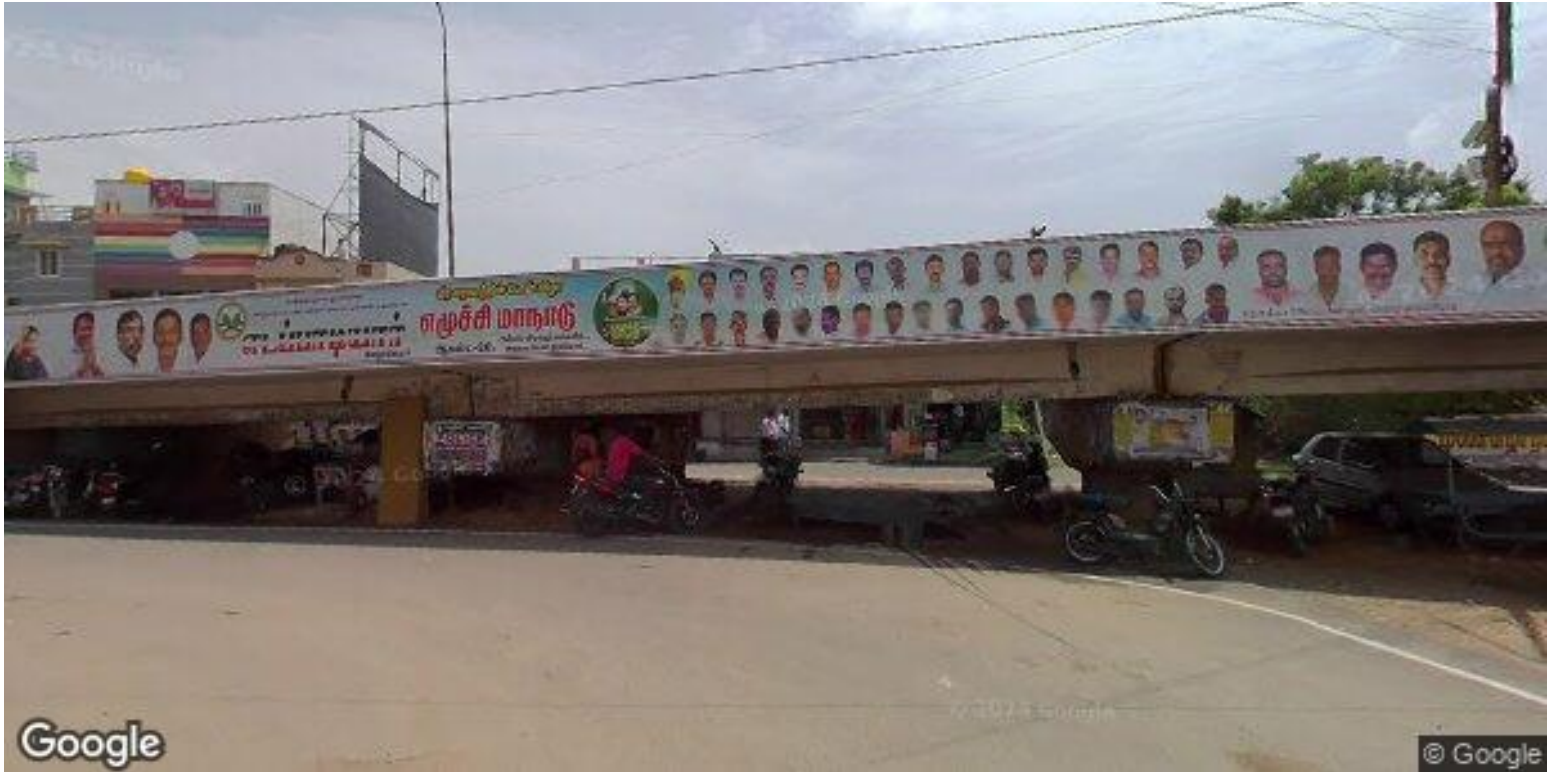
Coordinates: 12.12757, 78.39470

Risk Type: Turn

Risk Level: High

Speed Limit: 15 KM/Hr
