## JOURNEY RISK MANAGEMENT (JRM) STUDY

### Salem Terminal TO GOPALAKRISHNA AGENCY UNIT - II

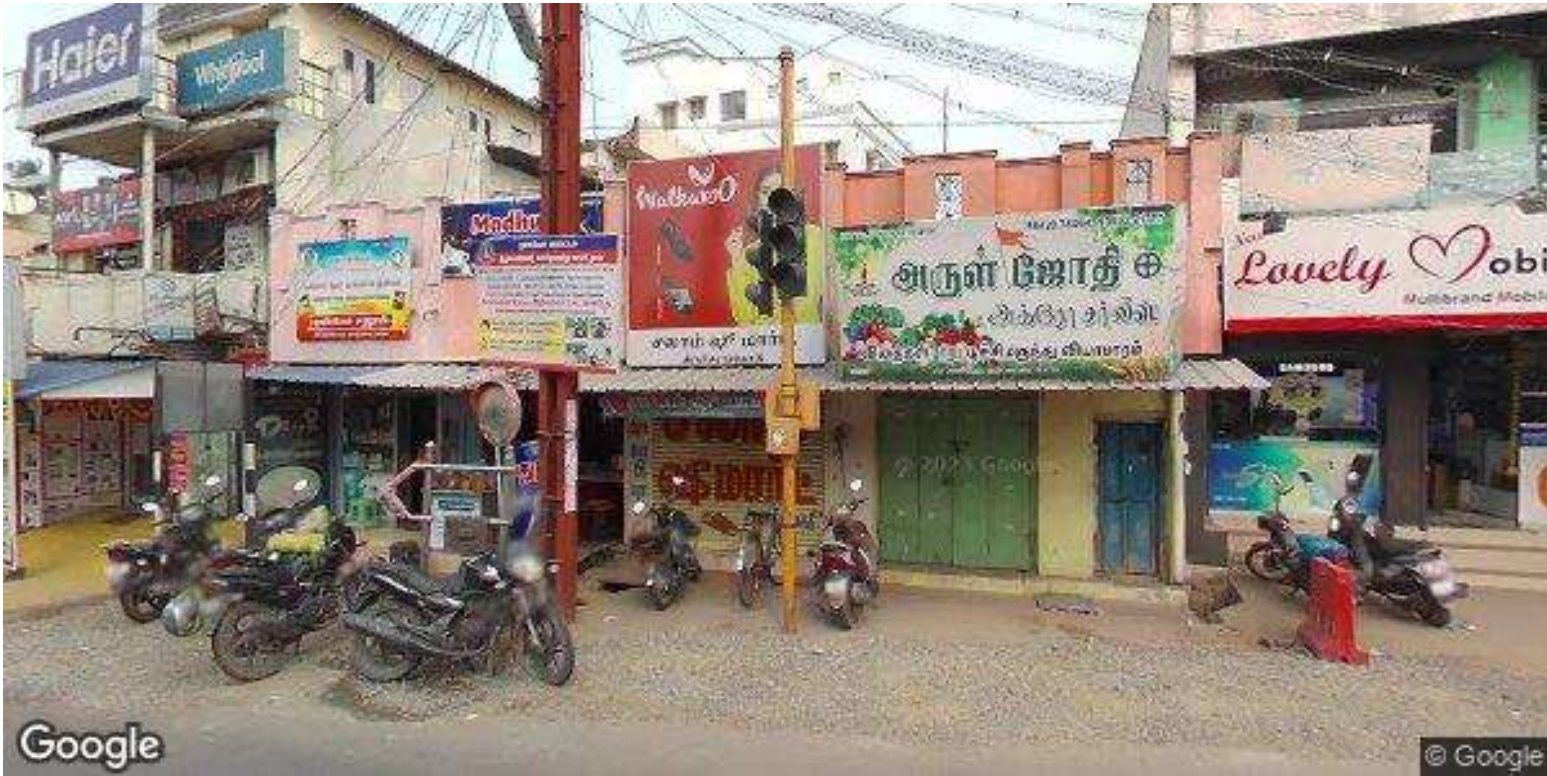
Coordinates: 11.37850, 77.89453

Risk Type: Turn

Risk Level: High

Speed Limit: 15 KM/Hr

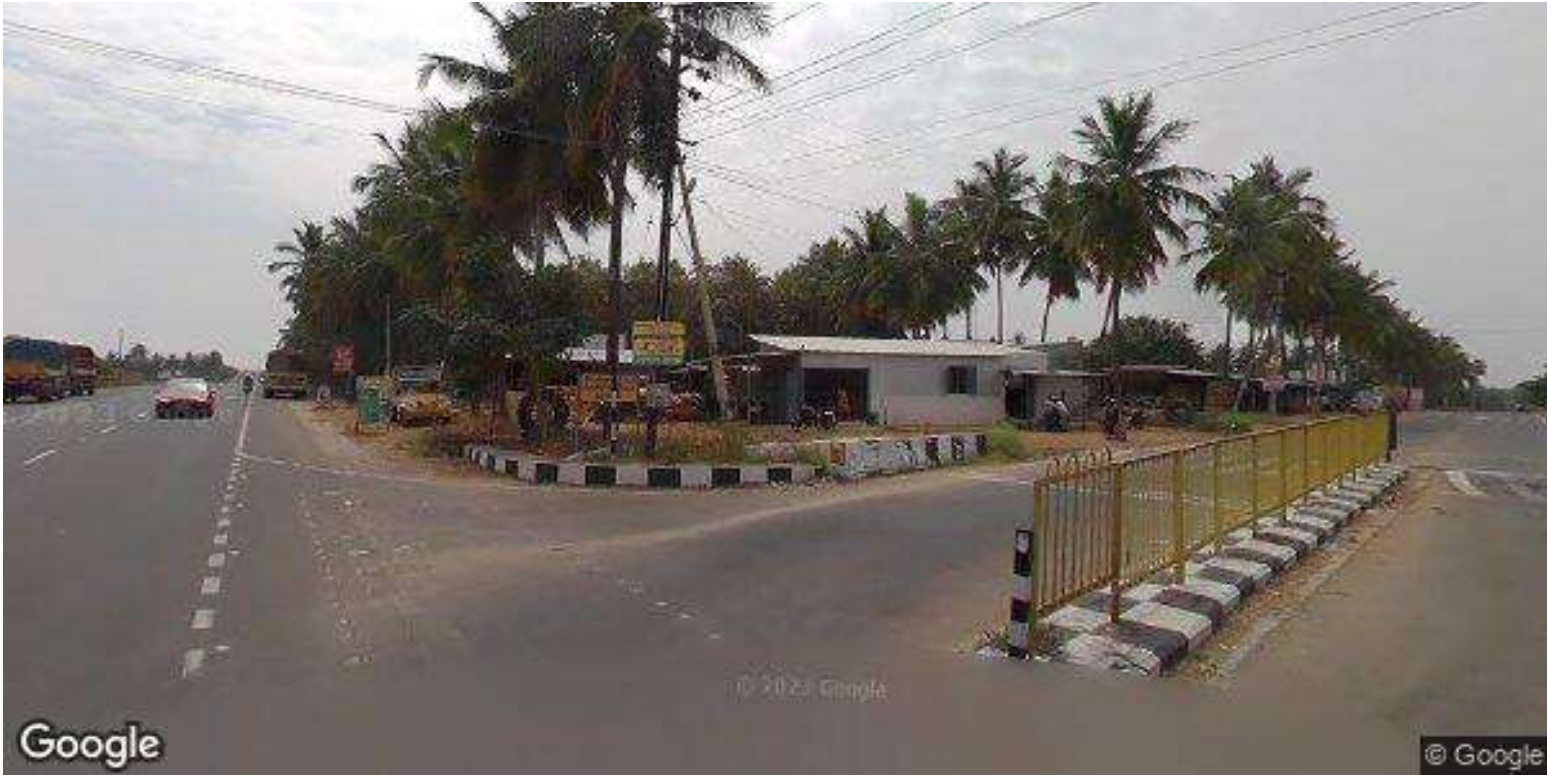
Coordinates: 11.30859, 77.92918

Risk Type: Turn

Risk Level: High

Speed Limit: 15 KM/Hr
