# IndianOil

## JOURNEY RISK MANAGEMENT (JRM) STUDY

### Salem Terminal TO RAFI FUELS

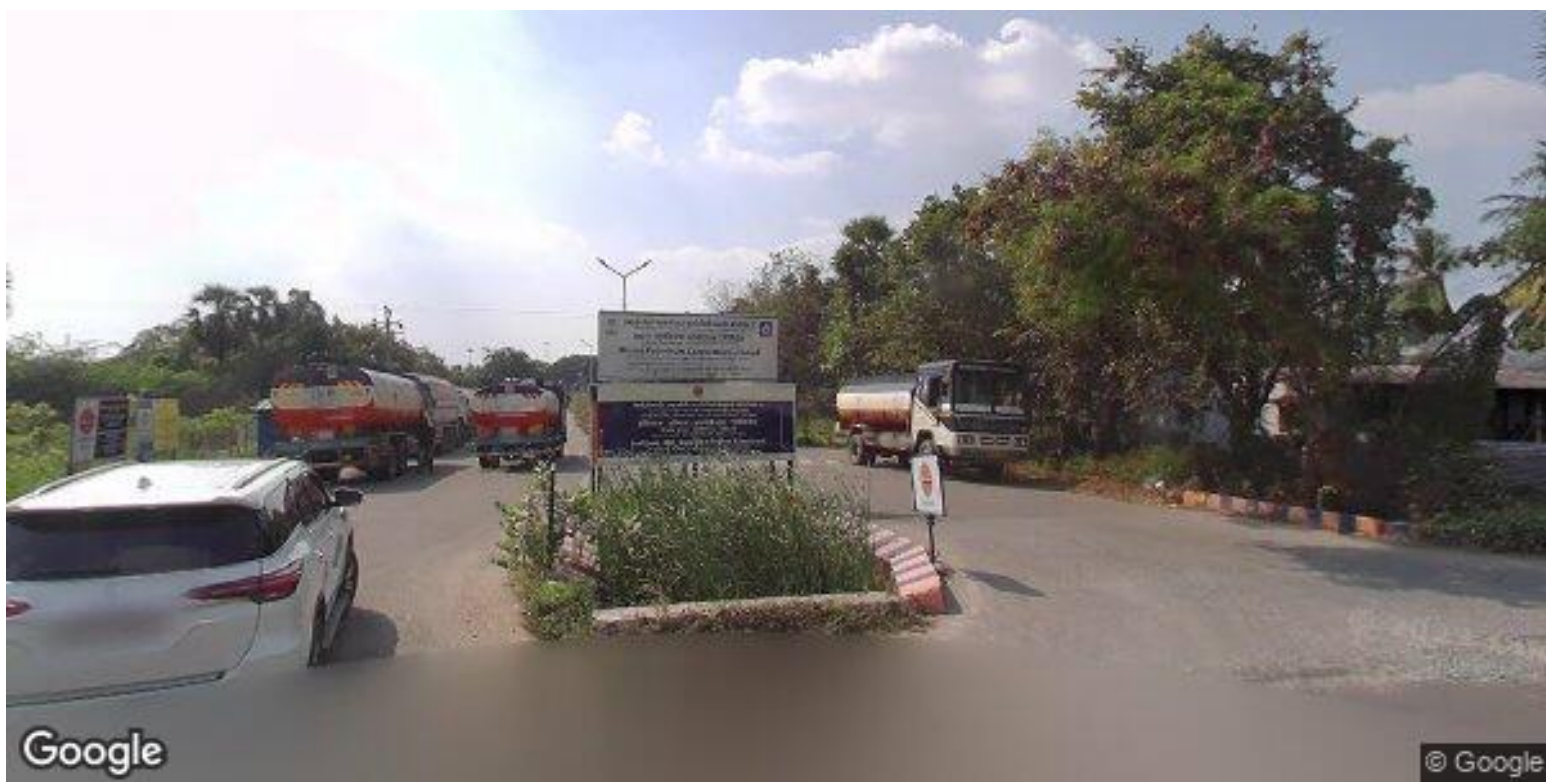
**Coordinates:** 11.44024, 77.87528

**Risk Type:** Turn

**Risk Level:** High

**Speed Limit:** 15 KM/Hr

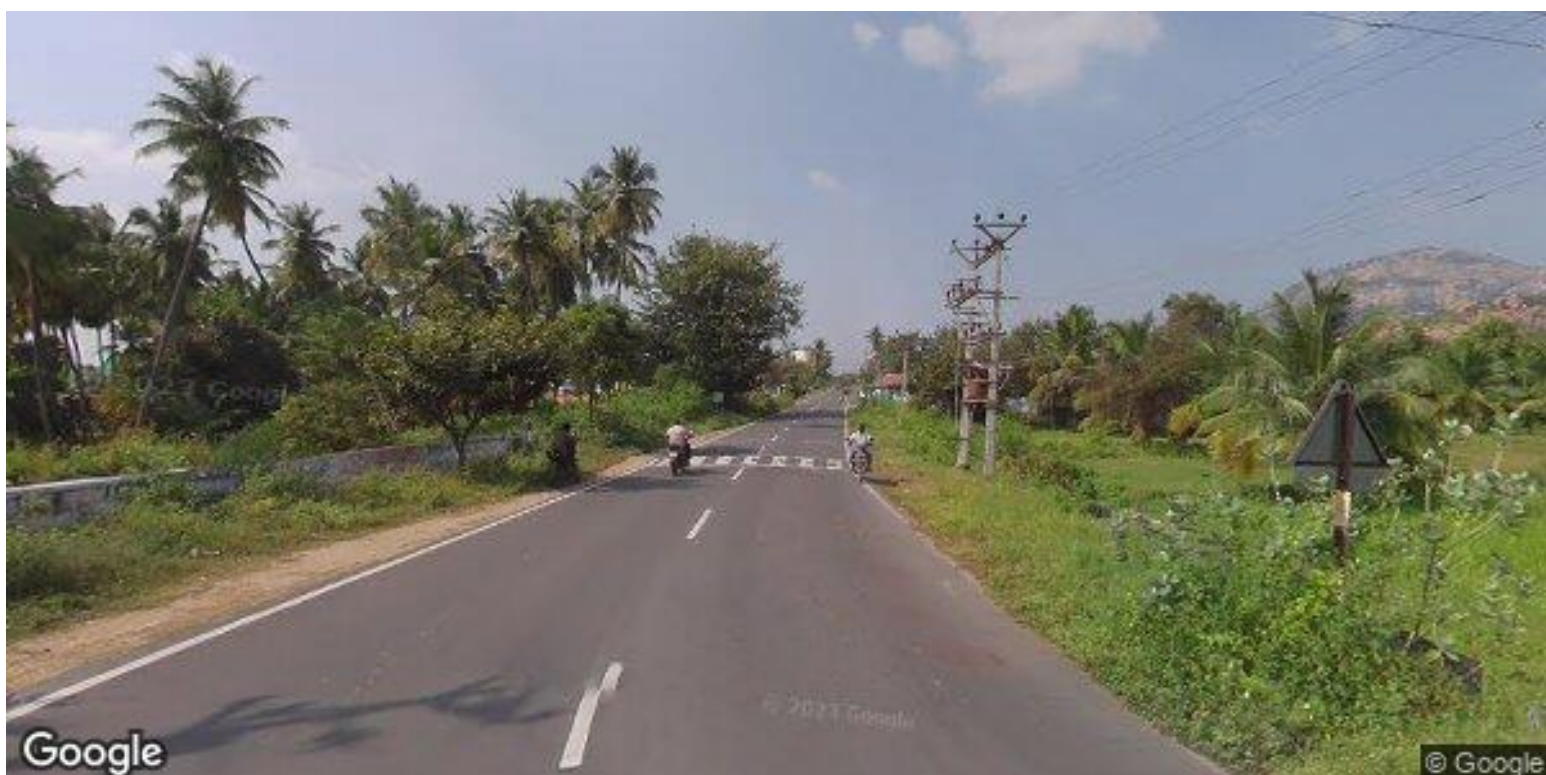
**Risk Type:** Turn  
**Risk Level:** High  
**Speed Limit:** 15 KM/Hr  
**Coordinates:** 11.45352, 77.85698

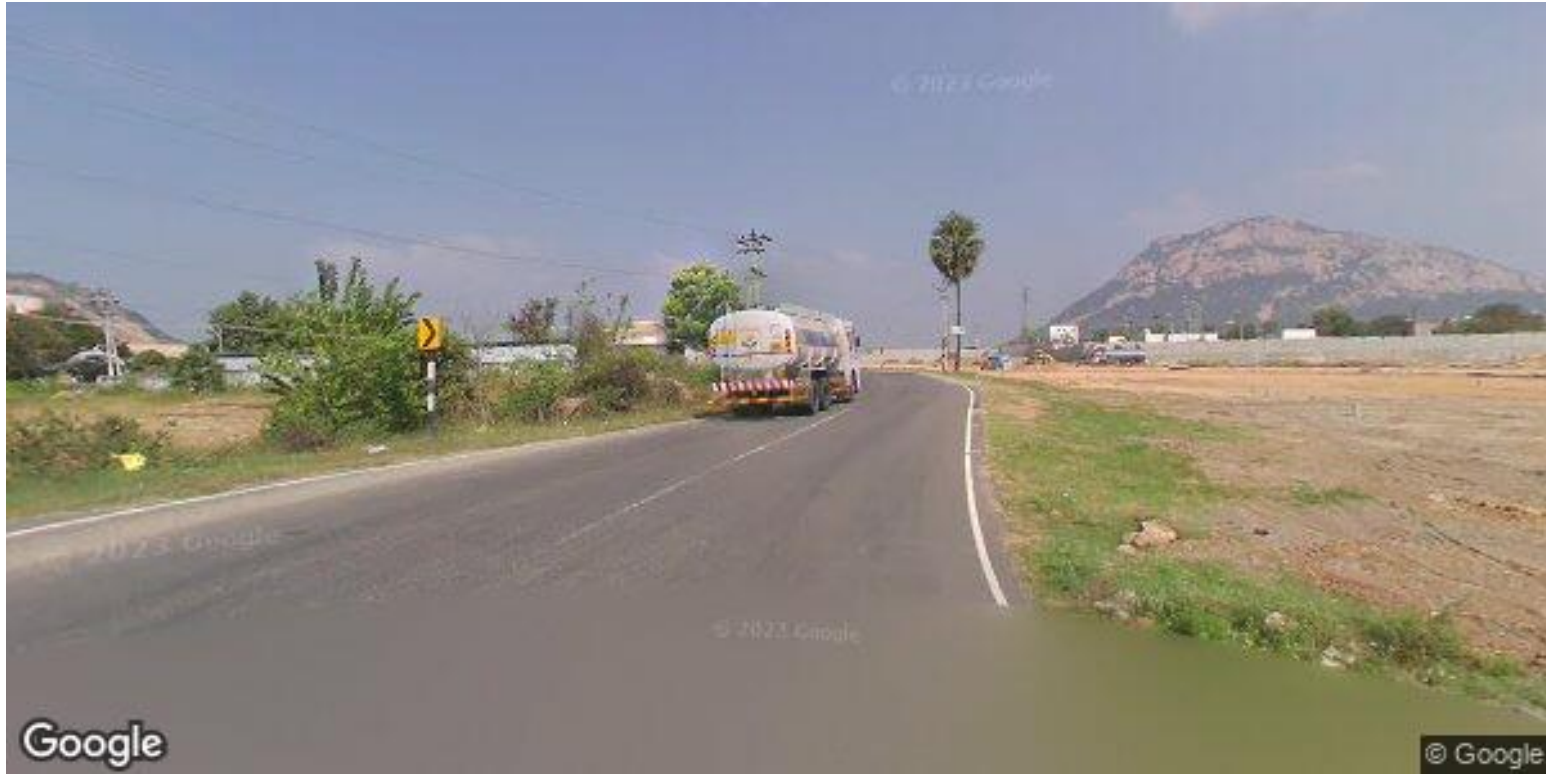
**Risk Type:** Turn  
**Risk Level:** Medium  
**Speed Limit:** 30 KM/Hr  
**Coordinates:** 11.45847, 77.85140

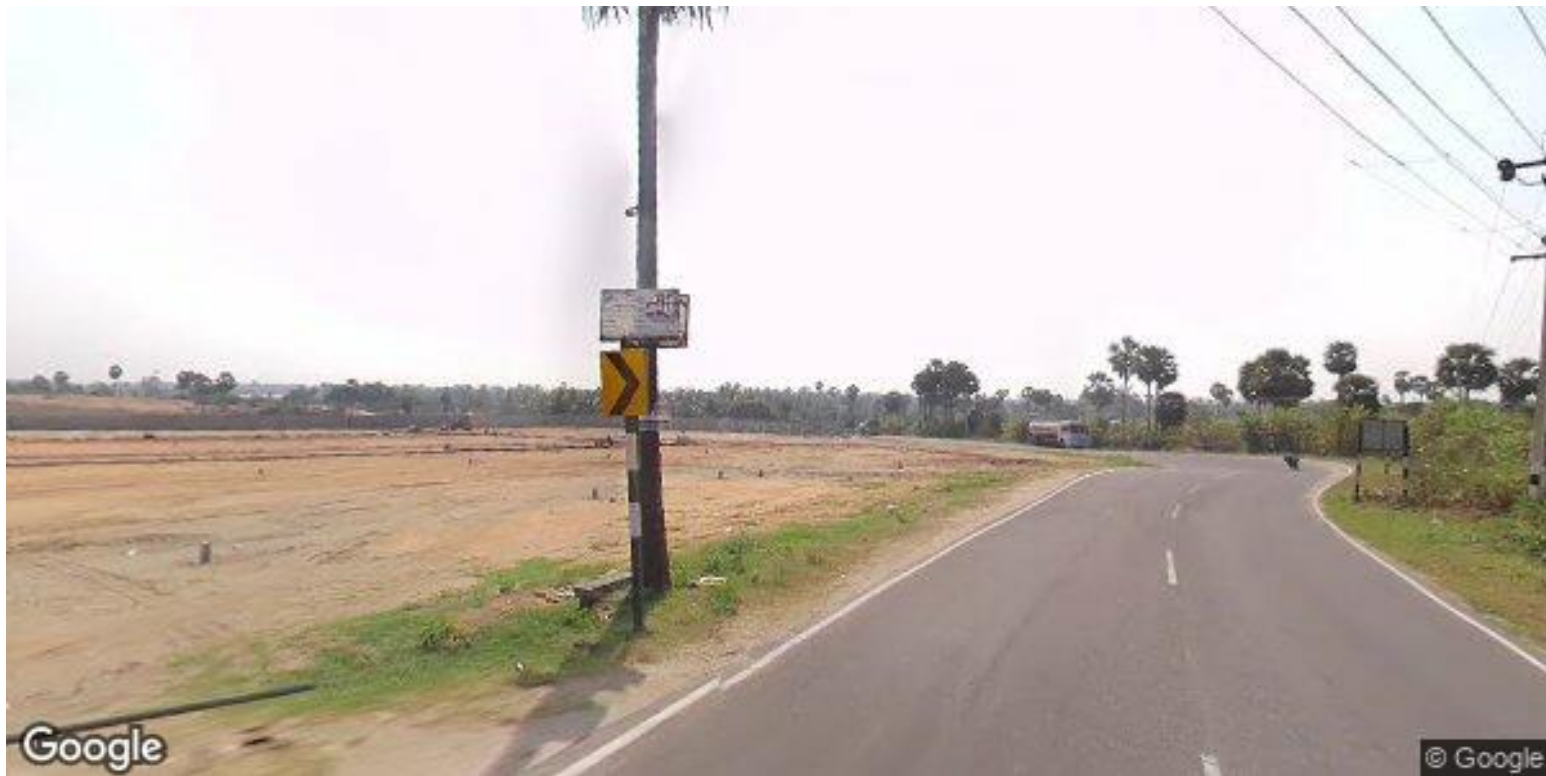
**Risk Type:** Turn  
**Risk Level:** Medium  
**Speed Limit:** 30 KM/Hr  
**Coordinates:** 11.45898, 77.85135

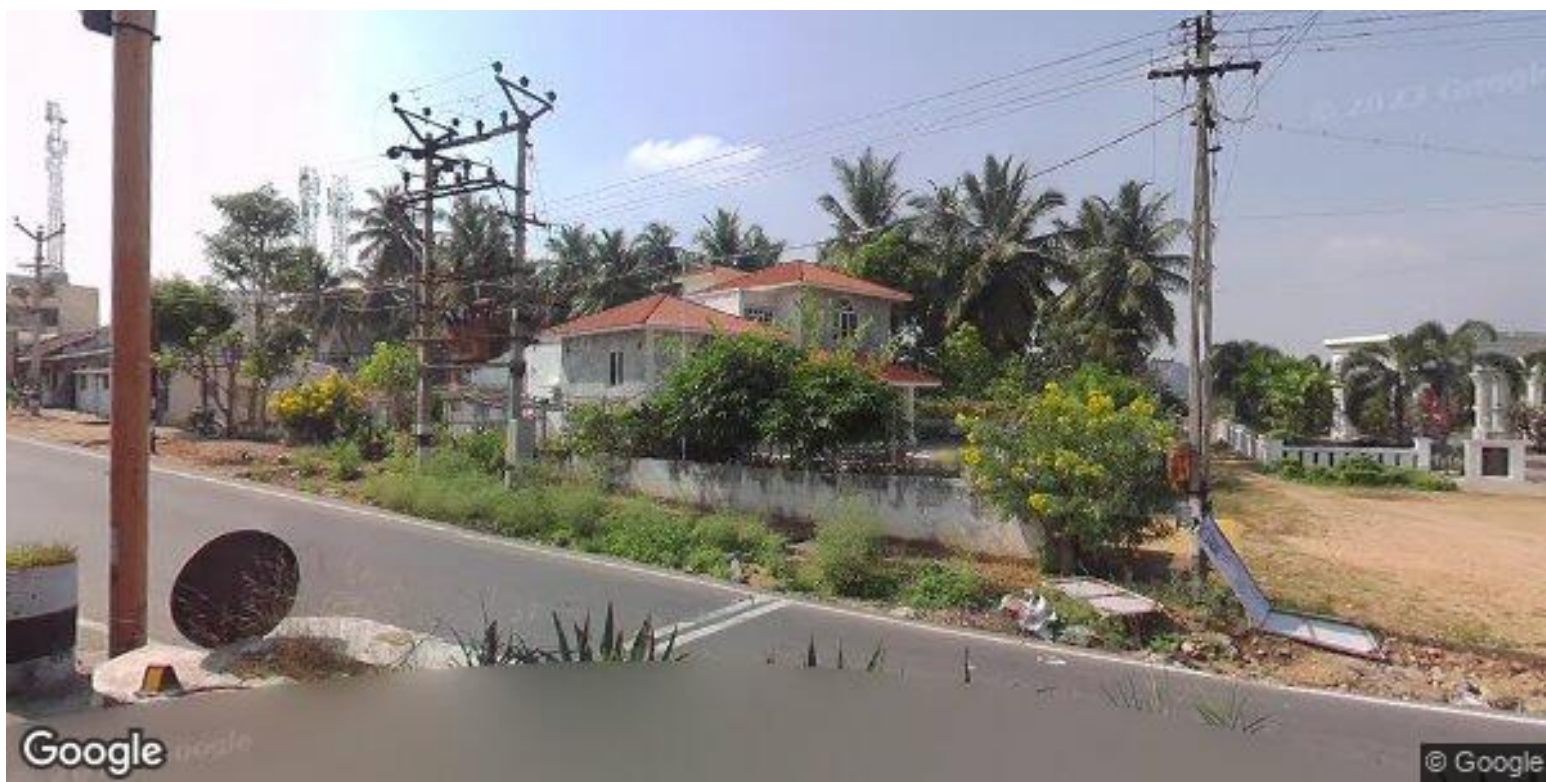
**Coordinates:** 11.46303, 77.84945

**Risk Type:** Turn

**Risk Level:** High

**Speed Limit:** 15 KM/Hr

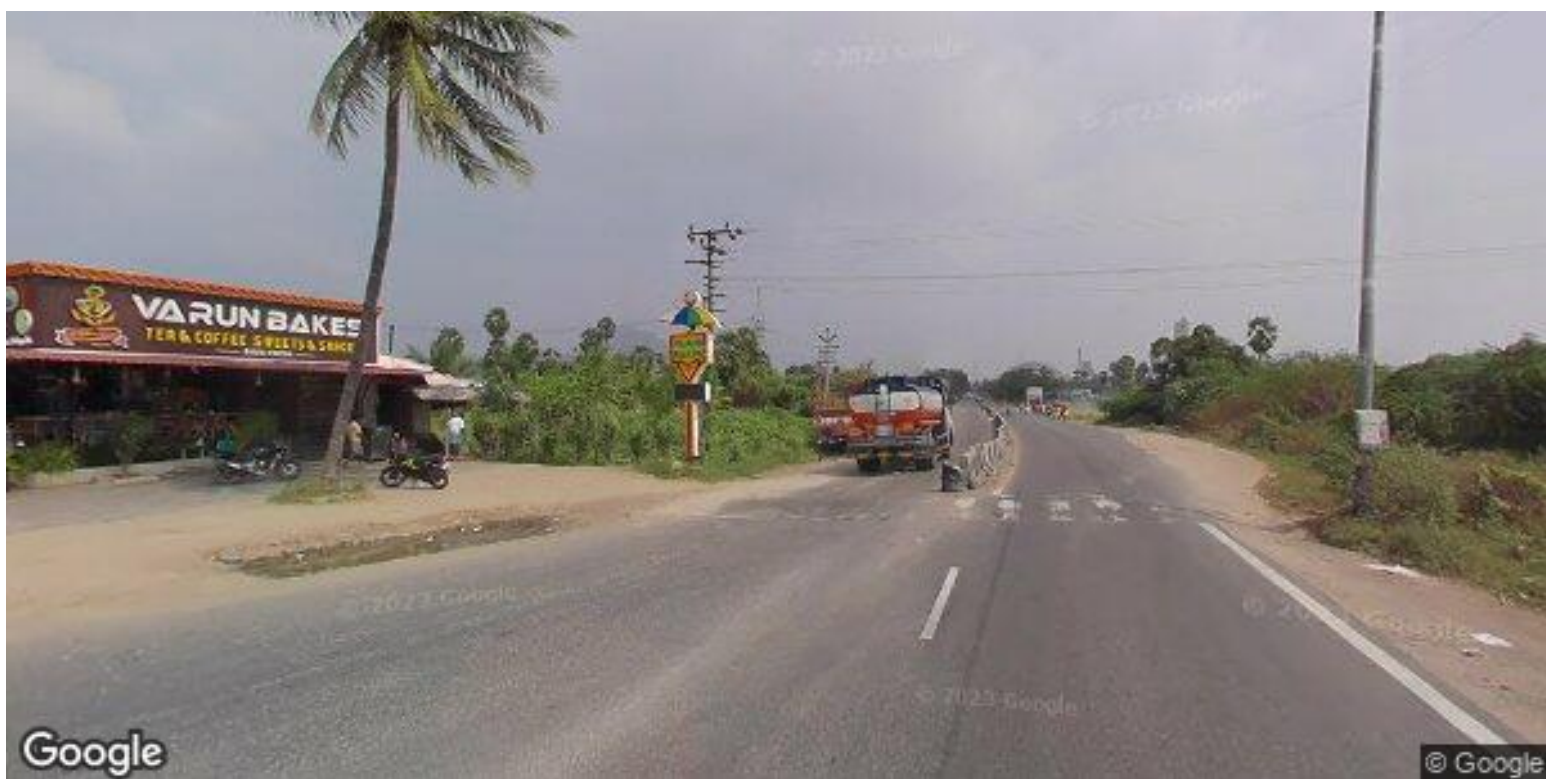
**Coordinates:** 11.45543, 77.81740

**Risk Type:** Turn

**Risk Level:** Medium

**Speed Limit:** 30 KM/Hr

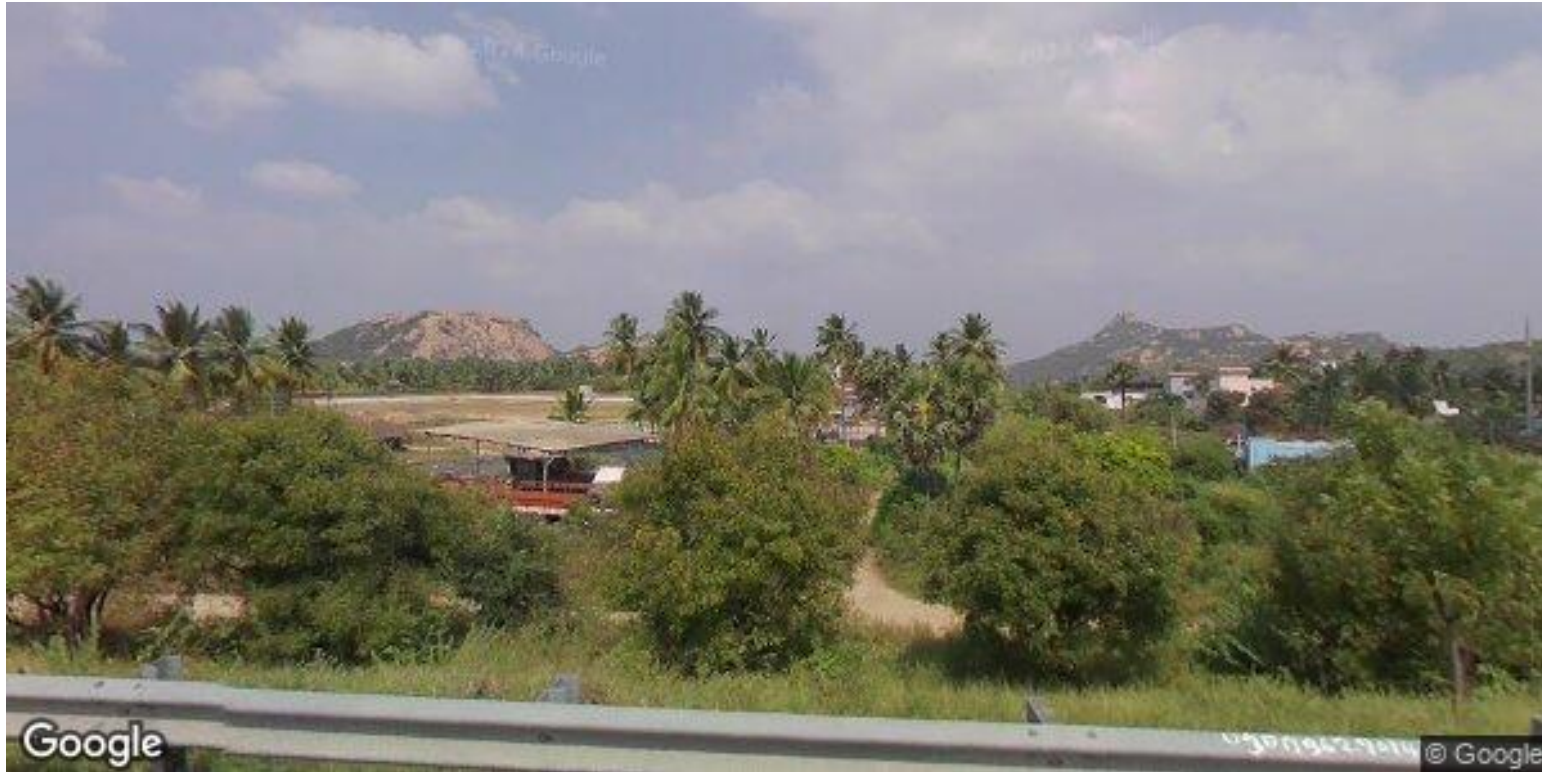
**Risk Type:** Turn  
**Risk Level:** High  
**Speed Limit:** 15 KM/Hr  
**Coordinates:** 11.49383, 77.88442

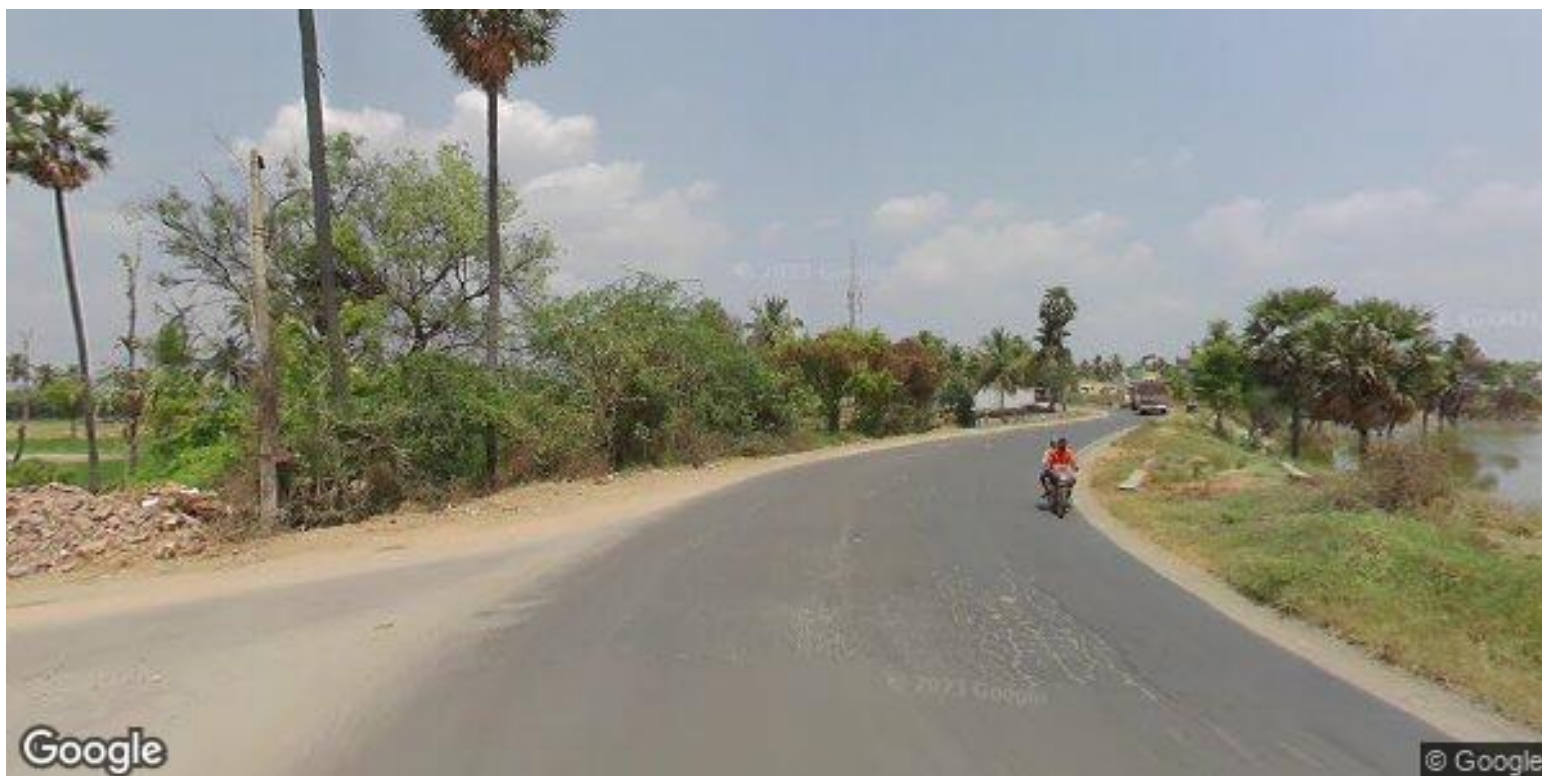
**Risk Type:** Turn  
**Risk Level:** Medium  
**Speed Limit:** 30 KM/Hr  
**Coordinates:** 11.56083, 77.89921

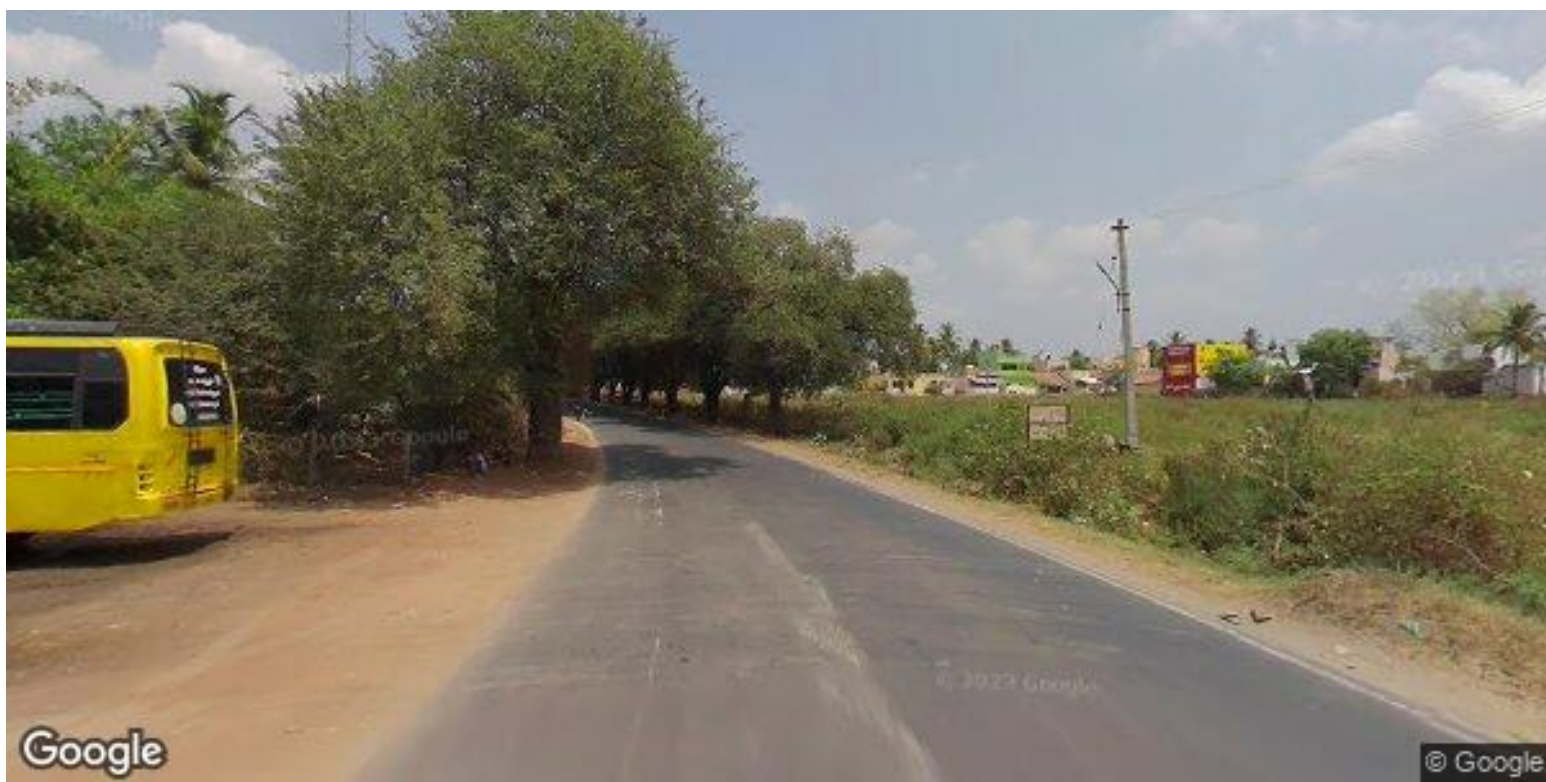
**Coordinates:** 11.56180, 77.90019

**Risk Type:** Turn

**Risk Level:** Medium

**Speed Limit:** 30 KM/Hr

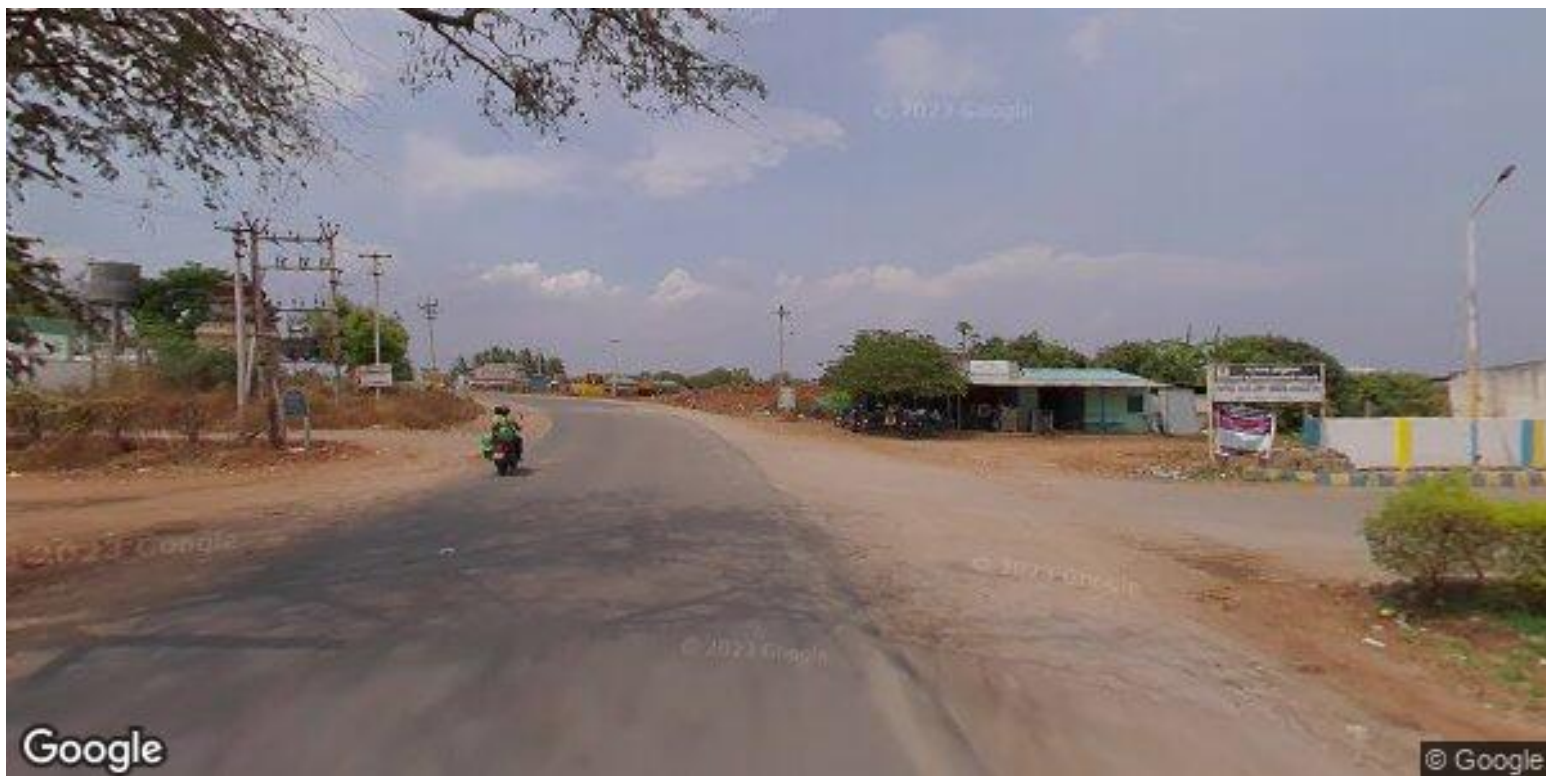
**Coordinates:** 11.58254, 77.90656

**Risk Type:** Turn

**Risk Level:** Medium

**Speed Limit:** 30 KM/Hr

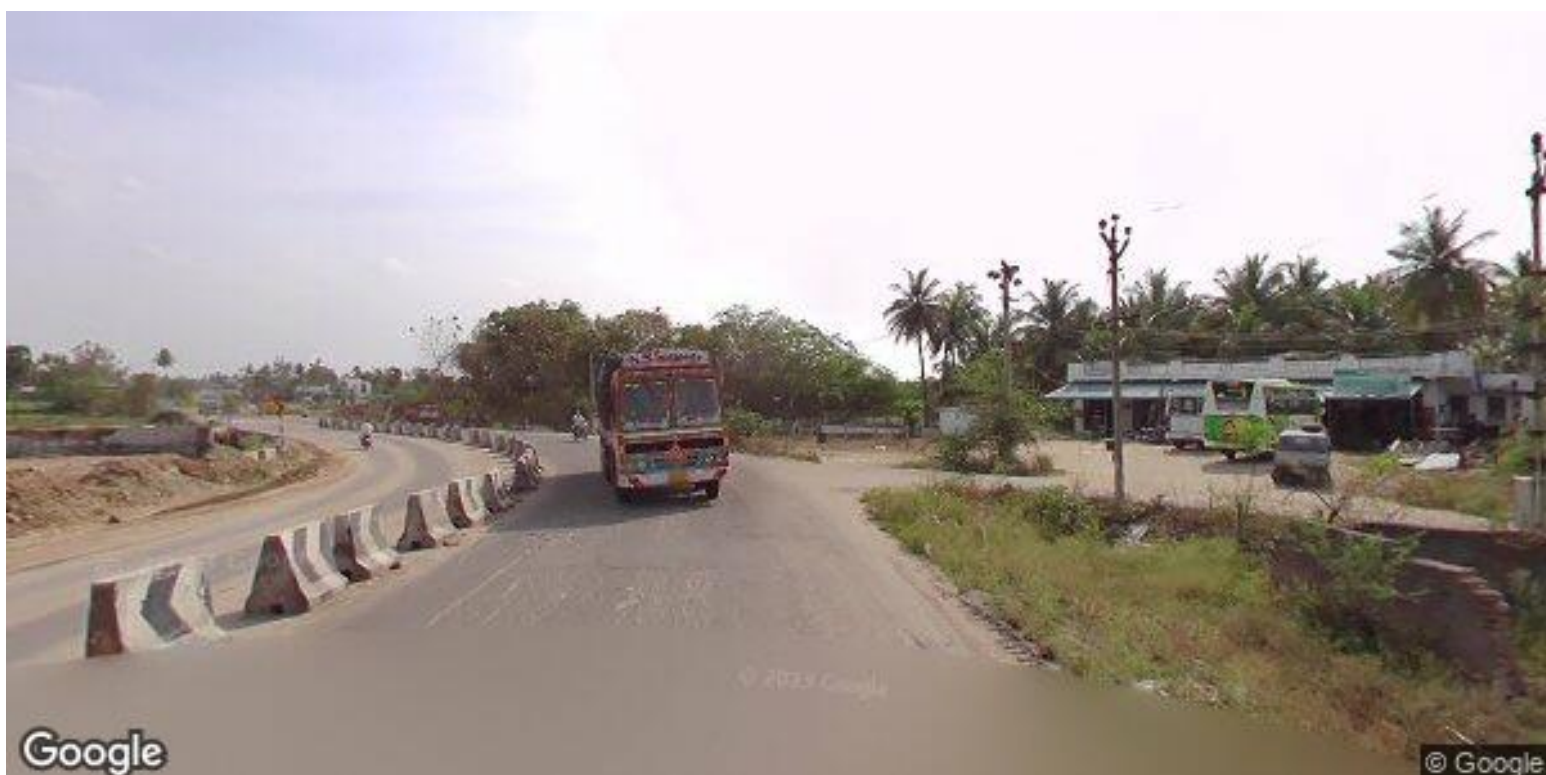
**Coordinates: 11.63867, 77.94841**

**Risk Type: Turn**

**Risk Level: Medium**

**Speed Limit: 30 KM/Hr**

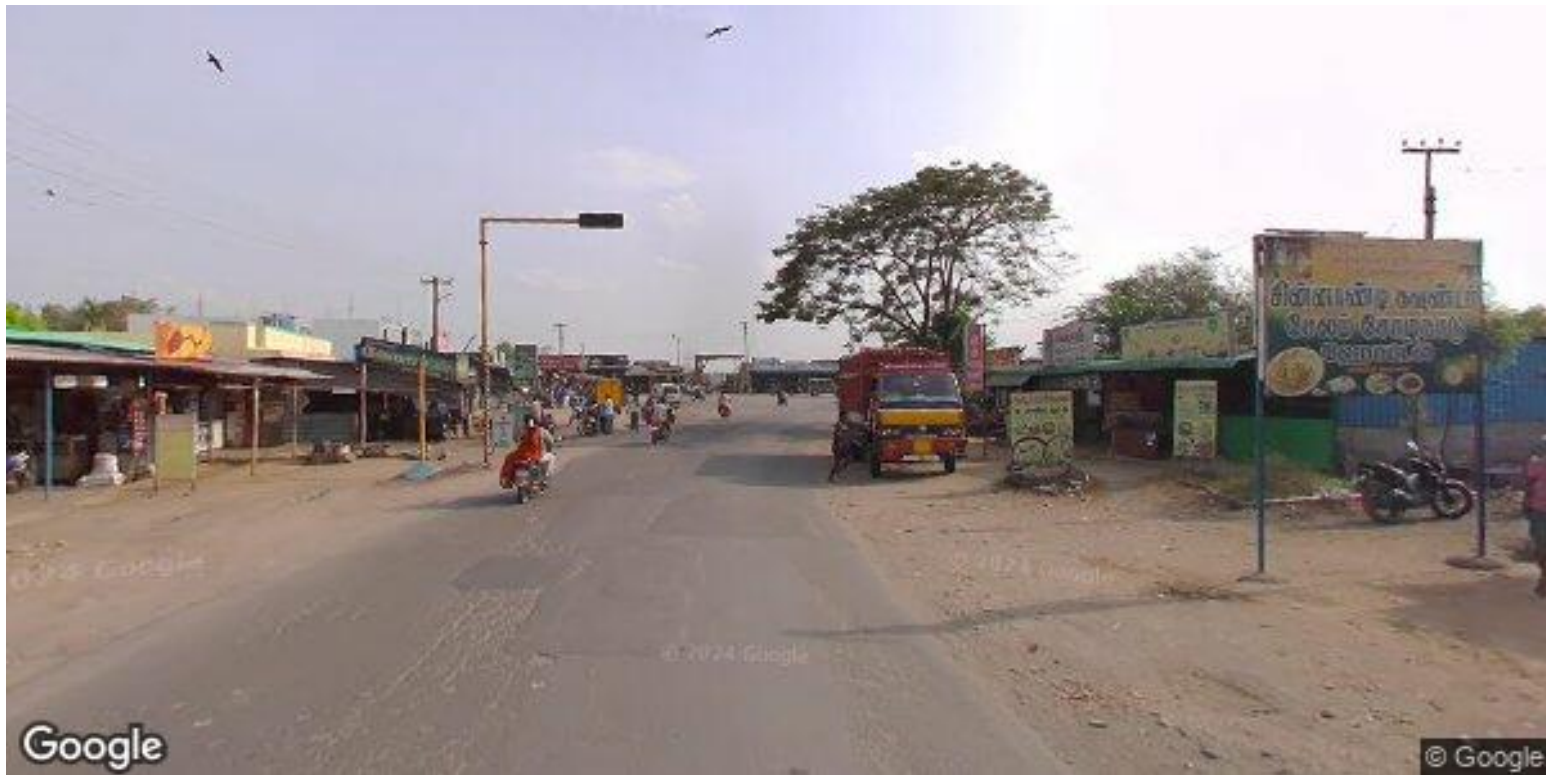
**Coordinates: 11.64217, 77.95200**

**Risk Type: Turn**

**Risk Level: Medium**

**Speed Limit: 30 KM/Hr**

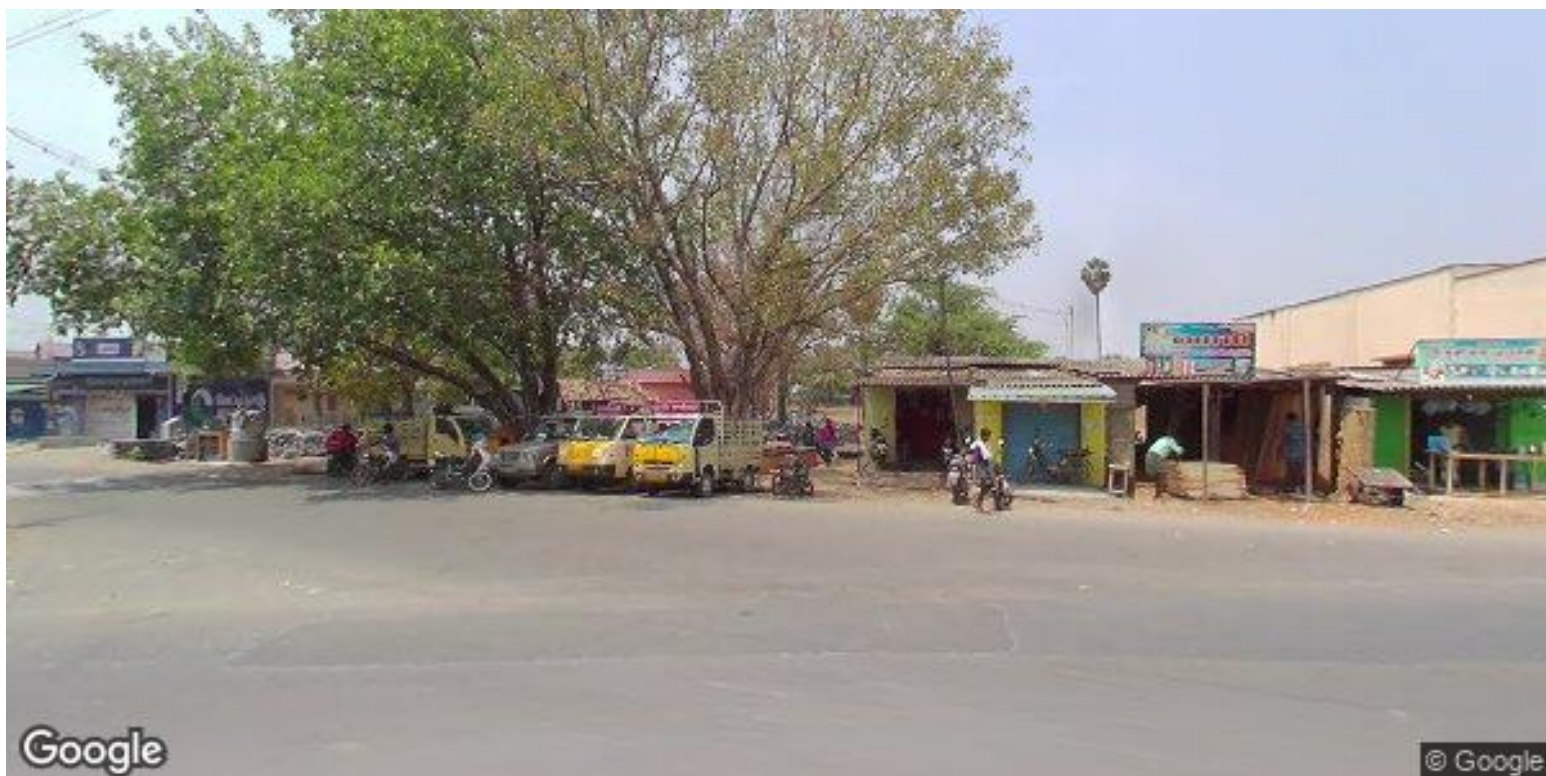
**Coordinates: 11.64712, 77.95118**

**Risk Type: Turn**

**Risk Level: Medium**

**Speed Limit: 30 KM/Hr**

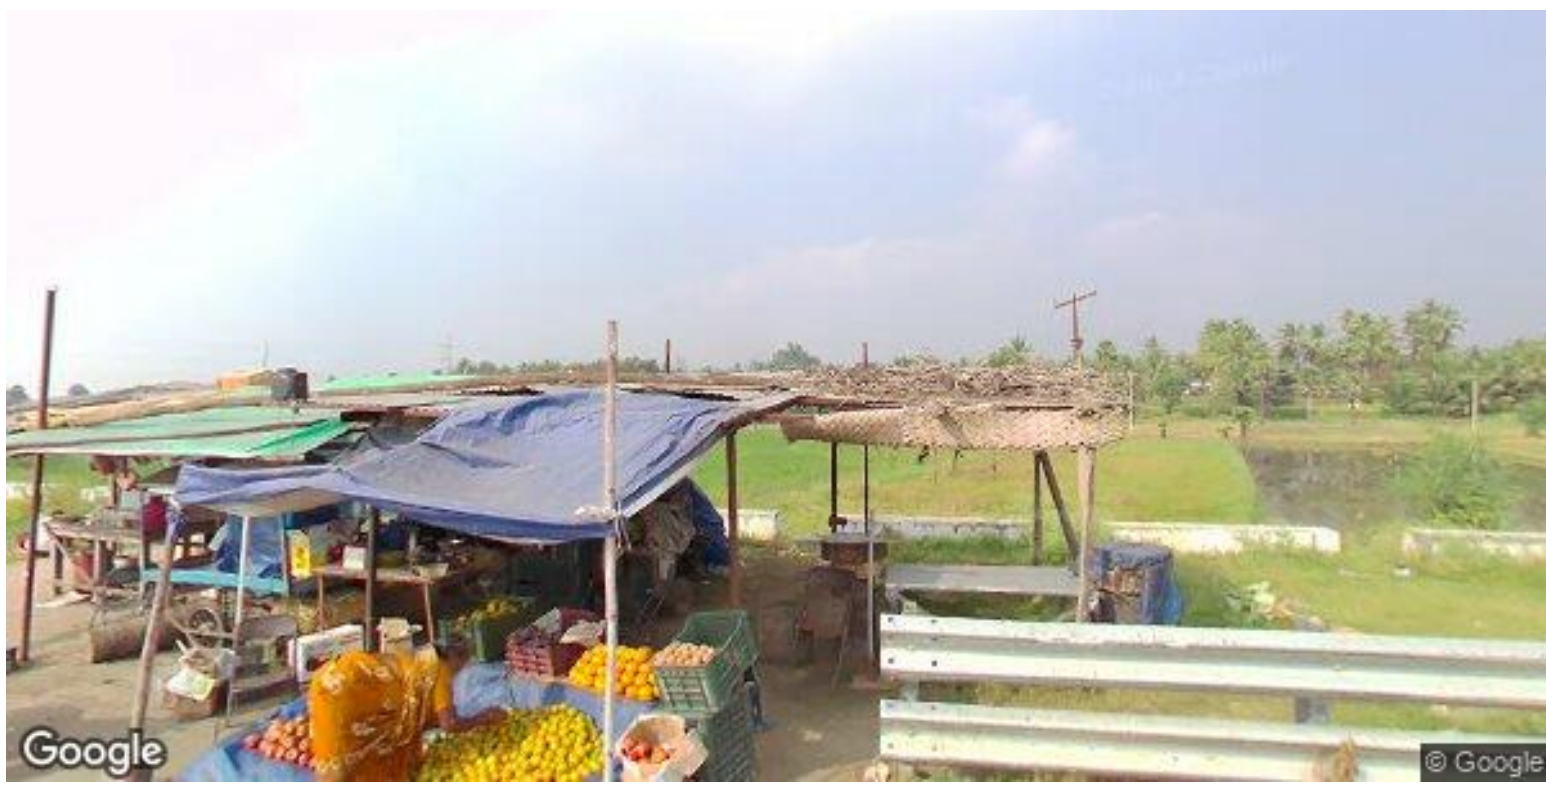
**Coordinates:** 11.67858, 77.96834

**Risk Type:** Turn

**Risk Level:** High

**Speed Limit:** 15 KM/Hr

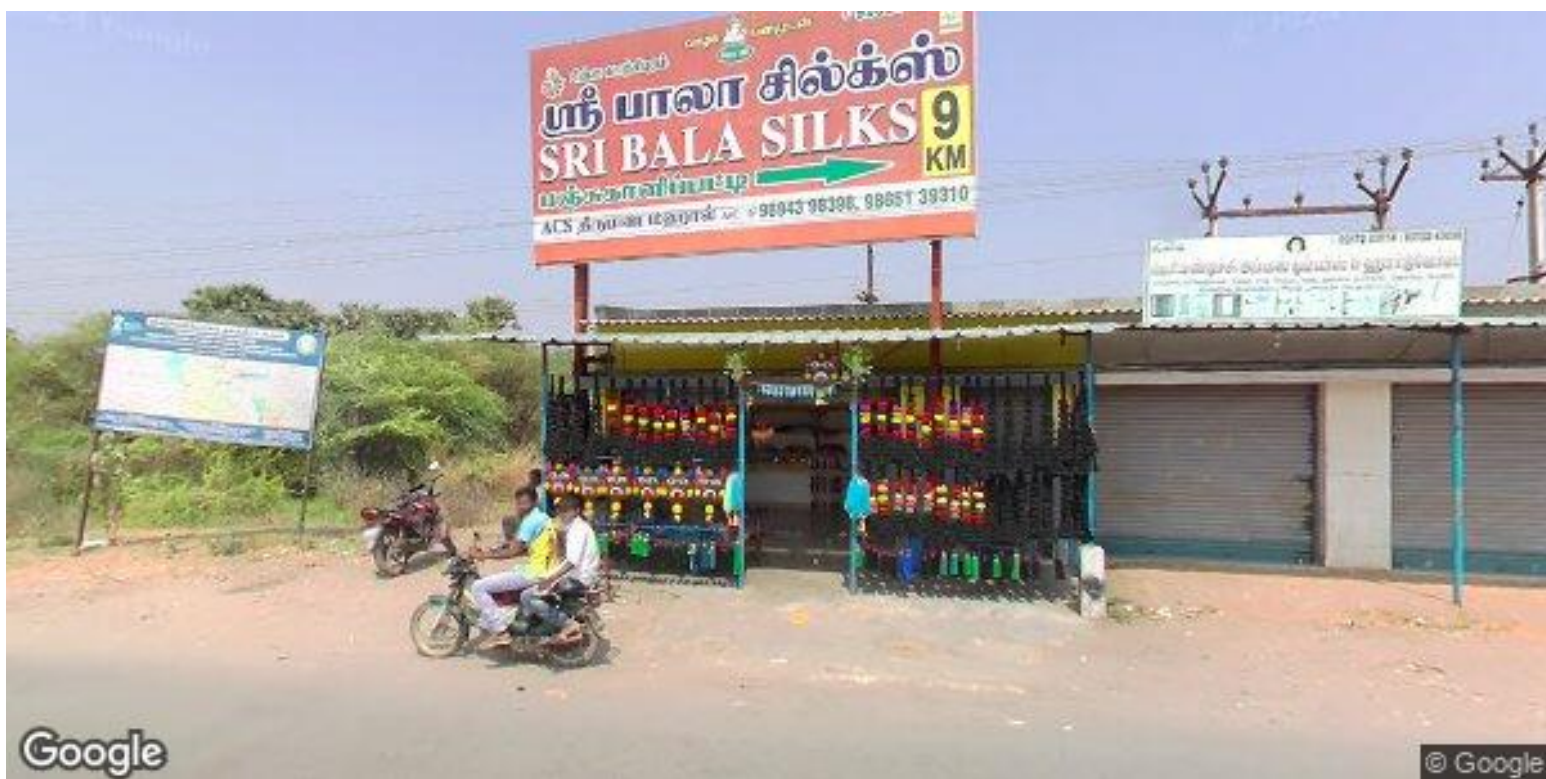
**Coordinates:** 11.70233, 77.97869

**Risk Type:** Turn

**Risk Level:** High

**Speed Limit:** 15 KM/Hr

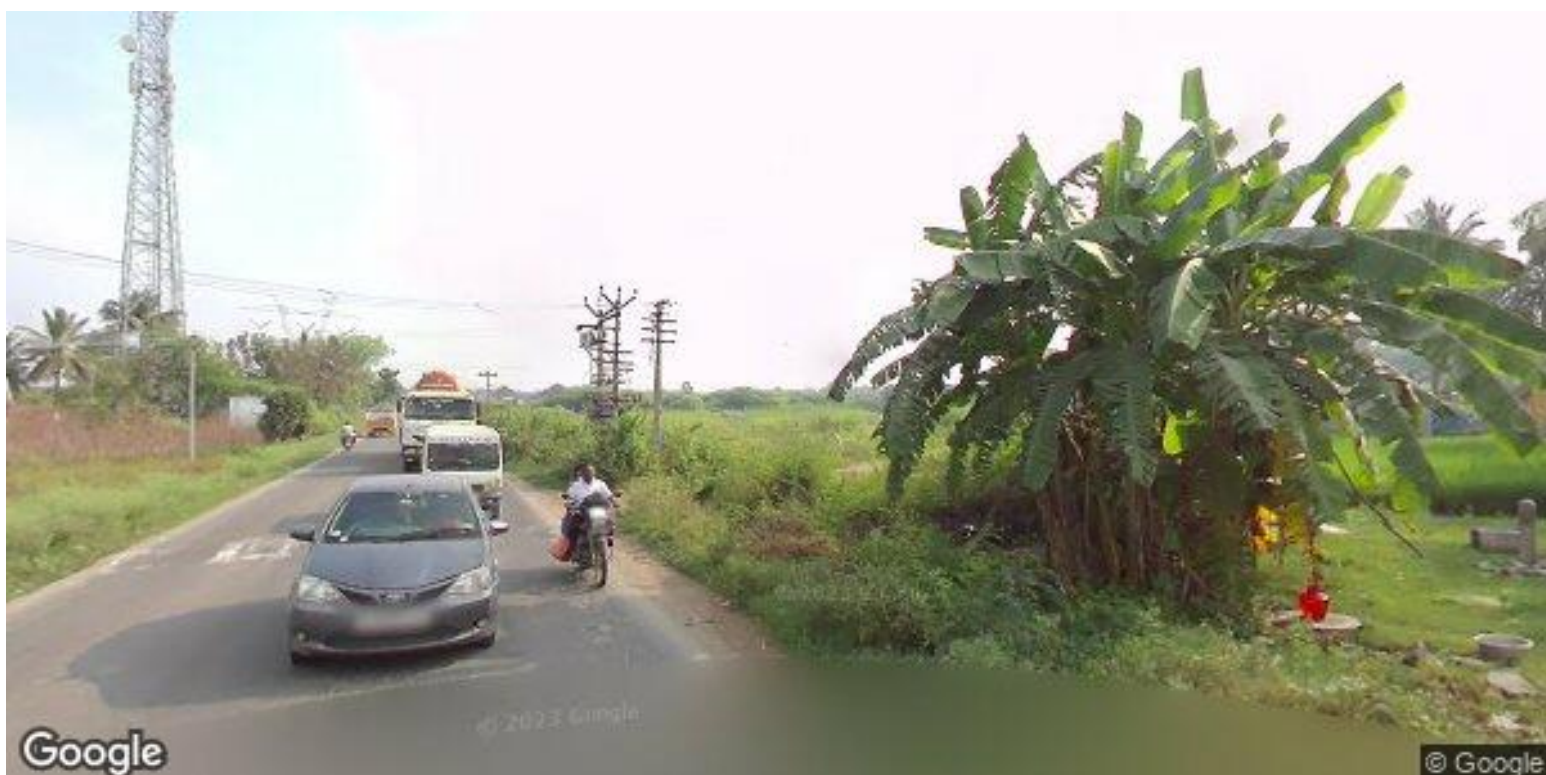
**Coordinates:** 11.71394, 77.99572

**Risk Type:** Turn

**Risk Level:** Medium

**Speed Limit:** 30 KM/Hr

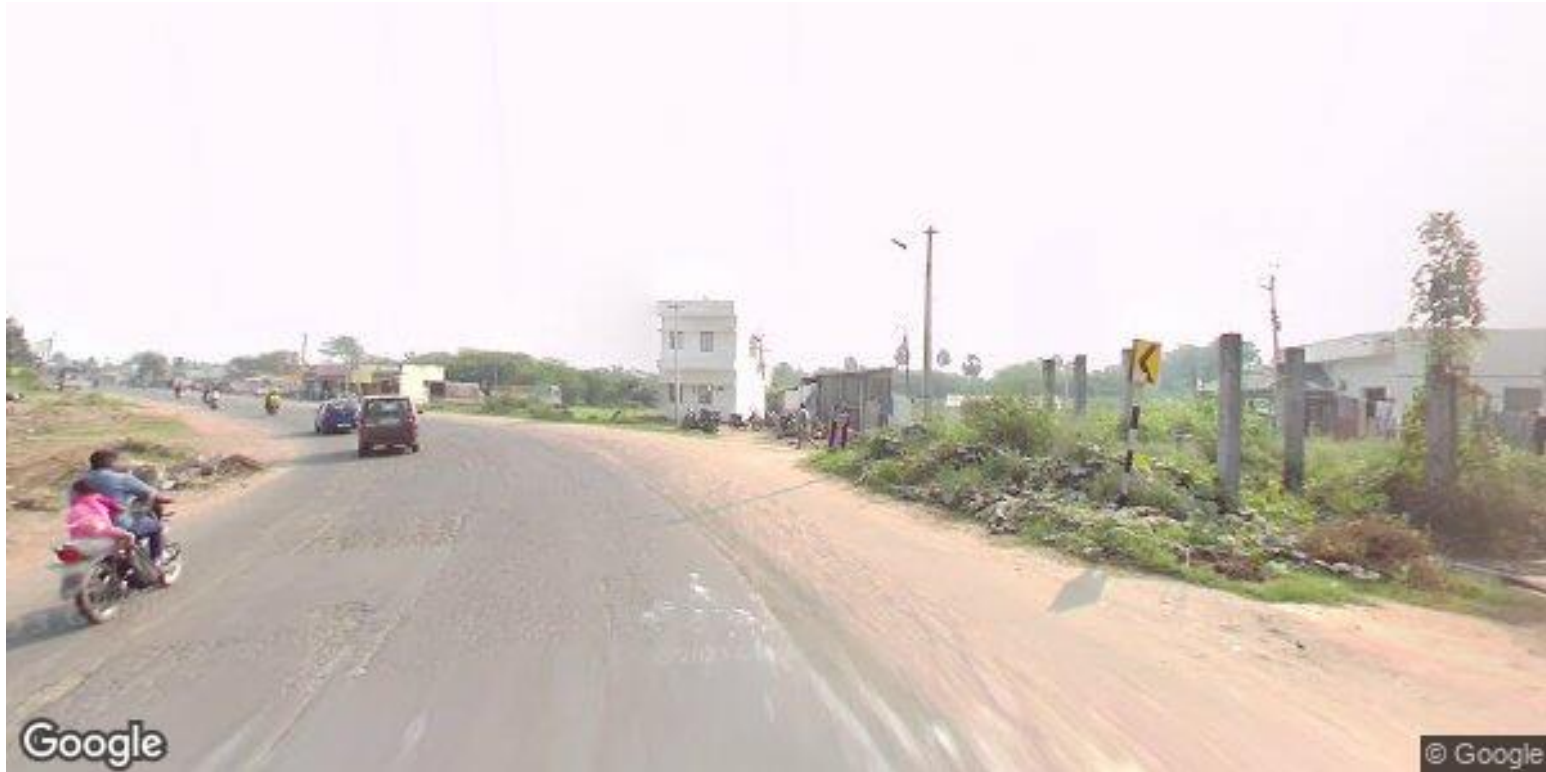
**Coordinates:** 11.71916, 78.01117

**Risk Type:** Turn

**Risk Level:** Medium

**Speed Limit:** 30 KM/Hr

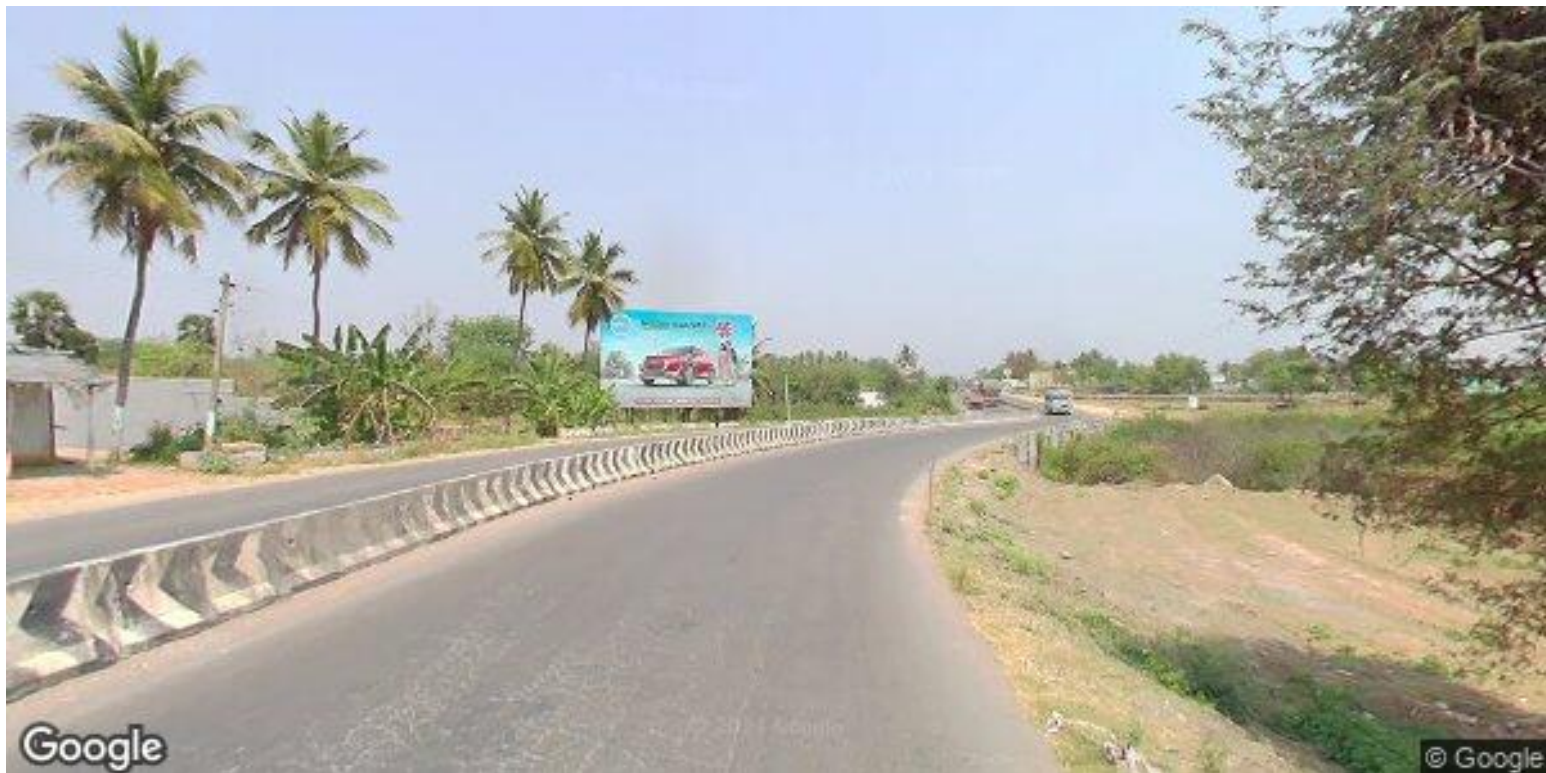
**Coordinates:** 11.72559, 78.01758

**Risk Type:** Turn

**Risk Level:** Medium

**Speed Limit:** 30 KM/Hr

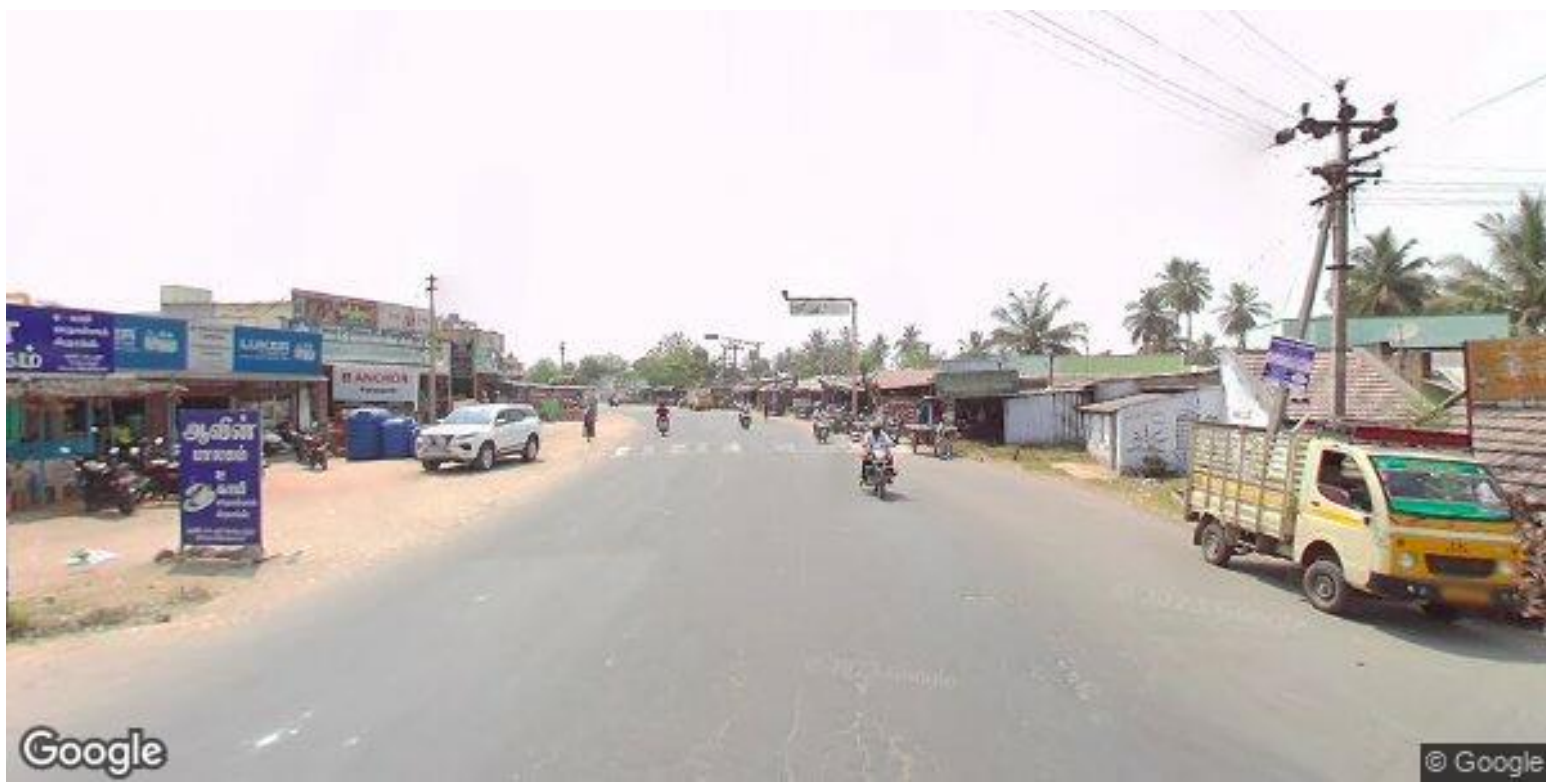
**Coordinates:** 11.73787, 78.03528

**Risk Type:** Turn

**Risk Level:** Medium

**Speed Limit:** 30 KM/Hr
