# IndianOil

## JOURNEY RISK MANAGEMENT (JRM) STUDY

### Salem Terminal TO RAFI FUELS

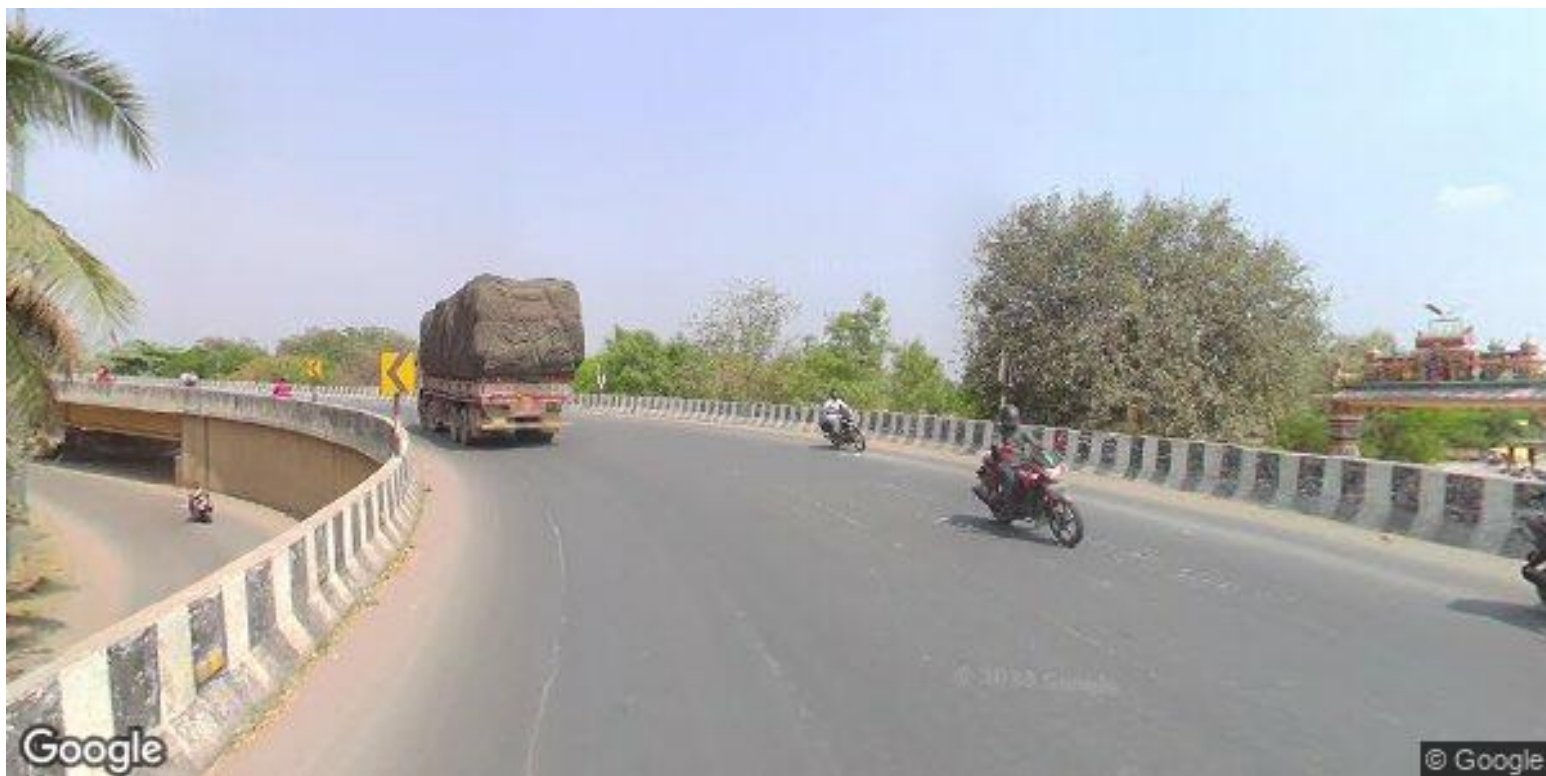
**Coordinates:** 11.73651, 78.03868

**Risk Type:** Turn

**Risk Level:** High

**Speed Limit:** 15 KM/Hr

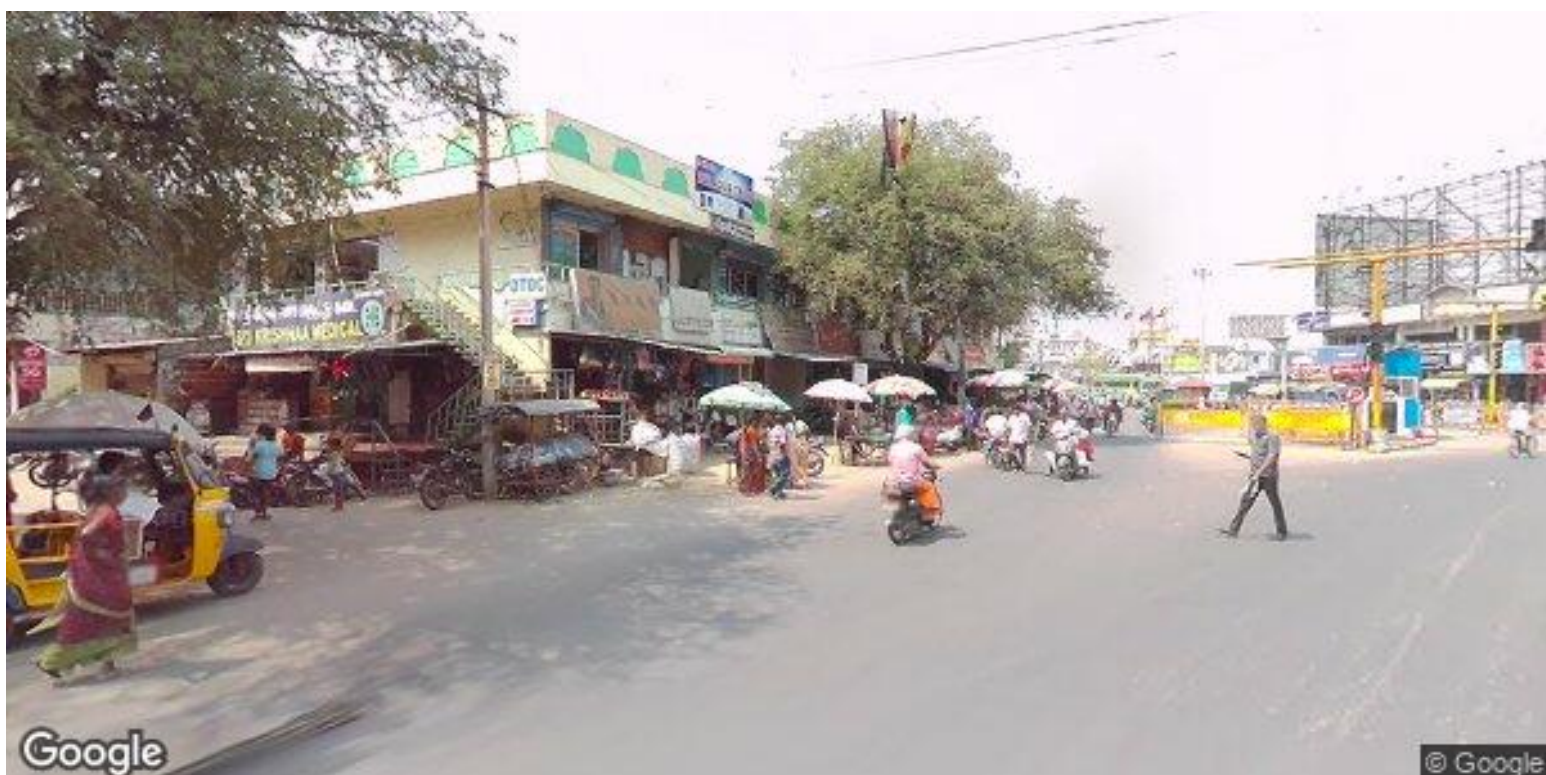
**Coordinates:** 11.74257, 78.04708

**Risk Type:** Turn

**Risk Level:** Medium

**Speed Limit:** 30 KM/Hr

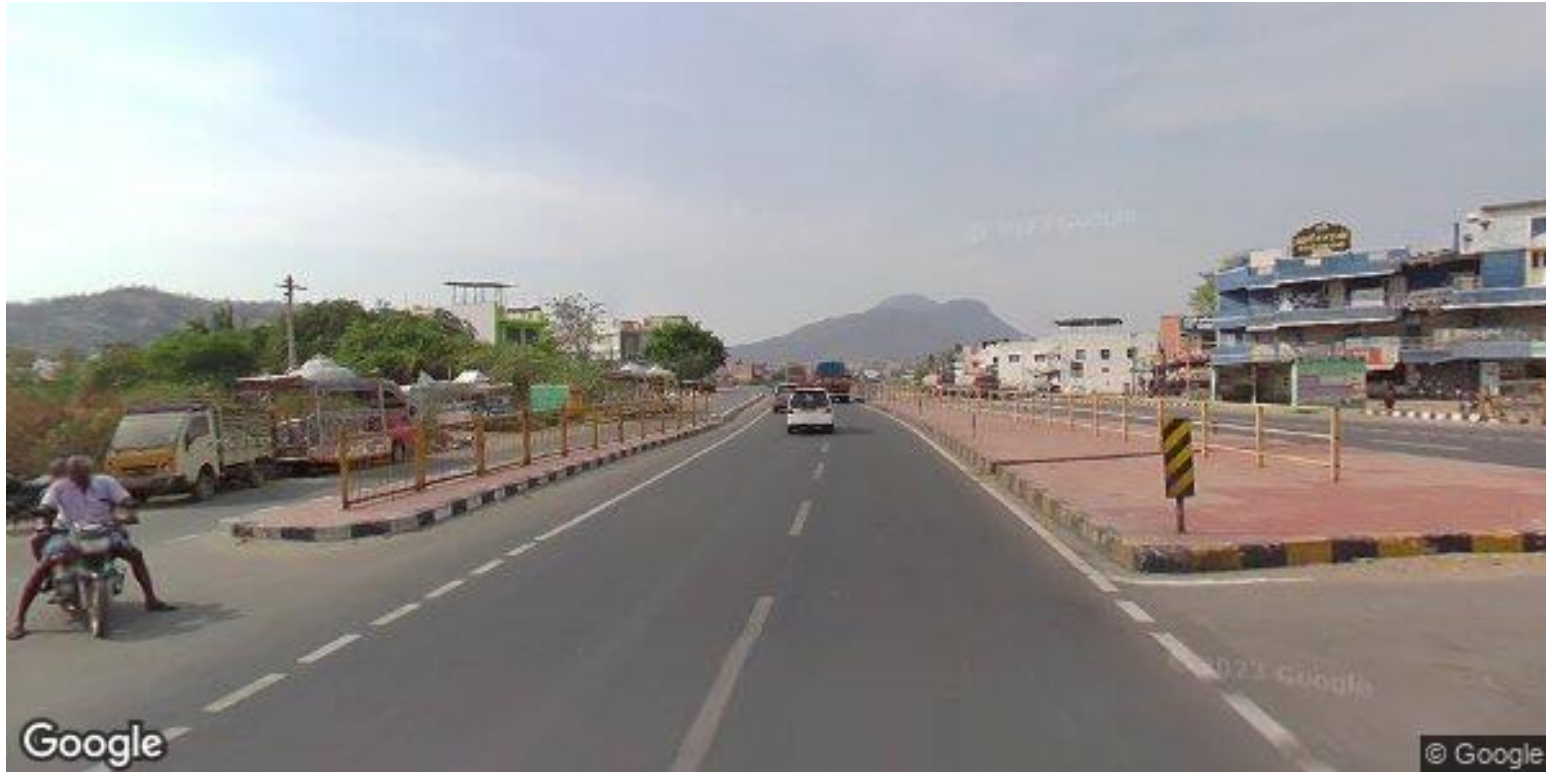
**Coordinates:** 11.87104, 78.08356

**Risk Type:** Blind Spot

**Risk Level:** Blind Spot

**Speed Limit:** 10 KM/Hr

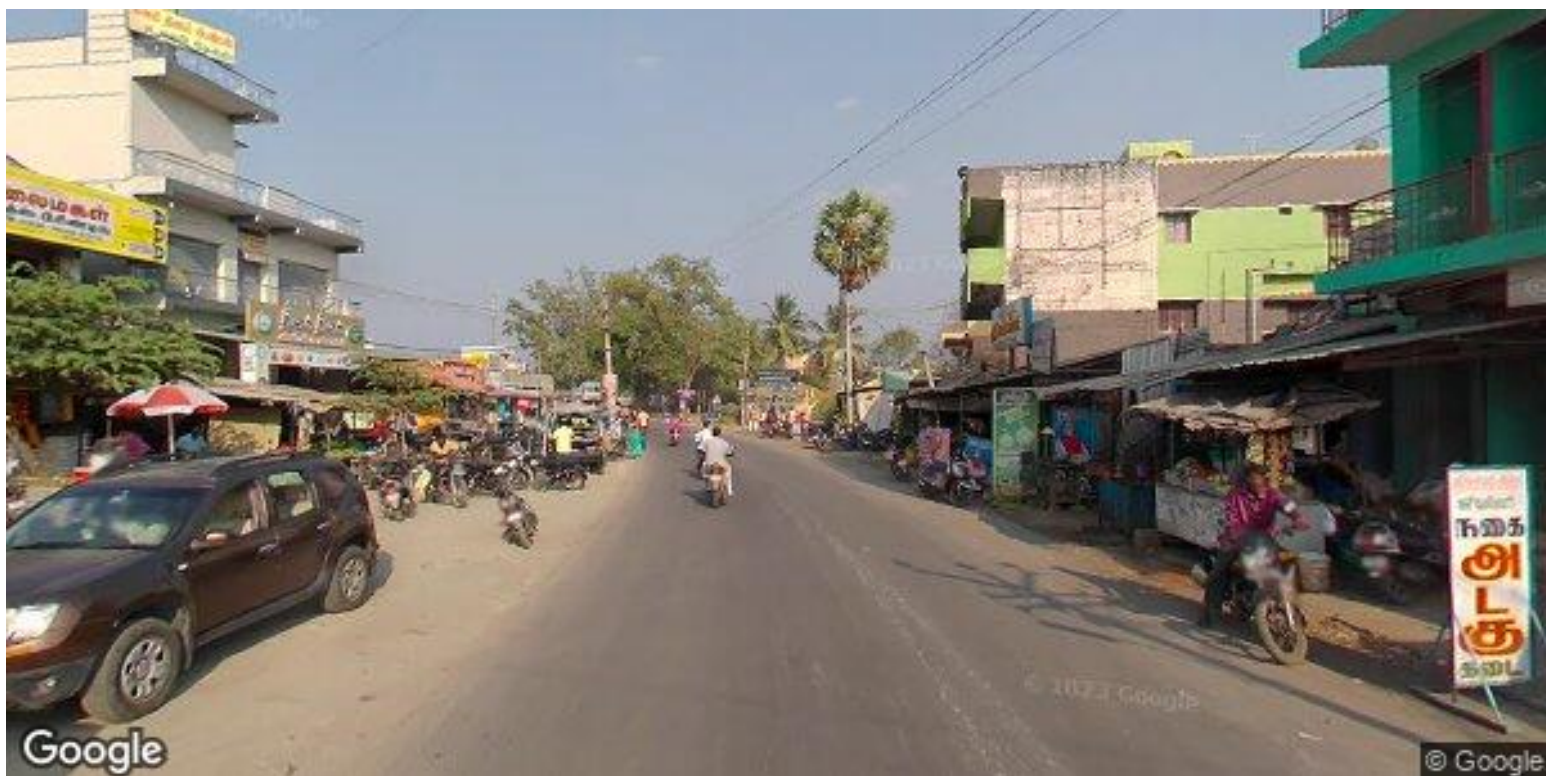
**Coordinates:** 11.87071, 78.08450

**Risk Type:** Turn

**Risk Level:** Medium

**Speed Limit:** 30 KM/Hr

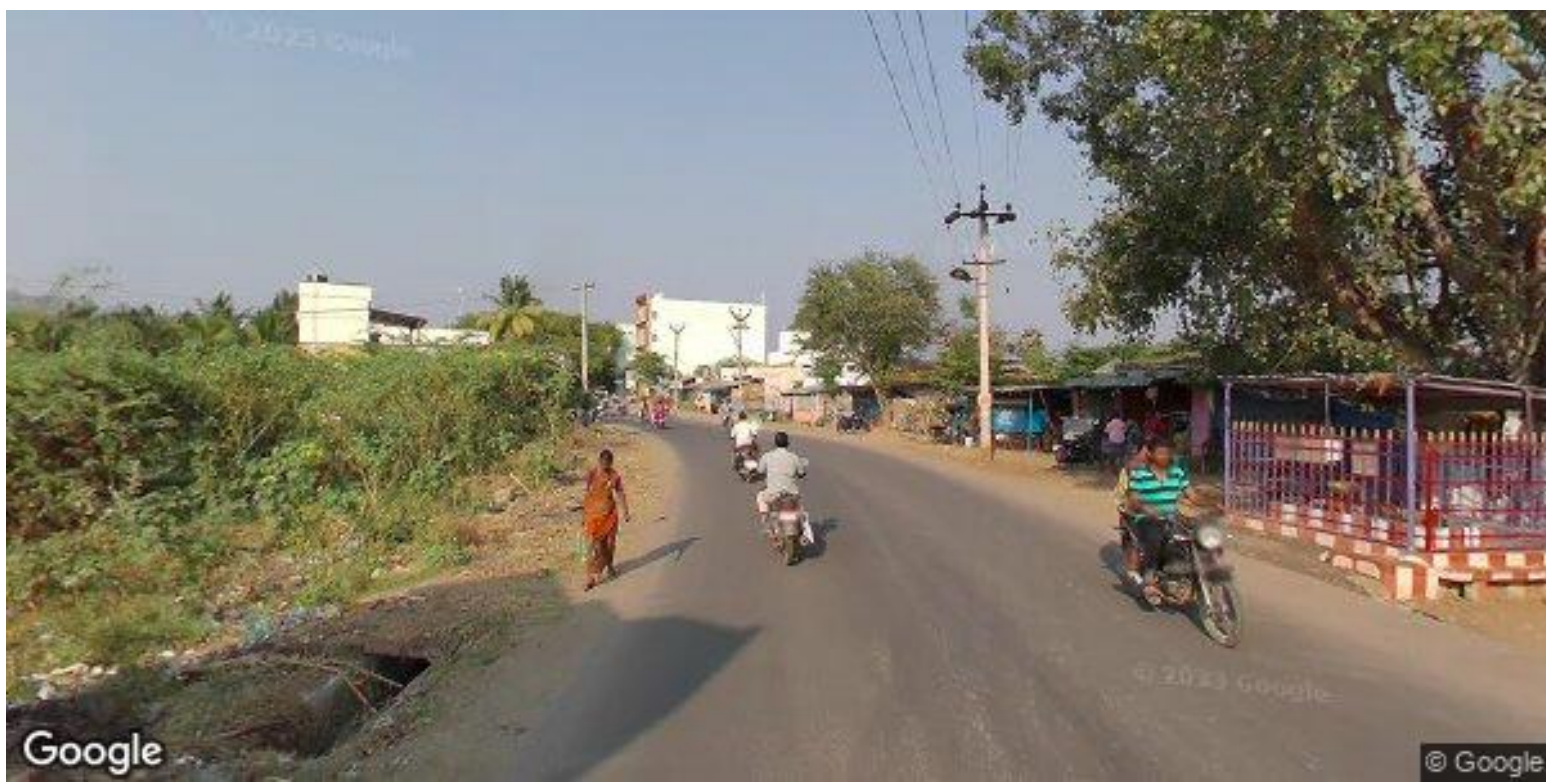
**Coordinates:** 11.87089, 78.08558

**Risk Type:** Turn

**Risk Level:** Medium

**Speed Limit:** 30 KM/Hr

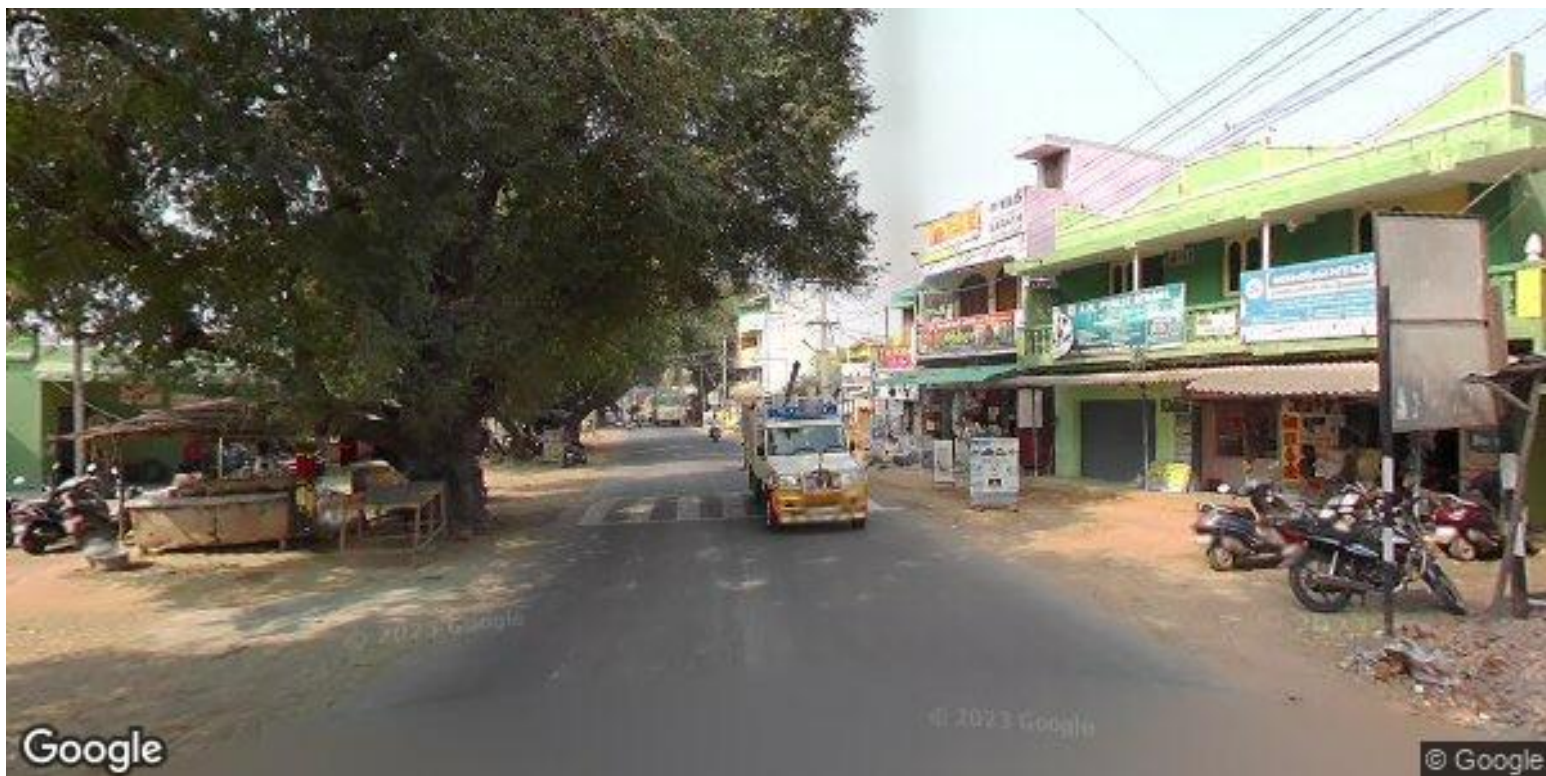
**Coordinates:** 11.87249, 78.08707

**Risk Type:** Turn

**Risk Level:** Medium

**Speed Limit:** 30 KM/Hr

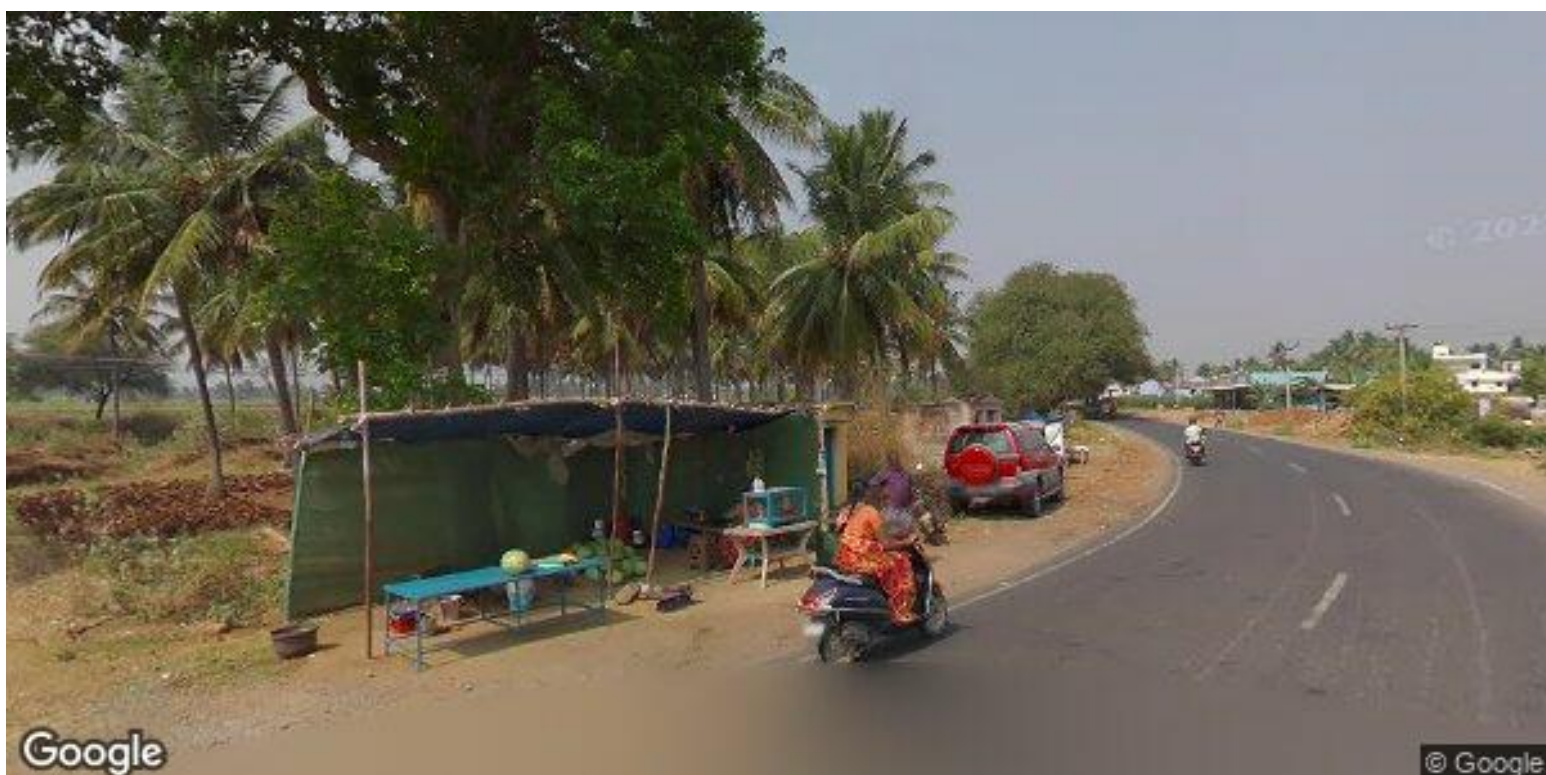
**Risk Type:** Turn  
**Risk Level:** Medium  
**Speed Limit:** 30 KM/Hr  
**Coordinates:** 11.86893, 78.12084

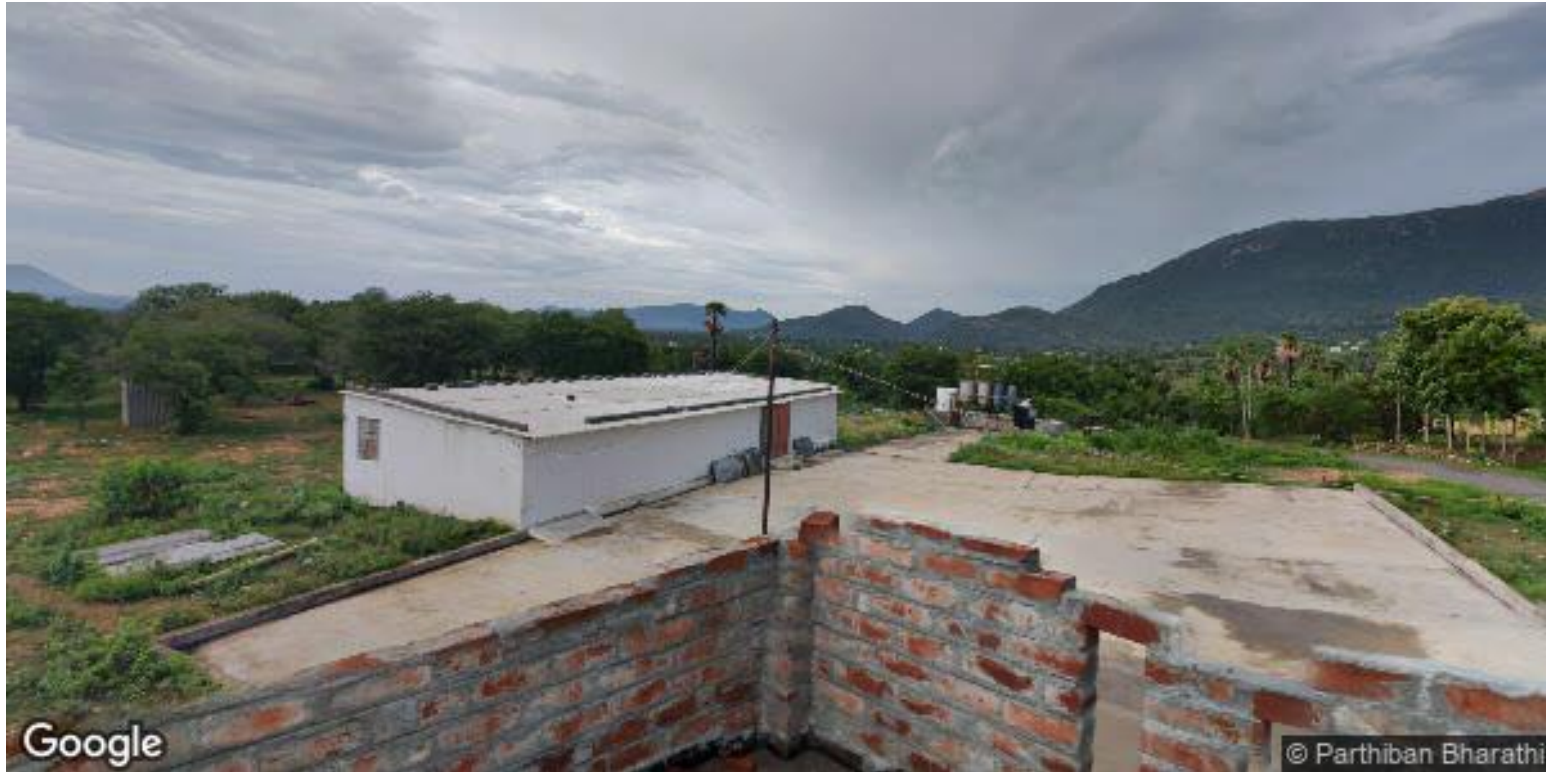
**Risk Type:** Turn  
**Risk Level:** Medium  
**Speed Limit:** 30 KM/Hr  
**Coordinates:** 11.95116, 78.20647

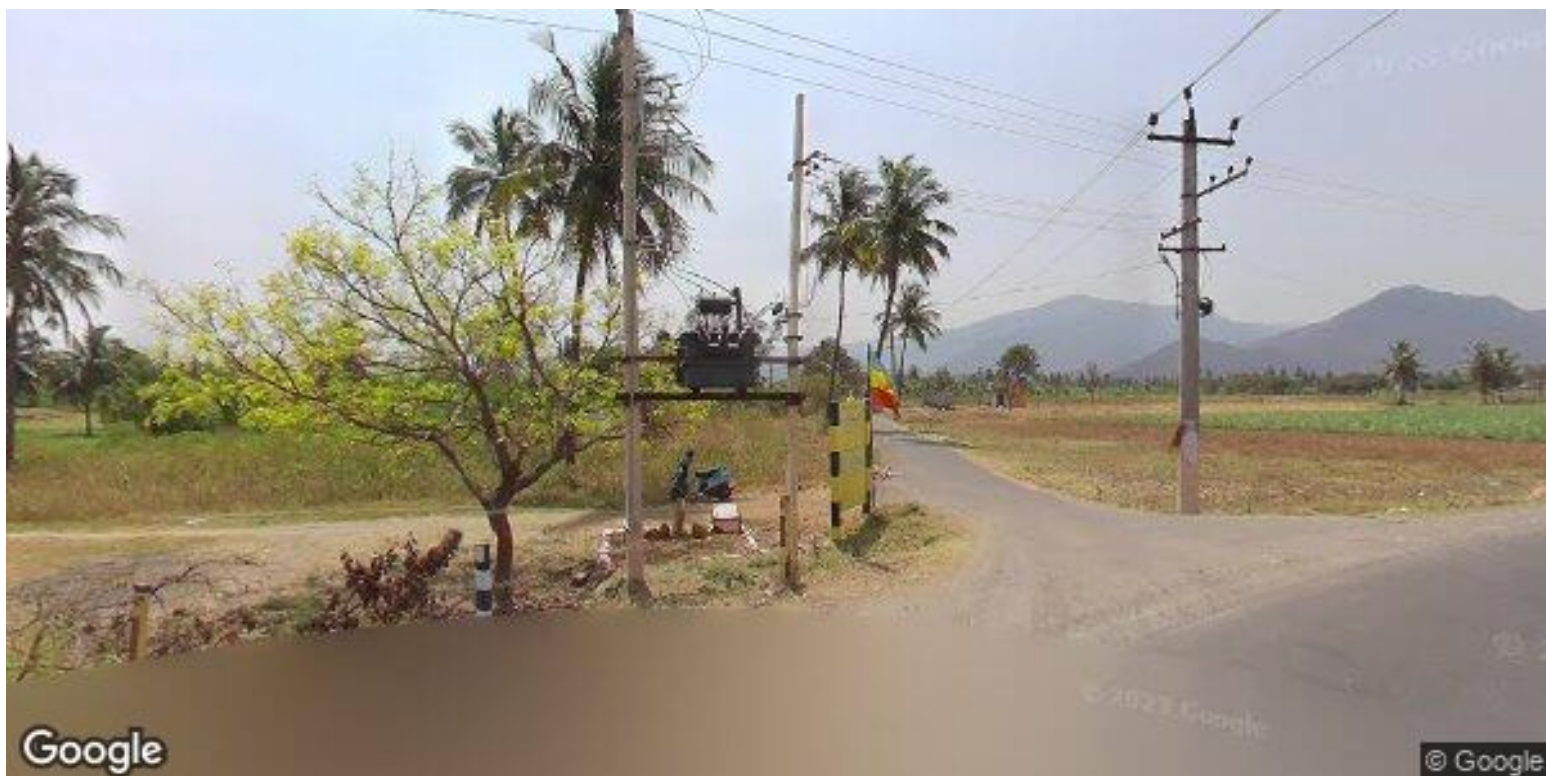
**Risk Type:** Turn  
**Risk Level:** High  
**Speed Limit:** 15 KM/Hr  
**Coordinates:** 11.97325, 78.23714

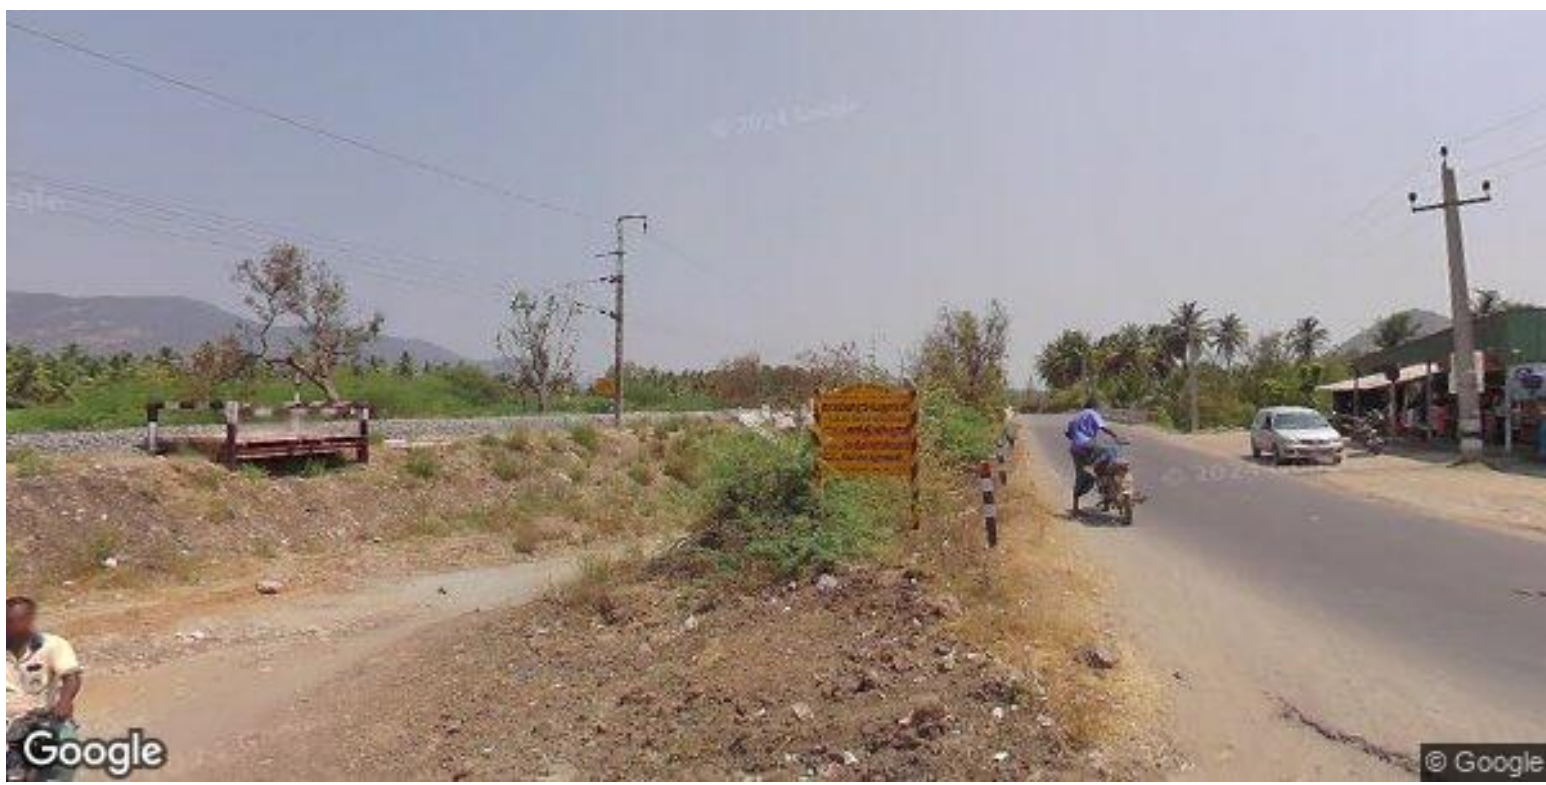
**Coordinates:** 11.97765, 78.23556

**Risk Type:** Turn

**Risk Level:** High

**Speed Limit:** 15 KM/Hr

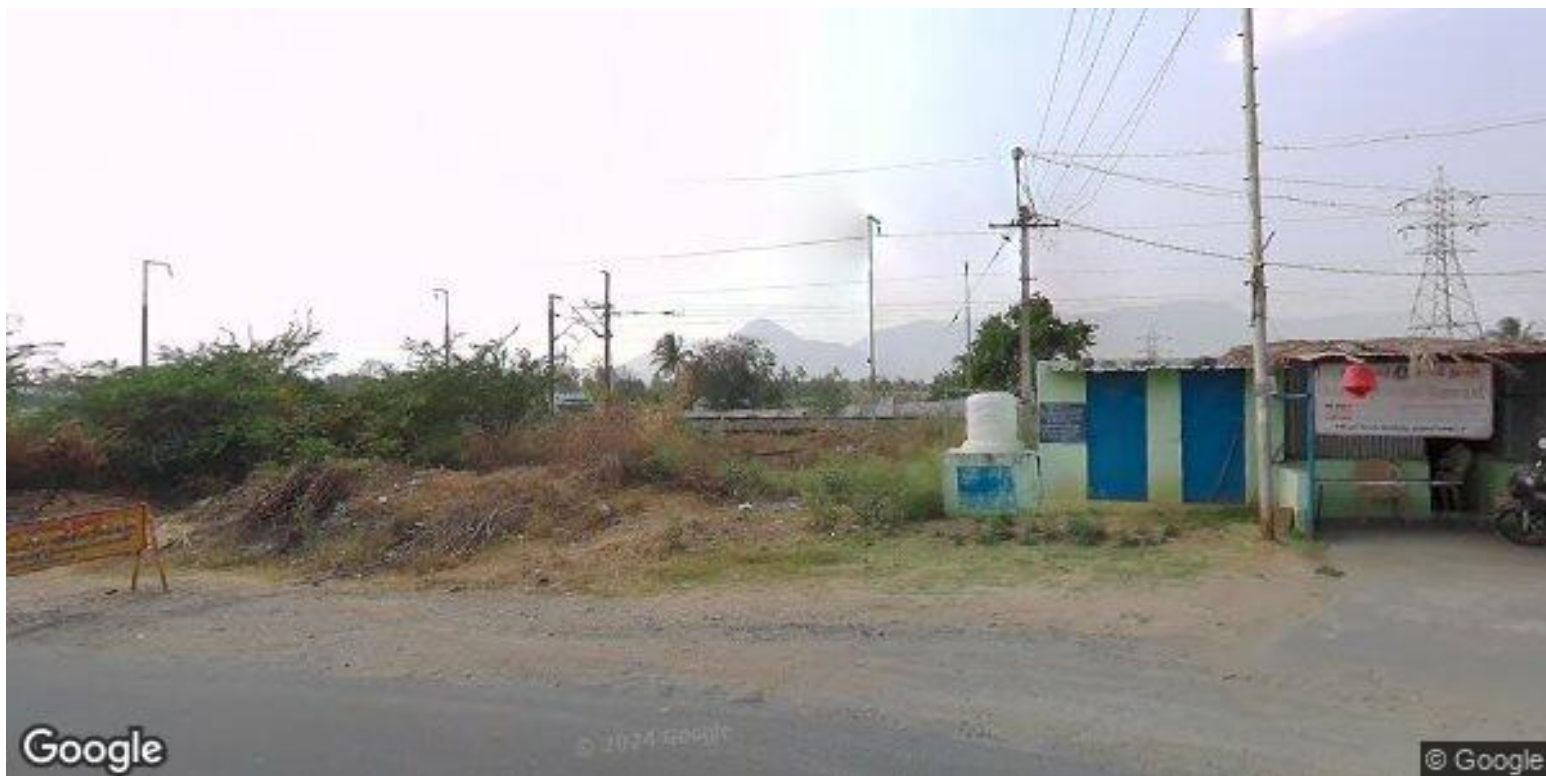
**Coordinates:** 11.98243, 78.24308

**Risk Type:** Turn

**Risk Level:** High

**Speed Limit:** 15 KM/Hr

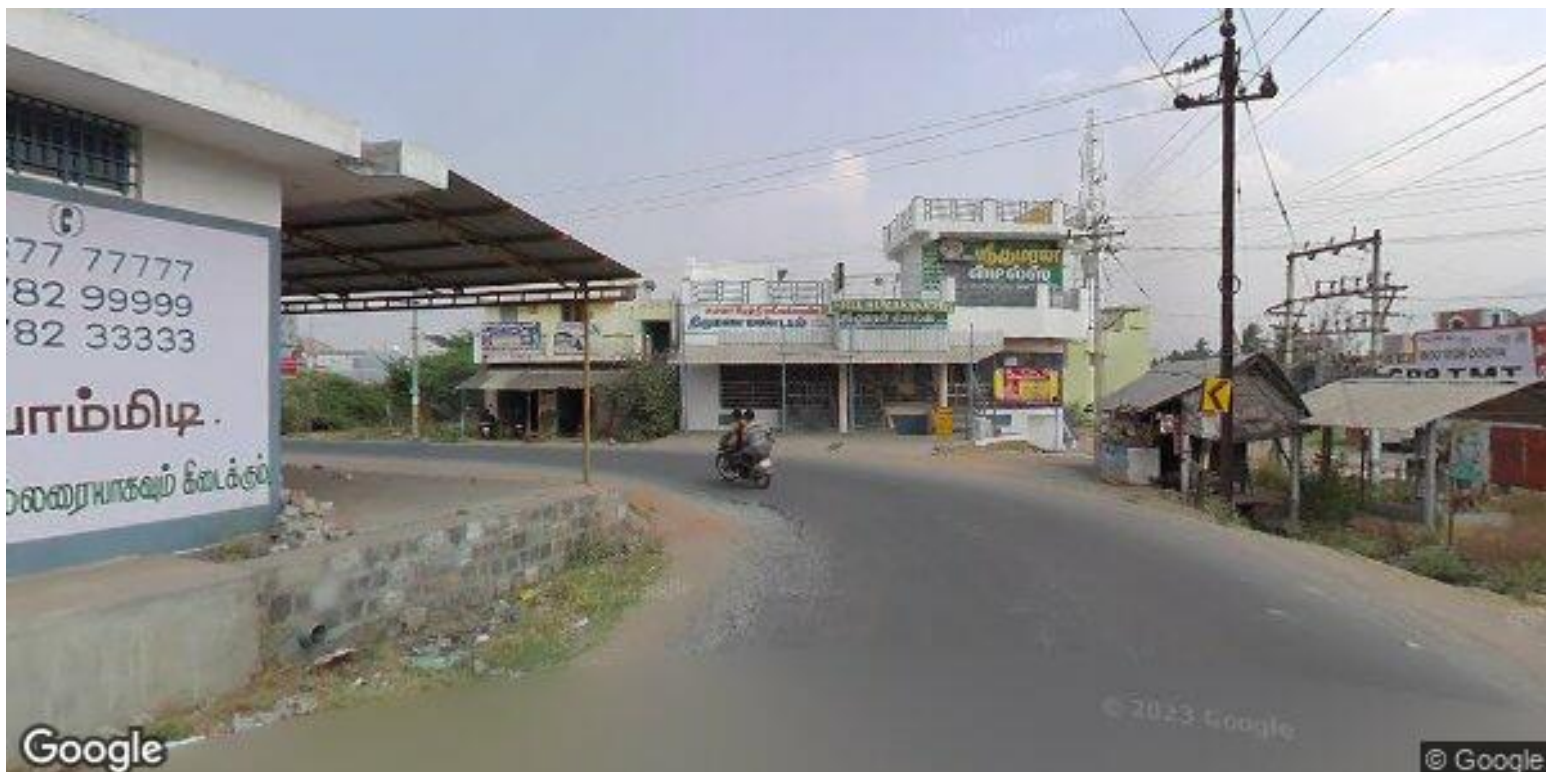
**Coordinates:** 11.98206, 78.24332

**Risk Type:** Turn

**Risk Level:** High

**Speed Limit:** 15 KM/Hr

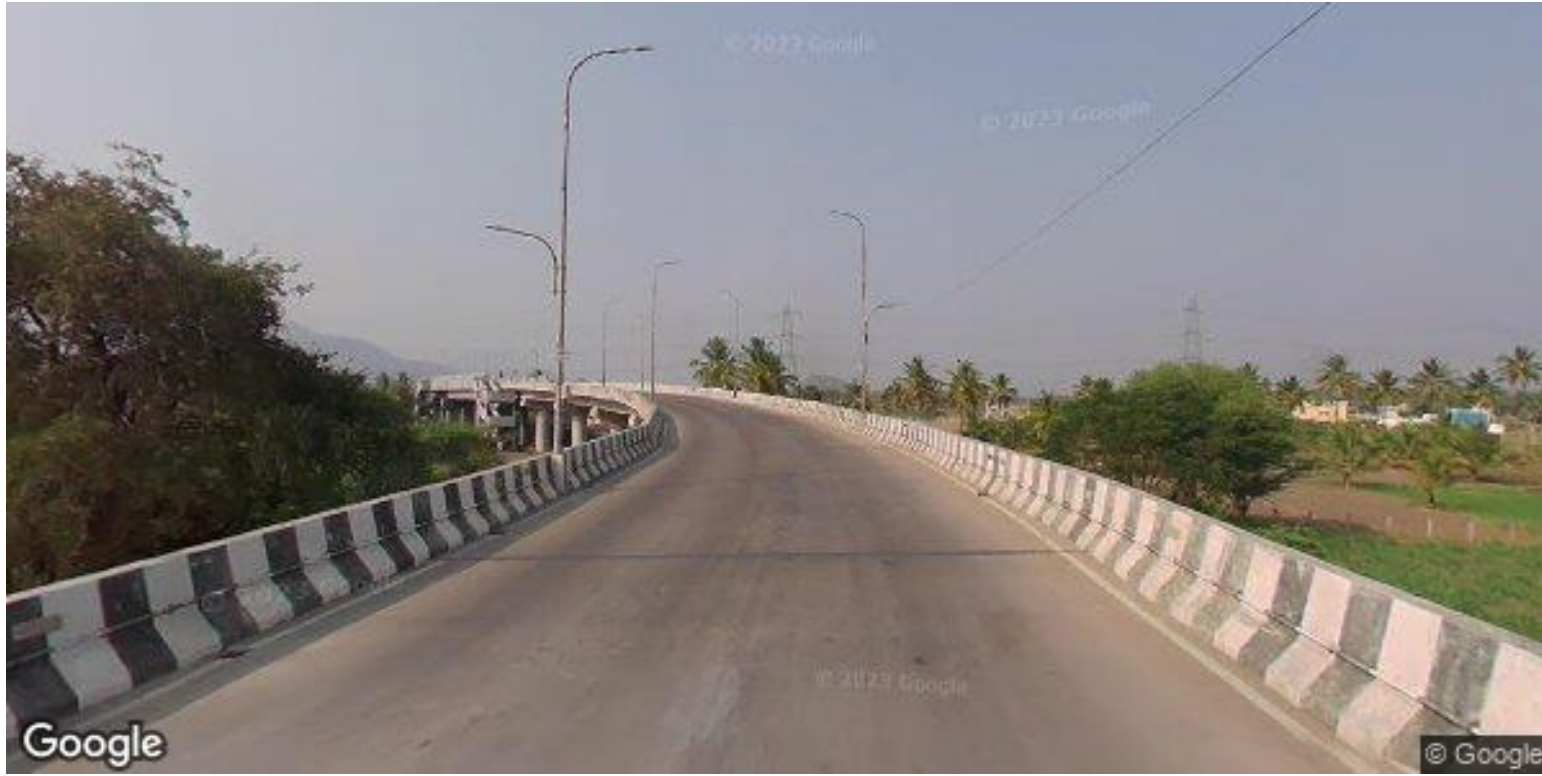
**Coordinates:** 11.99307, 78.25808

**Risk Type:** Turn

**Risk Level:** Medium

**Speed Limit:** 30 KM/Hr
