# IndianOil

## JOURNEY RISK MANAGEMENT (JRM) STUDY

### Salem Terminal to TPC FUELS

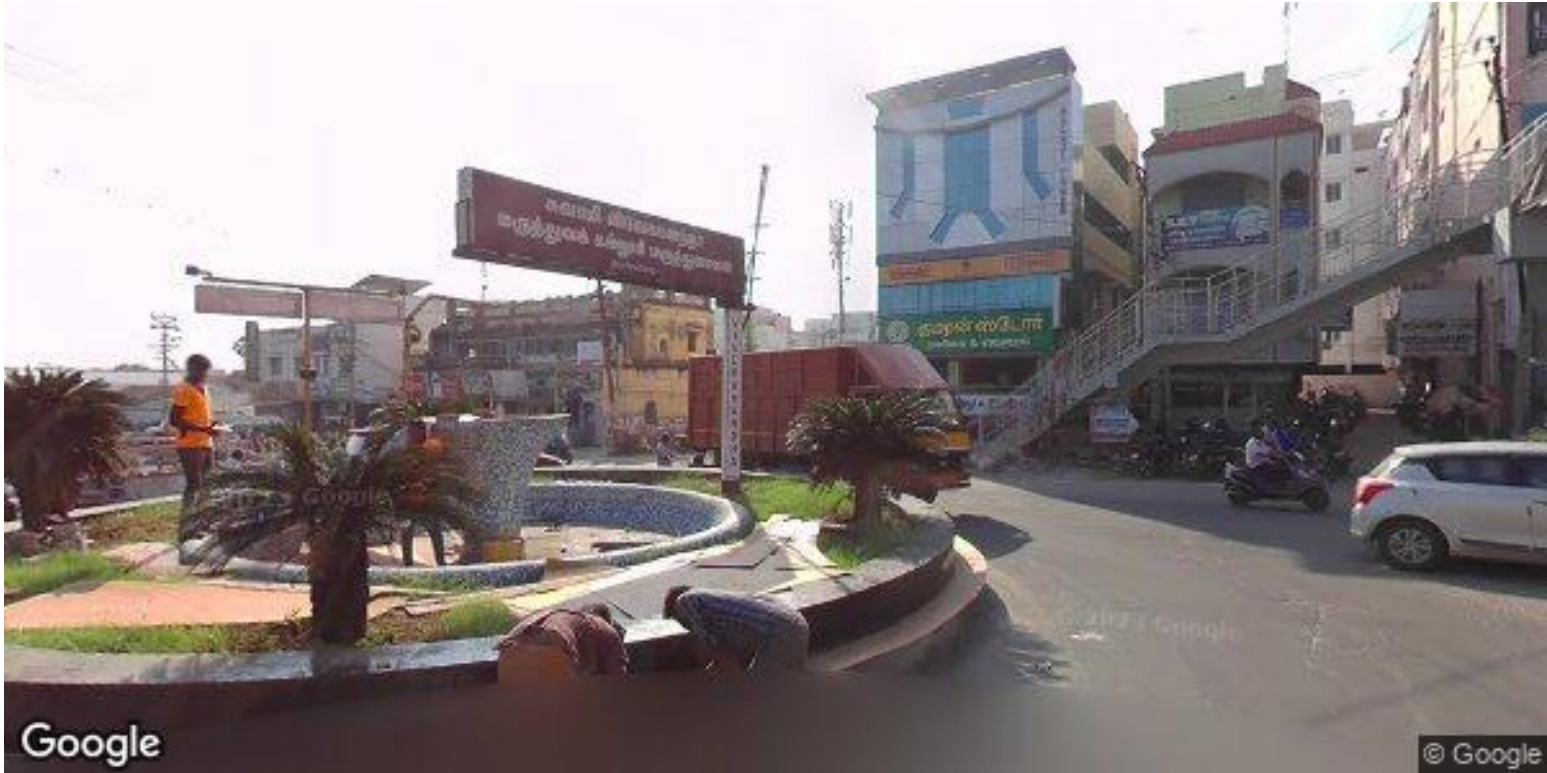
Risk Type: Roundabout  
Risk Level: High  
Speed Limit: 15 KM/Hr  
Coordinates: 11.38395, 77.89480

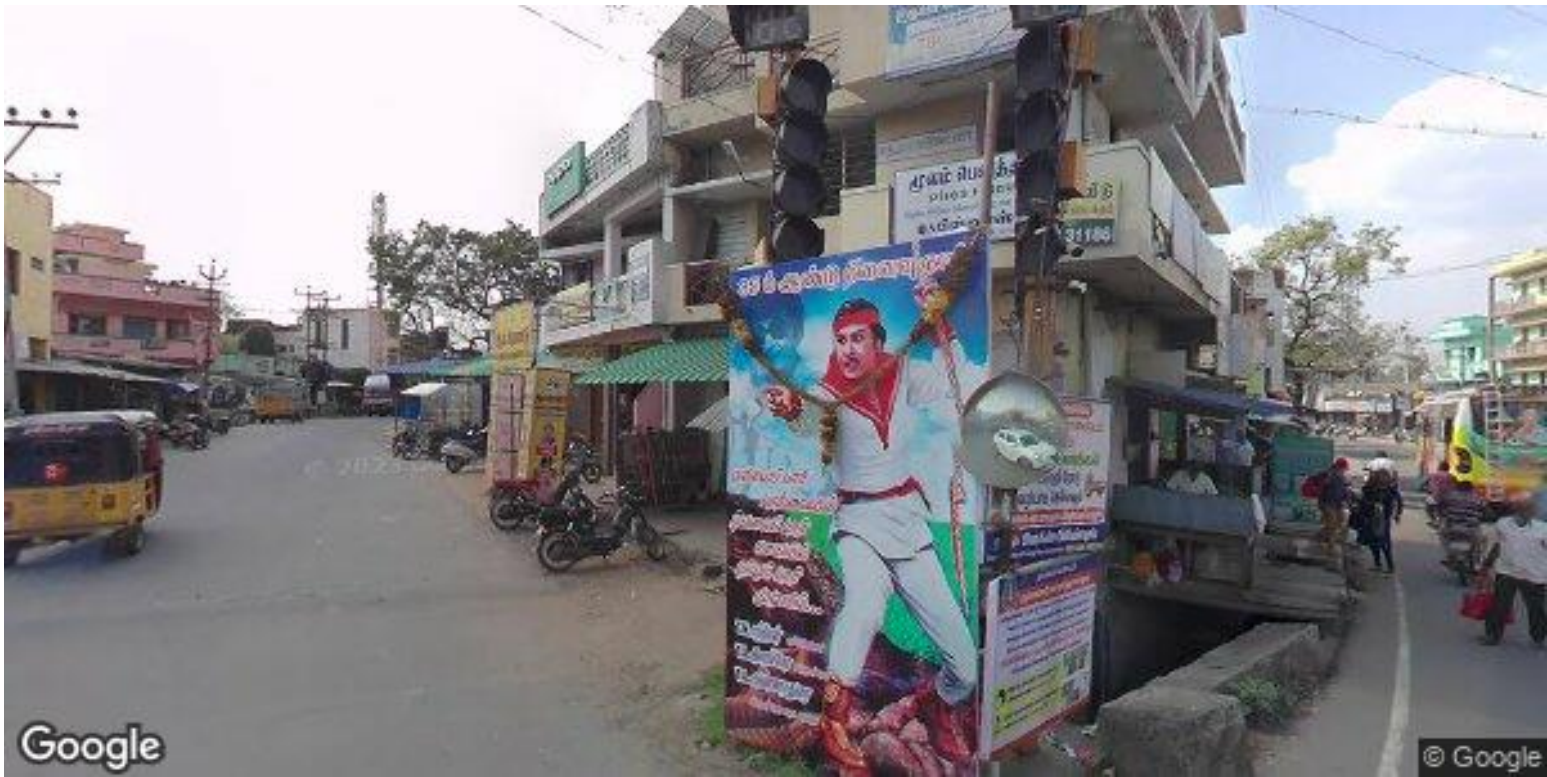
**Risk Type: Turn**  
**Risk Level: Medium**  
**Speed Limit: 30 KM/Hr**  
**Coordinates: 11.38342, 77.89975**

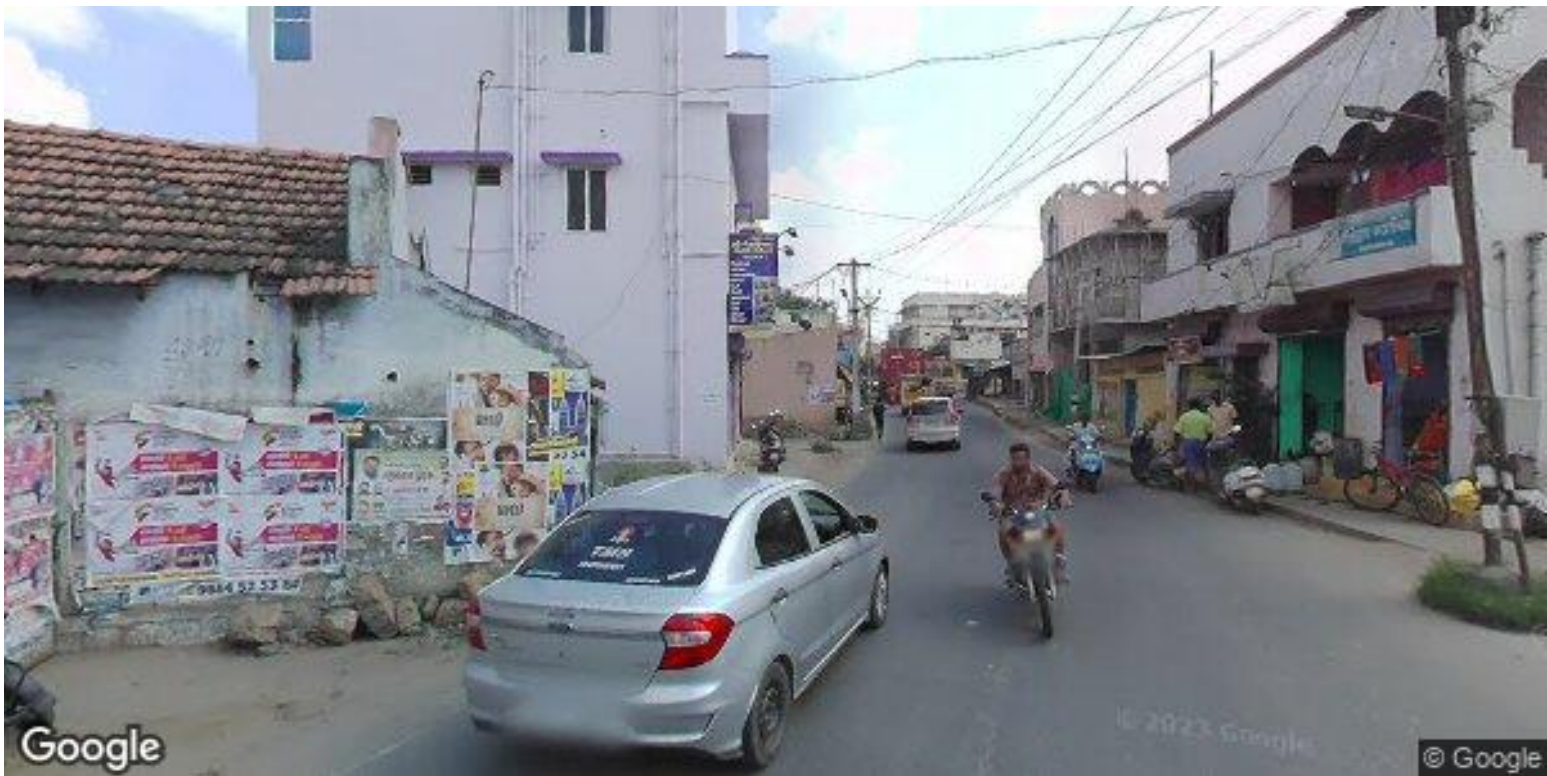
**Risk Type: Turn**  
**Risk Level: Medium**  
**Speed Limit: 30 KM/Hr**  
**Coordinates: 11.38295, 77.90001**

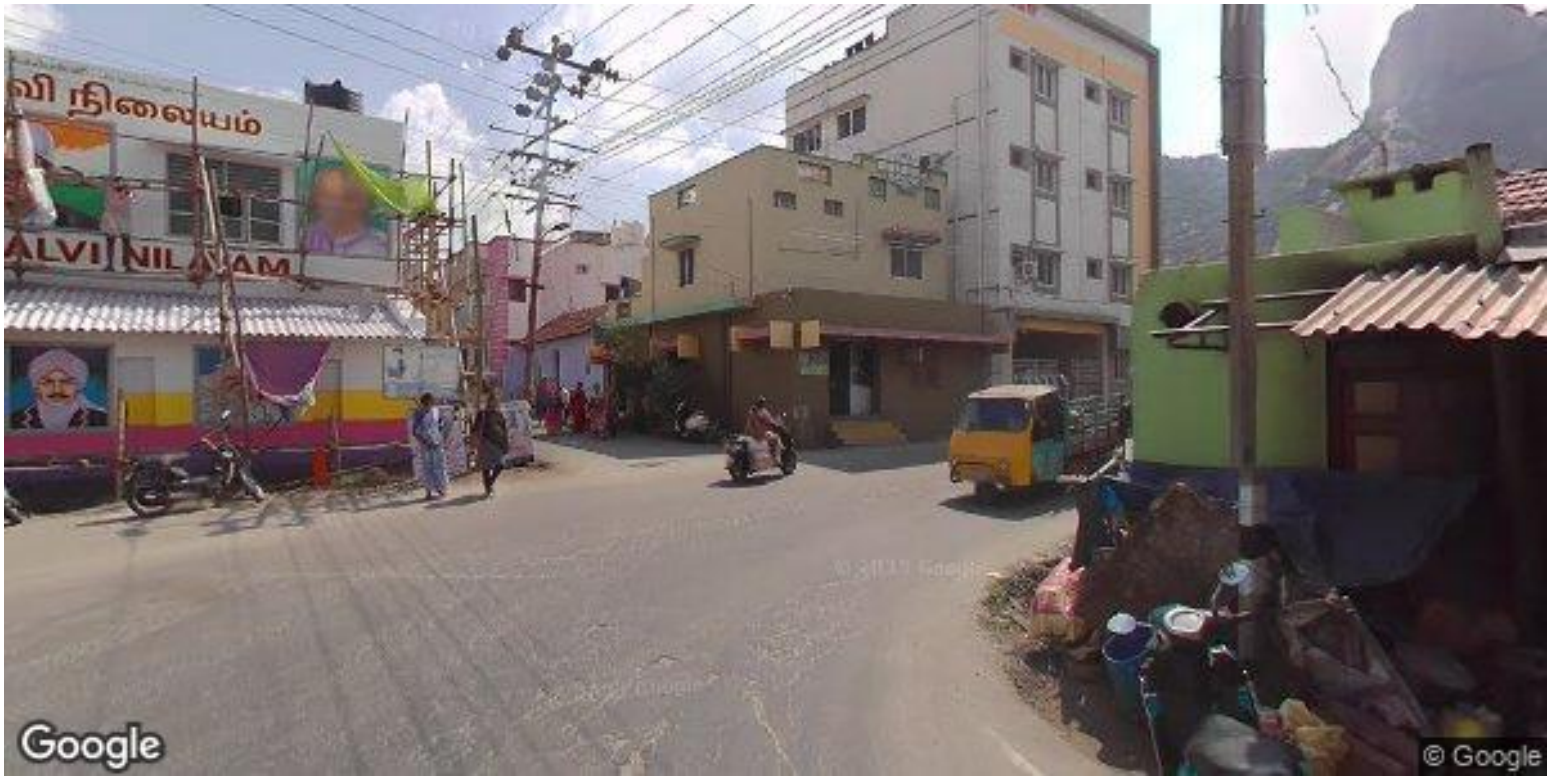
**Risk Type:** Turn  
**Risk Level:** High  
**Speed Limit:** 15 KM/Hr  
**Coordinates:** 11.38186, 77.90258

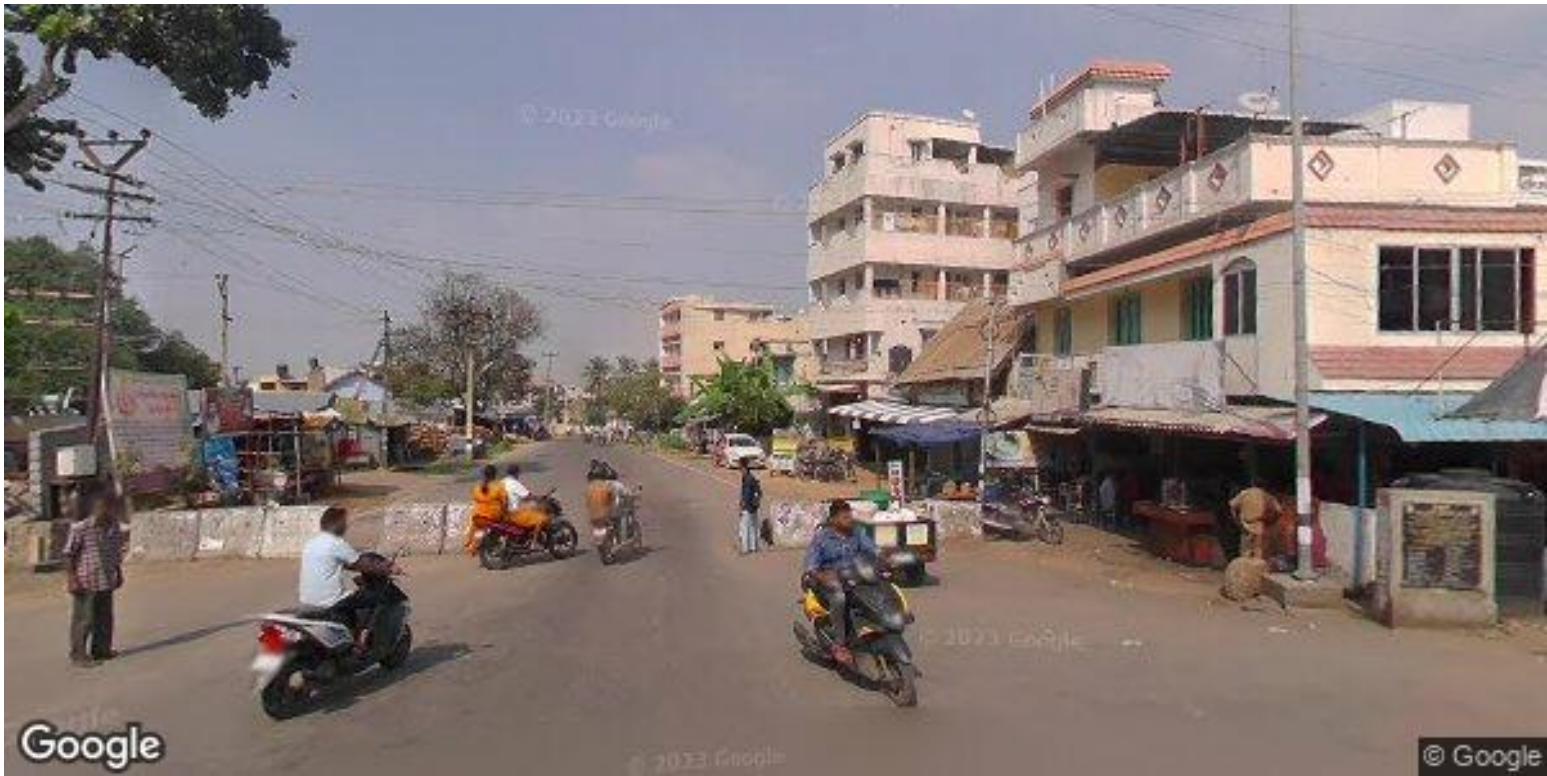
**Risk Type:** Blind Spot  
**Risk Level:** Blind Spot  
**Speed Limit:** 10 KM/Hr  
**Coordinates:** 11.37841, 77.90140

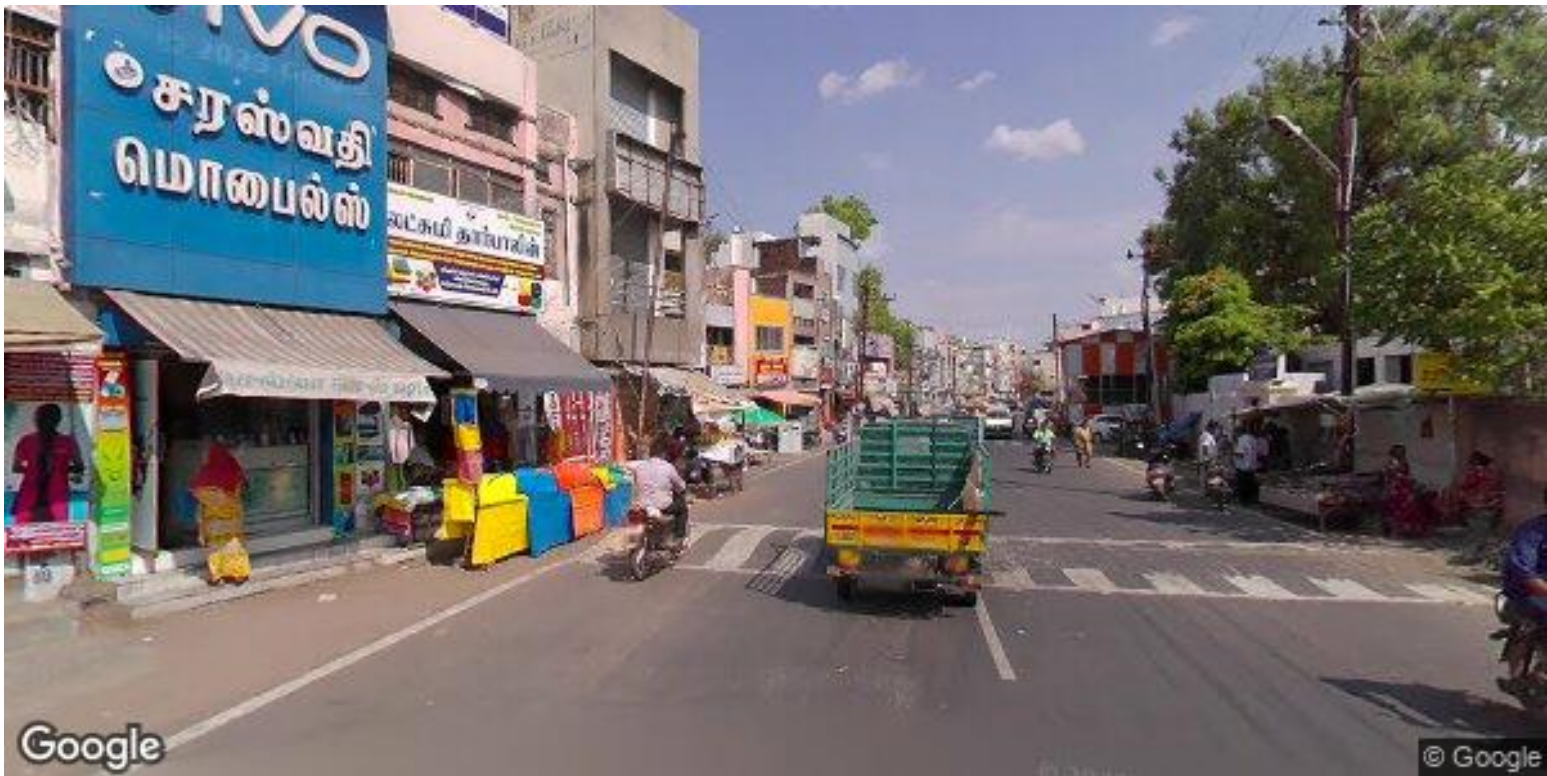
**Risk Type:** Turn  
**Risk Level:** Medium  
**Speed Limit:** 30 KM/Hr  
**Coordinates:** 11.22407, 78.16640

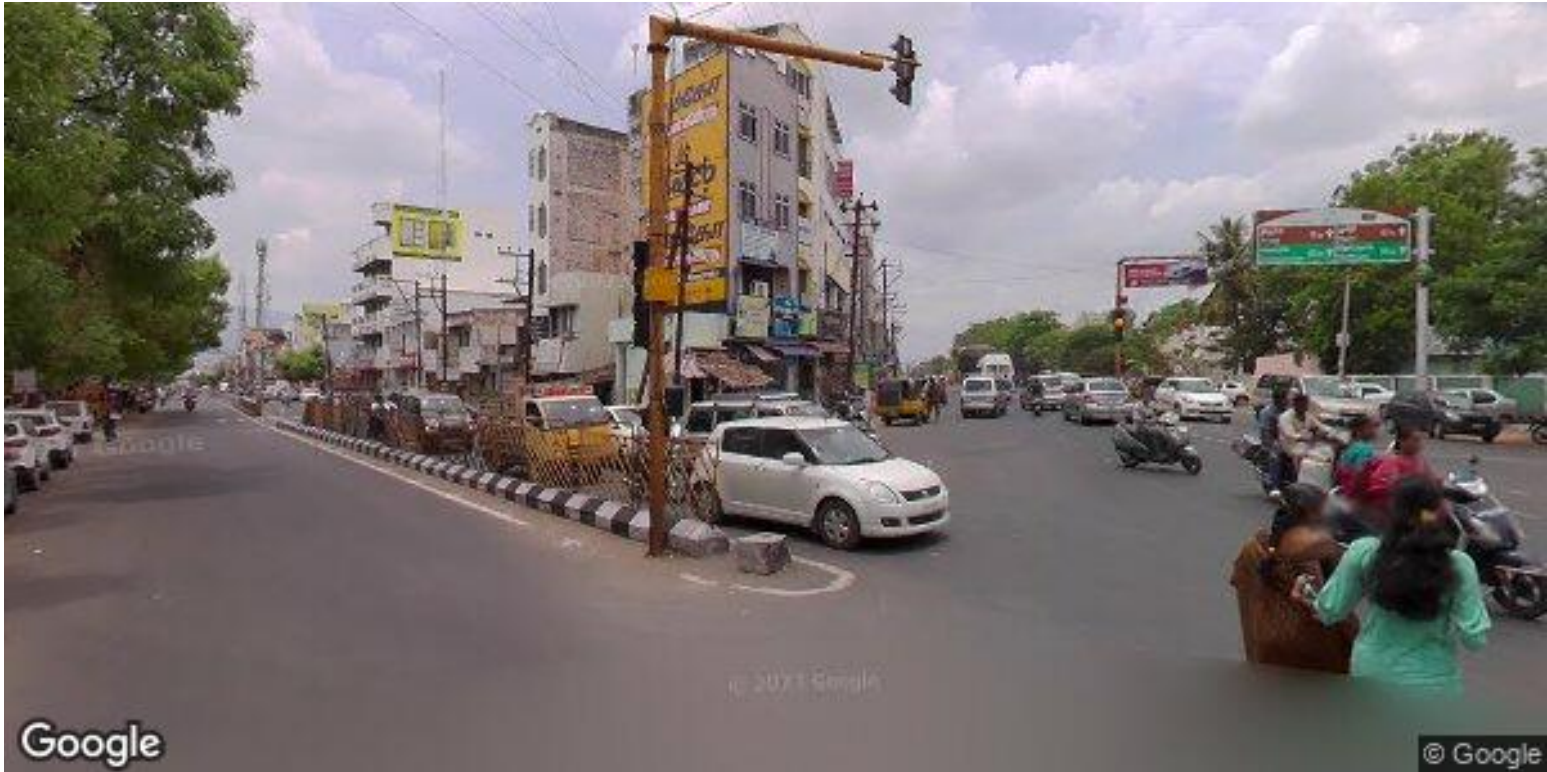
**Risk Type:** Turn  
**Risk Level:** High  
**Speed Limit:** 15 KM/Hr  
**Coordinates:** 11.21816, 78.16934

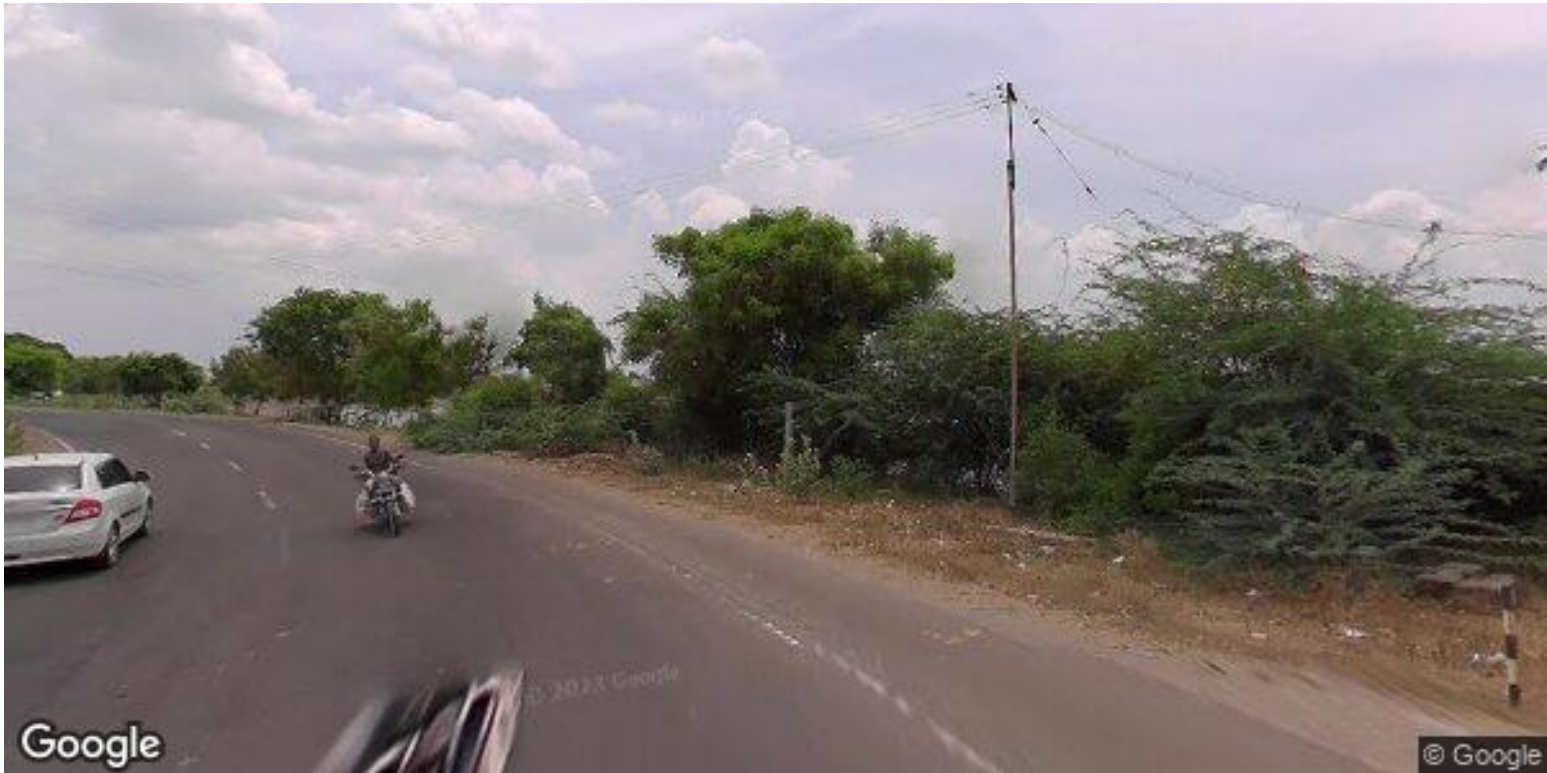
**Risk Type:** Turn  
**Risk Level:** Medium  
**Speed Limit:** 30 KM/Hr  
**Coordinates:** 11.20105, 78.23198

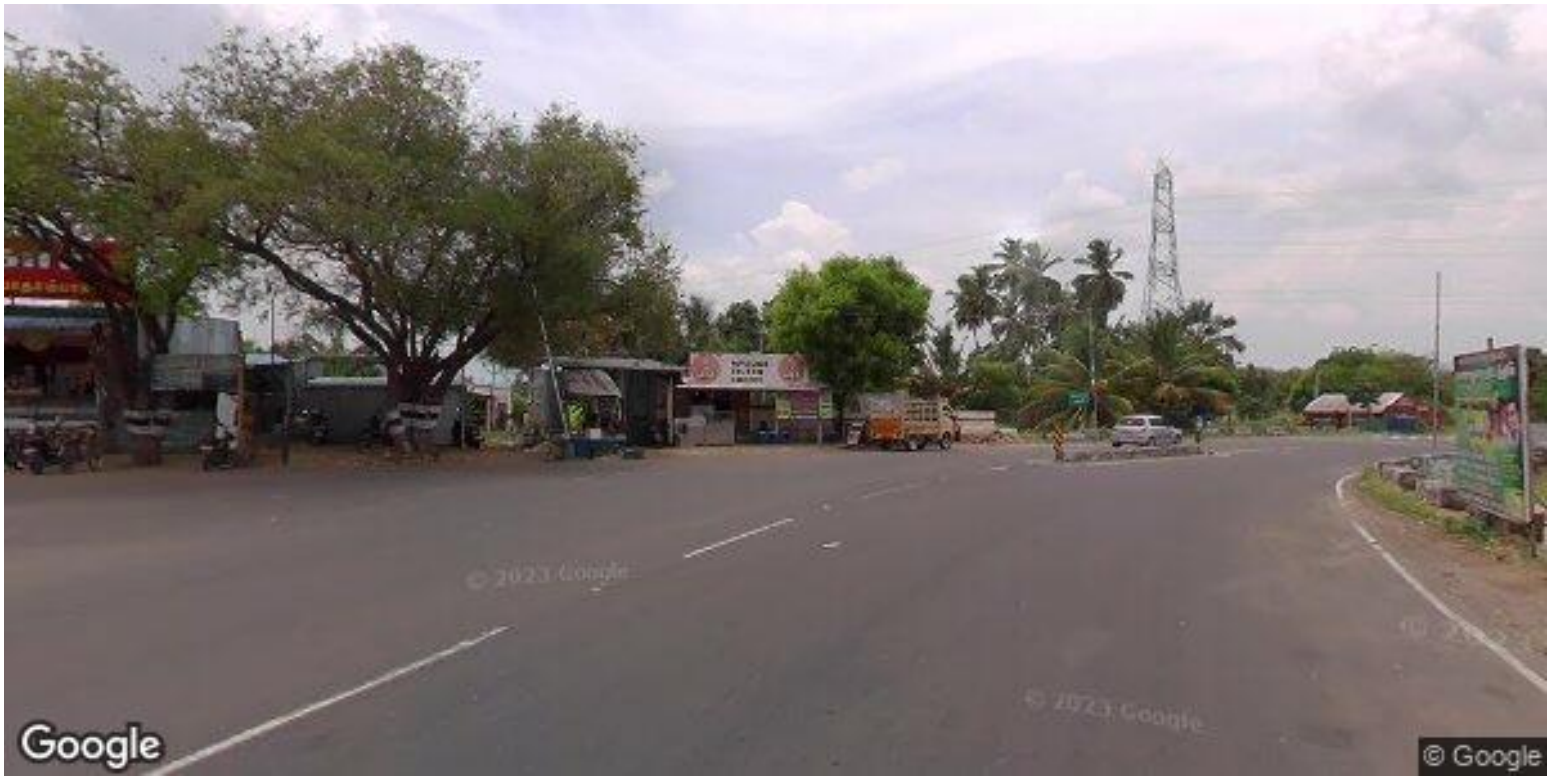
**Risk Type:** Turn  
**Risk Level:** High  
**Speed Limit:** 15 KM/Hr  
**Coordinates:** 11.16124, 78.28095

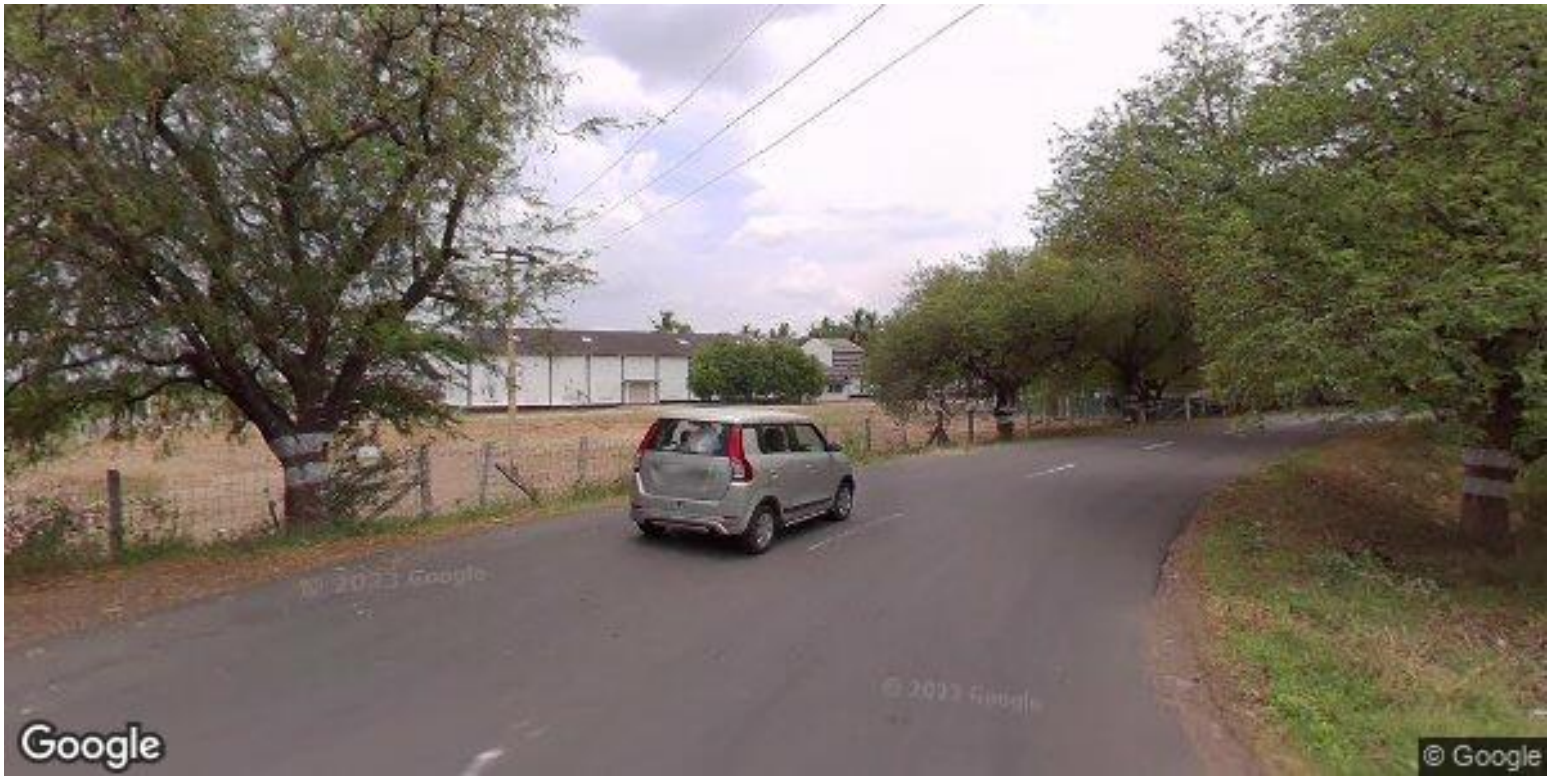
**Risk Type:** Turn  
**Risk Level:** Medium  
**Speed Limit:** 30 KM/Hr  
**Coordinates:** 11.15975, 78.28885

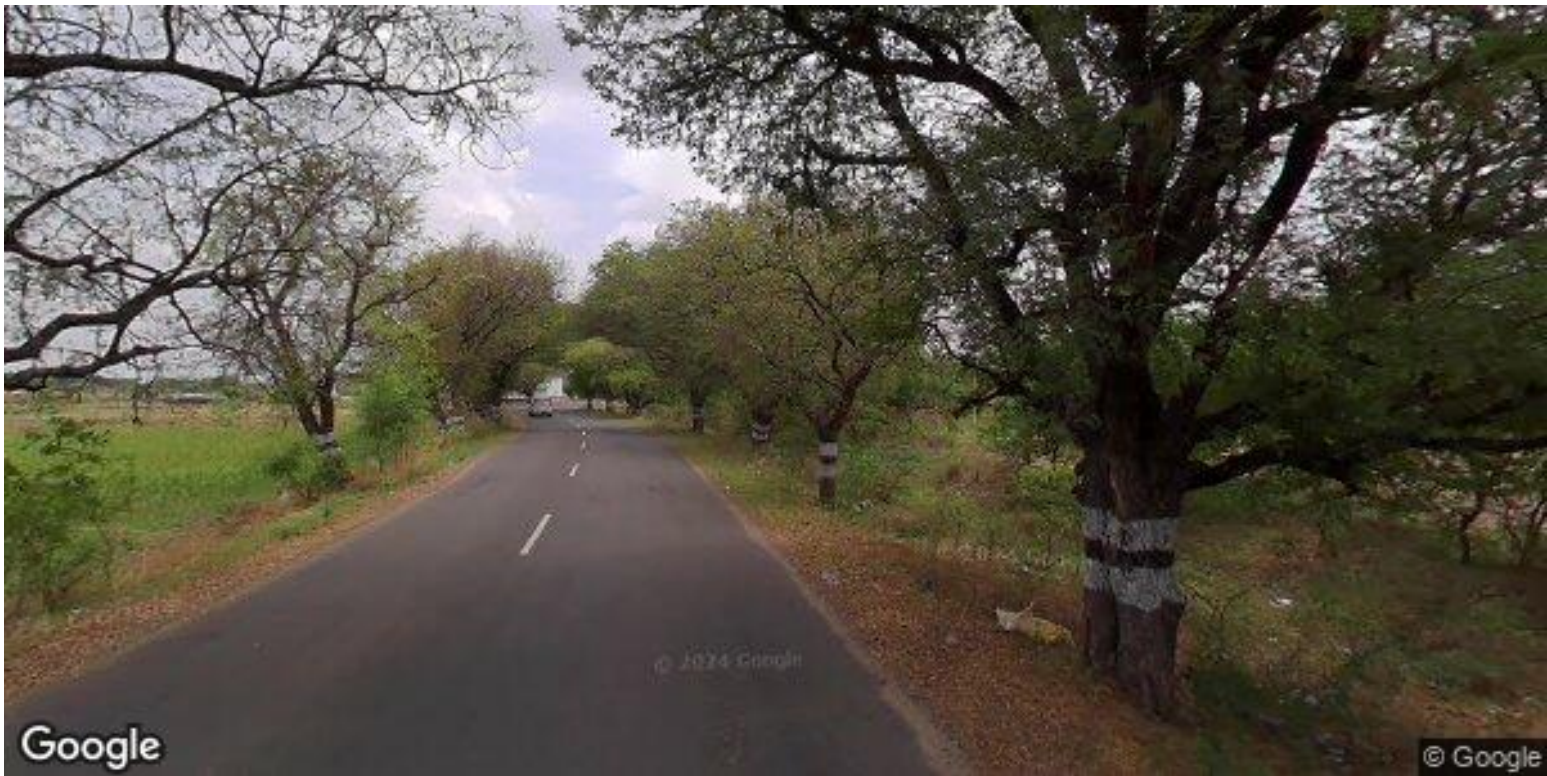
Risk Type: Turn

Risk Level: Medium

Speed Limit: 30 KM/Hr

Coordinates: 11.16047, 78.28943

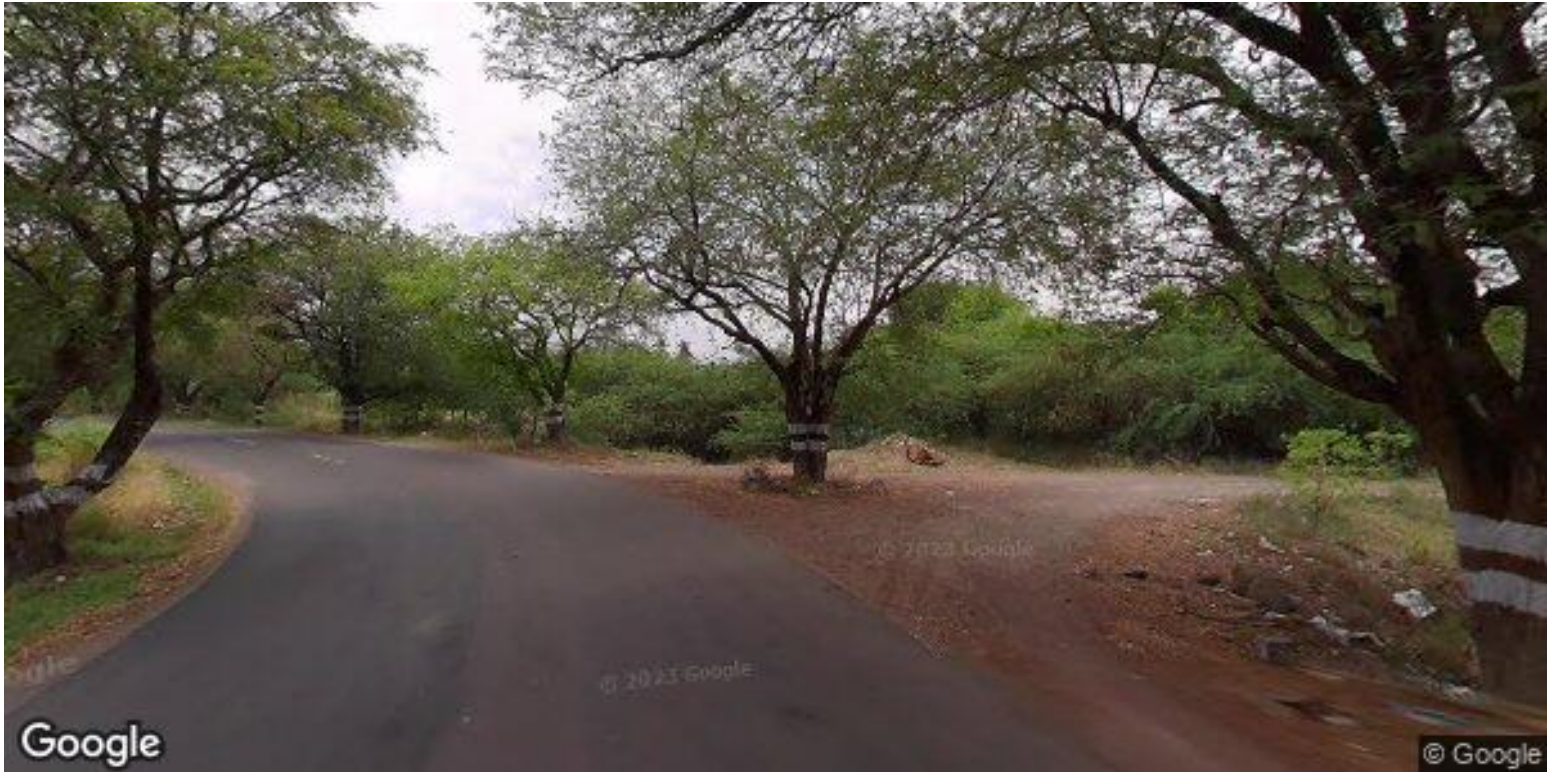
Risk Type: Turn

Risk Level: Medium

Speed Limit: 30 KM/Hr

Coordinates: 11.16056, 78.28971
