# IndianOil

## JOURNEY RISK MANAGEMENT (JRM) STUDY

### Salem Terminal TO SRI STAR AGENCIES

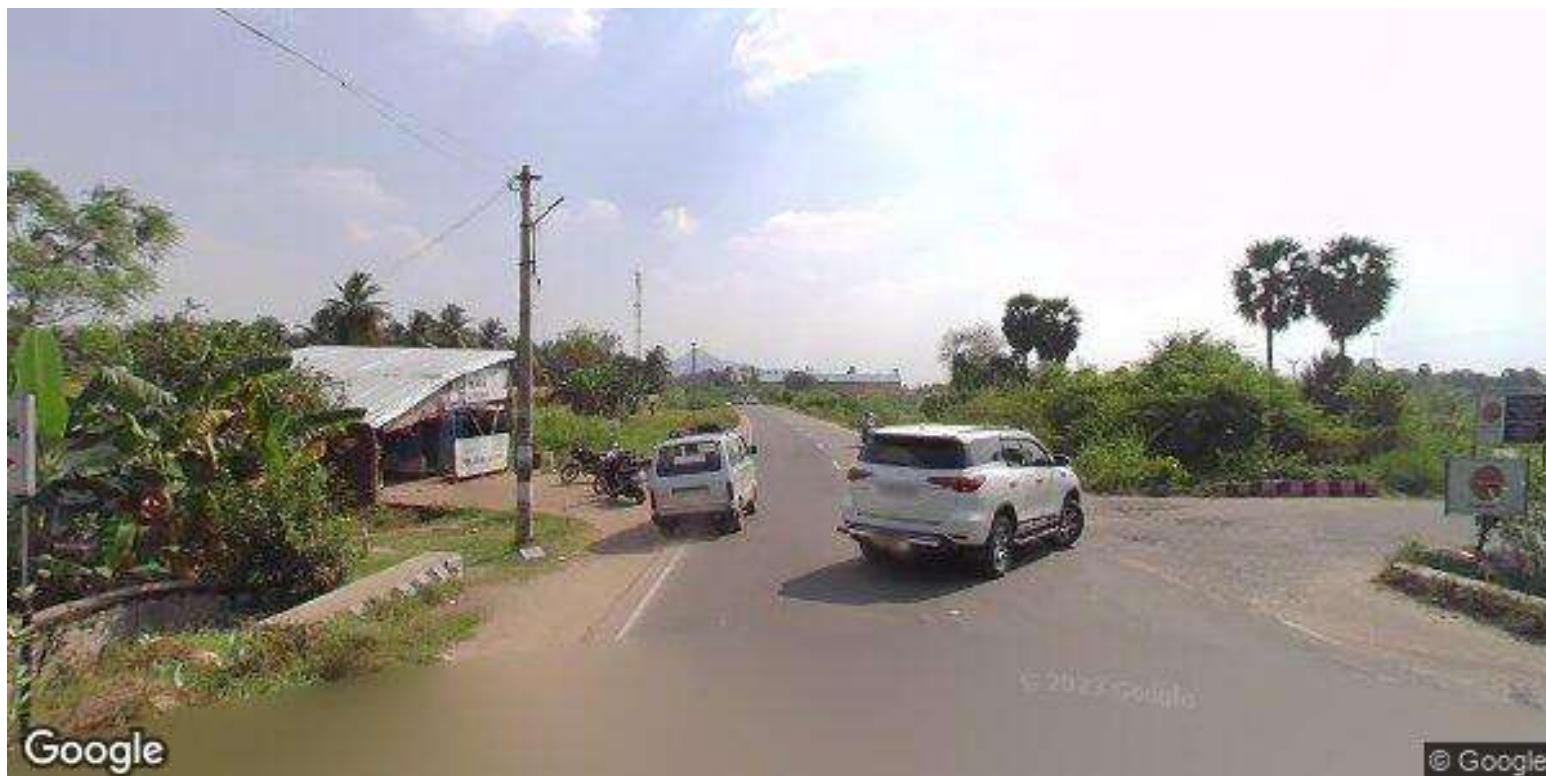
**Coordinates:** 11.44029, 77.87544

**Risk Type:** Turn

**Risk Level:** High

**Speed Limit:** 15 KM/Hr

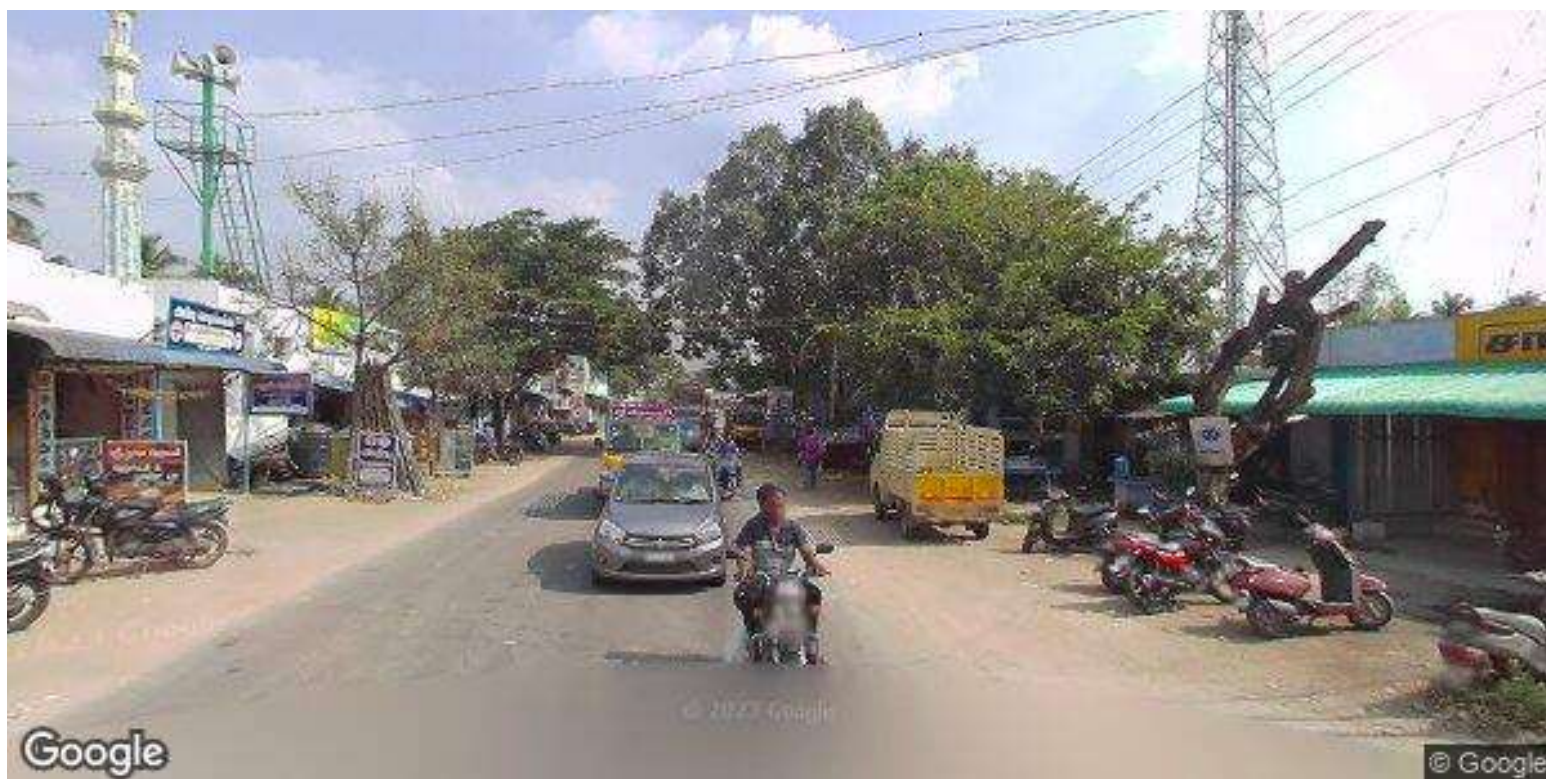
**Coordinates:** 11.44958, 77.87296

**Risk Type:** Blind Spot

**Risk Level:** Blind Spot

**Speed Limit:** 10 KM/Hr

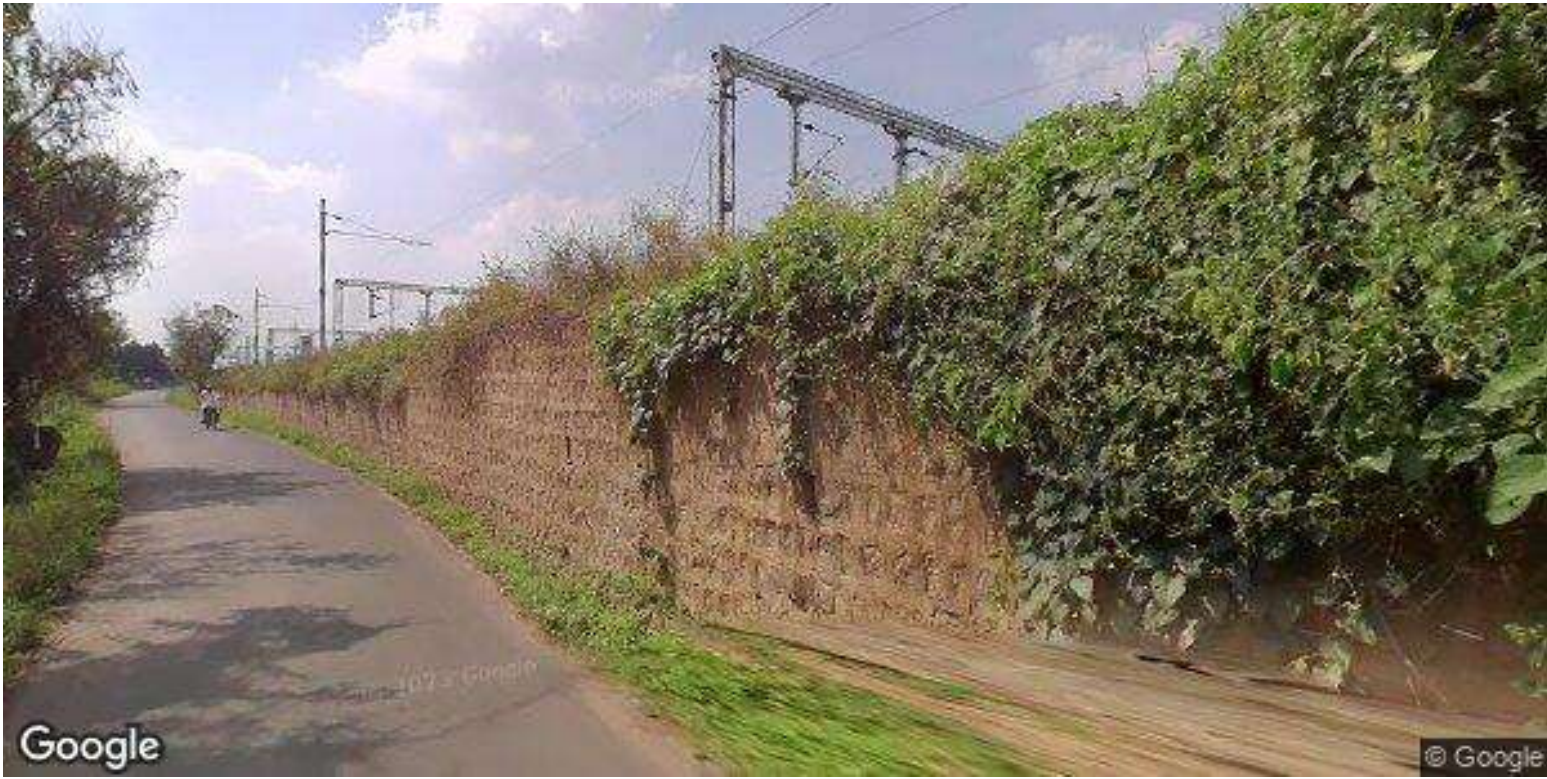
**Risk Type:** Turn  
**Risk Level:** Medium  
**Speed Limit:** 30 KM/Hr  
**Coordinates:** 11.44561, 77.87070

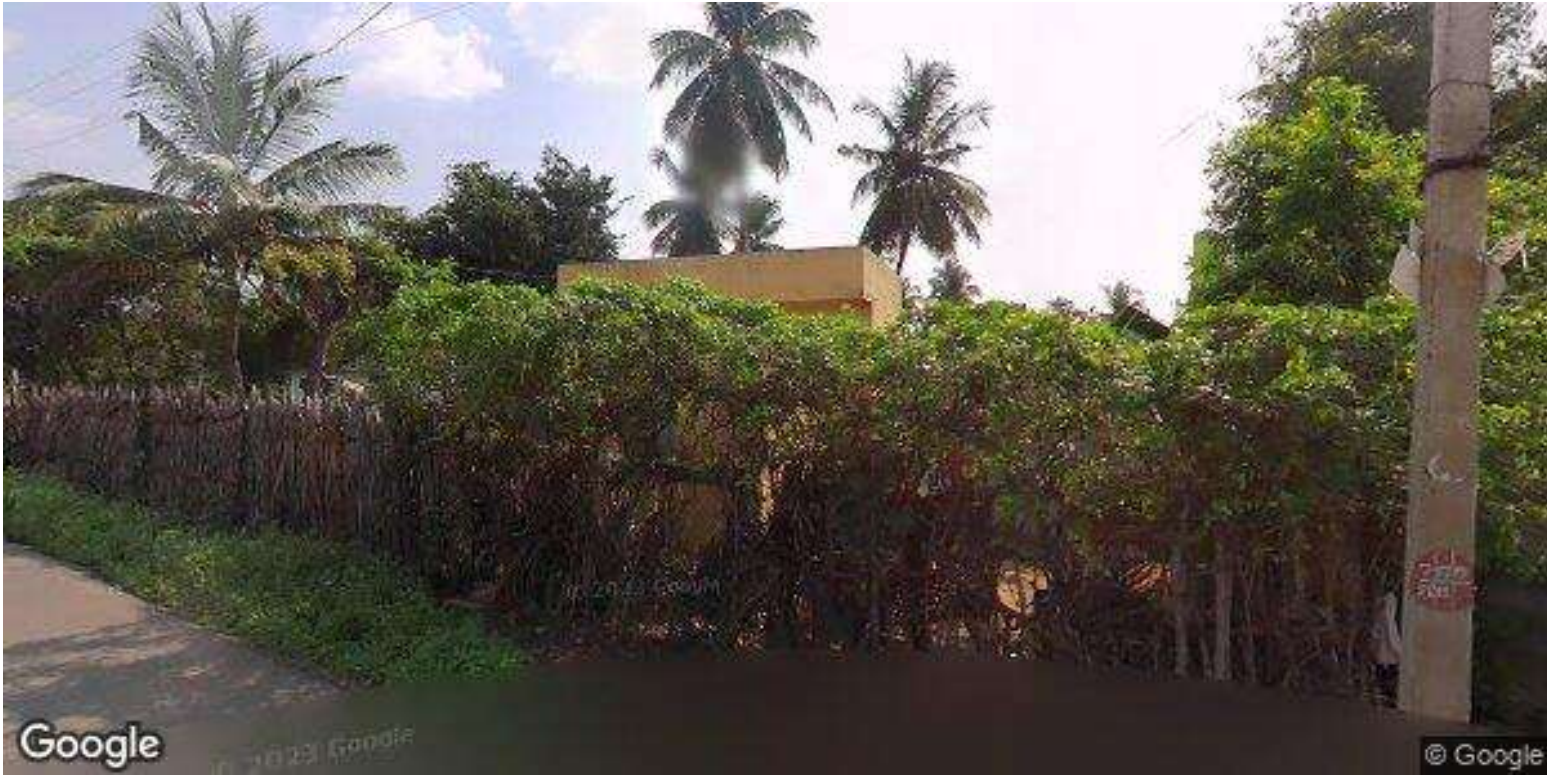
**Risk Type:** Blind Spot  
**Risk Level:** Blind Spot  
**Speed Limit:** 10 KM/Hr  
**Coordinates:** 11.43502, 77.86063

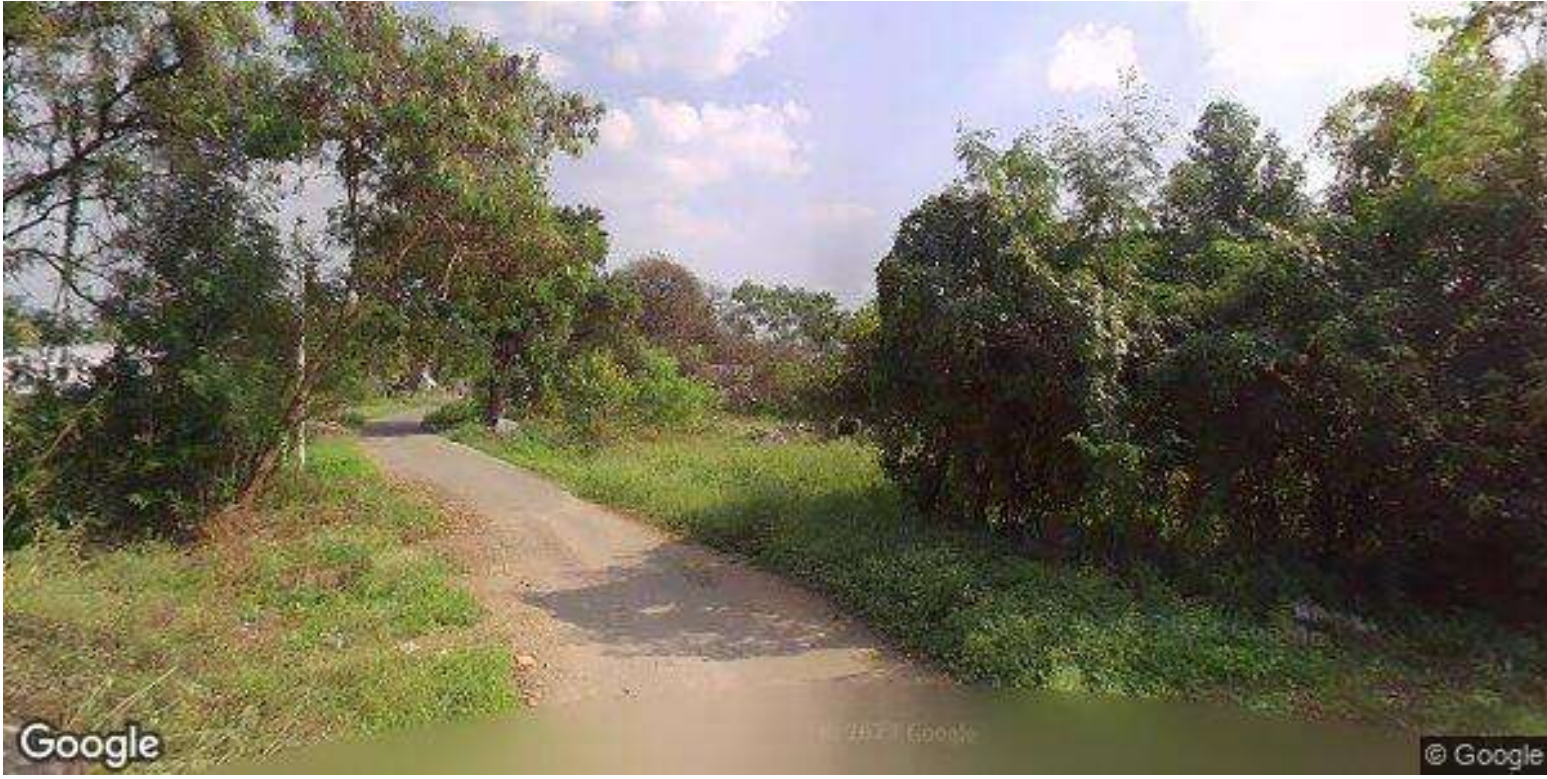
**Risk Type:** Turn  
**Risk Level:** Medium  
**Speed Limit:** 30 KM/Hr  
**Coordinates:** 11.43535, 77.85967

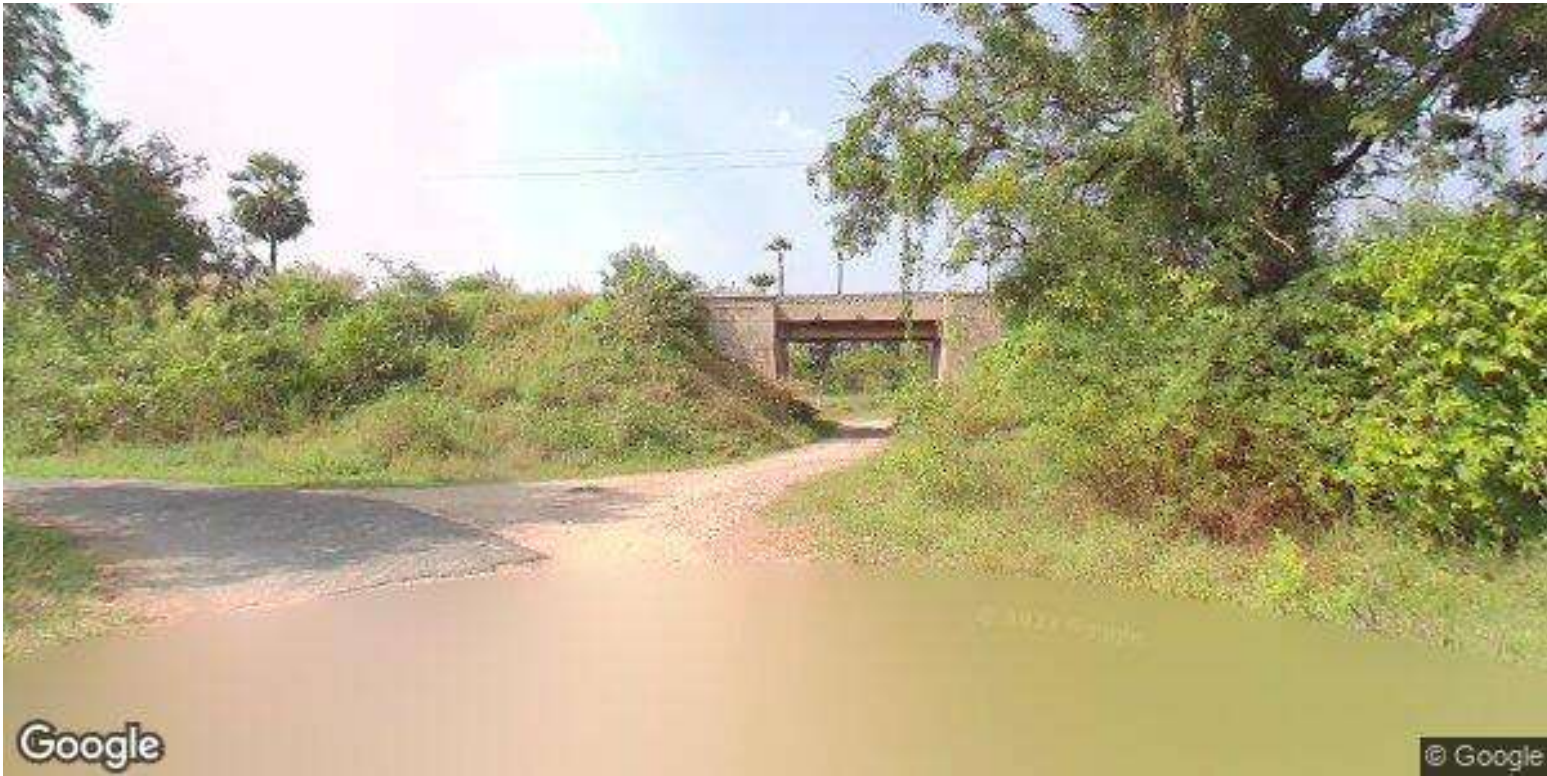
**Risk Type:** Turn  
**Risk Level:** Medium  
**Speed Limit:** 30 KM/Hr  
**Coordinates:** 11.43548, 77.85957

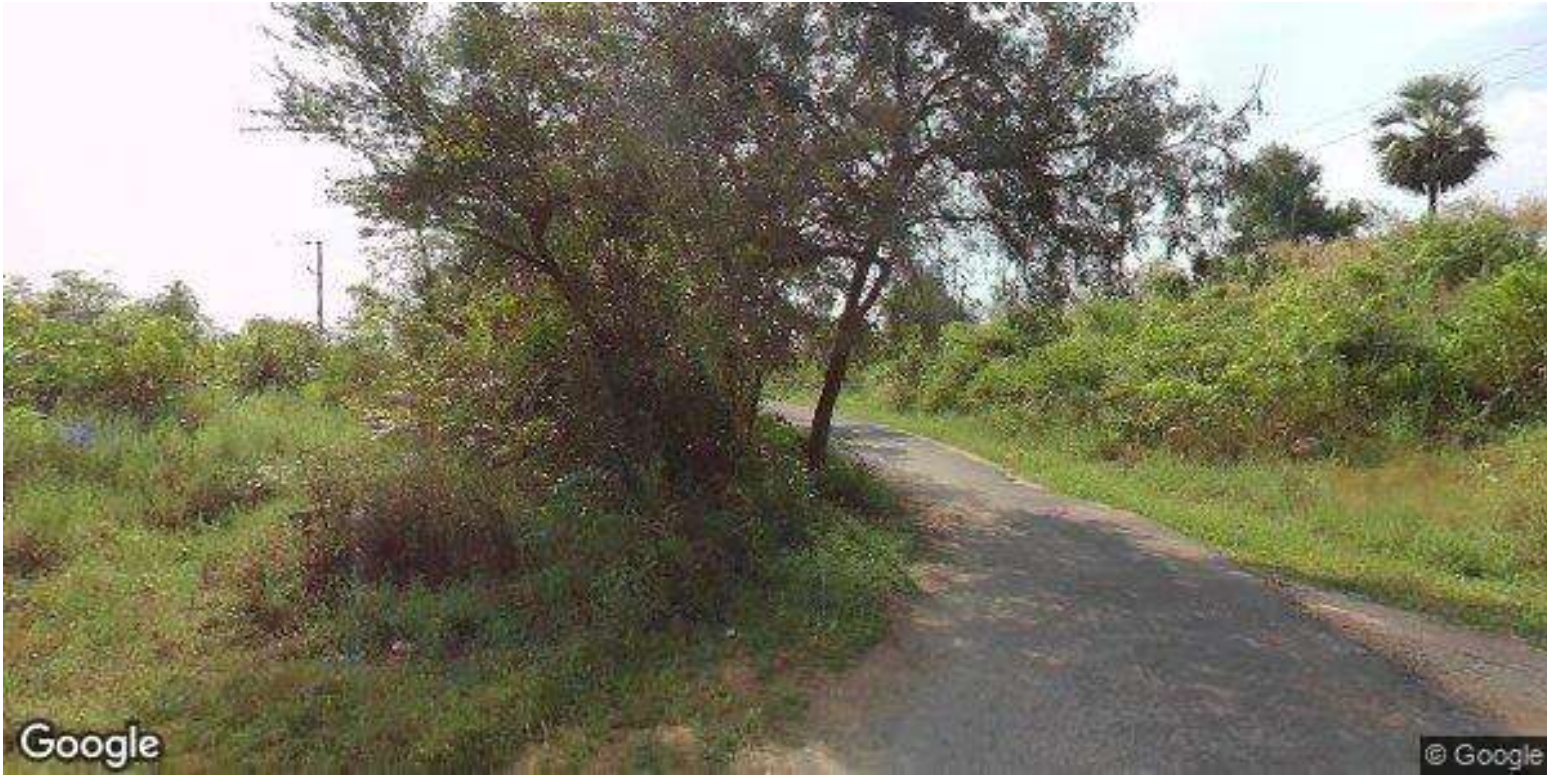
**Risk Type:** Turn  
**Risk Level:** Medium  
**Speed Limit:** 30 KM/Hr  
**Coordinates:** 11.43551, 77.85951

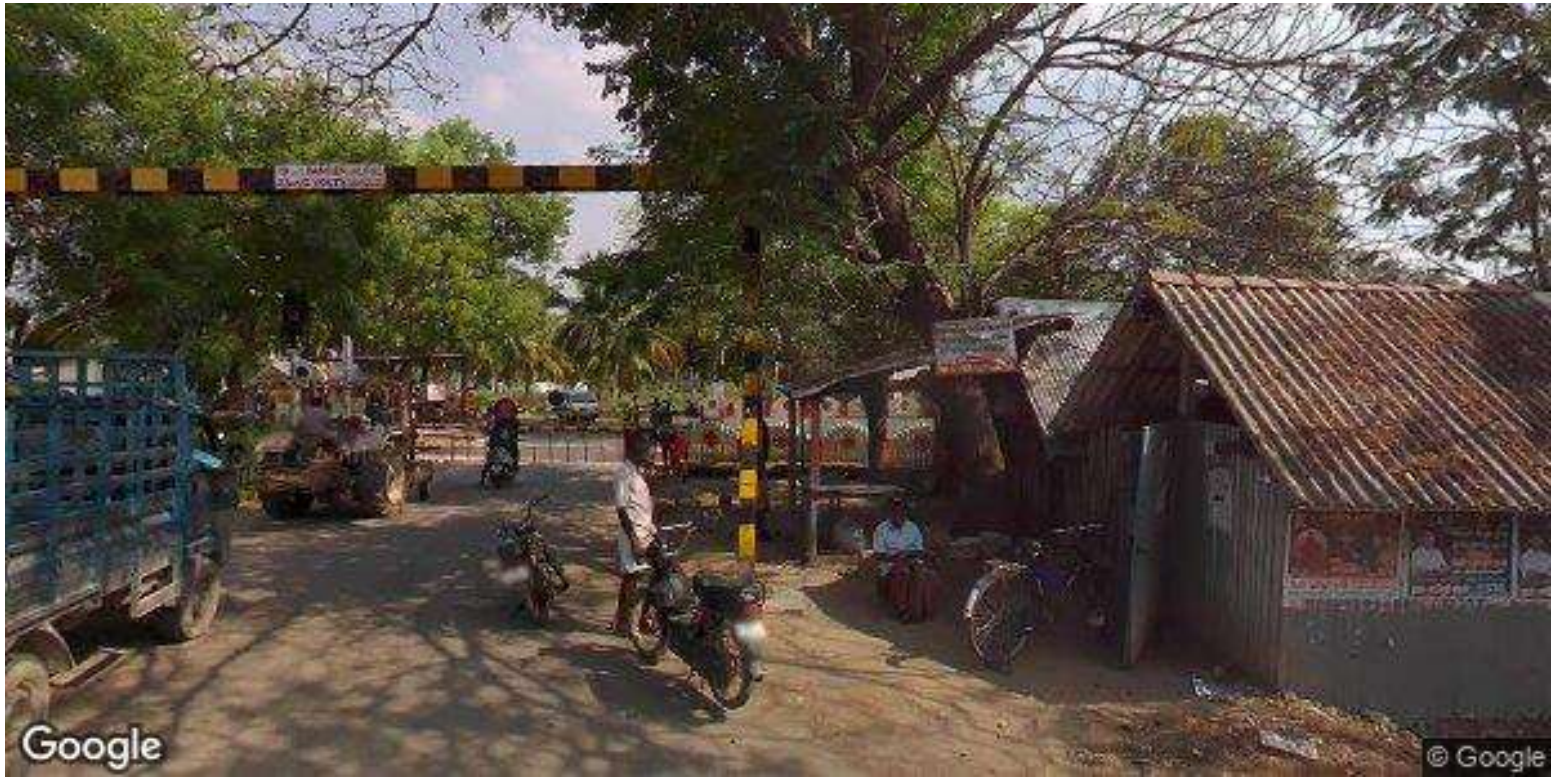
**Coordinates:** 11.41960, 77.84301

**Risk Type:** Turn

**Risk Level:** High

**Speed Limit:** 15 KM/Hr
