## **JOURNEY RISK MANAGEMENT (JRM) STUDY**

### **Salem Terminal TO THE NAMAKKAL DISTRICT CONSUMER CO**

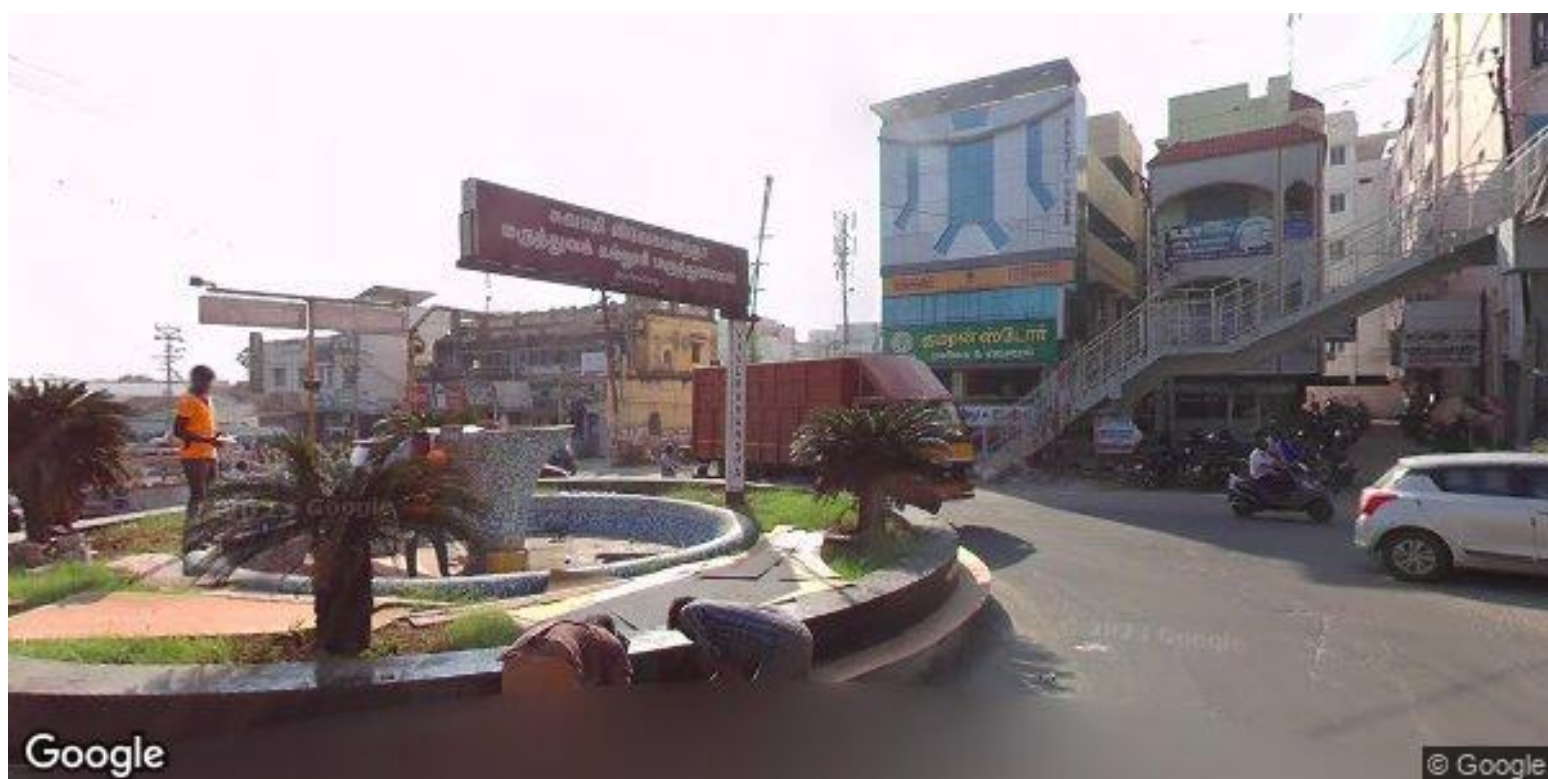
**Coordinates:** 11.38395, 77.89480

**Risk Type:** Roundabout

**Risk Level:** High

**Speed Limit:** 15 KM/Hr

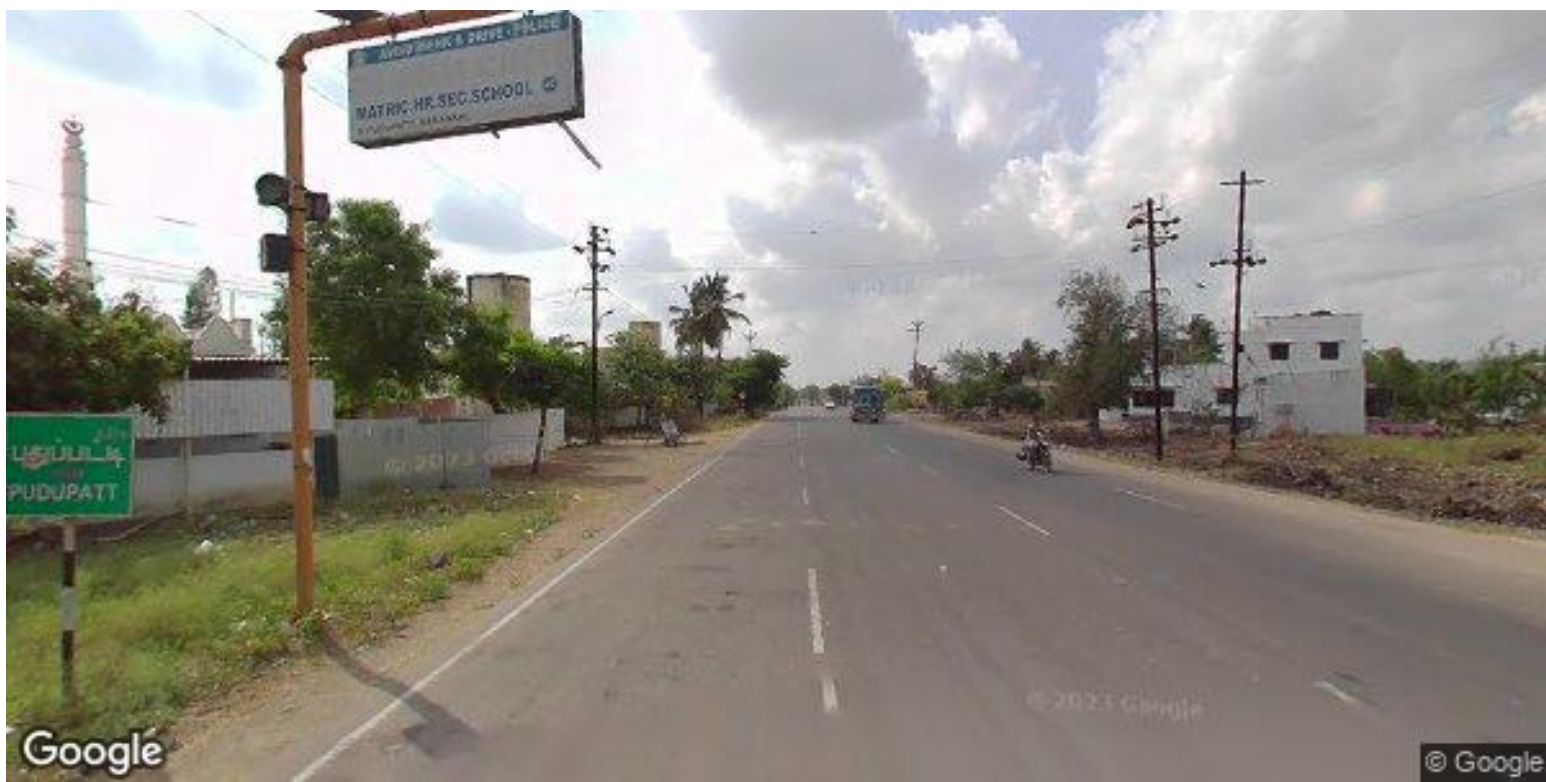
**Coordinates:** 11.1553071, 78.21111839999999

**Risk Type:** U-Turn

**Risk Level:** High

**Speed Limit:** 10 KM/Hr

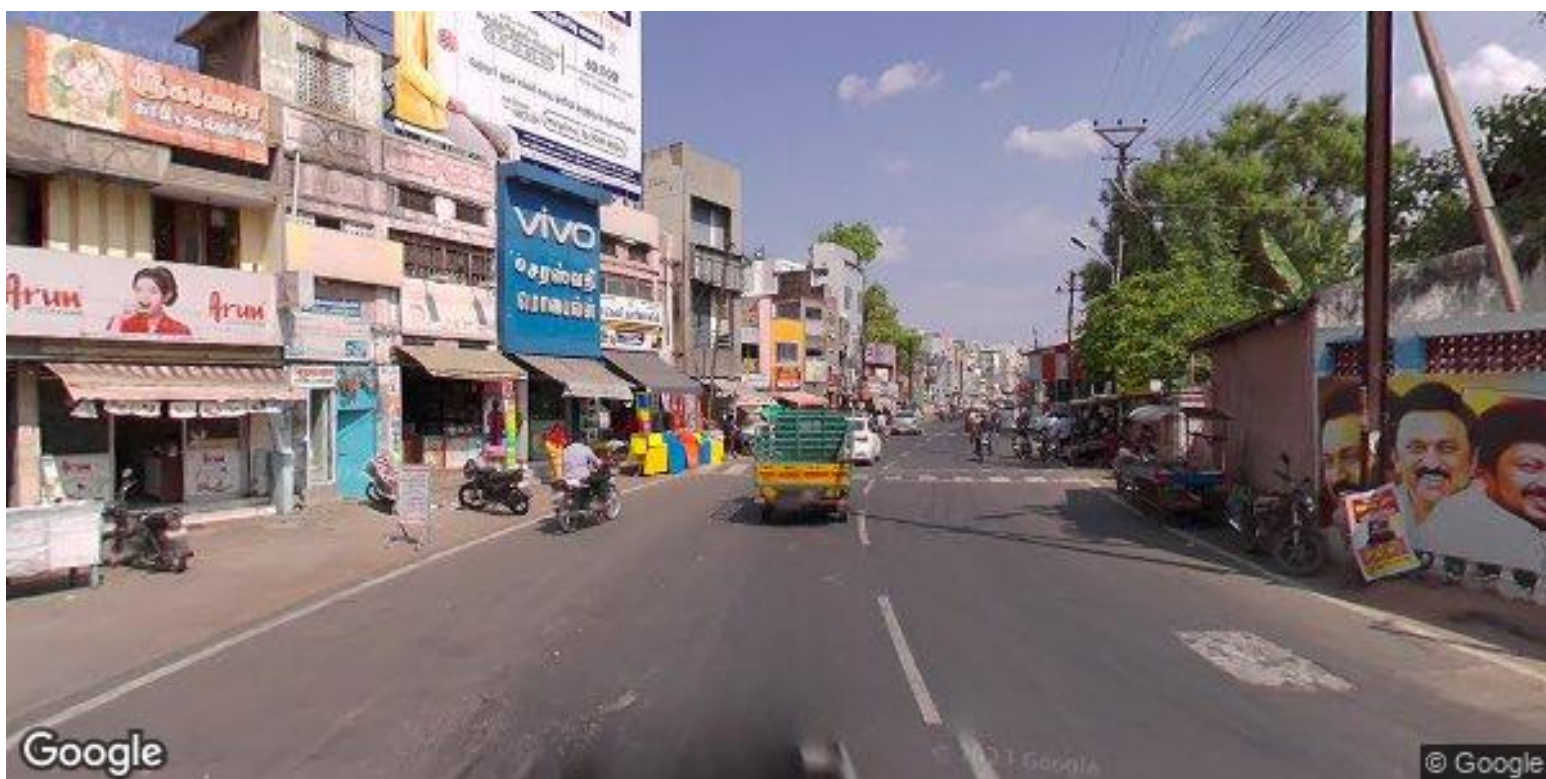
**Coordinates:** 11.22415, 78.16634

**Risk Type:** Turn

**Risk Level:** Medium

**Speed Limit:** 30 KM/Hr

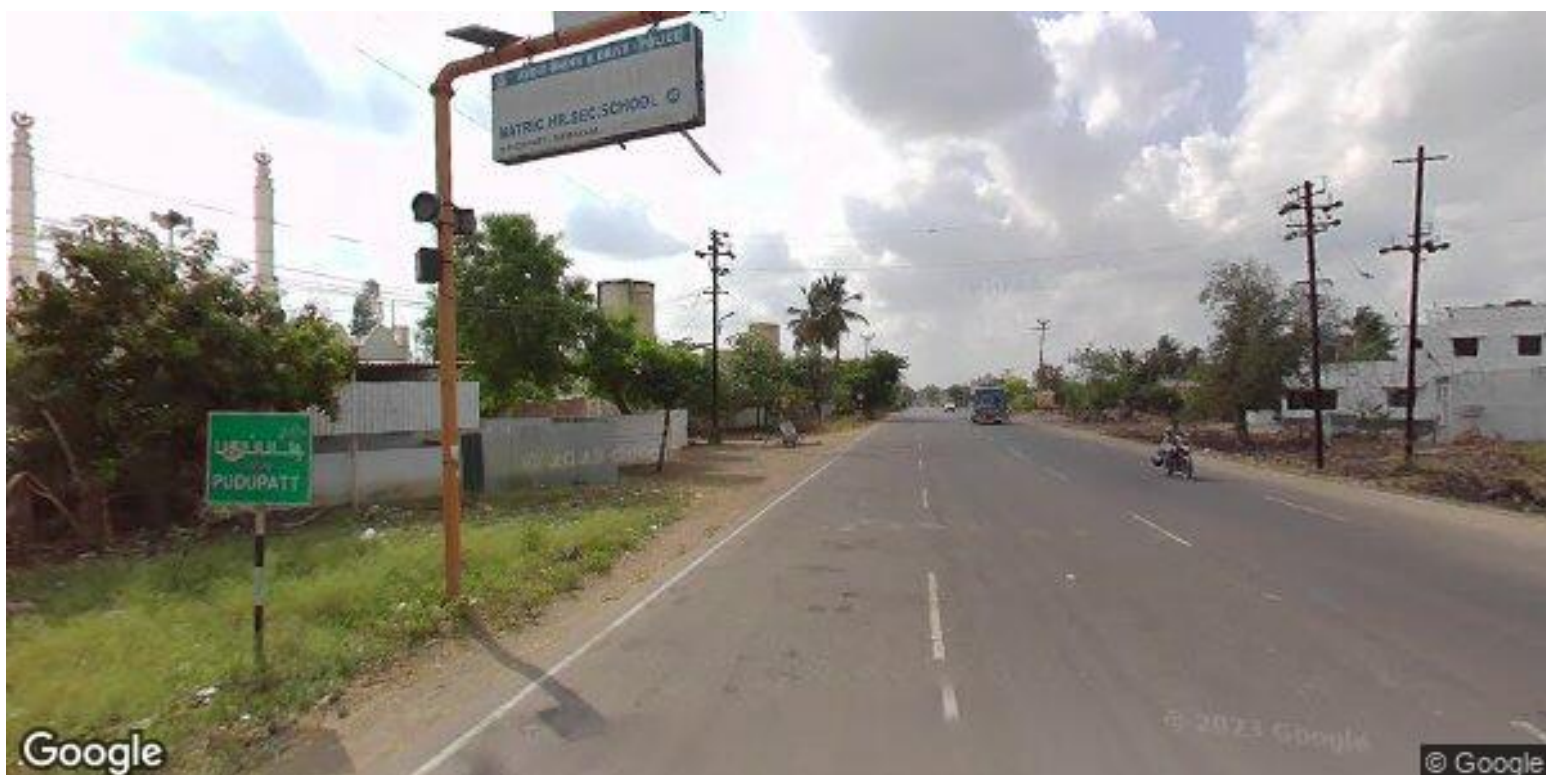
**Risk Type:** Turn  
**Risk Level:** High  
**Speed Limit:** 15 KM/Hr  
**Coordinates:** 11.15531, 78.21112

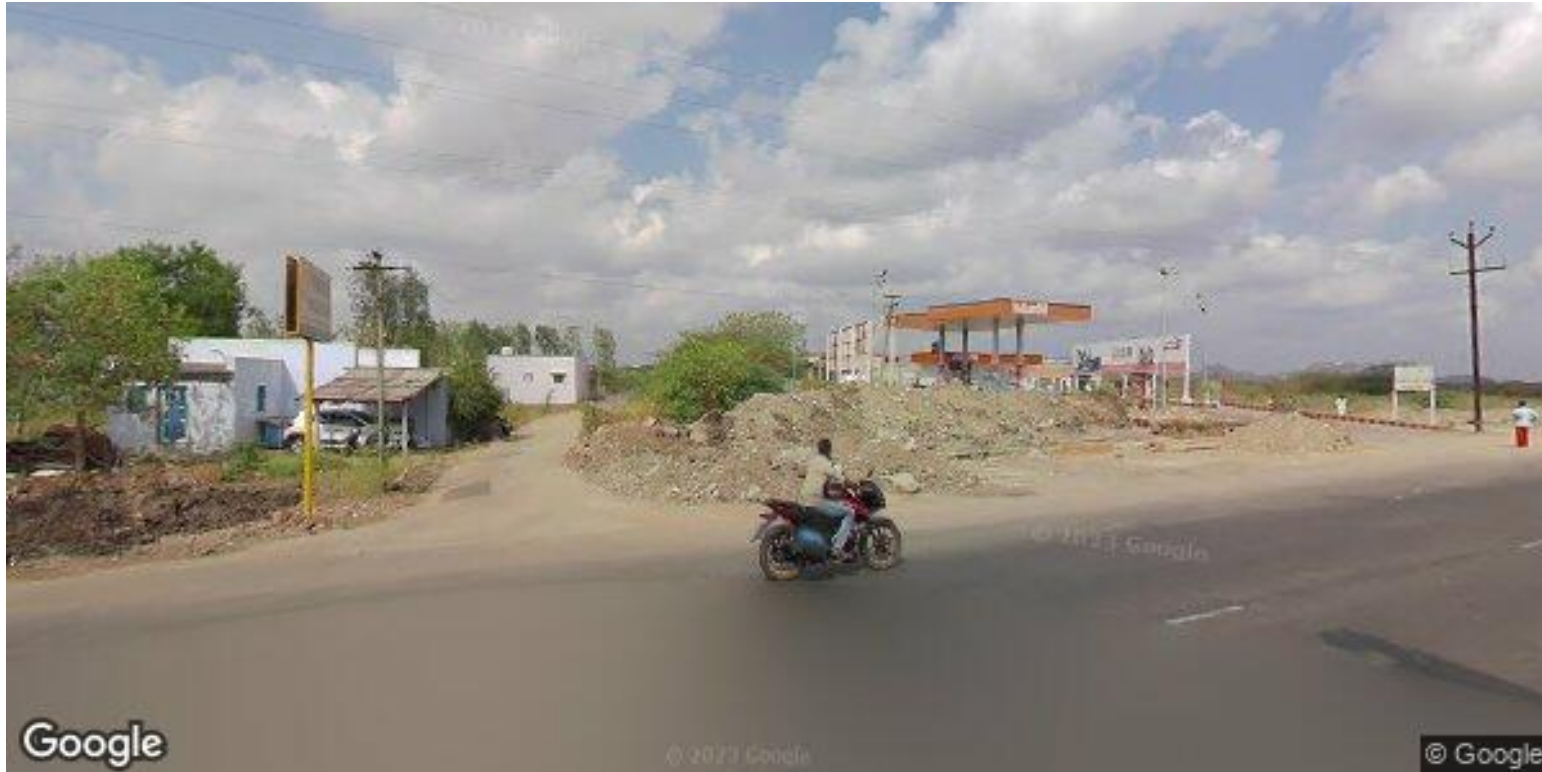
**Risk Type:** Blind Spot  
**Risk Level:** Blind Spot  
**Speed Limit:** 10 KM/Hr  
**Coordinates:** 11.15524, 78.21106
