# IndianOil

## JOURNEY RISK MANAGEMENT (JRM) STUDY

### Salem Terminal to SHREE RAMACHANDRAN PETROLEUM

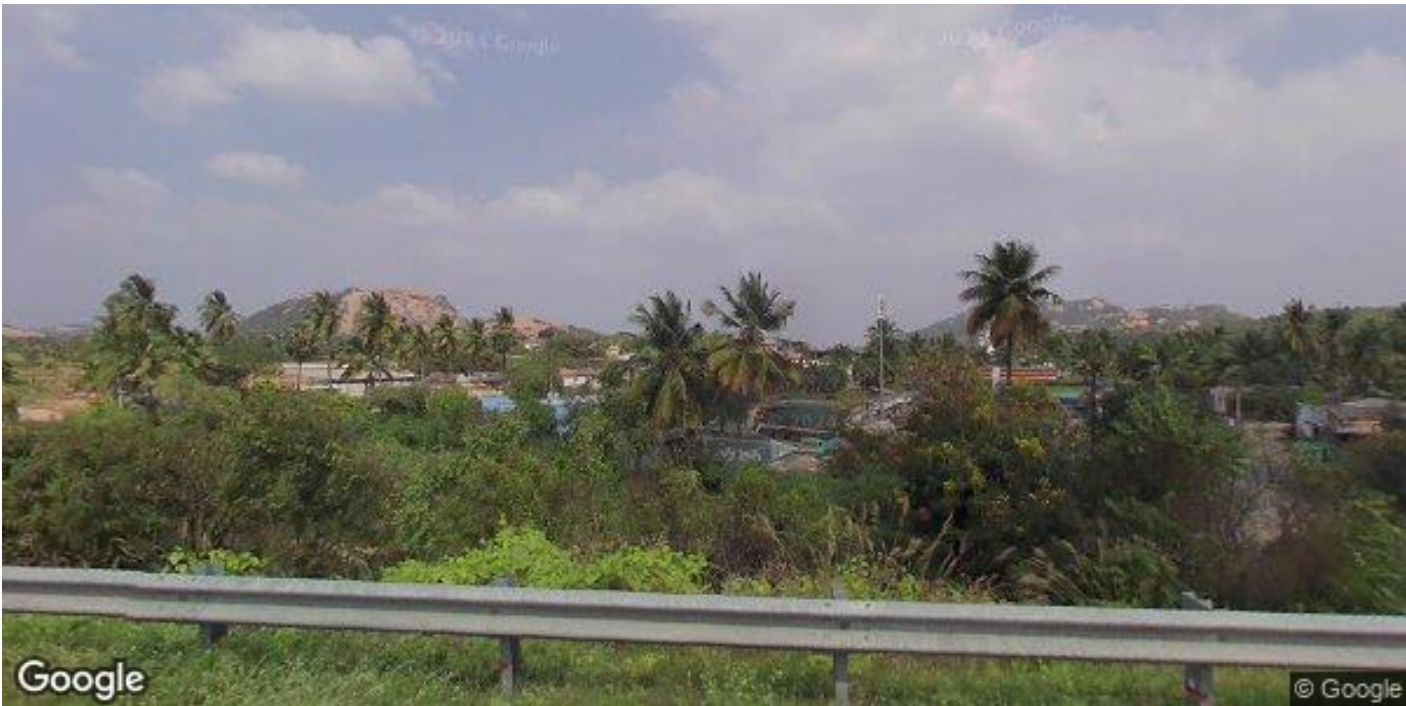
**Risk Type:** Turn  
**Risk Level:** Medium  
**Speed Limit:** 30 KM/Hr  
**Coordinates:** 11.49383, 77.88501

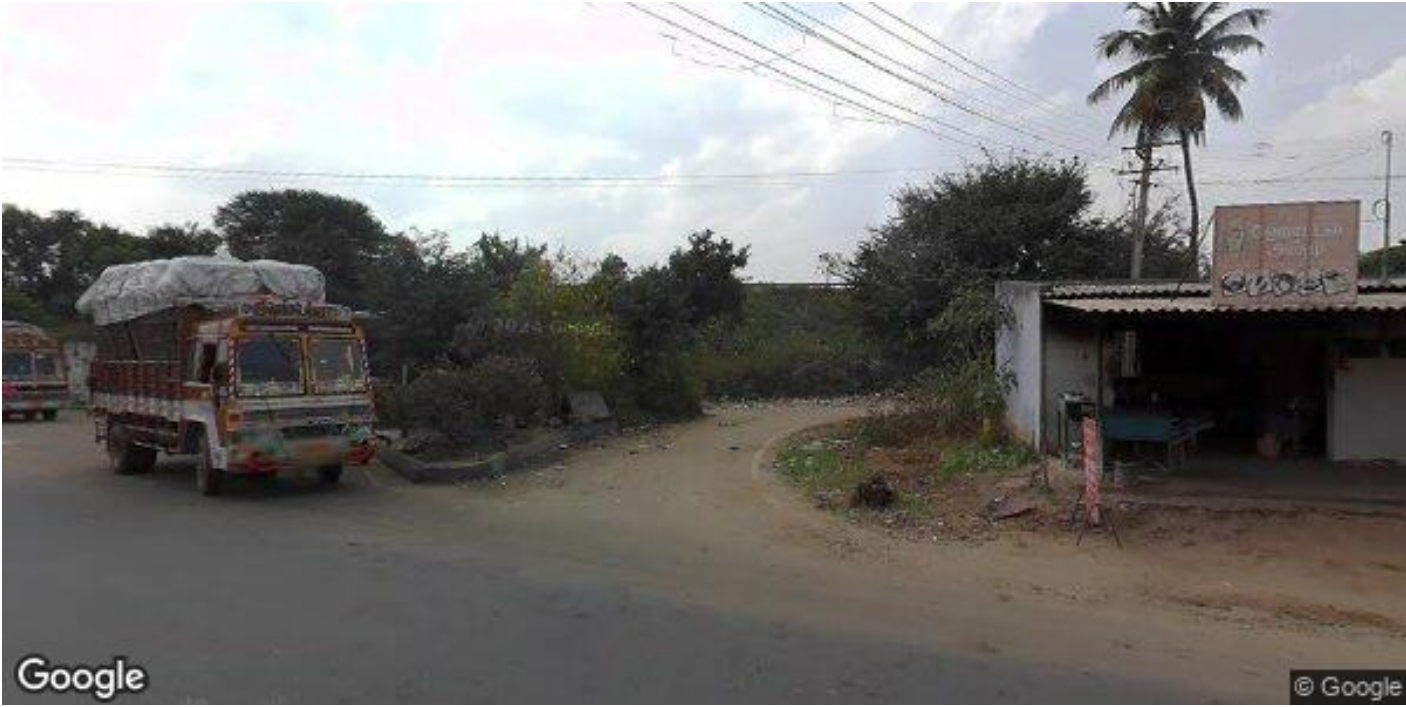
**Risk Type:** Blind Spot  
**Risk Level:** Blind Spot  
**Speed Limit:** 10 KM/Hr  
**Coordinates:** 11.49400, 77.88538

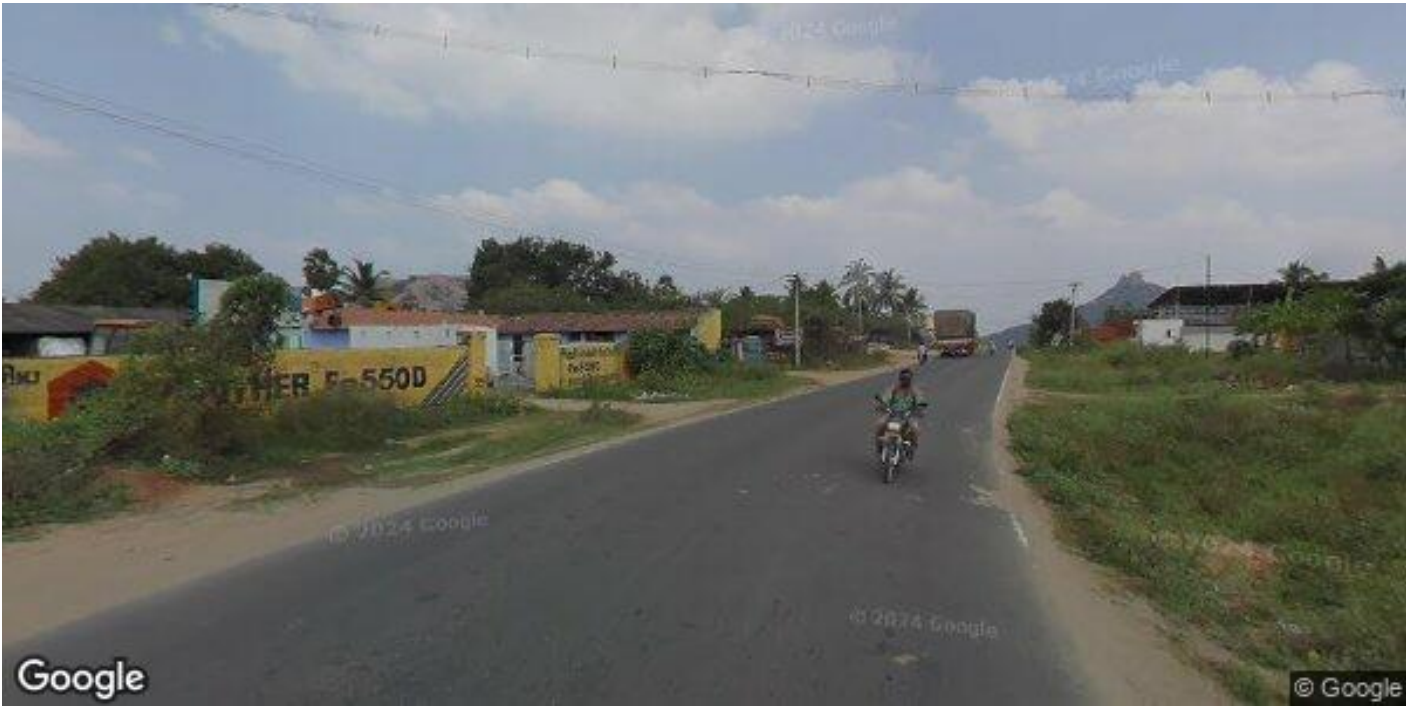
**Risk Type:** Turn  
**Risk Level:** High  
**Speed Limit:** 15 KM/Hr  
**Coordinates:** 11.49469, 77.88488

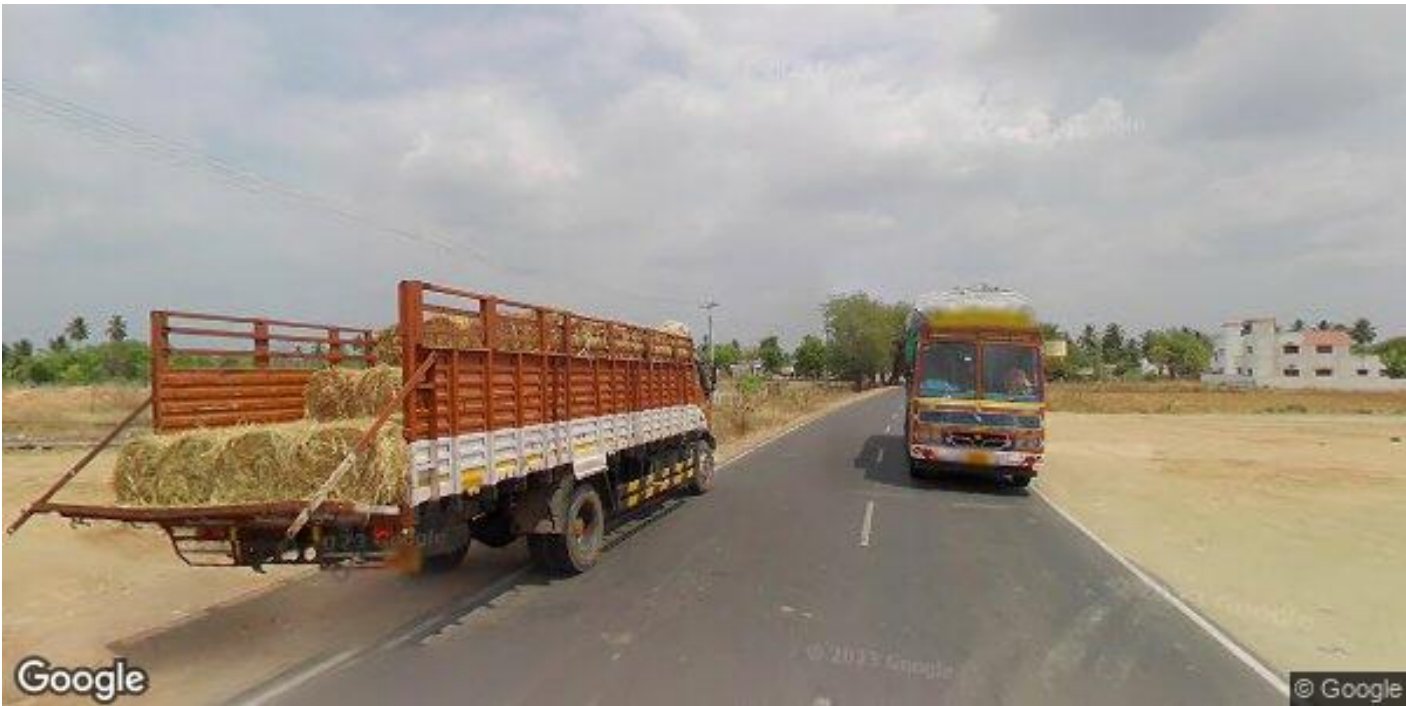
**Risk Type:** Turn  
**Risk Level:** Medium  
**Speed Limit:** 30 KM/Hr  
**Coordinates:** 11.55594, 77.89757

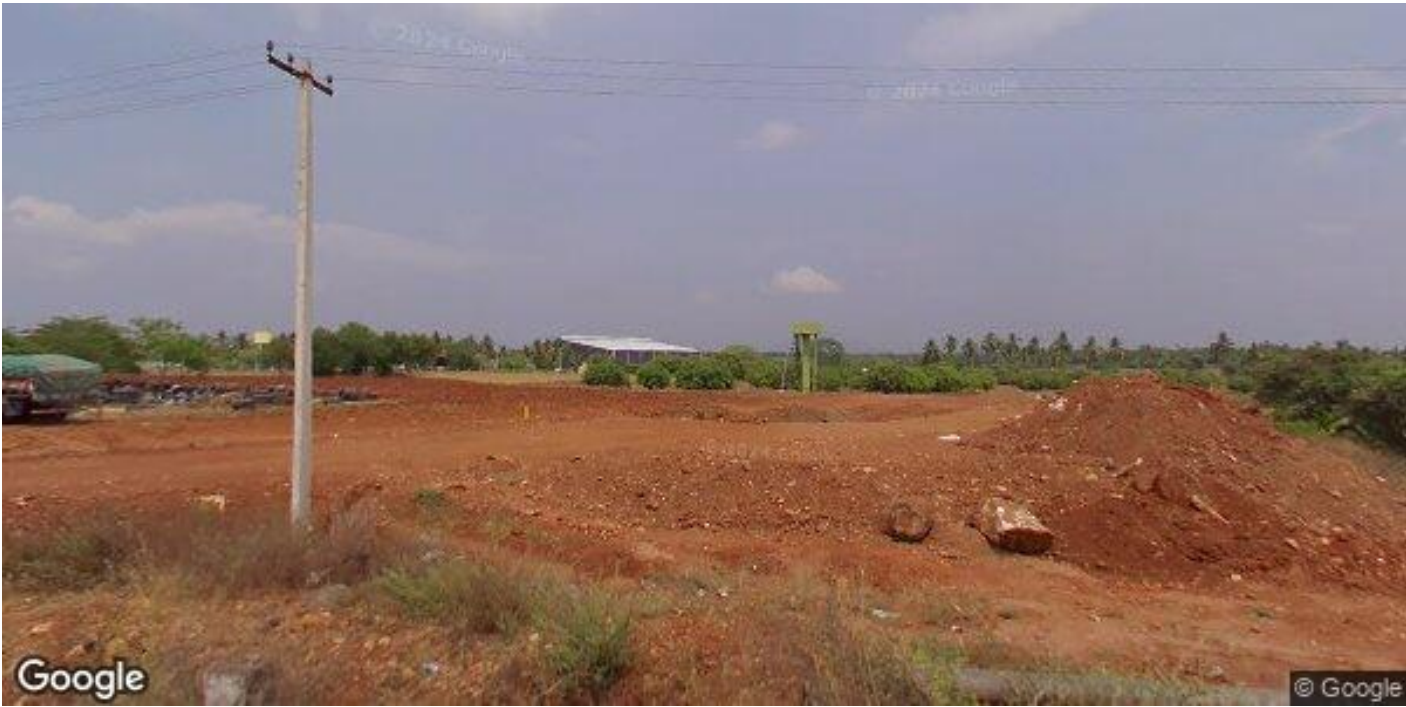
**Risk Type:** Turn  
**Risk Level:** Medium  
**Speed Limit:** 30 KM/Hr  
**Coordinates:** 11.58318, 77.90659

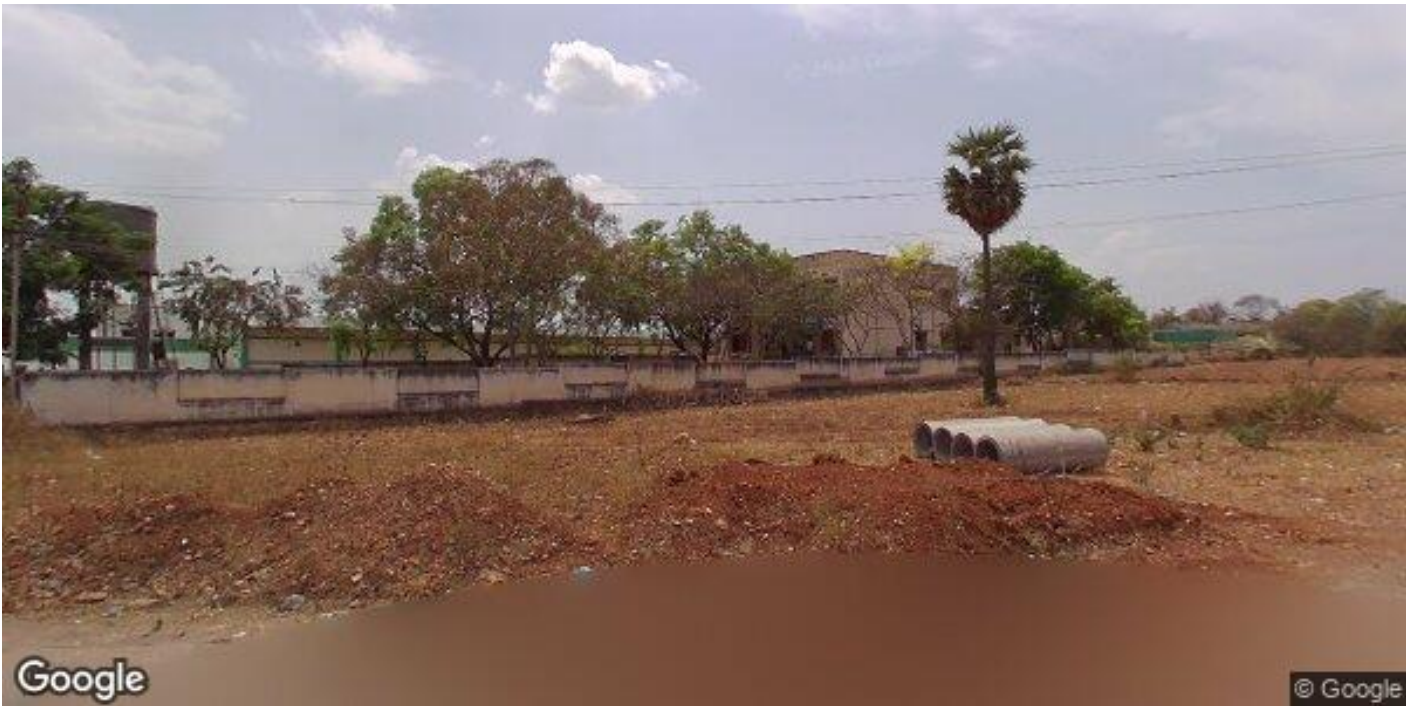
**Risk Type:** Turn  
**Risk Level:** Medium  
**Speed Limit:** 30 KM/Hr  
**Coordinates:** 11.58340, 77.90637

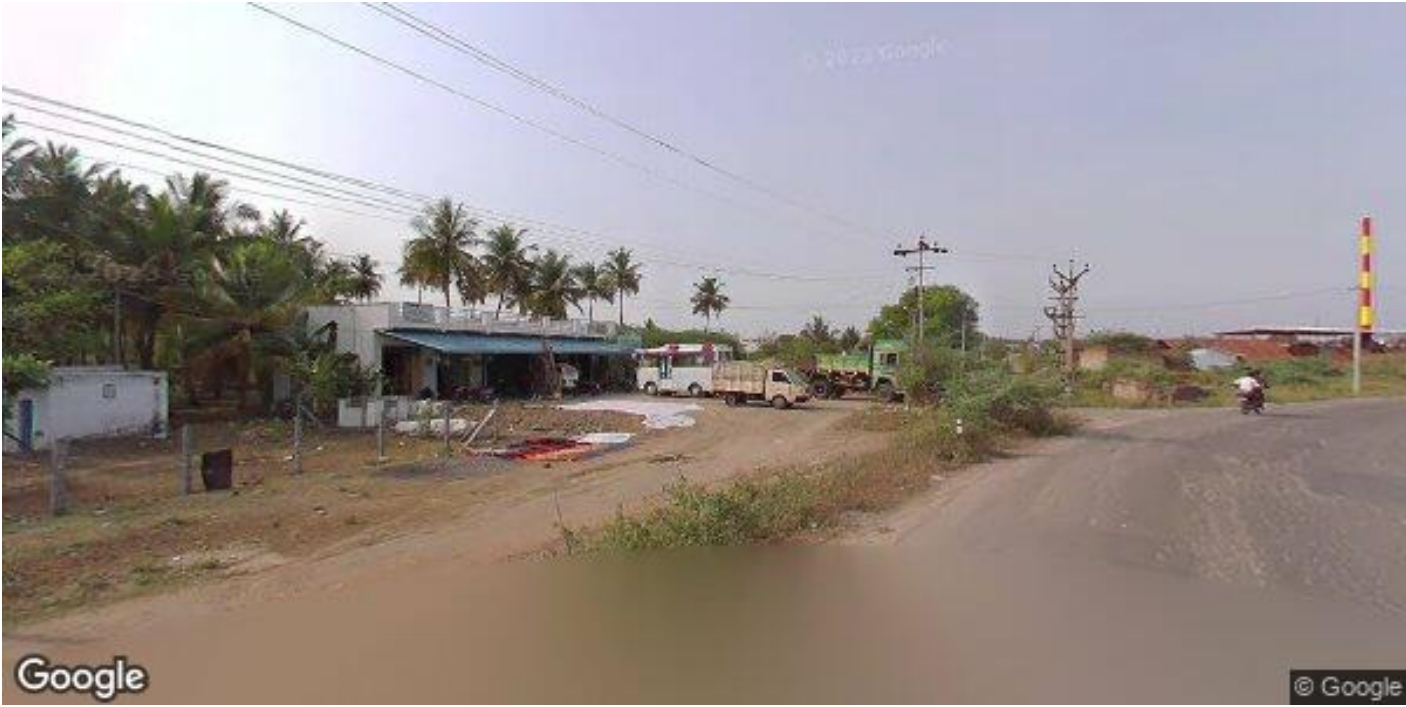
**Risk Type:** Turn  
**Risk Level:** Medium  
**Speed Limit:** 30 KM/Hr  
**Coordinates:** 11.63832, 77.94818

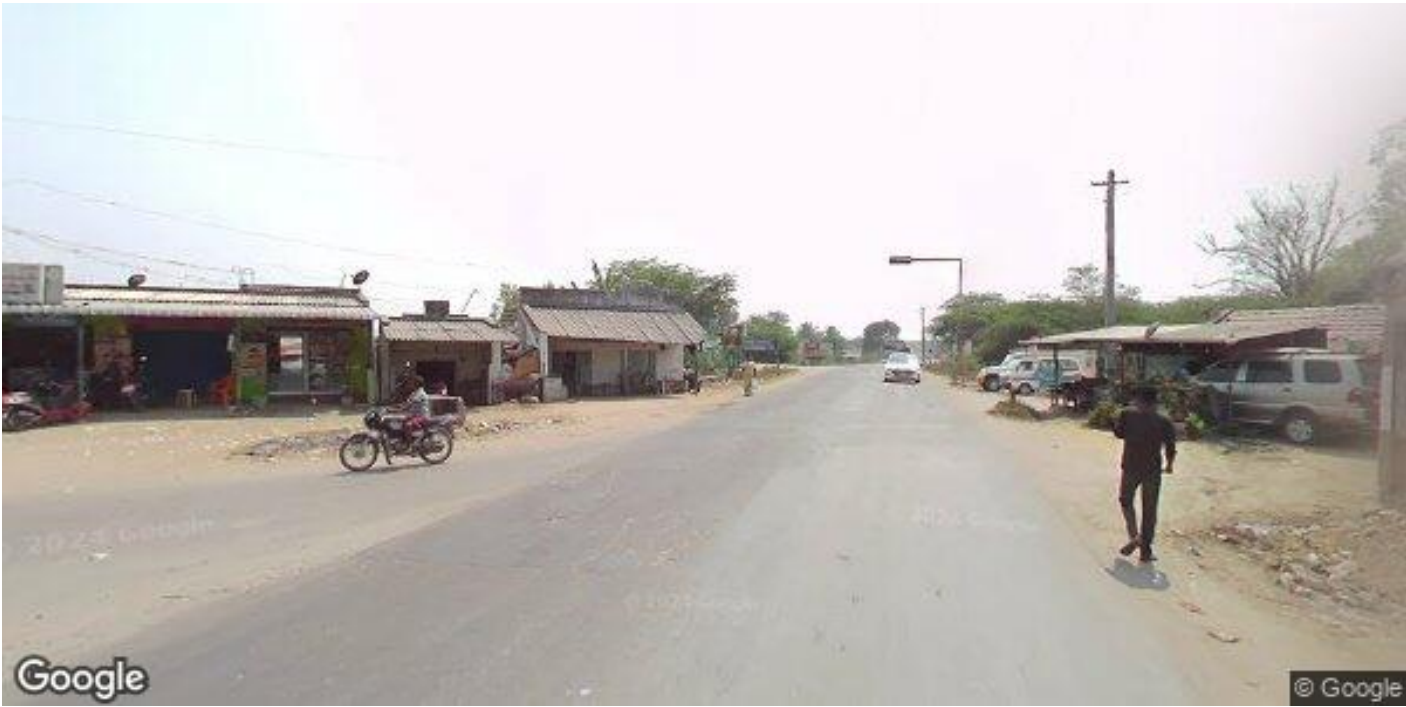
**Risk Type:** Turn  
**Risk Level:** Medium  
**Speed Limit:** 30 KM/Hr  
**Coordinates:** 11.64161, 77.95177

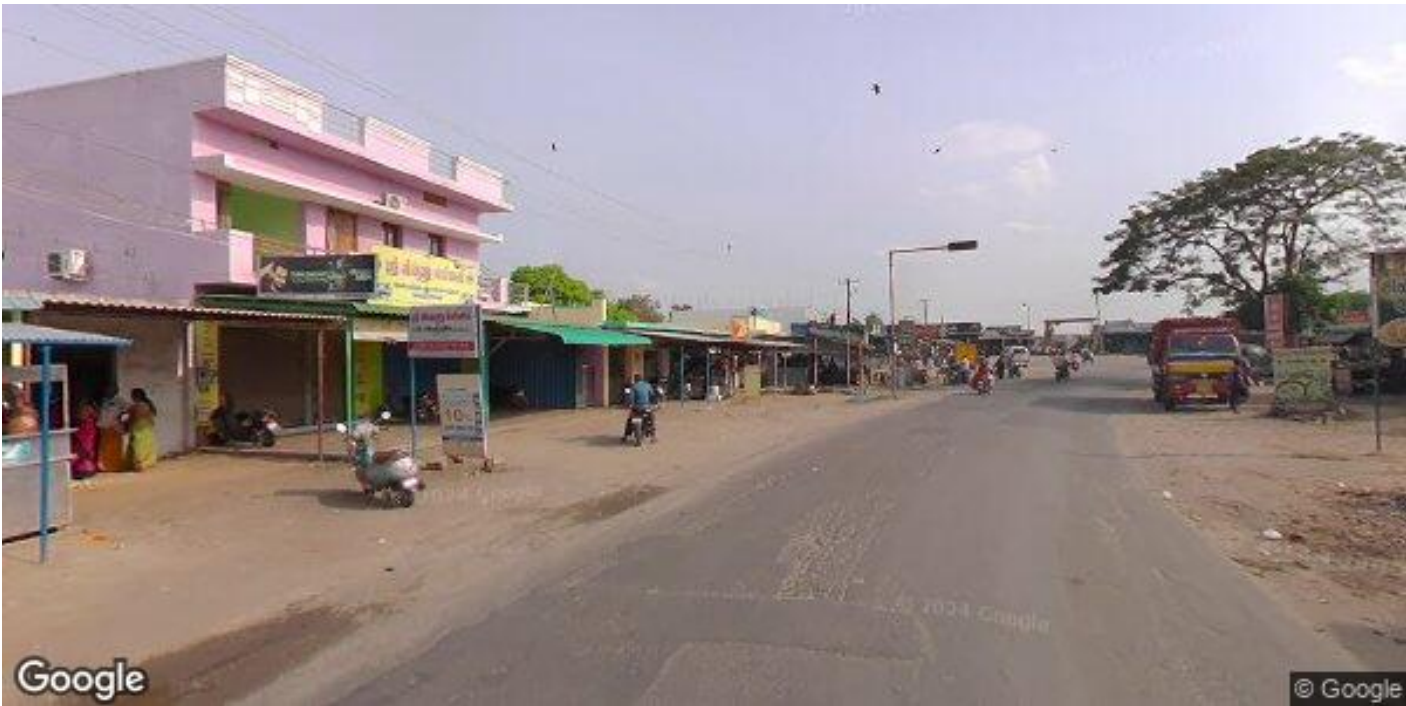
**Risk Type:** Turn  
**Risk Level:** Medium  
**Speed Limit:** 30 KM/Hr  
**Coordinates:** 11.64226, 77.95200

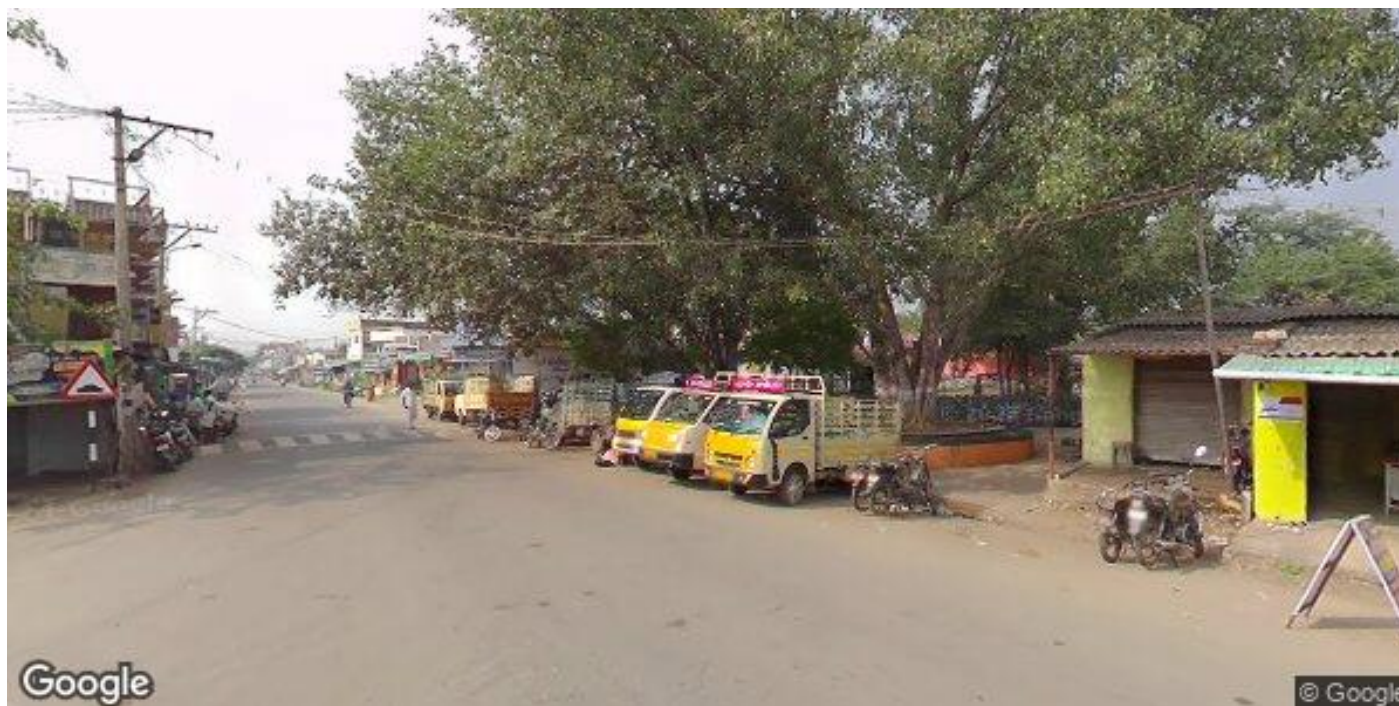
**Risk Type:** Turn  
**Risk Level:** Medium  
**Speed Limit:** 30 KM/Hr  
**Coordinates:** 11.64716, 77.95118

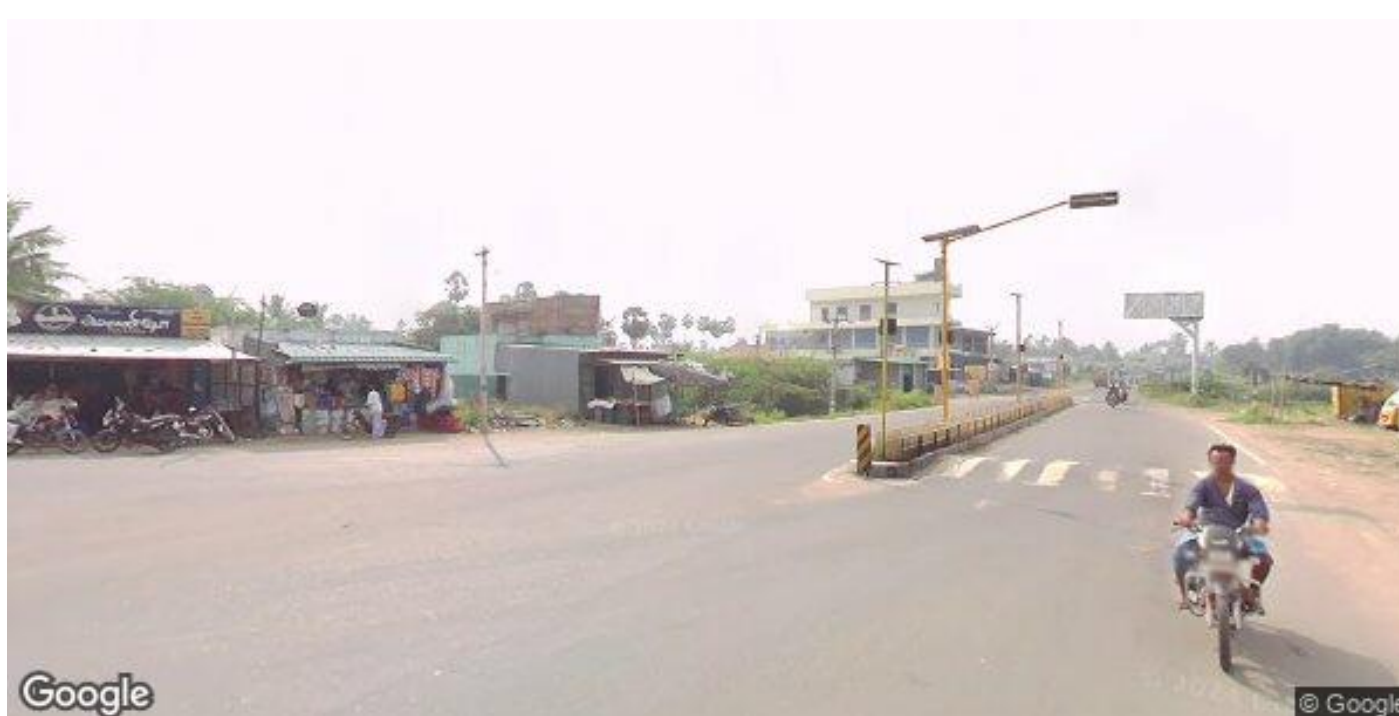
**Risk Type:** Turn  
**Risk Level:** High  
**Speed Limit:** 15 KM/Hr  
**Coordinates:** 11.67868, 77.96836

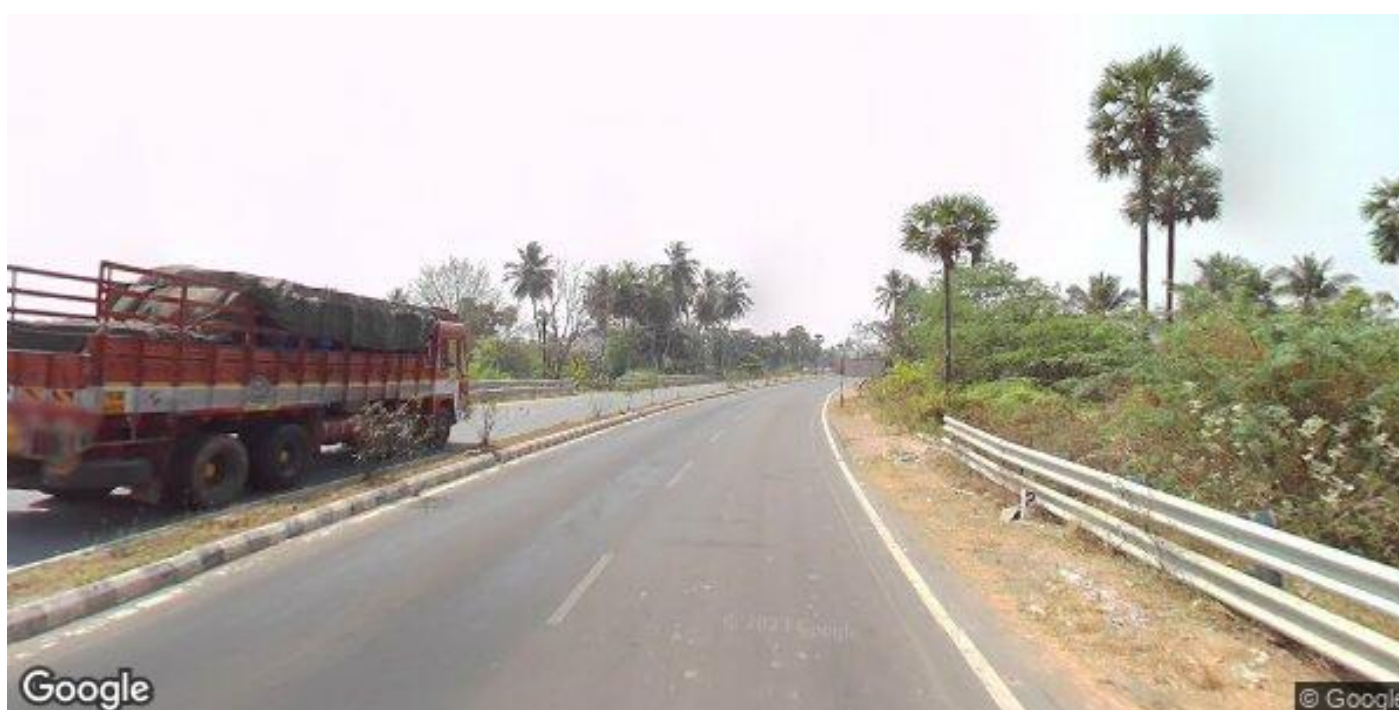
**Risk Type:** Turn  
**Risk Level:** Medium  
**Speed Limit:** 30 KM/Hr  
**Coordinates:** 11.70077, 77.97957

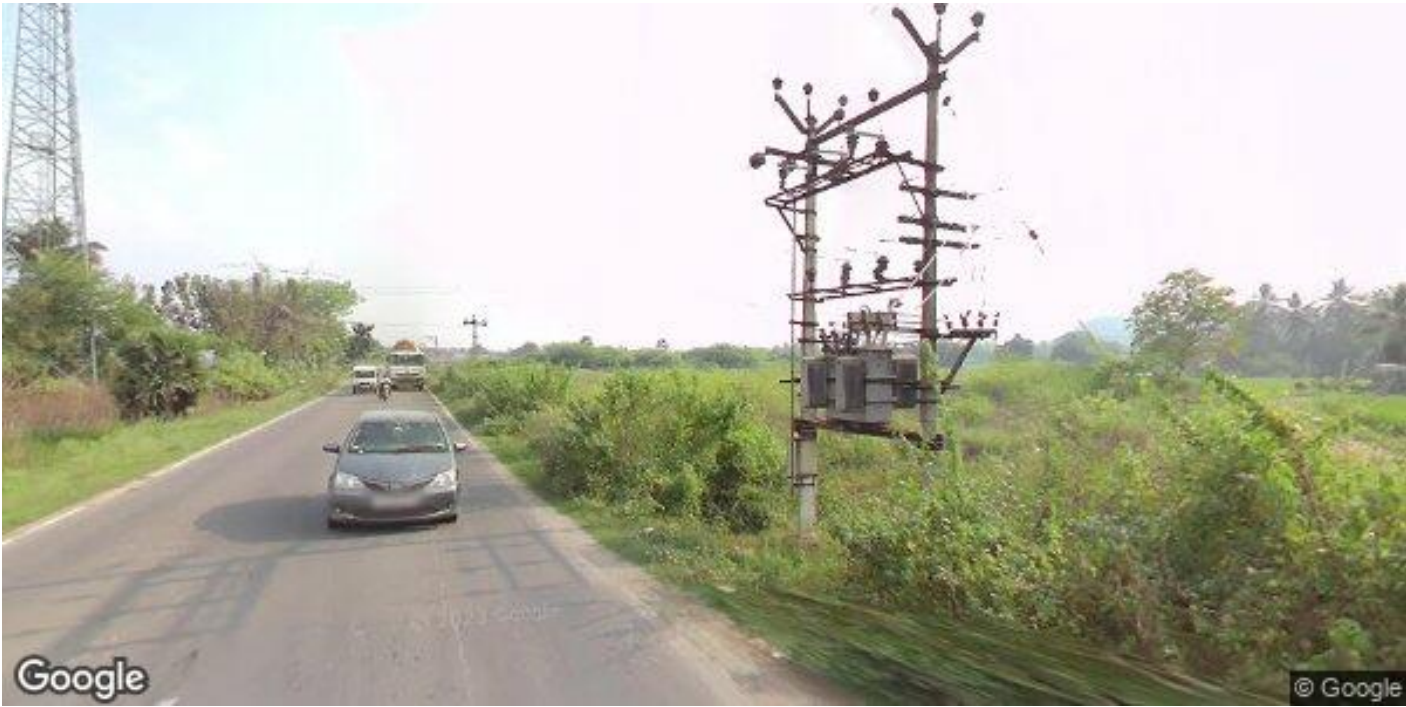
**Risk Type:** Turn  
**Risk Level:** Medium  
**Speed Limit:** 30 KM/Hr  
**Coordinates:** 11.71402, 77.99586

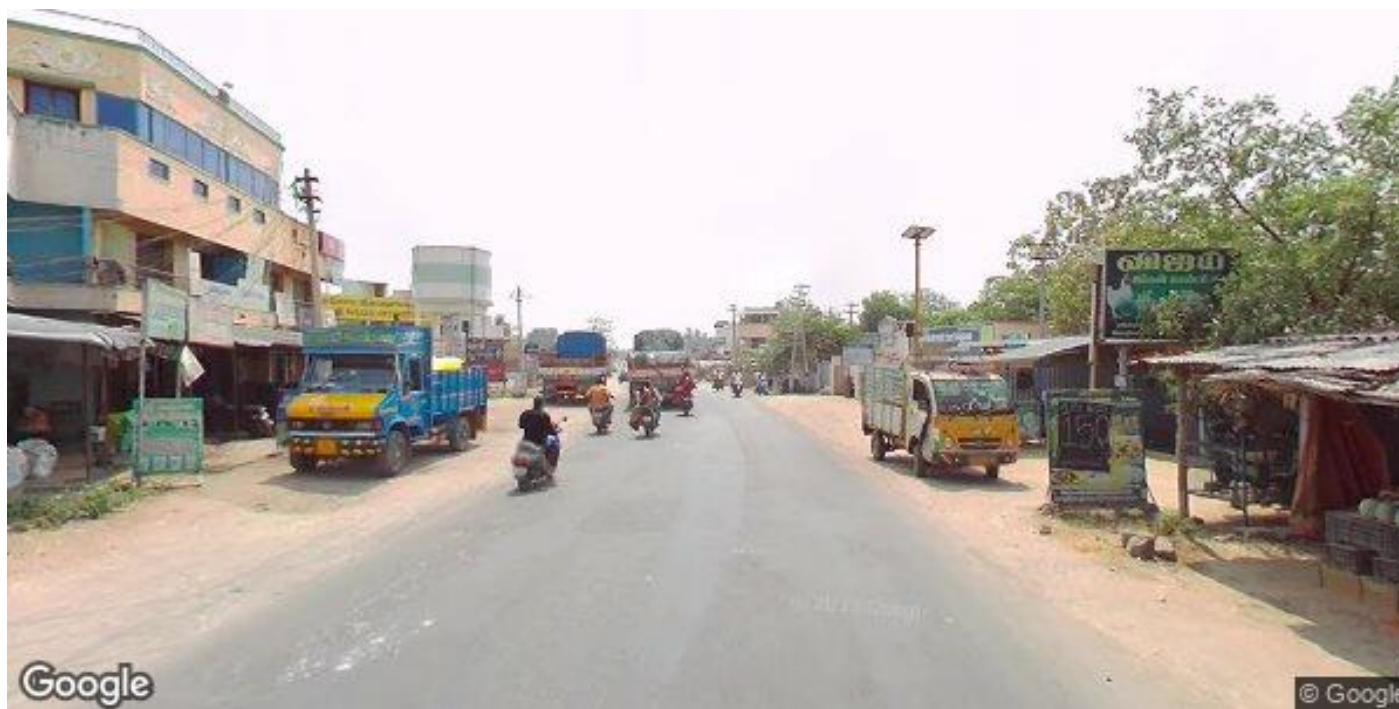
**Risk Type:** Turn  
**Risk Level:** Medium  
**Speed Limit:** 30 KM/Hr  
**Coordinates:** 11.73769, 78.03451

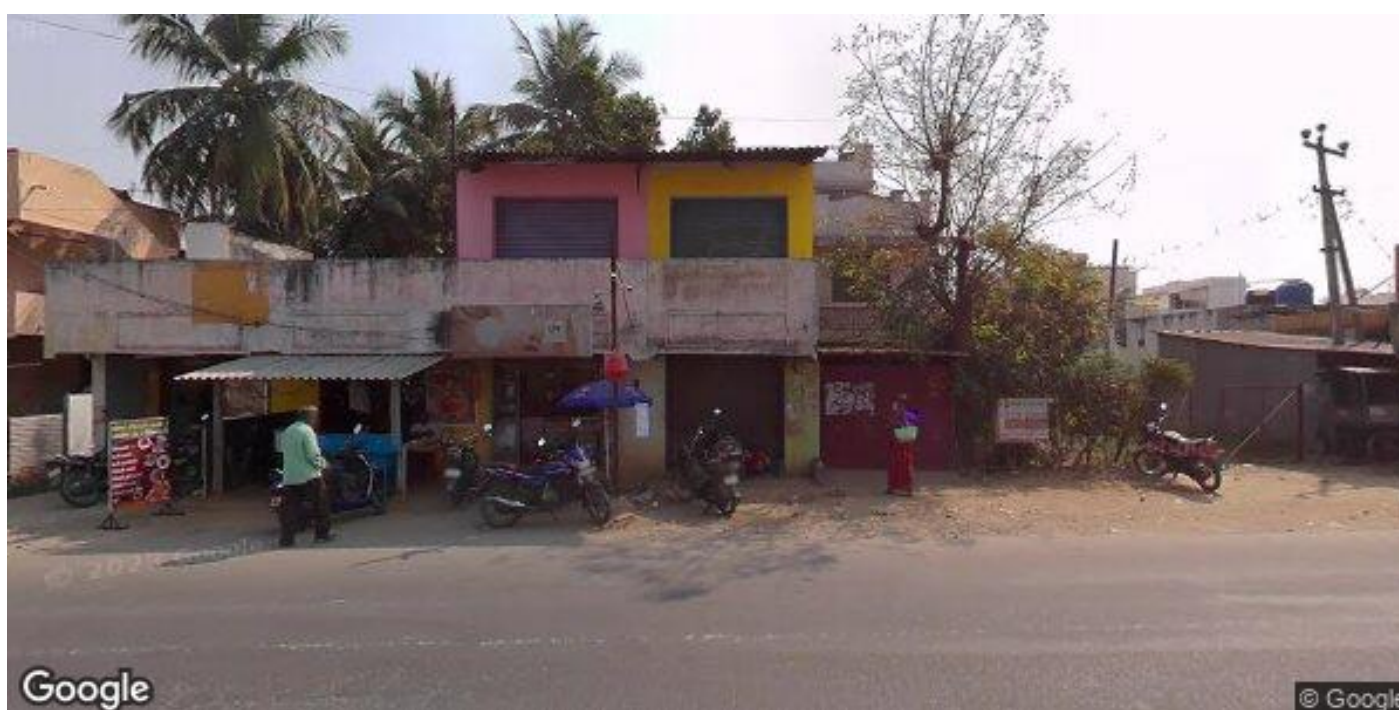
**Risk Type:** Turn  
**Risk Level:** Medium  
**Speed Limit:** 30 KM/Hr  
**Coordinates:** 11.73785, 78.03551

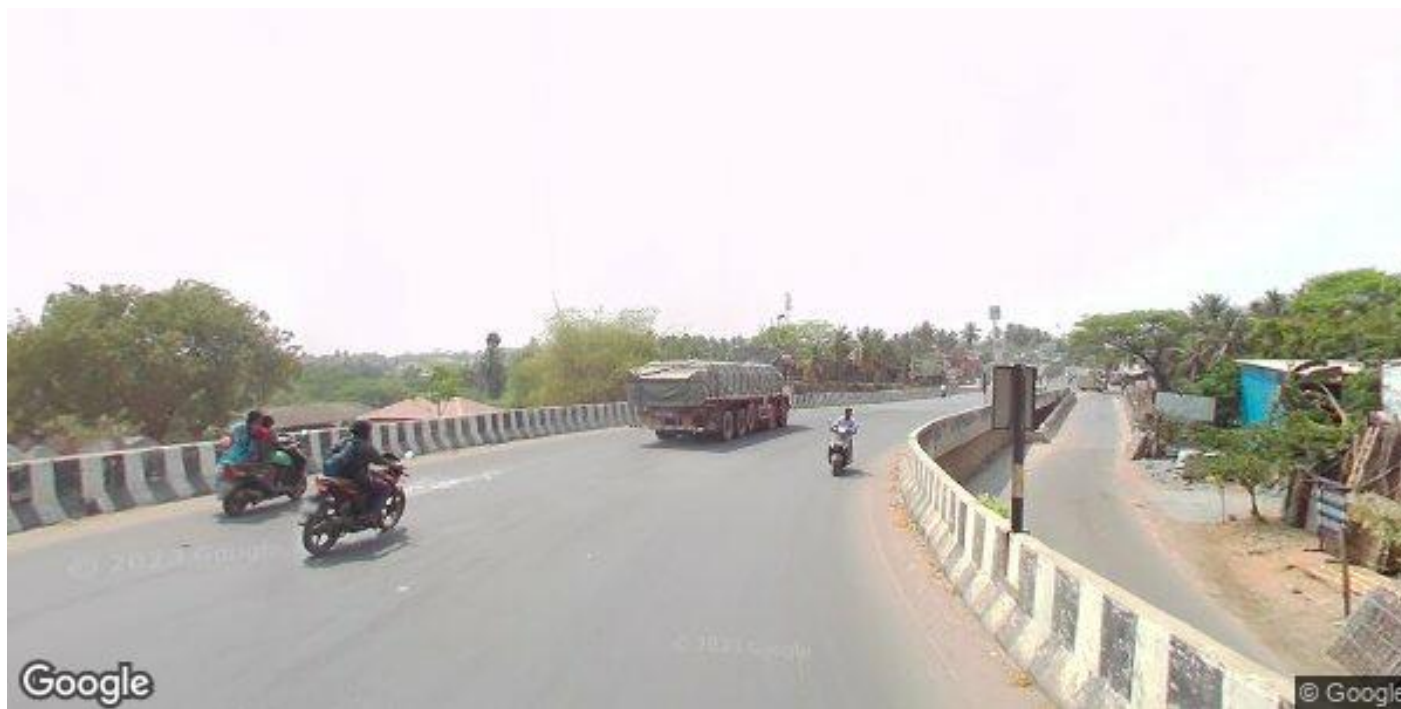
**Risk Type:** Turn  
**Risk Level:** High  
**Speed Limit:** 15 KM/Hr  
**Coordinates:** 11.73651, 78.03871

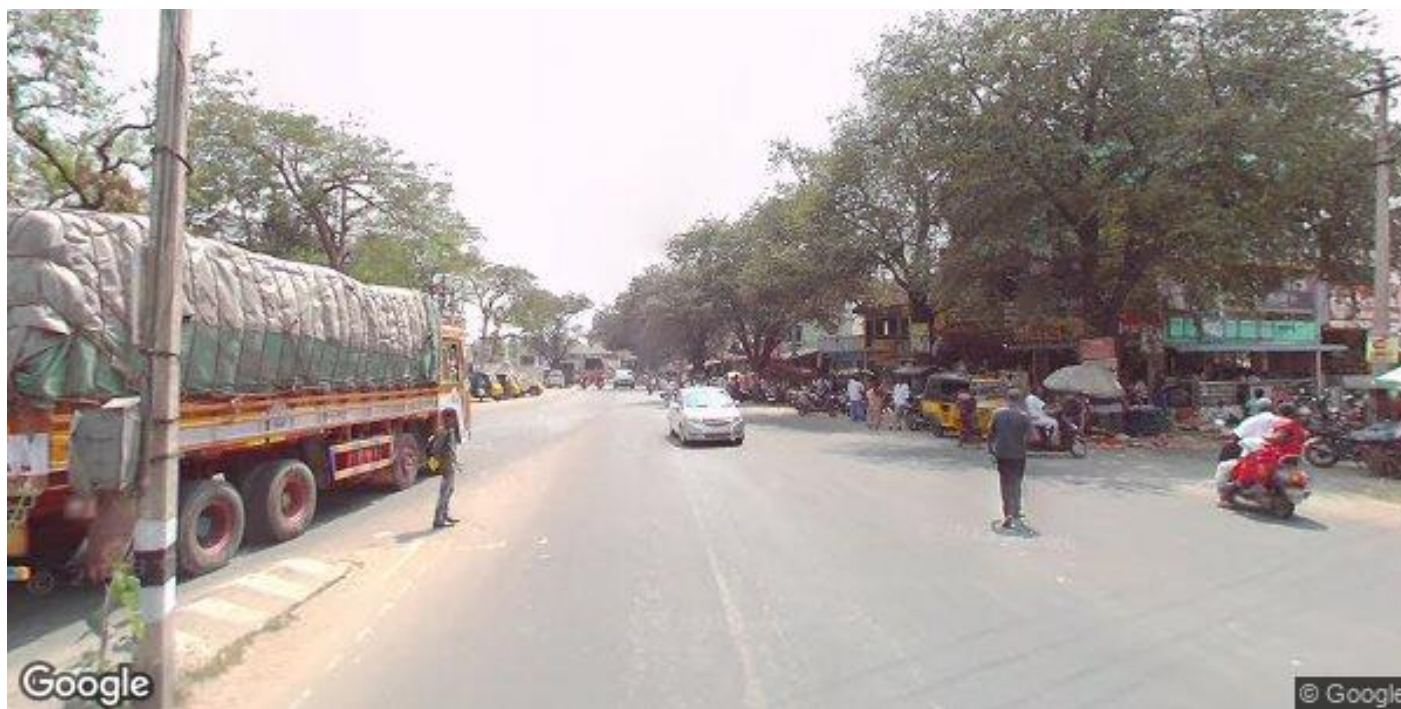
**Risk Type:** Turn  
**Risk Level:** Medium  
**Speed Limit:** 30 KM/Hr  
**Coordinates:** 11.74271, 78.04717

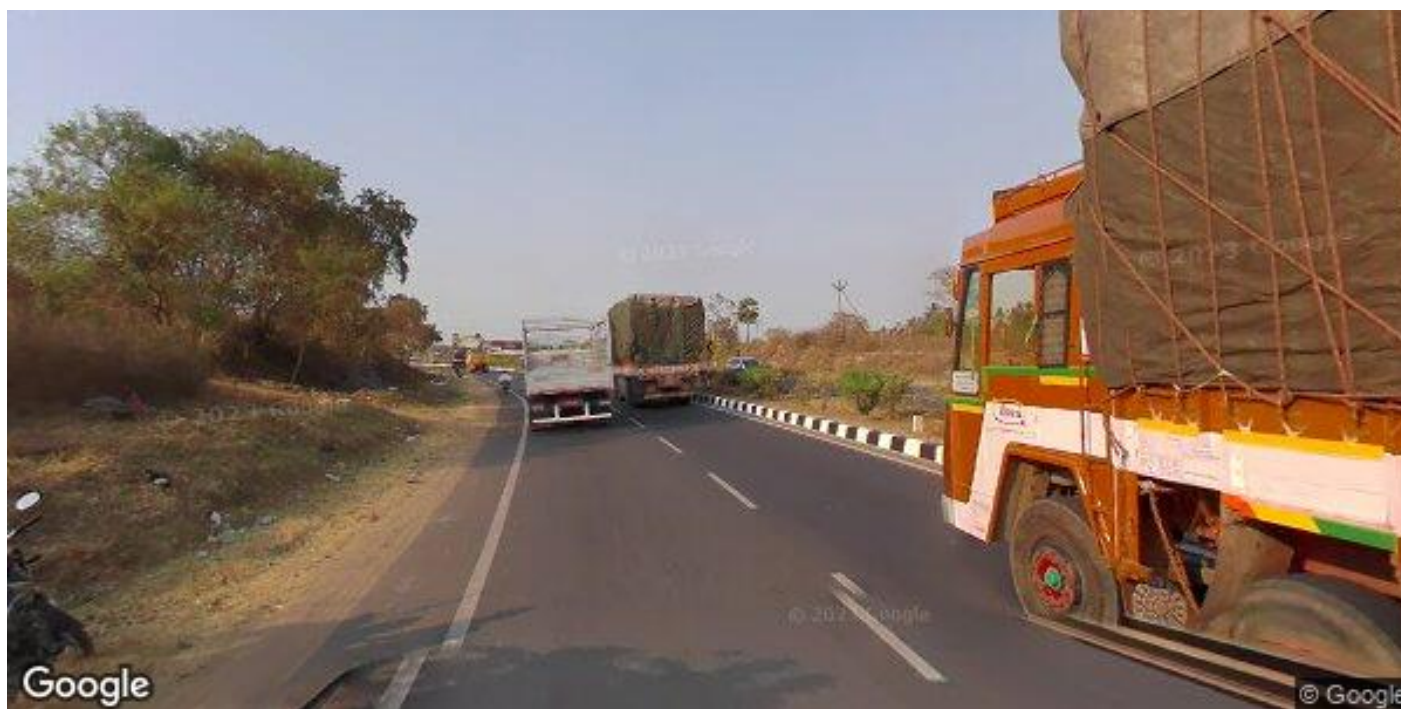
**Risk Type:** Turn  
**Risk Level:** Medium  
**Speed Limit:** 30 KM/Hr  
**Coordinates:** 11.78017, 78.05790

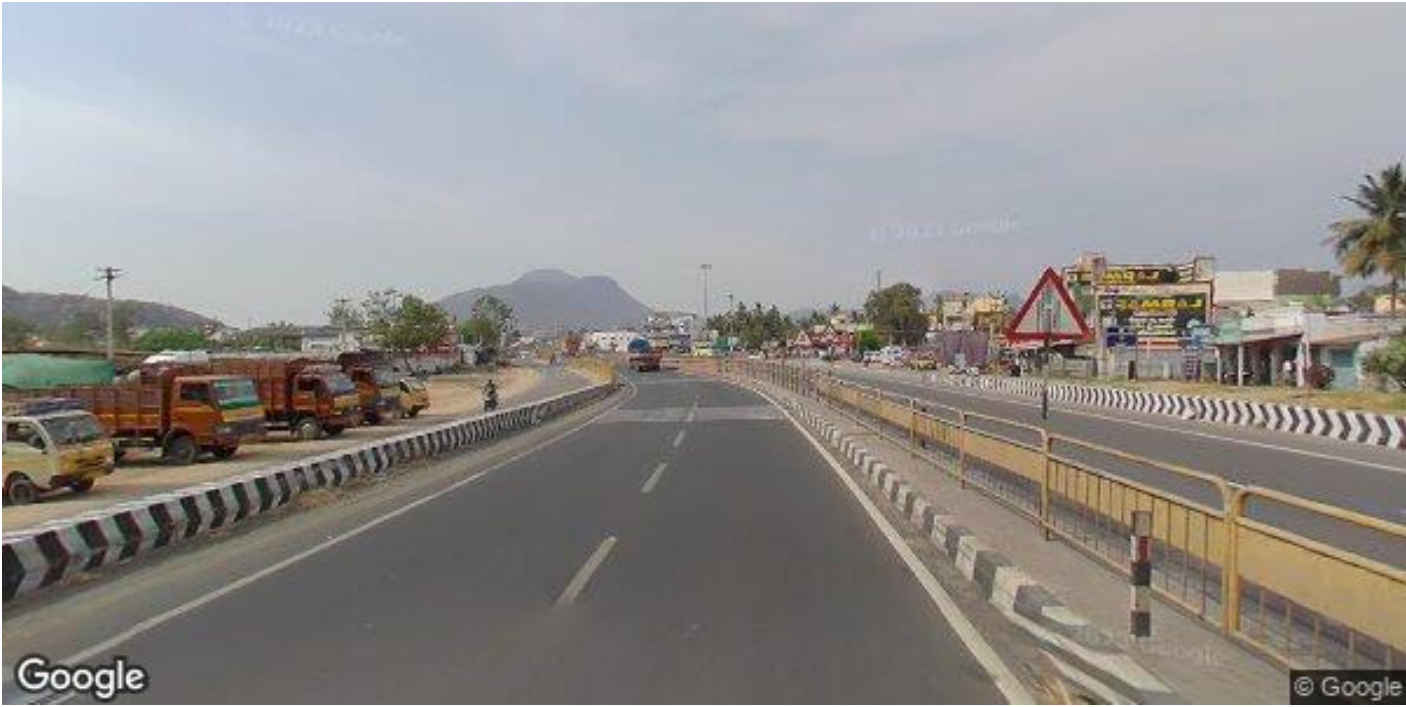
**Risk Type:** Turn  
**Risk Level:** Medium  
**Speed Limit:** 30 KM/Hr  
**Coordinates:** 11.86953, 78.08386

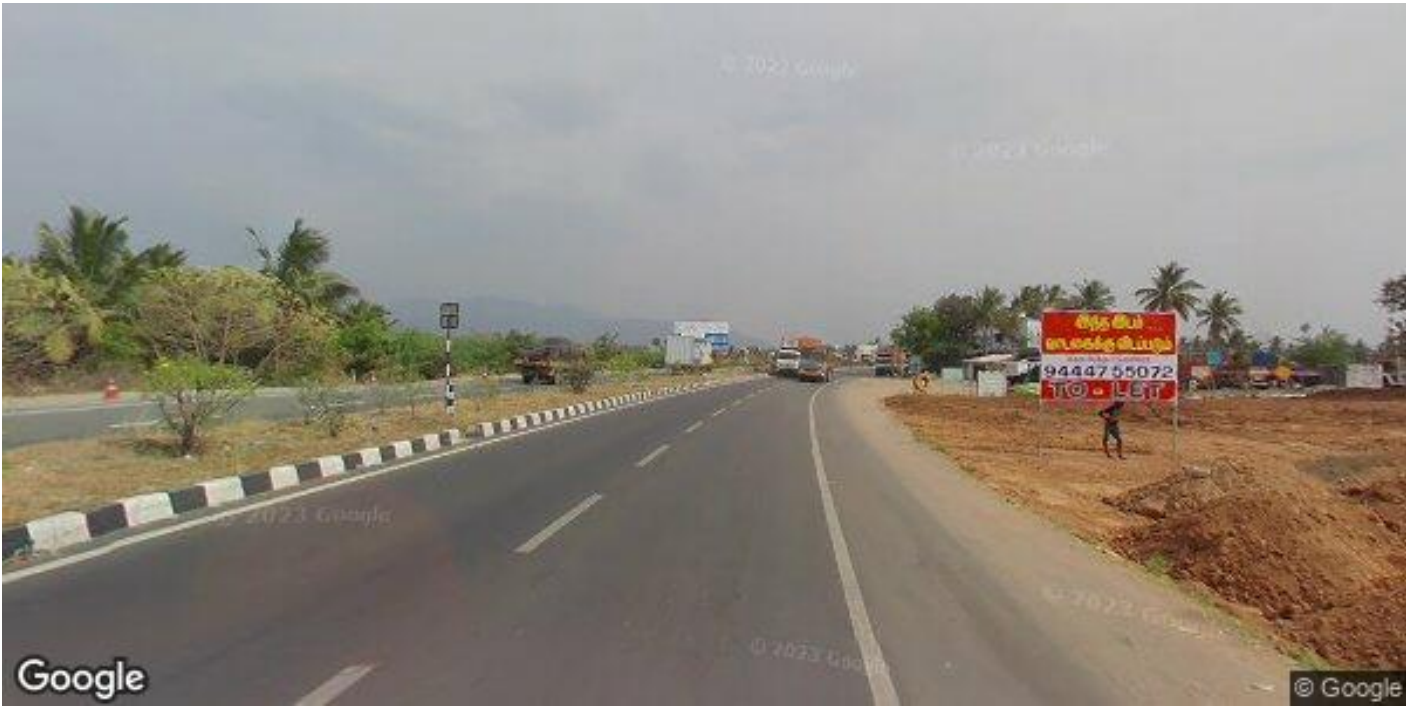
**Risk Type:** Turn  
**Risk Level:** Medium  
**Speed Limit:** 30 KM/Hr  
**Coordinates:** 11.88019, 78.08158

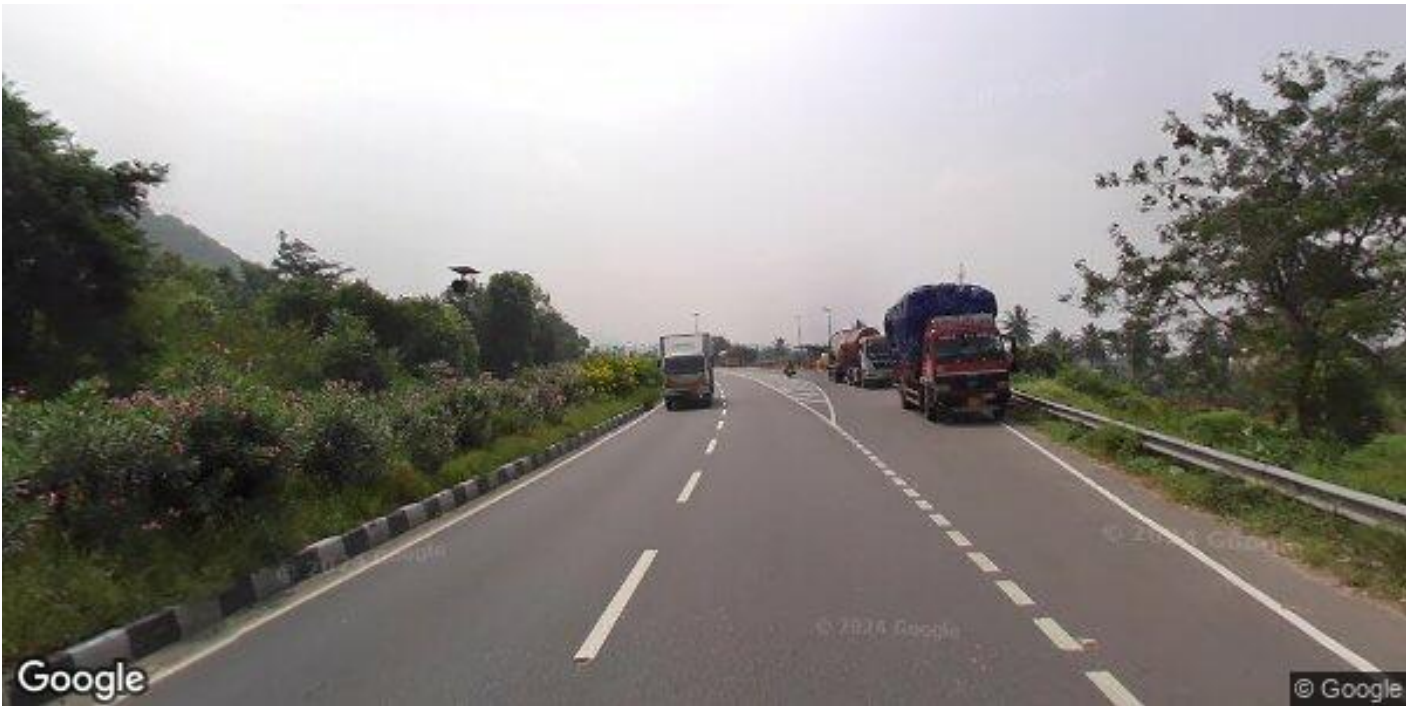
**Risk Type:** Turn  
**Risk Level:** Medium  
**Speed Limit:** 30 KM/Hr  
**Coordinates:** 11.91282, 78.05854

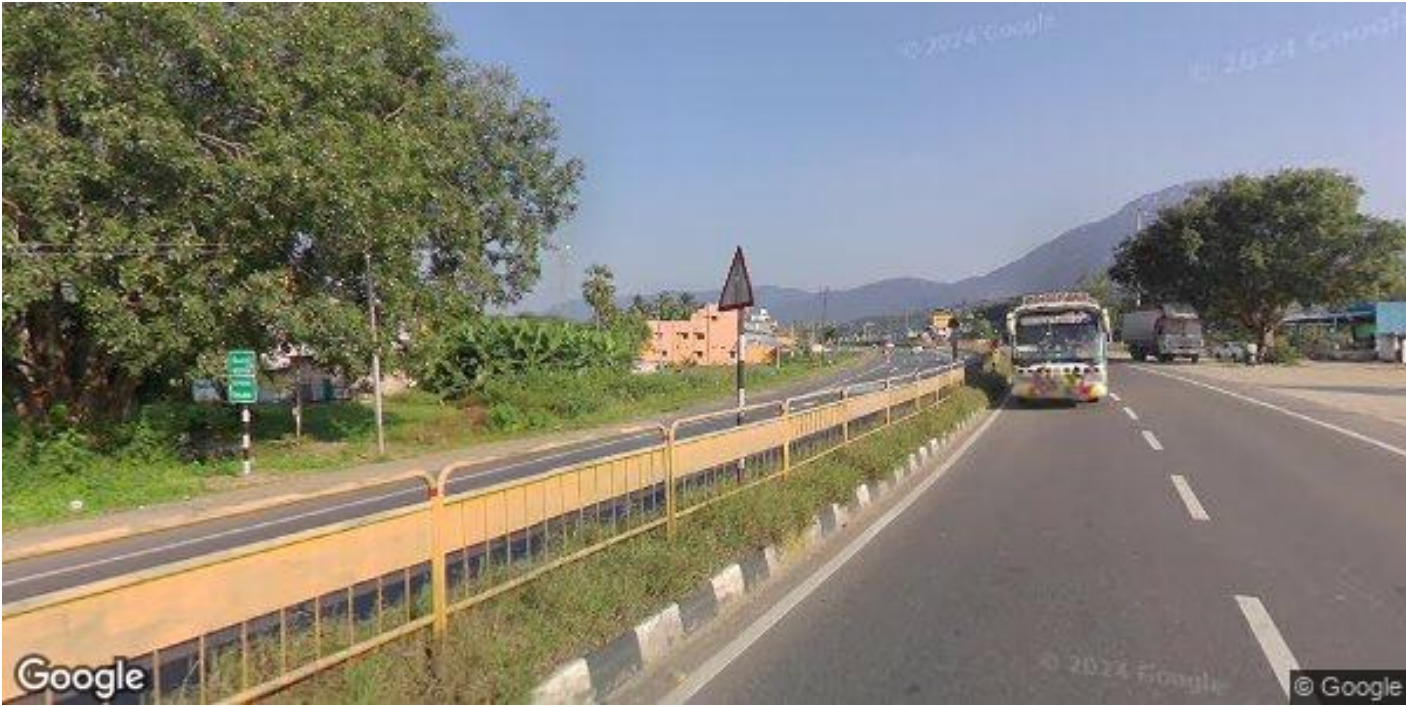
**Risk Type:** Turn  
**Risk Level:** Medium  
**Speed Limit:** 30 KM/Hr  
**Coordinates:** 11.93757, 78.05319
