# IndianOil

## JOURNEY RISK MANAGEMENT (JRM) STUDY

### Salem Terminal to SHREE RAMACHANDRAN PETROLEUM

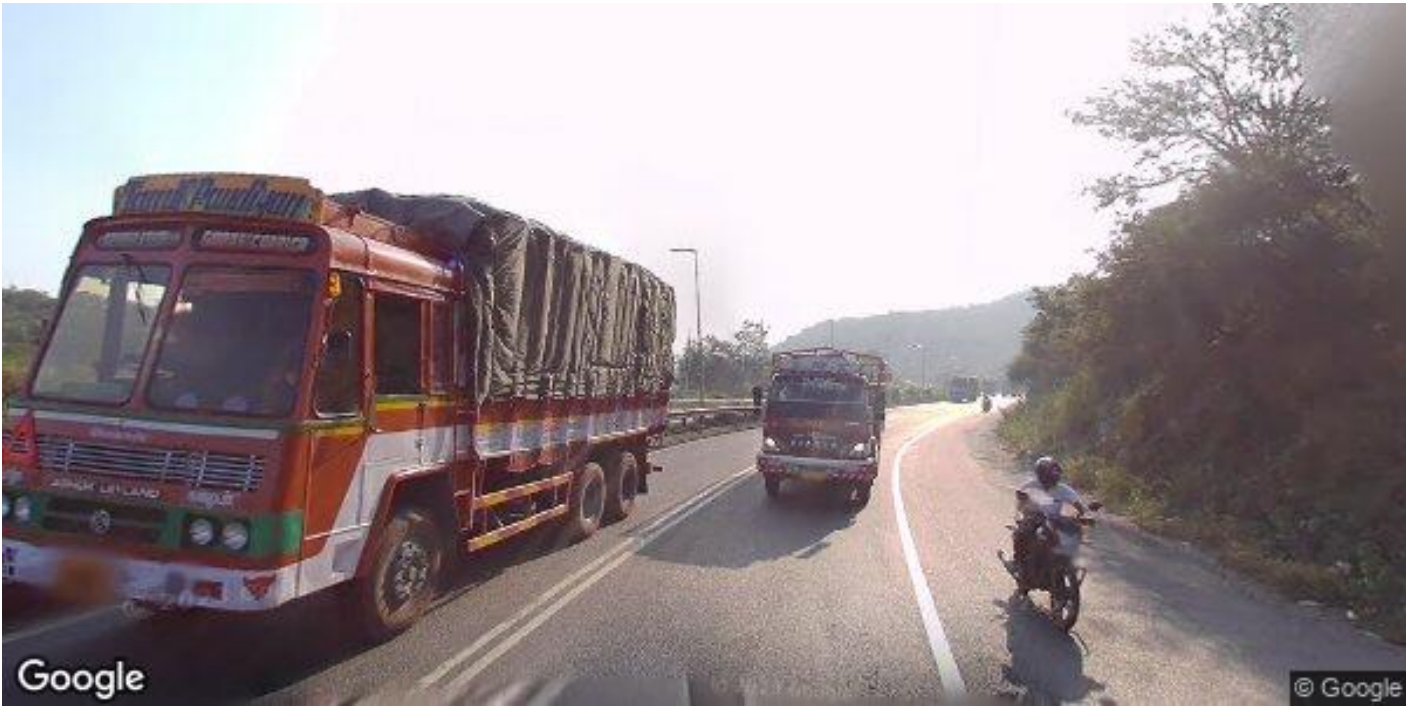
**Risk Type:** Turn  
**Risk Level:** Medium  
**Speed Limit:** 30 KM/Hr  
**Coordinates:** 11.95816, 78.04976

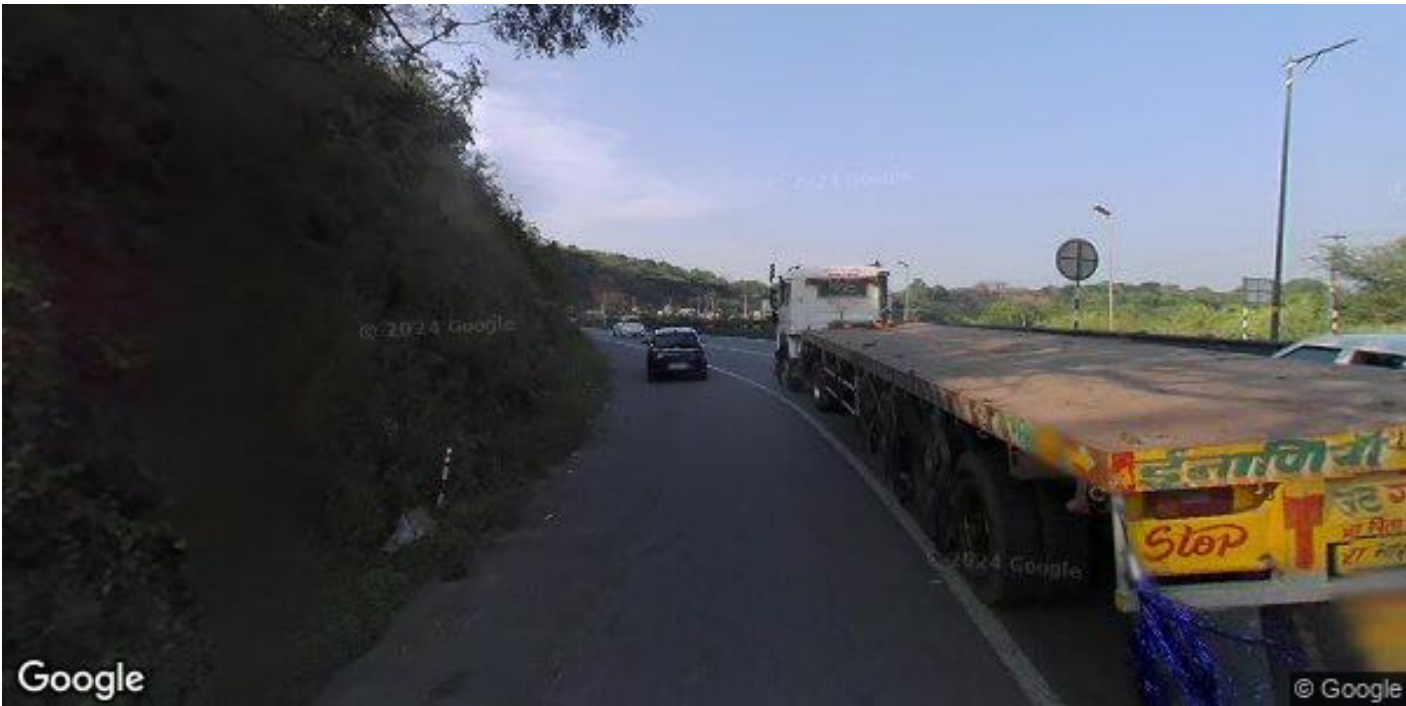
**Risk Type:** Turn  
**Risk Level:** Medium  
**Speed Limit:** 30 KM/Hr  
**Coordinates:** 11.95870, 78.04990

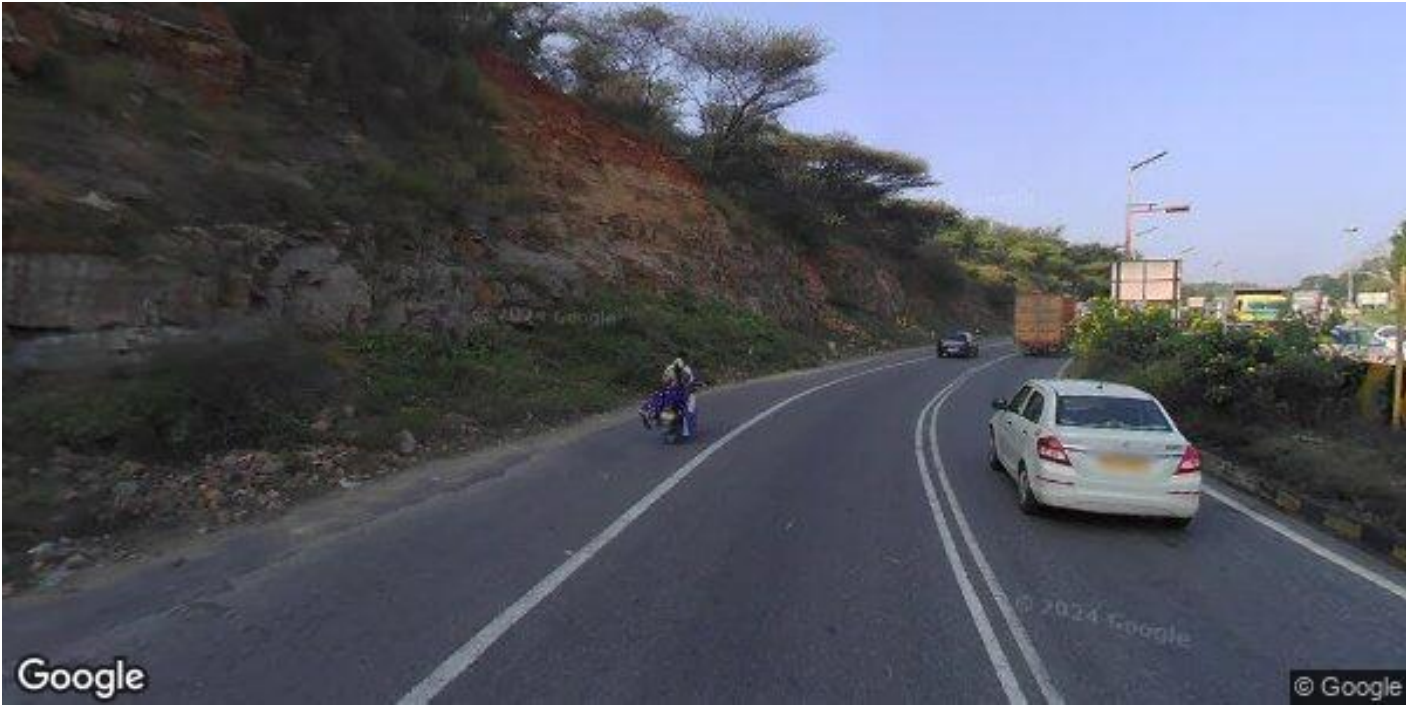
**Risk Type:** Turn  
**Risk Level:** High  
**Speed Limit:** 15 KM/Hr  
**Coordinates:** 11.96031, 78.04945

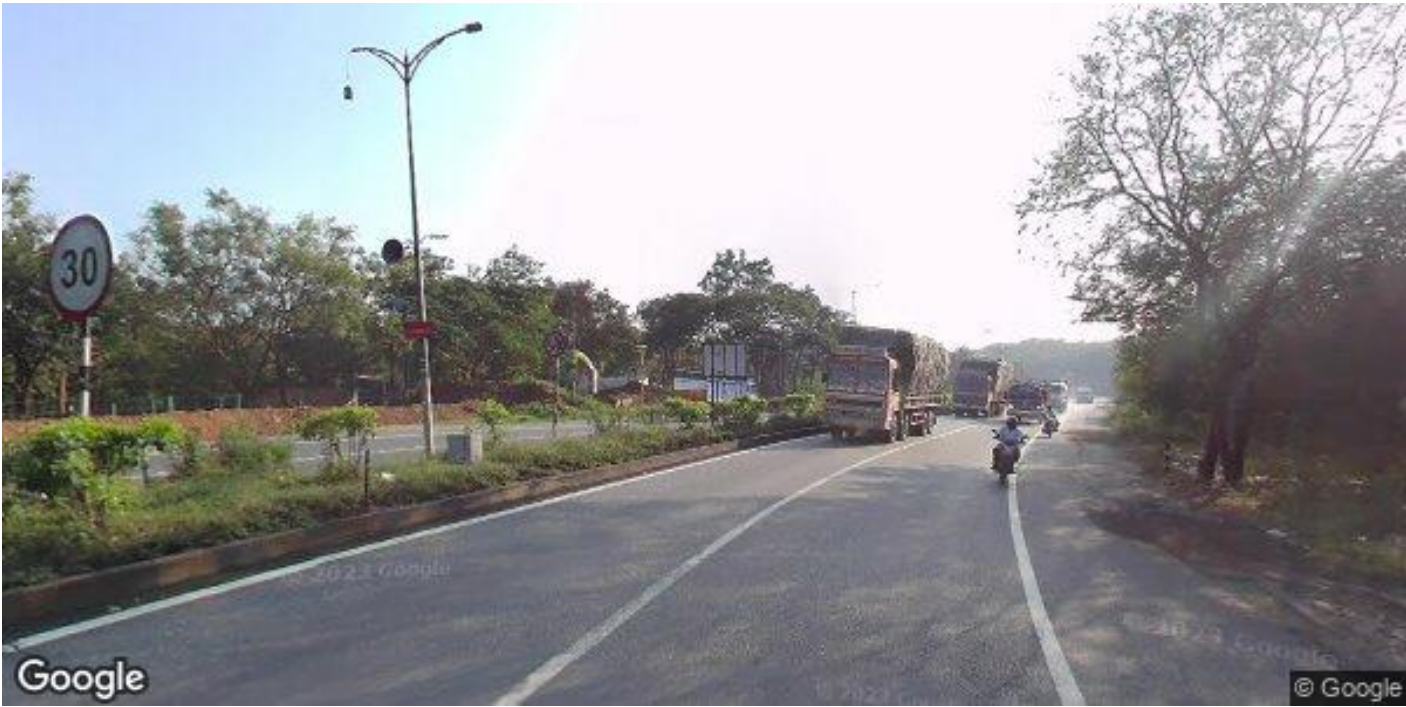
**Risk Type:** Turn  
**Risk Level:** Medium  
**Speed Limit:** 30 KM/Hr  
**Coordinates:** 11.96291, 78.05131

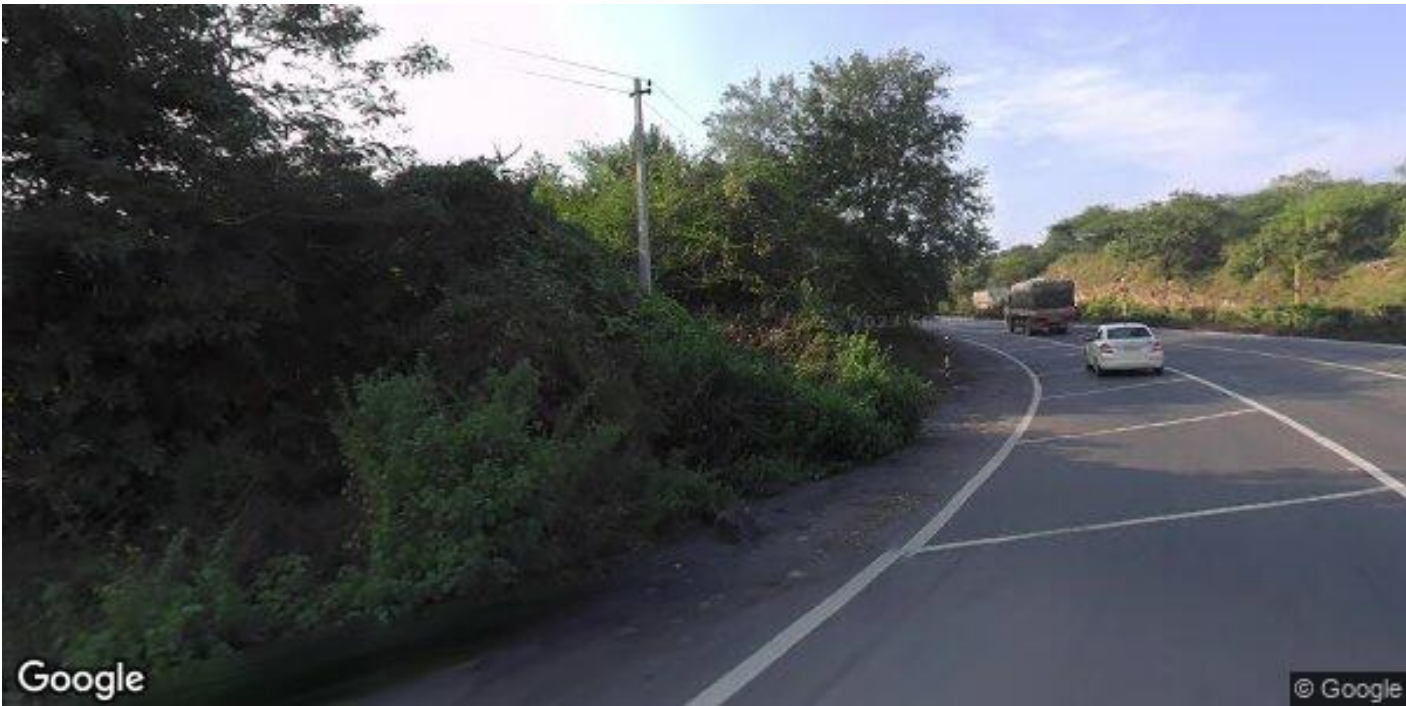
**Risk Type:** Turn  
**Risk Level:** Medium  
**Speed Limit:** 30 KM/Hr  
**Coordinates:** 11.96390, 78.05138

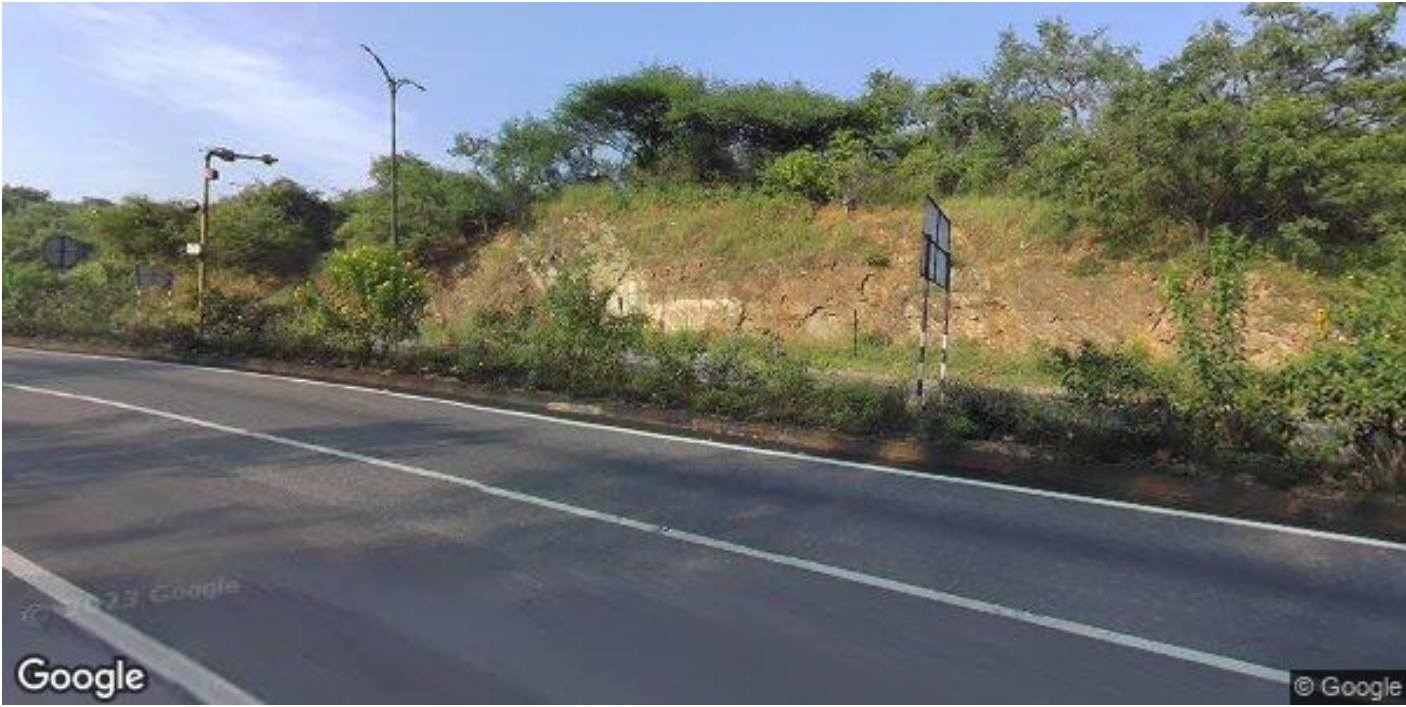
**Risk Type:** Turn  
**Risk Level:** Medium  
**Speed Limit:** 30 KM/Hr  
**Coordinates:** 11.96453, 78.05092

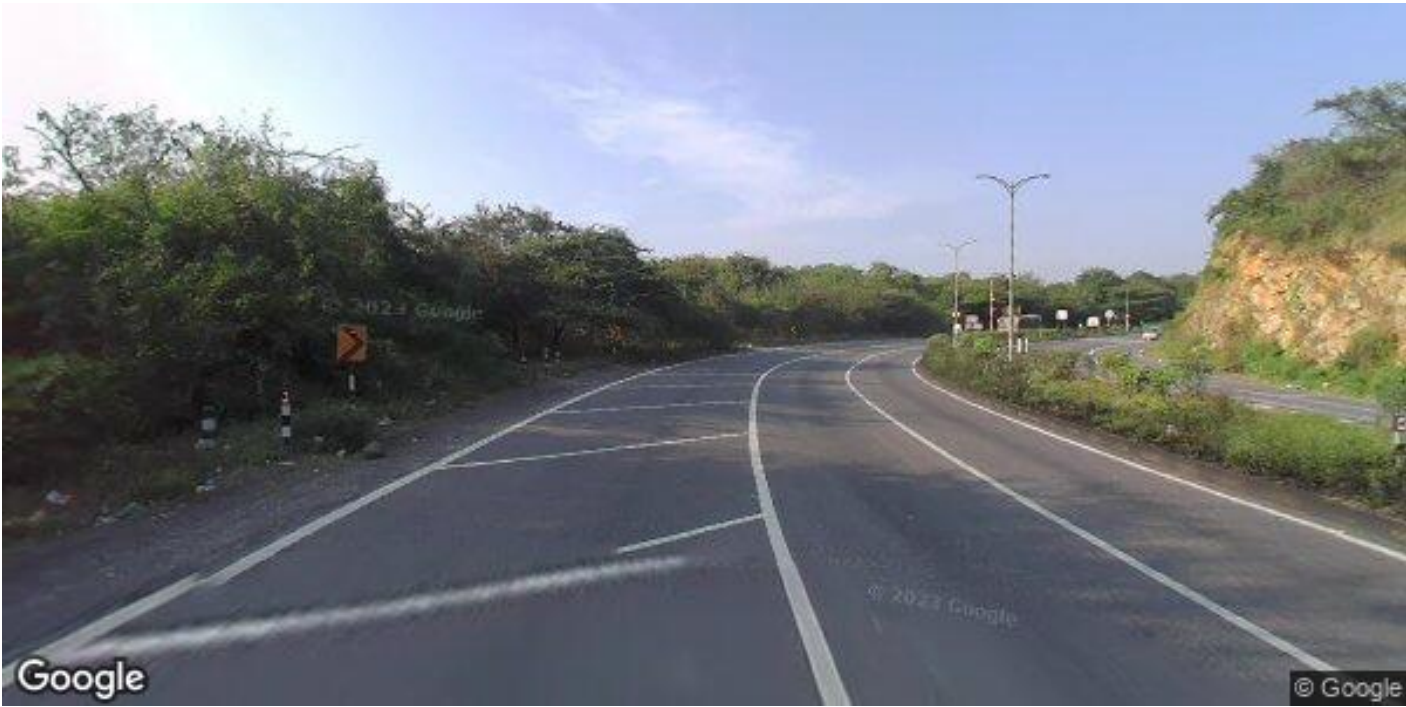
**Risk Type:** Turn  
**Risk Level:** High  
**Speed Limit:** 15 KM/Hr  
**Coordinates:** 11.96562, 78.04928

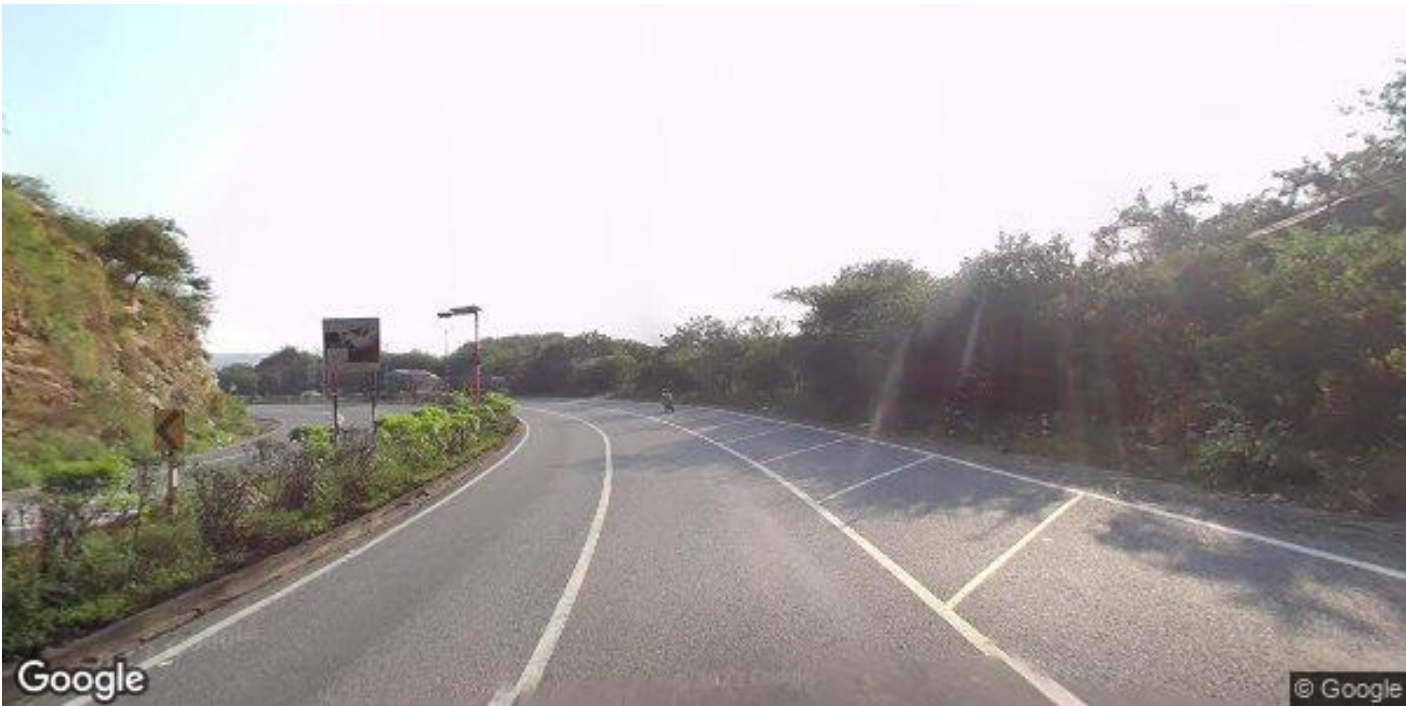
**Risk Type:** Turn  
**Risk Level:** High  
**Speed Limit:** 15 KM/Hr  
**Coordinates:** 11.96667, 78.04934

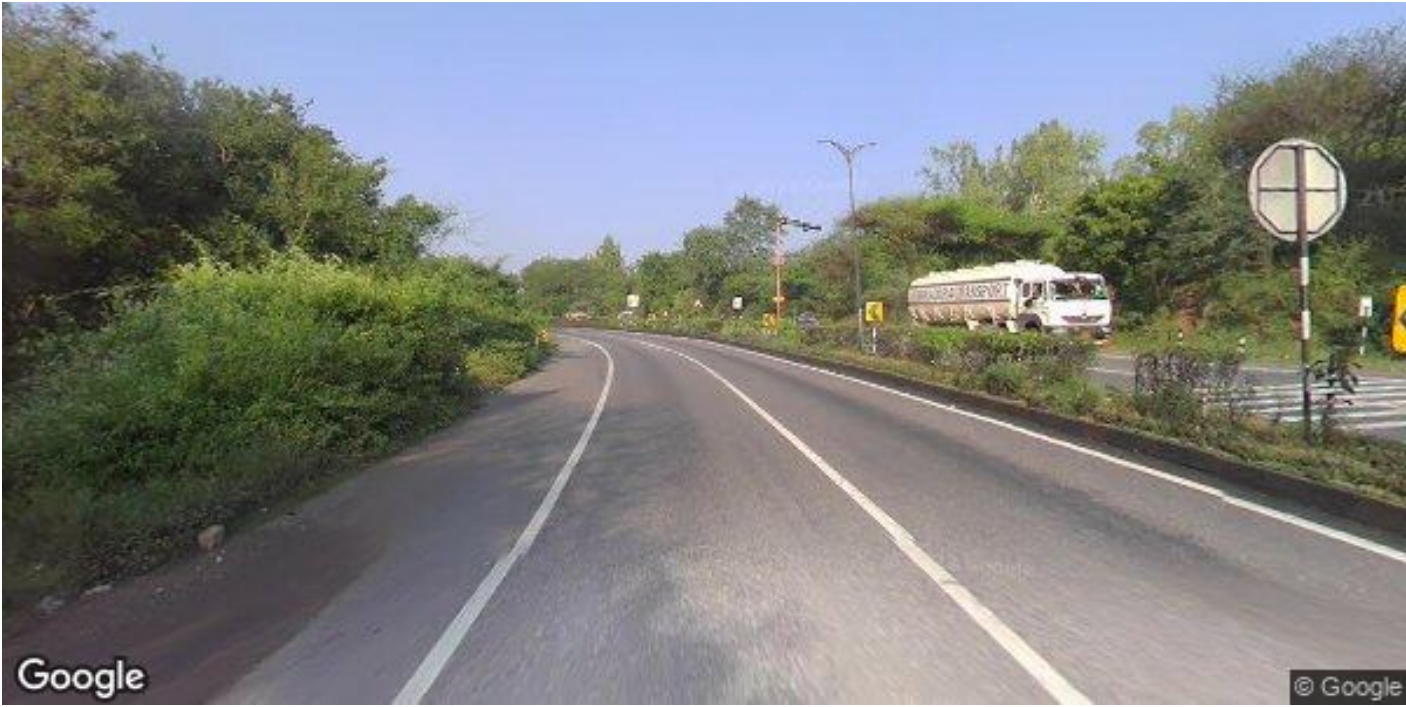
**Risk Type:** Turn  
**Risk Level:** Medium  
**Speed Limit:** 30 KM/Hr  
**Coordinates:** 11.96775, 78.05056

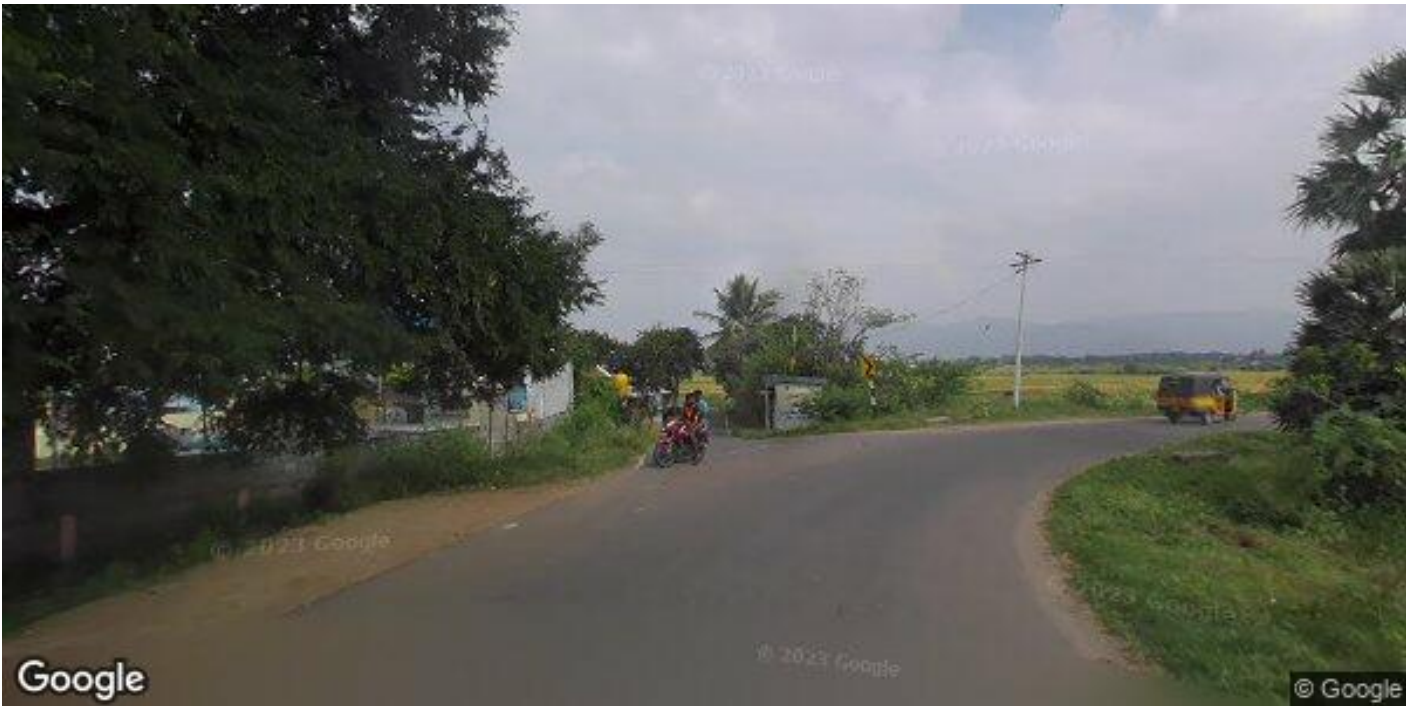
**Risk Type:** Turn  
**Risk Level:** High  
**Speed Limit:** 15 KM/Hr  
**Coordinates:** 12.05929, 78.12487
