## JOURNEY RISK MANAGEMENT (JRM) STUDY

**Salem Terminal to KDCMPU LTD.**

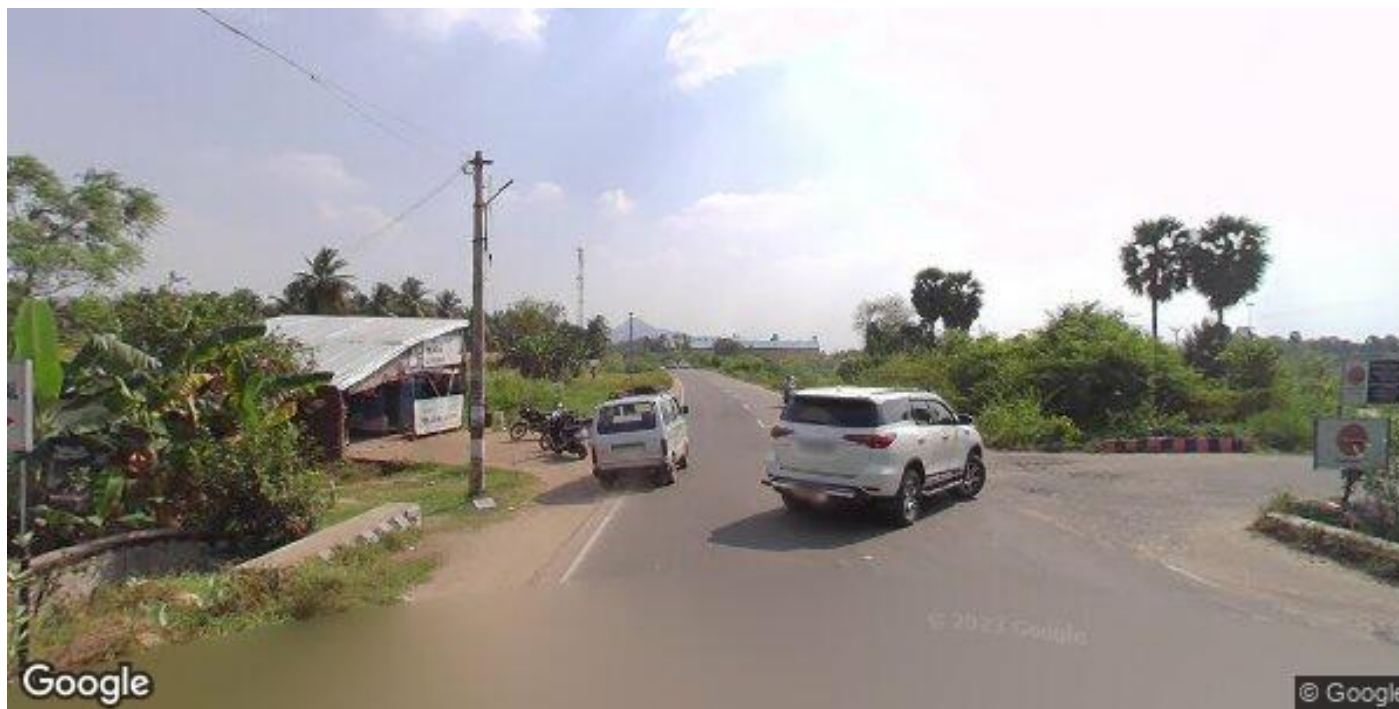
**Risk Type:** Turn  
**Risk Level:** High  
**Speed Limit:** 15 KM/Hr  
**Coordinates:** 11.44029, 77.87544

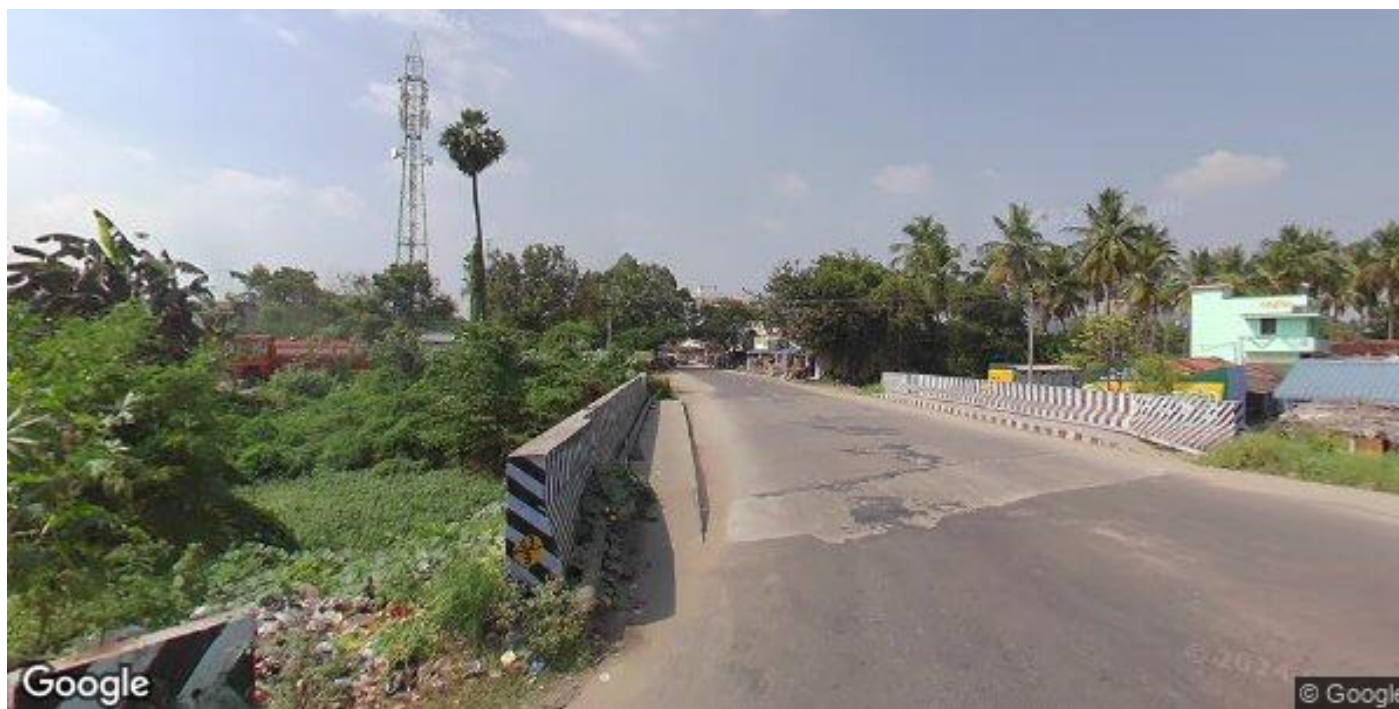
**Risk Type:** Turn  
**Risk Level:** High  
**Speed Limit:** 15 KM/Hr  
**Coordinates:** 11.44900, 77.87406

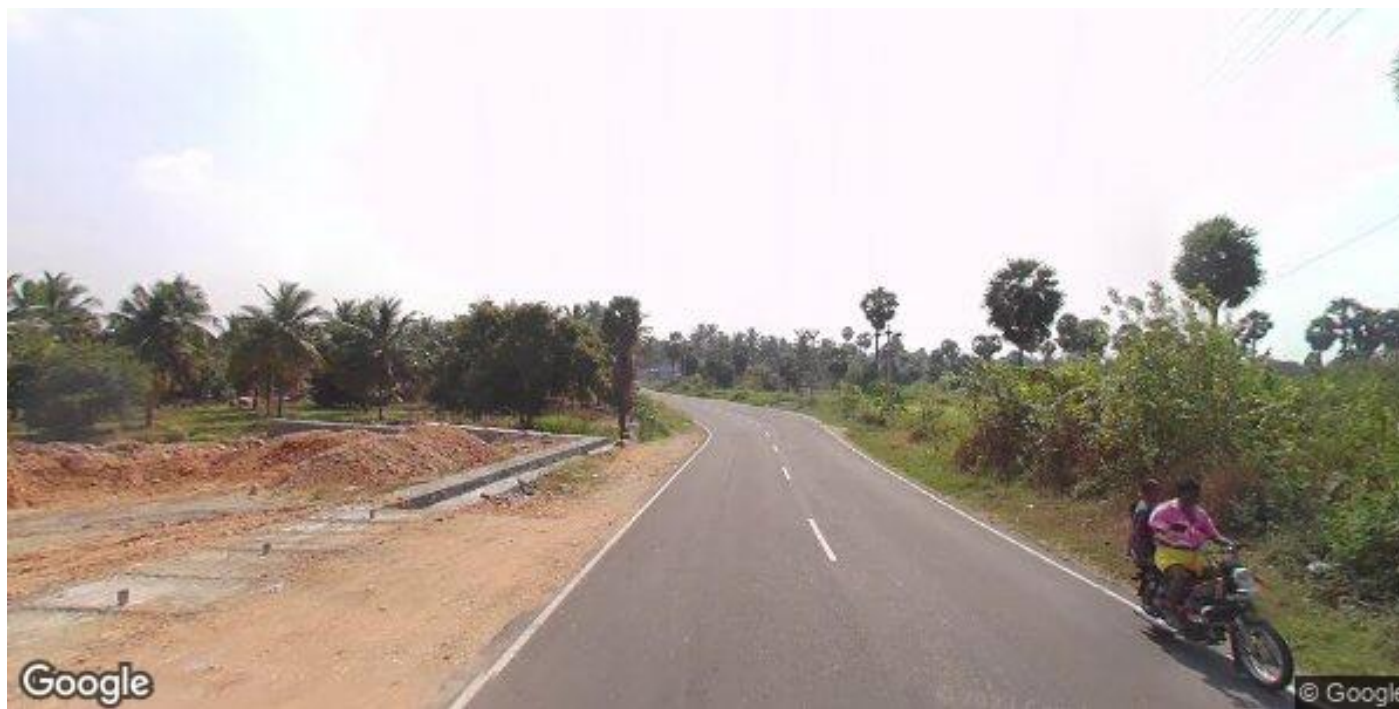
**Risk Type:** Turn  
**Risk Level:** Medium  
**Speed Limit:** 30 KM/Hr  
**Coordinates:** 11.45781, 77.85203

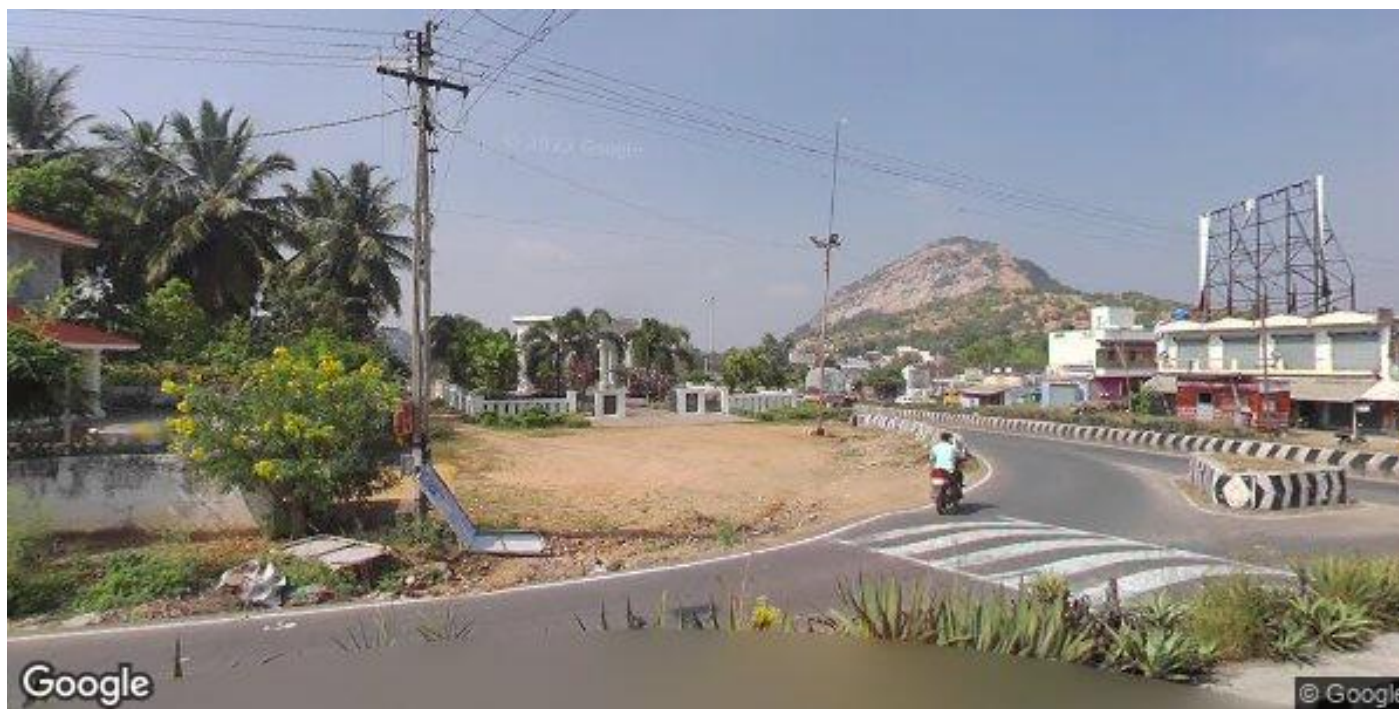
**Risk Type:** Turn  
**Risk Level:** High  
**Speed Limit:** 15 KM/Hr  
**Coordinates:** 11.46307, 77.84941

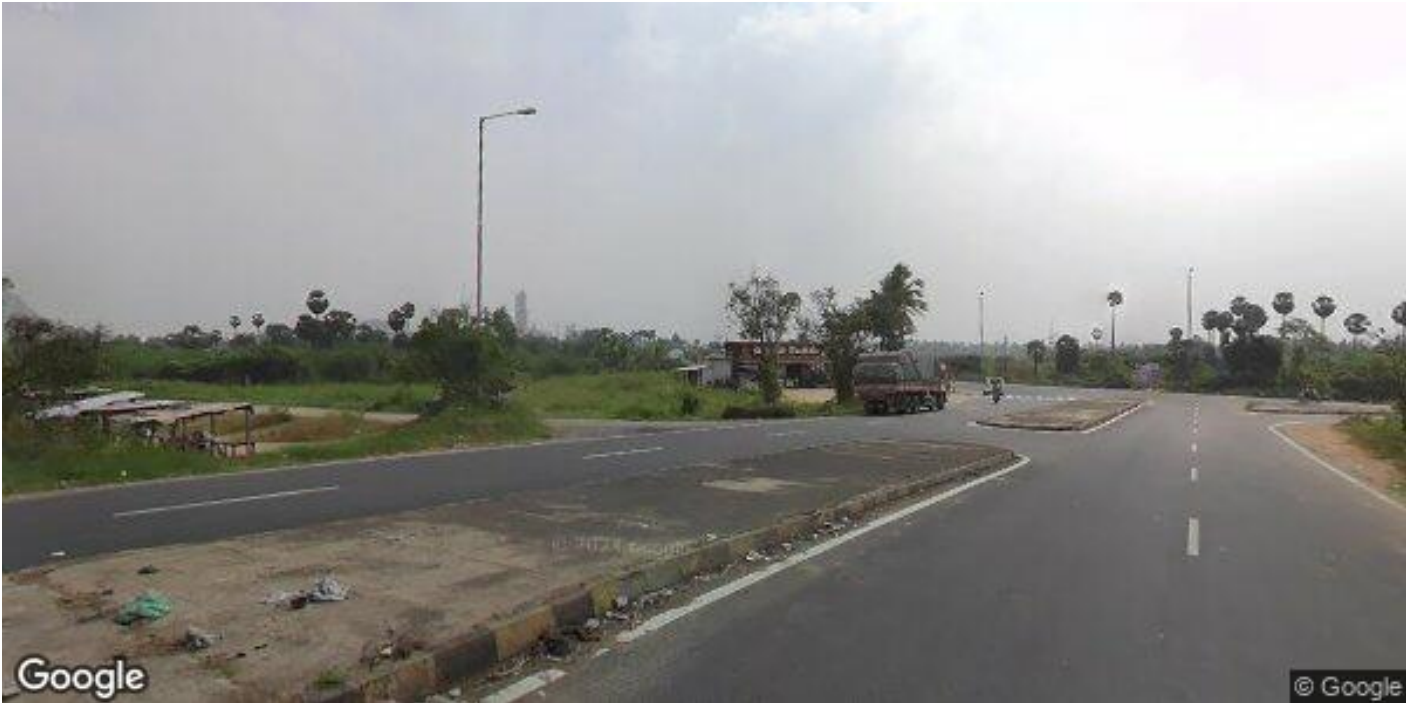
**Risk Type:** Turn  
**Risk Level:** High  
**Speed Limit:** 15 KM/Hr  
**Coordinates:** 11.45605, 77.81683

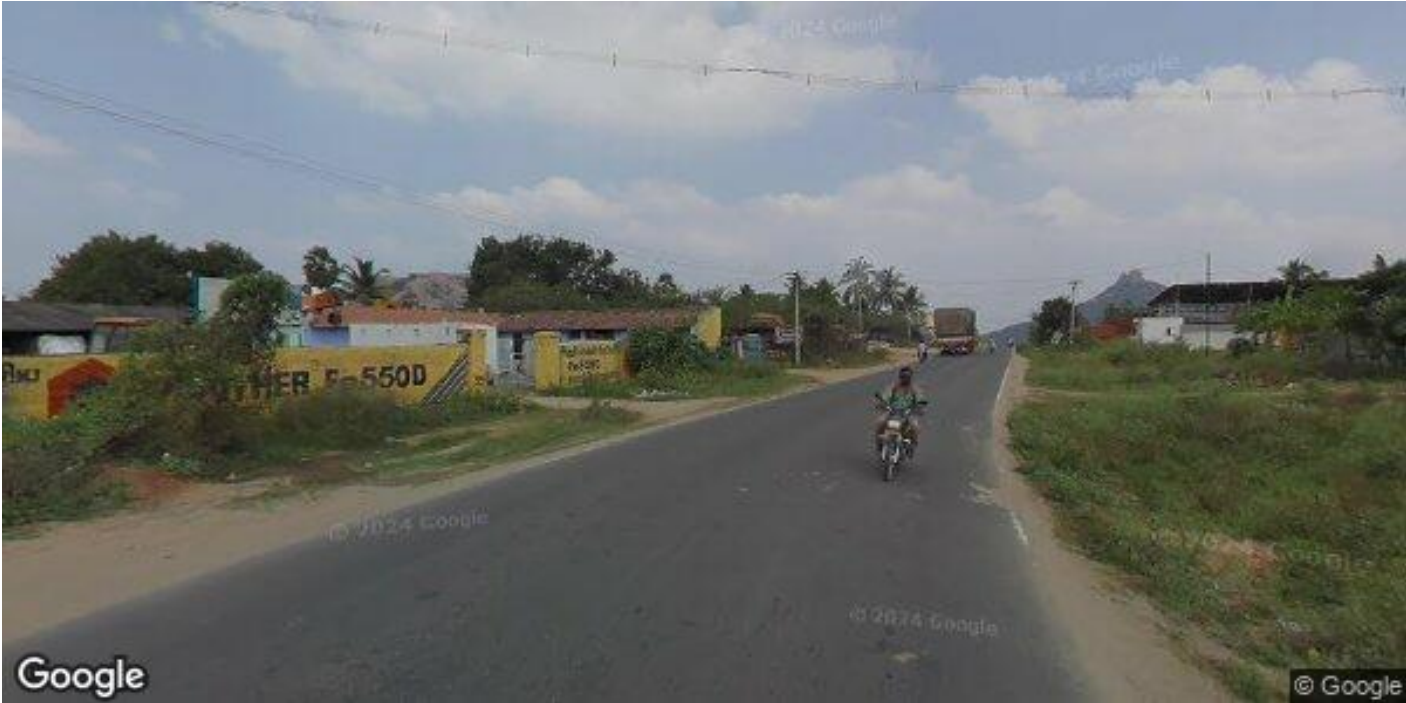
**Risk Type:** Turn  
**Risk Level:** High  
**Speed Limit:** 15 KM/Hr  
**Coordinates:** 11.49469, 77.88488

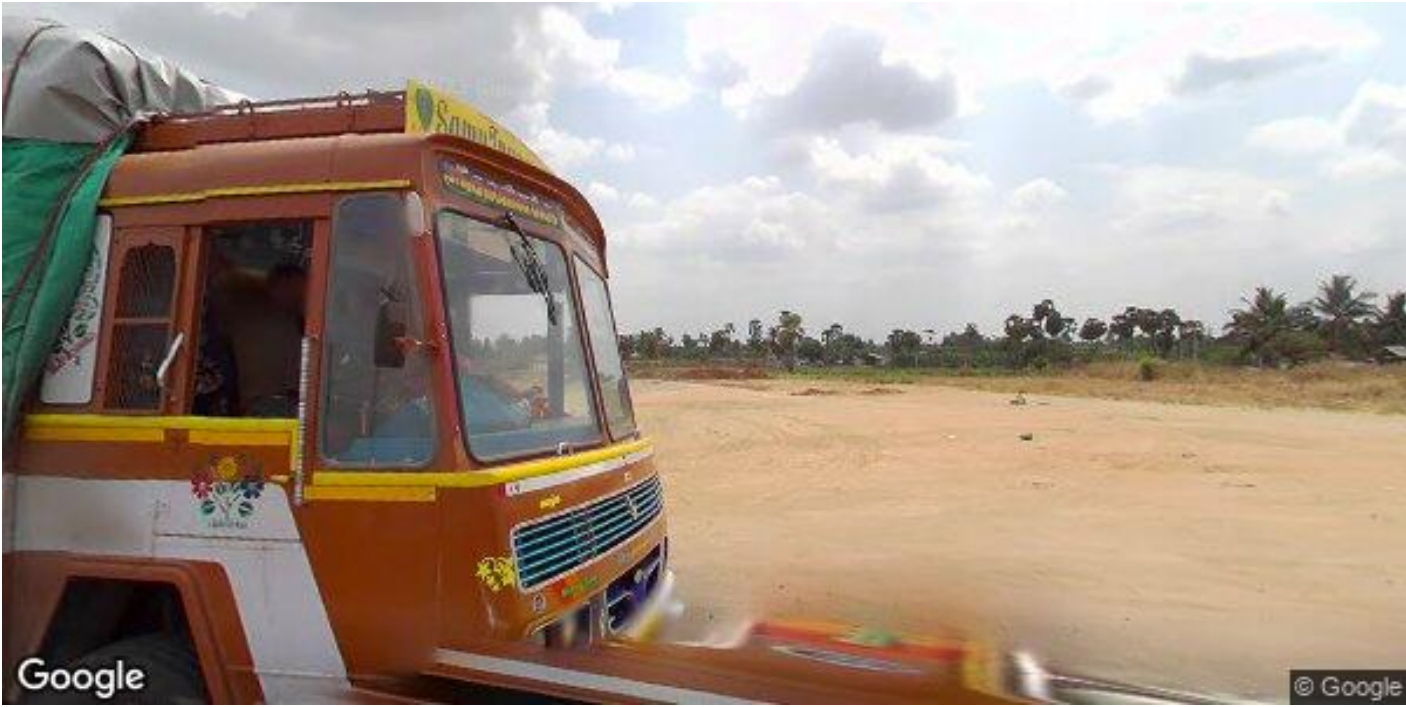
**Risk Type:** Turn  
**Risk Level:** Medium  
**Speed Limit:** 30 KM/Hr  
**Coordinates:** 11.55618, 77.89789

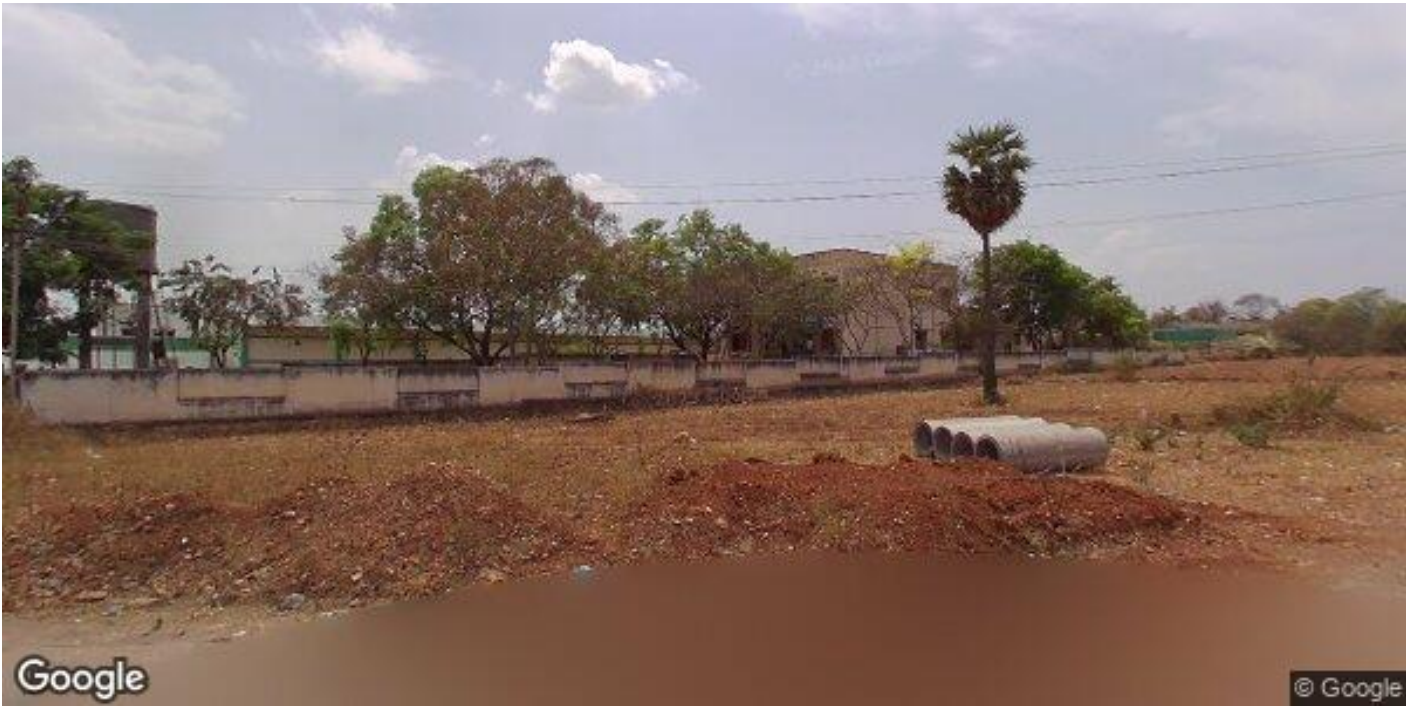
**Risk Type:** Turn  
**Risk Level:** High  
**Speed Limit:** 15 KM/Hr  
**Coordinates:** 11.58340, 77.90637

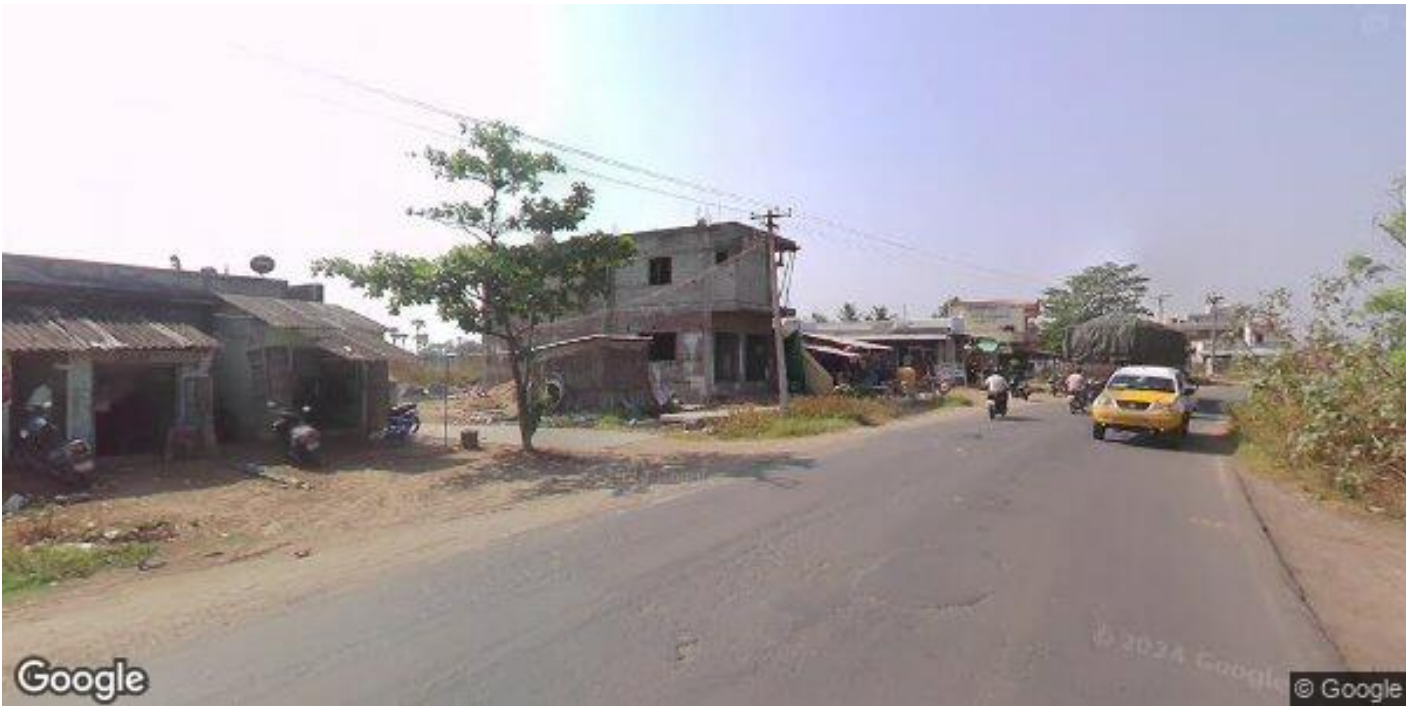
**Risk Type:** Turn  
**Risk Level:** Medium  
**Speed Limit:** 30 KM/Hr  
**Coordinates:** 11.59201, 77.90649

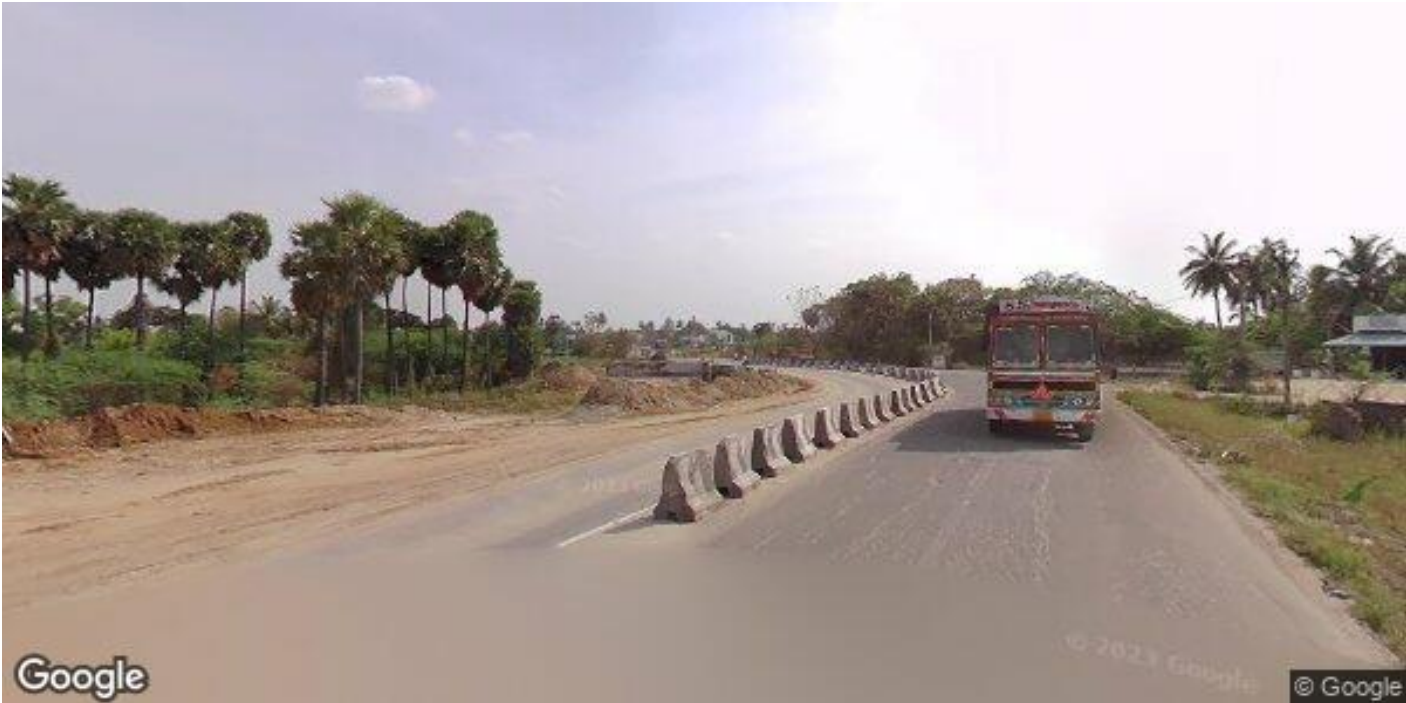
**Risk Type:** Turn  
**Risk Level:** Medium  
**Speed Limit:** 30 KM/Hr  
**Coordinates:** 11.63882, 77.94859

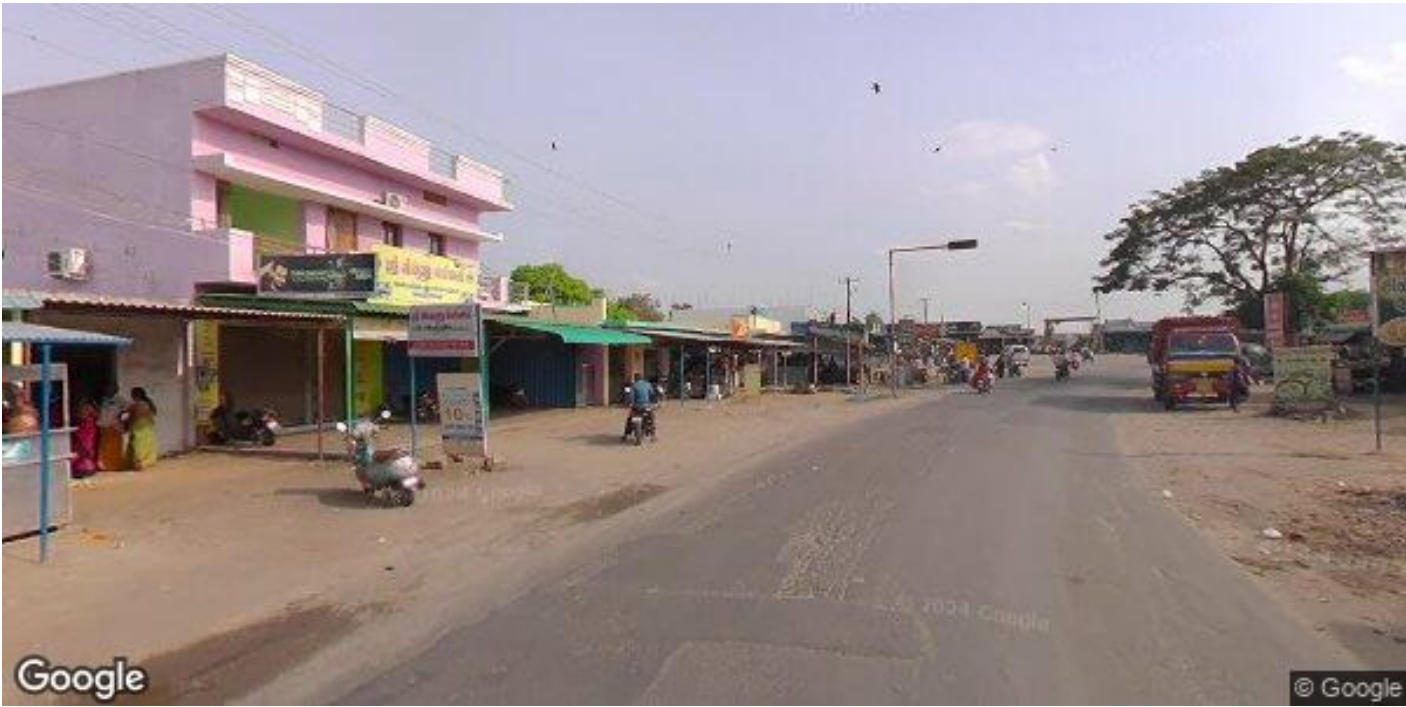
**Risk Type:** Turn  
**Risk Level:** High  
**Speed Limit:** 15 KM/Hr  
**Coordinates:** 11.64226, 77.95200

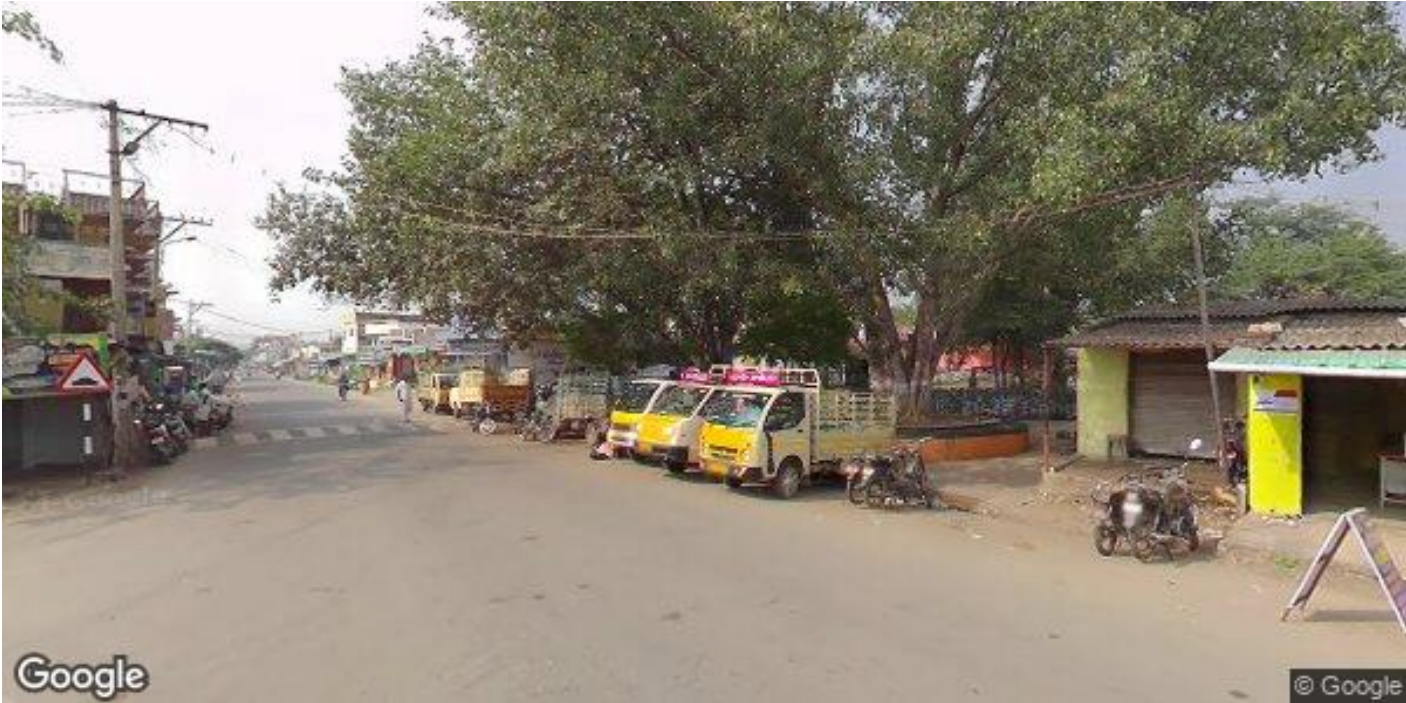
**Risk Type:** Turn  
**Risk Level:** Medium  
**Speed Limit:** 30 KM/Hr  
**Coordinates:** 11.64716, 77.95118

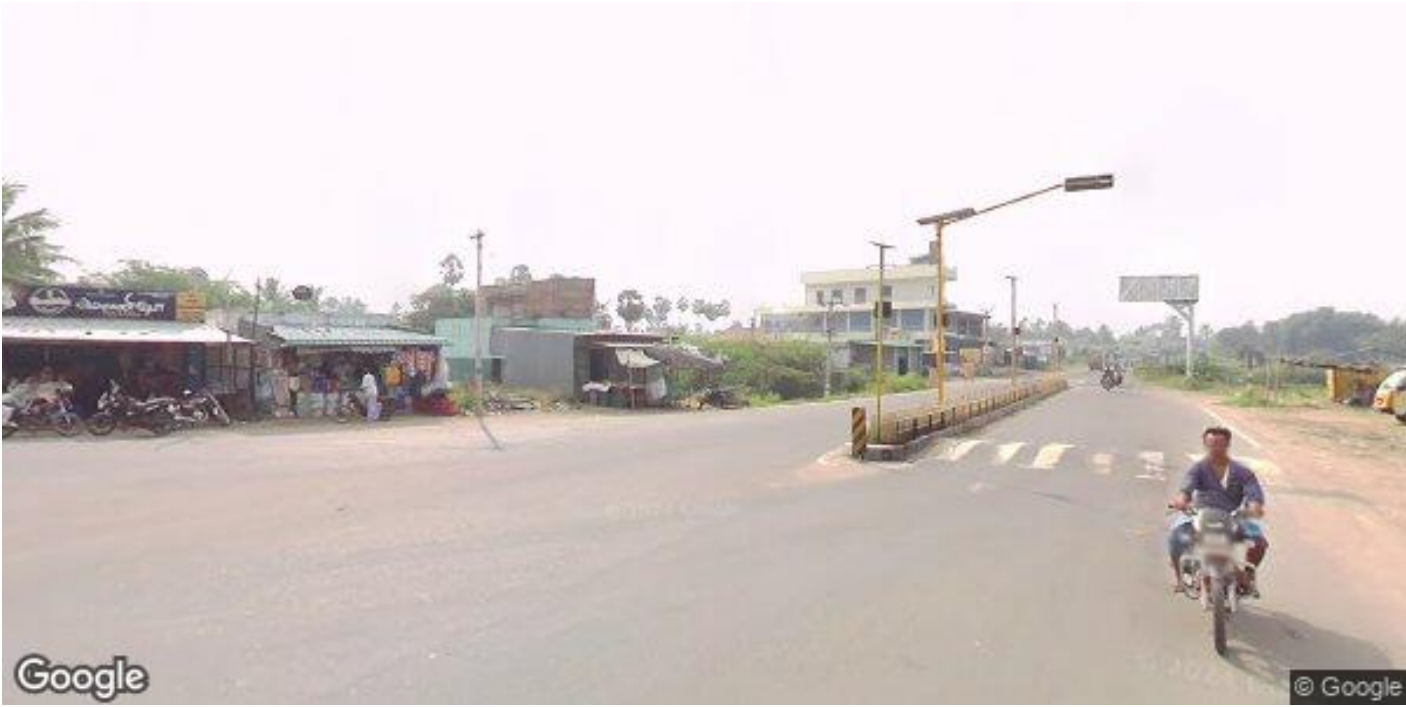
**Risk Type:** Turn  
**Risk Level:** Medium  
**Speed Limit:** 30 KM/Hr  
**Coordinates:** 11.67868, 77.96836

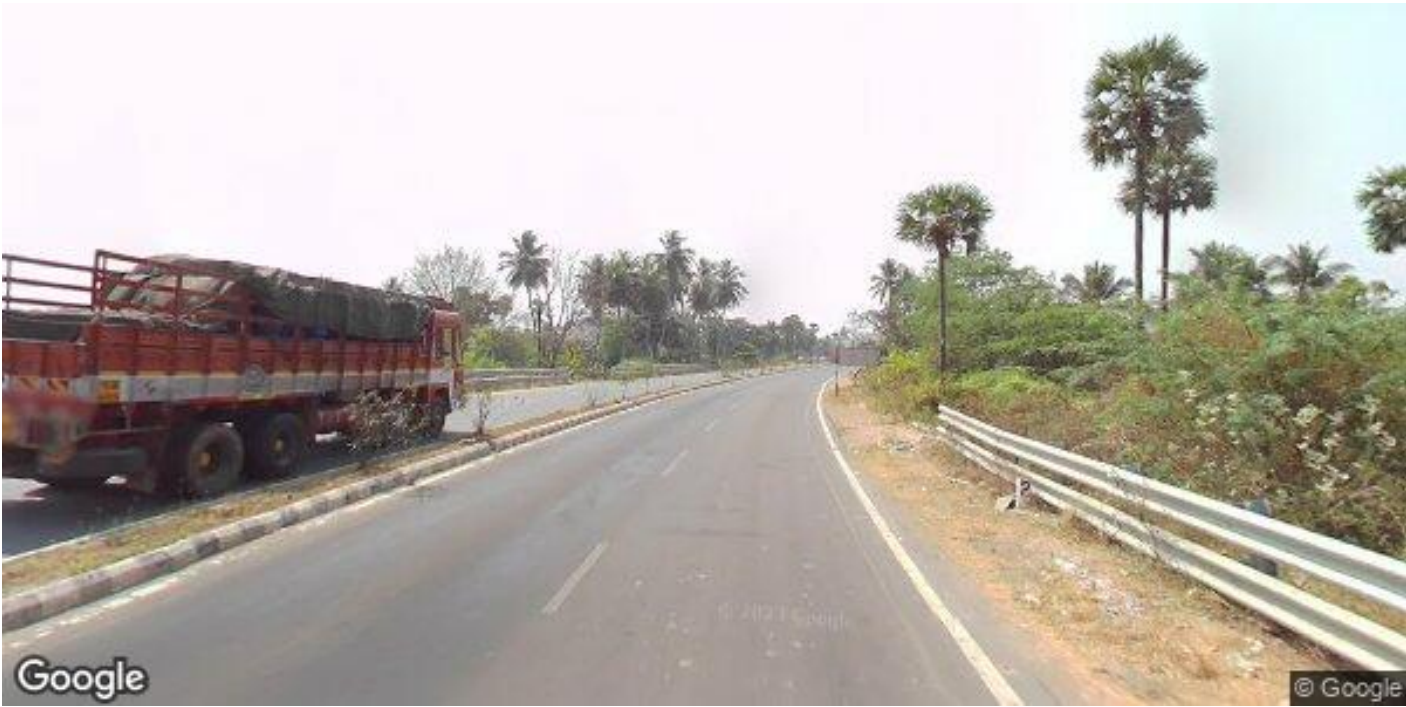
**Risk Type:** Turn  
**Risk Level:** Medium  
**Speed Limit:** 30 KM/Hr  
**Coordinates:** 11.70077, 77.97957

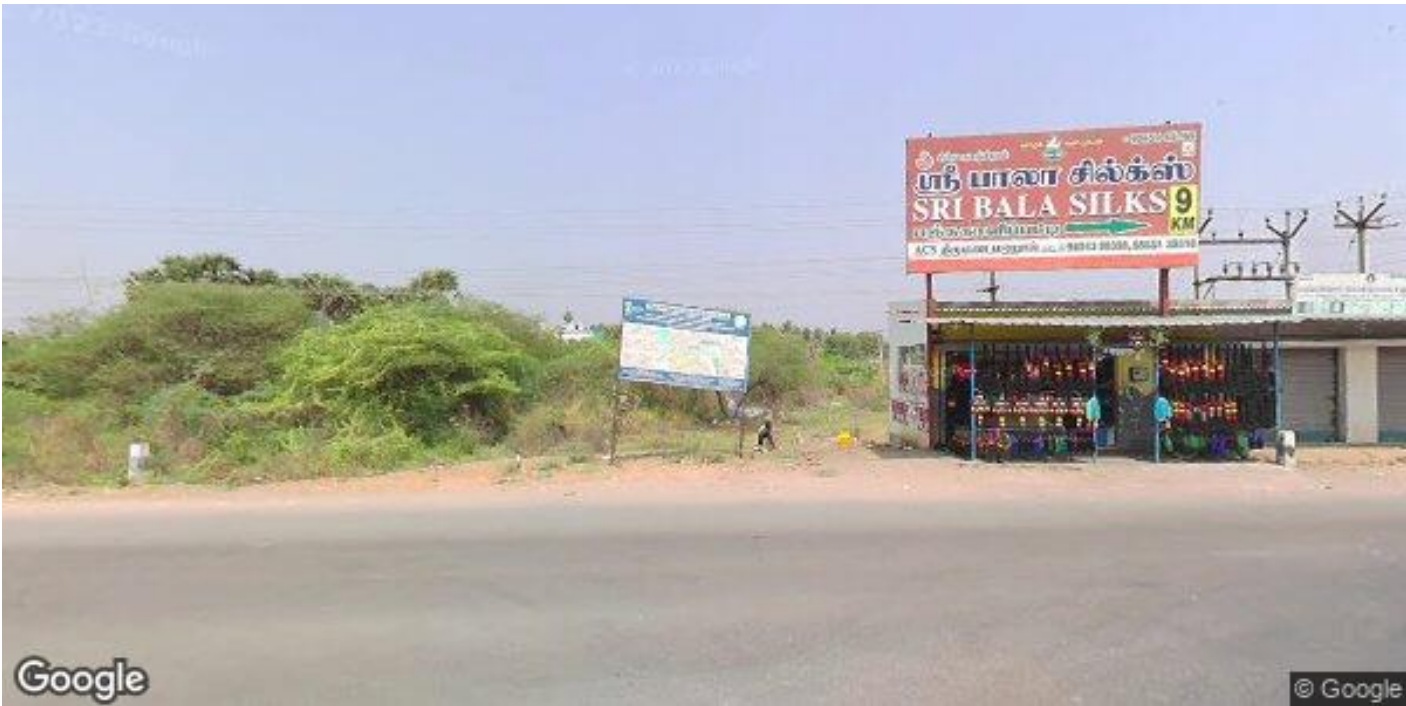
**Risk Type:** Turn  
**Risk Level:** High  
**Speed Limit:** 15 KM/Hr  
**Coordinates:** 11.70223, 77.97860

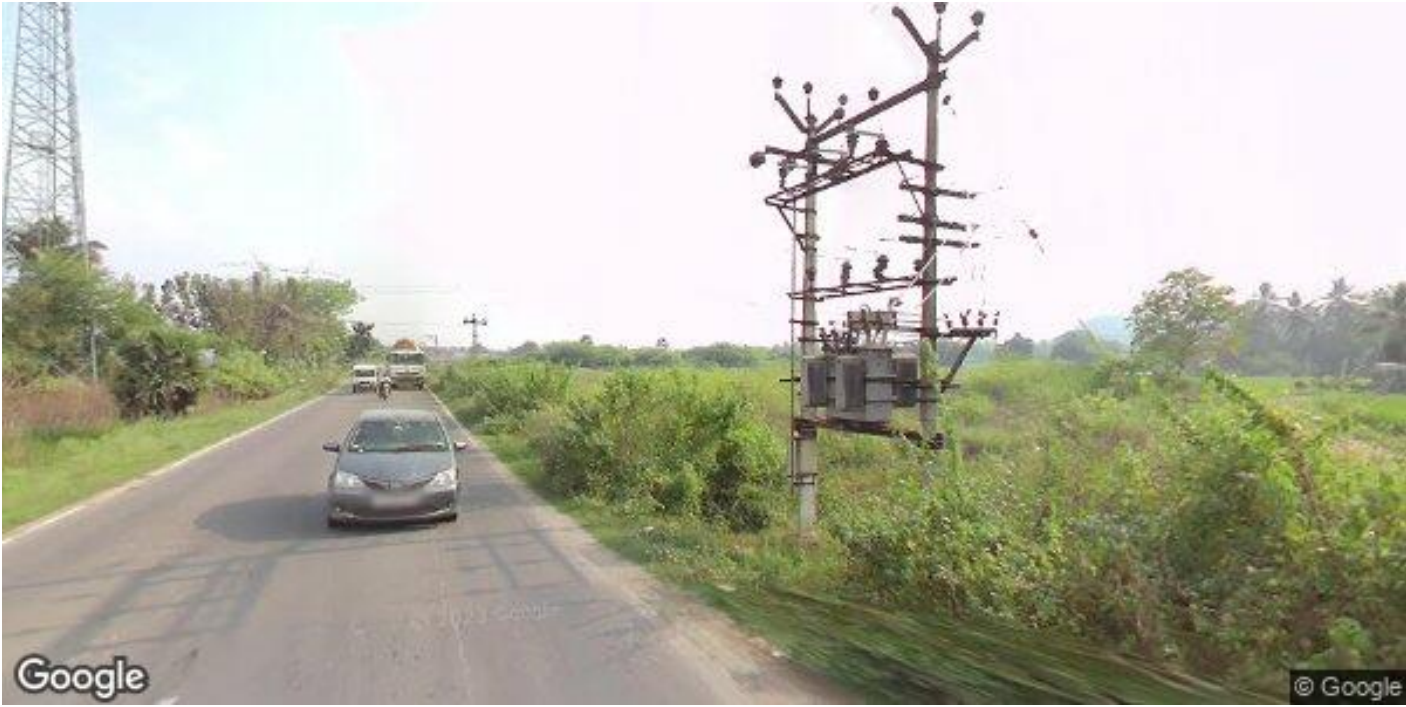
**Risk Type:** Turn  
**Risk Level:** Medium  
**Speed Limit:** 30 KM/Hr  
**Coordinates:** 11.71402, 77.99586

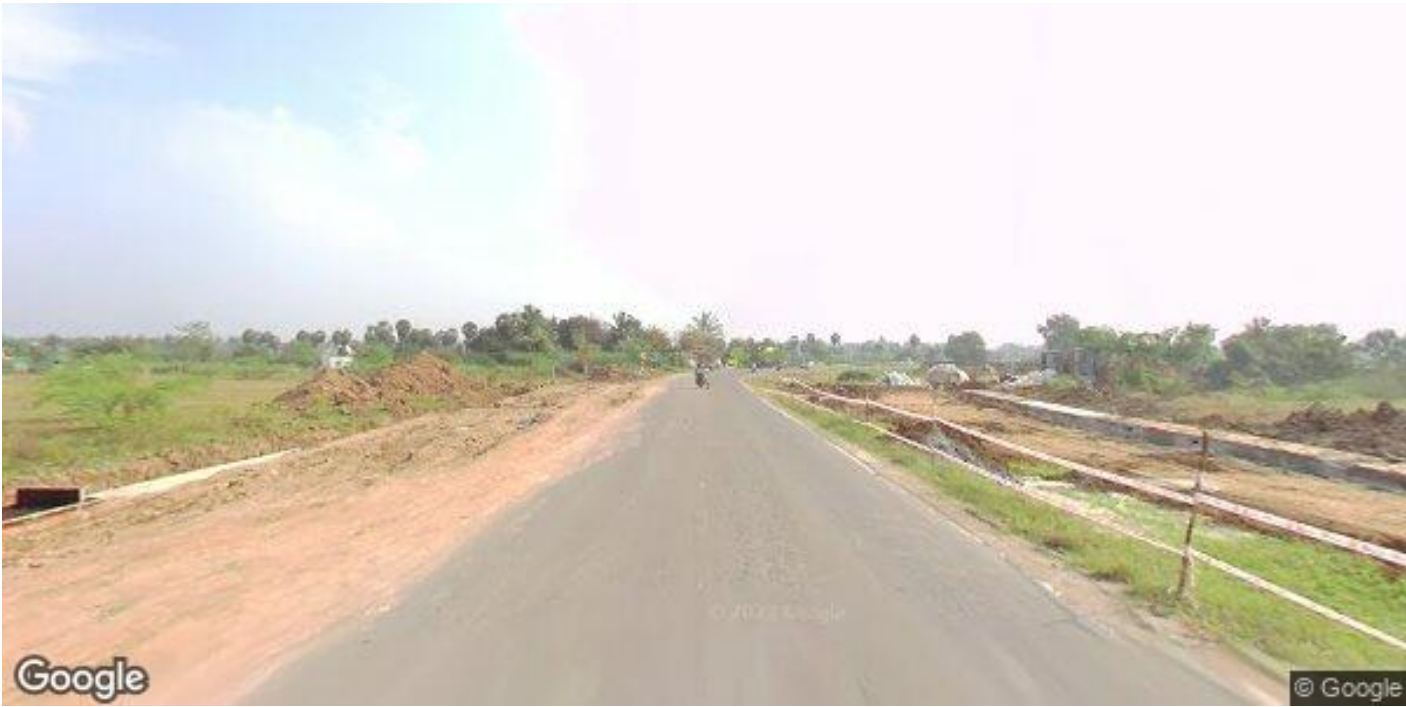
**Risk Type:** Turn  
**Risk Level:** Medium  
**Speed Limit:** 30 KM/Hr  
**Coordinates:** 11.71704, 77.99948

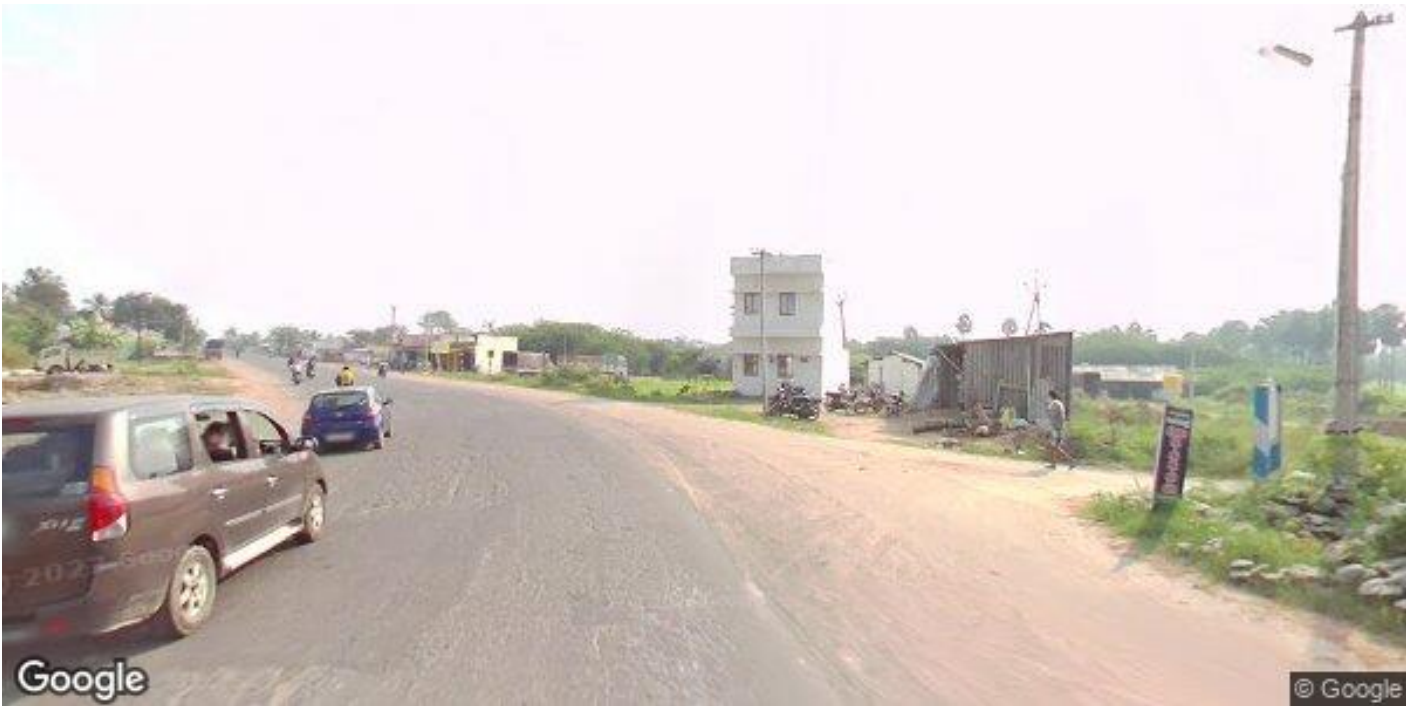
**Risk Type:** Turn  
**Risk Level:** Medium  
**Speed Limit:** 30 KM/Hr  
**Coordinates:** 11.71918, 78.01127

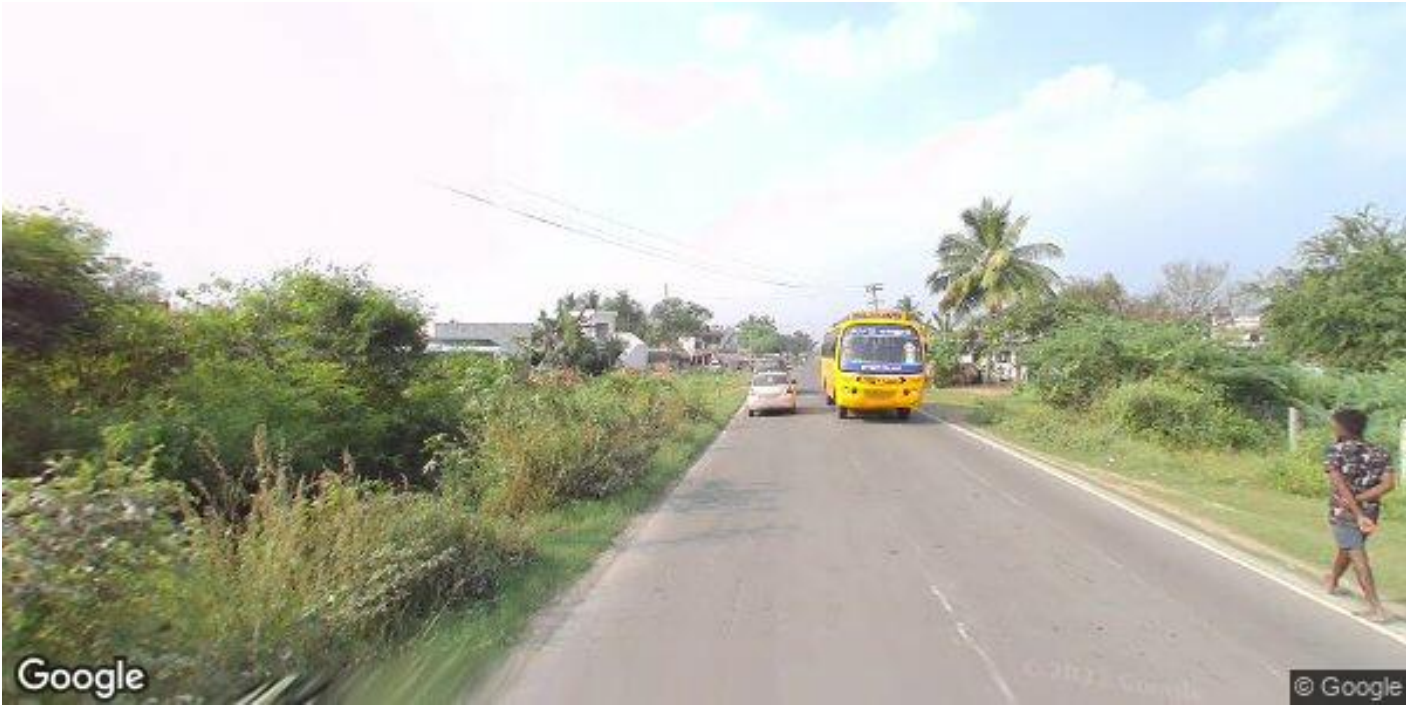
**Risk Type:** Turn  
**Risk Level:** Medium  
**Speed Limit:** 30 KM/Hr  
**Coordinates:** 11.72708, 78.02197

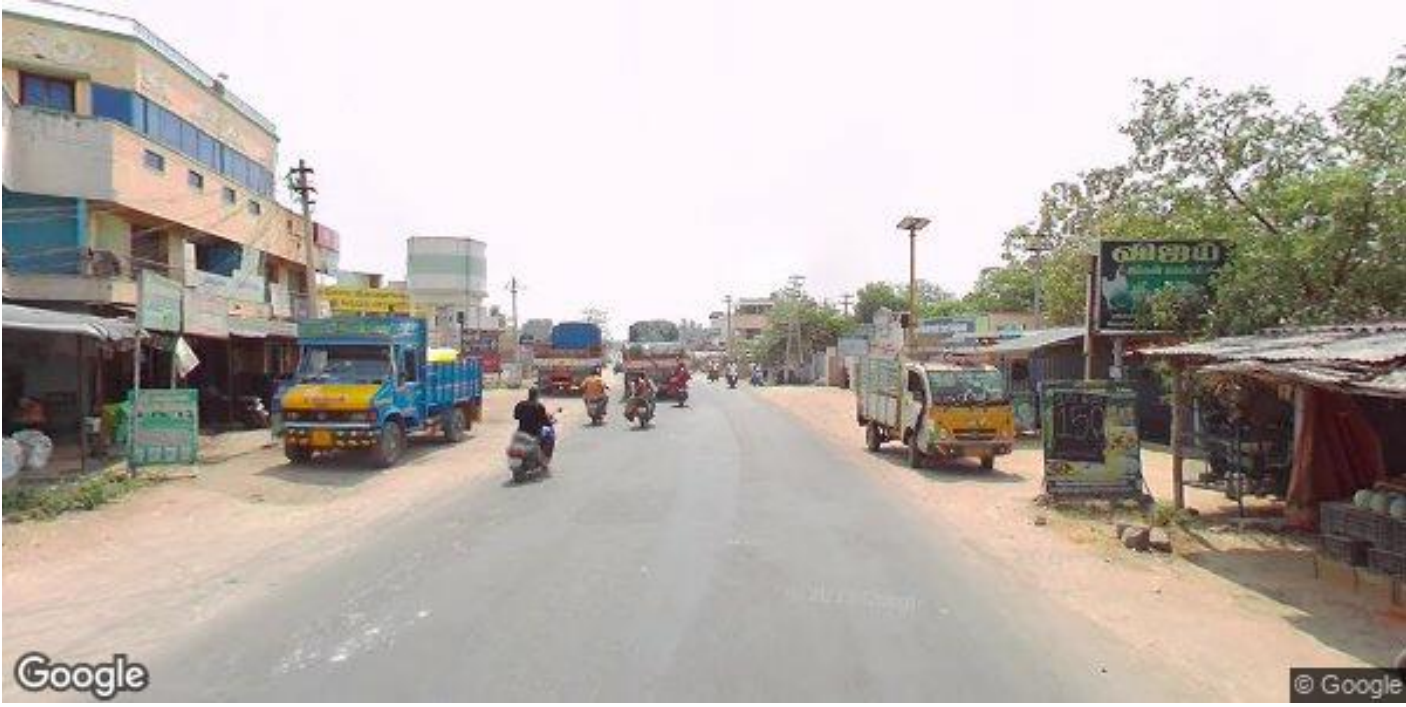
**Risk Type:** Turn  
**Risk Level:** High  
**Speed Limit:** 15 KM/Hr  
**Coordinates:** 11.73769, 78.03451

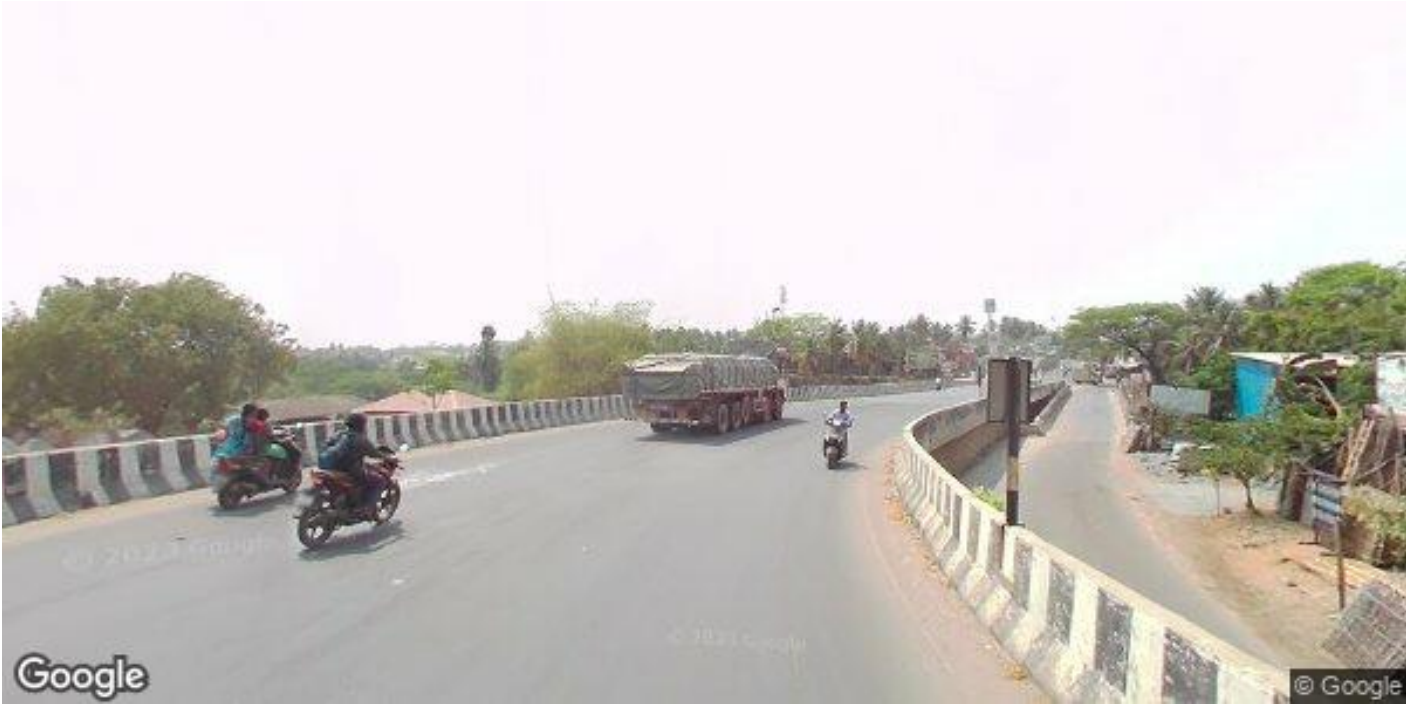
**Risk Type:** Turn  
**Risk Level:** High  
**Speed Limit:** 15 KM/Hr  
**Coordinates:** 11.73651, 78.03871

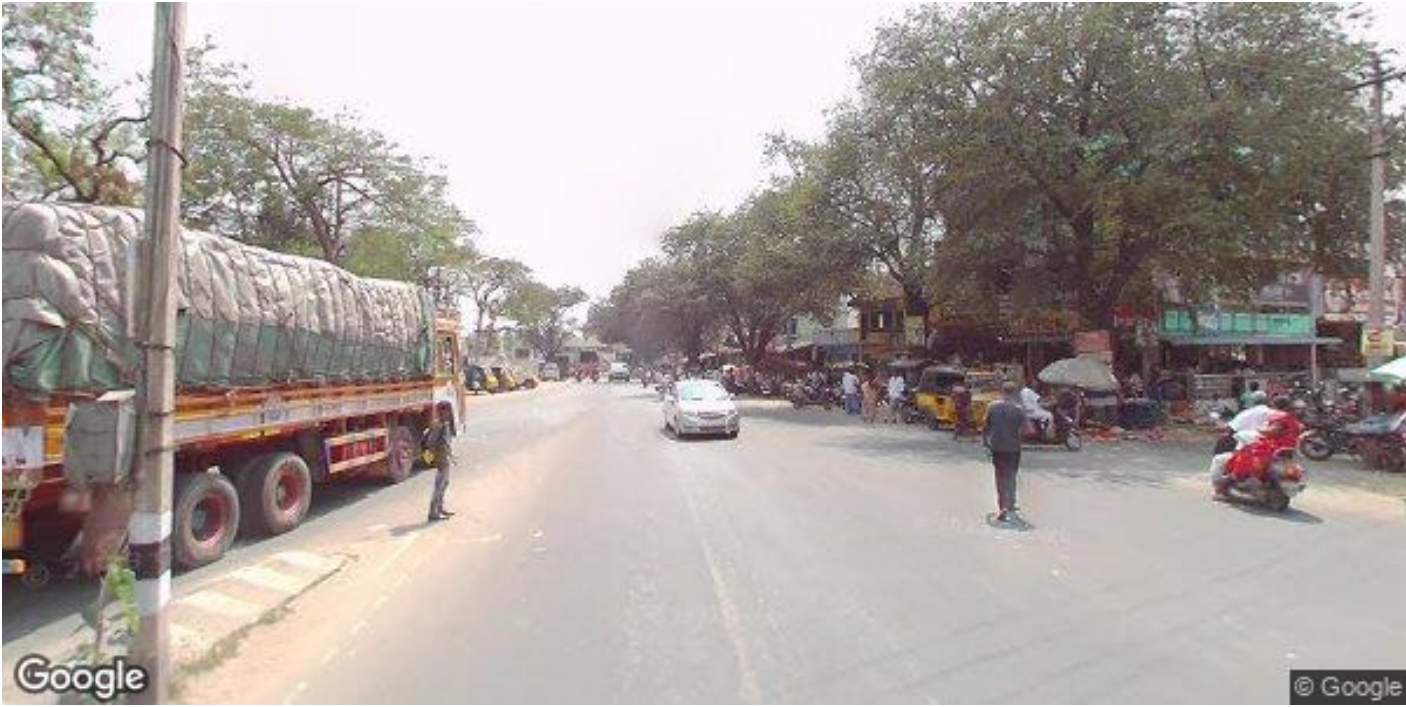
**Risk Type:** Turn  
**Risk Level:** Medium  
**Speed Limit:** 30 KM/Hr  
**Coordinates:** 11.74271, 78.04717
