## JOURNEY RISK MANAGEMENT (JRM) STUDY

**Salem Terminal to KDCMPU LTD.**

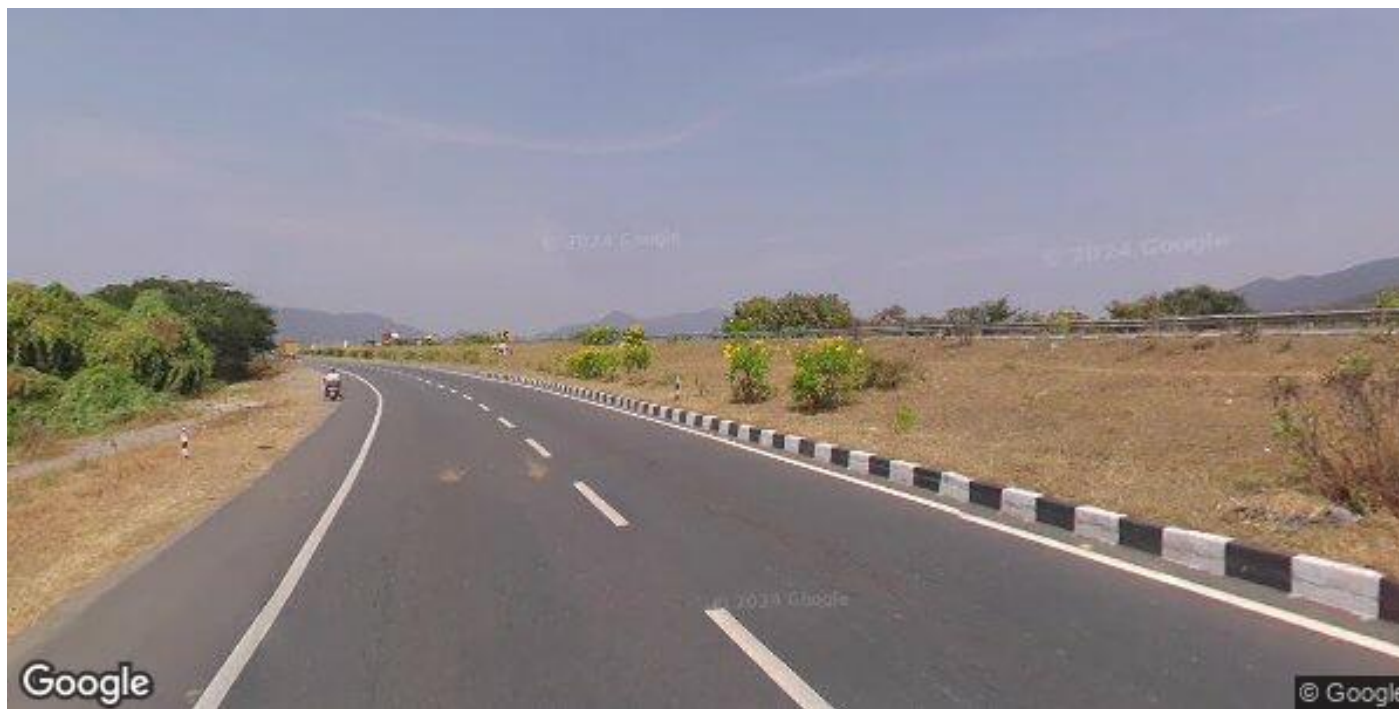
**Risk Type:** Turn  
**Risk Level:** Medium  
**Speed Limit:** 30 KM/Hr  
**Coordinates:** 11.92585, 78.06507

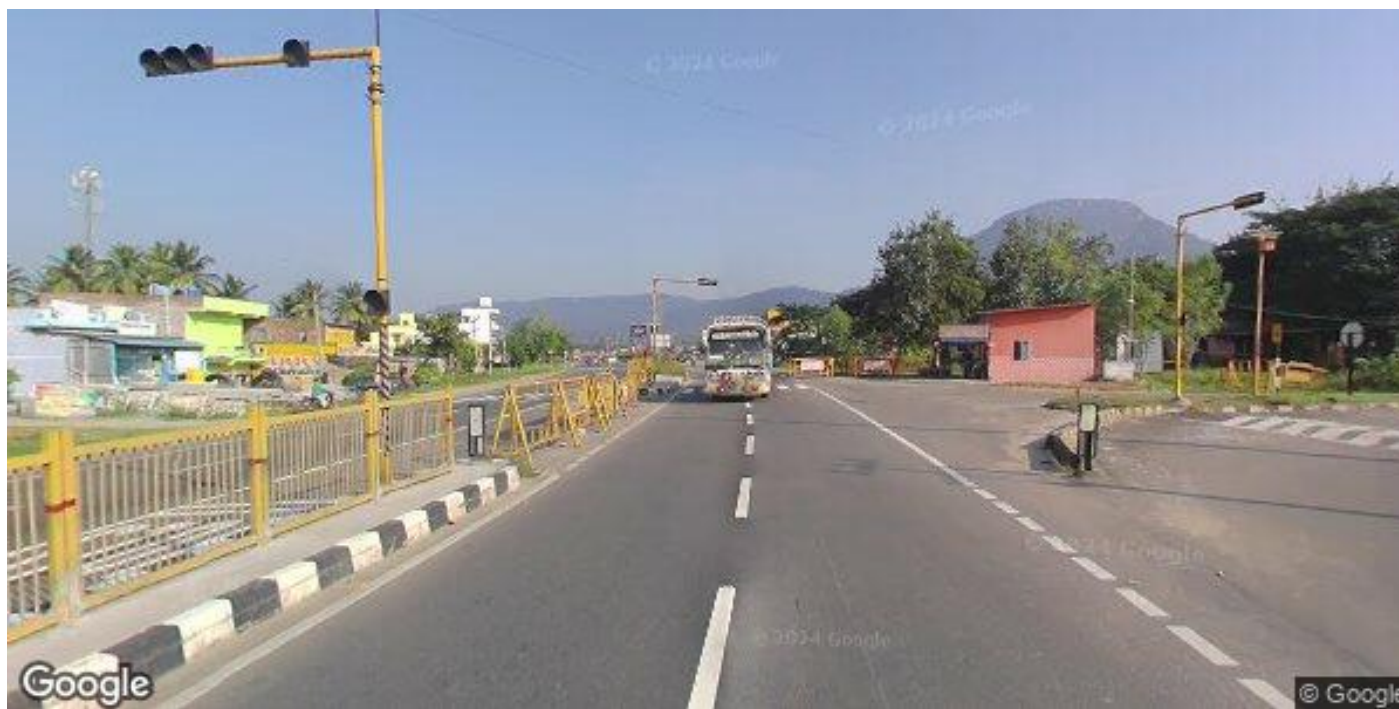
**Risk Type:** Turn  
**Risk Level:** Medium  
**Speed Limit:** 30 KM/Hr  
**Coordinates:** 11.93704, 78.05402

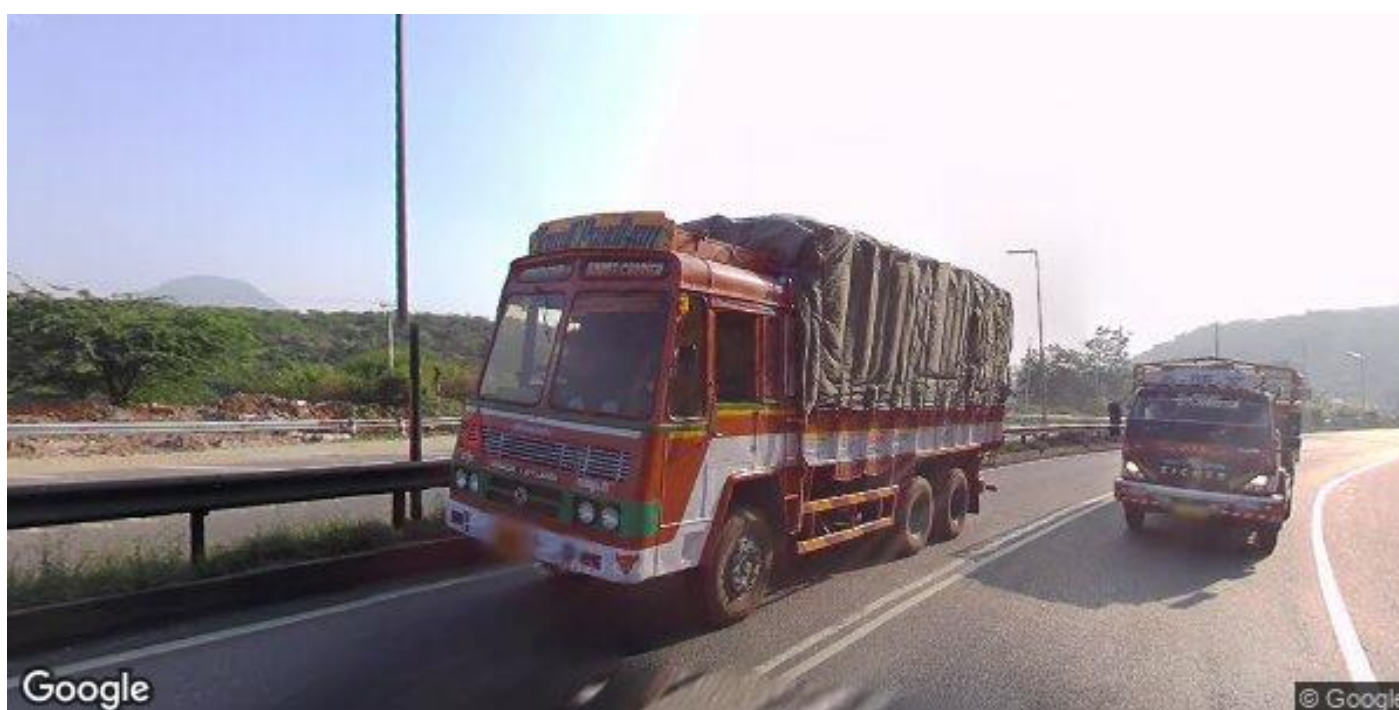
**Risk Type:** Turn  
**Risk Level:** High  
**Speed Limit:** 15 KM/Hr  
**Coordinates:** 11.95818, 78.04978

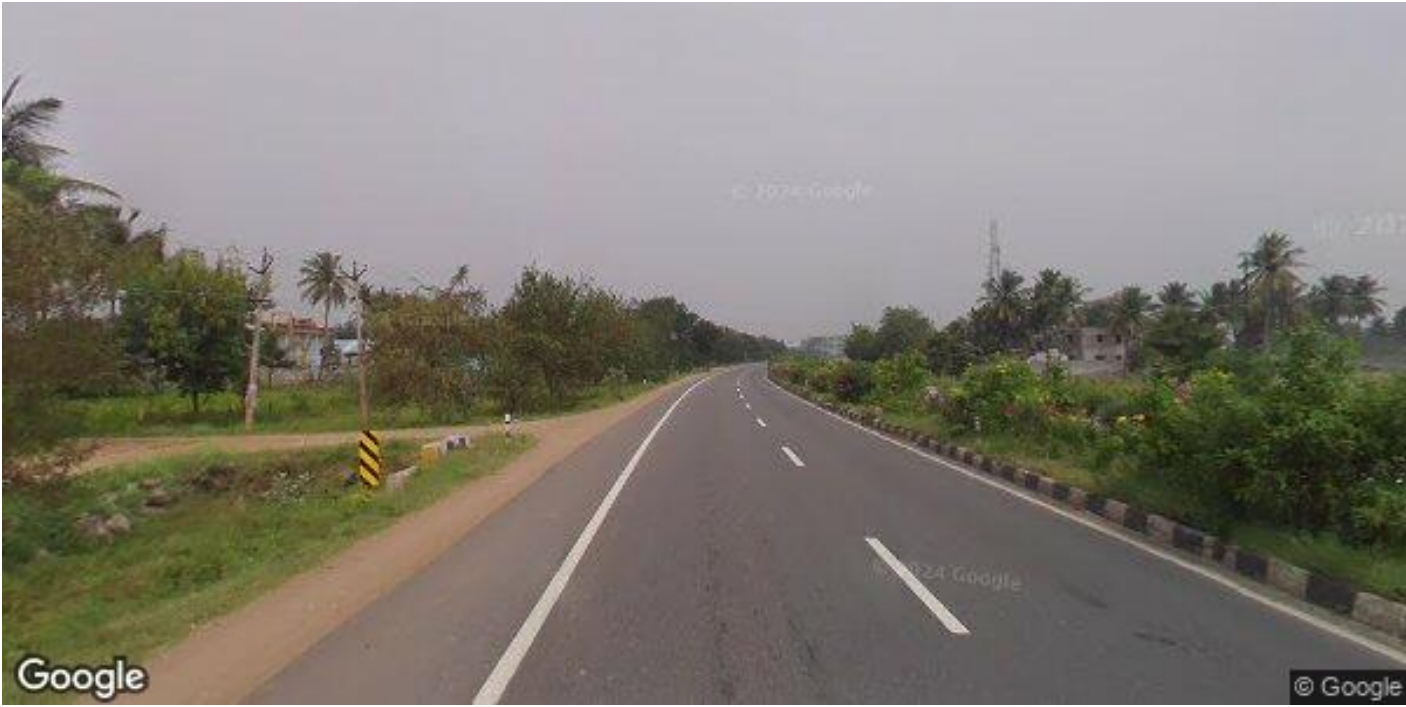
**Risk Type:** Turn  
**Risk Level:** Medium  
**Speed Limit:** 30 KM/Hr  
**Coordinates:** 12.19881, 78.18157

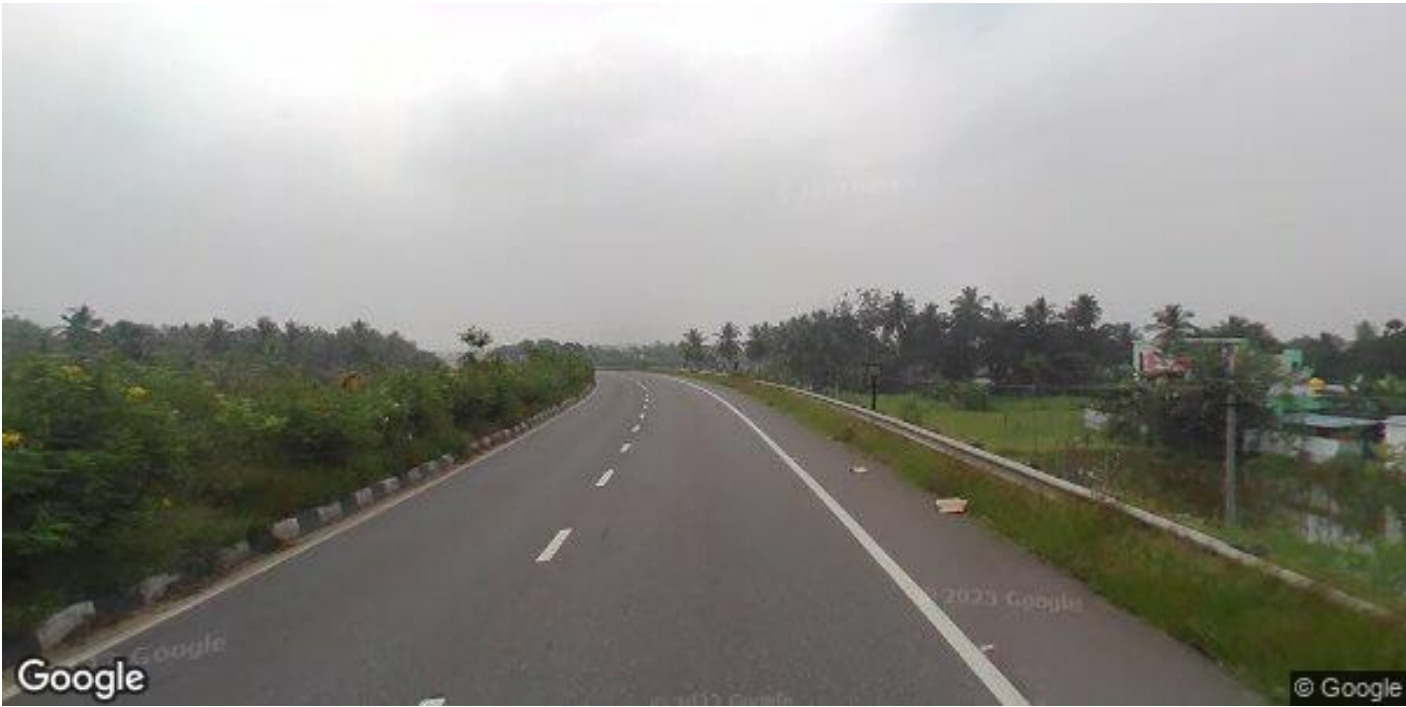
**Risk Type:** Turn  
**Risk Level:** Medium  
**Speed Limit:** 30 KM/Hr  
**Coordinates:** 12.22459, 78.19136

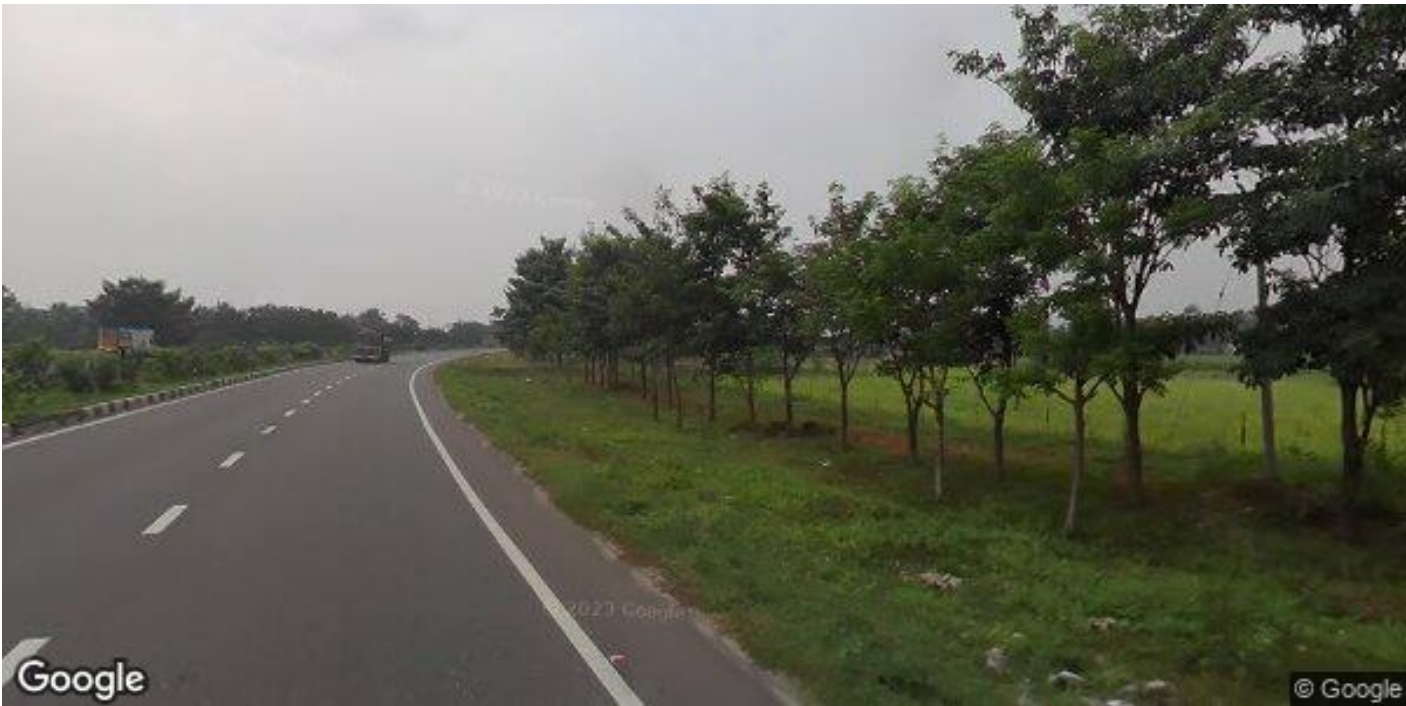
**Risk Type:** Turn  
**Risk Level:** Medium  
**Speed Limit:** 30 KM/Hr  
**Coordinates:** 12.25060, 78.19977

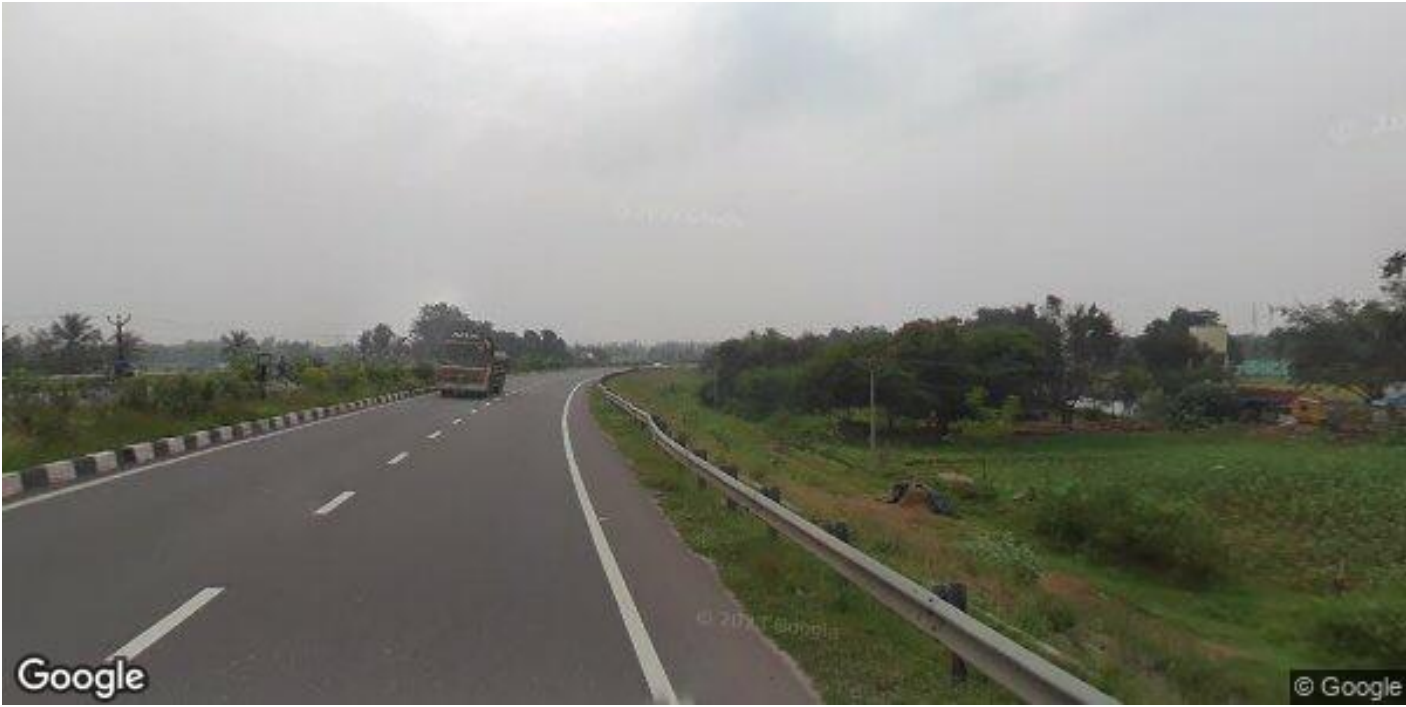
**Risk Type:** Turn  
**Risk Level:** Medium  
**Speed Limit:** 30 KM/Hr  
**Coordinates:** 12.25329, 78.20039

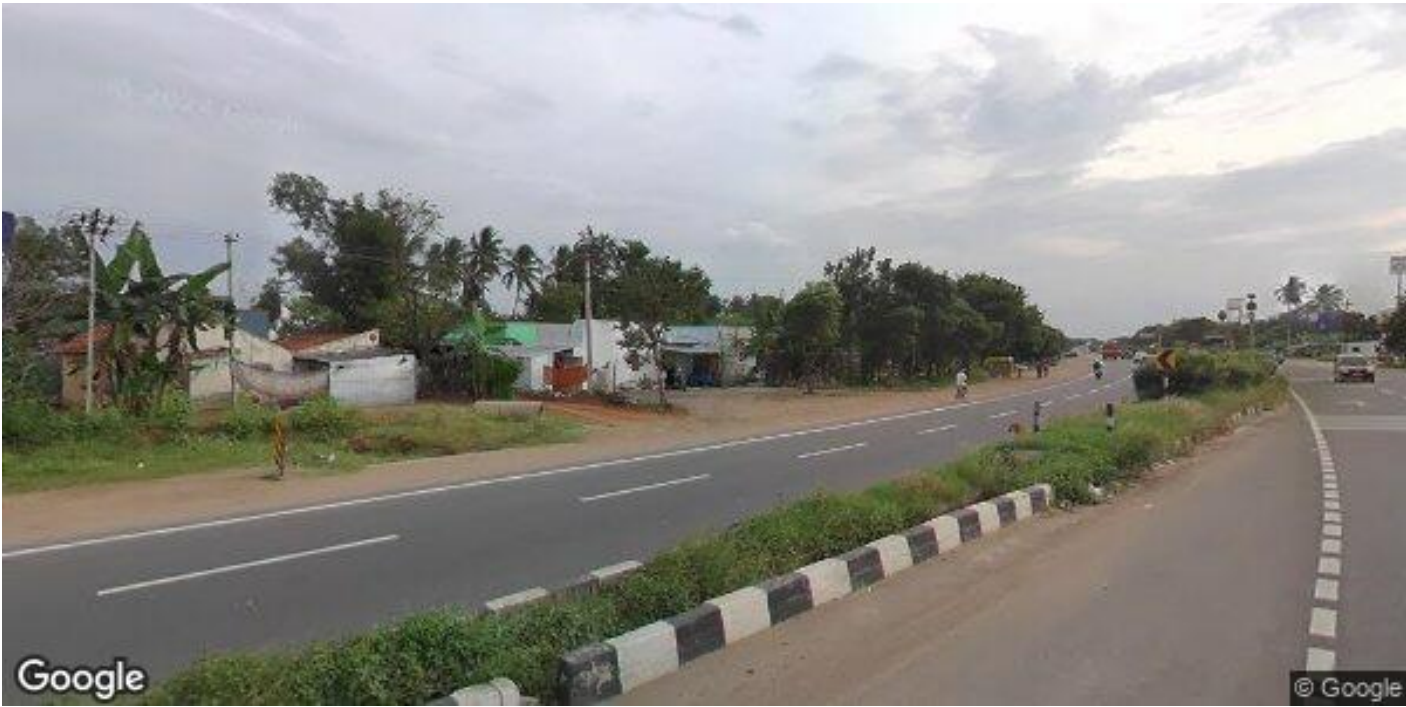
**Risk Type:** Turn  
**Risk Level:** Medium  
**Speed Limit:** 30 KM/Hr  
**Coordinates:** 12.29110, 78.19909

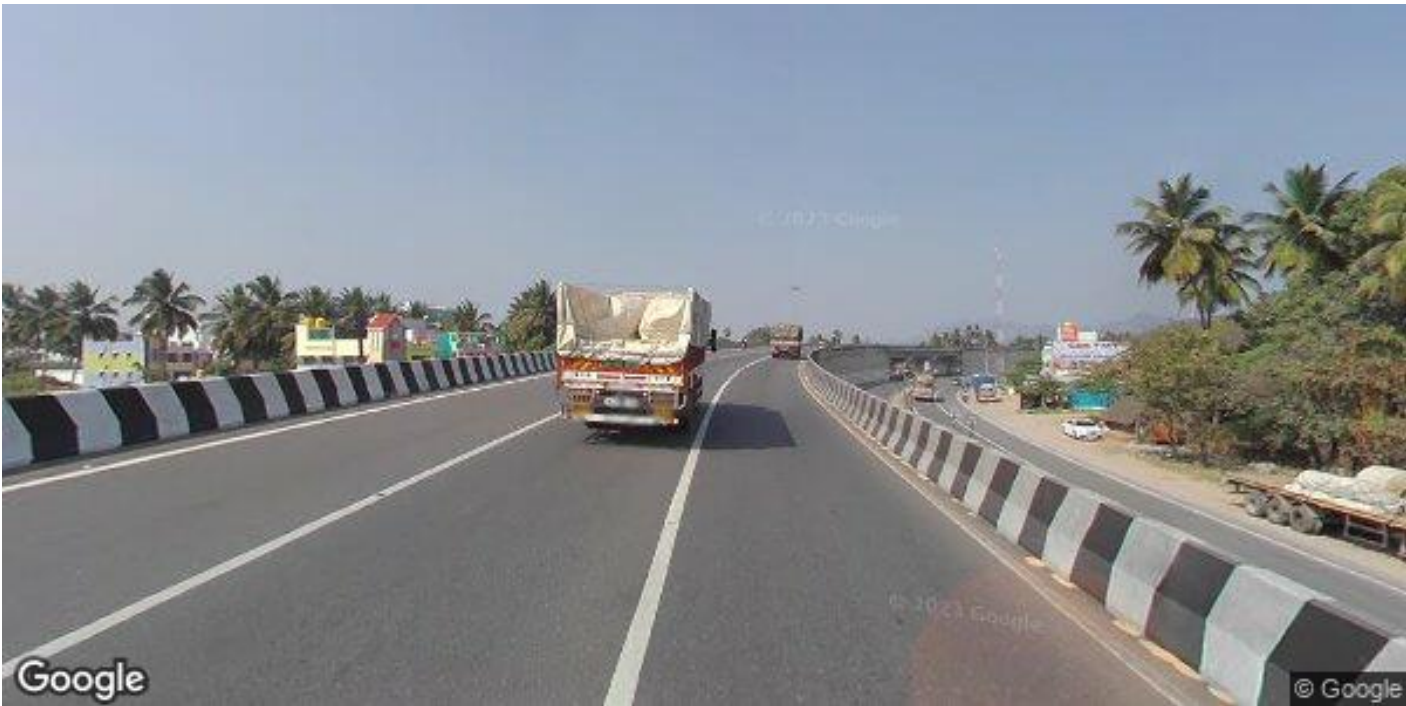
**Risk Type:** Turn  
**Risk Level:** Medium  
**Speed Limit:** 30 KM/Hr  
**Coordinates:** 12.39904, 78.21764

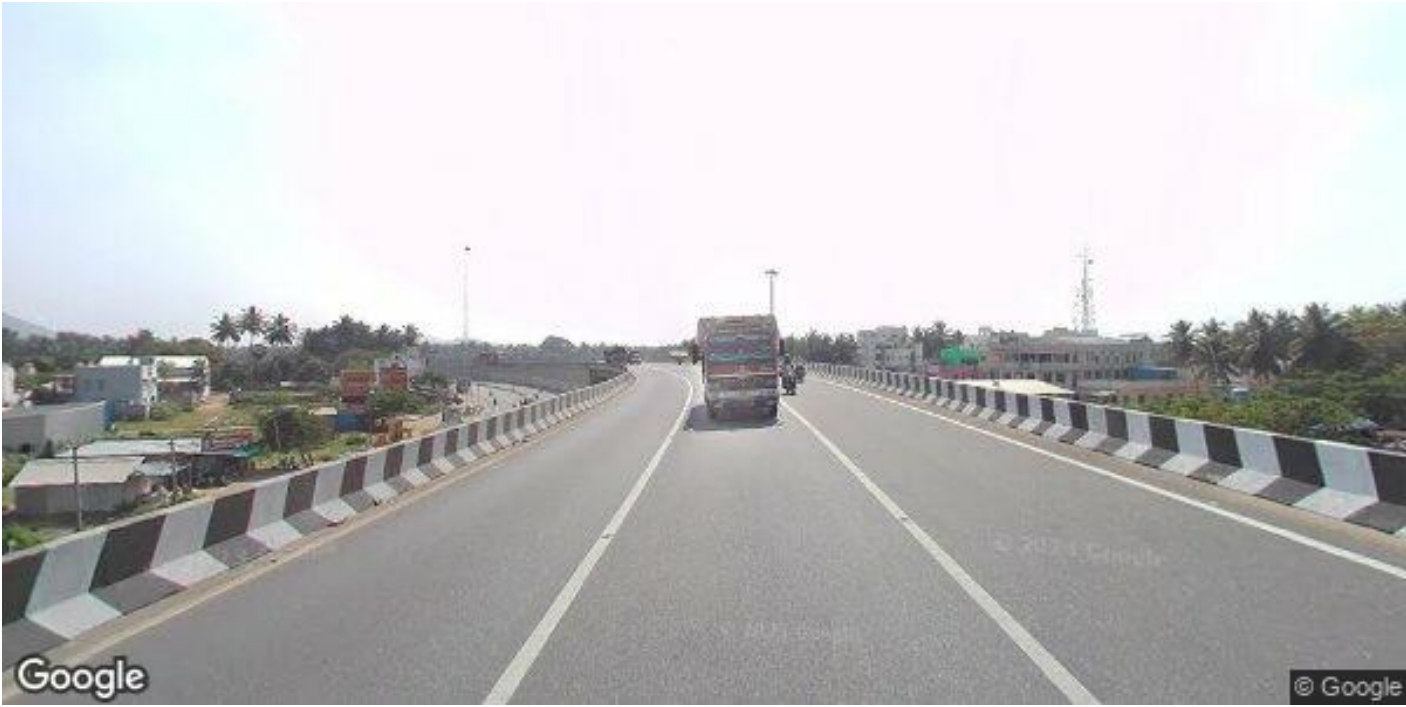
**Risk Type:** Turn  
**Risk Level:** Medium  
**Speed Limit:** 30 KM/Hr  
**Coordinates:** 12.40156, 78.21845

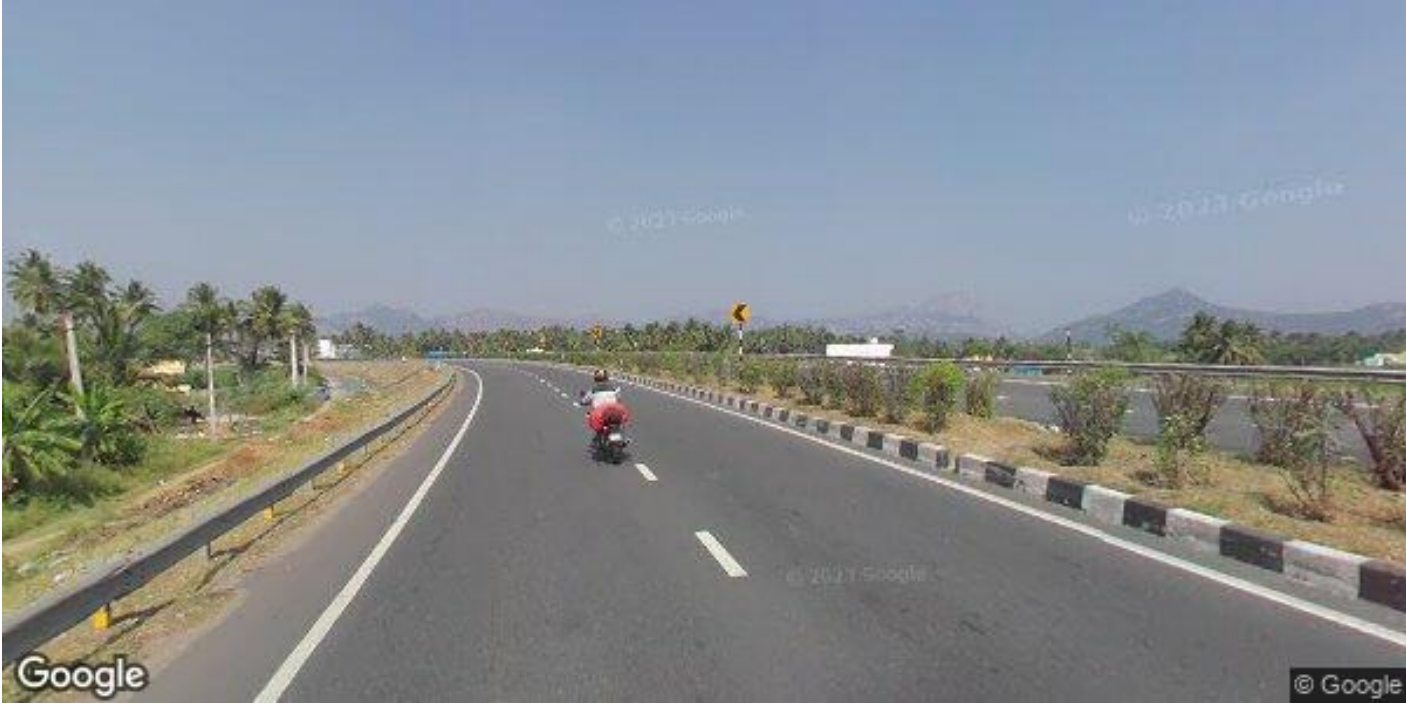
**Risk Type:** Turn  
**Risk Level:** Medium  
**Speed Limit:** 30 KM/Hr  
**Coordinates:** 12.40589, 78.22275

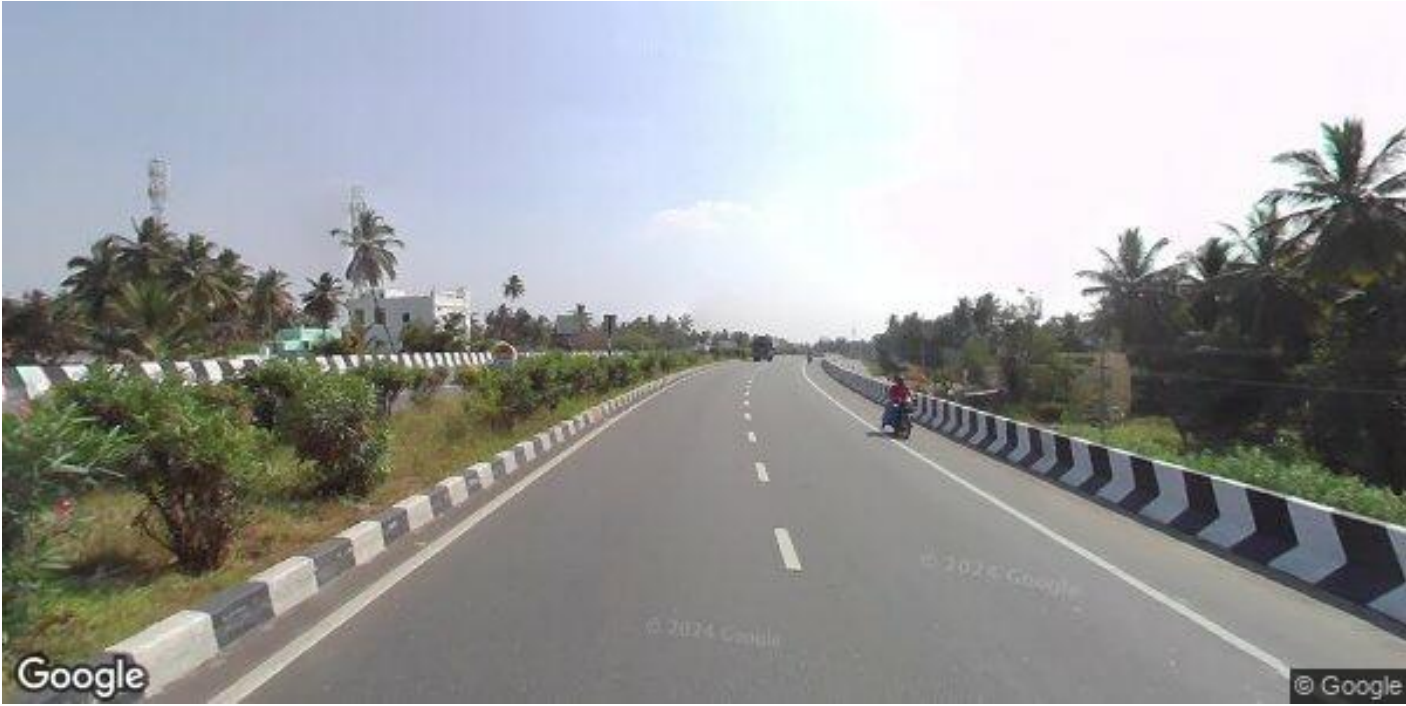
**Risk Type:** Turn  
**Risk Level:** Medium  
**Speed Limit:** 30 KM/Hr  
**Coordinates:** 12.45018, 78.21828

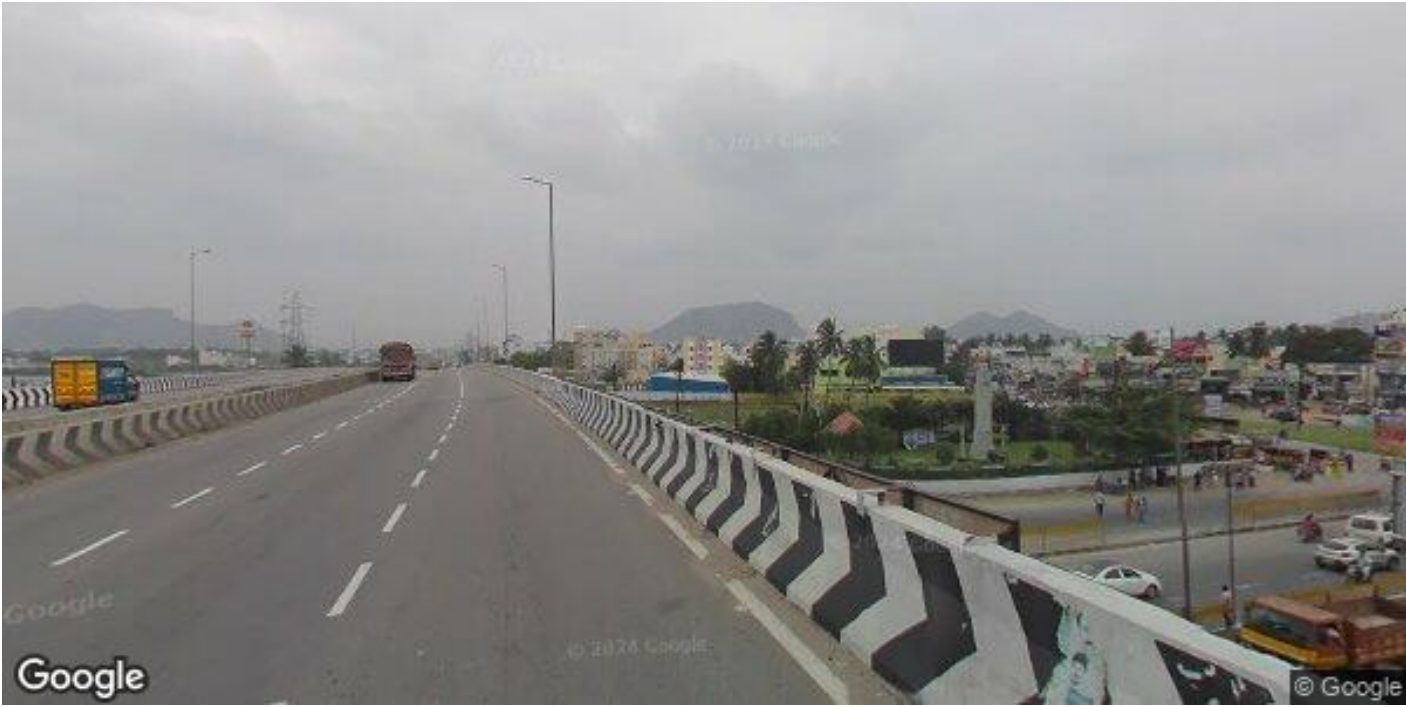
**Risk Type:** Blind Spot  
**Risk Level:** Blind Spot  
**Speed Limit:** 10 KM/Hr  
**Coordinates:** 12.50718, 78.22253
