## JOURNEY RISK MANAGEMENT (JRM) STUDY

### Salem Terminal TO SATHYA AGENCIES

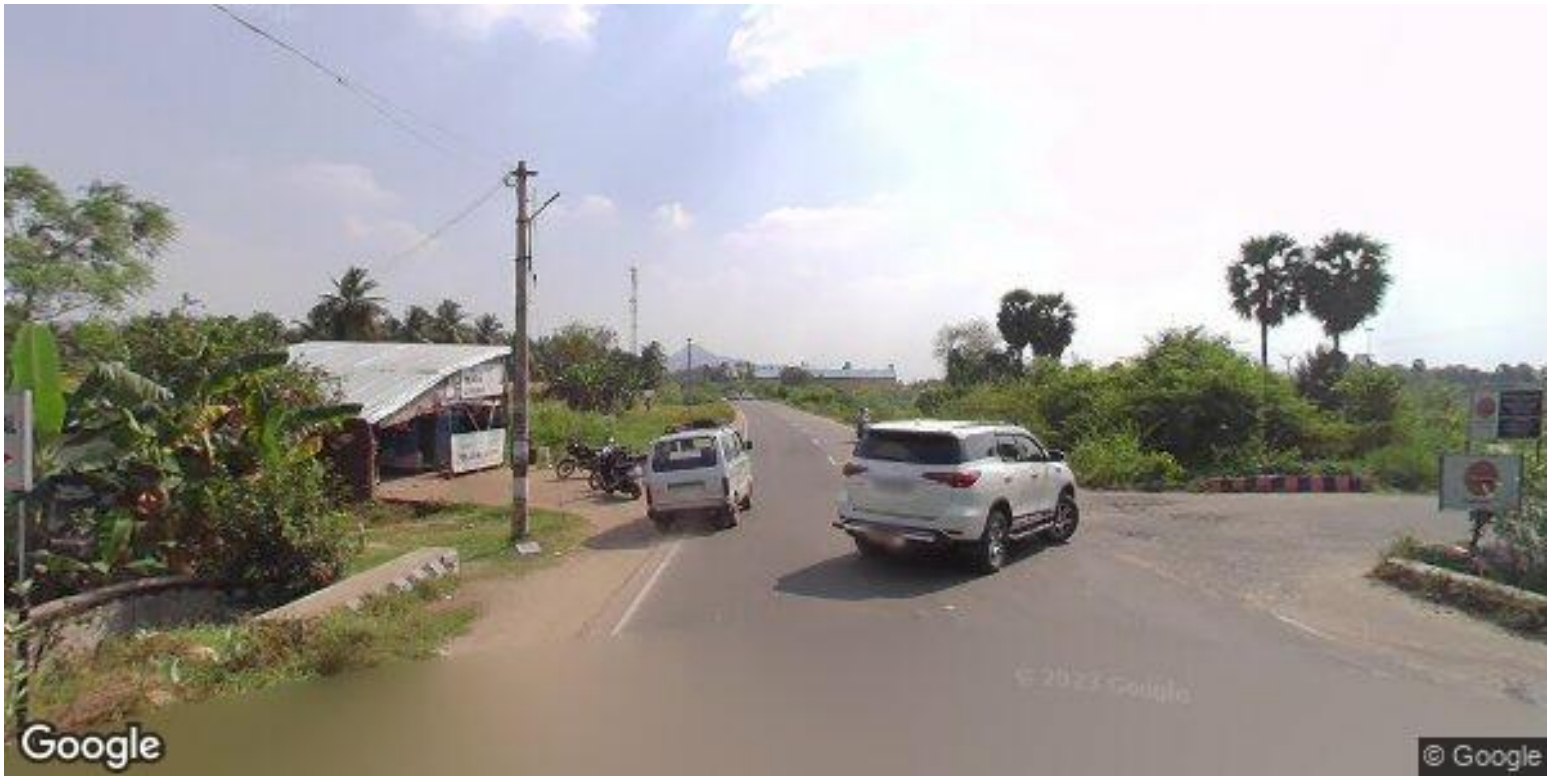
**Risk Type:** Blind Spot  
**Risk Level:** Blind Spot  
**Speed Limit:** 10 KM/Hr  
**Coordinates:** 11.44029, 77.87544

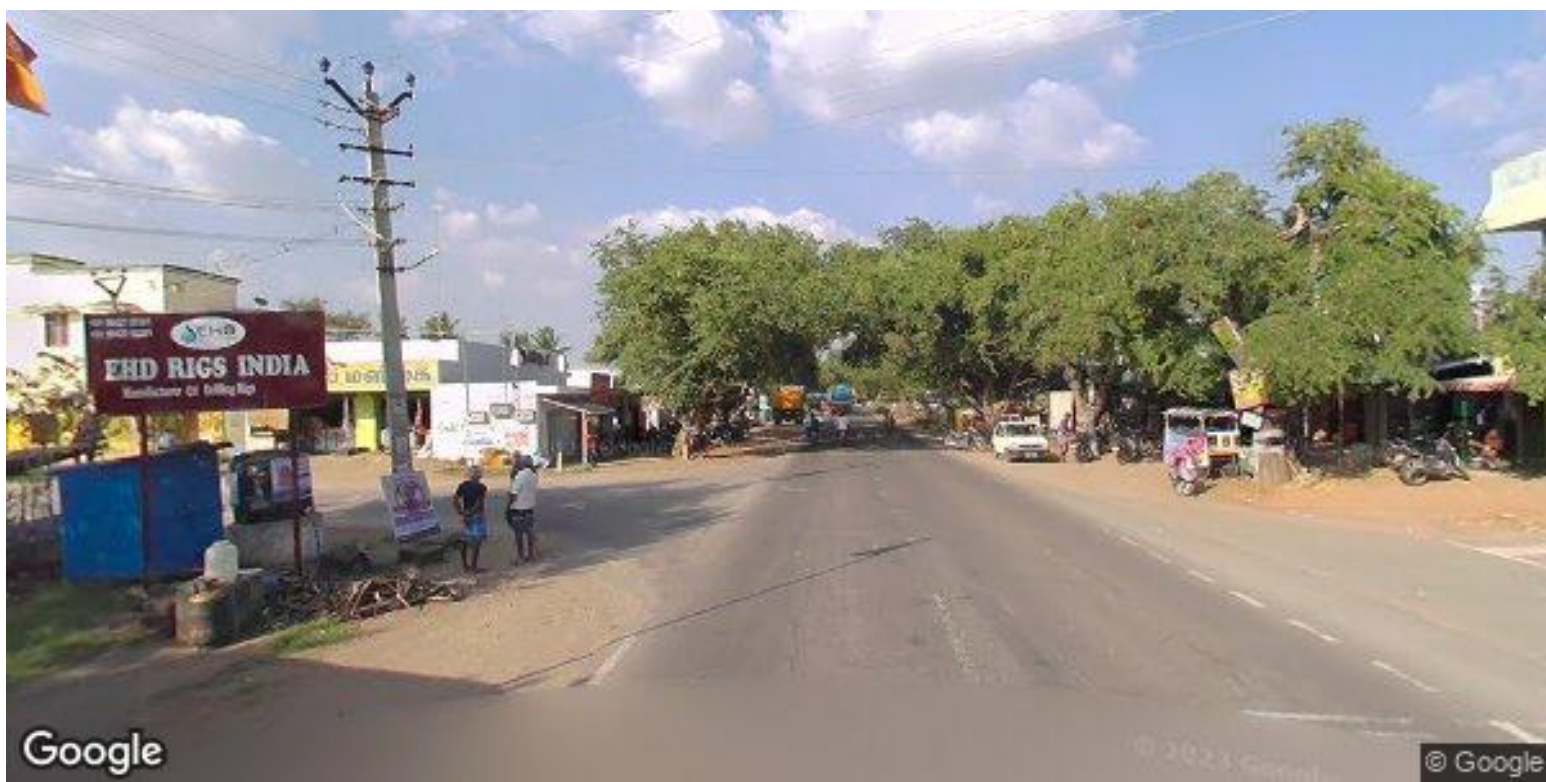
**Coordinates:** 11.41975, 77.88075

**Risk Type:** Turn

**Risk Level:** High

**Speed Limit:** 15 KM/Hr

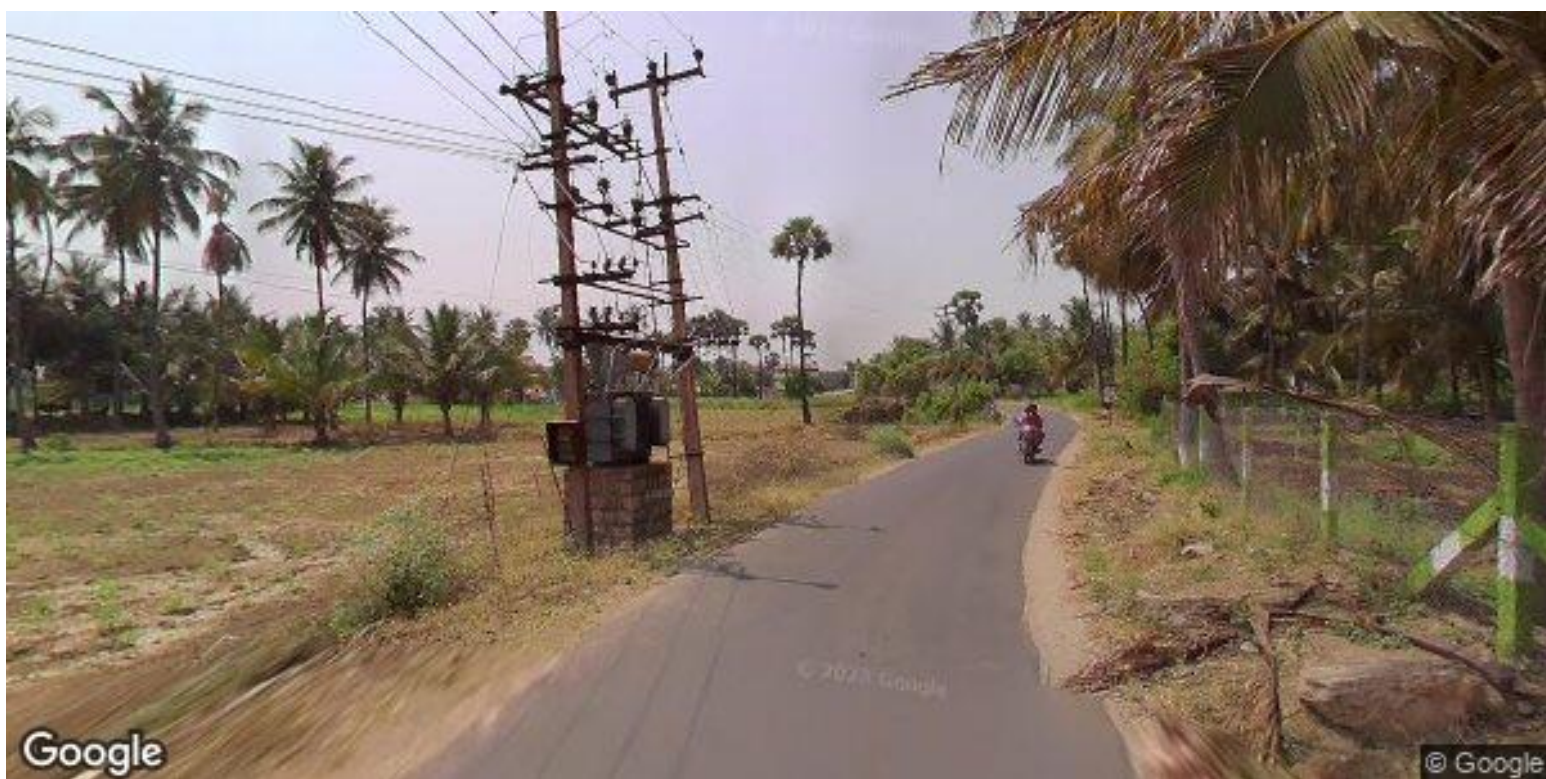
**Coordinates:** 11.41840, 77.88528

**Risk Type:** Turn

**Risk Level:** Medium

**Speed Limit:** 30 KM/Hr

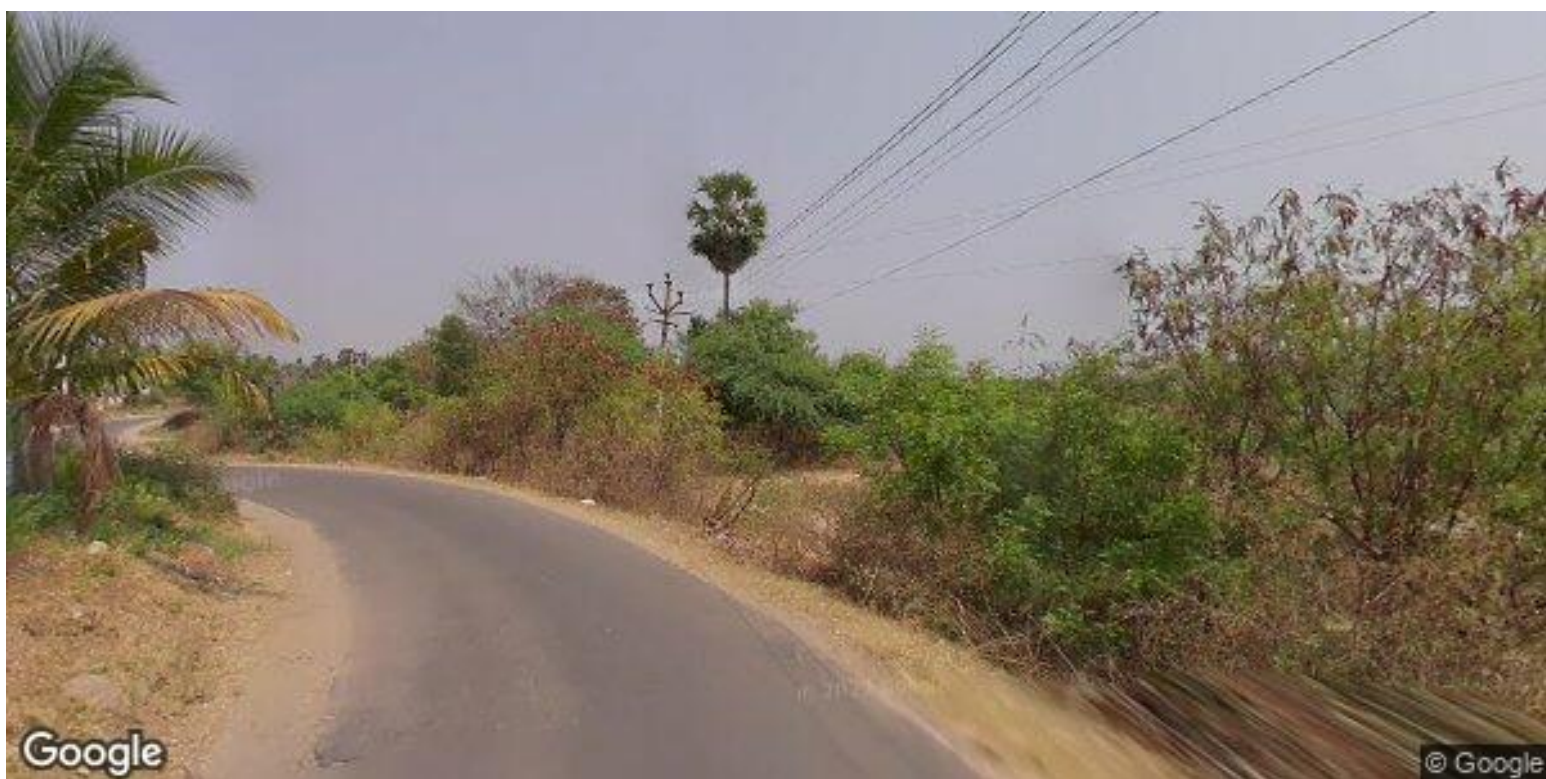
**Risk Type:** Turn  
**Risk Level:** Medium  
**Speed Limit:** 30 KM/Hr  
**Coordinates:** 11.41829, 77.88568

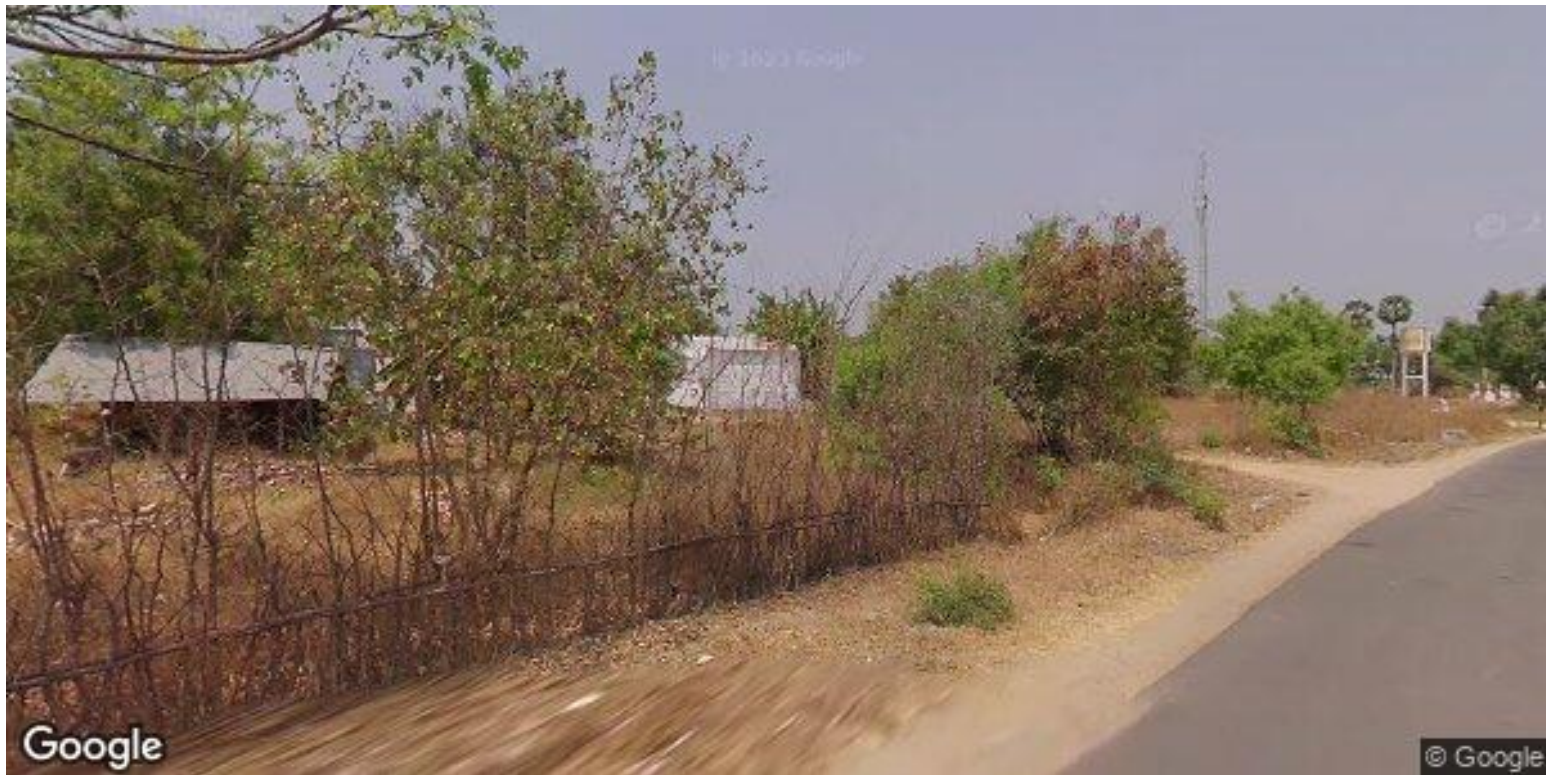
**Risk Type:** Turn  
**Risk Level:** Medium  
**Speed Limit:** 30 KM/Hr  
**Coordinates:** 11.41849, 77.88613

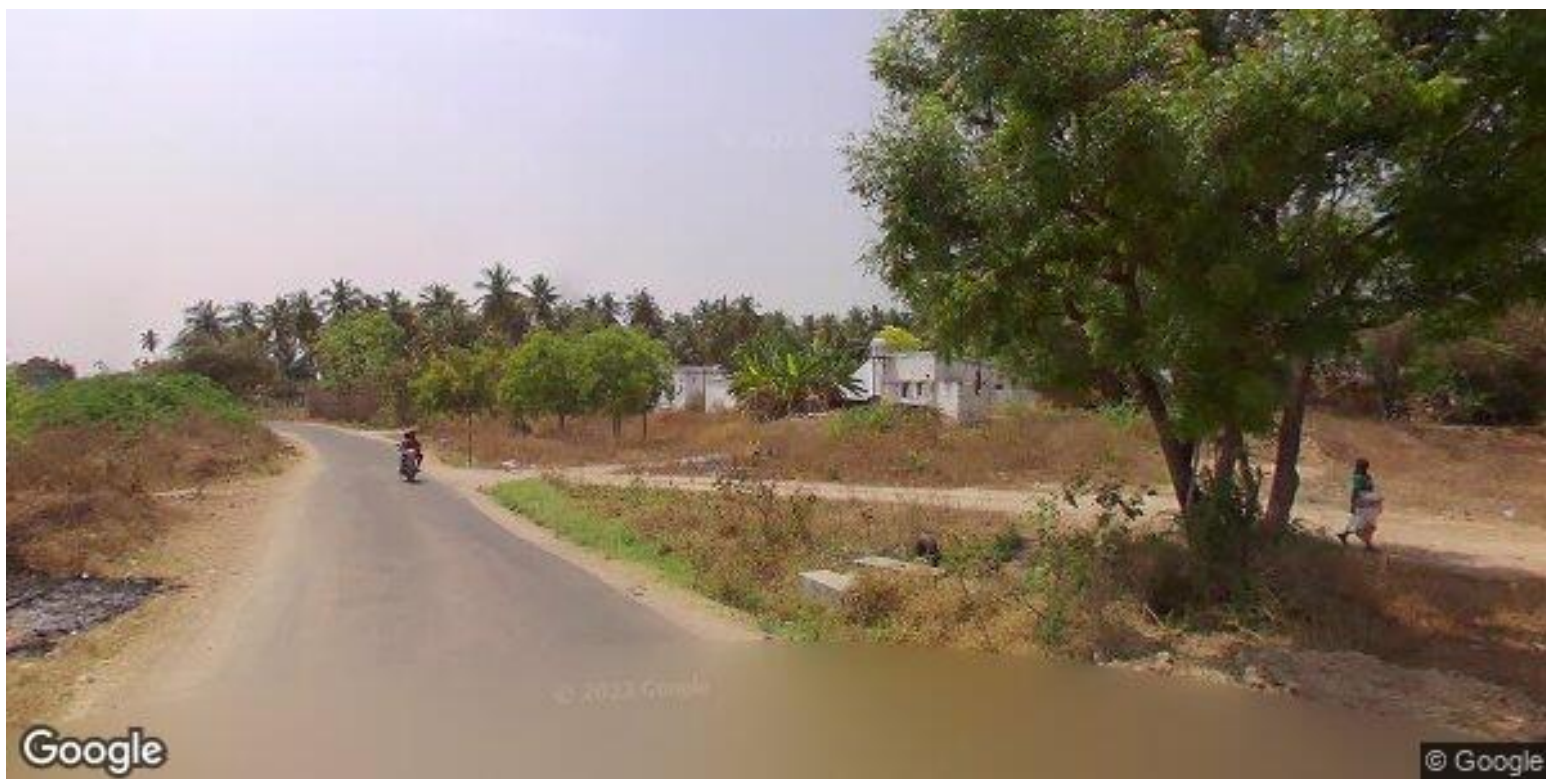
**Risk Type:** Turn  
**Risk Level:** Medium  
**Speed Limit:** 30 KM/Hr  
**Coordinates:** 11.41861, 77.88687

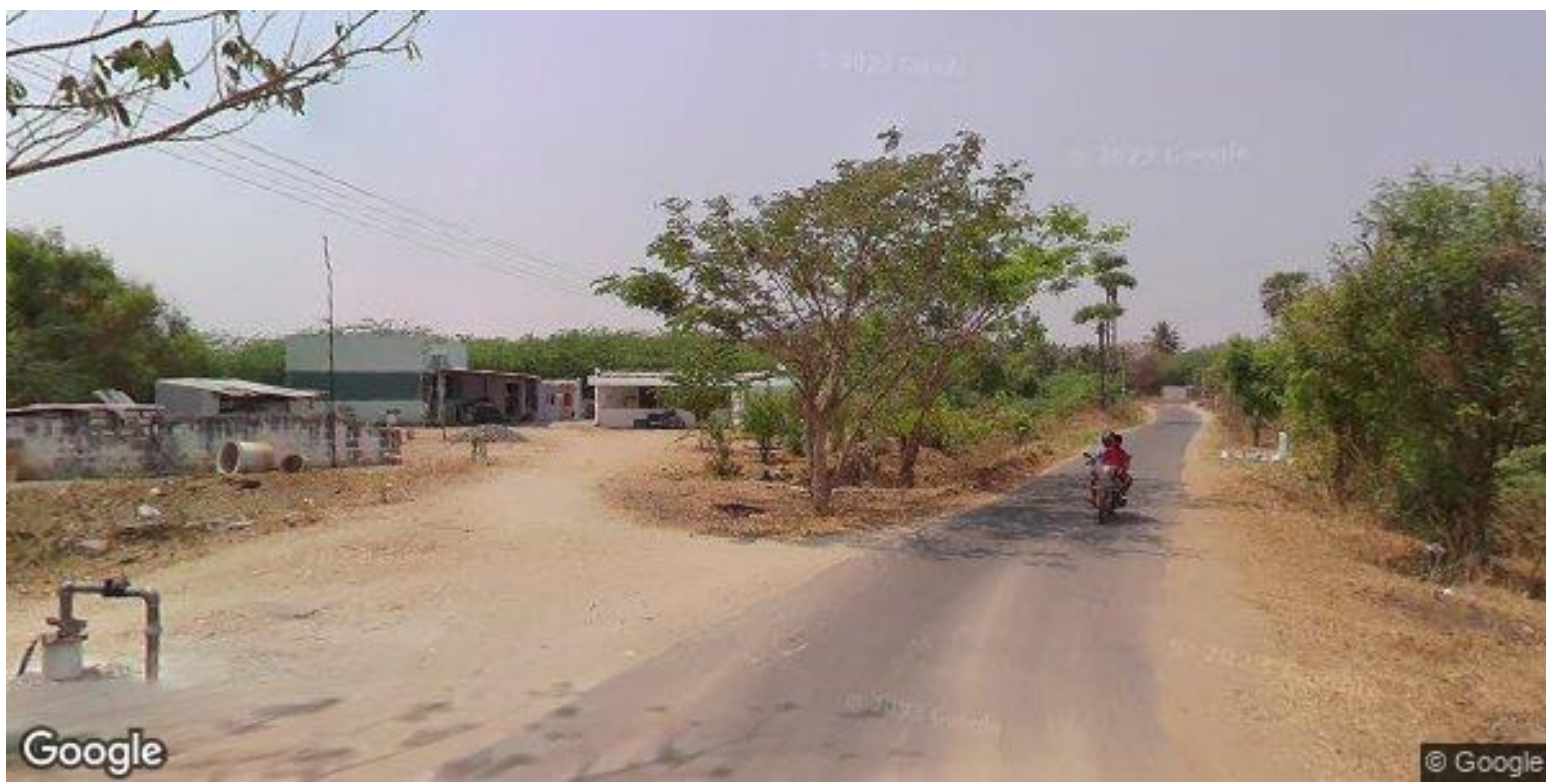
**Coordinates:** 11.41768, 77.88731

**Risk Type:** Turn

**Risk Level:** Medium

**Speed Limit:** 30 KM/Hr

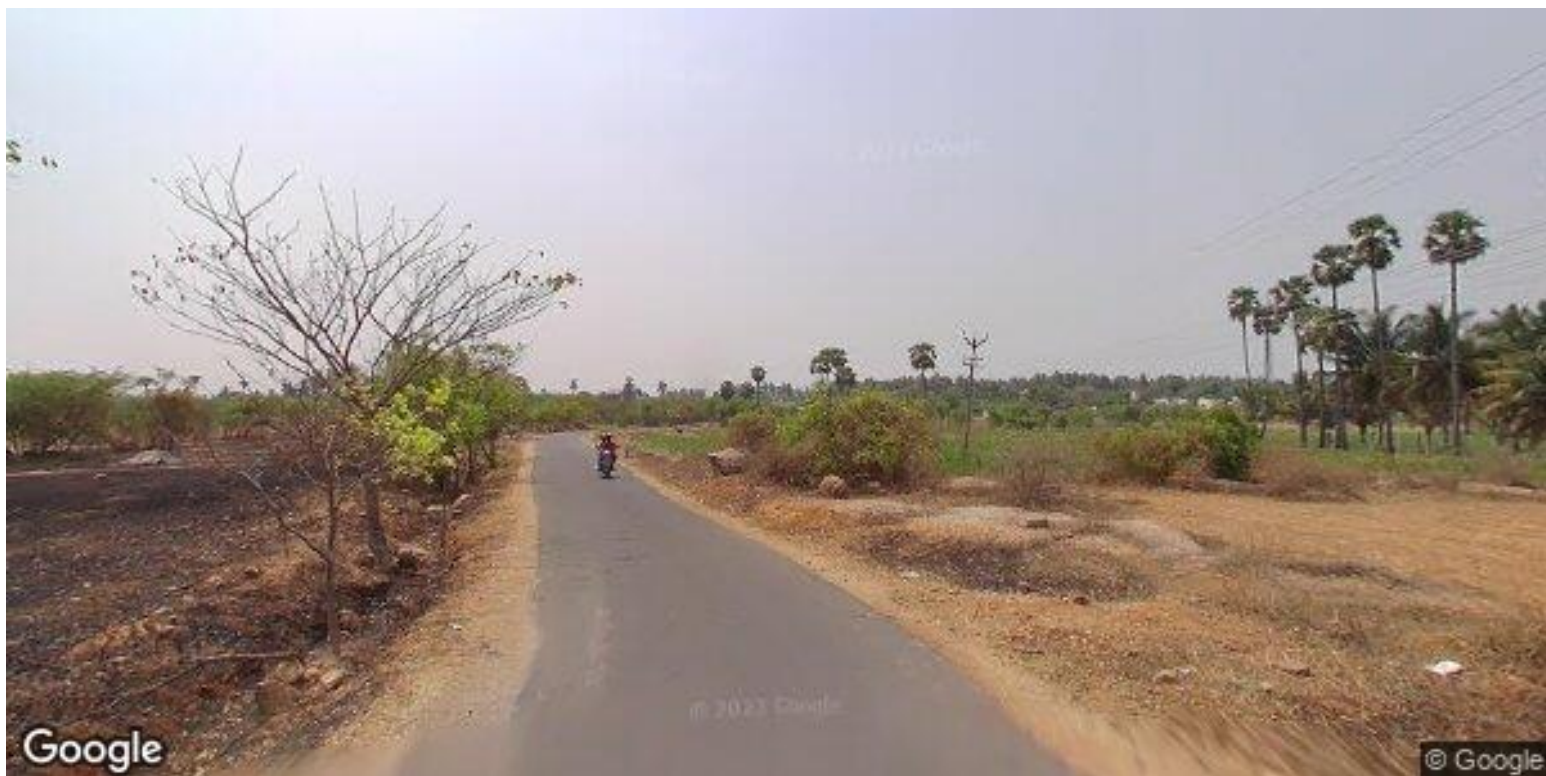
**Coordinates:** 11.41721, 77.88924

**Risk Type:** Turn

**Risk Level:** Medium

**Speed Limit:** 30 KM/Hr

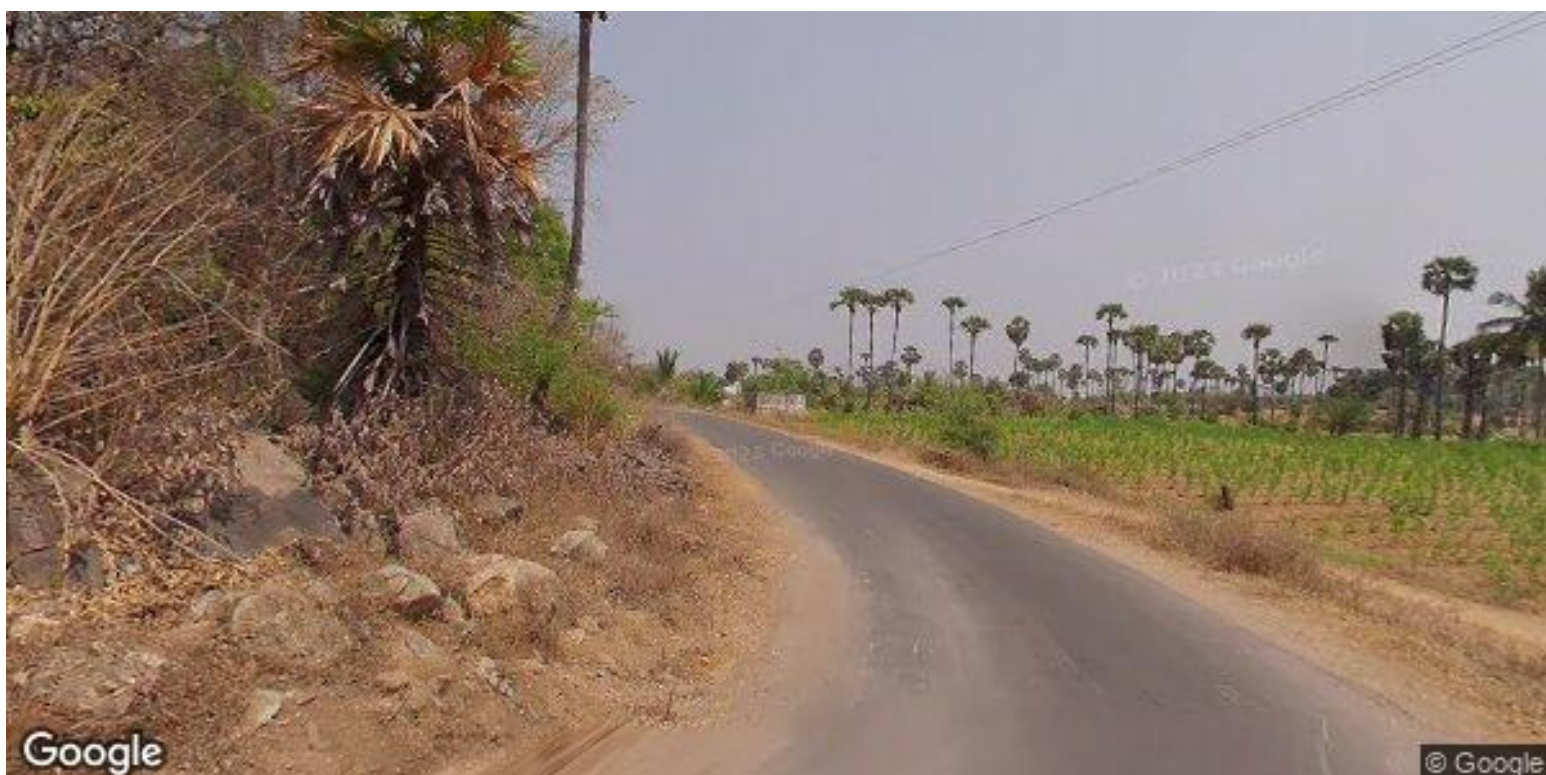
**Risk Type:** Turn  
**Risk Level:** Medium  
**Speed Limit:** 30 KM/Hr  
**Coordinates:** 11.41378, 77.90072

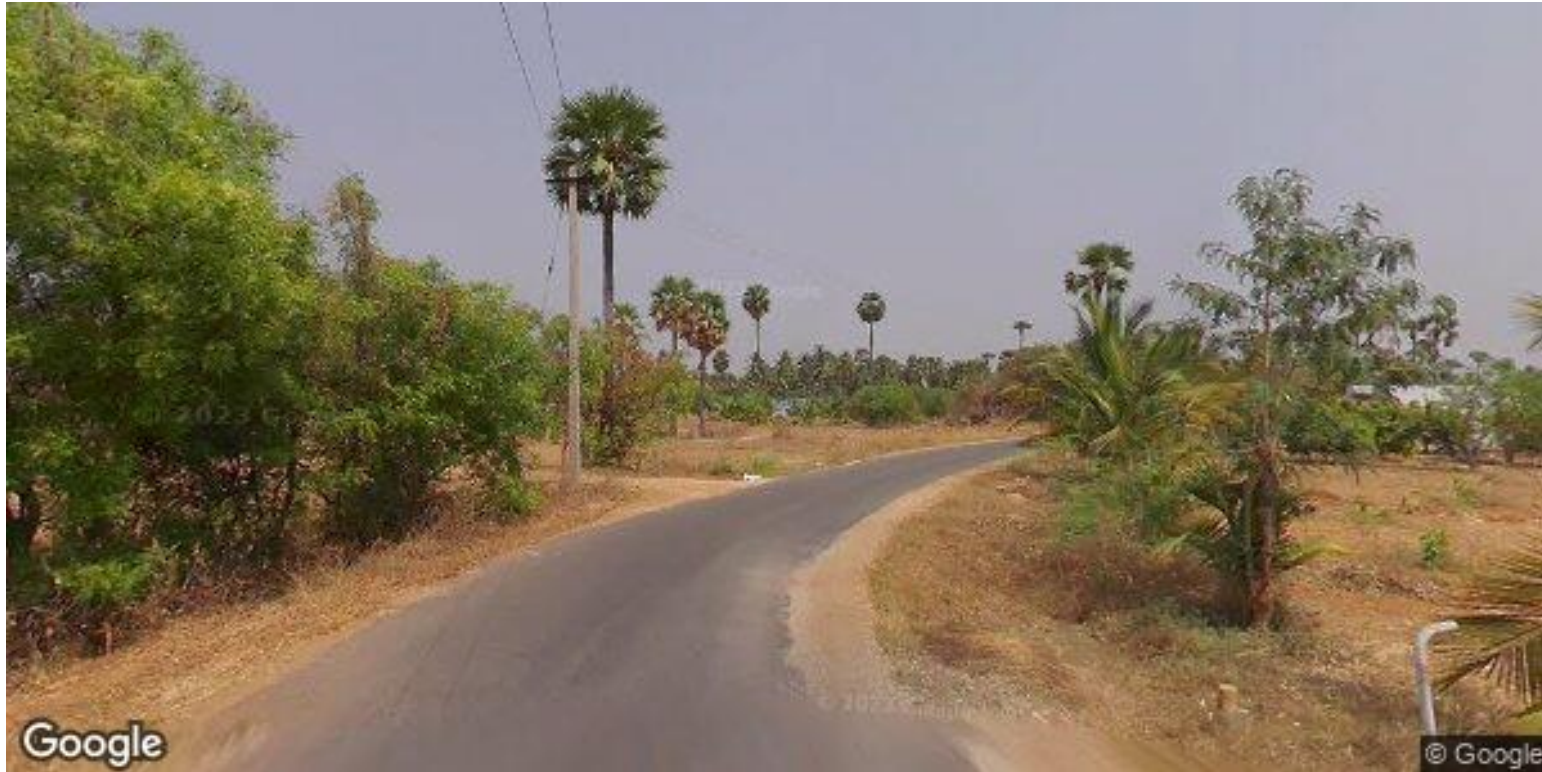
**Risk Type:** Turn  
**Risk Level:** Medium  
**Speed Limit:** 30 KM/Hr  
**Coordinates:** 11.41389, 77.90165

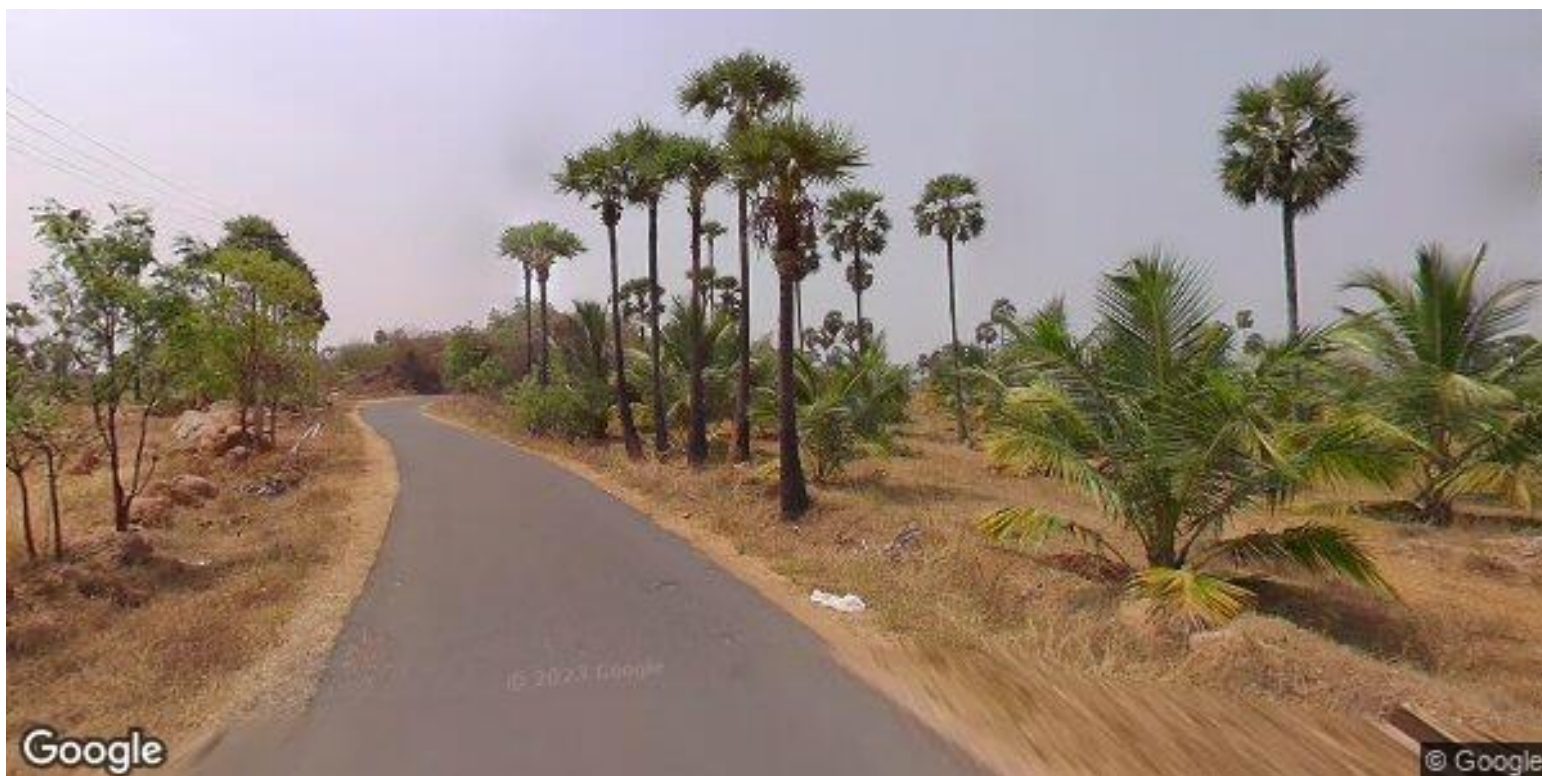
**Risk Type:** Turn  
**Risk Level:** Medium  
**Speed Limit:** 30 KM/Hr  
**Coordinates:** 11.41330, 77.90306

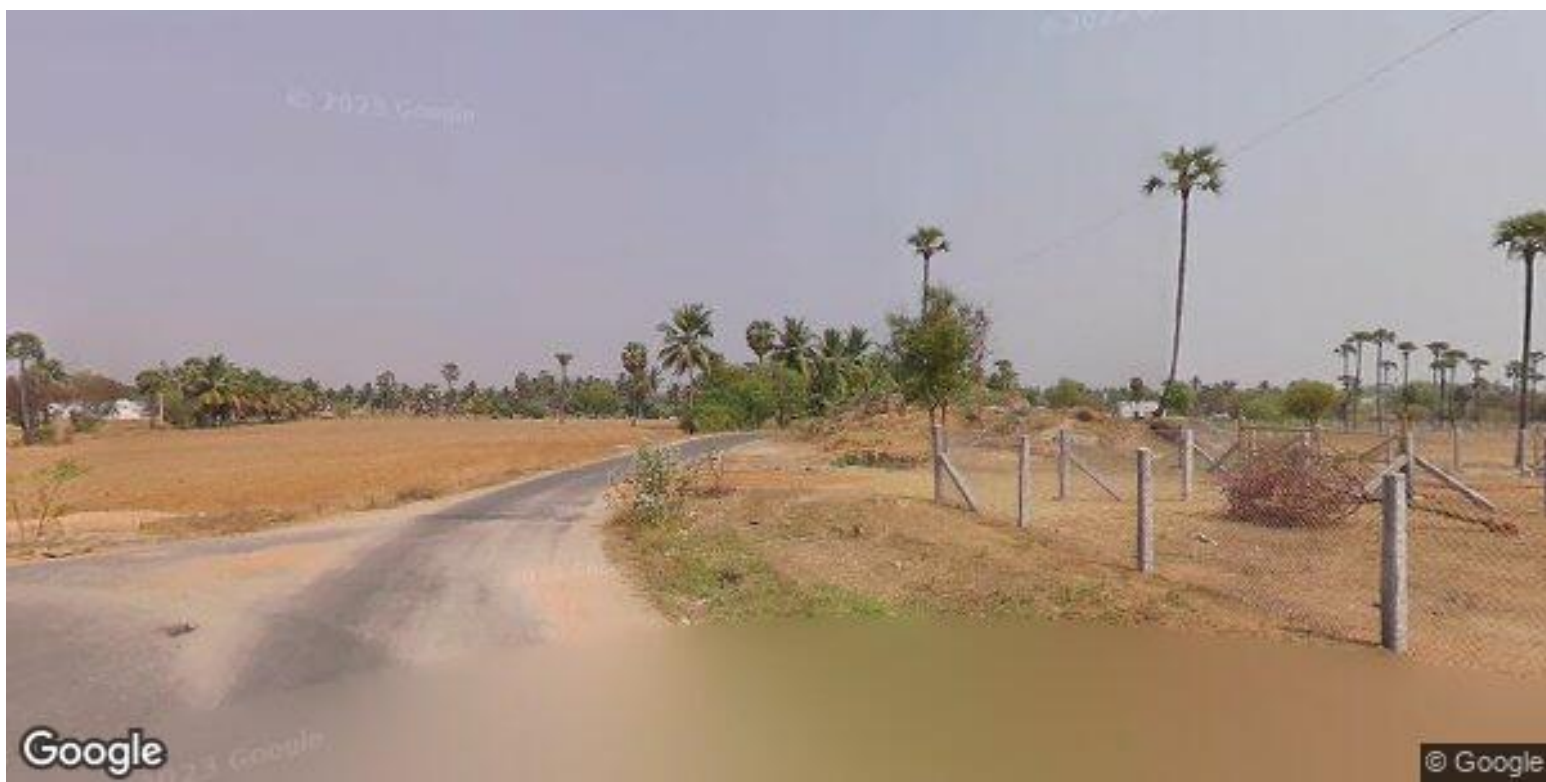
**Coordinates:** 11.41231, 77.90487

**Risk Type:** Turn

**Risk Level:** Medium

**Speed Limit:** 30 KM/Hr

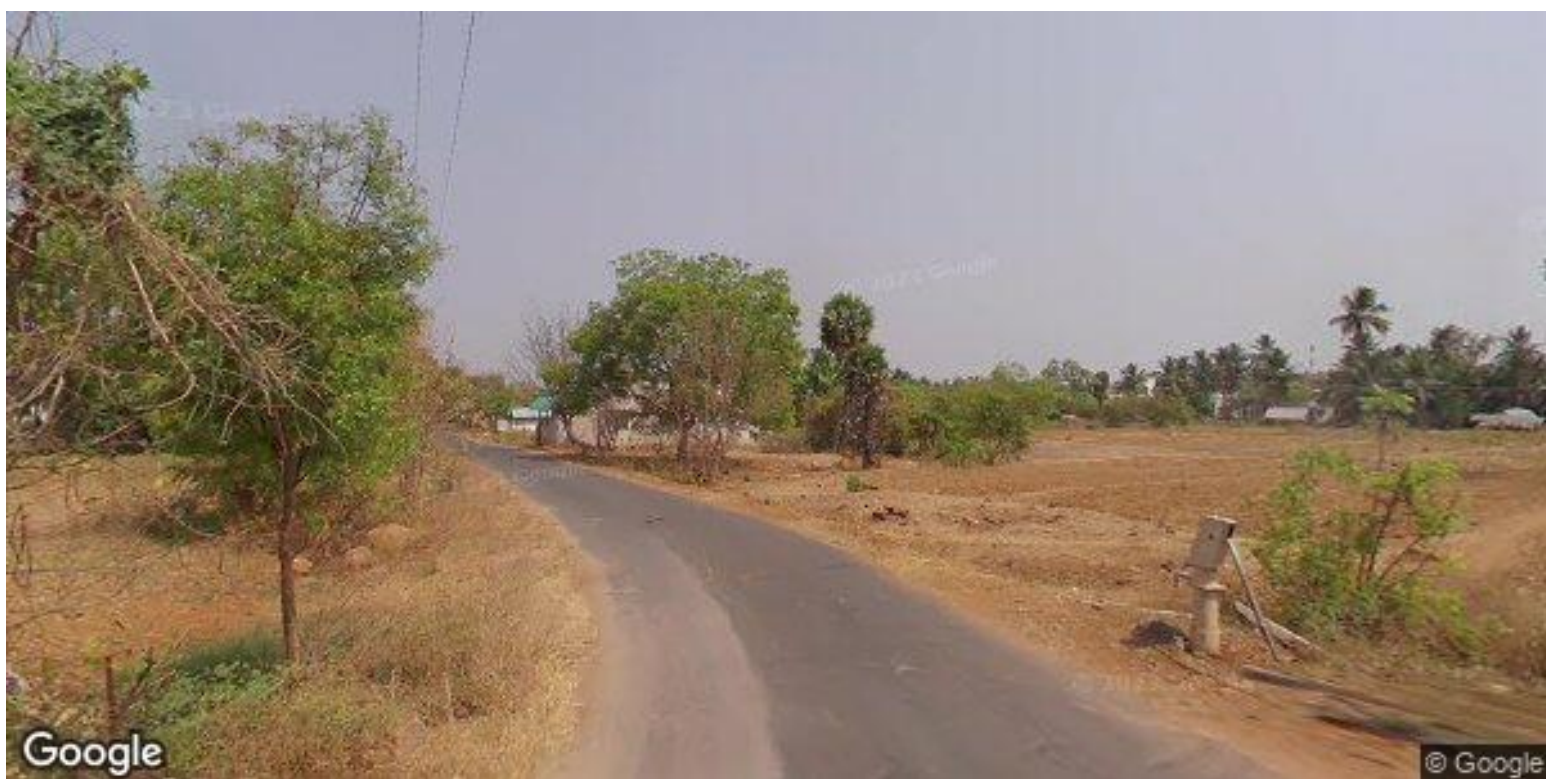
**Coordinates:** 11.41110, 77.90632

**Risk Type:** Turn

**Risk Level:** Medium

**Speed Limit:** 30 KM/Hr

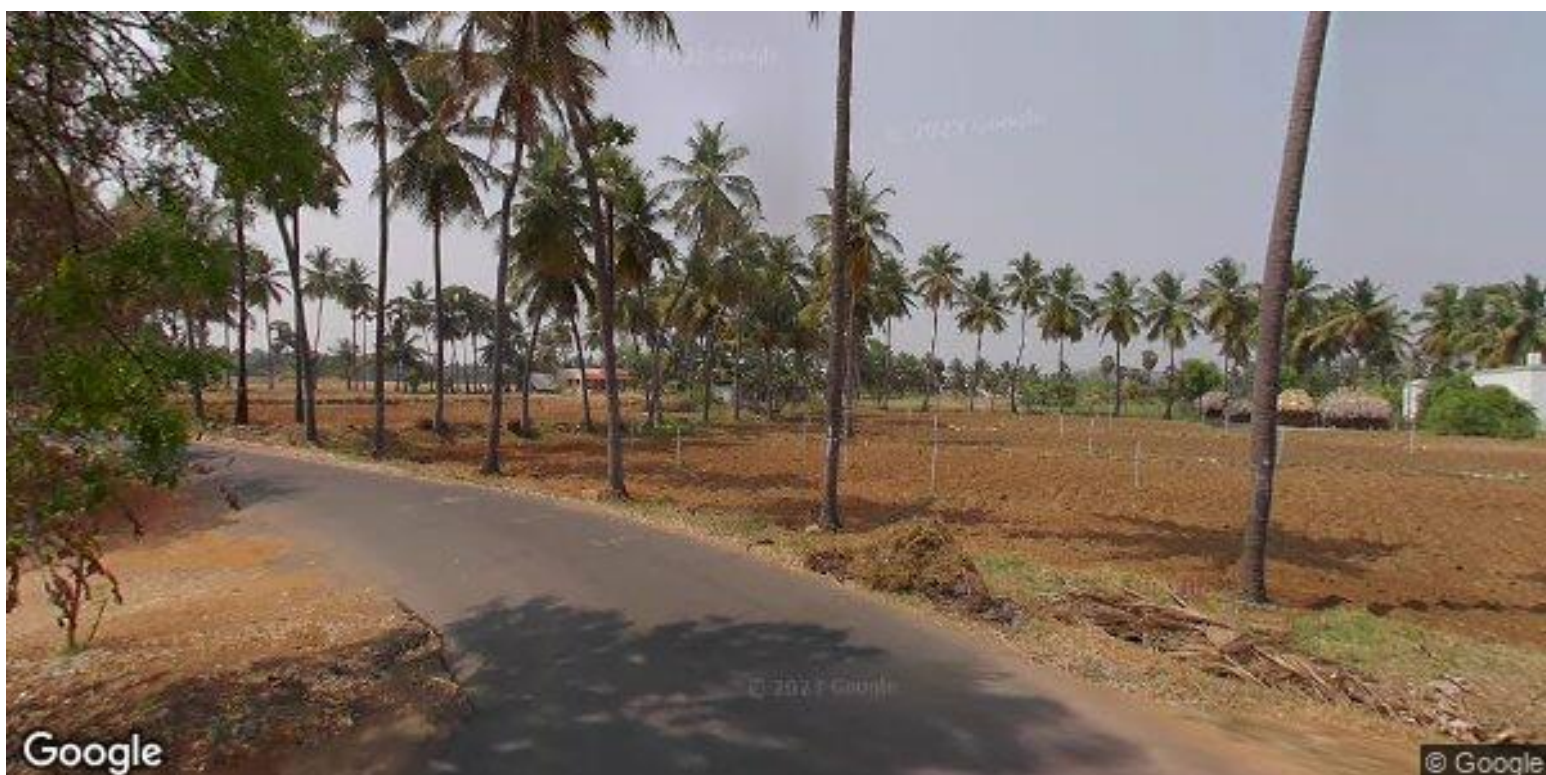
**Risk Type:** Turn  
**Risk Level:** High  
**Speed Limit:** 15 KM/Hr  
**Coordinates:** 11.41087, 77.90784

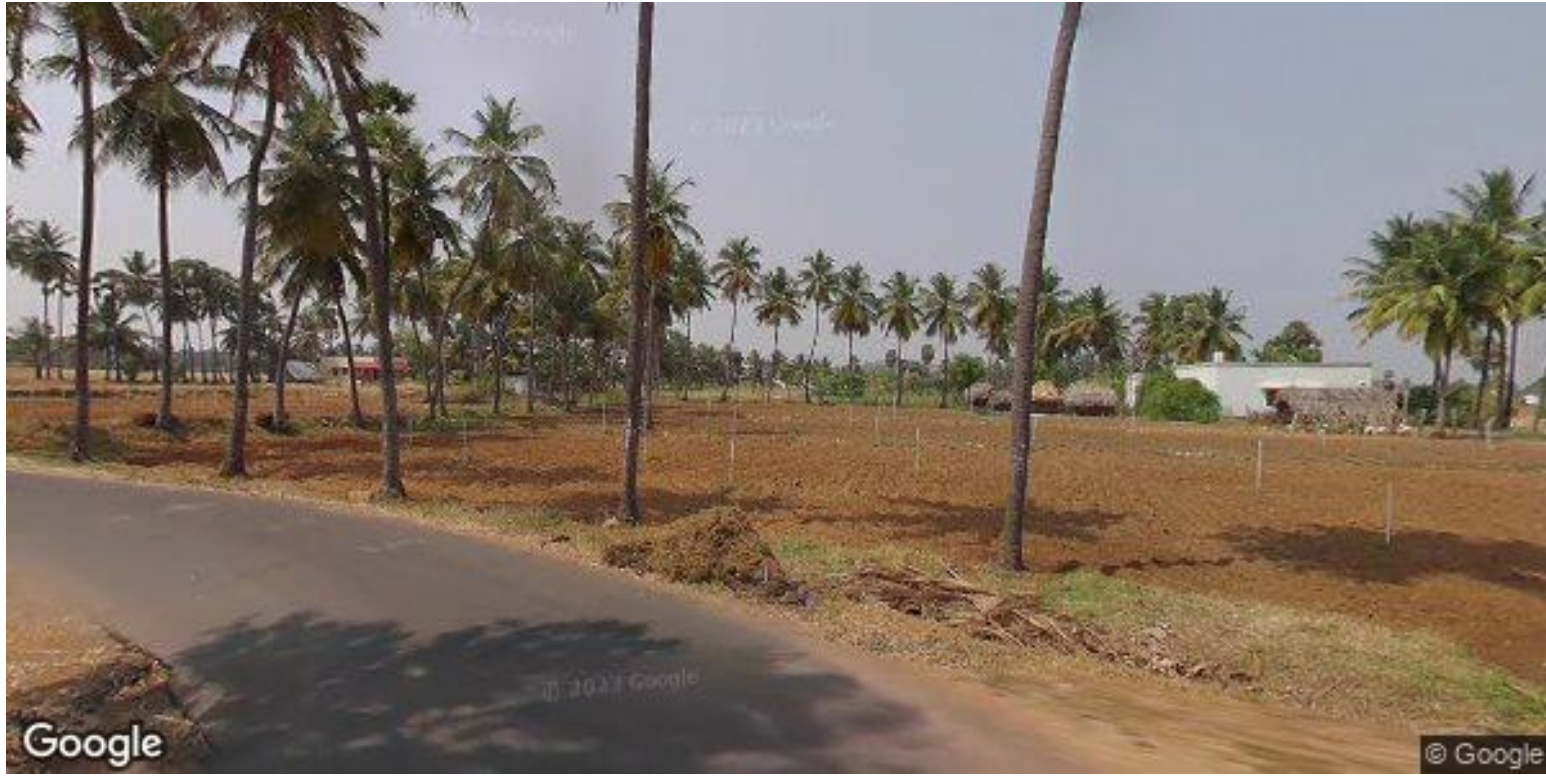
**Risk Type:** Turn  
**Risk Level:** Medium  
**Speed Limit:** 30 KM/Hr  
**Coordinates:** 11.41083, 77.90786

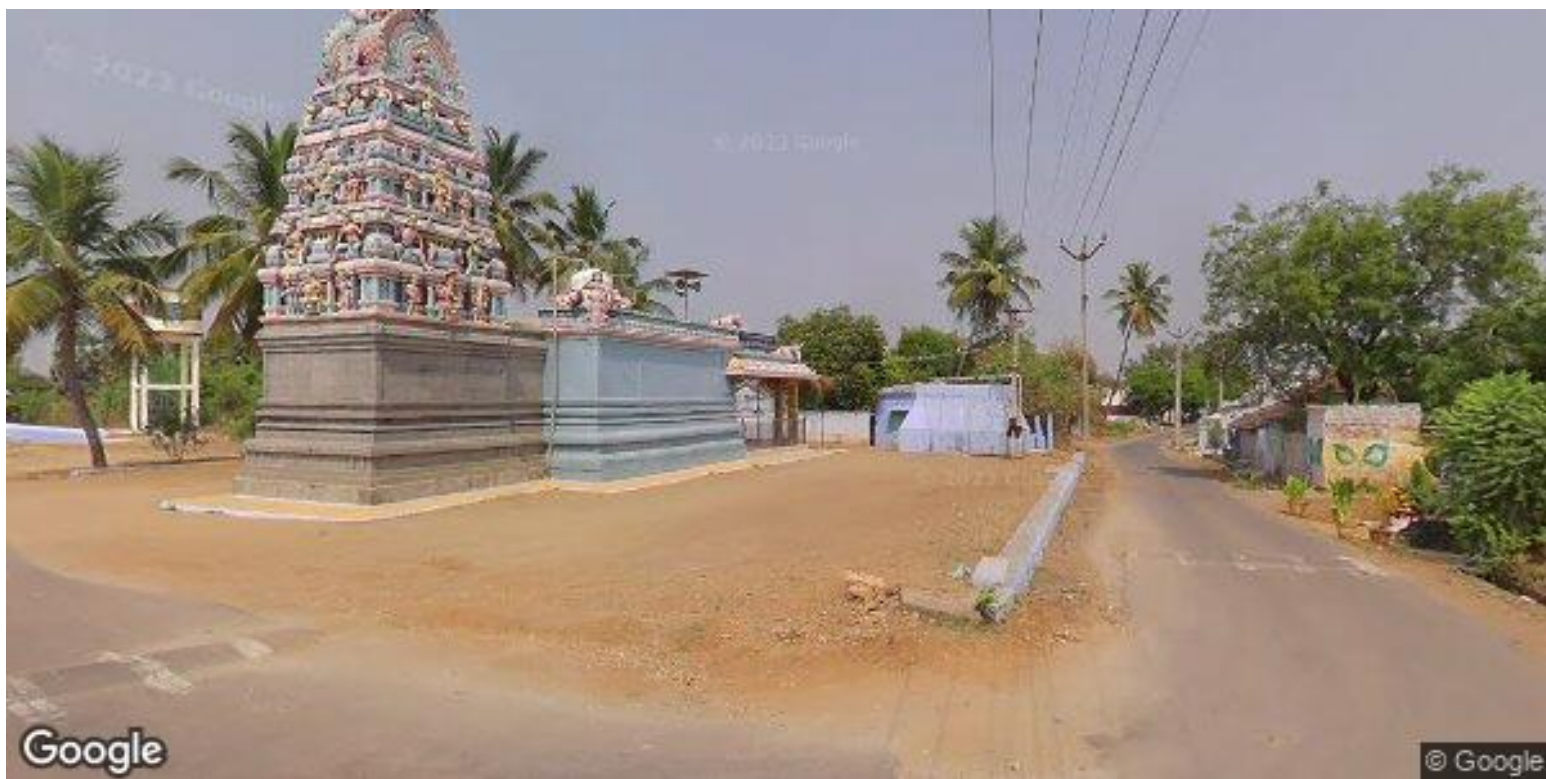
**Risk Type:** Blind Spot  
**Risk Level:** Blind Spot  
**Speed Limit:** 10 KM/Hr  
**Coordinates:** 11.40927, 77.90787

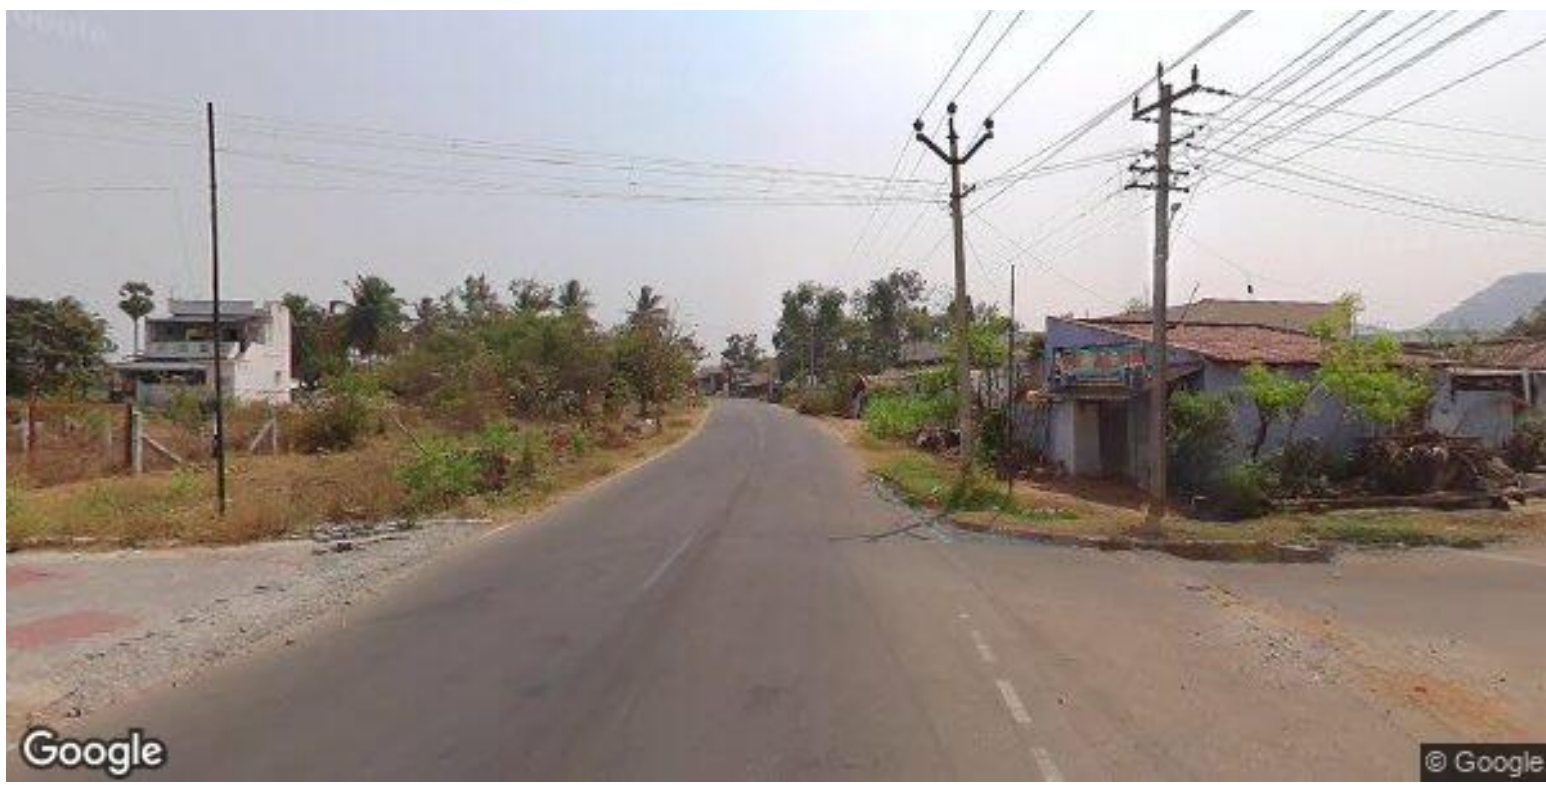
**Coordinates:** 11.40911, 77.90939

**Risk Type:** Blind Spot

**Risk Level:** Blind Spot

**Speed Limit:** 10 KM/Hr

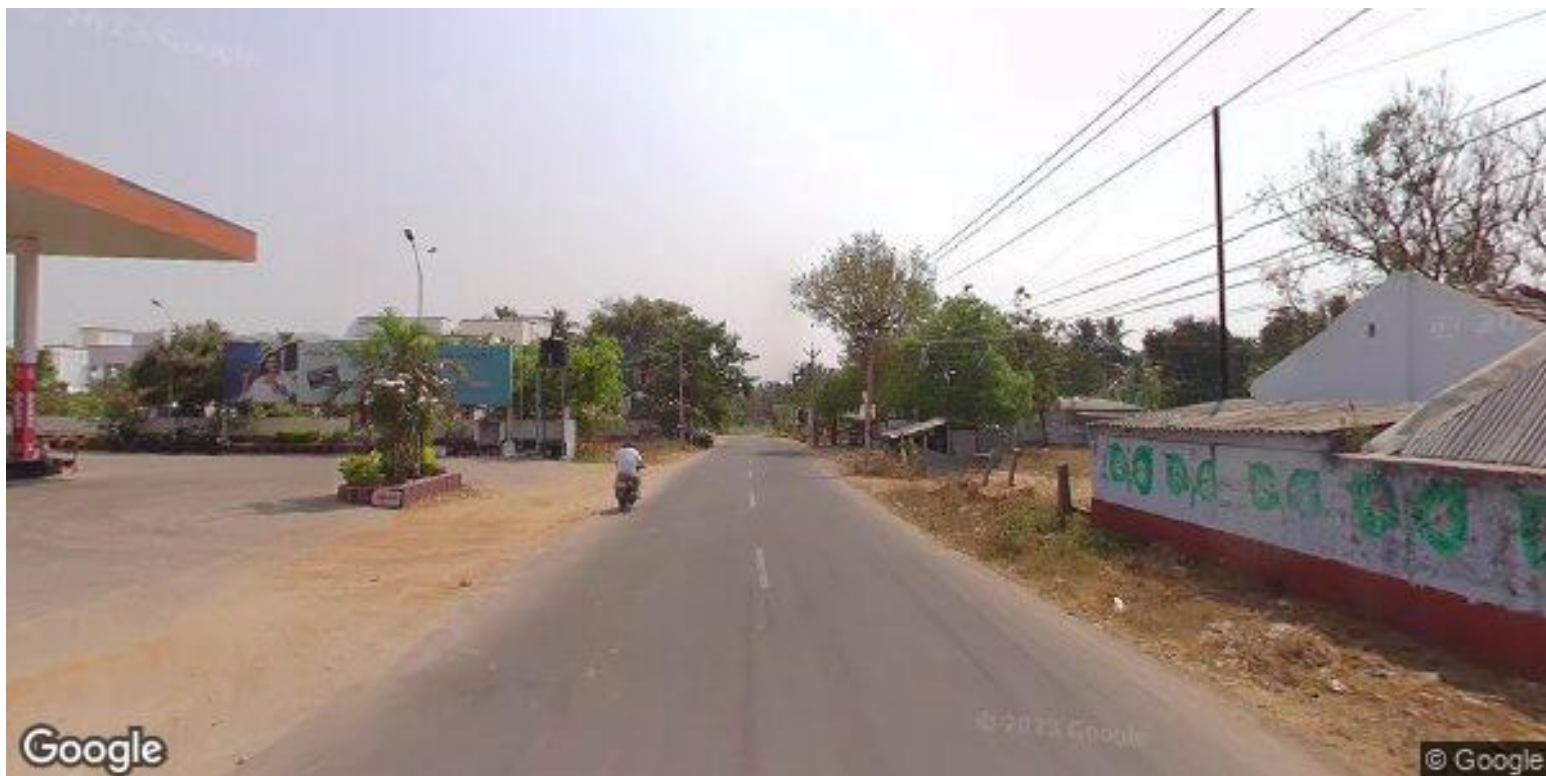
**Coordinates:** 11.40243, 77.90667

**Risk Type:** Blind Spot

**Risk Level:** Blind Spot

**Speed Limit:** 10 KM/Hr
