# IndianOil

## JOURNEY RISK MANAGEMENT (JRM) STUDY

### Salem Terminal TO ERODE PRECISION FARM PRODUCER

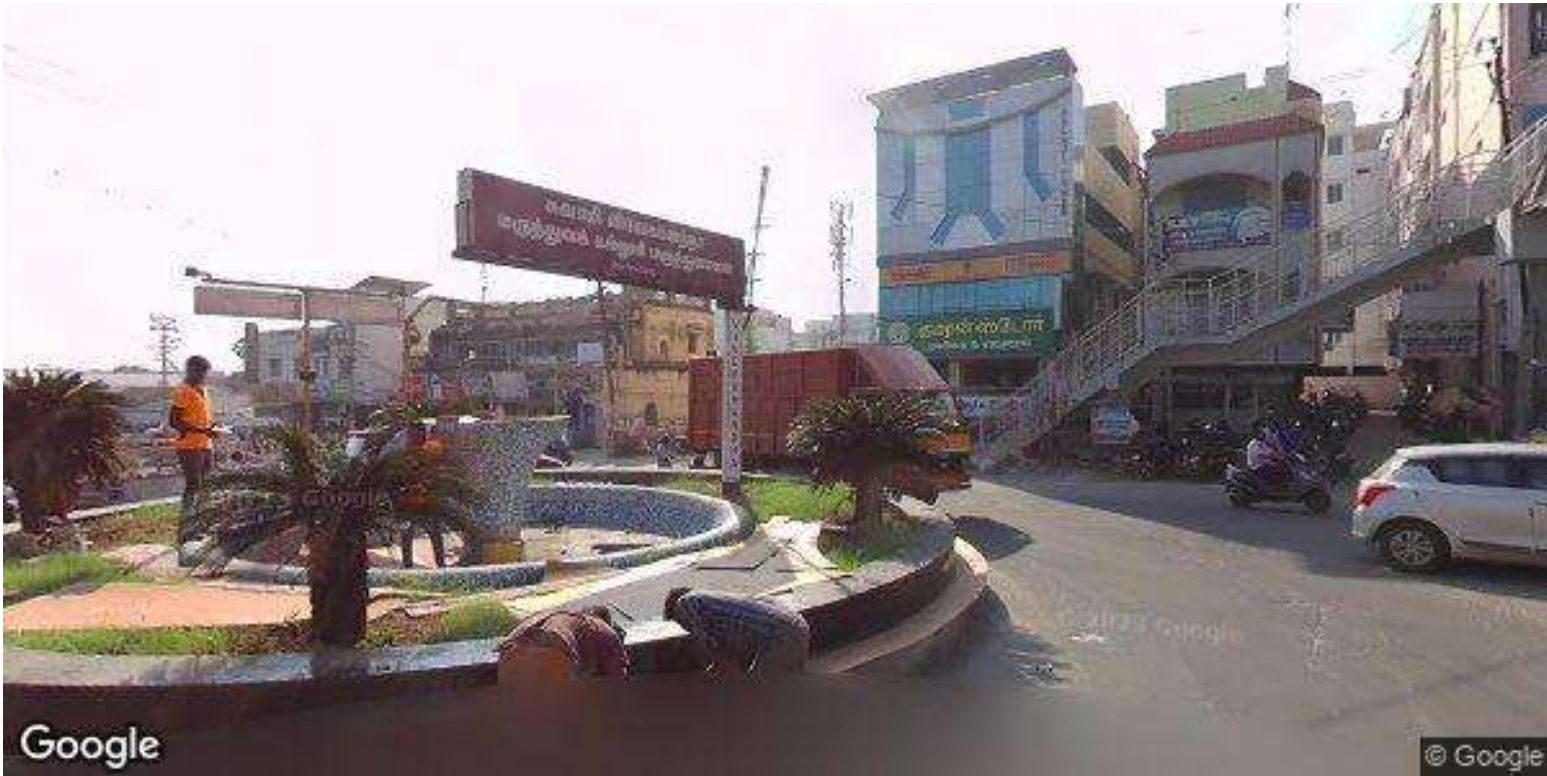
Risk Type: Roundabout  
Risk Level: High  
Speed Limit: 15 KM/Hr  
Coordinates: 11.38395, 77.89480

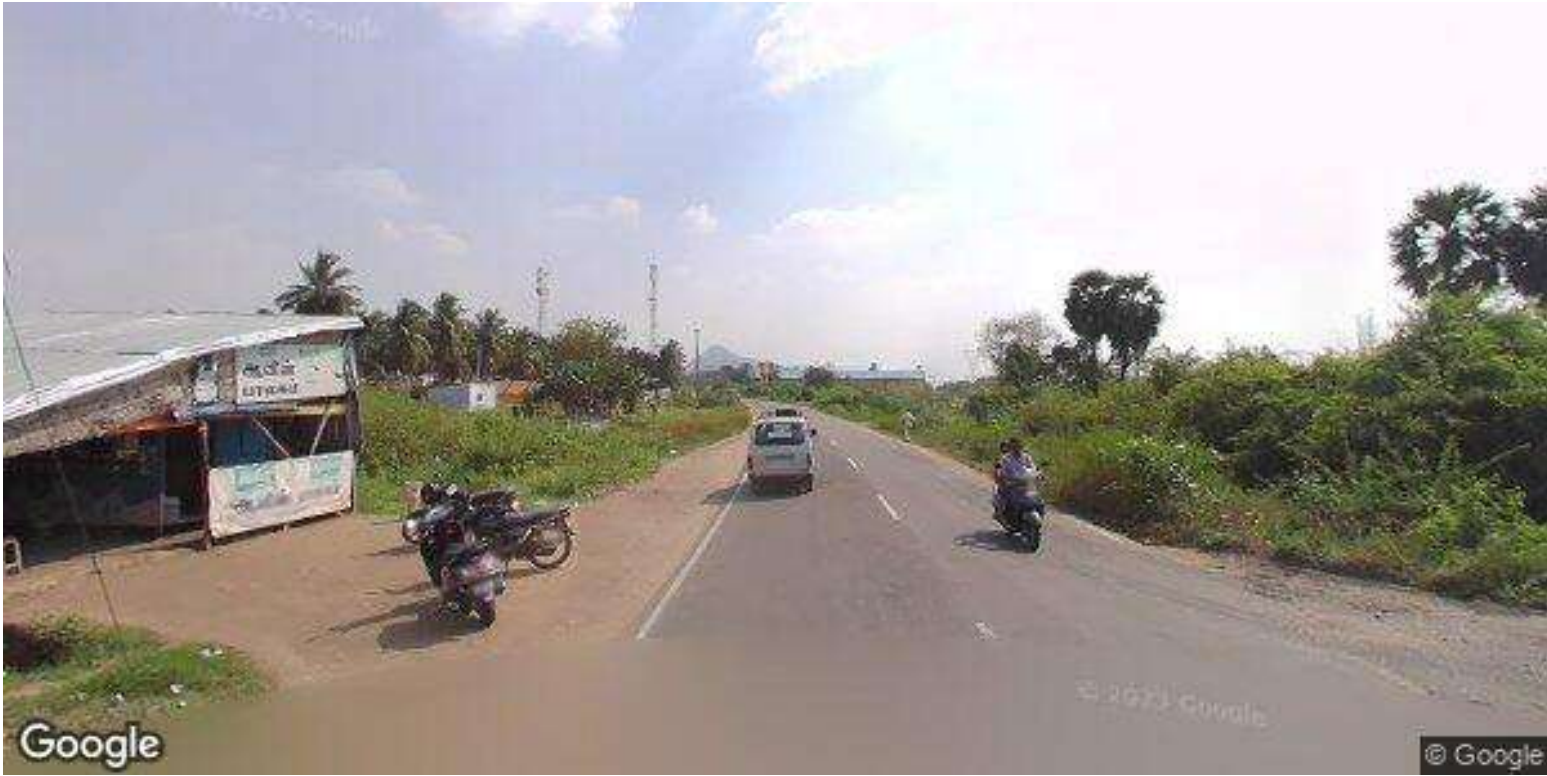
Risk Type: Turn  
Risk Level: High  
Speed Limit: 15 KM/Hr  
Coordinates: 11.44022, 77.87546

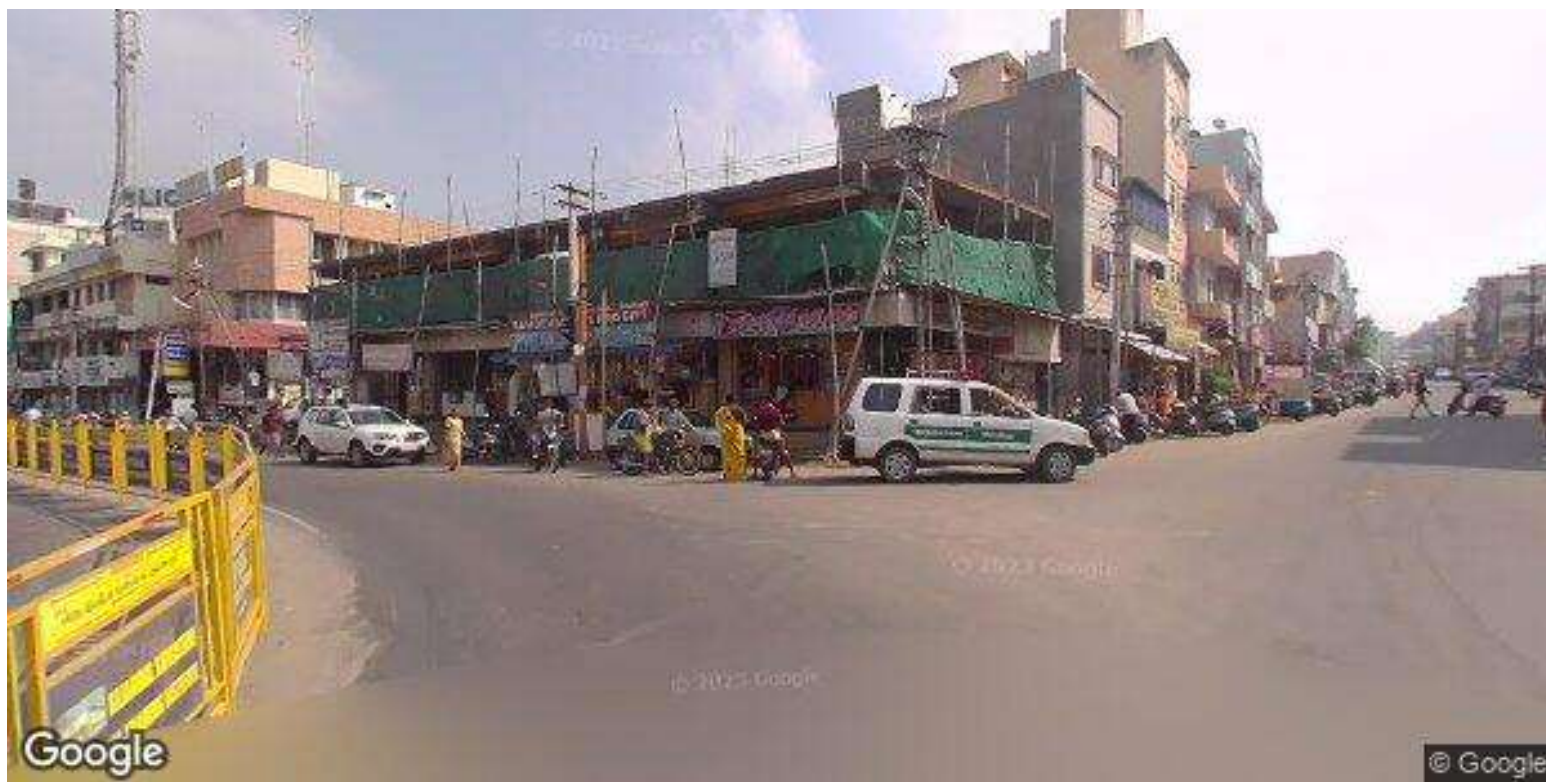
**Risk Type: Turn**

**Risk Level: High**

**Speed Limit: 15 KM/Hr**

**Coordinates: 11.37868, 77.89498**

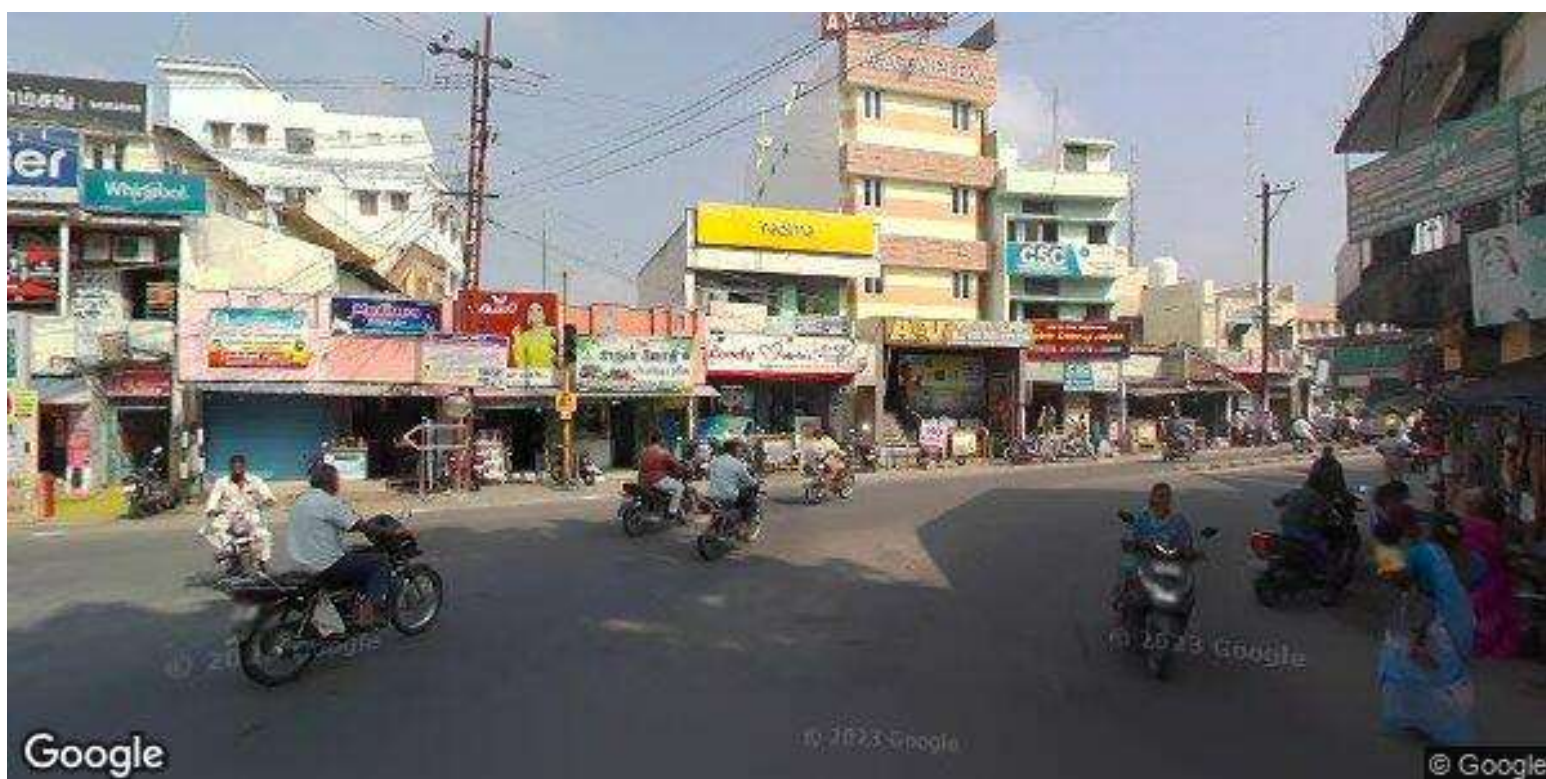
**Risk Type: Turn**

**Risk Level: Medium**

**Speed Limit: 30 KM/Hr**

**Coordinates: 11.37842, 77.89452**

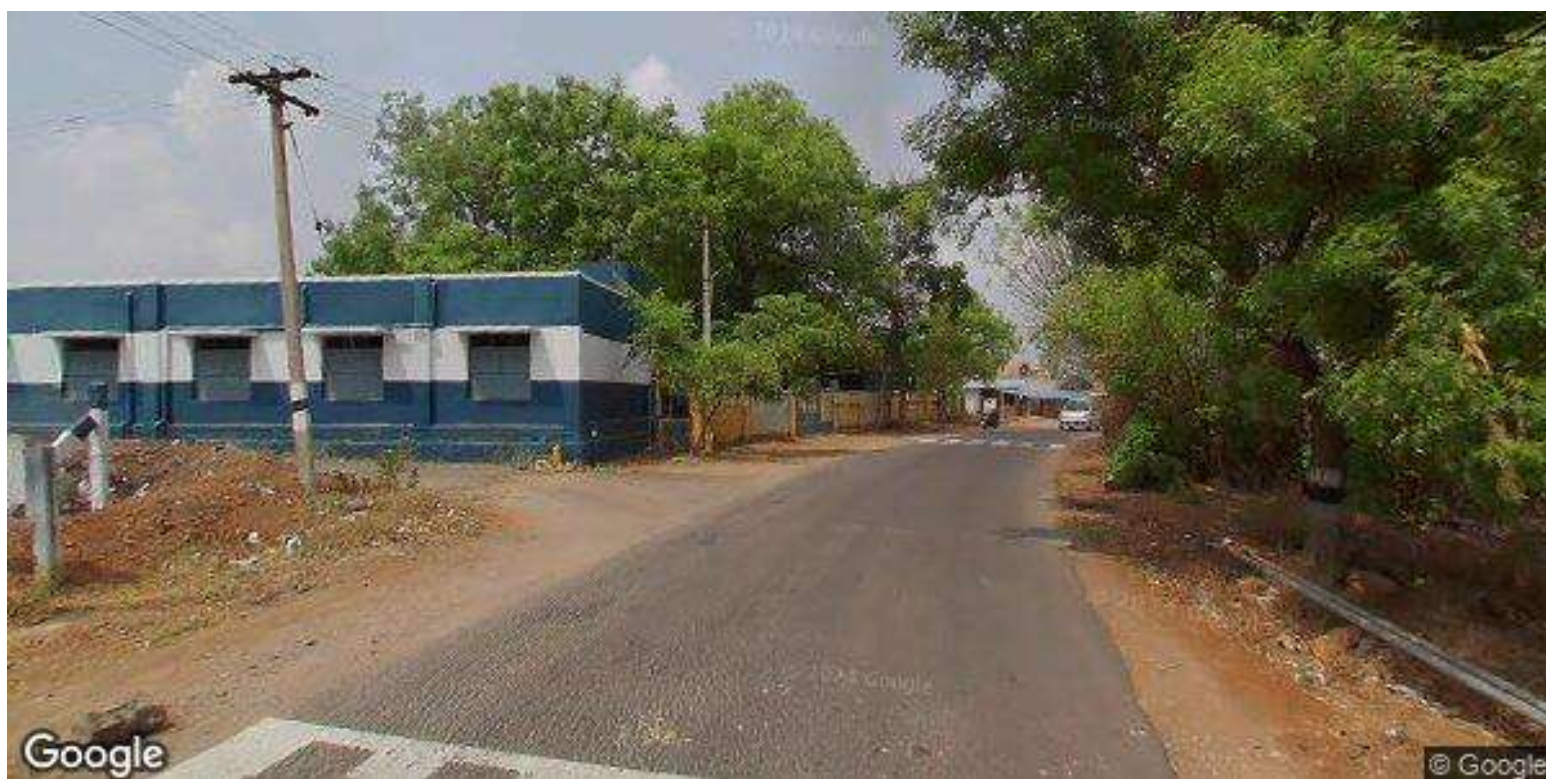
**Risk Type:** Turn  
**Risk Level:** High  
**Speed Limit:** 15 KM/Hr  
**Coordinates:** 11.33268, 77.88827

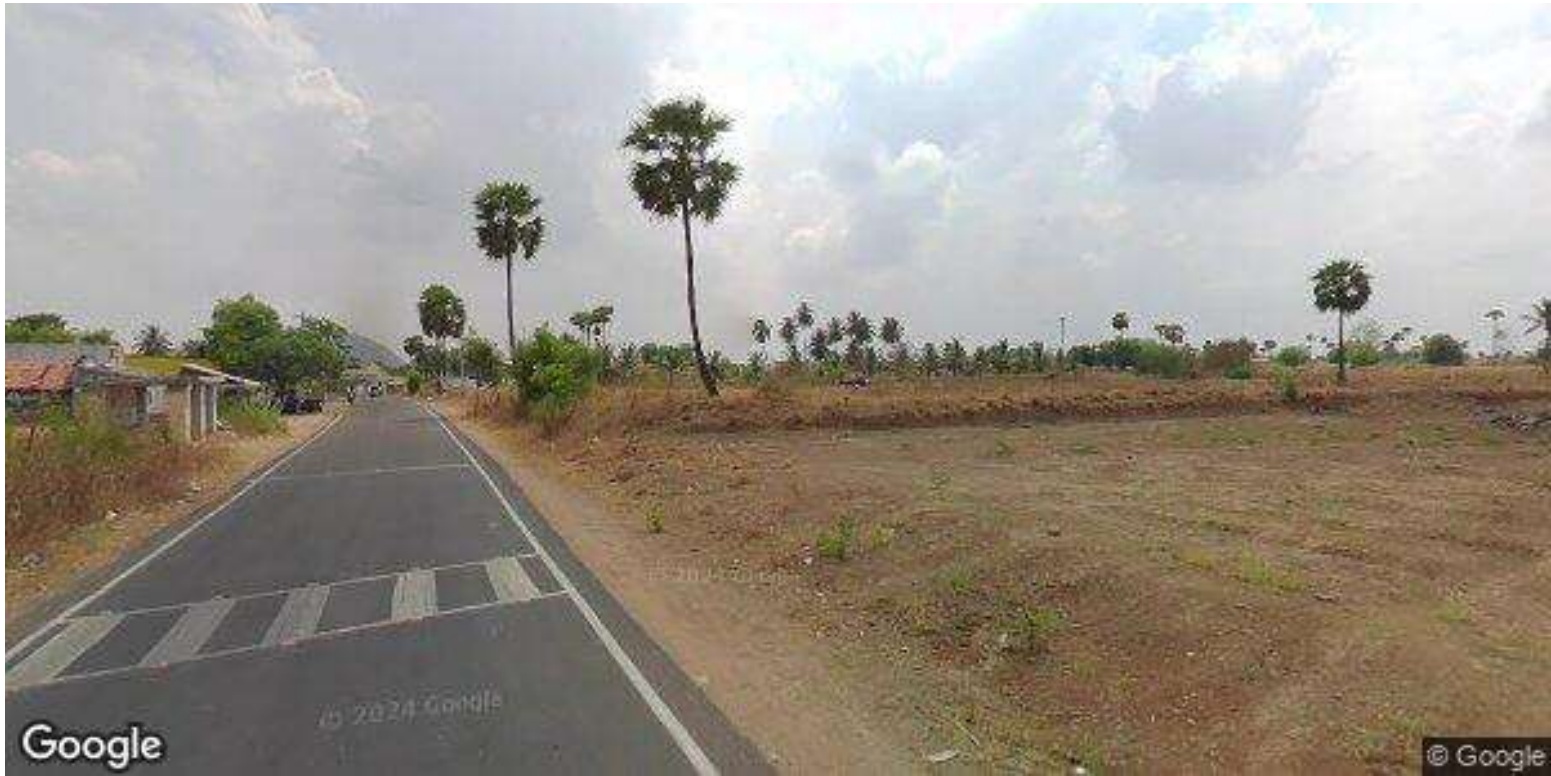
**Risk Type:** Turn  
**Risk Level:** Medium  
**Speed Limit:** 30 KM/Hr  
**Coordinates:** 11.33071, 77.88660

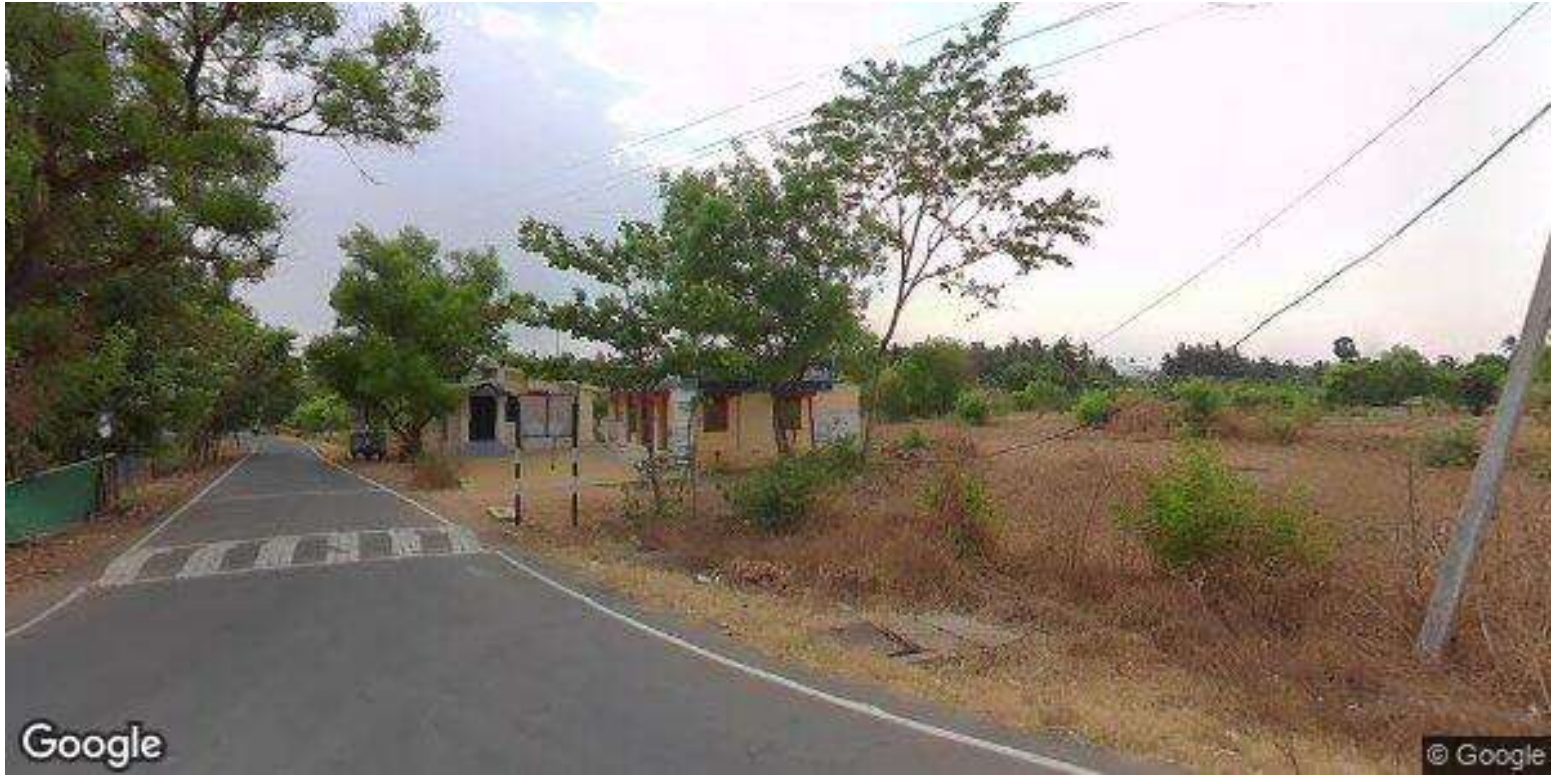
**Risk Type:** Turn  
**Risk Level:** High  
**Speed Limit:** 15 KM/Hr  
**Coordinates:** 11.33065, 77.88650

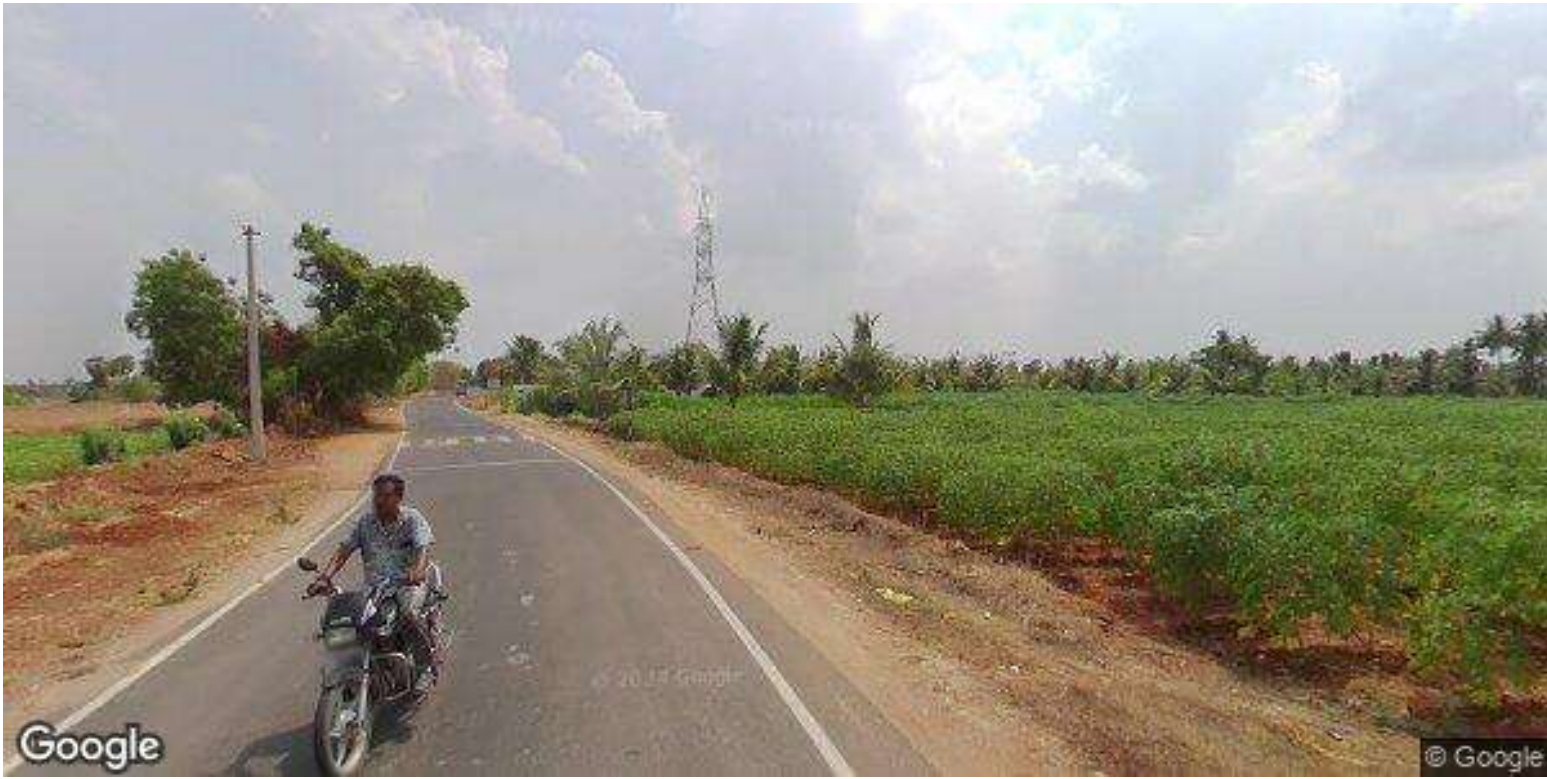
**Risk Type:** Turn  
**Risk Level:** Medium  
**Speed Limit:** 30 KM/Hr  
**Coordinates:** 11.32155, 77.88499

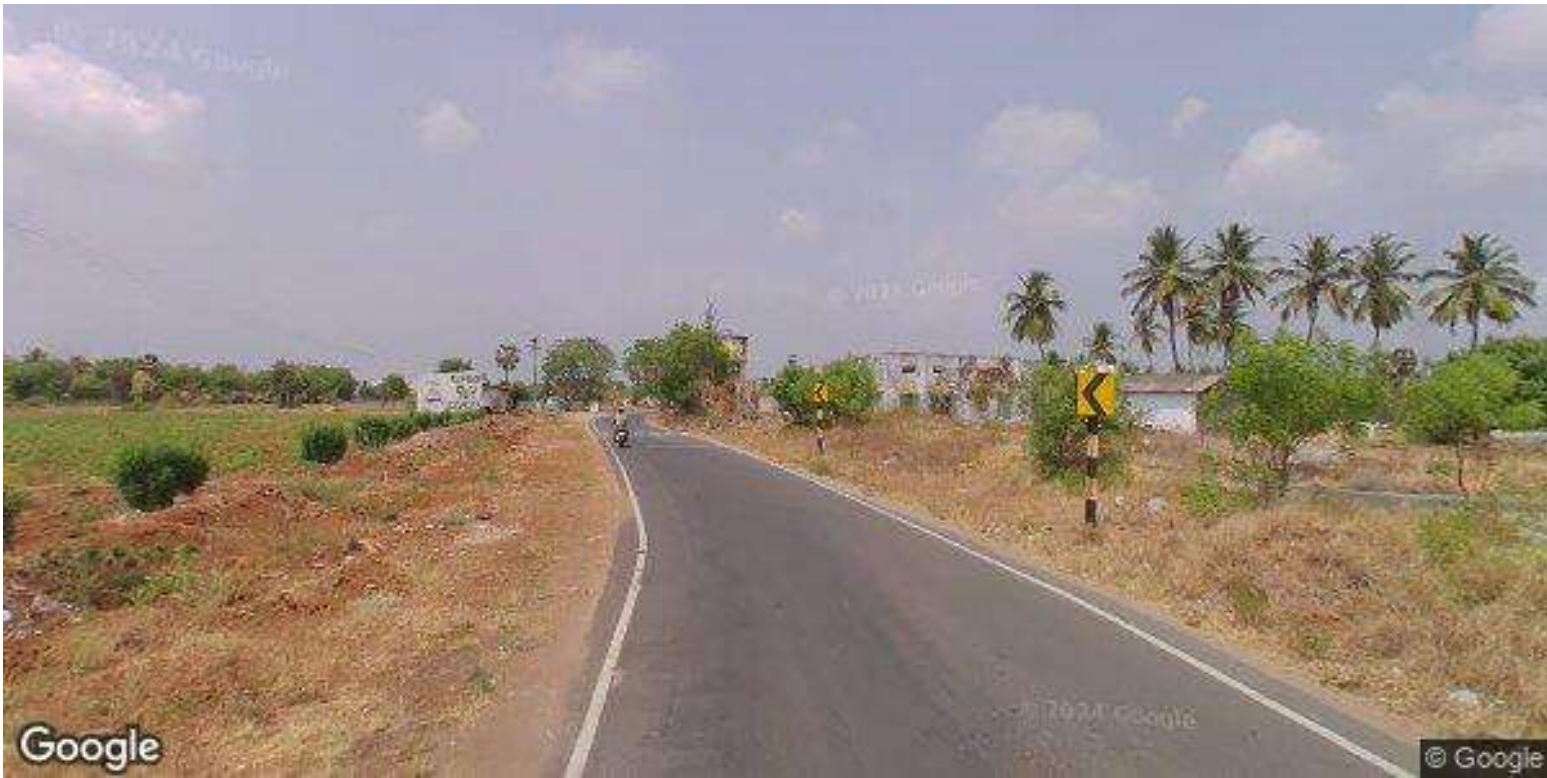
**Risk Type:** Turn  
**Risk Level:** Medium  
**Speed Limit:** 30 KM/Hr  
**Coordinates:** 11.32102, 77.88435

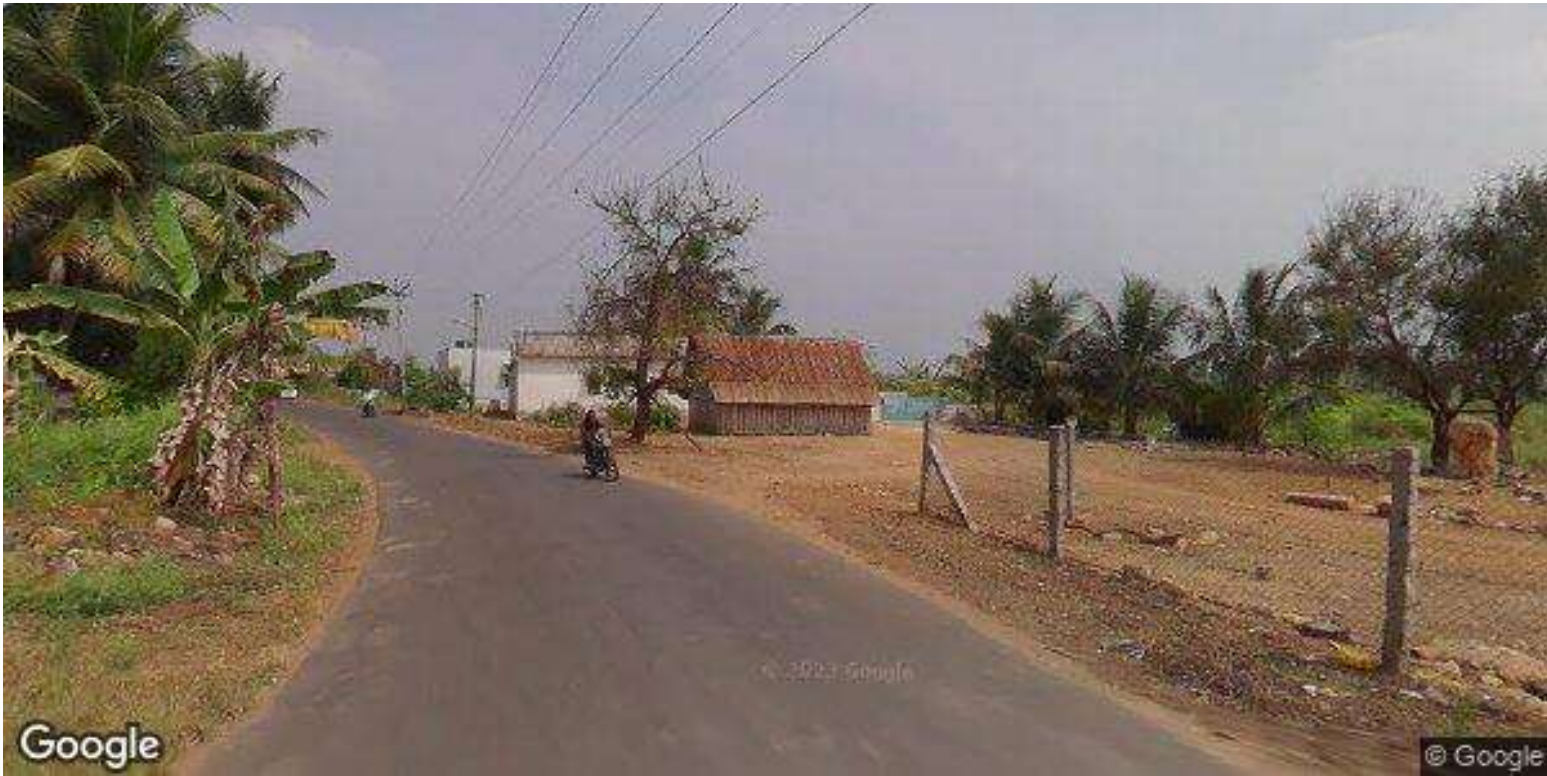
**Risk Type:** Turn  
**Risk Level:** Medium  
**Speed Limit:** 30 KM/Hr  
**Coordinates:** 11.31205, 77.88131

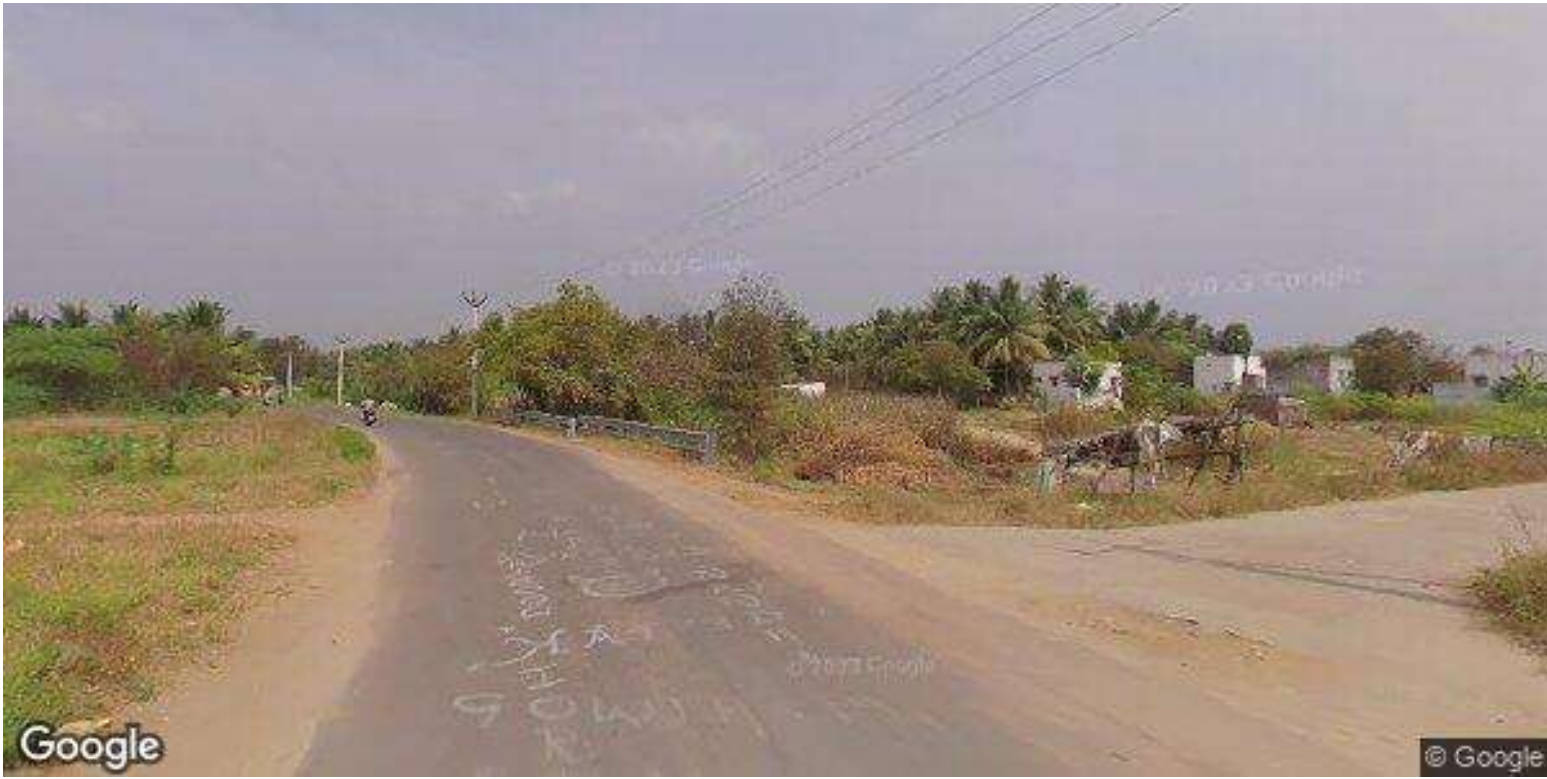
**Risk Type:** Turn  
**Risk Level:** Medium  
**Speed Limit:** 30 KM/Hr  
**Coordinates:** 11.30805, 77.87934

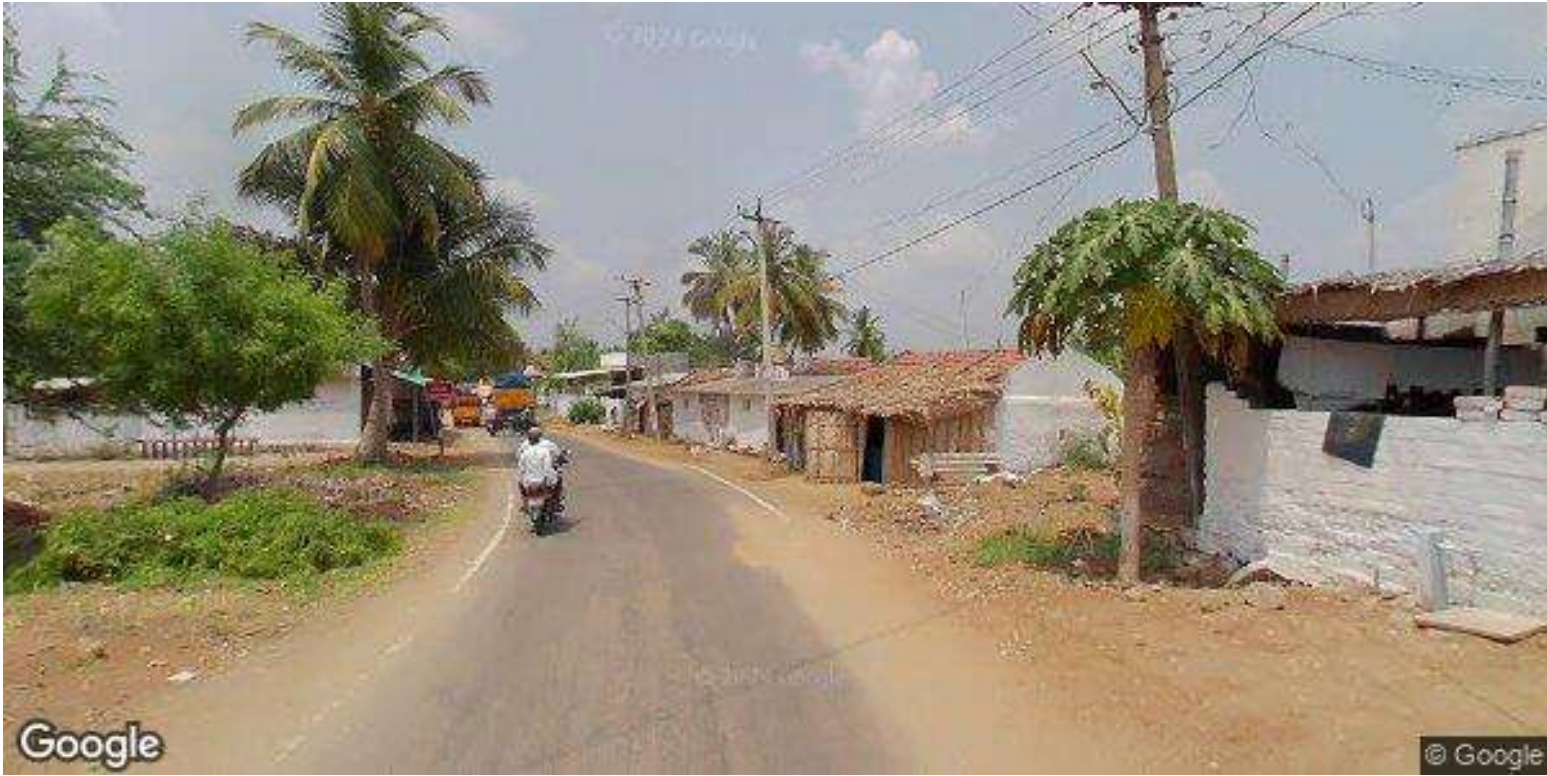
**Risk Type:** Turn  
**Risk Level:** Medium  
**Speed Limit:** 30 KM/Hr  
**Coordinates:** 11.30625, 77.87776

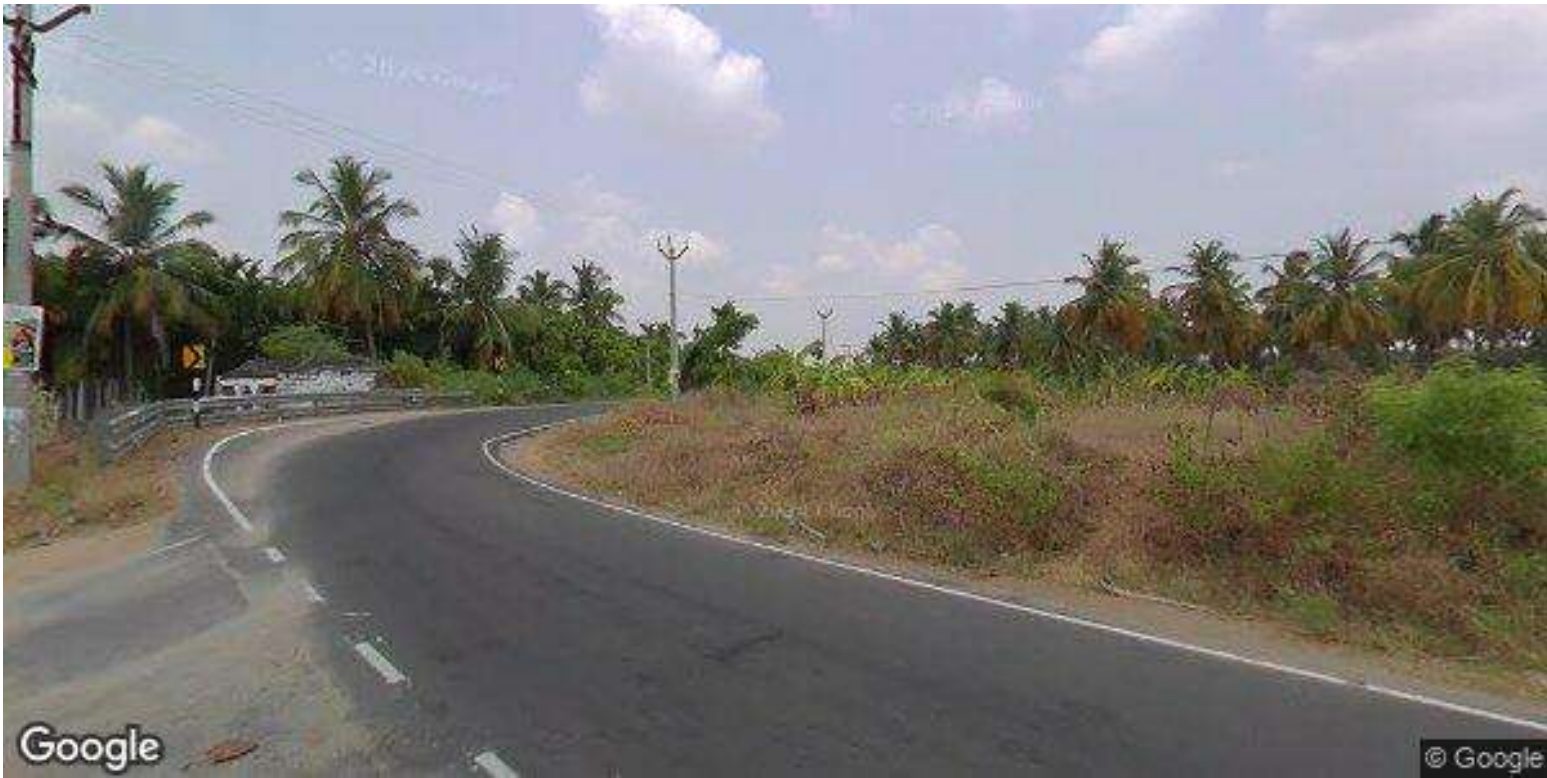
**Risk Type:** Turn  
**Risk Level:** High  
**Speed Limit:** 15 KM/Hr  
**Coordinates:** 11.29763, 77.87710

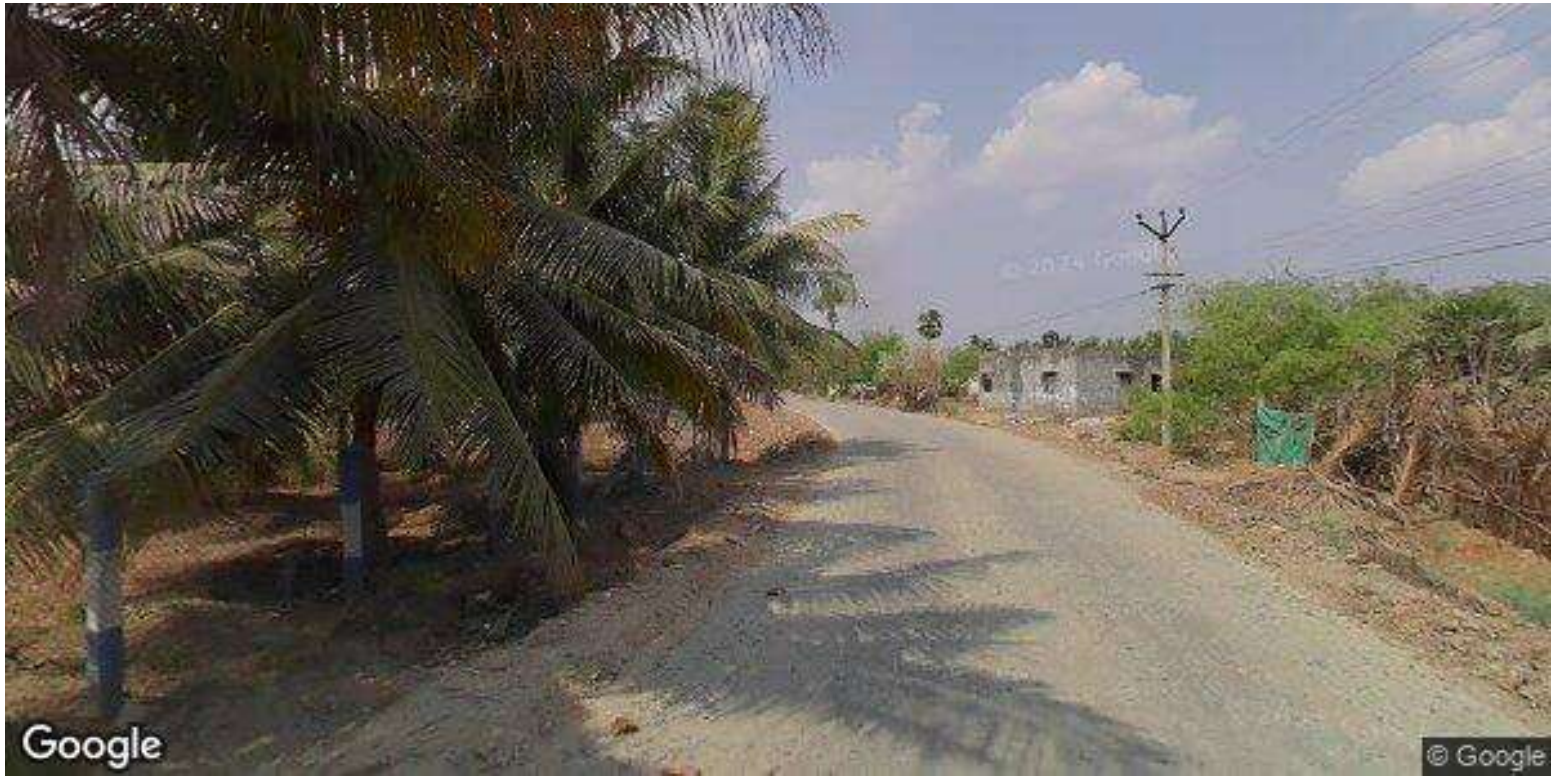
**Risk Type:** Turn  
**Risk Level:** Medium  
**Speed Limit:** 30 KM/Hr  
**Coordinates:** 11.27096, 77.87034

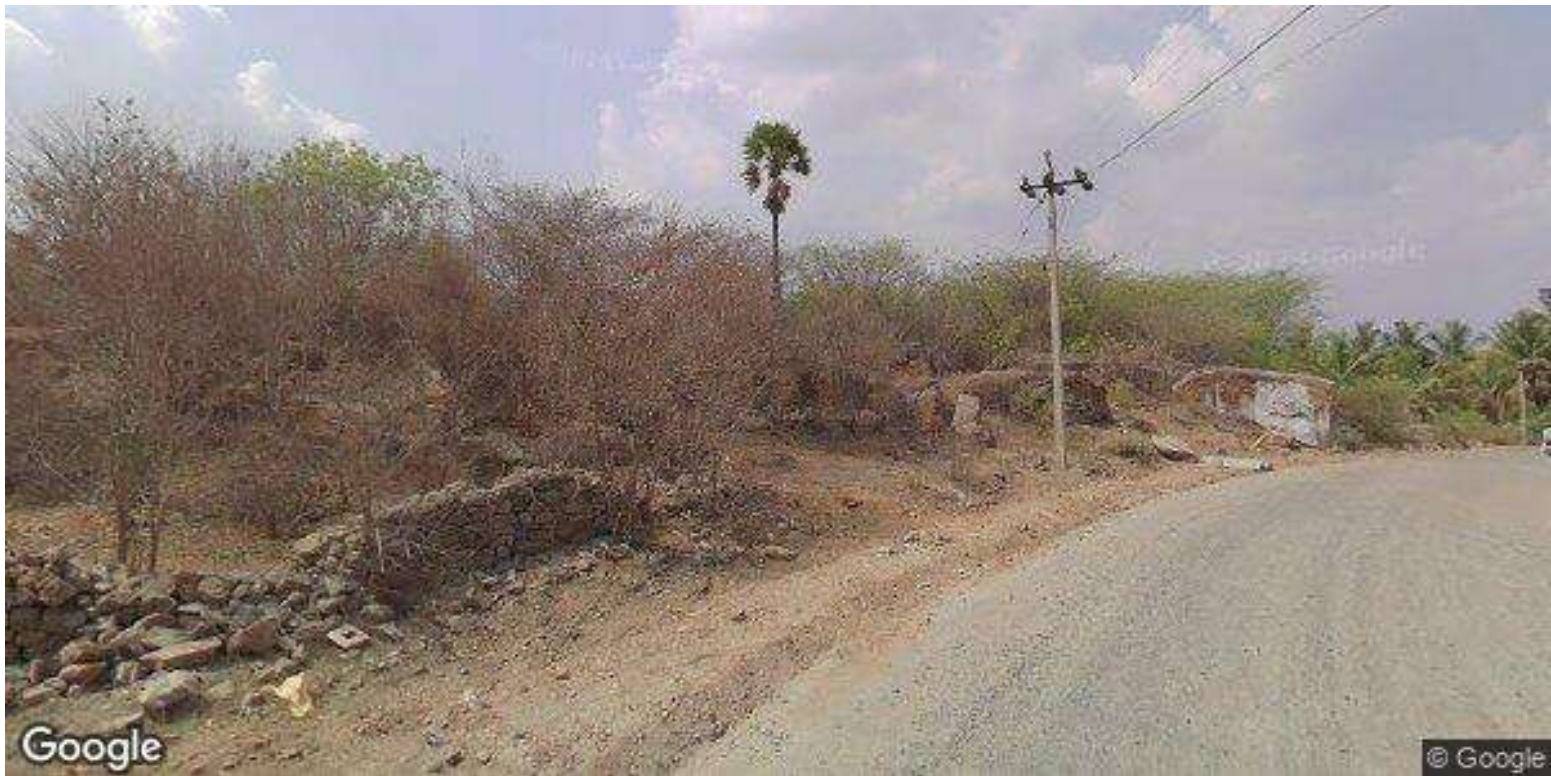
**Risk Type:** Turn  
**Risk Level:** Medium  
**Speed Limit:** 30 KM/Hr  
**Coordinates:** 11.27057, 77.86827

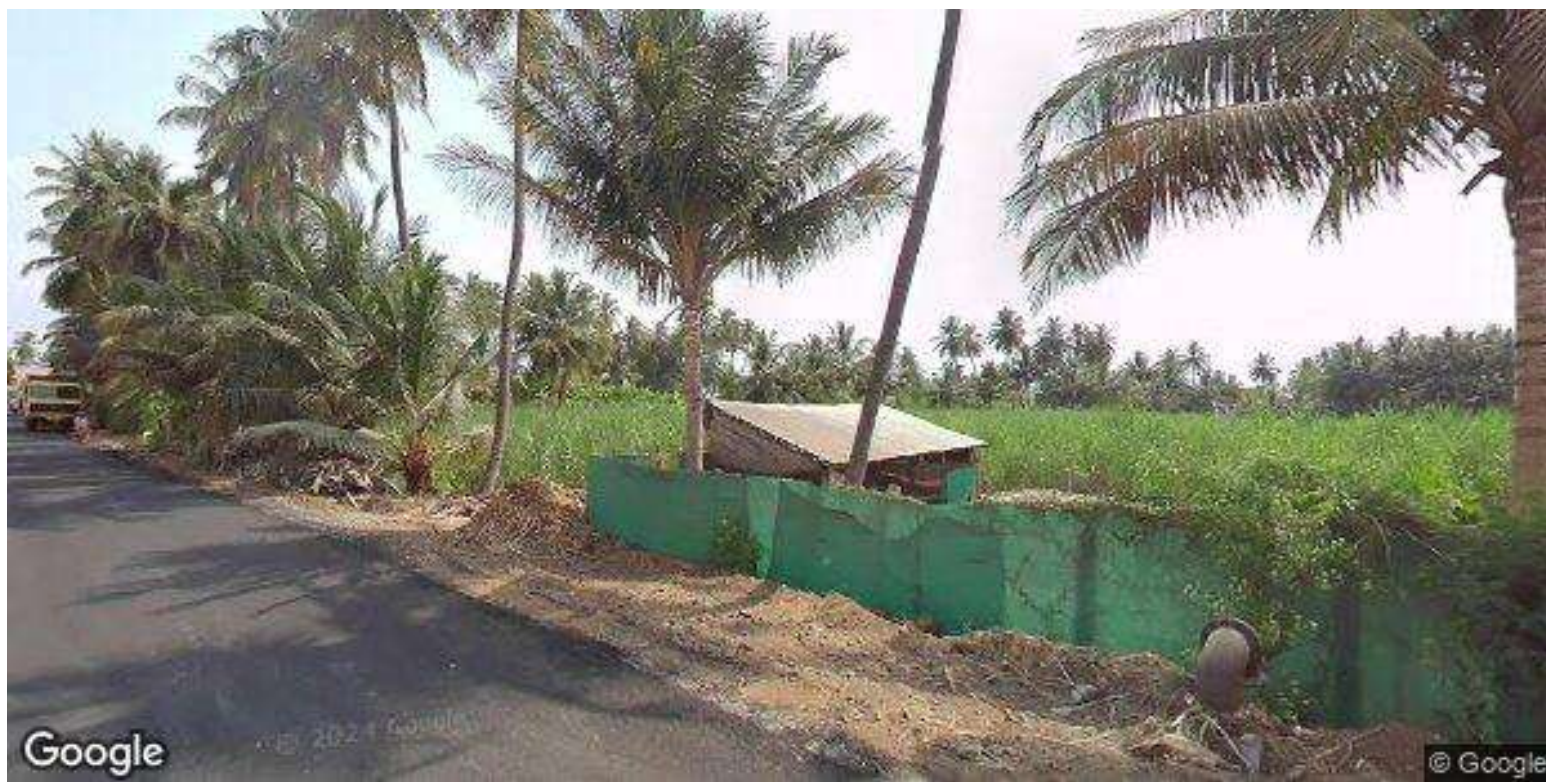
**Risk Type:** Turn

**Risk Level:** High

**Speed Limit:** 15 KM/Hr

**Coordinates:** 11.26017, 77.85606

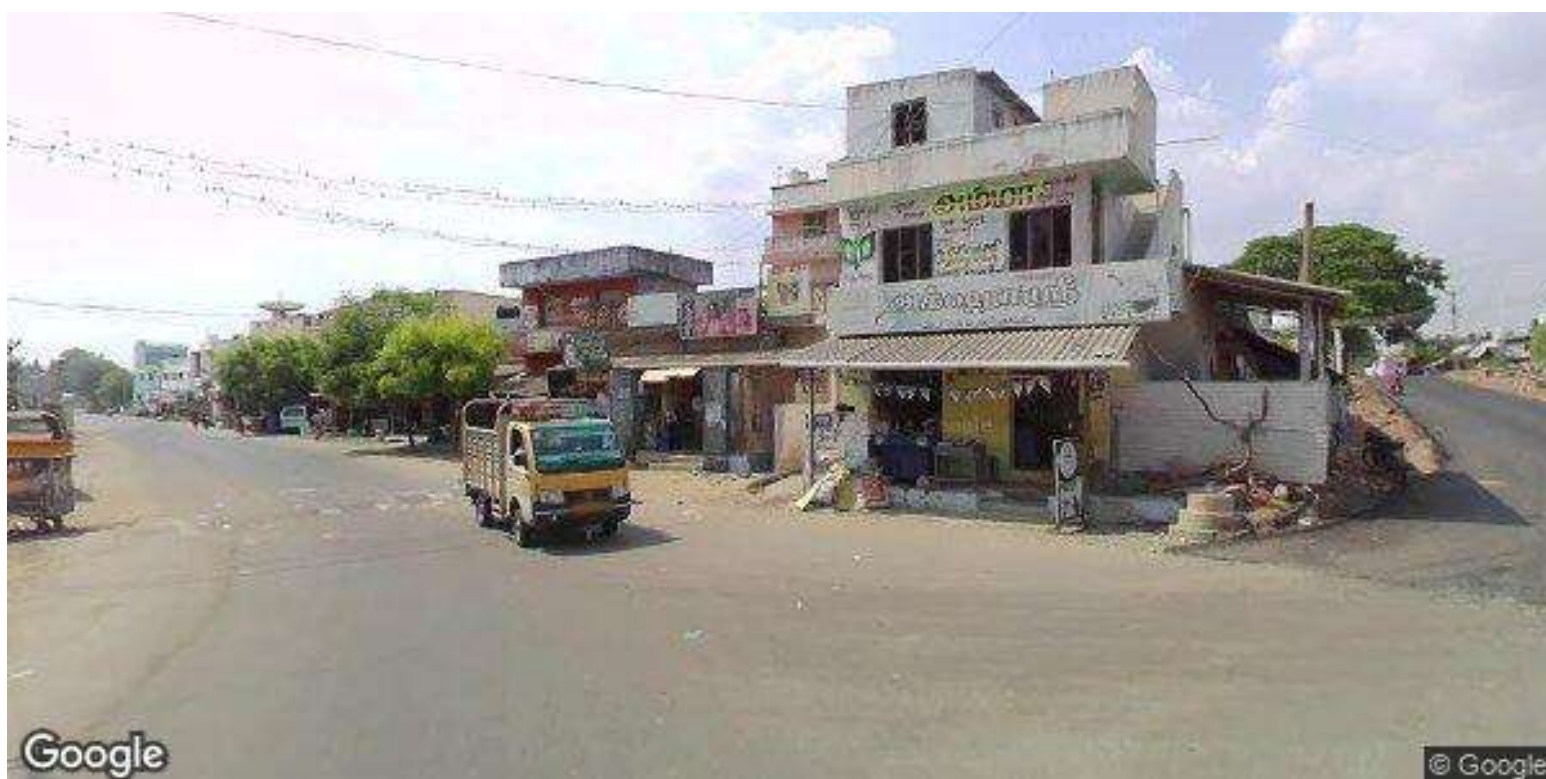
**Risk Type:** Turn

**Risk Level:** High

**Speed Limit:** 15 KM/Hr

**Coordinates:** 11.25802, 77.85511

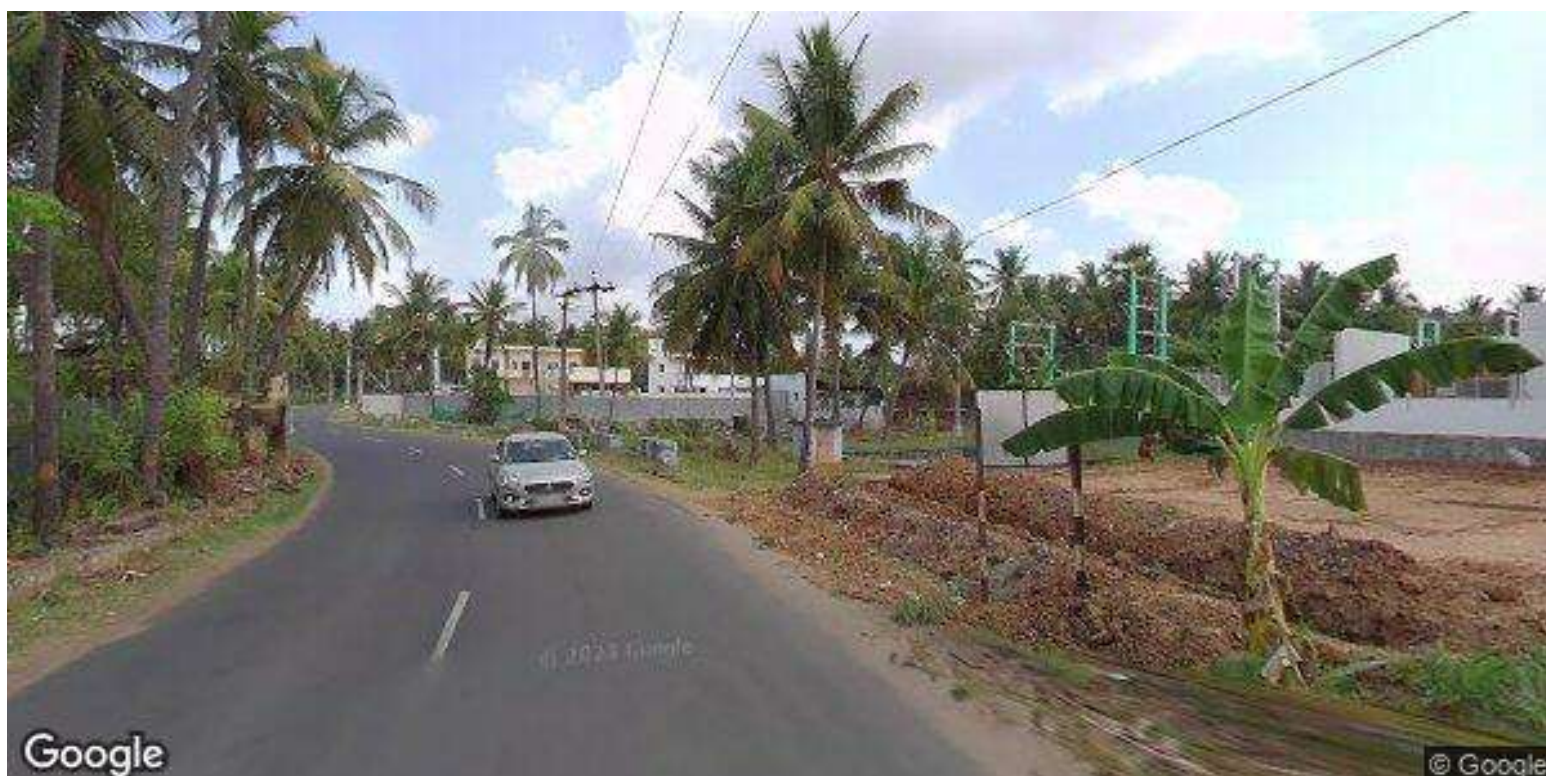
**Risk Type:** Turn  
**Risk Level:** Medium  
**Speed Limit:** 30 KM/Hr  
**Coordinates:** 11.25287, 77.86220
