# IndianOil

## JOURNEY RISK MANAGEMENT (JRM) STUDY

### Salem Terminal TO ERODE PRECISION FARM PRODUCER

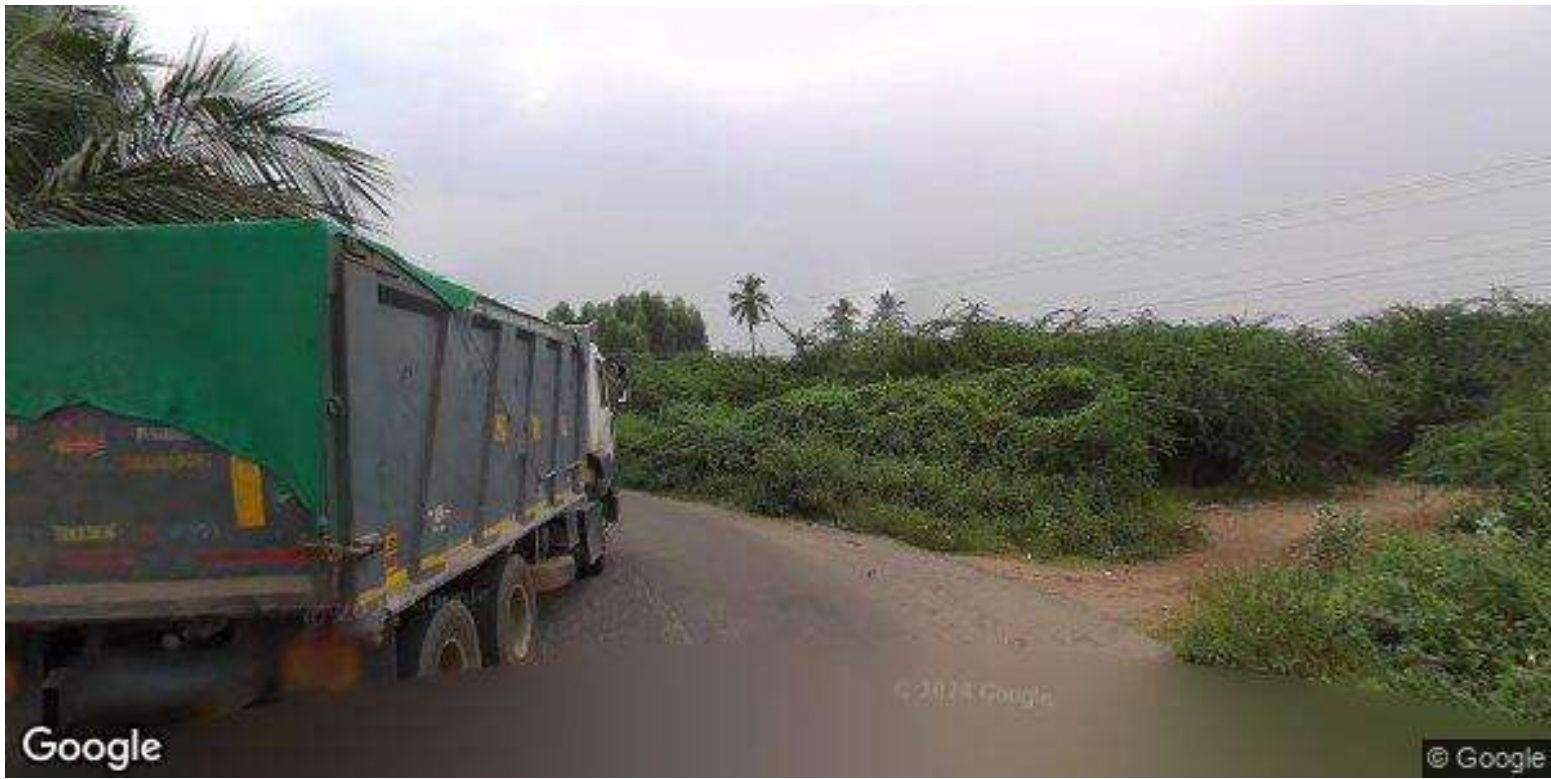
**Risk Type:** Turn  
**Risk Level:** High  
**Speed Limit:** 15 KM/Hr  
**Coordinates:** 11.24100, 77.86030

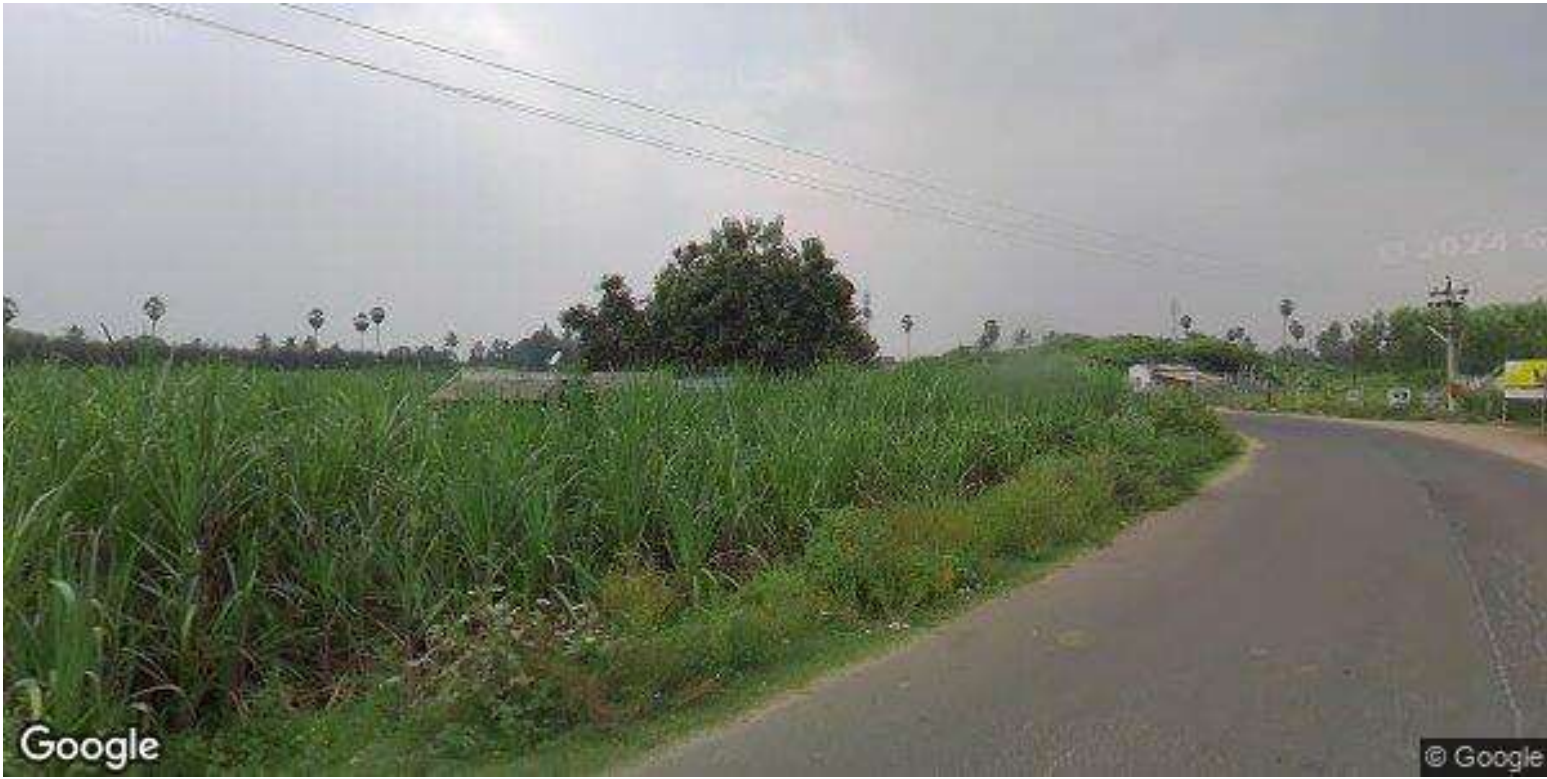
**Risk Type:** Turn  
**Risk Level:** Medium  
**Speed Limit:** 30 KM/Hr  
**Coordinates:** 11.24196, 77.85902

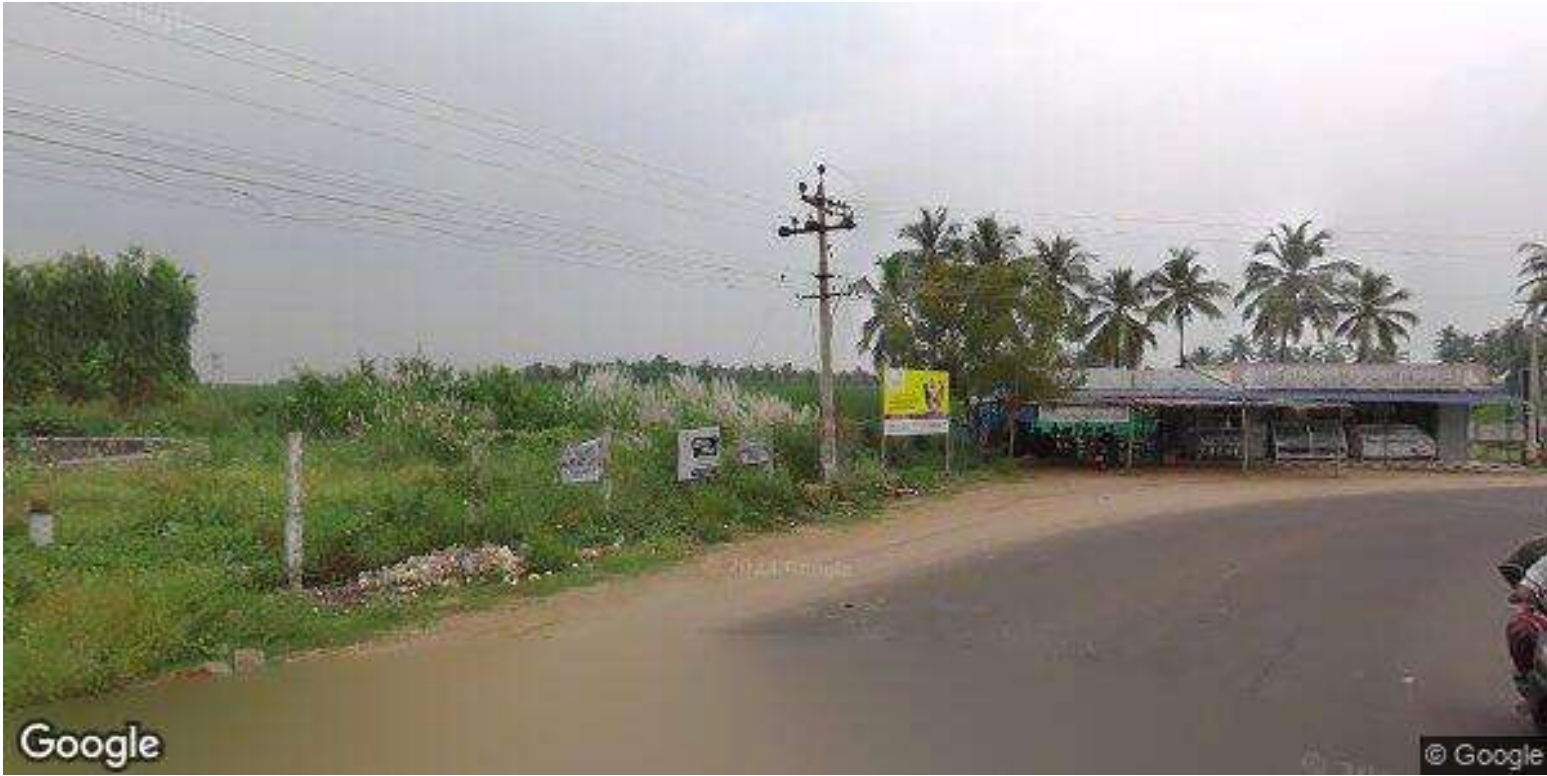
**Risk Type:** Turn  
**Risk Level:** Medium  
**Speed Limit:** 30 KM/Hr  
**Coordinates:** 11.24193, 77.85850

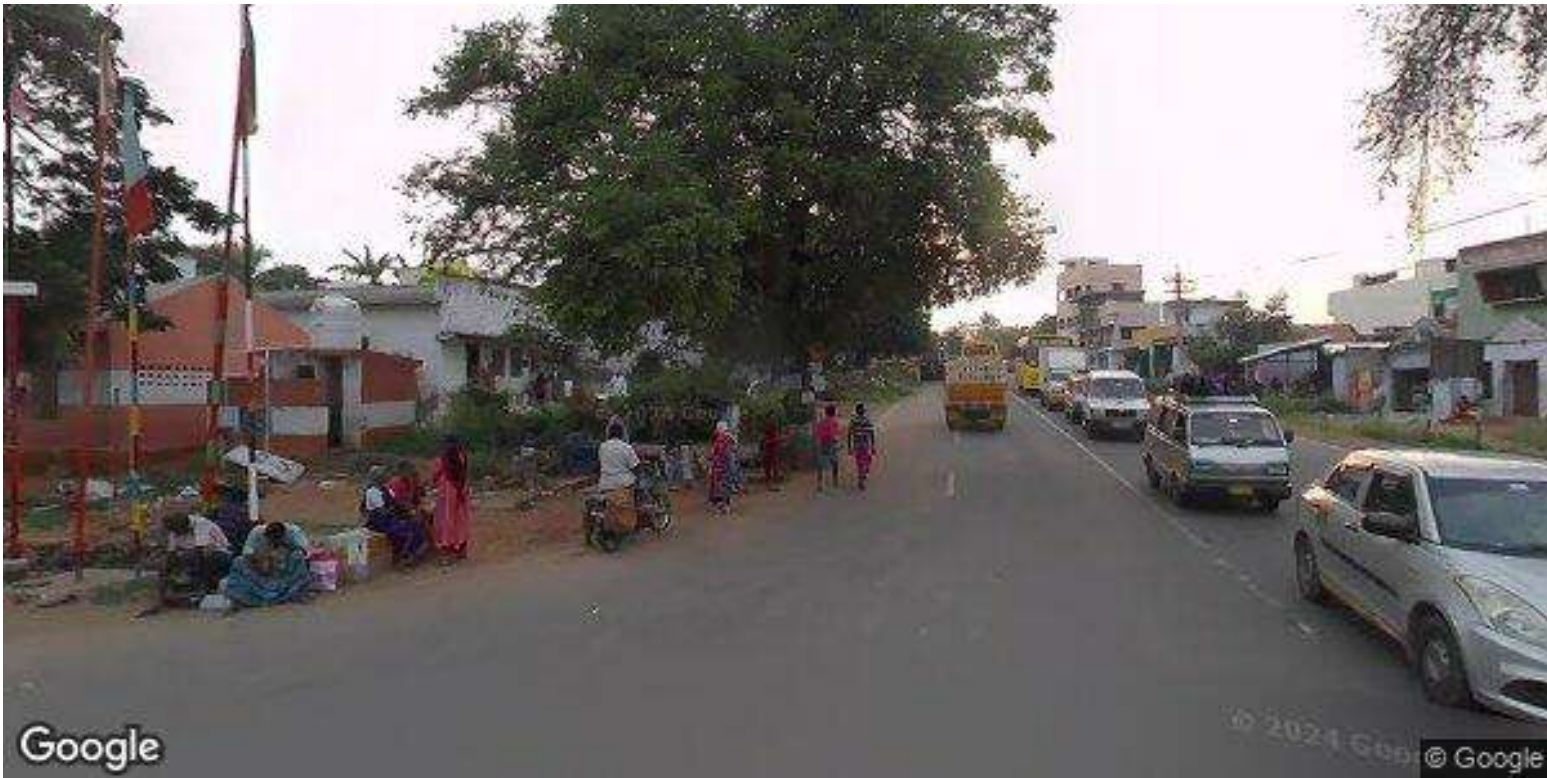
**Risk Type:** Turn  
**Risk Level:** Medium  
**Speed Limit:** 30 KM/Hr  
**Coordinates:** 11.23960, 77.85563

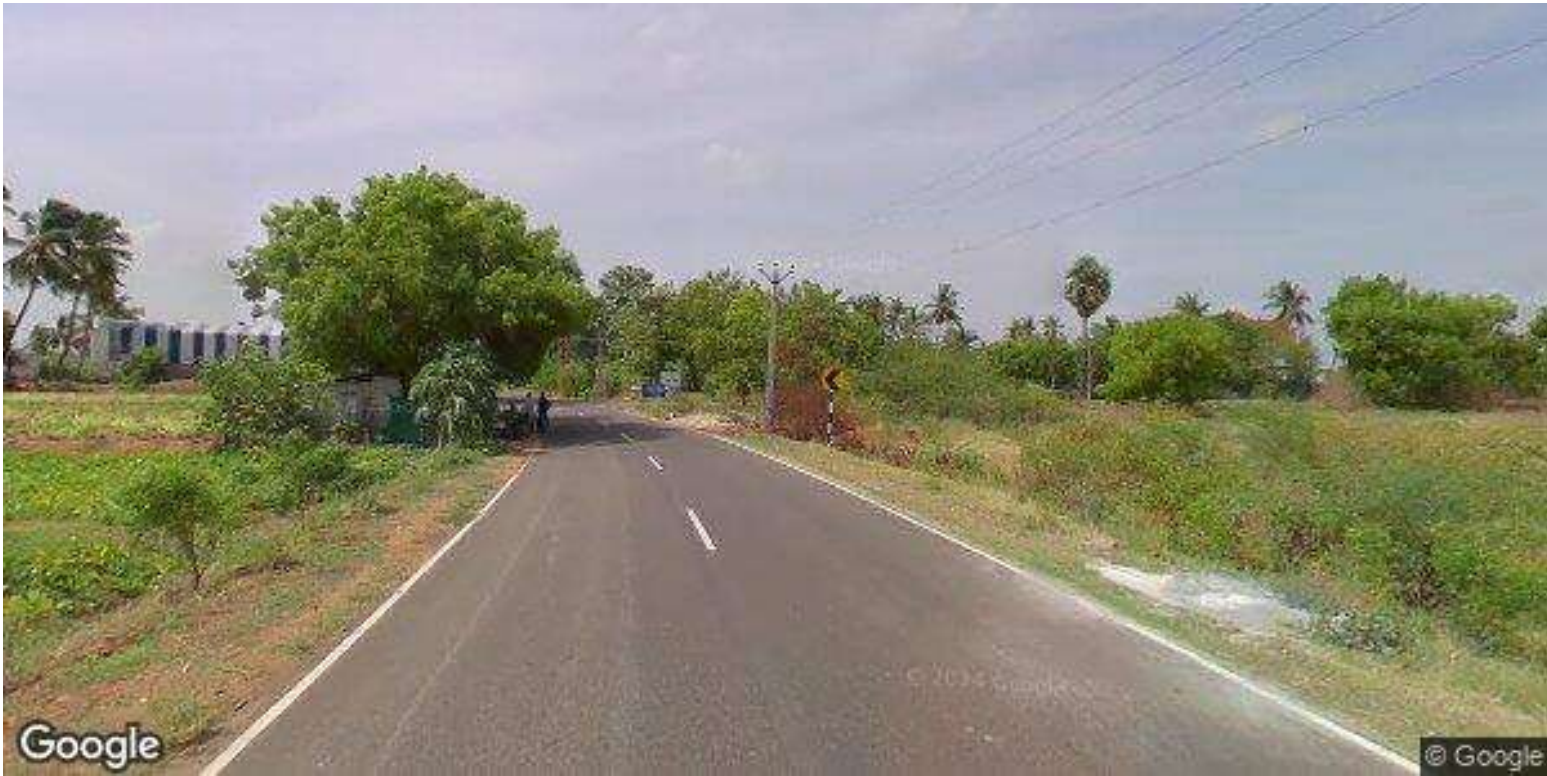
**Risk Type:** Turn  
**Risk Level:** Medium  
**Speed Limit:** 30 KM/Hr  
**Coordinates:** 11.20949, 77.81173

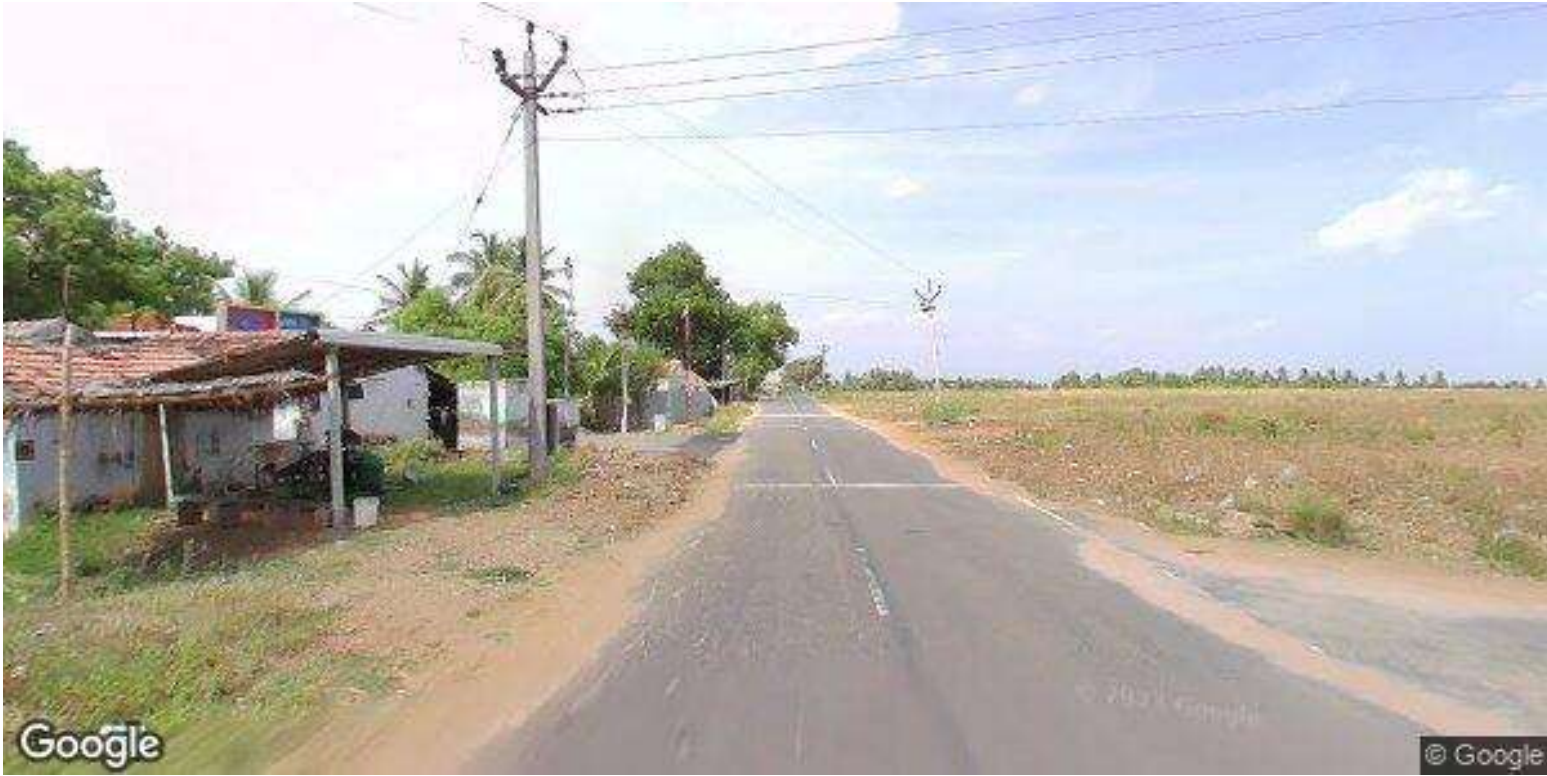
**Risk Type:** Turn  
**Risk Level:** High  
**Speed Limit:** 15 KM/Hr  
**Coordinates:** 11.20231, 77.79886

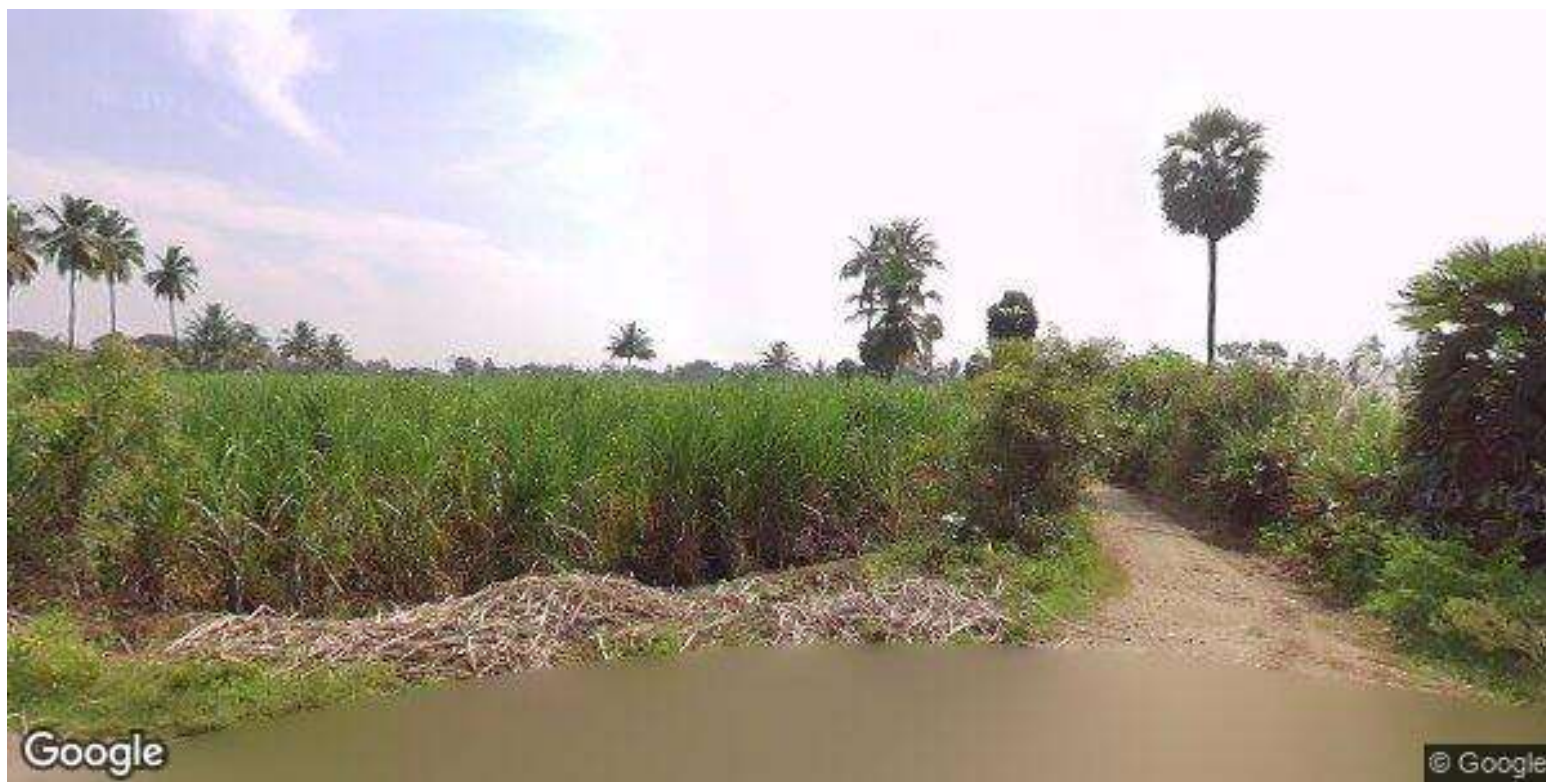
**Risk Type: Turn**

**Risk Level: High**

**Speed Limit: 15 KM/Hr**

**Coordinates: 11.18798, 77.80052**

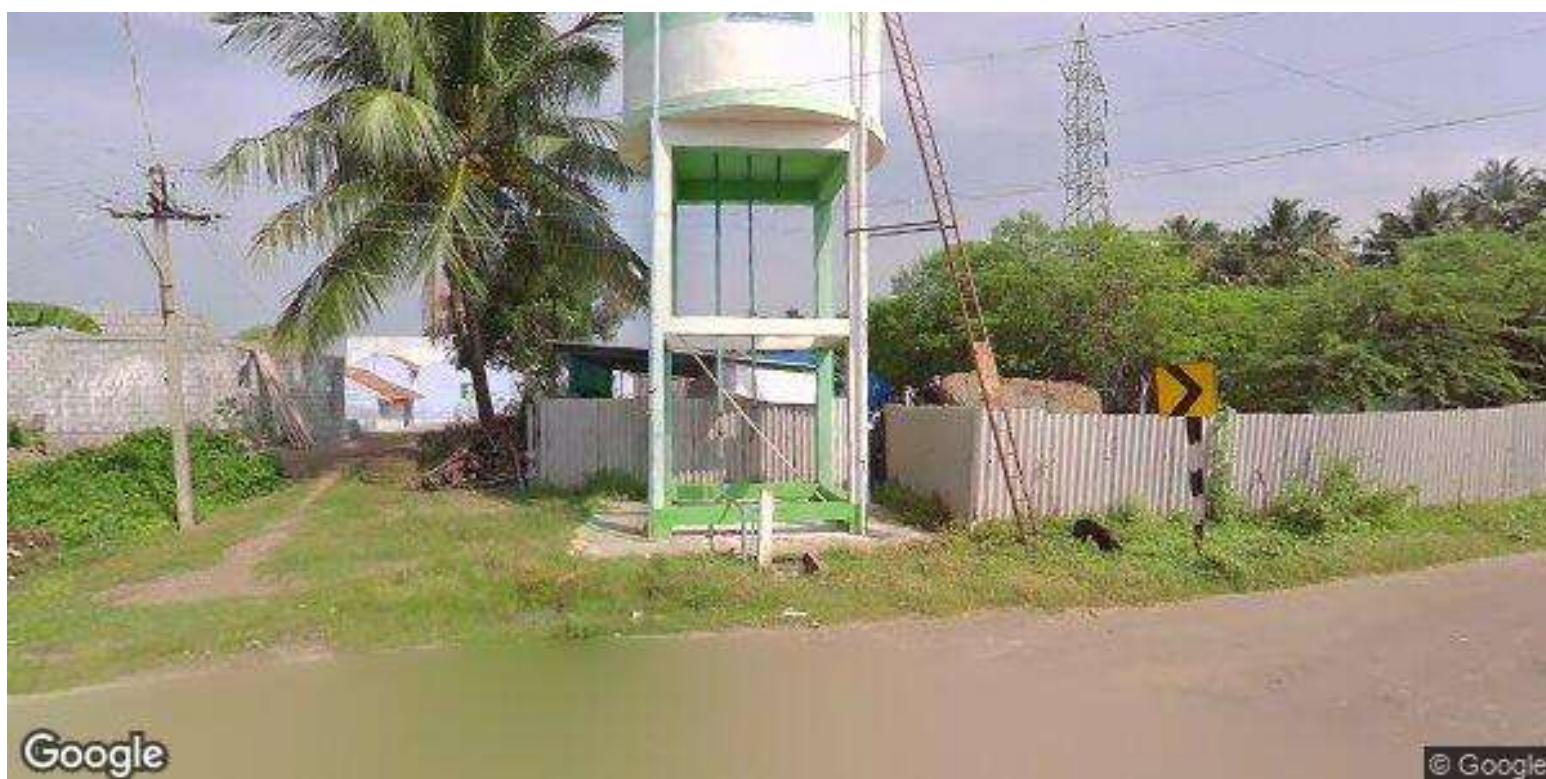
**Risk Type: Turn**

**Risk Level: High**

**Speed Limit: 15 KM/Hr**

**Coordinates: 11.18779, 77.79733**

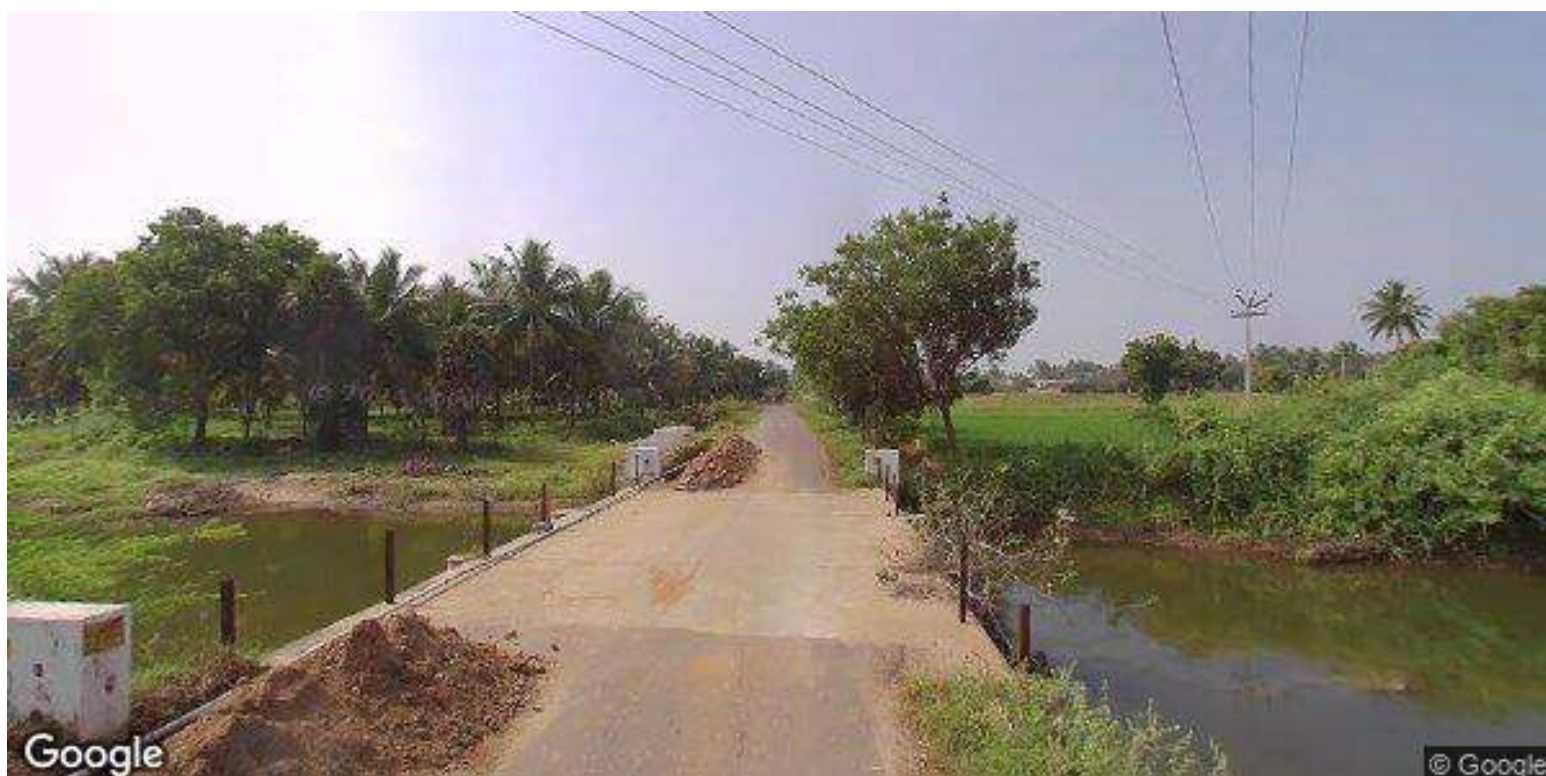
**Risk Type:** Turn  
**Risk Level:** Medium  
**Speed Limit:** 30 KM/Hr  
**Coordinates:** 11.18542, 77.79672

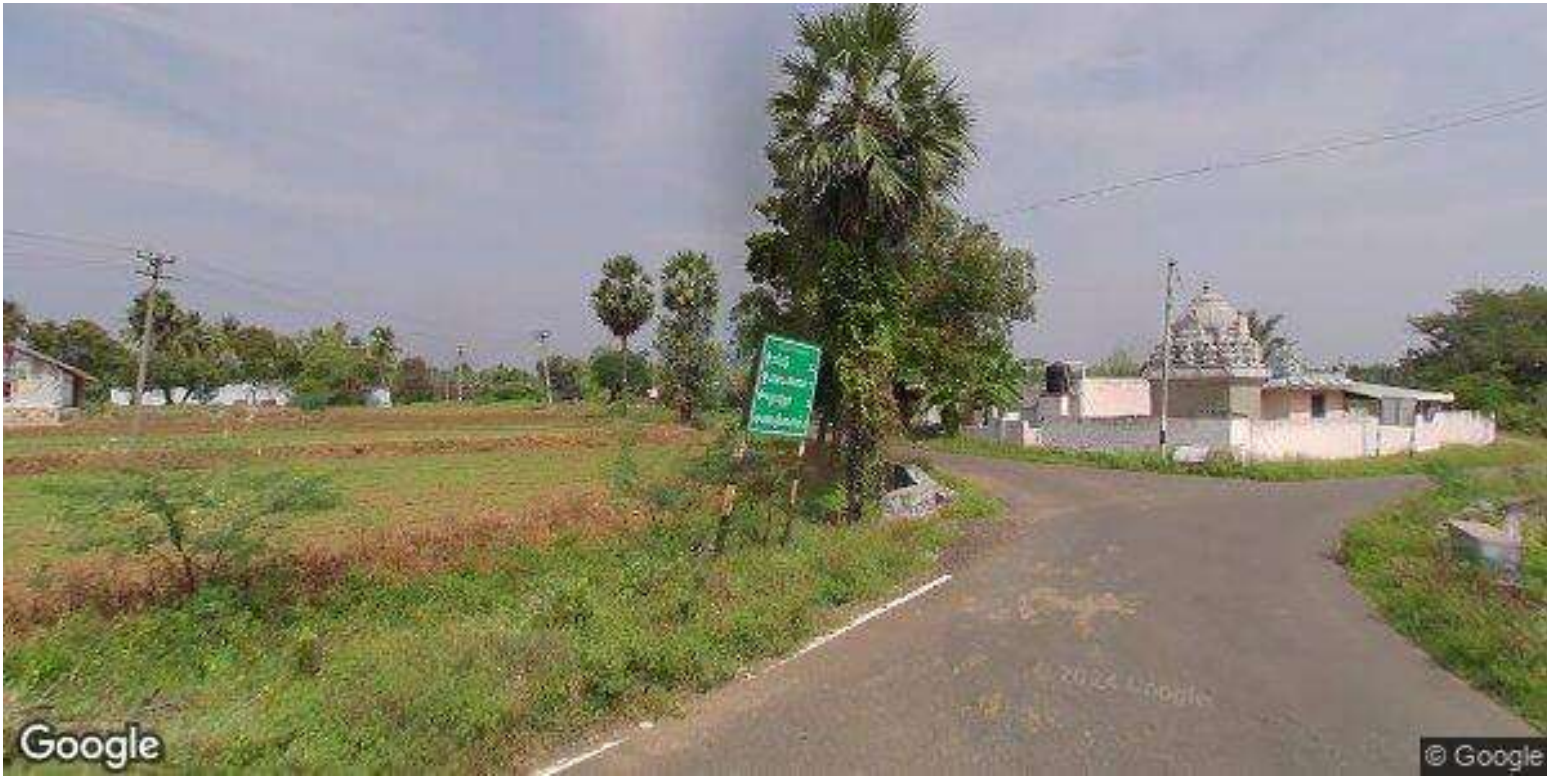
**Risk Type:** Turn  
**Risk Level:** High  
**Speed Limit:** 15 KM/Hr  
**Coordinates:** 11.18312, 77.79425

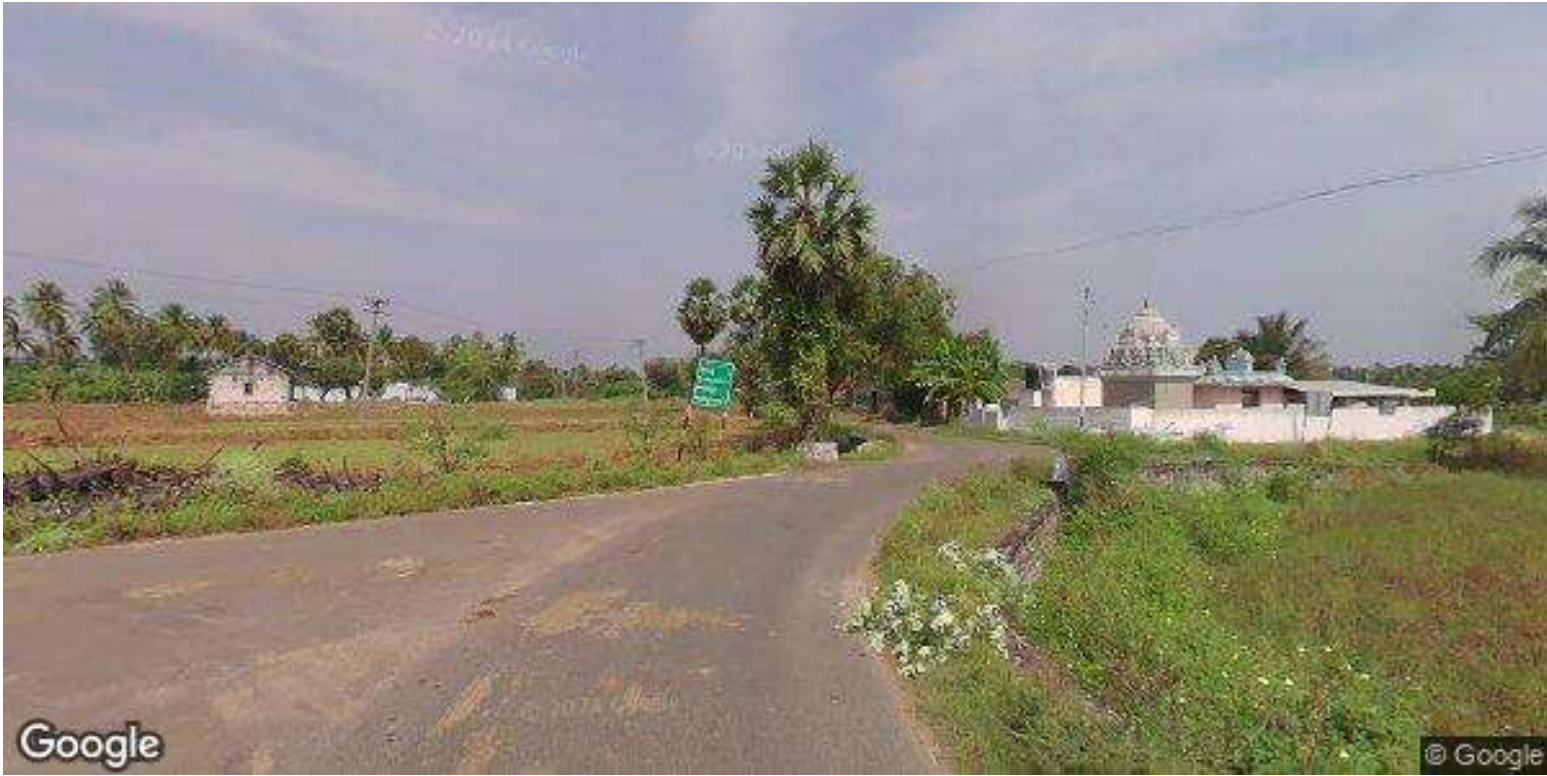
**Risk Type:** Turn  
**Risk Level:** Medium  
**Speed Limit:** 30 KM/Hr  
**Coordinates:** 11.18298, 77.79420

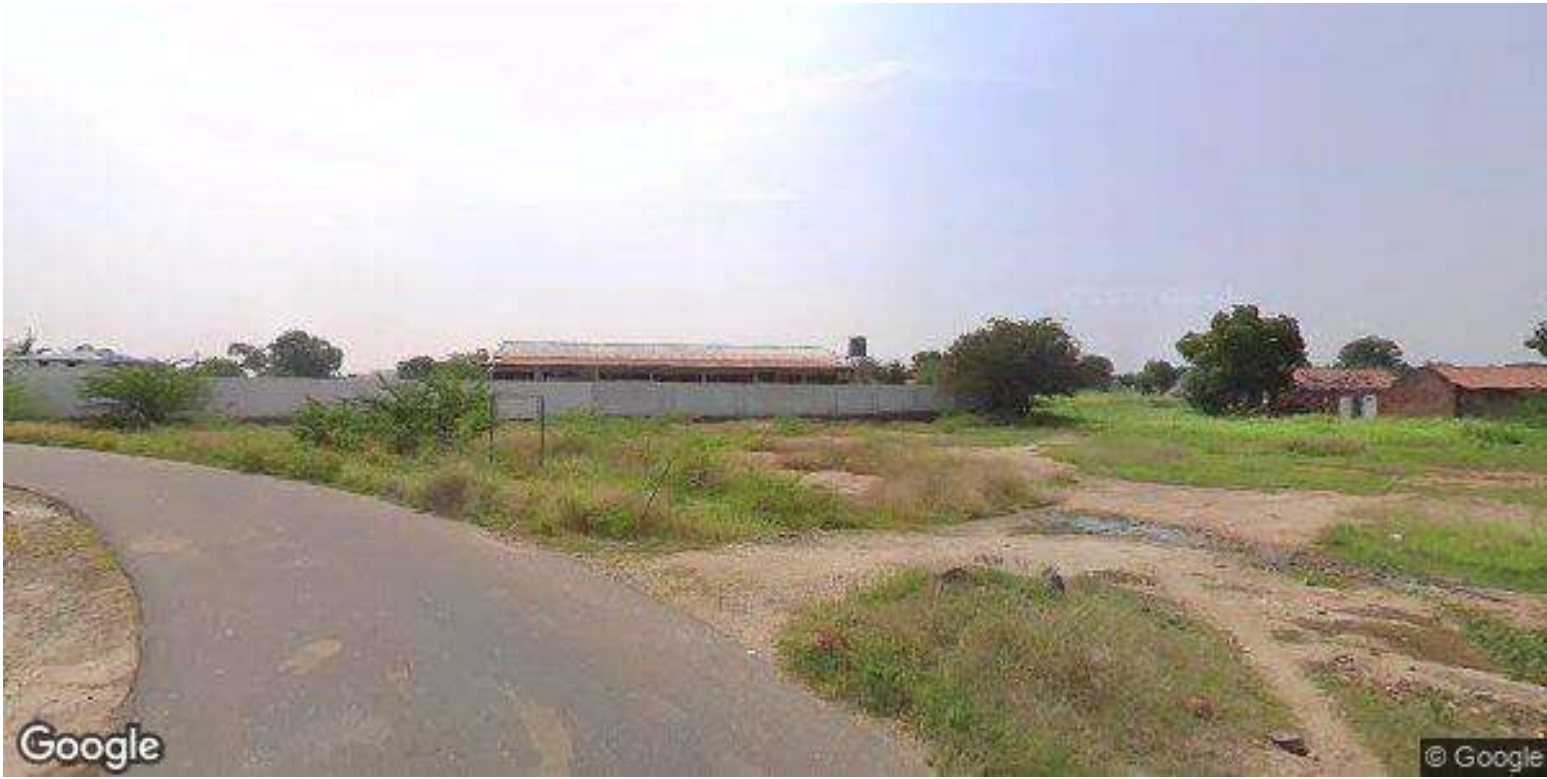
**Risk Type:** Turn  
**Risk Level:** Medium  
**Speed Limit:** 30 KM/Hr  
**Coordinates:** 11.17594, 77.79491

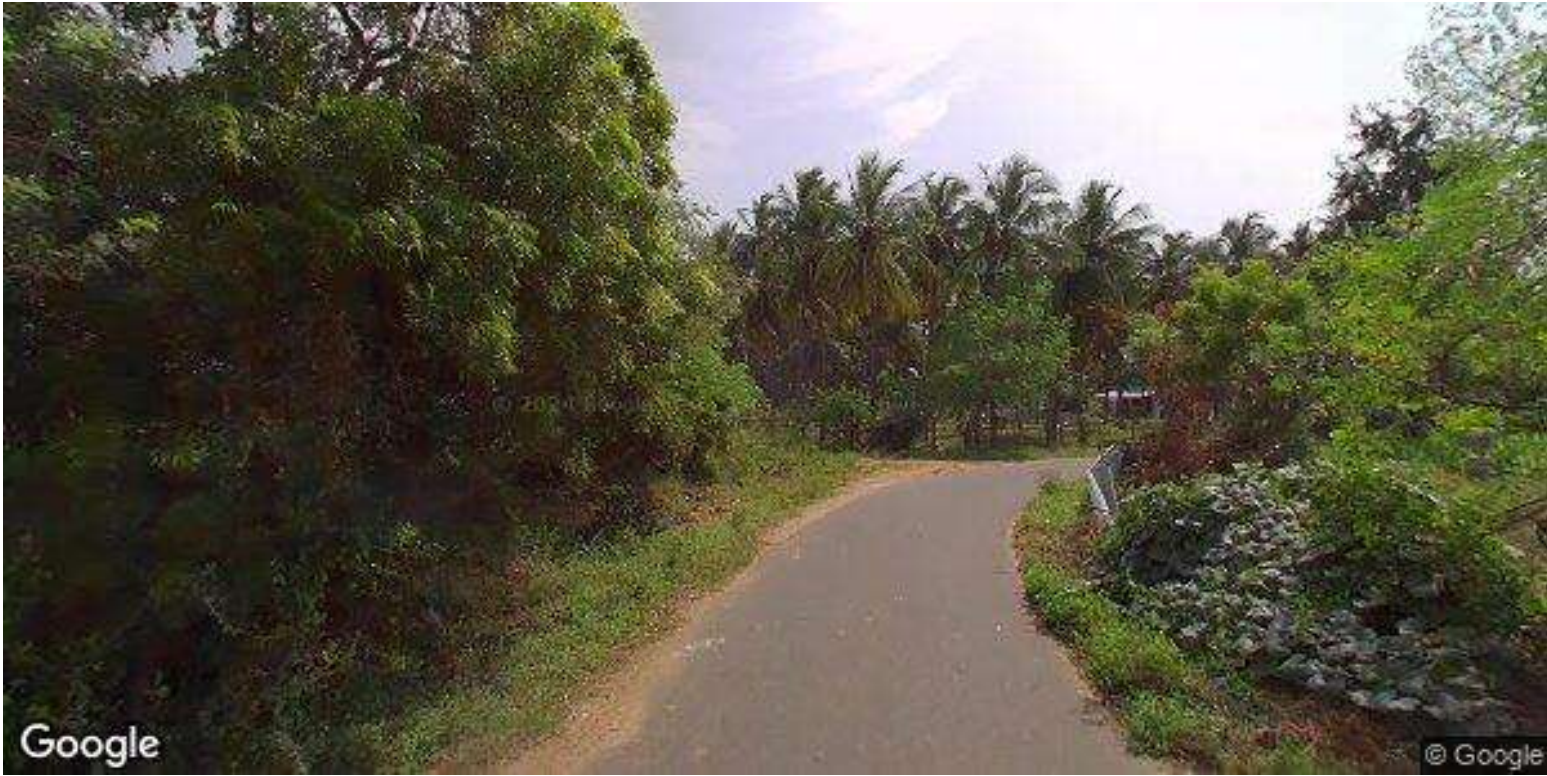
**Risk Type:** Turn  
**Risk Level:** Medium  
**Speed Limit:** 30 KM/Hr  
**Coordinates:** 11.17301, 77.79650

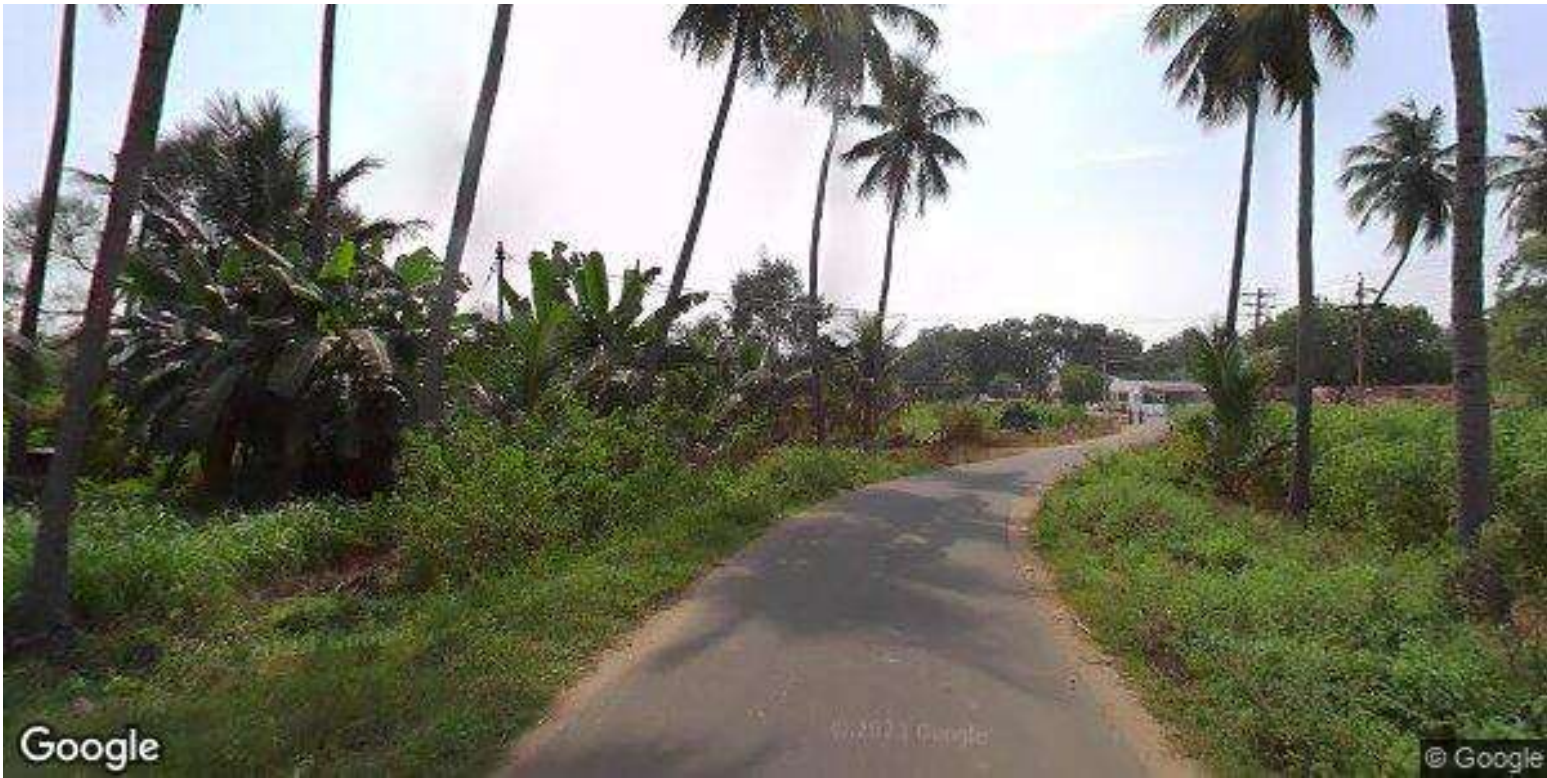
**Risk Type:** Turn  
**Risk Level:** Medium  
**Speed Limit:** 30 KM/Hr  
**Coordinates:** 11.16706, 77.79514

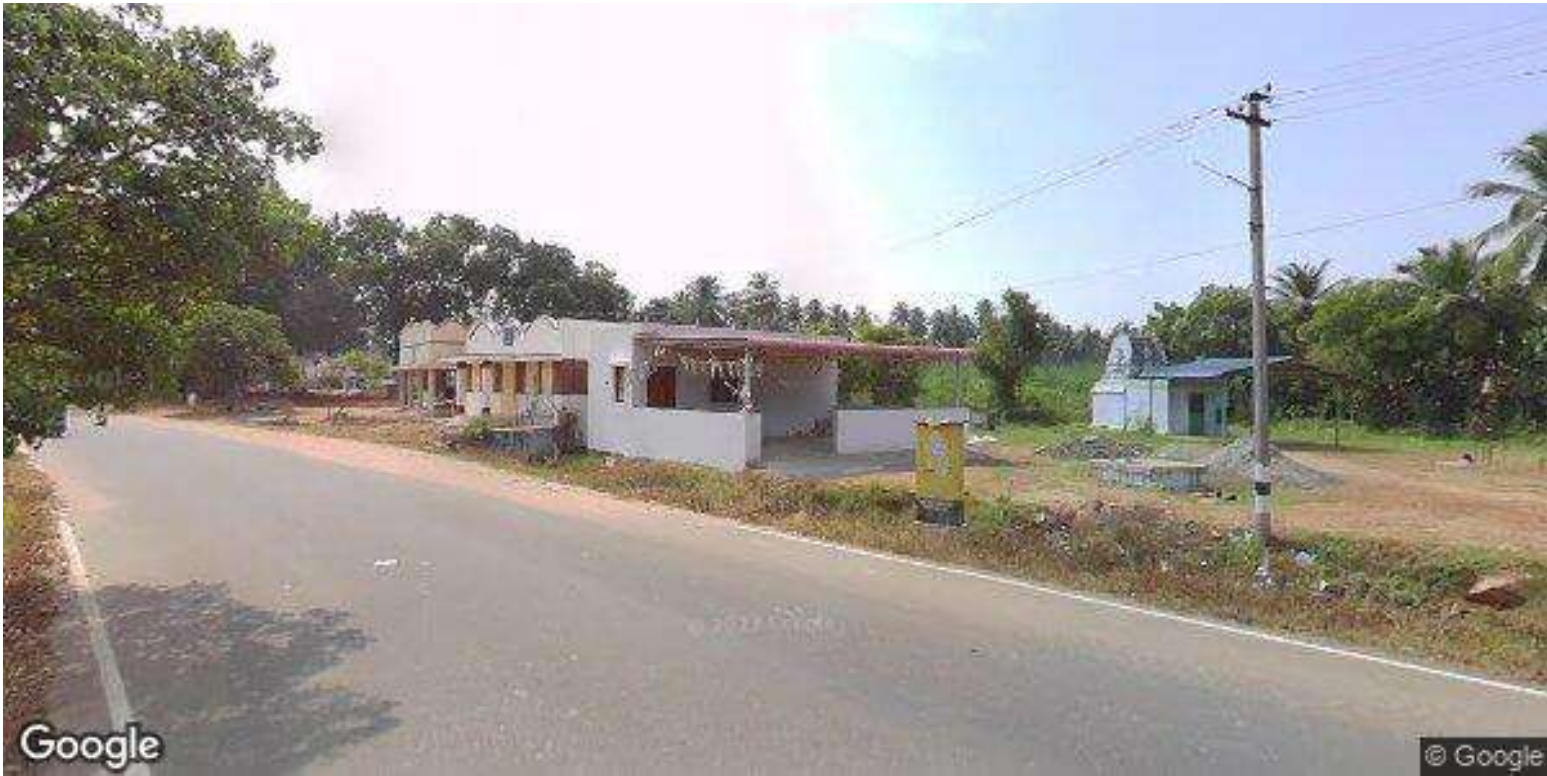
**Risk Type:** Turn  
**Risk Level:** Medium  
**Speed Limit:** 30 KM/Hr  
**Coordinates:** 11.16632, 77.79476

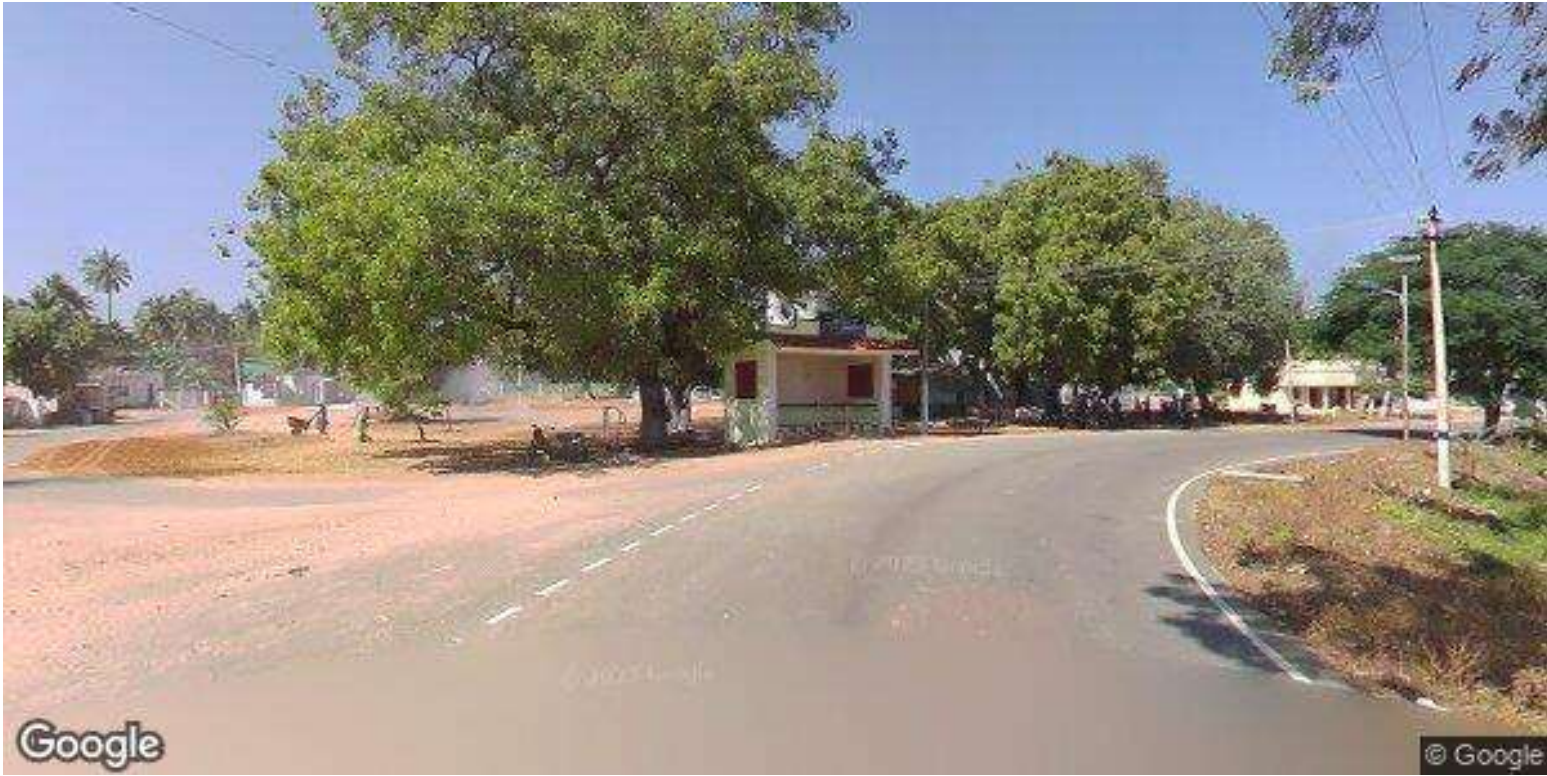
**Risk Type:** Blind Spot  
**Risk Level:** Blind Spot  
**Speed Limit:** 10 KM/Hr  
**Coordinates:** 11.16520, 77.79528

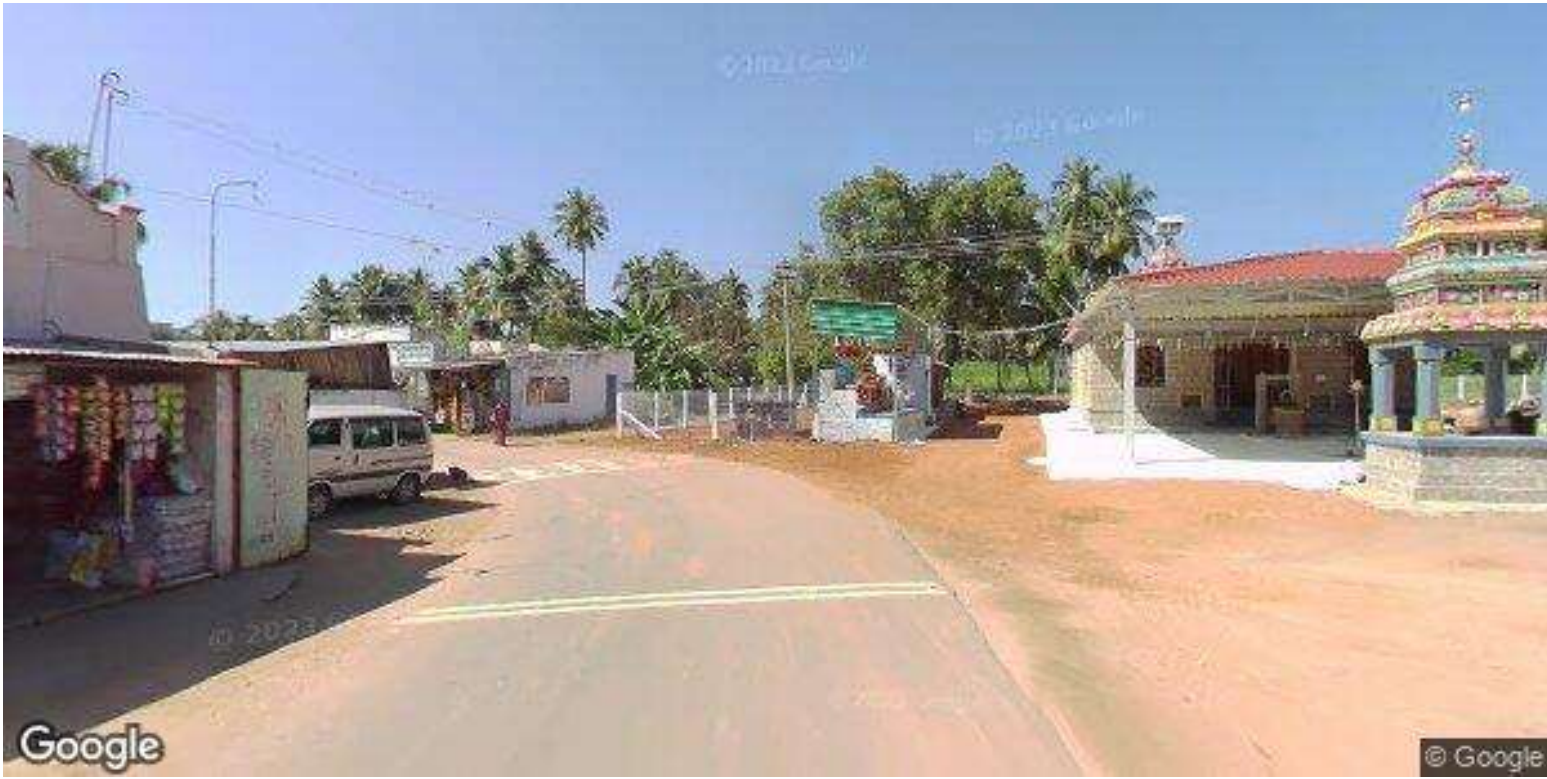
**Risk Type:** Turn  
**Risk Level:** Medium  
**Speed Limit:** 30 KM/Hr  
**Coordinates:** 11.16499, 77.79473

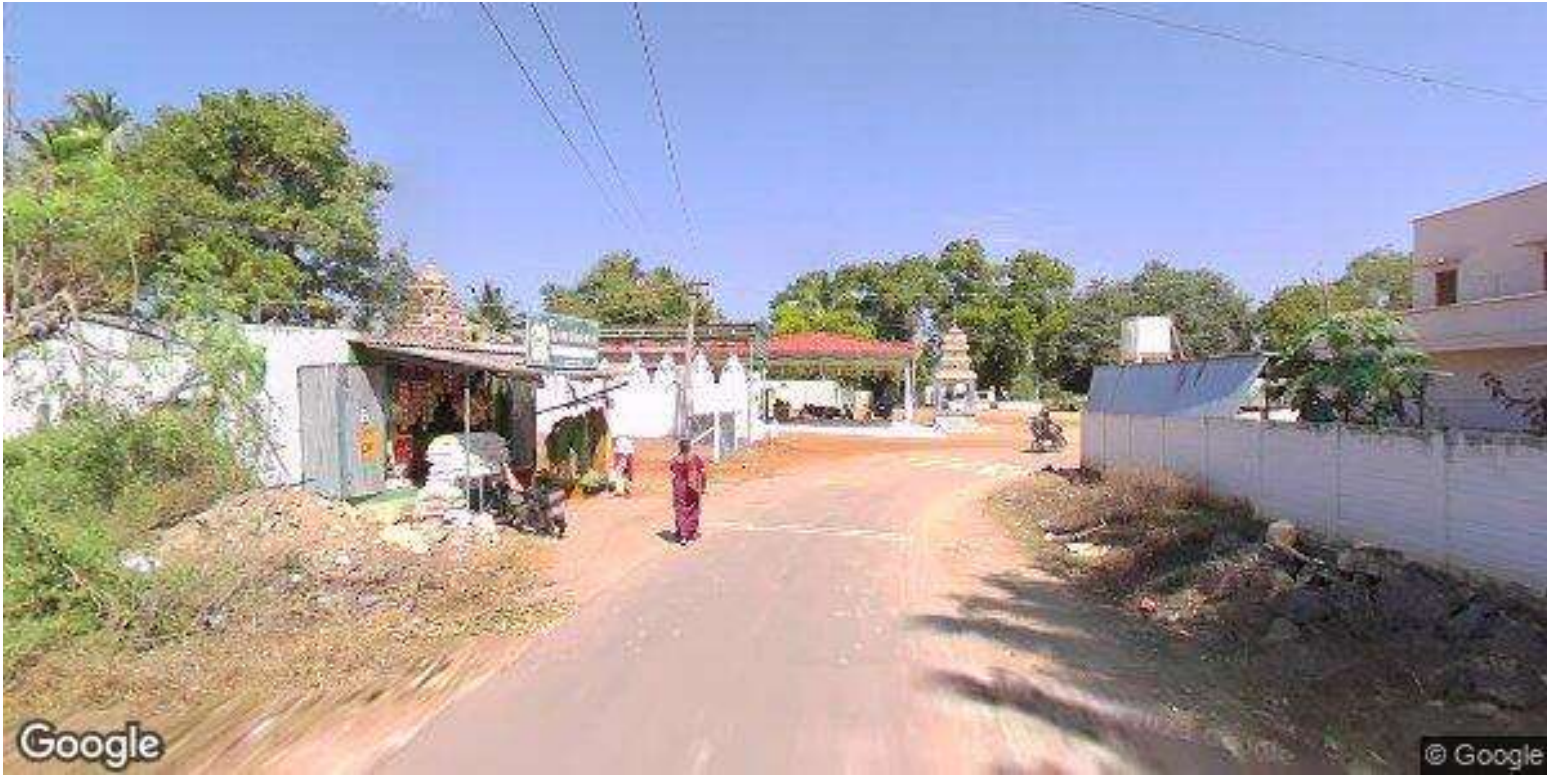
**Risk Type:** Turn  
**Risk Level:** High  
**Speed Limit:** 15 KM/Hr  
**Coordinates:** 11.16470, 77.79449
