# IndianOil

## JOURNEY RISK MANAGEMENT (JRM) STUDY

### Salem Terminal TO ERODE PRECISION FARM PRODUCER

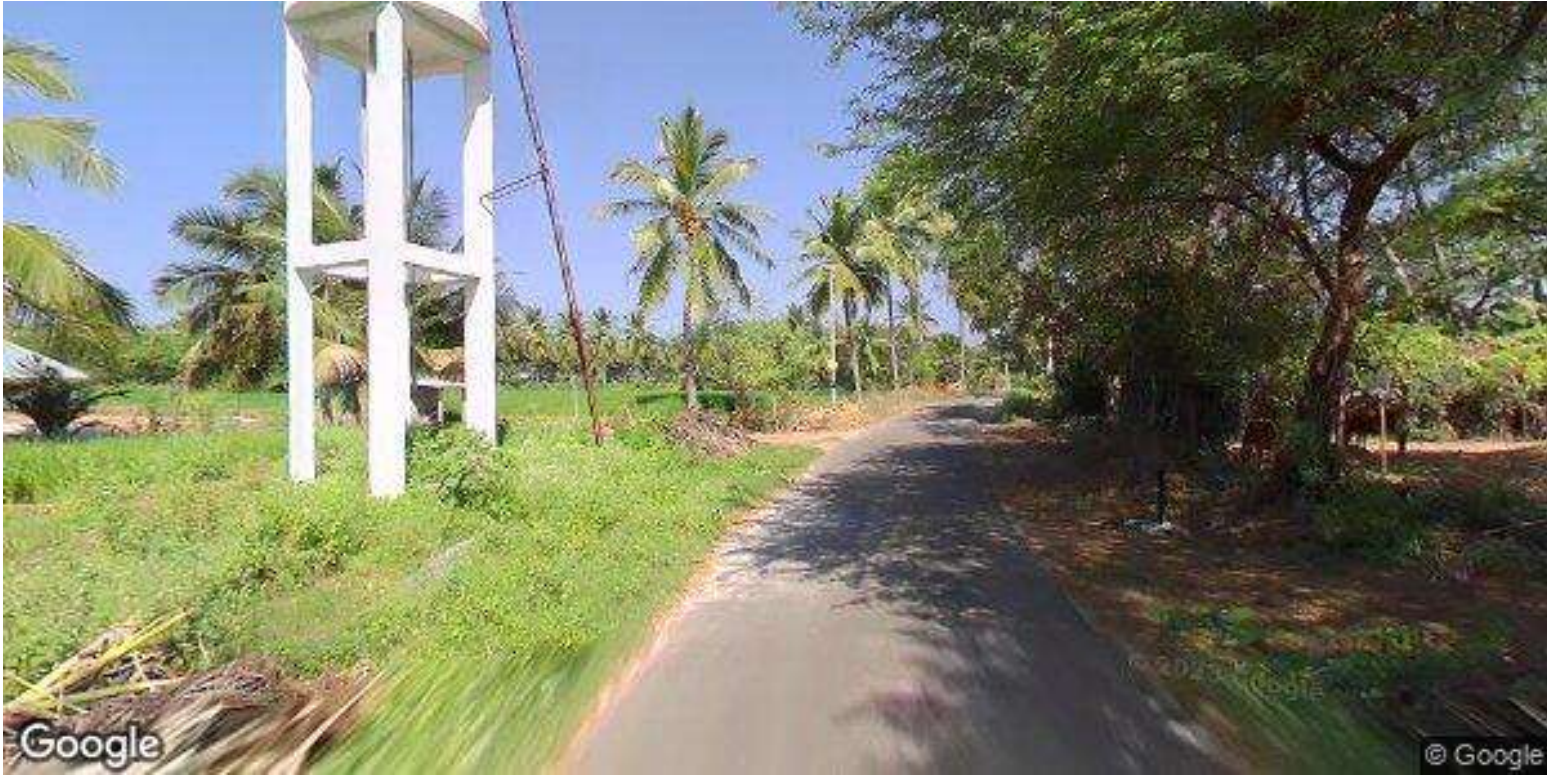
**Risk Type:** Turn  
**Risk Level:** Medium  
**Speed Limit:** 30 KM/Hr  
**Coordinates:** 11.16107, 77.79366

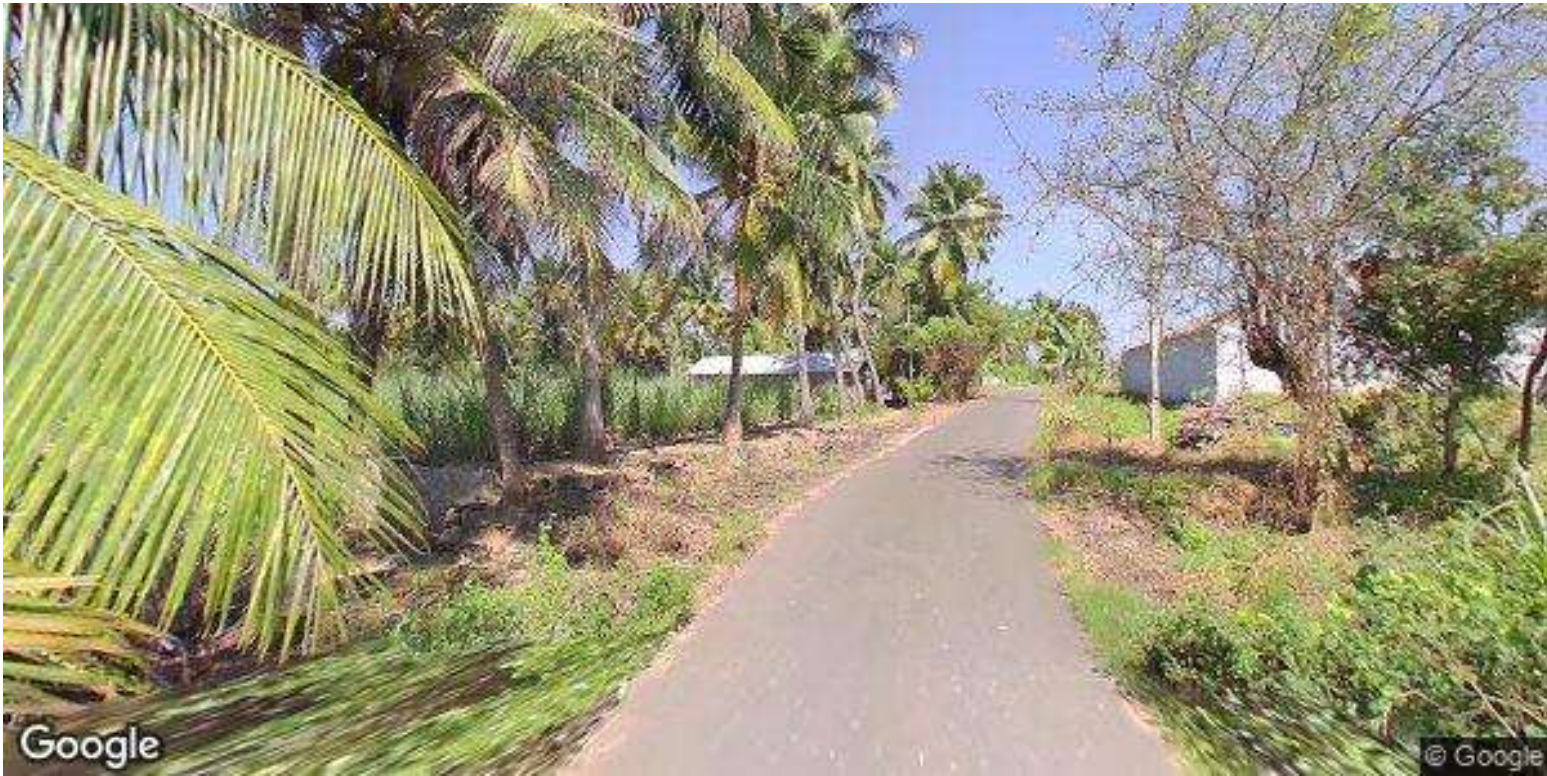
**Risk Type:** Turn  
**Risk Level:** Medium  
**Speed Limit:** 30 KM/Hr  
**Coordinates:** 11.15590, 77.79390

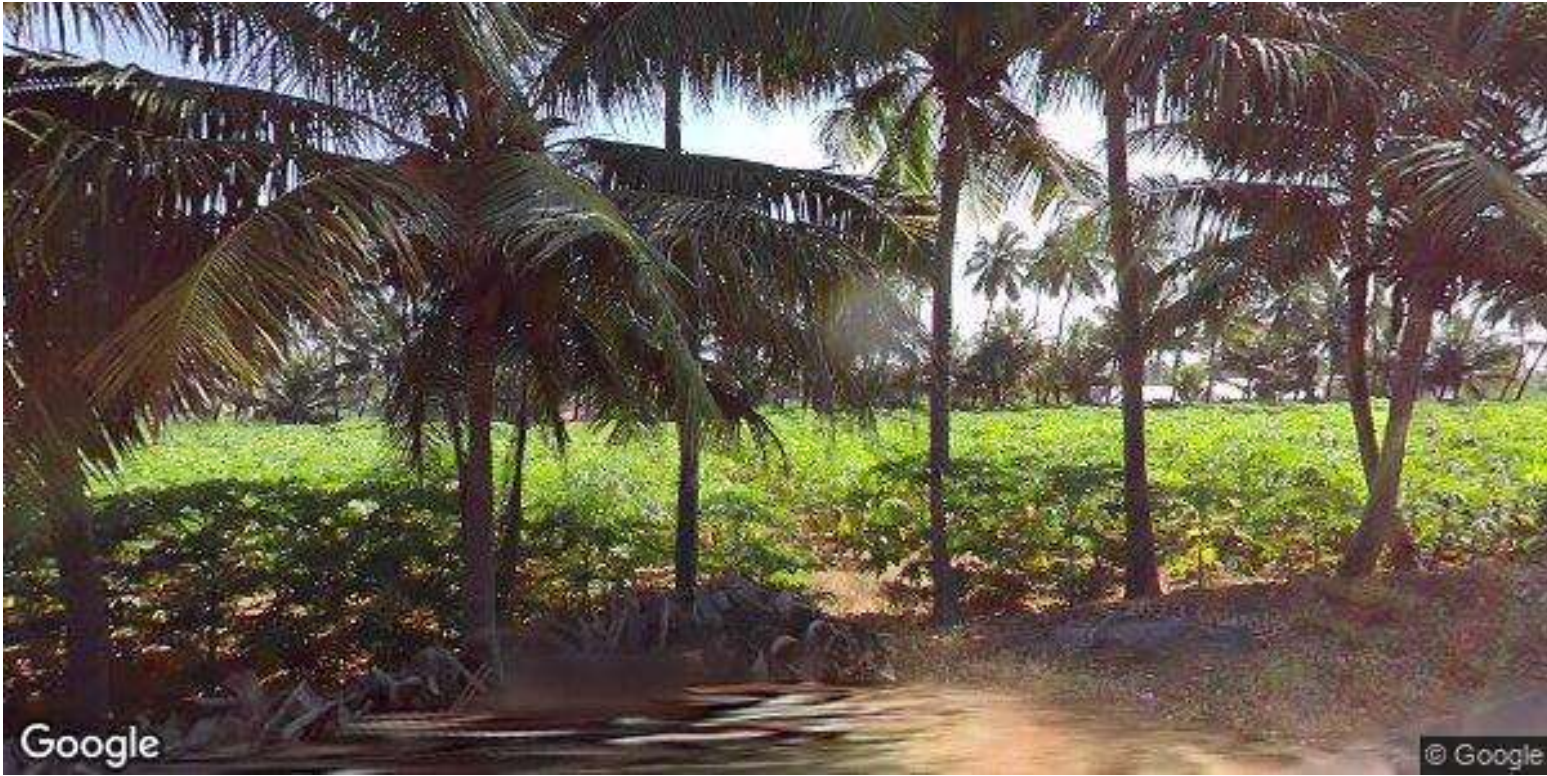
**Risk Type:** Turn  
**Risk Level:** Medium  
**Speed Limit:** 30 KM/Hr  
**Coordinates:** 11.15044, 77.79729

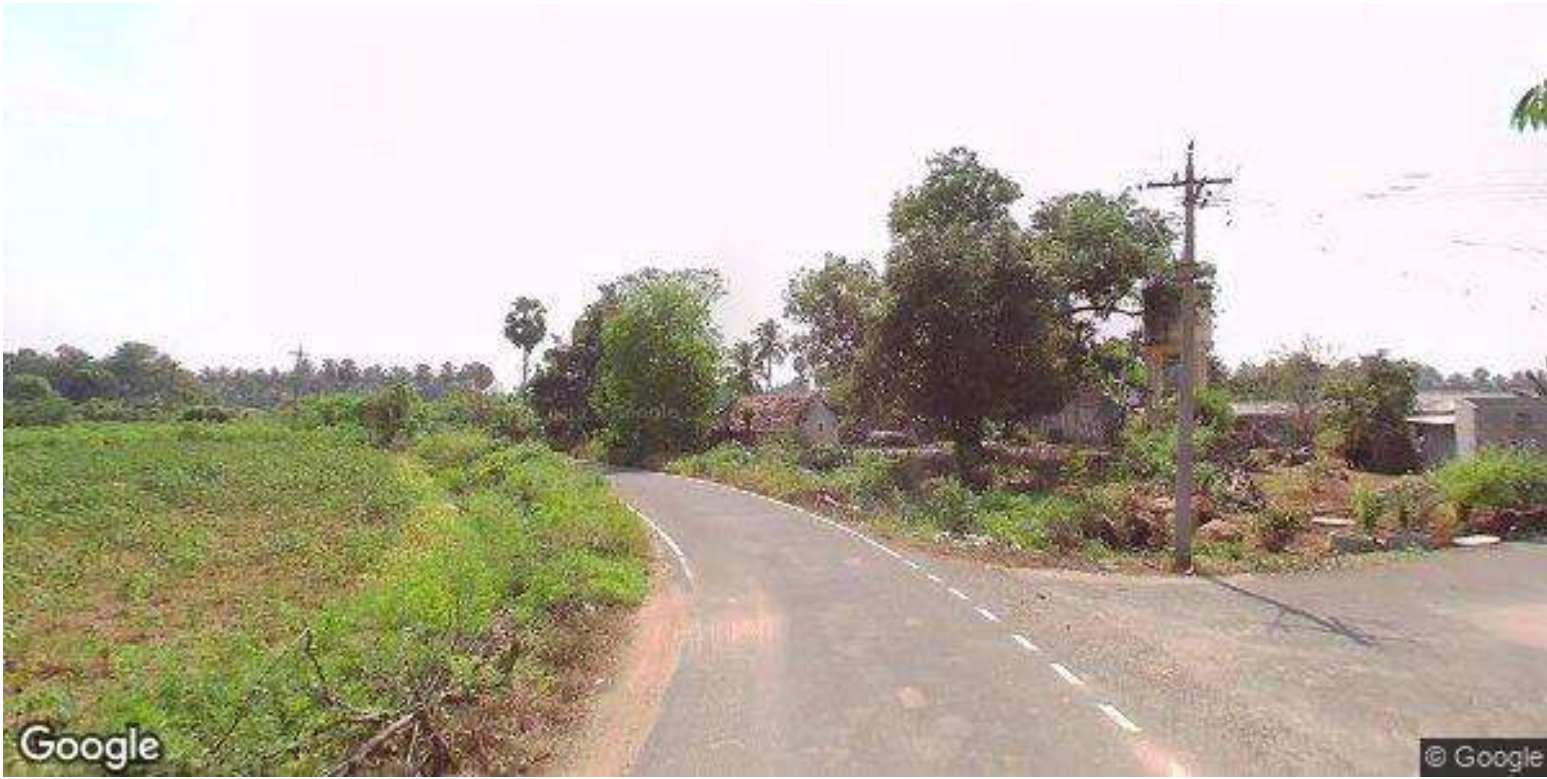
**Risk Type:** Turn  
**Risk Level:** Medium  
**Speed Limit:** 30 KM/Hr  
**Coordinates:** 11.13966, 77.79872

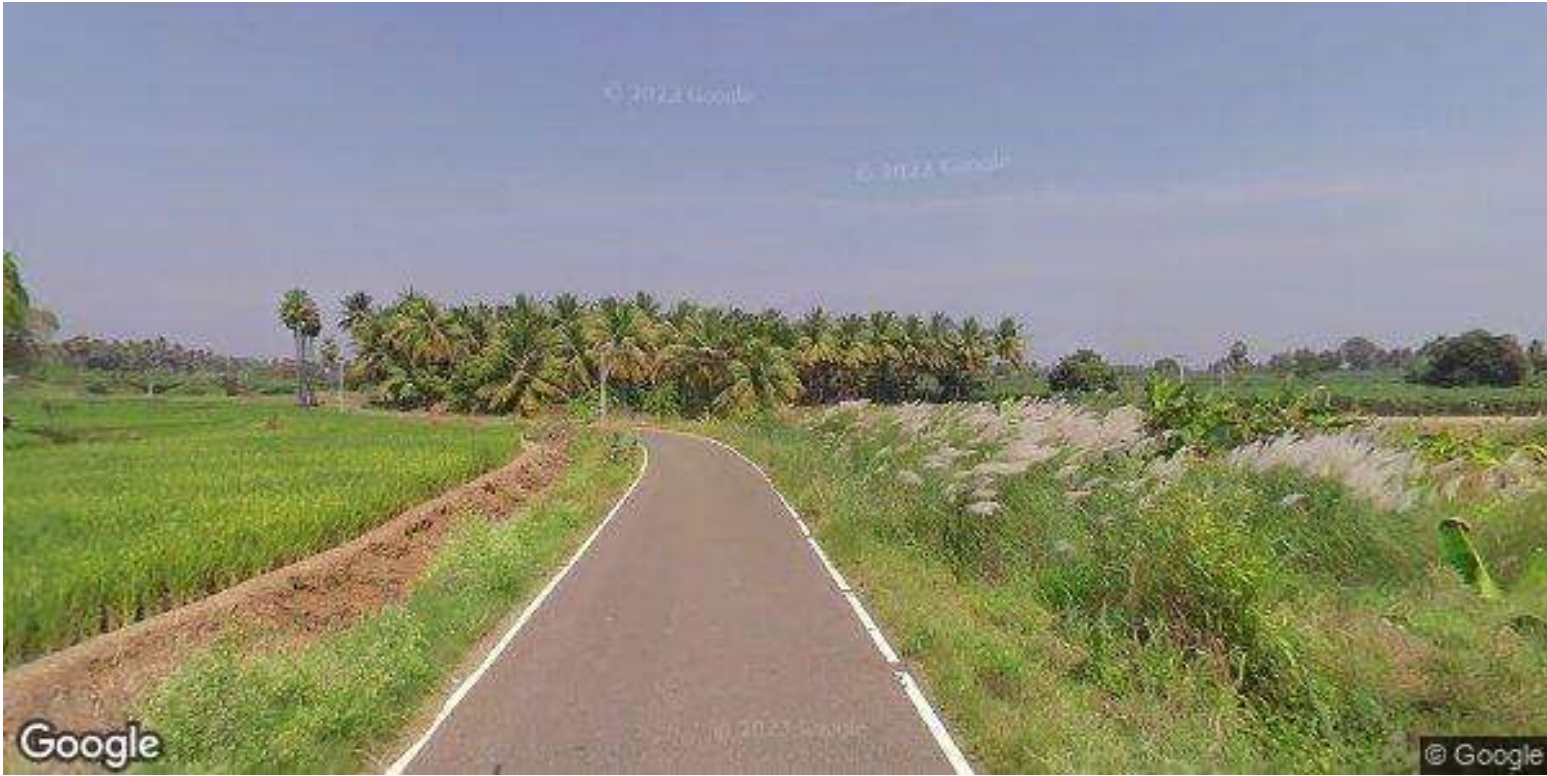
**Risk Type:** Turn  
**Risk Level:** Medium  
**Speed Limit:** 30 KM/Hr  
**Coordinates:** 11.13645, 77.80023

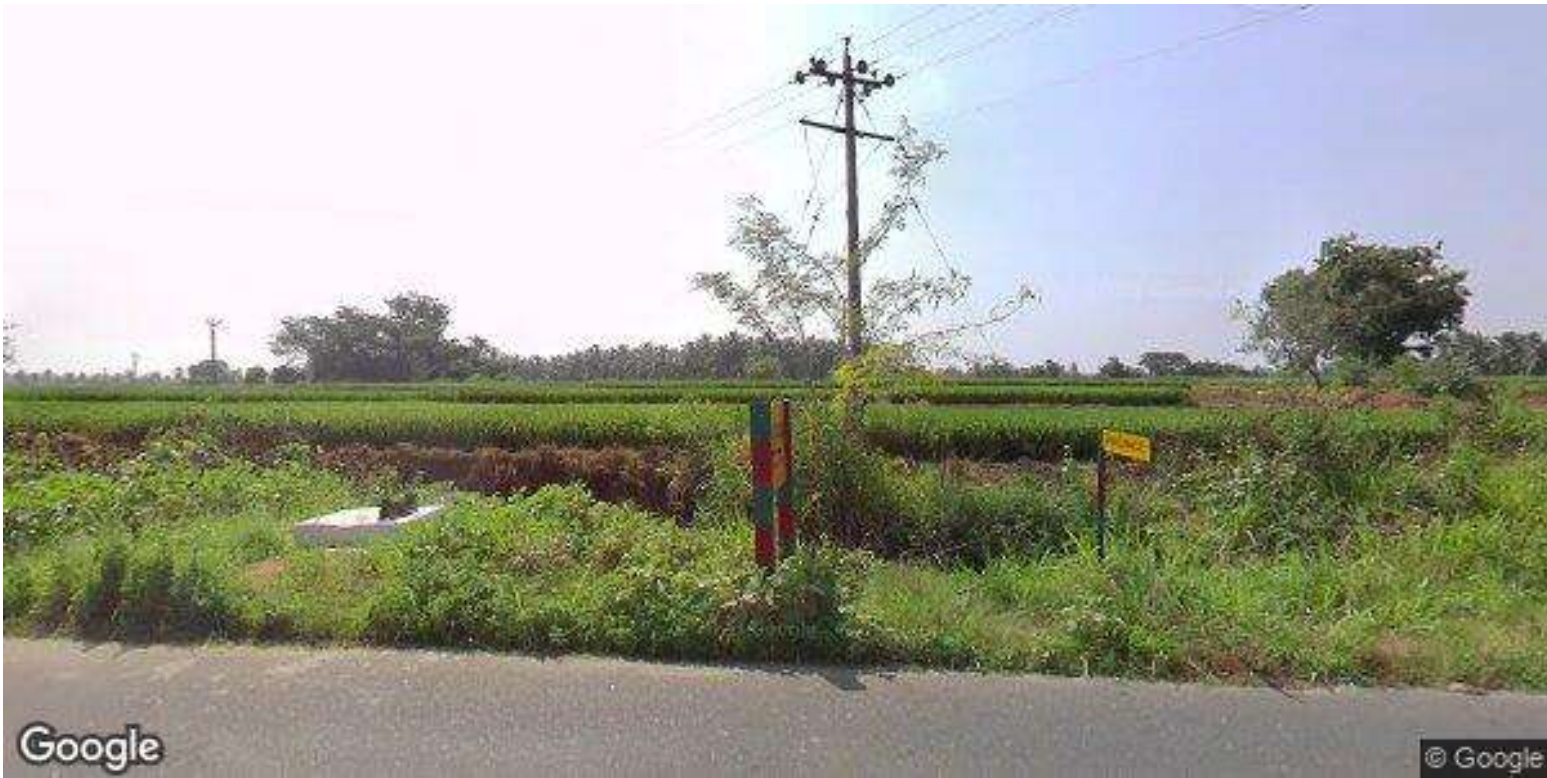
**Risk Type:** Turn  
**Risk Level:** High  
**Speed Limit:** 15 KM/Hr  
**Coordinates:** 11.13519, 77.79955

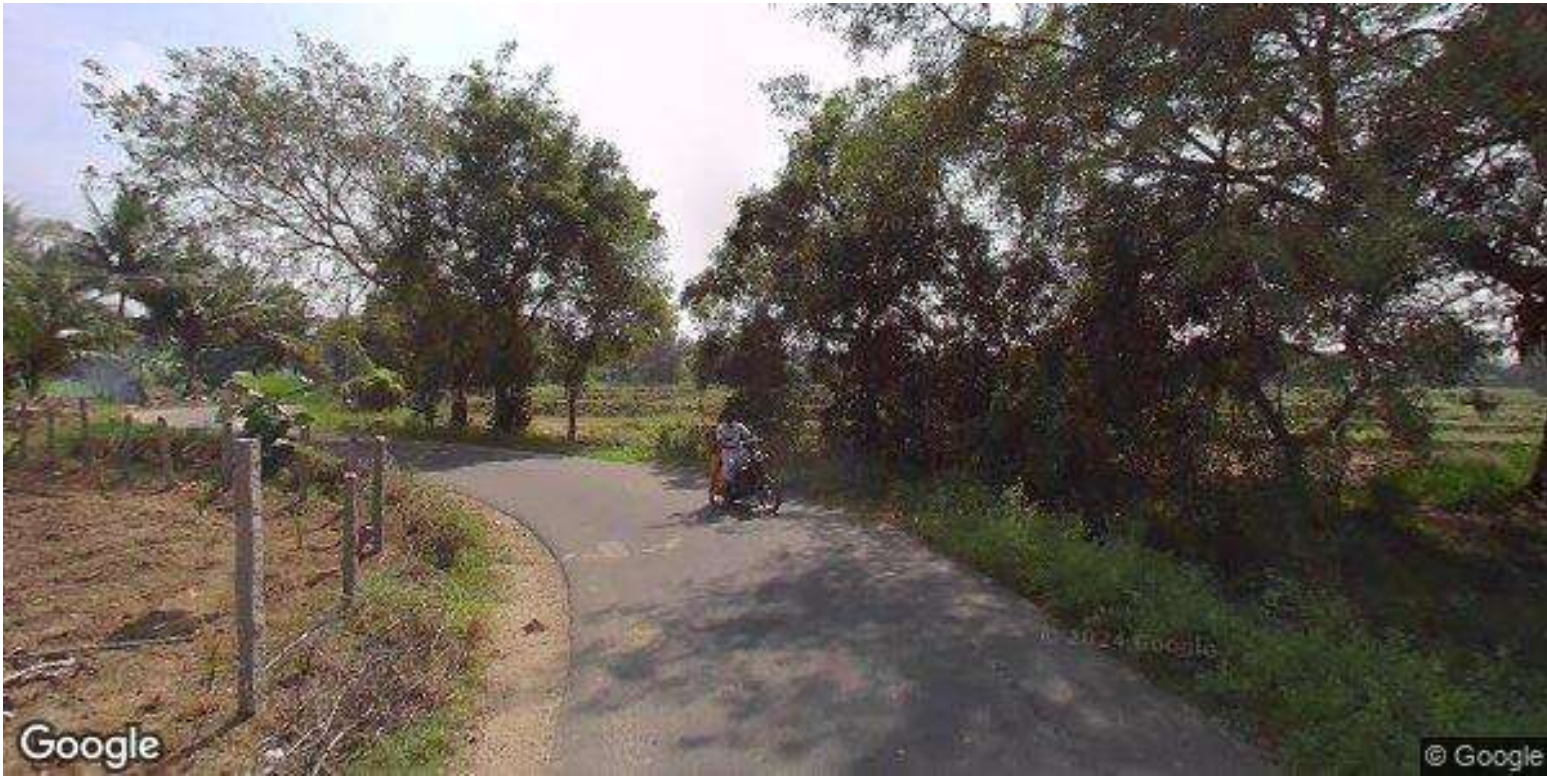
**Risk Type:** Turn  
**Risk Level:** High  
**Speed Limit:** 15 KM/Hr  
**Coordinates:** 11.13046, 77.80159

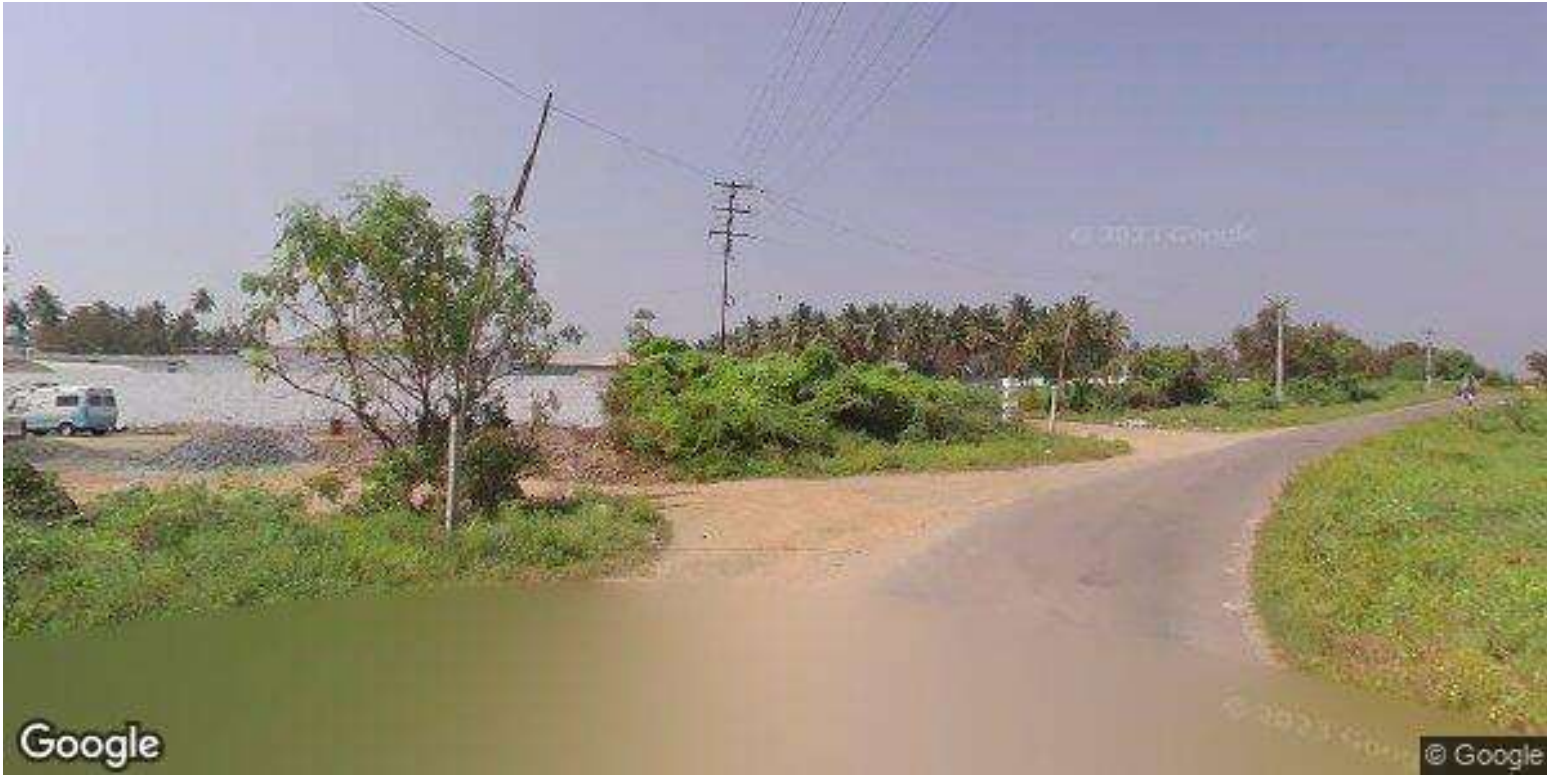
**Risk Type:** Turn  
**Risk Level:** Medium  
**Speed Limit:** 30 KM/Hr  
**Coordinates:** 11.12680, 77.80416

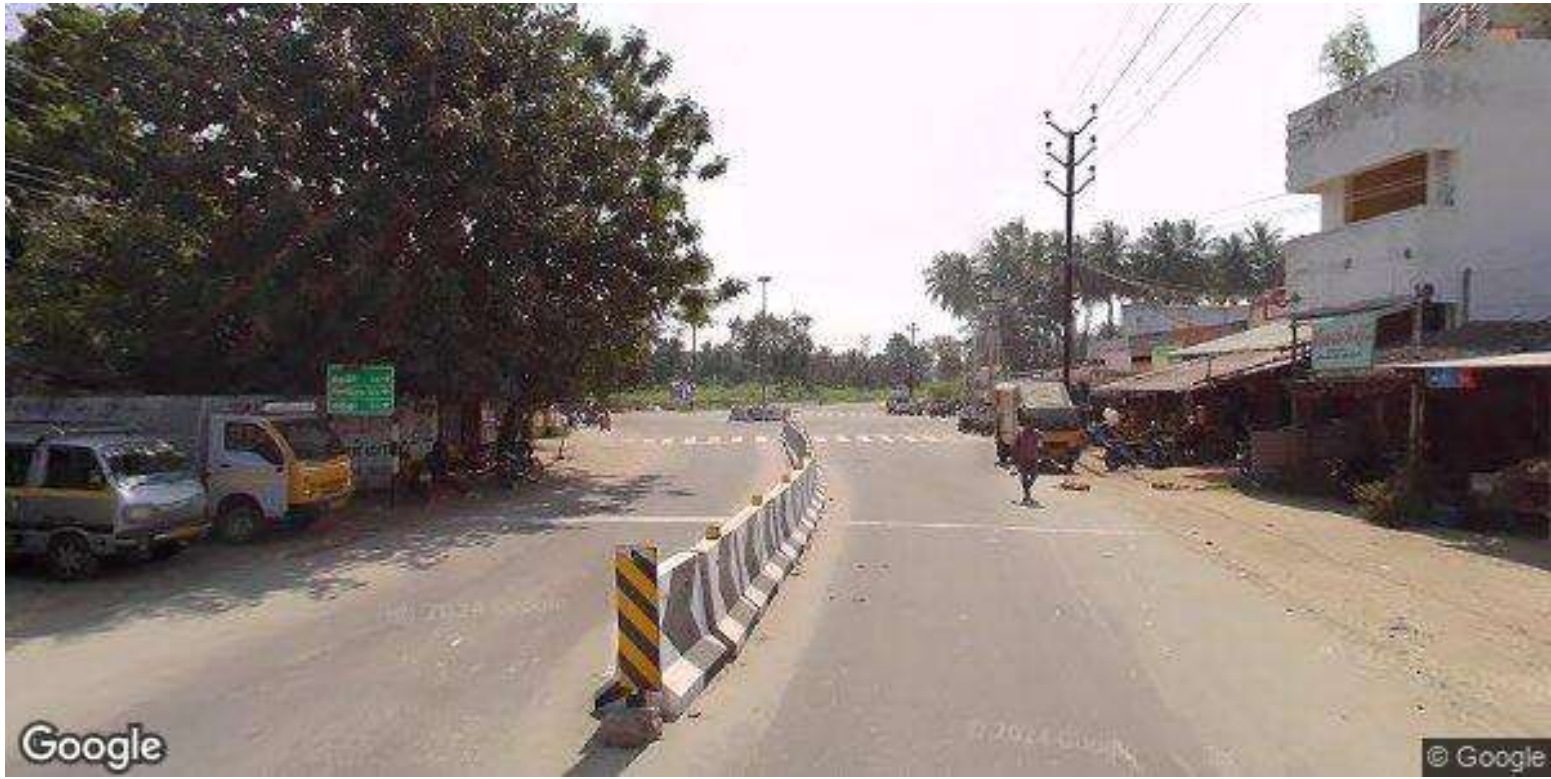
**Risk Type:** Turn  
**Risk Level:** High  
**Speed Limit:** 15 KM/Hr  
**Coordinates:** 11.12661, 77.80462

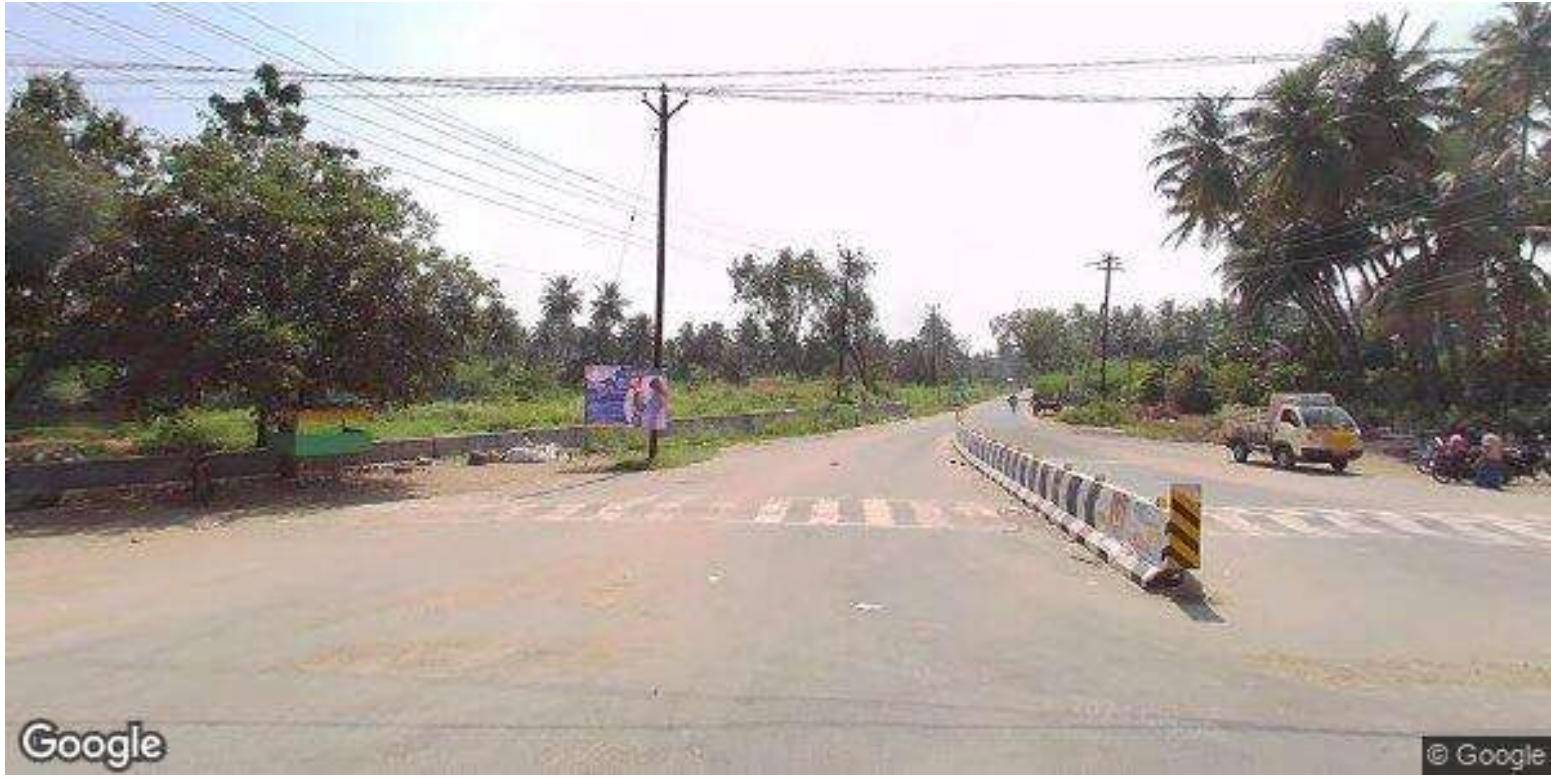
**Risk Type:** Turn  
**Risk Level:** High  
**Speed Limit:** 15 KM/Hr  
**Coordinates:** 11.12613, 77.80463
