# IndianOil

## JOURNEY RISK MANAGEMENT (JRM) STUDY

**Salem Terminal TO S K AGENCY**

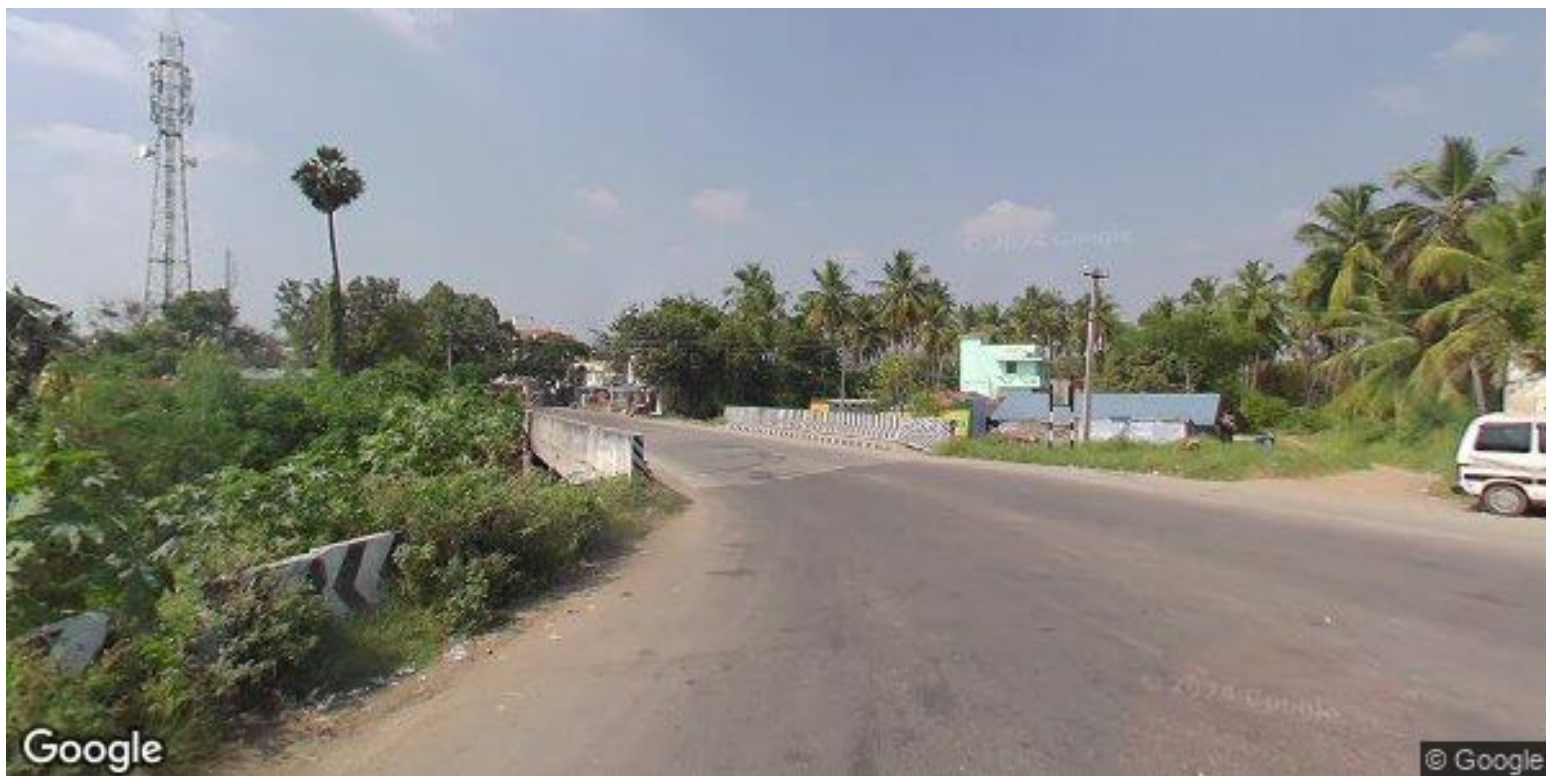
**Coordinates:** 11.44893, 77.87413

**Risk Type:** Turn

**Risk Level:** Medium

**Speed Limit:** 30 KM/Hr

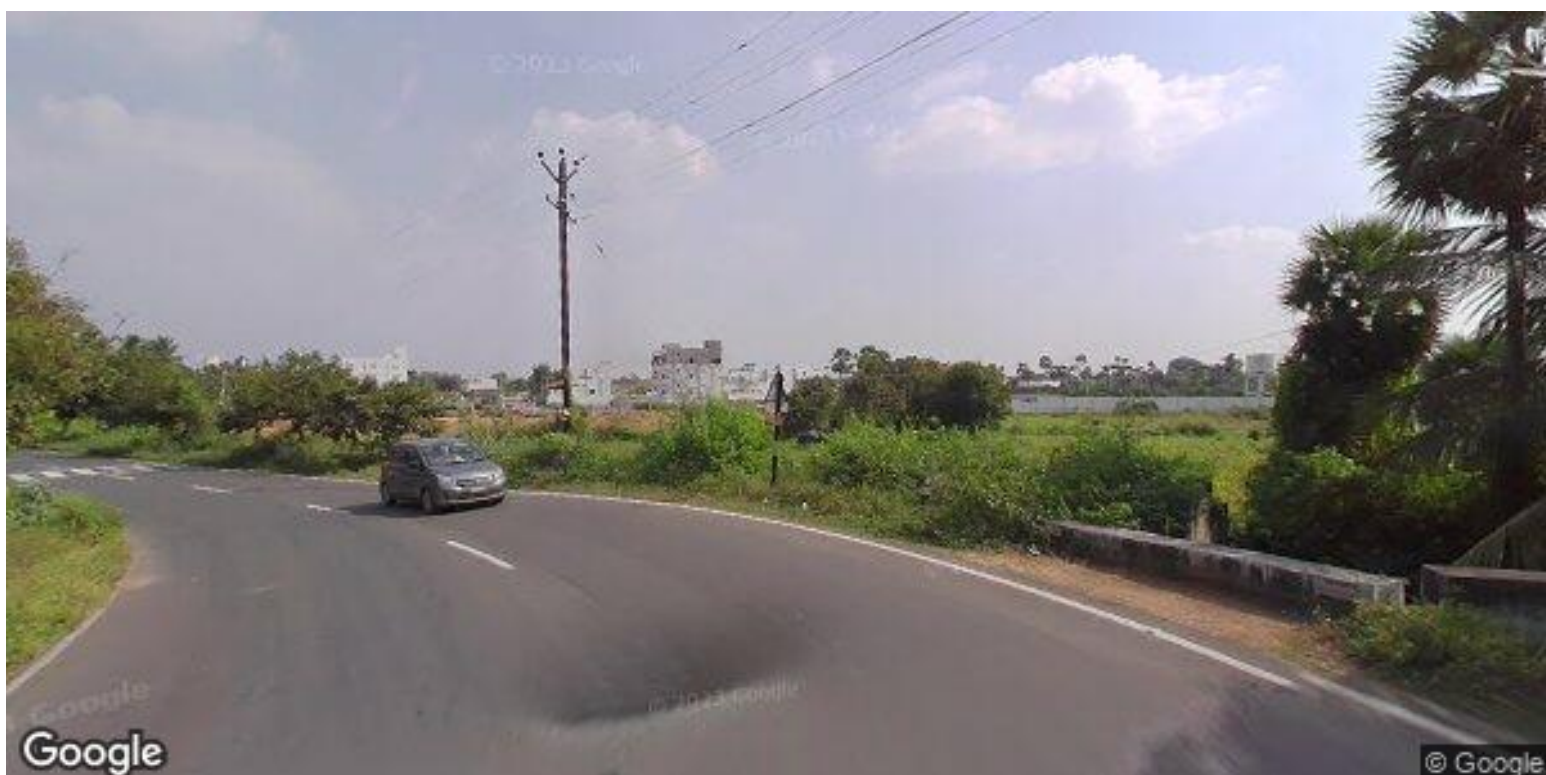
**Risk Type:** Turn  
**Risk Level:** High  
**Speed Limit:** 15 KM/Hr  
**Coordinates:** 11.45350, 77.85700

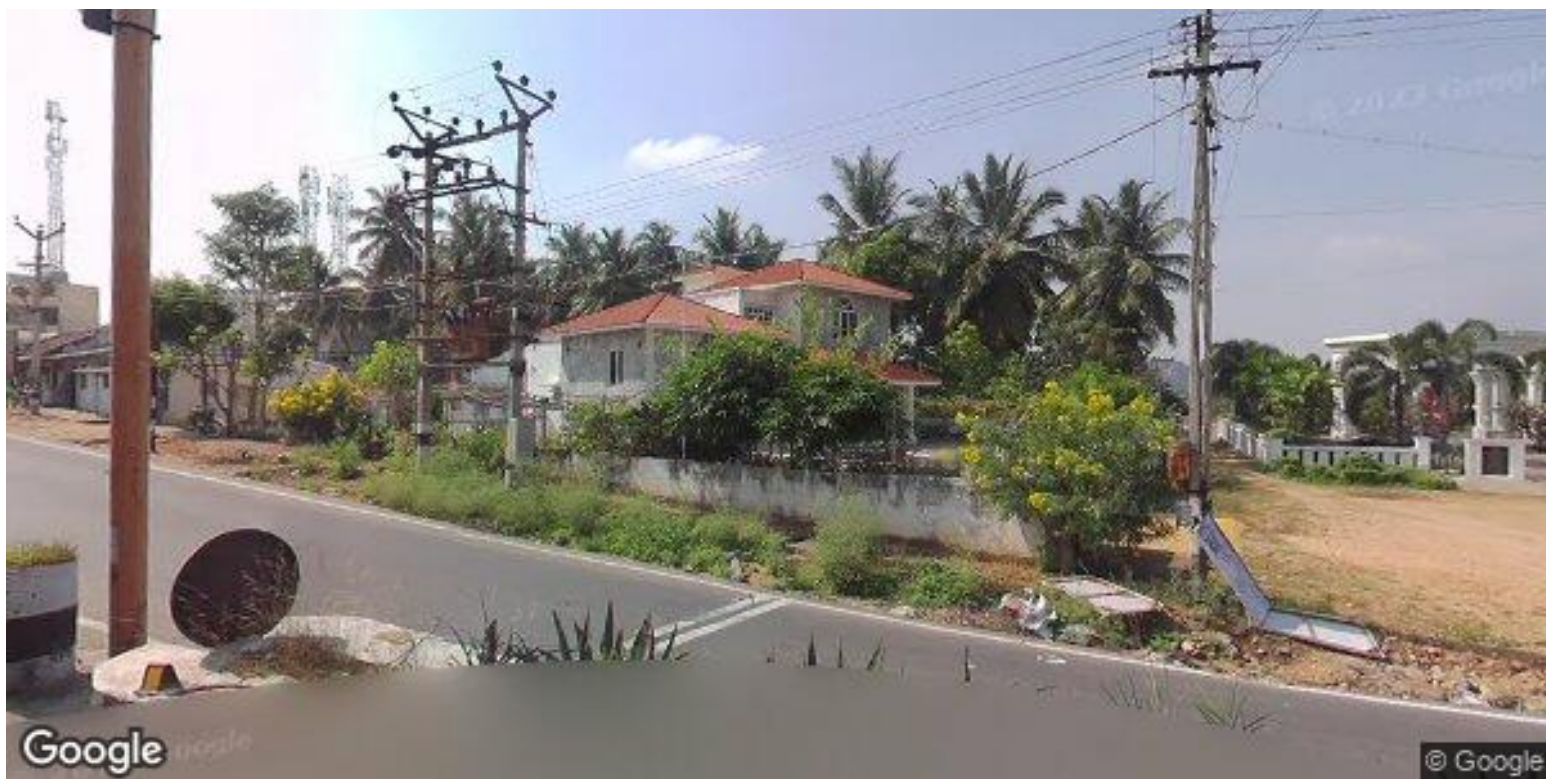
**Risk Type:** Turn  
**Risk Level:** Medium  
**Speed Limit:** 30 KM/Hr  
**Coordinates:** 11.46303, 77.84945

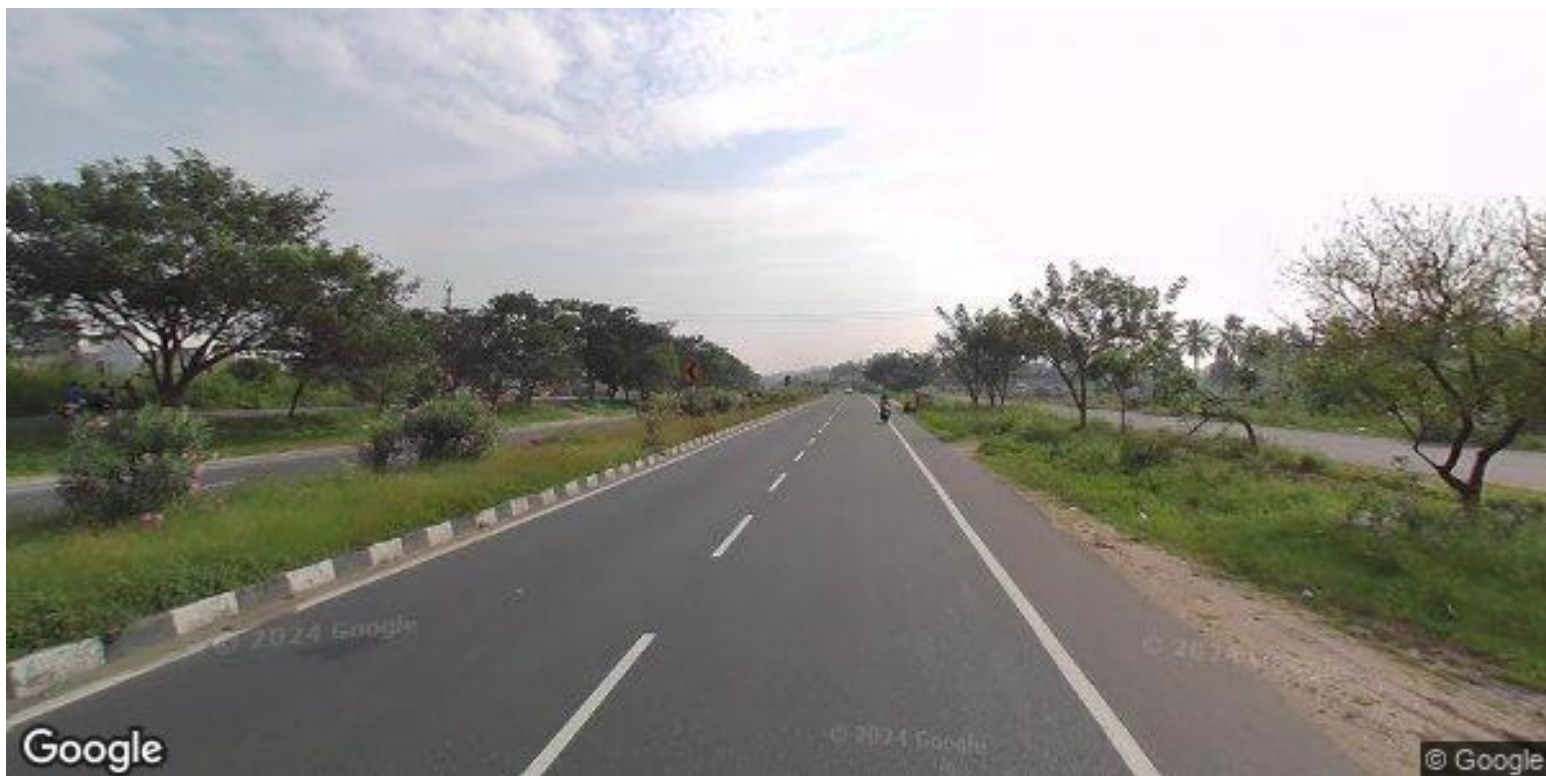
**Coordinates:** 11.44467, 77.72092

**Risk Type:** Turn

**Risk Level:** Medium

**Speed Limit:** 30 KM/Hr

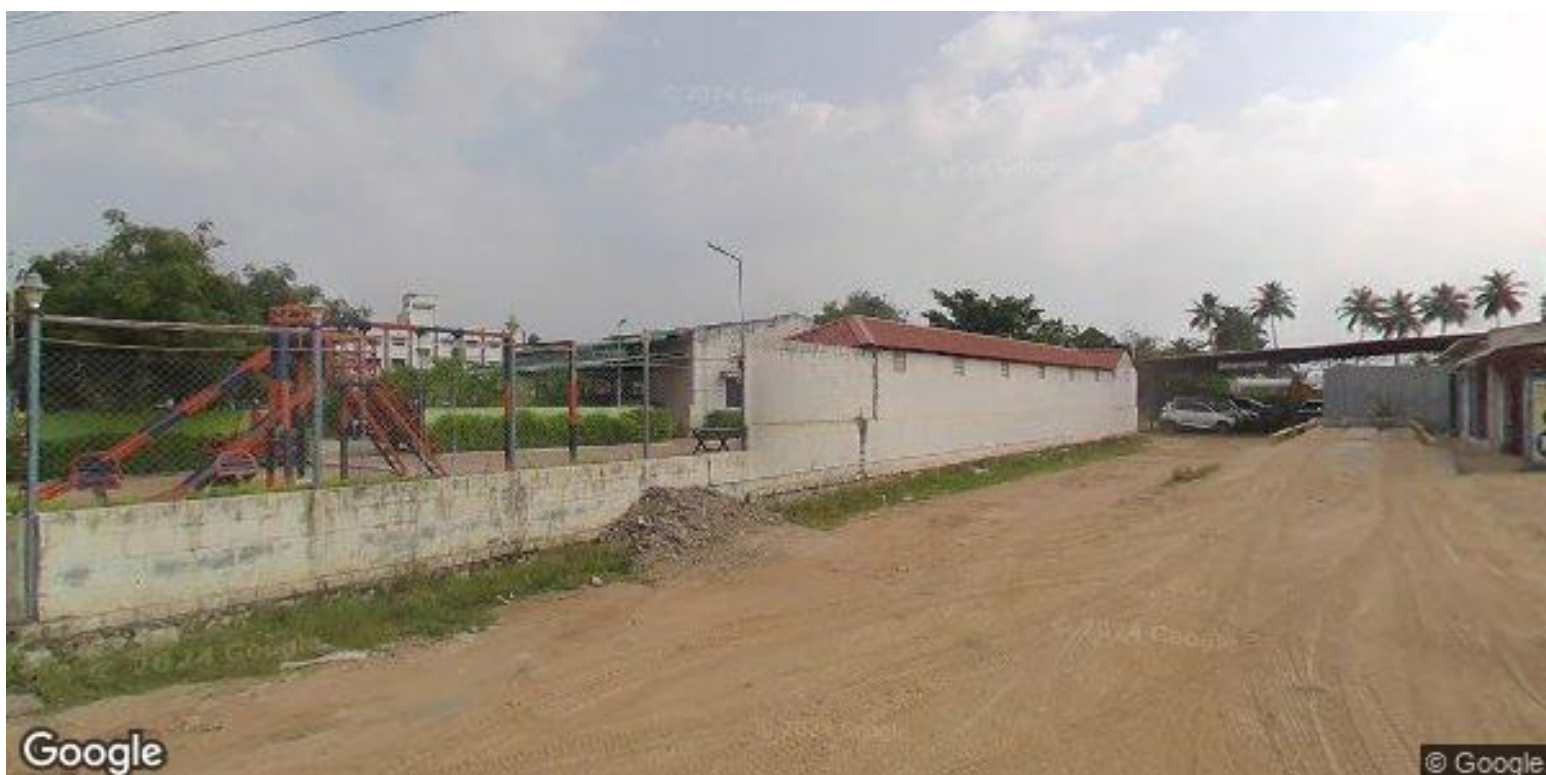
**Risk Type:** Turn  
**Risk Level:** High  
**Speed Limit:** 15 KM/Hr  
**Coordinates:** 11.44377, 77.71562

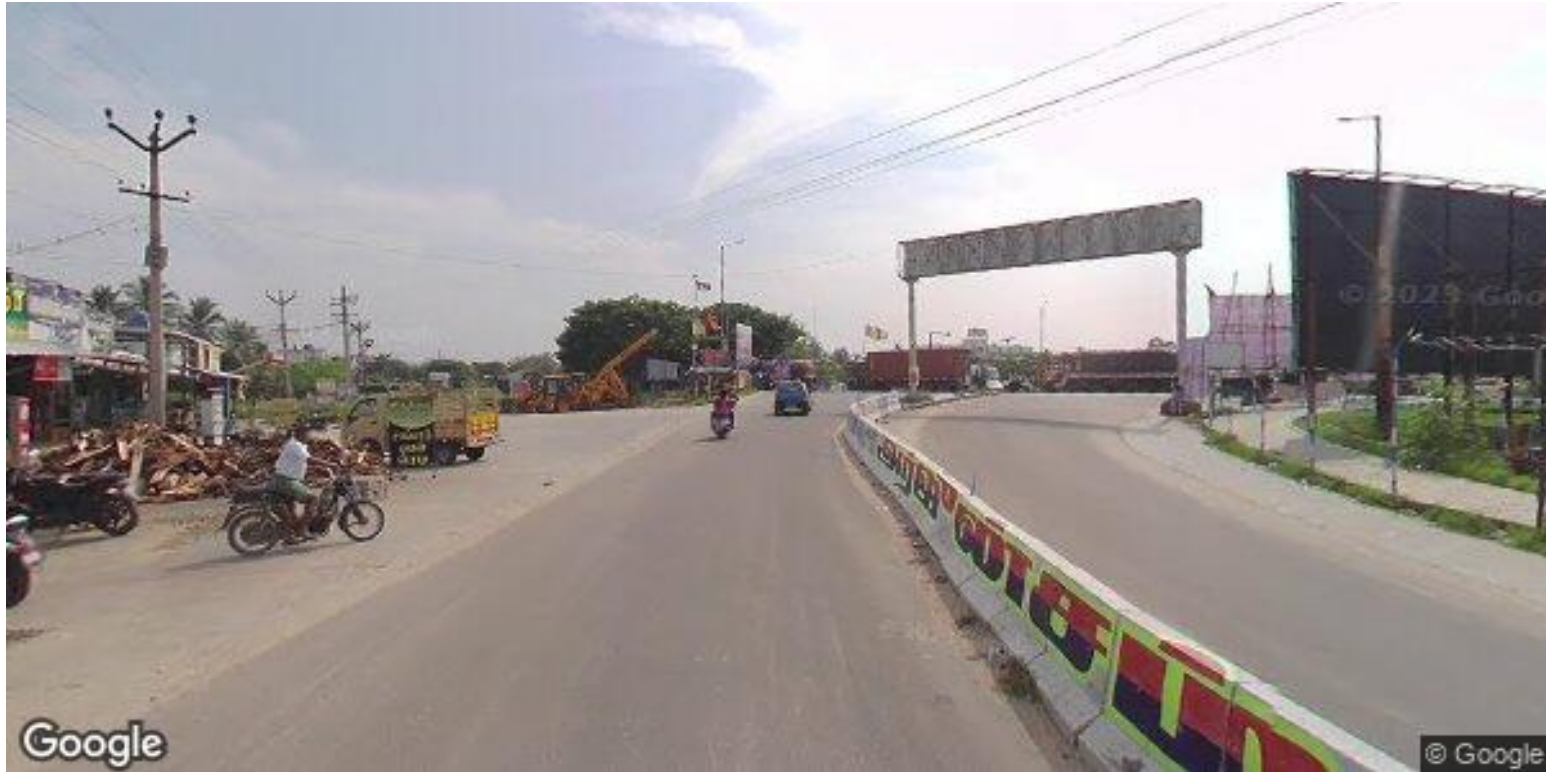
**Risk Type:** Turn  
**Risk Level:** Medium  
**Speed Limit:** 30 KM/Hr  
**Coordinates:** 11.44438, 77.71501

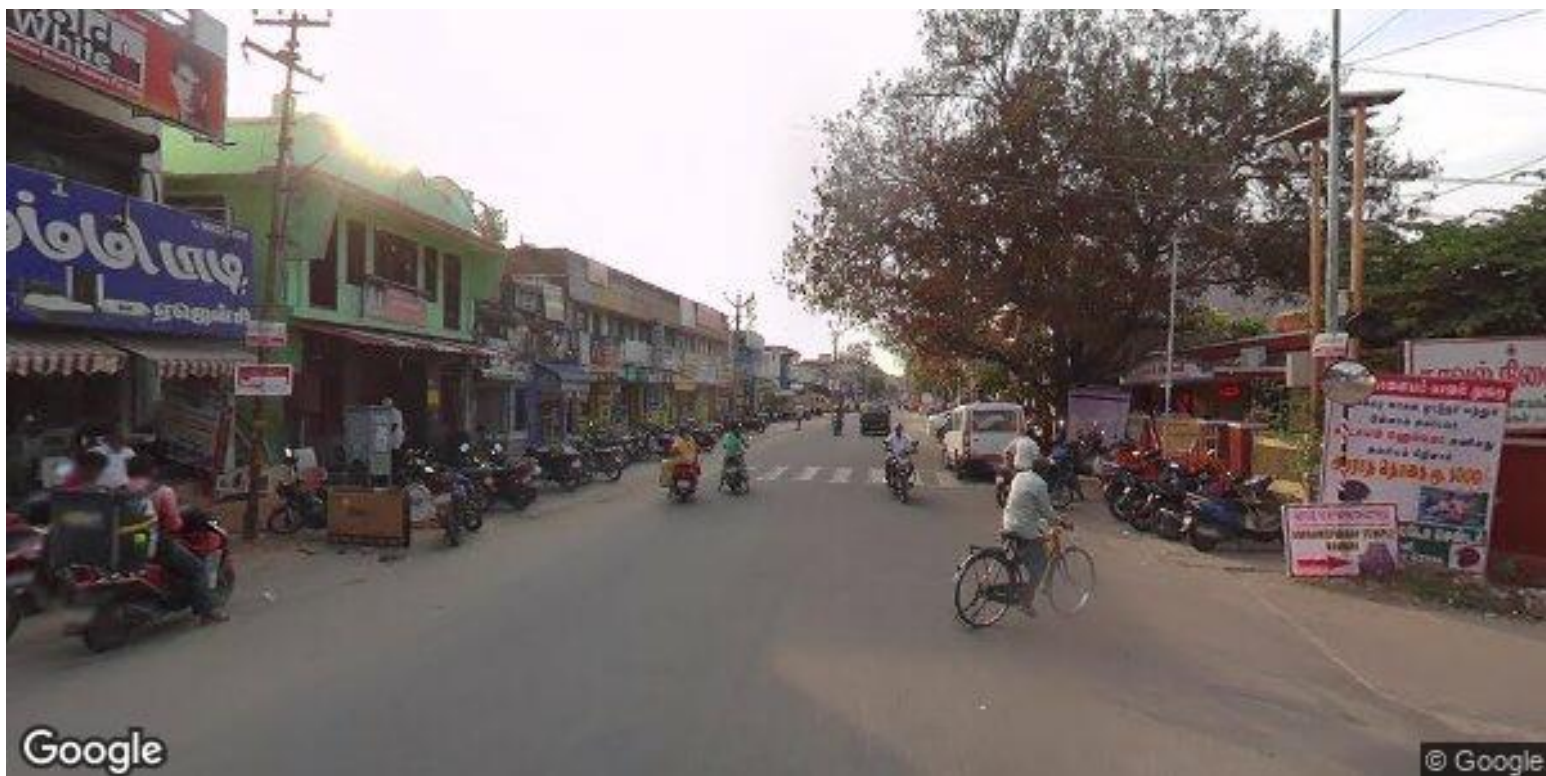
**Risk Type:** Blind Spot  
**Risk Level:** Blind Spot  
**Speed Limit:** 10 KM/Hr  
**Coordinates:** 11.44105, 77.69331

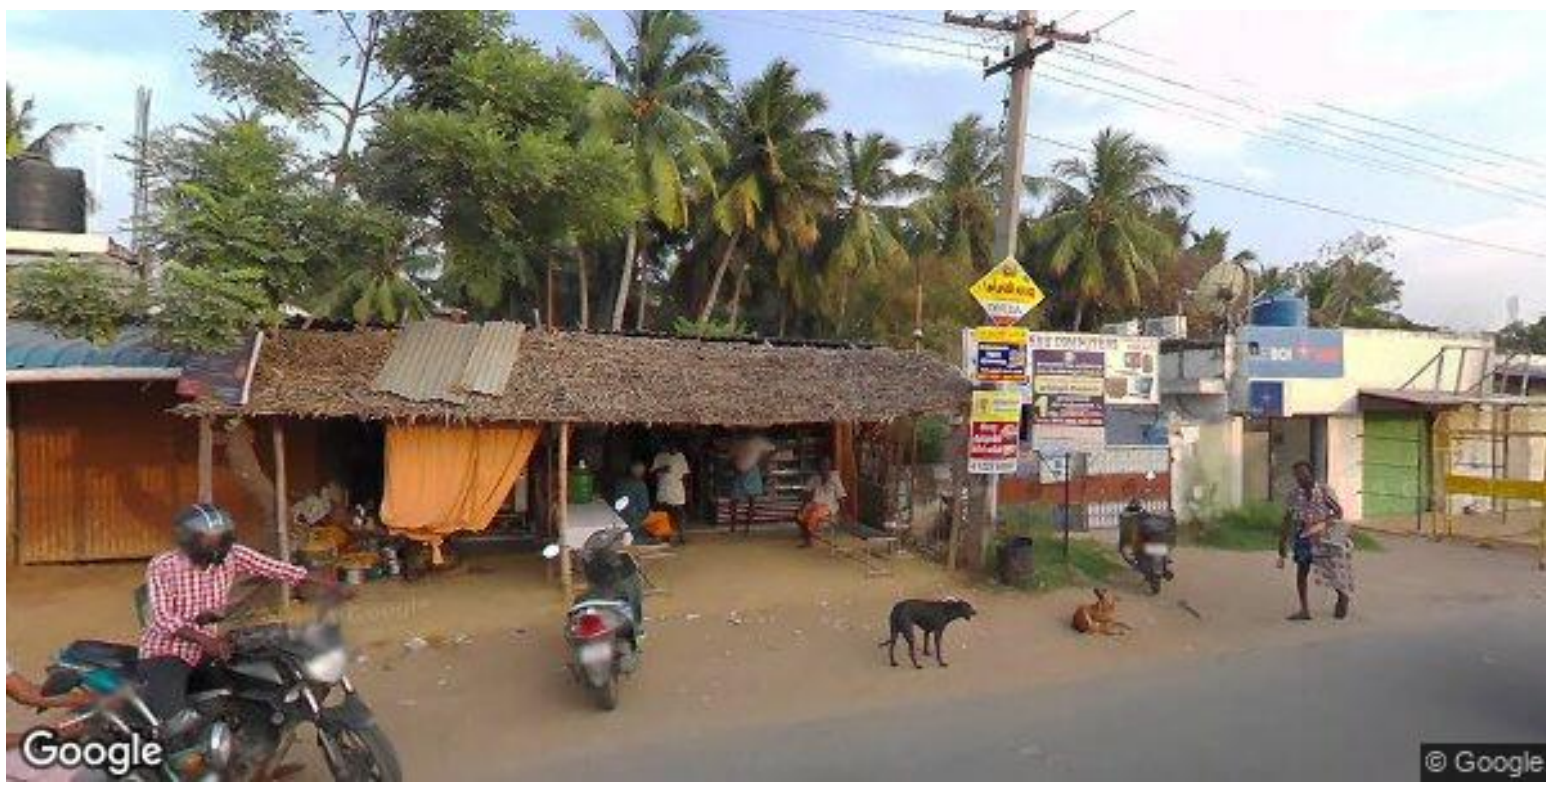
**Coordinates:** 11.44985, 77.69520

**Risk Type:** Turn

**Risk Level:** High

**Speed Limit:** 15 KM/Hr

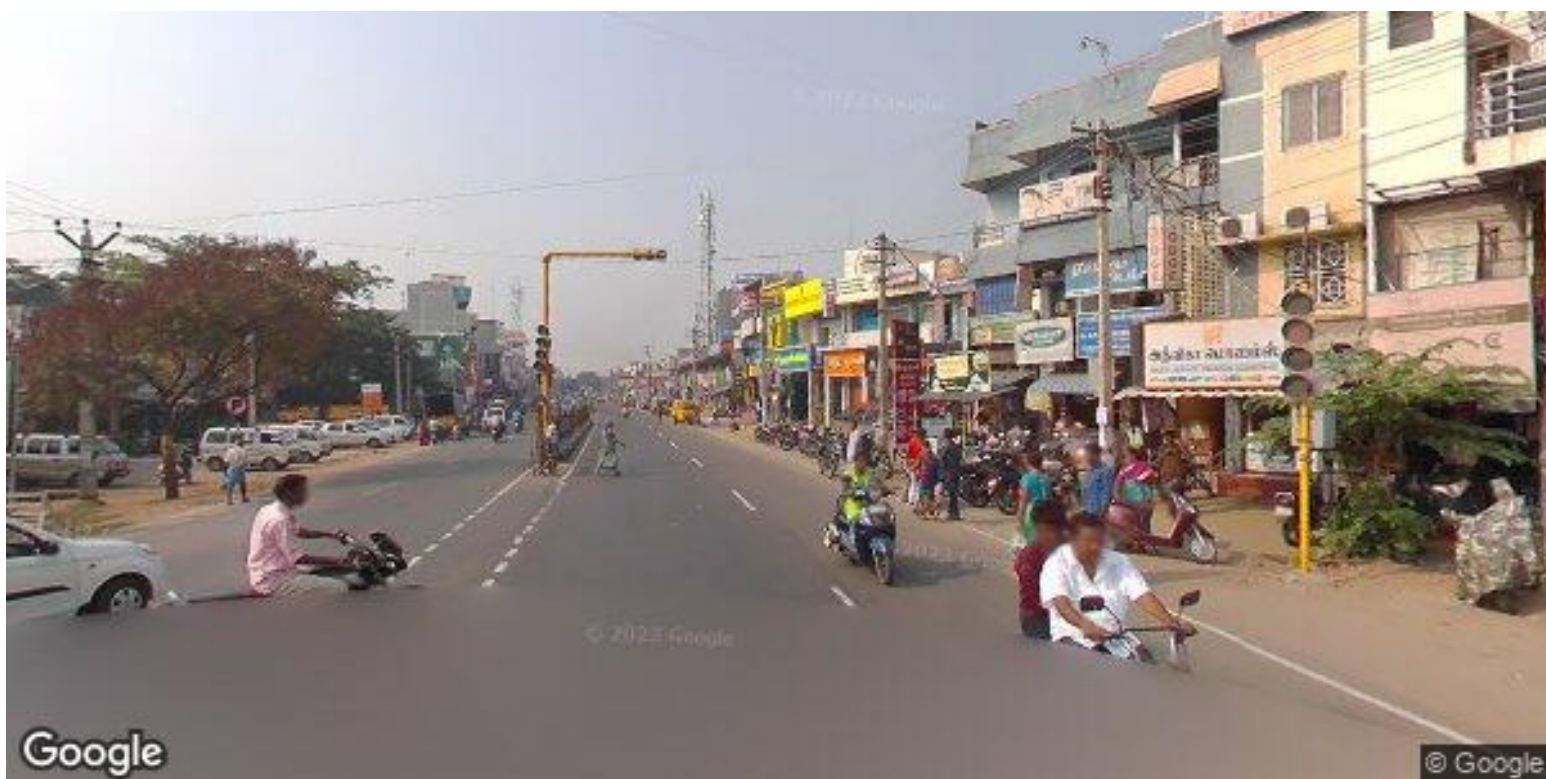
**Coordinates:** 11.45331, 77.68803

**Risk Type:** Turn

**Risk Level:** High

**Speed Limit:** 15 KM/Hr

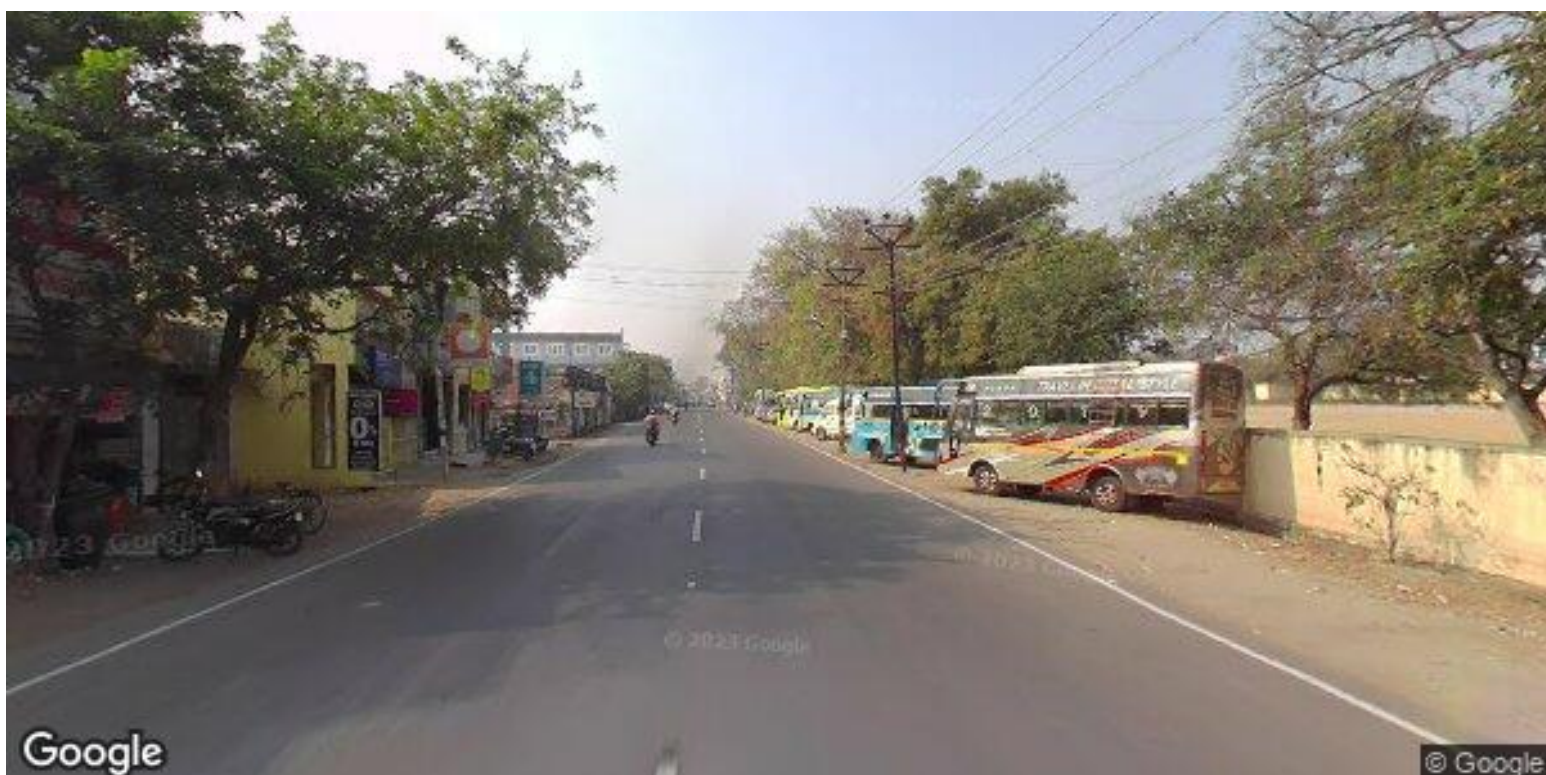
**Risk Type:** Blind Spot  
**Risk Level:** Blind Spot  
**Speed Limit:** 10 KM/Hr  
**Coordinates:** 11.44979, 77.68549

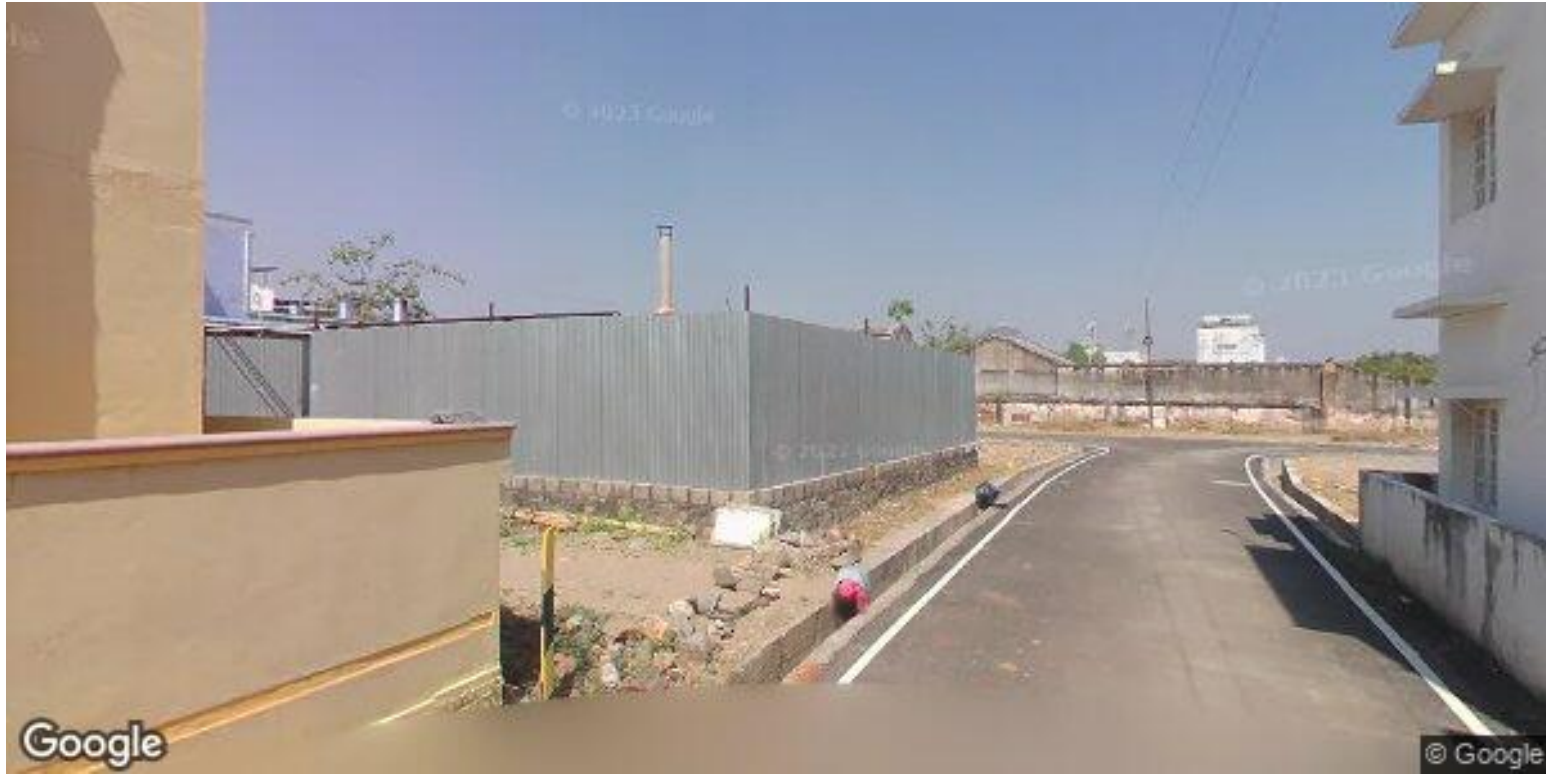
**Risk Type:** Turn  
**Risk Level:** High  
**Speed Limit:** 15 KM/Hr  
**Coordinates:** 11.44948, 77.68645

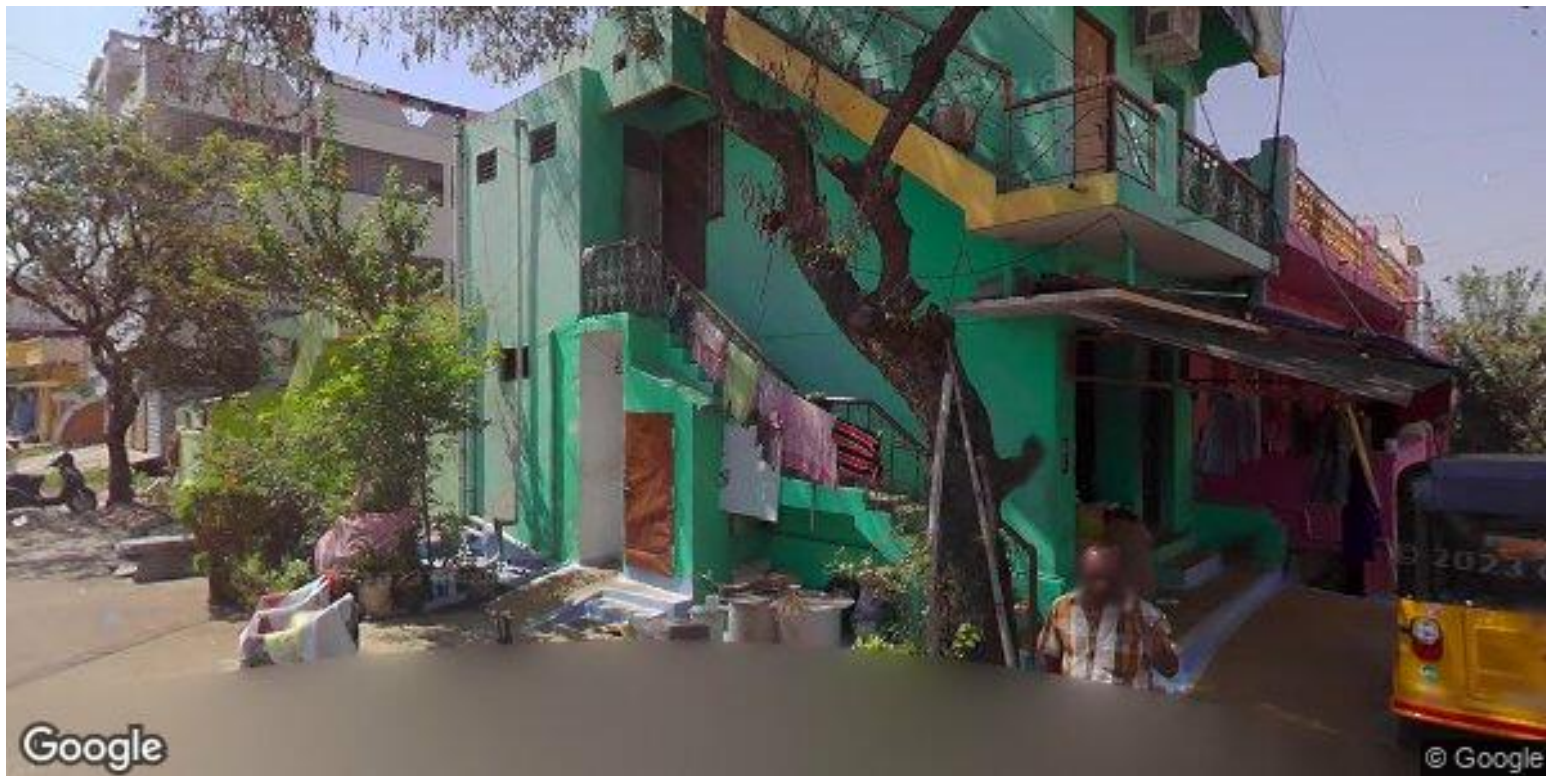
**Risk Type:** Turn  
**Risk Level:** High  
**Speed Limit:** 15 KM/Hr  
**Coordinates:** 11.44801, 77.68596

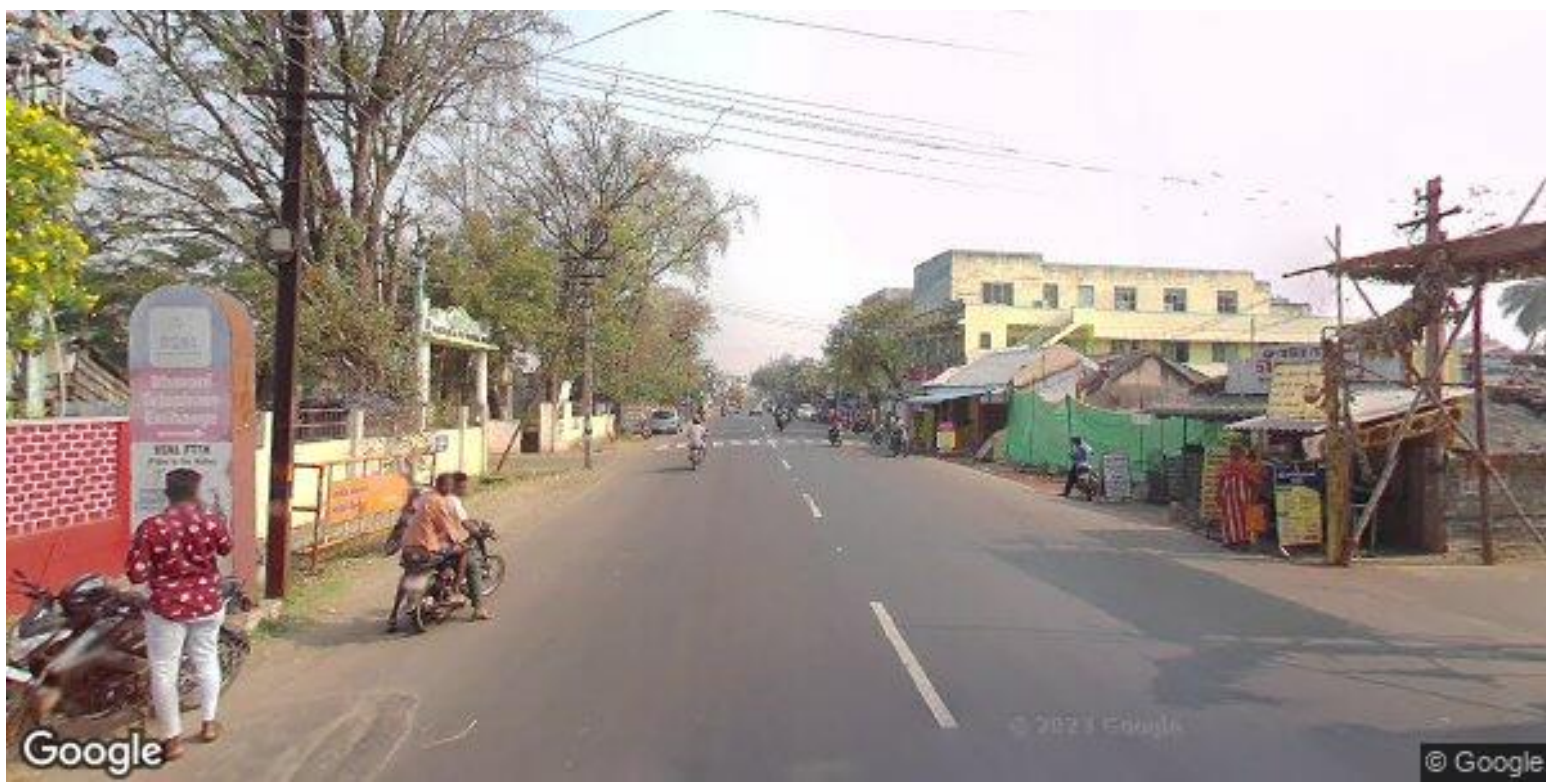
**Coordinates:** 11.44842, 77.68473

**Risk Type:** Blind Spot

**Risk Level:** Blind Spot

**Speed Limit:** 10 KM/Hr

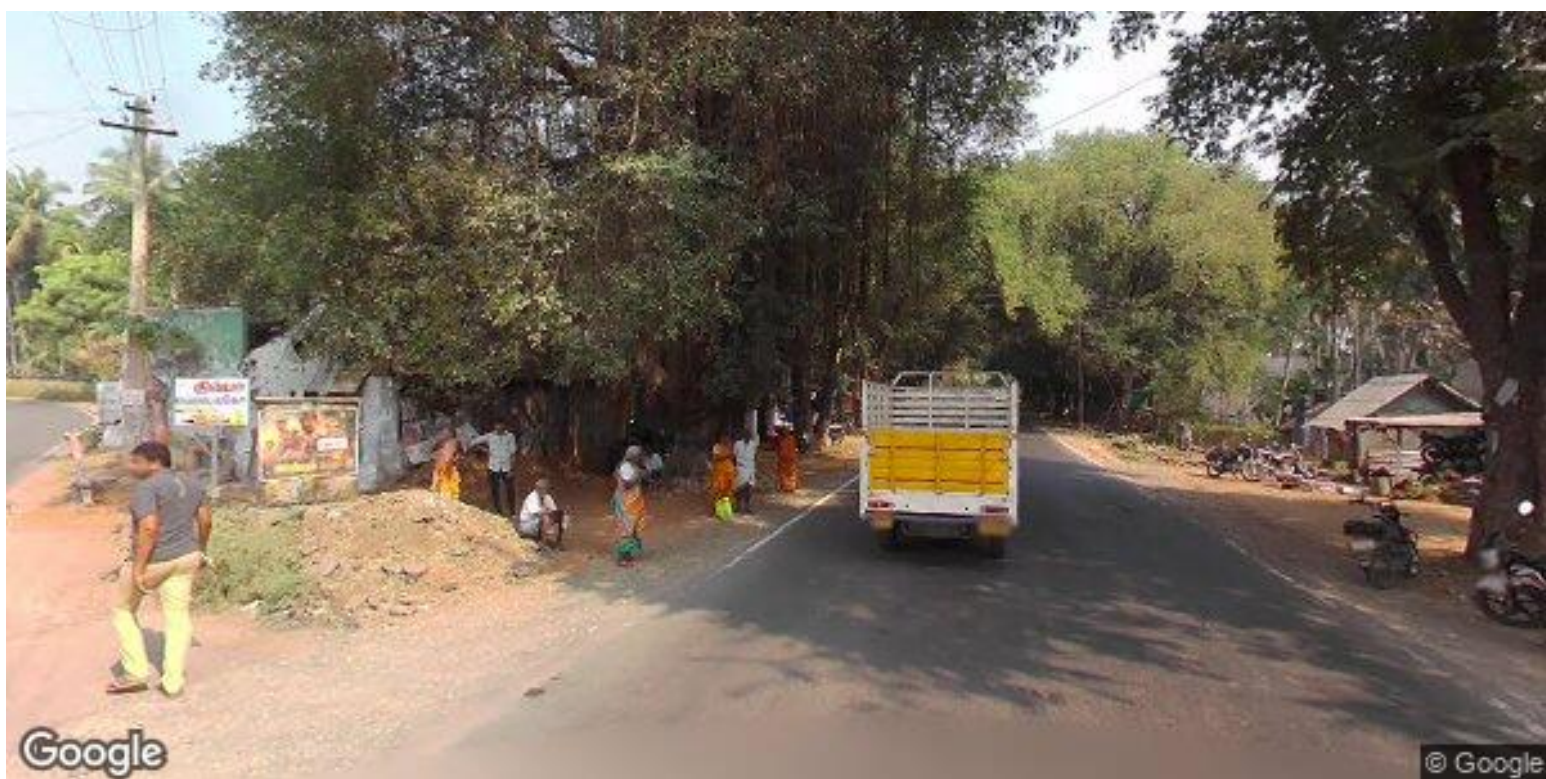
**Coordinates:** 11.59946, 77.73130

**Risk Type:** Turn

**Risk Level:** Medium

**Speed Limit:** 30 KM/Hr

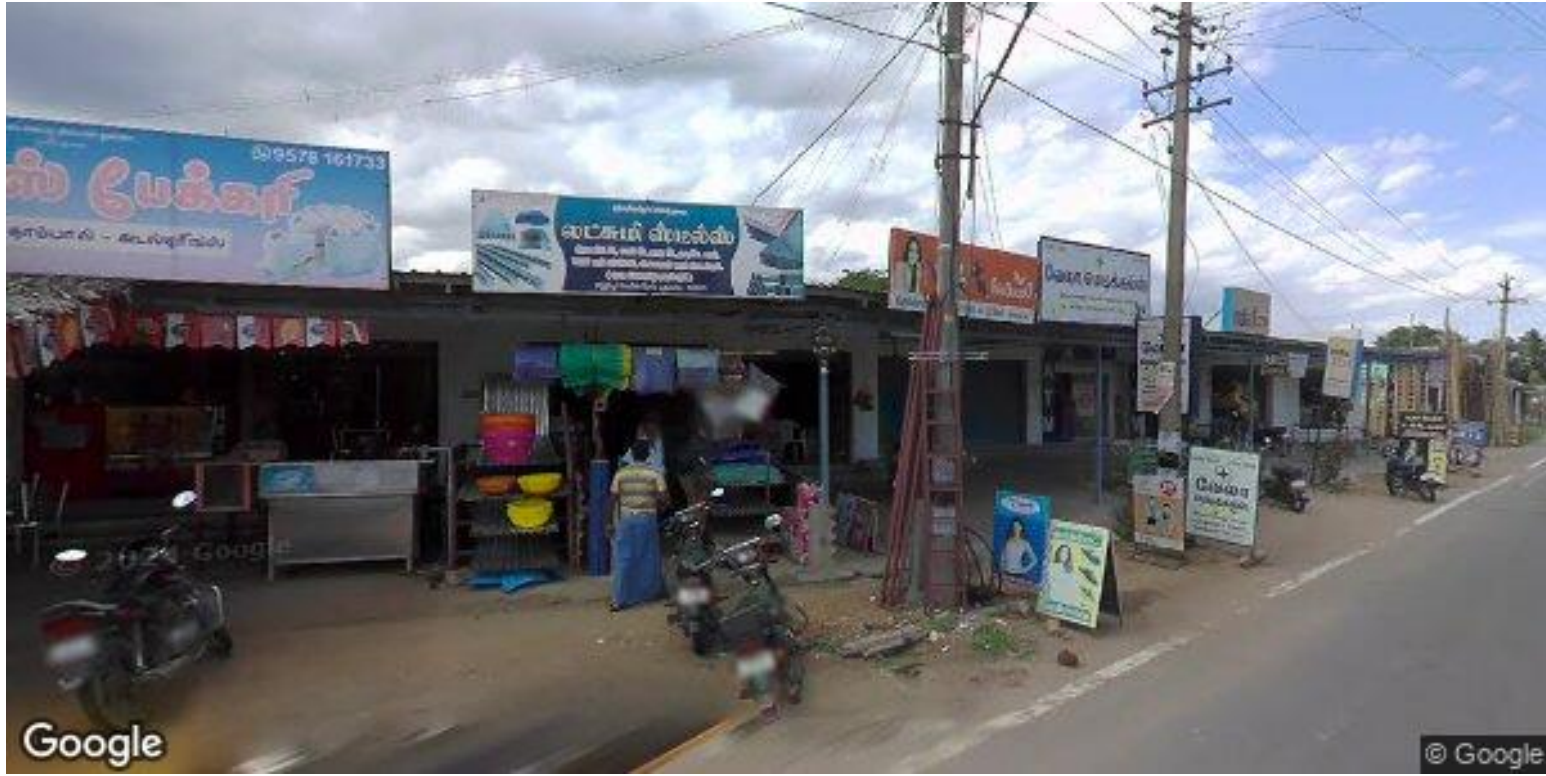
**Coordinates:** 11.61026, 77.71748

**Risk Type:** Blind Spot

**Risk Level:** Blind Spot

**Speed Limit:** 10 KM/Hr

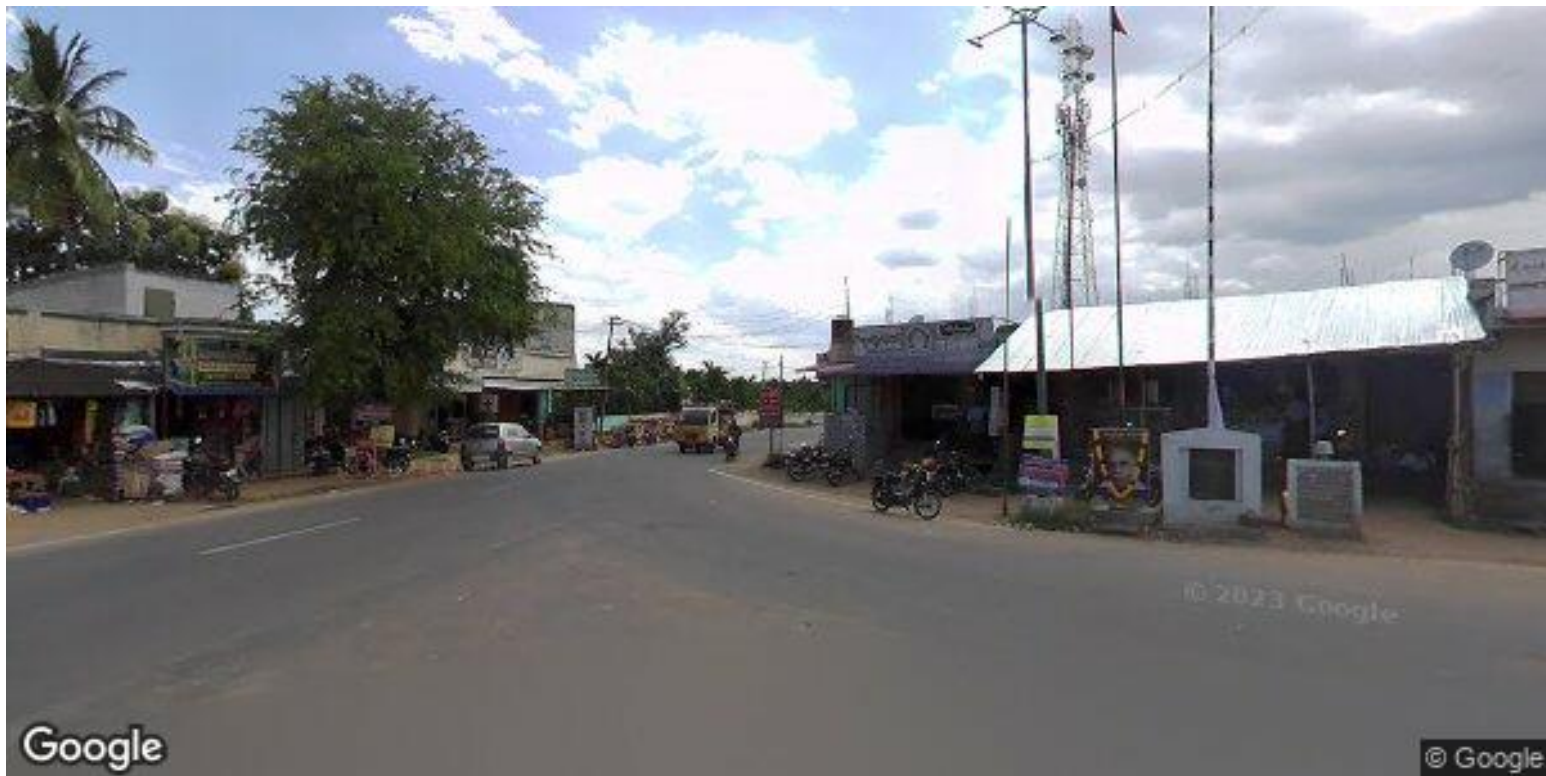
**Coordinates:** 11.60971, 77.71572

**Risk Type:** Blind Spot

**Risk Level:** Blind Spot

**Speed Limit:** 10 KM/Hr
