# IndianOil

## JOURNEY RISK MANAGEMENT (JRM) STUDY

### Salem Terminal to SANTHOSH AGENCIES

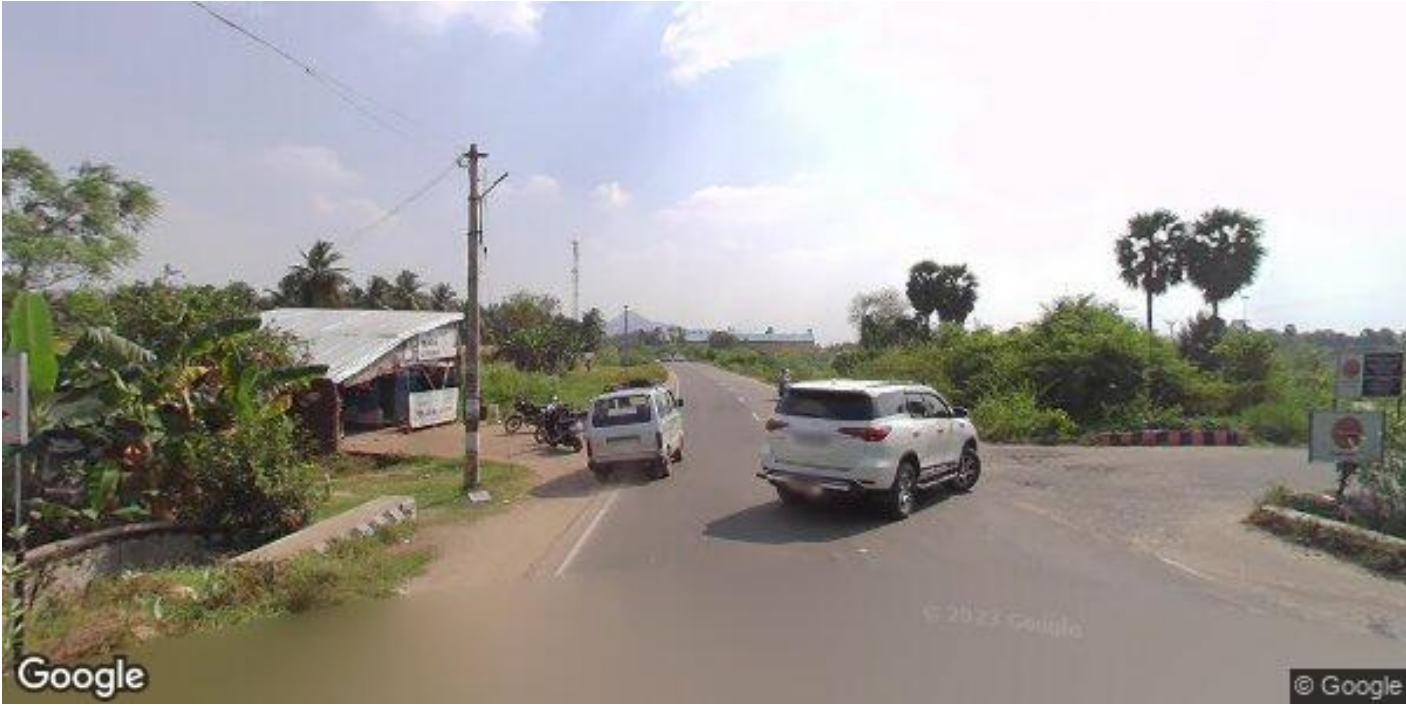
| | Risk Type | Risk Level | Coordinates | Speed Limit |
|---|---|---|---|---|
| 3 | Blind Spot | Blind Spot | 11.44029, 77.87544 | 10 KM/Hr |

Risk Type: Blind Spot  
Risk Level: Blind Spot  
Speed Limit: 10 KM/Hr  
Coordinates: 11.44029, 77.87544

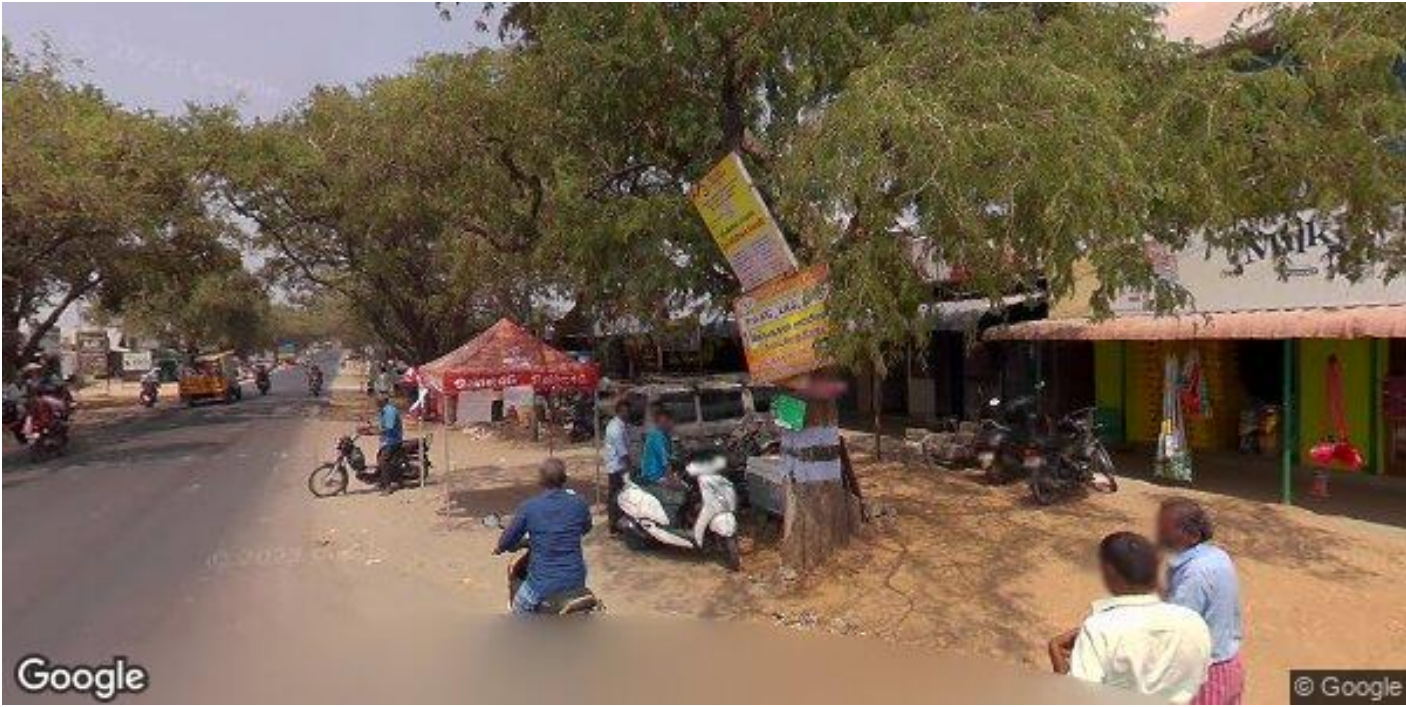
| | Risk Type | Risk Level | Coordinates | Speed Limit |
|---|---|---|---|---|
| 4 | Blind Spot | Blind Spot | 11.41981, 77.88078 | 10 KM/Hr |

**Risk Type:** Blind Spot  
**Risk Level:** Blind Spot  
**Speed Limit:** 10 KM/Hr  
**Coordinates:** 11.41981, 77.88078

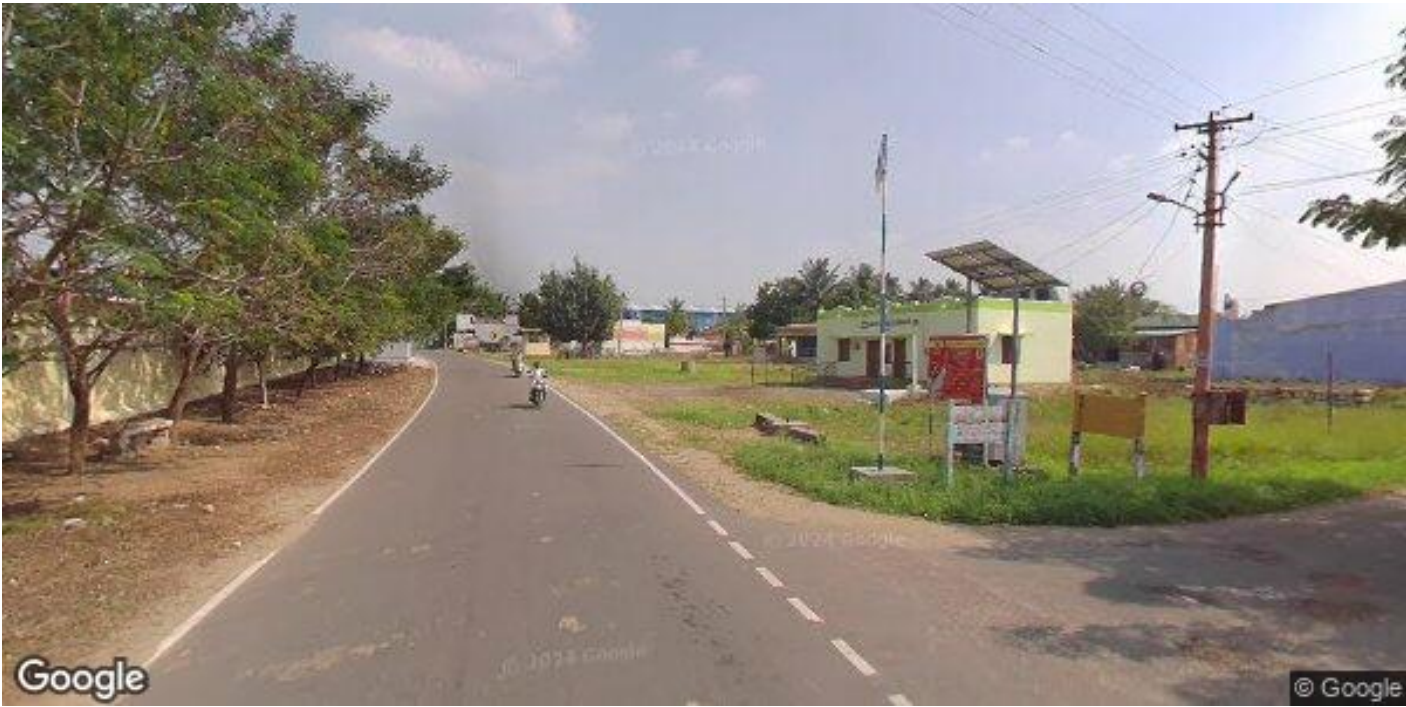
| | Risk Type | Risk Level | Coordinates | Speed Limit |
|---|---|---|---|---|
| 8 | Blind Spot | Blind Spot | 11.42333, 77.87394 | 10 KM/Hr |

**Risk Type:** Blind Spot  
**Risk Level:** Blind Spot  
**Speed Limit:** 10 KM/Hr  
**Coordinates:** 11.42333, 77.87394

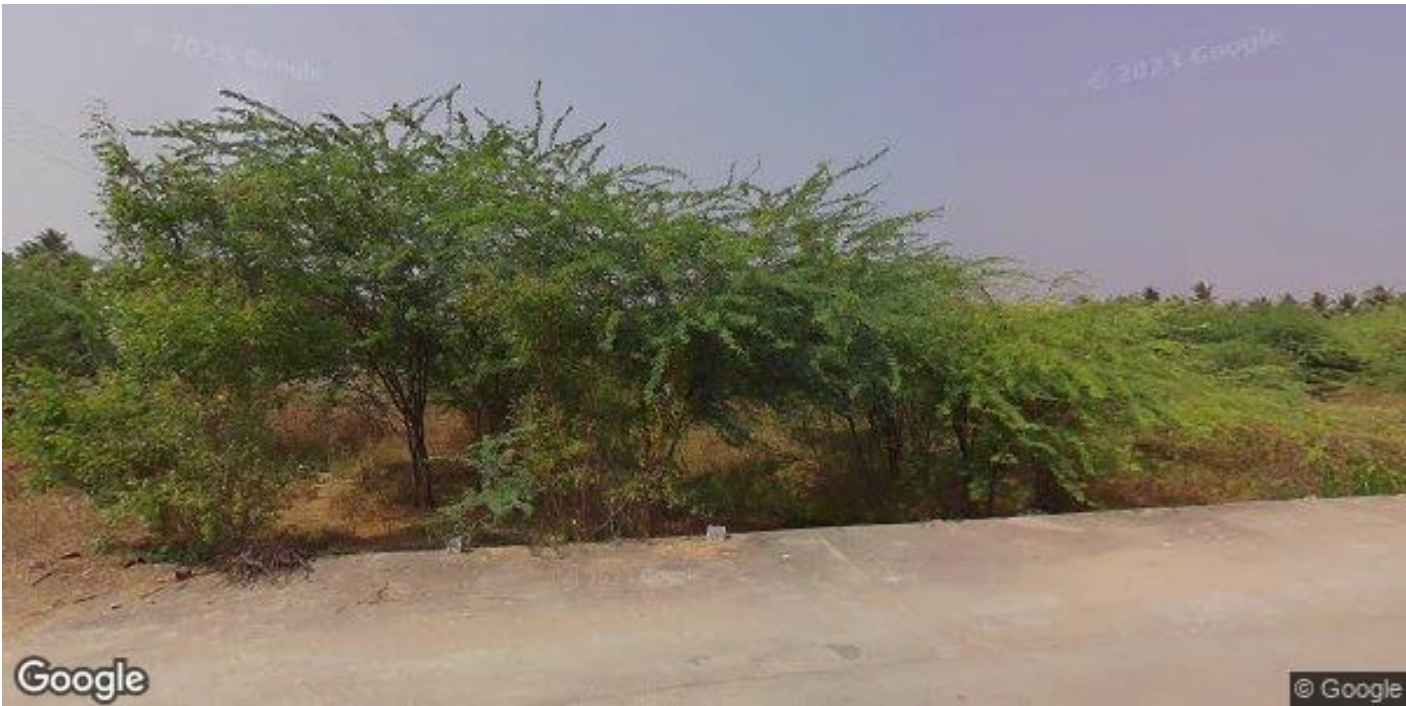
| | Risk Type | Risk Level | Coordinates | Speed Limit |
|---|---|---|---|---|
| 10 | Turn | High | 11.41917, 77.87022 | 15 KM/Hr |

**Risk Type:** Turn  
**Risk Level:** High  
**Speed Limit:** 15 KM/Hr  
**Coordinates:** 11.41917, 77.87022

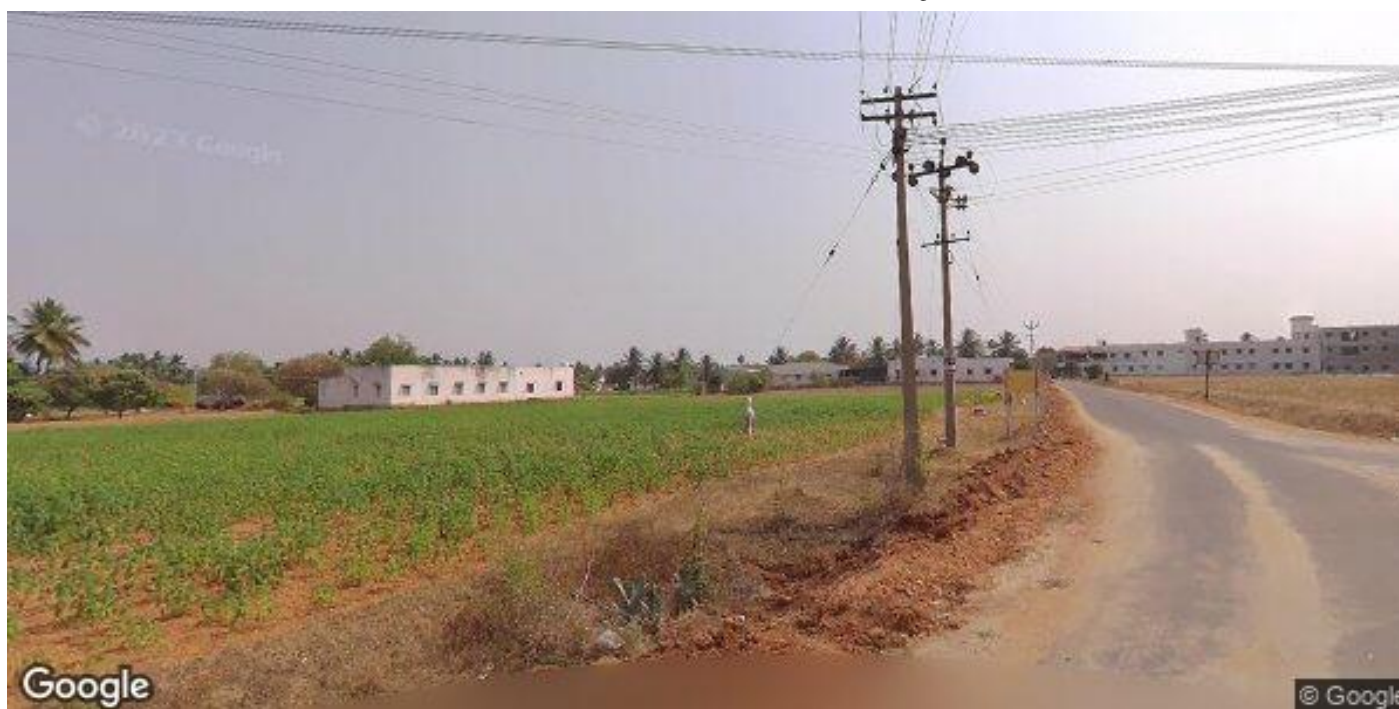
| | Risk Type | Risk Level | Coordinates | Speed Limit |
|---|---|---|---|---|
| 11 | Turn | High | 11.40478, 77.86020 | 15 KM/Hr |

**Risk Type:** Turn  
**Risk Level:** High  
**Speed Limit:** 15 KM/Hr  
**Coordinates:** 11.40478, 77.86020

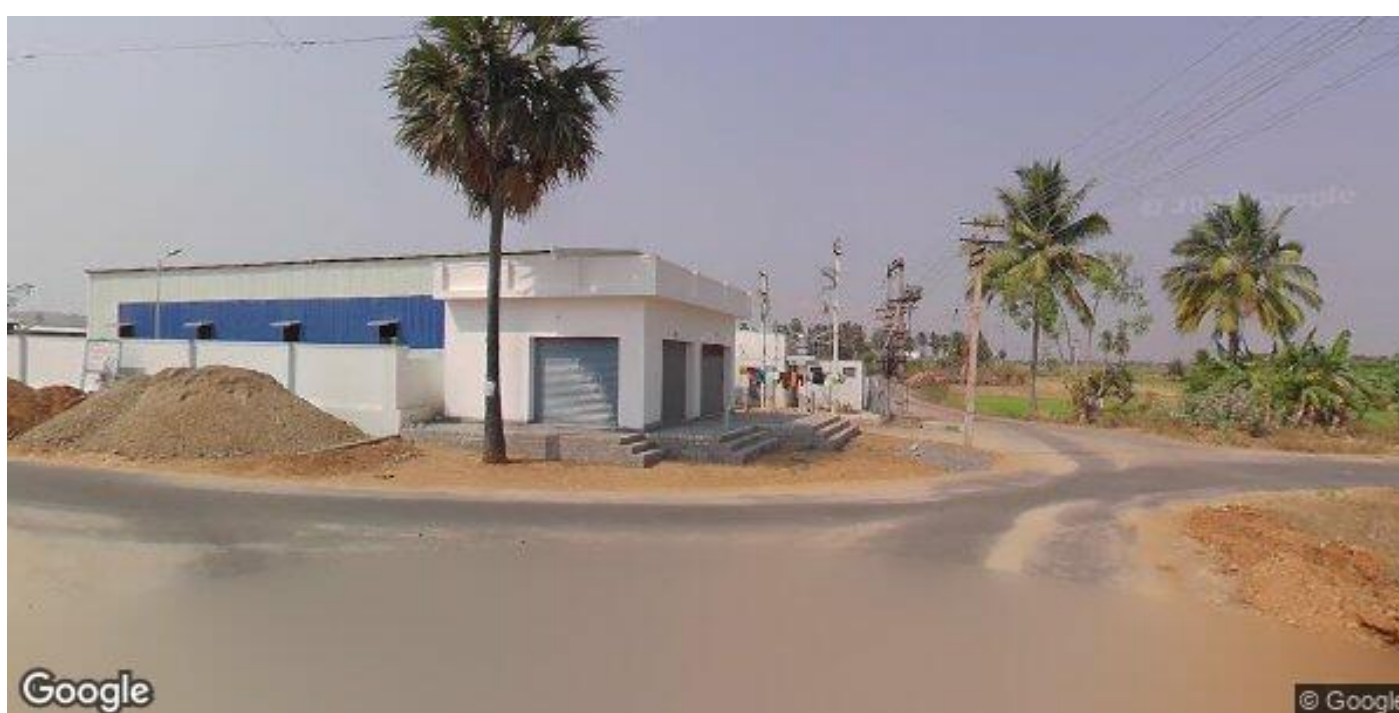
| | Risk Type | Risk Level | Coordinates | Speed Limit |
|---|---|---|---|---|
| 12 | Turn | High | 11.40471, 77.86004 | 15 KM/Hr |

**Risk Type:** Turn  
**Risk Level:** High  
**Speed Limit:** 15 KM/Hr  
**Coordinates:** 11.40471, 77.86004

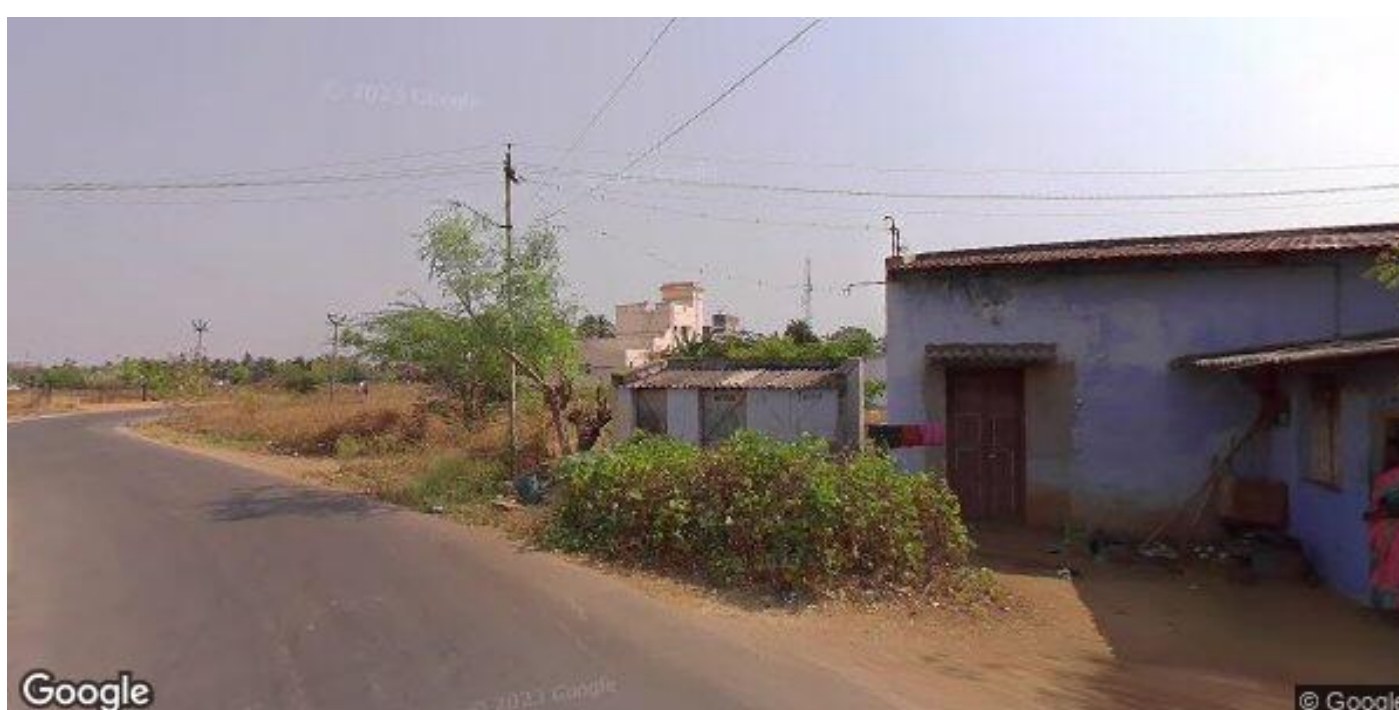
| | Risk Type | Risk Level | Coordinates | Speed Limit |
|---|---|---|---|---|
| 13 | Turn | Medium | 11.39361, 77.85502 | 30 KM/Hr |

**Risk Type:** Turn  
**Risk Level:** Medium  
**Speed Limit:** 30 KM/Hr  
**Coordinates:** 11.39361, 77.85502

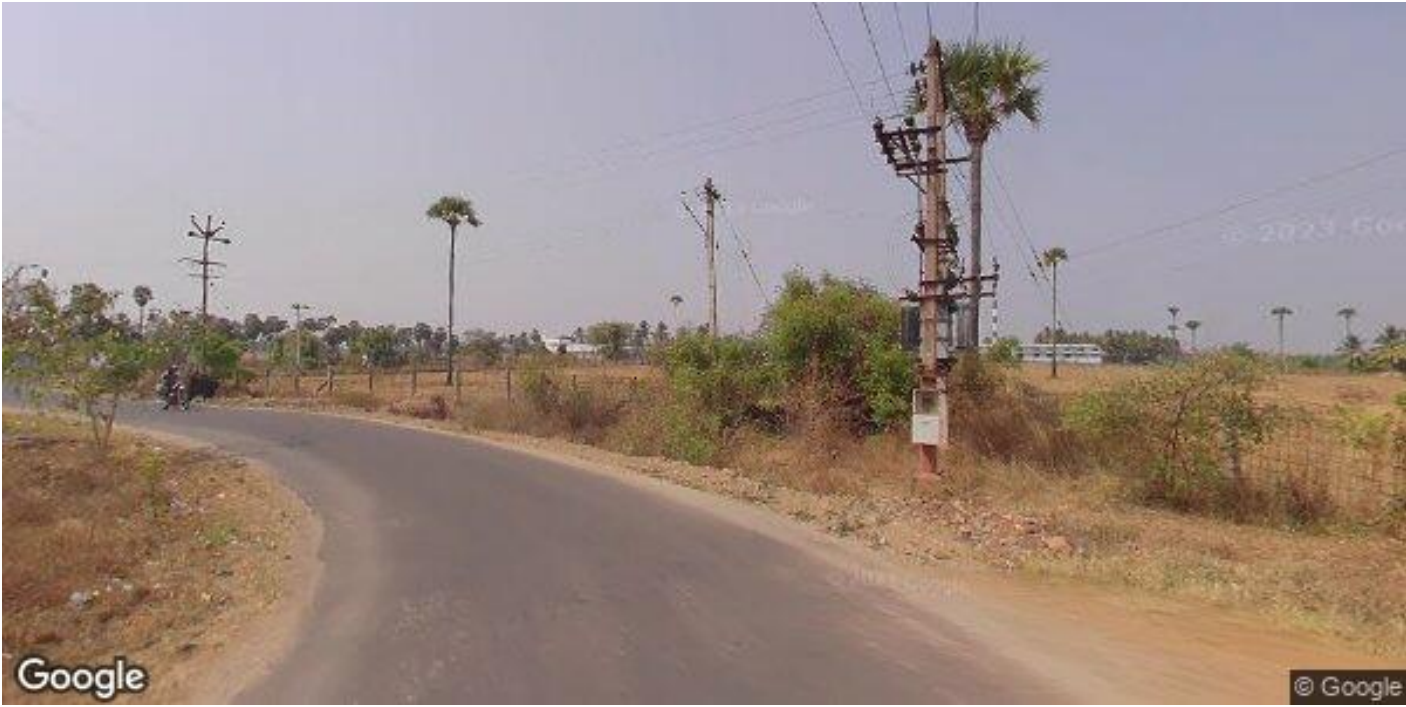
| | Risk Type | Risk Level | Coordinates | Speed Limit |
|---|---|---|---|---|
| 14 | Turn | Medium | 11.39323, 77.85539 | 30 KM/Hr |

**Risk Type:** Turn  
**Risk Level:** Medium  
**Speed Limit:** 30 KM/Hr  
**Coordinates:** 11.39323, 77.85539

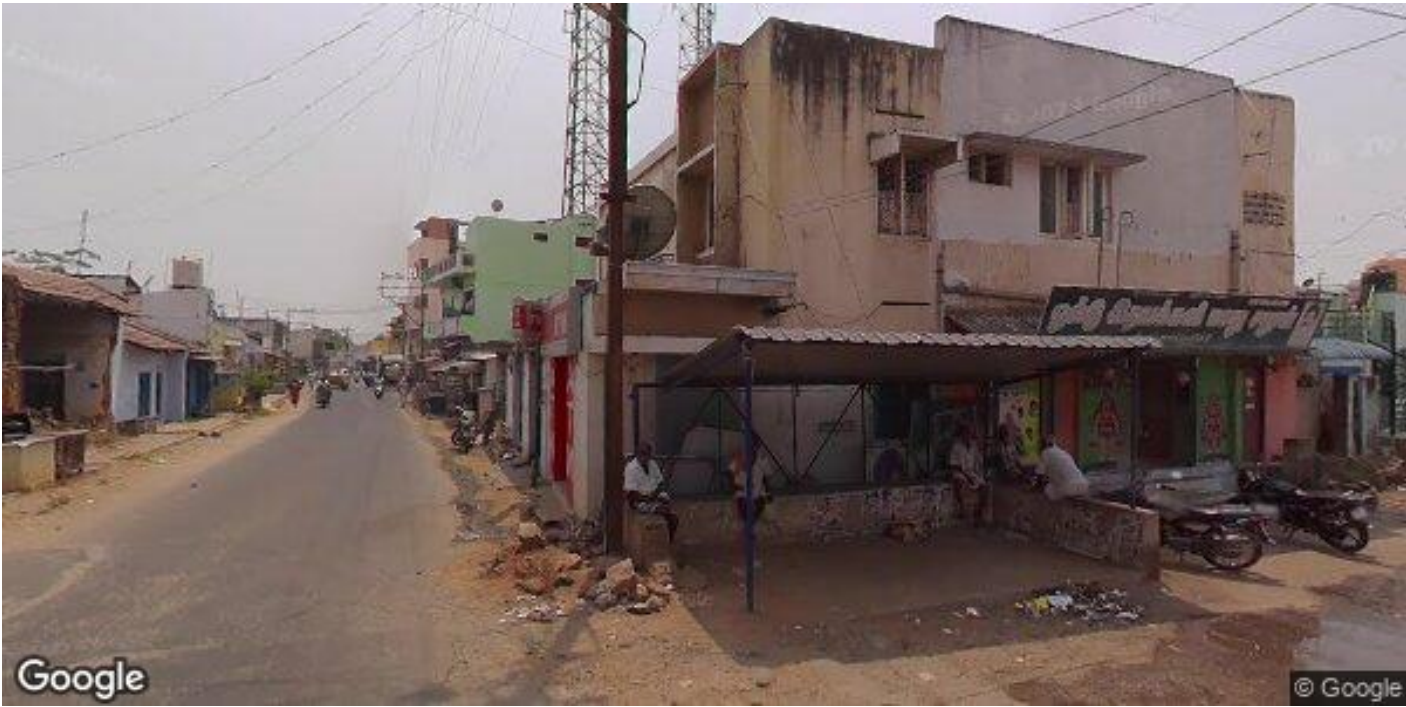
| | Risk Type | Risk Level | Coordinates | Speed Limit |
|---|---|---|---|---|
| 15 | Blind Spot | Blind Spot | 11.39047, 77.85509 | 10 KM/Hr |

**Risk Type:** Blind Spot  
**Risk Level:** Blind Spot  
**Speed Limit:** 10 KM/Hr  
**Coordinates:** 11.39047, 77.85509

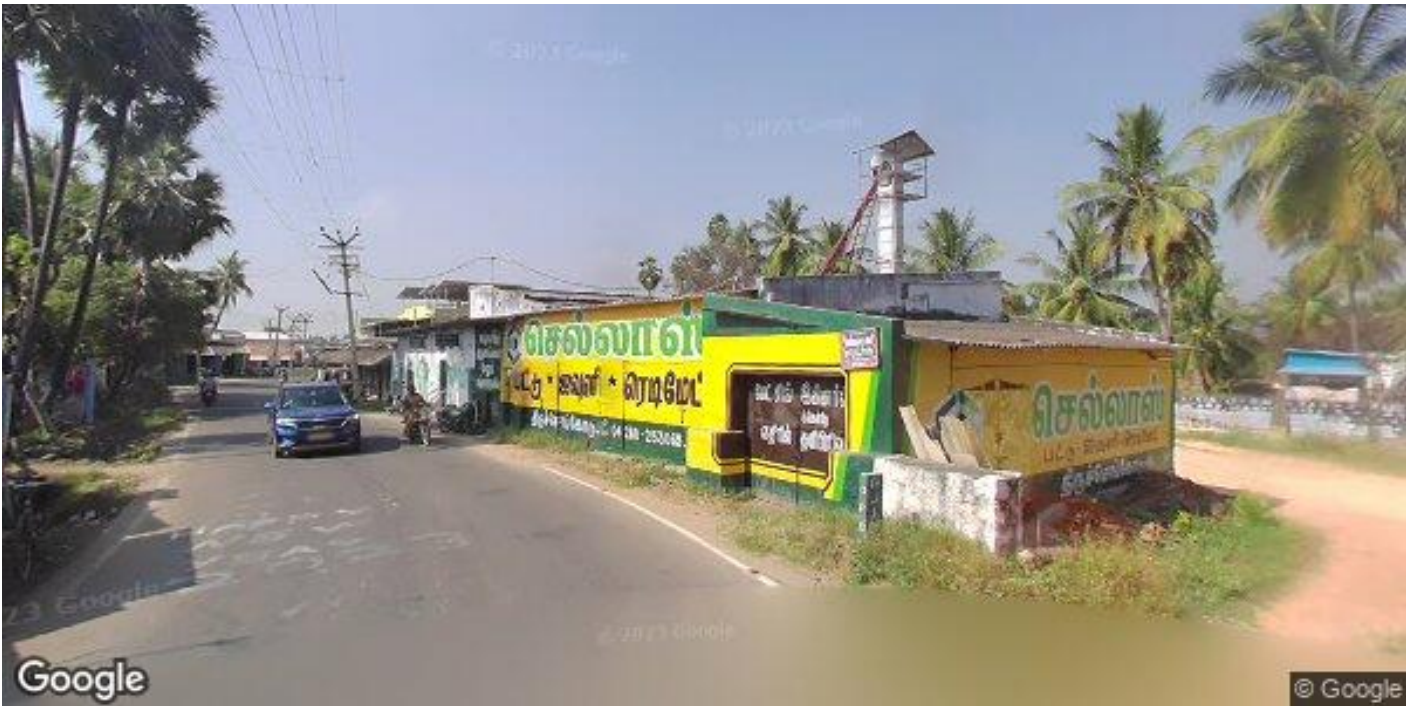
| | Risk Type | Risk Level | Coordinates | Speed Limit |
|---|---|---|---|---|
| 16 | Turn | Medium | 11.39431, 77.83265 | 30 KM/Hr |

**Risk Type:** Turn  
**Risk Level:** Medium  
**Speed Limit:** 30 KM/Hr  
**Coordinates:** 11.39431, 77.83265

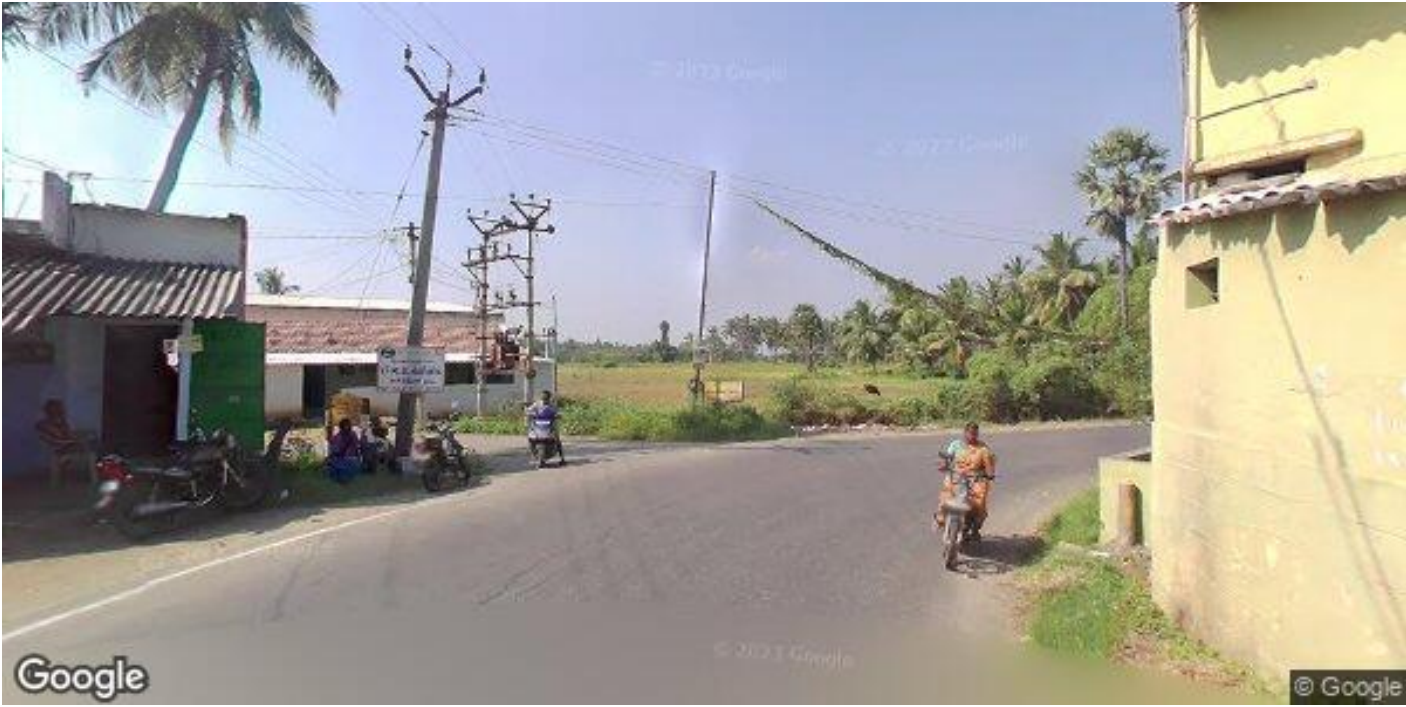
| | Risk Type | Risk Level | Coordinates | Speed Limit |
|---|---|---|---|---|
| 17 | Turn | Medium | 11.39383, 77.83222 | 30 KM/Hr |

**Risk Type:** Turn  
**Risk Level:** Medium  
**Speed Limit:** 30 KM/Hr  
**Coordinates:** 11.39383, 77.83222

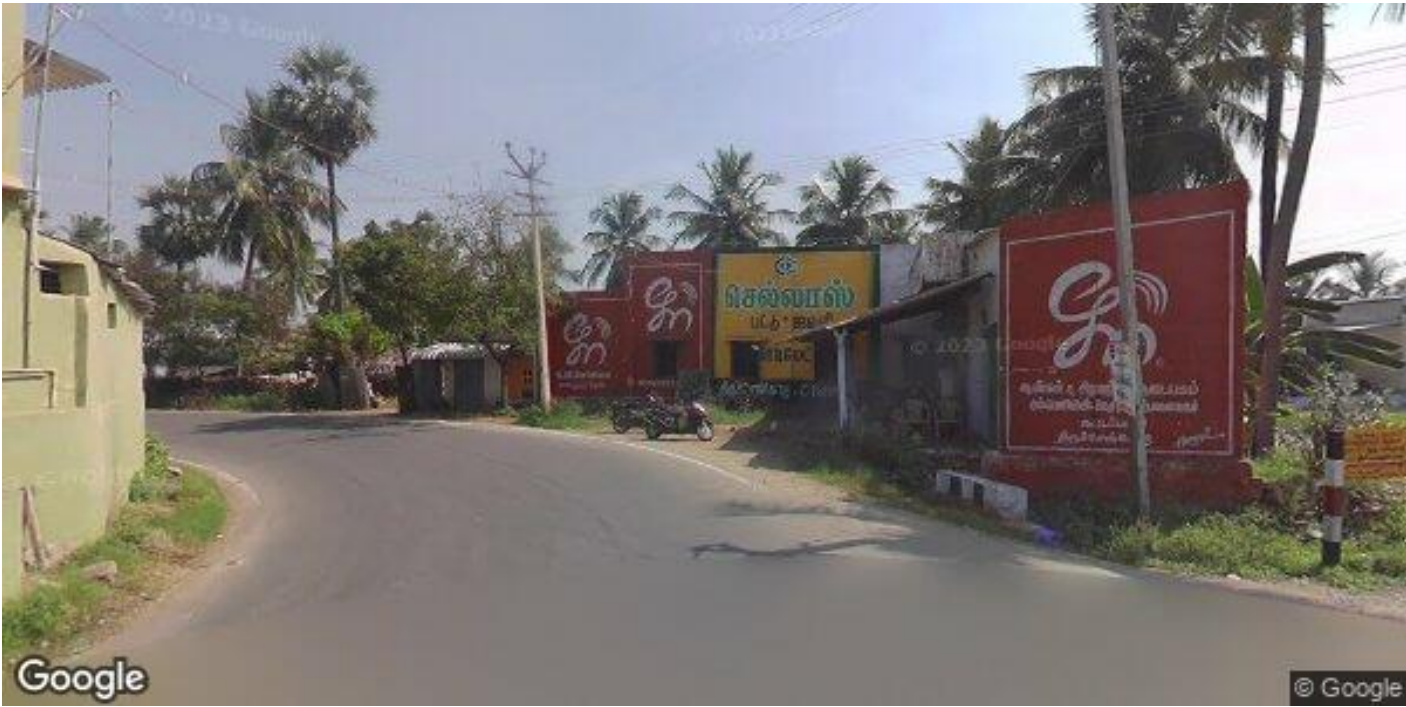
| | Risk Type | Risk Level | Coordinates | Speed Limit |
|---|---|---|---|---|
| 18 | Turn | Medium | 11.39381, 77.83208 | 30 KM/Hr |

**Risk Type:** Turn  
**Risk Level:** Medium  
**Speed Limit:** 30 KM/Hr  
**Coordinates:** 11.39381, 77.83208

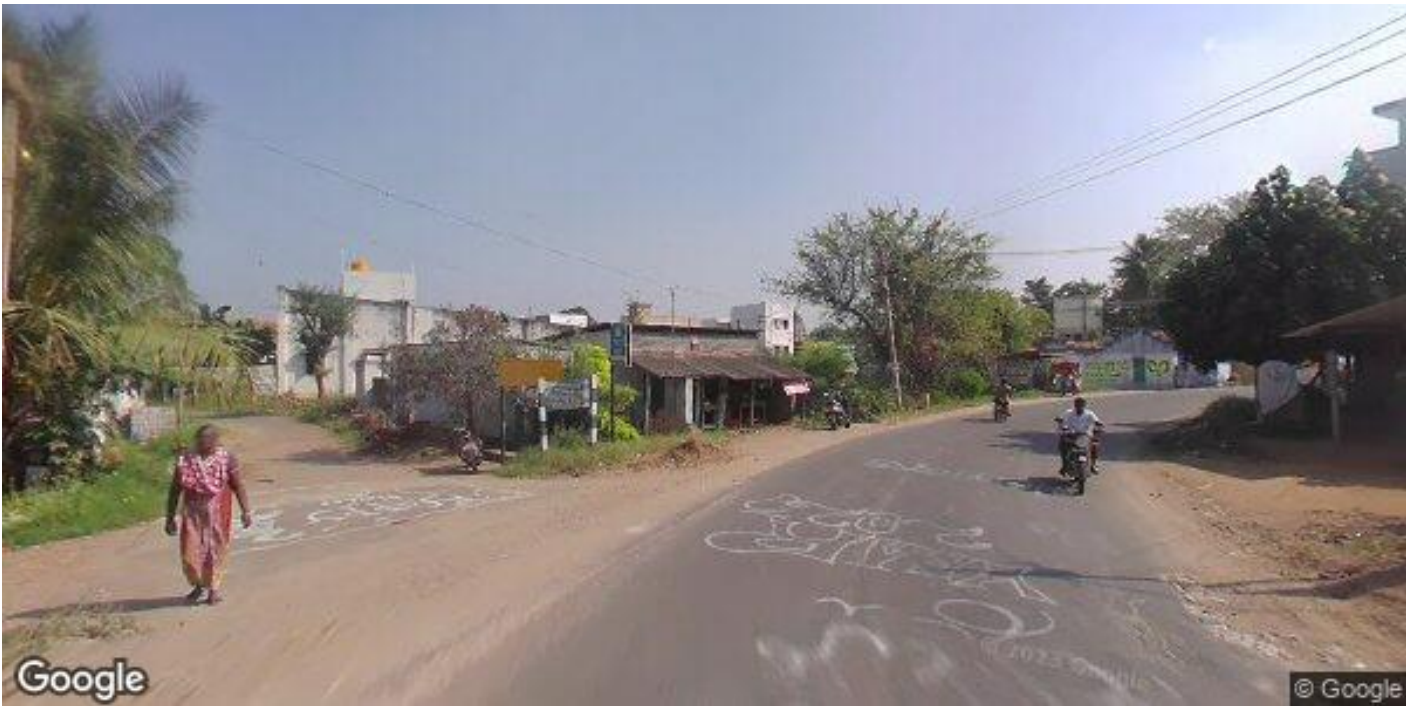
| | Risk Type | Risk Level | Coordinates | Speed Limit |
|---|---|---|---|---|
| 19 | Turn | Medium | 11.39468, 77.82800 | 30 KM/Hr |

**Risk Type:** Turn  
**Risk Level:** Medium  
**Speed Limit:** 30 KM/Hr  
**Coordinates:** 11.39468, 77.82800

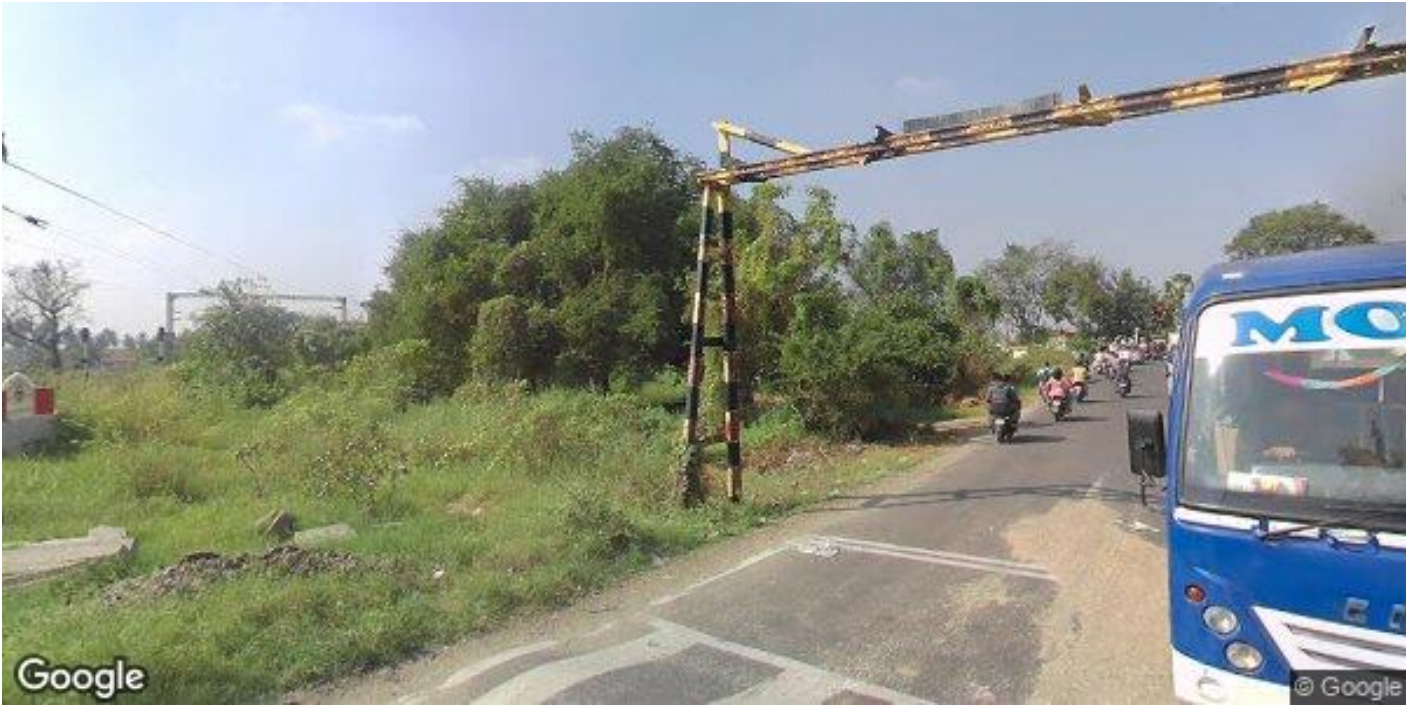
| | Risk Type | Risk Level | Coordinates | Speed Limit |
|---|---|---|---|---|
| 20 | Turn | Medium | 11.39692, 77.81974 | 30 KM/Hr |

**Risk Type:** Turn  
**Risk Level:** Medium  
**Speed Limit:** 30 KM/Hr  
**Coordinates:** 11.39692, 77.81974

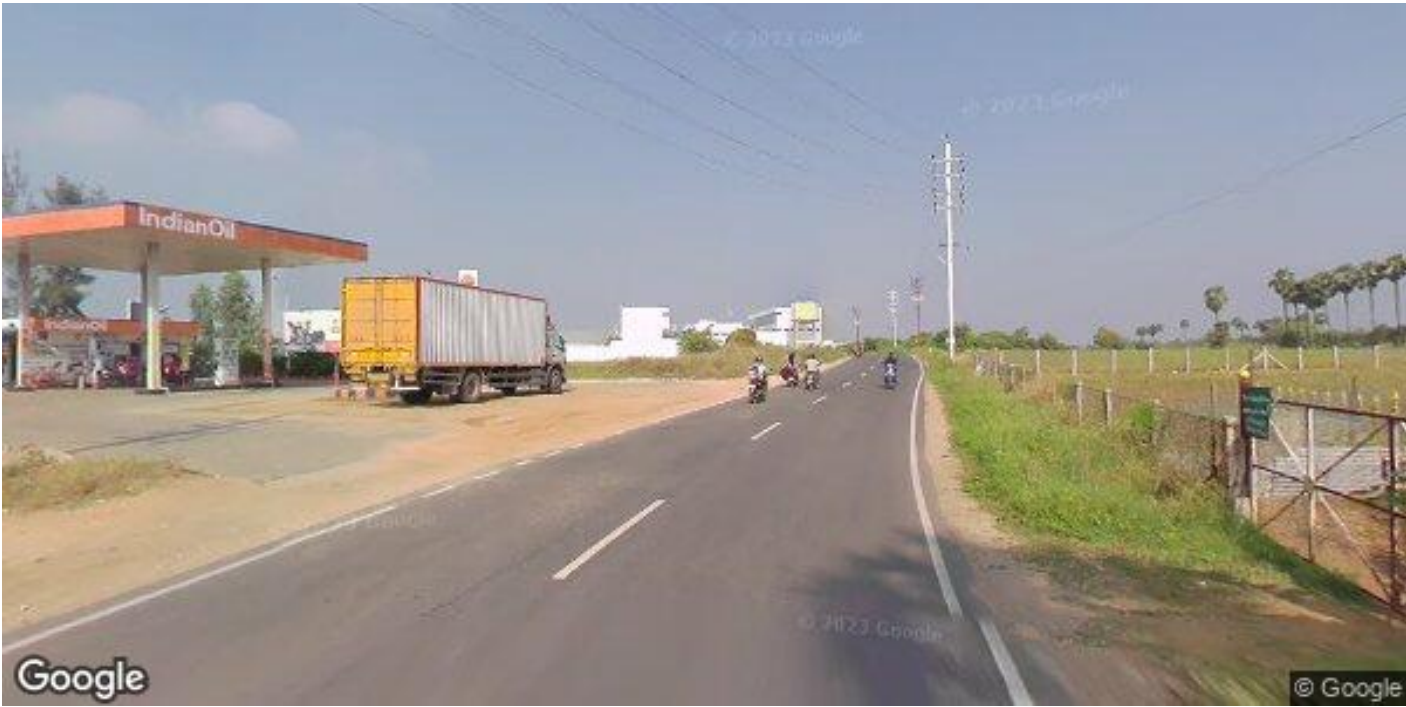
| | Risk Type | Risk Level | Coordinates | Speed Limit |
|---|---|---|---|---|
| 21 | Turn | High | 11.39915, 77.81187 | 15 KM/Hr |

**Risk Type:** Turn  
**Risk Level:** High  
**Speed Limit:** 15 KM/Hr  
**Coordinates:** 11.39915, 77.81187
