# IndianOil

## JOURNEY RISK MANAGEMENT (JRM) STUDY

### Salem Terminal to SRI LINGESH AGENCY

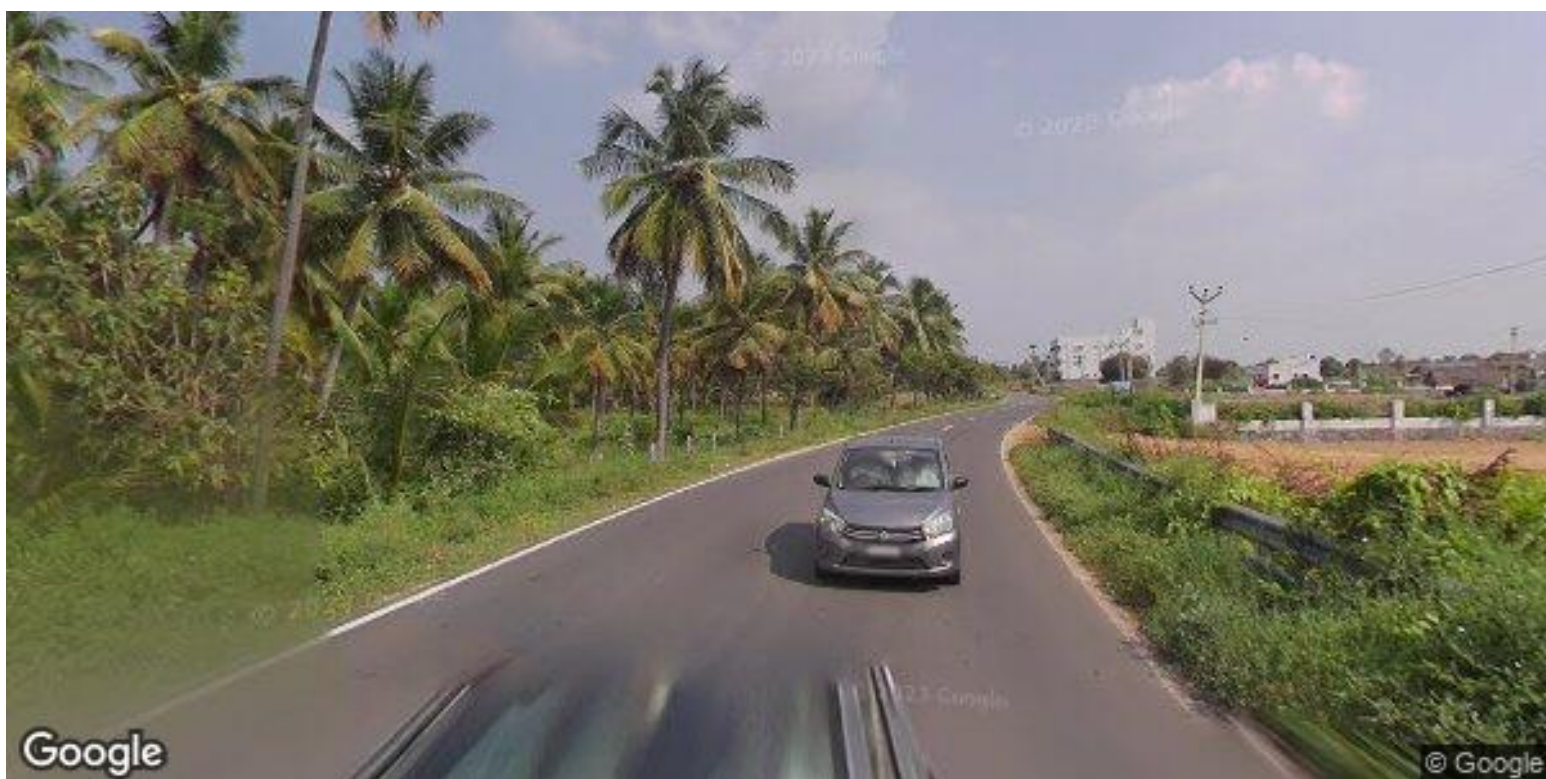
**Coordinates:** 11.45357, 77.85789

**Risk Type:** Turn

**Risk Level:** Medium

**Speed Limit:** 30 KM/Hr

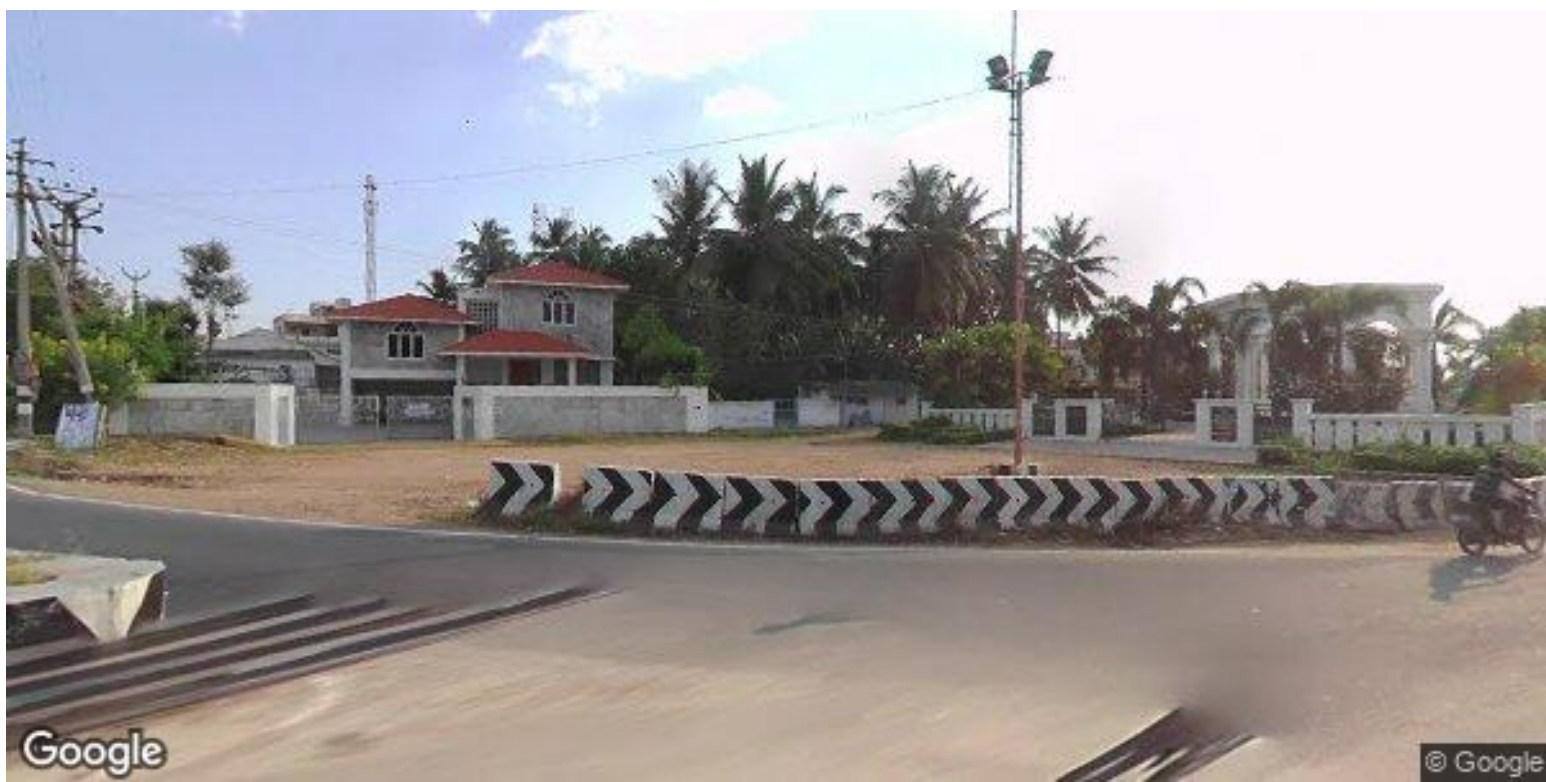
**Coordinates:** 11.46314, 77.84928

**Risk Type:** Turn

**Risk Level:** Medium

**Speed Limit:** 30 KM/Hr

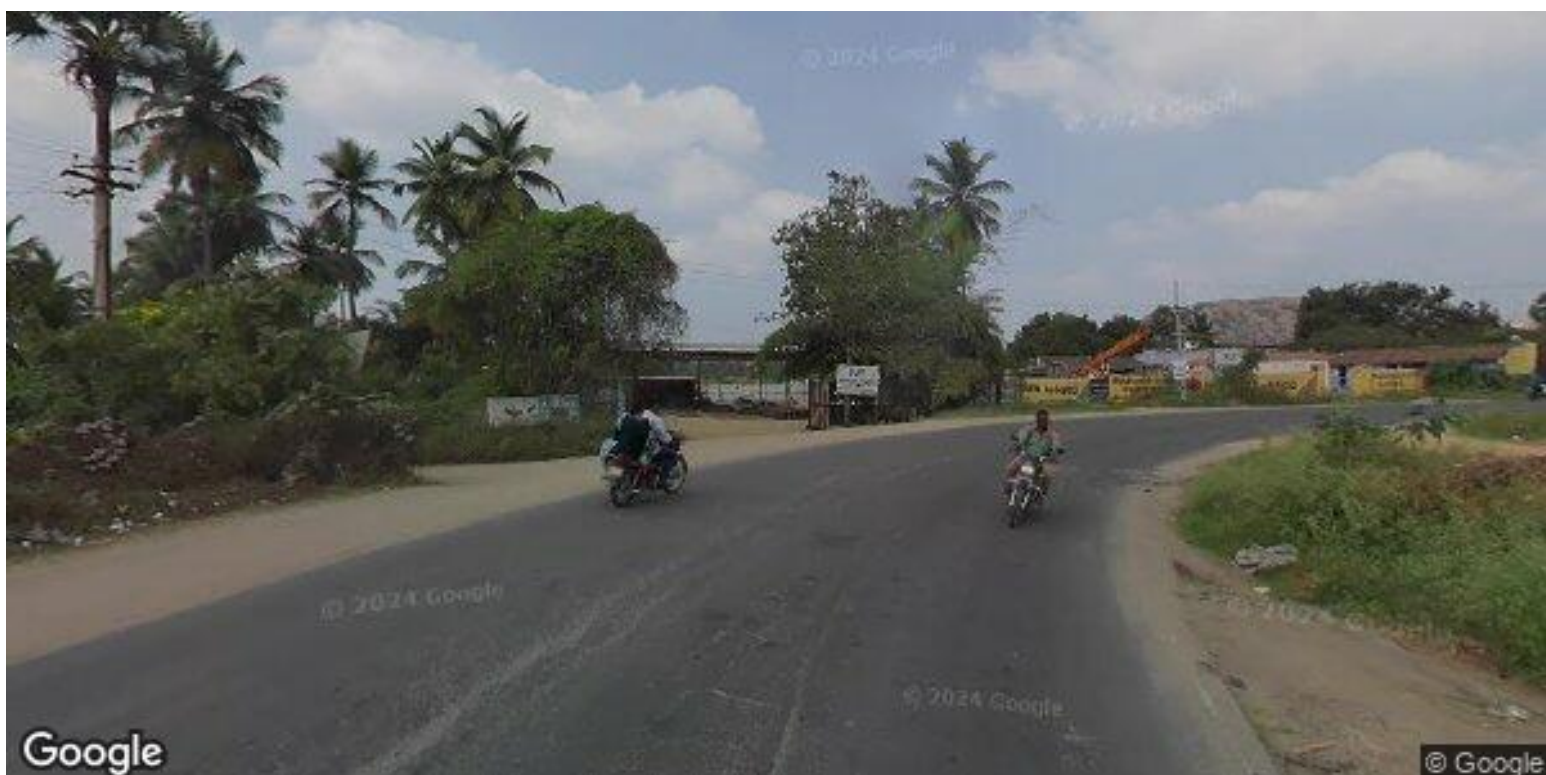
**Risk Type:** Turn  
**Risk Level:** Medium  
**Speed Limit:** 30 KM/Hr  
**Coordinates:** 11.49435, 77.88499

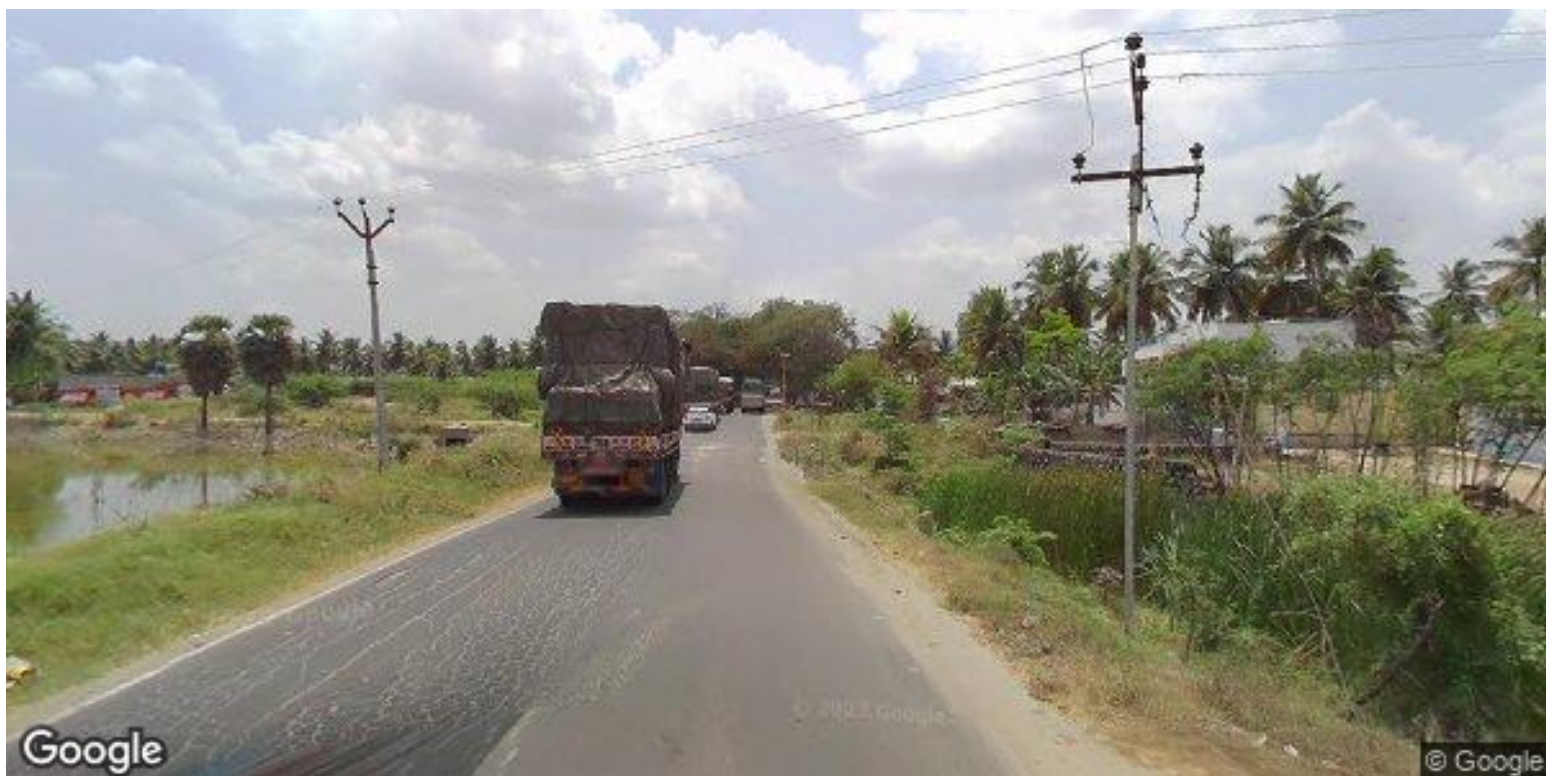
**Risk Type:** Turn  
**Risk Level:** Medium  
**Speed Limit:** 30 KM/Hr  
**Coordinates:** 11.56072, 77.89919

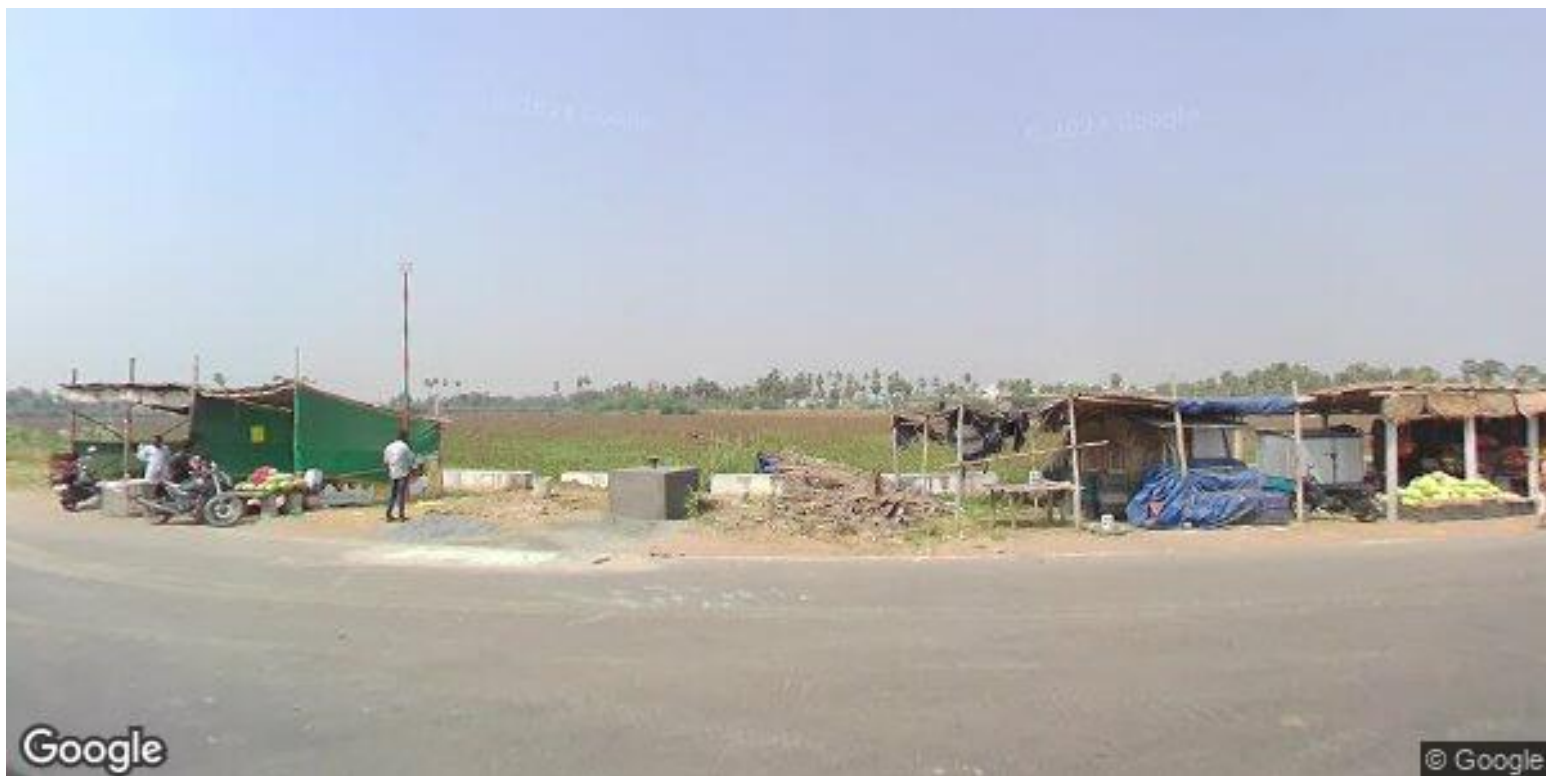
**Coordinates:** 11.68915, 77.97734

**Risk Type:** Turn

**Risk Level:** High

**Speed Limit:** 15 KM/Hr

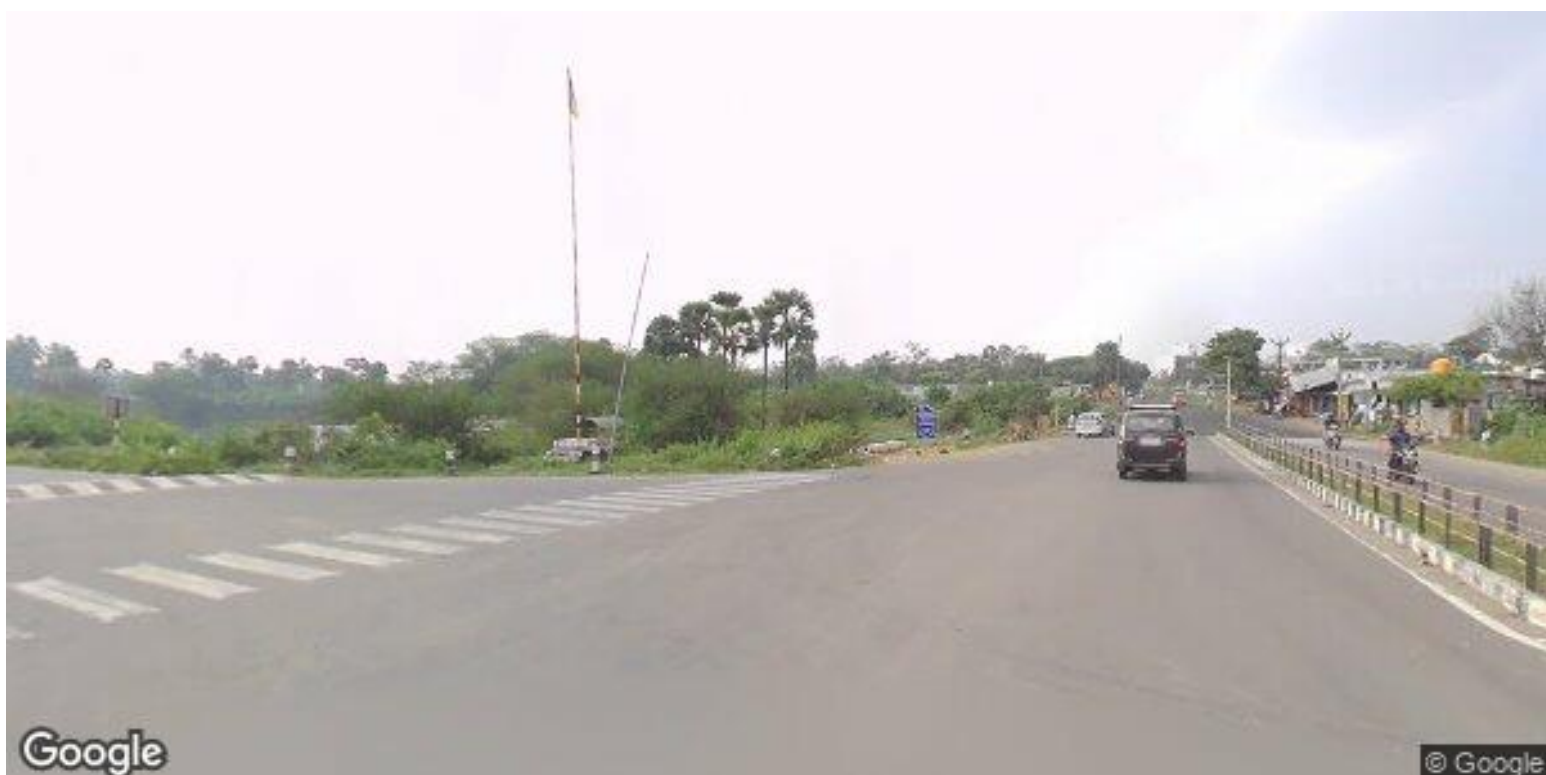
**Risk Type:** Turn  
**Risk Level:** Medium  
**Speed Limit:** 30 KM/Hr  
**Coordinates:** 11.70218, 77.97866

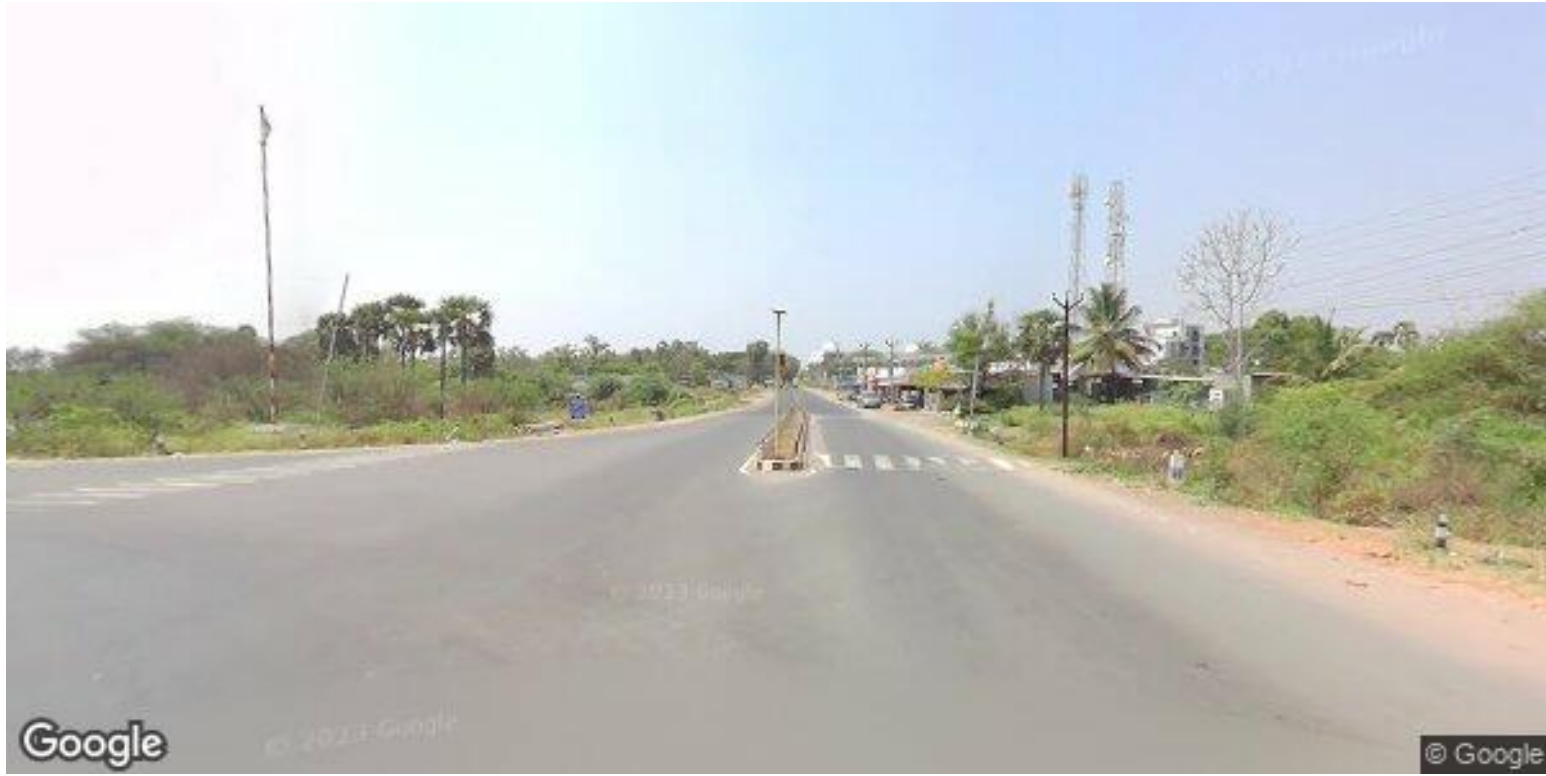
**Risk Type:** Turn  
**Risk Level:** High  
**Speed Limit:** 15 KM/Hr  
**Coordinates:** 11.70227, 77.97864

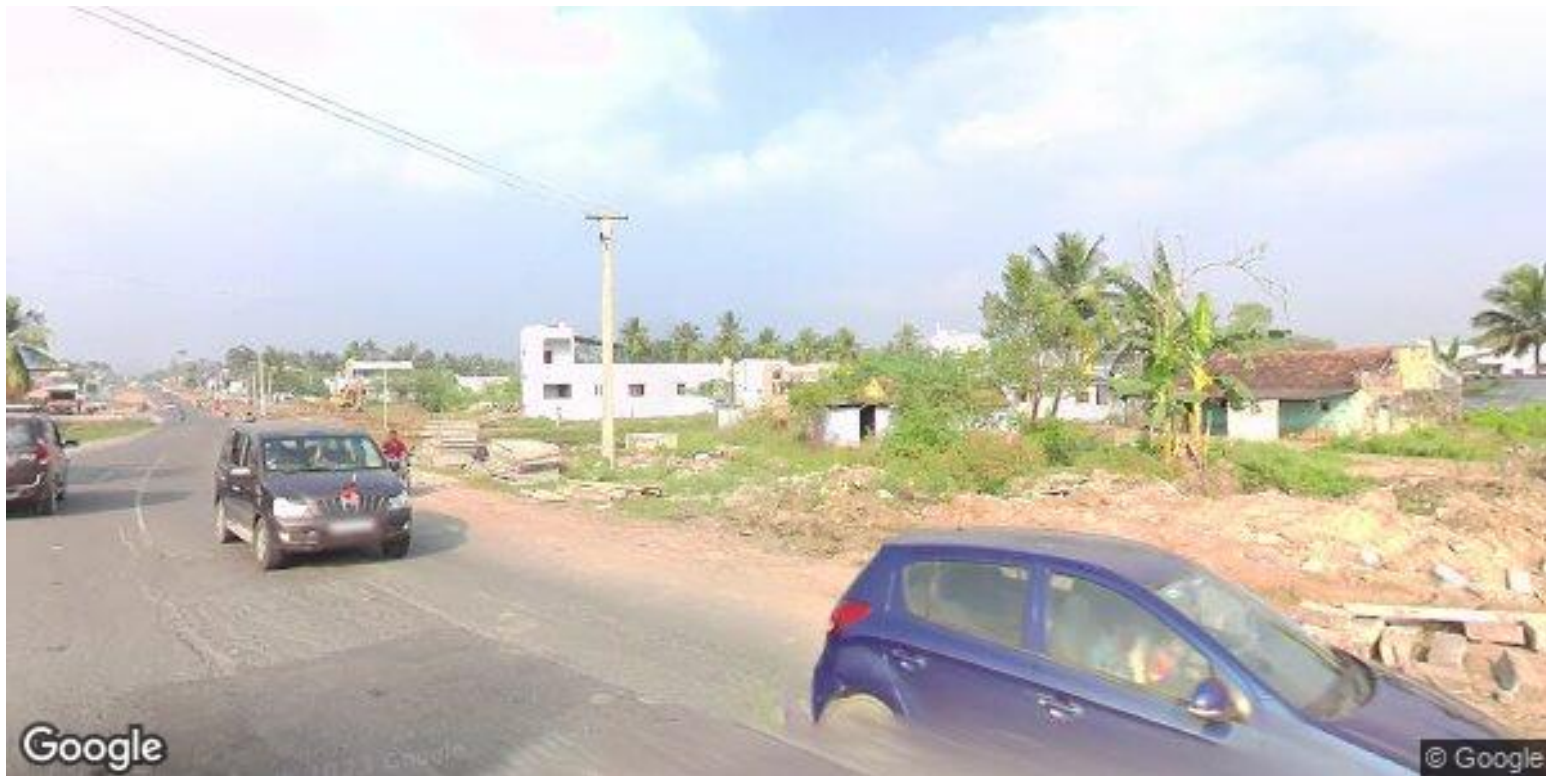
**Risk Type:** Turn  
**Risk Level:** Medium  
**Speed Limit:** 30 KM/Hr  
**Coordinates:** 11.71921, 78.01133

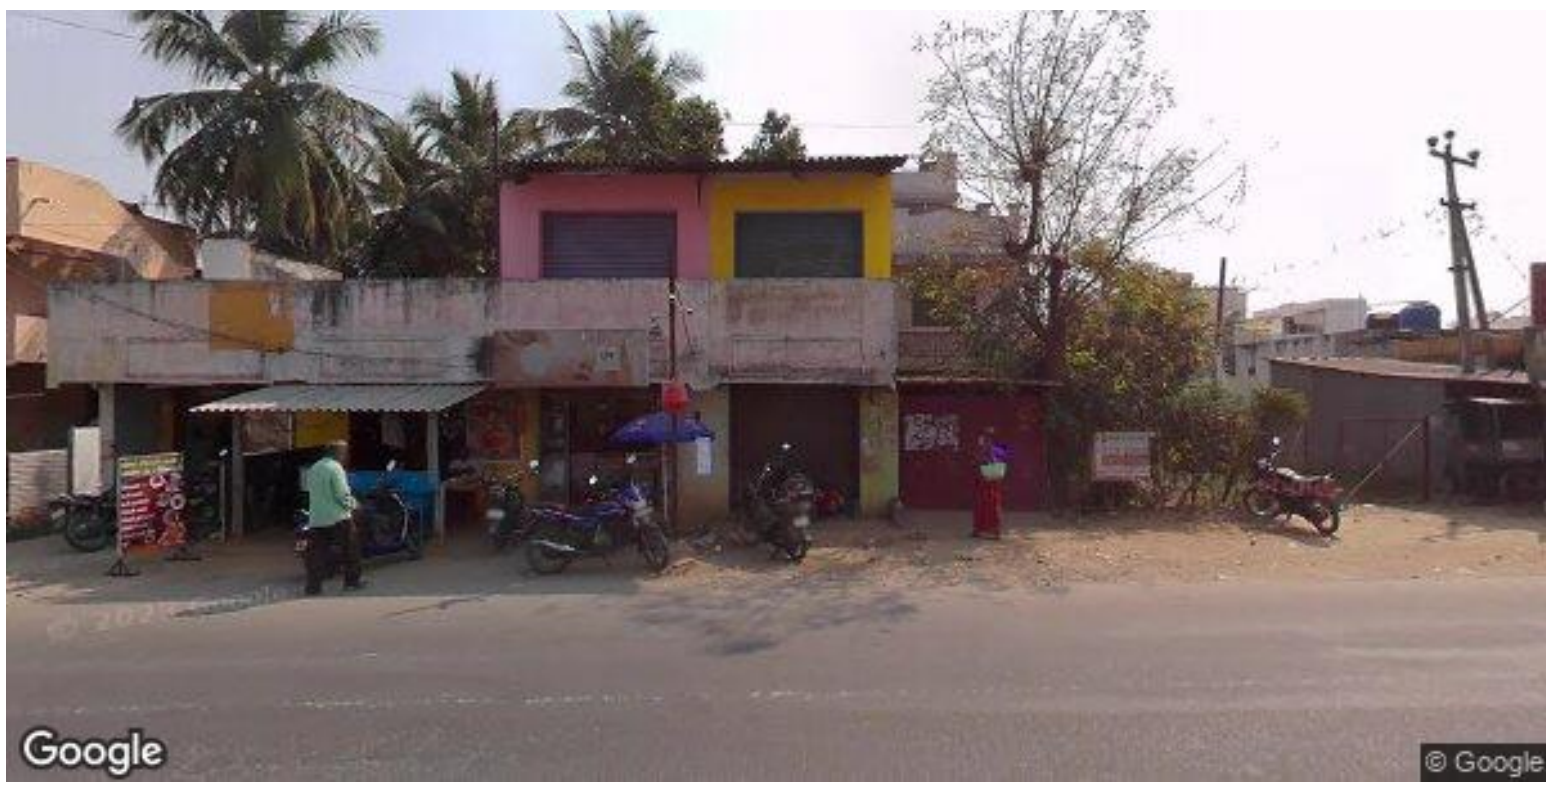
**Coordinates:** 11.73785, 78.03551

**Risk Type:** Blind Spot

**Risk Level:** Blind Spot

**Speed Limit:** 10 KM/Hr
