## JOURNEY RISK MANAGEMENT (JRM) STUDY

### Salem Terminal to PPS FUELS

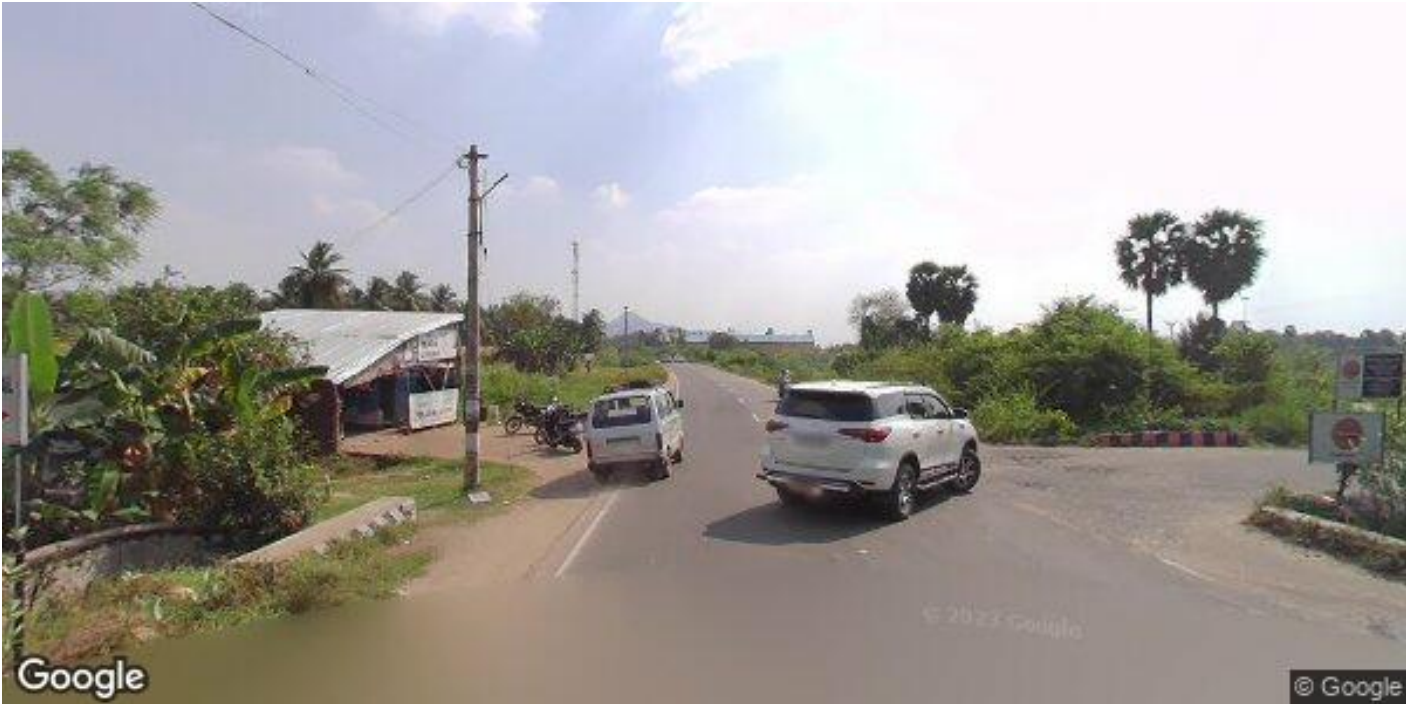
Risk Type: Turn  
Risk Level: High  
Speed Limit: 15 KM/Hr  
Coordinates: 11.44029, 77.87544

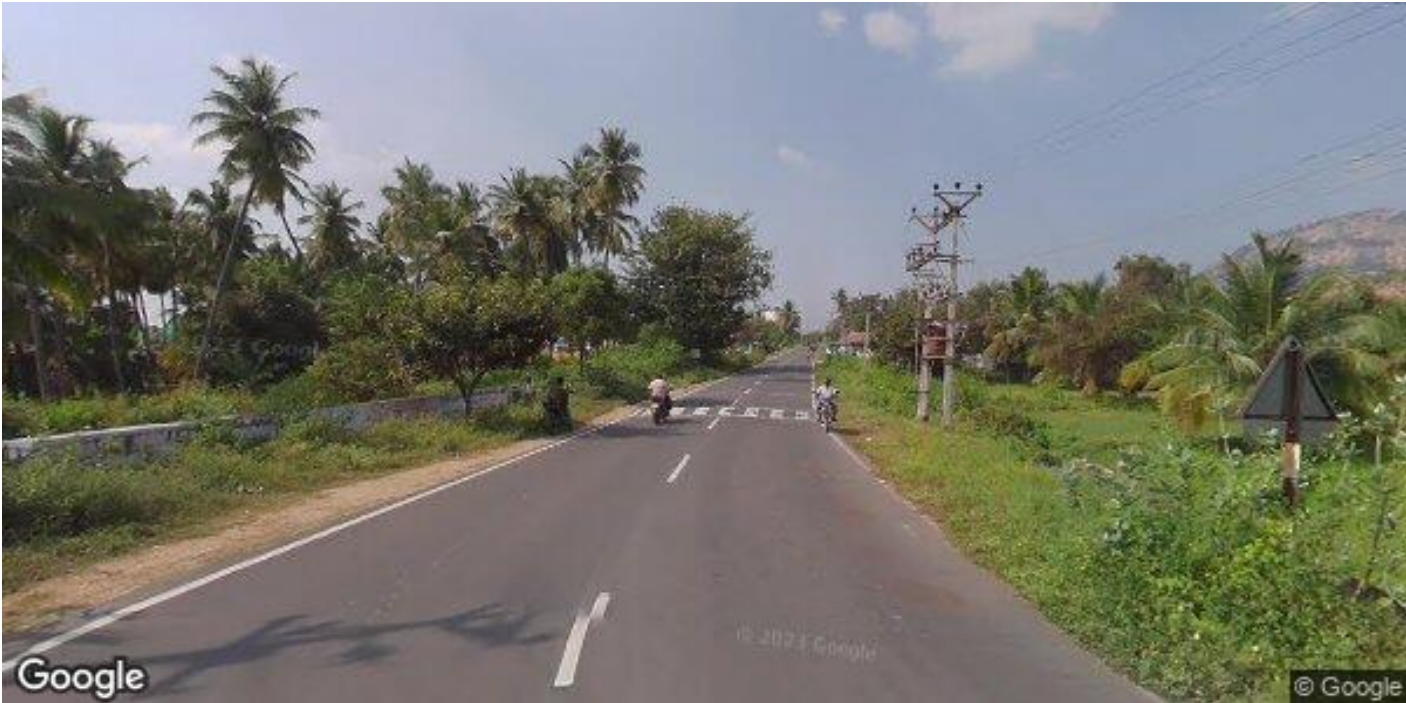
Risk Type: Turn  
Risk Level: Medium

**Speed Limit: 30 KM/Hr**  
**Coordinates: 11.45353, 77.85697**

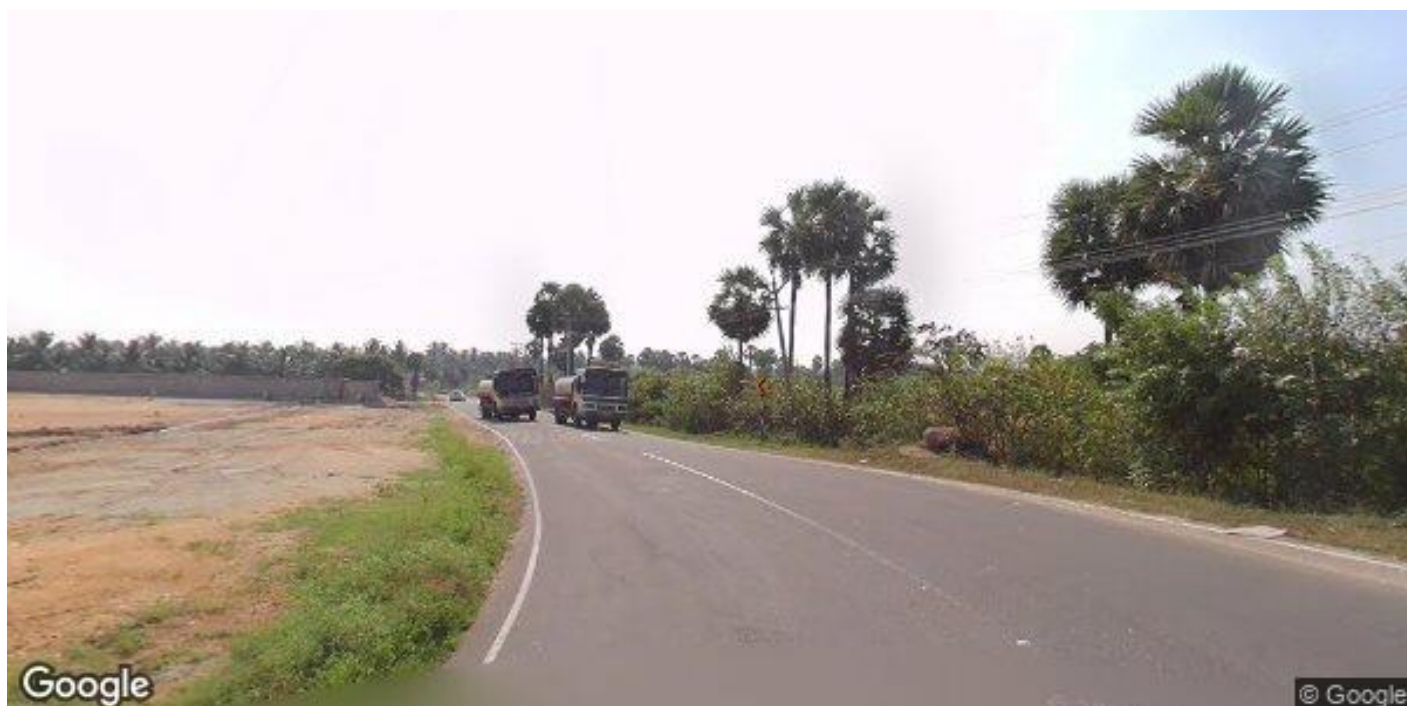
**Risk Type: Turn**  
**Risk Level: Medium**  
**Speed Limit: 30 KM/Hr**  
**Coordinates: 11.45839, 77.85143**

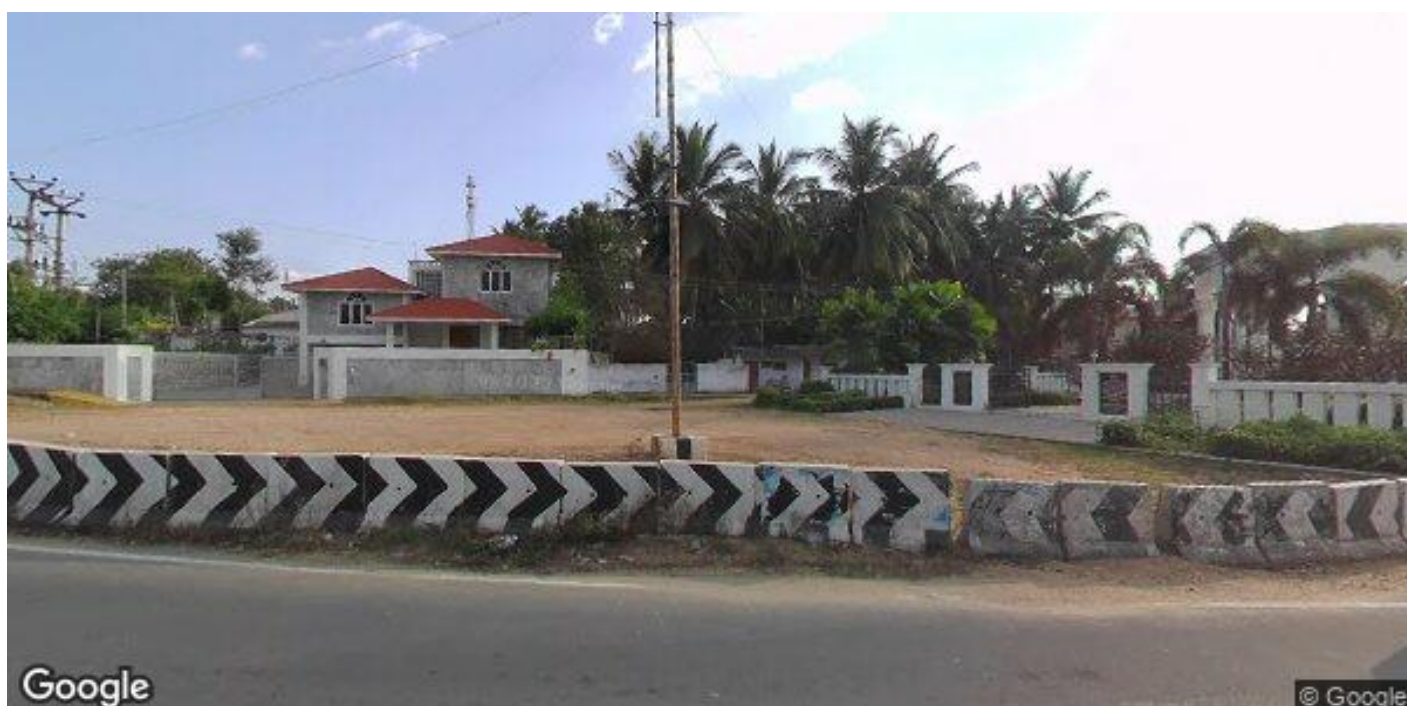
**Risk Type:** Turn  
**Risk Level:** Medium  
**Speed Limit:** 30 KM/Hr  
**Coordinates:** 11.46316, 77.84921

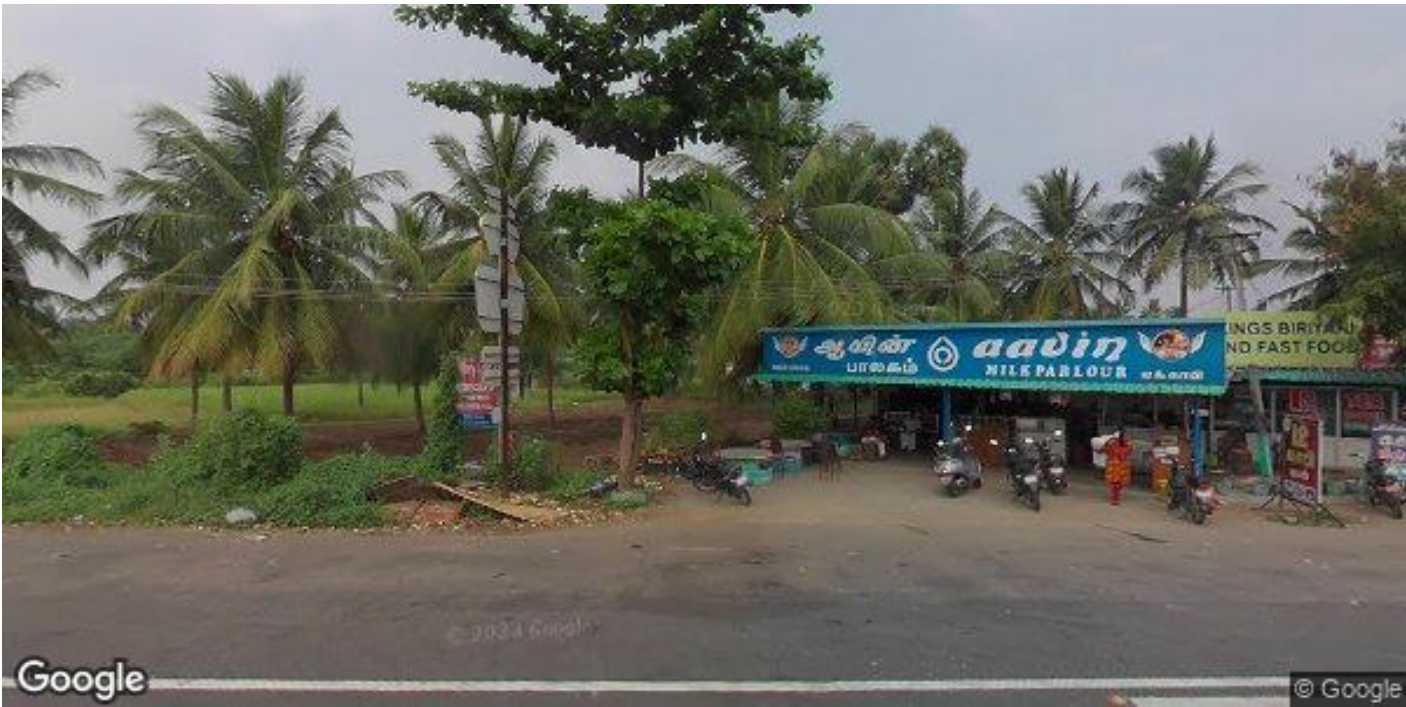
**Risk Type:** Blind Spot  
**Risk Level:** Blind Spot  
**Speed Limit:** 10 KM/Hr  
**Coordinates:** 11.45631, 77.81668

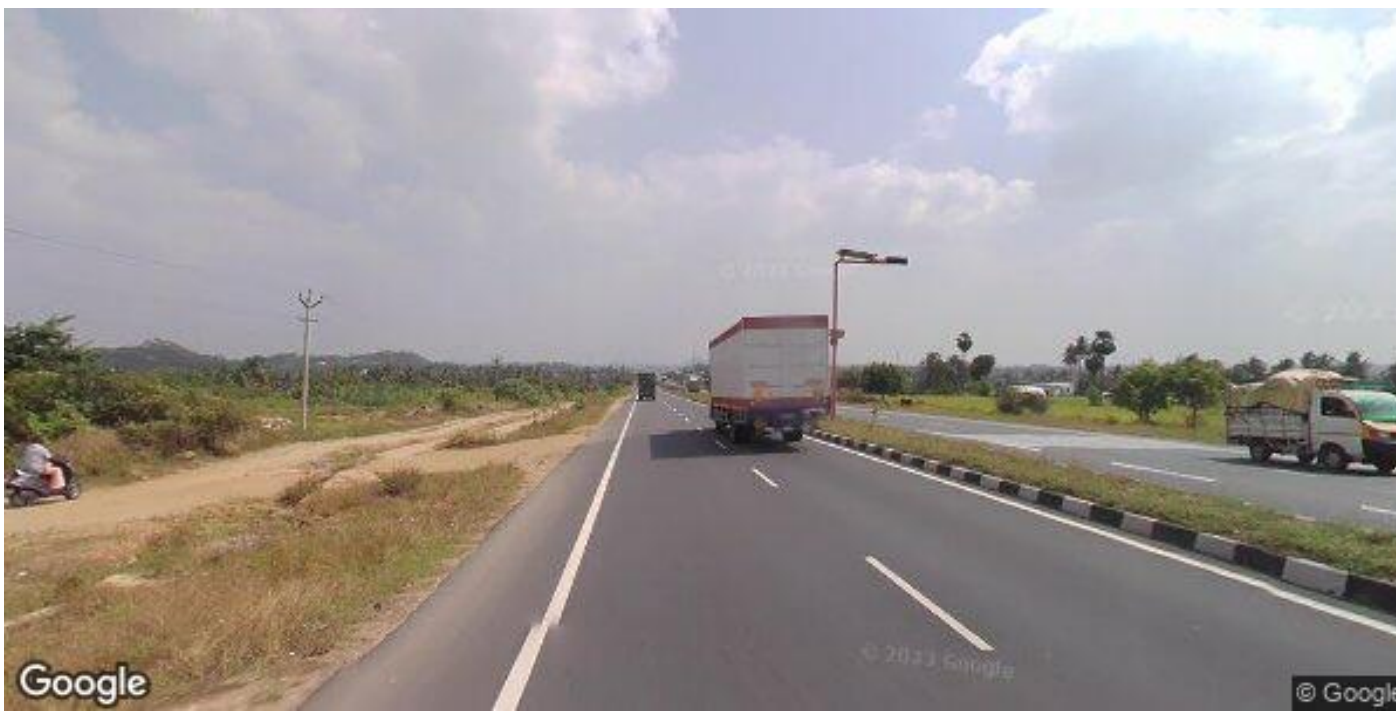
**Risk Type:** Turn  
**Risk Level:** High  
**Speed Limit:** 15 KM/Hr  
**Coordinates:** 11.49409, 77.88004

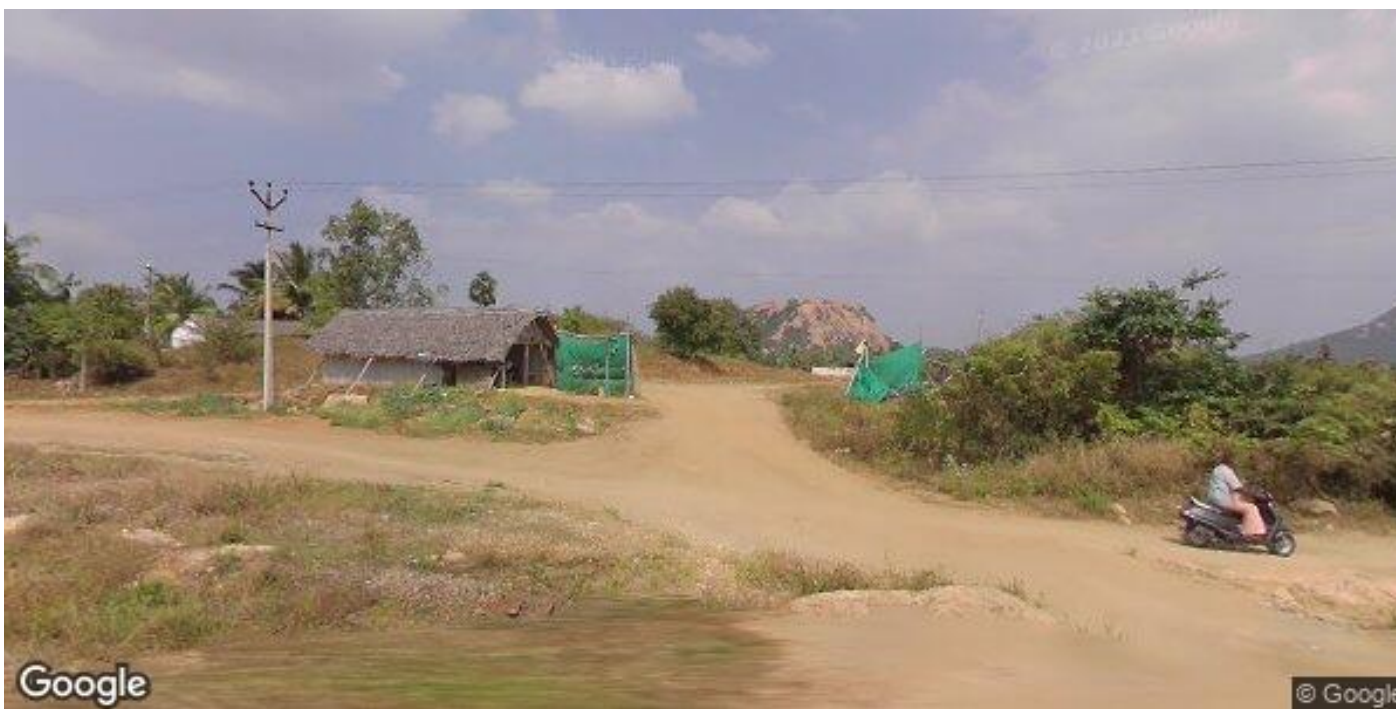
**Risk Type:** Turn  
**Risk Level:** Medium  
**Speed Limit:** 30 KM/Hr  
**Coordinates:** 11.49420, 77.88016

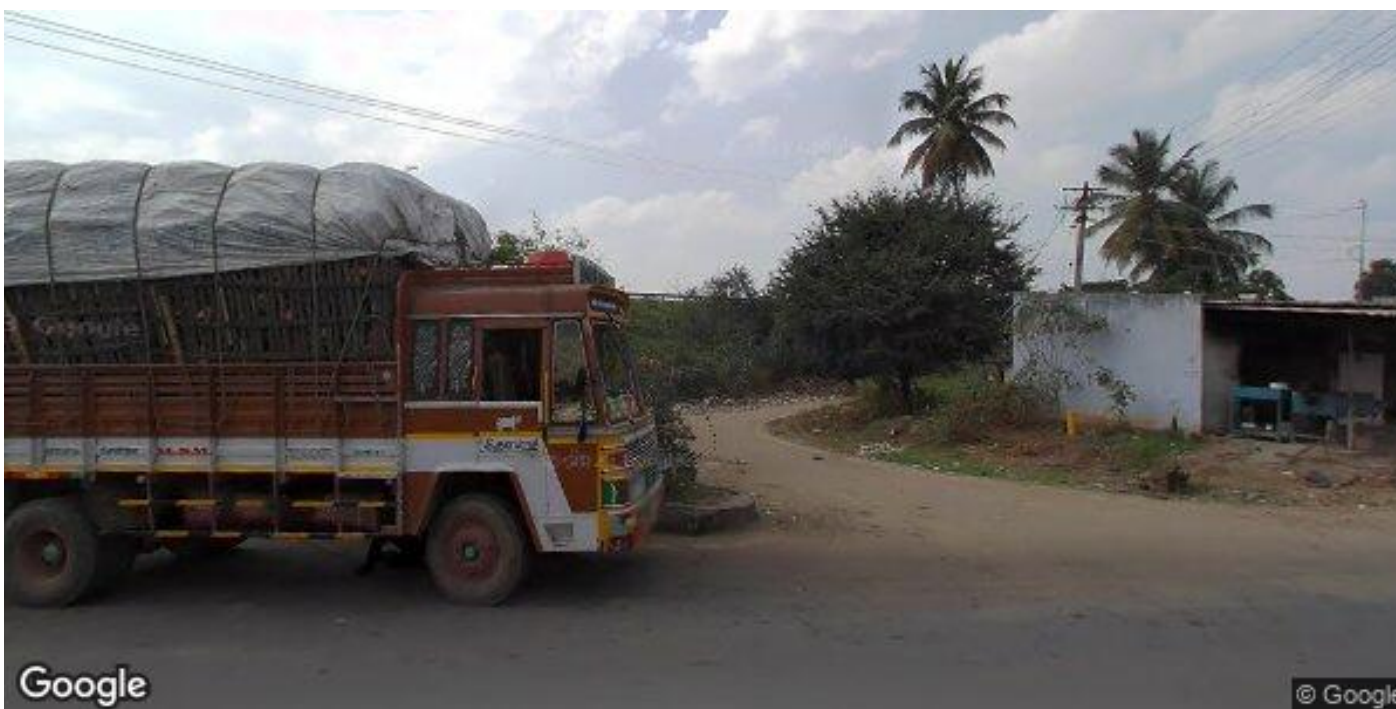
**Risk Type:** Turn  
**Risk Level:** High  
**Speed Limit:** 15 KM/Hr  
**Coordinates:** 11.49382, 77.88530

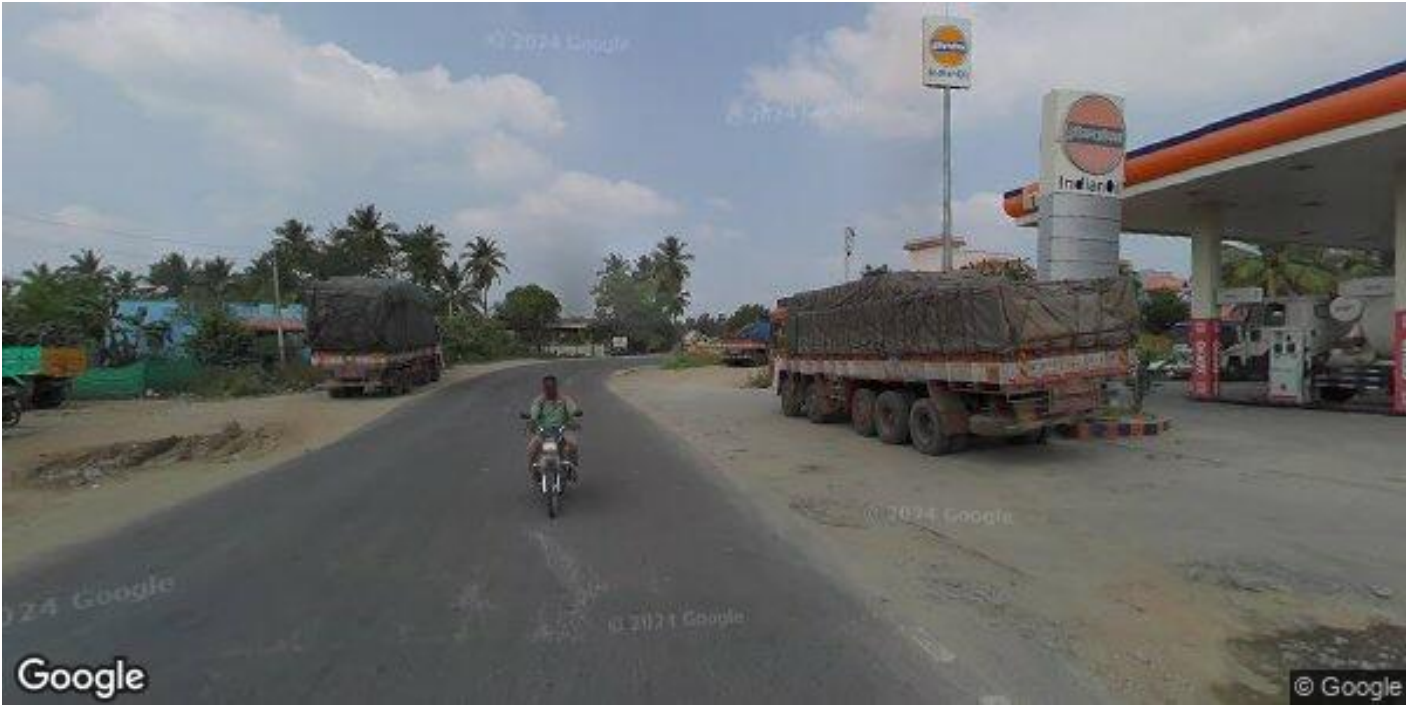
**Risk Type:** Turn  
**Risk Level:** High  
**Speed Limit:** 15 KM/Hr  
**Coordinates:** 11.49408, 77.88538

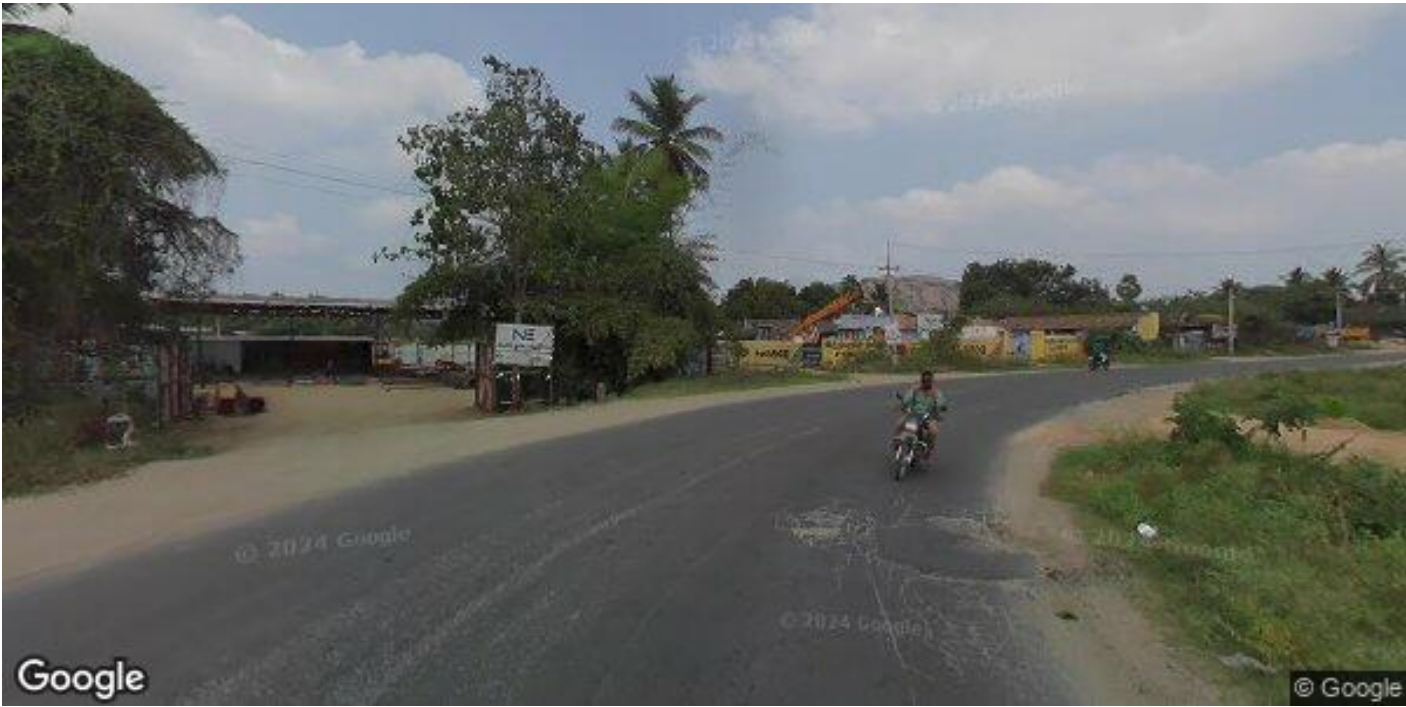
**Risk Type:** Turn  
**Risk Level:** Medium  
**Speed Limit:** 30 KM/Hr  
**Coordinates:** 11.49444, 77.88492

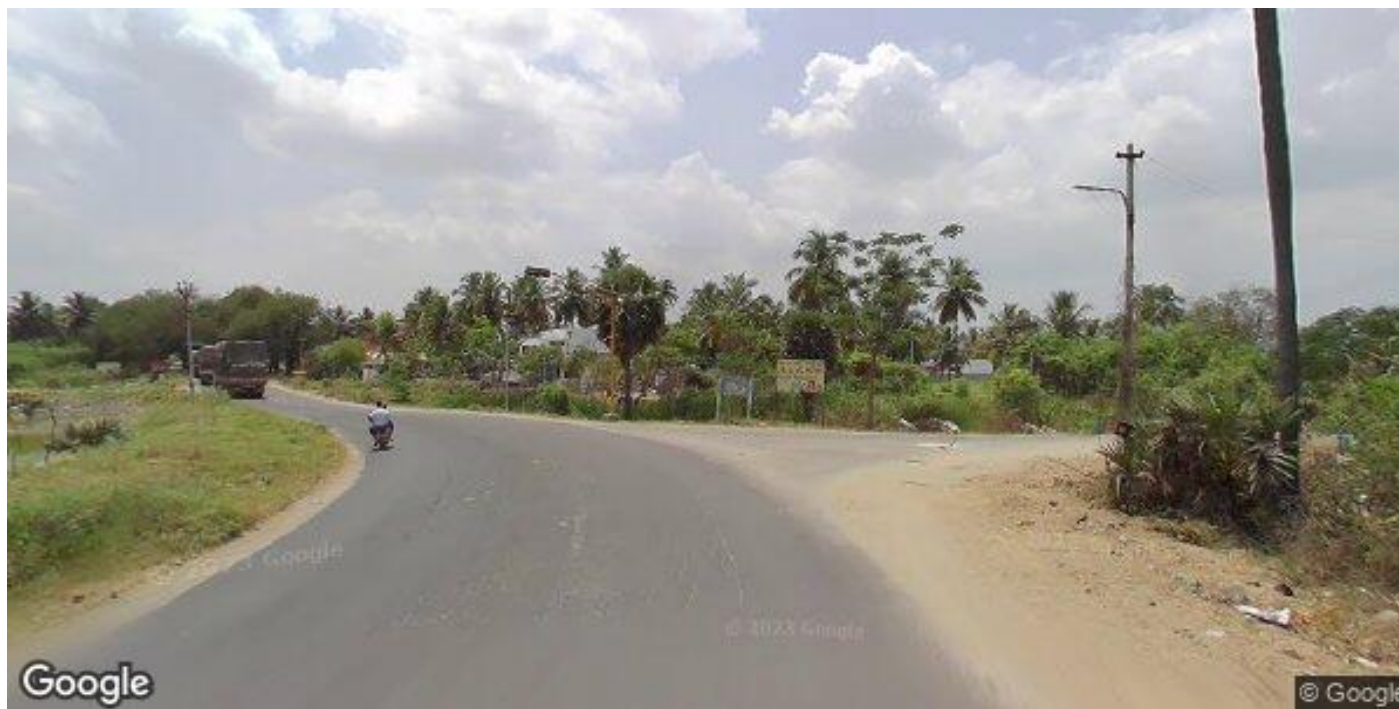
**Risk Type:** Turn  
**Risk Level:** Medium  
**Speed Limit:** 30 KM/Hr  
**Coordinates:** 11.56096, 77.89931

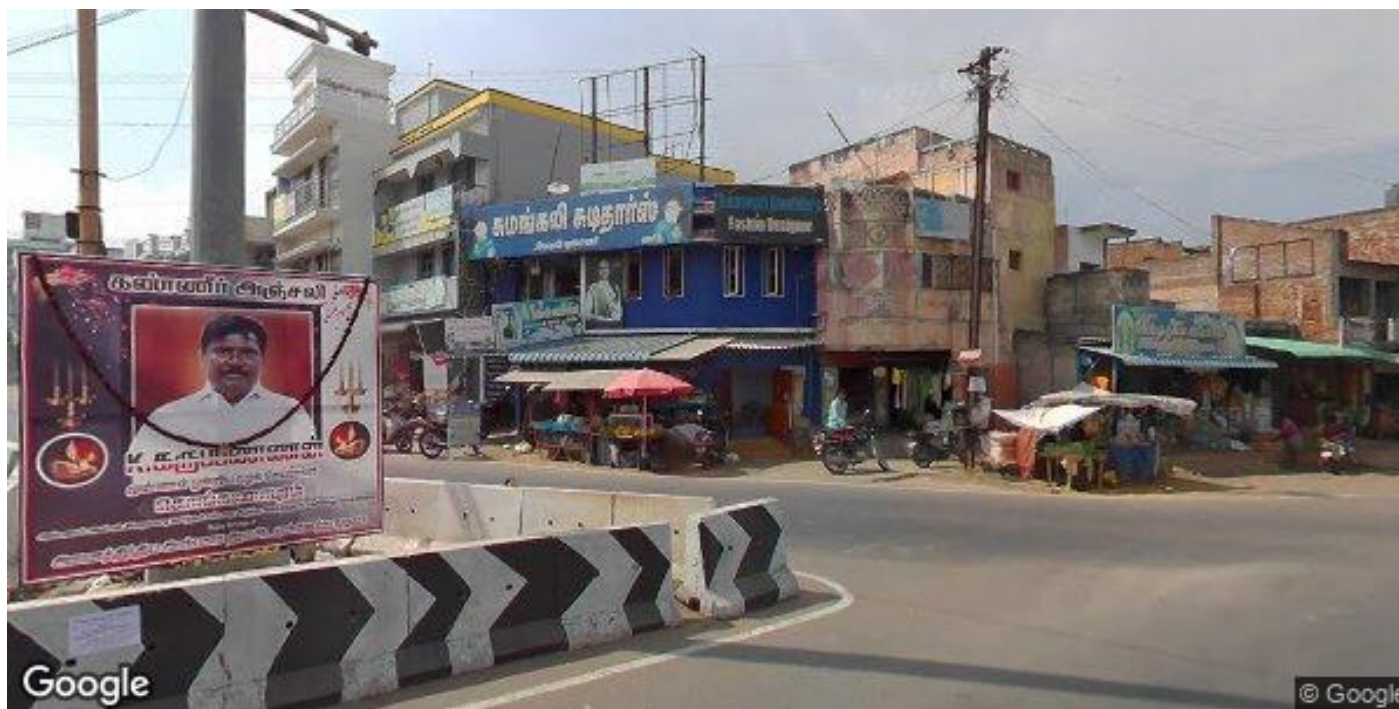
**Risk Type:** Turn  
**Risk Level:** Medium  
**Speed Limit:** 30 KM/Hr  
**Coordinates:** 11.57036, 77.90223

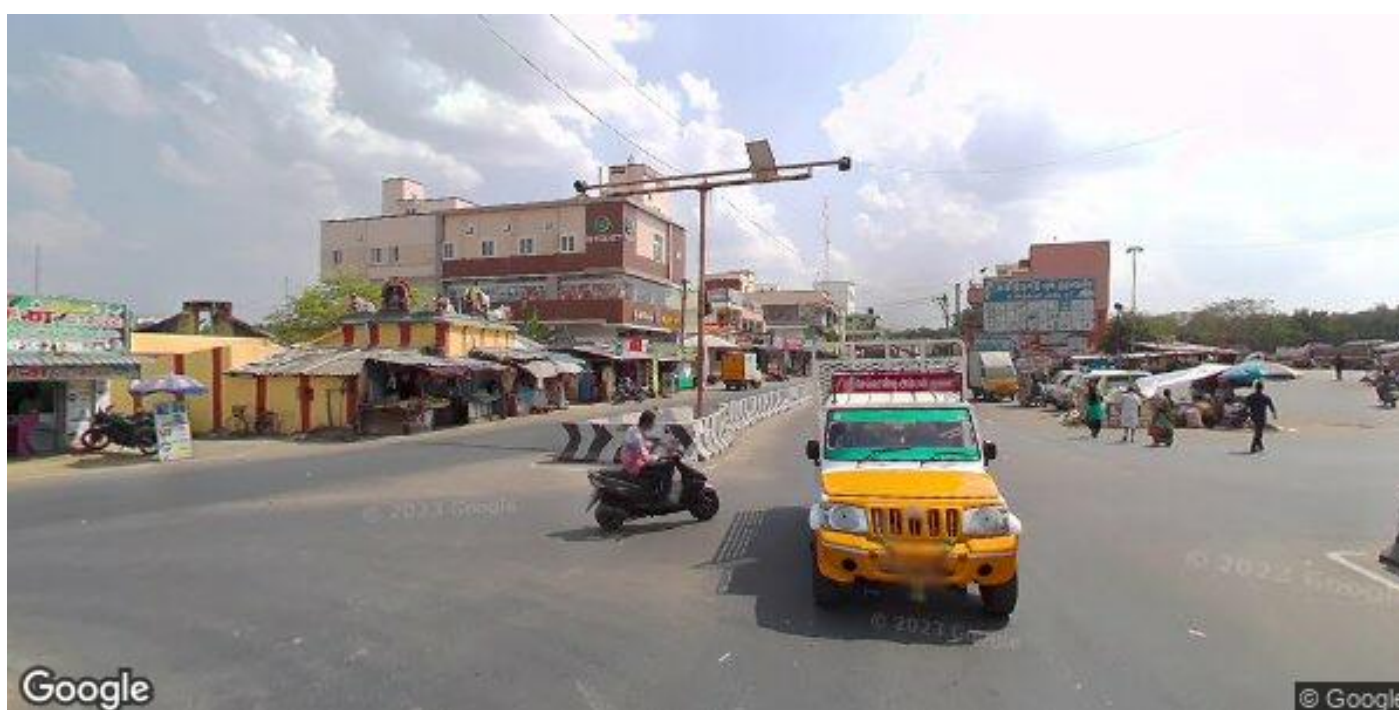
**Risk Type:** Turn  
**Risk Level:** Medium  
**Speed Limit:** 30 KM/Hr  
**Coordinates:** 11.57042, 77.90222

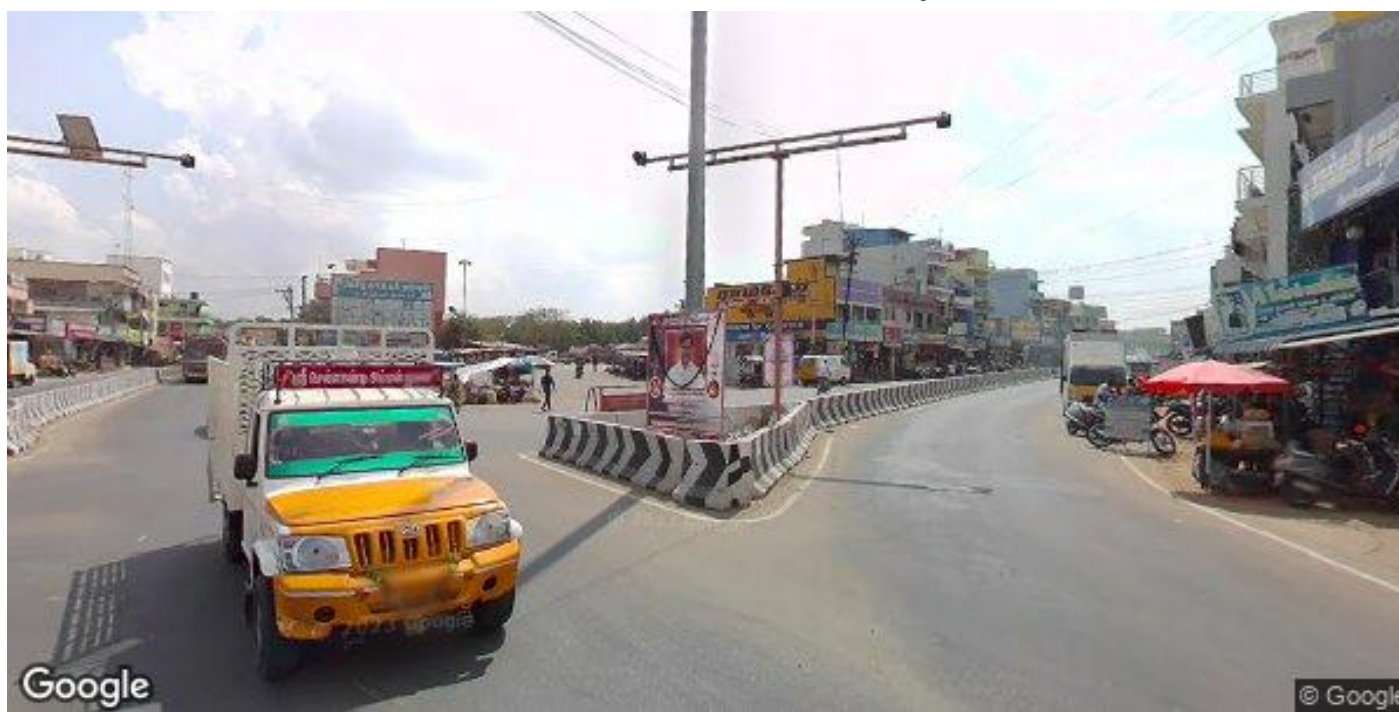
**Risk Type:** Turn  
**Risk Level:** Medium  
**Speed Limit:** 30 KM/Hr  
**Coordinates:** 11.57053, 77.90227

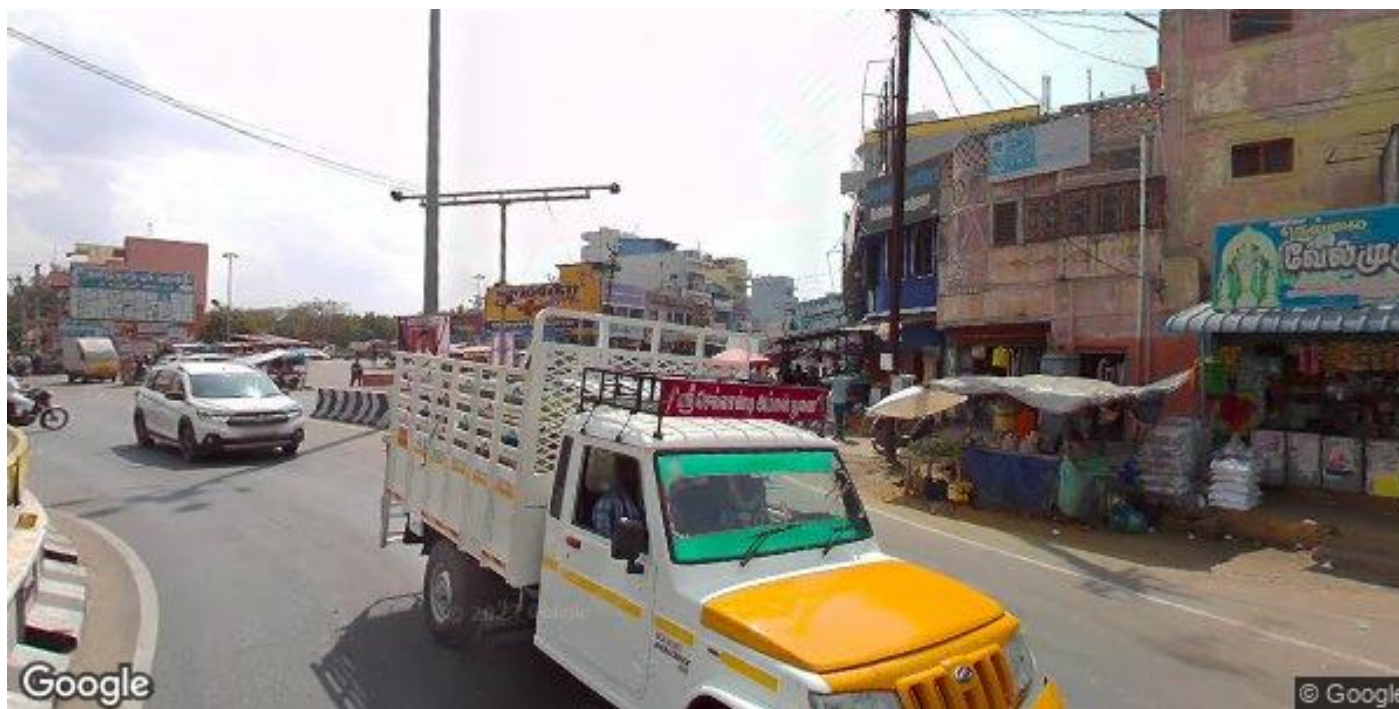
**Risk Type:** Turn  
**Risk Level:** Medium  
**Speed Limit:** 30 KM/Hr  
**Coordinates:** 11.57056, 77.90234

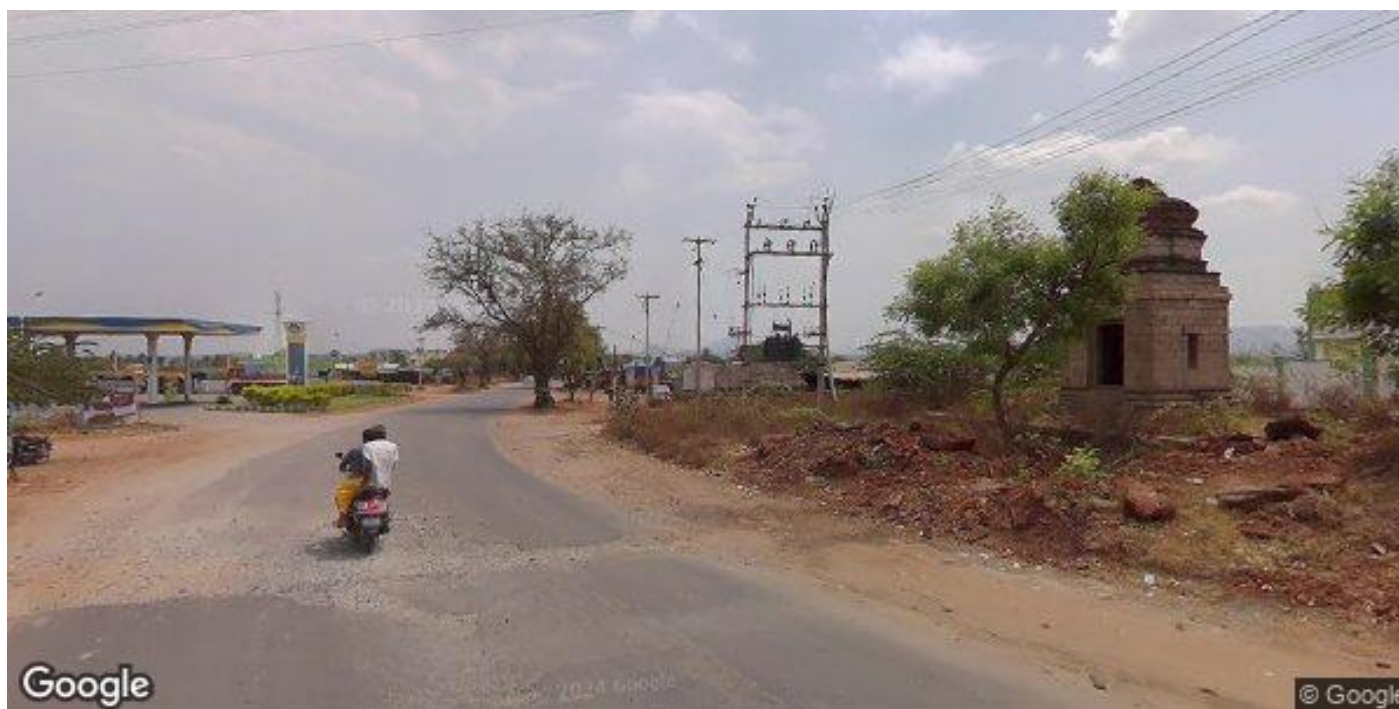
**Risk Type:** Turn  
**Risk Level:** Medium  
**Speed Limit:** 30 KM/Hr  
**Coordinates:** 11.58304, 77.90656

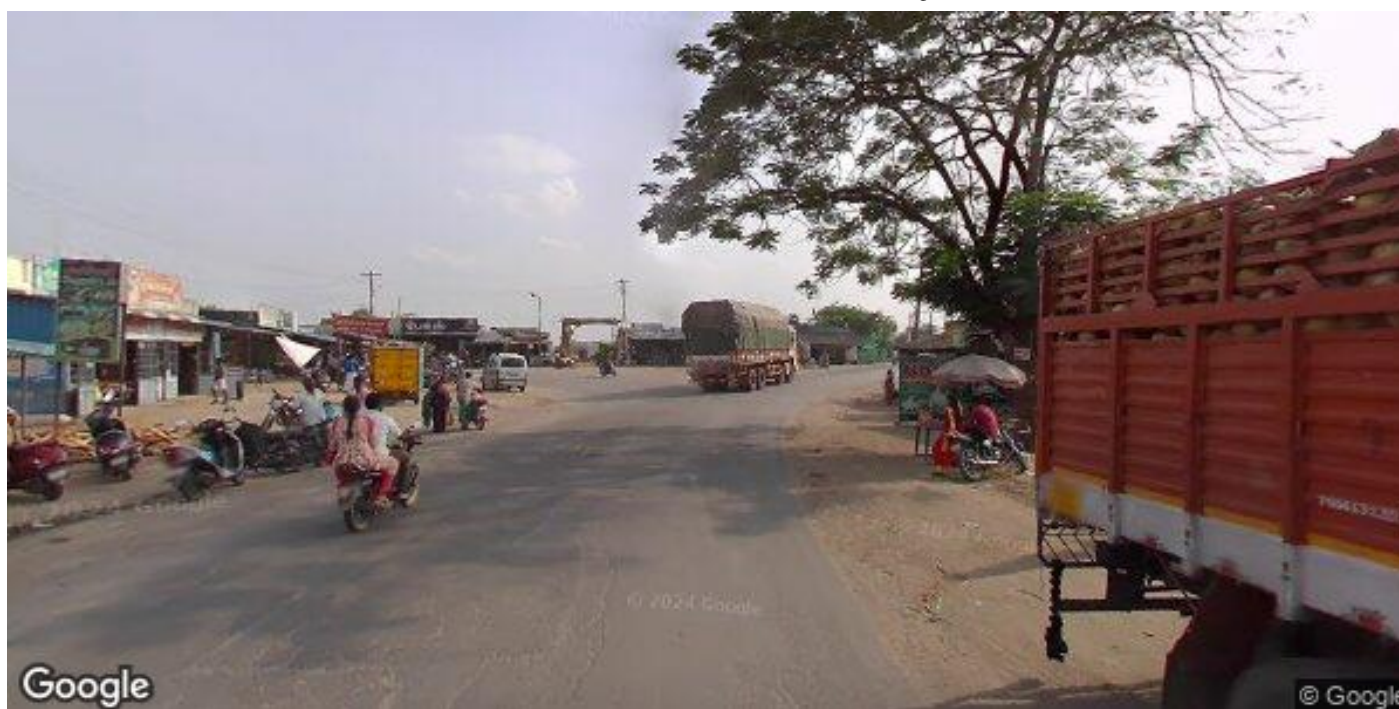
**Risk Type:** Turn  
**Risk Level:** Medium  
**Speed Limit:** 30 KM/Hr  
**Coordinates:** 11.64197, 77.95197

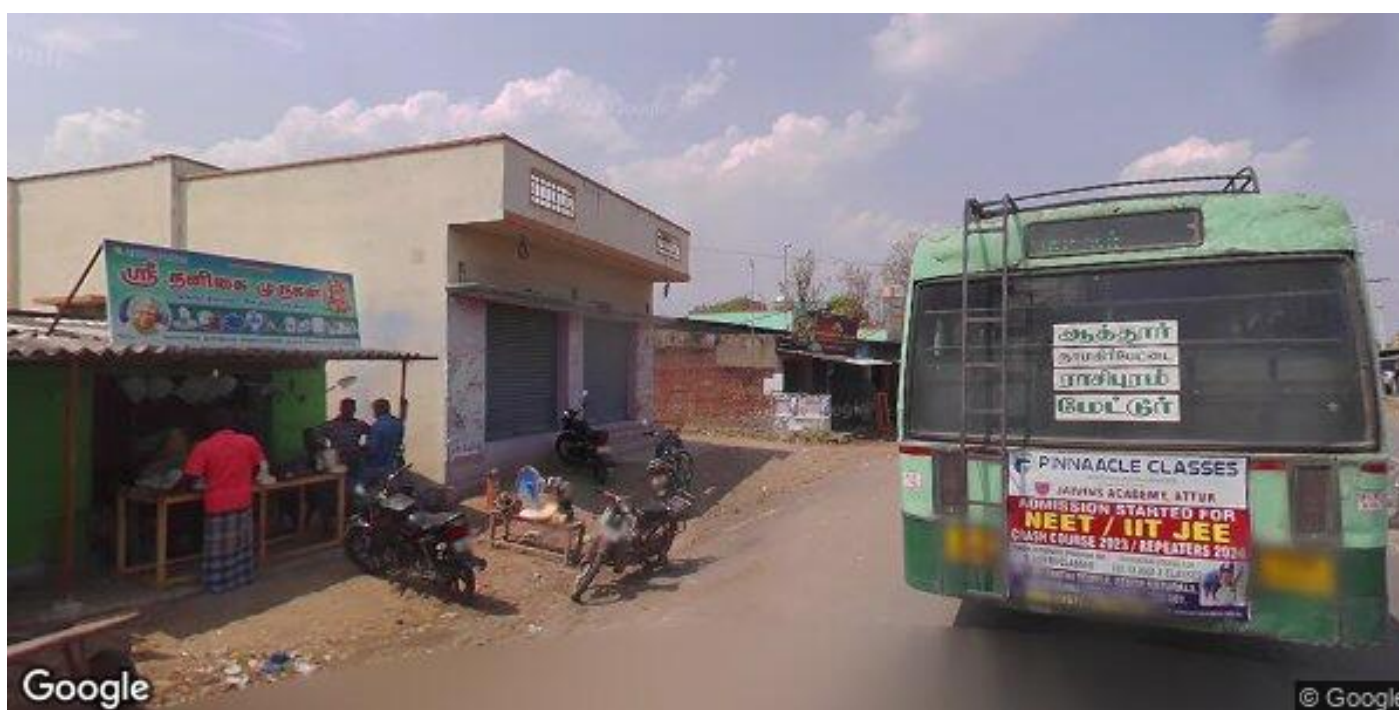
**Risk Type:** Turn  
**Risk Level:** Medium  
**Speed Limit:** 30 KM/Hr  
**Coordinates:** 11.64721, 77.95118

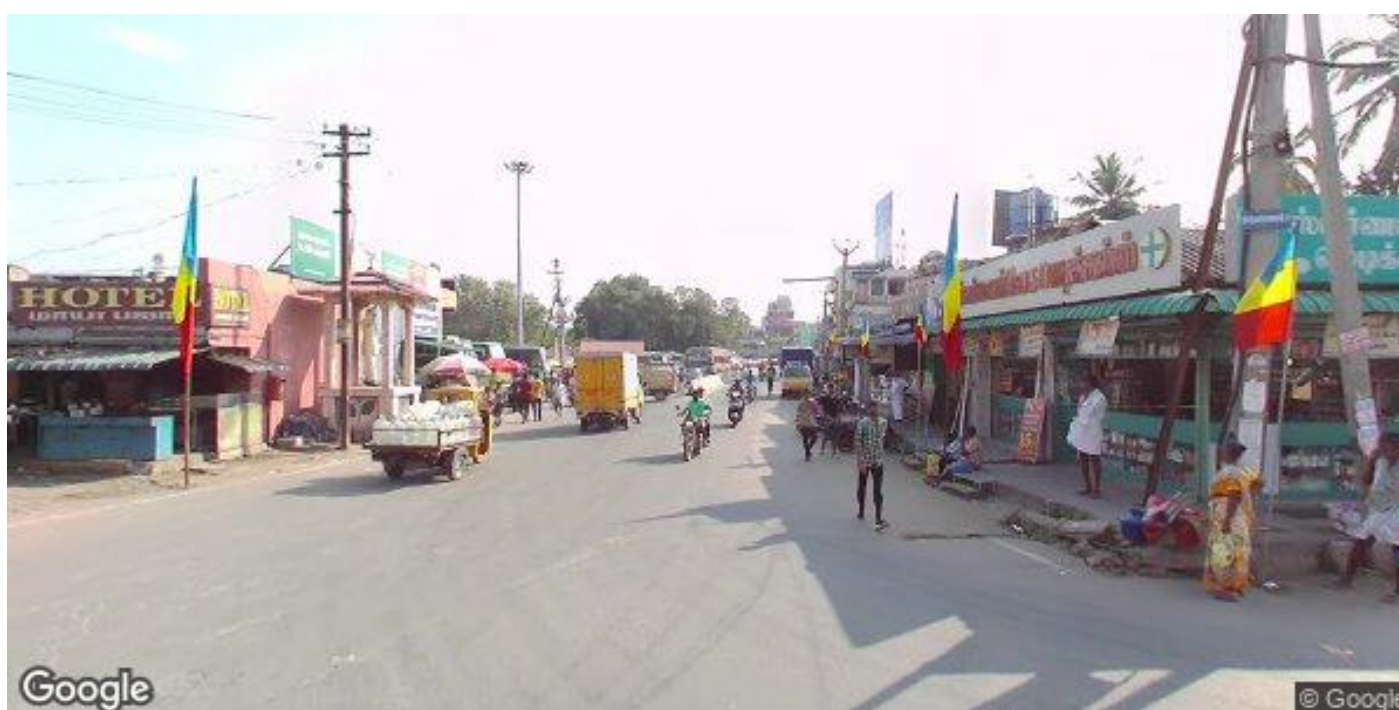
**Risk Type:** Blind Spot  
**Risk Level:** Blind Spot  
**Speed Limit:** 10 KM/Hr  
**Coordinates:** 11.69590, 77.97114
