# IndianOil

## JOURNEY RISK MANAGEMENT (JRM) STUDY

### Salem Terminal to SHREE VARI CORPORATION

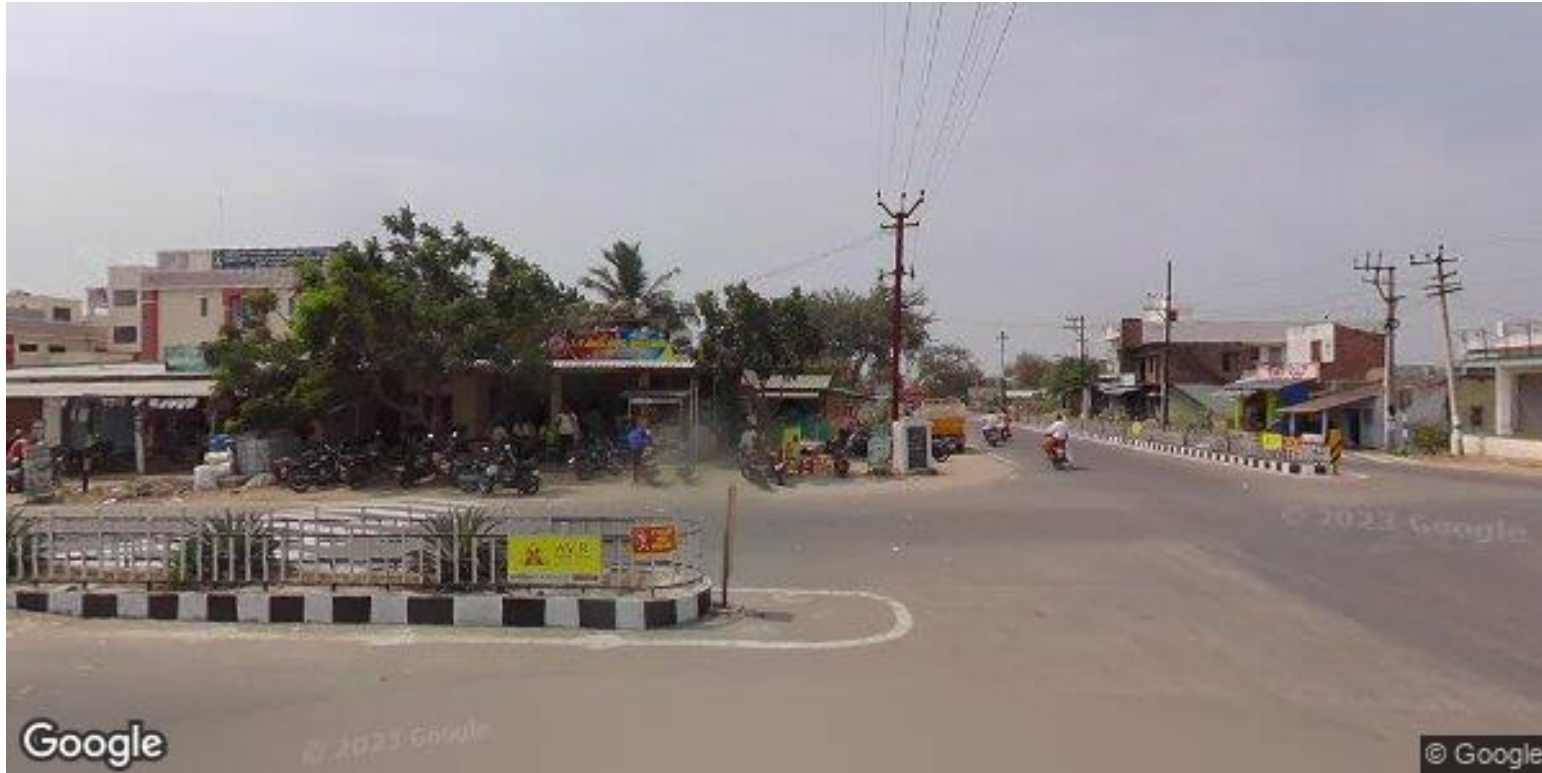
**Coordinates:** 11.58300, 77.85813

**Risk Type:** Roundabout

**Risk Level:** High

**Speed Limit:** 15 KM/Hr

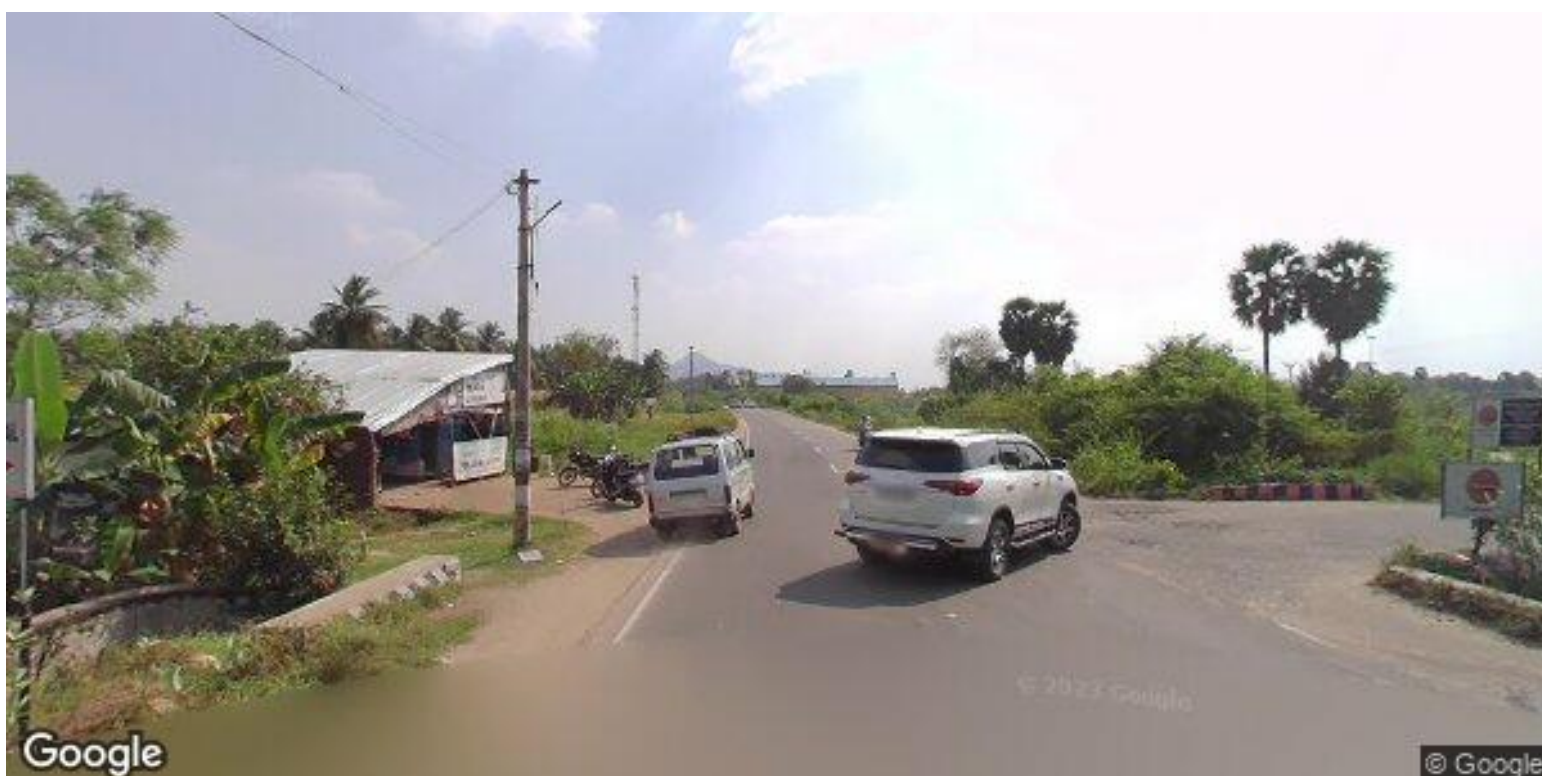
**Coordinates:** 11.44029, 77.87544

**Risk Type:** Turn

**Risk Level:** High

**Speed Limit:** 15 KM/Hr

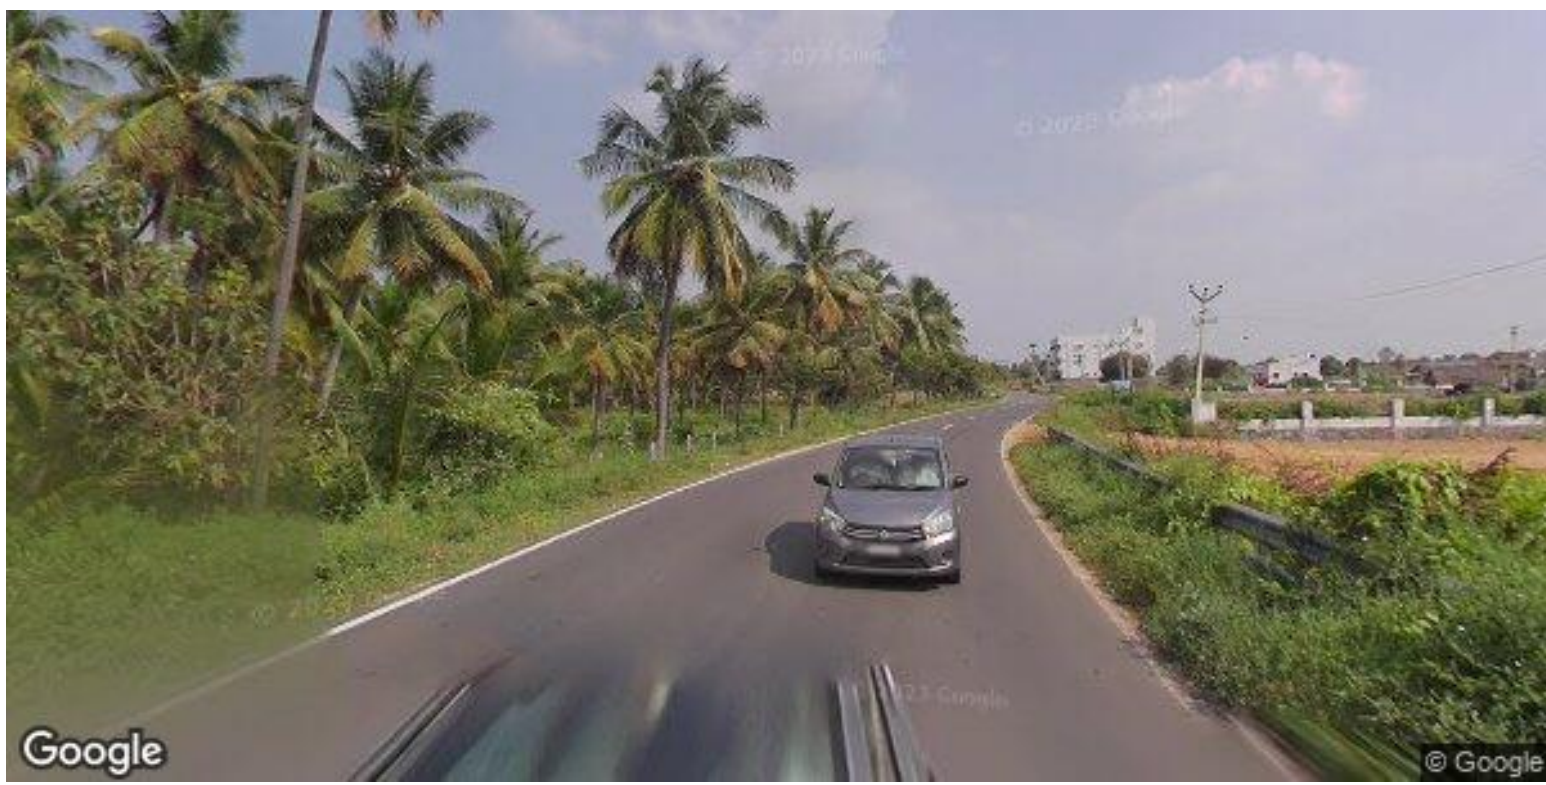
**Coordinates:** 11.45357, 77.85789

**Risk Type:** Turn

**Risk Level:** Medium

**Speed Limit:** 30 KM/Hr

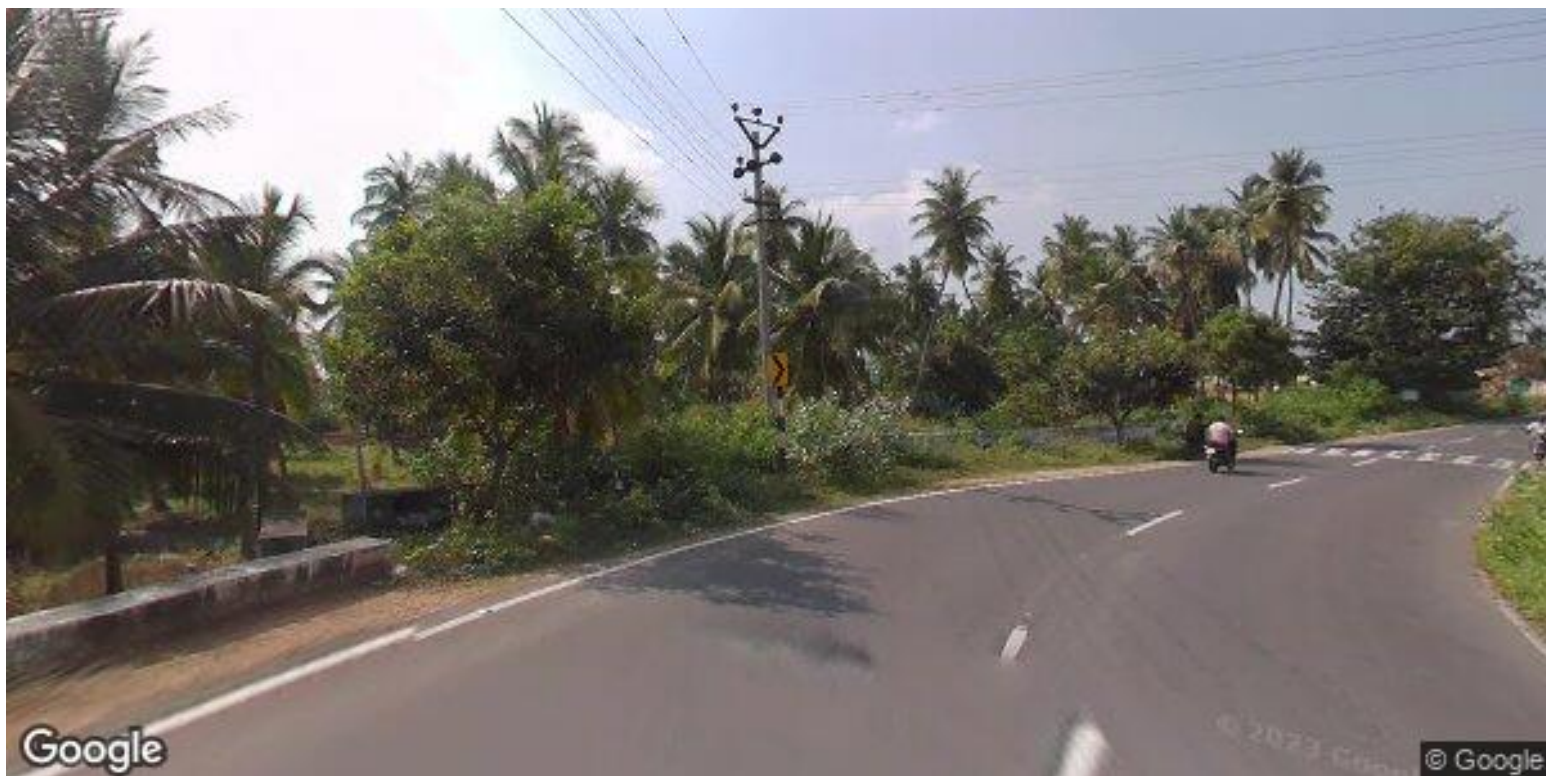
**Coordinates:** 11.45348, 77.85706

**Risk Type:** Turn

**Risk Level:** Medium

**Speed Limit:** 30 KM/Hr

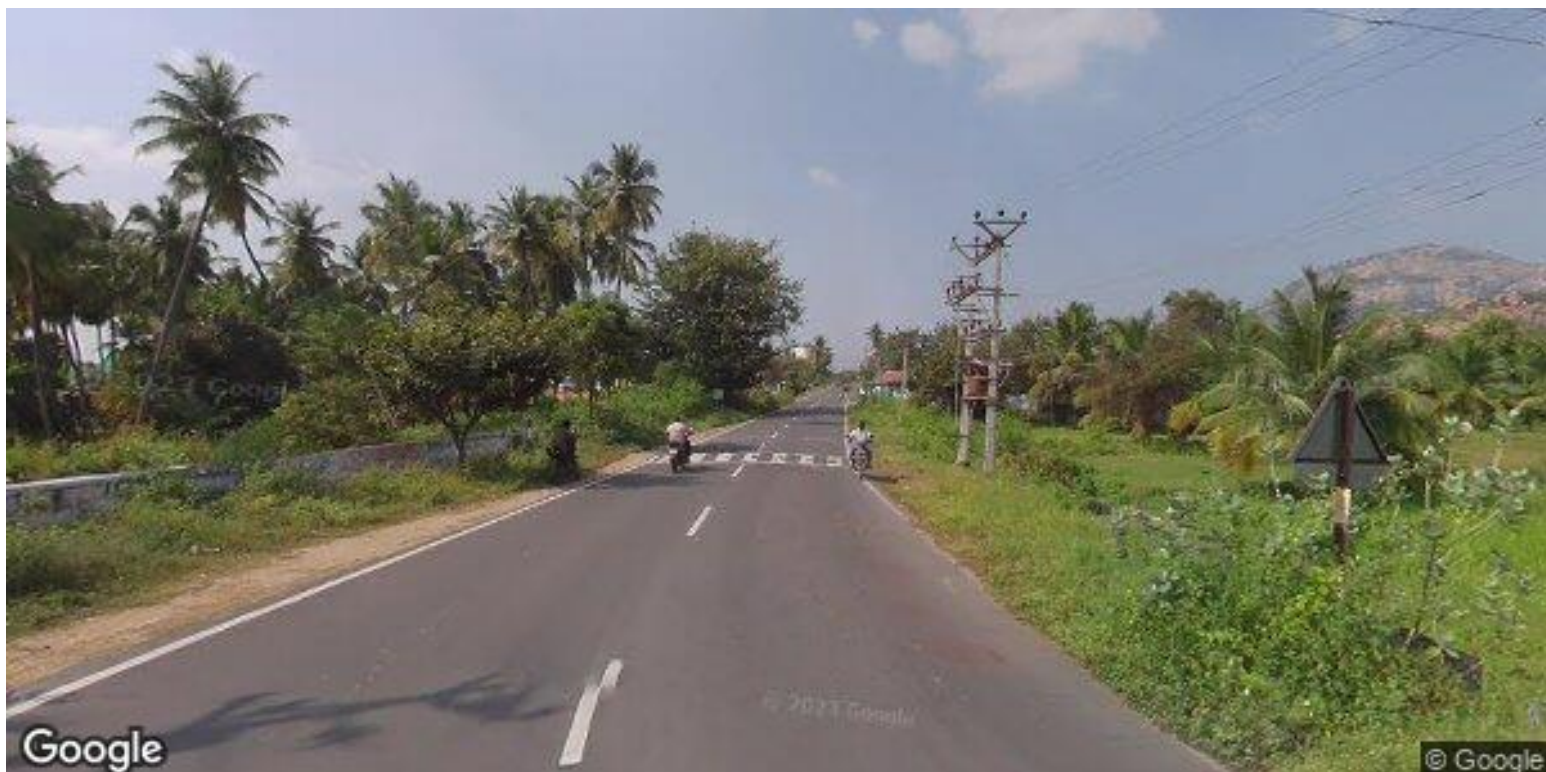
**Risk Type:** Turn  
**Risk Level:** Medium  
**Speed Limit:** 30 KM/Hr  
**Coordinates:** 11.45352, 77.85698

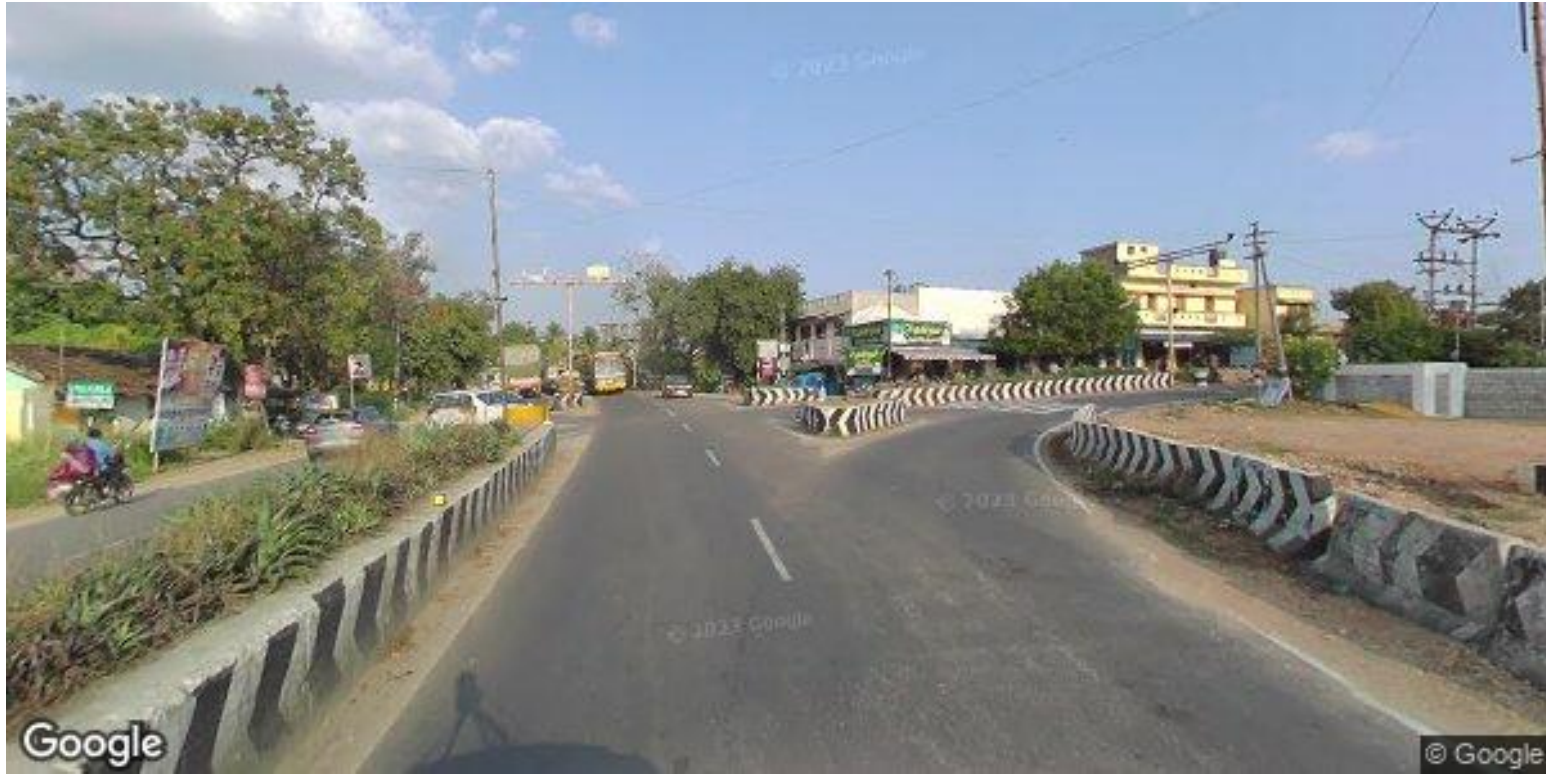
**Risk Type:** Turn  
**Risk Level:** Medium  
**Speed Limit:** 30 KM/Hr  
**Coordinates:** 11.46318, 77.84913

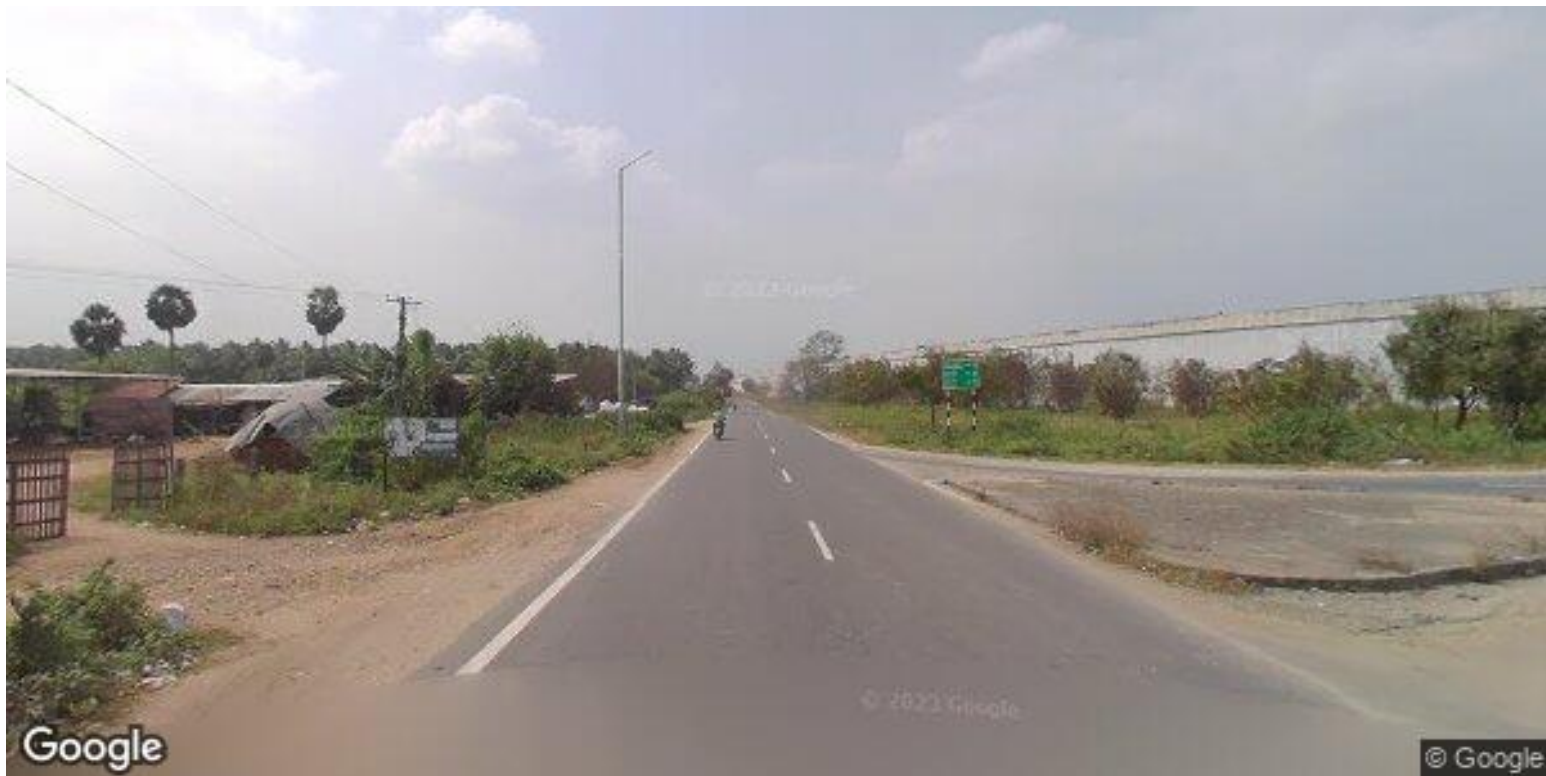
**Risk Type:** Turn  
**Risk Level:** High  
**Speed Limit:** 15 KM/Hr  
**Coordinates:** 11.45542, 77.81725

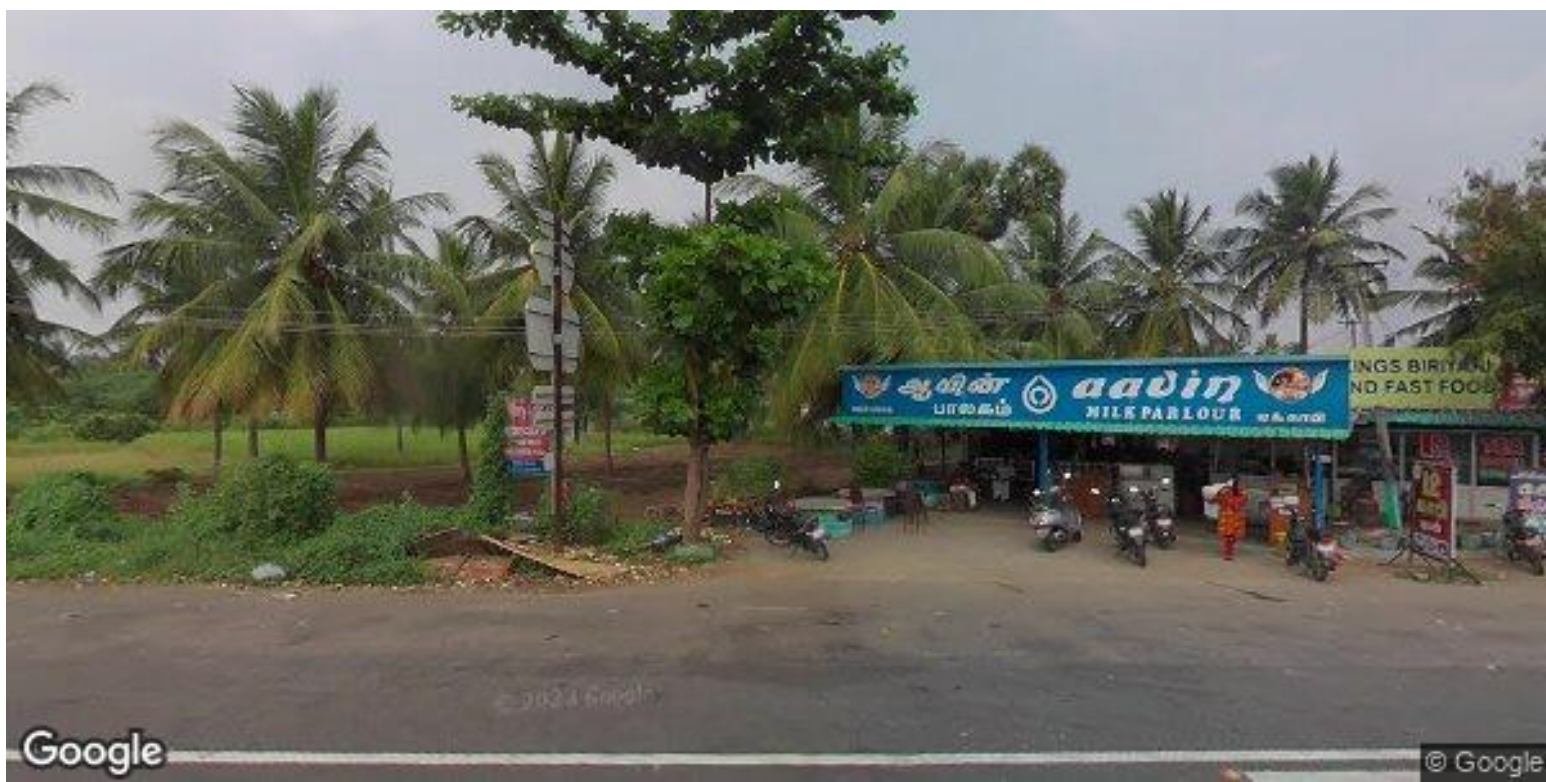
**Coordinates:** 11.45631, 77.81668

**Risk Type:** Turn

**Risk Level:** High

**Speed Limit:** 15 KM/Hr

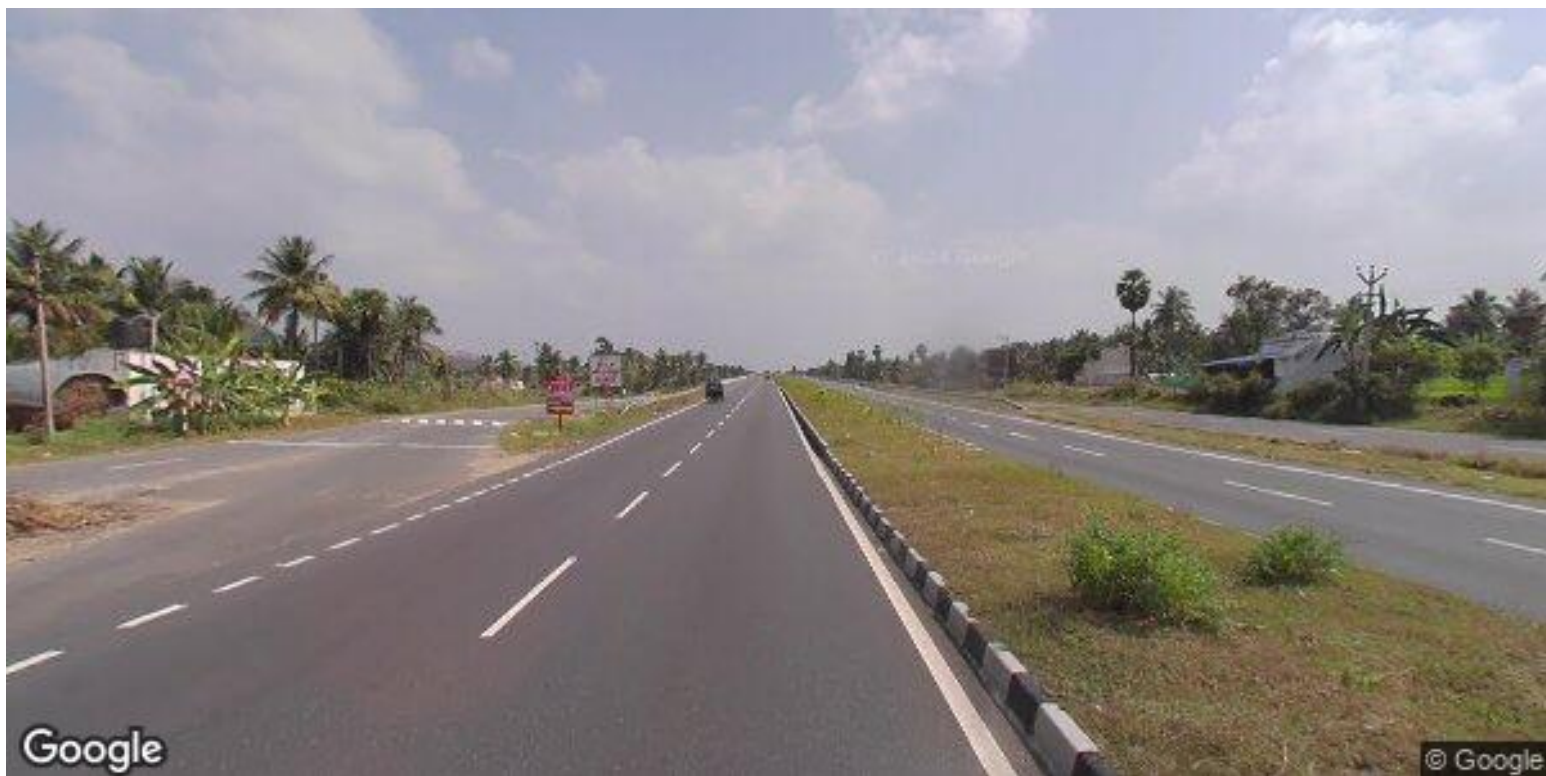
**Coordinates:** 11.49249, 77.85820

**Risk Type:** Turn

**Risk Level:** Medium

**Speed Limit:** 30 KM/Hr

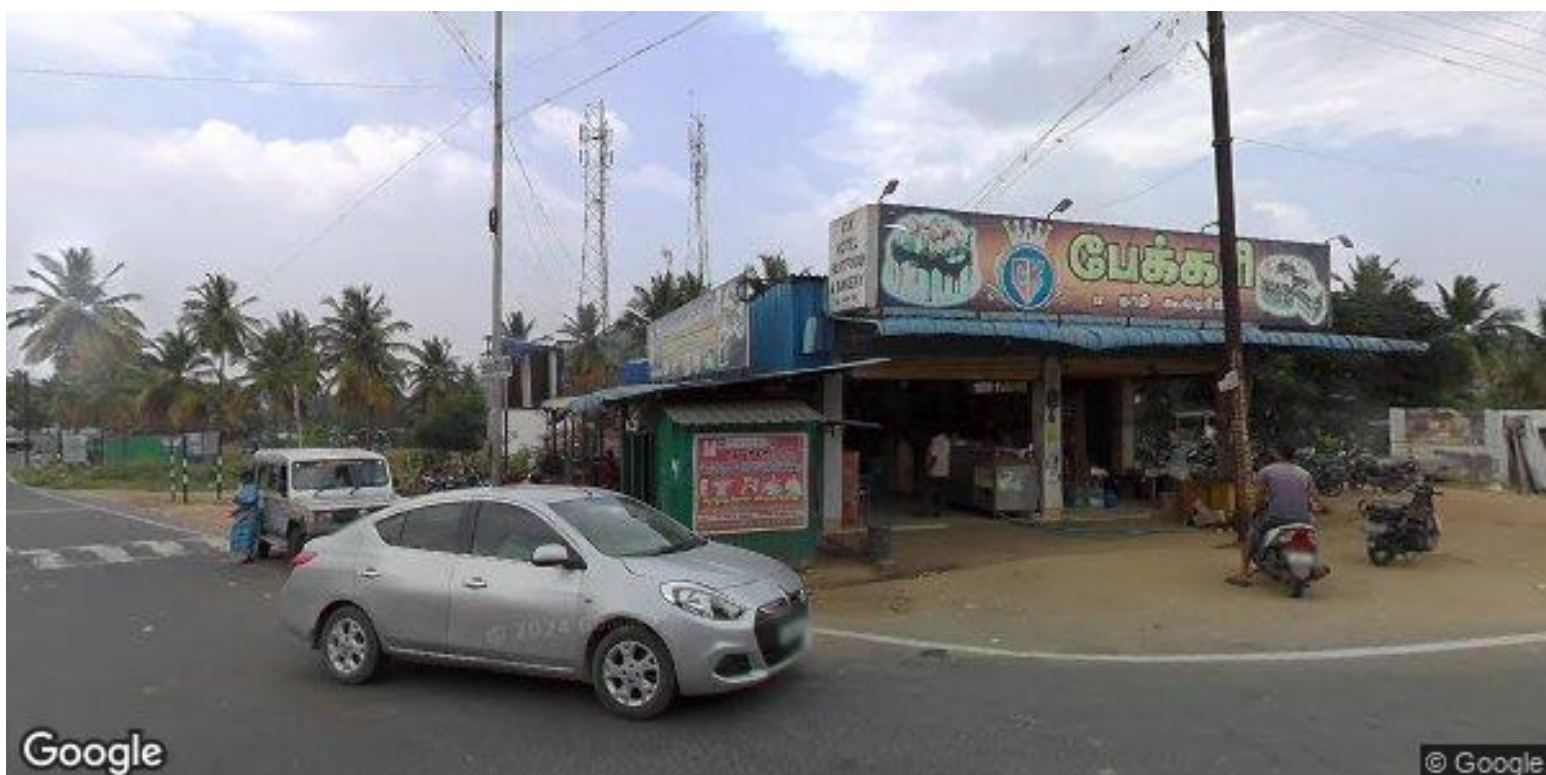
**Risk Type:** Blind Spot  
**Risk Level:** Blind Spot  
**Speed Limit:** 10 KM/Hr  
**Coordinates:** 11.49390, 77.86748

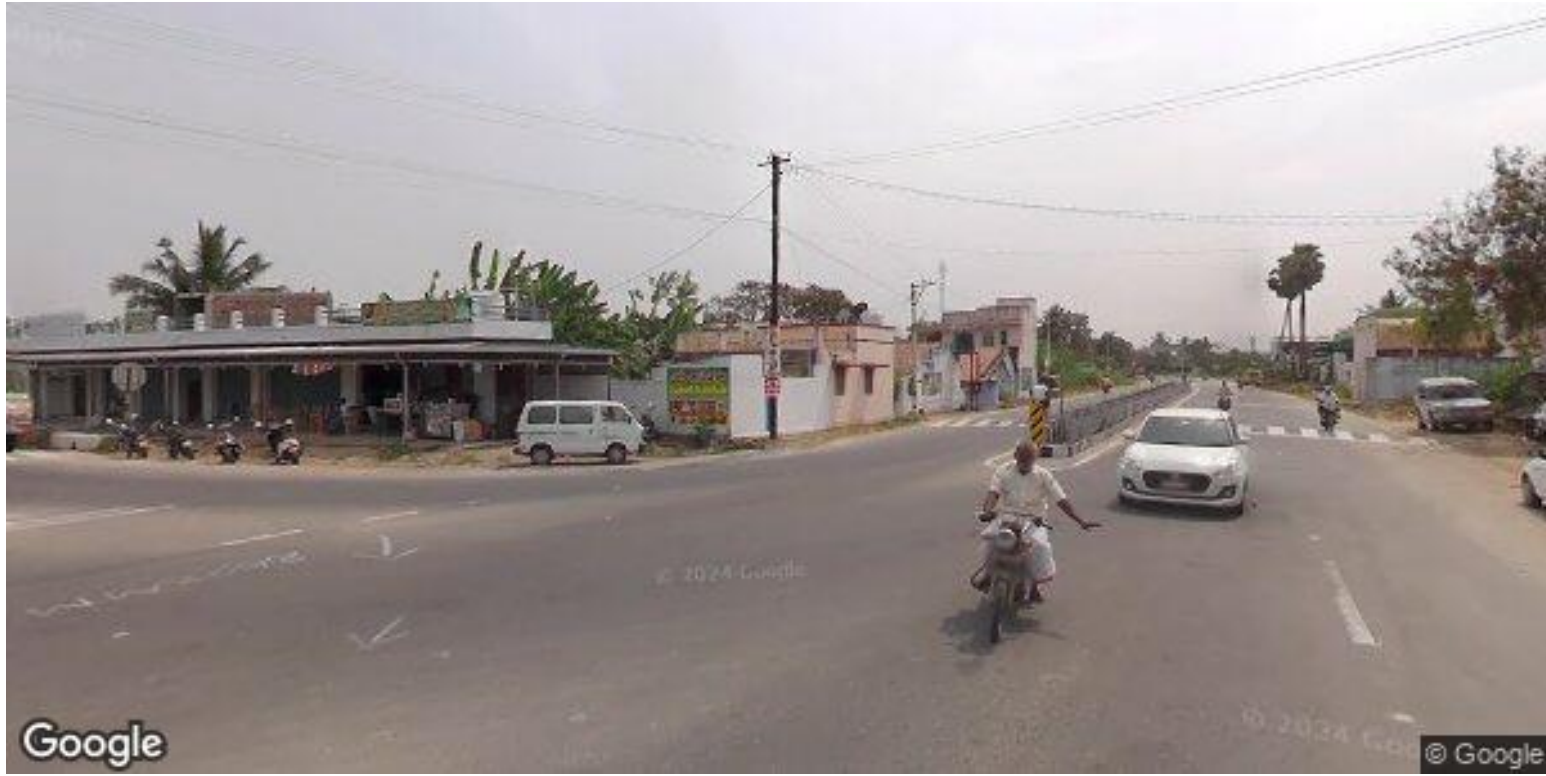
**Risk Type:** Turn  
**Risk Level:** High  
**Speed Limit:** 15 KM/Hr  
**Coordinates:** 11.57903, 77.85432
