## **JOURNEY RISK MANAGEMENT (JRM) STUDY**

### **Salem Terminal To SPK PETROLEUM**

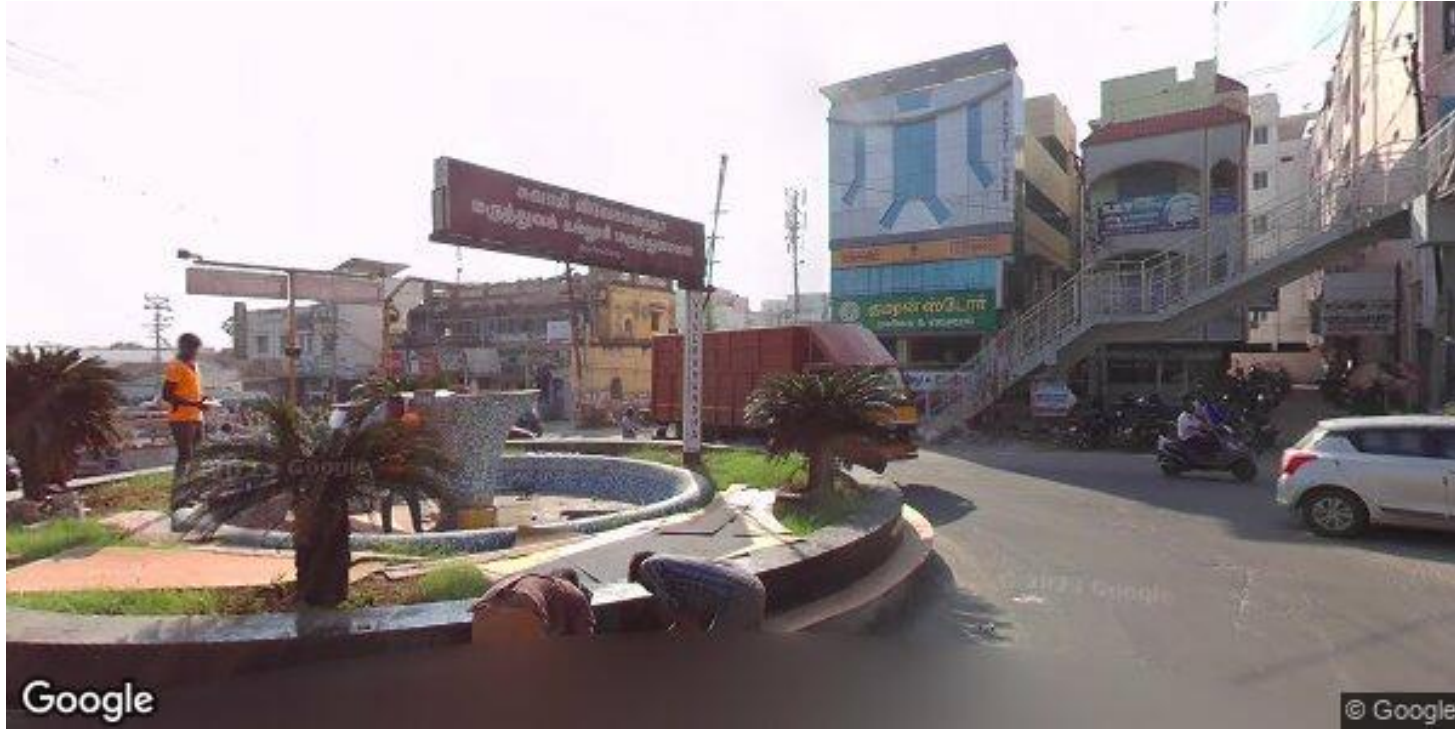
**Coordinates:** 11.38395, 77.89480

**Risk Type:** Roundabout

**Risk Level:** High

**Speed Limit:** 15 KM/Hr

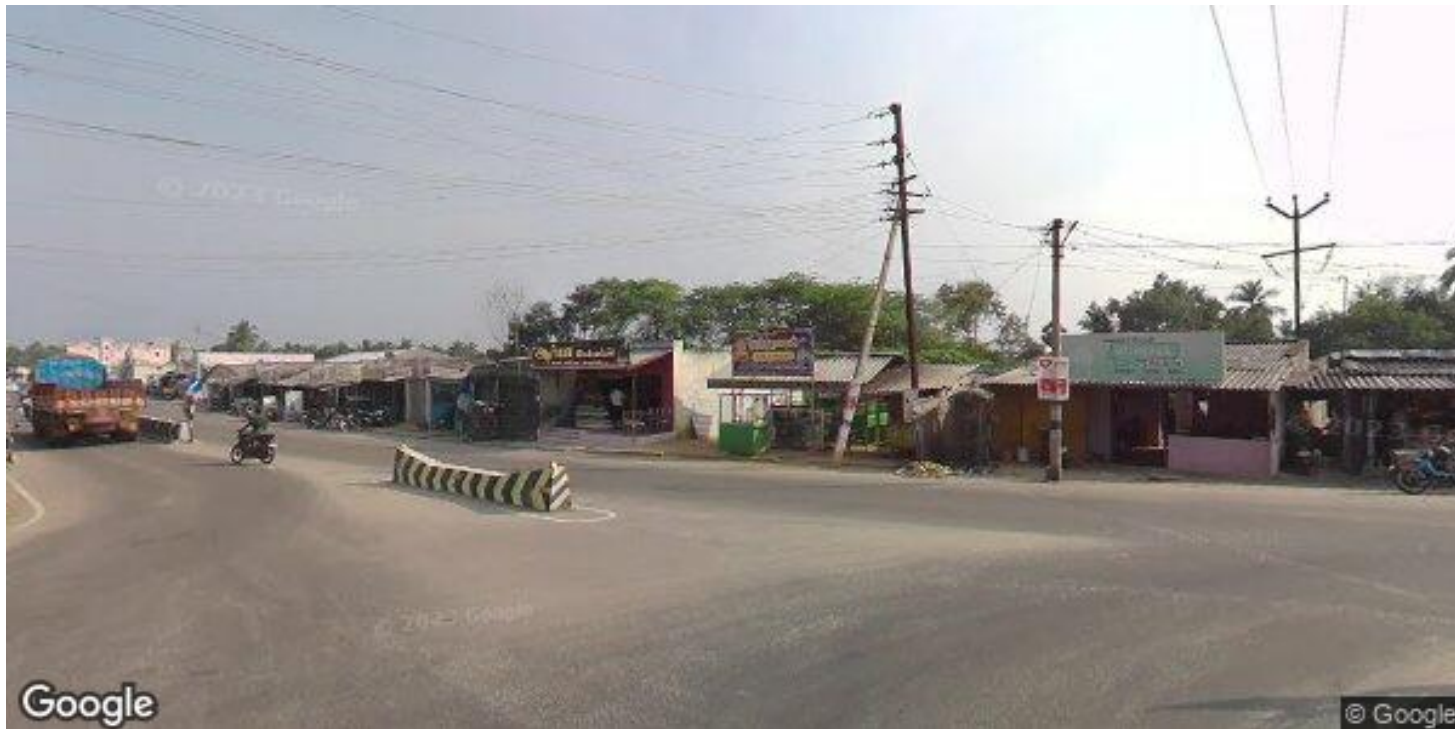
**Risk Type:** Roundabout  
**Risk Level:** High  
**Speed Limit:** 15 KM/Hr  
**Coordinates:** 11.04637, 77.73761

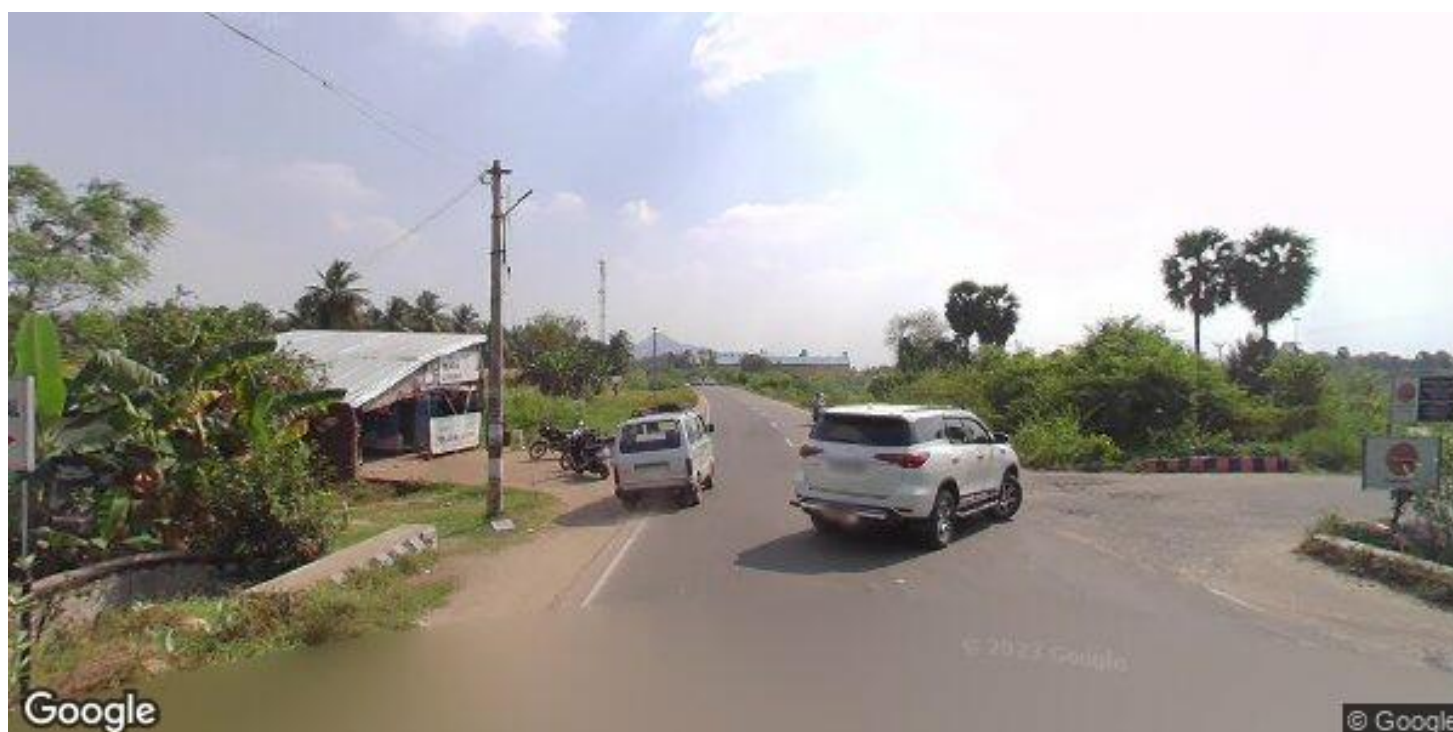
**Risk Type:** Turn  
**Risk Level:** High  
**Speed Limit:** 15 KM/Hr  
**Coordinates:** 11.44029, 77.87544

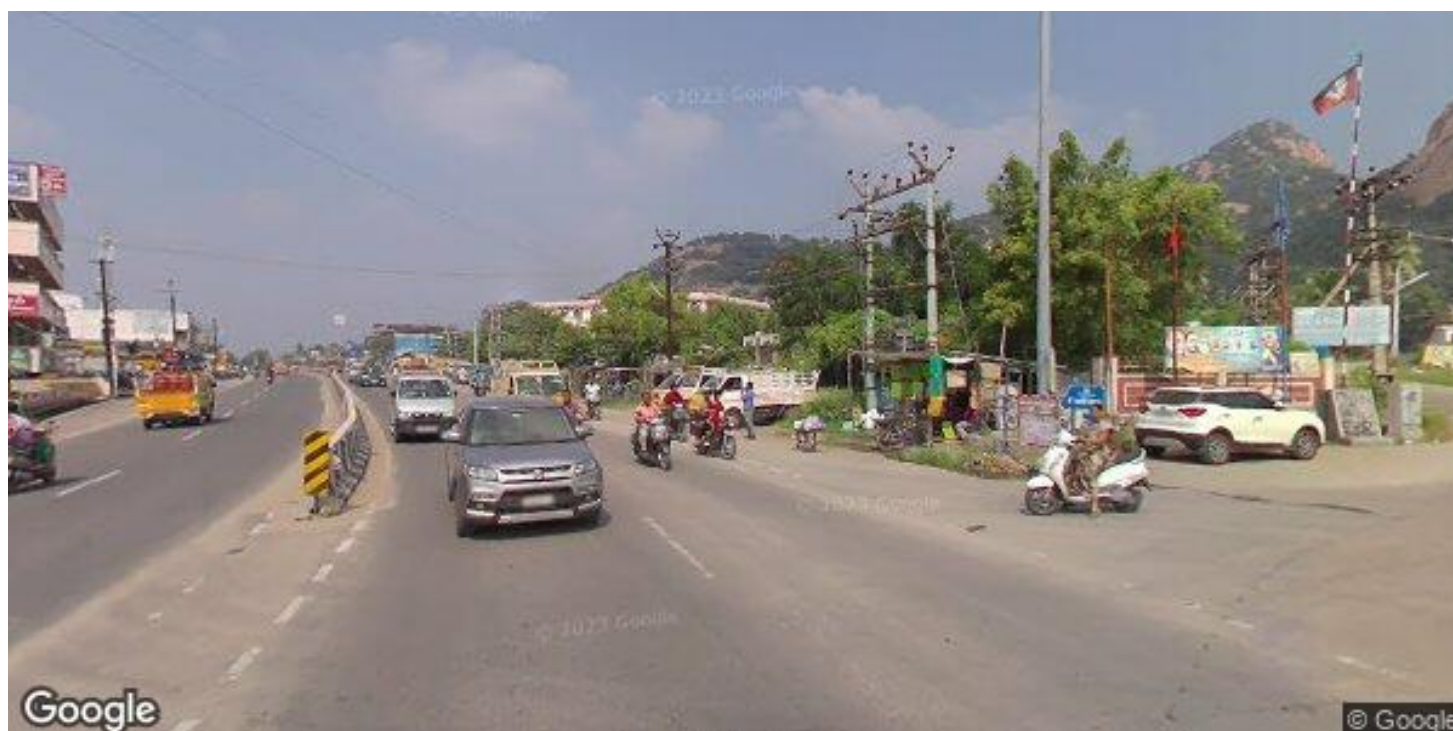
**Risk Type:** Turn  
**Risk Level:** Medium  
**Speed Limit:** 30 KM/Hr  
**Coordinates:** 11.39671, 77.88878

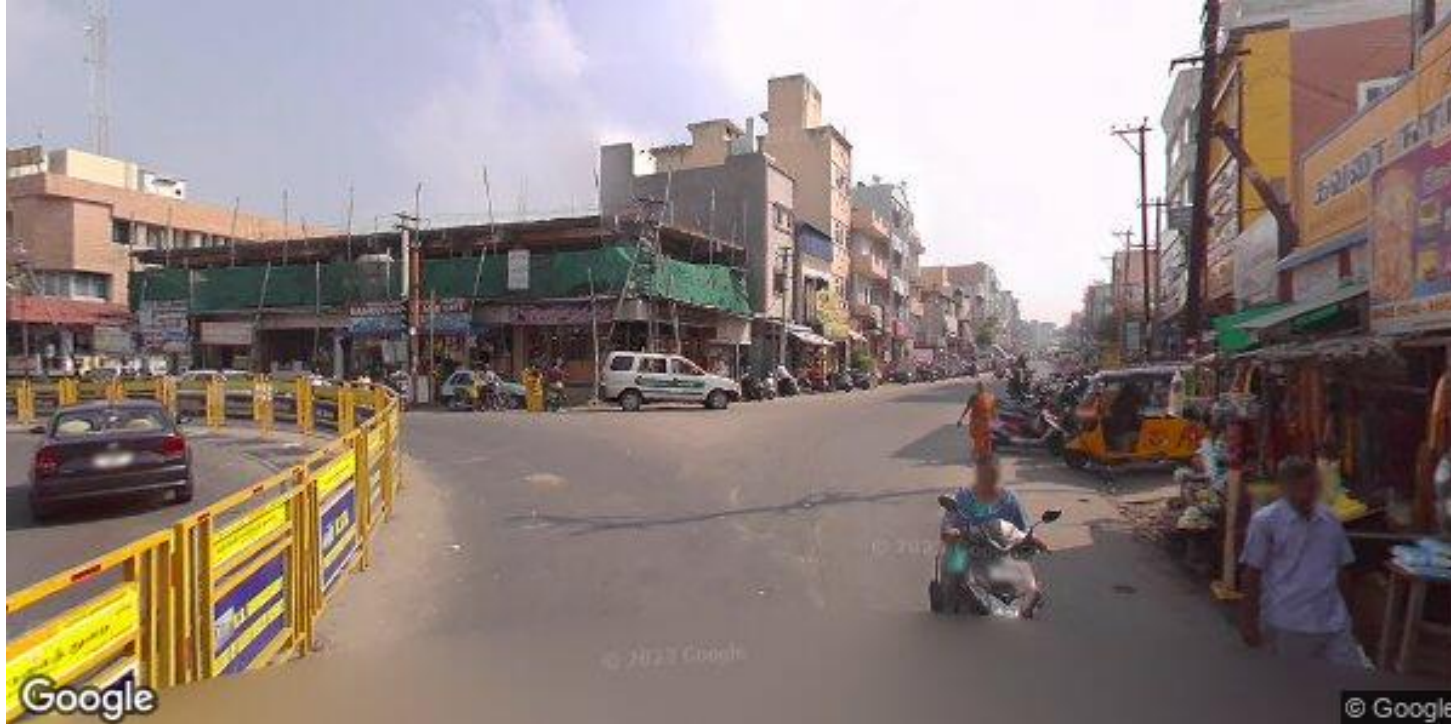
**Coordinates:** 11.37862, 77.89488

**Risk Type:** Turn

**Risk Level:** High

**Speed Limit:** 15 KM/Hr

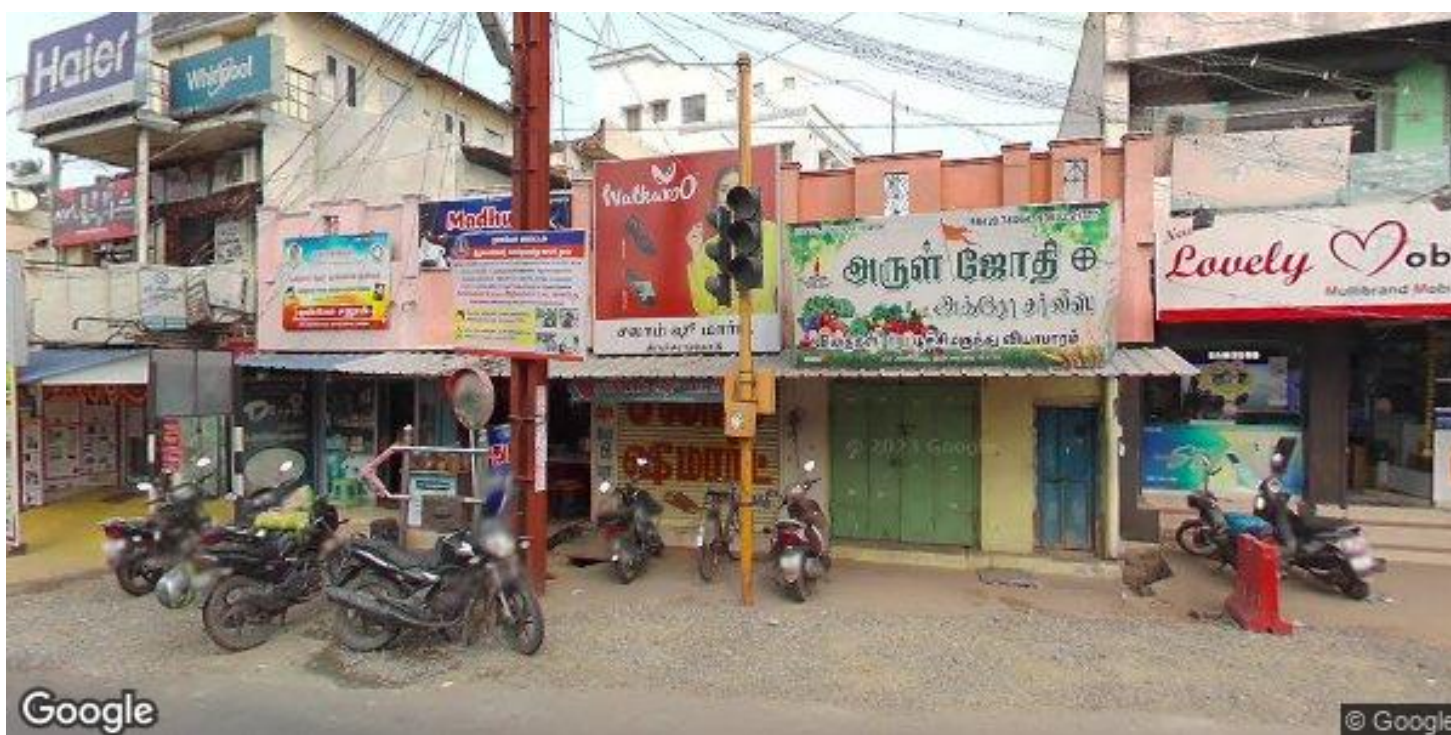
**Coordinates:** 11.37850, 77.89453

**Risk Type:** Turn

**Risk Level:** High

**Speed Limit:** 15 KM/Hr

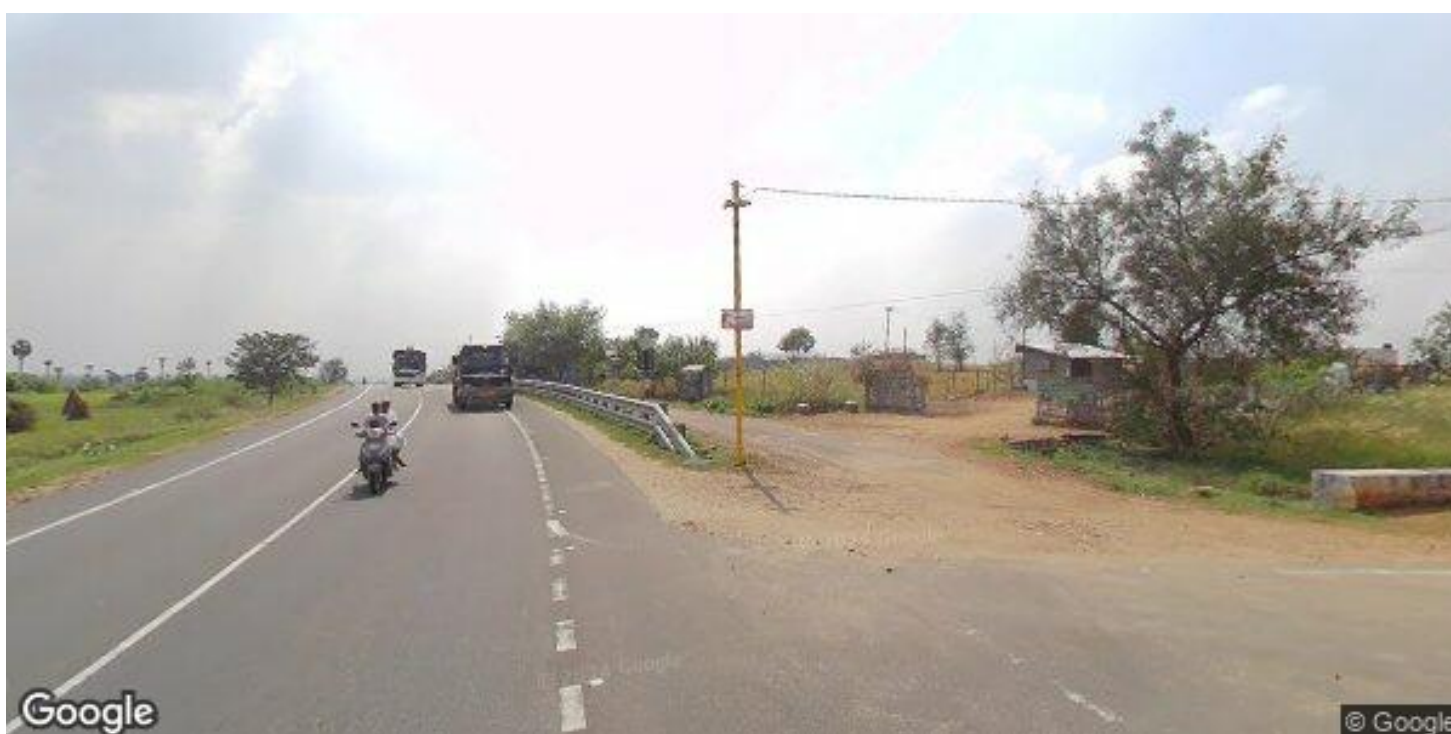
**Coordinates: 11.34151, 77.90137**

**Risk Type:** Turn

**Risk Level:** Medium

**Speed Limit: 30 KM/Hr**

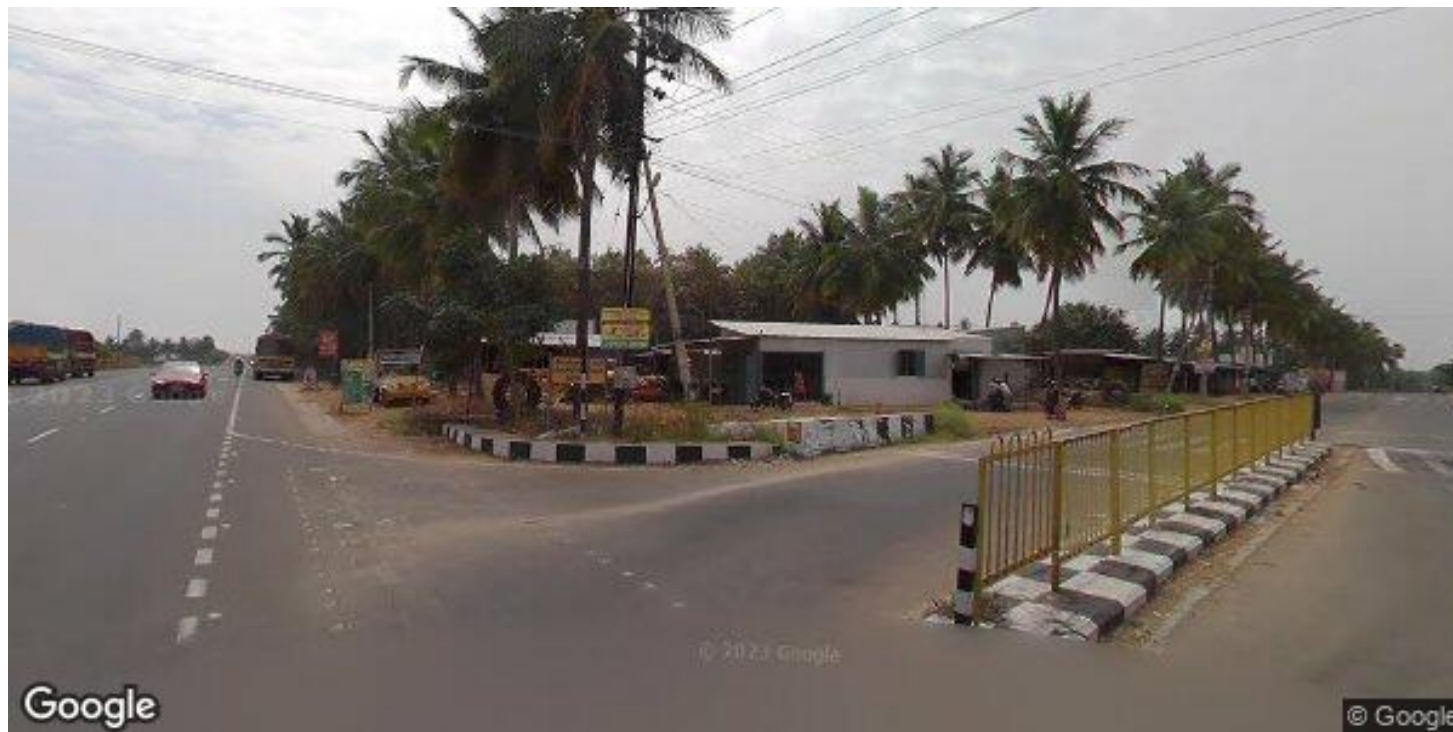
**Coordinates: 11.30859, 77.92918**

**Risk Type: Turn**

**Risk Level: High**

**Speed Limit: 15 KM/Hr**

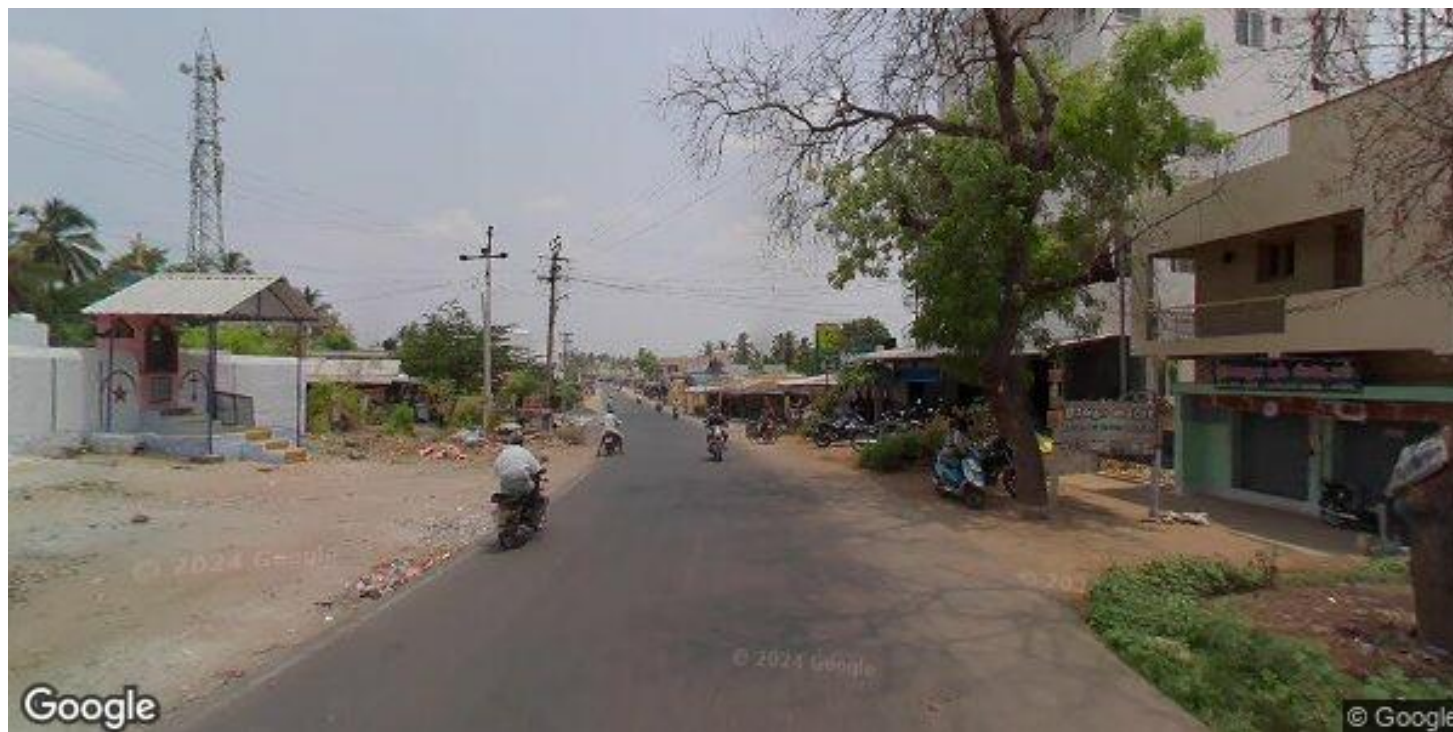
**Coordinates: 11.24421, 77.87541**

**Risk Type: Turn**

**Risk Level: Medium**

**Speed Limit: 30 KM/Hr**

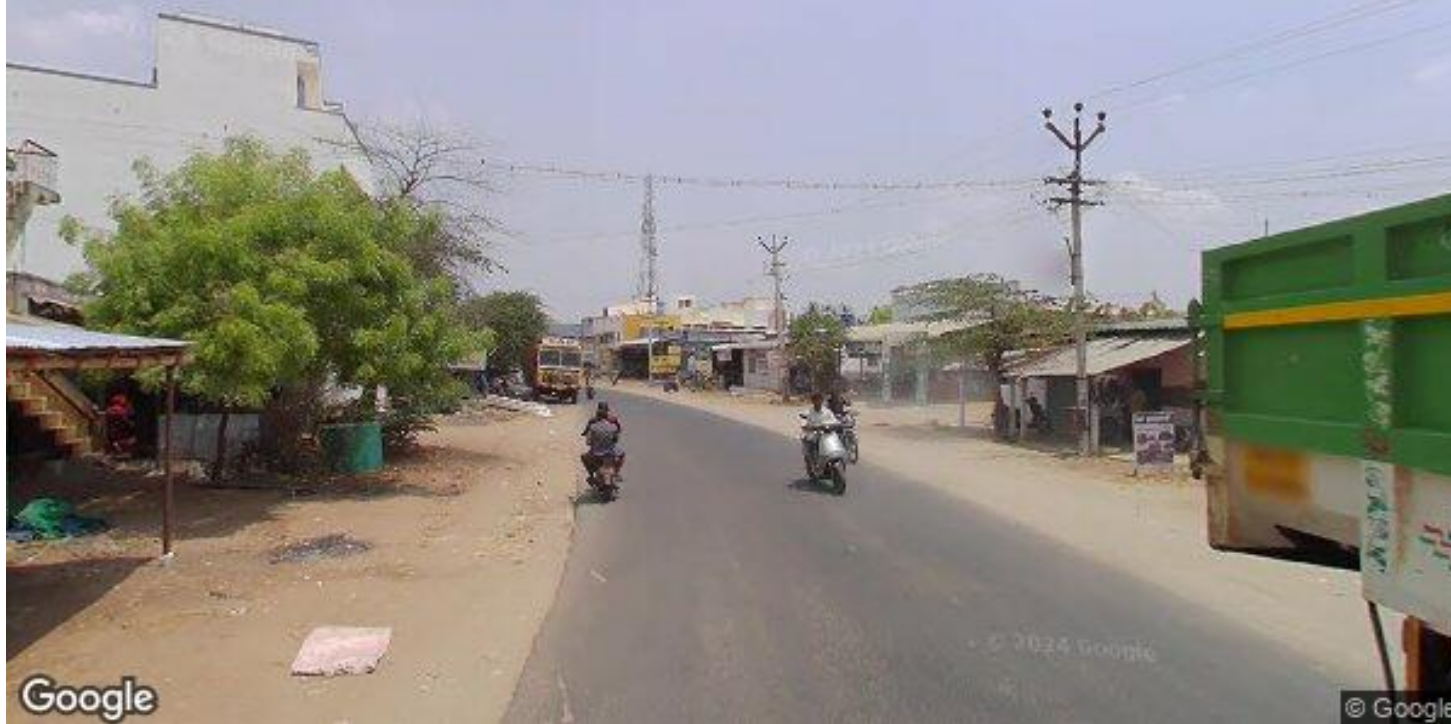
**Coordinates:** 11.24192, 77.87363

**Risk Type:** Turn

**Risk Level:** Medium

**Speed Limit:** 30 KM/Hr

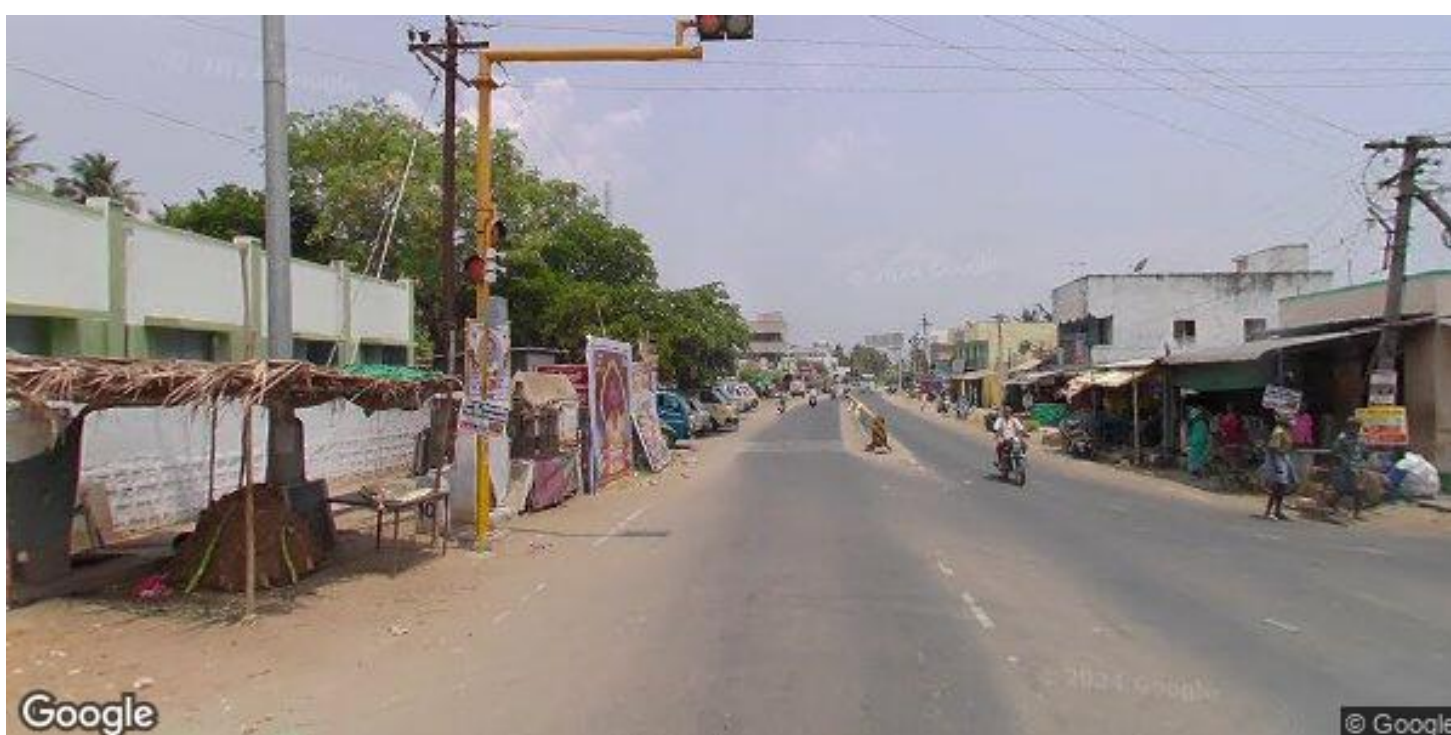
**Coordinates:** 11.24001, 77.87368

**Risk Type:** Turn

**Risk Level:** High

**Speed Limit:** 15 KM/Hr

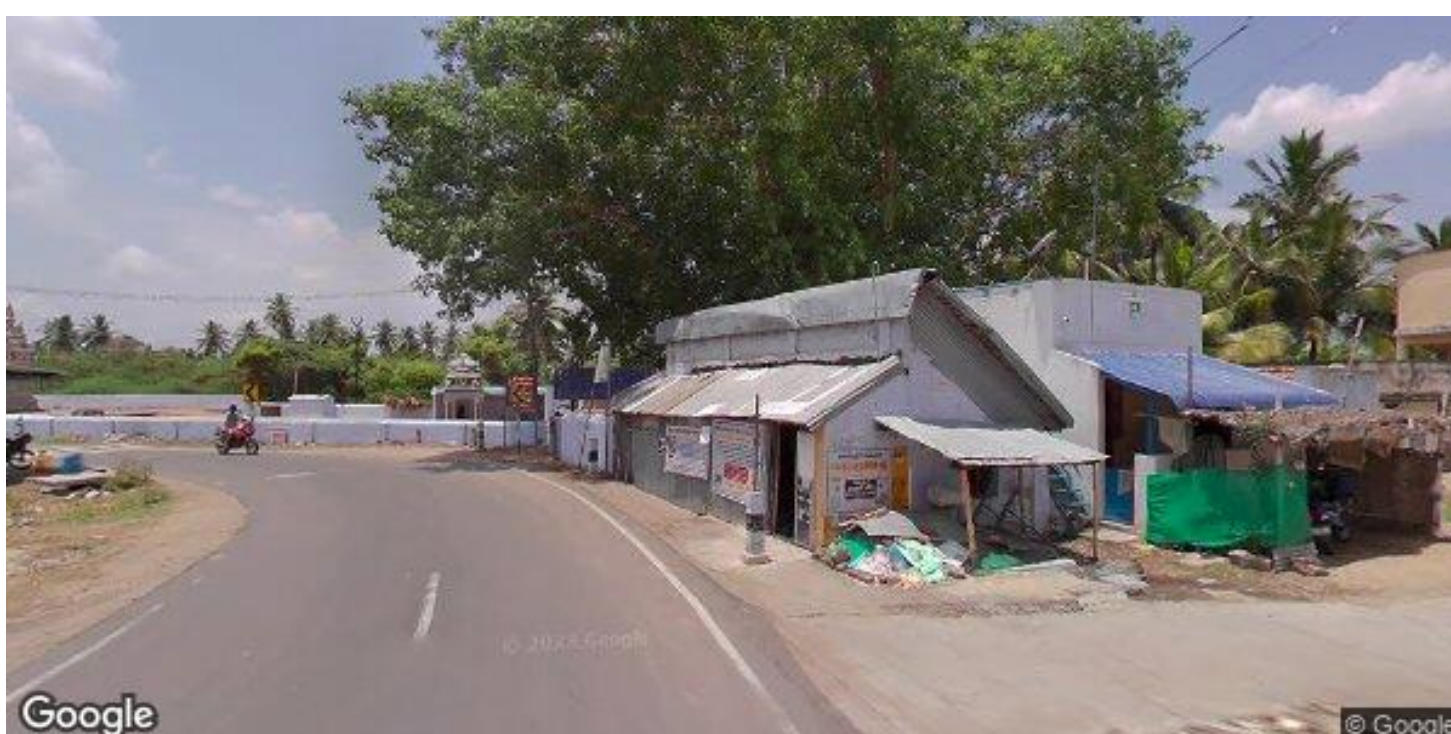
**Coordinates: 11.24061, 77.86899**

**Risk Type:** Turn

**Risk Level:** High

**Speed Limit: 15 KM/Hr**

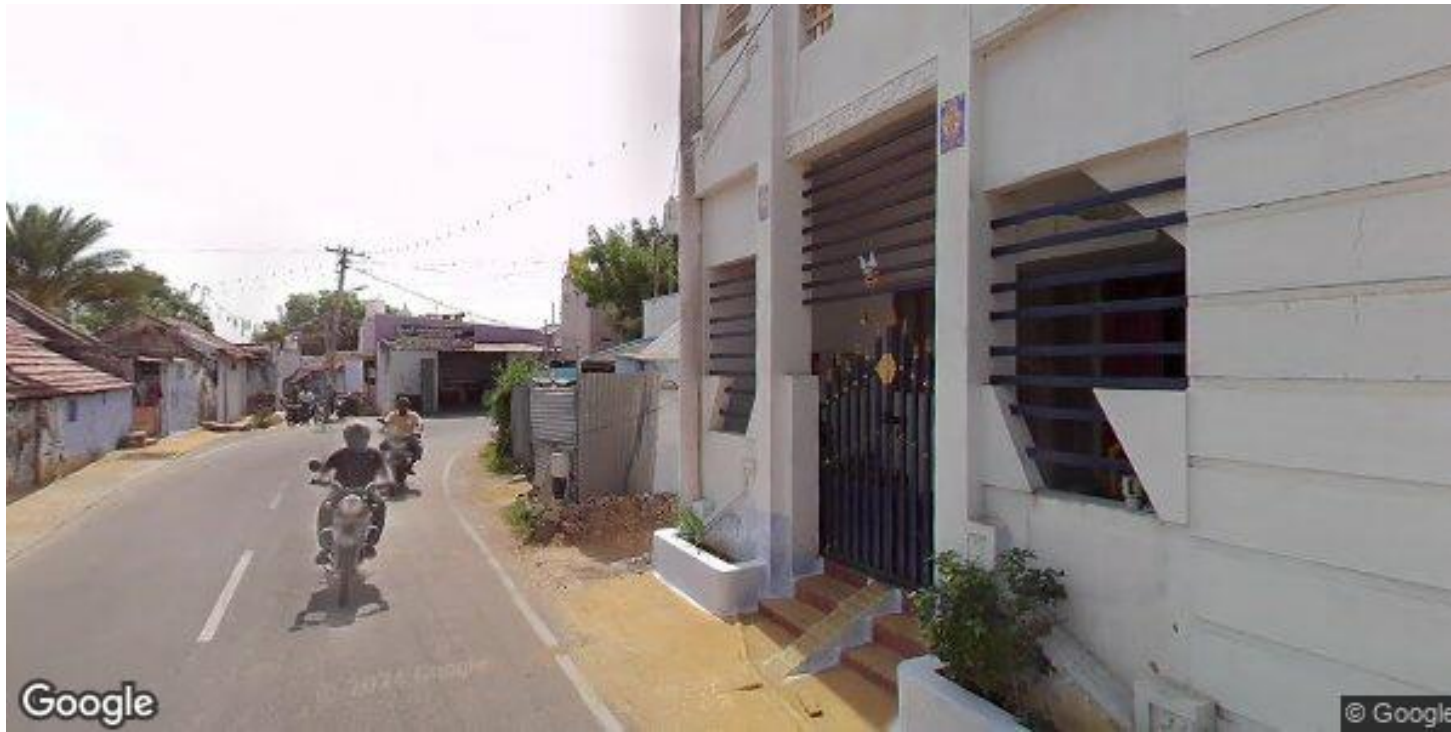
**Coordinates: 11.24157, 77.86876**

**Risk Type: Turn**

**Risk Level: High**

**Speed Limit: 15 KM/Hr**

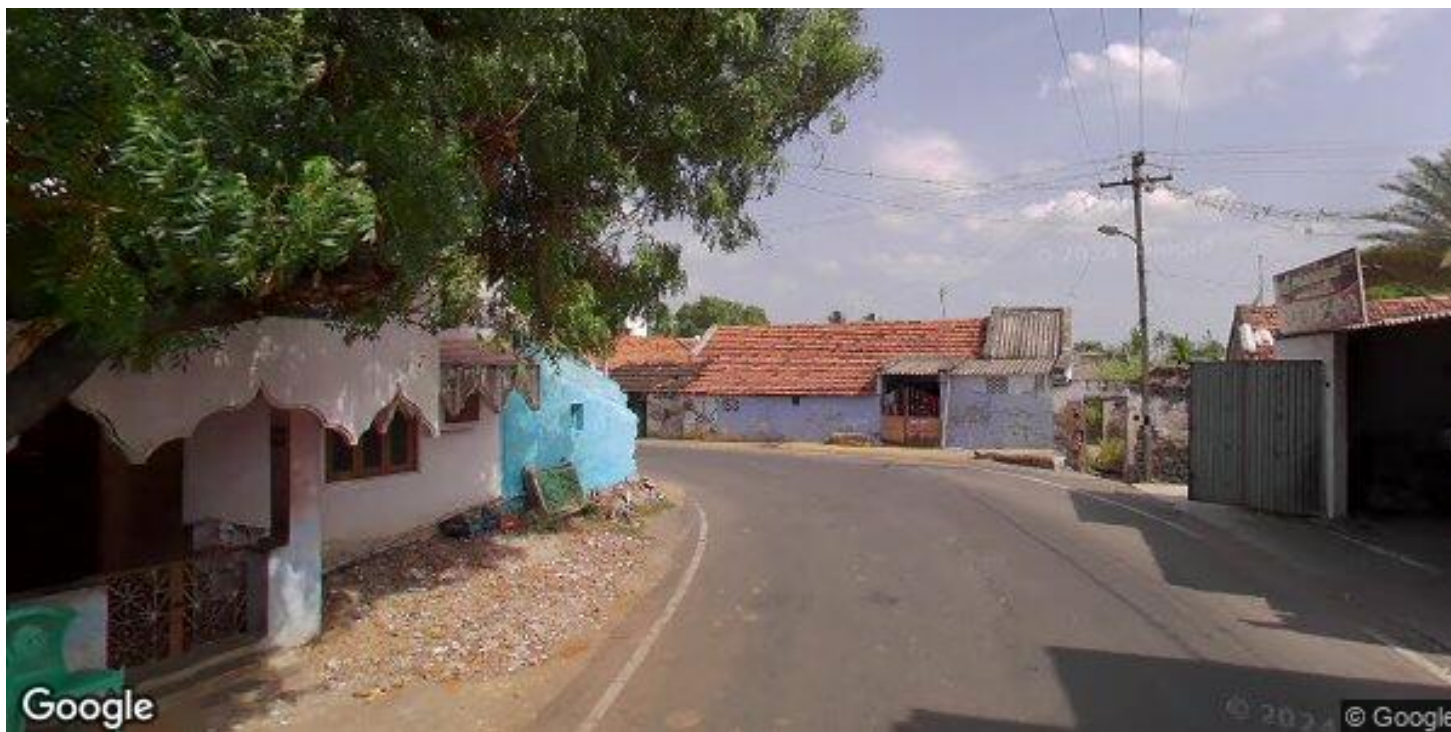
**Coordinates: 11.24167, 77.86843**

**Risk Type: Turn**

**Risk Level: High**

**Speed Limit: 15 KM/Hr**

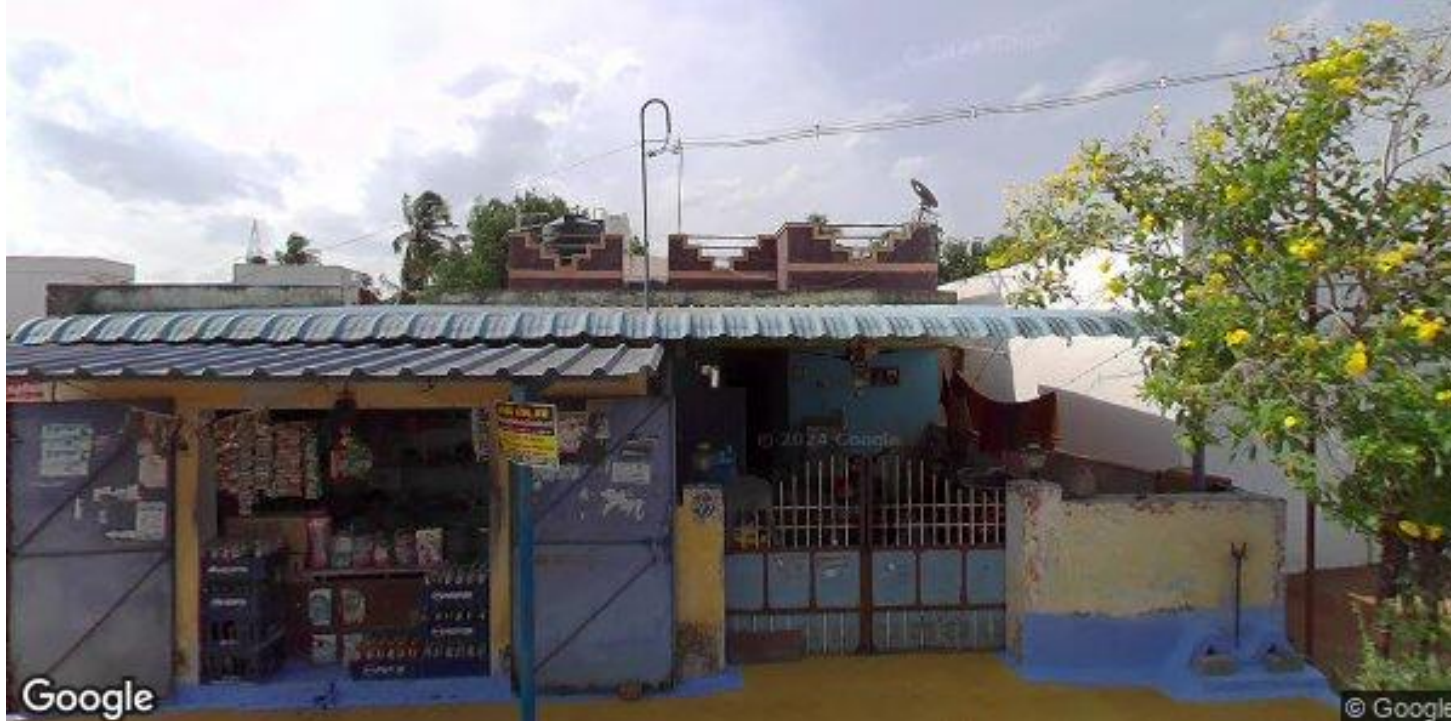
Coordinates: 11.24242, 77.86833

Risk Type: Turn

Risk Level: High

Speed Limit: 15 KM/Hr

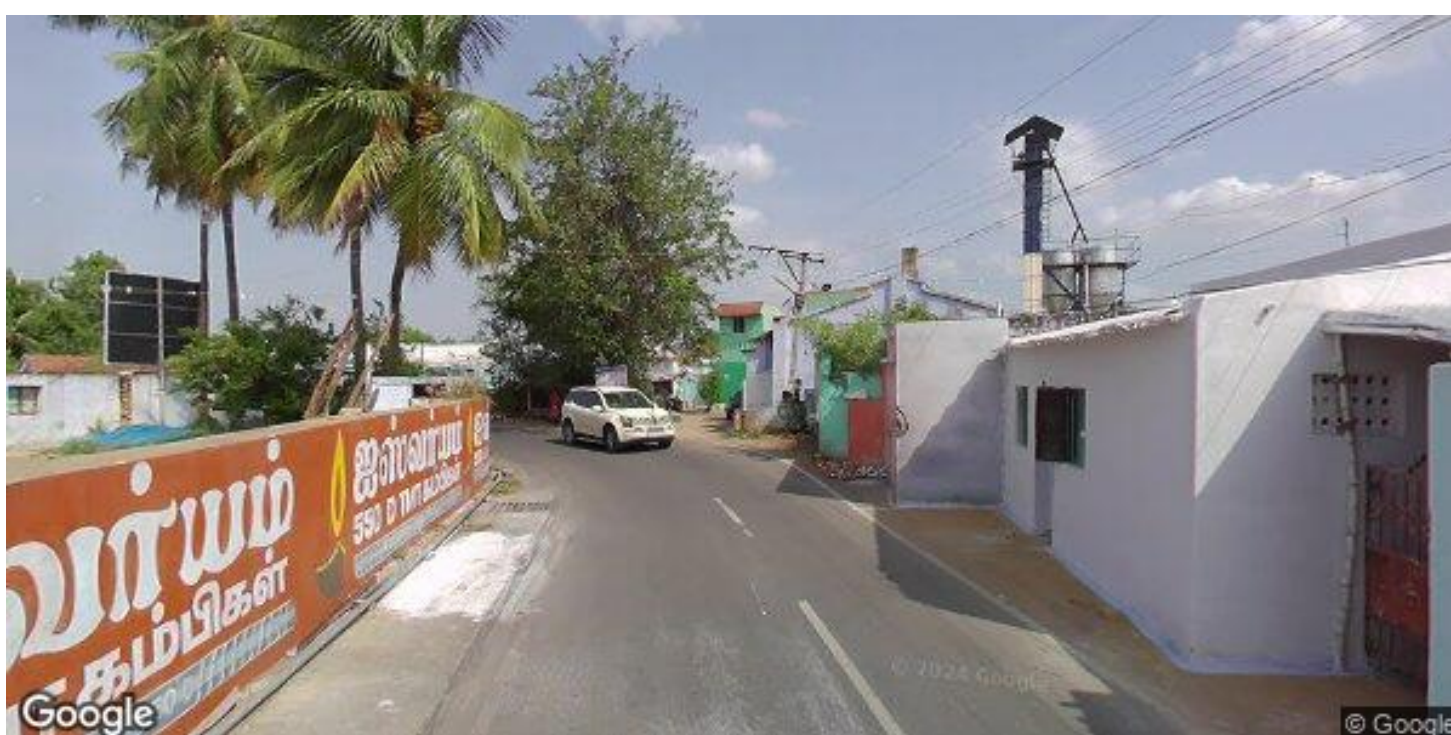
Coordinates: 11.24252, 77.86780

Risk Type: Turn

Risk Level: Medium

Speed Limit: 30 KM/Hr

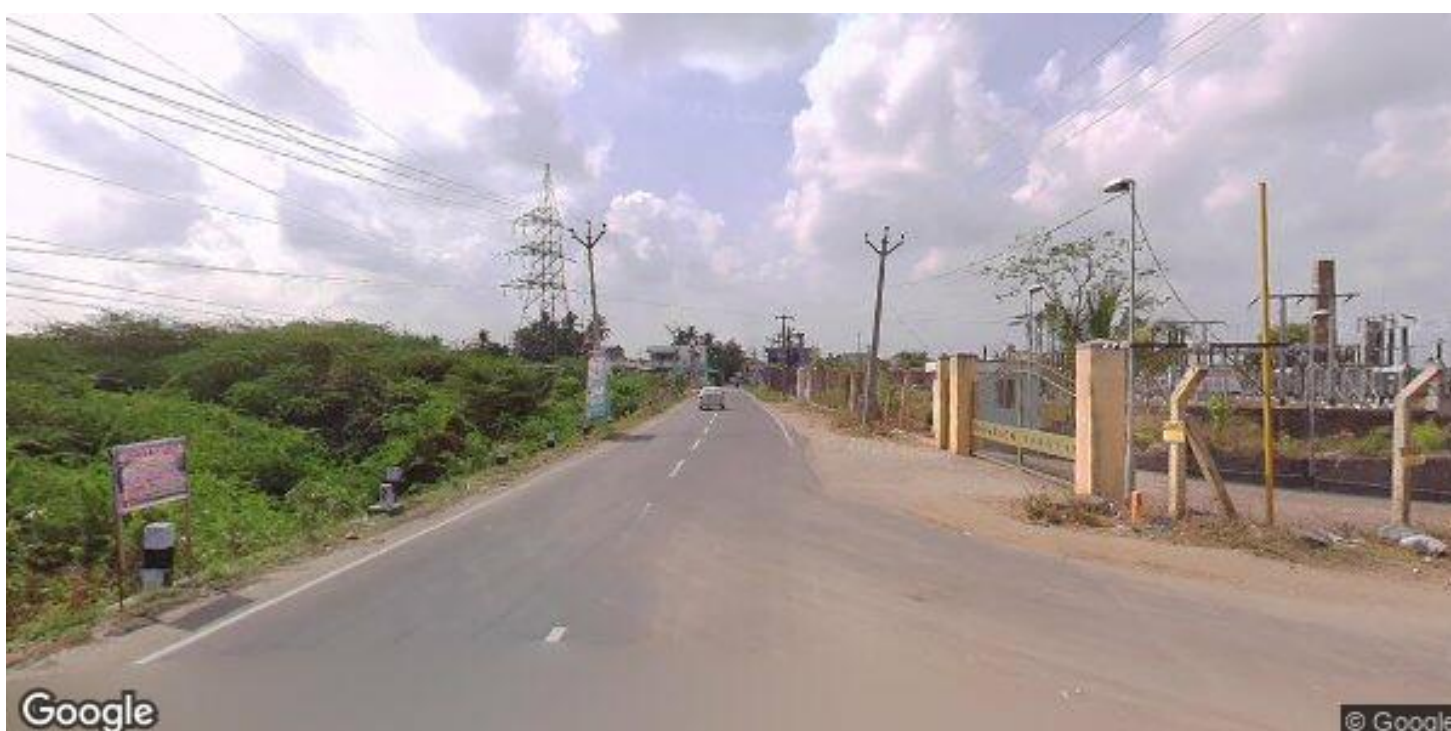
**Coordinates: 11.24384, 77.86689**

Risk Type: Blind Spot

Risk Level: Blind Spot

**Speed Limit: 10 KM/Hr**

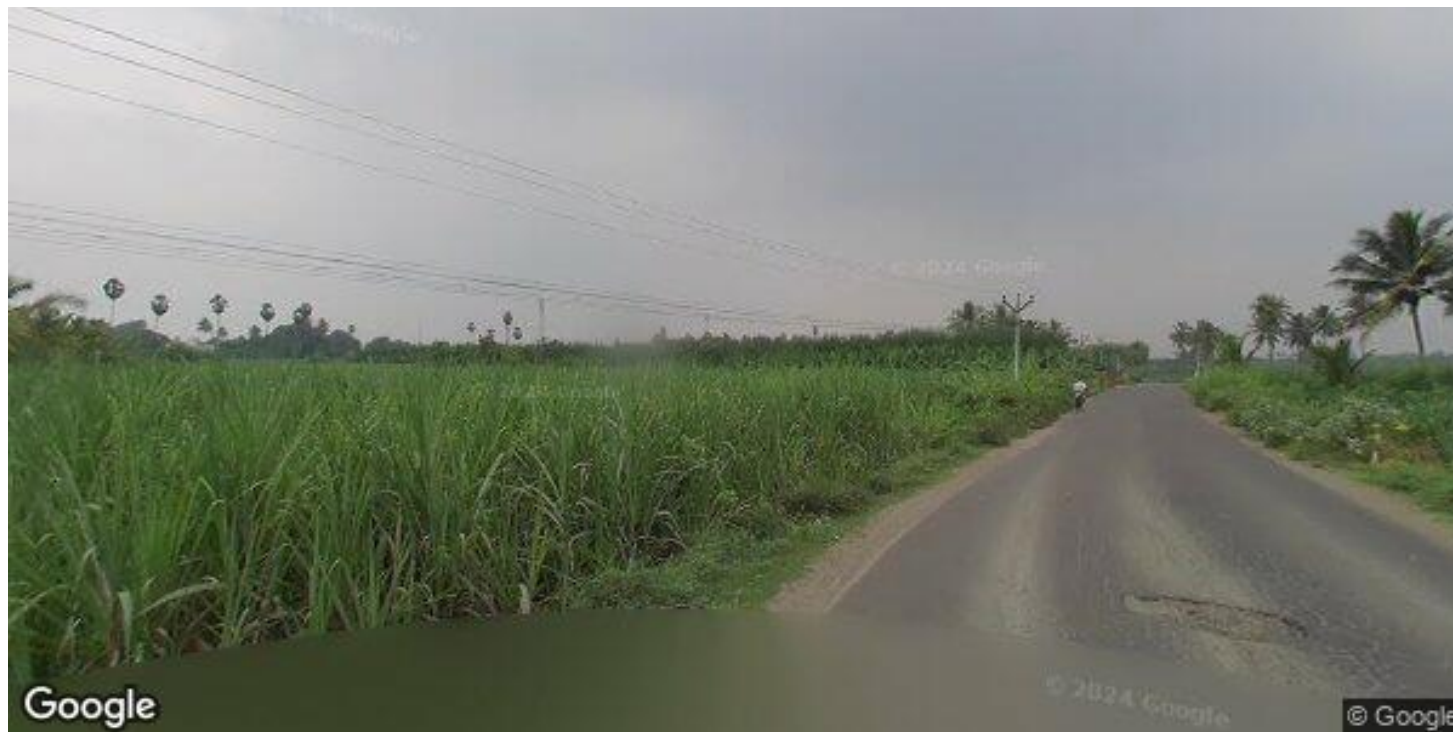
**Coordinates: 11.24101, 77.86023**

**Risk Type: Turn**

**Risk Level: High**

**Speed Limit: 15 KM/Hr**

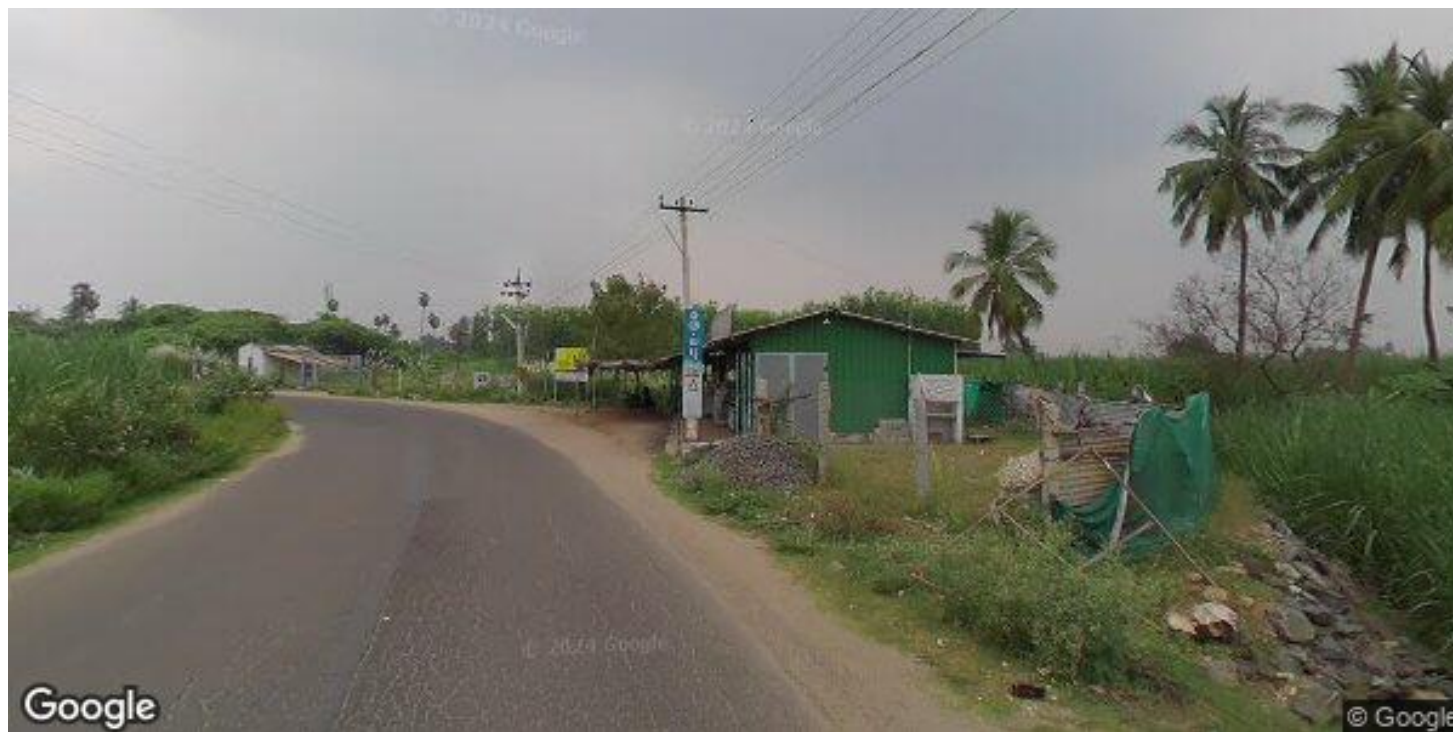
**Coordinates: 11.24198, 77.85893**

**Risk Type: Turn**

**Risk Level: Medium**

**Speed Limit: 30 KM/Hr**

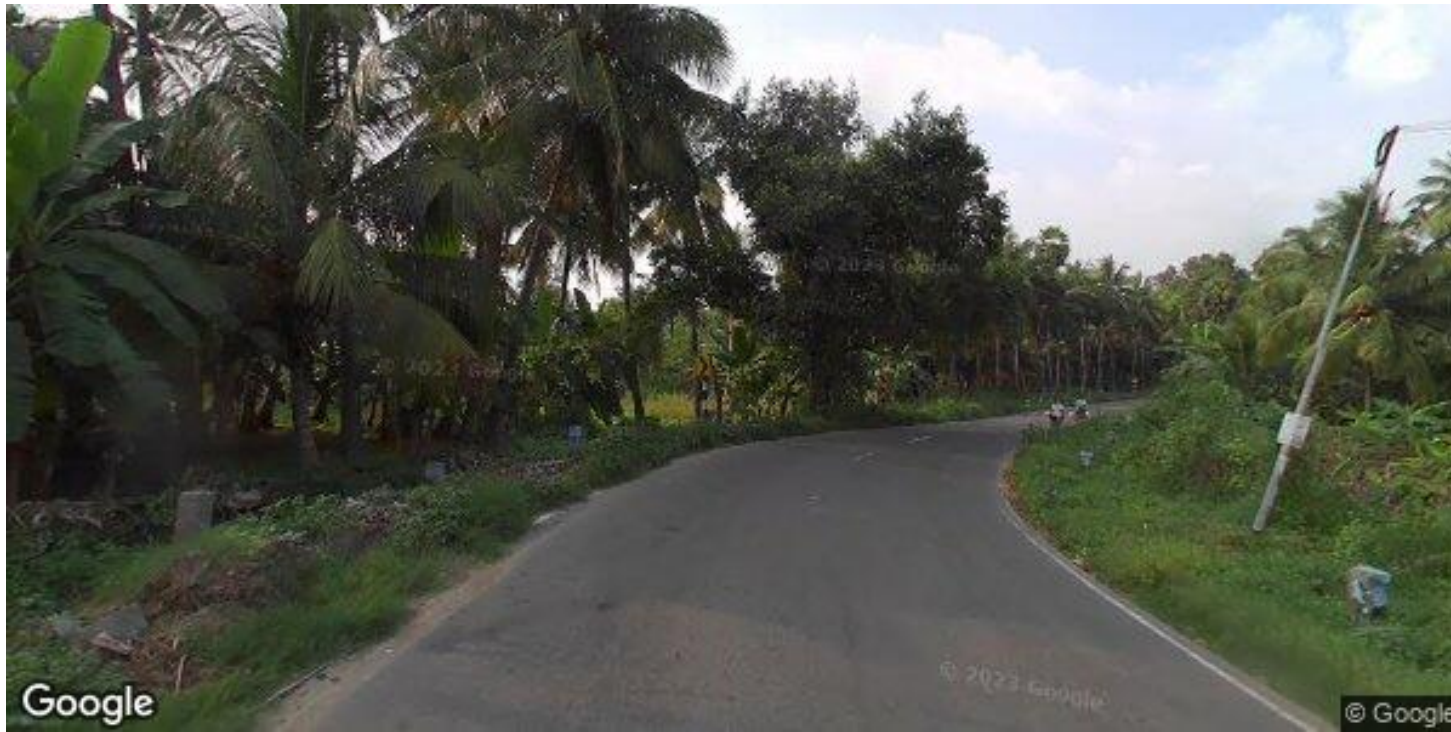
**Coordinates: 11.16407, 77.77376**

**Risk Type: Turn**

**Risk Level: Medium**

**Speed Limit: 30 KM/Hr**

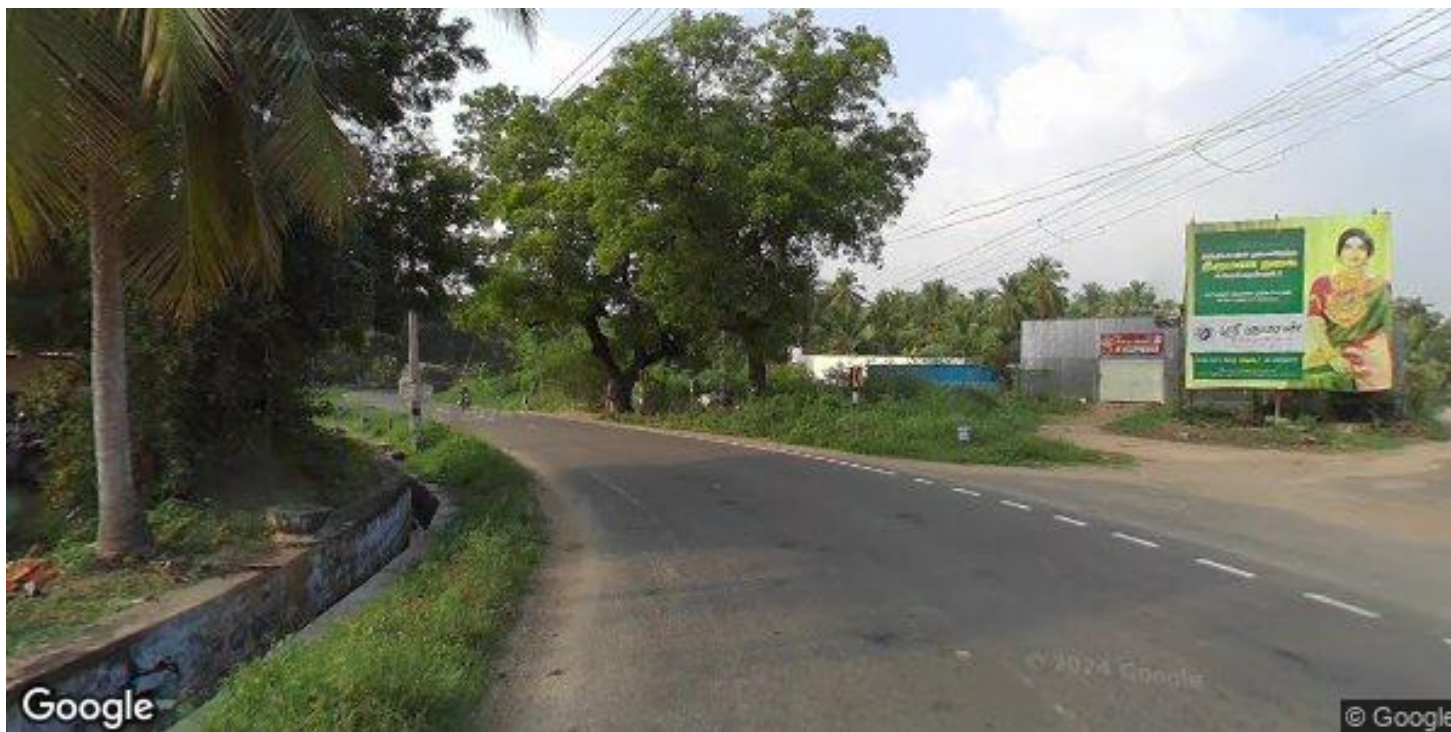
**Coordinates: 11.16357, 77.77434**

**Risk Type: Turn**

**Risk Level: Medium**

**Speed Limit: 30 KM/Hr**
