## **JOURNEY RISK MANAGEMENT (JRM) STUDY**

### **Salem Terminal To SPK PETROLEUM**

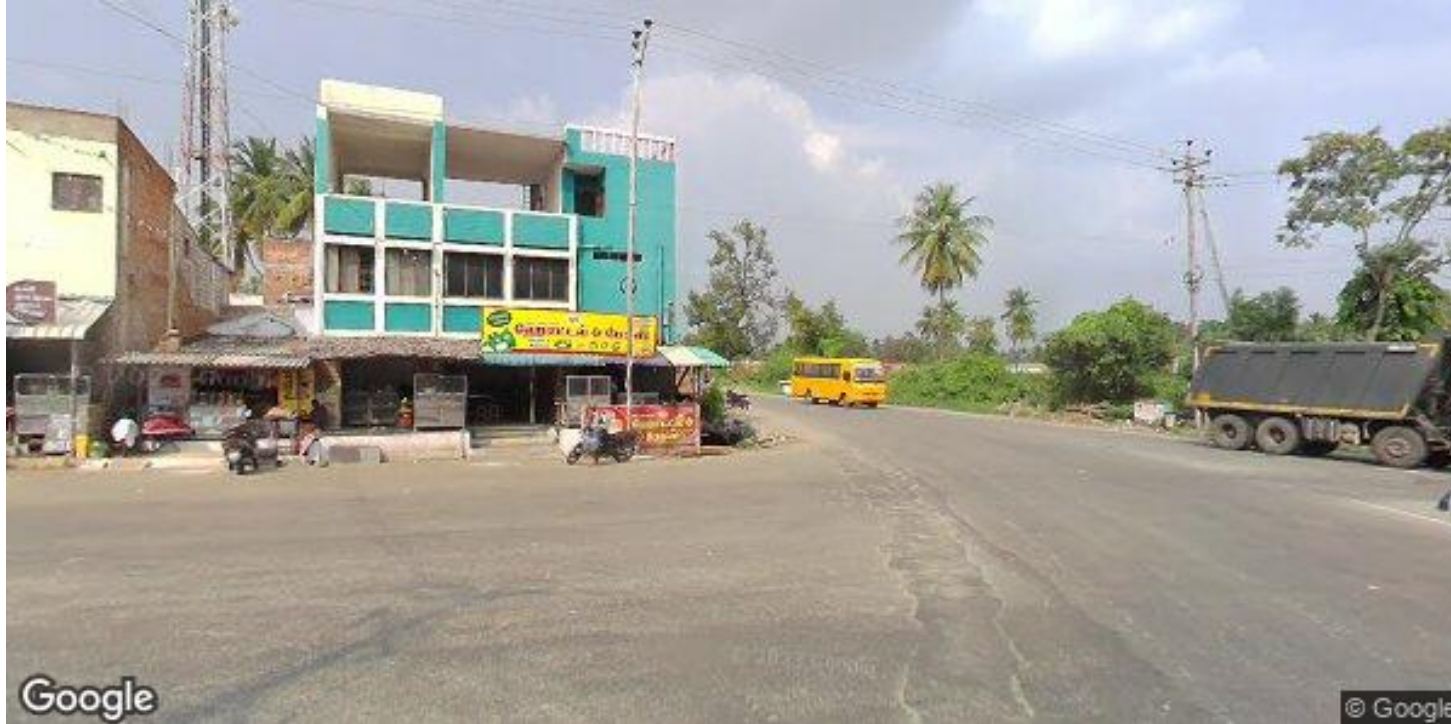
**Risk Type:** Turn  
**Risk Level:** High  
**Speed Limit:** 15 KM/Hr  
**Coordinates:** 11.13667, 77.76526

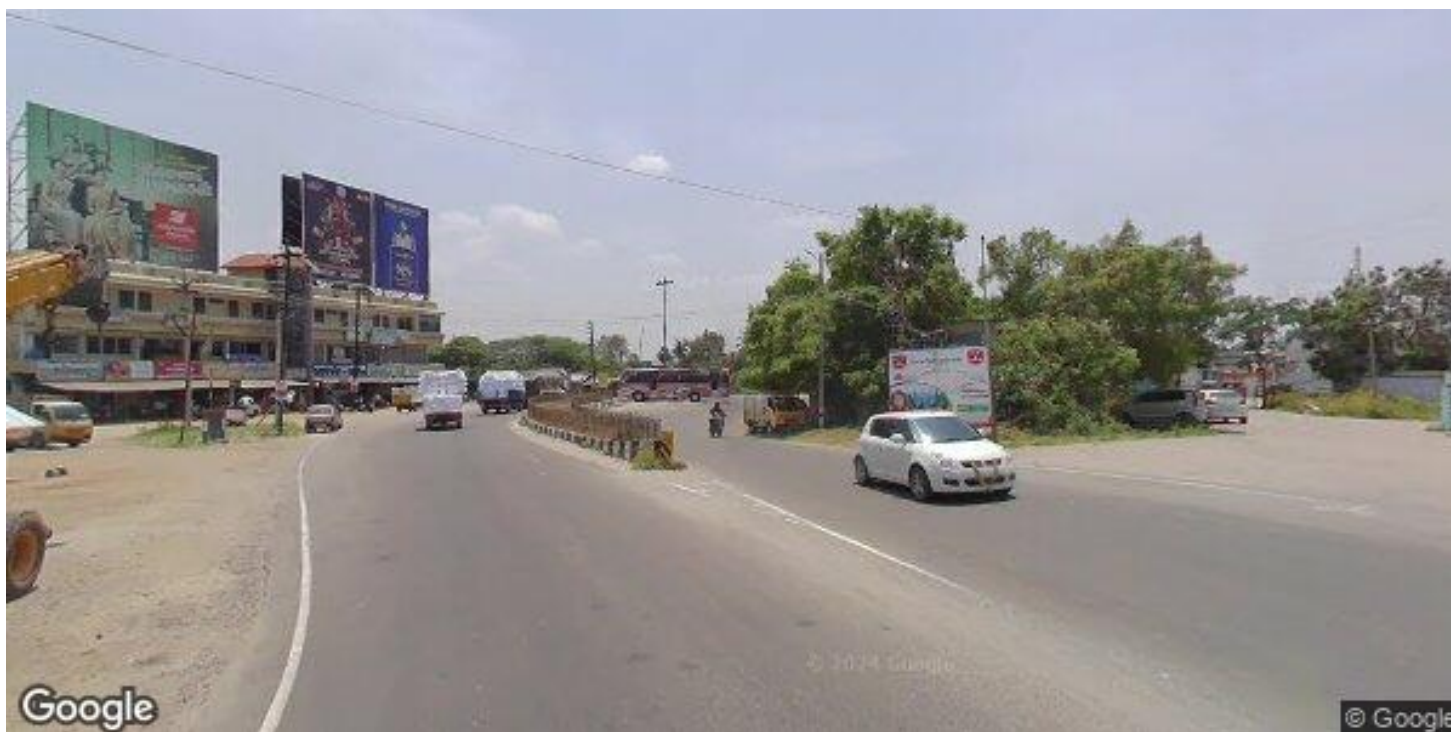
**Risk Type:** Turn  
**Risk Level:** Medium  
**Speed Limit:** 30 KM/Hr  
**Coordinates:** 11.04703, 77.73745

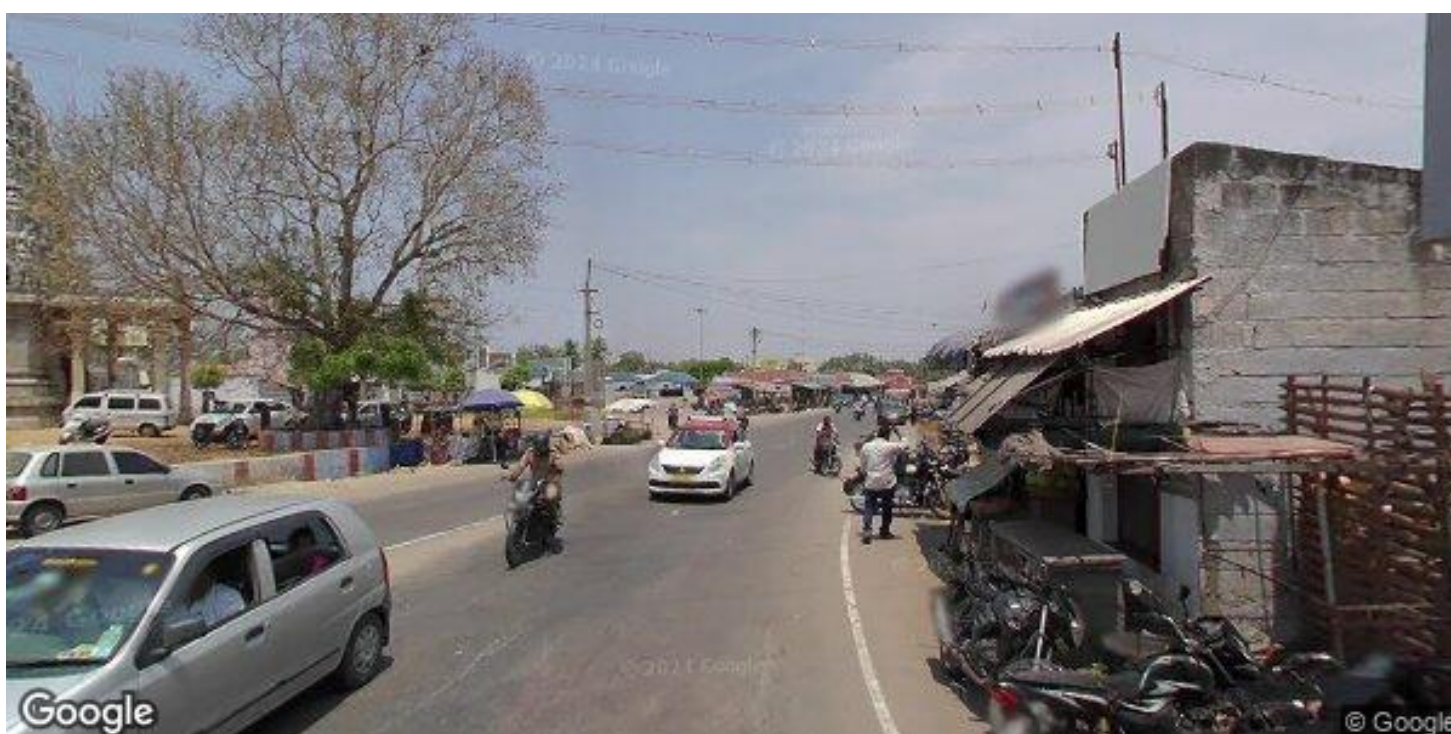
**Coordinates: 11.04528, 77.73627**

**Risk Type:** Turn  
**Risk Level:** Medium

**Speed Limit: 30 KM/Hr**

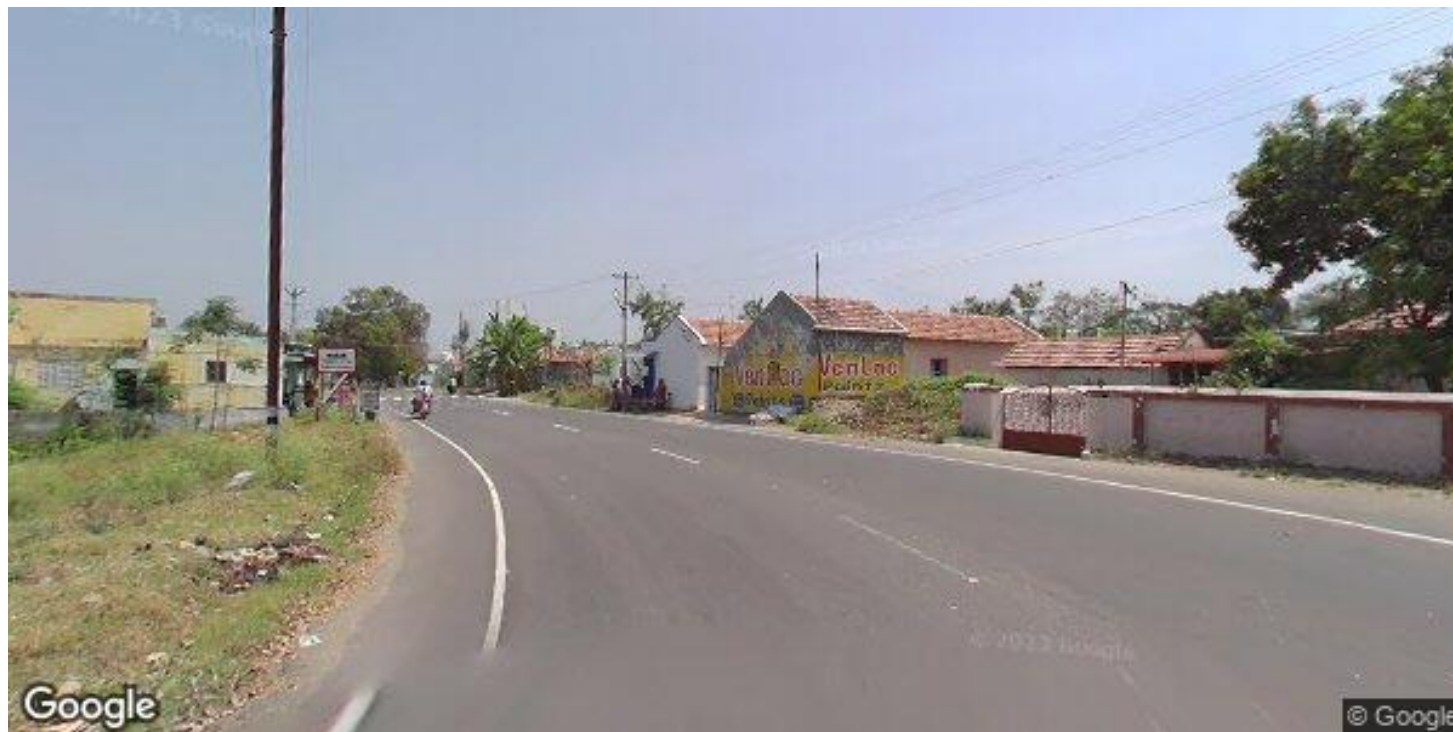
**Coordinates: 10.99029, 77.72513**

**Risk Type: Turn**

**Risk Level: High**

**Speed Limit: 15 KM/Hr**

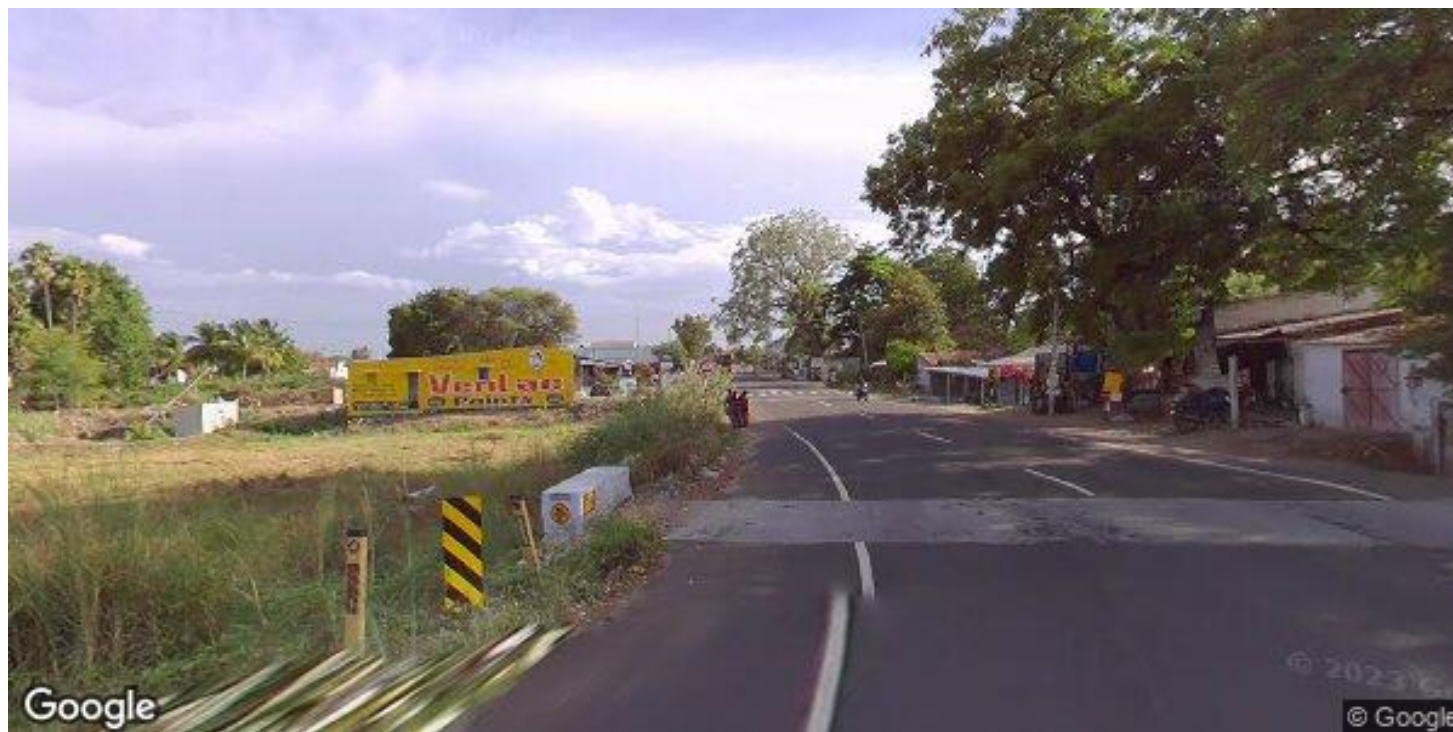
**Coordinates: 10.98961, 77.72379**

**Risk Type: Turn**

**Risk Level: Medium**

**Speed Limit: 30 KM/Hr**

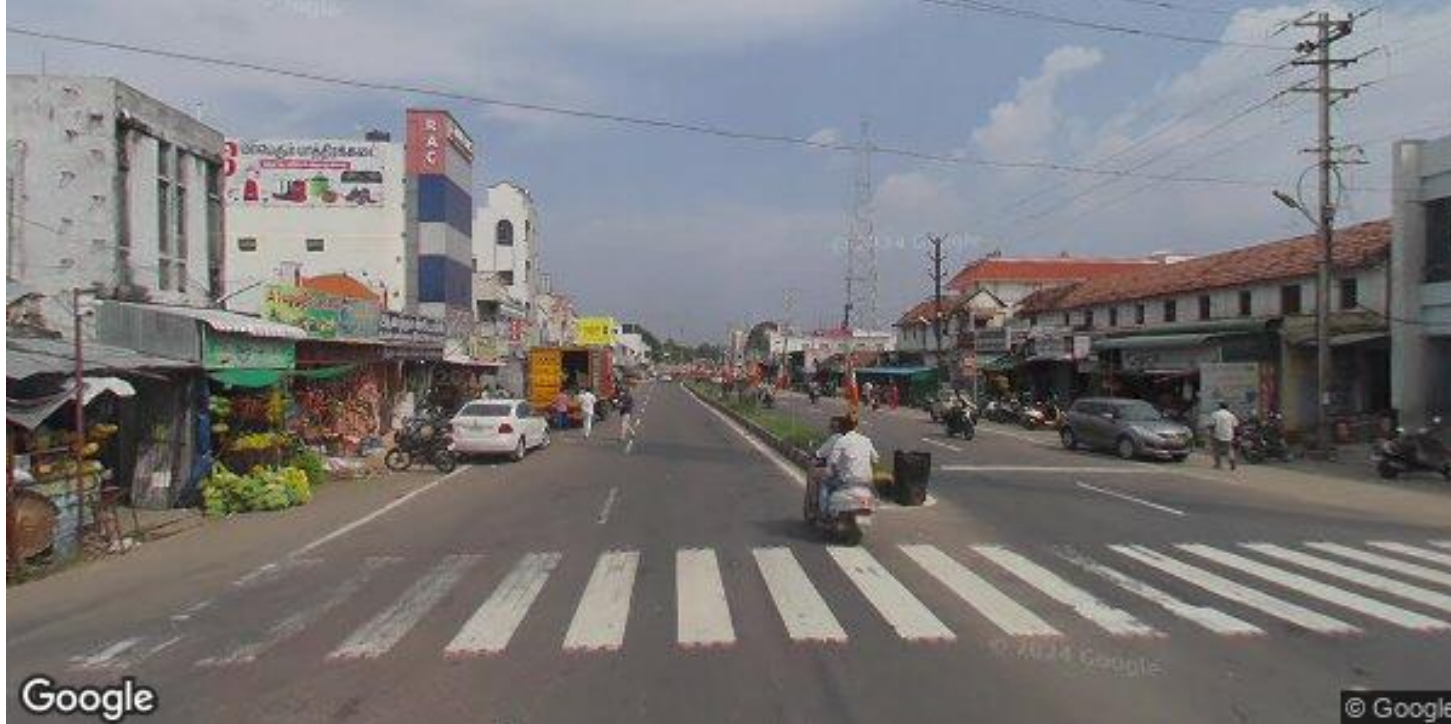
**Risk Type:** Turn  
**Risk Level:** High  
**Speed Limit:** 15 KM/Hr  
**Coordinates:** 10.94597, 77.71319

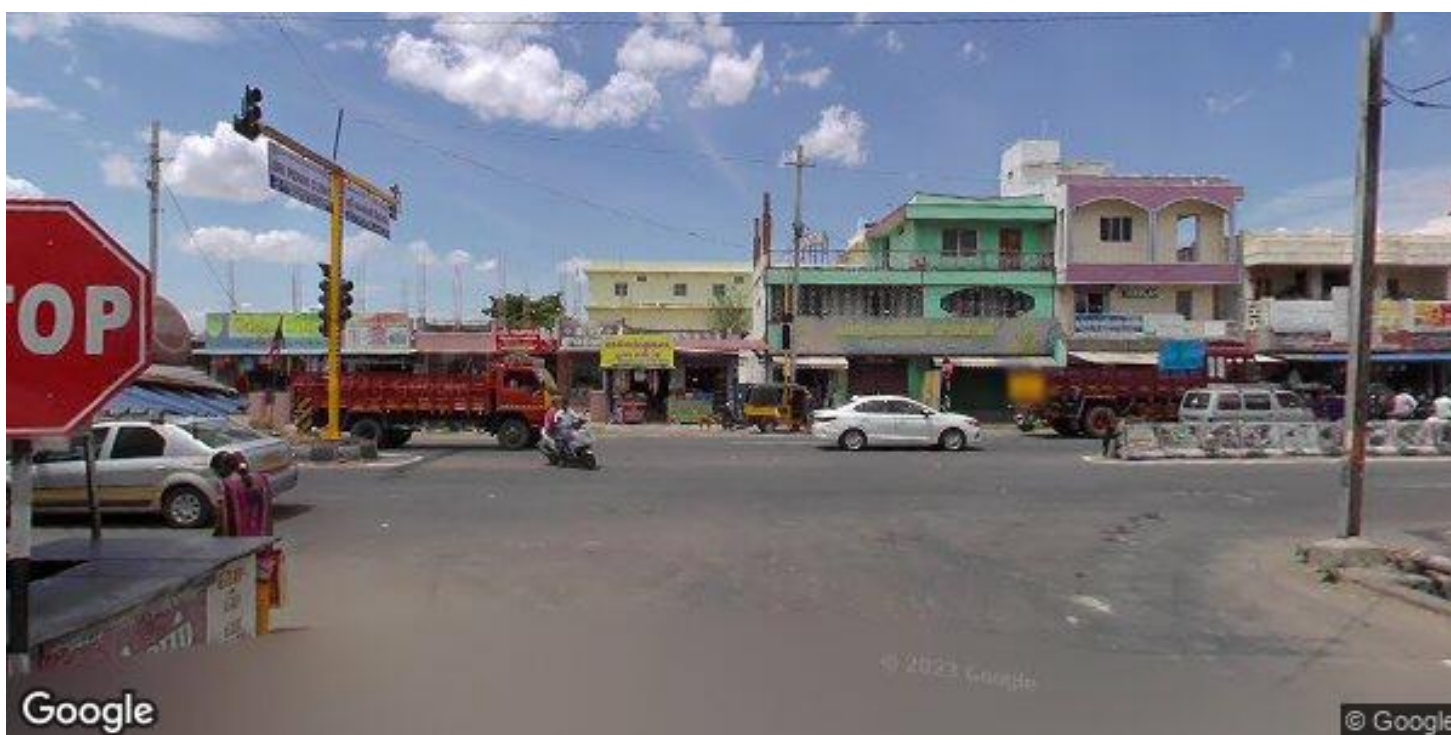
**Risk Type:** Turn  
**Risk Level:** High  
**Speed Limit:** 15 KM/Hr  
**Coordinates:** 10.94582, 77.71257

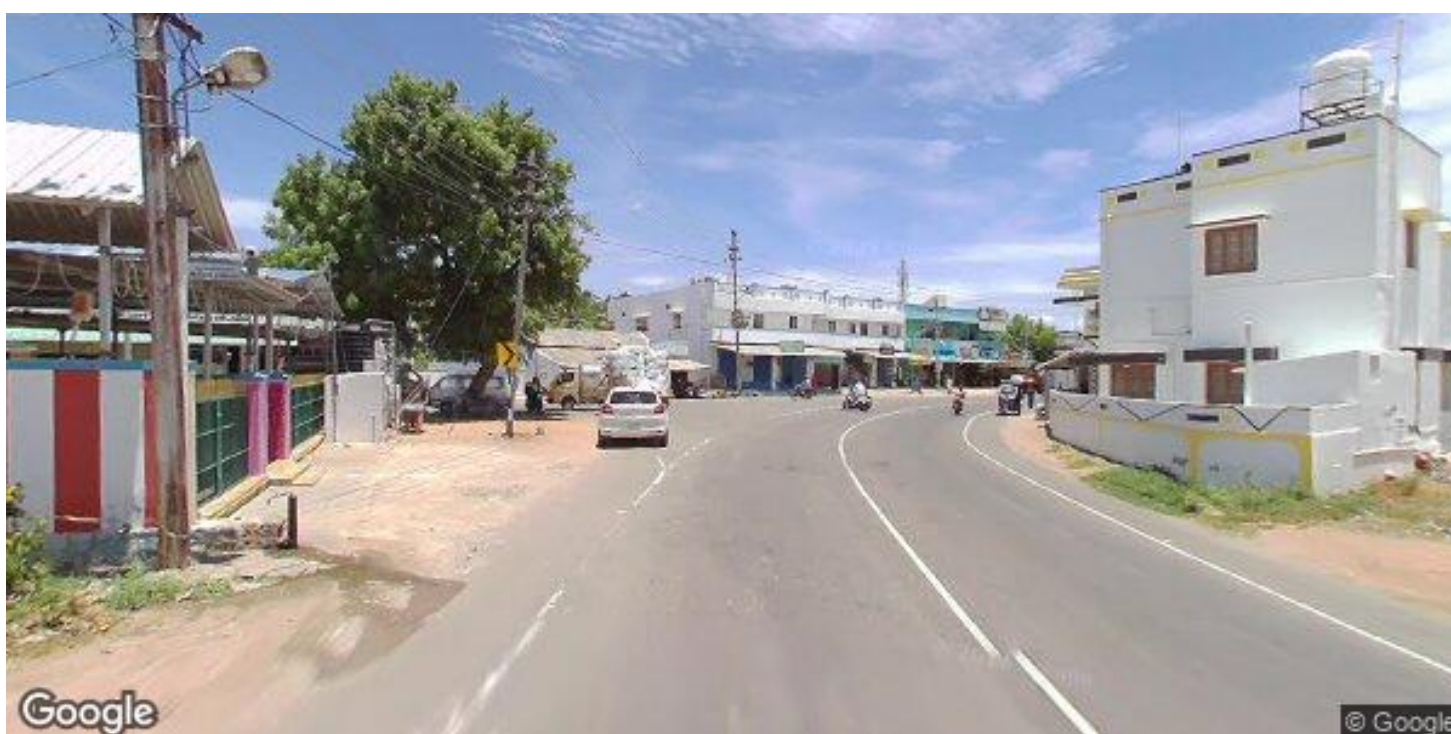
**Risk Type:** Turn  
**Risk Level:** Medium

**Speed Limit:** 30 KM/Hr  
**Coordinates:** 10.93825, 77.70342
