# IndianOil

## JOURNEY RISK MANAGEMENT (JRM) STUDY

### Salem Terminal TO ESAAN AGENCIES

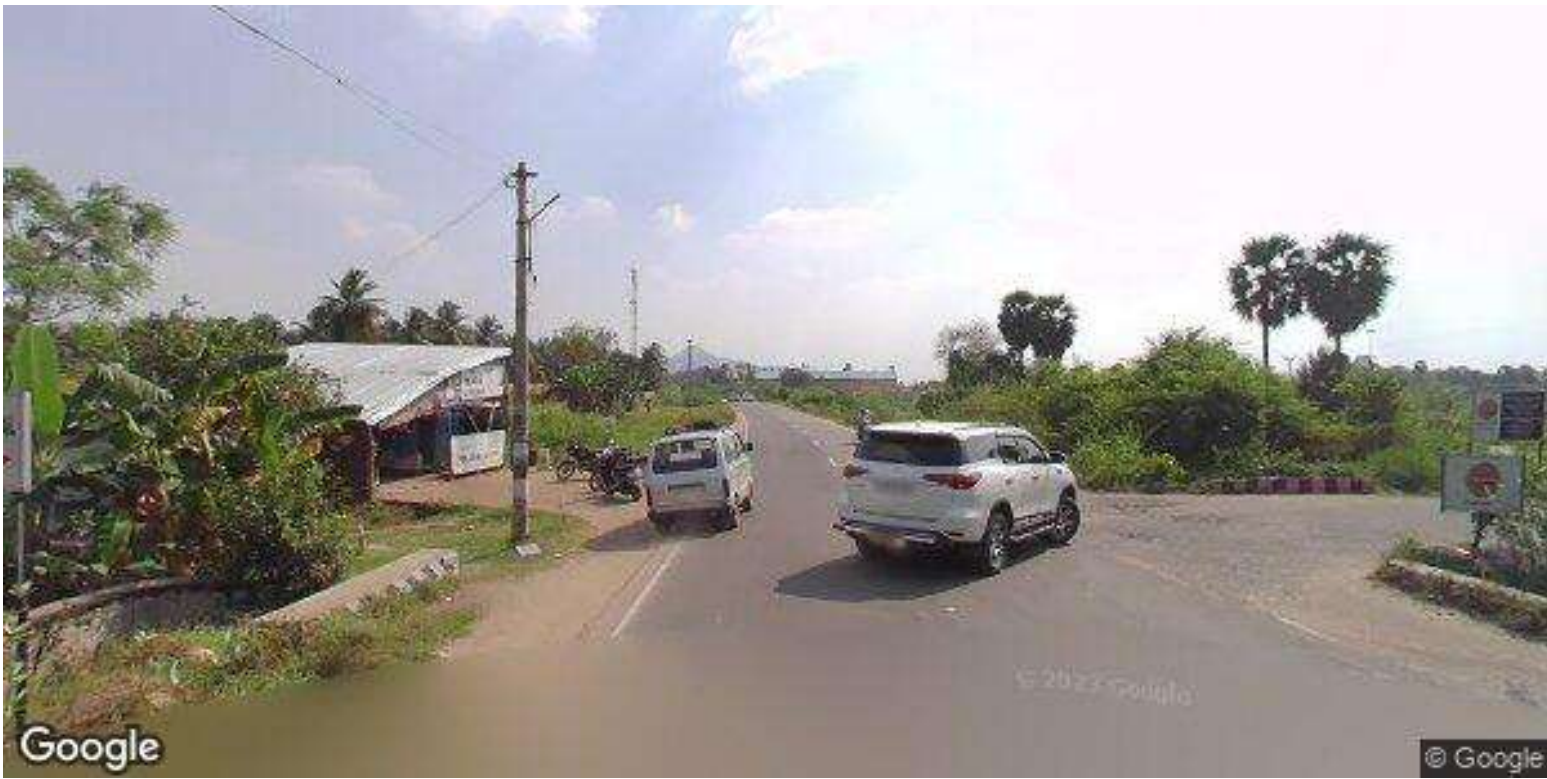
Coordinates: 11.44029, 77.87544

Risk Type: Turn

Risk Level: High

Speed Limit: 15 KM/Hr

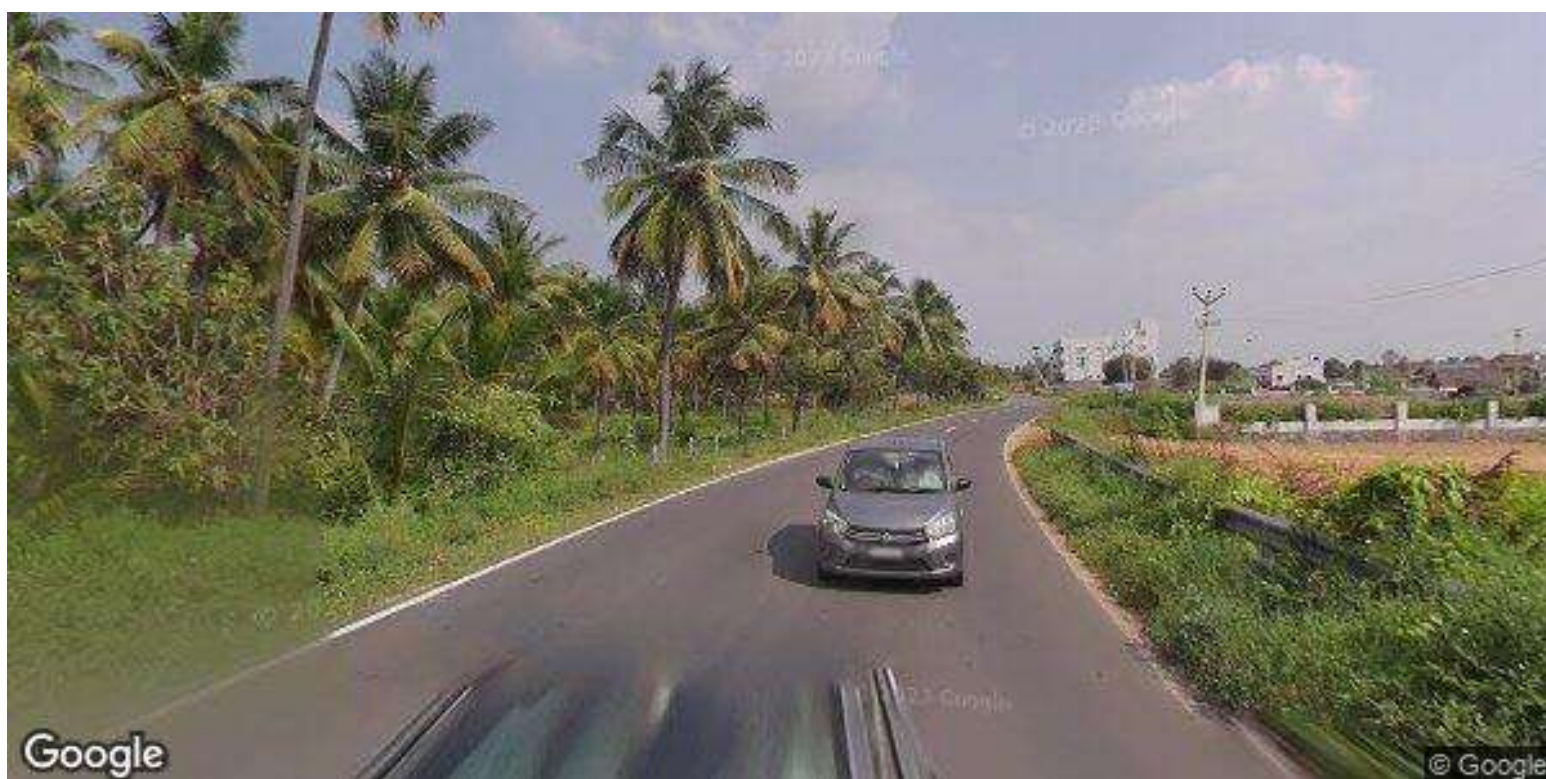
**Coordinates: 11.45357, 77.85789**

**Risk Type: Turn**

**Risk Level: Medium**

**Speed Limit: 30 KM/Hr**

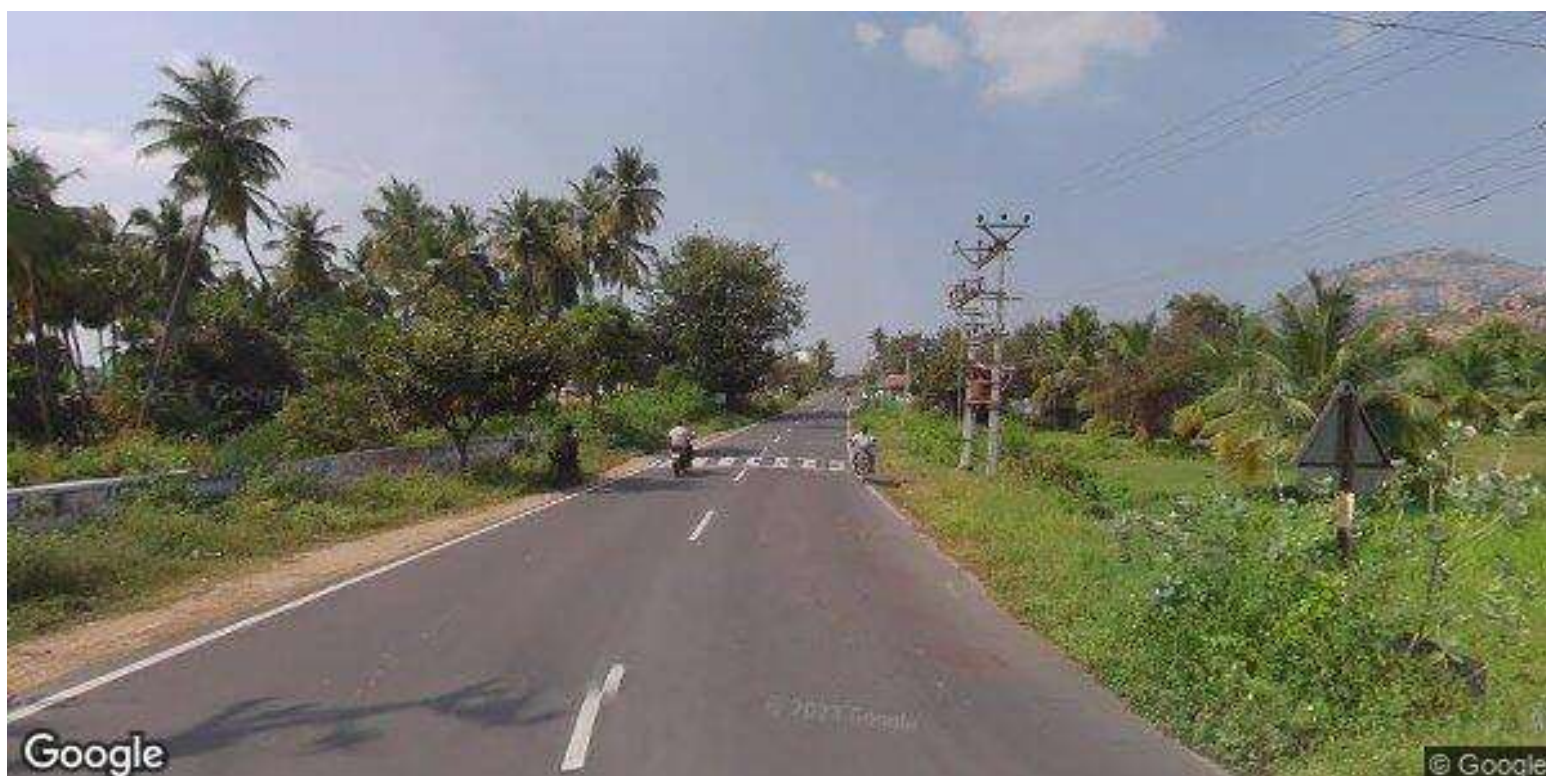
**Coordinates:** 11.45352, 77.85698

**Risk Type:** Turn

**Risk Level:** High

**Speed Limit:** 15 KM/Hr

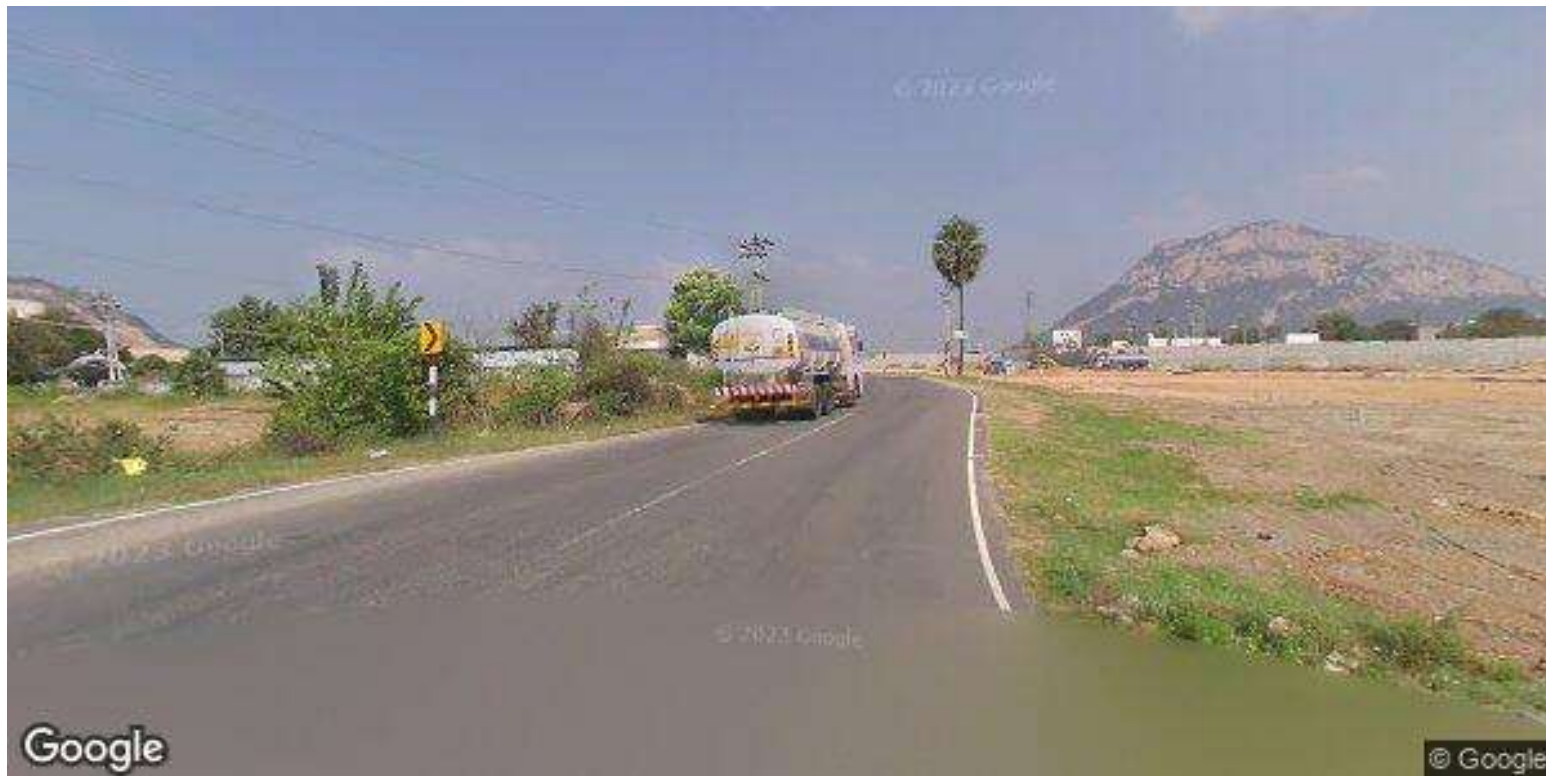
**Coordinates:** 11.45847, 77.85140

**Risk Type:** Turn

**Risk Level:** Medium

**Speed Limit:** 30 KM/Hr

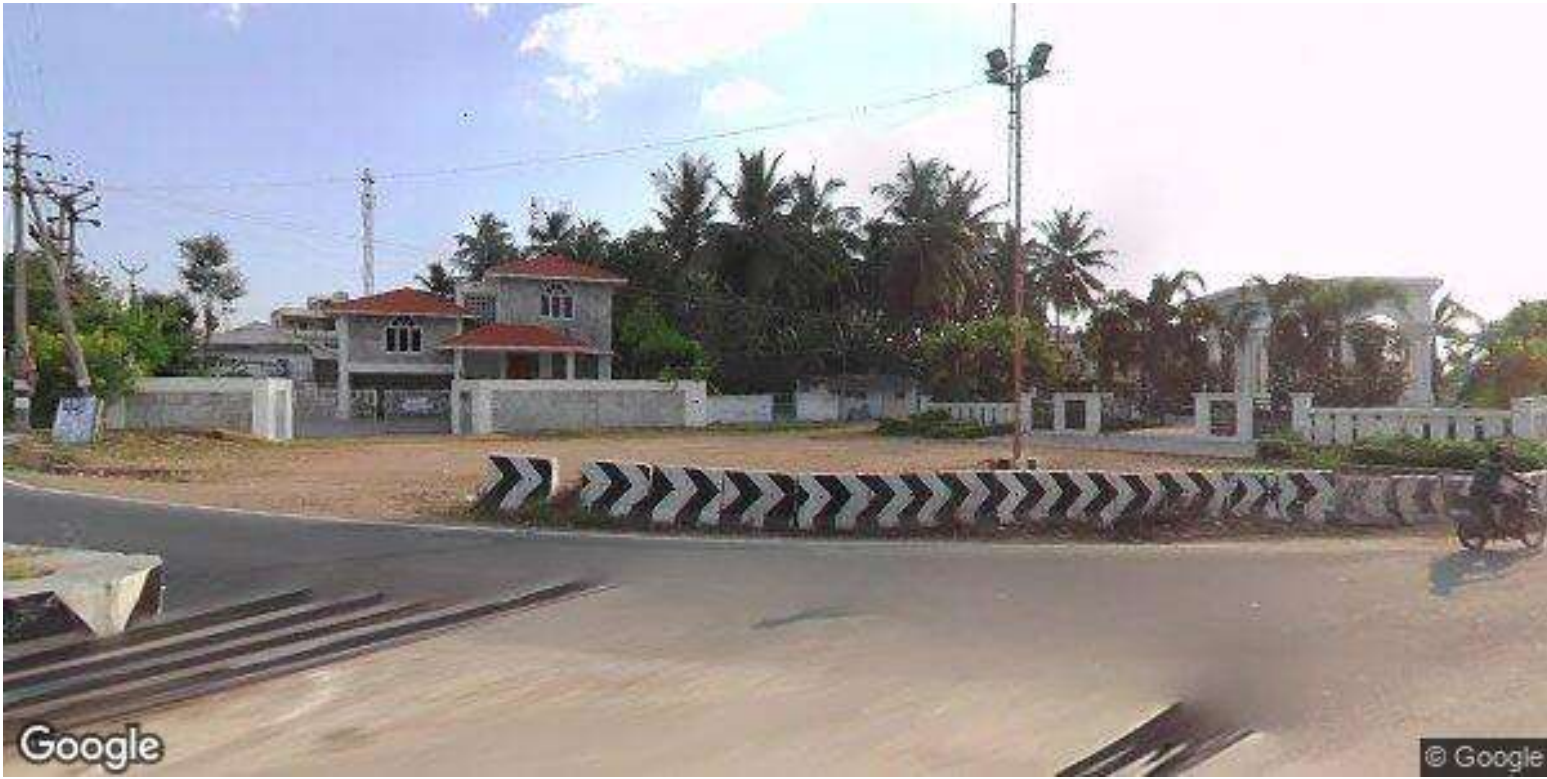
**Risk Type:** Turn  
**Risk Level:** Medium  
**Speed Limit:** 30 KM/Hr  
**Coordinates:** 11.46314, 77.84928

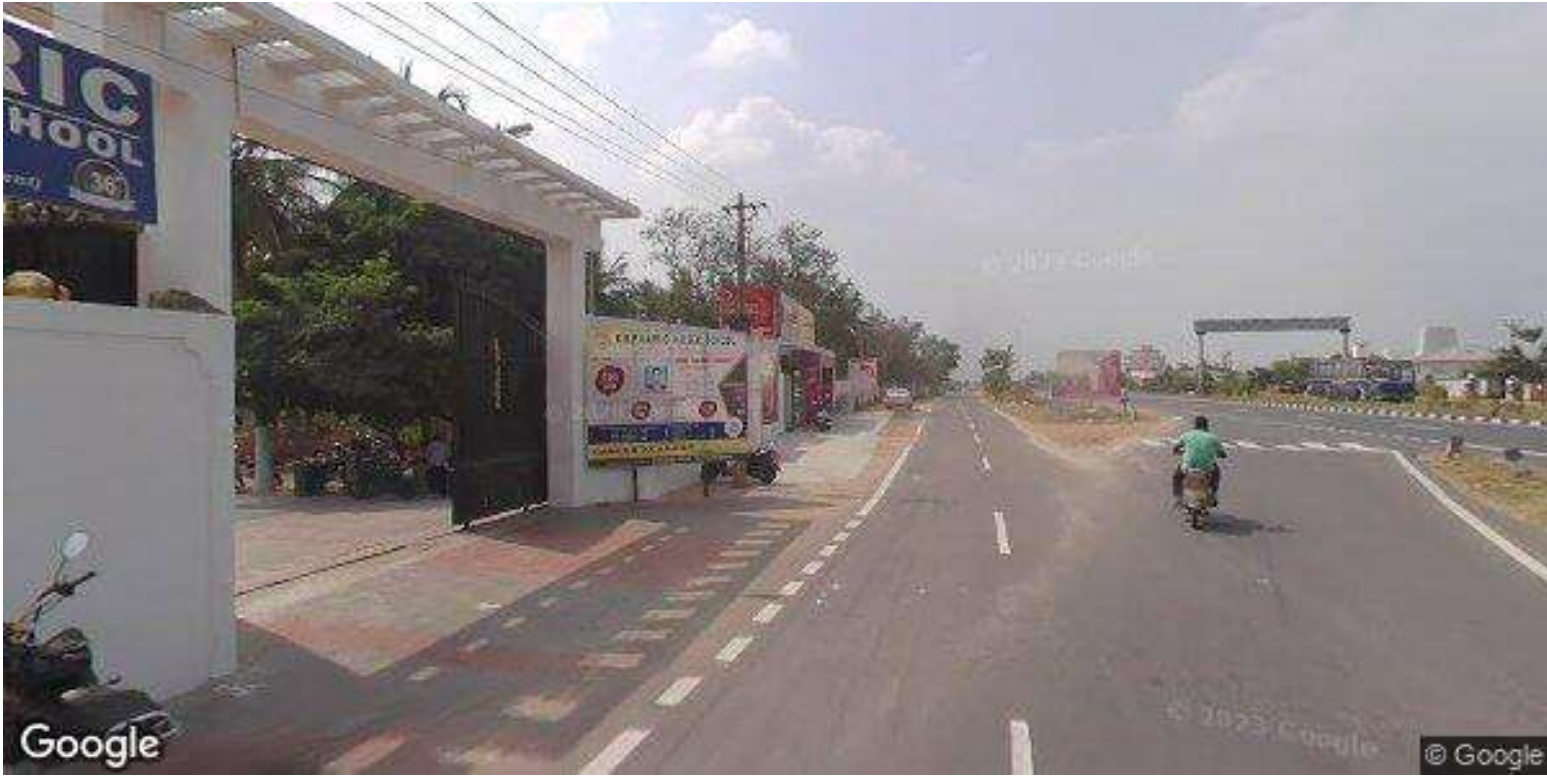
**Risk Type:** Turn  
**Risk Level:** Medium  
**Speed Limit:** 30 KM/Hr  
**Coordinates:** 11.45509, 77.81383

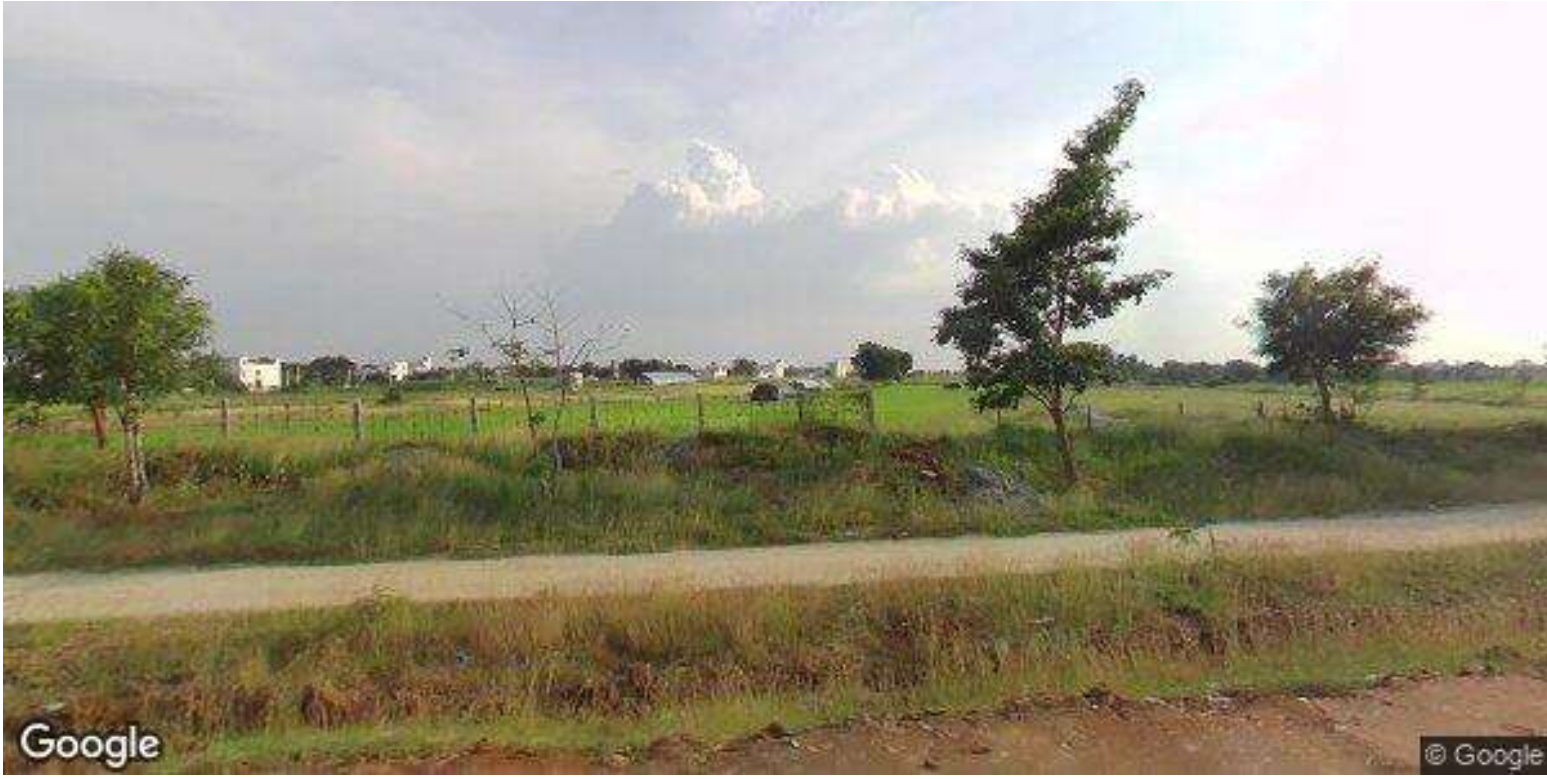
**Risk Type:** Turn  
**Risk Level:** Medium  
**Speed Limit:** 30 KM/Hr  
**Coordinates:** 11.29288, 77.59029

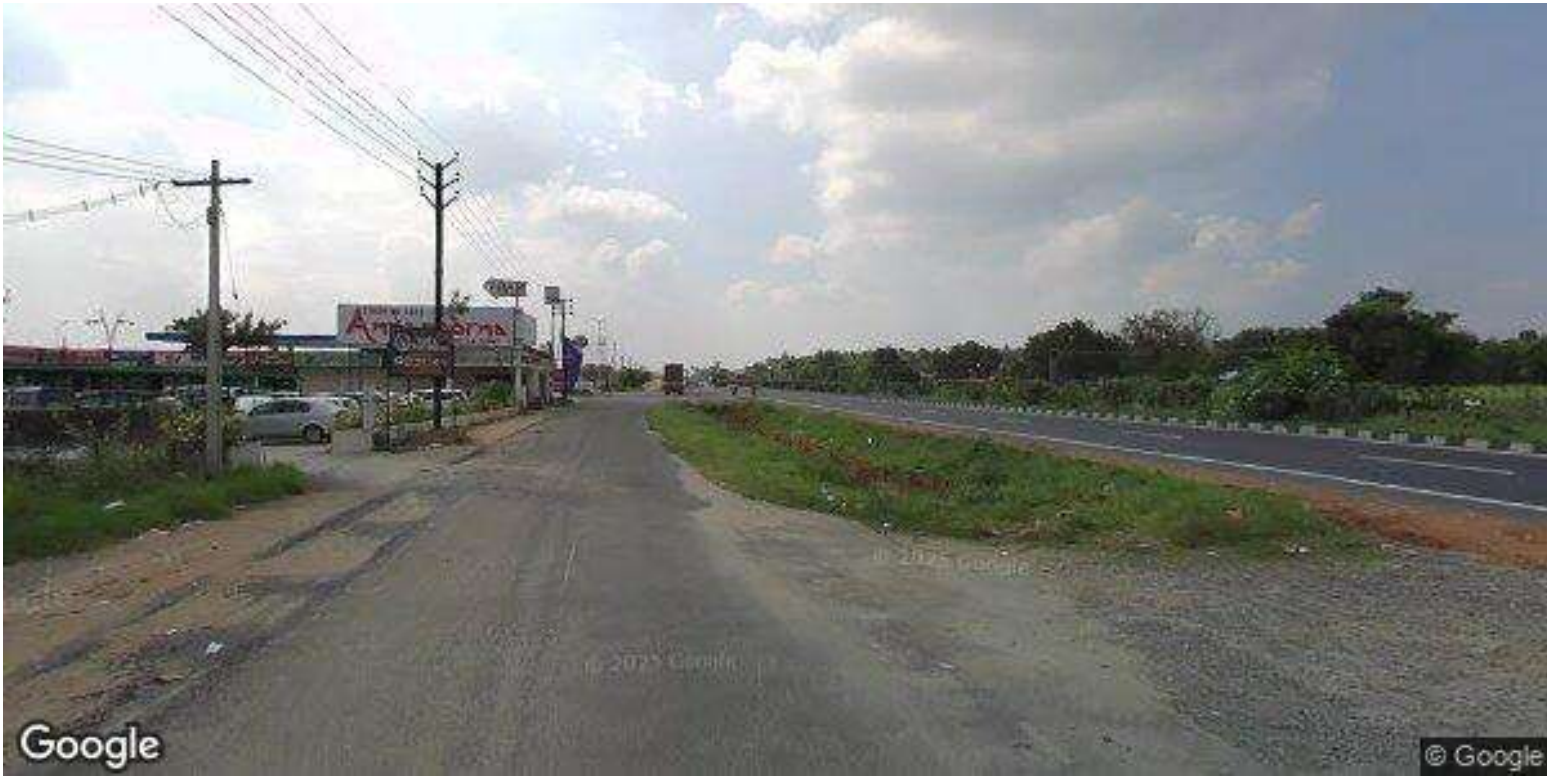
**Risk Type:** Turn  
**Risk Level:** Medium  
**Speed Limit:** 30 KM/Hr  
**Coordinates:** 11.29140, 77.58253

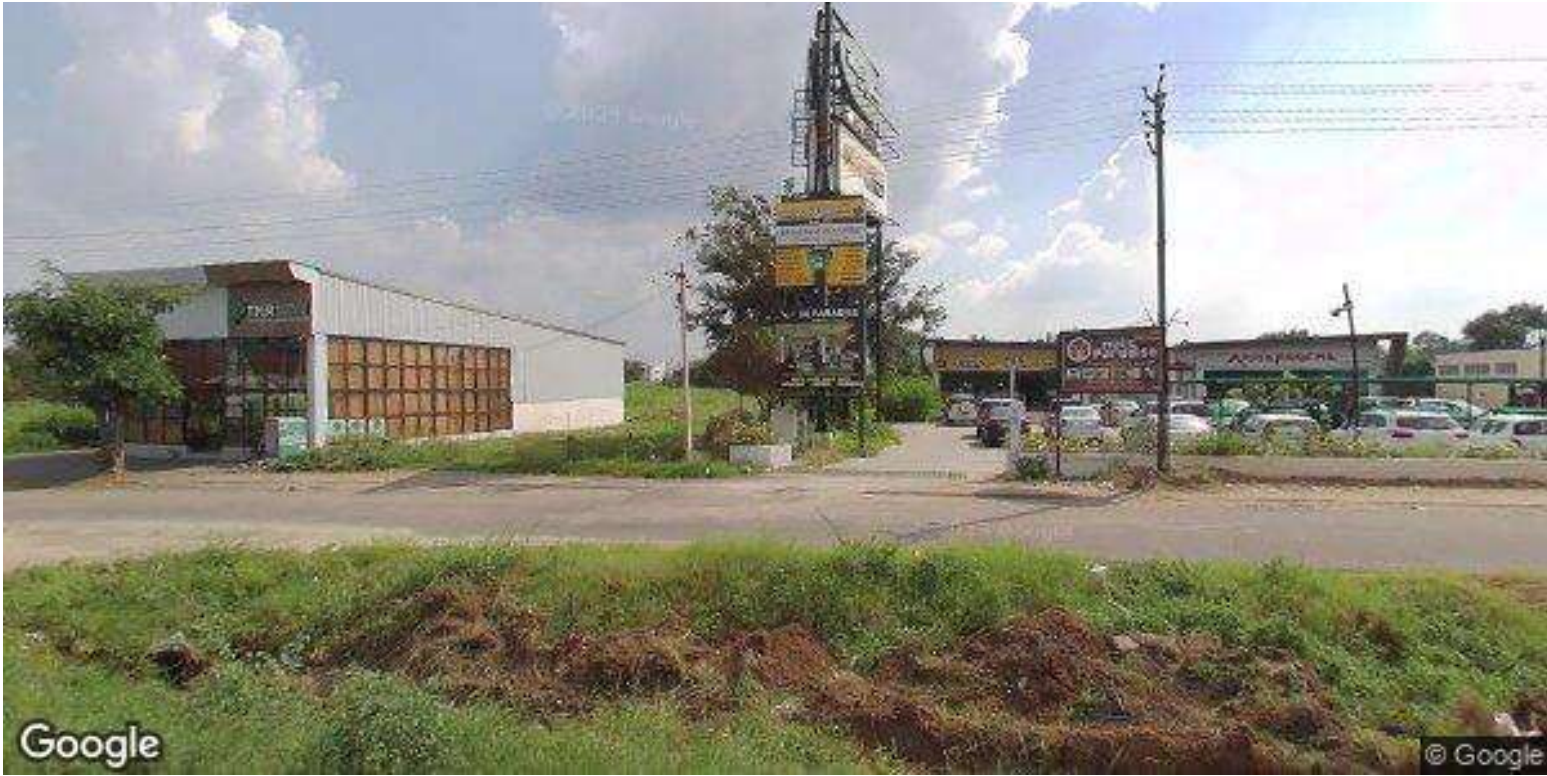
**Risk Type:** Turn  
**Risk Level:** Medium  
**Speed Limit:** 30 KM/Hr  
**Coordinates:** 11.29154, 77.58236

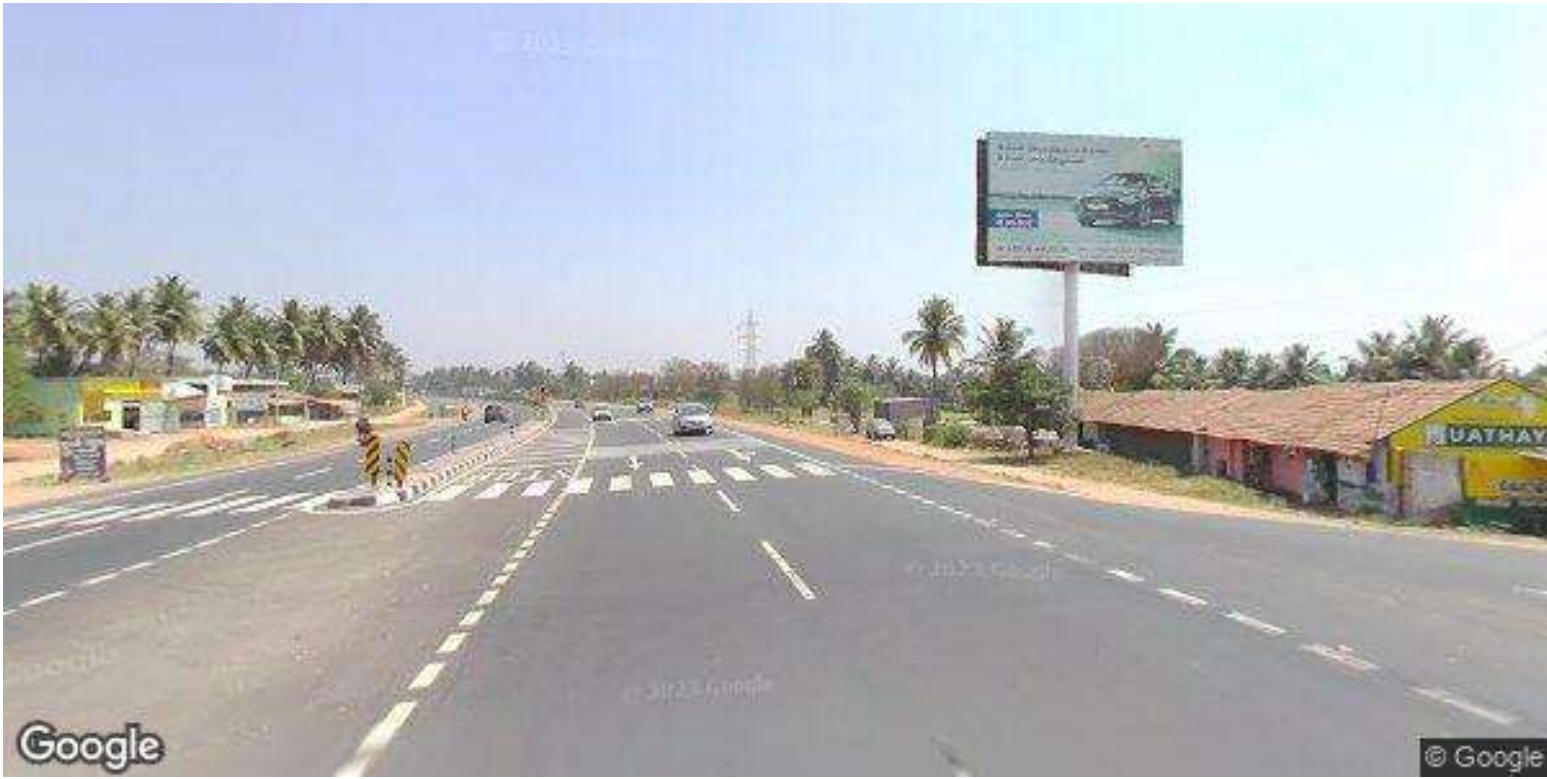
**Risk Type:** Blind Spot  
**Risk Level:** Blind Spot  
**Speed Limit:** 10 KM/Hr  
**Coordinates:** 11.23716, 77.50666

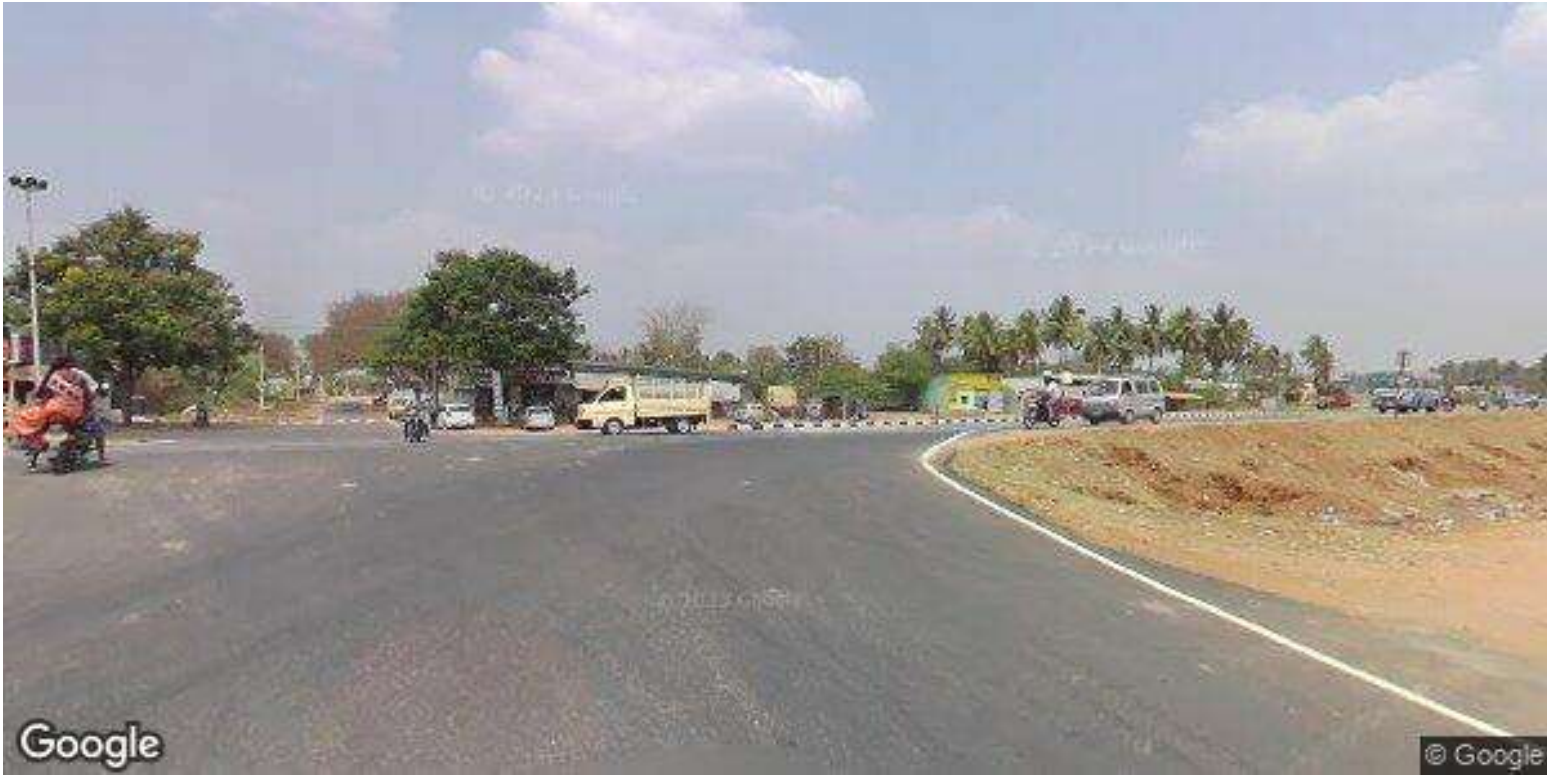
**Risk Type:** Blind Spot  
**Risk Level:** Blind Spot  
**Speed Limit:** 10 KM/Hr  
**Coordinates:** 11.23704, 77.50676

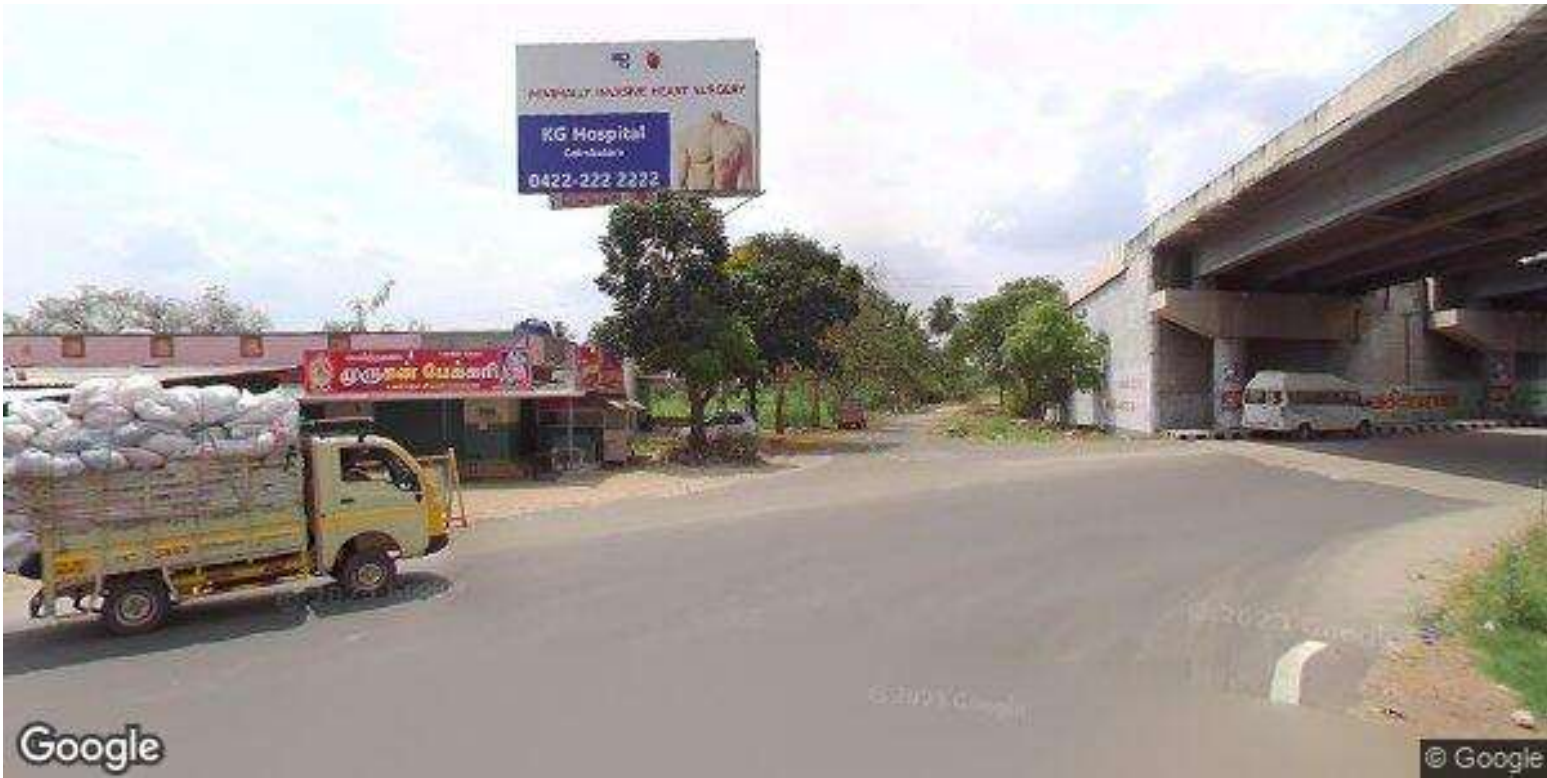
**Coordinates:** 11.23686, 77.50216

**Risk Type:** Blind Spot

**Risk Level:** Blind Spot

**Speed Limit:** 10 KM/Hr

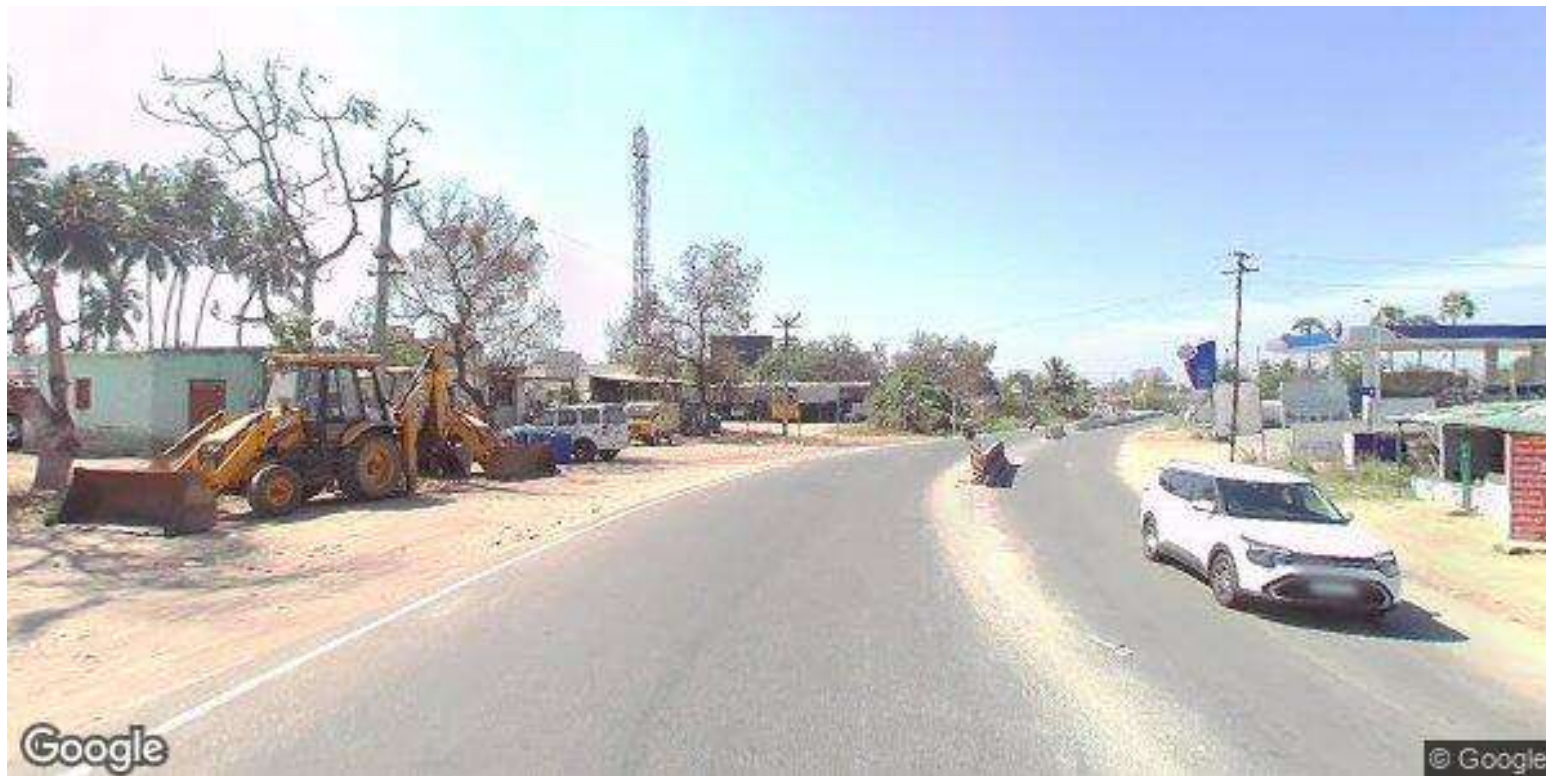
**Coordinates:** 11.23649, 77.50219

**Risk Type:** Turn

**Risk Level:** Medium

**Speed Limit:** 30 KM/Hr

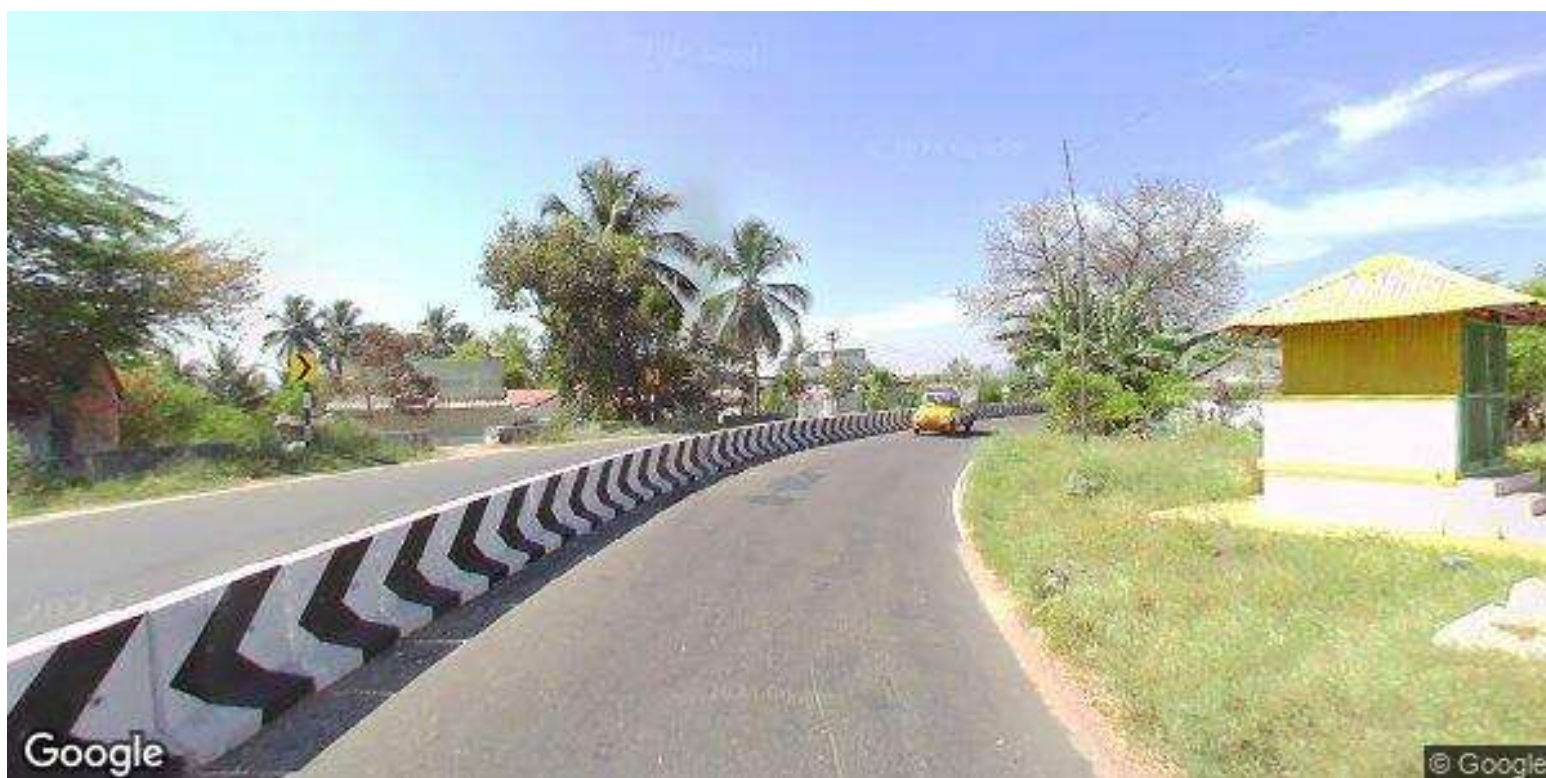
**Coordinates:** 11.23396, 77.50105

**Risk Type:** Turn

**Risk Level:** Medium

**Speed Limit:** 30 KM/Hr

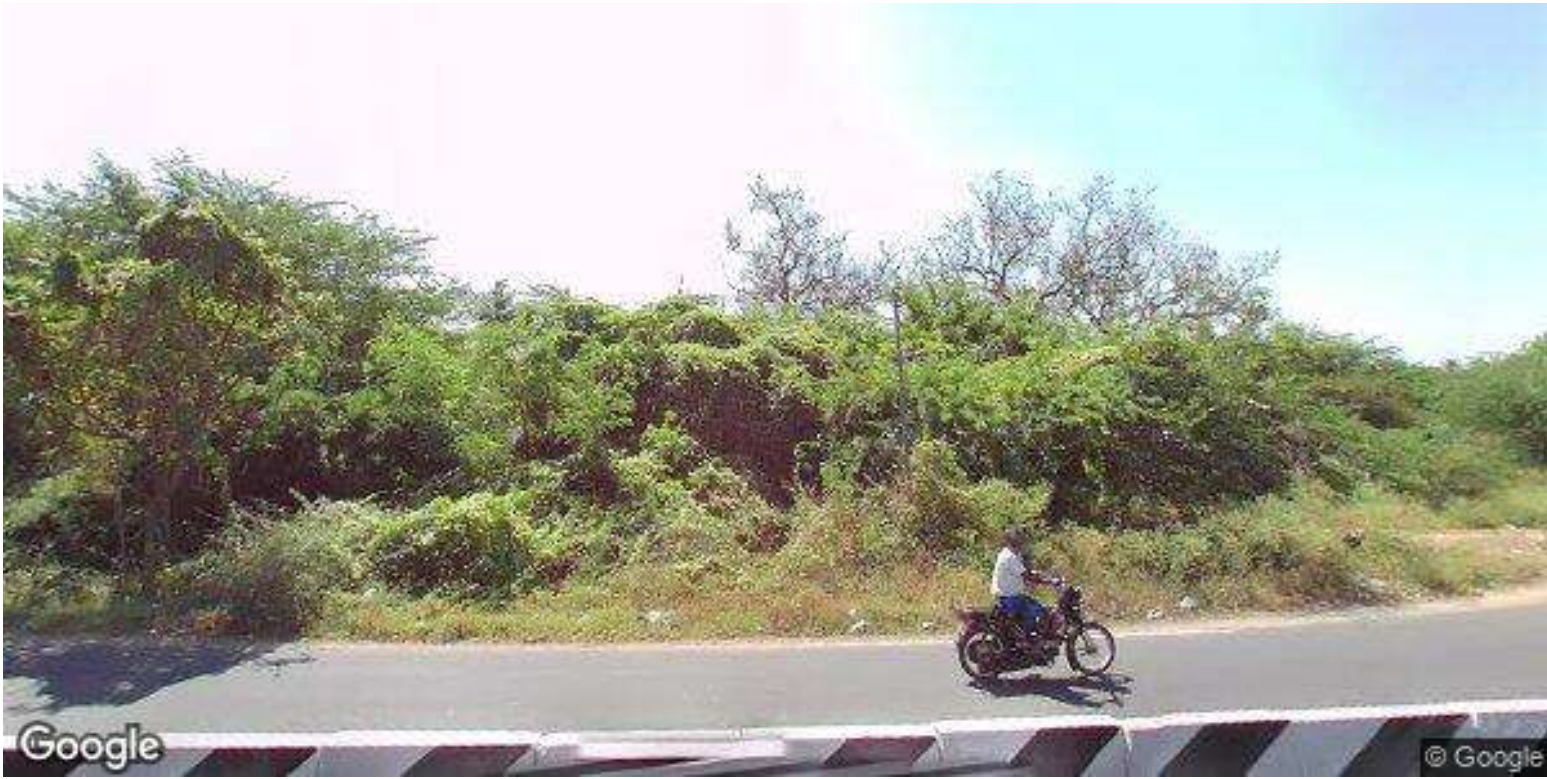
**Risk Type:** Turn  
**Risk Level:** Medium  
**Speed Limit:** 30 KM/Hr  
**Coordinates:** 11.23329, 77.49966

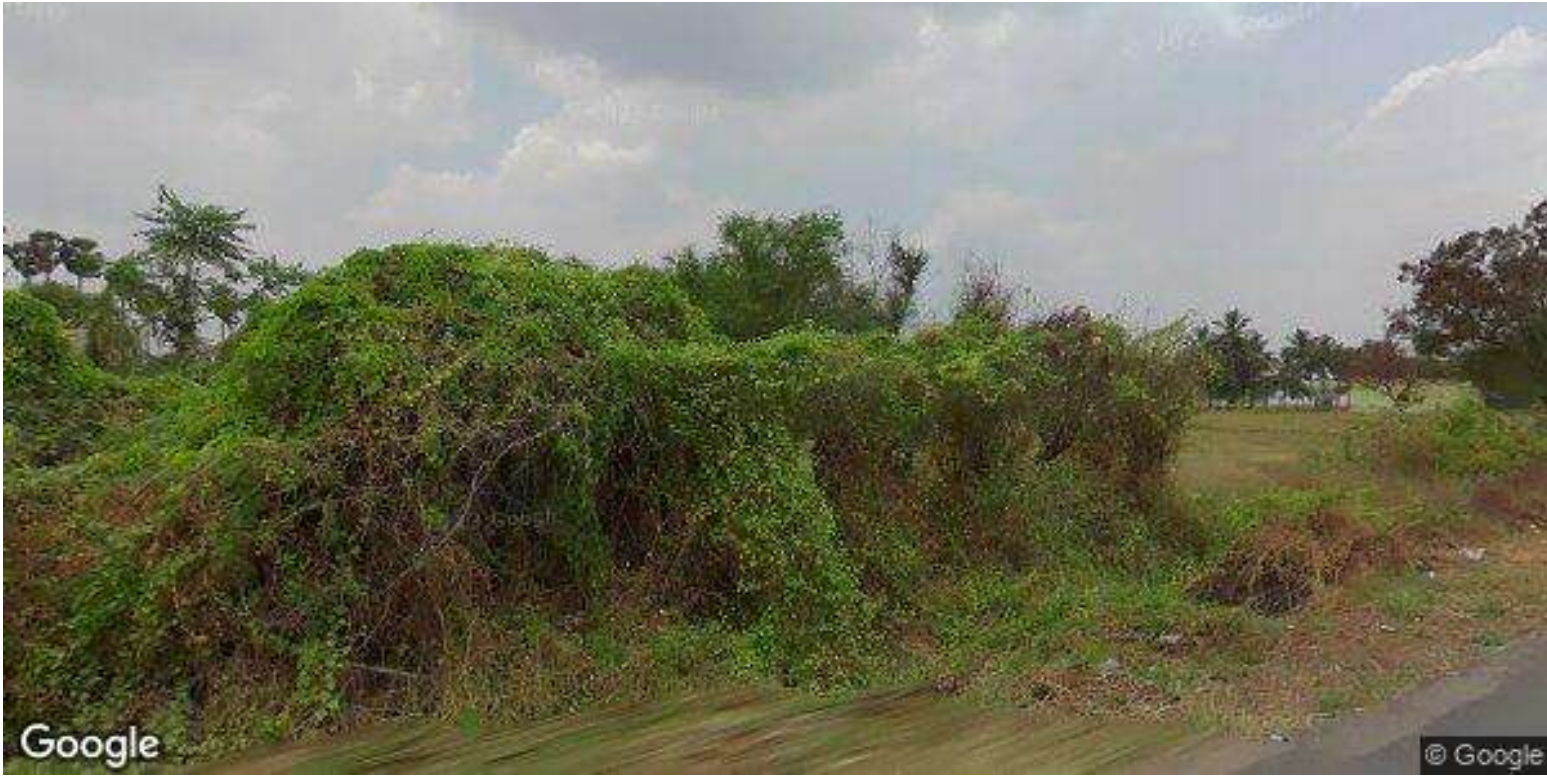
**Risk Type:** Turn  
**Risk Level:** Medium  
**Speed Limit:** 30 KM/Hr  
**Coordinates:** 11.17851, 77.46169

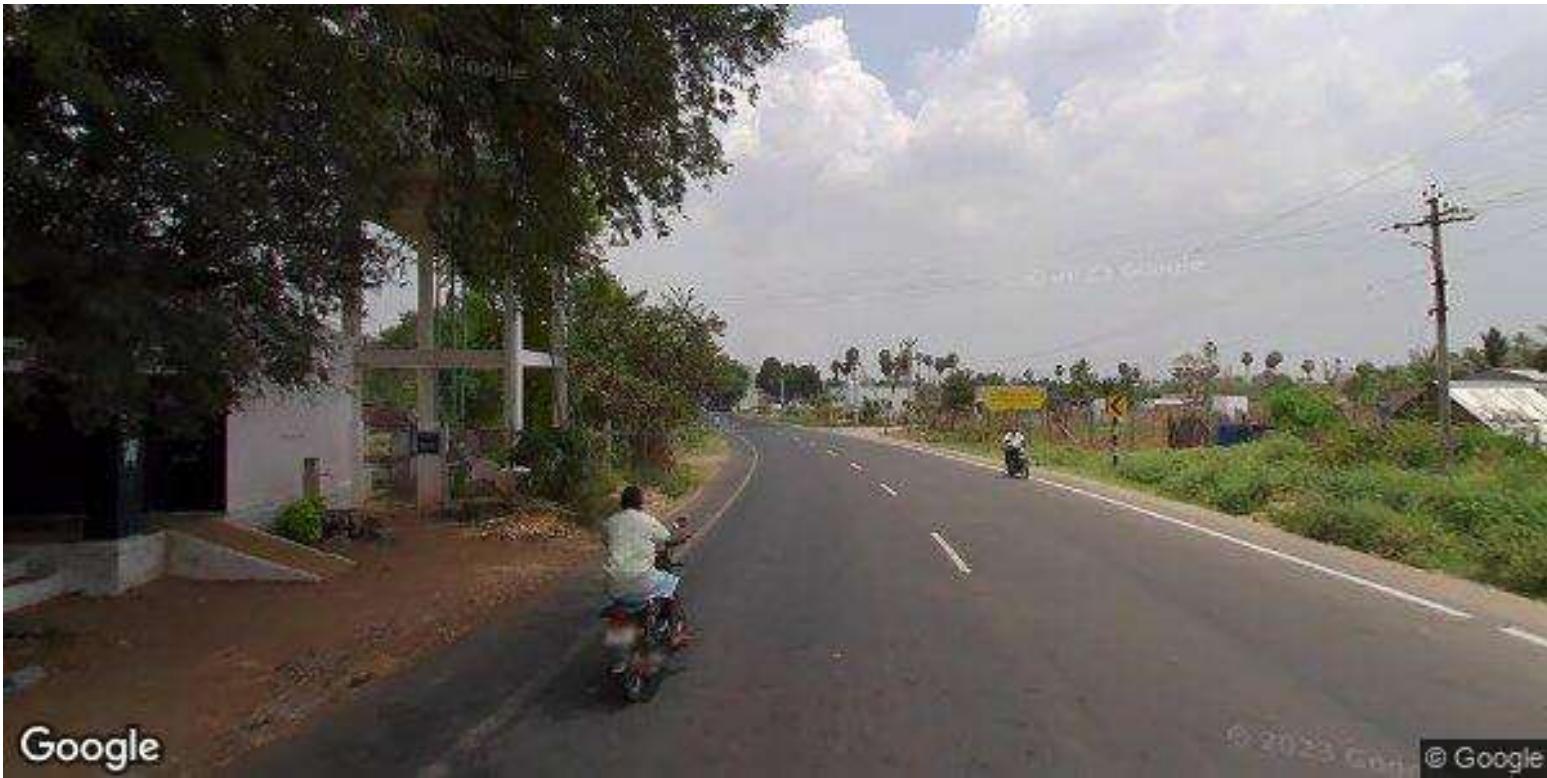
**Risk Type:** Turn  
**Risk Level:** Medium  
**Speed Limit:** 30 KM/Hr  
**Coordinates:** 11.17521, 77.45978

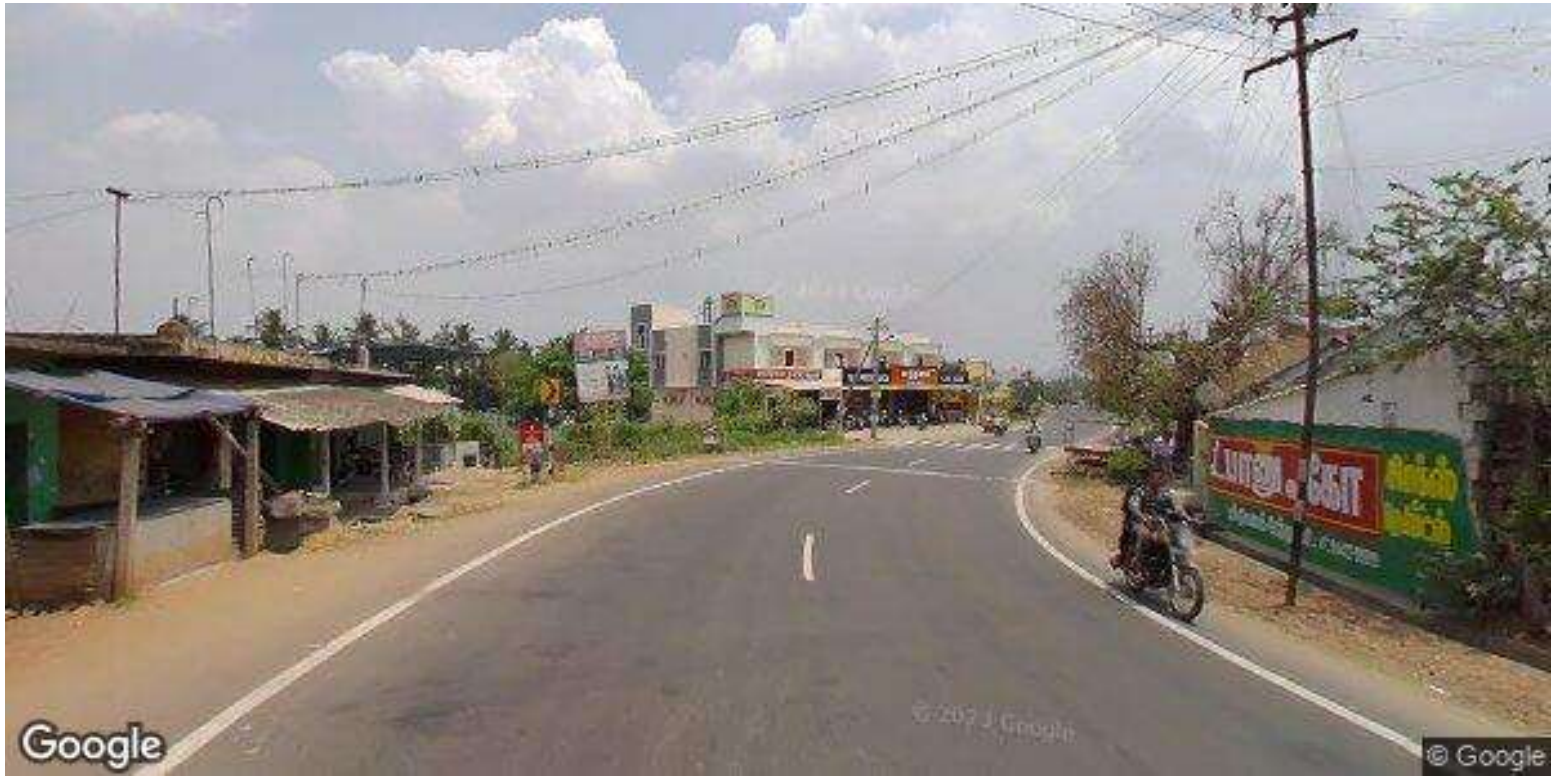
**Risk Type:** Turn  
**Risk Level:** Medium  
**Speed Limit:** 30 KM/Hr  
**Coordinates:** 11.17368, 77.45730
