# IndianOil

## JOURNEY RISK MANAGEMENT (JRM) STUDY

### Salem Terminal TO ESAAN AGENCIES

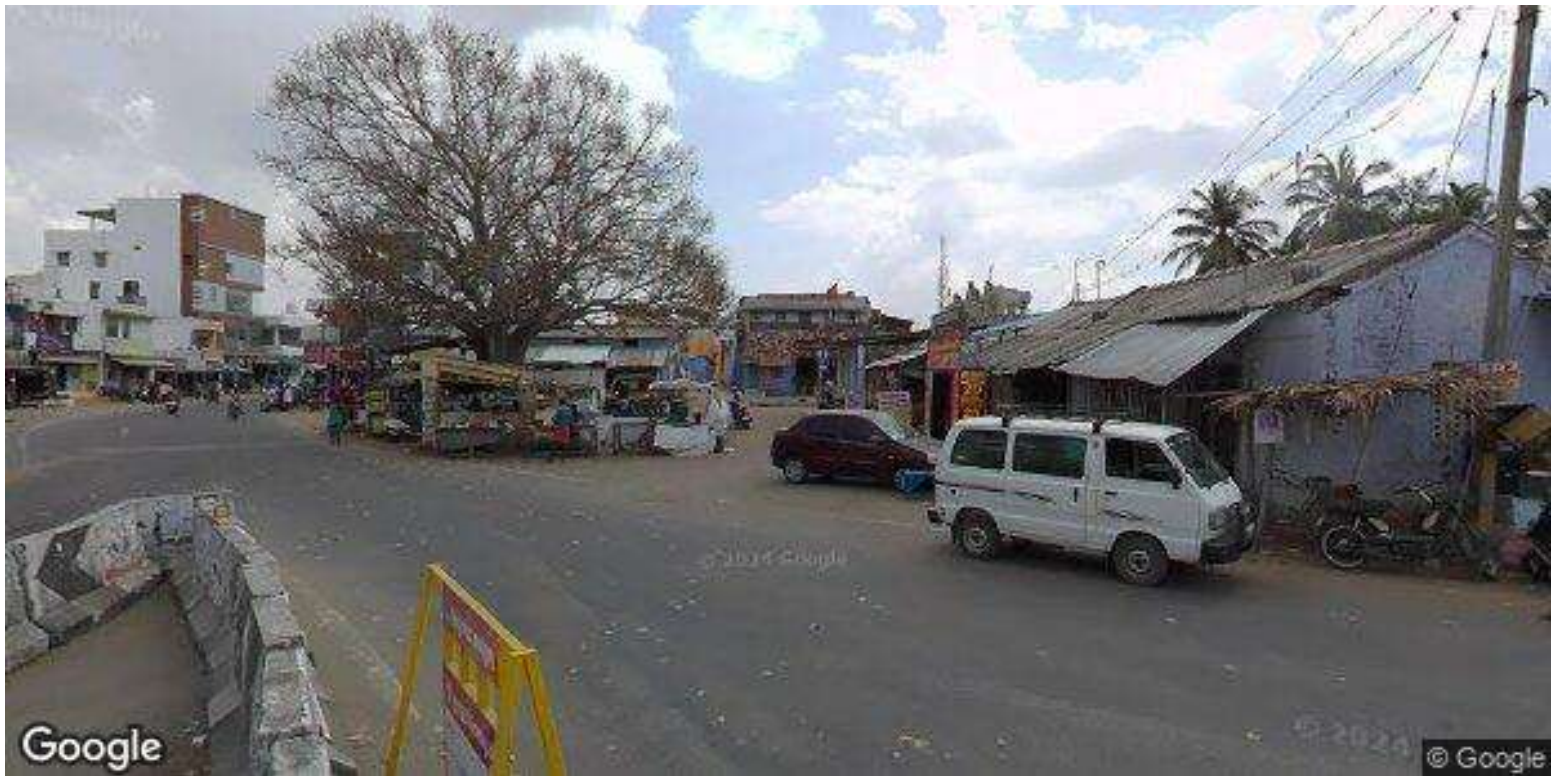
**Risk Type:** Turn  
**Risk Level:** High  
**Speed Limit:** 15 KM/Hr  
**Coordinates:** 11.17096, 77.45516

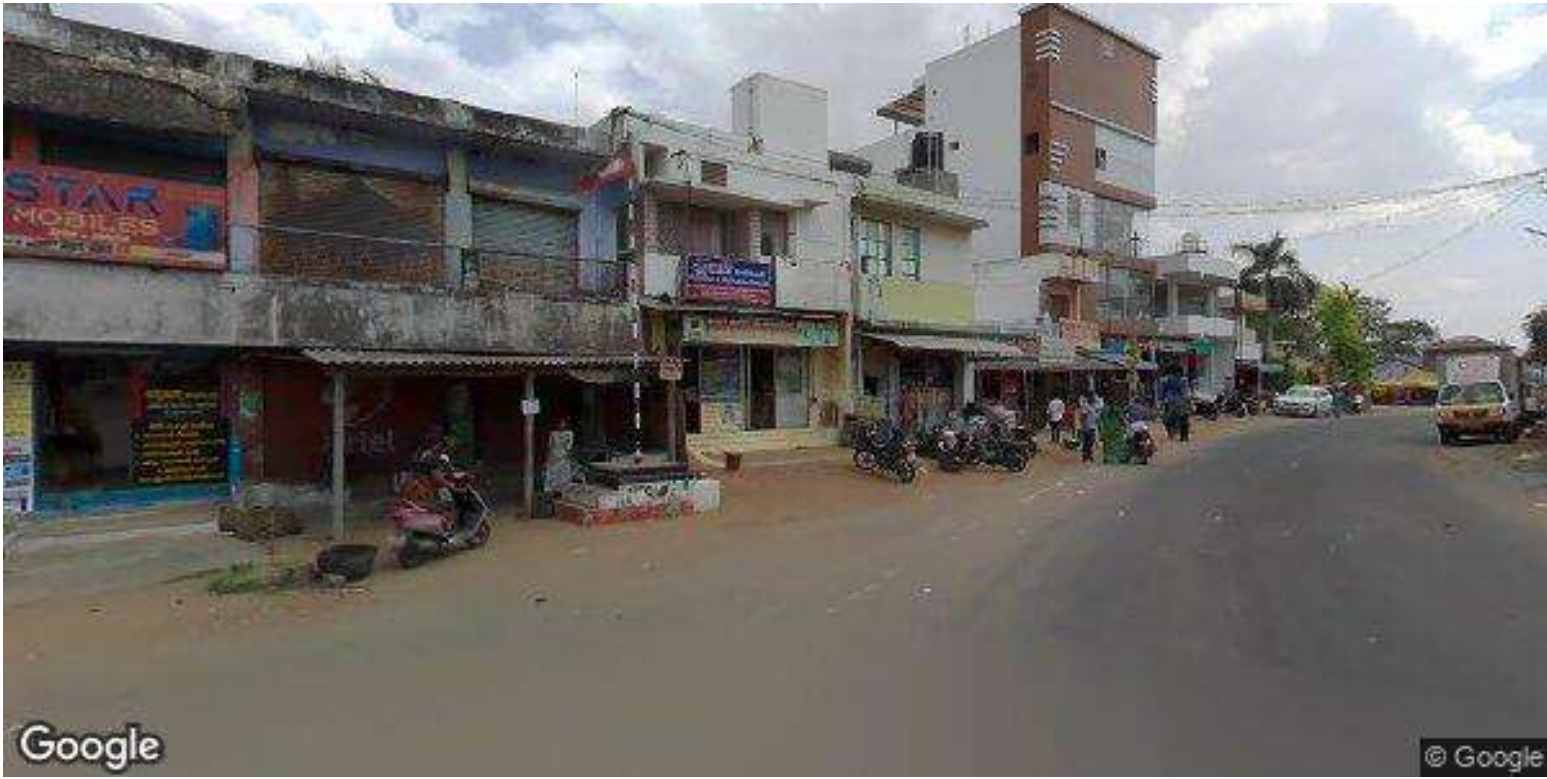
**Risk Type:** Turn  
**Risk Level:** Medium  
**Speed Limit:** 30 KM/Hr  
**Coordinates:** 11.17048, 77.45544

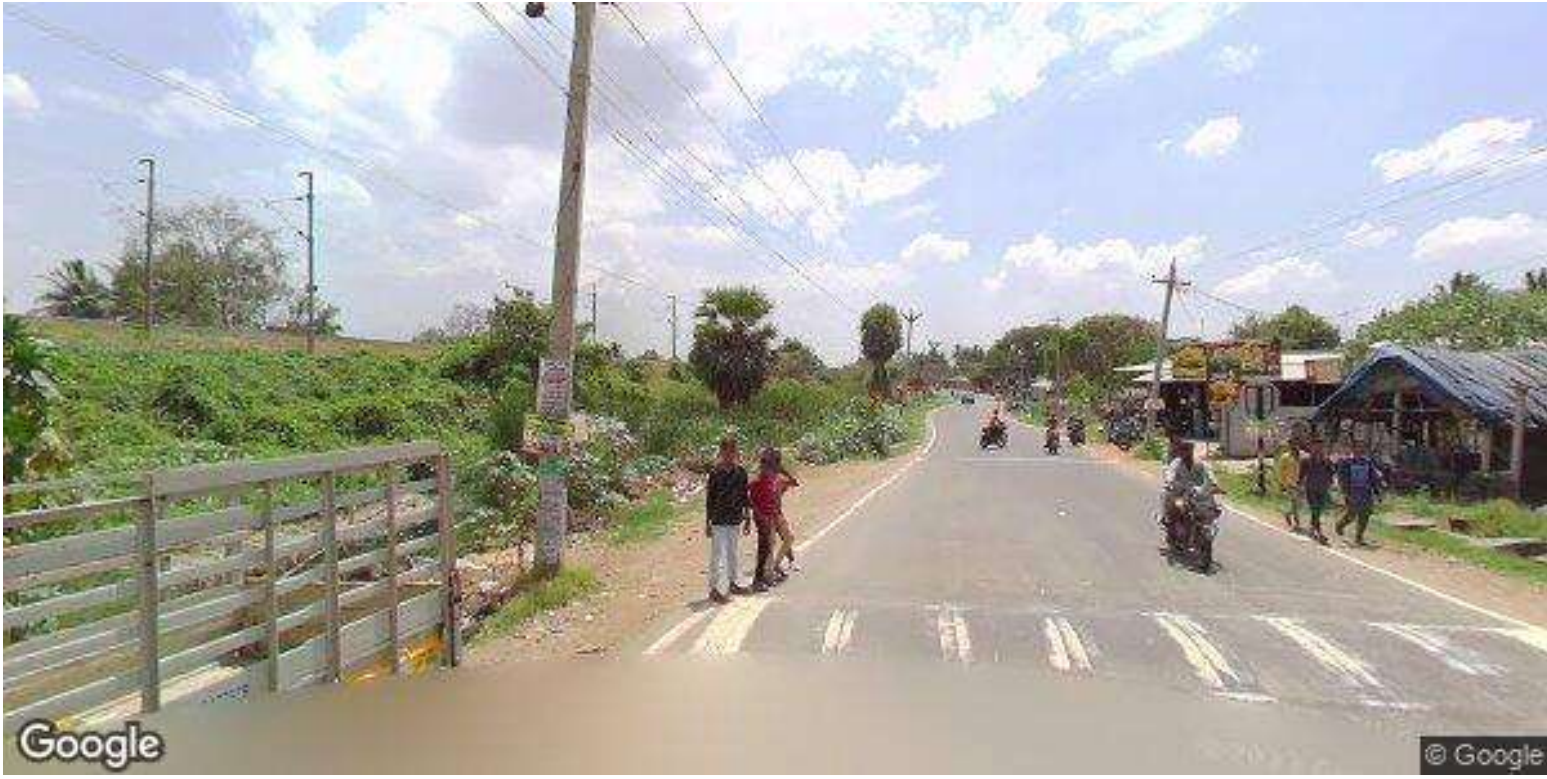
**Risk Type:** Turn  
**Risk Level:** Medium  
**Speed Limit:** 30 KM/Hr  
**Coordinates:** 11.16706, 77.45494
