# IndianOil

## JOURNEY RISK MANAGEMENT (JRM) STUDY

### Salem Terminal to ANDAVAR AGENCIES

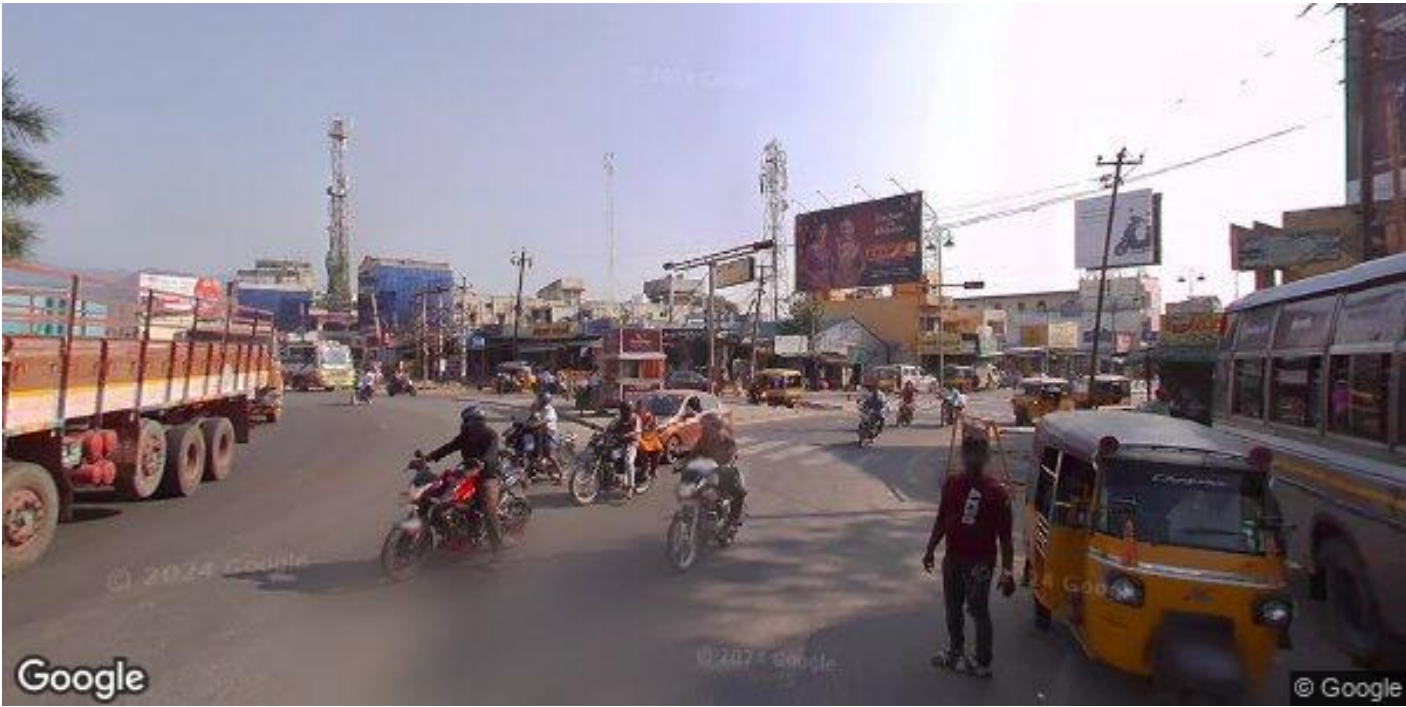
Risk Type: Roundabout

Risk Level: High

Speed Limit: 15 KM/Hr

Coordinates: 11.63266, 78.12699

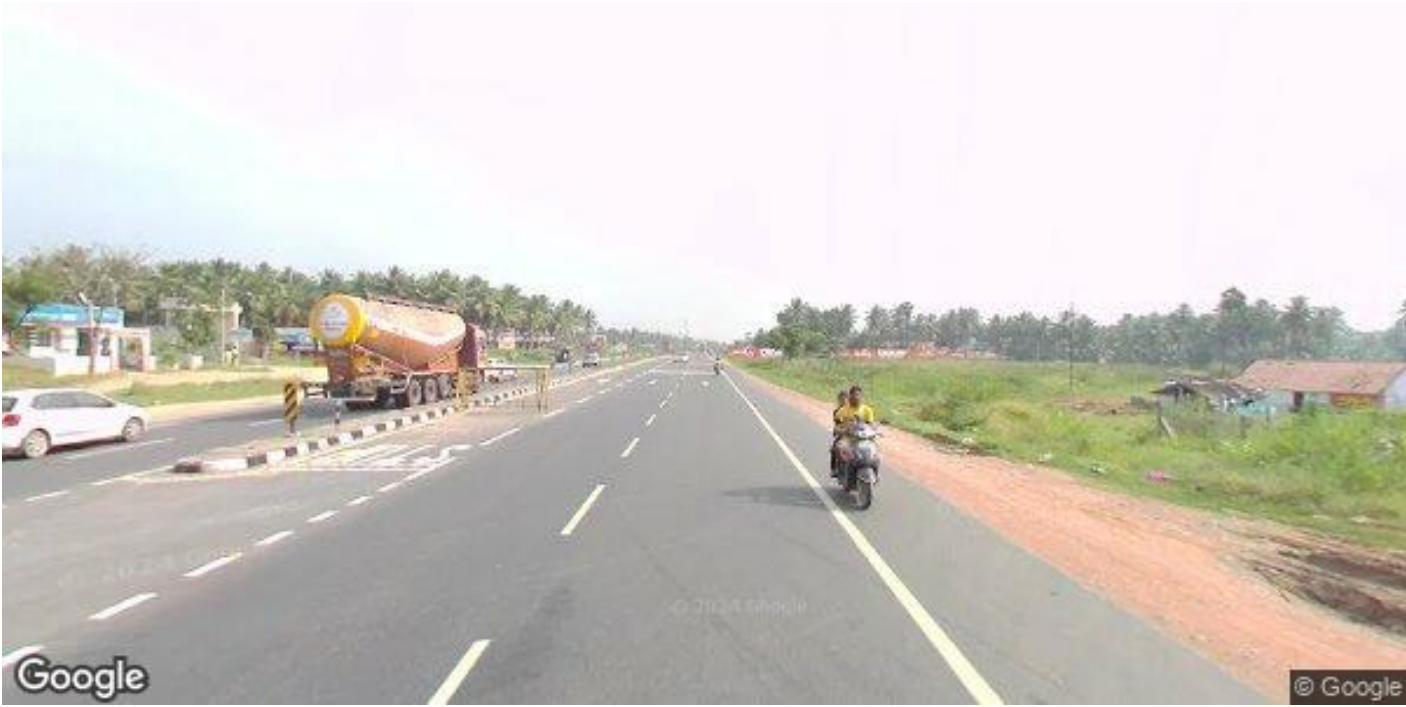
**Risk Type:** U-Turn  
**Risk Level:** High  
**Speed Limit:** 10 KM/Hr  
**Coordinates:** 11.5991031, 78.0887685

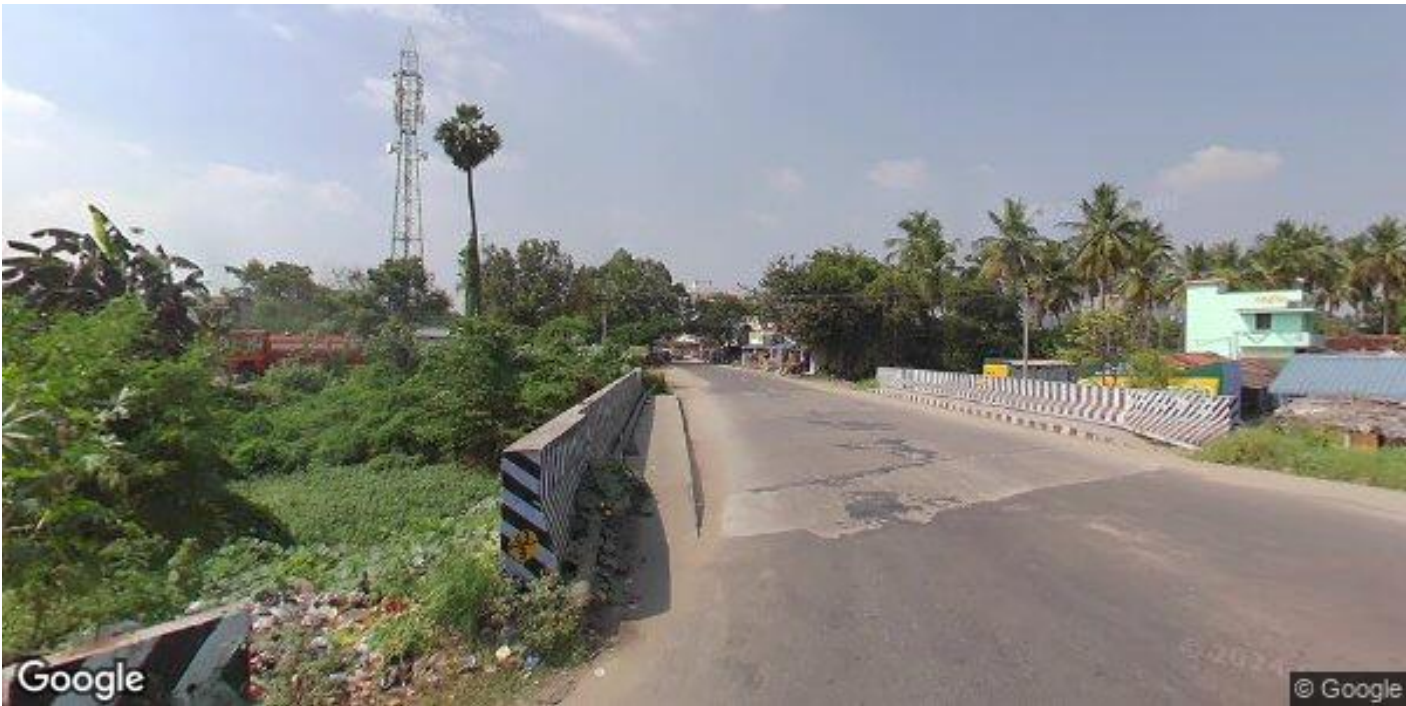
**Risk Type:** Turn  
**Risk Level:** Medium  
**Speed Limit:** 30 KM/Hr  
**Coordinates:** 11.44900, 77.87406

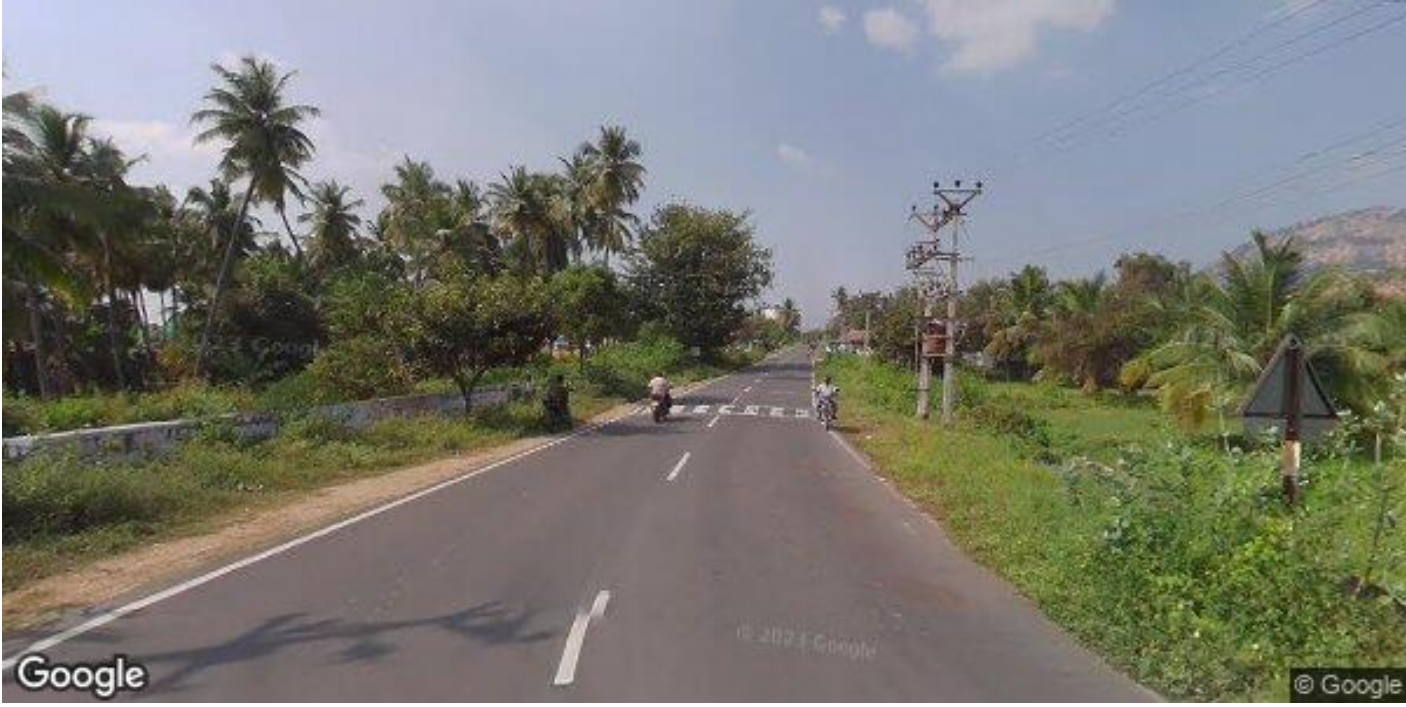
**Risk Type:** Turn  
**Risk Level:** High  
**Speed Limit:** 15 KM/Hr  
**Coordinates:** 11.45353, 77.85697

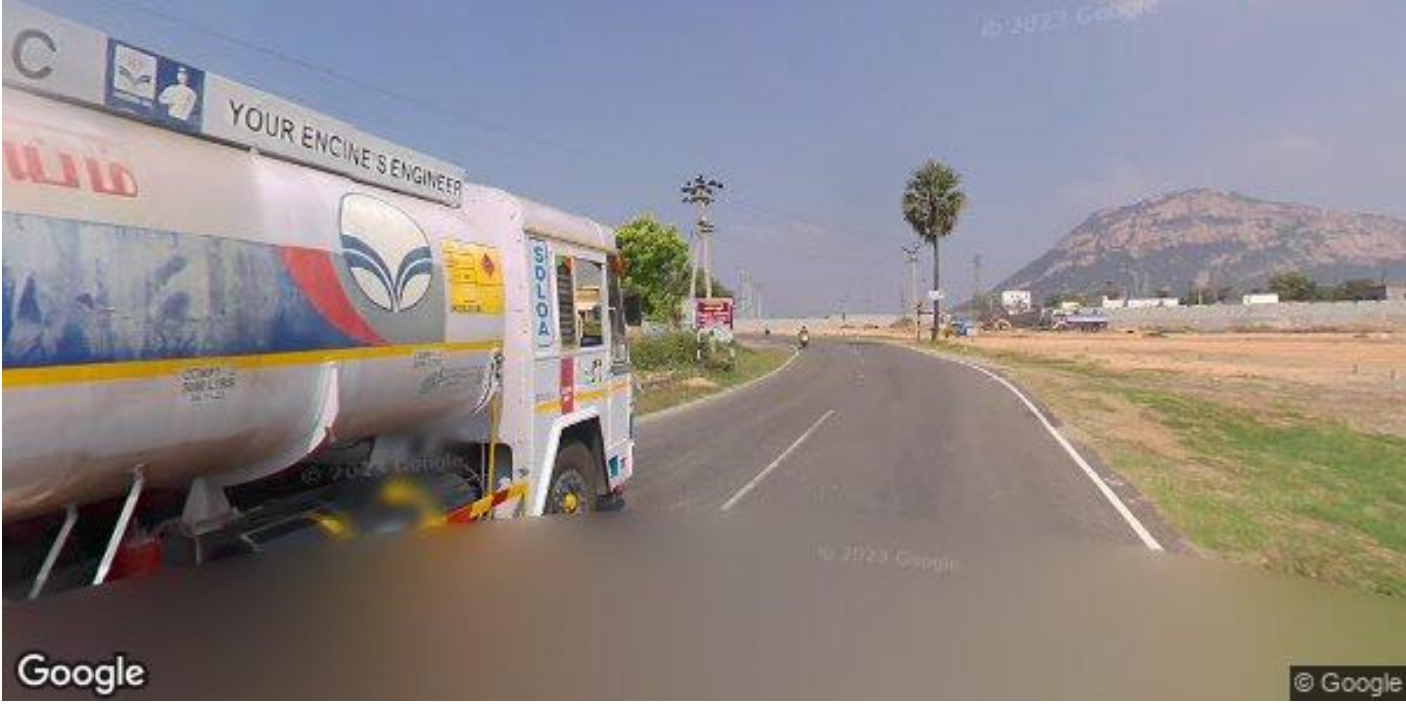
**Risk Type:** Turn  
**Risk Level:** Medium  
**Speed Limit:** 30 KM/Hr  
**Coordinates:** 11.45853, 77.85139

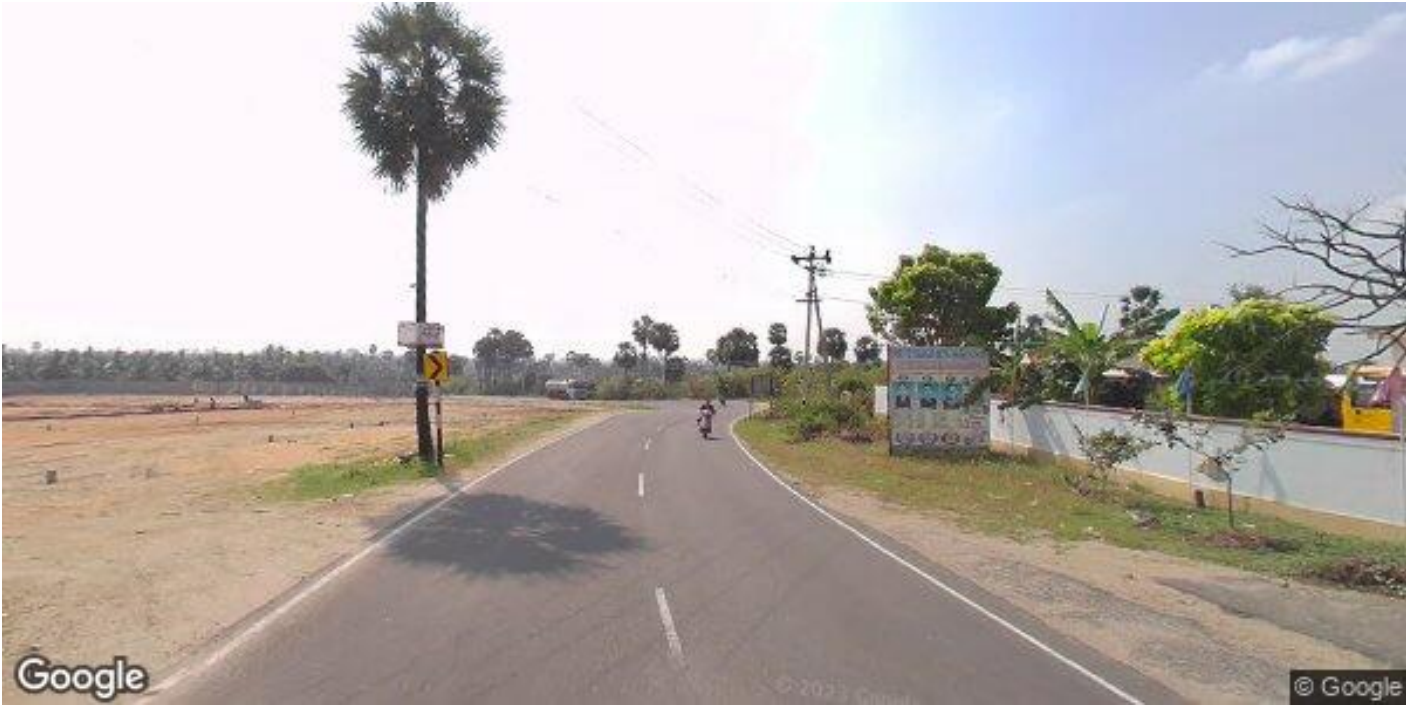
**Risk Type:** Turn  
**Risk Level:** Medium  
**Speed Limit:** 30 KM/Hr  
**Coordinates:** 11.45906, 77.85132

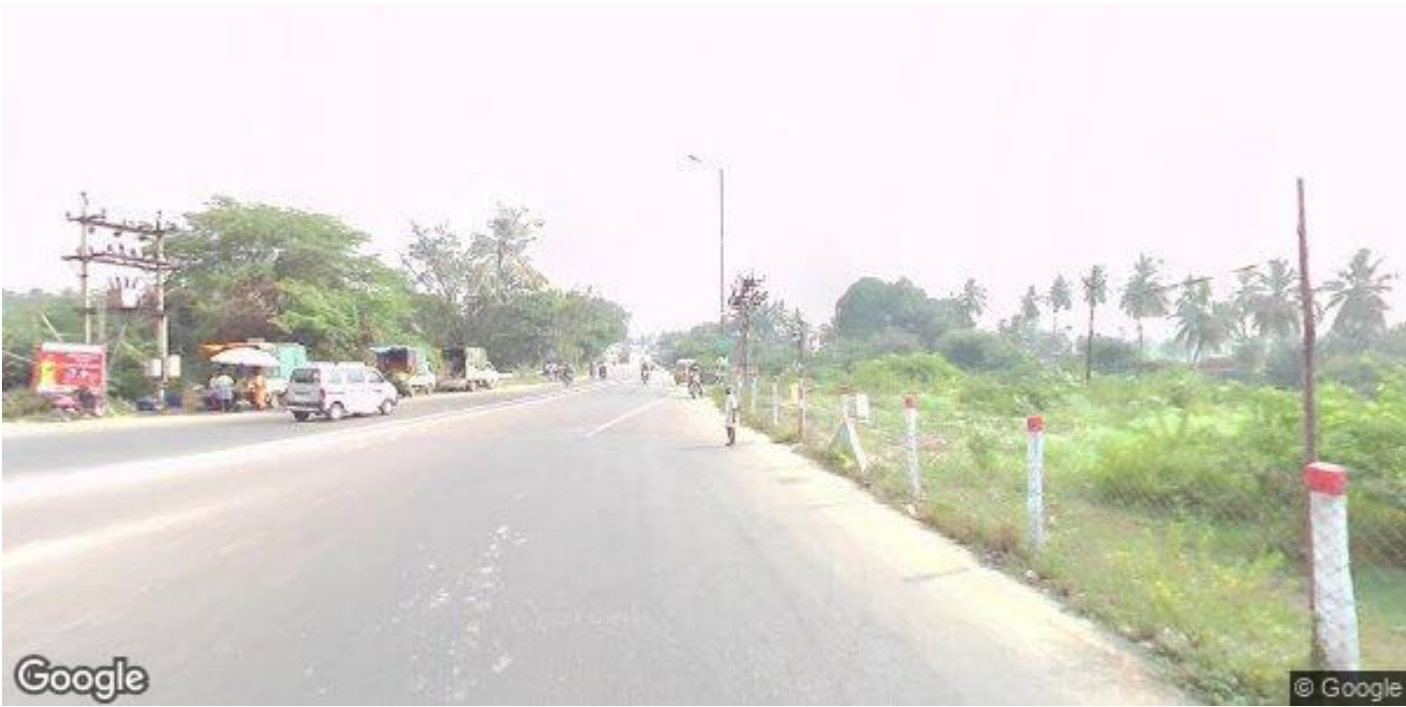
**Risk Type:** Turn  
**Risk Level:** Medium  
**Speed Limit:** 30 KM/Hr  
**Coordinates:** 11.61205, 78.10427

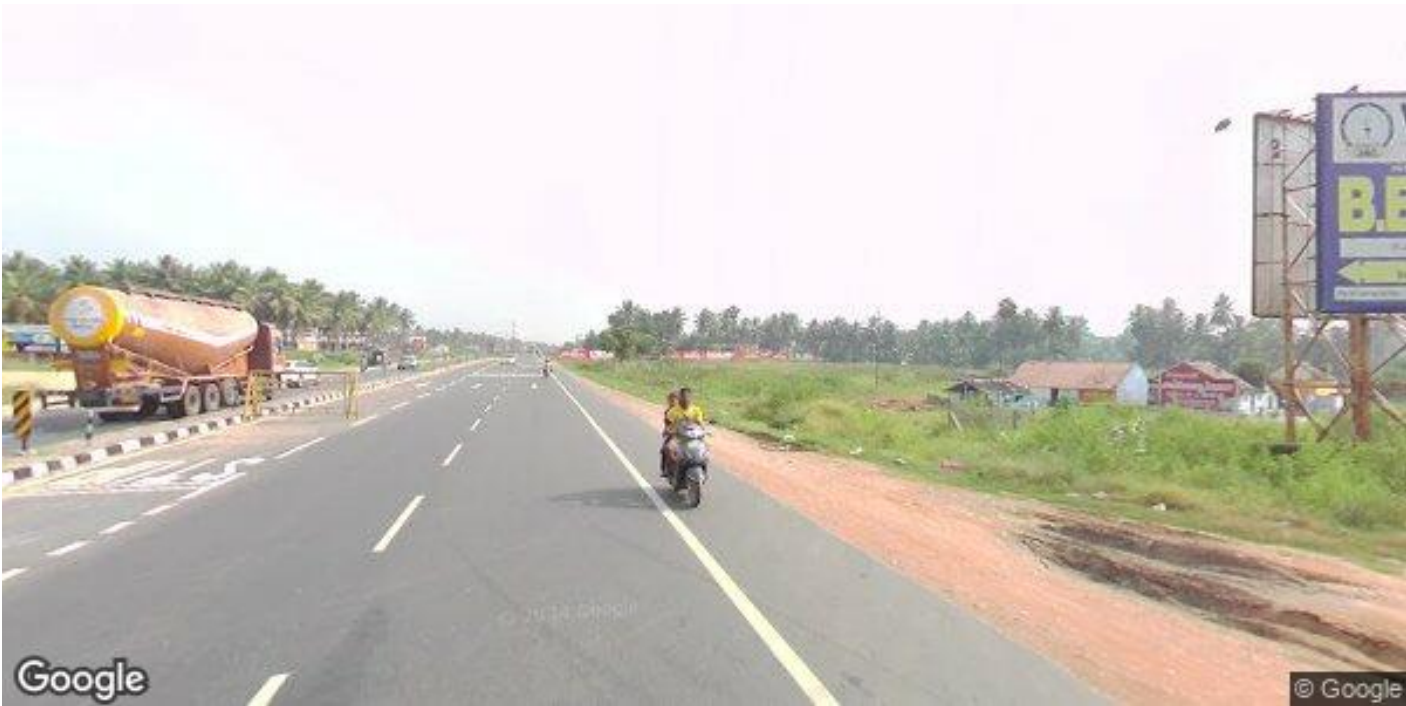
**Risk Type:** Turn  
**Risk Level:** High  
**Speed Limit:** 15 KM/Hr  
**Coordinates:** 11.59910, 78.08877

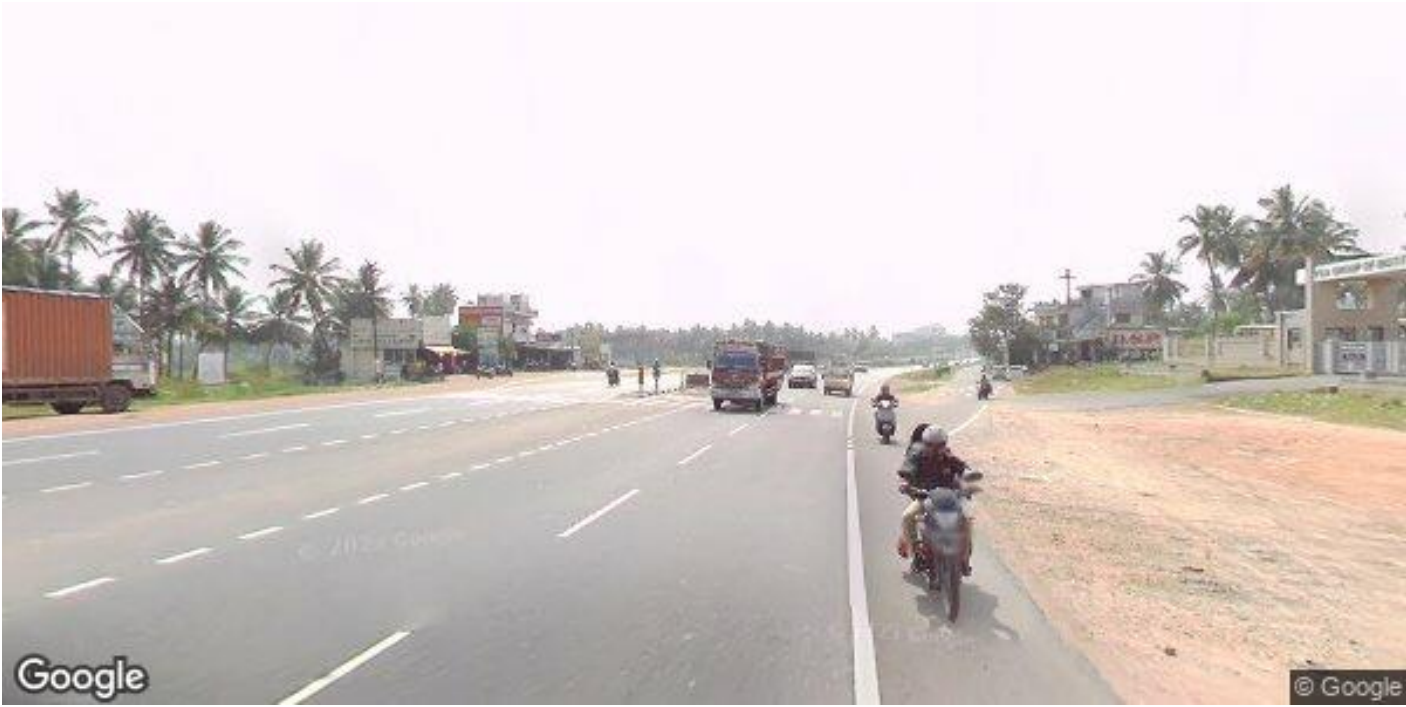
**Risk Type:** Blind Spot  
**Risk Level:** Blind Spot  
**Speed Limit:** 10 KM/Hr  
**Coordinates:** 11.59918, 78.08868

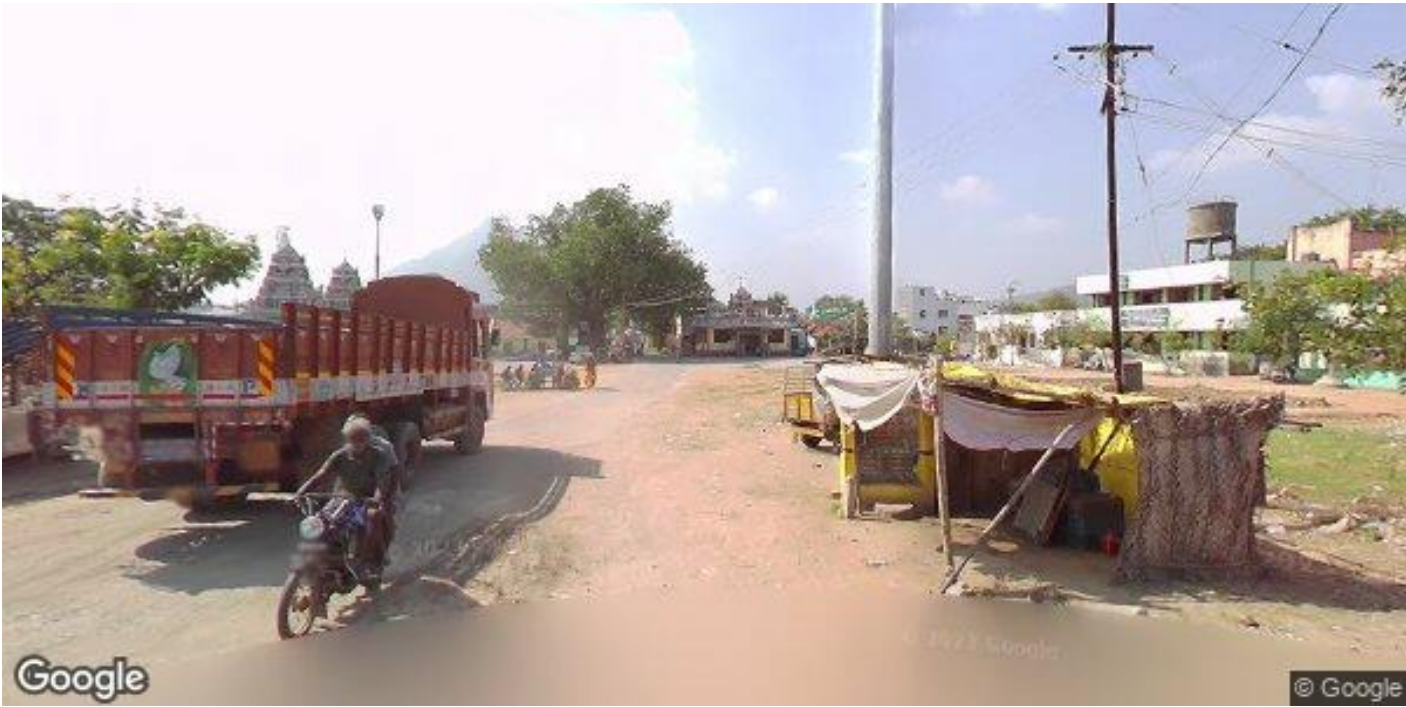
**Risk Type:** Blind Spot  
**Risk Level:** Blind Spot  
**Speed Limit:** 10 KM/Hr  
**Coordinates:** 11.62145, 78.10740

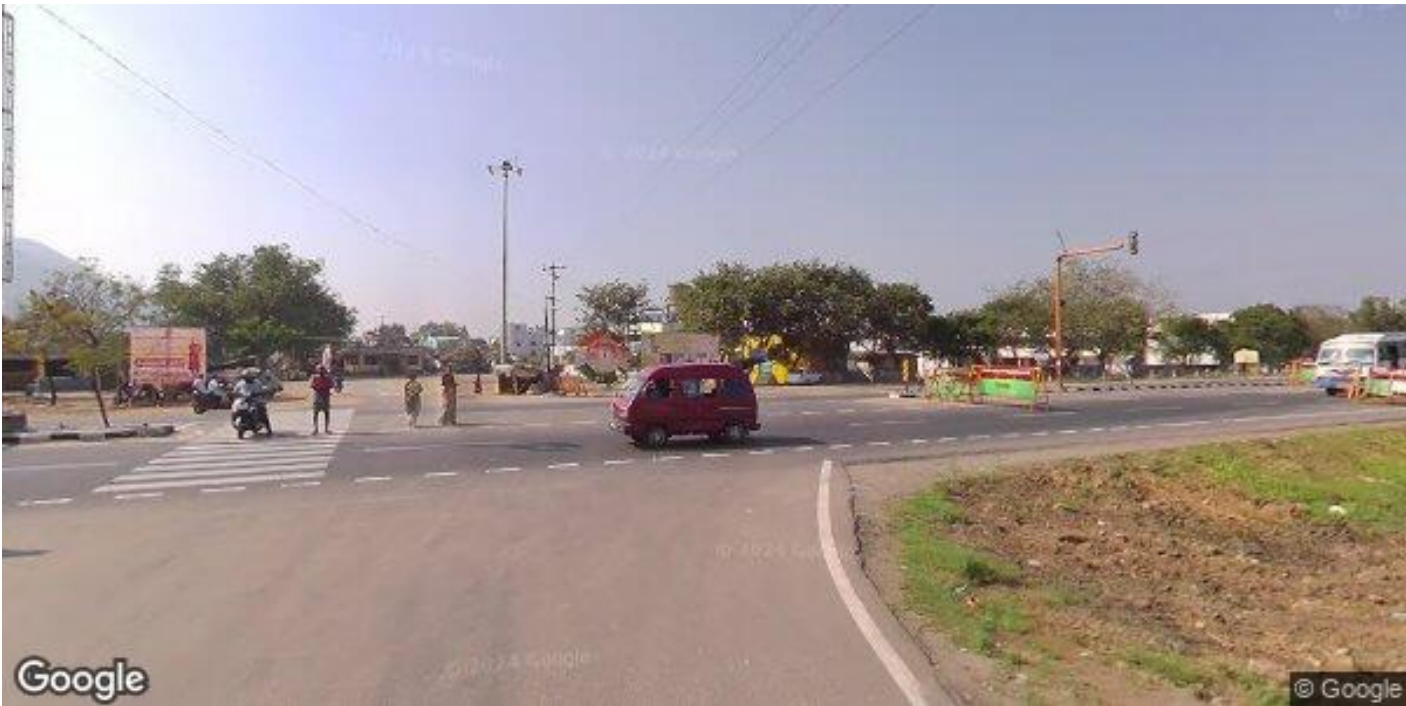
**Risk Type:** Turn  
**Risk Level:** High  
**Speed Limit:** 15 KM/Hr  
**Coordinates:** 11.62130, 78.10776

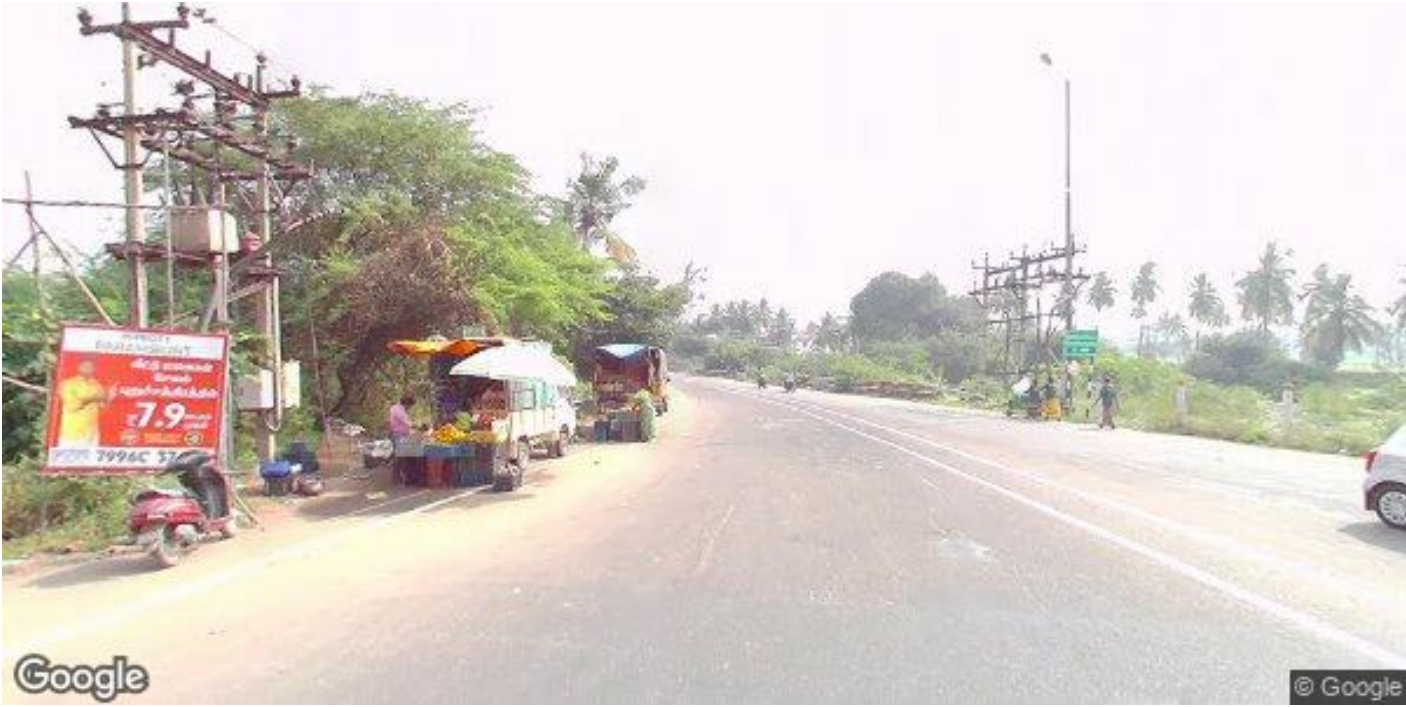
**Risk Type:** Blind Spot  
**Risk Level:** Blind Spot  
**Speed Limit:** 10 KM/Hr  
**Coordinates:** 11.61217, 78.10439

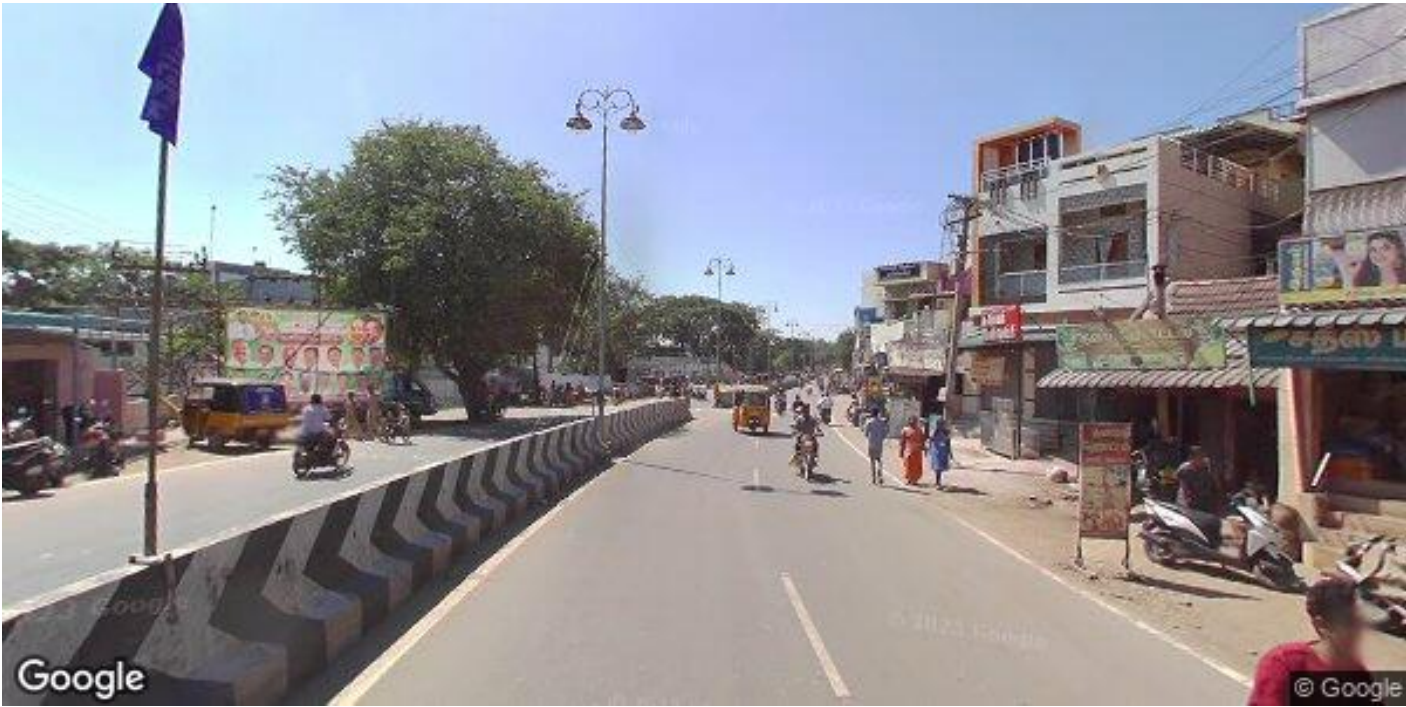
**Risk Type:** Turn  
**Risk Level:** Medium  
**Speed Limit:** 30 KM/Hr  
**Coordinates:** 11.62498, 78.12011

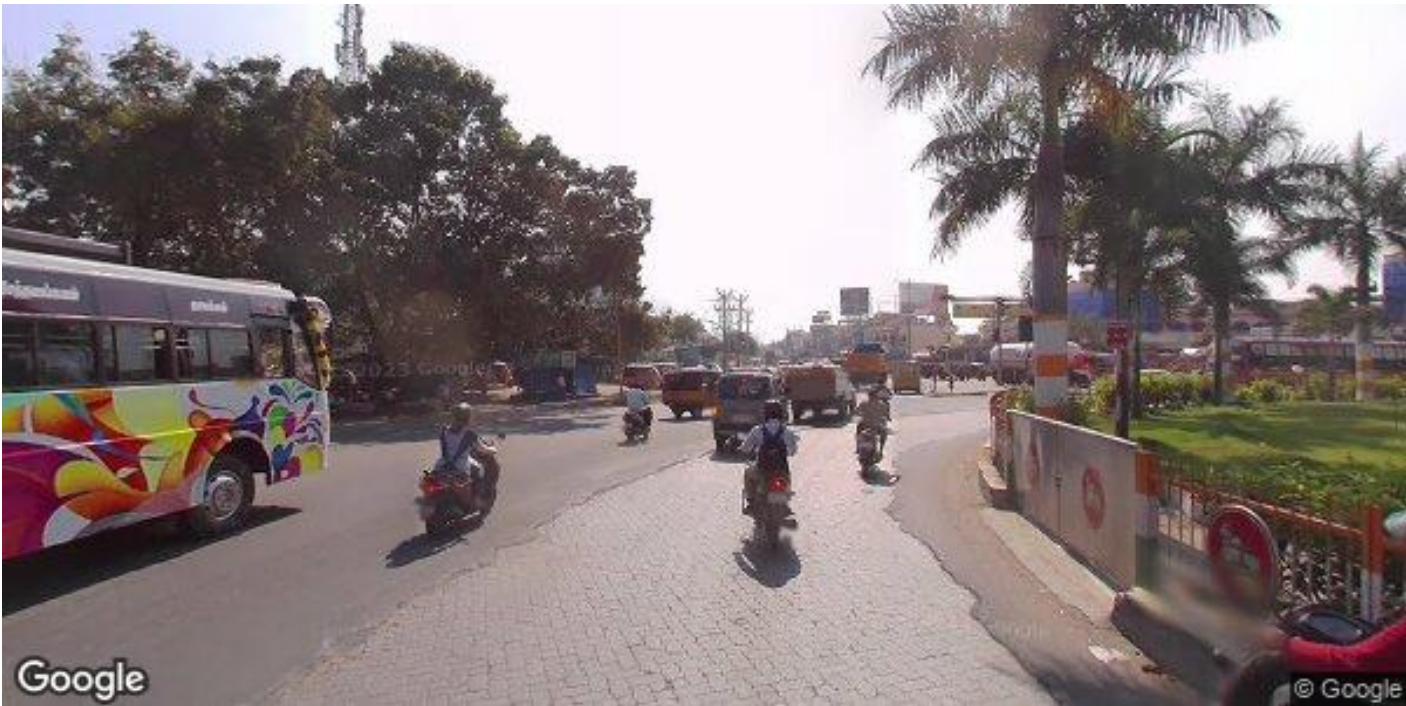
**Risk Type:** Turn  
**Risk Level:** High  
**Speed Limit:** 15 KM/Hr  
**Coordinates:** 11.63297, 78.12749

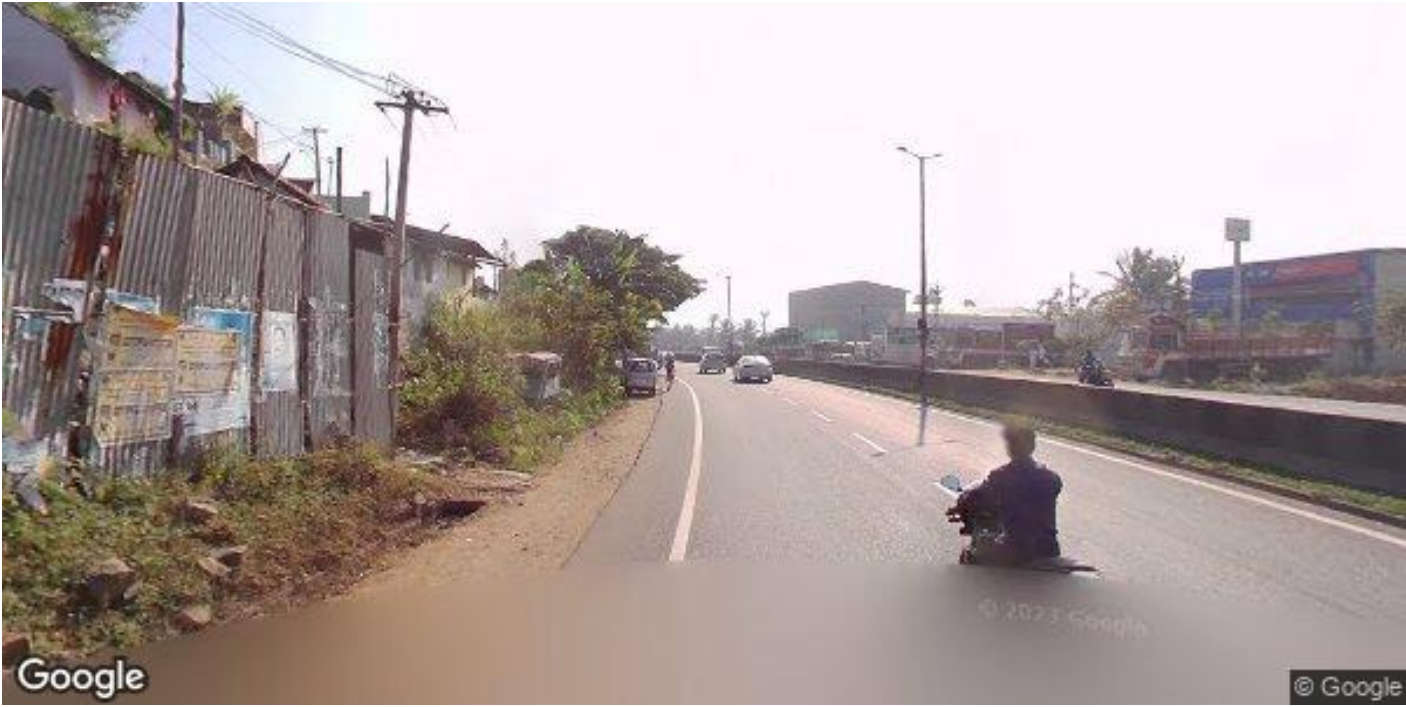
**Risk Type:** Turn  
**Risk Level:** Medium  
**Speed Limit:** 30 KM/Hr  
**Coordinates:** 11.62826, 78.13337

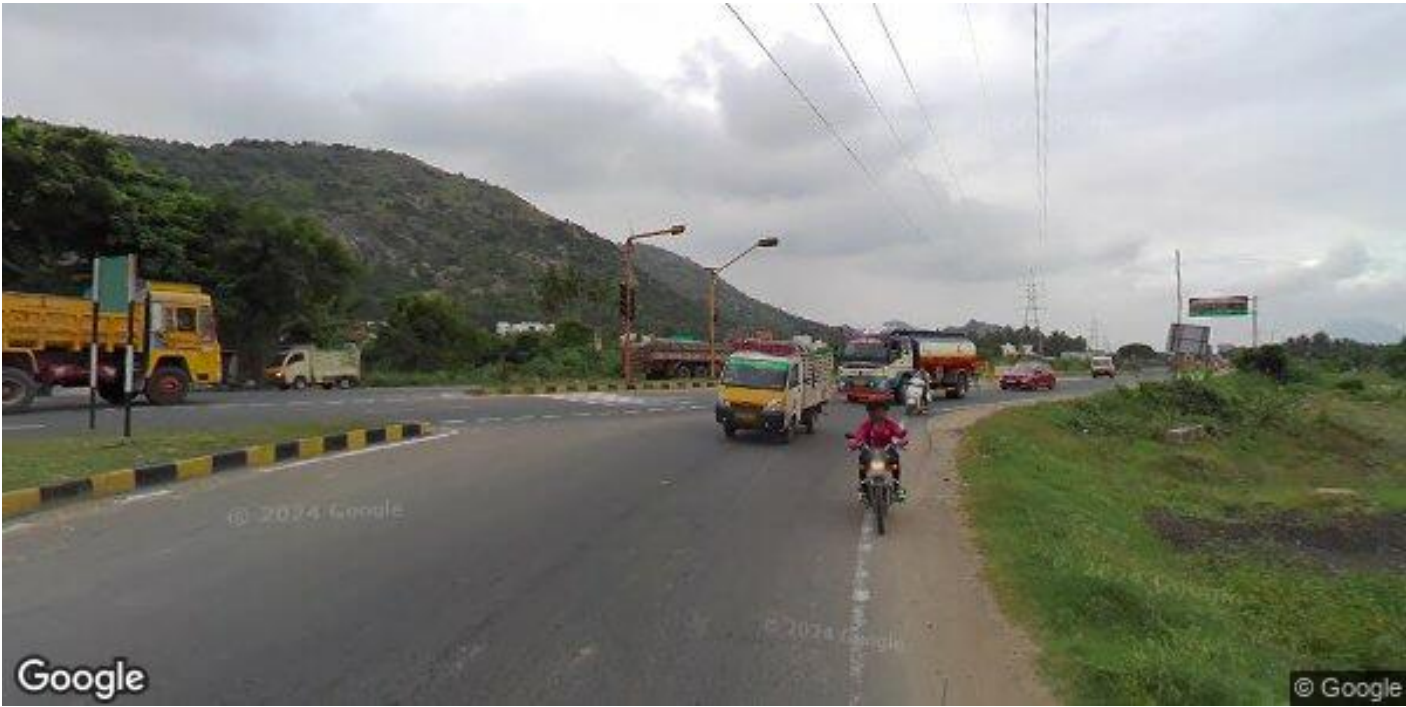
**Risk Type:** Turn  
**Risk Level:** Medium  
**Speed Limit:** 30 KM/Hr  
**Coordinates:** 11.65632, 78.20220

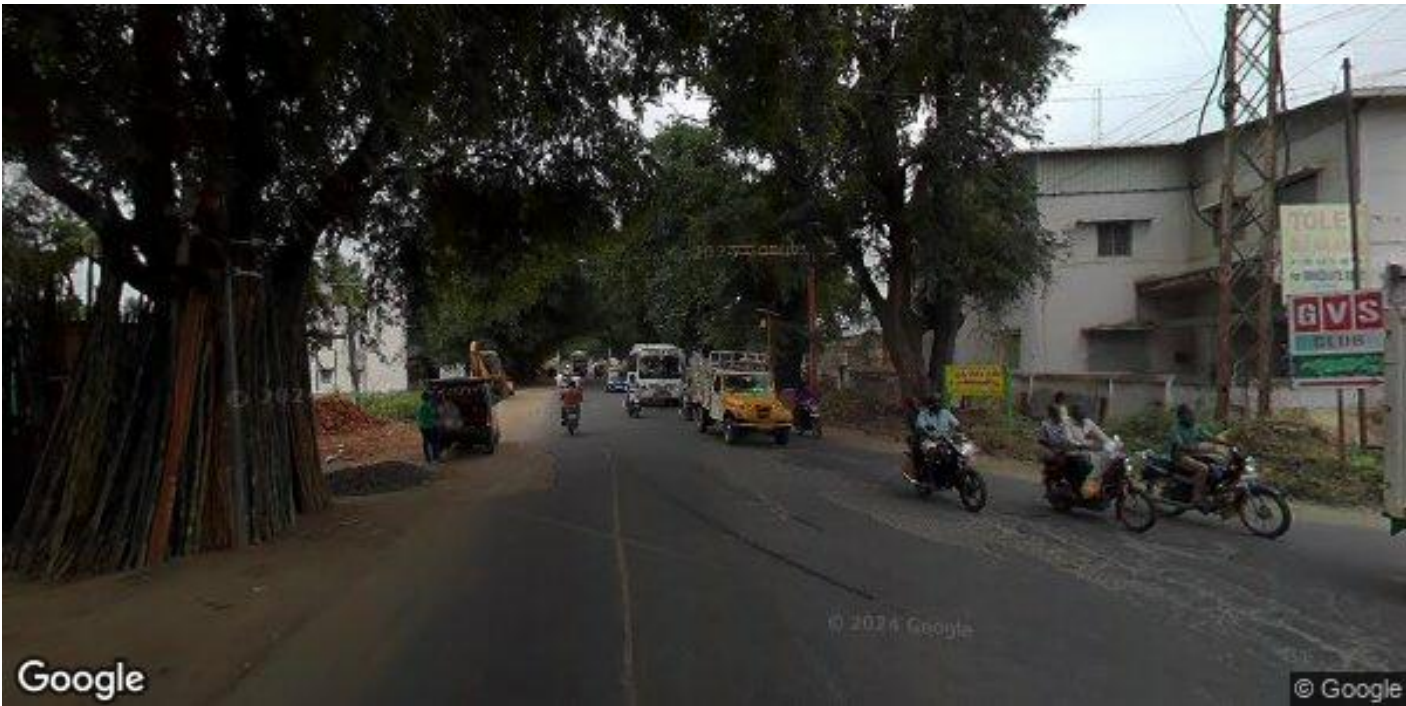
**Risk Type:** Turn  
**Risk Level:** High  
**Speed Limit:** 15 KM/Hr  
**Coordinates:** 11.66380, 78.20648

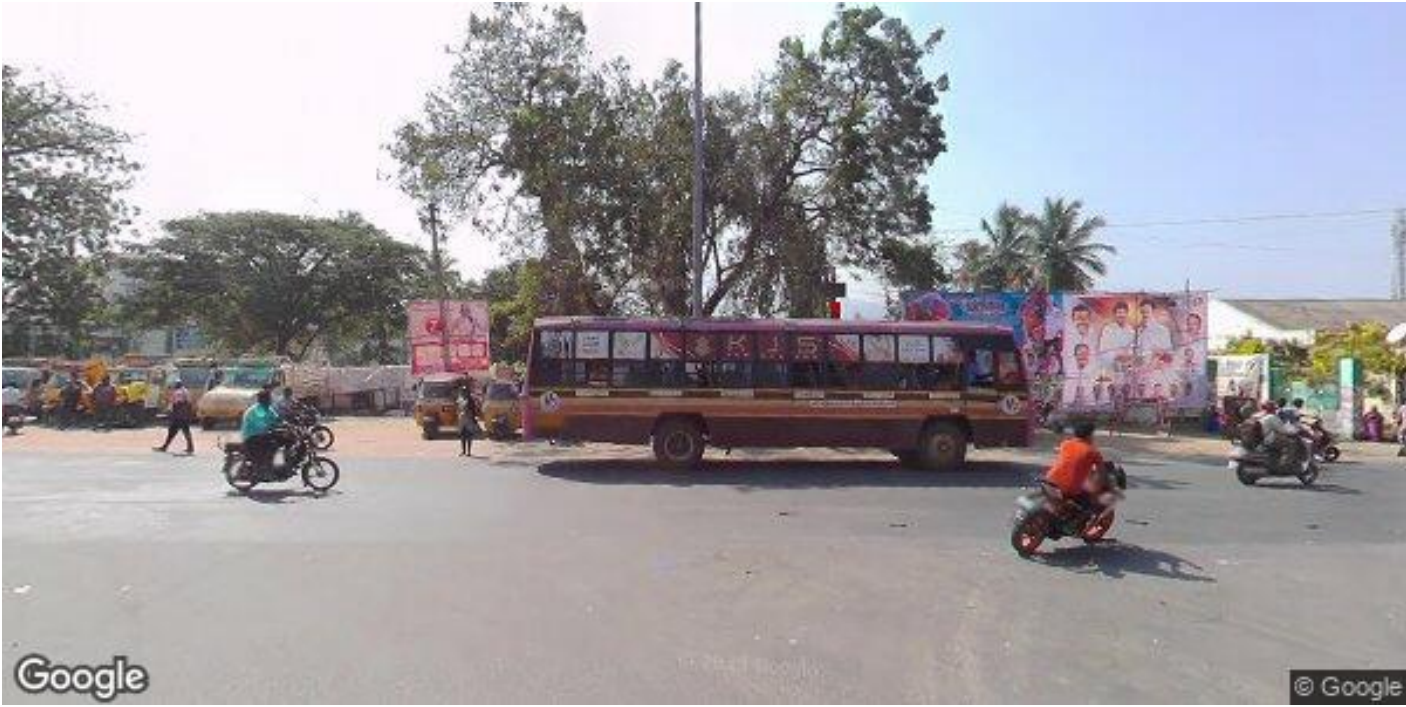
**Risk Type:** Turn  
**Risk Level:** High  
**Speed Limit:** 15 KM/Hr  
**Coordinates:** 11.67120, 78.23136

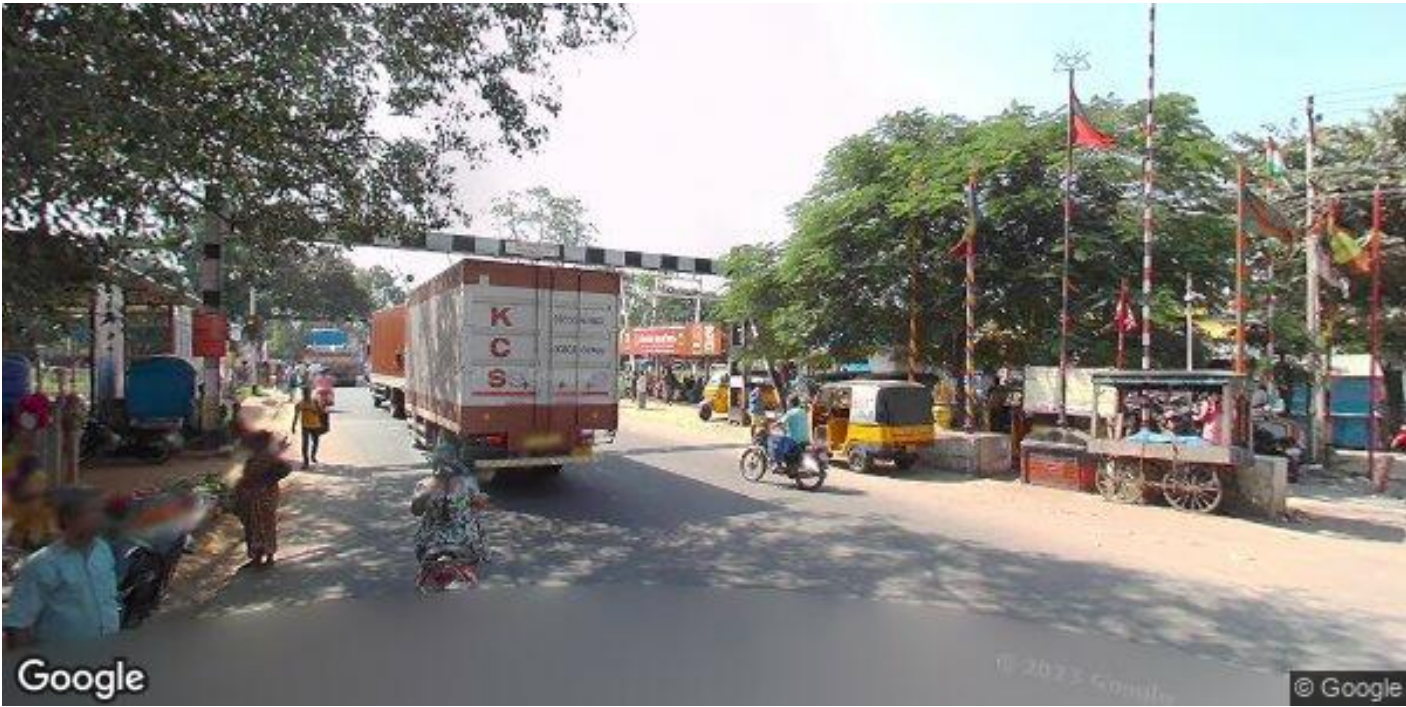
**Risk Type:** Turn  
**Risk Level:** Medium  
**Speed Limit:** 30 KM/Hr  
**Coordinates:** 11.67190, 78.23144

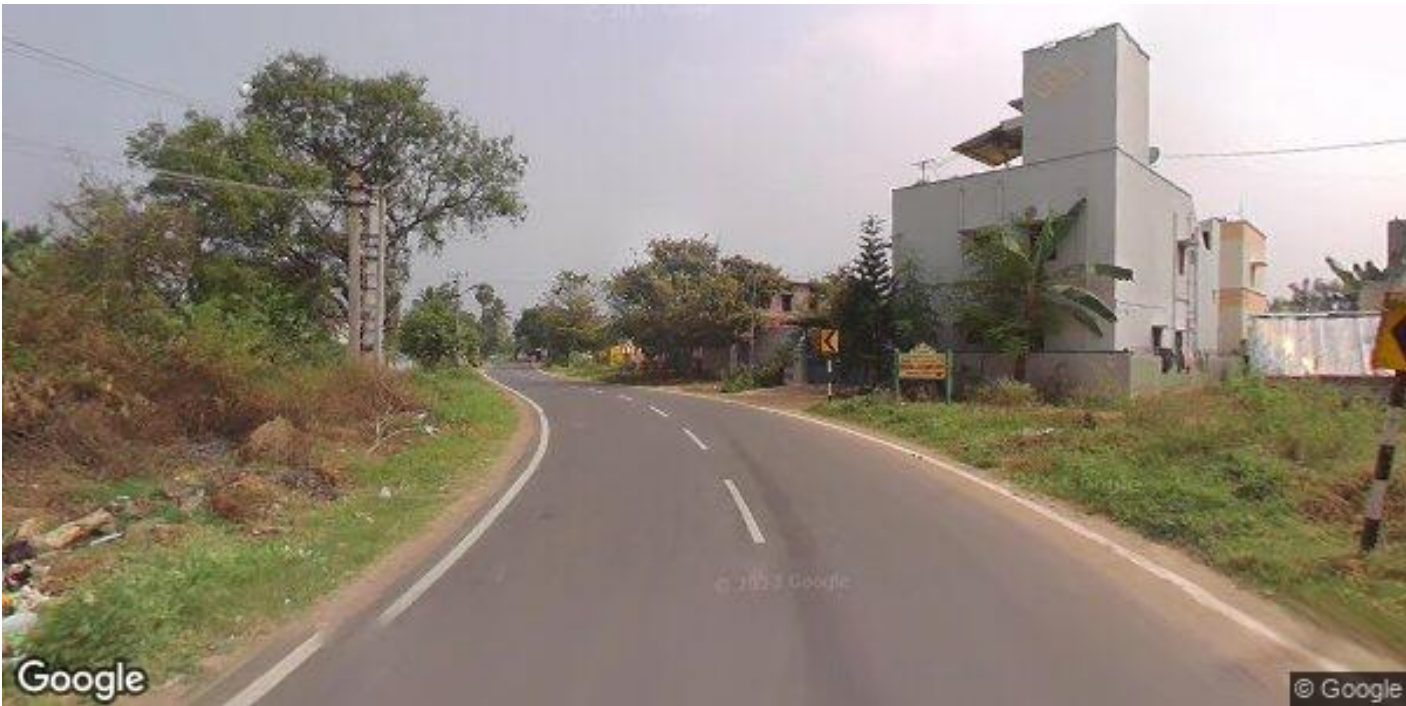
**Risk Type:** Turn  
**Risk Level:** Medium  
**Speed Limit:** 30 KM/Hr  
**Coordinates:** 11.67672, 78.24922

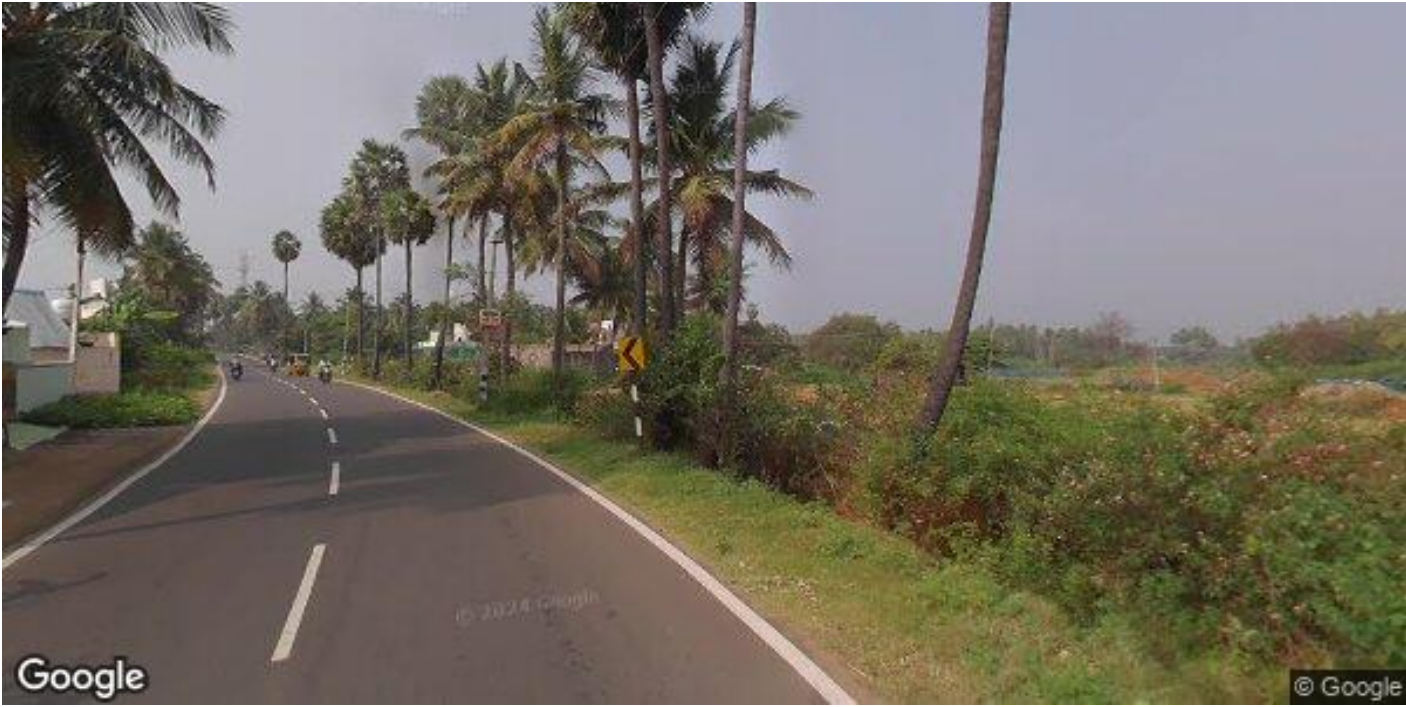
**Risk Type:** Turn  
**Risk Level:** Medium  
**Speed Limit:** 30 KM/Hr  
**Coordinates:** 11.67944, 78.25198

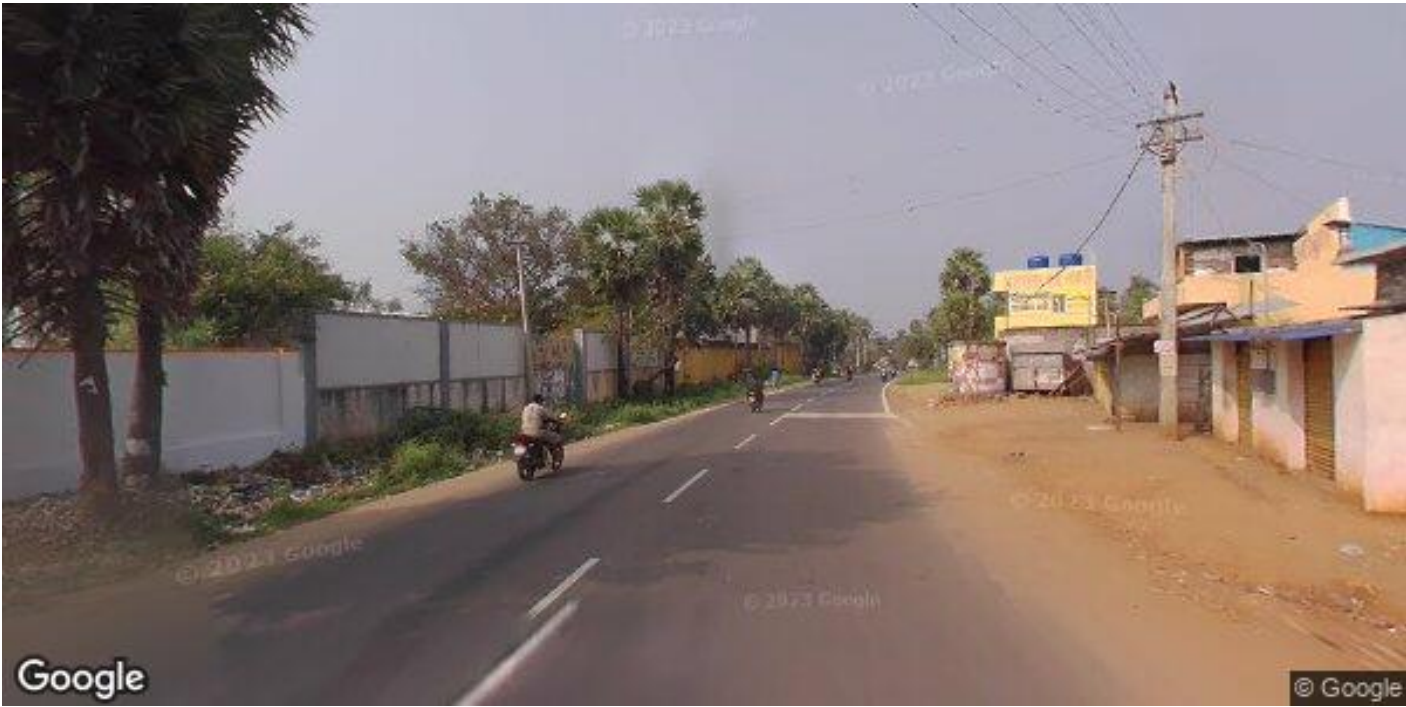
**Risk Type:** Turn  
**Risk Level:** Medium  
**Speed Limit:** 30 KM/Hr  
**Coordinates:** 11.68547, 78.26757
