## JOURNEY RISK MANAGEMENT (JRM) STUDY

### Salem Terminal TO BALAKRISHNA AGENCIES

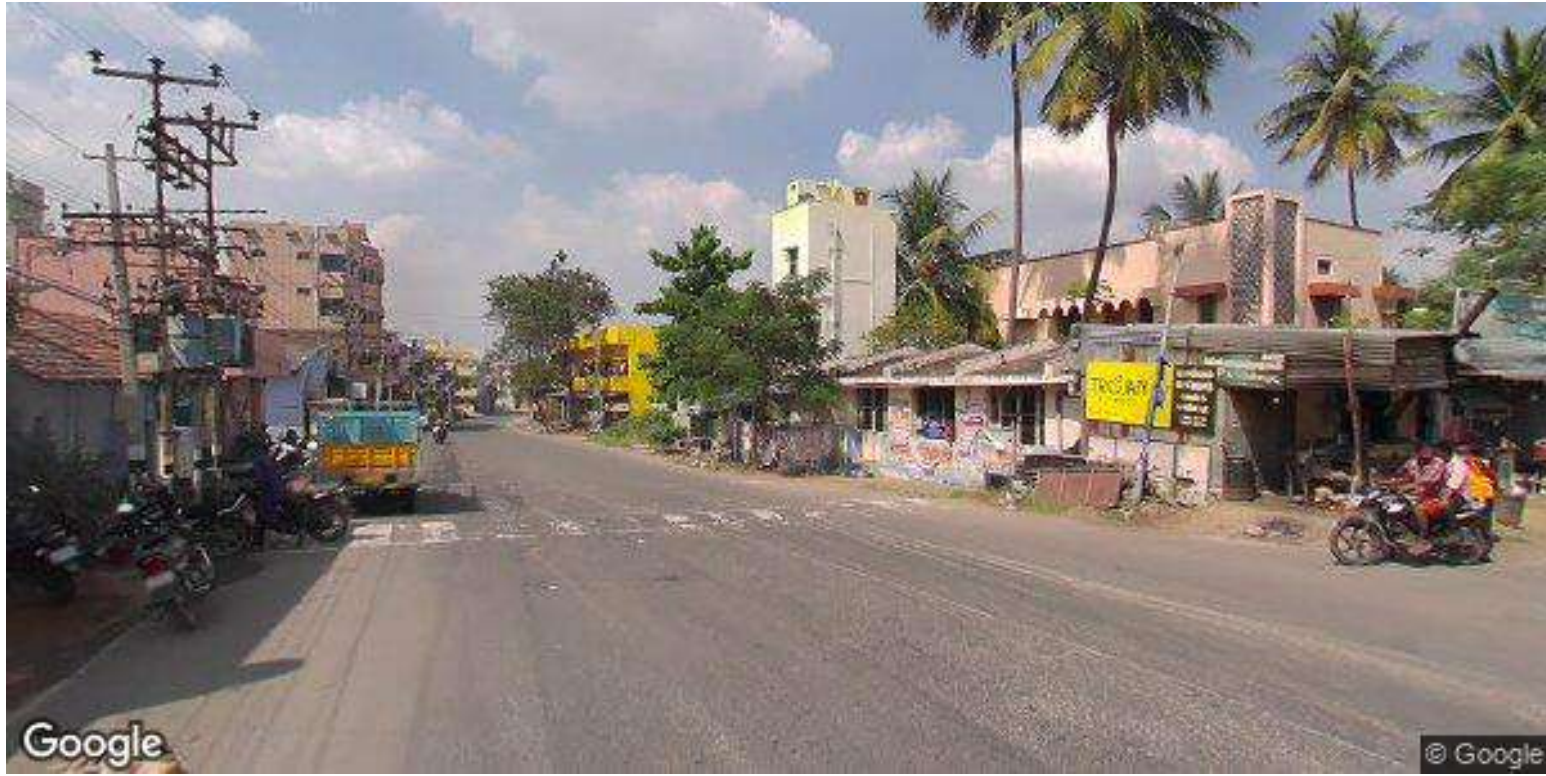
**Coordinates: 11.38190, 77.90254**

**Risk Type: Turn**

**Risk Level: Medium**

**Speed Limit: 30 KM/Hr**

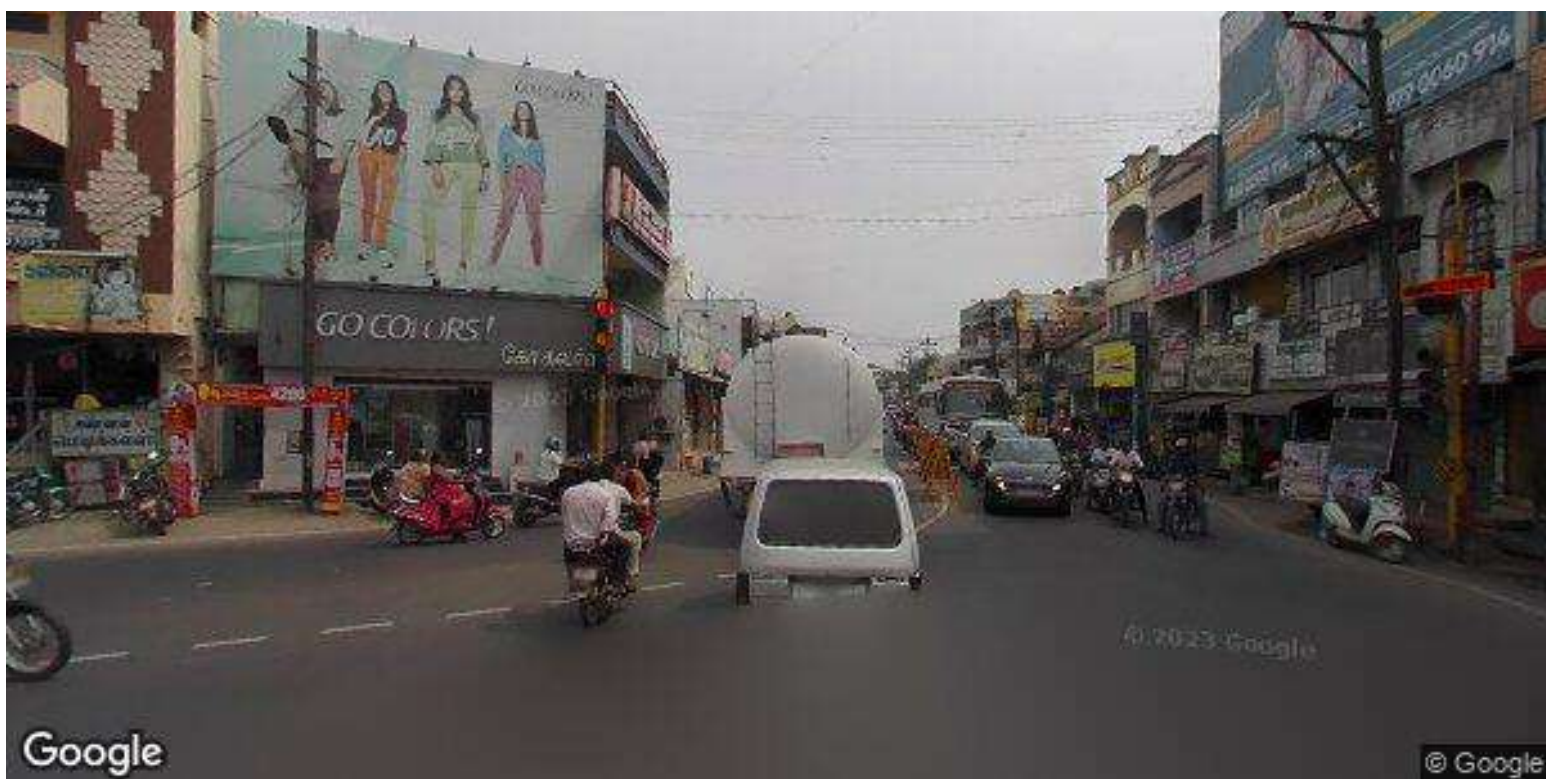
**Coordinates:** 11.22546, 78.16416

**Risk Type:** Blind Spot

**Risk Level:** Blind Spot

**Speed Limit:** 10 KM/Hr
