## JOURNEY RISK MANAGEMENT (JRM) STUDY

### Salem Terminal TO VIJAY TRADERS

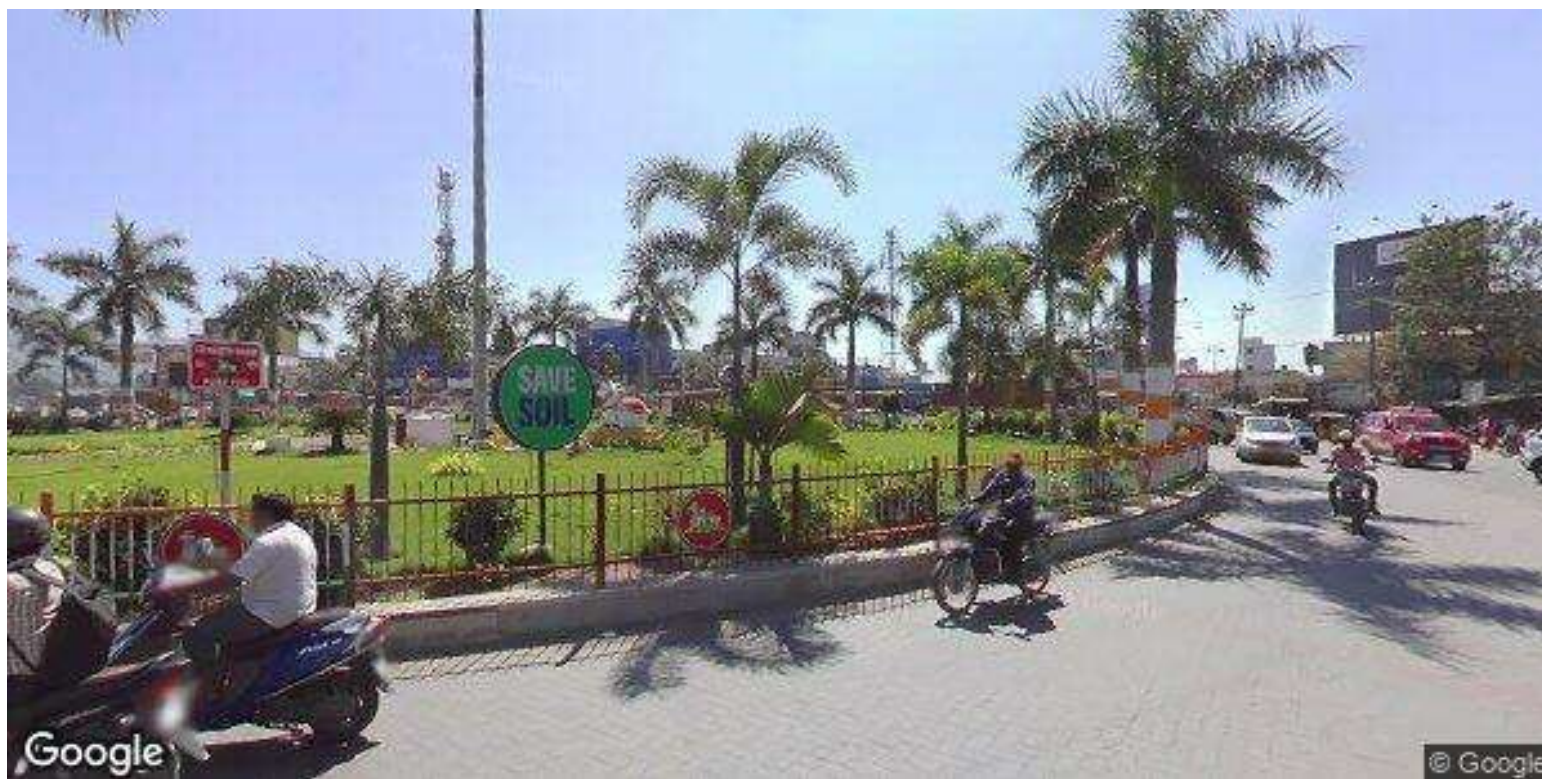
**Coordinates: 11.63303, 78.12713**

**Risk Type: Roundabout**

**Risk Level: High**

**Speed Limit: 15 KM/Hr**

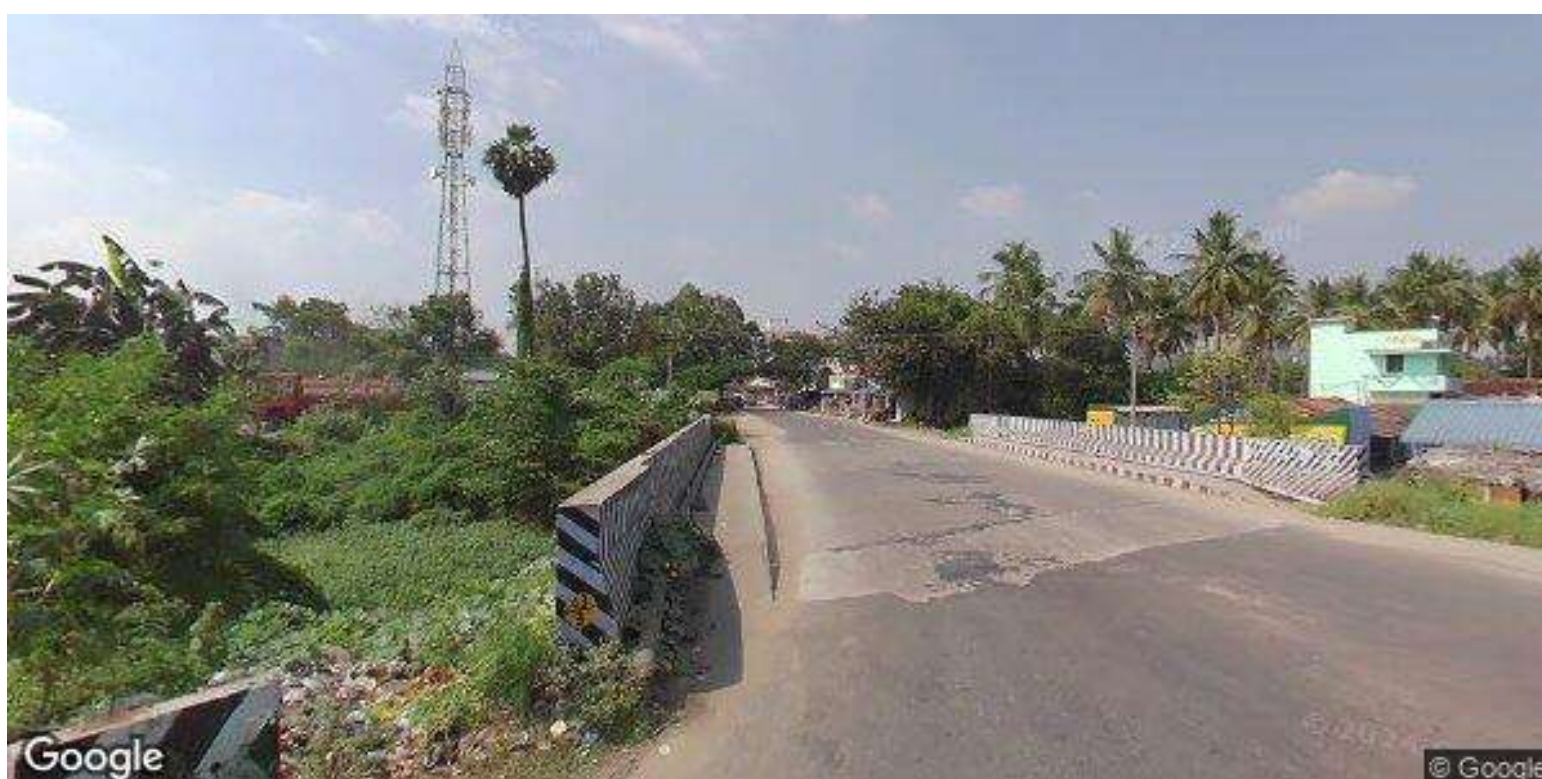
Coordinates: 11.44900, 77.87406

Risk Type: Turn

Risk Level: Medium

Speed Limit: 30 KM/Hr

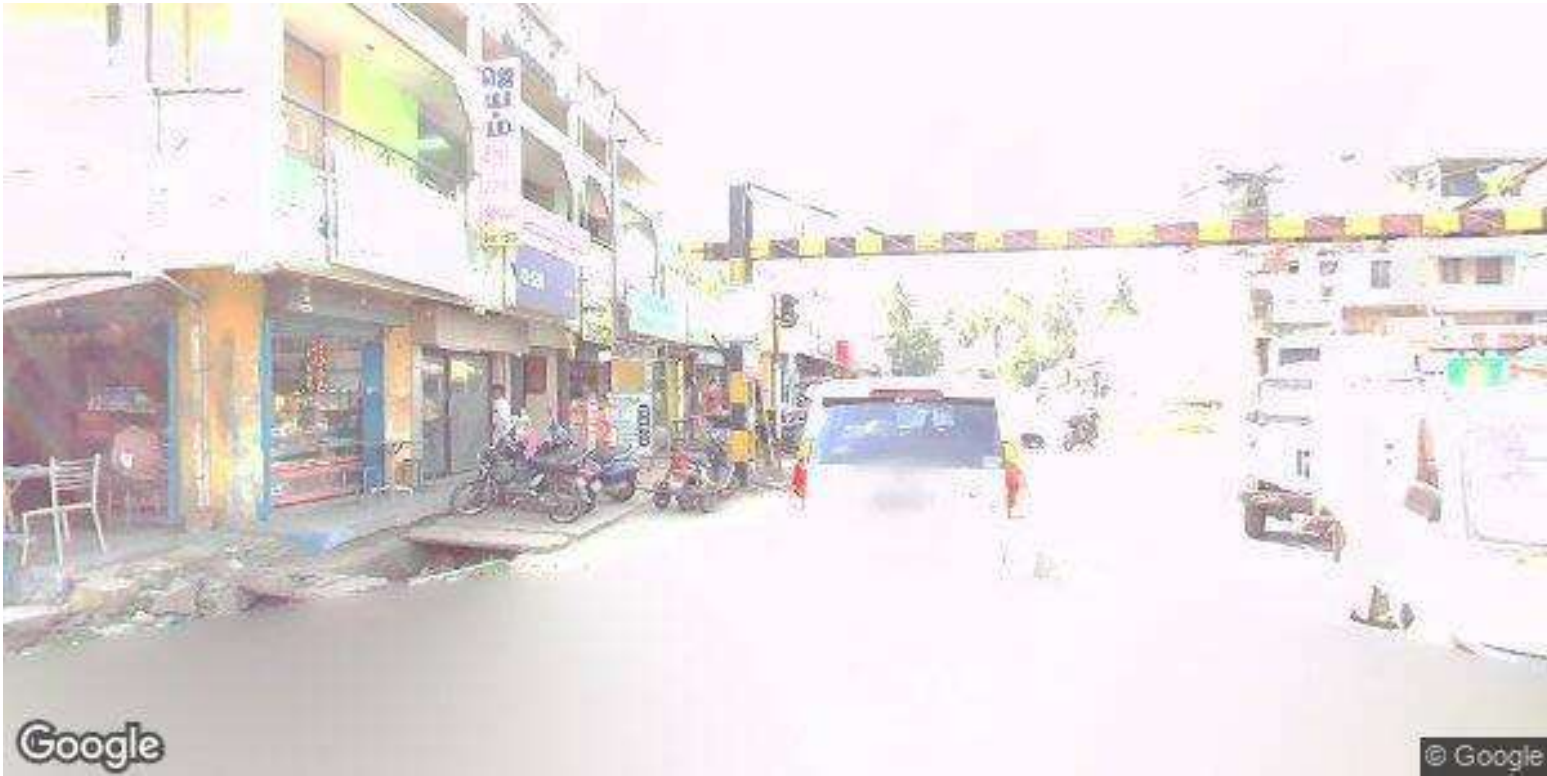
Coordinates: 11.45000, 77.87213

Risk Type: Turn

Risk Level: Medium

Speed Limit: 30 KM/Hr

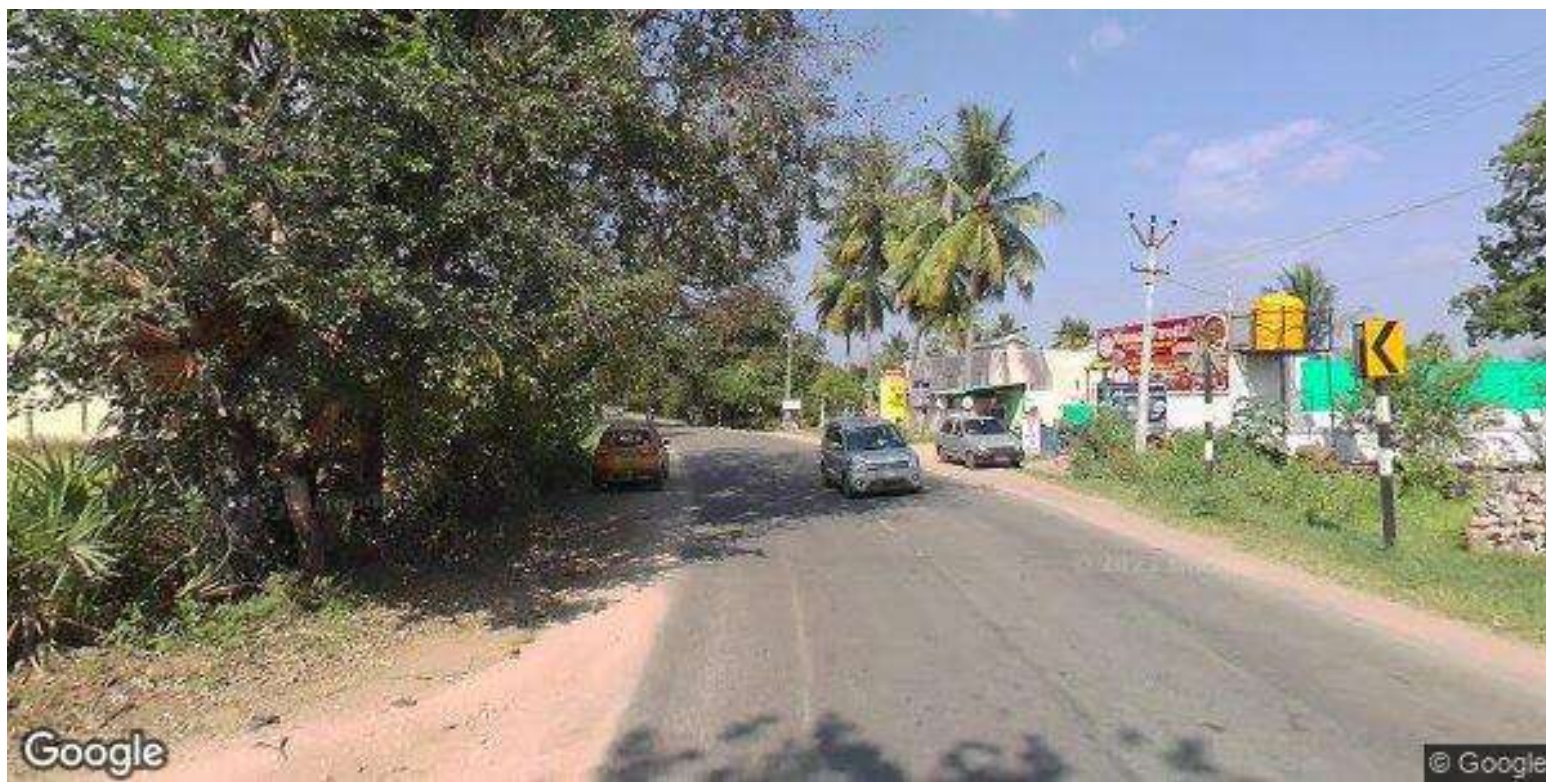
**Coordinates: 11.45309, 77.87325**

**Risk Type: Turn**

**Risk Level: Medium**

**Speed Limit: 30 KM/Hr**

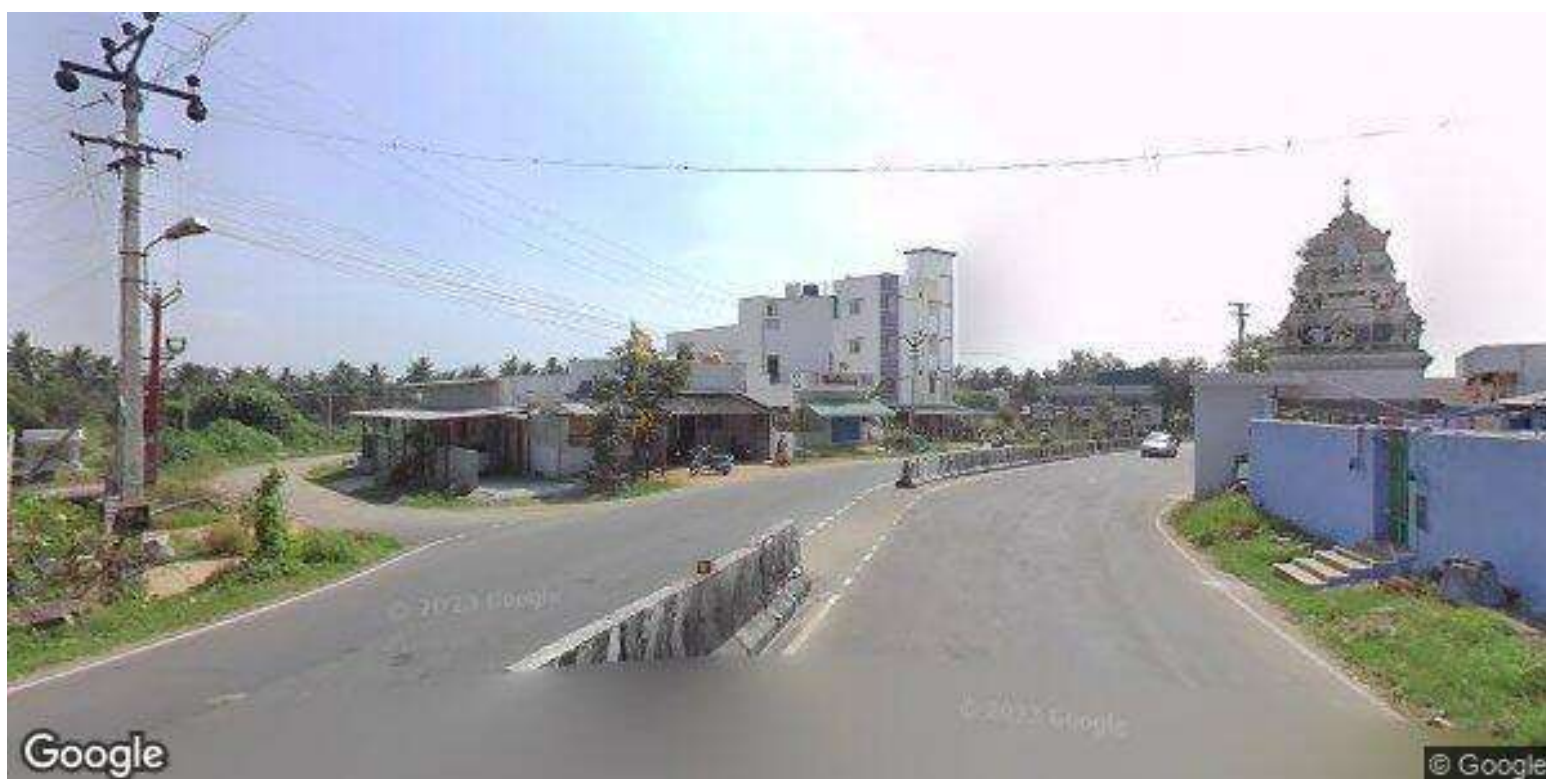
**Coordinates: 11.46400, 77.87323**

**Risk Type: Turn**

**Risk Level: Medium**

**Speed Limit: 30 KM/Hr**

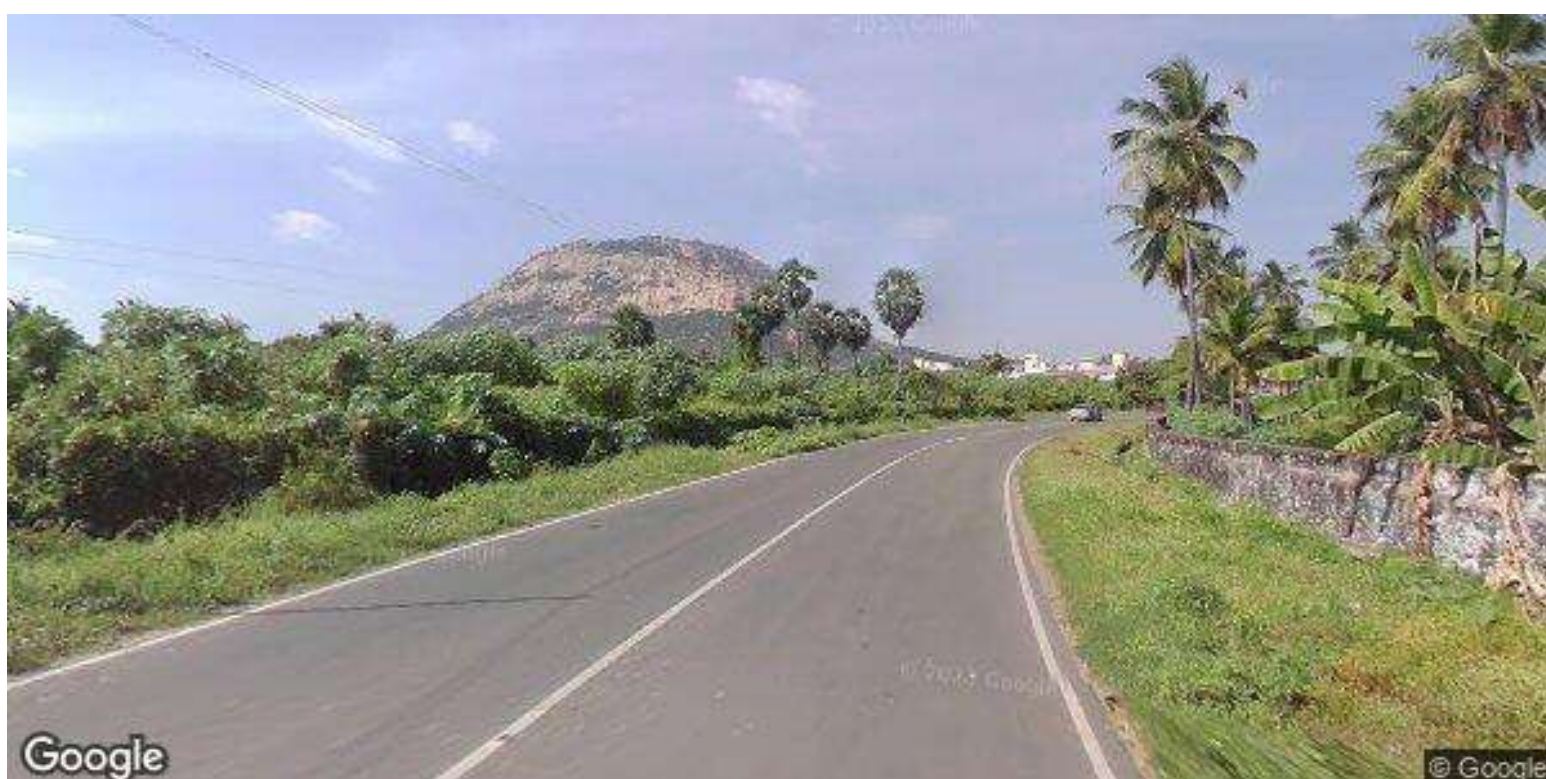
Coordinates: 11.46765, 77.87037

Risk Type: Turn

Risk Level: Medium

Speed Limit: 30 KM/Hr

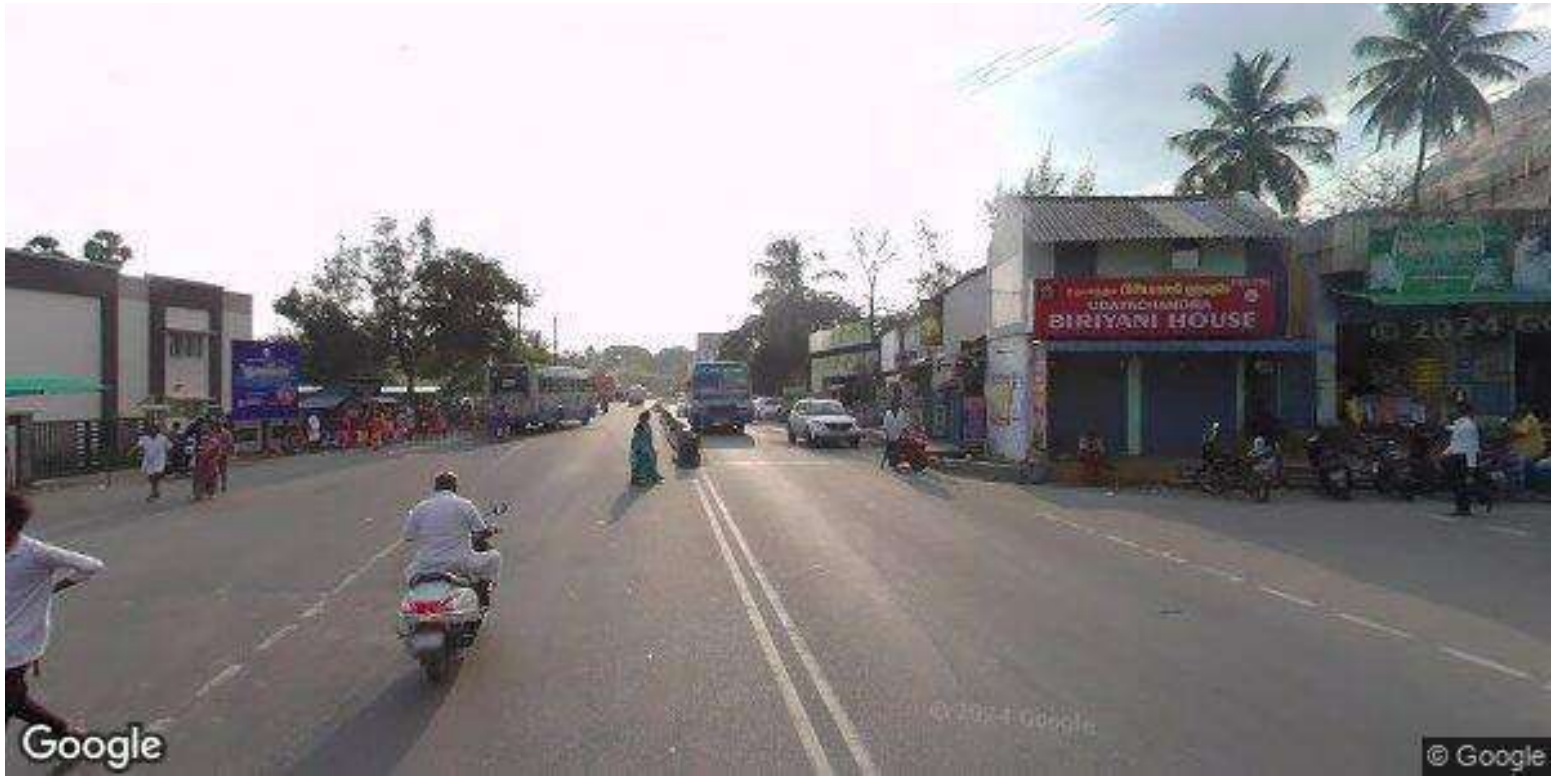
Coordinates: 11.47403, 77.86841

Risk Type: Turn

Risk Level: High

Speed Limit: 15 KM/Hr

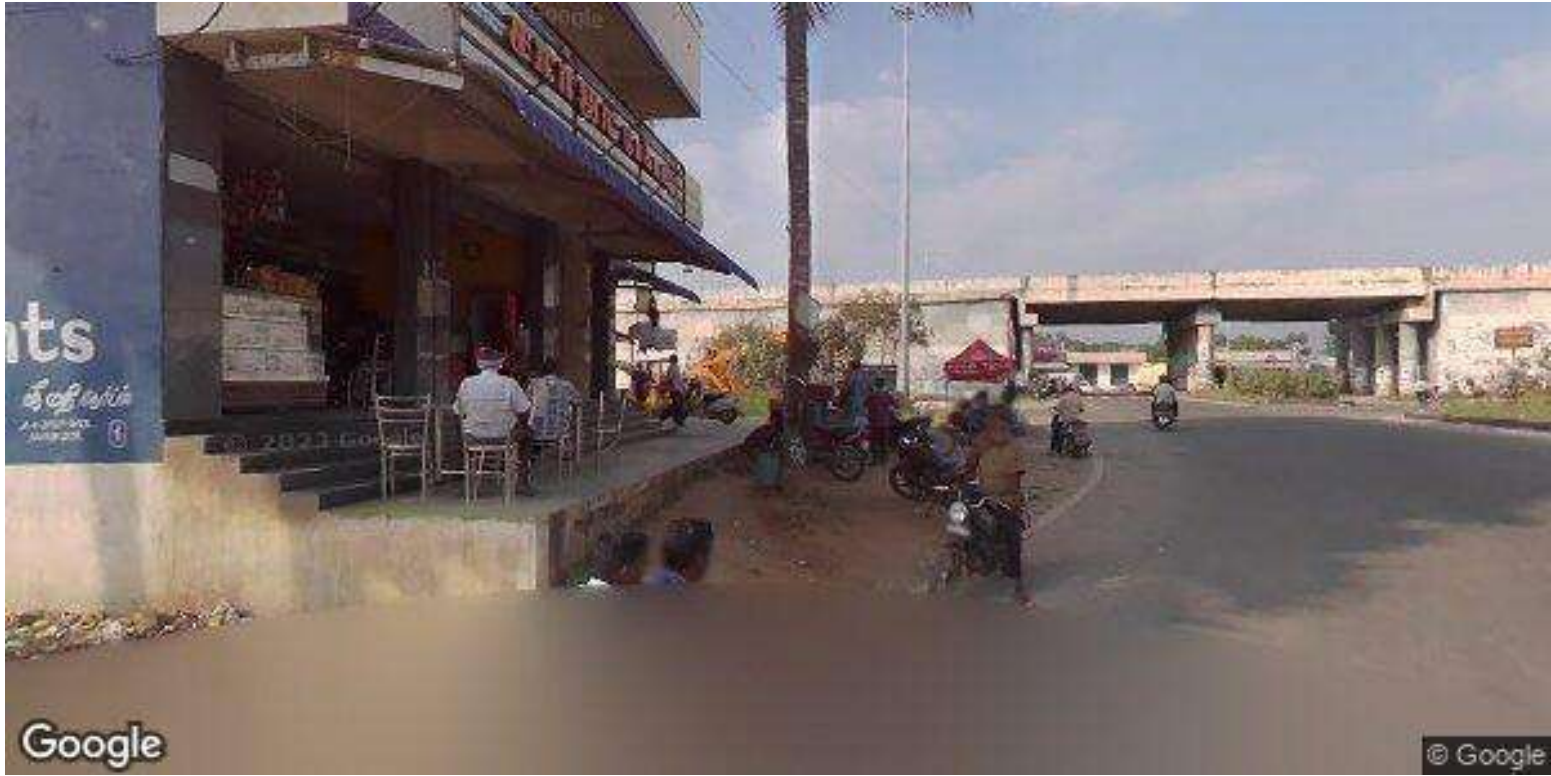
Coordinates: 11.49149, 77.89601

Risk Type: Turn

Risk Level: High

Speed Limit: 15 KM/Hr

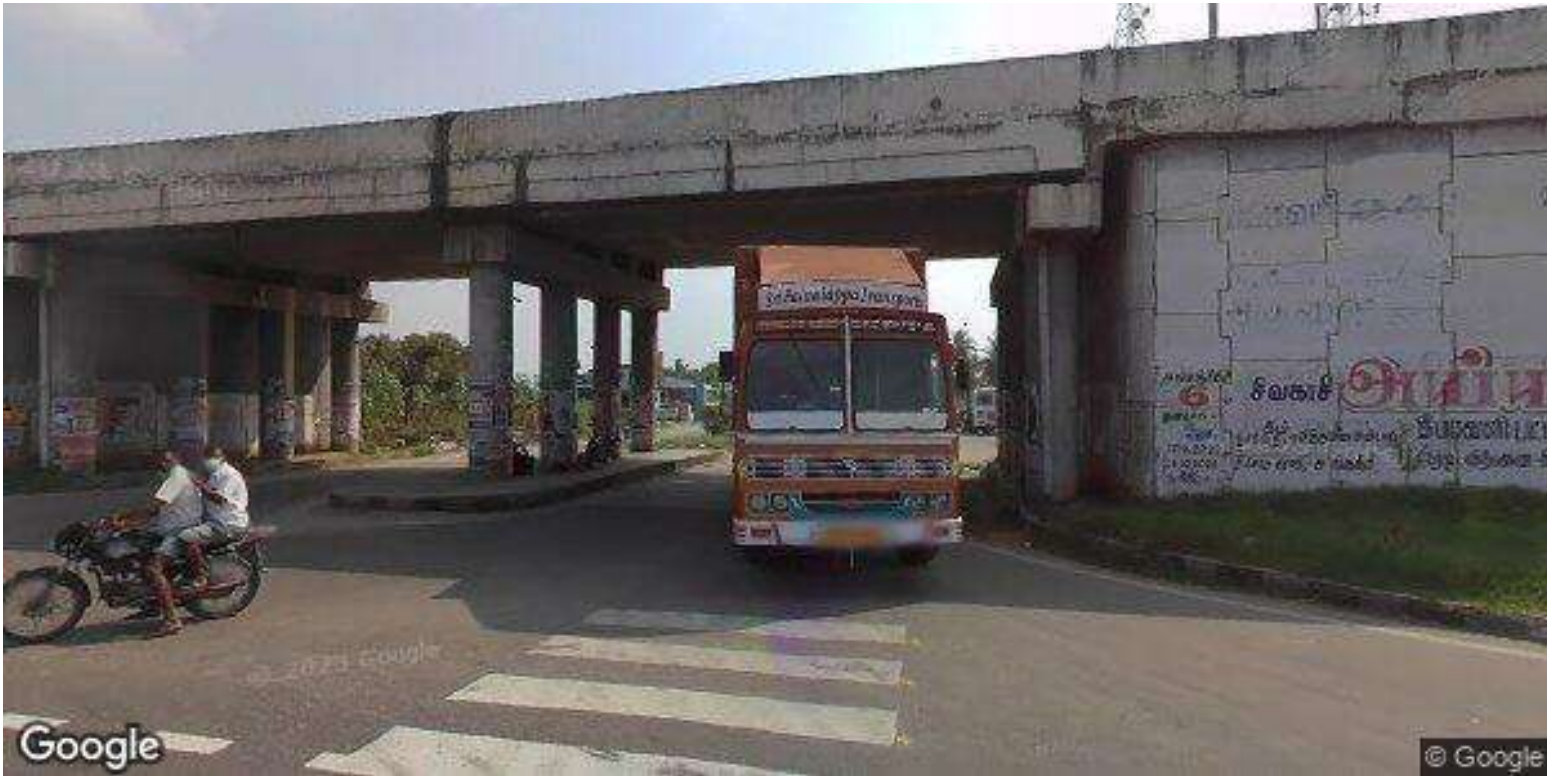
**Risk Type:** Turn  
**Risk Level:** High  
**Speed Limit:** 15 KM/Hr  
**Coordinates:** 11.49224, 77.89601

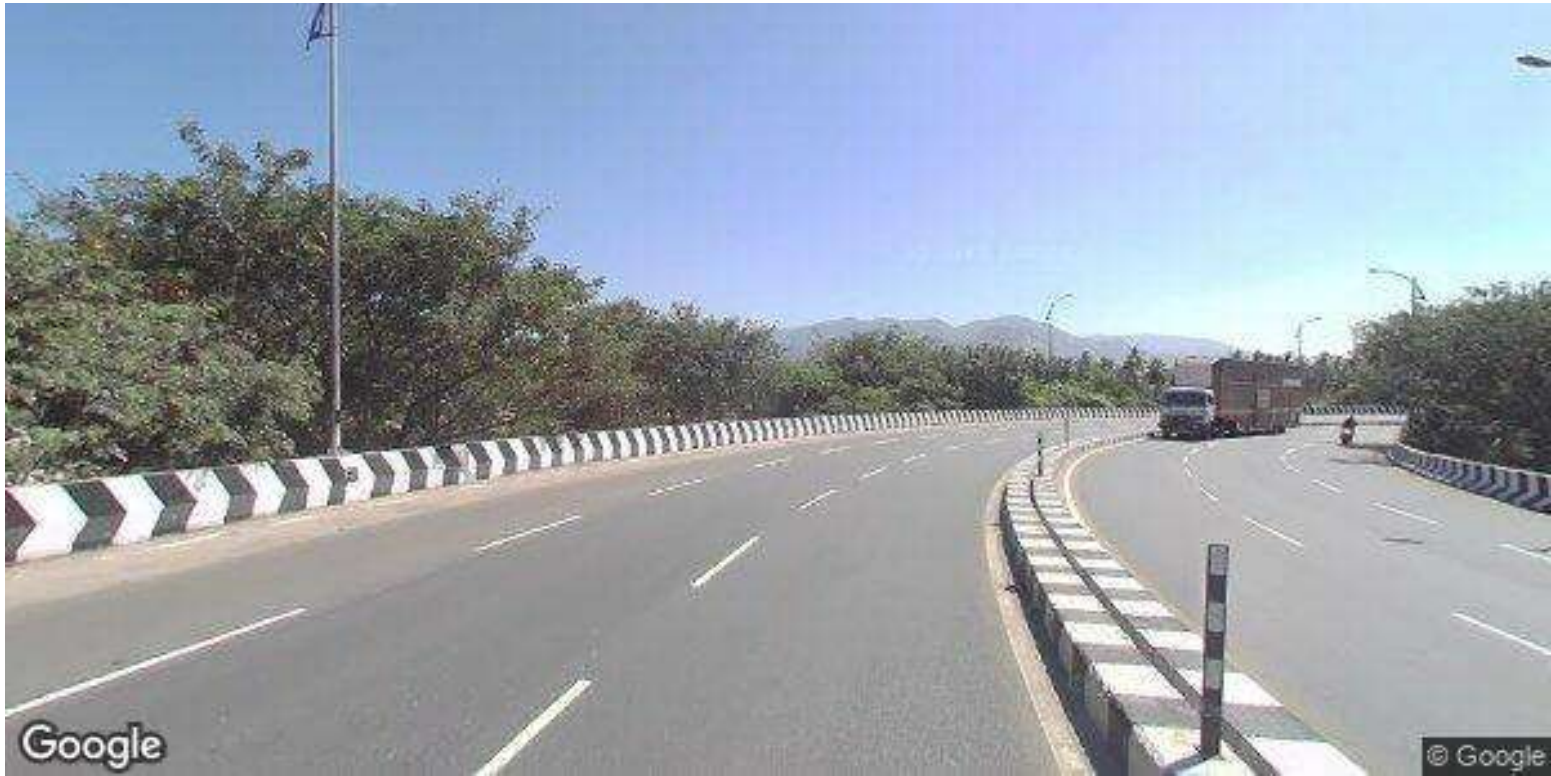
**Risk Type:** Turn  
**Risk Level:** Medium  
**Speed Limit:** 30 KM/Hr  
**Coordinates:** 11.64195, 78.12129

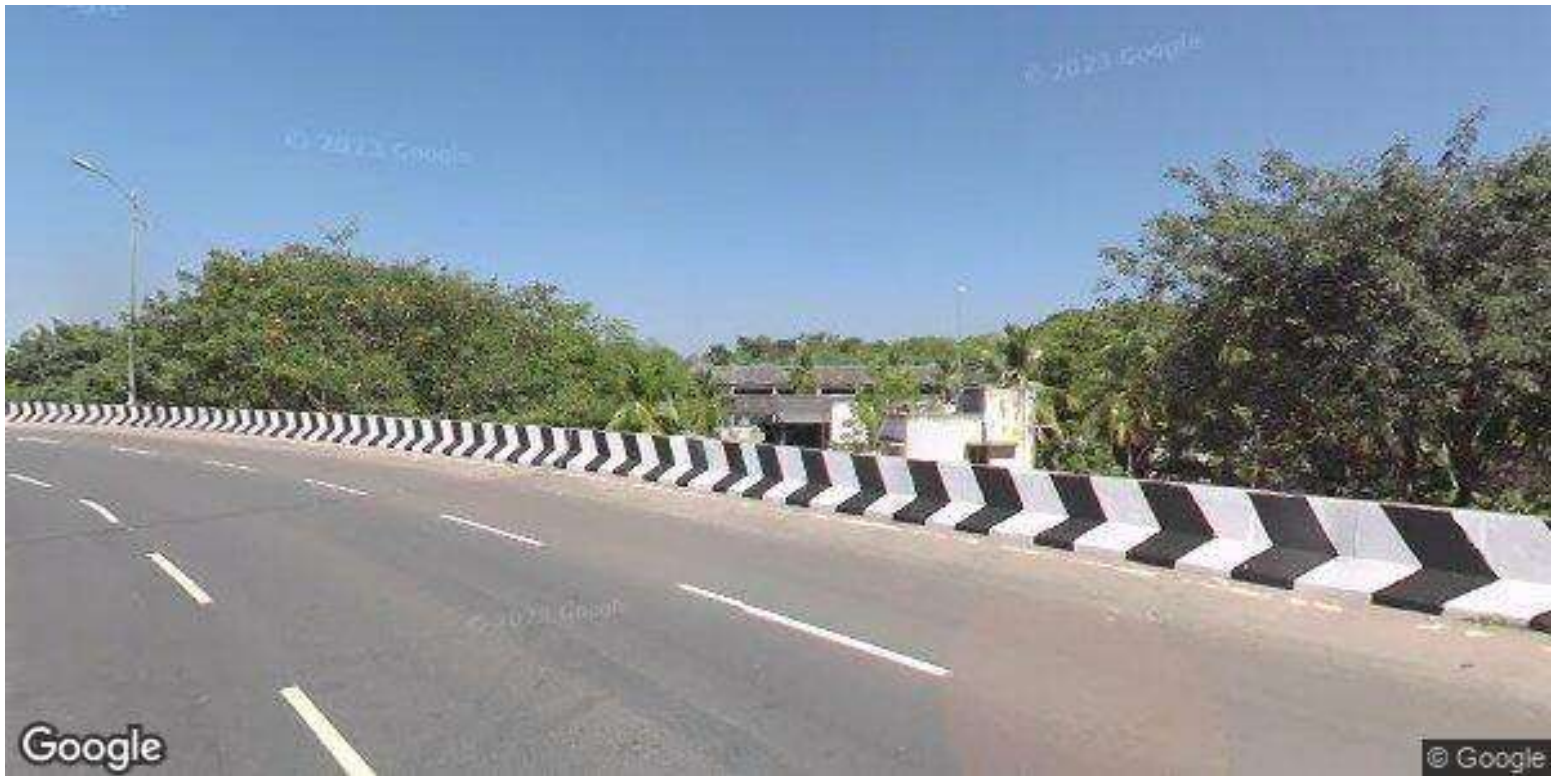
**Risk Type:** Turn  
**Risk Level:** Medium  
**Speed Limit:** 30 KM/Hr  
**Coordinates:** 11.64162, 78.12160

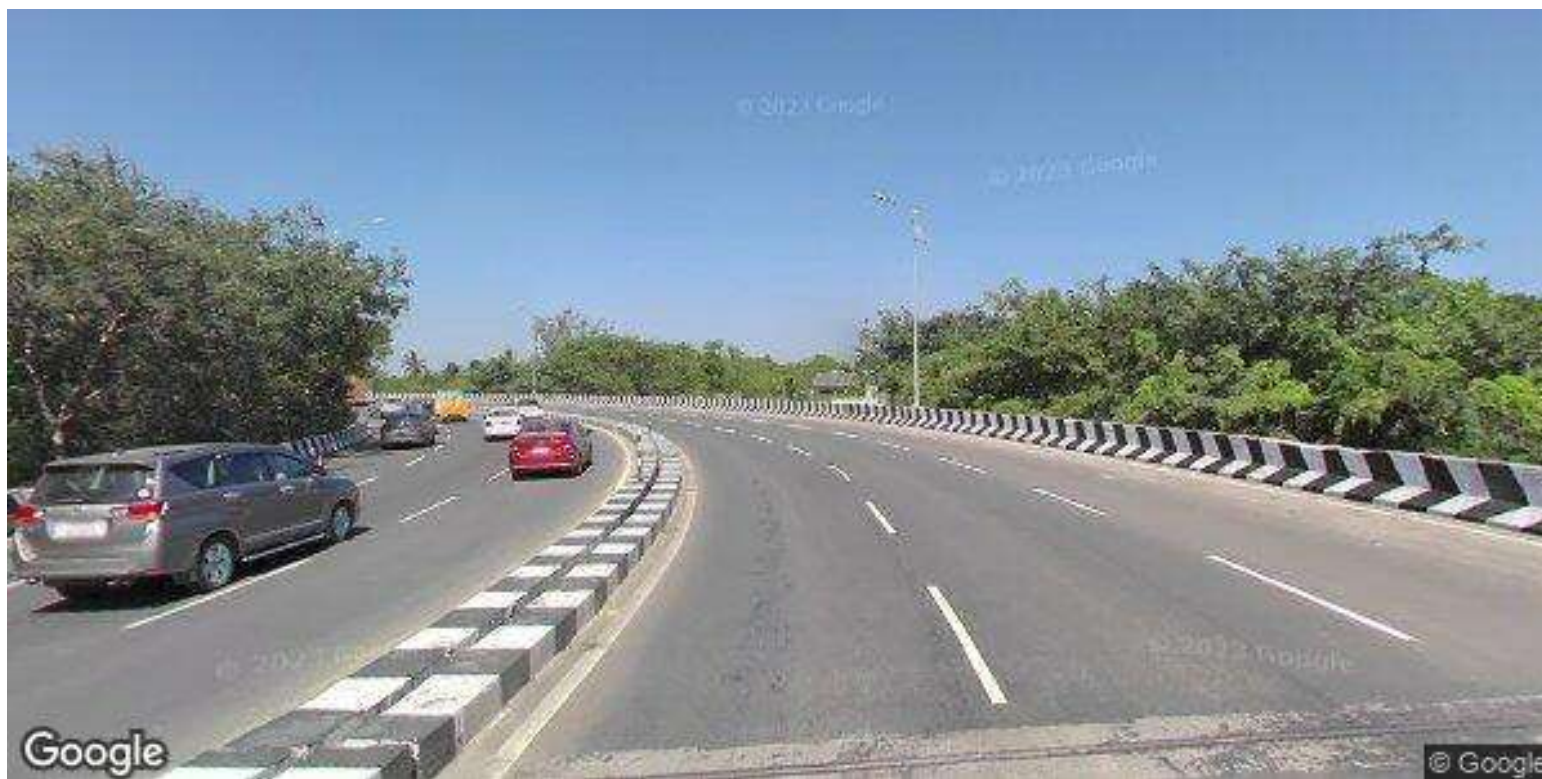
**Coordinates:** 11.64120, 78.12168

**Risk Type:** Turn

**Risk Level:** Medium

**Speed Limit:** 30 KM/Hr

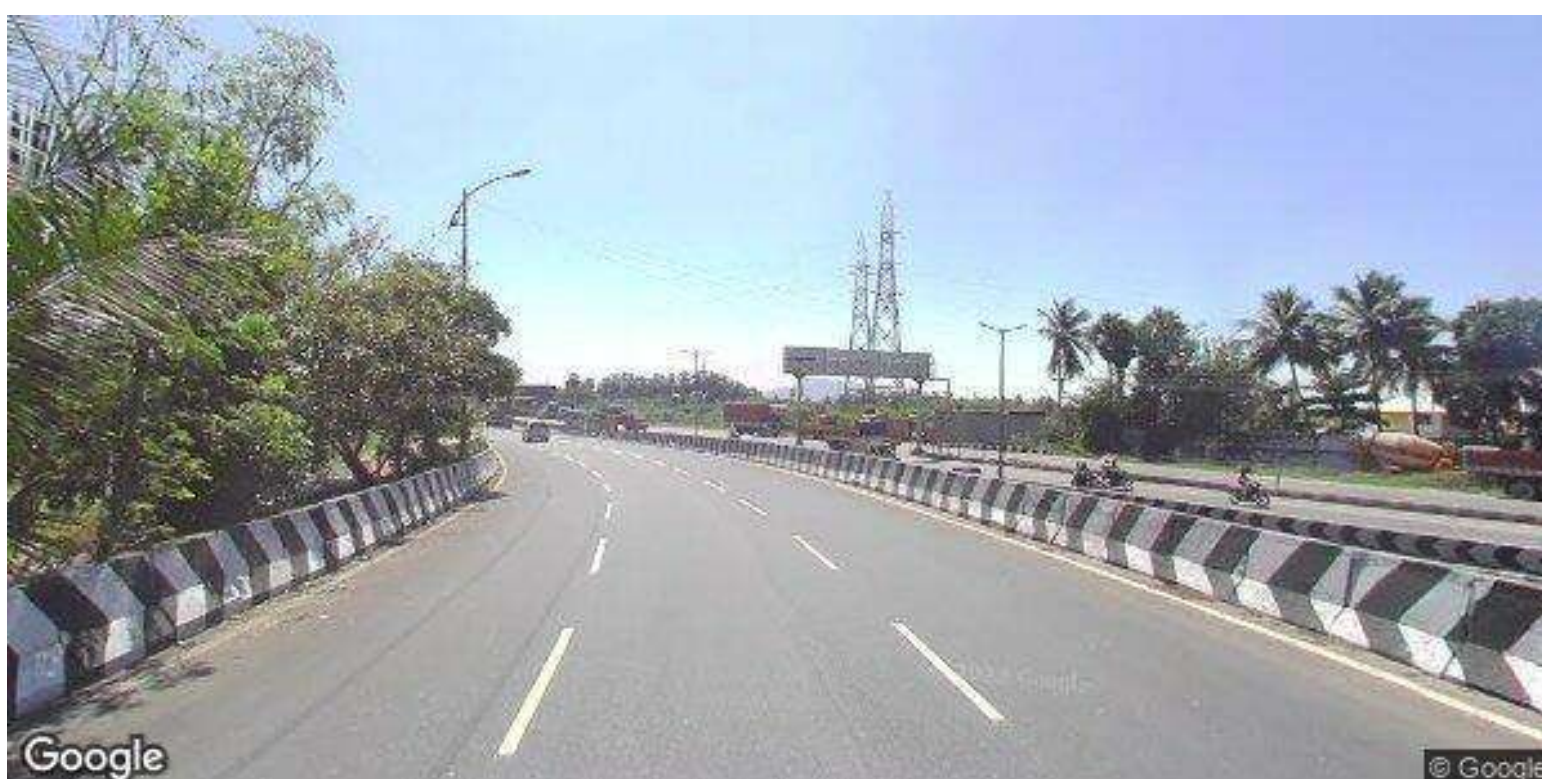
**Coordinates:** 11.63948, 78.12081

**Risk Type:** Turn

**Risk Level:** Medium

**Speed Limit:** 30 KM/Hr

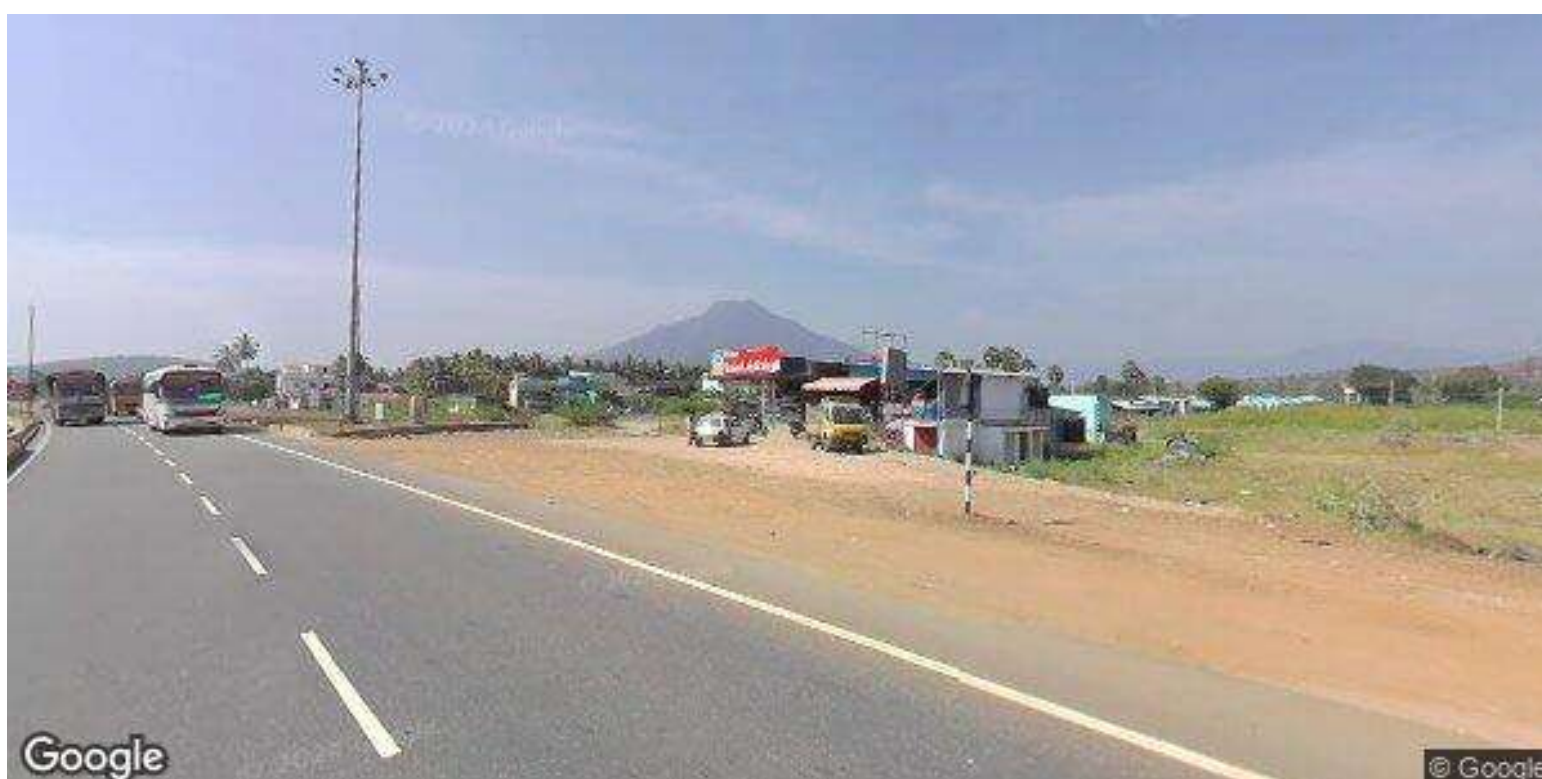
**Risk Type:** Turn  
**Risk Level:** Medium  
**Speed Limit:** 30 KM/Hr  
**Coordinates:** 11.65441, 78.38090

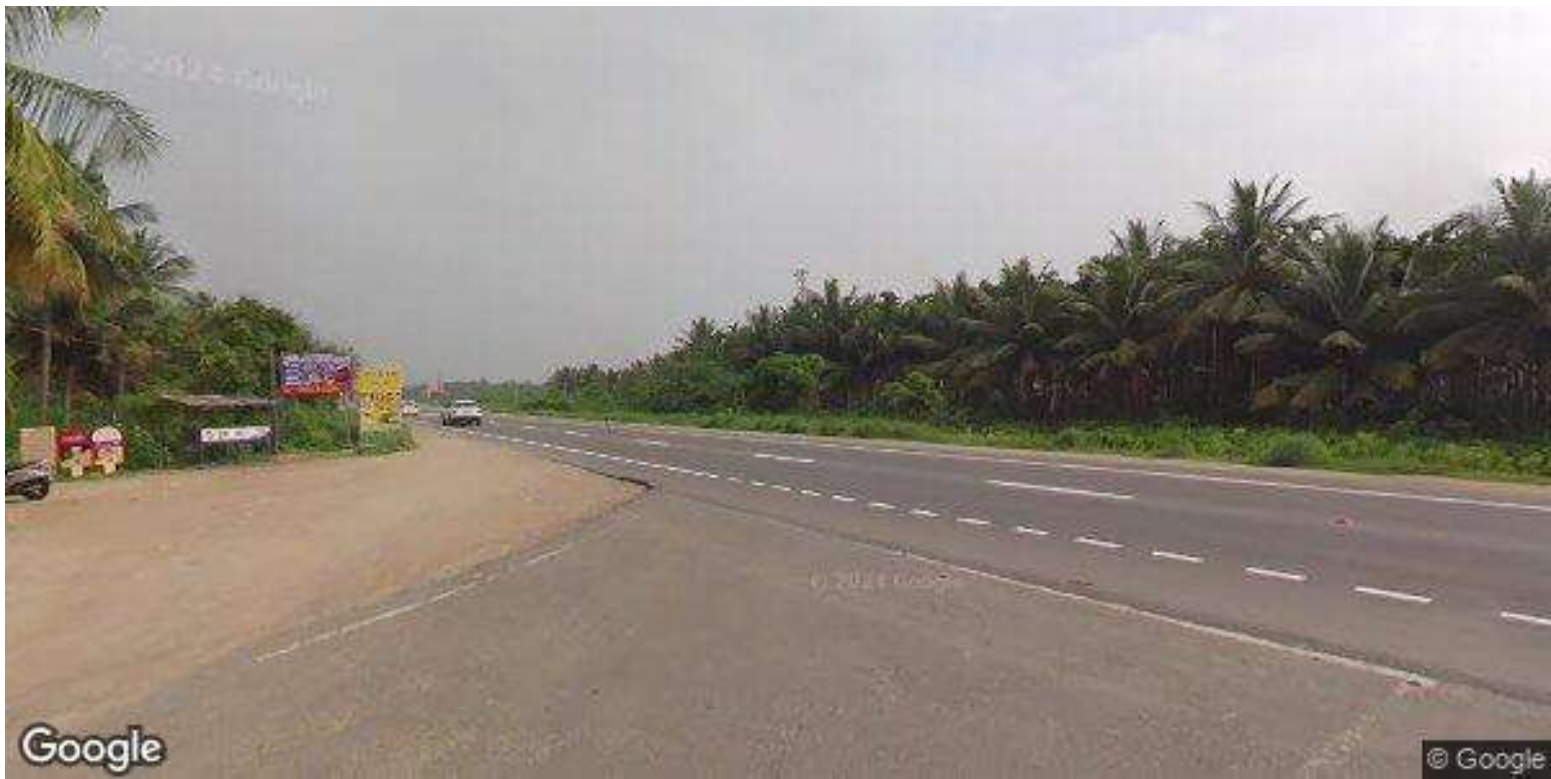
**Risk Type:** Blind Spot  
**Risk Level:** Blind Spot  
**Speed Limit:** 10 KM/Hr  
**Coordinates:** 11.61369, 78.57920

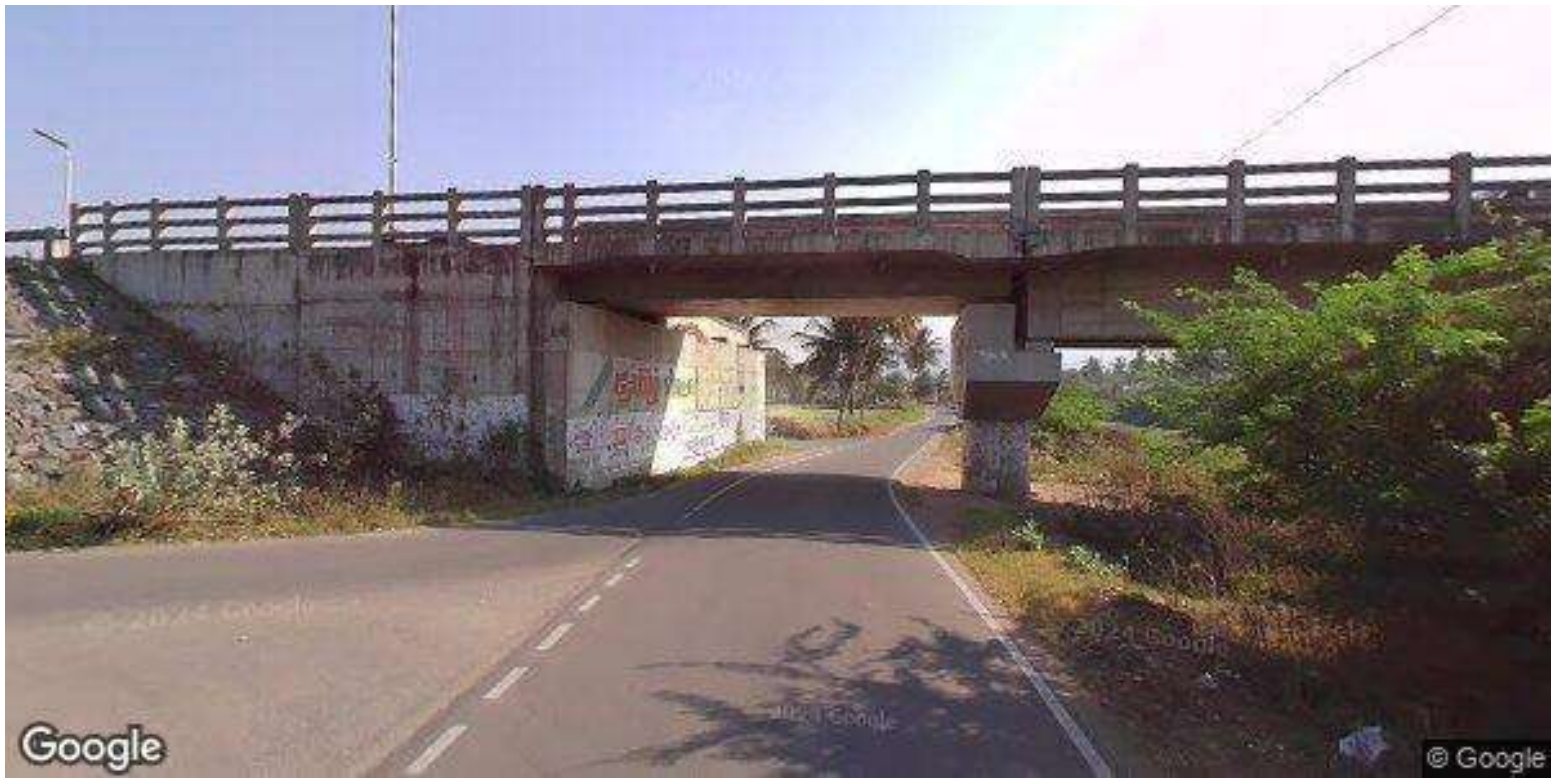
**Risk Type:** Turn  
**Risk Level:** High  
**Speed Limit:** 15 KM/Hr  
**Coordinates:** 11.61426, 78.57274

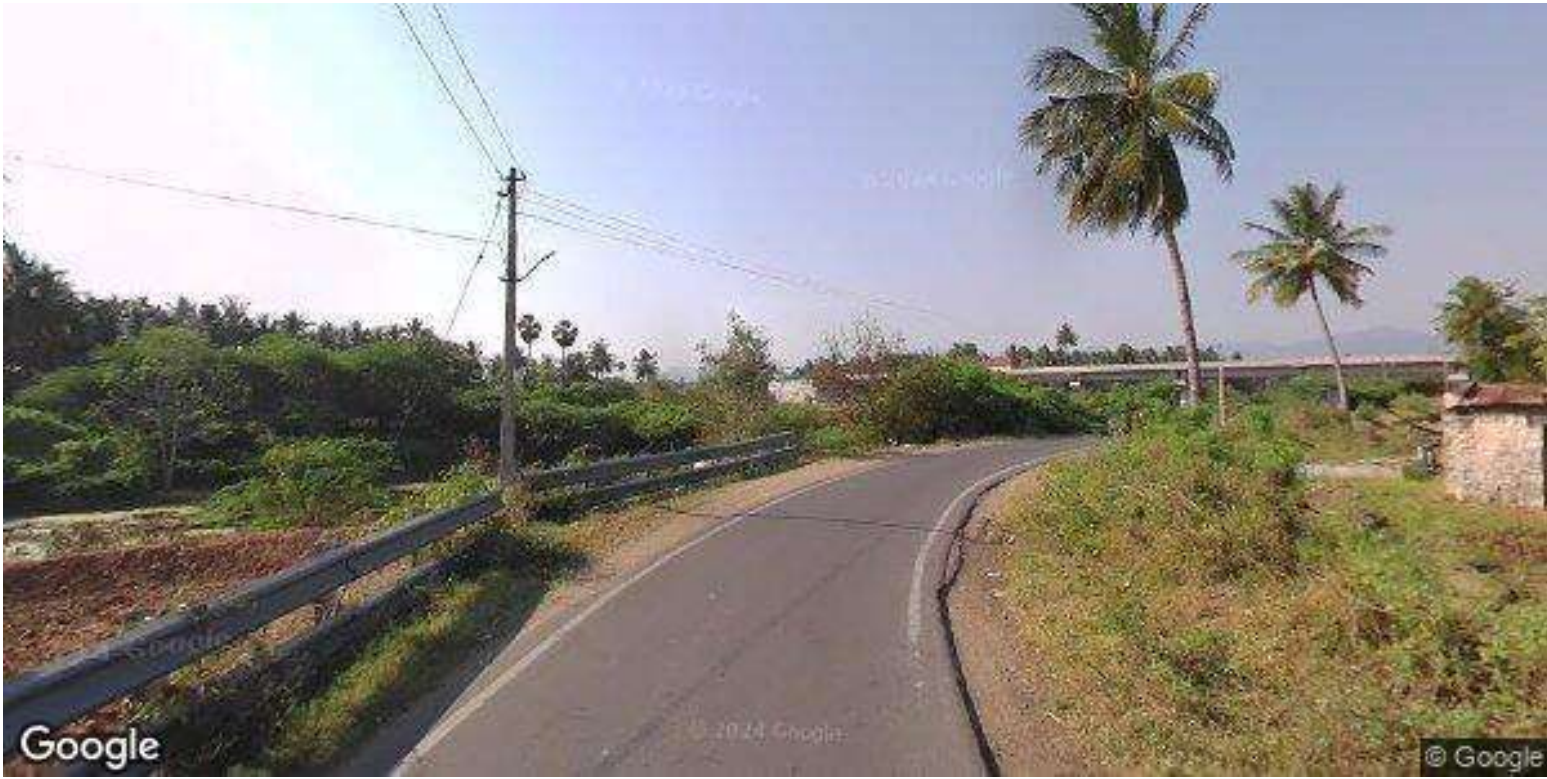
**Risk Type:** Turn  
**Risk Level:** Medium  
**Speed Limit:** 30 KM/Hr  
**Coordinates:** 11.61260, 78.57264

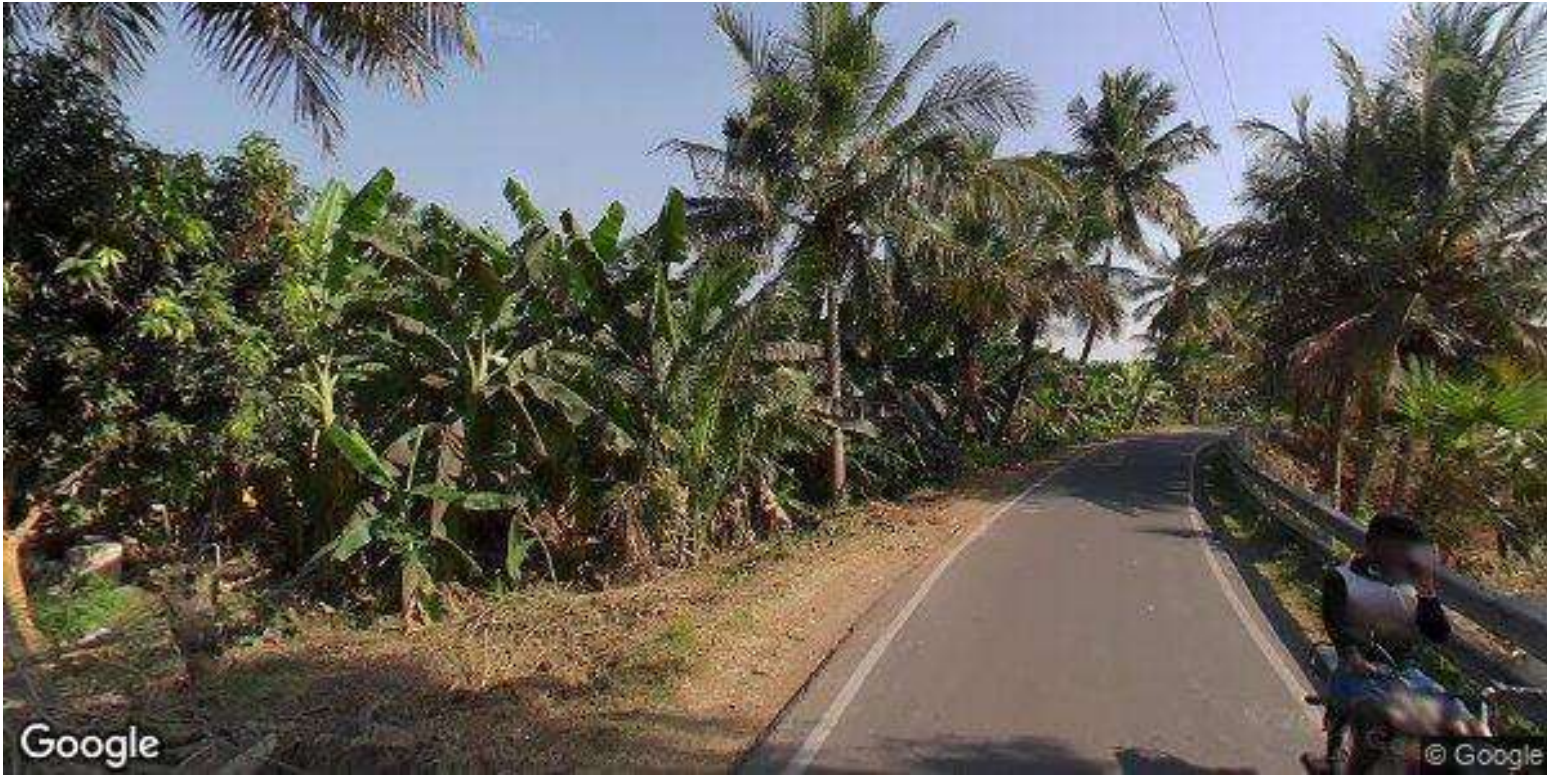
**Risk Type:** Turn  
**Risk Level:** Medium  
**Speed Limit:** 30 KM/Hr  
**Coordinates:** 11.61237, 78.57287
