## JOURNEY RISK MANAGEMENT (JRM) STUDY

### Salem Terminal TO VIJAY TRADERS

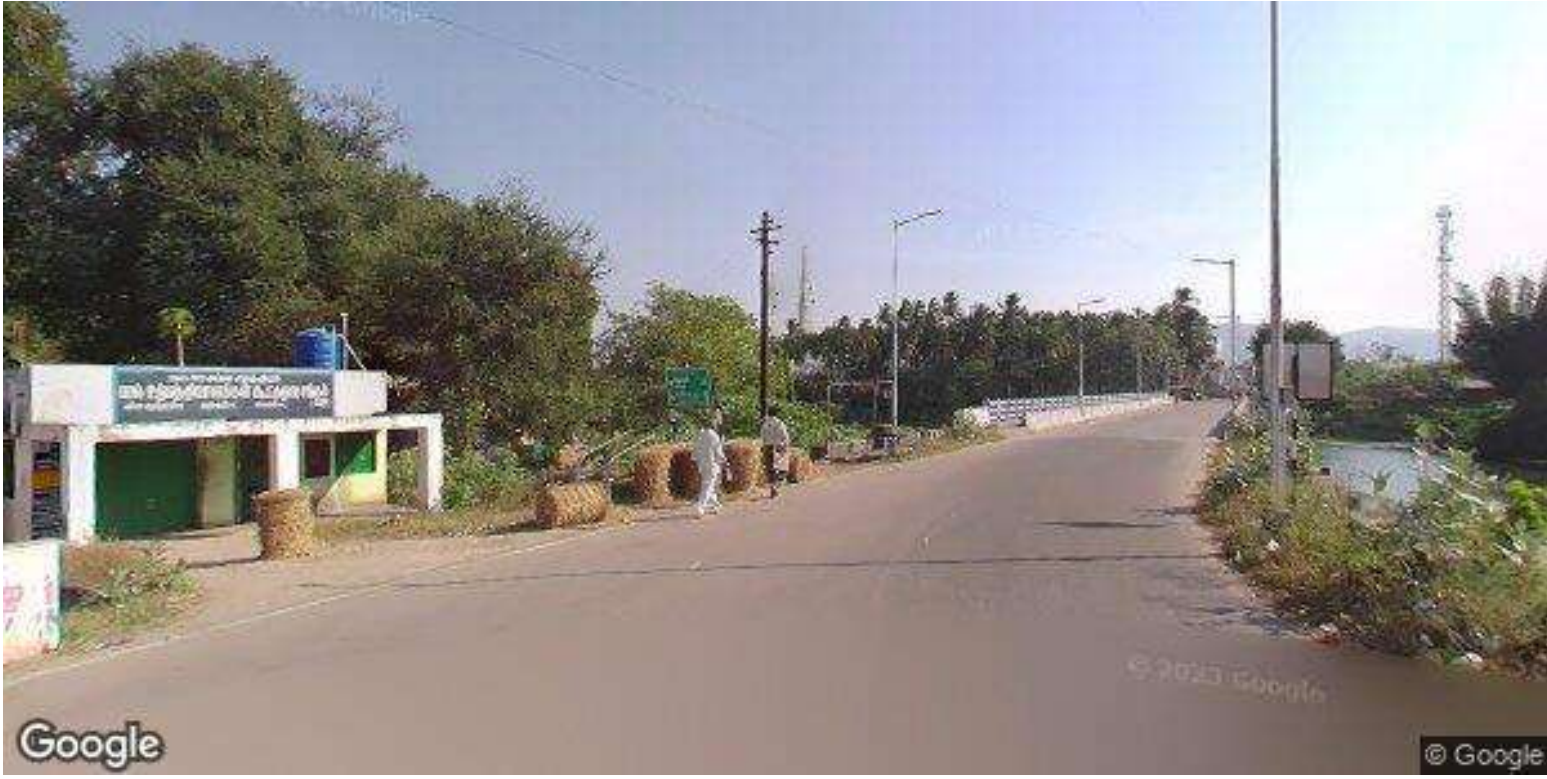
**Coordinates: 11.60852, 78.57382**

**Risk Type: Turn**

**Risk Level: Medium**

**Speed Limit: 30 KM/Hr**

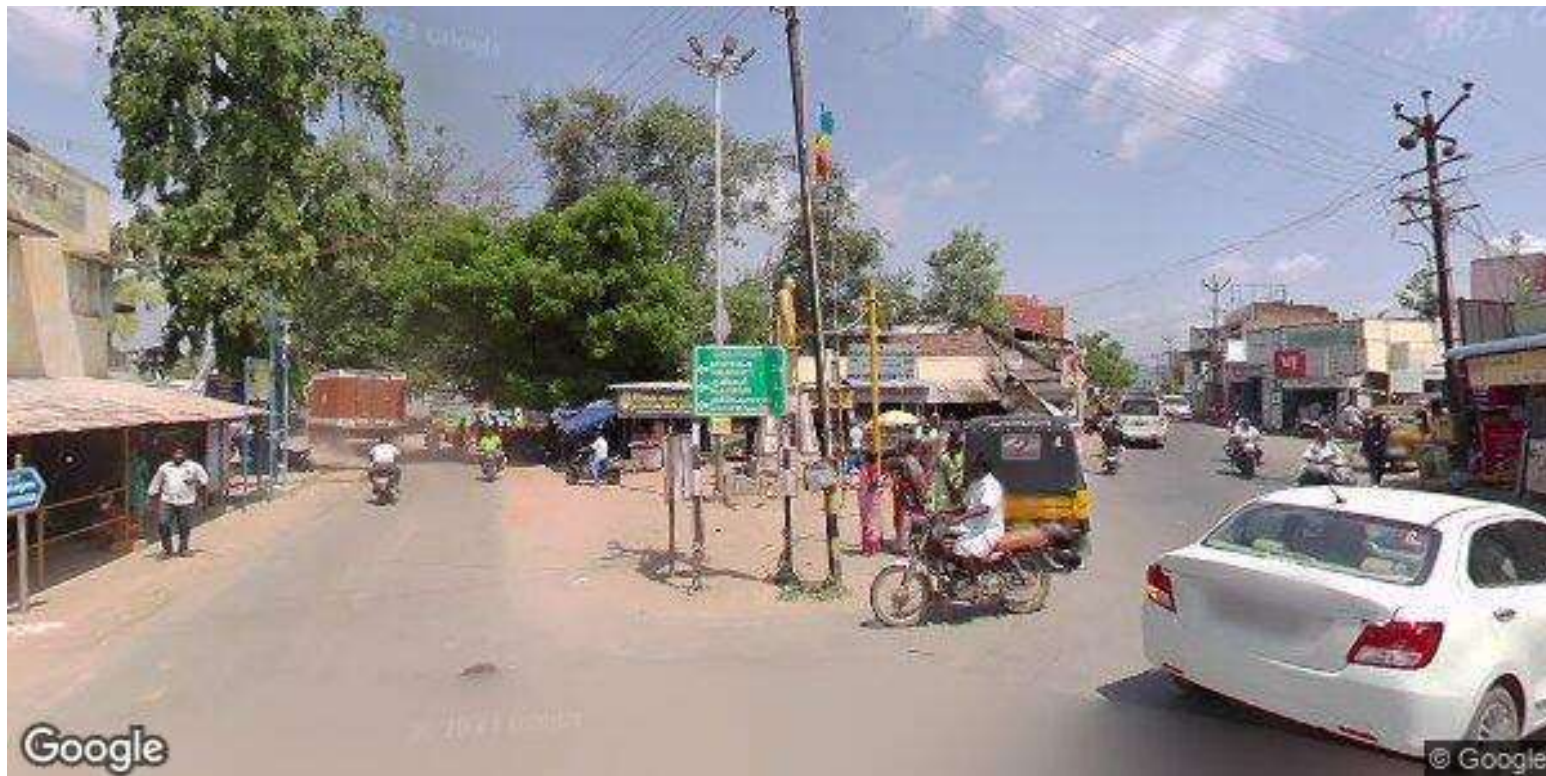
**Coordinates: 11.60476, 78.57394**

**Risk Type: Turn**

**Risk Level: Medium**

**Speed Limit: 30 KM/Hr**

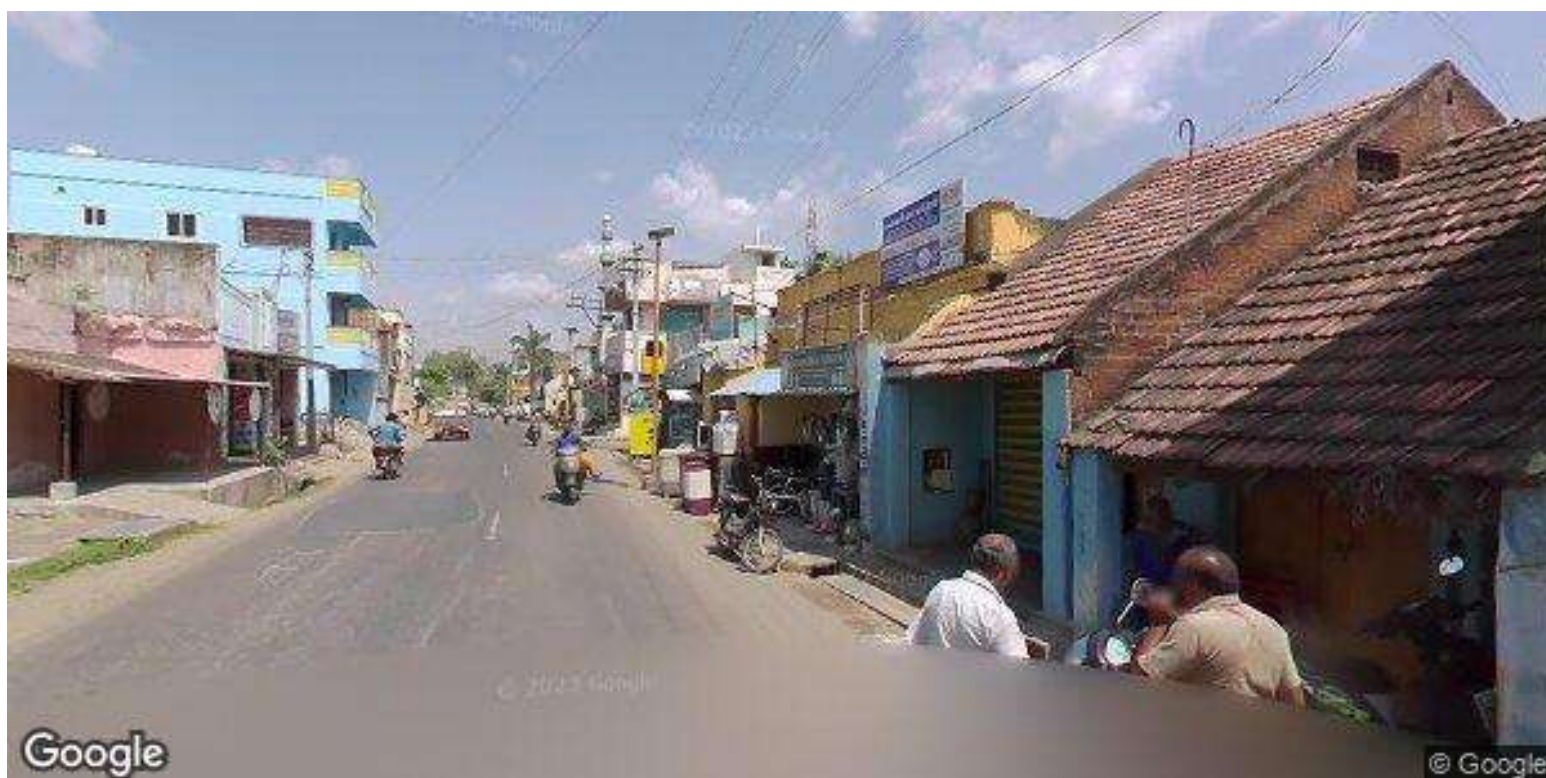
**Coordinates: 11.60442, 78.57618**

**Risk Type: Turn**

**Risk Level: Medium**

**Speed Limit: 30 KM/Hr**

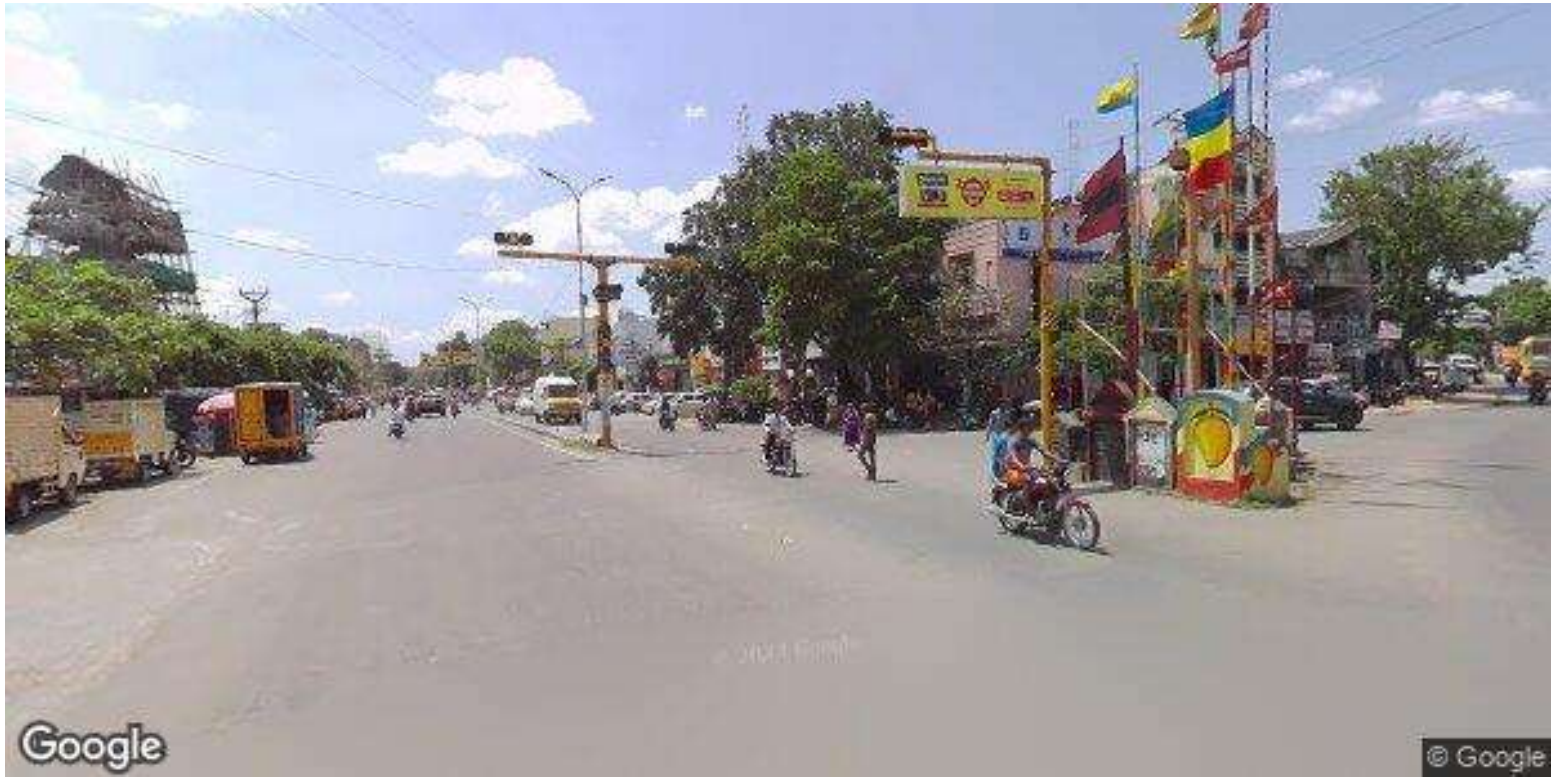
**Coordinates:** 11.59965, 78.59643

**Risk Type:** Turn

**Risk Level:** High

**Speed Limit:** 15 KM/Hr
