# IndianOil

## JOURNEY RISK MANAGEMENT (JRM) STUDY

### Salem Terminal to MAHALAKSHMI TRADERS

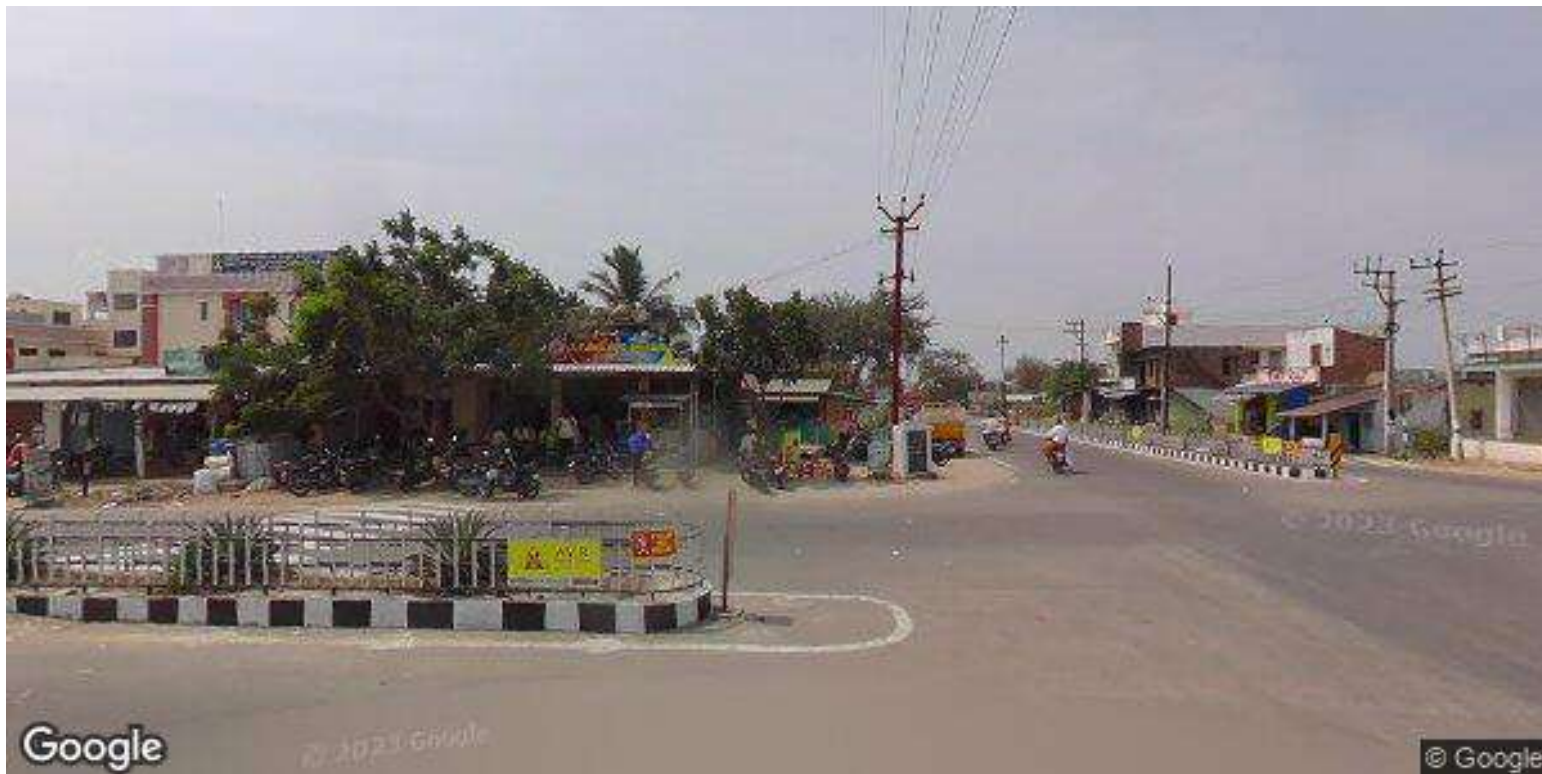
**Coordinates:** 11.58300, 77.85813

**Risk Type:** Roundabout

**Risk Level:** High

**Speed Limit:** 15 KM/Hr

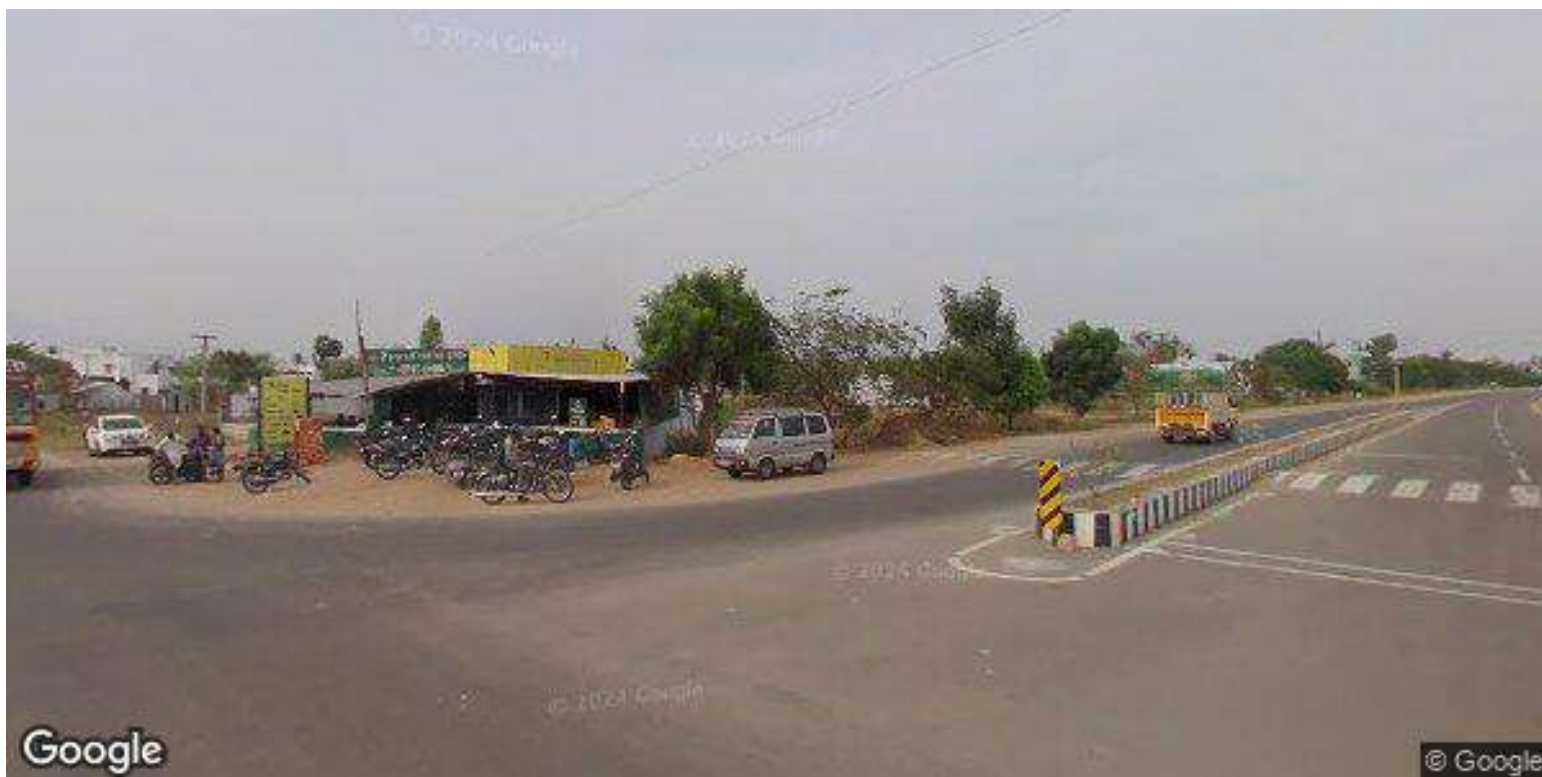
**Coordinates:** 11.60019, 77.81968

**Risk Type:** Roundabout

**Risk Level:** High

**Speed Limit:** 15 KM/Hr

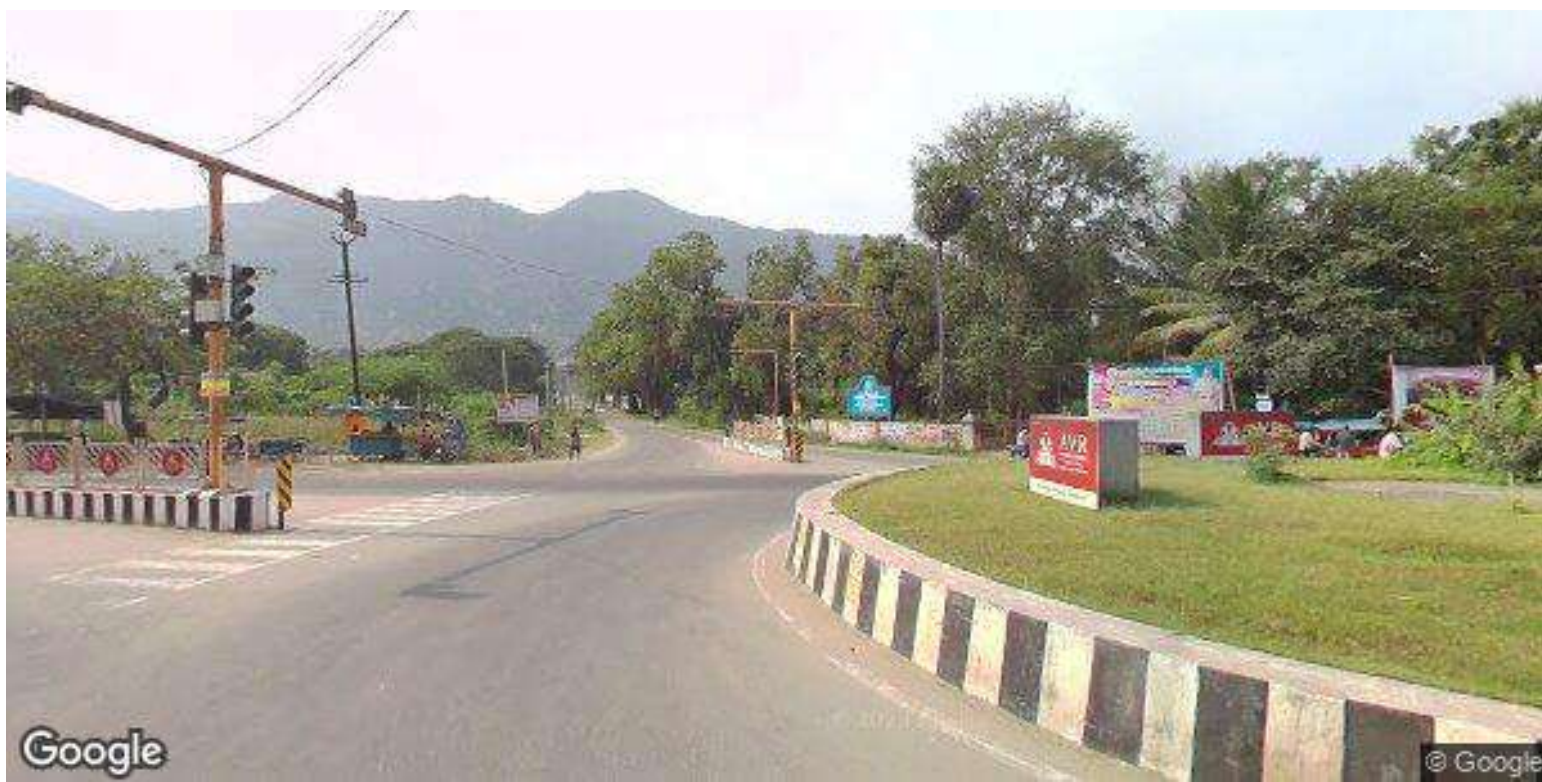
**Coordinates:** 11.77576, 77.79789

**Risk Type:** Roundabout

**Risk Level:** High

**Speed Limit:** 15 KM/Hr

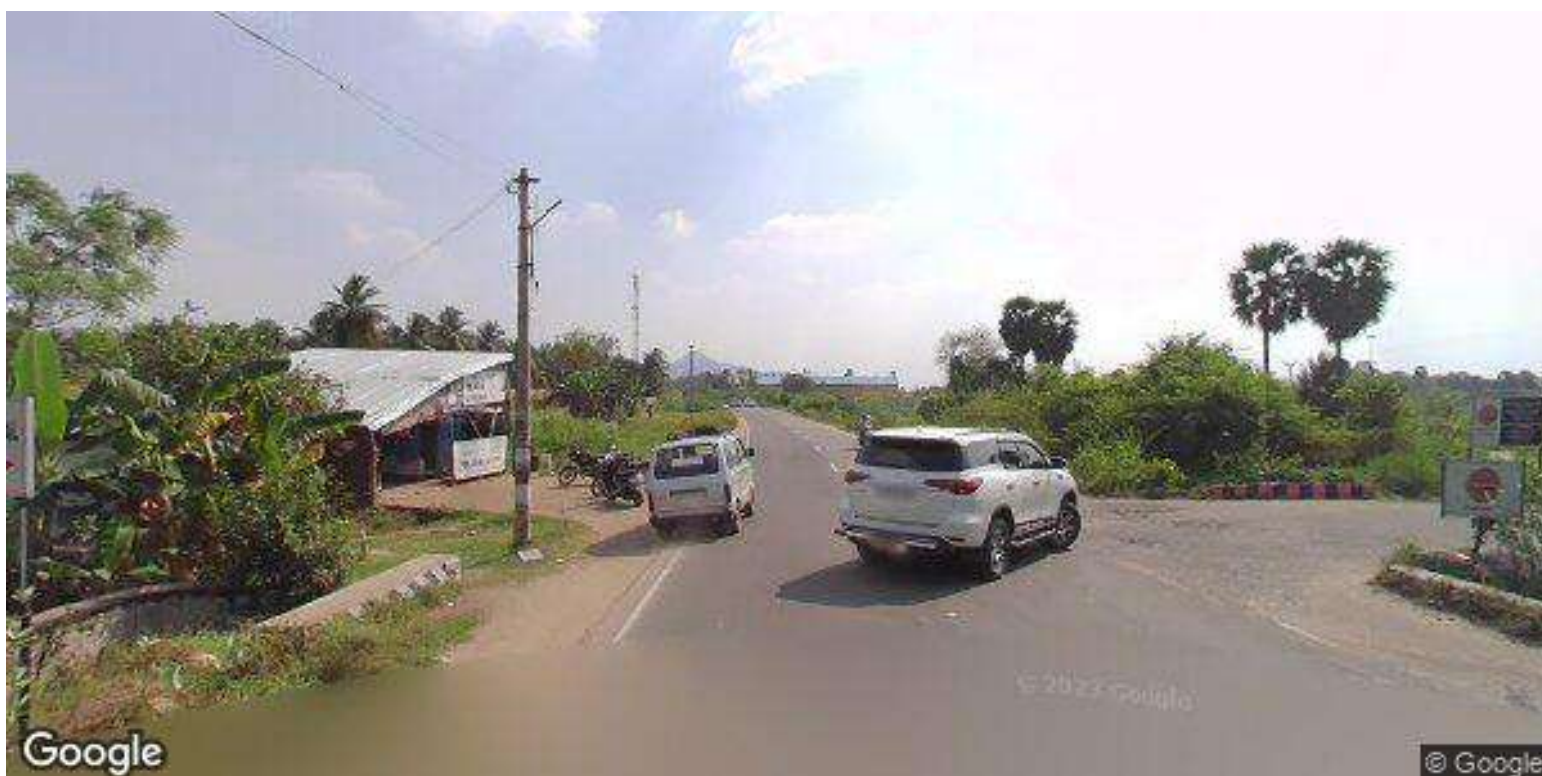
**Coordinates:** 11.44029, 77.87544

**Risk Type:** Turn

**Risk Level:** High

**Speed Limit:** 15 KM/Hr

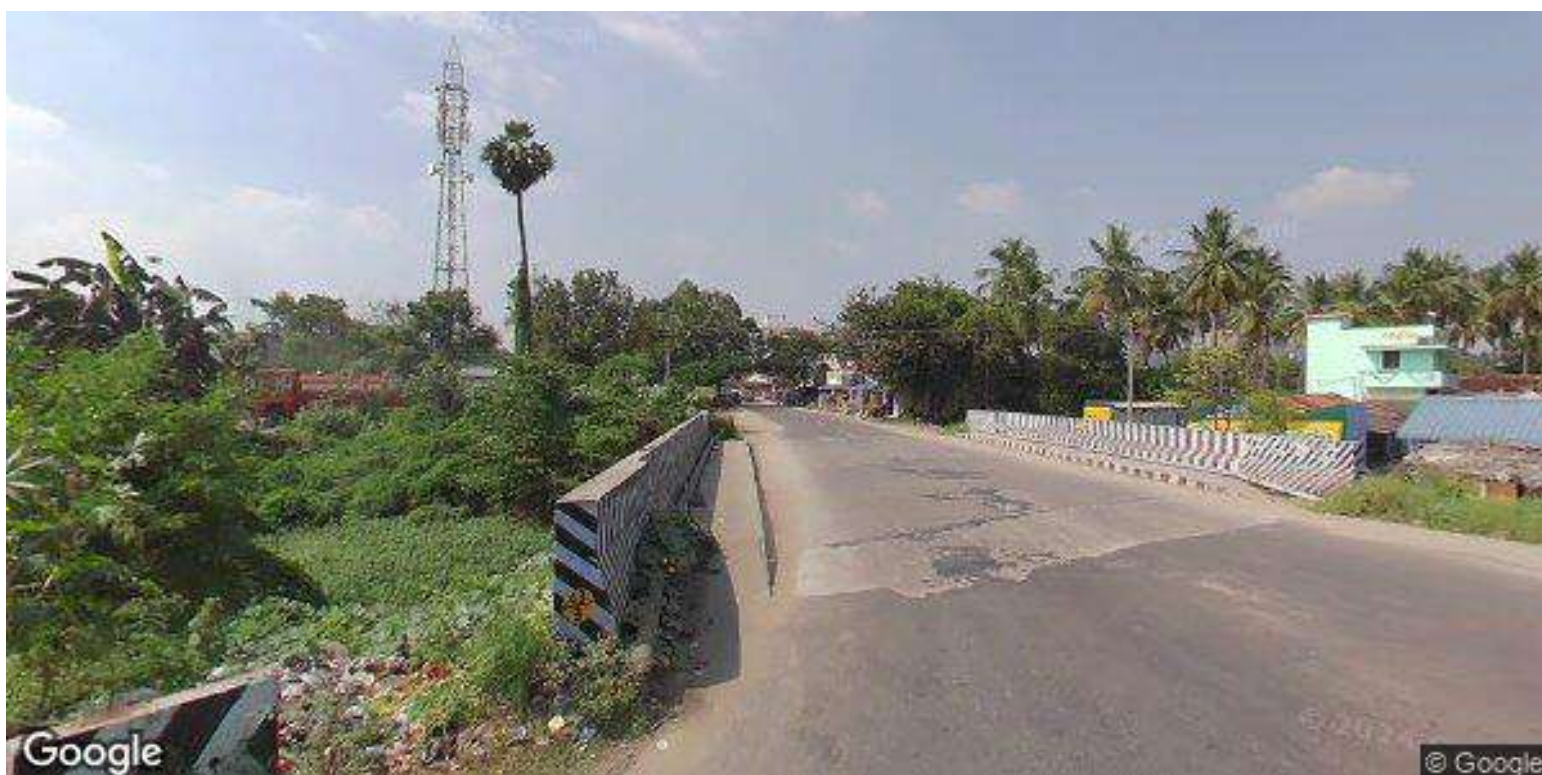
**Risk Type:** Turn  
**Risk Level:** Medium  
**Speed Limit:** 30 KM/Hr  
**Coordinates:** 11.44900, 77.87406

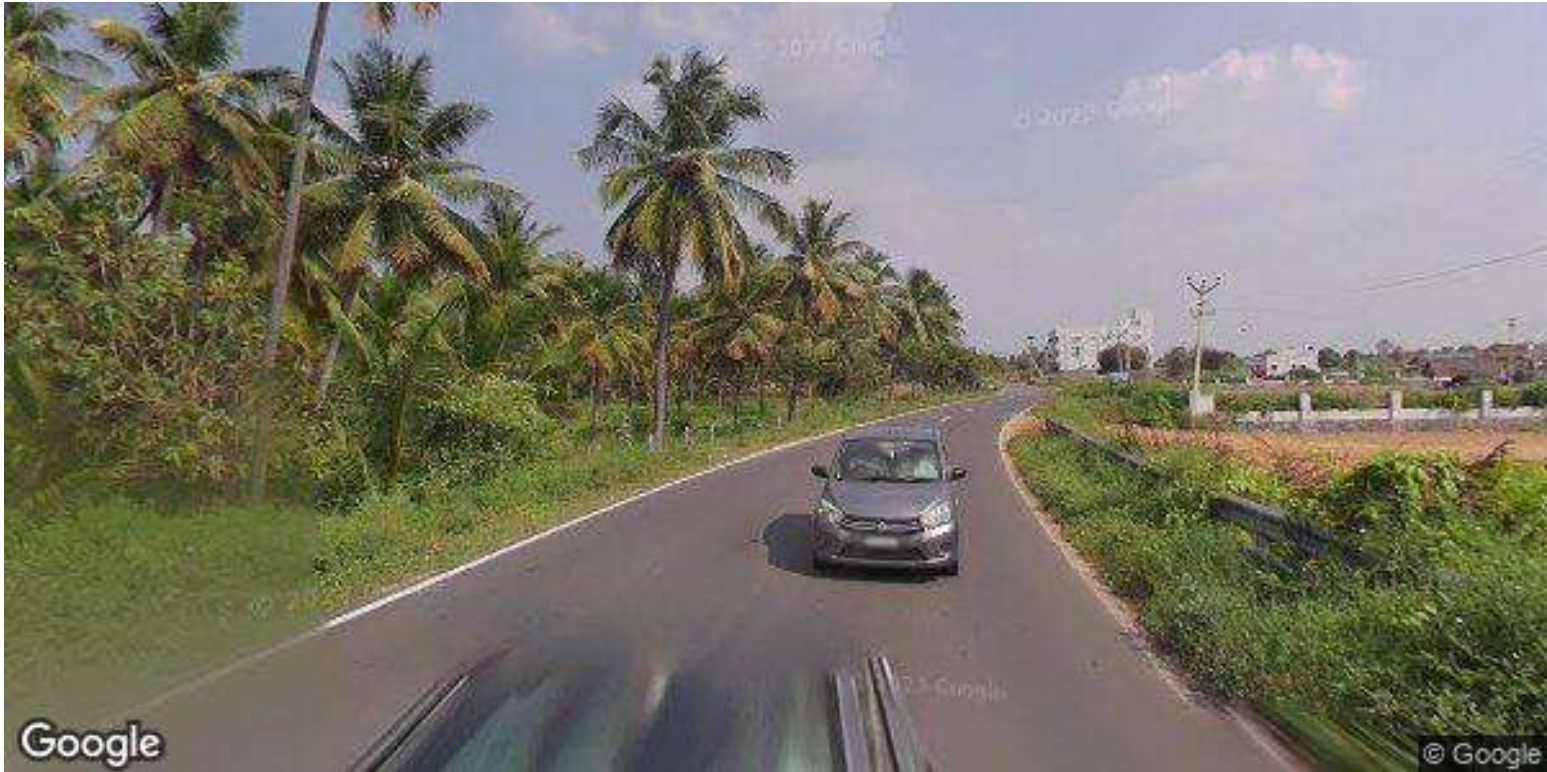
**Risk Type:** Turn  
**Risk Level:** Medium  
**Speed Limit:** 30 KM/Hr  
**Coordinates:** 11.45357, 77.85789

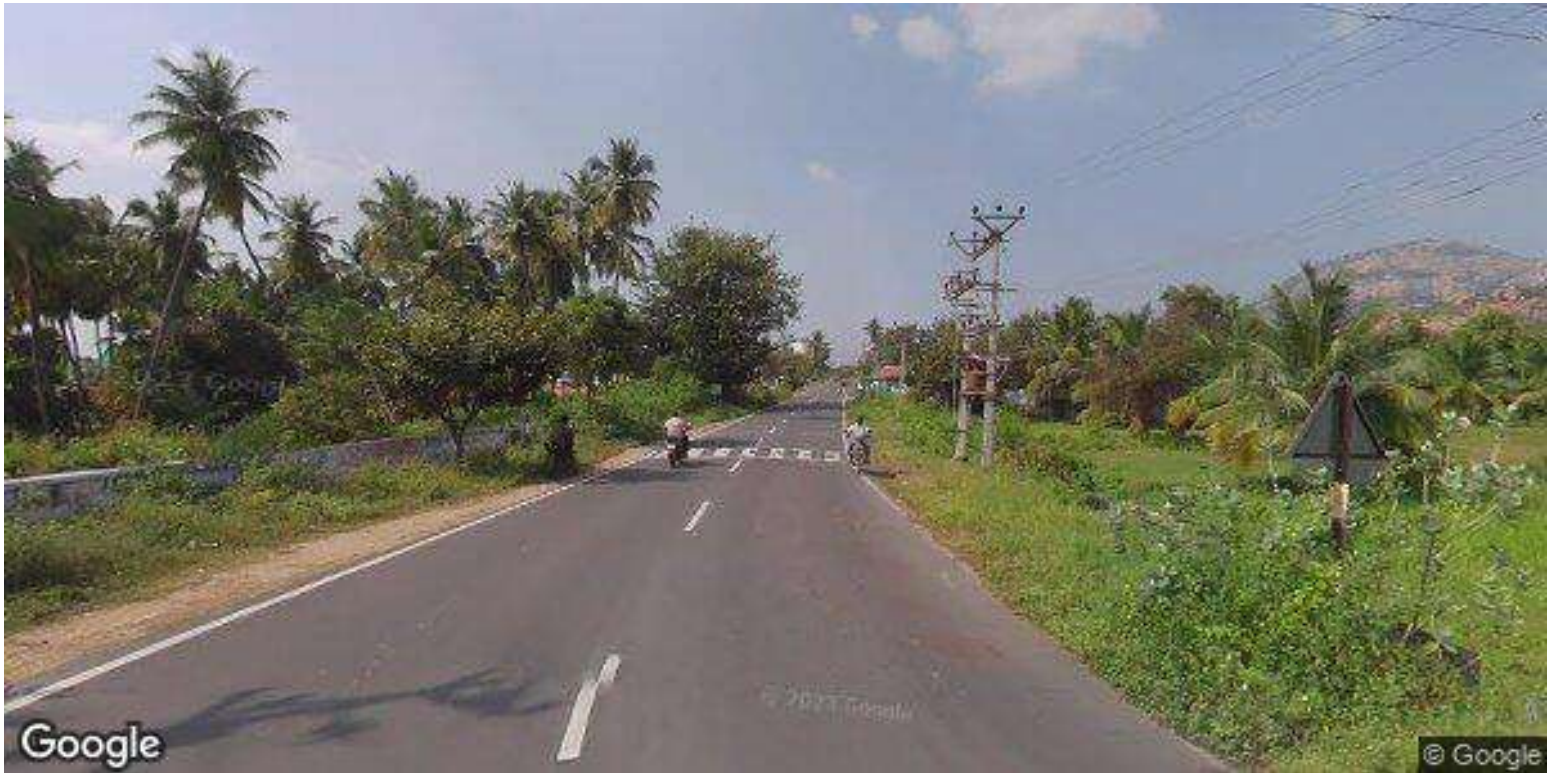
**Risk Type:** Turn  
**Risk Level:** High  
**Speed Limit:** 15 KM/Hr  
**Coordinates:** 11.45352, 77.85698

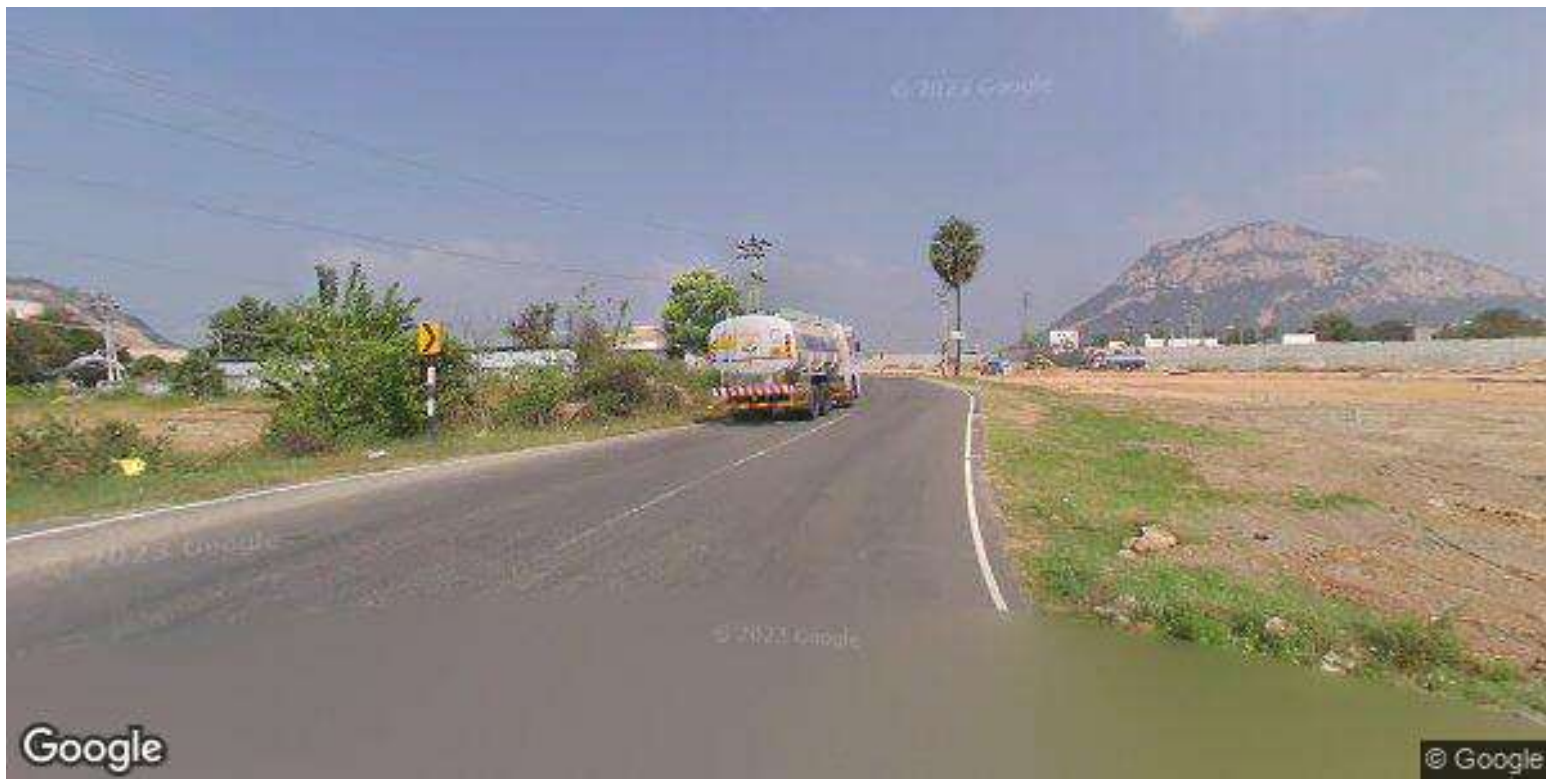
**Coordinates:** 11.45847, 77.85140

**Risk Type:** Turn

**Risk Level:** Medium

**Speed Limit:** 30 KM/Hr

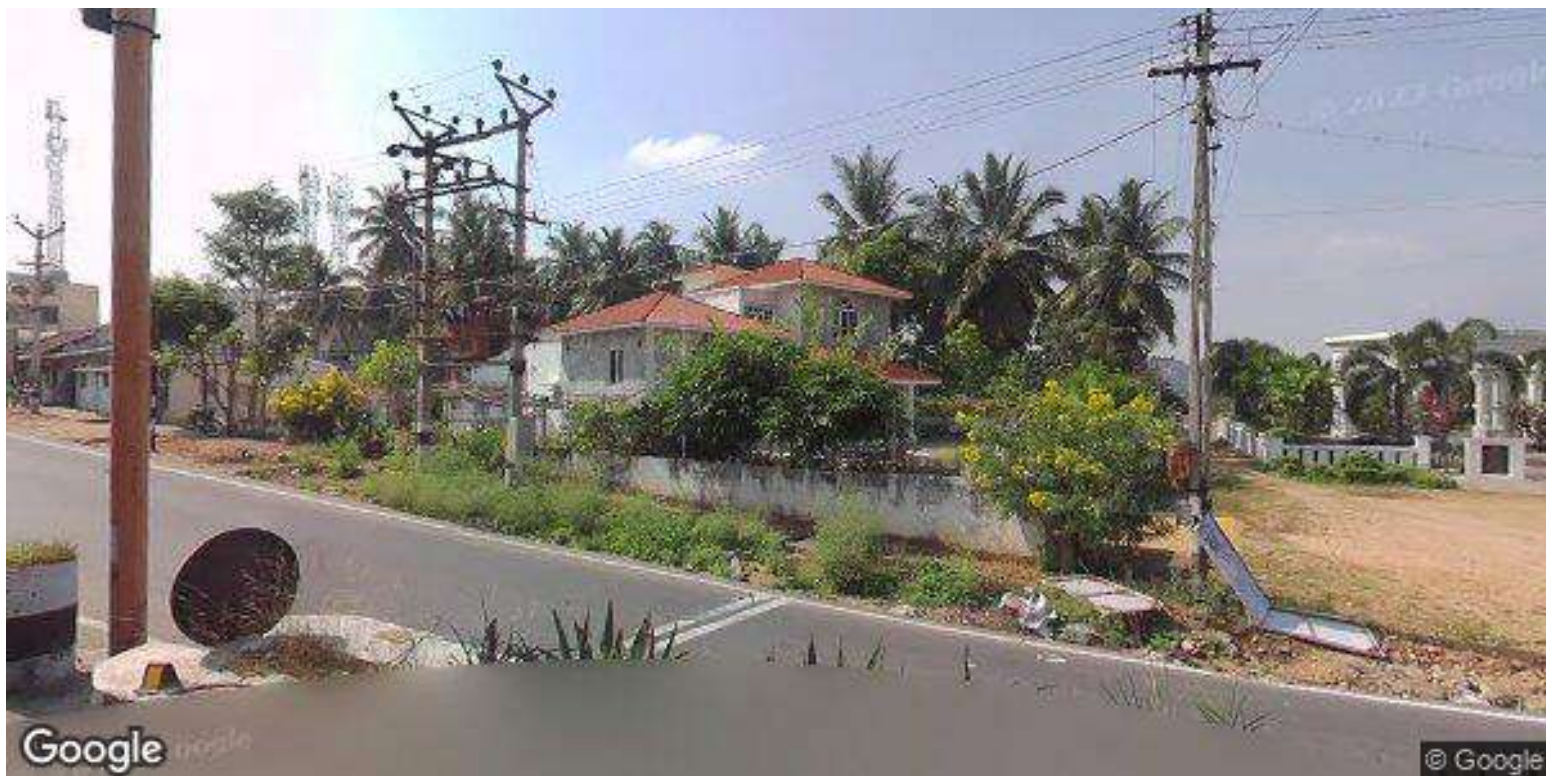
**Coordinates:** 11.46303, 77.84945

**Risk Type:** Turn

**Risk Level:** Medium

**Speed Limit:** 30 KM/Hr

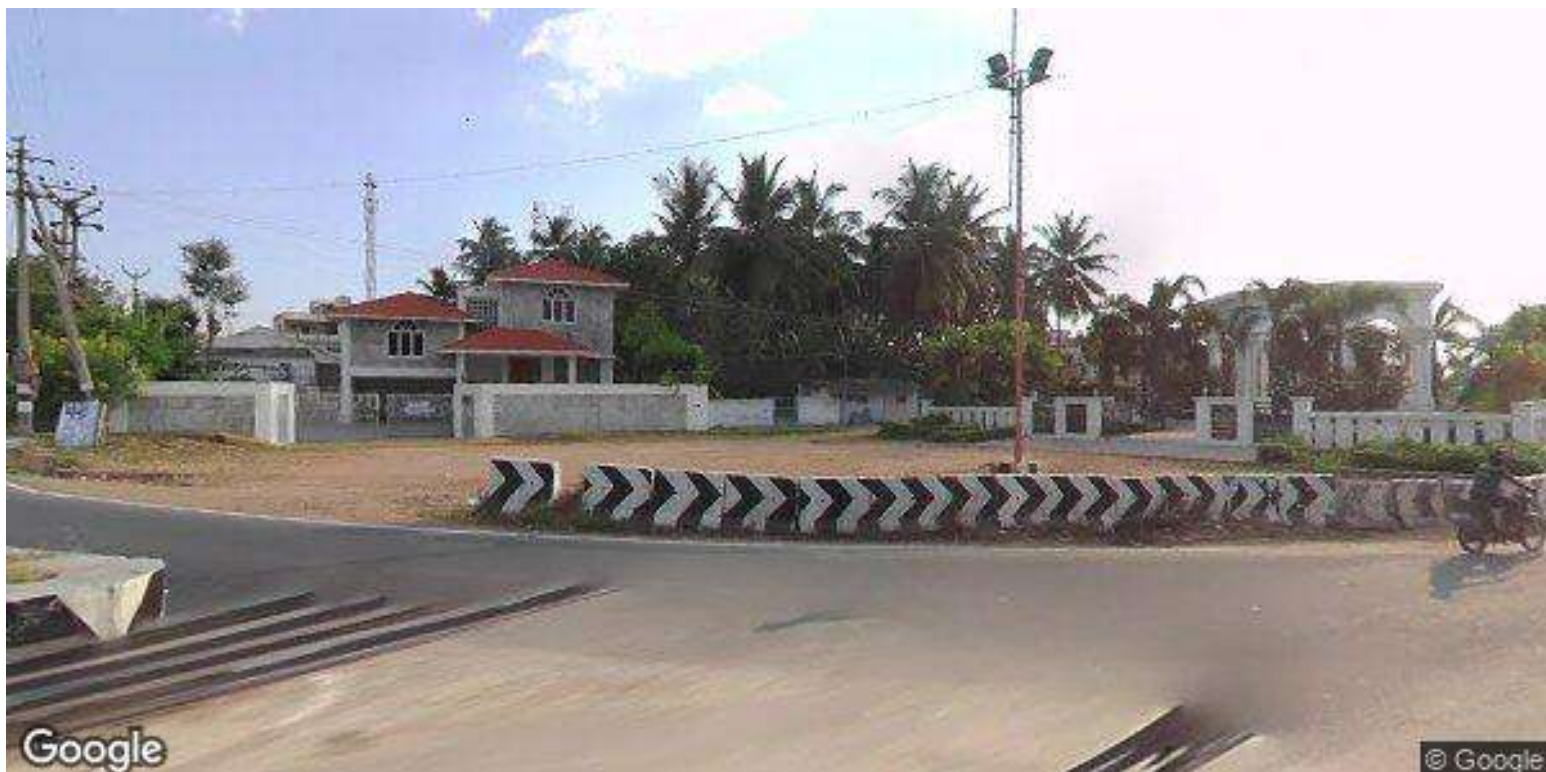
**Risk Type:** Turn  
**Risk Level:** Medium  
**Speed Limit:** 30 KM/Hr  
**Coordinates:** 11.46314, 77.84928

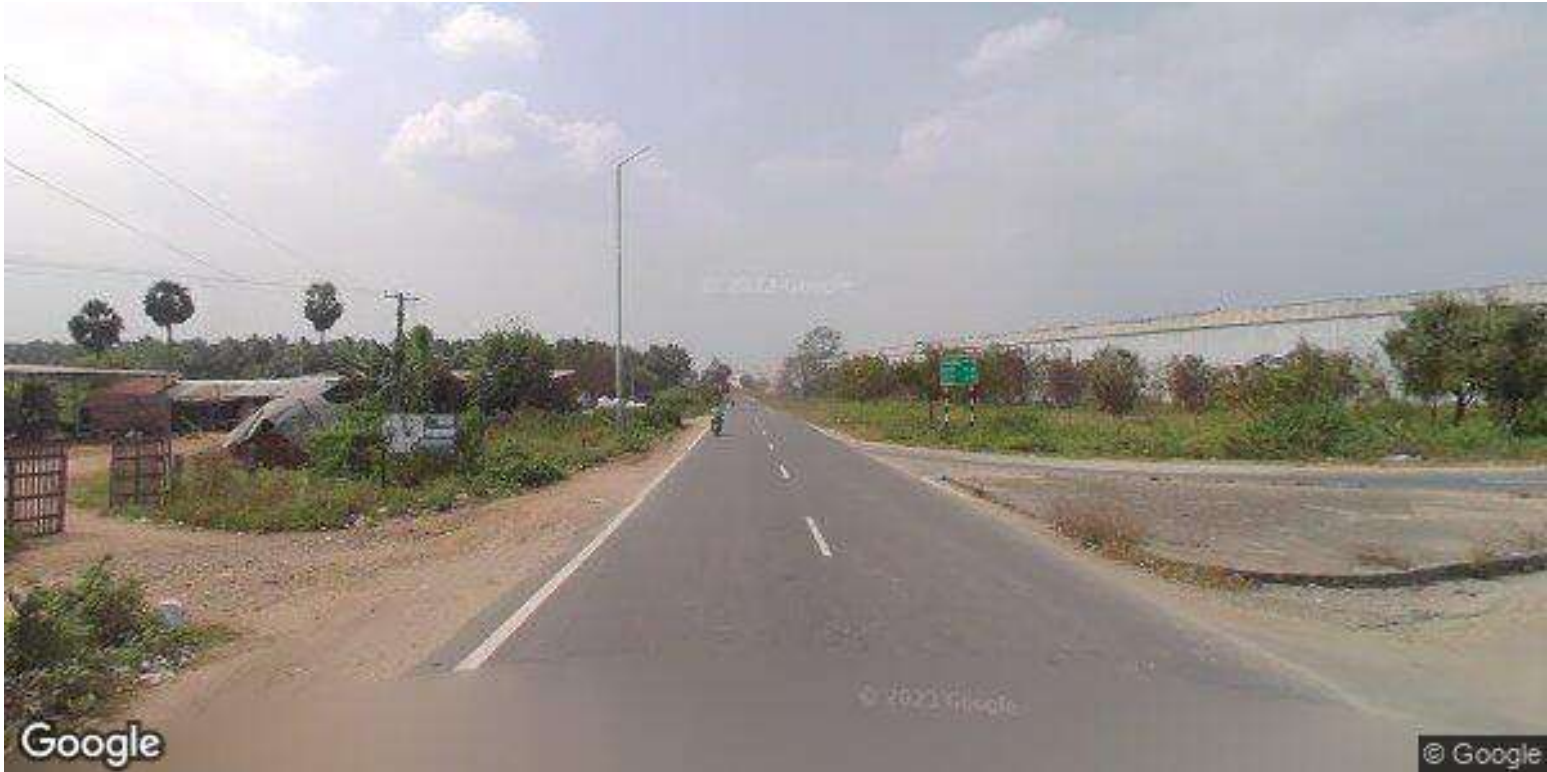
**Risk Type:** Turn  
**Risk Level:** High  
**Speed Limit:** 15 KM/Hr  
**Coordinates:** 11.45542, 77.81725

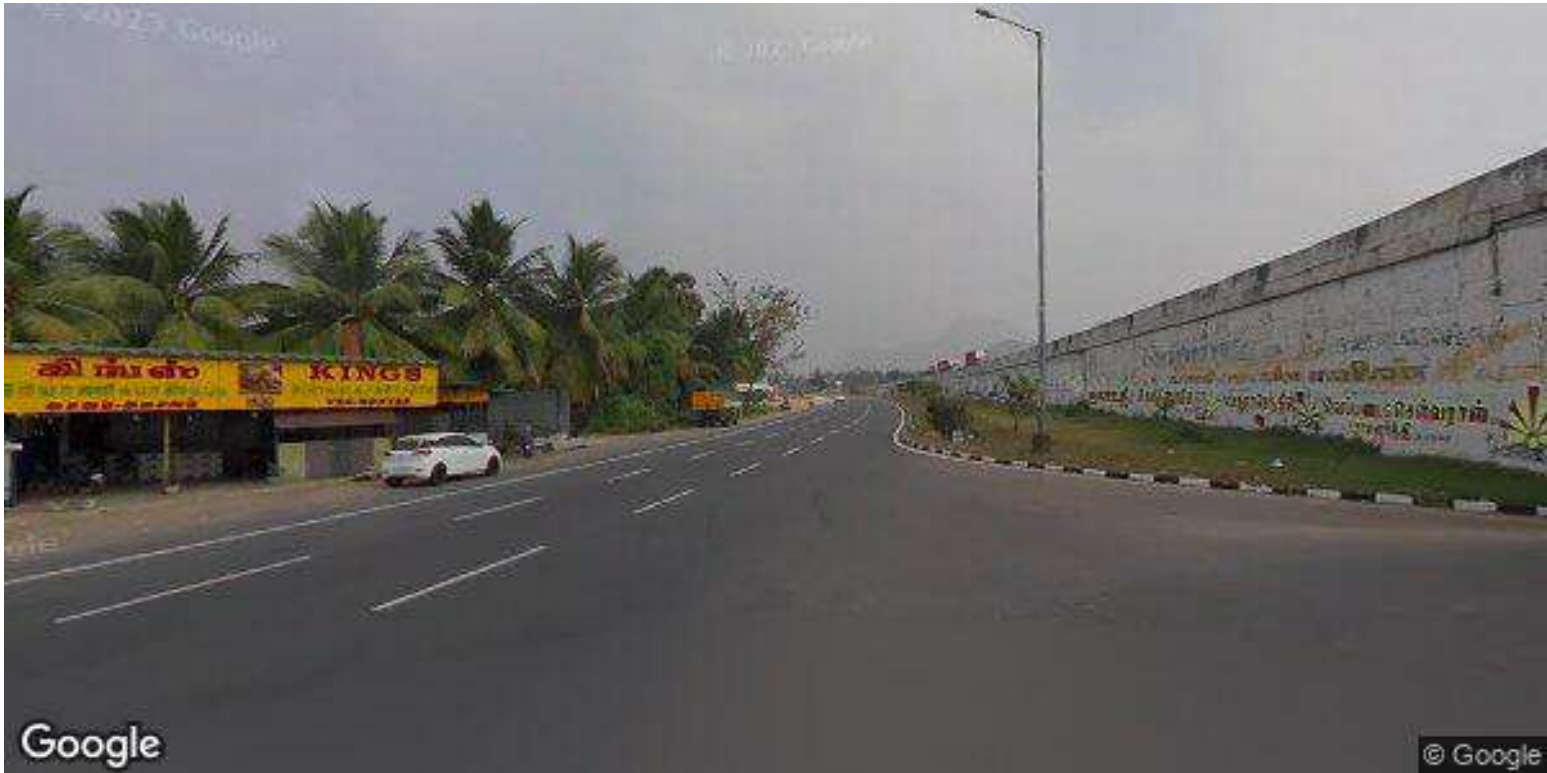
**Risk Type:** Turn  
**Risk Level:** High  
**Speed Limit:** 15 KM/Hr  
**Coordinates:** 11.45634, 77.81673

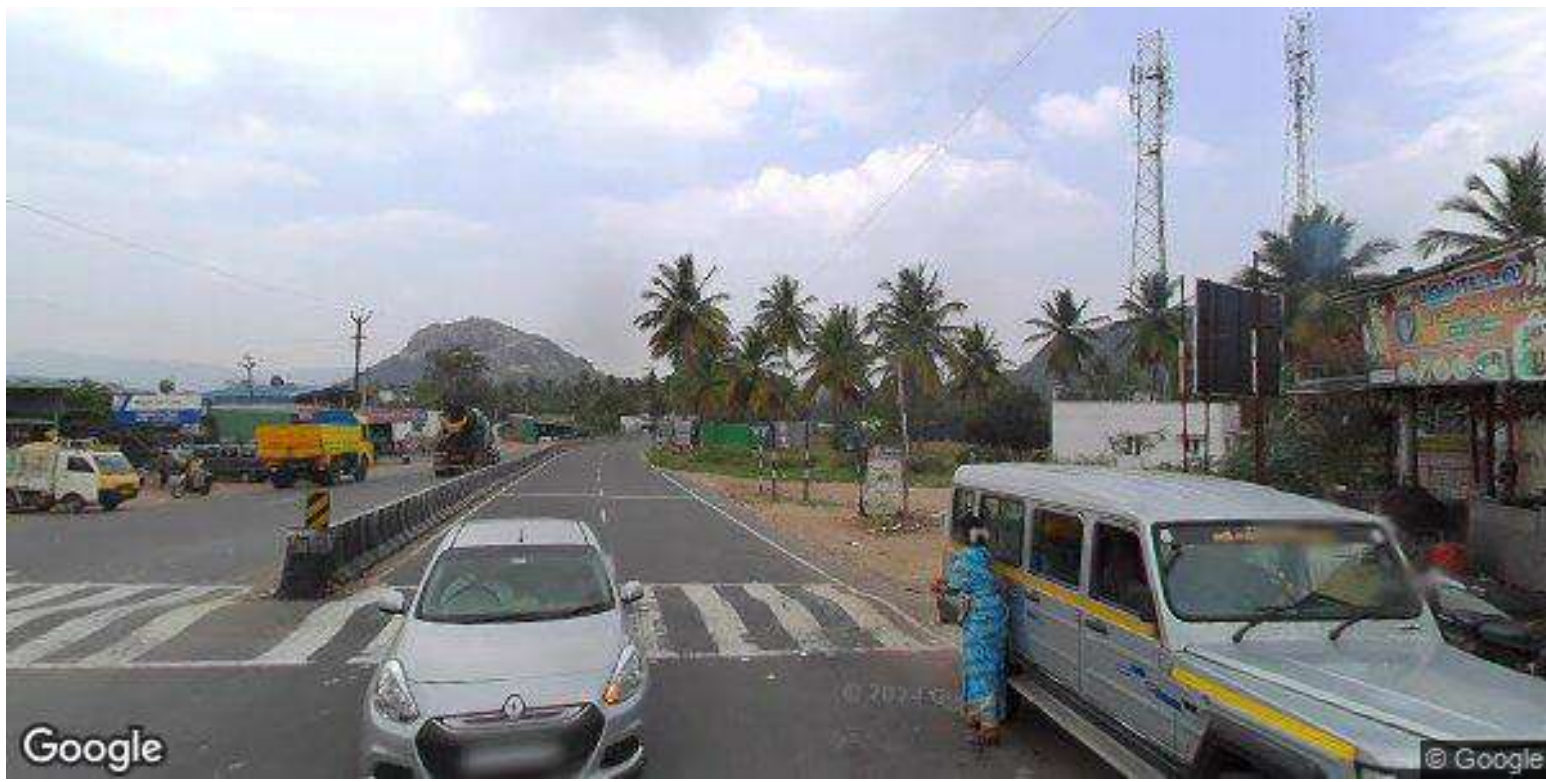
**Coordinates:** 11.49397, 77.86740

**Risk Type:** Blind Spot

**Risk Level:** Blind Spot

**Speed Limit:** 10 KM/Hr

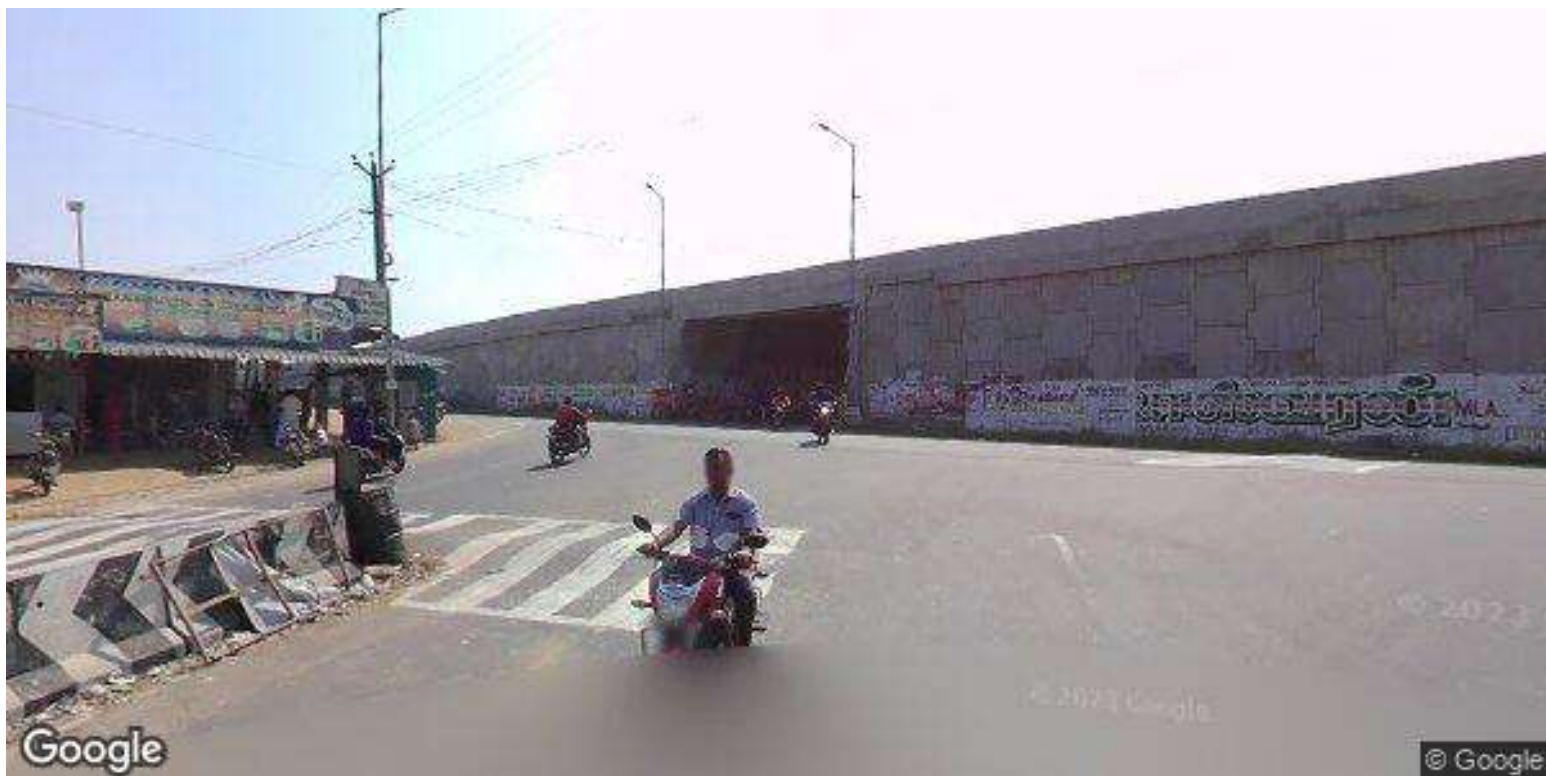
**Coordinates:** 11.49404, 77.86724

**Risk Type:** Turn

**Risk Level:** Medium

**Speed Limit:** 30 KM/Hr

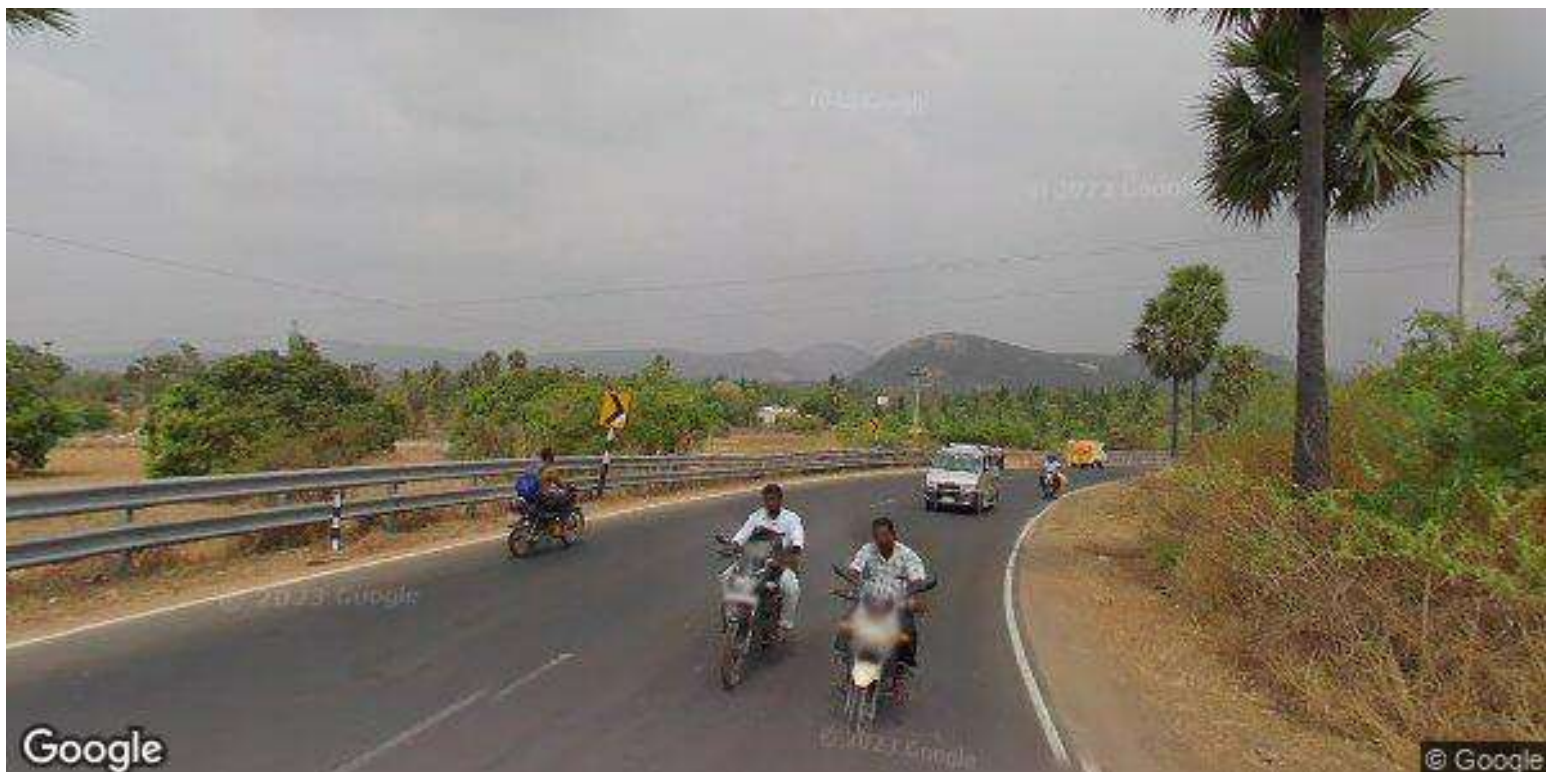
**Coordinates: 11.50866, 77.86053**

**Risk Type: Turn**

**Risk Level: Medium**

**Speed Limit: 30 KM/Hr**

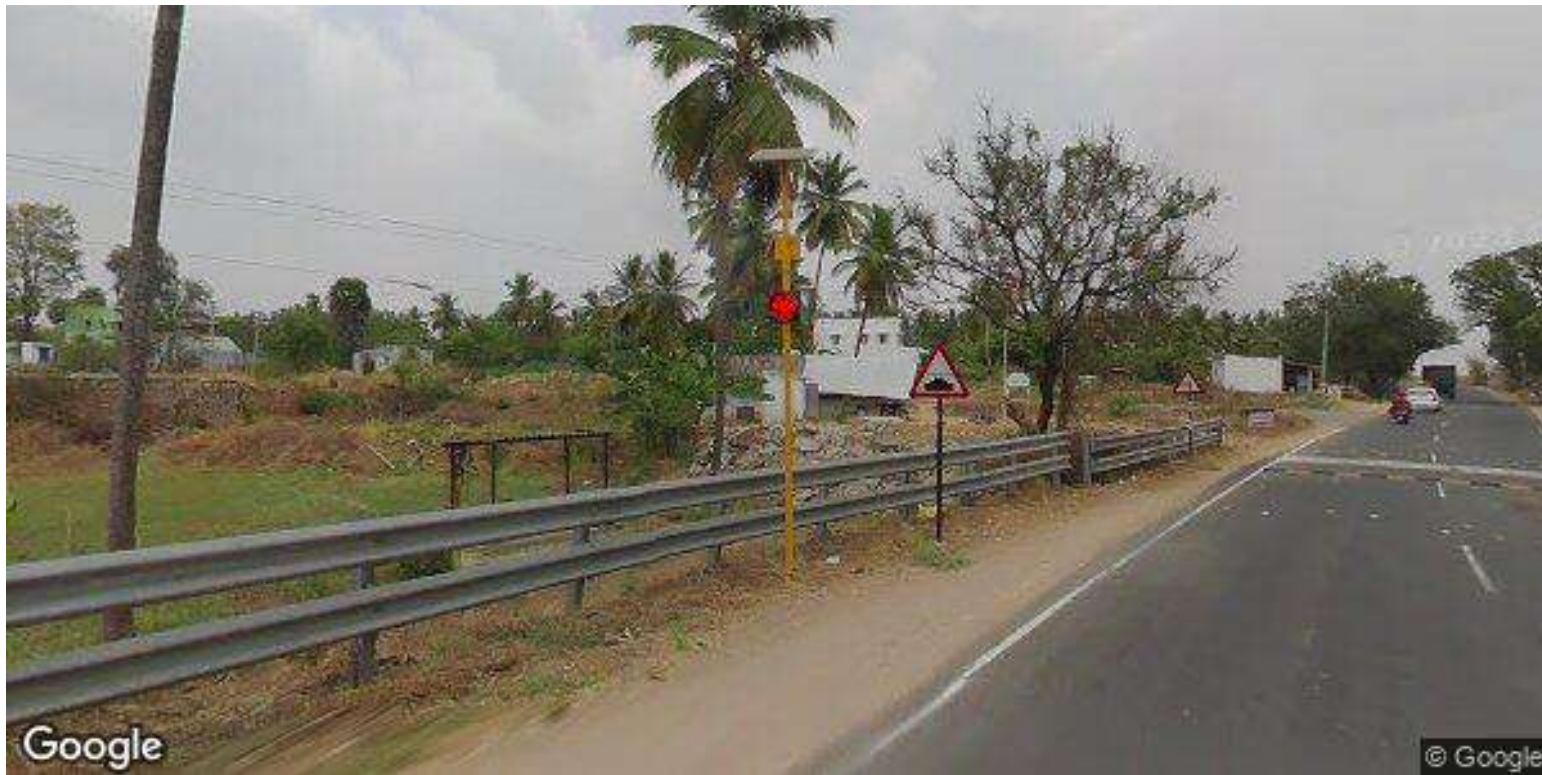
**Coordinates: 11.52587, 77.85524**

**Risk Type: Turn**

**Risk Level: Medium**

**Speed Limit: 30 KM/Hr**

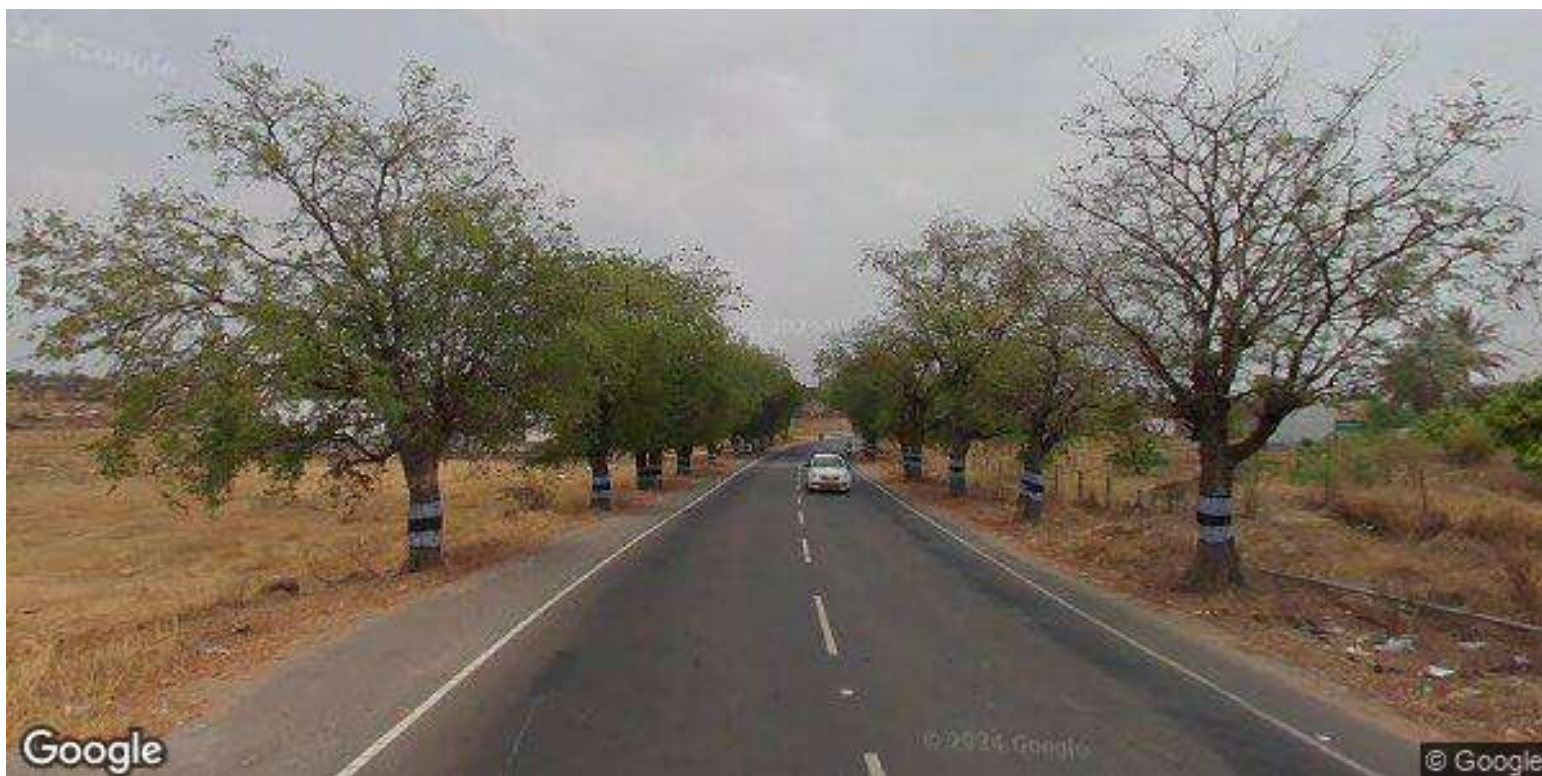
**Coordinates: 11.54750, 77.85273**

**Risk Type: Turn**

**Risk Level: Medium**

**Speed Limit: 30 KM/Hr**

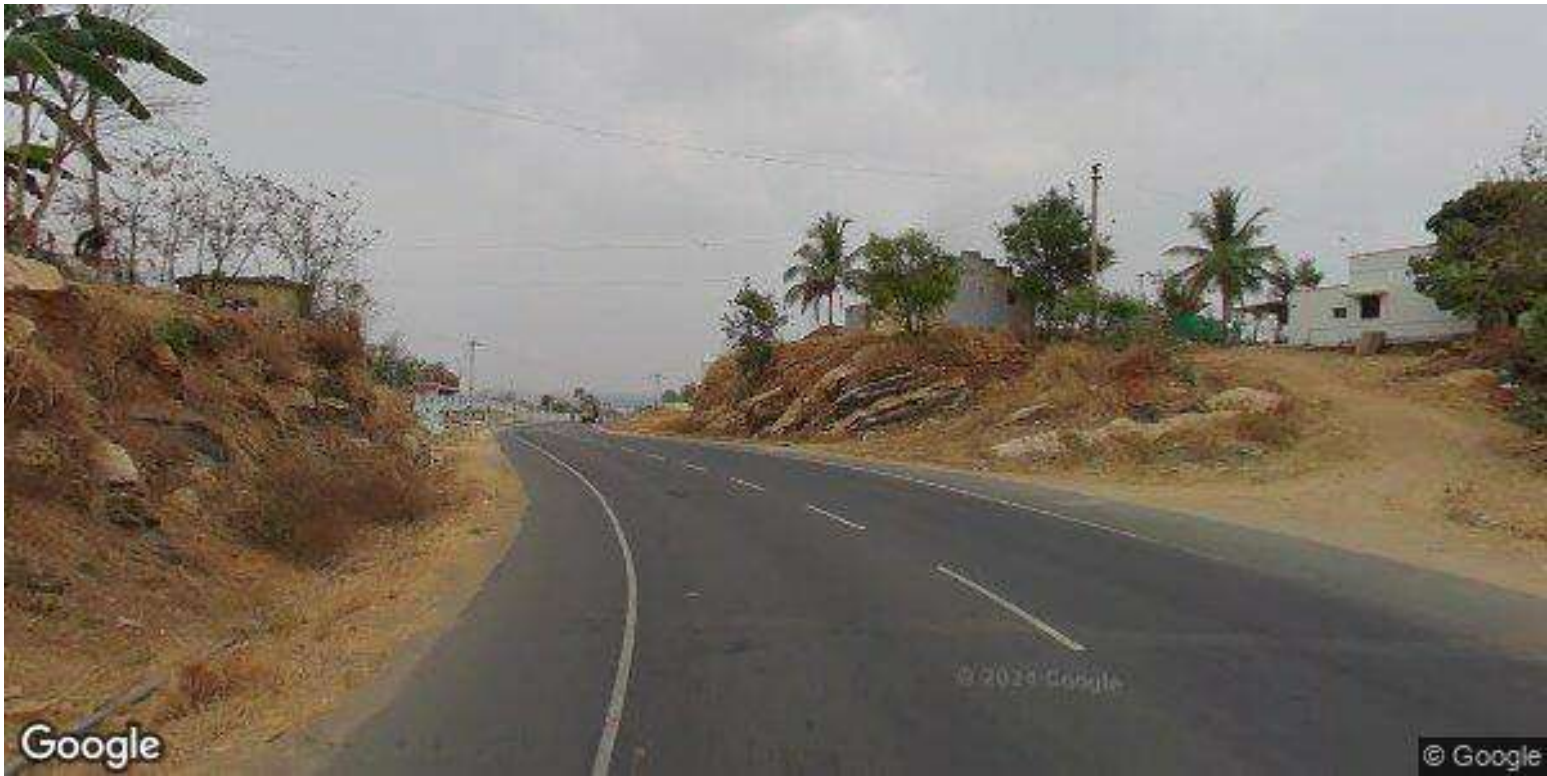
**Risk Type:** Turn  
**Risk Level:** Medium  
**Speed Limit:** 30 KM/Hr  
**Coordinates:** 11.55039, 77.85511

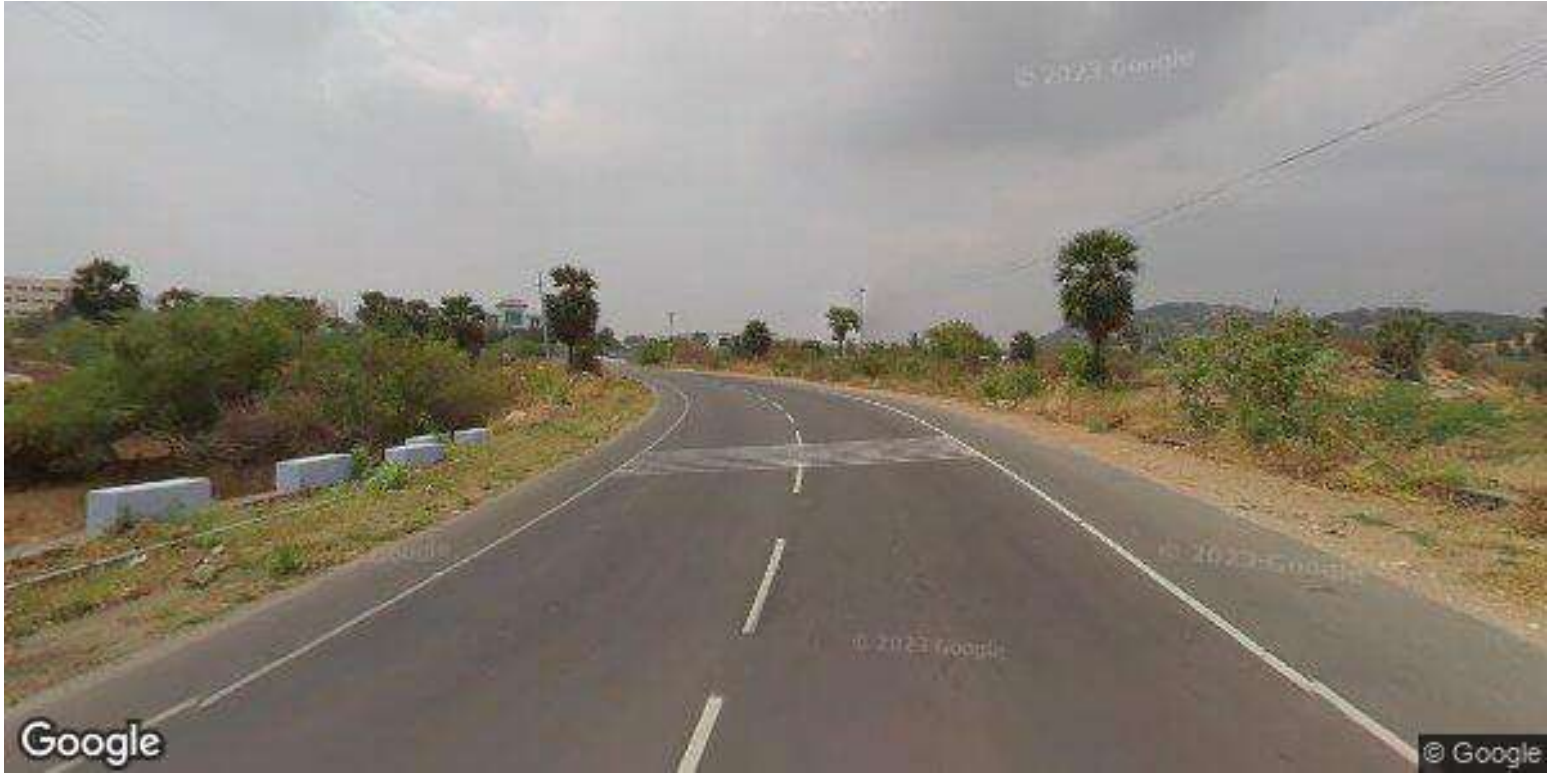
**Risk Type:** Turn  
**Risk Level:** Medium  
**Speed Limit:** 30 KM/Hr  
**Coordinates:** 11.55481, 77.85639
