# IndianOil

## JOURNEY RISK MANAGEMENT (JRM) STUDY

### Salem Terminal to MAHALAKSHMI TRADERS

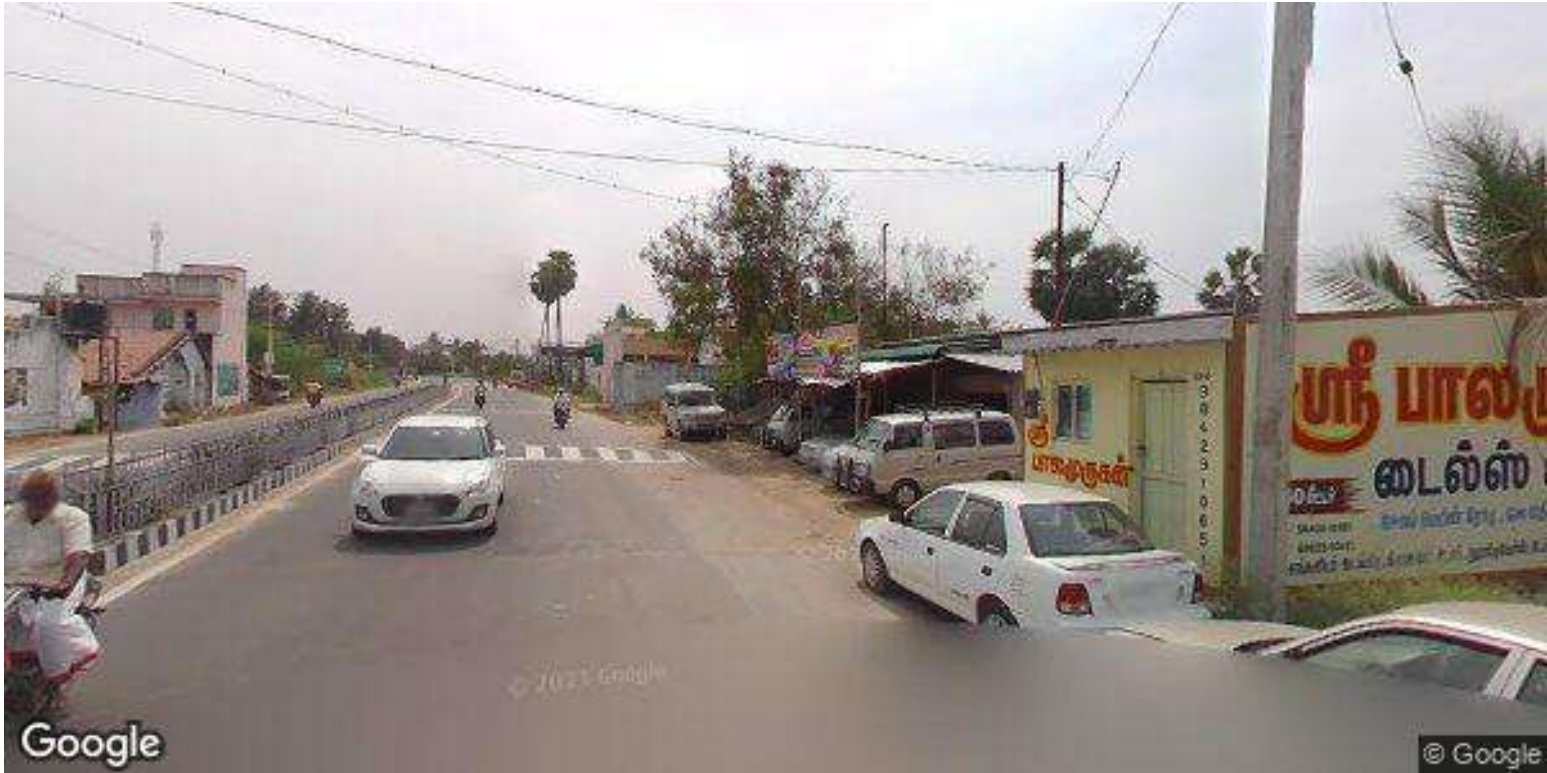
**Risk Type:** Turn  
**Risk Level:** High  
**Speed Limit:** 15 KM/Hr  
**Coordinates:** 11.57893, 77.85430

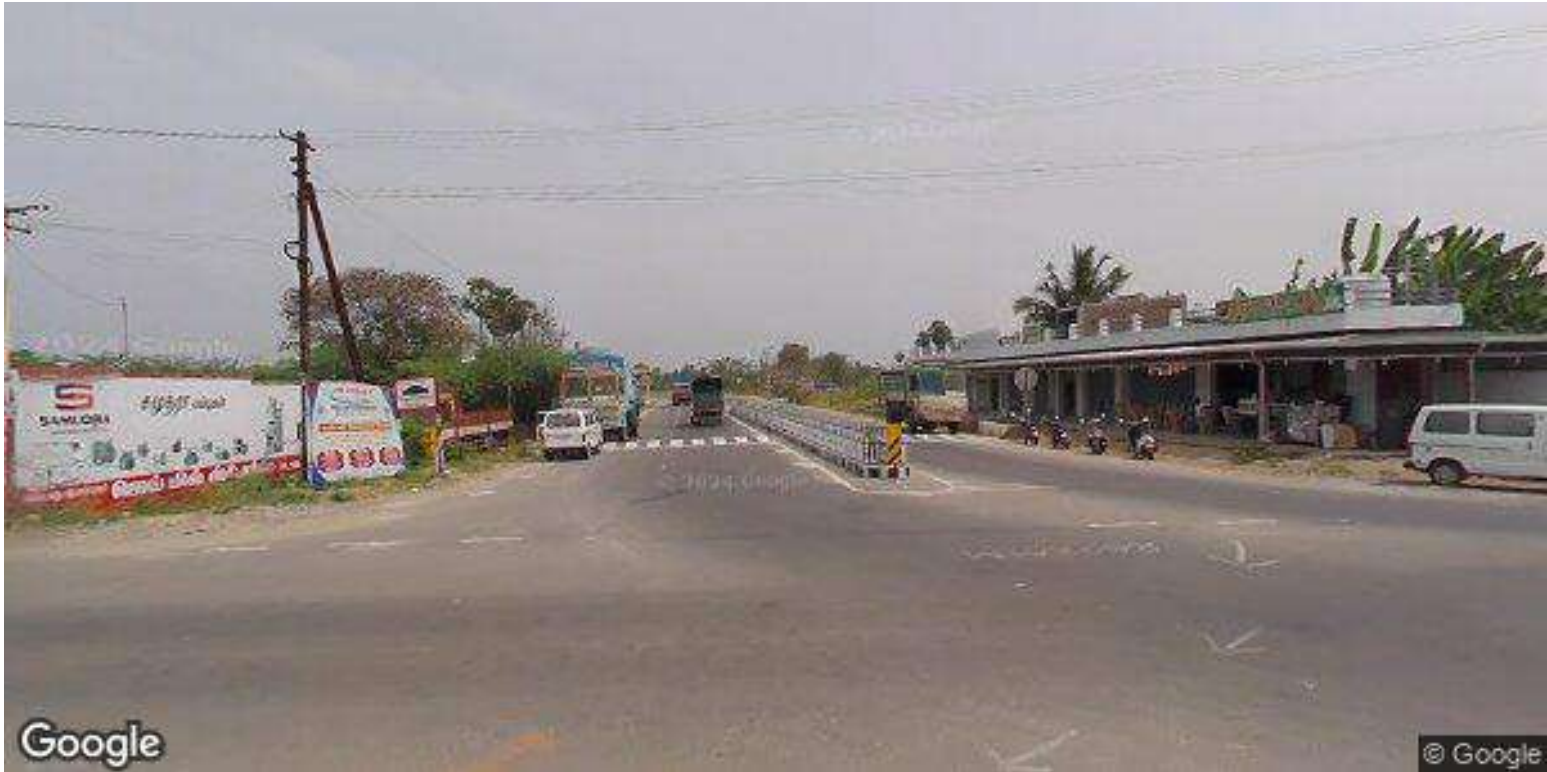
**Risk Type:** Turn  
**Risk Level:** Medium  
**Speed Limit:** 30 KM/Hr  
**Coordinates:** 11.57903, 77.85441

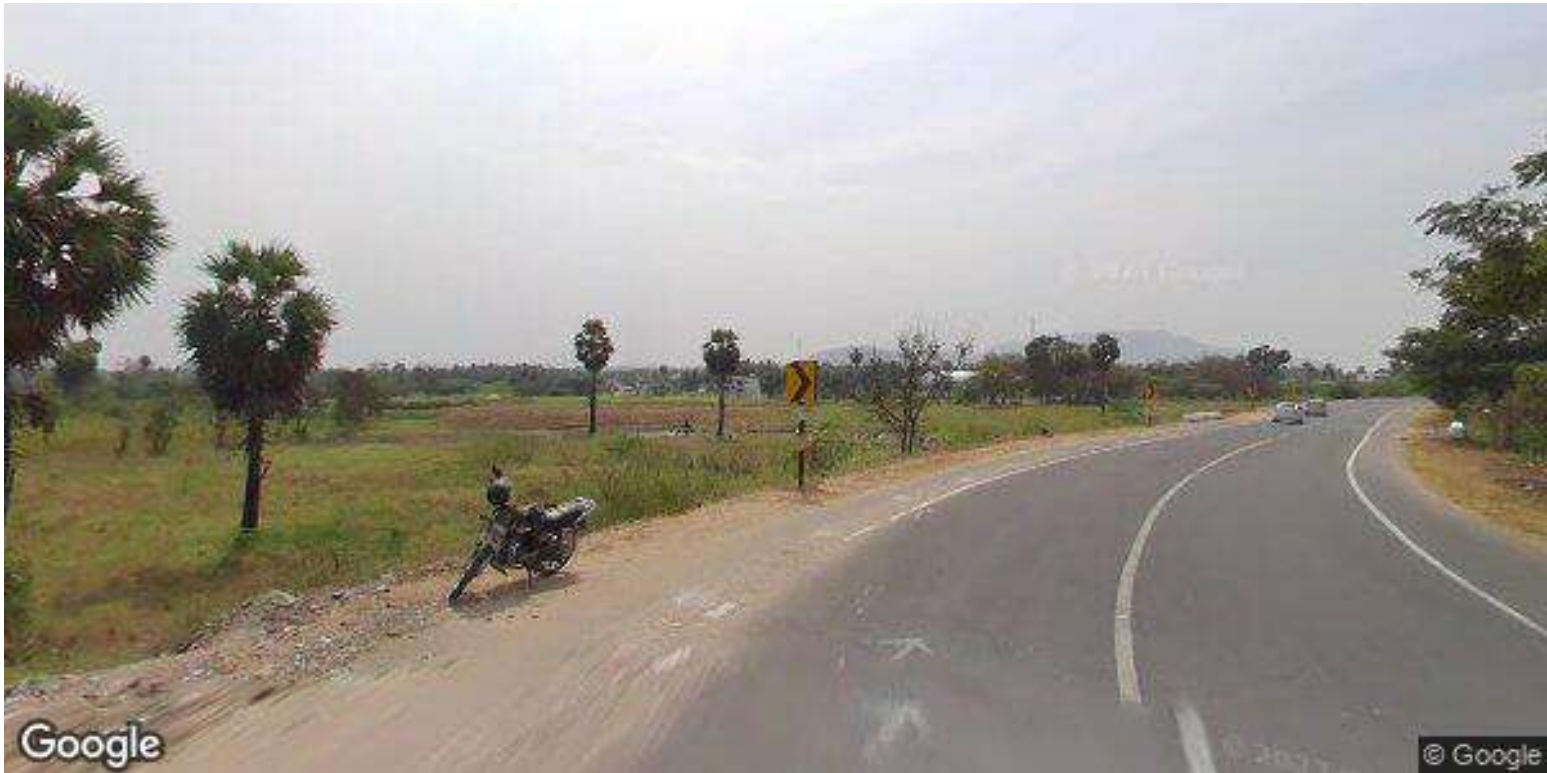
**Risk Type:** Turn  
**Risk Level:** Medium  
**Speed Limit:** 30 KM/Hr  
**Coordinates:** 11.58022, 77.85744

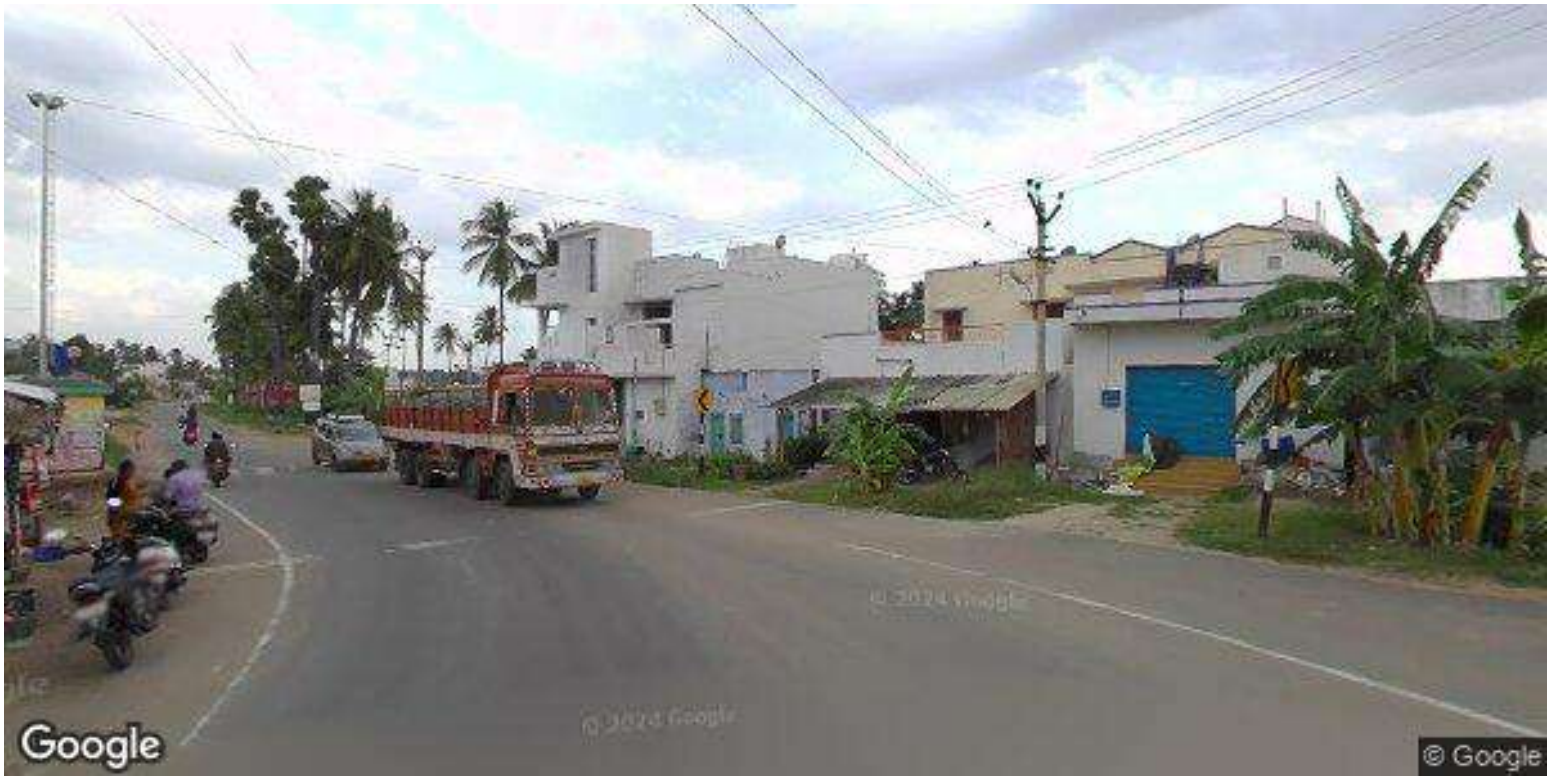
**Risk Type:** Turn  
**Risk Level:** High  
**Speed Limit:** 15 KM/Hr  
**Coordinates:** 11.65398, 77.76444

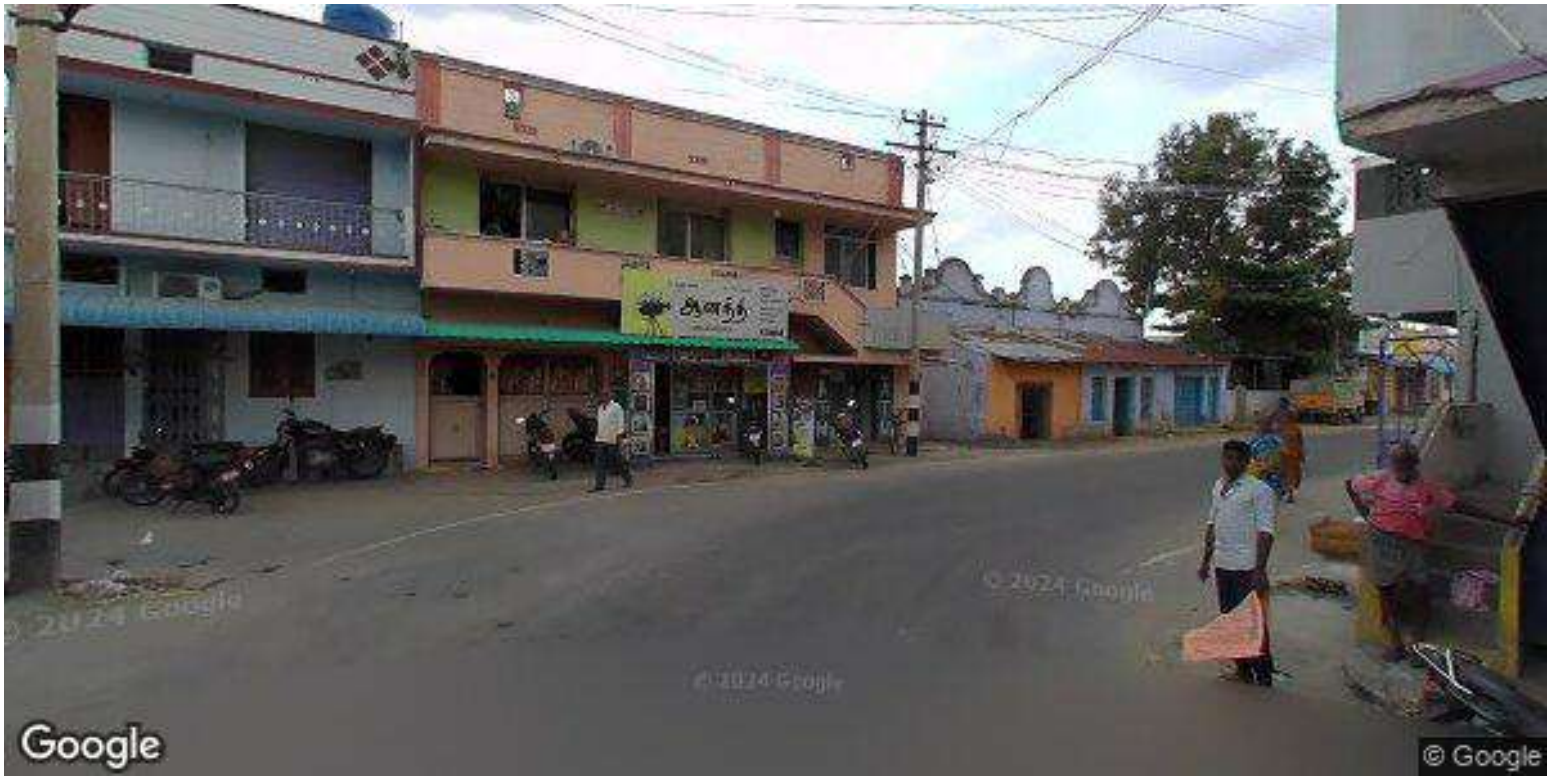
**Risk Type:** Turn  
**Risk Level:** High  
**Speed Limit:** 15 KM/Hr  
**Coordinates:** 11.65608, 77.76465

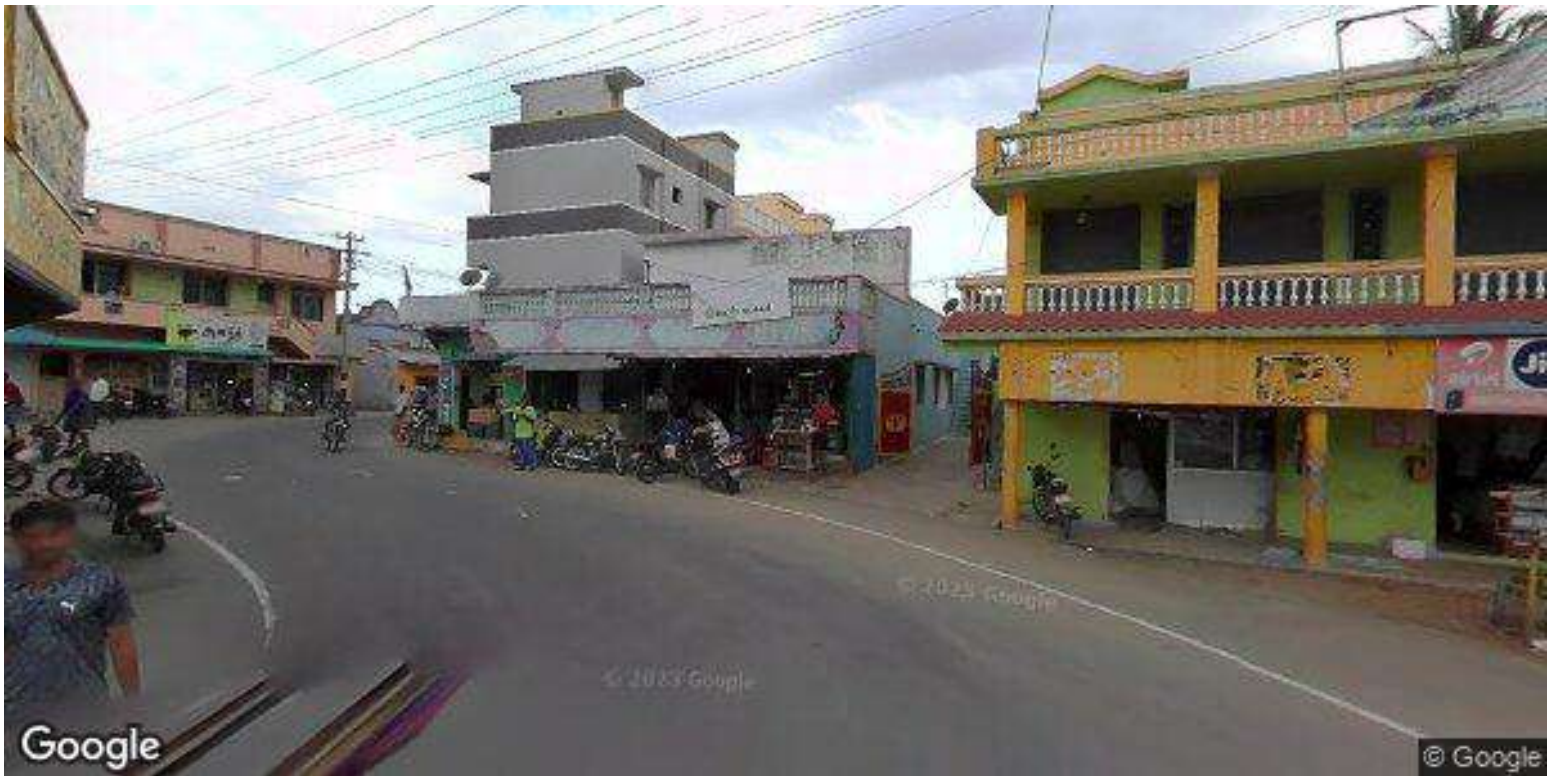
**Coordinates: 11.65623, 77.76451**

**Risk Type: Turn**

**Risk Level: High**

**Speed Limit: 15 KM/Hr**

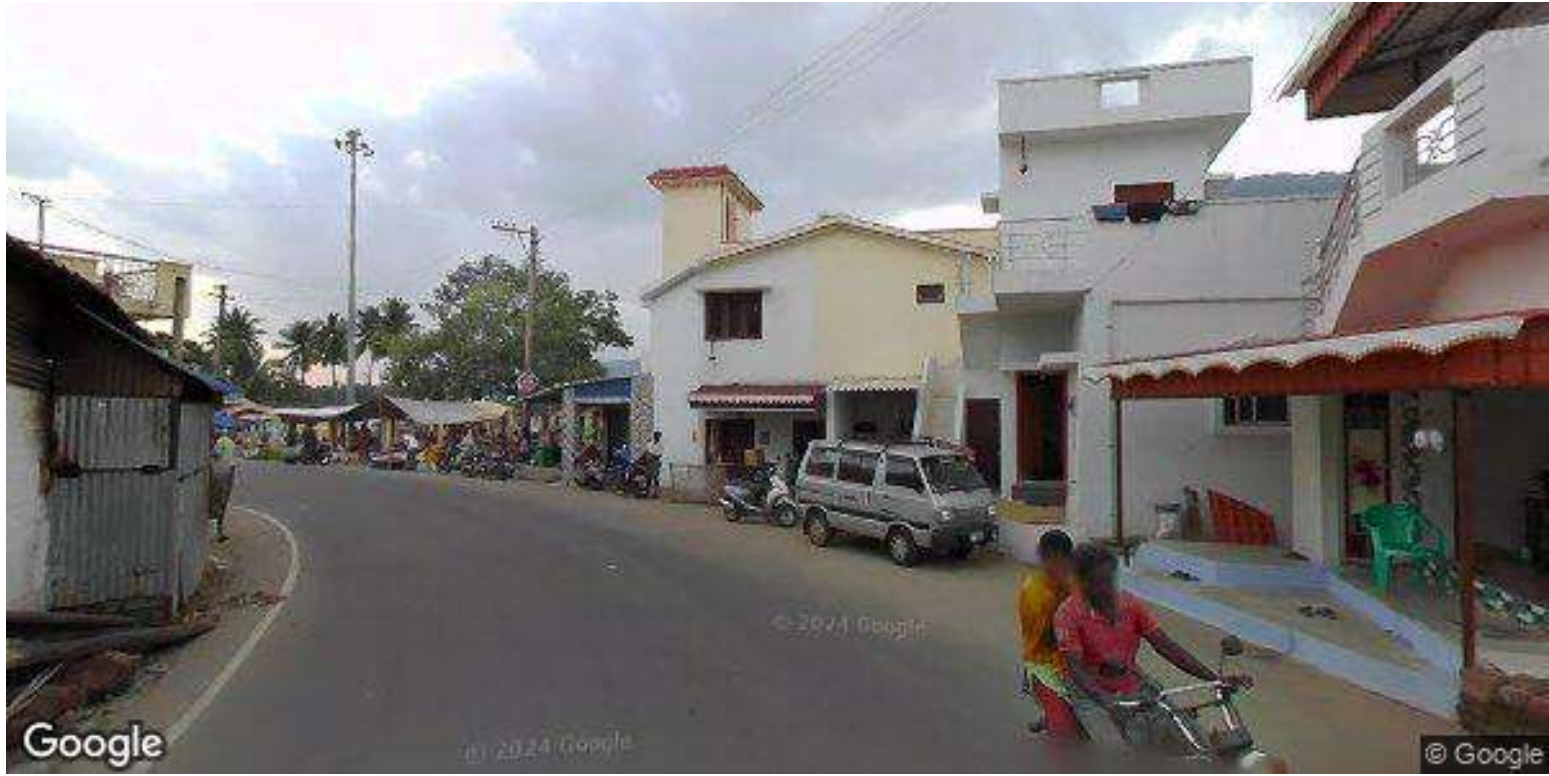
**Coordinates: 11.65760, 77.76513**

**Risk Type: Turn**

**Risk Level: Medium**

**Speed Limit: 30 KM/Hr**

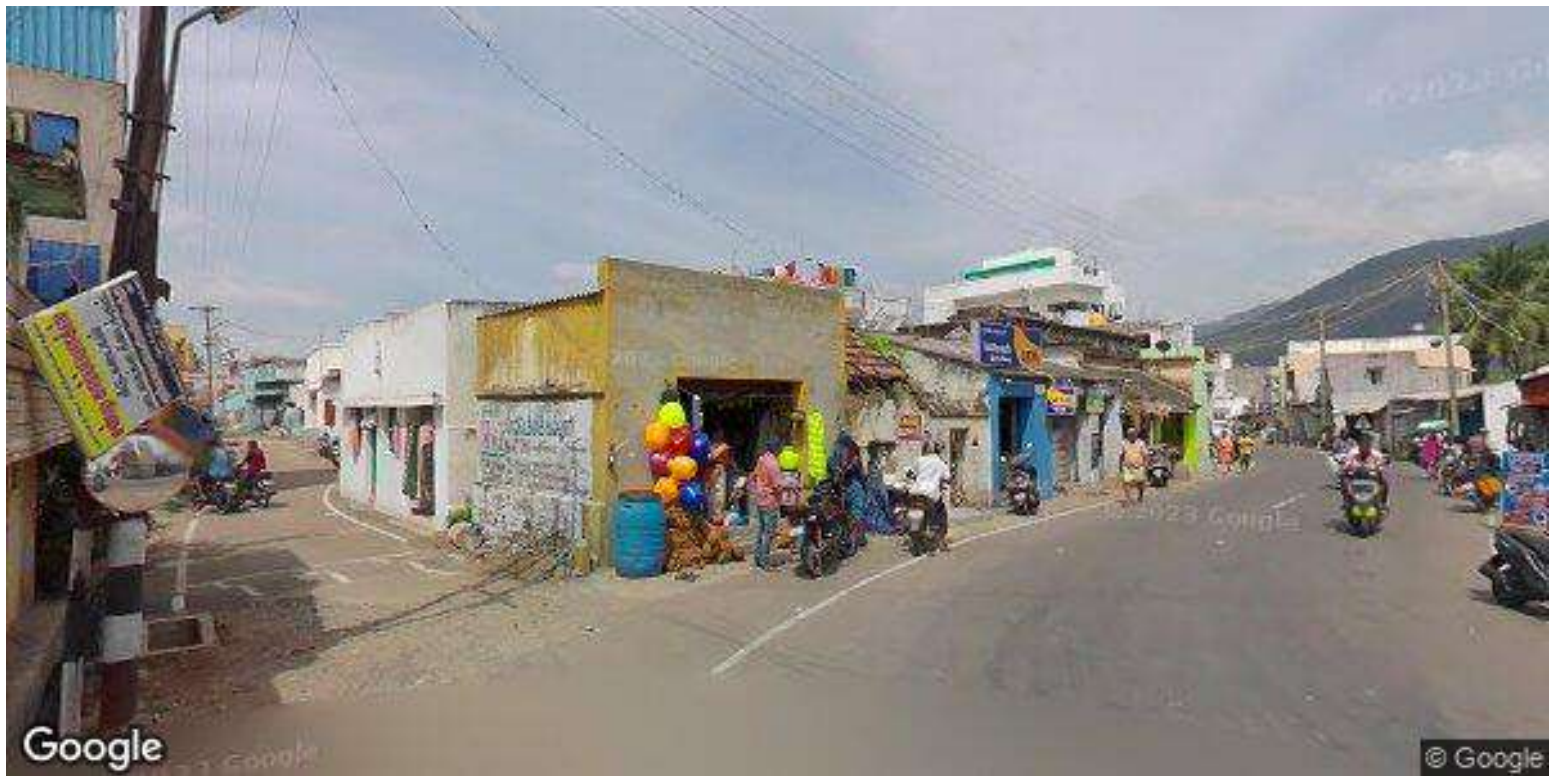
**Coordinates: 11.65764, 77.76613**

**Risk Type: Turn**

**Risk Level: High**

**Speed Limit: 15 KM/Hr**

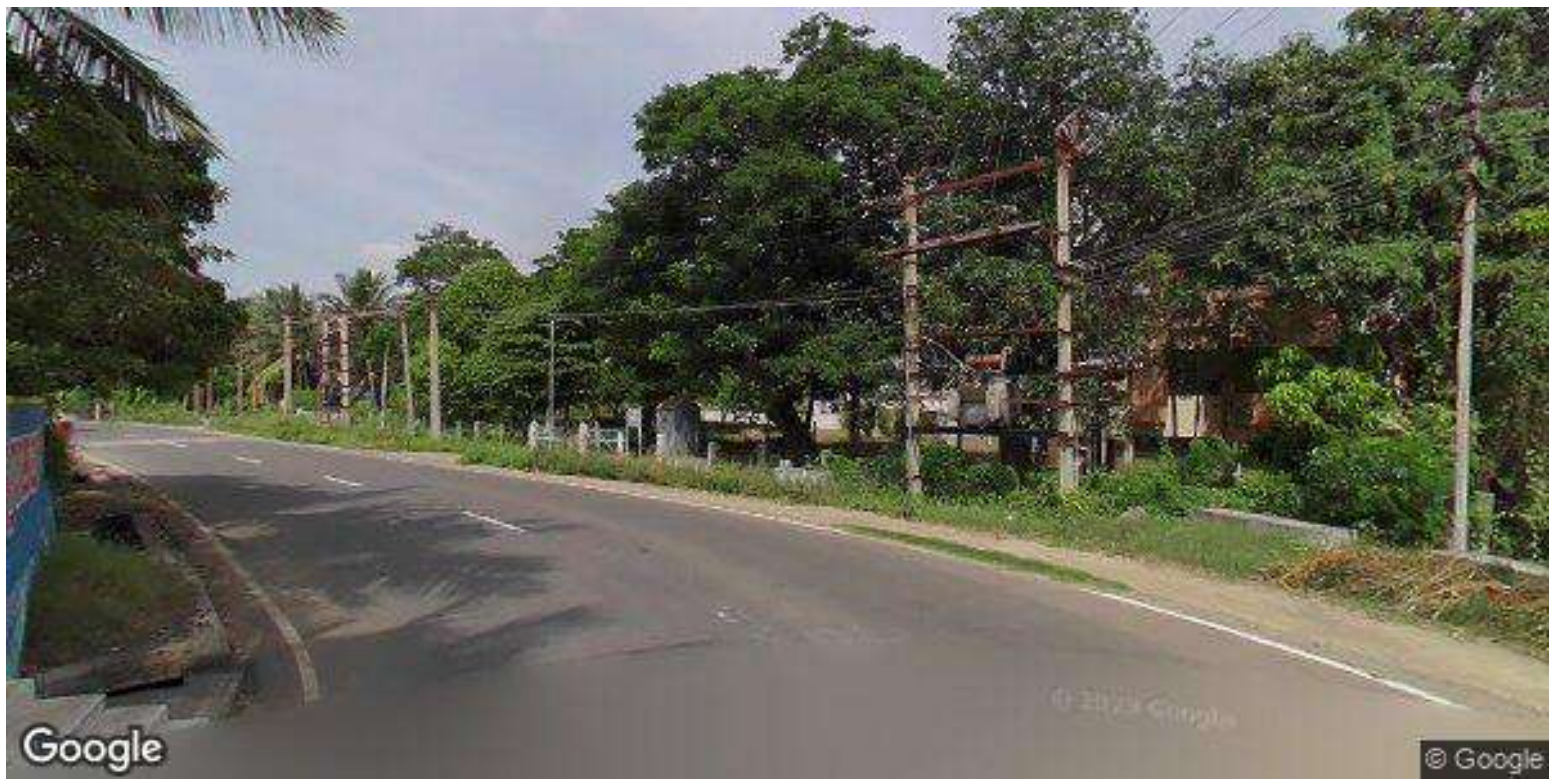
**Risk Type:** Turn  
**Risk Level:** High  
**Speed Limit:** 15 KM/Hr  
**Coordinates:** 11.66103, 77.76757

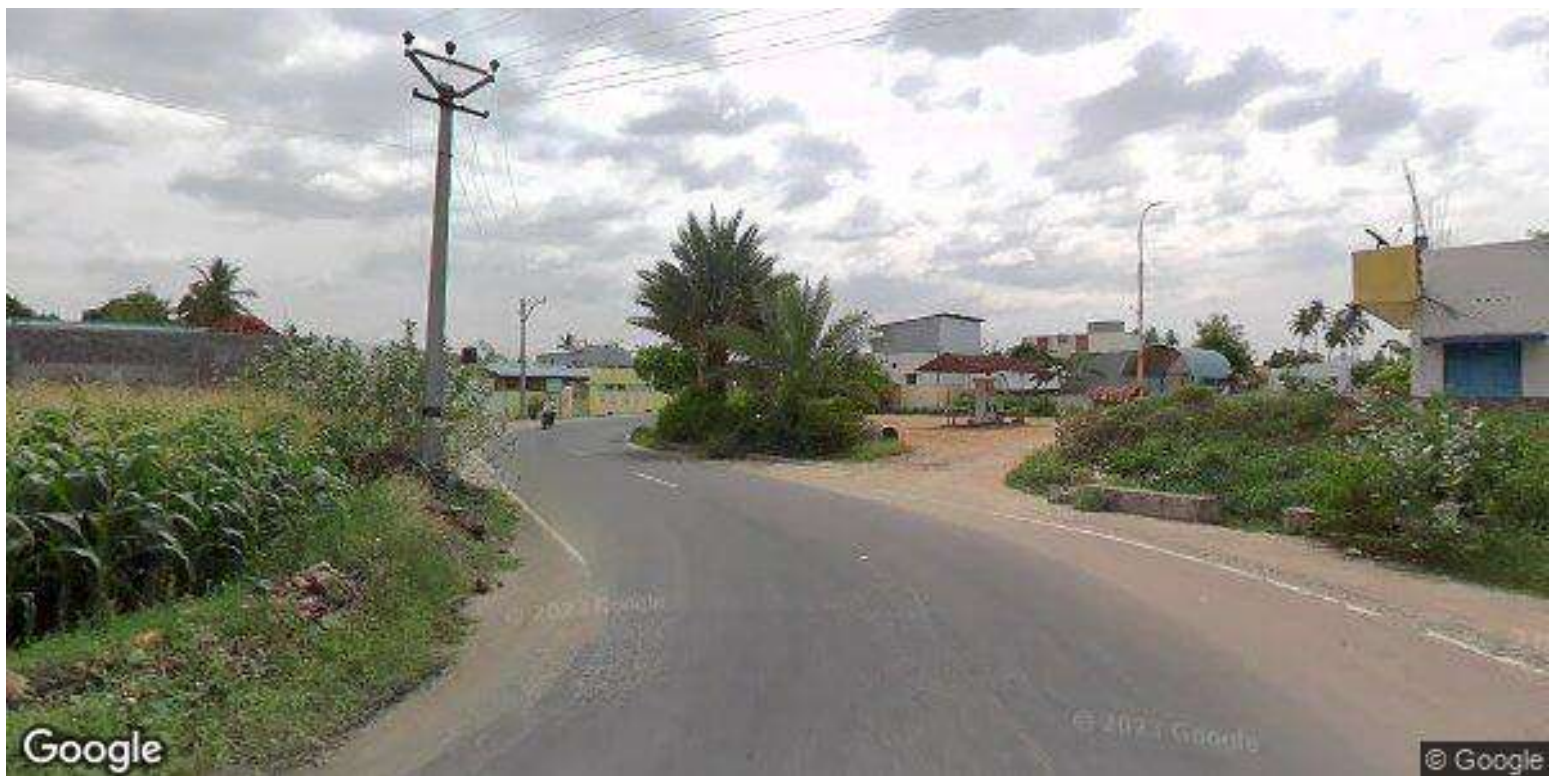
**Risk Type:** Turn  
**Risk Level:** High  
**Speed Limit:** 15 KM/Hr  
**Coordinates:** 11.66090, 77.76849

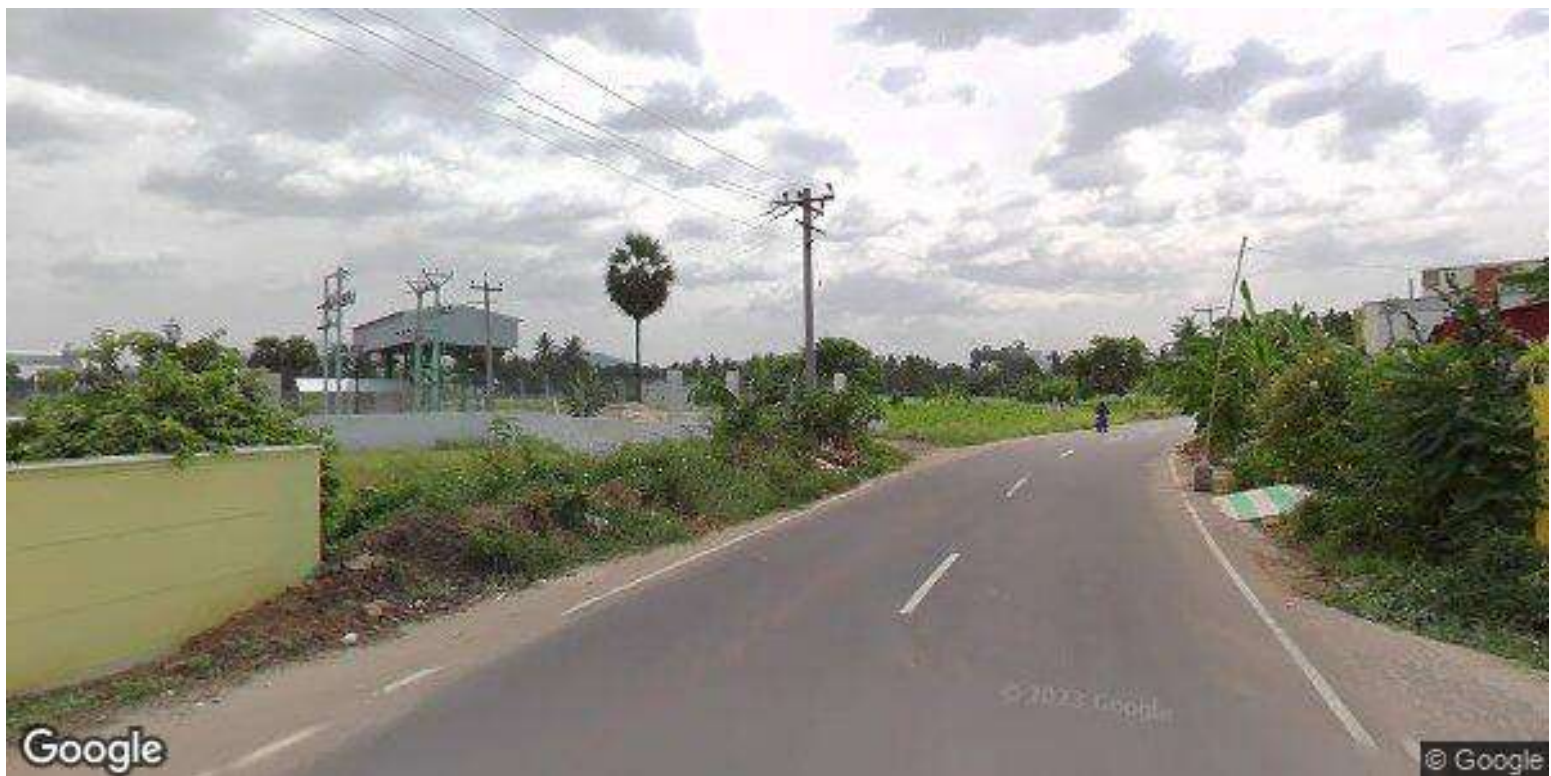
**Coordinates: 11.66123, 77.76890**

**Risk Type: Turn**

**Risk Level: Medium**

**Speed Limit: 30 KM/Hr**

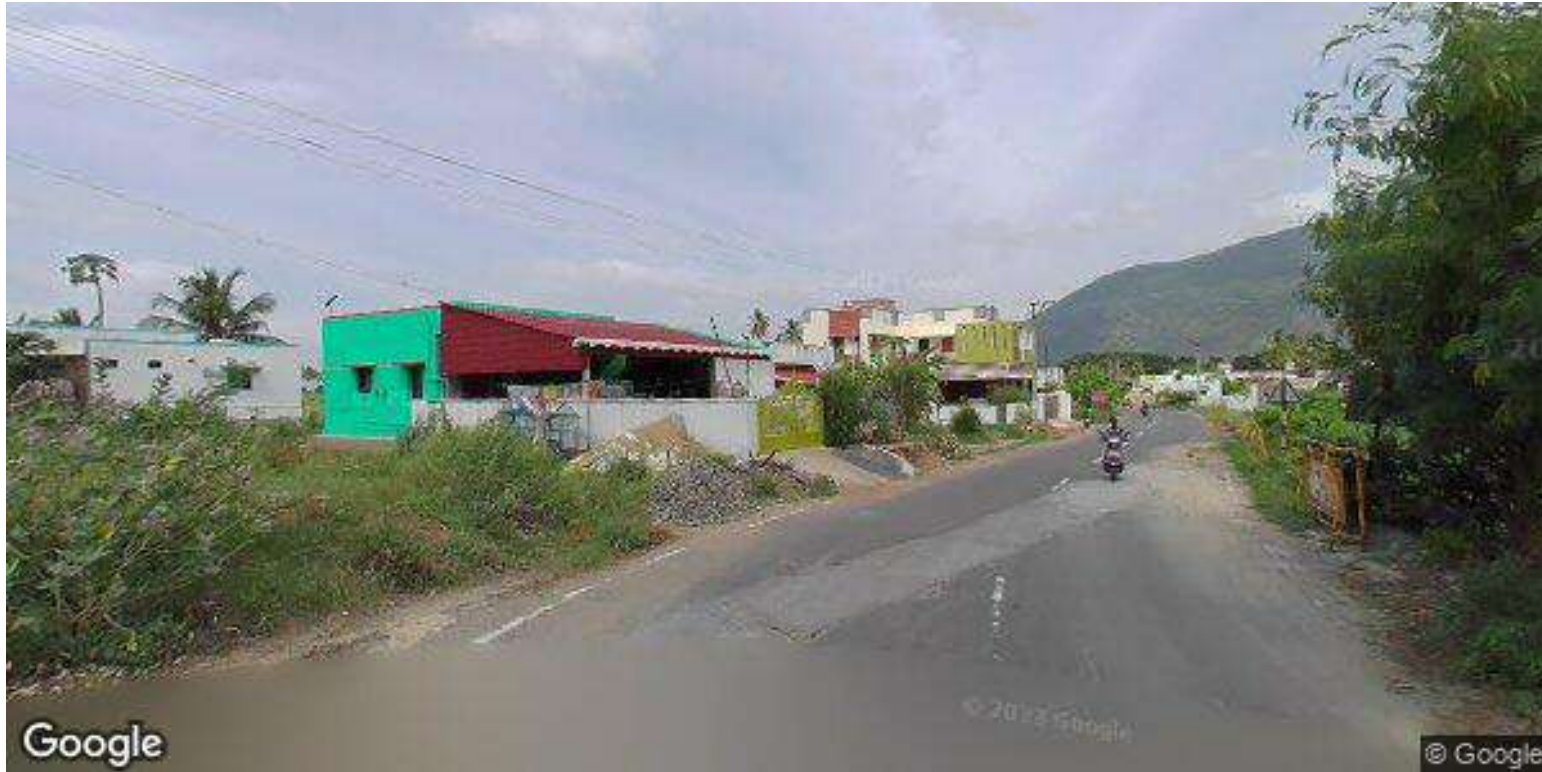
**Coordinates: 11.66122, 77.76992**

**Risk Type: Turn**

**Risk Level: High**

**Speed Limit: 15 KM/Hr**

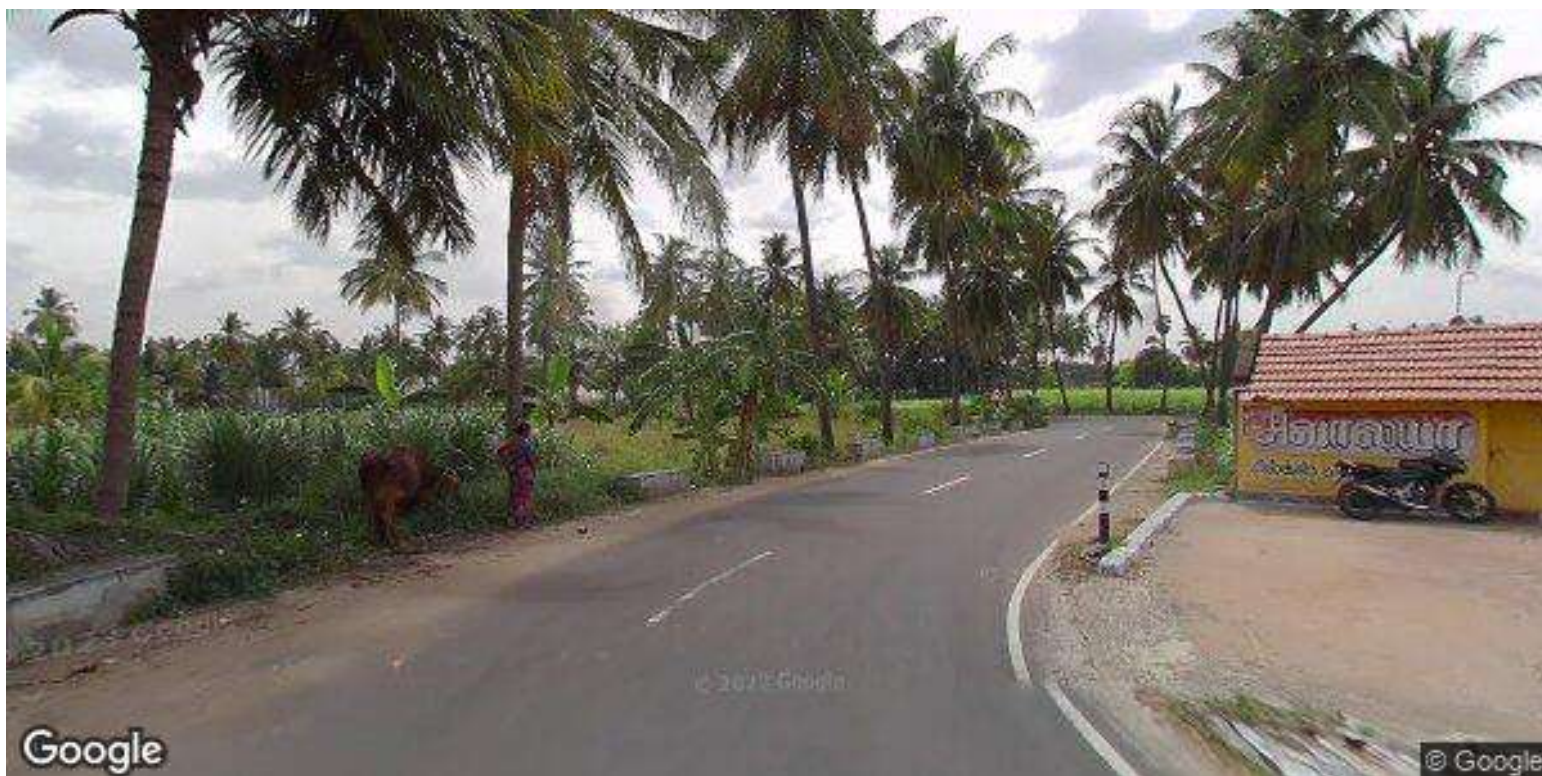
**Coordinates: 11.66386, 77.77083**

**Risk Type: Turn**

**Risk Level: High**

**Speed Limit: 15 KM/Hr**

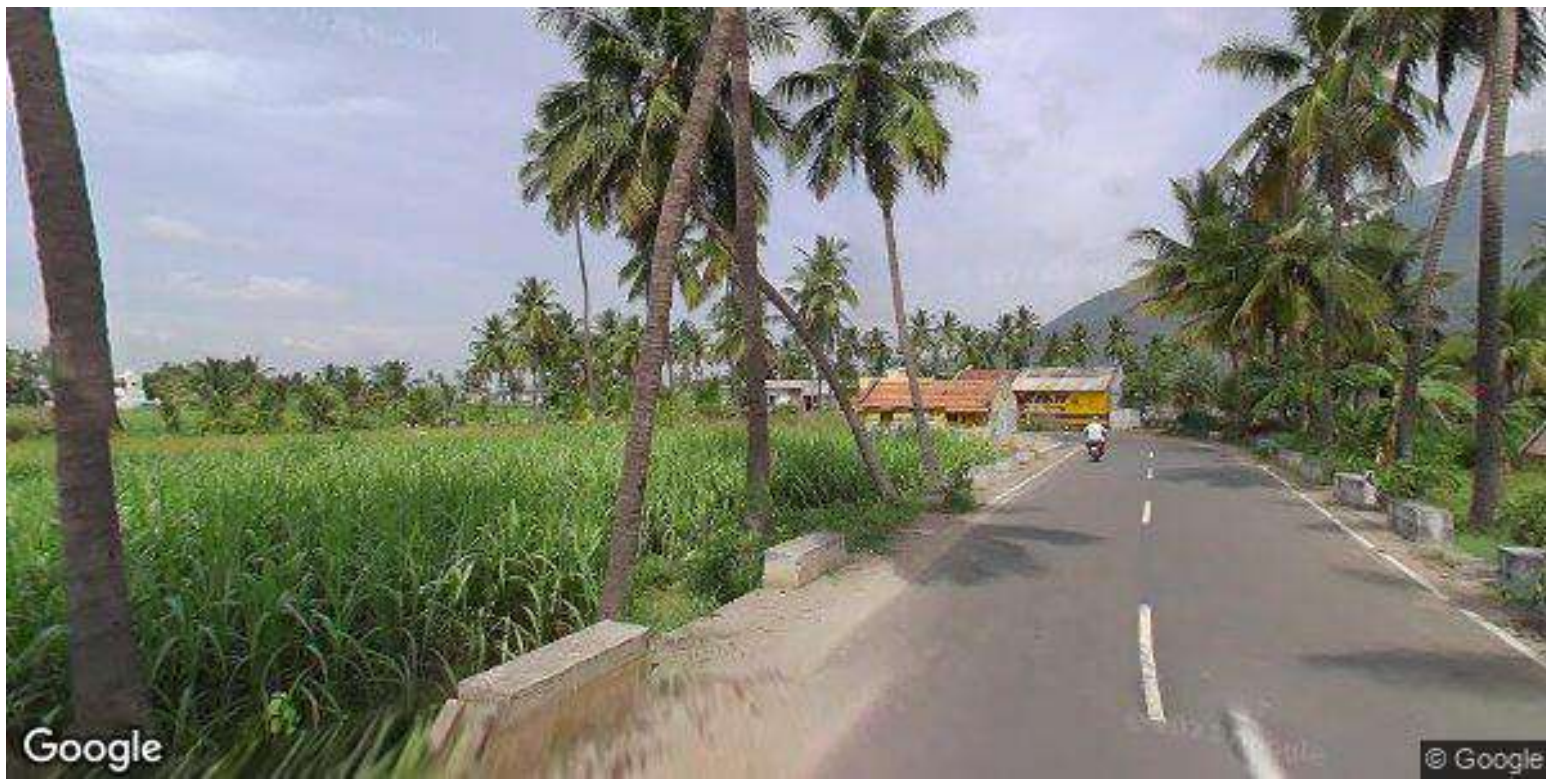
**Coordinates: 11.66386, 77.77125**

**Risk Type: Turn**

**Risk Level: High**

**Speed Limit: 15 KM/Hr**

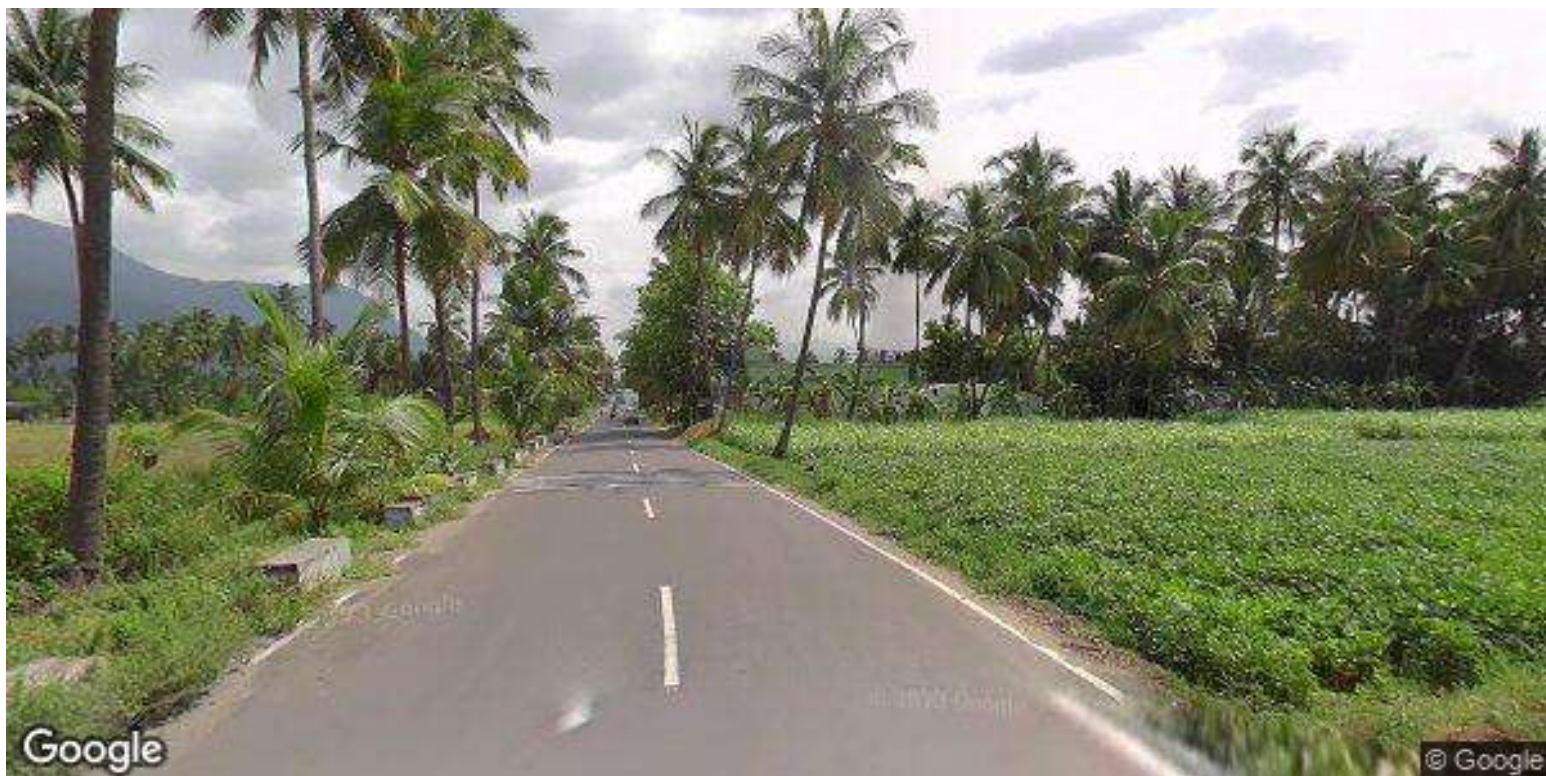
**Coordinates: 11.66400, 77.77136**

**Risk Type: Turn**

**Risk Level: Medium**

**Speed Limit: 30 KM/Hr**

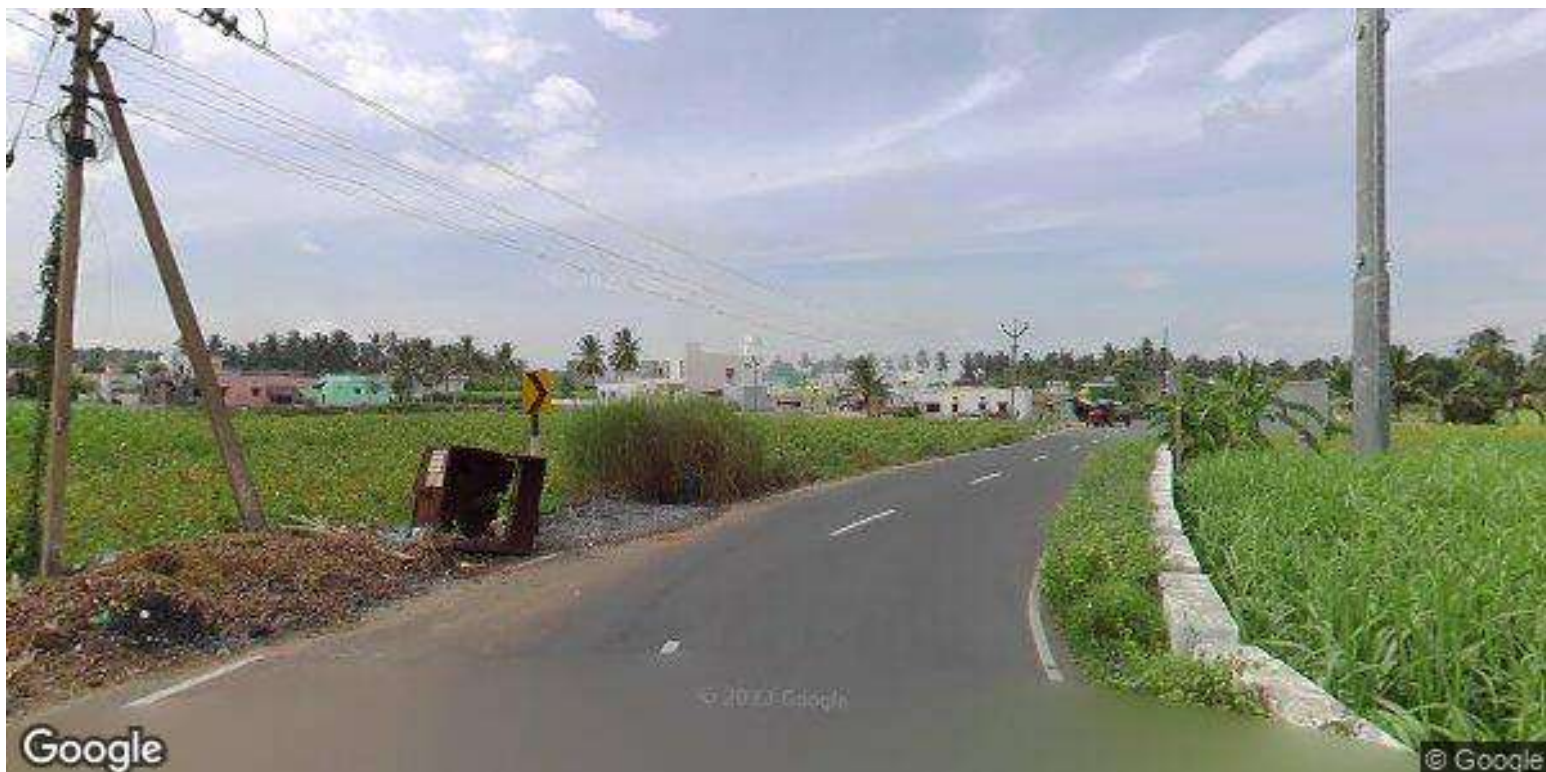
**Coordinates: 11.66857, 77.77231**

**Risk Type: Turn**

**Risk Level: High**

**Speed Limit: 15 KM/Hr**

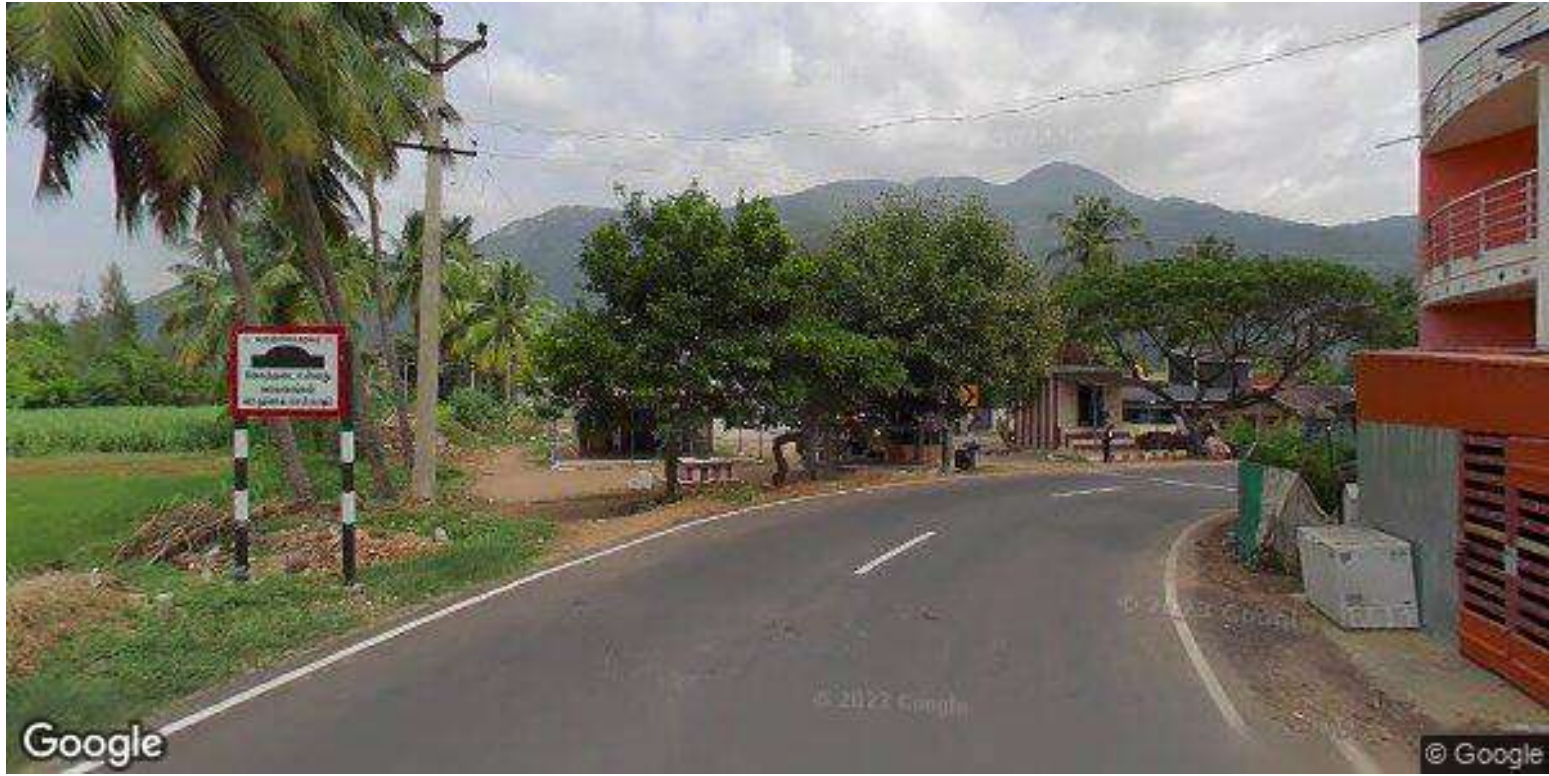
**Coordinates: 11.66873, 77.77191**

**Risk Type: Turn**

**Risk Level: Medium**

**Speed Limit: 30 KM/Hr**

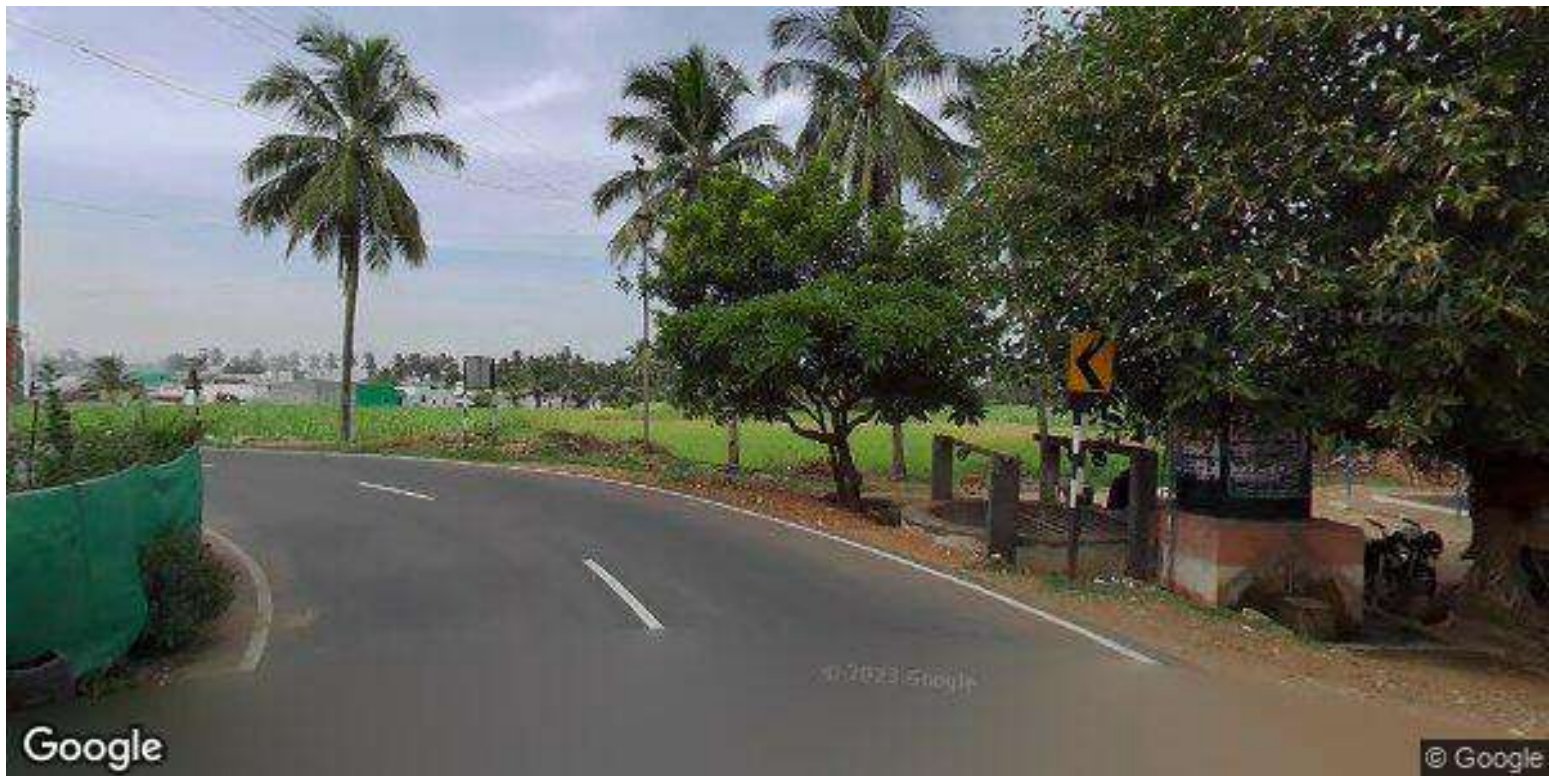
**Coordinates: 11.66890, 77.77178**

**Risk Type: Turn**

**Risk Level: High**

**Speed Limit: 15 KM/Hr**

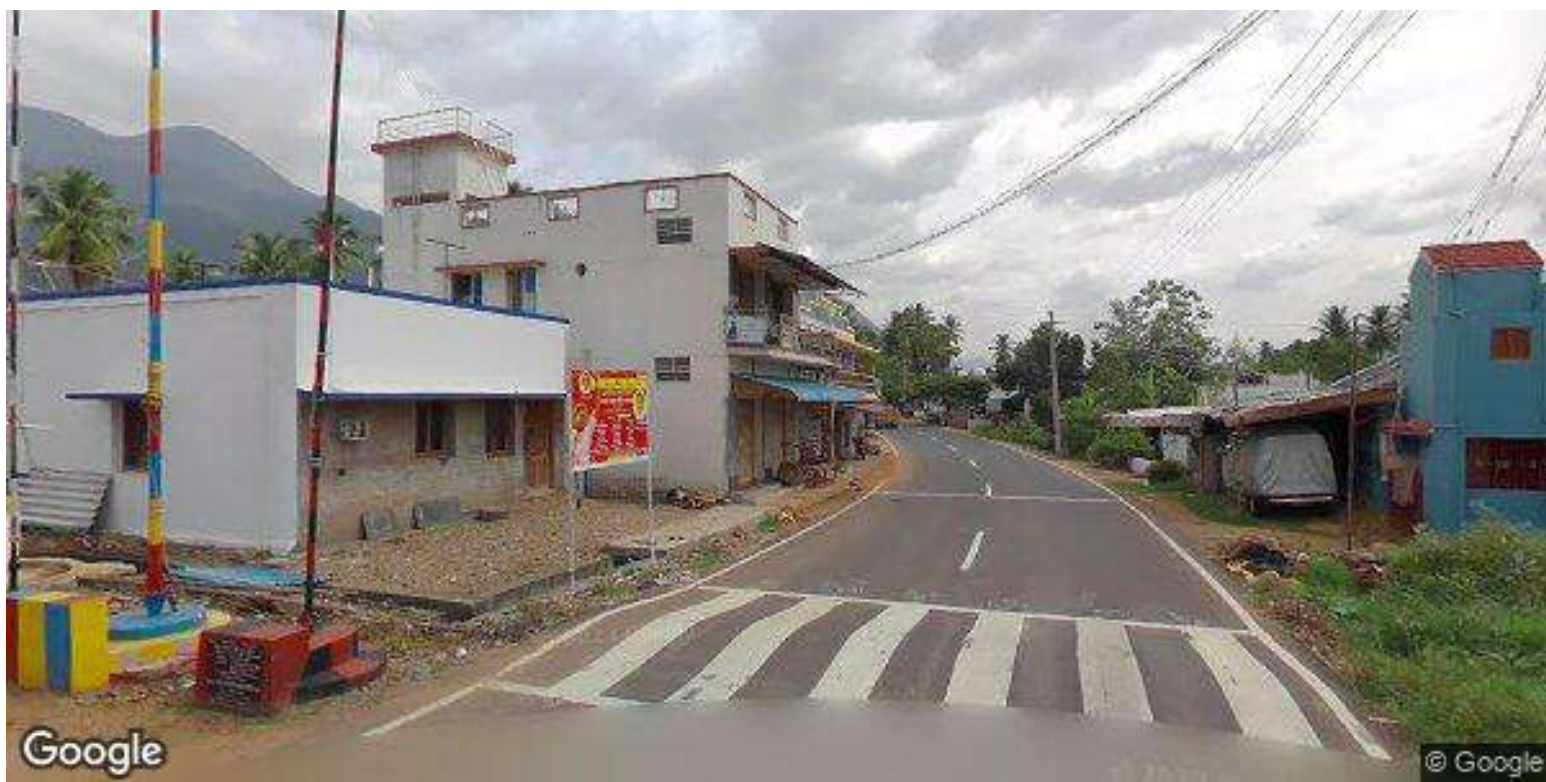
**Coordinates:** 11.66947, 77.77209

**Risk Type:** Turn

**Risk Level:** Medium

**Speed Limit:** 30 KM/Hr
