# IndianOil

## JOURNEY RISK MANAGEMENT (JRM) STUDY

### Salem Terminal to MAHALAKSHMI TRADERS

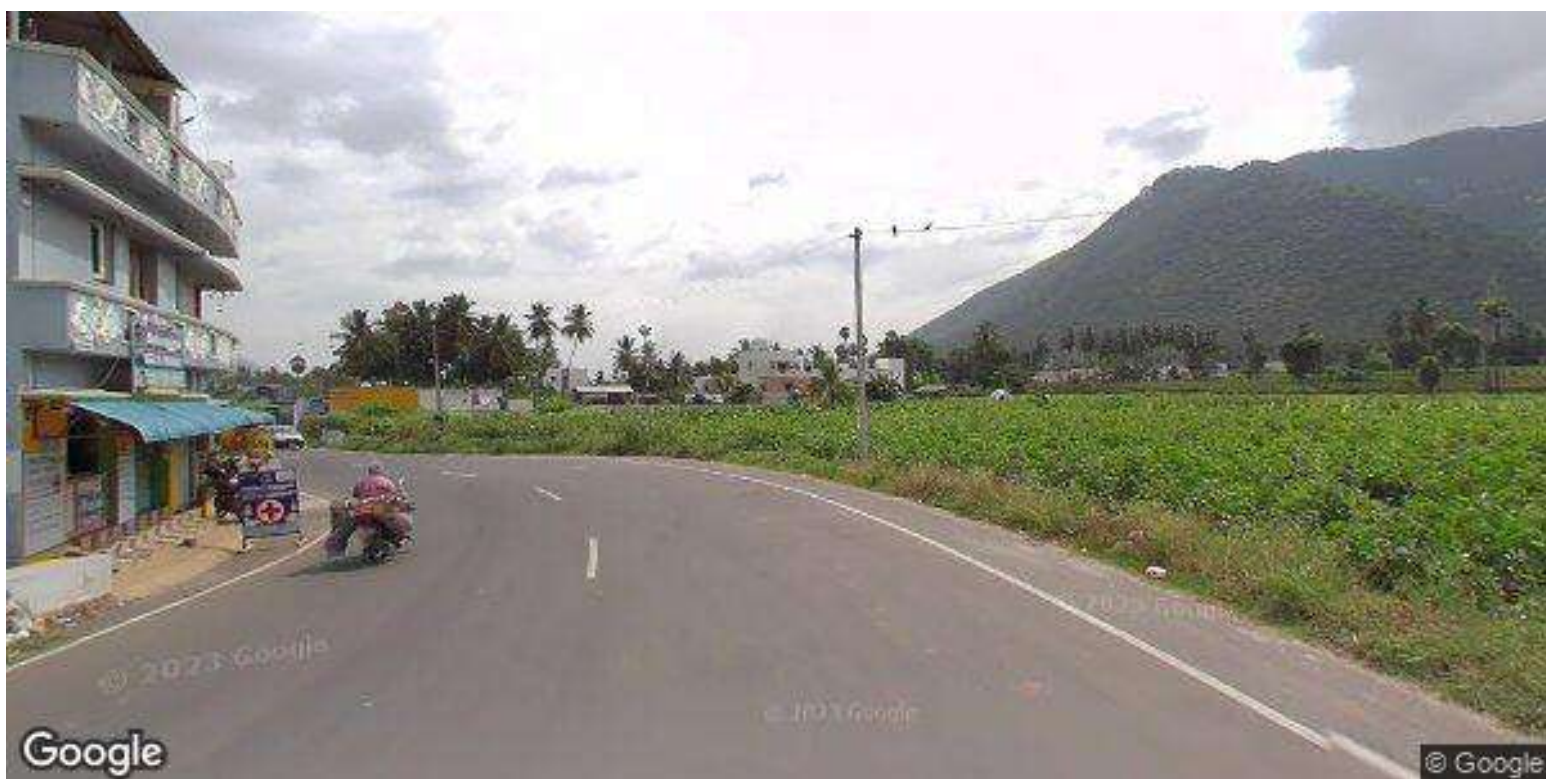
**Coordinates:** 11.72628, 77.78415

**Risk Type:** Turn

**Risk Level:** High

**Speed Limit:** 15 KM/Hr

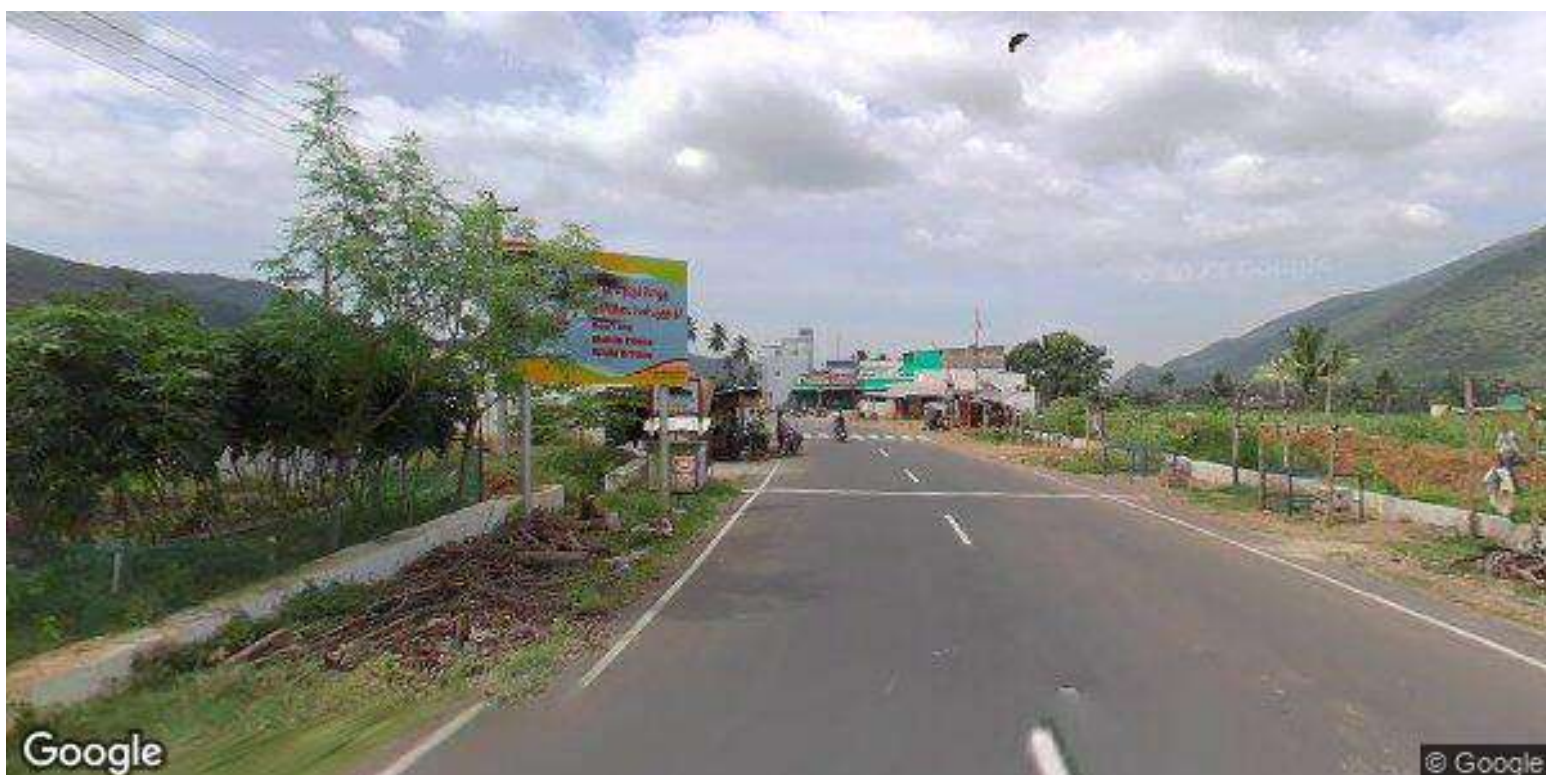
**Coordinates: 11.72745, 77.78411**

**Risk Type: Turn**

**Risk Level: High**

**Speed Limit: 15 KM/Hr**

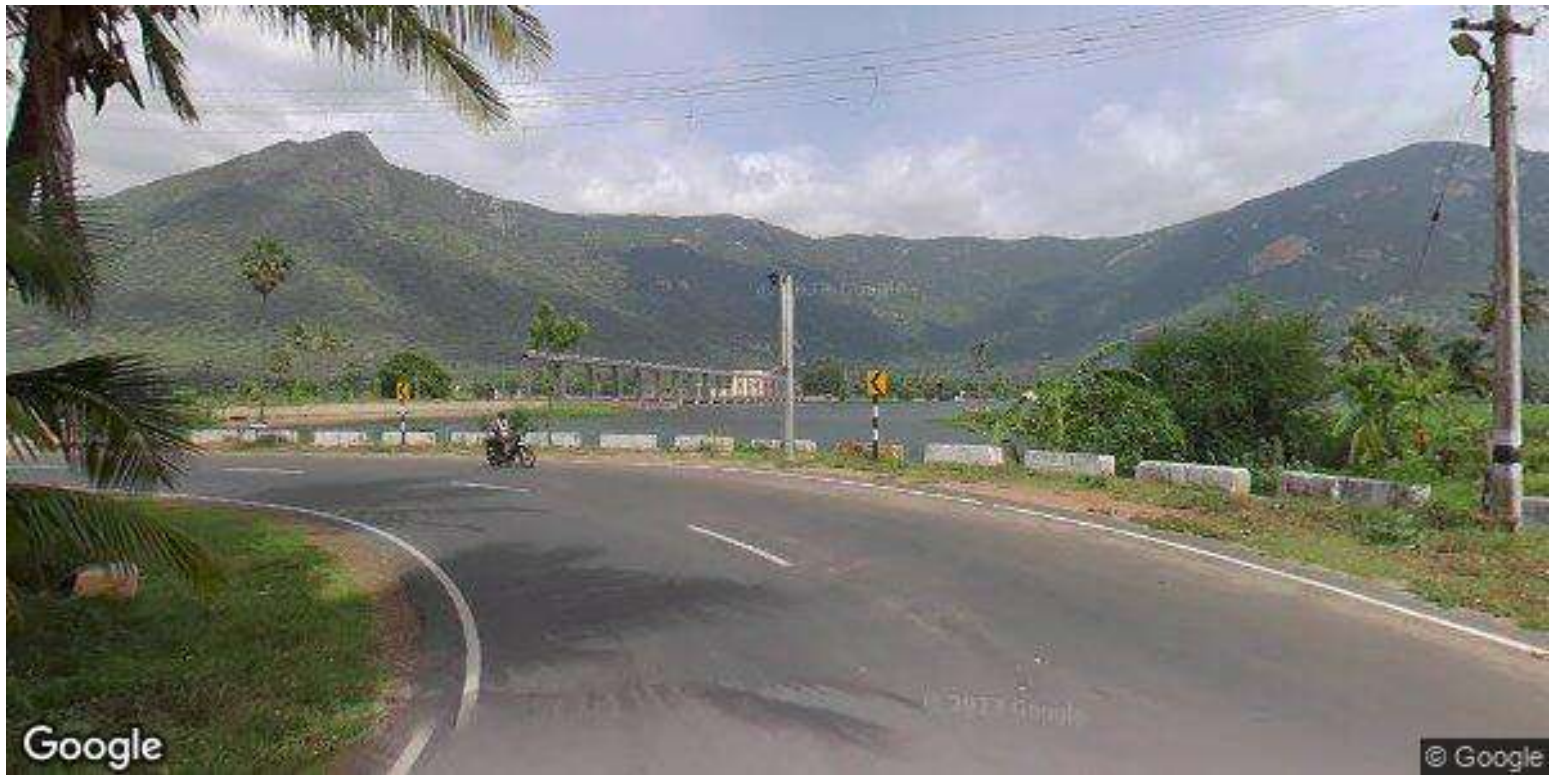
**Coordinates: 11.72759, 77.78433**

**Risk Type: Turn**

**Risk Level: Medium**

**Speed Limit: 30 KM/Hr**

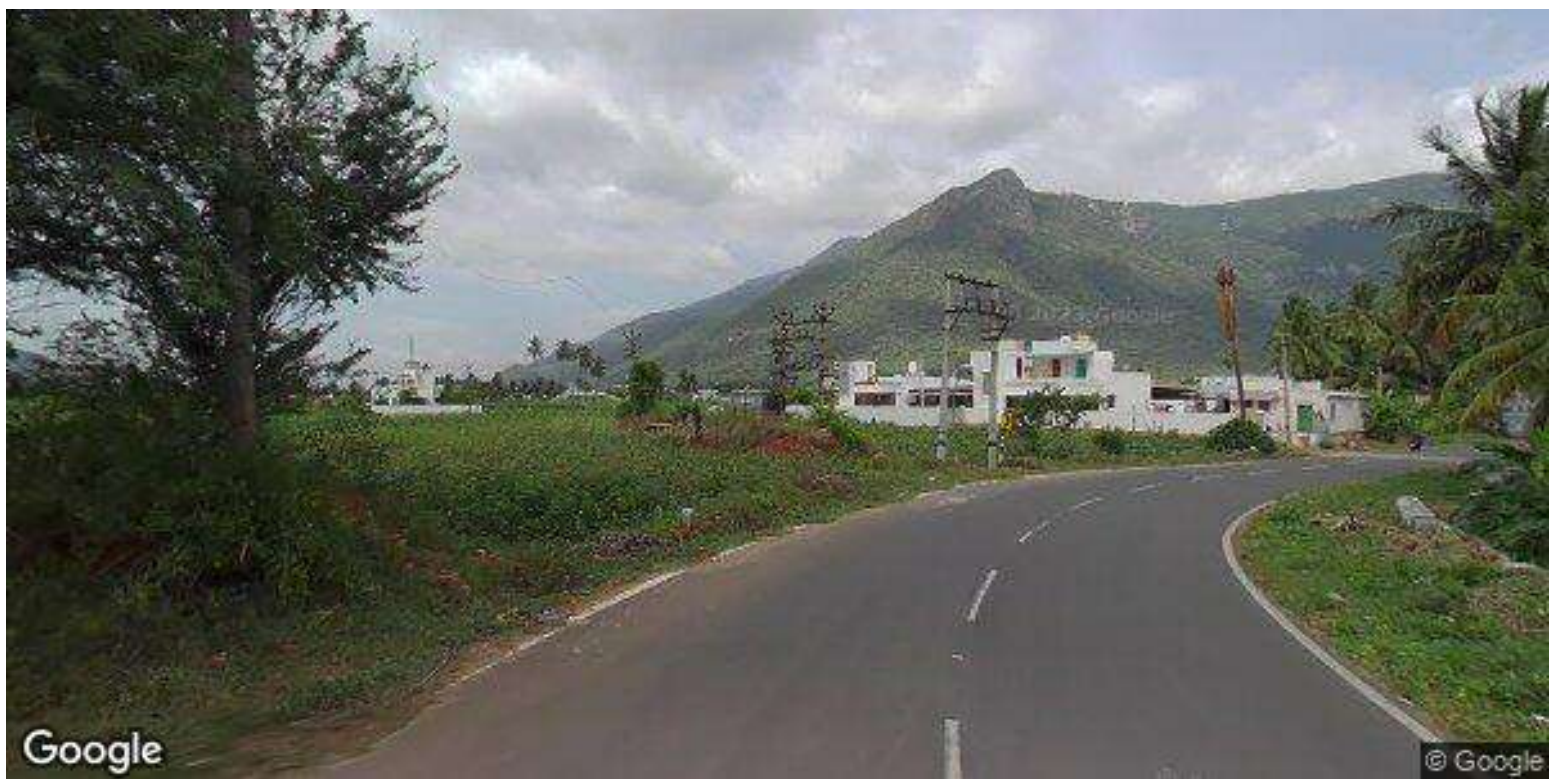
**Coordinates: 11.72751, 77.78550**

**Risk Type: Turn**

**Risk Level: Medium**

**Speed Limit: 30 KM/Hr**

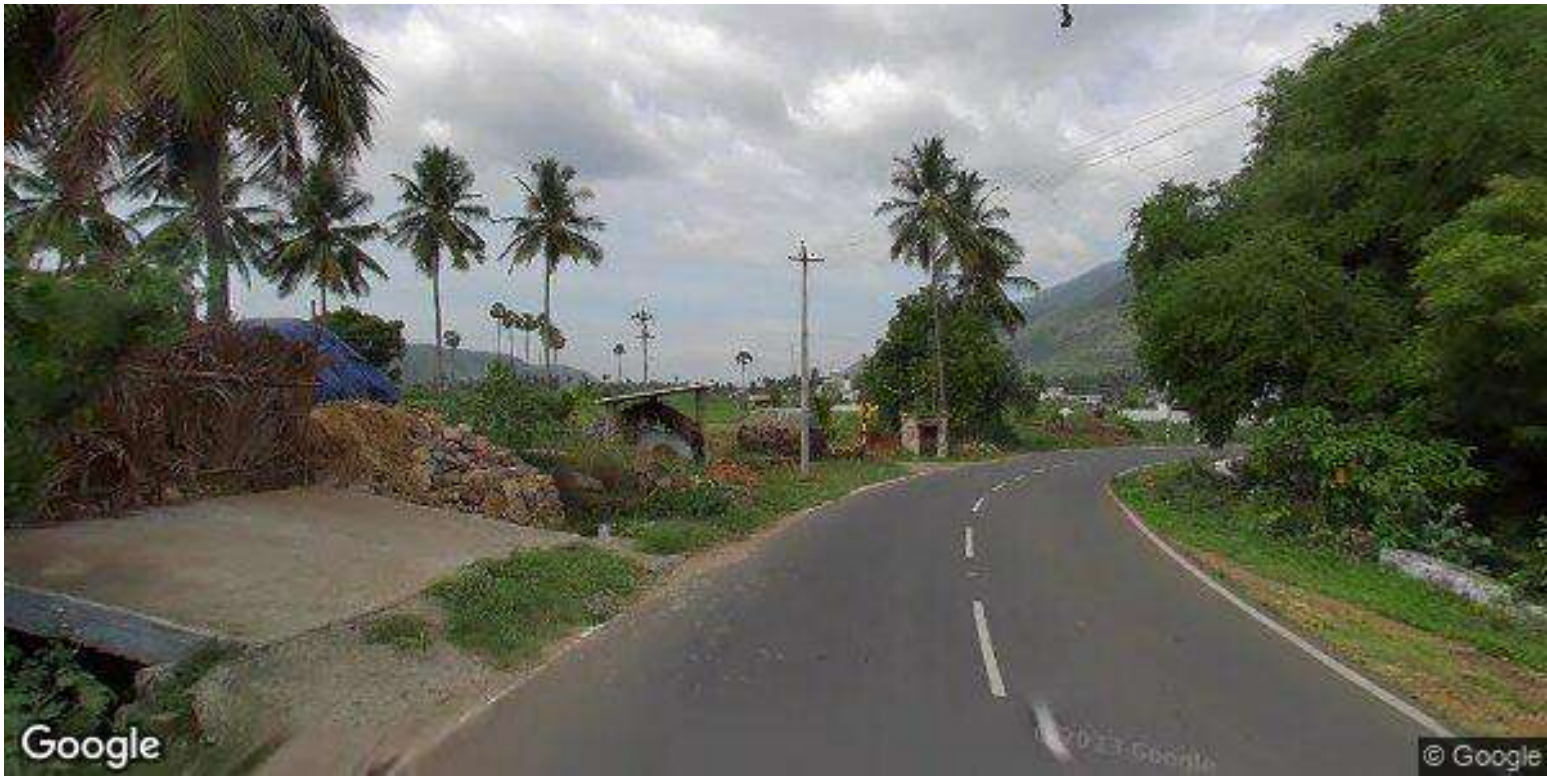
**Coordinates:** 11.72785, 77.78582

**Risk Type:** Turn

**Risk Level:** Medium

**Speed Limit:** 30 KM/Hr

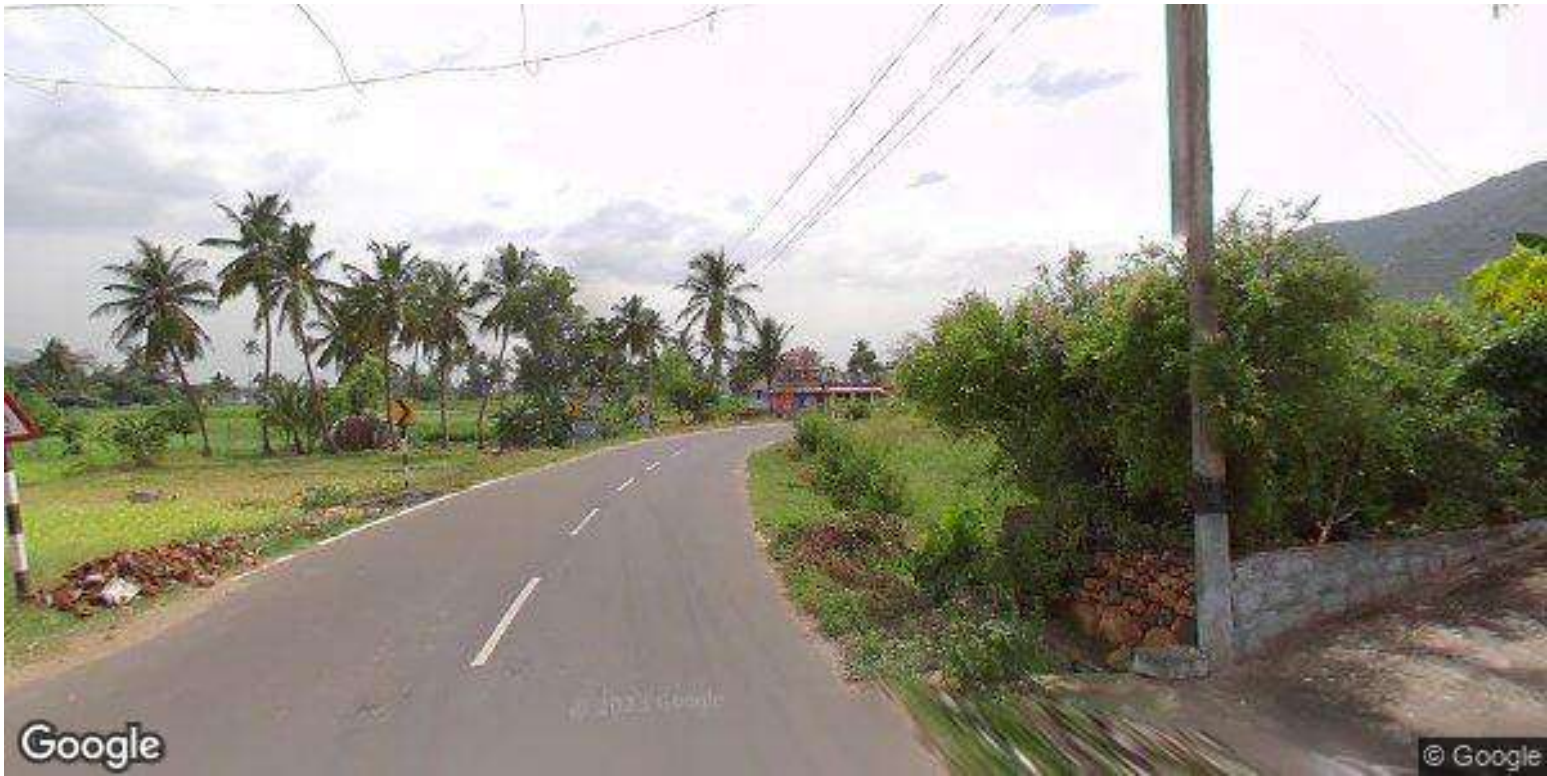
**Coordinates:** 11.73941, 77.78811

**Risk Type:** Turn

**Risk Level:** Medium

**Speed Limit:** 30 KM/Hr

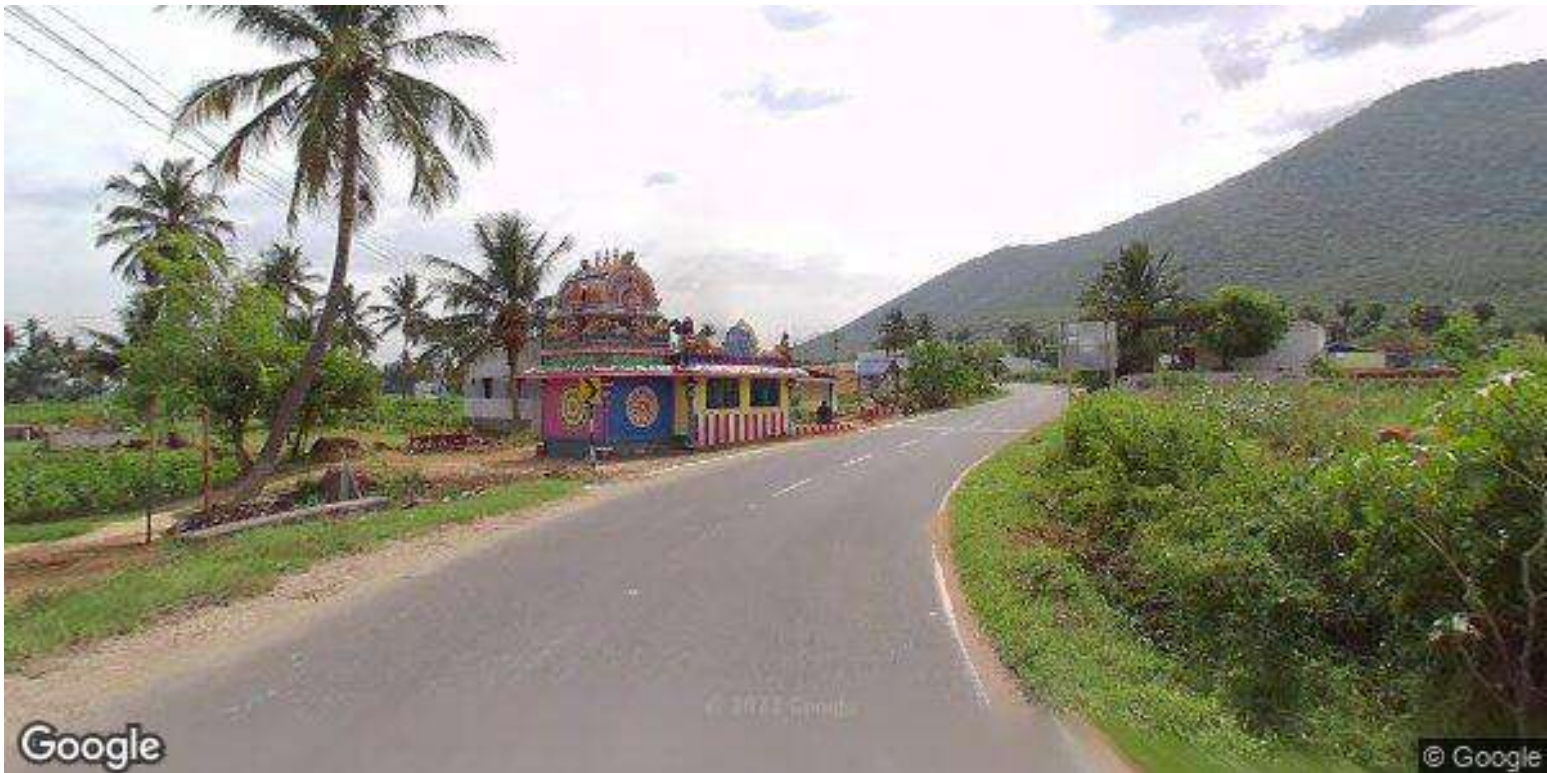
**Coordinates: 11.73971, 77.78838**

**Risk Type: Turn**

**Risk Level: Medium**

**Speed Limit: 30 KM/Hr**

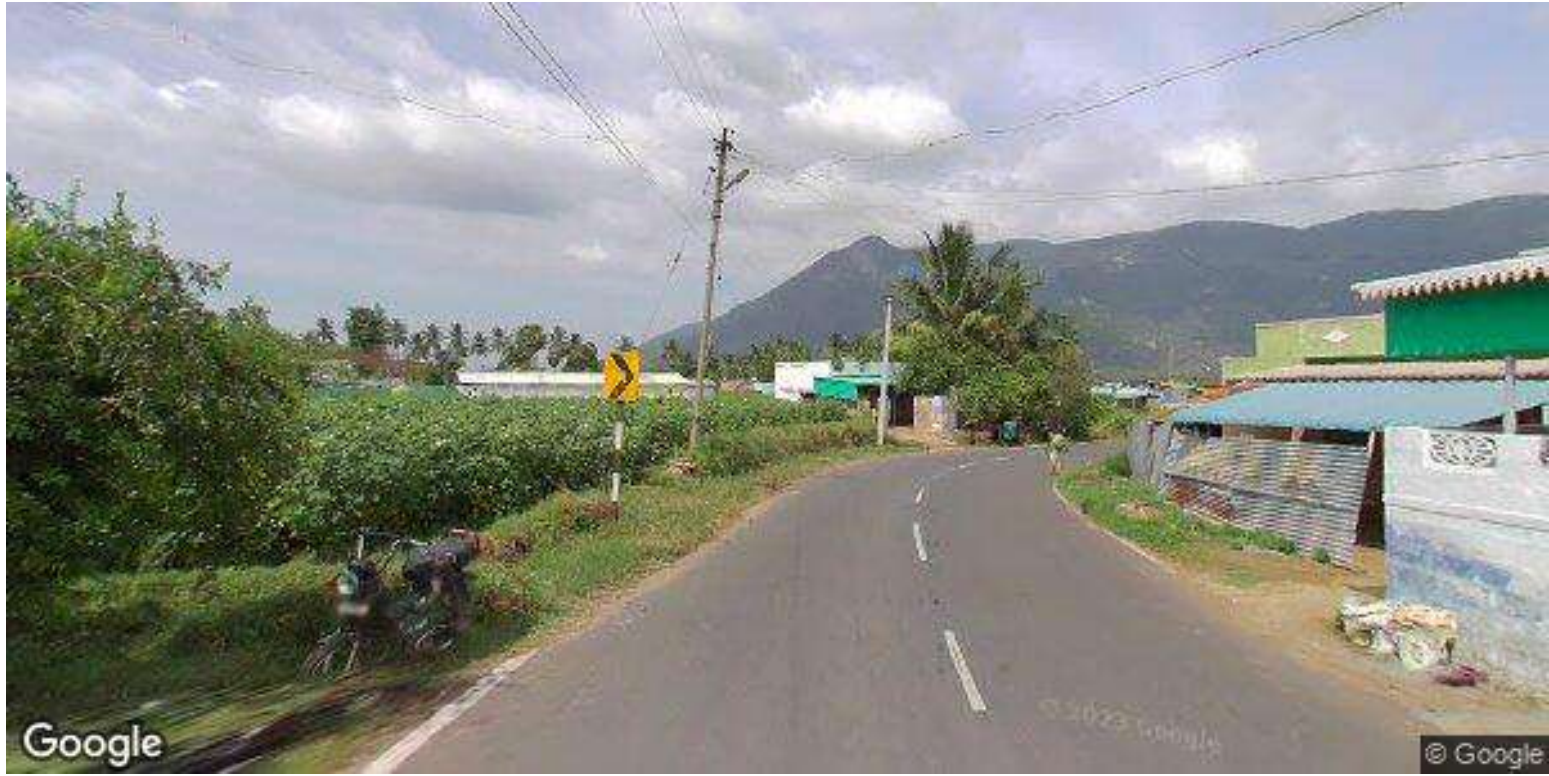
**Coordinates: 11.74000, 77.78938**

**Risk Type: Turn**

**Risk Level: Medium**

**Speed Limit: 30 KM/Hr**

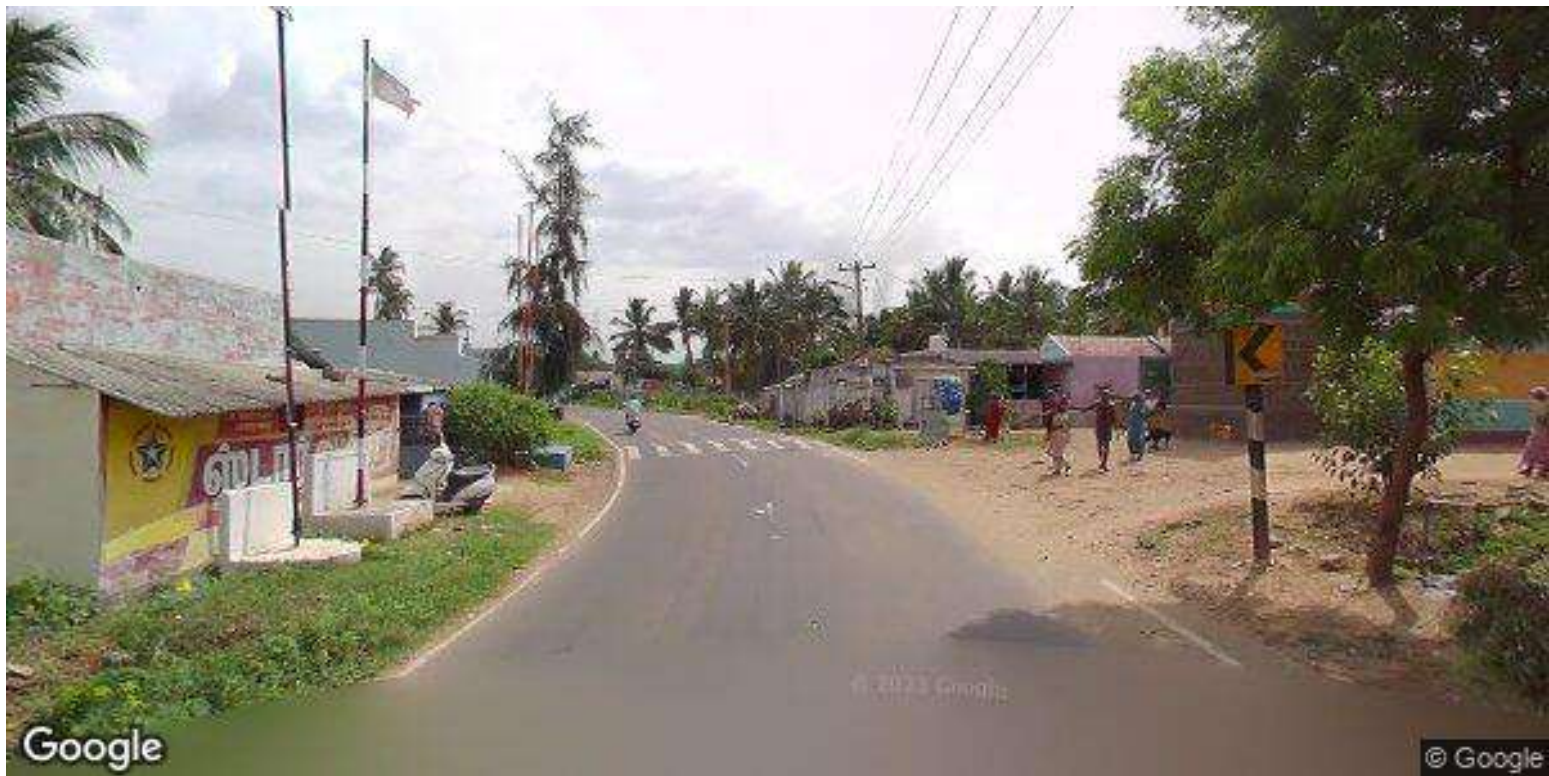
**Coordinates: 11.75274, 77.79710**

**Risk Type: Turn**

**Risk Level: Medium**

**Speed Limit: 30 KM/Hr**

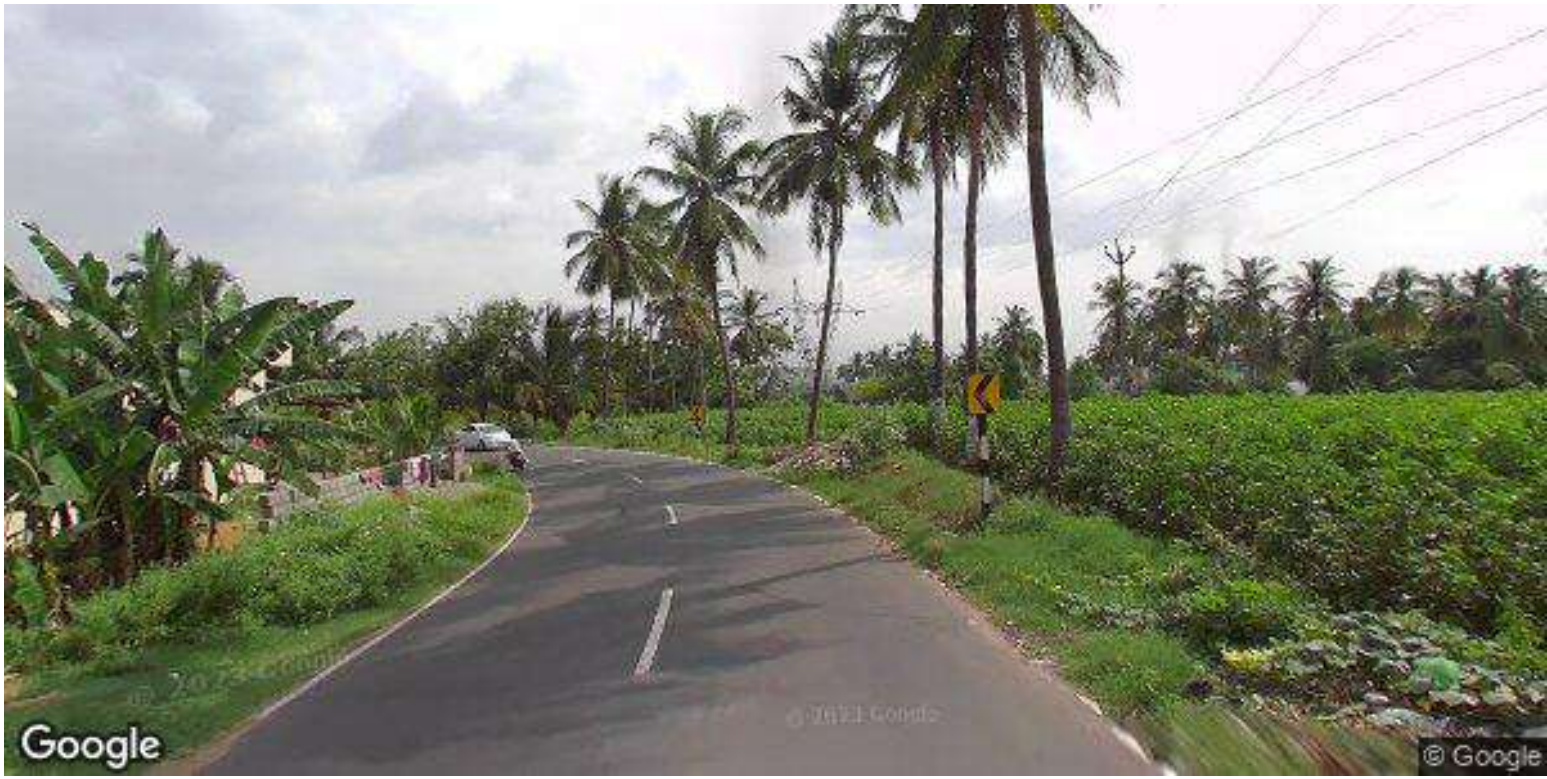
**Coordinates: 11.75599, 77.79872**

**Risk Type: Turn**

**Risk Level: Medium**

**Speed Limit: 30 KM/Hr**

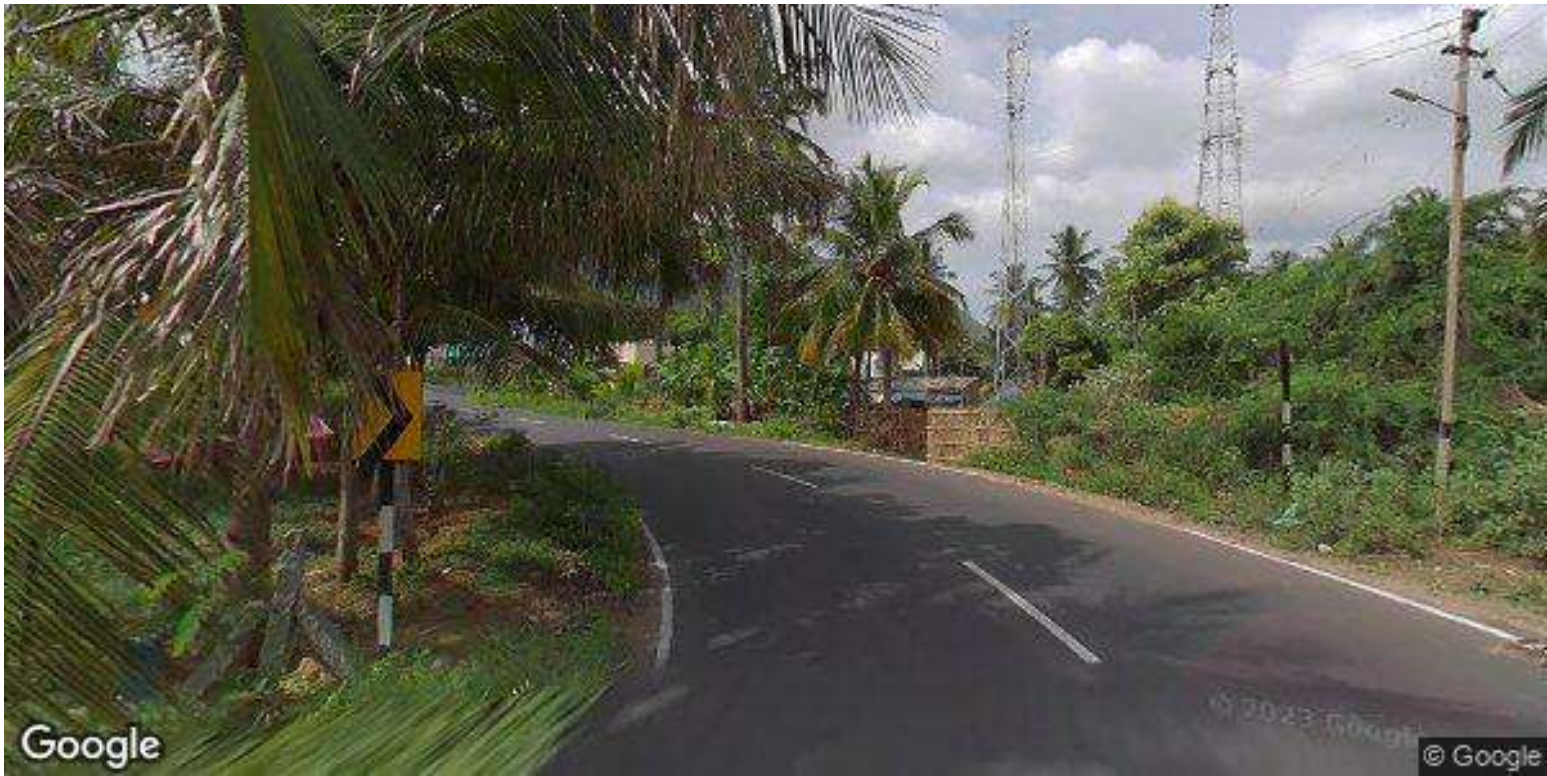
**Coordinates: 11.75676, 77.79842**

**Risk Type: Turn**

**Risk Level: High**

**Speed Limit: 15 KM/Hr**

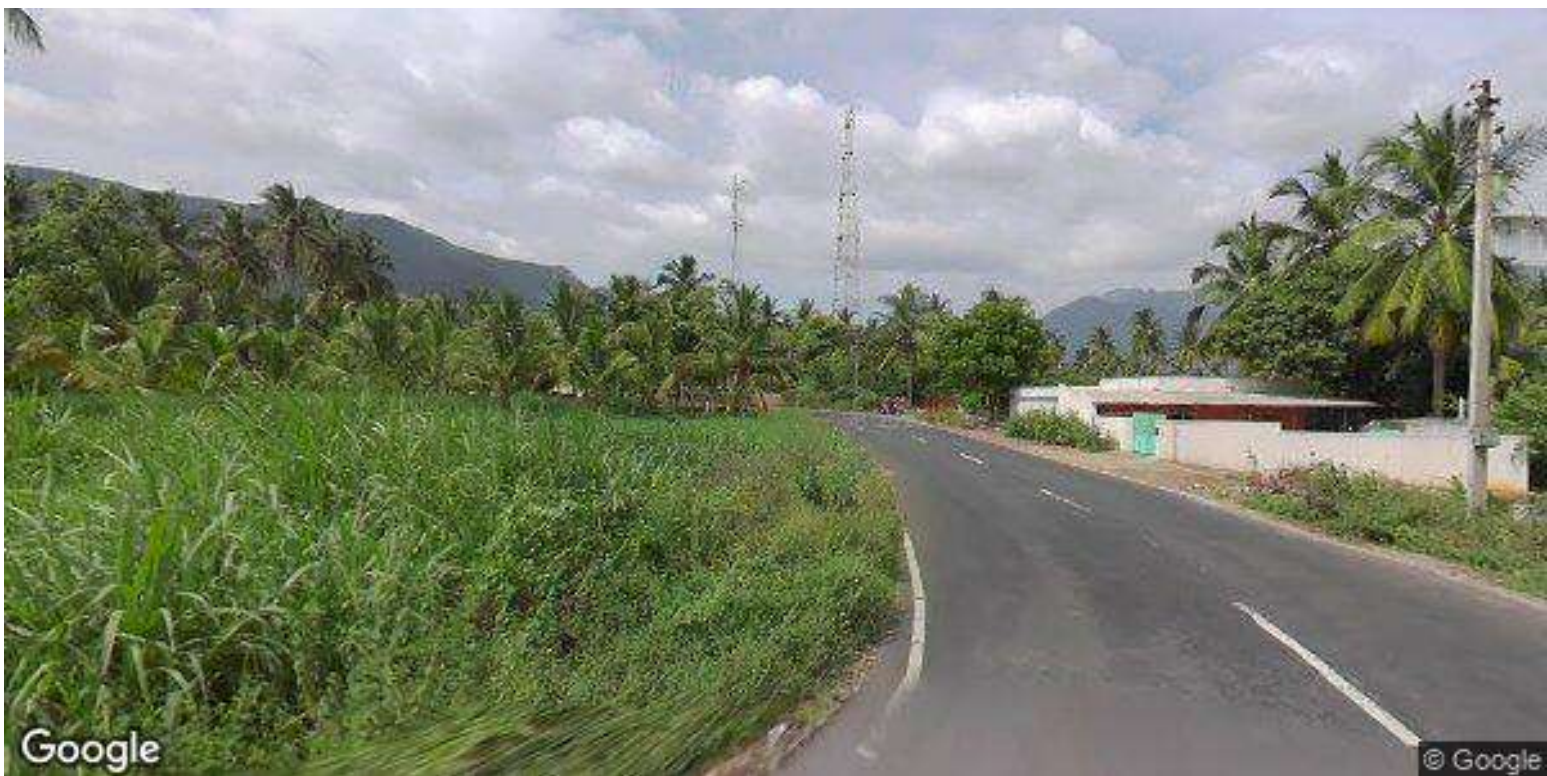
**Coordinates: 11.75724, 77.79860**

**Risk Type: Turn**

**Risk Level: High**

**Speed Limit: 15 KM/Hr**

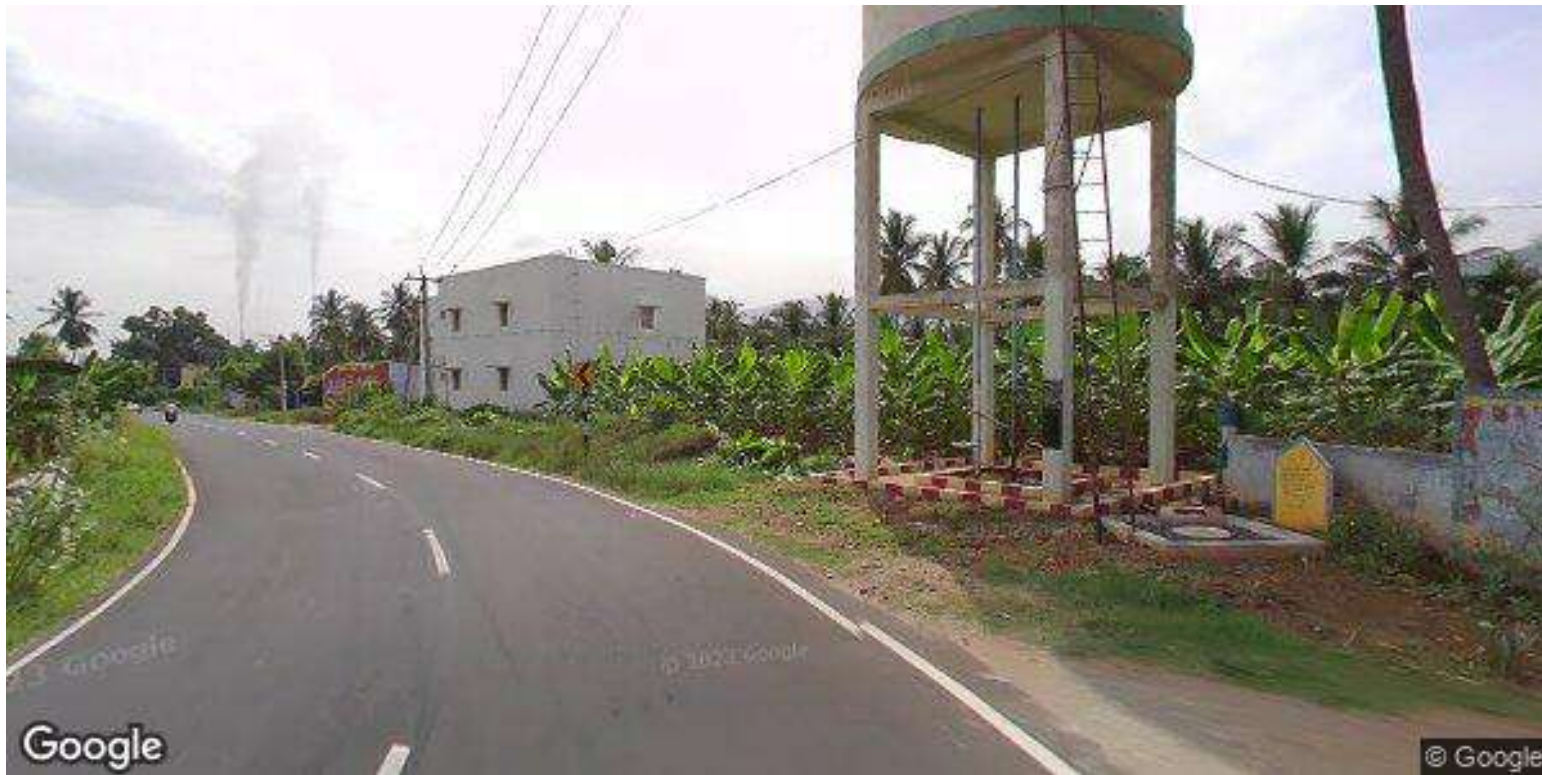
**Coordinates: 11.75752, 77.79996**

**Risk Type: Turn**

**Risk Level: Medium**

**Speed Limit: 30 KM/Hr**

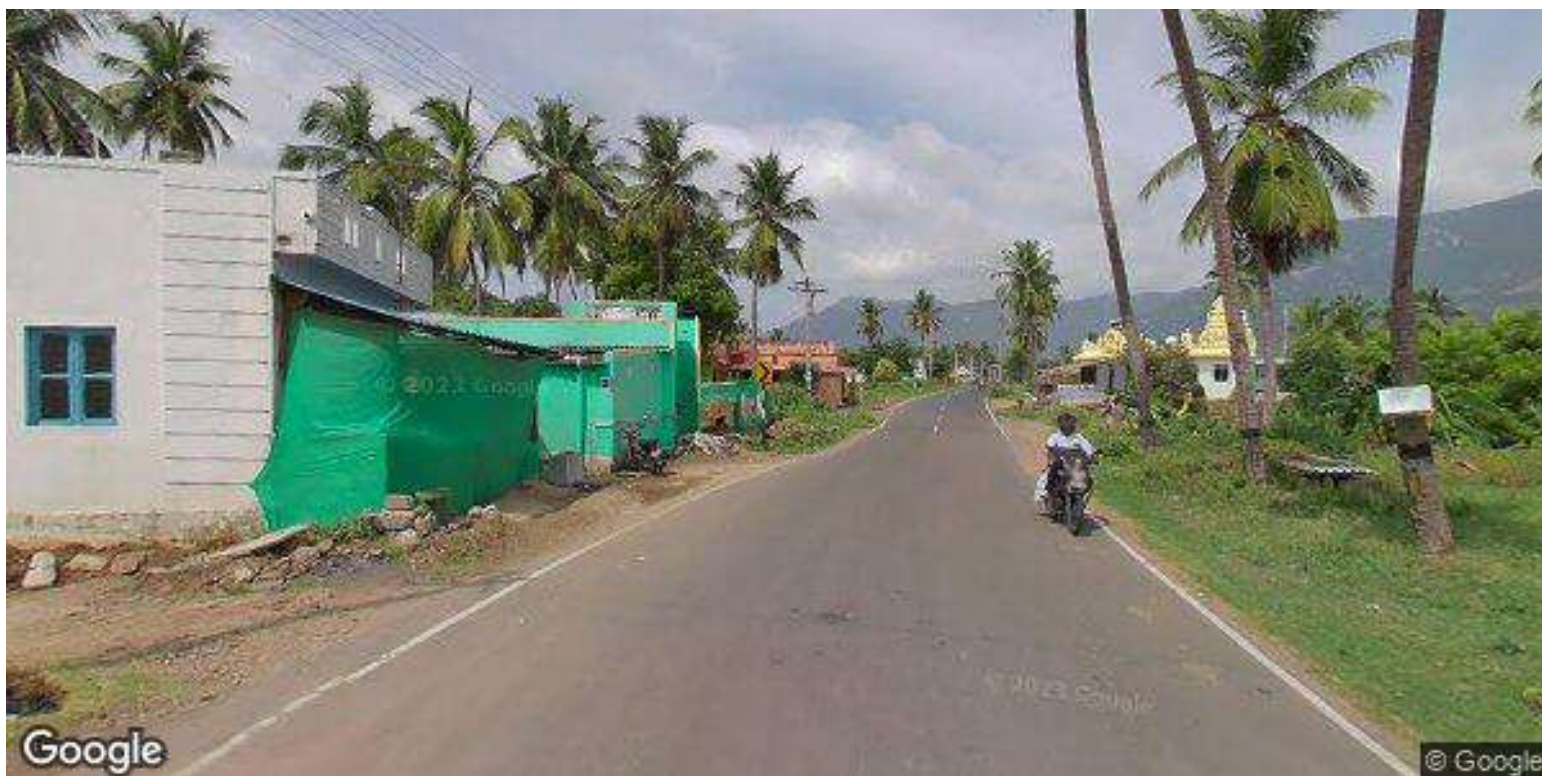
**Coordinates: 11.76229, 77.80500**

**Risk Type: Turn**

**Risk Level: Medium**

**Speed Limit: 30 KM/Hr**

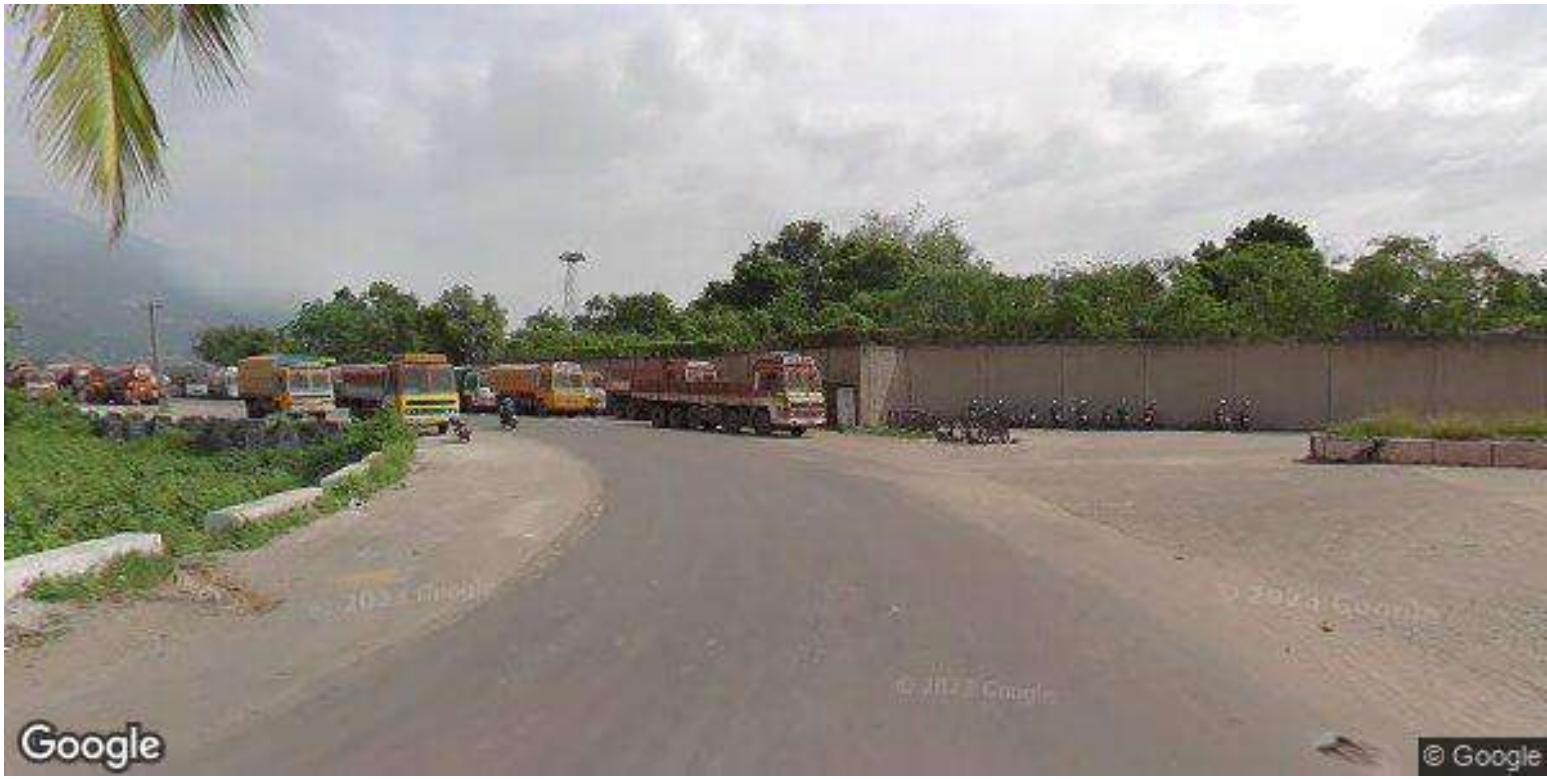
**Coordinates:** 11.76312, 77.80533

**Risk Type:** Turn

**Risk Level:** High

**Speed Limit:** 15 KM/Hr

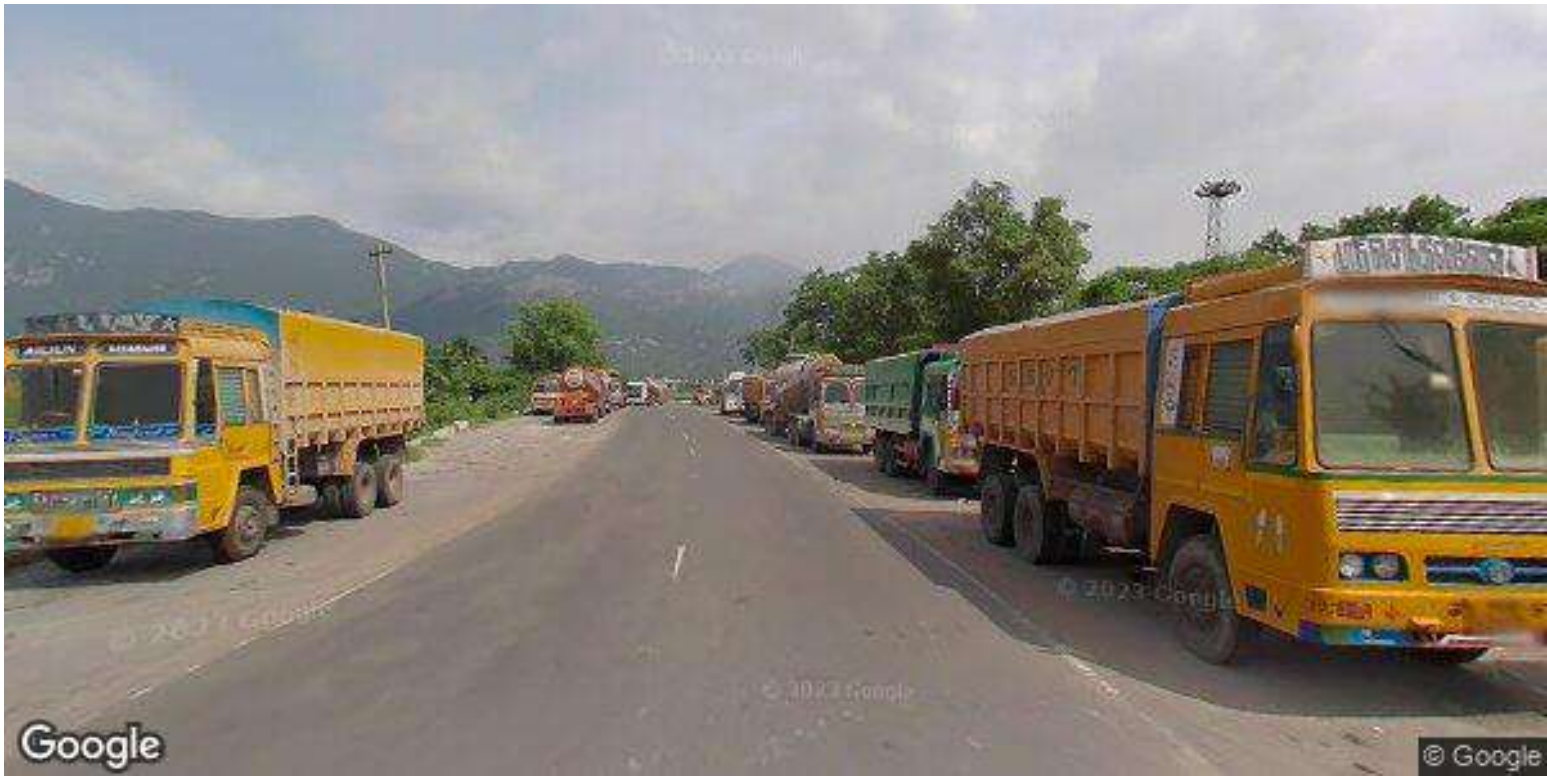
**Coordinates:** 11.76347, 77.80512

**Risk Type:** Turn

**Risk Level:** Medium

**Speed Limit:** 30 KM/Hr

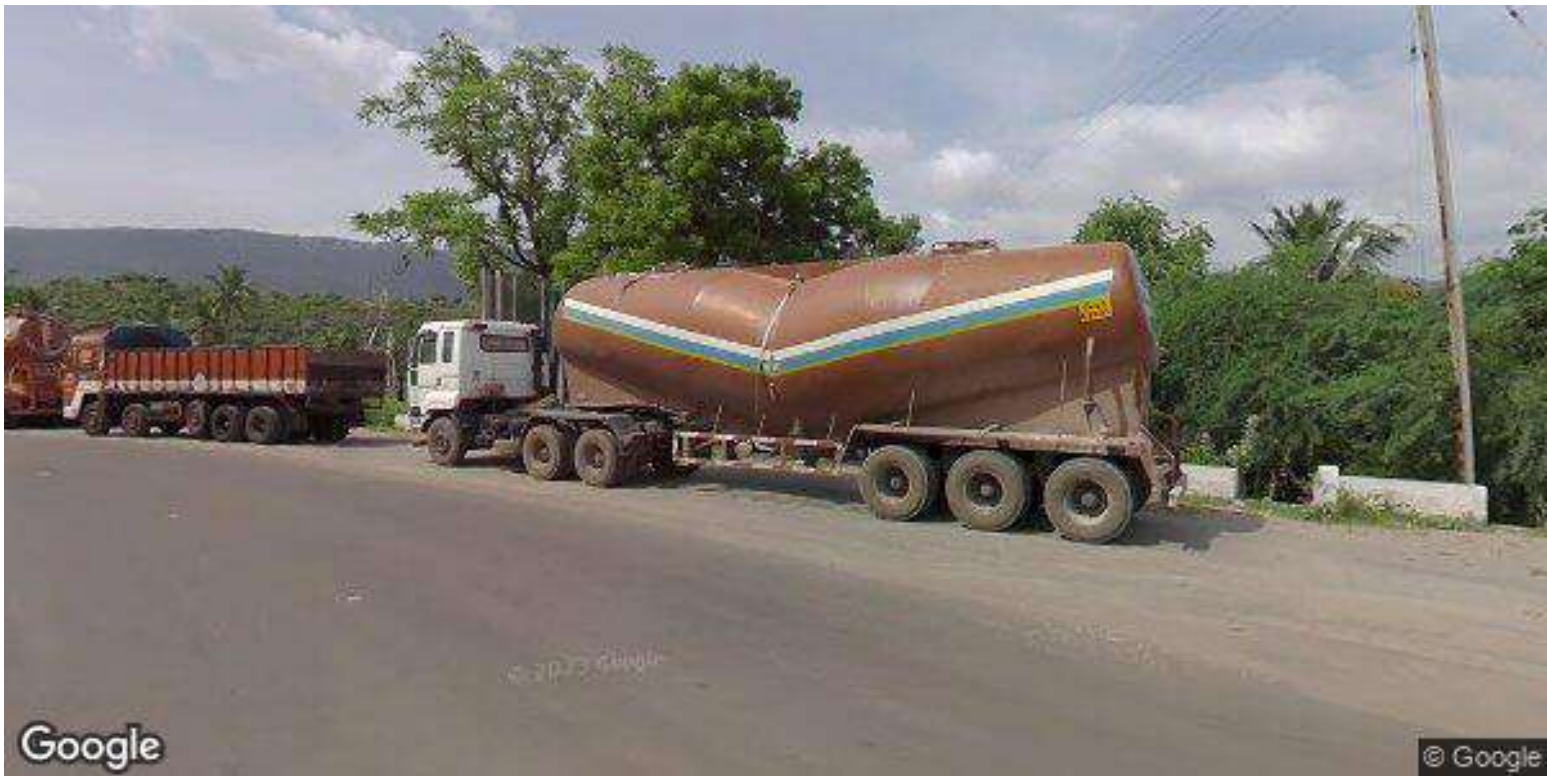
**Coordinates:** 11.76402, 77.80425

**Risk Type:** Turn

**Risk Level:** High

**Speed Limit:** 15 KM/Hr

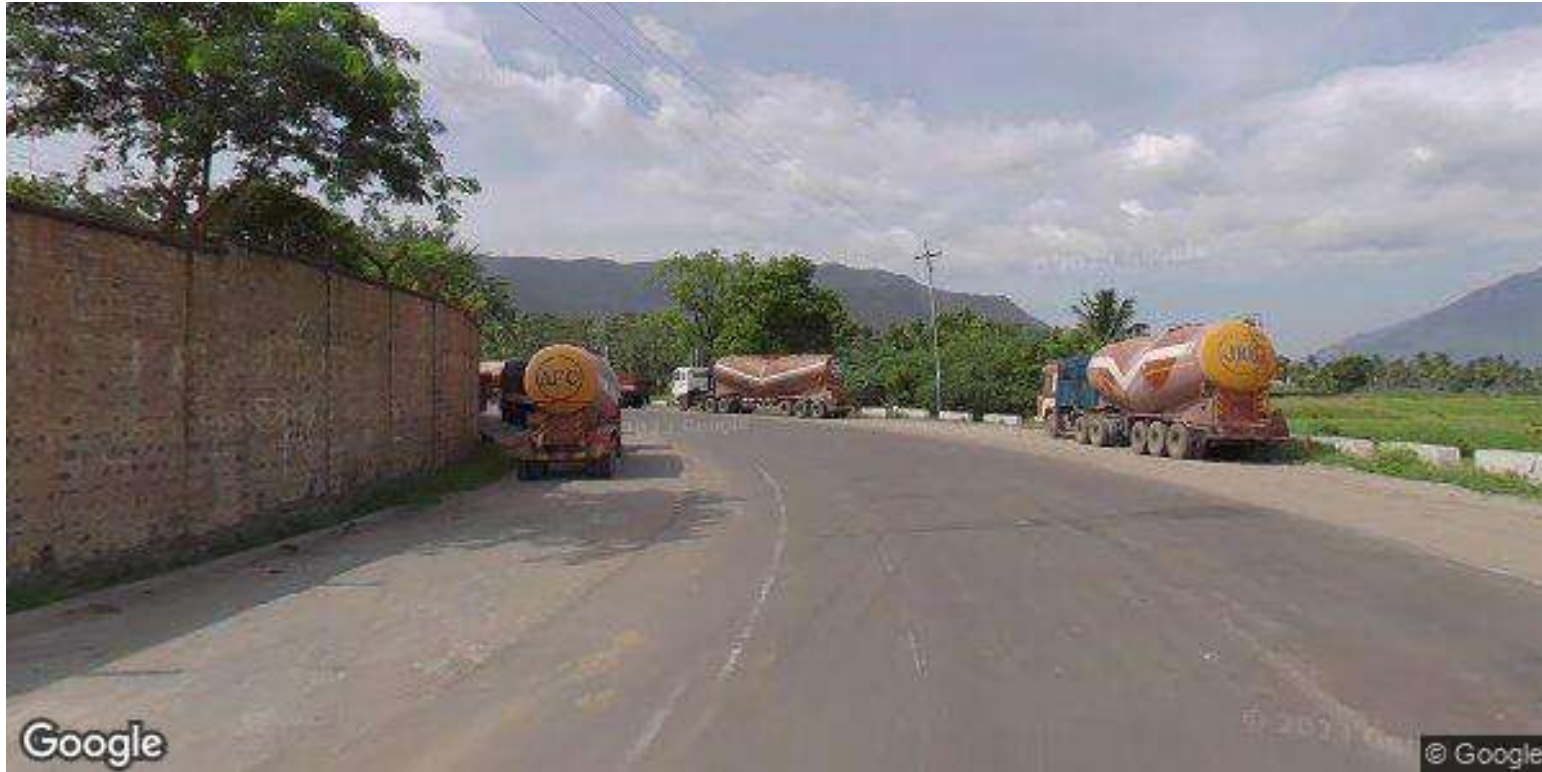
**Coordinates:** 11.76436, 77.80420

**Risk Type:** Turn

**Risk Level:** Medium

**Speed Limit:** 30 KM/Hr

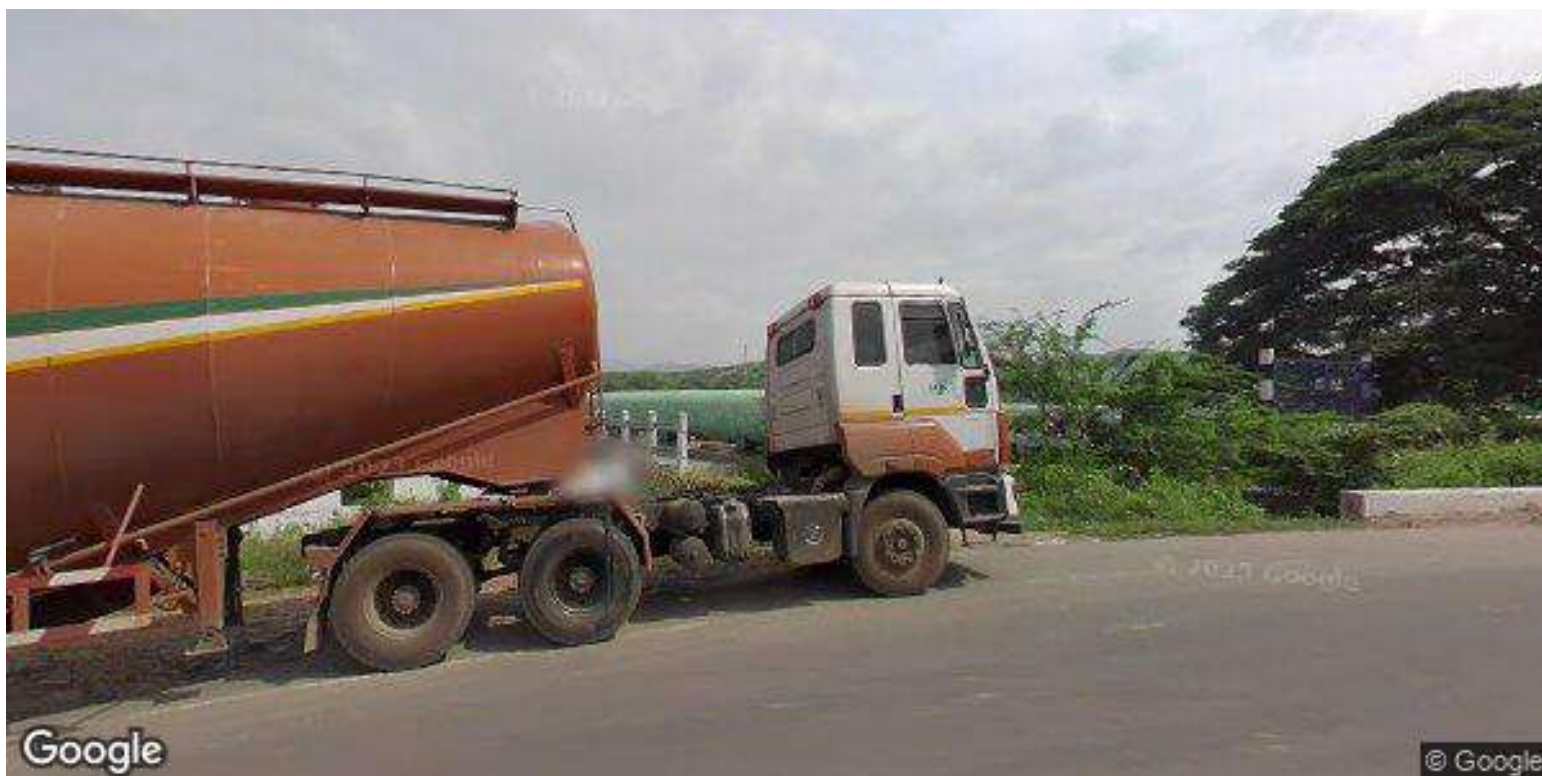
**Coordinates:** 11.76990, 77.80761

**Risk Type:** Turn

**Risk Level:** Medium

**Speed Limit:** 30 KM/Hr
