# IndianOil

## JOURNEY RISK MANAGEMENT (JRM) STUDY

### Salem Terminal to MAHALAKSHMI TRADERS

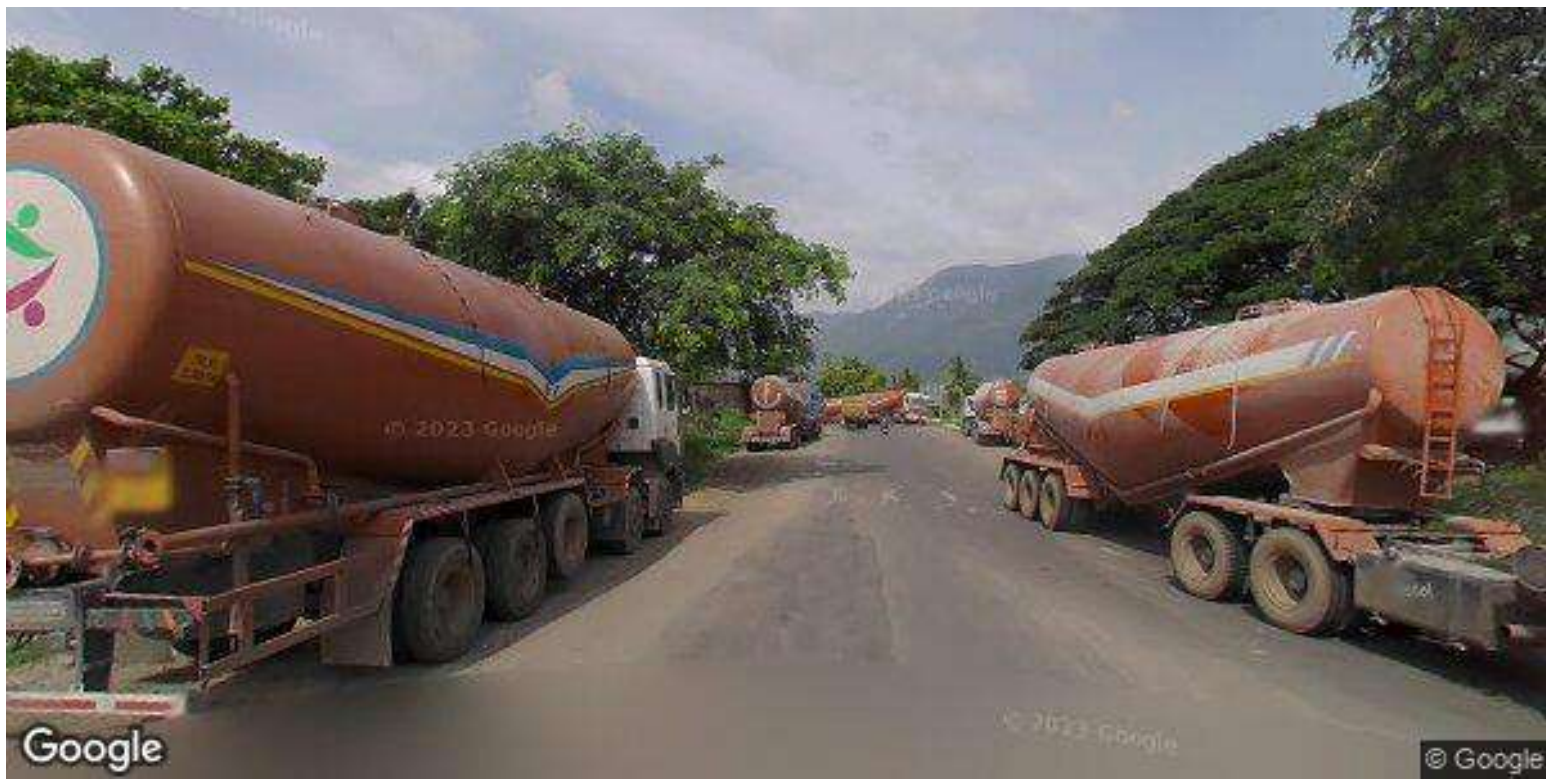
**Coordinates:** 11.77028, 77.80821

**Risk Type:** Turn

**Risk Level:** High

**Speed Limit:** 15 KM/Hr

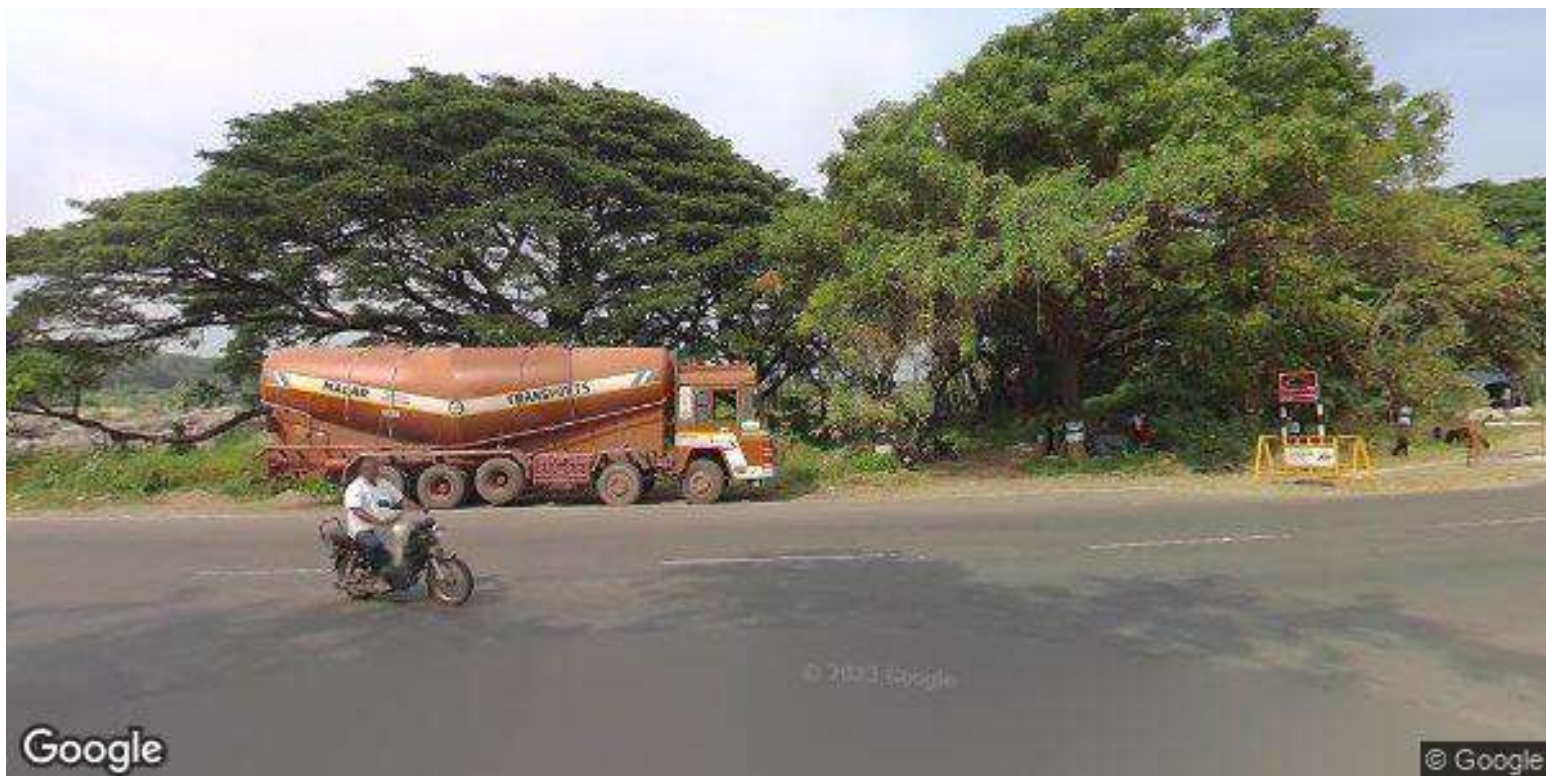
**Coordinates:** 11.77045, 77.80821

**Risk Type:** Turn

**Risk Level:** High

**Speed Limit:** 15 KM/Hr
